# An investigation of the effect of high-temperature cyclic straining and creep loading on tensile mechanical properties of GH4145/SQ alloy

DUYI YE, ZHENLIN WANG

*Department of Mechanics, Zhejiang University,, Hangzhou 310027, People's Republic of China*

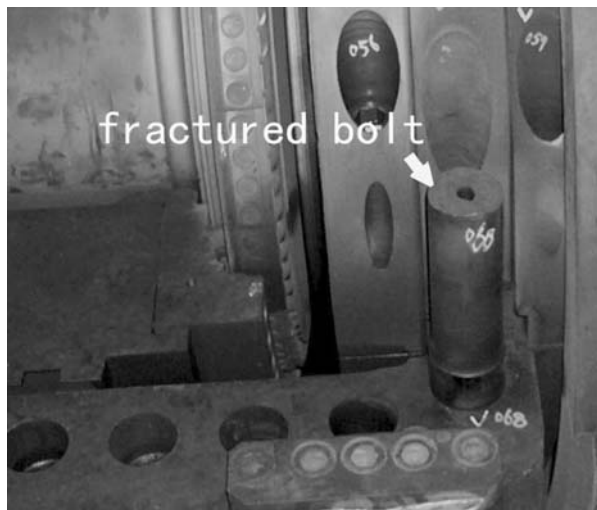
Figure 1 Photograph of a fractured bolt in high-pressure turbine inner cylinder.

GH4145/SQ is a precipitation-strengthened nickel-based superalloy with good high temperature strength and oxidation resistance. This alloy is currently used for the fabrication of high-temperature turbine and valve studs/bolts in high (middle)-pressure cylinders of high capacity steam turbines in power plant. In such applications it is usually subjected to creep loading due to tensile stress resulting from tightening by thermal and mechanical means in the studs/bolts and fatigue loading due to start-stop operation and power fluctuations during turbine running. The failure of the high-temperature turbine and valve studs/bolts mostly results from the interaction of creep and low-cycle fatigue (LCF) in their practical service conditions [7, 8]. As an example, Fig. 1 shows a photograph of a broken high-pressure inner cylinder stud. Therefore, it is of important practical significance to investigate the effect of high-temperature cyclic straining and creep loading on the tensile mechanical properties of GH4145/SQ superalloy, such as the strength, ductility and static toughness, and accordingly to provide a basis for the establishment of remaining lifetime prediction methods for turbine and valve studs/bolts operating in high-temperature where creep deformation exists and where cyclic conditions prevail. In this paper we reported experimental results on this aspect. The variation of the various tensile mechanical properties during LCF and creep loading of the alloy was further discussed by means of examinations of deformation microstructures and fracture features of the specimens.

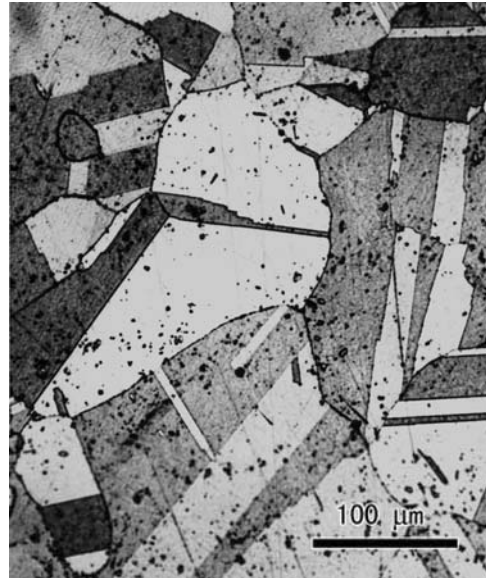
Figure 2 Optical micrograph showing as-heat-treated microstructure of GH4145/SQ alloy.

Optical micrograph showing the microstructure of the alloy in the heat-treatment conditions is presented in Fig. 2. Fig. 3 displays TEM micrograph for the same conditions. It is seen from Fig. 2 that the previously mentioned heat treatment produced an average equiaxed grain size of  $110 \mu\text{m}$ . Both bulk and grain boundaries were covered with discrete carbide particles probably being of the MC type. Fig. 3 shows that the two-step aging employed to the alloy results in

tion of foreign particles (MC) in the alloy undergo an insignificant variation, as a whole, in comparison with those observed in the as-heat treated microstructures shown in Fig. 2. This observation can be mostly attributed to highly stable carbide particles distributed throughout the matrix and along the grain boundaries in the alloy at the present testing temperature [2]. However, in the case of the specimen crept to failure there is a significant amount of grain boundary cavitation (see Fig. 10c), and cavity linkage to give grain boundary facet cracking is clearly shown in Fig. 10d. The possible mechanisms for the formation of grain boundary cavities in the nickel-base superalloy were suggested as vacancy injection, creep due to oxide growth stresses, and gas formation [2]. It has also been indicated in previous investigations [16] that during creeping deformation of metallic materials, there is a combination of complex mechanisms that can be summarized as follows: a large amount of lattice dislocations preexist in the structure, but new dislocations are continuously created during the creep process due to the imposed load. The load makes most dislocations in grains and grain boundaries move, resulting in a lot of interactions with other components of the microstructure, such as neighboring
