# A Quality Control Method by Ultrasonic Vibration Energy and Diagnosis System at Trimming Process

Chang-Min Suh<sup>a,\*</sup>, Gil-Ho Song<sup>b</sup>, Young-Shik Pyoun<sup>c</sup>

<sup>b</sup>*Technical Research Center, POSCO, Pohang, Korea*

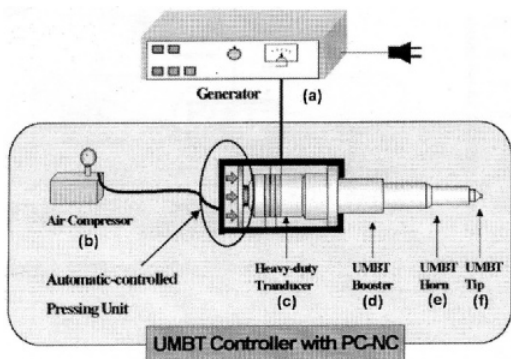
UCFT uses ultrasonic vibration energy (UVE) as a source, and tens of thousand times per second are struck on the material surface as constant pressure is applied. These strikes bring severe plastic deformation to surface layers and induce a nano-scale crystal structure. Configuration of the UCF device is shown in Fig. 1. It consists of several components such as (a) the ultrasonic generator which generates electric ultrasonic frequency, (b) the air compressor which pushes ultrasonic generator unit with constant pressure, (c) the piezo-transducer [Pb(Zr, Ti)O<sub>3</sub>], (d) the booster amplifying the ultrasonic vibration, (e) the horn transmitting the ultrasonic vibration and (f) ball tip [tungsten carbide].

Fig. 1. Configuration of the UCF device.

To verify the feasibility of the UCFT, various experiments were carried out with SKD61 which is the material of the trimming knife used in the cold rolling mill. Specimens were fabricated by the UCF device shown Fig. 1. 20 kHz of frequency was applied to the ball tip, and the applied static force was 10 kgf.

20 kHz of vibrator were selected to find out the optimal frequency in this study. The range was chosen by the most common frequencies for cutting and by considering the adding mass (knife, spindle, etc) from the system. This vibrator is similar with Fig. 1.

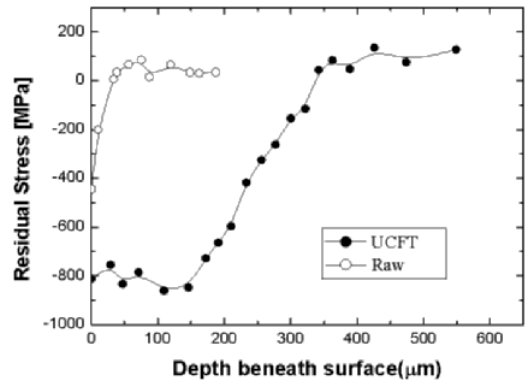
Figure 2 shows the variation of residual stress along the direction of depth both before and after the UCFT. Compressive residual stress is the most crucial factor in shock resistance. The residual stress was measured every 20 μm depth using a X-ray residual stress measurement equipment. Electrolysis-polishing was

used to cut out the constant depth. As shown in Fig. 2, compressive residual stress after the UCFT remains to 150 μm depth. Its magnitude is 2 times higher than that of before the UCFT. It was also observed that the effective depth by the UCFT was about 350 μm. These results demonstrate the increment of compressive residual stress and depth by the shock resistance.

Fig. 2. Variation of compressive residual stress before and after the UCFT.

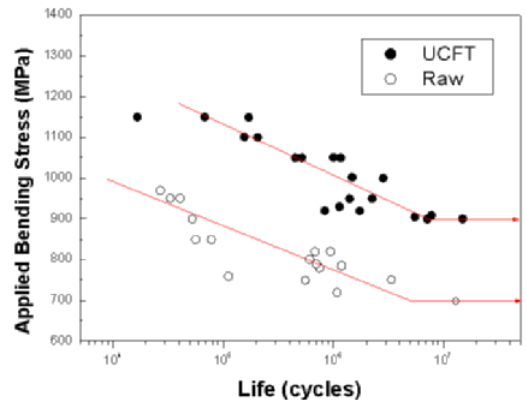
Fatigue test was conducted using Ono type rotary bending machine (H5 type, 98 Nm, Shimadzu Co.) at 3400 rpm of revolution under room temperature, and the specimens were prepared under the JIS Z2274 standard. The fatigue characteristics before and after the UCFT were shown in Fig. 3. The 10<sup>7</sup> cycles fatigue strength before the UCFT was 719 MPa, whereas that after UCFT was 899MPa, which is 25% higher.

Fig. 3. S-N curves of SKD61 before and after the UCFT.

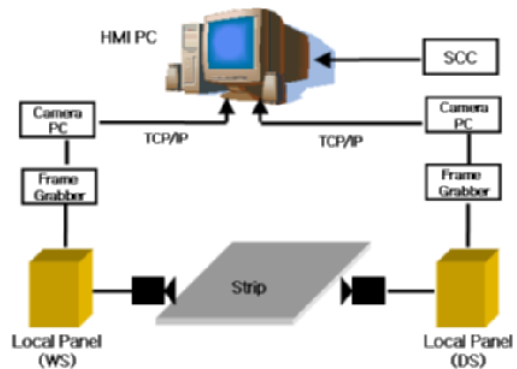
are shown in Fig. 8. Two CCD cameras facing each other are mounted at the delivery side (the entry of the burr masher roll) of the side trimmer. Images obtained from the cameras are inputted to the frame grabber converts the image from analog to digital signal. Then, the numeric values determining the state of the knives and cutting faces are calculated based on the level of digital image signal at the camera PC. The camera PC has a special function; saving raw images.

A HMI (Human-Machine Interface) PC is used to determine the state of the cutting faces base on the values calculated at the camera PC, which is done by means of a internet protocol, namely TCP/IP communication with the camera PC. It also guides operators with the diagnosis results of the state of knives and faces. The HMI PC has a function that operators can easily monitor the trimming states by the periodically displayed images of strip cutting face on the screen. Light is generated from the light source in the control panel and transferred to the light guide which is installed in front of camera through the fiber optic cable.

Fig. 8. Layout of the diagnosis system.

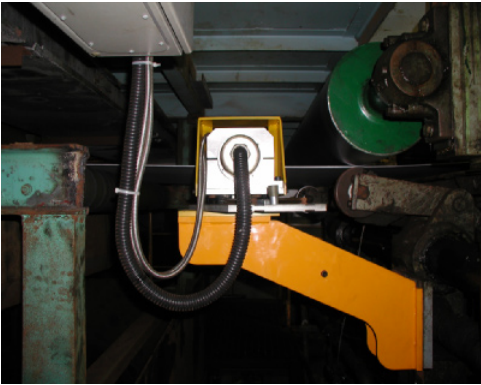
Figure 9 shows the CCD cameras installed at the location of 3 meters away from the delivery side of the side trimmer, just right before the bur masher roll which is decreased the magnitude of the bur created in trimming process. The distance between the camera and the strip edge should always remain constant in order to obtain vivid images from the CCD camera. Even though the strip width changes, the camera position should be controlled according to the strip width. To adjust the position precisely, a mechanical structure used for installation of the camera housing is attached to the structural frame on the bur masher roll, and the frame transports the bur masher roll to keep the constant distance.

Fig. 9. Installation of CCD camera in plant.
