# An estimation of failure stress condition in rocker arm shaft through FEA and microscopic fractography<sup>†</sup>

The failure analysis of a rocker arm shaft for a 4-cylinder SOHC engine is presented. Fracture accidents occur in the interface between the rocker arm shaft and the engine block. These fractures are responsible for bolt tightening. The failure boundary condition is estimated by using an orthogonal array and ANOVA. Stress range is obtained by fatigue striation spacing and fracture mechanical simplification. Minimum and maximum stresses are predicted by FEA for the failure boundary condition. This study shows that the stress conditions for a fracture surface with fatigue striation can be determined by FEA and SEM.

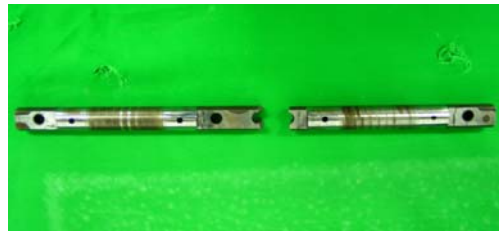
(a) Failure of rocker arm shaft in the 4-Cylinder SOHC engine

A typical fractured rocker arm shaft is shown in Fig. 3(a). The traveling distance of the vehicle used in this study is 115,320 km. The dominant fracture was due to the through hole in the rocker arm shaft. The crack was initiated at the bottom of the through hole and subsequently propagated along its sidewall, as shown in Fig. 3(b). The fracture surface is divided into the fatigue initiation region A, fatigue propagation region B, and the final fracture region C by separate surfaces.

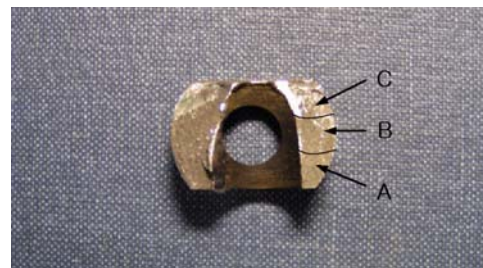
(b) Fractured surface of rocker arm shaft

initiated and propagated the fatigue crack. But the compressive bending stress by the movement of another cam and the unstable boundary condition caused the separate surfaces to compress each other.

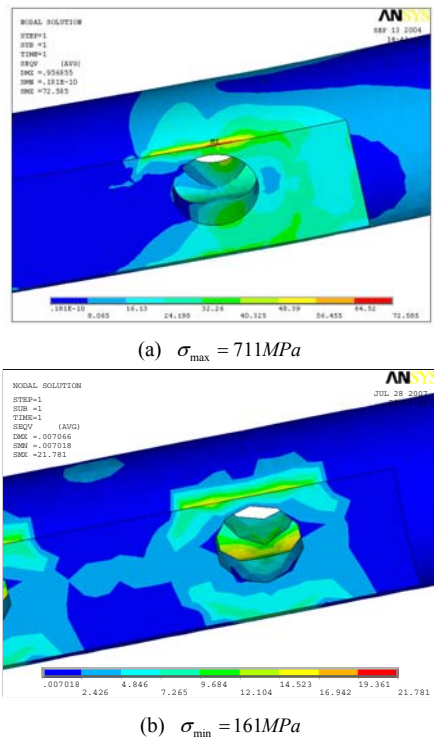
Fig. 8. FEA results of rocker arm shaft.

Fig. 8(a) shows the FEA result for the failure boundary condition obtained from orthogonal array and ANOVA. In this figure, the maximum stress is 711MPa. Fig. 8(b) shows the FEA result for the rocker arm shaft subjected to only the clamping force. In this figure, the minimum stress is 161MPa. Therefore, the stress range  $\Delta\sigma$  at the failure region was 711 MPa -161MPa = 550MPa.

(1) FEA results for the failure boundary condition obtained from orthogonal array indicated that the maximum and minimum stresses were 711 MPa and 161 MPa, respectively. The stress range  $\Delta\sigma$  was 550 MPa.

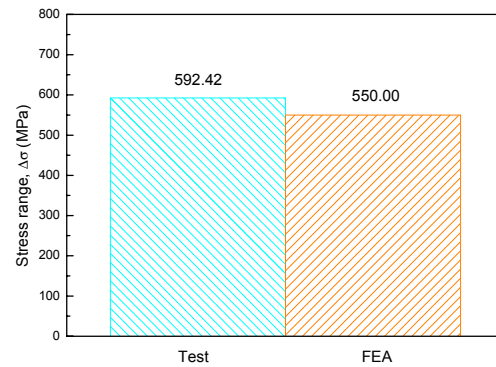
Fig. 9. Comparison between test and FEA results in stress range.

Fig. 9 compares the stress range from fracture mechanics with the stress range from FEA. The failure boundary condition obtained from orthogonal array and ANOVA was valid because the relative error between the test results obtained from failure analysis of rocker arm shaft and FEA results was within 7%. Therefore, the maximum and minimum stresses applied to the rocker arm shaft were 711 MPa and 161 MPa, respectively.

(3) The failure boundary condition estimated by using an orthogonal array and ANOVA was very useful because the relative error between the stress ranges obtained from striation and the stress ranges from FEA fell within 7%.
