Some principles of service life calculation of reinforcements and in situ corrosion monitoring by sensors in the radioactive waste containers of El Cabril disposal (Spain)

C. Andrade ^a, I. Martínez ^{a,*}, M. Castellote ^a, P. Zuloaga ^b

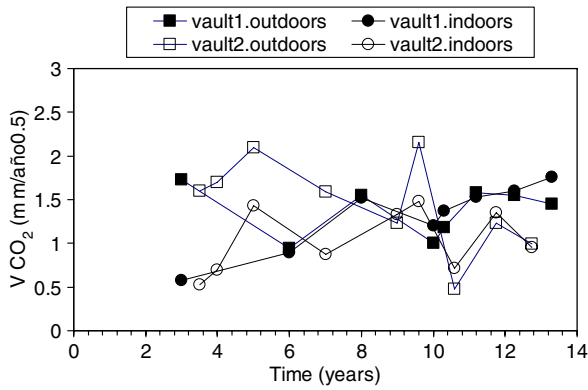
Fig. 3. Evolution with time of the carbonation rate calculated on the control specimens in El Cabril.

The carbonation velocity is calculated using expression (1). As can be observed in Fig. 3, the rate of carbonation presents some scatter but it is quite stable, not showing an influence of the exposure outdoors or indoors of a building. The low values found, with an average of (V_{CO_2}) around $1.5 \text{ mm/year}^{0.5}$, confirm the good carbonation resistance of the concrete designed.

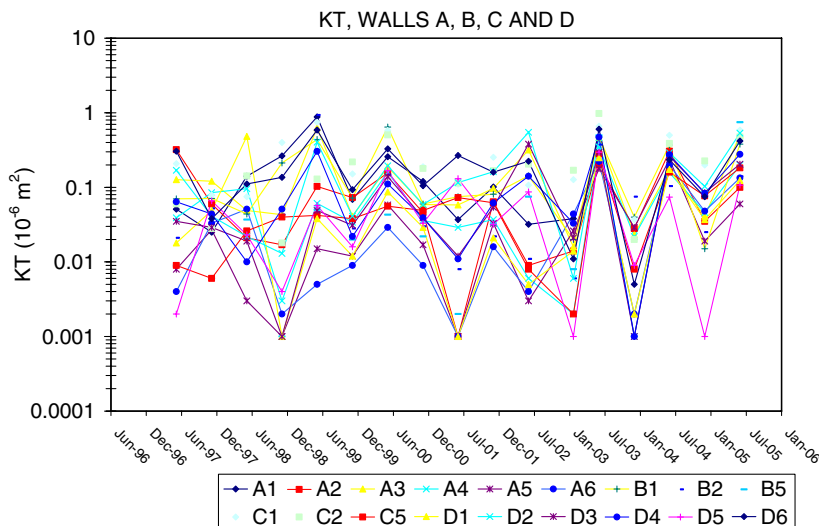
Fig. 4. Results of permeability coefficient (KT) measured during several years over the internal walls of the real concrete container.

These measurements have been made two times per year directly over the concrete surface of the vaults. In the same points corrosion rate measurements are also made. The trend shows that the coefficient of the values KT changes between 10^{-2} and $10^{-1} \times 10^{-6} \text{ m}^2$ (Fig. 4). These values provide a concrete class between 1 and 3, following the Torrent's classification, which is shown in Fig. 5. That means a normal, good or very good quality of the concrete cover.

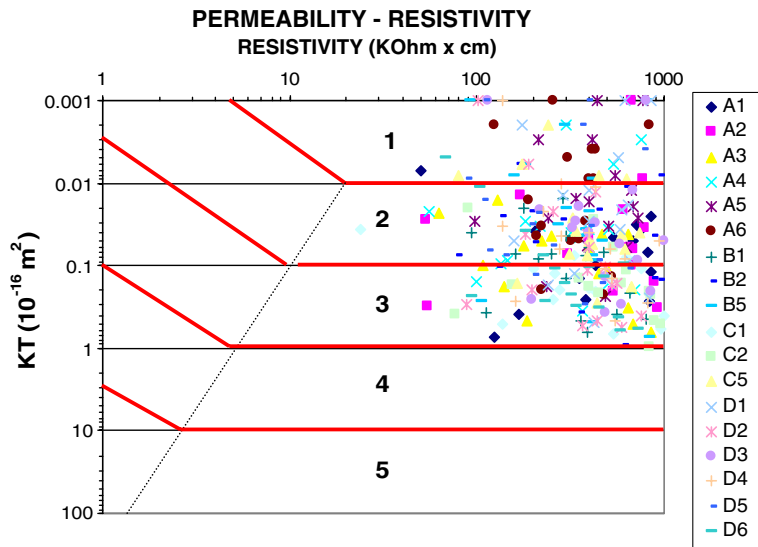
Fig. 5. Relationship between resistivity and KT . Nomogram for the connection by resistivity of the quality cover classification. No connection was necessary due the high values of resistivity.

Since the permeability measurements depend on the concrete moisture, resistivity values are measured simultaneously. There is no criteria for the relation between resistivity and permeability, but as mentioned in [2], that when the concrete is not completely dry, it is necessary to calibrate the classification with the resistivity values (measured in the same points than permeability), as is presented in Fig. 5.

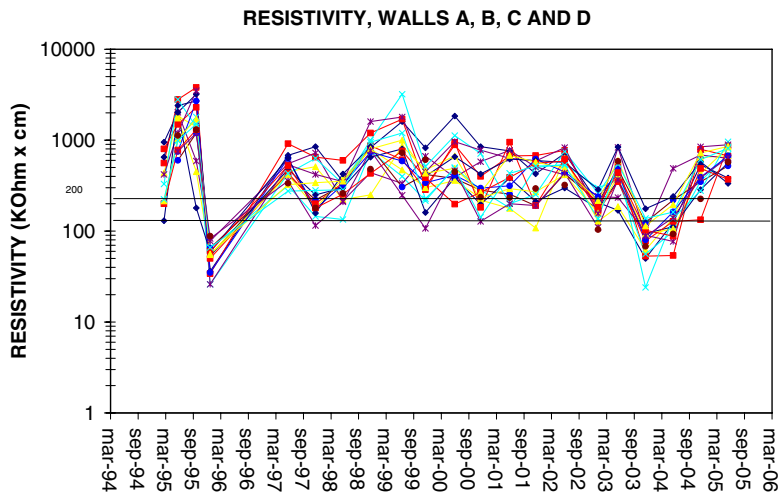
Fig. 6. Results of resistivity measured during several years over the internal walls of the real container.

In the same places where permeability, resistivity, corrosion potential and corrosion rate of reinforcement are determined. The electrochemical parameters are measured in the concrete vaults in El Cabril – Cordoba – Spain. These three parameters are measured twice a year with the corrosion rate meter Gecor 6. Fig. 6 shows the results of resistivity measured during several years. As said, resistivity has shown values between 100 and 300 K Ω cm, these values indicate that concrete is dry. More than 90% of the corrosion potential values are more positive than -200 mV (using Cu/CuSO₄ as reference electrode), (Fig. 7) indicating a non-active corrosion.

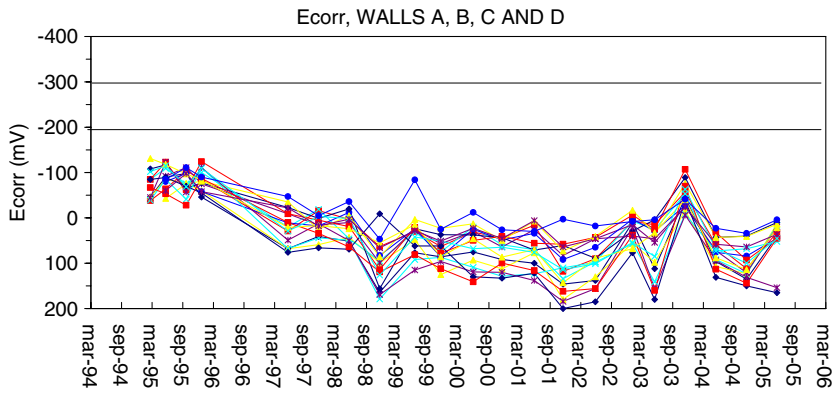
Fig. 7. Results of corrosion potential measured during several years over the internal walls of the real container.

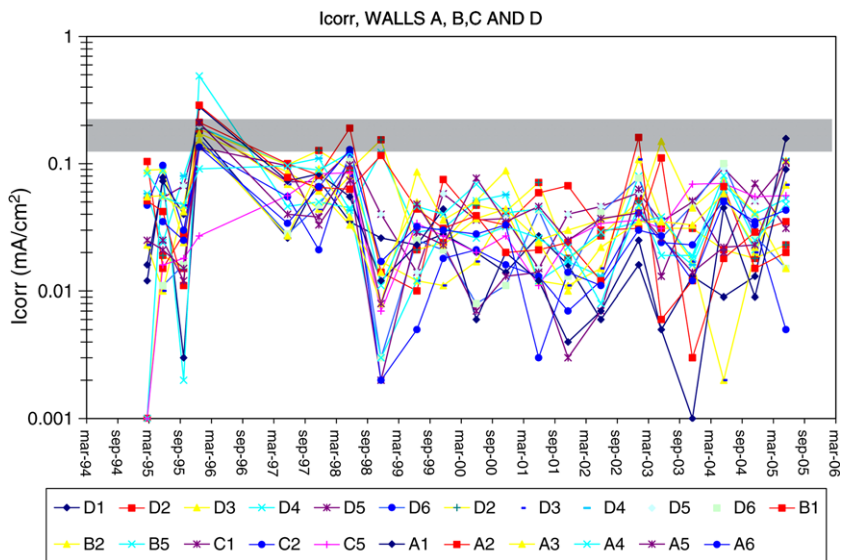
Fig. 8. Results of corrosion potential measured during several years over the internal walls of the real container.

The corrosion rate values (Fig. 8) are below the depassivation limit ($0.1 \mu\text{A}/\text{cm}^2$), so they indicate the passivity of reinforcement, as expected.

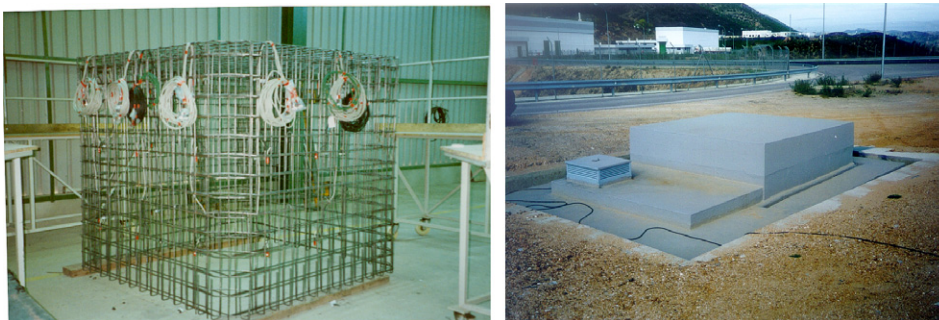
Fig. 9. Reinforcement of the pilot container with corrosion sensors and its aspect once buried. There is a main hole to have access to the chamber where the corrosion-data logger is placed besides the container.

The monitoring of corrosion parameters has been made by the instrumentation of a pilot container (Fig. 9) filled with drums that also have been

instrumented (Fig. 10) [4]. This pilot container has been monitored from 1995 by embedding 27 sets of electrodes. The parameters measured are: temperature, concrete deformation, corrosion potential, resistivity, oxygen availability and corrosion rate. The impact of yearly cycle of temperature on several of the parameters is remarkable, and therefore, care has to be taken when interpreting on-site results.

container (Fig. 9 right part). The system has 50 available channels for recording the several groups of sensors (Fig. 11).

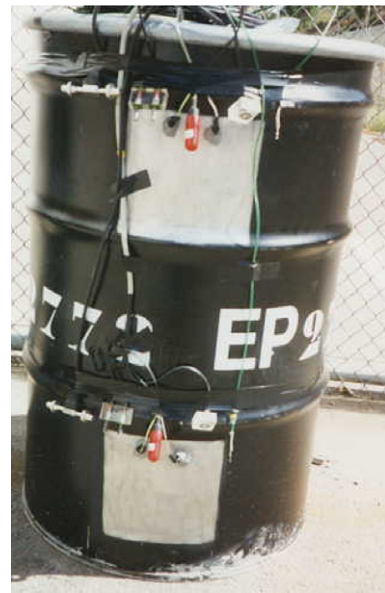
Fig. 10. Instrumented drum.

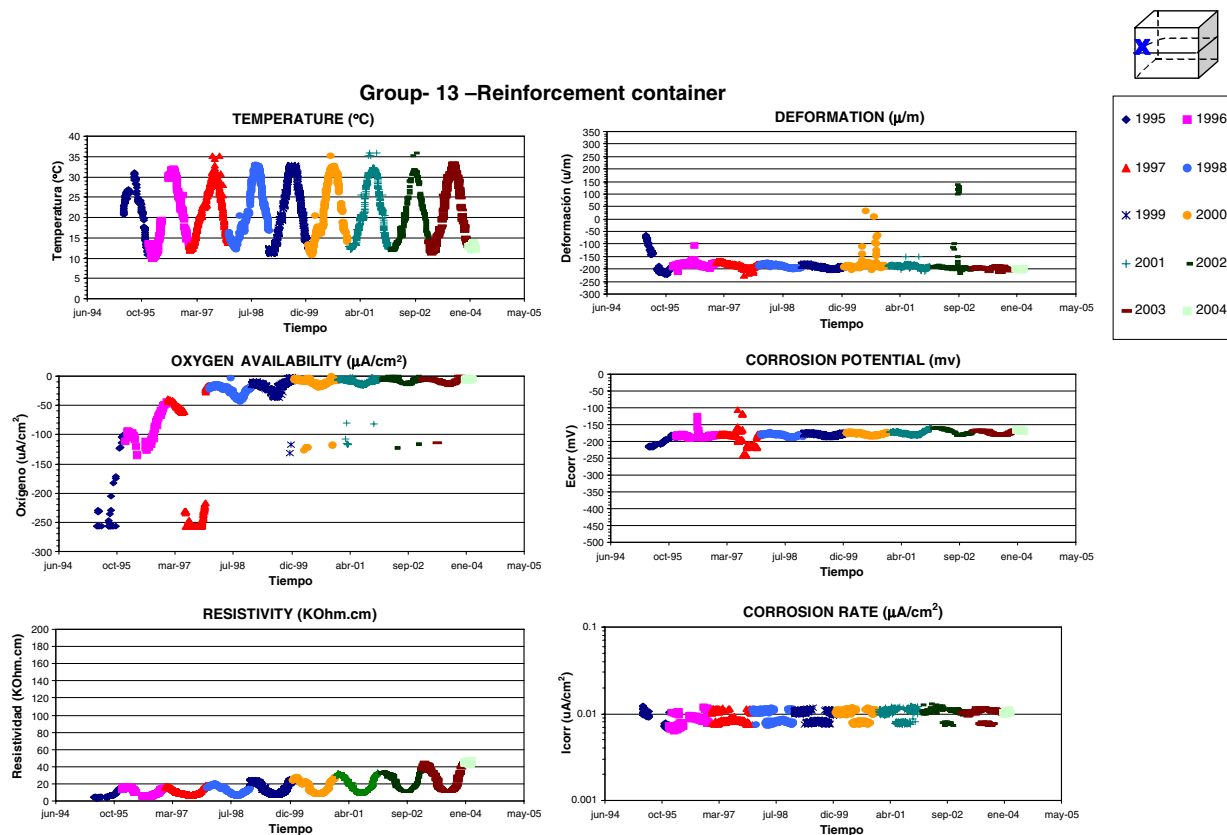
Fig. 12. Evolution with time of corrosion parameters in the sensors embedded in the pilot container (reinforcement structure).

From the 27 groups of sensors installed, only less than 10% of them have failed. The rest show a good response even 10 years after their installation. As an example, Figs. 12 and 13 show the results obtained from one group of sensors placed in one wall of the concrete container (group 13), and from another that is placed over one drum (group 26). From these figures is possible to deduce that the temperature evolution due to the seasonal changes is the most influencing factor for the trends recorded. The reinforcement remains passive as expected ($I_{CORR} < 0.1 \mu\text{A}/\text{cm}^2$).

The 10 years recording has enabled the deduction that a progressive decrease of the amount of oxygen is detected, without this being noticed by the values of the corrosion potential. The progression of hydration is well reflected by the increase in electrical resistivity and the strains are very good detectors of the presence of water in liquid state.

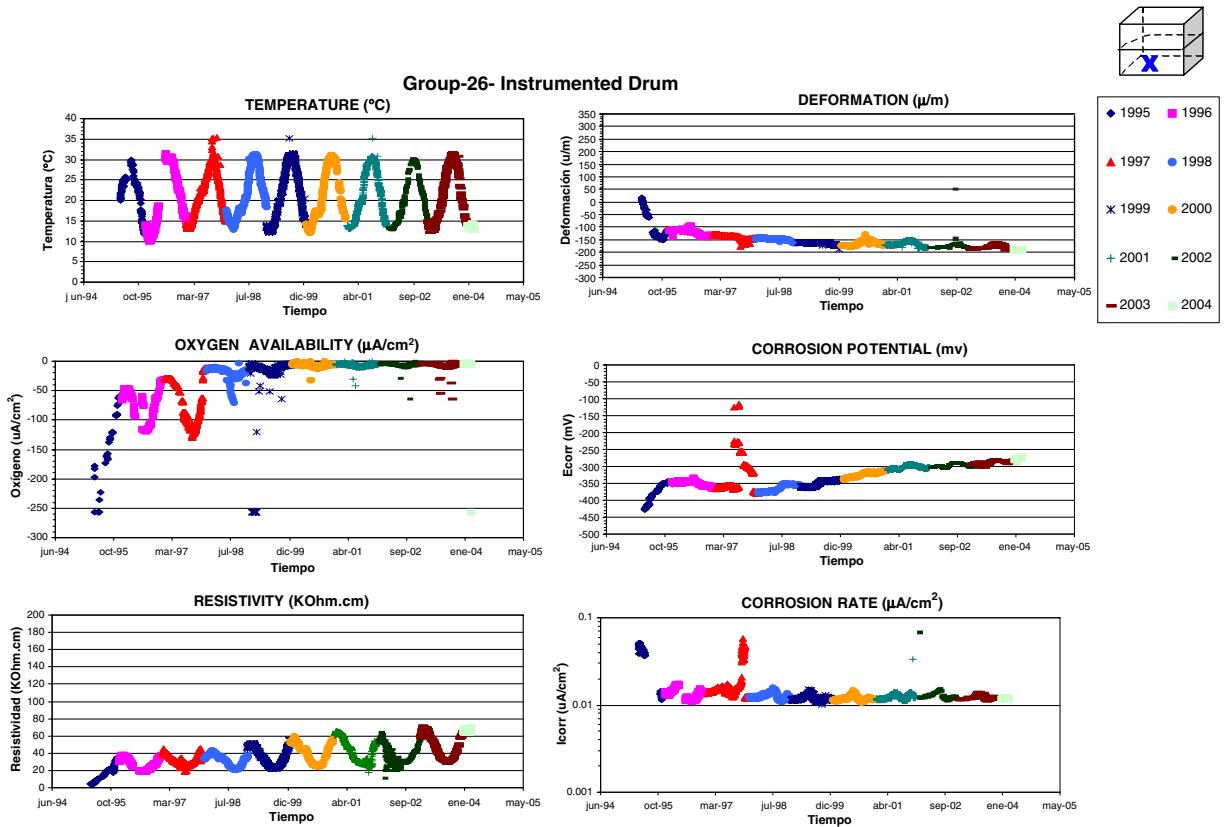
Fig. 13. Evolution with time of corrosion parameters in the sensors embedded in the pilot container (drum).

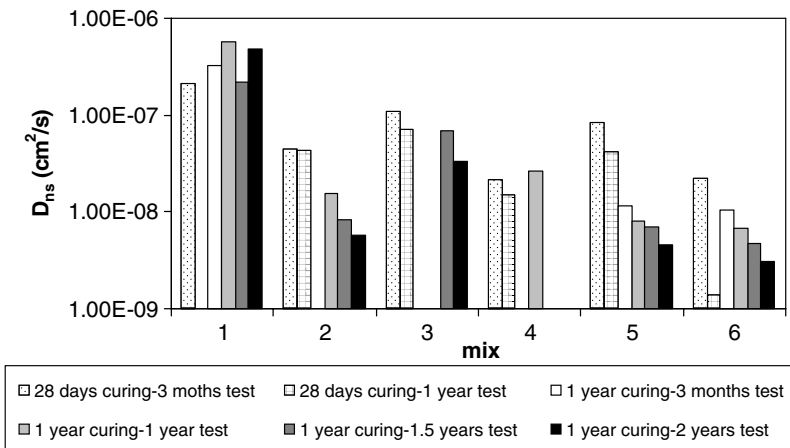
Fig. 16. Non-steady-state chloride diffusion coefficients for different time of exposure to chlorides and at different delay in exposing the six mixes studied.

The non-steady-state diffusion coefficients are given in Fig. 16. From Fig. 16, it can be deduced that for the data corresponding to concrete dosage 1, cast with ordinary Portland Cement (OPC) low in aluminates, there is not a decrease in the diffusion coefficient as long as the test or age of the specimens increases. In addition, they can be correlated in function of the duration of the test all together, independently of having been exposed to the

chloride solution after curing for 28 days or after one year sealed. Therefore, for that concretes, it seems that there is not a significant influence in the duration of the time previous to the exposure to chlorides, and of the age of the concrete in the coefficient obtained. The case of the rest of mixes, especially the case of mortars (dosages 5 and 6) is different, as there is a difference depending on the duration to the exposure to chlorides which, in addition, does not follow the same trend for the different mixes studied.

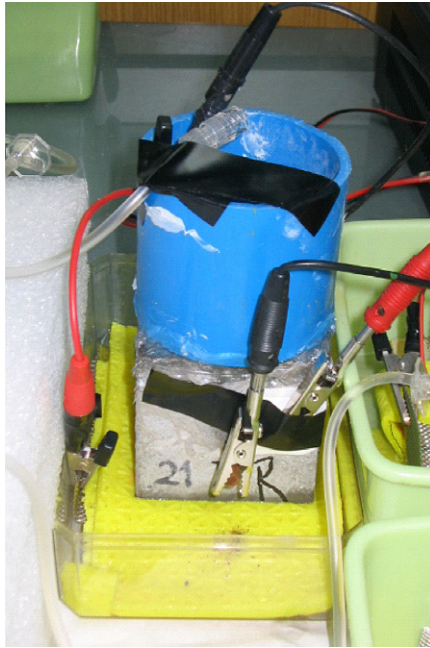
Fig. 17. Experimental arrangement used for the chloride threshold value tests.

been already carried out to study the chloride threshold value for depassivation of the steel embedded in the different types of concrete using an accelerated method, whose set up is shown in Fig. 17 [8]. For making this test, a container is sealed to one of the surfaces parallel to the rebar and it is filled up with a 1 M NaCl solution. In the solution a stainless iron mesh is immersed and it is connected to the negative pole of a power supply. As positive electrode, a steel plate is electrically connected to the bottom surface of the sample, maintaining the electrical contact by a wet sponge. A voltage drop of 12 V is applied between the

electrodes. During the tests, it is necessary to neutralize the solution with a continuous dropping of diluted acid, because of the increase in the concentration of hydroxyl ions, due to the hydrolysis of water. During the test, the electrical potential of the rebar have to be monitored, in order to detect the instant of the depassivation of the steel. Periodically, the power supply is switched off to also have the data of potential without the electrical field applied. The evolution of the potential of the steel indicates the depassivation of the rebar embedded in the specimen. Once this variation has been detected, the power supply has to be switched off and wait until depassivation in natural conditions.
