Journal of Sound and Vibration 278 (2004) 365–381

Periodic monitoring of physical property changes in a concrete box-girder bridge

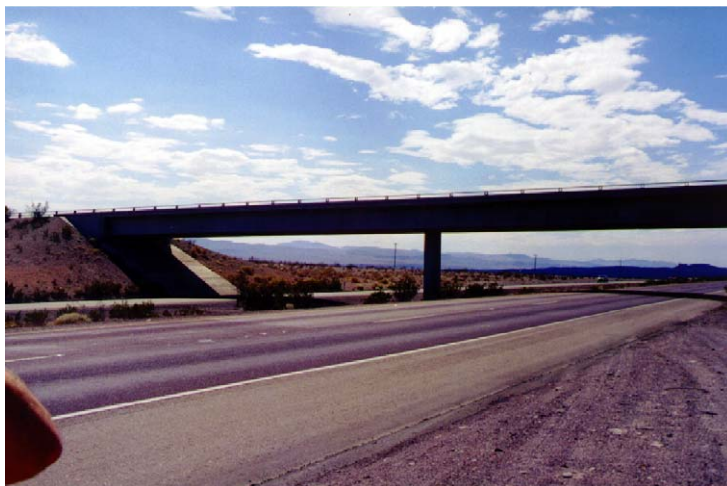
Fig. 1. View of the Lavic Road Bridge.

In an attempt to overcome these limitations, the authors have monitored a bridge located in California, the Lavic Road Bridge (Fig. 1), from 1997 as yearly basis [8]. The bridge was suspected of having been constructed with reactive aggregates. The modal tests were performed on the structure in December 1997, September 1998, September 1999, and October 1999, respectively. The resulting modal data were then used to identify and record the changes in stiffness properties of deck, column-footing, and abutment–soil system. A frequency-based system identification (SI) technique that can simultaneously account for gross changes in mass, stiffness, and boundary conditions of a structure is utilized in this paper [9]. A description of the theory supporting the

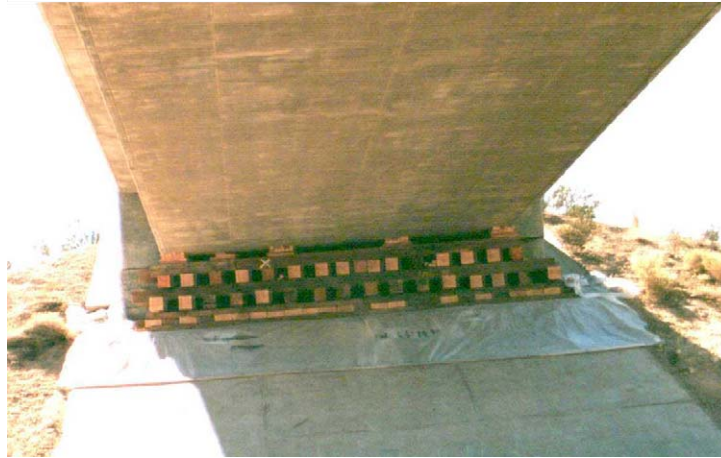
Fig. 4. A view of temporary shoring installed under the bridge superstructure.

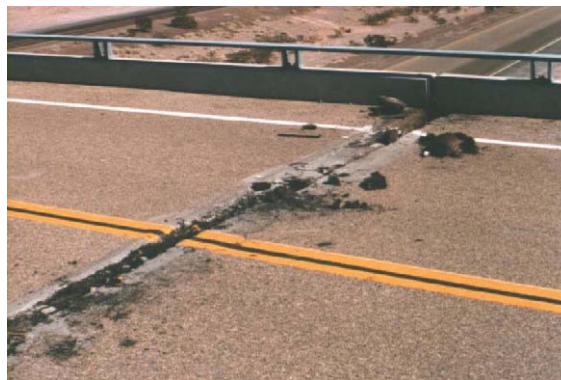
Fig. 5. View of damage to south abutment expansion joint.

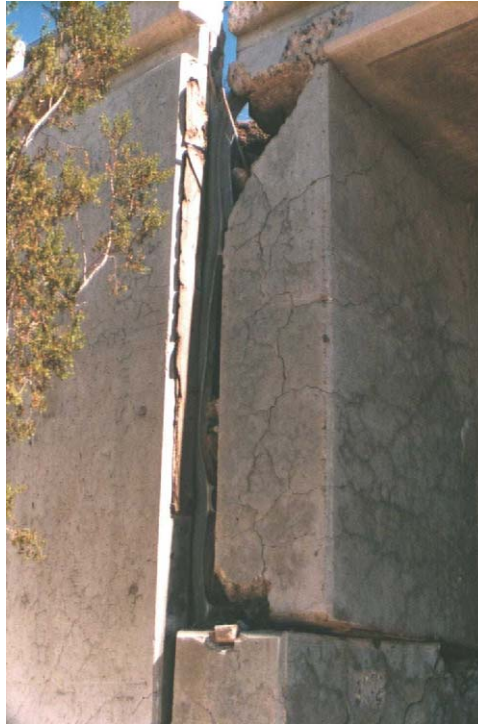
Fig. 6. Damage and misalignment of east wingwall and pier at south bridge abutment.

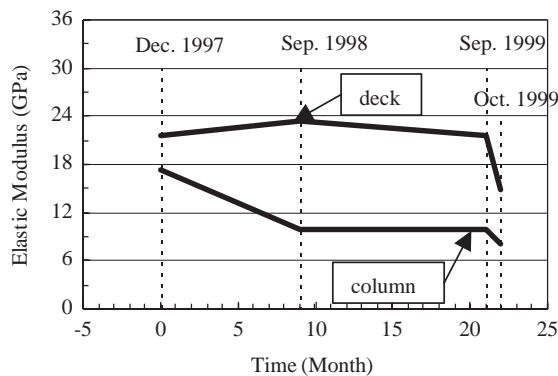
Fig. 11. Changes in elastic modulus of the deck and column.

A comparison of the identified stiffnesses for 2-year period is provided graphically in Figs. 11 and 12. In the figures, except the stiffness of the 1997 structures, the stiffness of the deck and column decreased reflecting the effect of time on the stiffness of the structural members. The effective reduction in stiffnesses of the deck, column, and abutments were, respectively, 32%, 53%, and 61% from 1997 to 1999. Especially, after the earthquake, the effective reduction in stiffnesses of the deck, columns, and abutments were, respectively, 32%, 18%, and 52%. In Table 15, the stiffness reductions in the bridge are further quantified. The method utilized here, updating of the FE model, agrees well with stiffness reduction calculated directly from changes in eigensensitivity [10].
