# The Behaviour of Single Crystals of Aluminium under Static and Repeated Stresses

H. J. Gough, D. Hanson and S. J. Wright

*Phil. Trans. R. Soc. Lond. A* 1927 **226**, 1-30

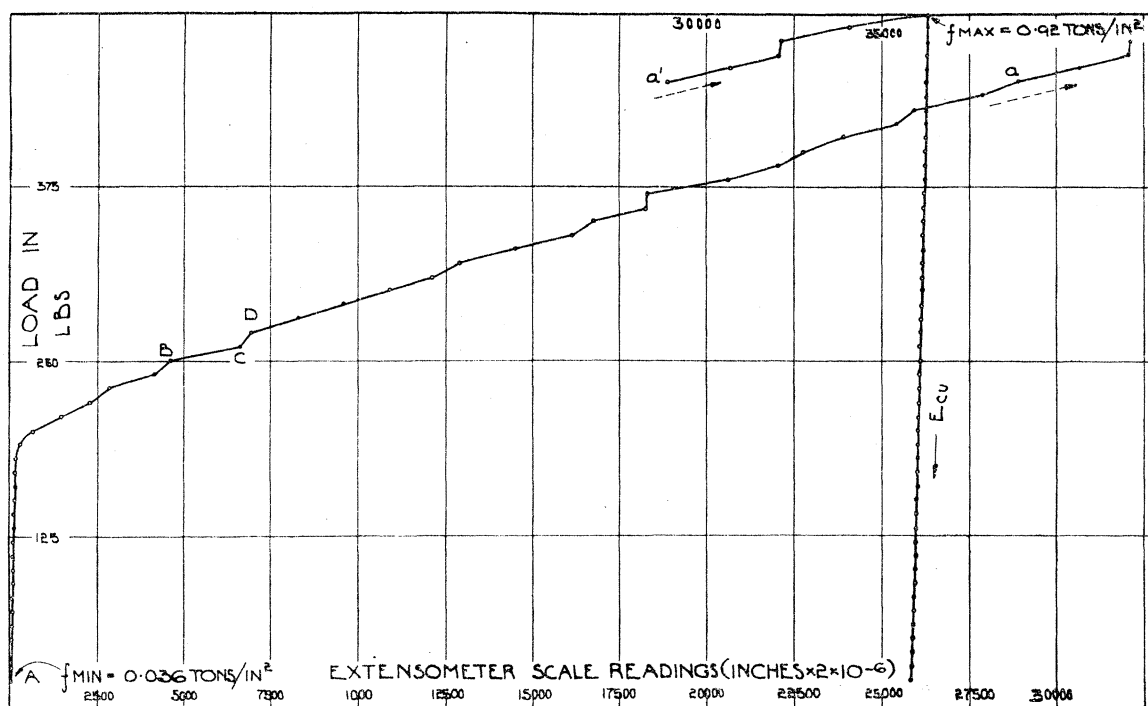
Fig. 5.

*Range of Loading, 20–500 lbs.*—The complete load elongation diagram obtained during the first cycle of loading is reproduced in fig. 5. It will be seen that marked discontinuities occurred at various loads, and it should be pointed out that there is no justification for drawing a smooth average curve through these points. In fig. 5, the portions BC and CD of the curve correspond to equal increments of load, but it will be seen that the strains due to these increments are widely different, being 2060 scale divisions in one case

corresponding to C, there is an appreciable time-lag before any movement is detected. The specimen then commences to extend, the rate of extension increasing to a maximum and then decreasing rapidly until movement ceases, the total time of movement being of the order of 3 or 4 seconds. On the other hand, the whole movement over the portion CD is of a slow uniform character with no appreciable lag. In neither case can any creep be observed if the load be maintained for a long time.

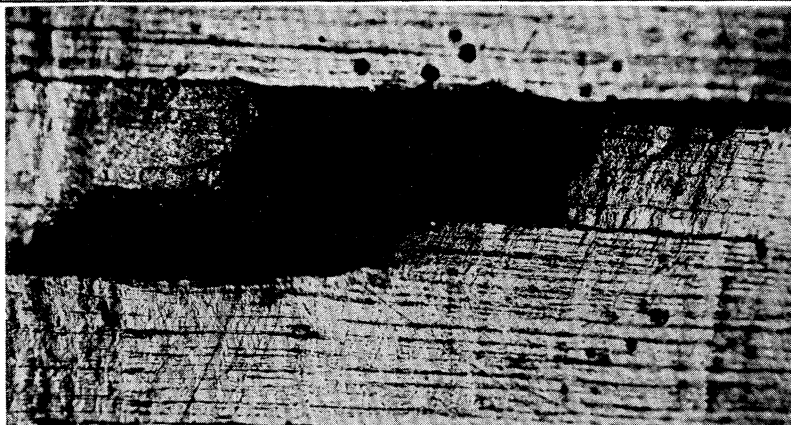
14

- Fig. 13.—BLL8A, after  $0\cdot592 \times 10^6$  reversals of  $+ 18\cdot13$  inch-lbs. : at reference mark 8. ( $\times 105$ .)  
 „ 14.—View of crack in BLL8A. ( $\times 210$ .)  
 „ 15.—BLL8A, after cracking : at reference mark 9. ( $\times 105$ .)  
 „ 16.—Polished cross-section of BLL8A. ( $\times 7$ .) *Note.*—For reference mark 0-9, read 6-0.  
 Compare diagram on page 19.  
 „ 17.—BLL11B, after fracture : at end of major axis. ( $\times 105$ .)  
 „ 18.—BLL11B, „ „ „ „ ( $\times 105$ .)
