B. THE PHYSICS OF IMPACT AND DEFORMATION: MULTIPLE IMPACT

VII. The erosion of solids by the repeated impact of liquid drops

BY N. L. HANCOX† and J. H. BRUNTON

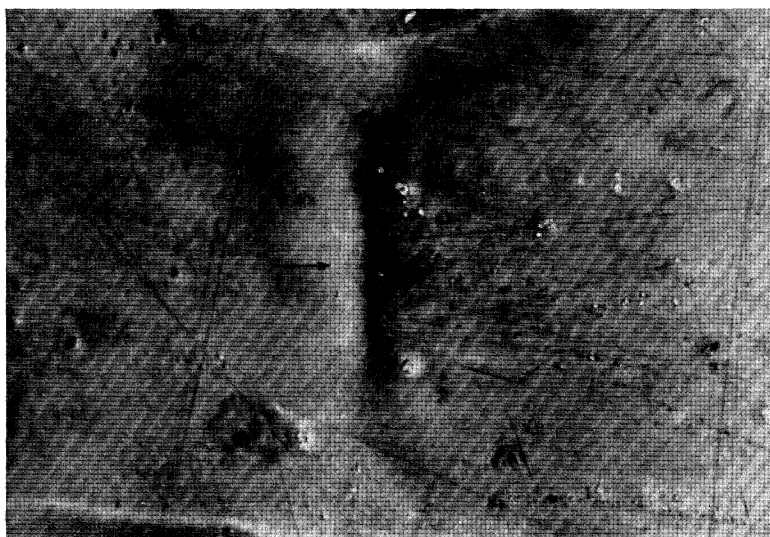
FIGURE 14. A small depression in copper. Depressions similar to this provide the first detectable signs of permanent deformation. The specimen illustrated has received 8000 impacts at 51 m/s. (Magn. $\times 500$.) Phase contrast photograph.

For impact velocities in the range 30 to 90 m/s and with a 1.3 mm diameter water jet, the first signs of damage were detected after several thousand impacts. The area of impact was found to be covered by randomly distributed depressions. An example is shown in figure 14, plate 18. The depressions varied somewhat in shape but it was usual to find that the bottom of the depression formed a linear fault in the surface. Maximum dimensions of these depressions lay in the range 5 to 15 μm . The position of the depressions was not related in any obvious way to grain or phase boundaries or to grain orientation and their size and distribution was not affected by different surface preparations. It was found that for the same exposure there were far fewer depressions in single crystals than in the corresponding polycrystalline specimens.

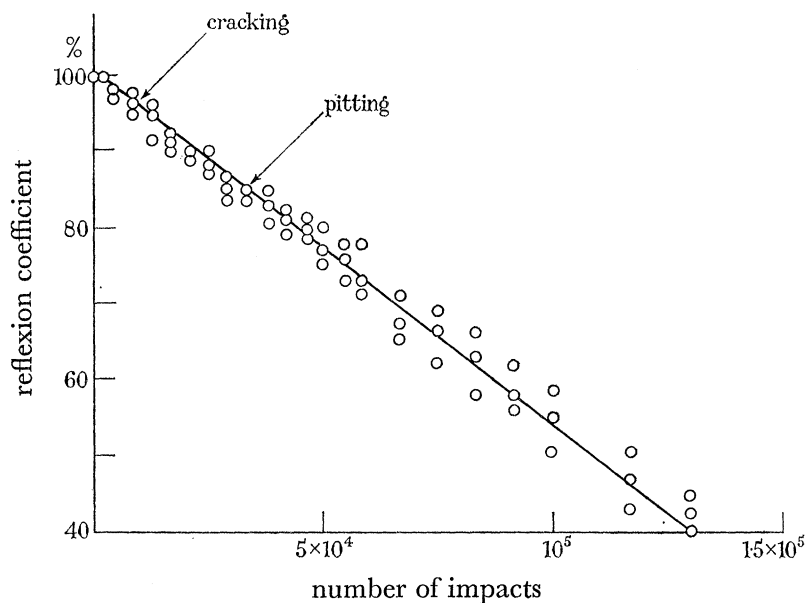
FIGURE 11. Development of erosion damage with number of impacts in polymethylmethacrylate. Water jet diameter, 1.35 mm.

The erosion damage of polymethylmethacrylate (measured with the lightmeter) as a function of the number of impacts is shown in figure 11. A feature common to curves of this kind is the initial delay period during which there is no apparent change in the surface structure. The erosion rate thereafter stays constant. The measurements shown here refer to the very early stages of erosion. Appreciable weight loss does not occur until a reflexion coefficient of about 75% is reached.

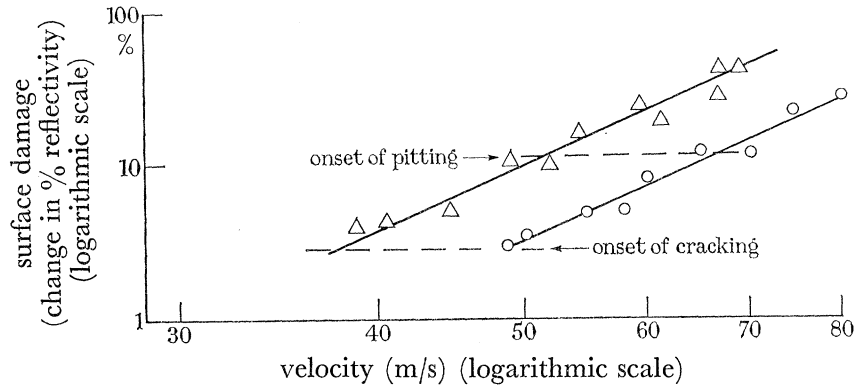
FIGURE 12. The effect of the impact velocity on the amount of erosion in polymethylmethacrylate at two different intervals of exposure. ○, Deformation after 10 000 impacts; Δ, deformation after 50 000 impacts. Water jet diameter, 1.35 mm.

The effect of impact velocity on the amount of erosion at two different exposure intervals is shown in figure 12. For this particular material the erosion rate varied as the velocity of impact raised to the power 4.5. This may be compared with a figure of 3.4 obtained from gravimetric measurements by Fyall *et al.* (1956-57). A threshold velocity of 24 m/s was found below which damage was not produced even after very long duration runs.

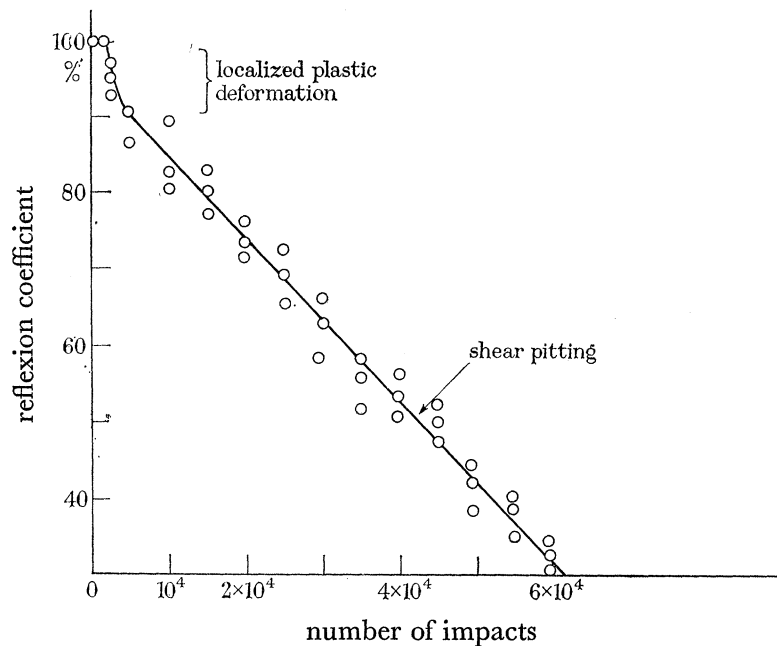
FIGURE 16. Development of erosion damage with number of impacts in copper. Water jet diameter, 1.35 mm.

The results obtained for the surface deformation of copper (measured with the light-meter) as a function of the number of impacts and the velocity of impact are shown in figures 16 and 17. The general behaviour, in spite of a considerable difference in the mechanism of failure, is similar to that found for the hard polymers. It can be seen in figure 16 that as with polymethylmethacrylate, there is a quiescent period during which no detectable change occurs in the surface—this is followed by the fairly sudden appearance

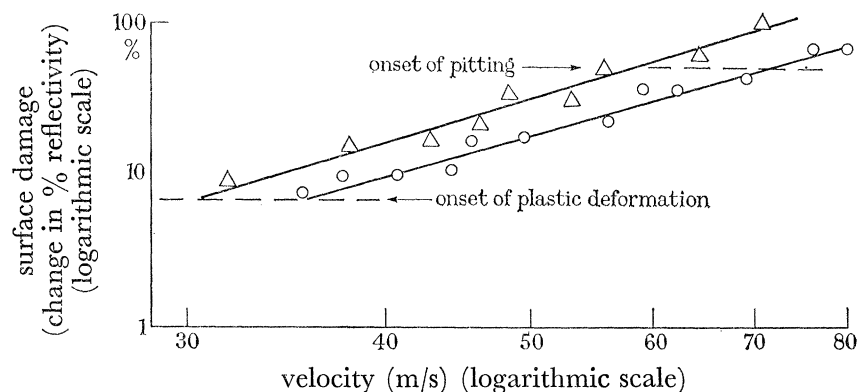
FIGURE 17. The effect of impact velocity on the erosion of copper. ○, Deformation after 20 000 impacts; △, deformation after 50 000 impacts. Water jet diameter, 1.35 mm.

of depressions and grain boundaries and finally by large erosion pits. A study of the velocity relation (figure 17) showed that the deformation increases as the velocity raised to the power 2.7.

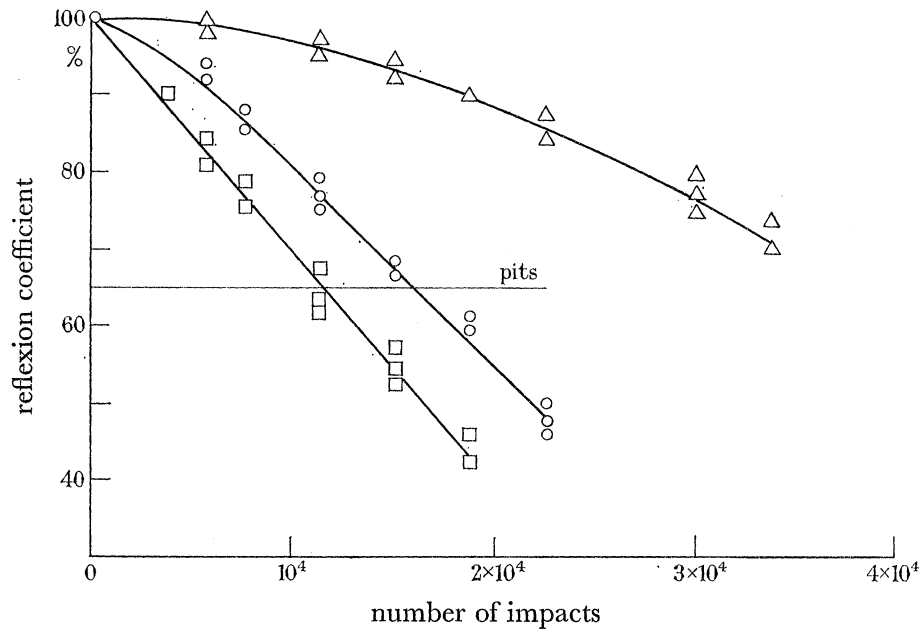
FIGURE 18. The effect of grain size on the erosion of pure aluminium. Δ , Small grain size (0.0045 mm); \circ , single crystal; \square , large grain size (0.045 mm).

The general pattern of failure in aluminium was found to be very similar to that in copper. With aluminium an experiment was carried out to examine the effect of grain size on erosion behaviour. The results are shown in figure 18. The specimens were of similar purity. In the polycrystalline material the variation in grain size was produced by cold rolling and annealing to bring about recrystallization. The mean microhardness values for small grained, large grained and single crystal specimens were 42, 30 and 27 Kg/mm² respectively. It was found that in spite of a lower hardness the single crystals had a greater resistance to erosion than the large grained specimens. This again emphasizes the importance of grain and phase boundaries in causing pitting.

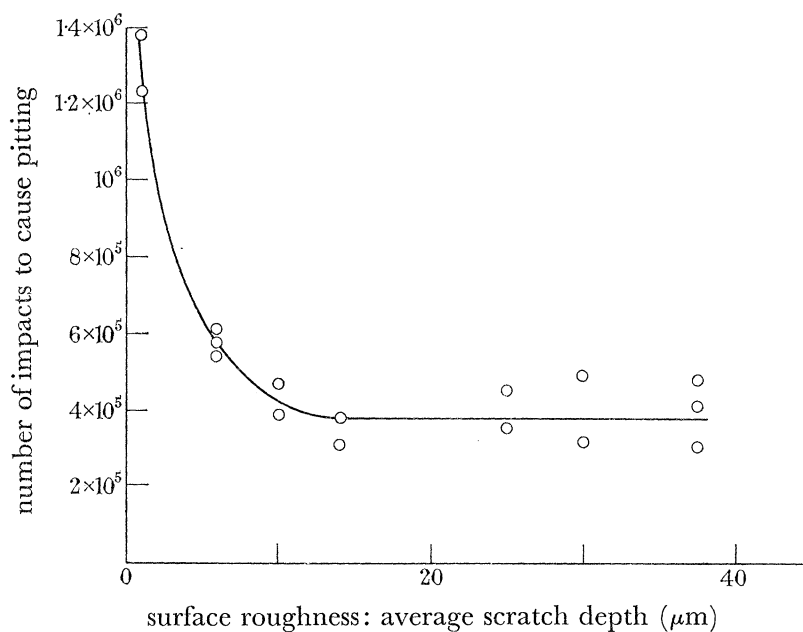
FIGURE 22. The effect of surface finish on the number of impacts required to produce erosion pits in 18/8 austenitic stainless steel.

Specimens of the austenitic steel were prepared with scratch finishes varying from $37 \mu\text{m}$ down to $1 \mu\text{m}$. The number of impacts necessary to produce pits and remove metal from the surface was measured for the different finishes. The results shown in figure 22 refer to an impact velocity of 90 m/s and a 1.3 mm diameter water jet. It can be seen that the finish has very little effect above $12 \mu\text{m}$. Finer finishes have a considerable effect on the rate of damage; a $1 \mu\text{m}$ finish requires an exposure nearly 4 times greater than a $12 \mu\text{m}$ finish to bring about equivalent damage.

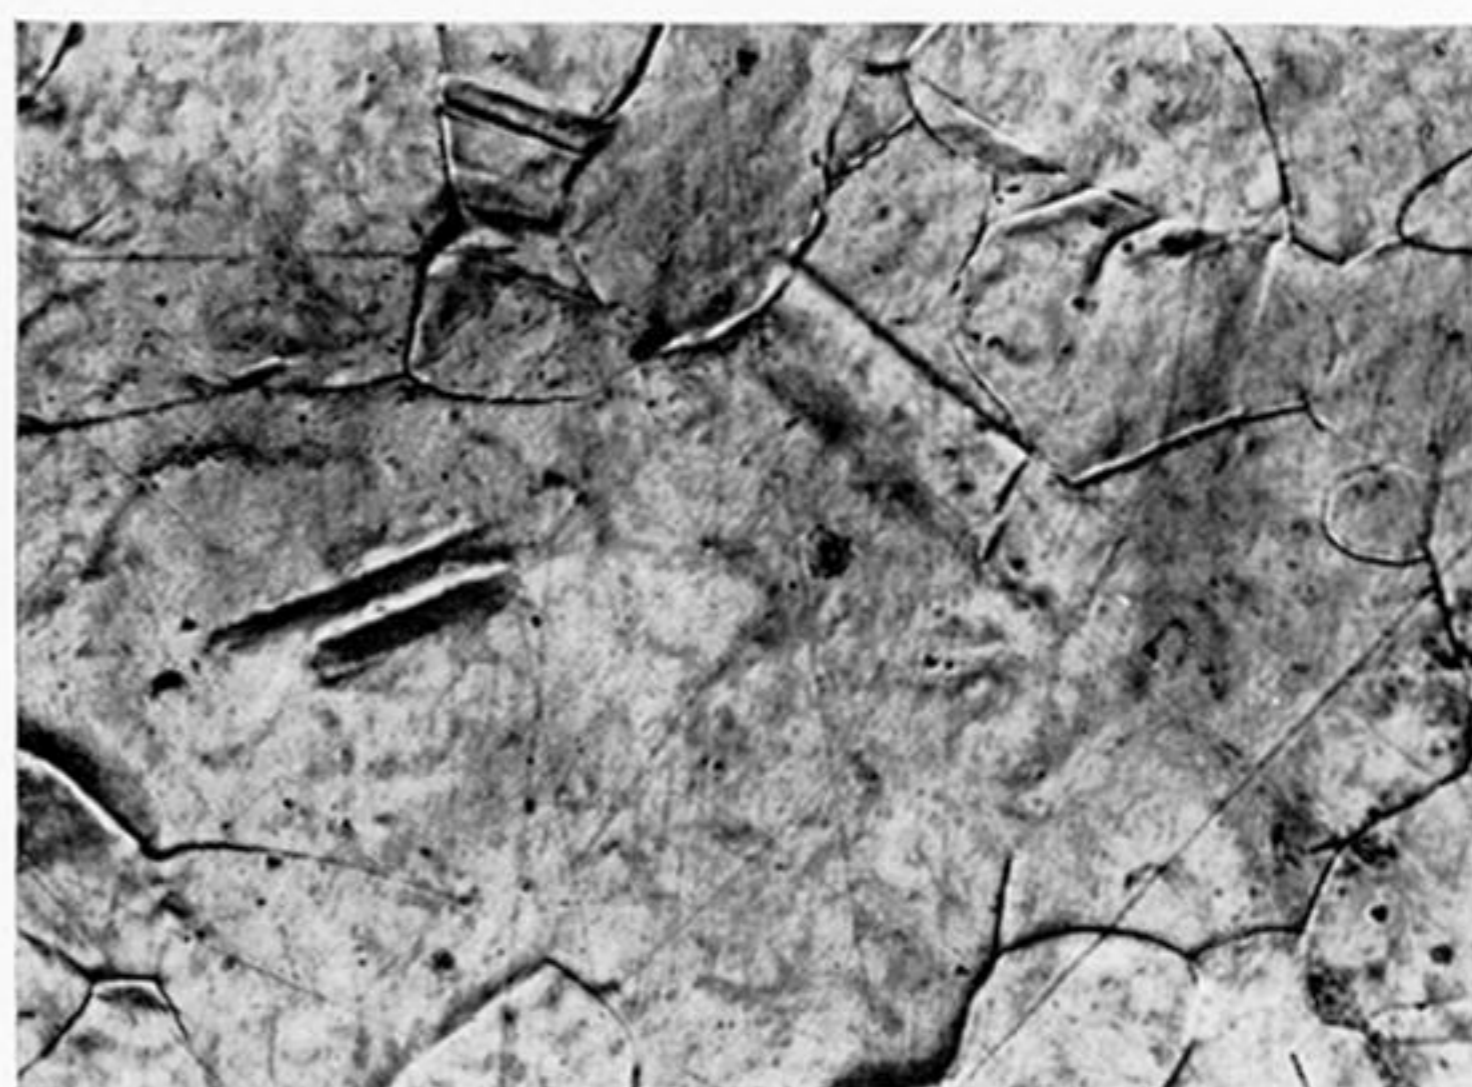
FIGURE 15. The development of erosion damage in copper. The number of impacts is shown besides each frame. The impact velocity was 52 m/s and the water jet diameter 1.35 mm. (Magn. $\times 190$.)

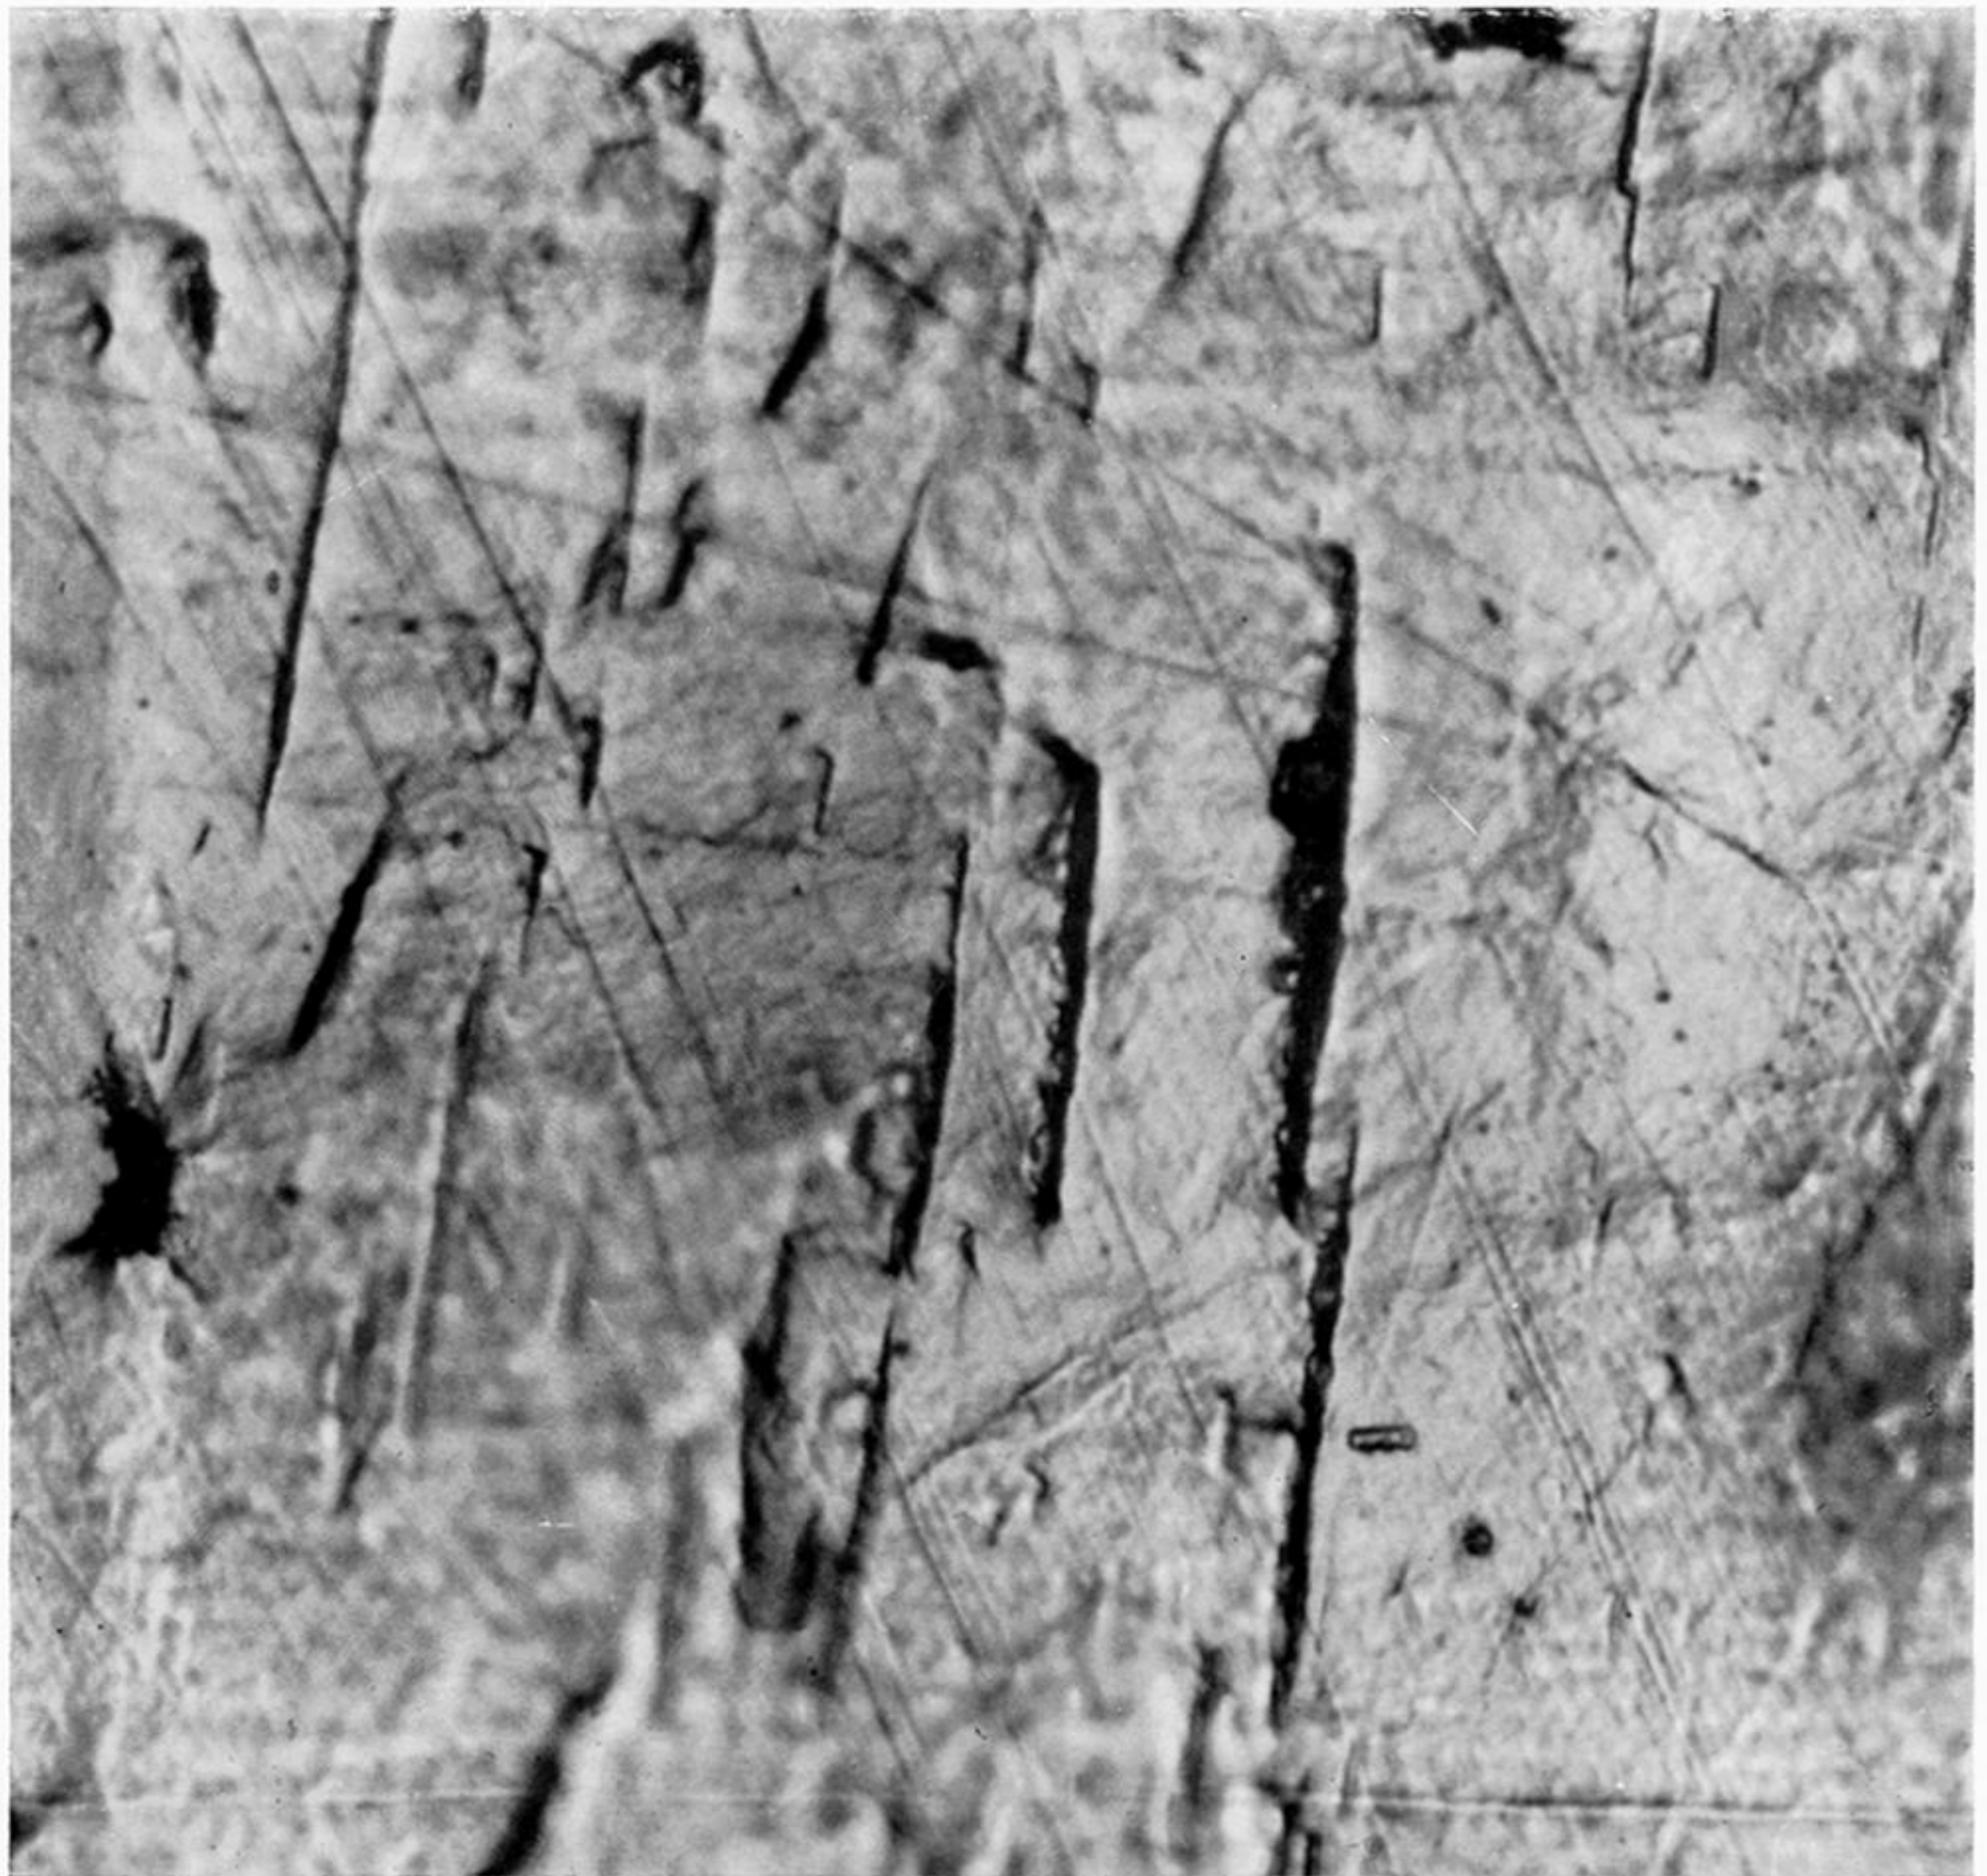
FIGURE 21. Shear deformation along twin boundaries in an iron single crystal. The centre of impact was to the right of the area photographed. 2.8×10^5 impacts at 85 m/s. (Magn. $\times 470$.)

depressions was reduced by a factor of 8 to 10 compared with a corresponding polycrystalline specimen. After the order of 10^5 impacts twins appeared in the surface; these were further deformed by the flow across the surface. Twins sheared in this way are shown in figure 21, plate 21. The pits produced along the twin steps were found, when sectioned, to have fractures running out from their tips. Perhaps the most remarkable feature about the deformation of the iron crystal was its excellent erosion resistance in spite of the low hardness value of 85 Kg/mm^2 . Irrespective of the method of measurement the deformation of the crystal at any stage during the erosion process was no more than that found with austenitic steel (hardness 400 Kg/mm^2) at the higher impact velocity. In the absence of twin steps in the surface it is very likely that an even greater erosion resistance would have been observed.
