Observation of Events Leading to the Formation of Water Drops which Cause Turbine Blade Erosion

D. G. Christie and G. W. Hayward

Phil. Trans. R. Soc. Lond. A 1966 **260**, 183-192

XV. Observation of events leading to the formation of water drops which cause turbine blade erosion

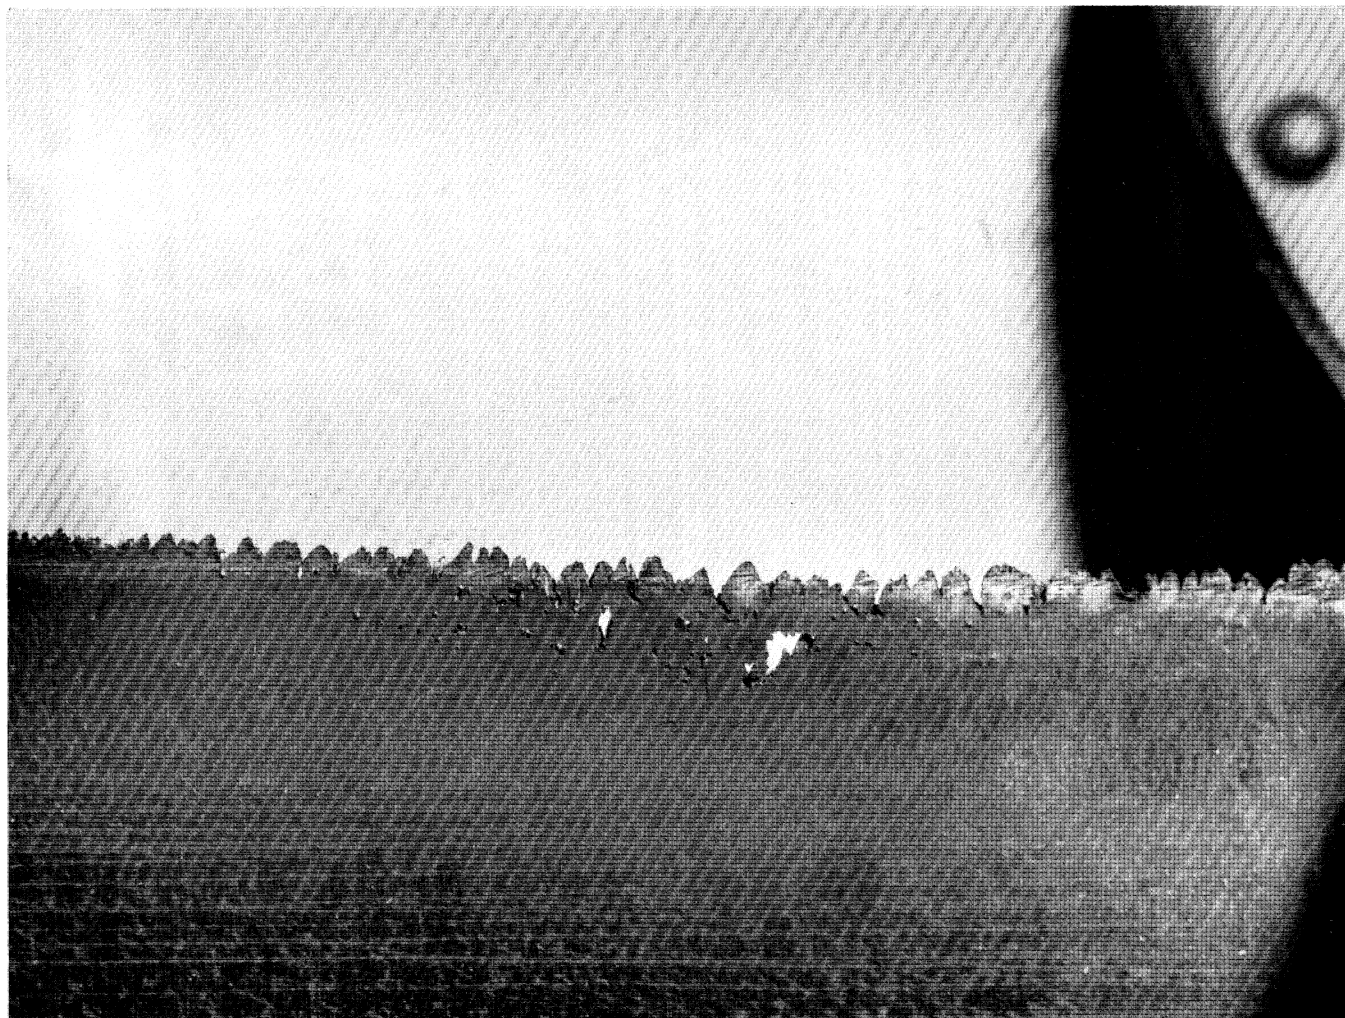
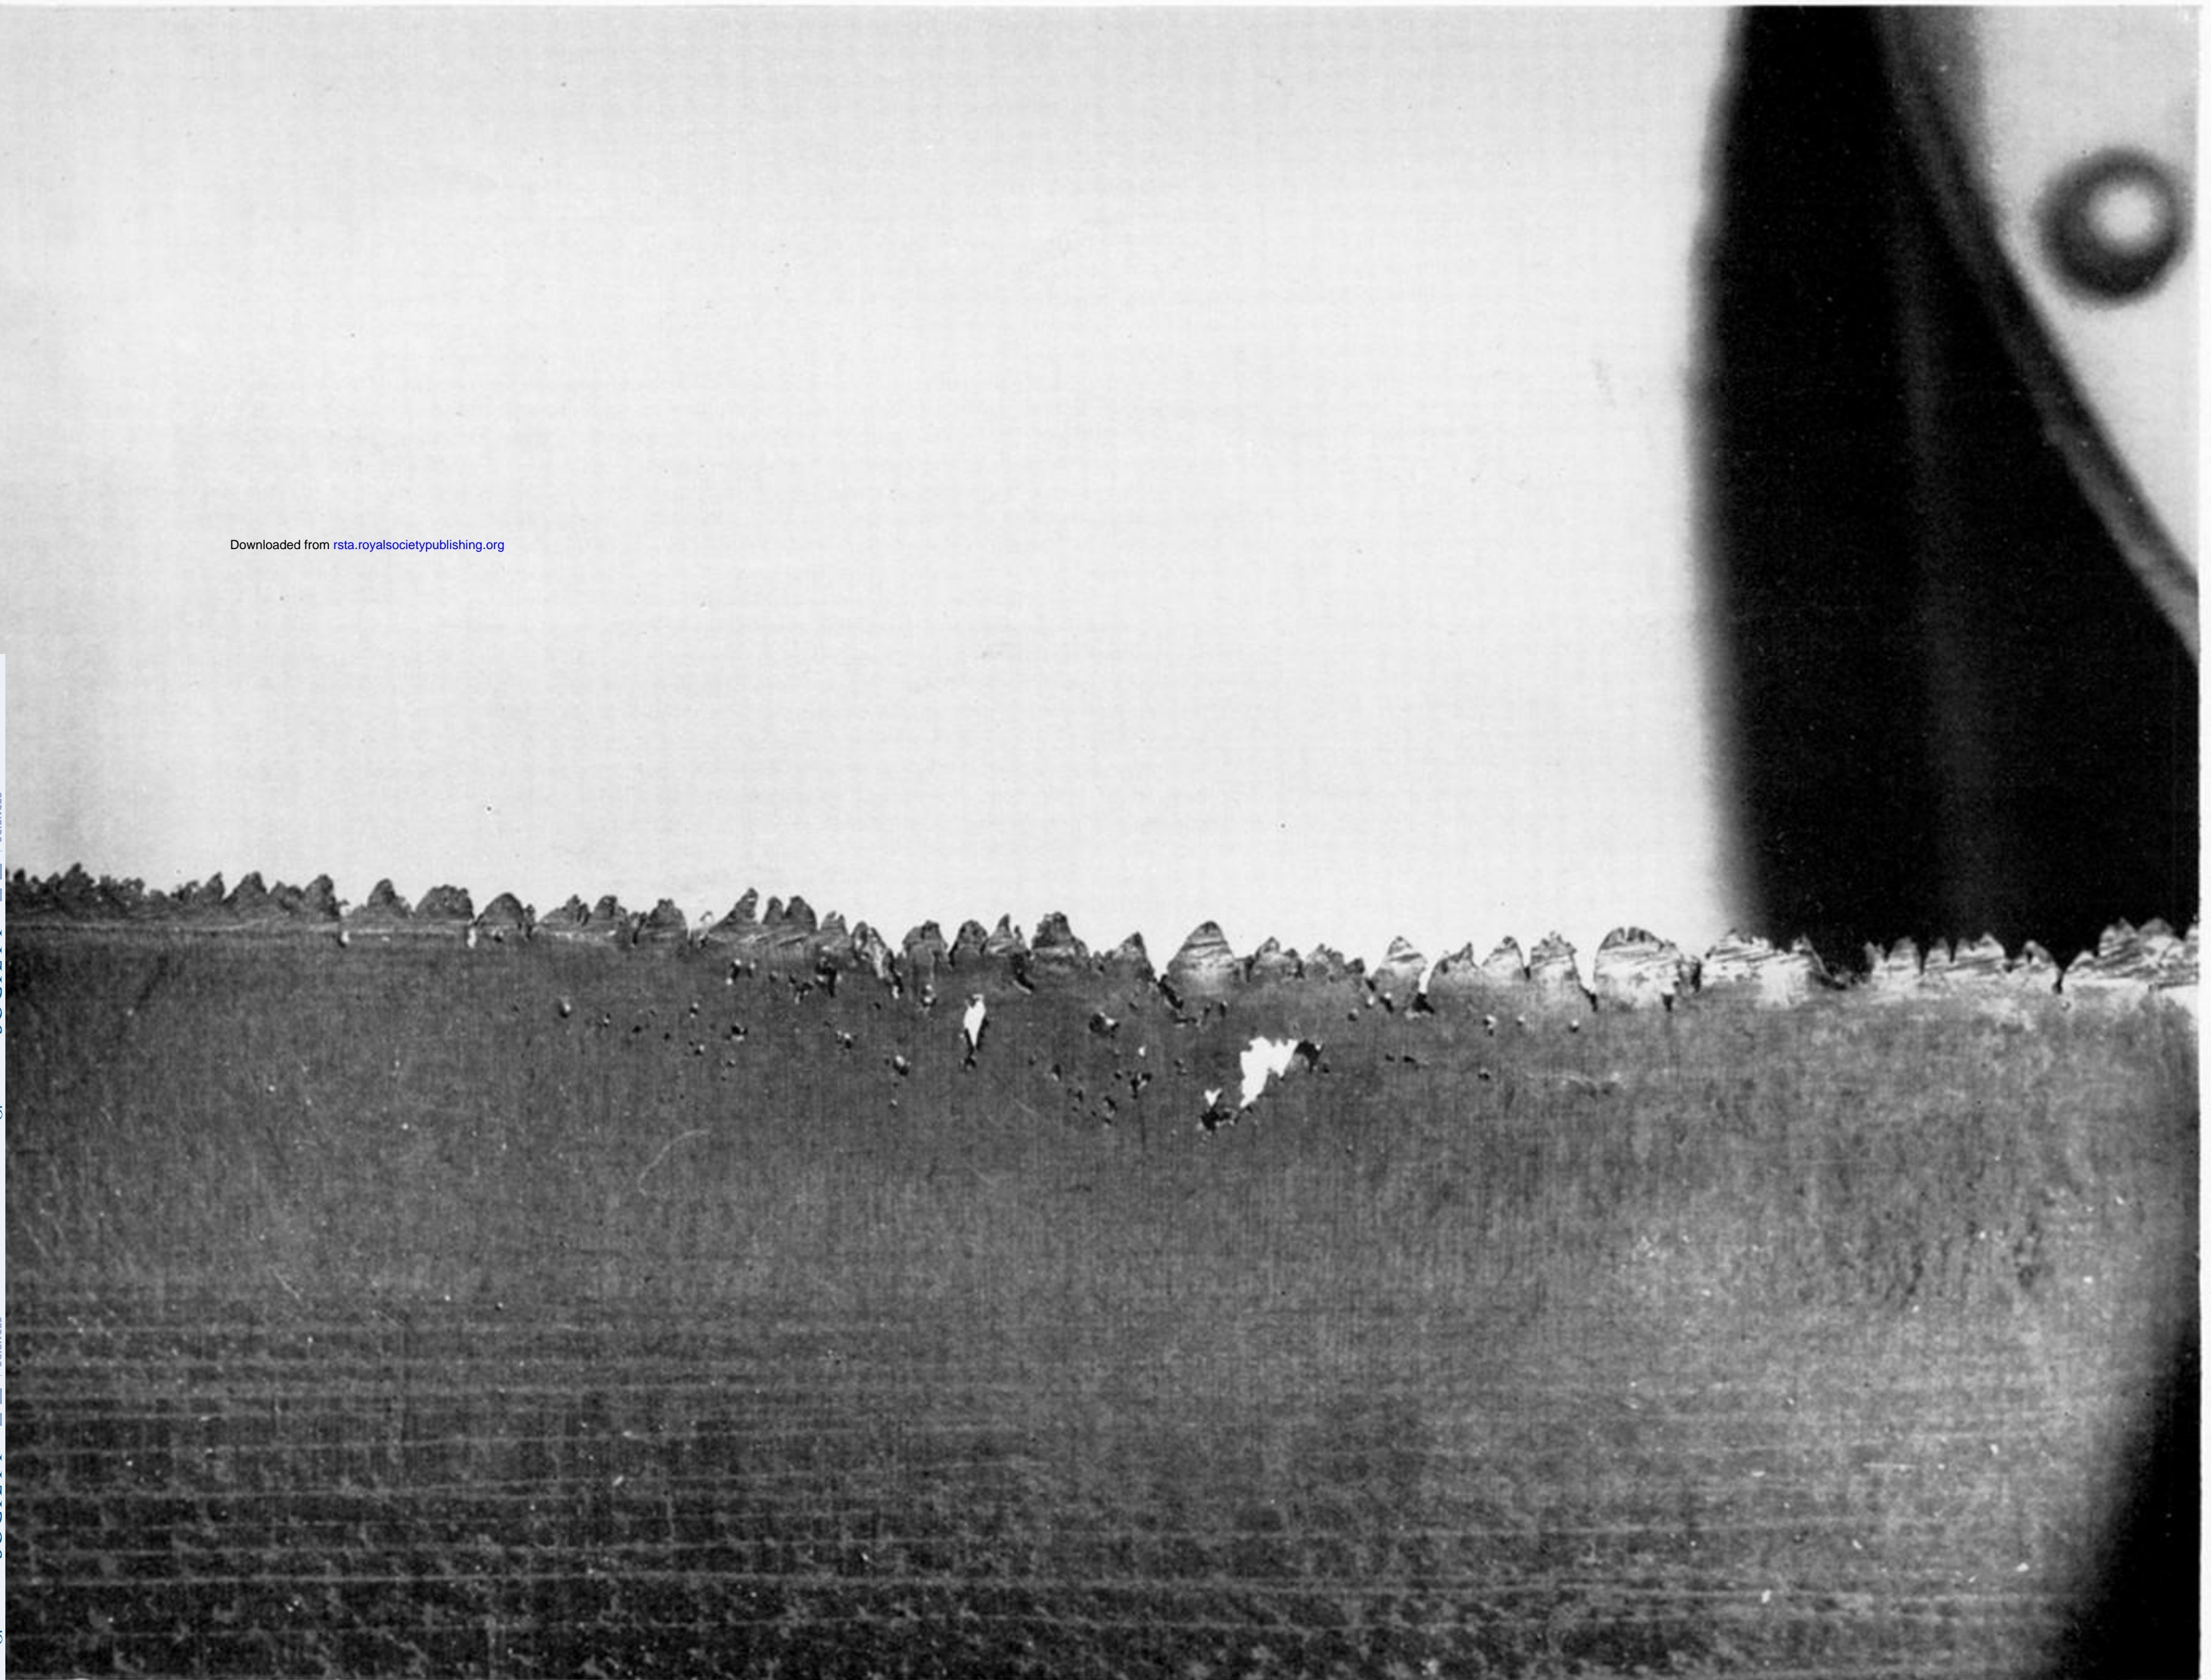
FIGURE 6. Working face of moving blade showing perforation damage caused by water *C* on figure 5 after 8200 h in service.

FIGURE 6. Working face of moving blade showing perforation damage caused by water C on figure 5 after 8200 h in service.

figure 6, plate 33 show the type of blade damage in this area using unshielded blades. Figure 7, plate 34, shows the water concentrated by the secondary flow on blade 3 where it first becomes visible at the overlap of blades 4 and 3.

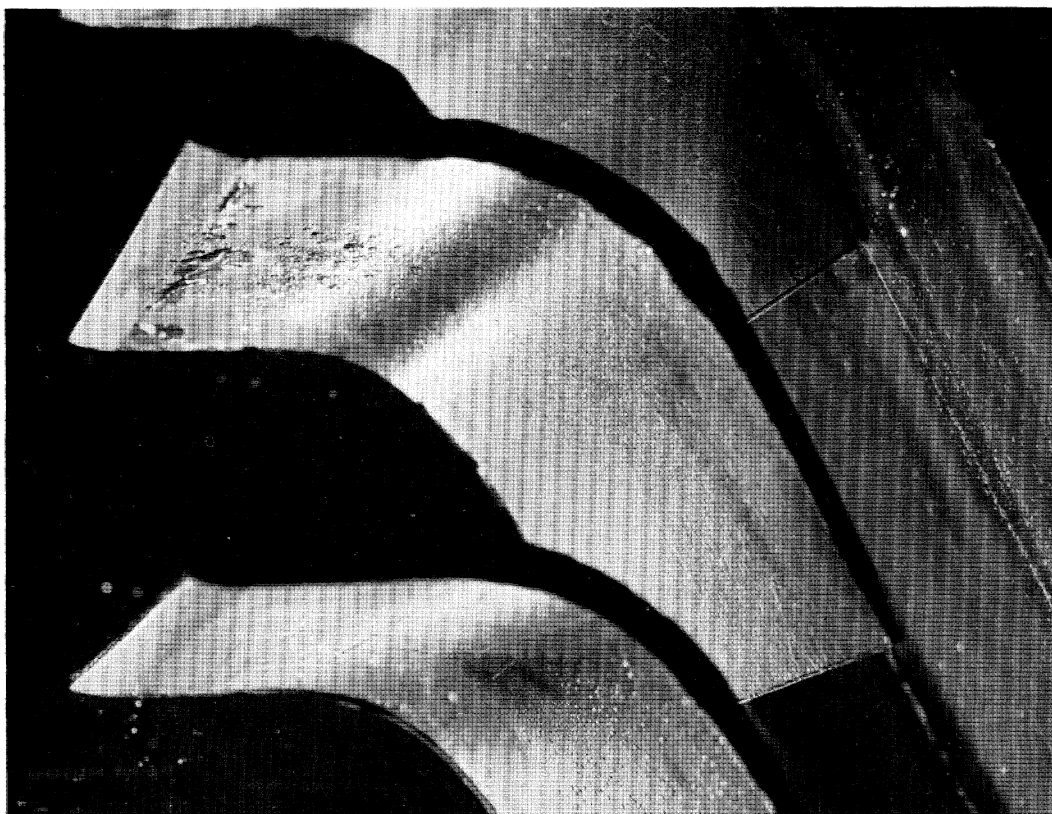
FIGURE 12. Quiescent water puddles in the region of flow separation on the concave surface of a stalled blade.

Figure 12, plate 32, is a photograph of the leading edge of the concave side of a blade in the cascade. The long photographic exposure time of 1 s indicates that the water puddles were almost stationary implying a separation of the steam flow over this region of the blade. Whether this unsatisfactory condition exists in the turbine can only be checked with new equipment since this part of the blade is beyond the field of view of the present periscope.

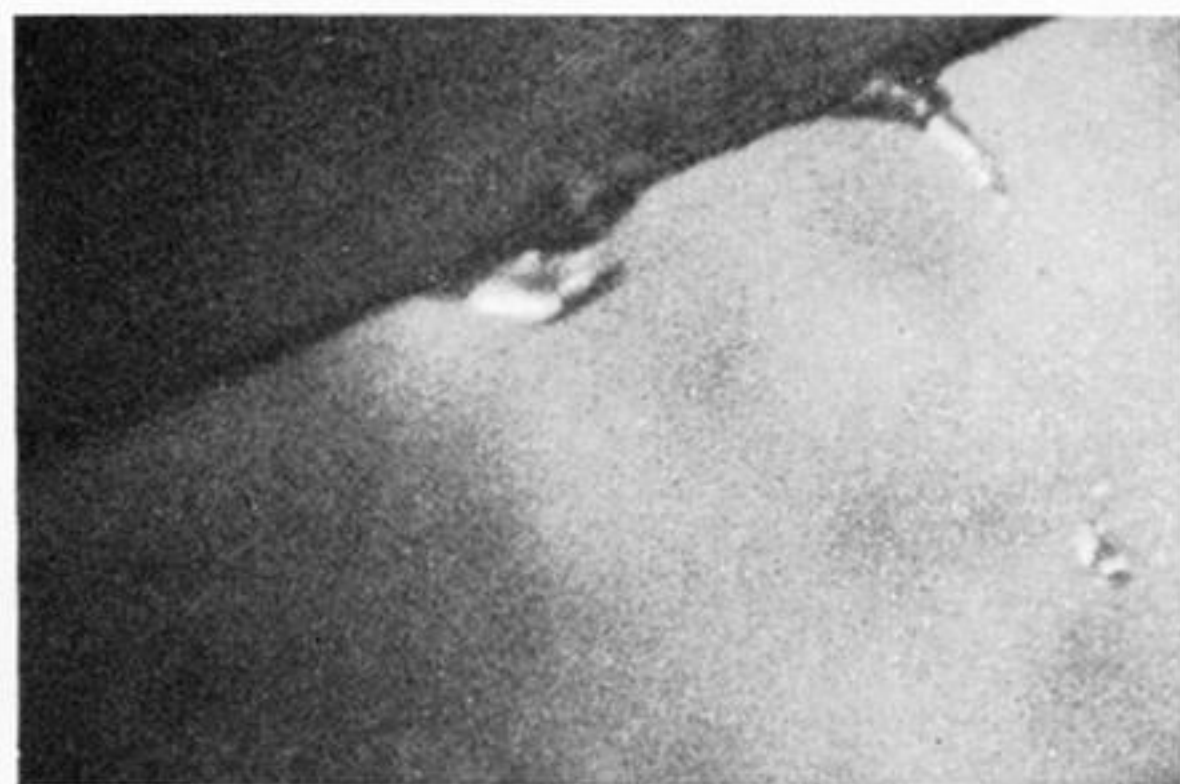
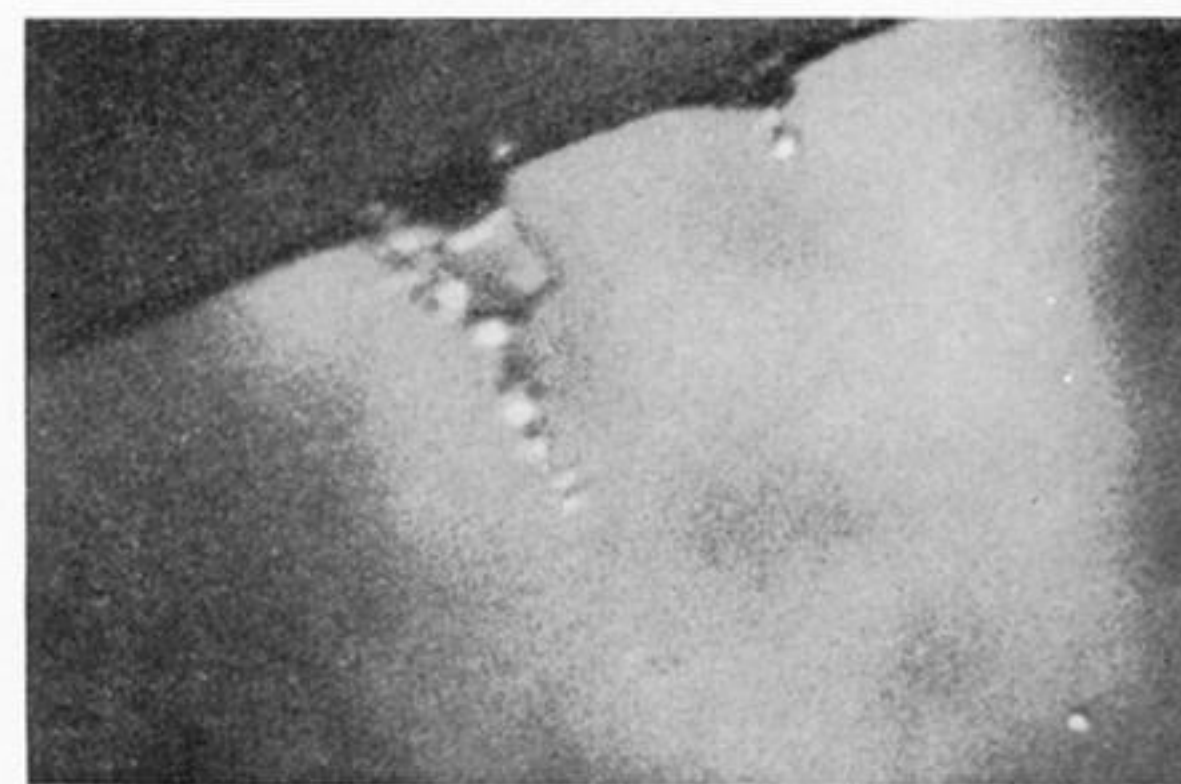
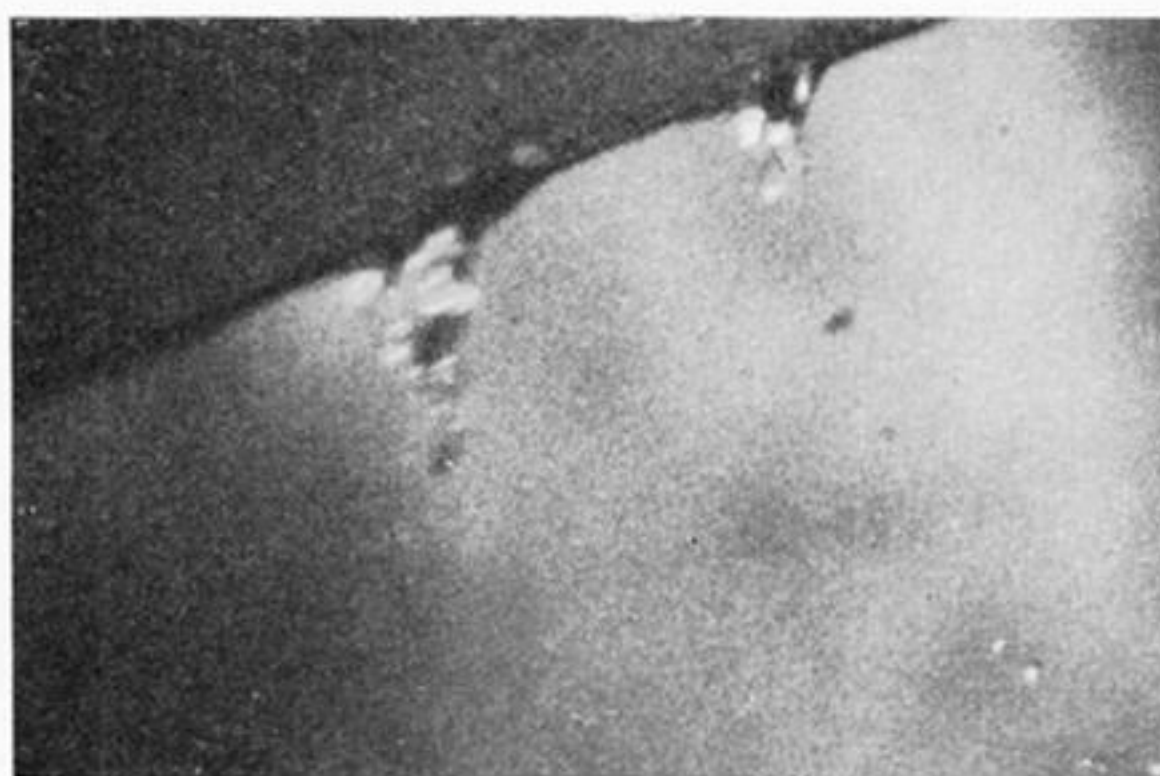
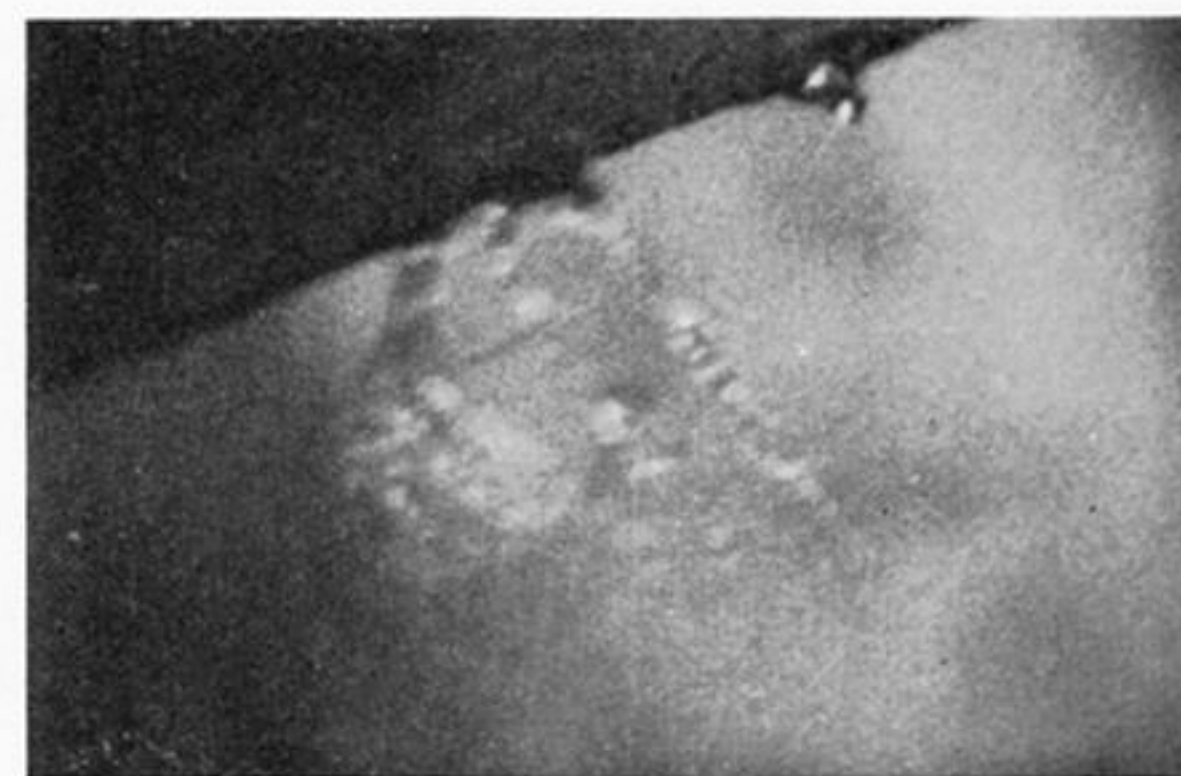
FIGURE 11. Section of ciné film showing water drops stripping from the trailing edge of the centre blade in figure 10. Steam conditions 0.66 Lb./in.^2 (abs.) and 1020 ft./s. (Read downwards, from left to right.)

FIGURE 11. Section of ciné film showing water drops stripping from the trailing edge of the centre blade in figure 10. Steam conditions 0.66 Lb./in.² (abs.) and 1020 ft./s. (Read downwards, from left to right.)

A typical sequence of frames printed from one of the ciné films is reproduced in figure 11, plate 36, and shows the drops formed downstream of the blade from the same viewpoint as figure 10, plate 35. An analysis of a number of films showed that a wide range of sizes were produced at any one steam condition but the average size decreased with both increasing pressure and velocity. The range was 700 to 1600 μm diameter for the lowest velocity and pressure and 350 to 700 μm diameter for the highest.

The corresponding average drop velocities $\frac{3}{4}$ in. downstream from the blade were only 25 and 60 ft./s respectively. Beyond this distance and within the region up to about $1\frac{1}{2}$ in. from the blade the drops were seen to accelerate and break up owing, it is assumed, to their leaving the low speed wake of the blade and entering the main stream. This is consistent with the periscope observations that drops up to 1400 μm diameter were seen leaving the fixed blades but no drops larger than 450 μm diameter were seen approaching the rotating blades. The secondary breakup mechanism is to be studied in more detail with a higher speed camera.
