Description of the Damage in Steam Turbine Blading due to Erosion by Water Droplets

J. Caldwell

Phil. Trans. R. Soc. Lond. A 1966 **260**, 204-208

The English Electric Company Limited, Rugby

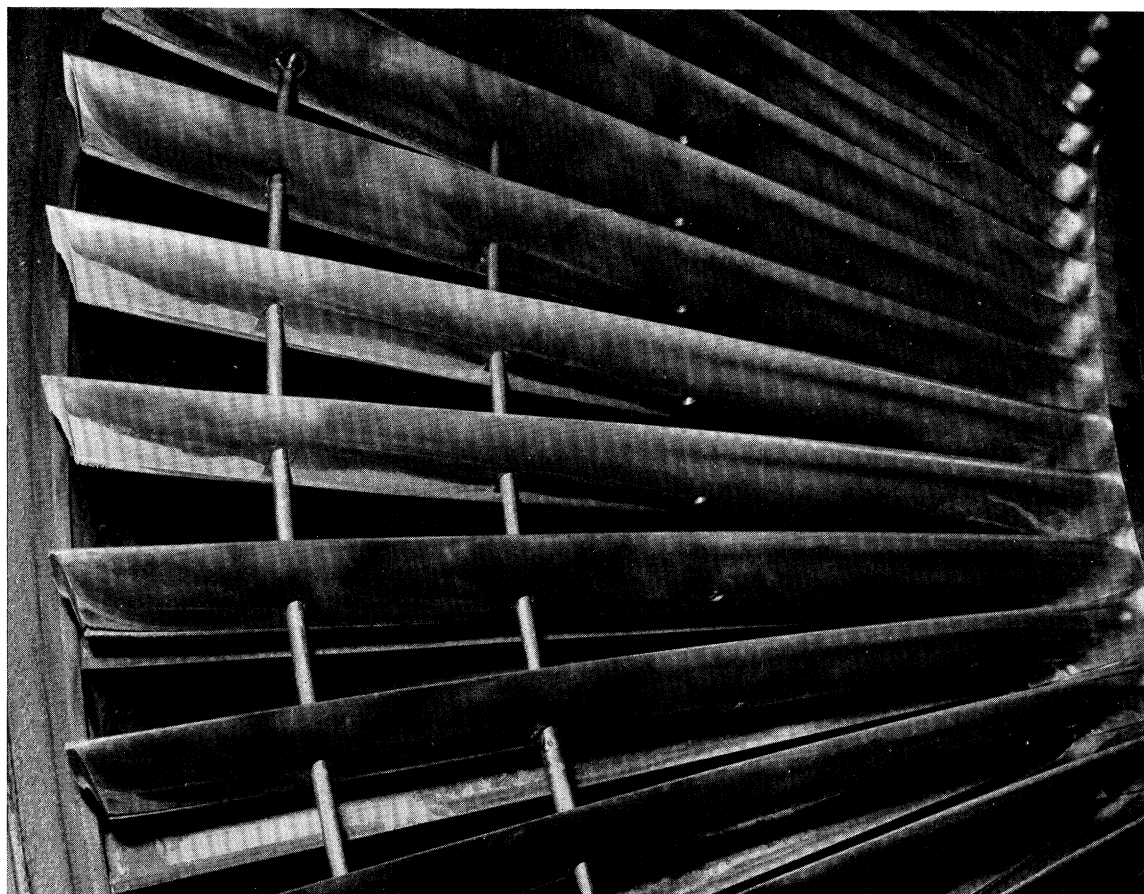
FIGURE 3. Tangential erosion of stainless iron blades behind the cobalt alloy shields. The middle blades are of stainless iron, those on either hand of manganese nickel steel (0.8% Mn, 0.9% Ni) hard chromium plated to a thickness of 0.001 in.

The turbine designer is naturally interested in deformation and damage to his blading caused by the impact of water drops. He knows from experience that blading steels in the moderately hard condition best suited to withstand the high mean stress due to centrifugal forces and the possible excitation of vibration are not in the best state for withstanding erosion attack. It is therefore the practice to harden blades by various means along the outer length of the leading edge or over the whole tip area. Alternatively, hardened shields may be attached on the leading edges by welding or the use of silver solder.

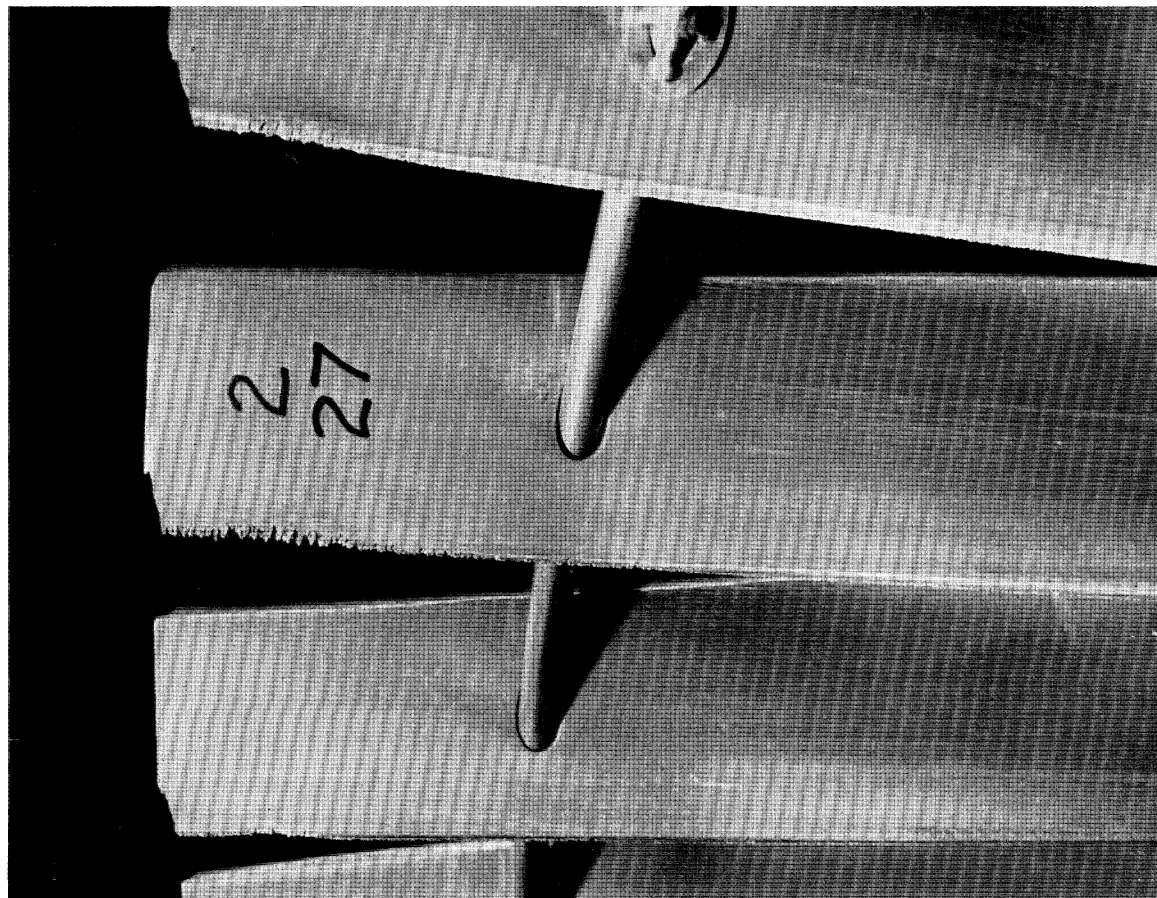
FIGURE 6. The erosion damage on the 36 in. blading run in connexion with the wide closely set diaphragm of figure 4 opposite.

Figures 4 and 5, plate 42, show two arrangements of the stationary diaphragm, or ring of nozzles, associated with a wheel carrying blades 36 in. long with a tip diameter of 136 in., operating at 3000 rev/min. The axial spacing has been increased from 0.9 to 4.3 in. and the nozzle vanes reduced in number and chord width. As the two arrangements constitute the last stages of the opposing halves of a double-flow low pressure turbine (back pressure 1 in.Hg) the exposure to wet steam conditions is identical for practical purposes. The diaphragm with the original area and close axial spacing shows severe notching at the tip and an erosion marking of the blading extending inwards for some 18 in. from the tip (figure 6, plate 43), while the reduced area diaphragm with wider spacing of 4.3 in. between diaphragm and running blades shows much less notching and a reduced eroded length of 8 in. (figure 7, plate 43).

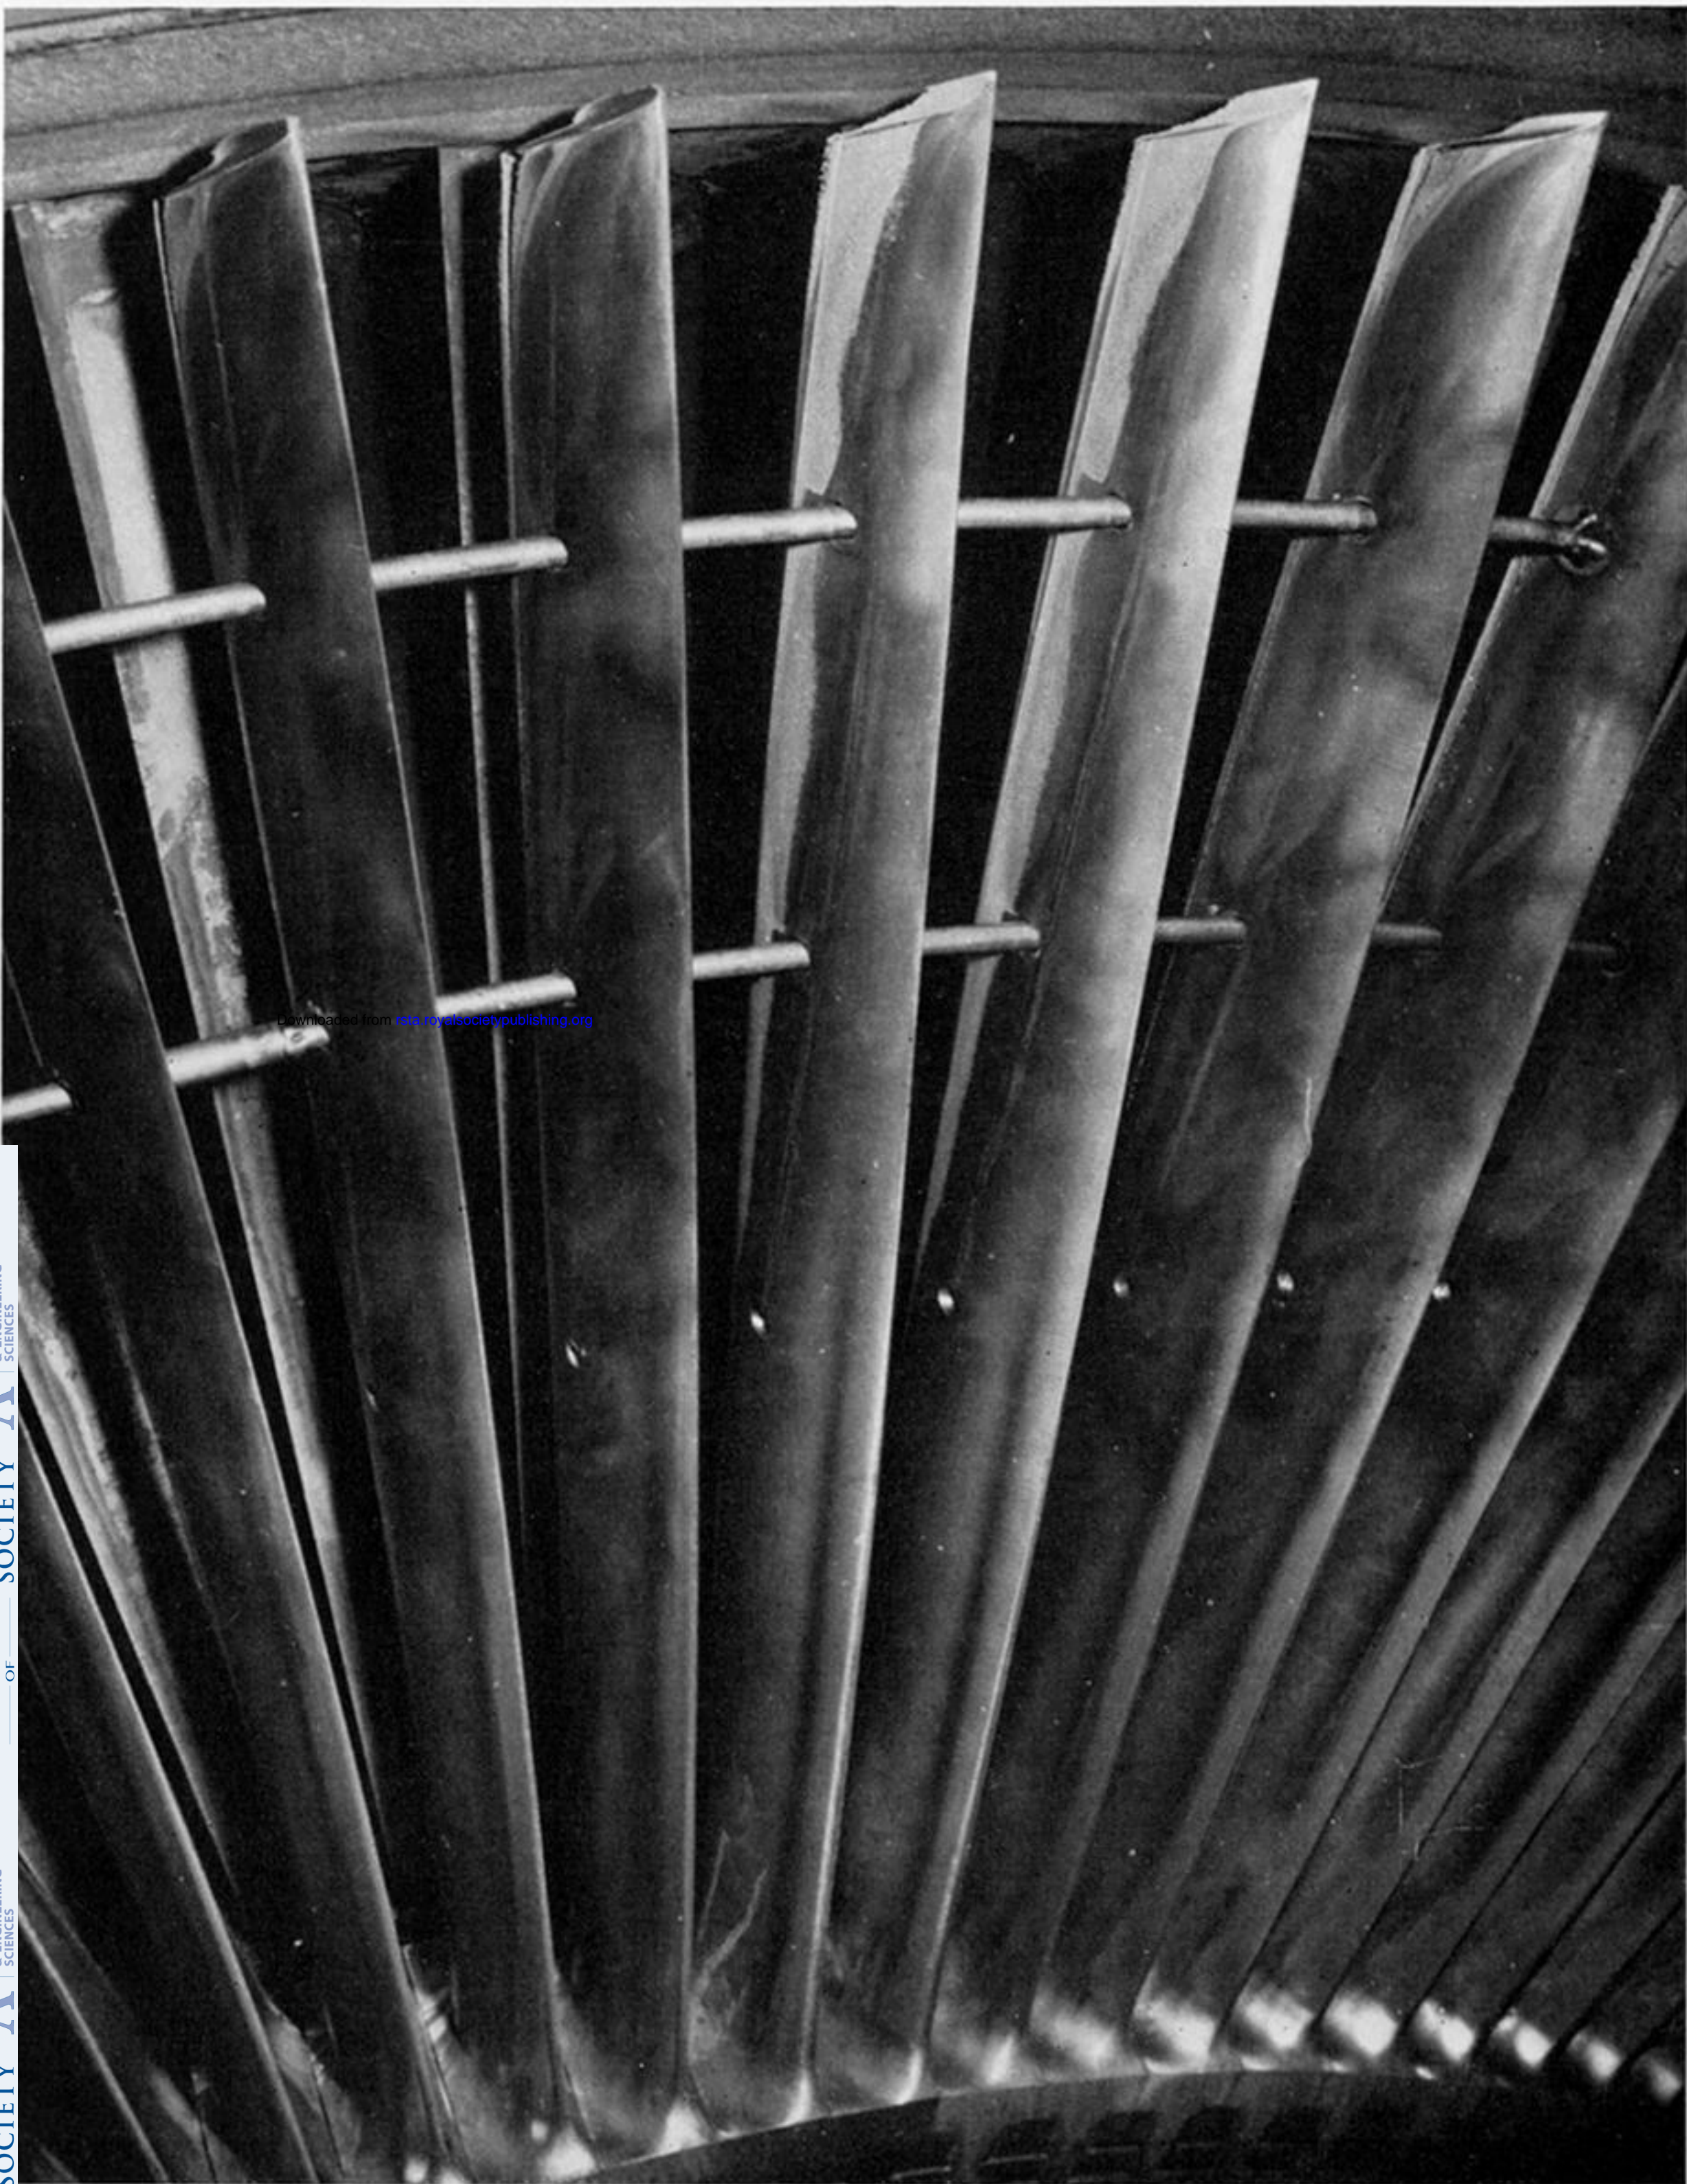
FIGURE 3. Tangential erosion of stainless iron blades behind the cobalt alloy shields. The middle blades are of stainless iron, those on either hand of manganese nickel steel (0.8 % Mn, 0.9 % Ni) hard chromium plated to a thickness of 0.001 in.

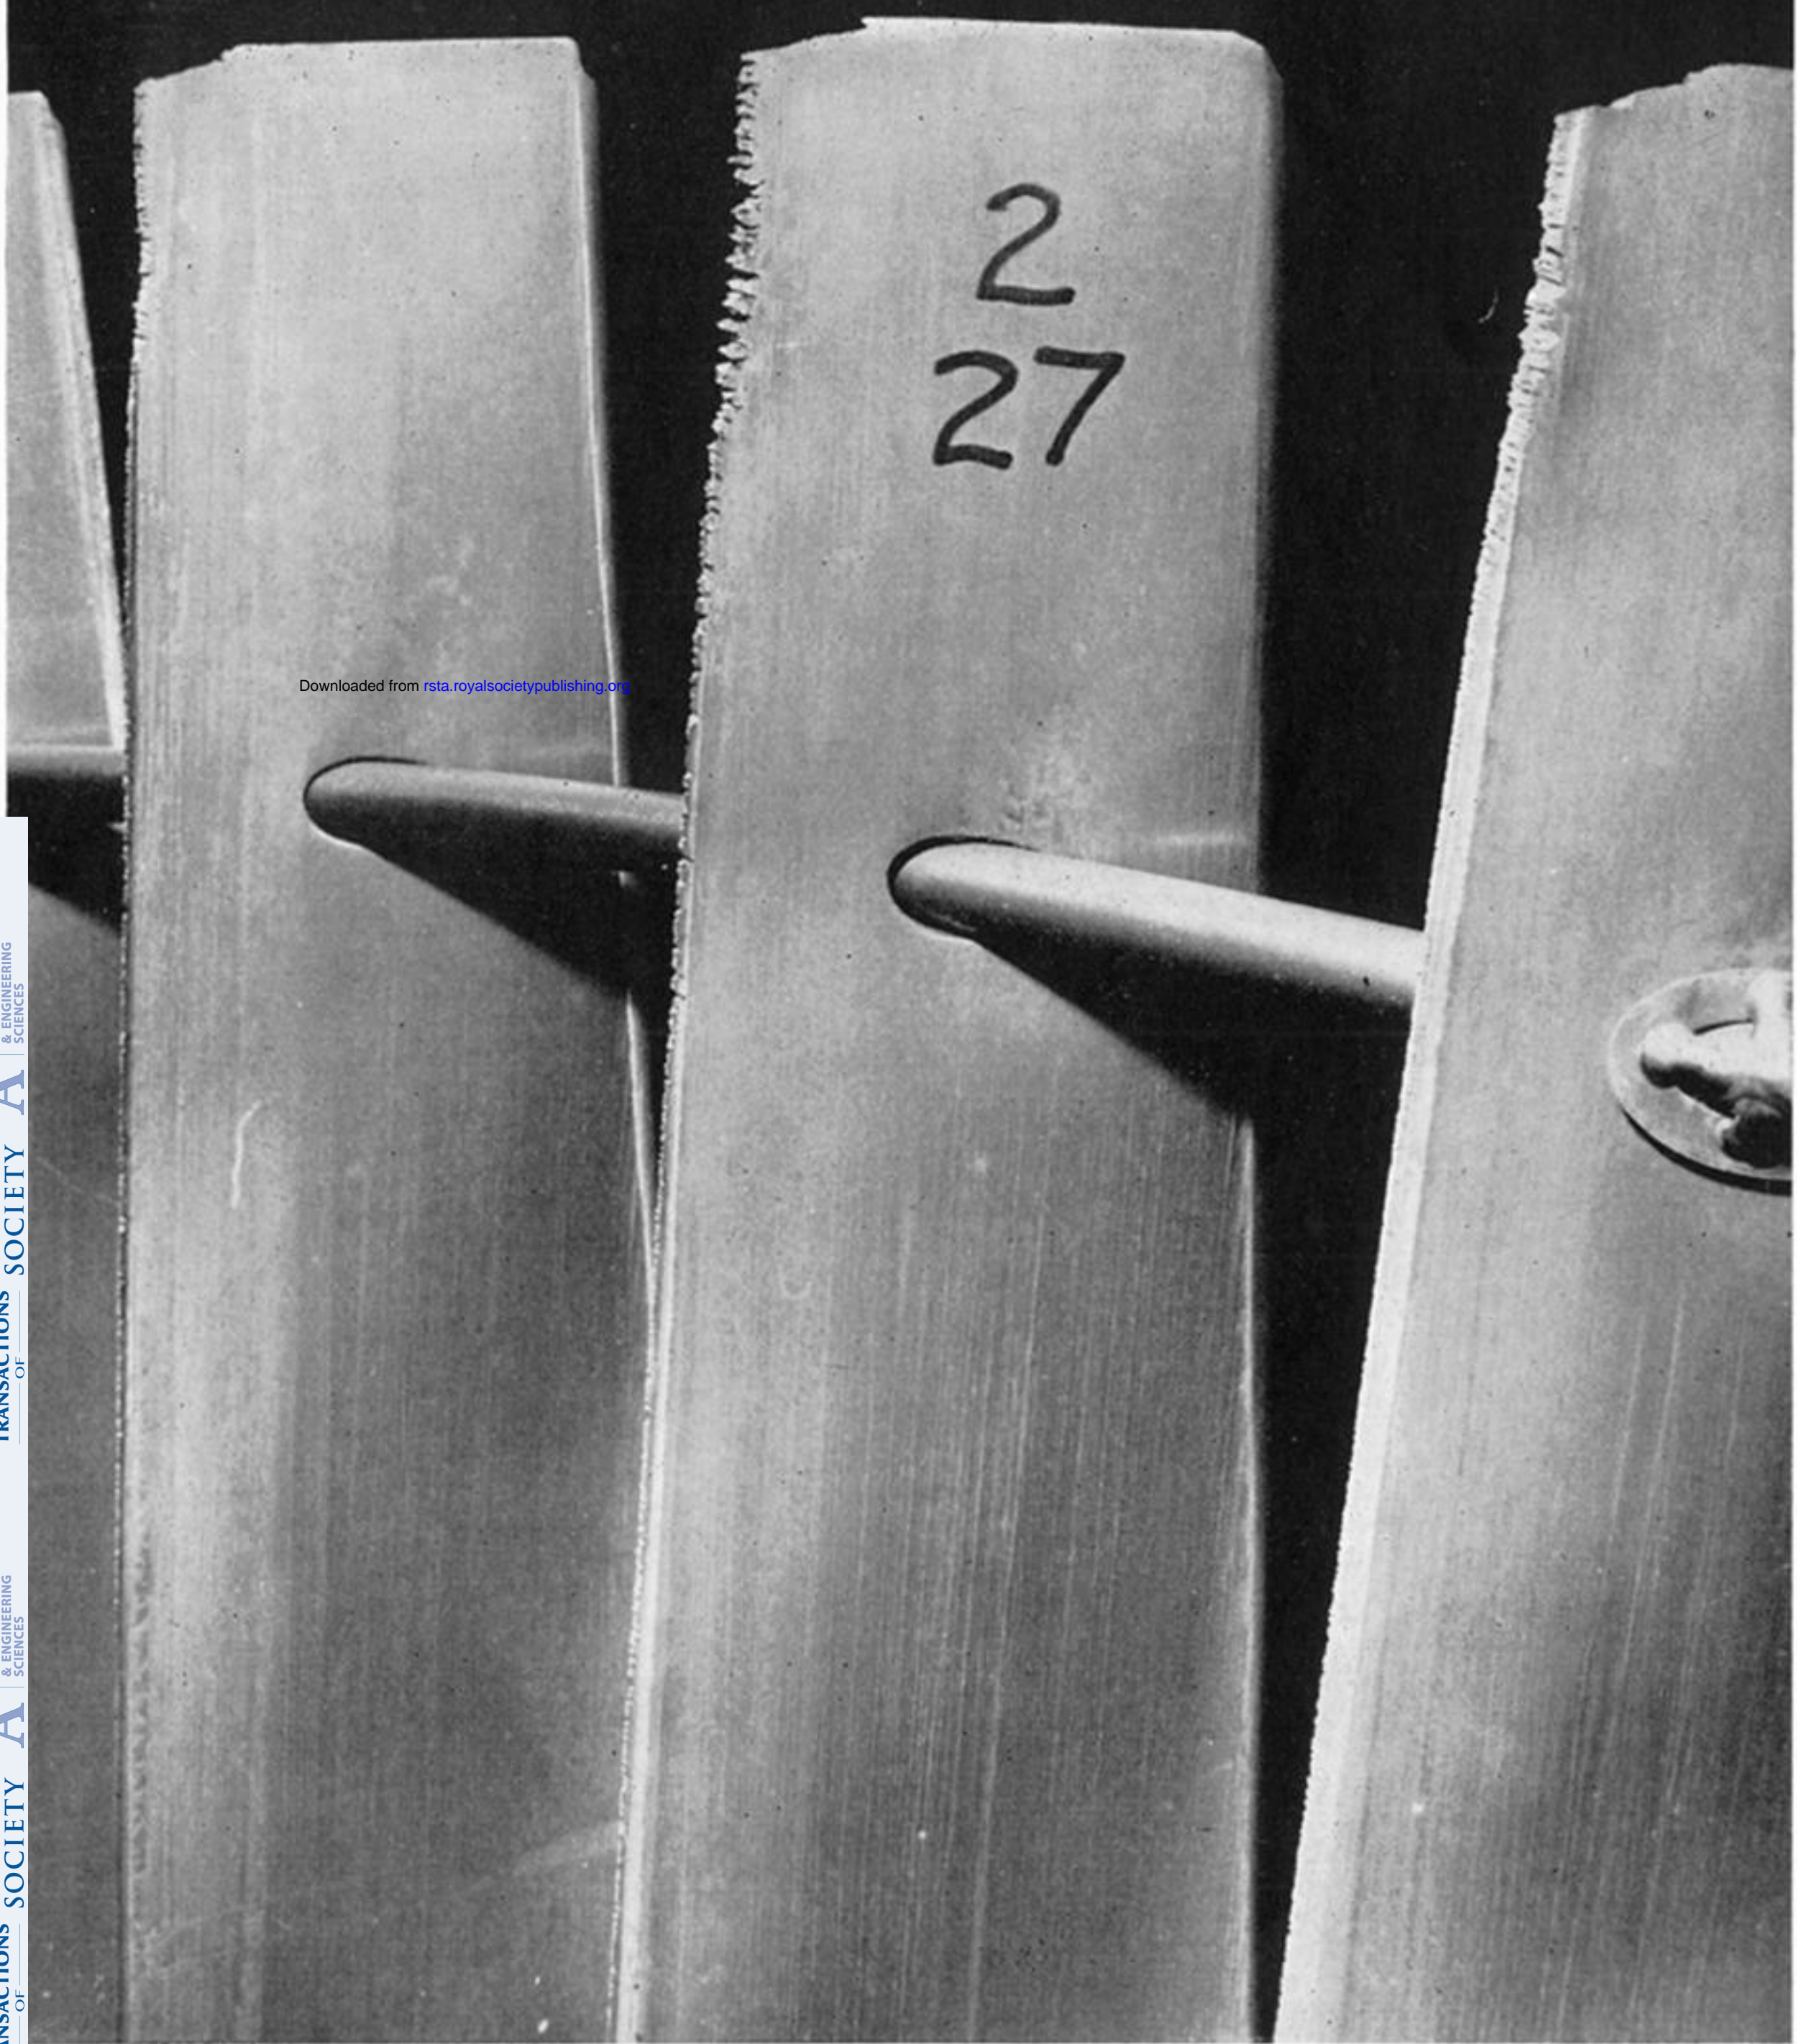
FIGURE 6. The erosion damage on the 36 in. blading run in connexion with the wide closely set diaphragm of figure 4 opposite.

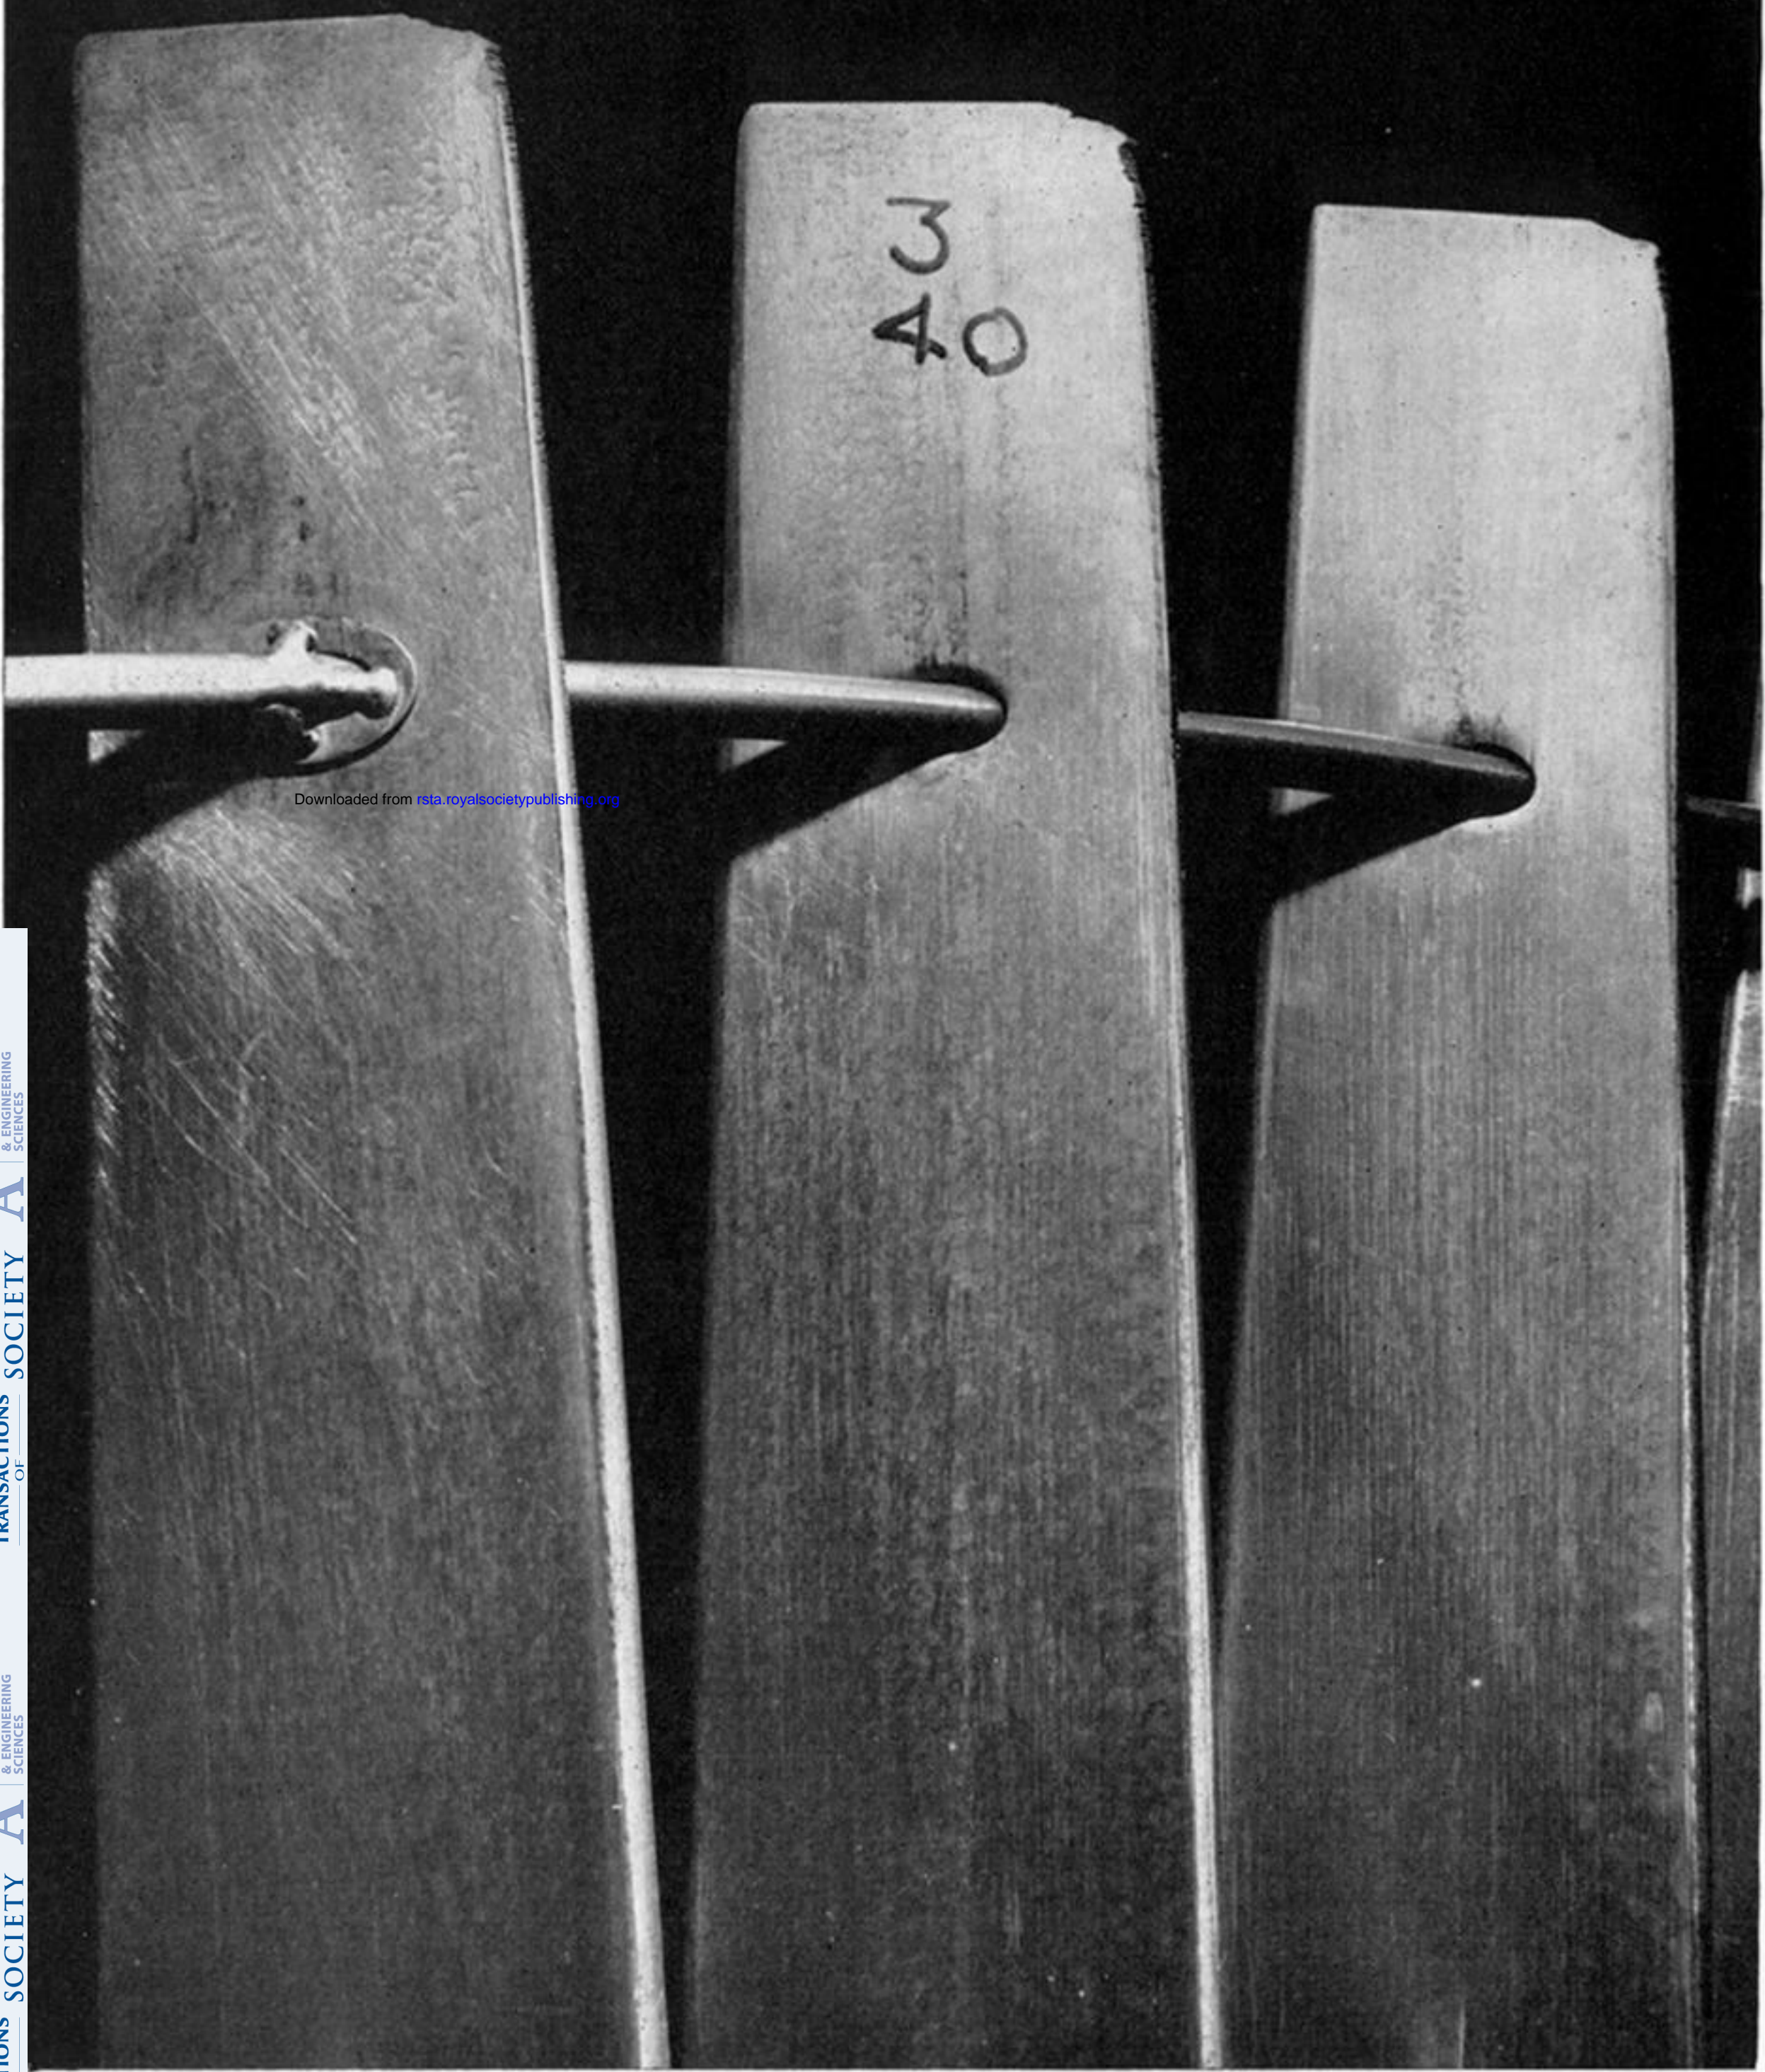
FIGURE 7. The greatly reduced damage resulting from the use of the narrow diaphragm set farther back from the running blades as in figure 5.
