## The development of an abandoned cliff in London Clay at Hadleigh, Essex

BY J. N. HUTCHINSON AND T. P. GOSTELOW

*Department of Civil Engineering, Imperial College, University of London*

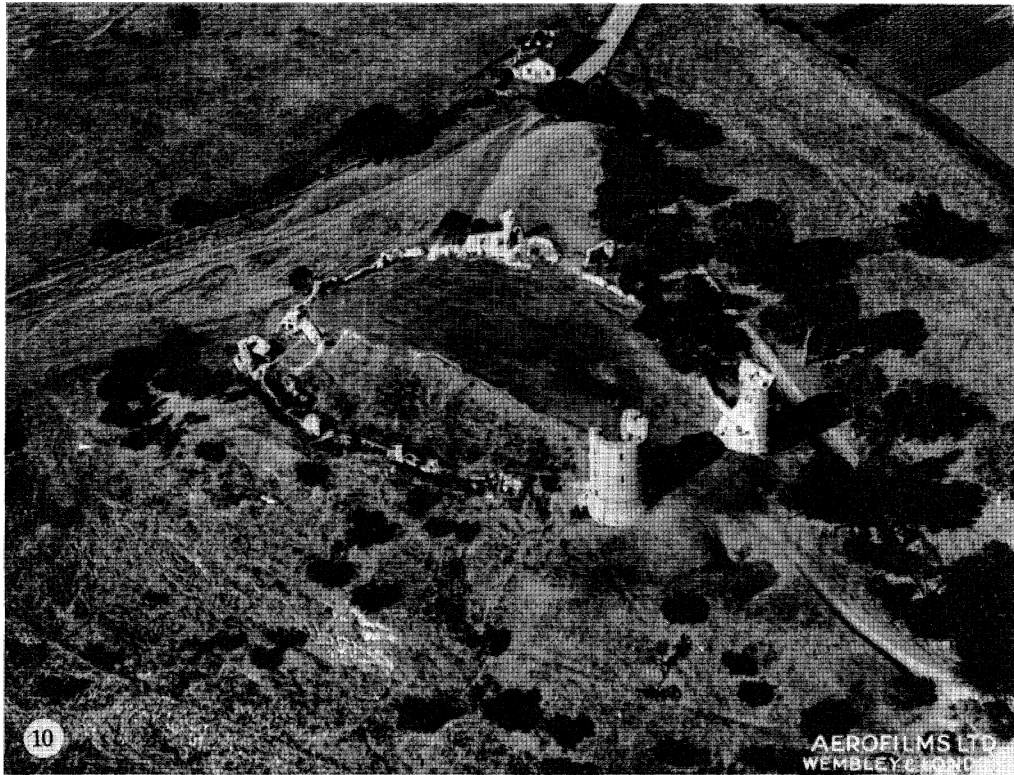
FIGURE 10. Oblique aerial photograph of Hadleigh Cliff, looking NW, taken 6 October 1928 (with acknowledgements to Aerofilms Ltd).

several related movements in about the 1890s. For convenience it will be referred to as the 'late-19th century landslip'. Oblique aerial photographs of Hadleigh Cliff and Castle, showing this landslip, have been taken on various dates. Those of 1928 and 1967 are shown, respectively, in figures 10 and 11, plate 9. From these photographs, and particularly from that of 1928, the sharp eastern boundary of the landslip and the relative stability of the adjoining part of the cliff below tower C are evident. These may reflect better drainage conditions there, resulting possibly from the proximity of the side valley to the northeast.

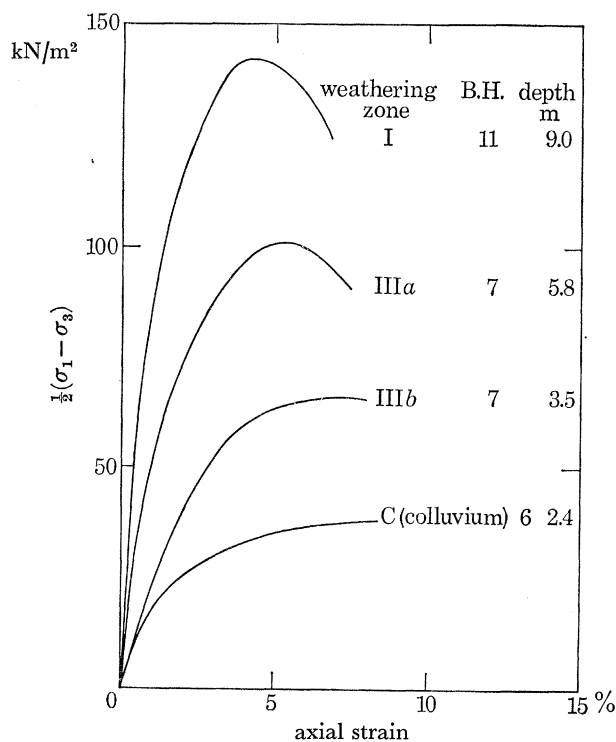
FIGURE 17. Stress-strain curves for quick undrained, 100 mm diameter triaxial tests on London Clay of various degrees of weathering.

The influence of the degree of weathering on the mechanical properties of the London Clay has been explored to a limited extent. Nineteen unconsolidated, undrained triaxial tests on 100 mm diameter samples taken from U100 sample tubes have been carried out on material from weathering zones I, IIIa and IIIb and on the colluvium. The samples were tested at a strain rate of 0.26 % per minute. Although other variables are also involved, the typical test results (figure 17) illustrate the tendency for the undrained modulus, peak shear strength and brittleness to decrease as the degree of weathering increases.

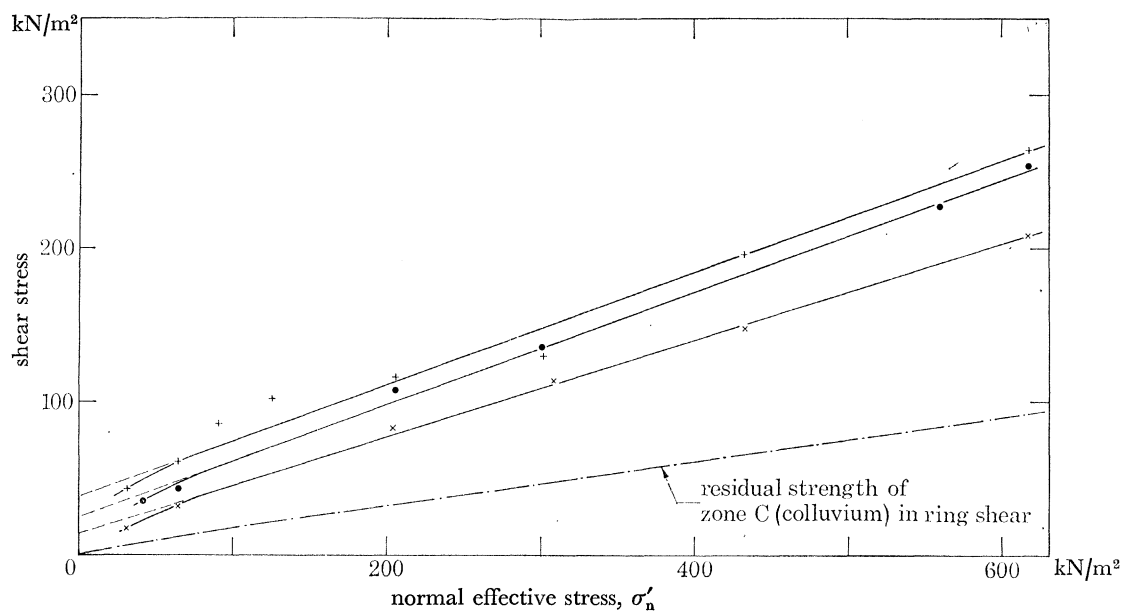
FIGURE 19. Drained peak failure envelopes for the London Clay samples tested in direct shear.

weathering zone	peak strength results in direct shear	approx. effective stress peak parameters for $\sigma'_n$ range of 300–600 kN/m <sup>2</sup>	
		$c'$ (kN/m <sup>2</sup> )	$\phi'$
I	+	38	20°
II	●	24	20°
C (colluvium)	×	14	17½°

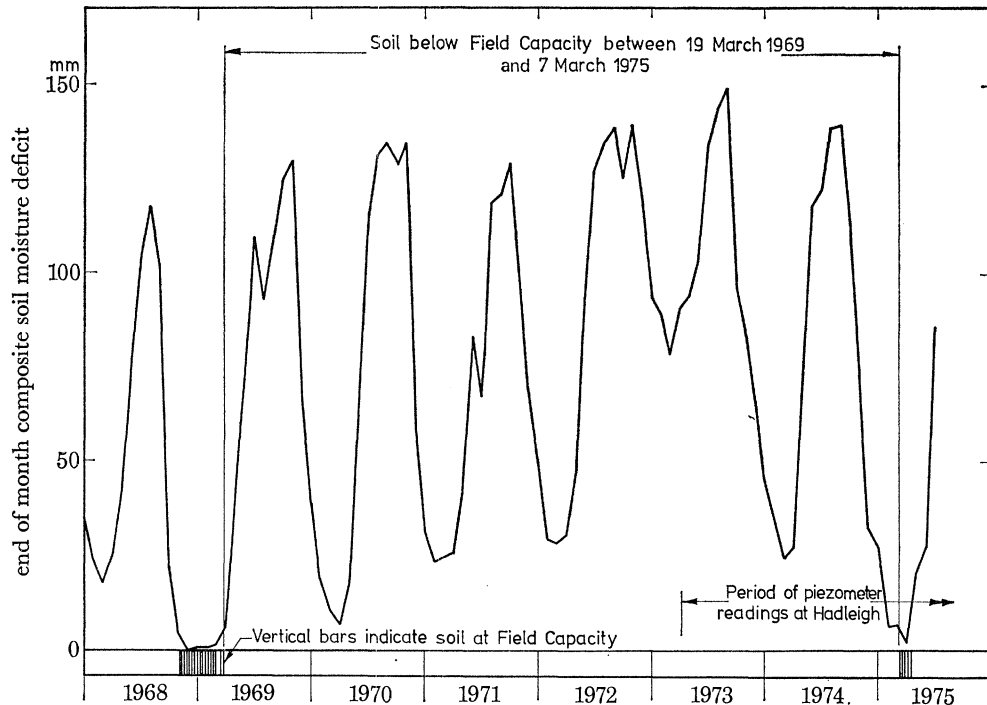
FIGURE 23. Plot showing variation in end of month, composite soil moisture deficit at Shoeburyness for the period 1968-75.

The general point to be drawn from the s.m.d. plot in figure 23 is that the conventional approach to the determination of maximum seasonal ground-water levels, of reading piezometers through the winter and spring, or even for a complete year, can be entirely inadequate in a climatic situation of the present type, where the ground-water levels may have to be observed through a number of consecutive winters before a reasonable approximation to their true maximum is found.

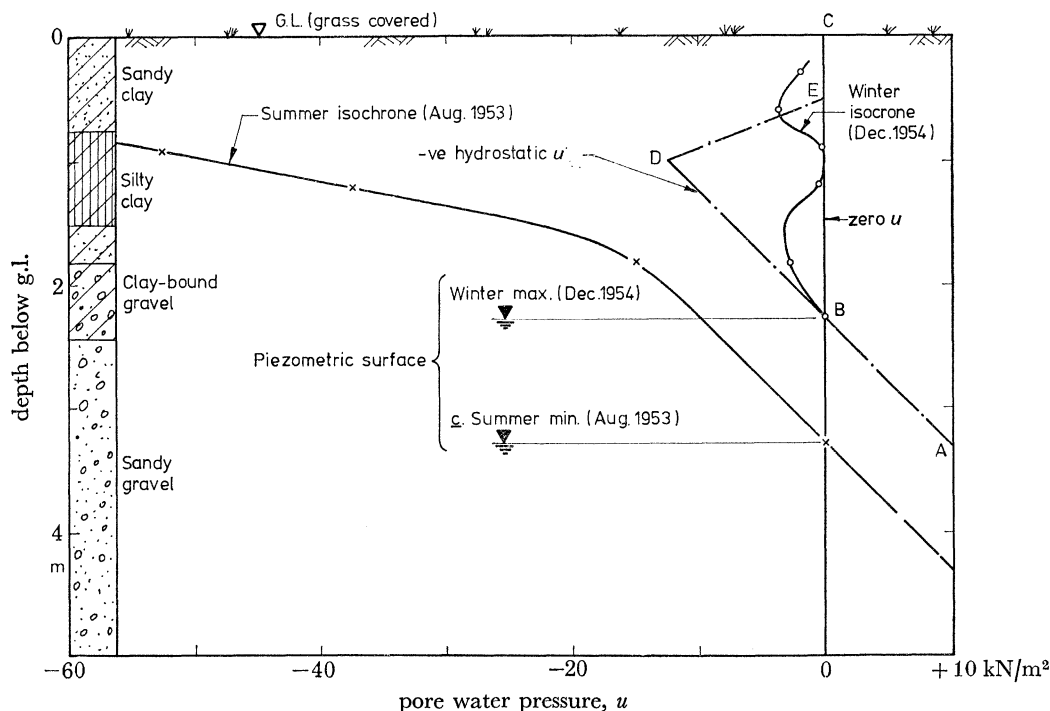
FIGURE 26. Summer and winter isochrones observed in a ground profile at Harmondsworth (after Black, Croney & Jacobs 1958).

No measurements of negative pore-water pressures have been made at Hadleigh. From the work of Black, Croney & Jacobs (1958), however, it is evident that a reasonable correlation exists between soil moisture deficits estimated from meteorological data (as above) and pore-water tensions in the capillary zone.

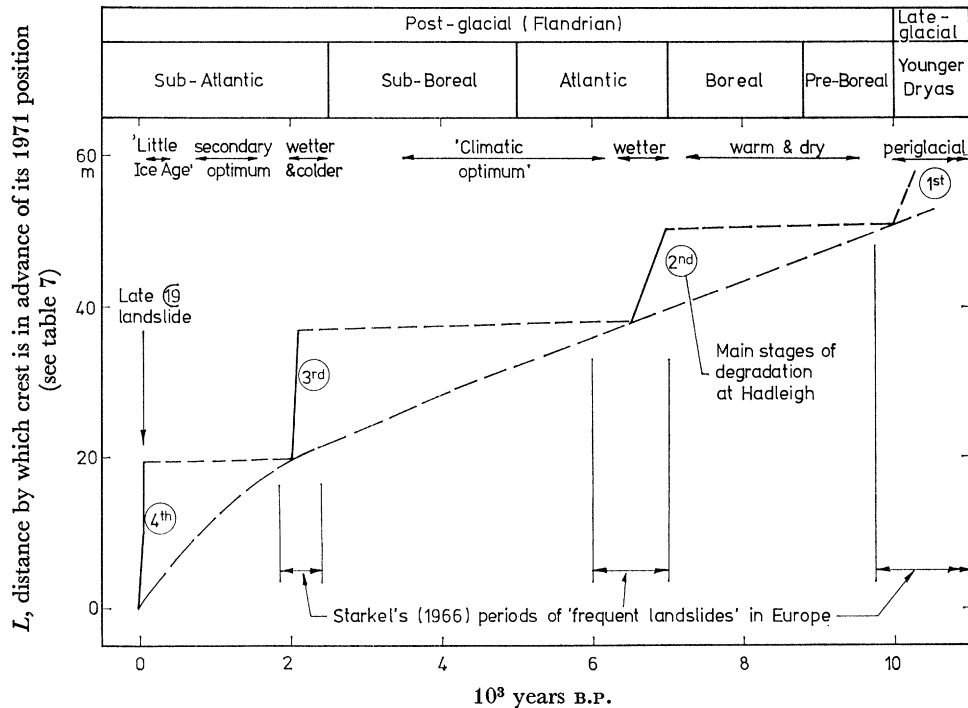
FIGURE 29. Estimated pattern of retreat in the crest of Hadleigh Cliff during the past 10 000 years. (The slight slope given to the plot in the periods of relative stability is purely nominal.) The main trends in the climate during that time (after Godwin 1956, Lamb 1959) are also shown.

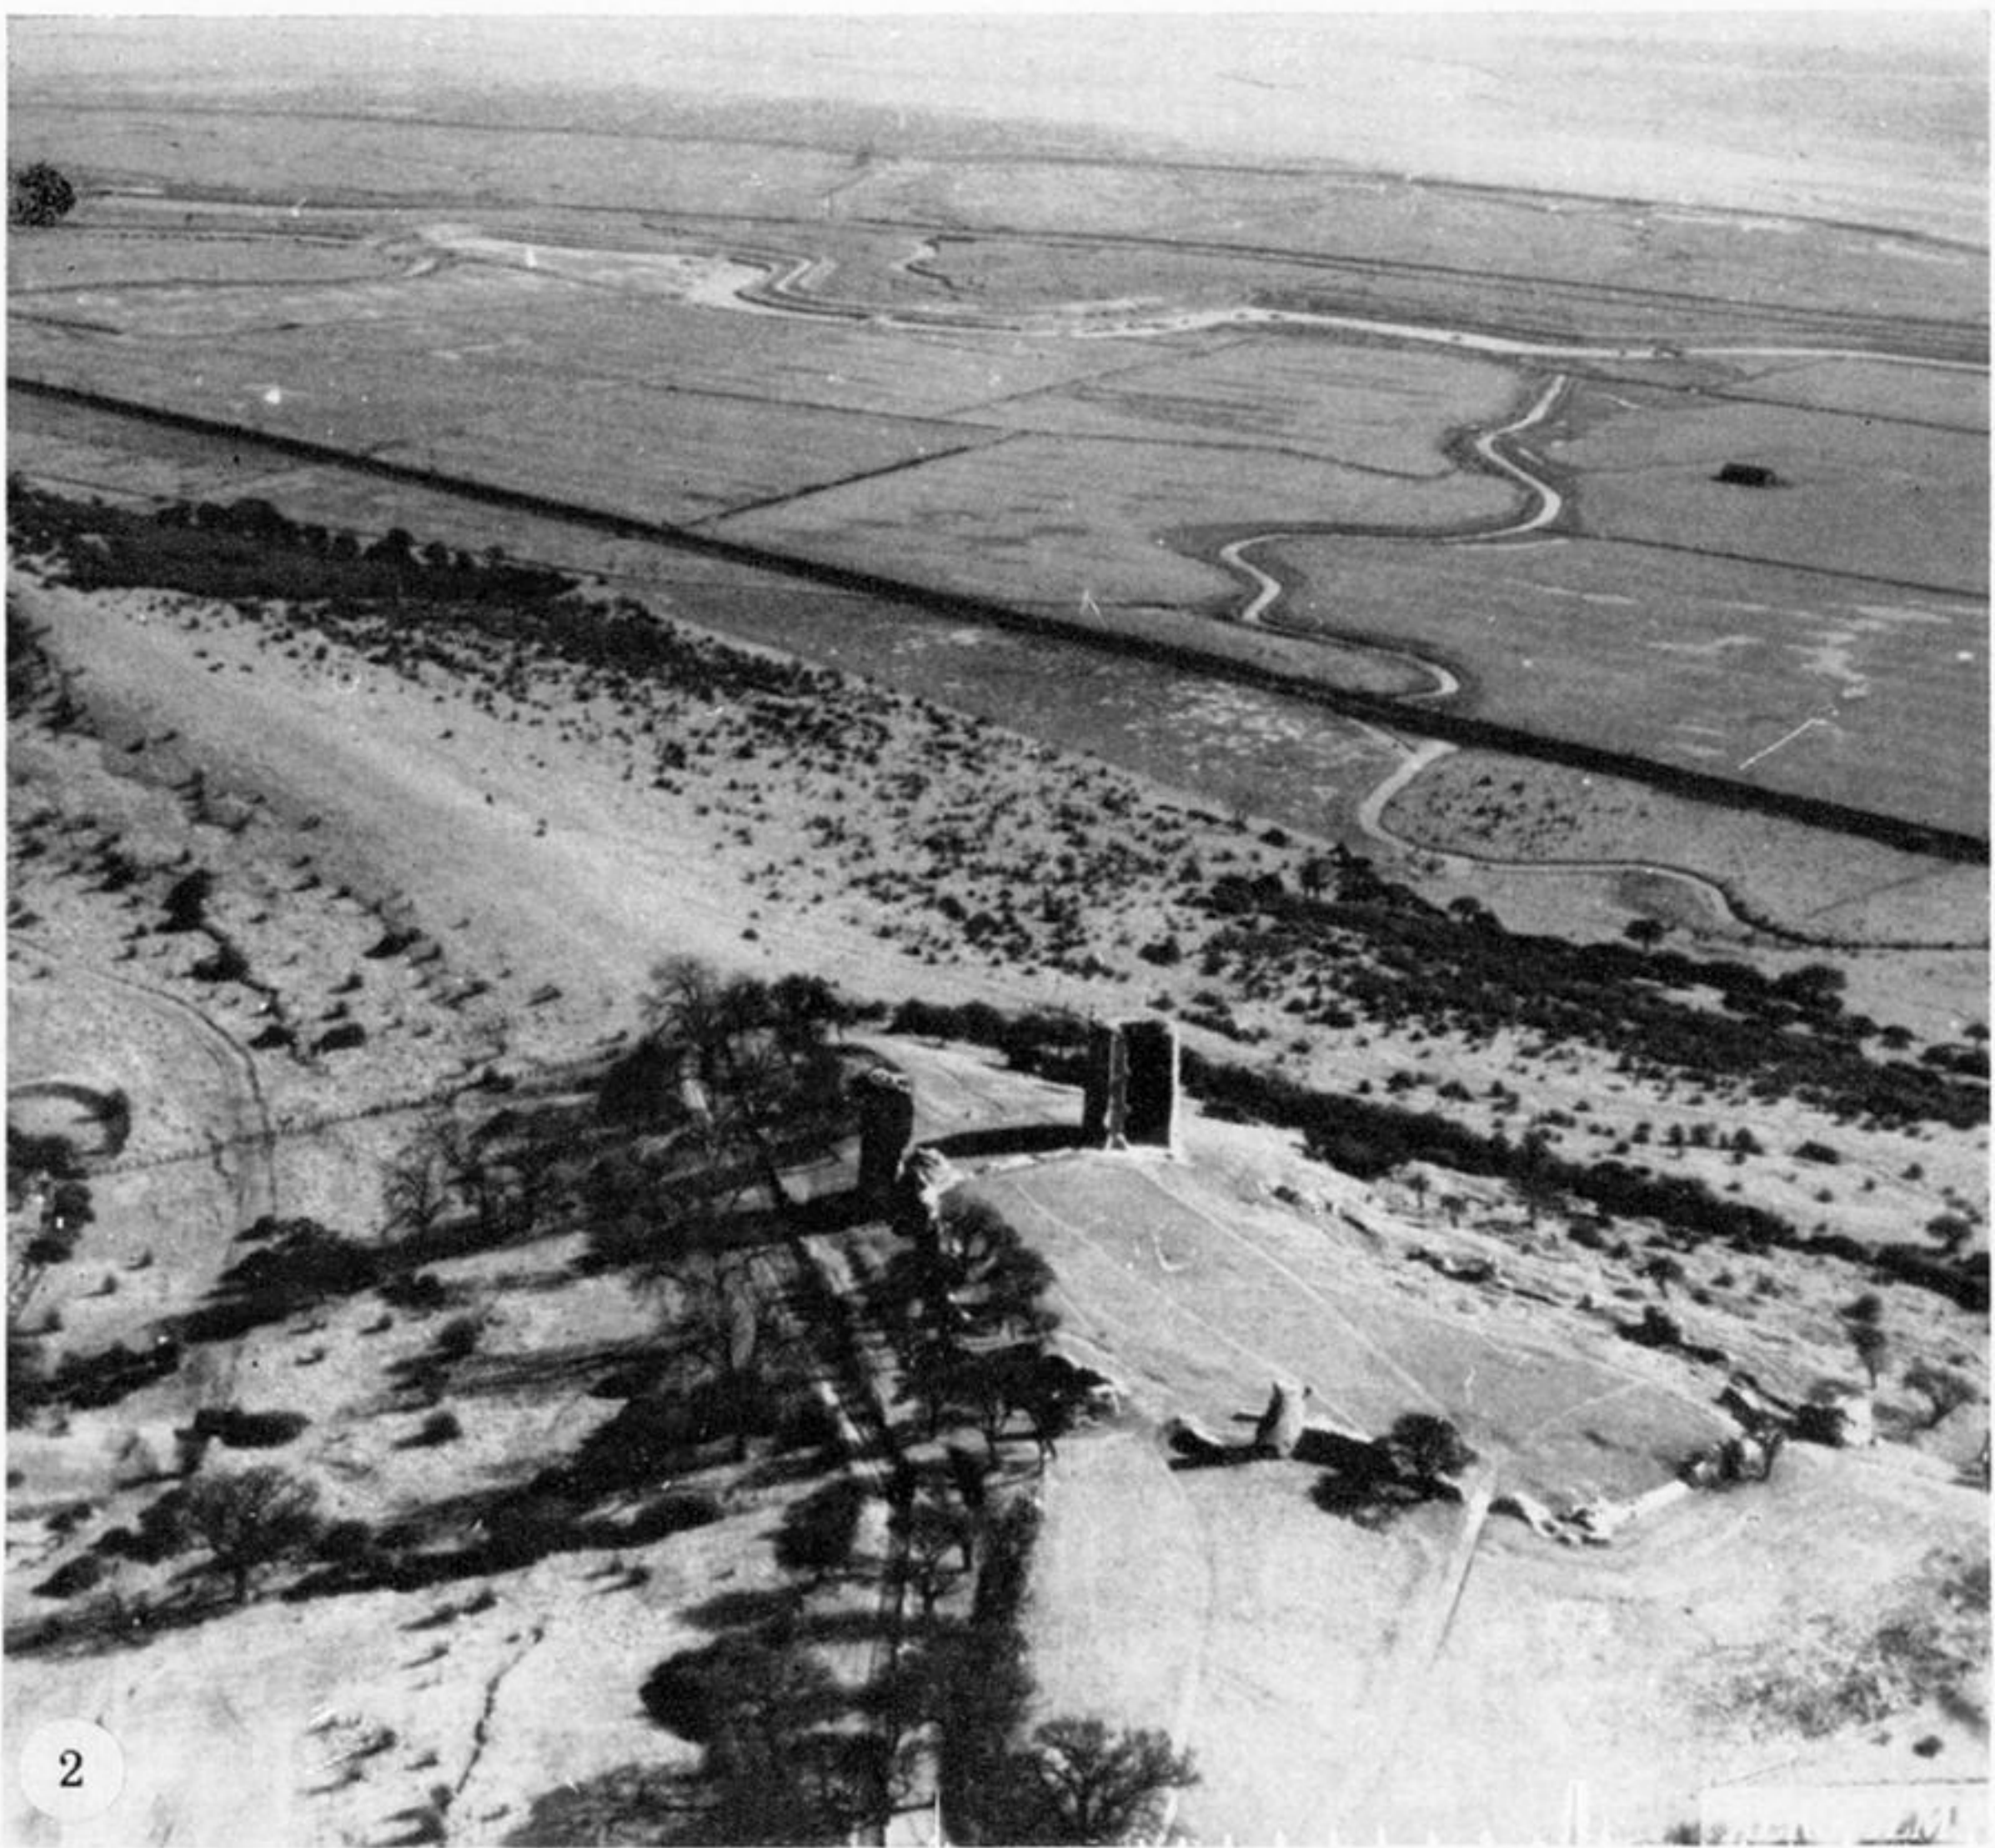
FIGURES 2 AND 6. For description see opposite.

FIGURE 2. Oblique aerial photograph of Hadleigh Castle looking southeast, taken 30 March 1954. The abandoned coastal cliff is encroaching on to the castle from the right and the River Thames is seen in the background (with acknowledgements to Aerofilms Ltd).

The present paper describes the detailed subsurface investigation of a part of the abandoned cliff line at Hadleigh (figure 2, plate 8), about 3 km west of Leigh on Sea. This slope was chosen for further study because it is geologically simple, consisting virtually entirely of London Clay, is unmodified by stabilization works, has at its foot a Flandrian marsh which seemed likely to yield datable organic material, and has on its crest a mediaeval castle which has been partly encroached upon by the more recent landslides affecting the cliff.

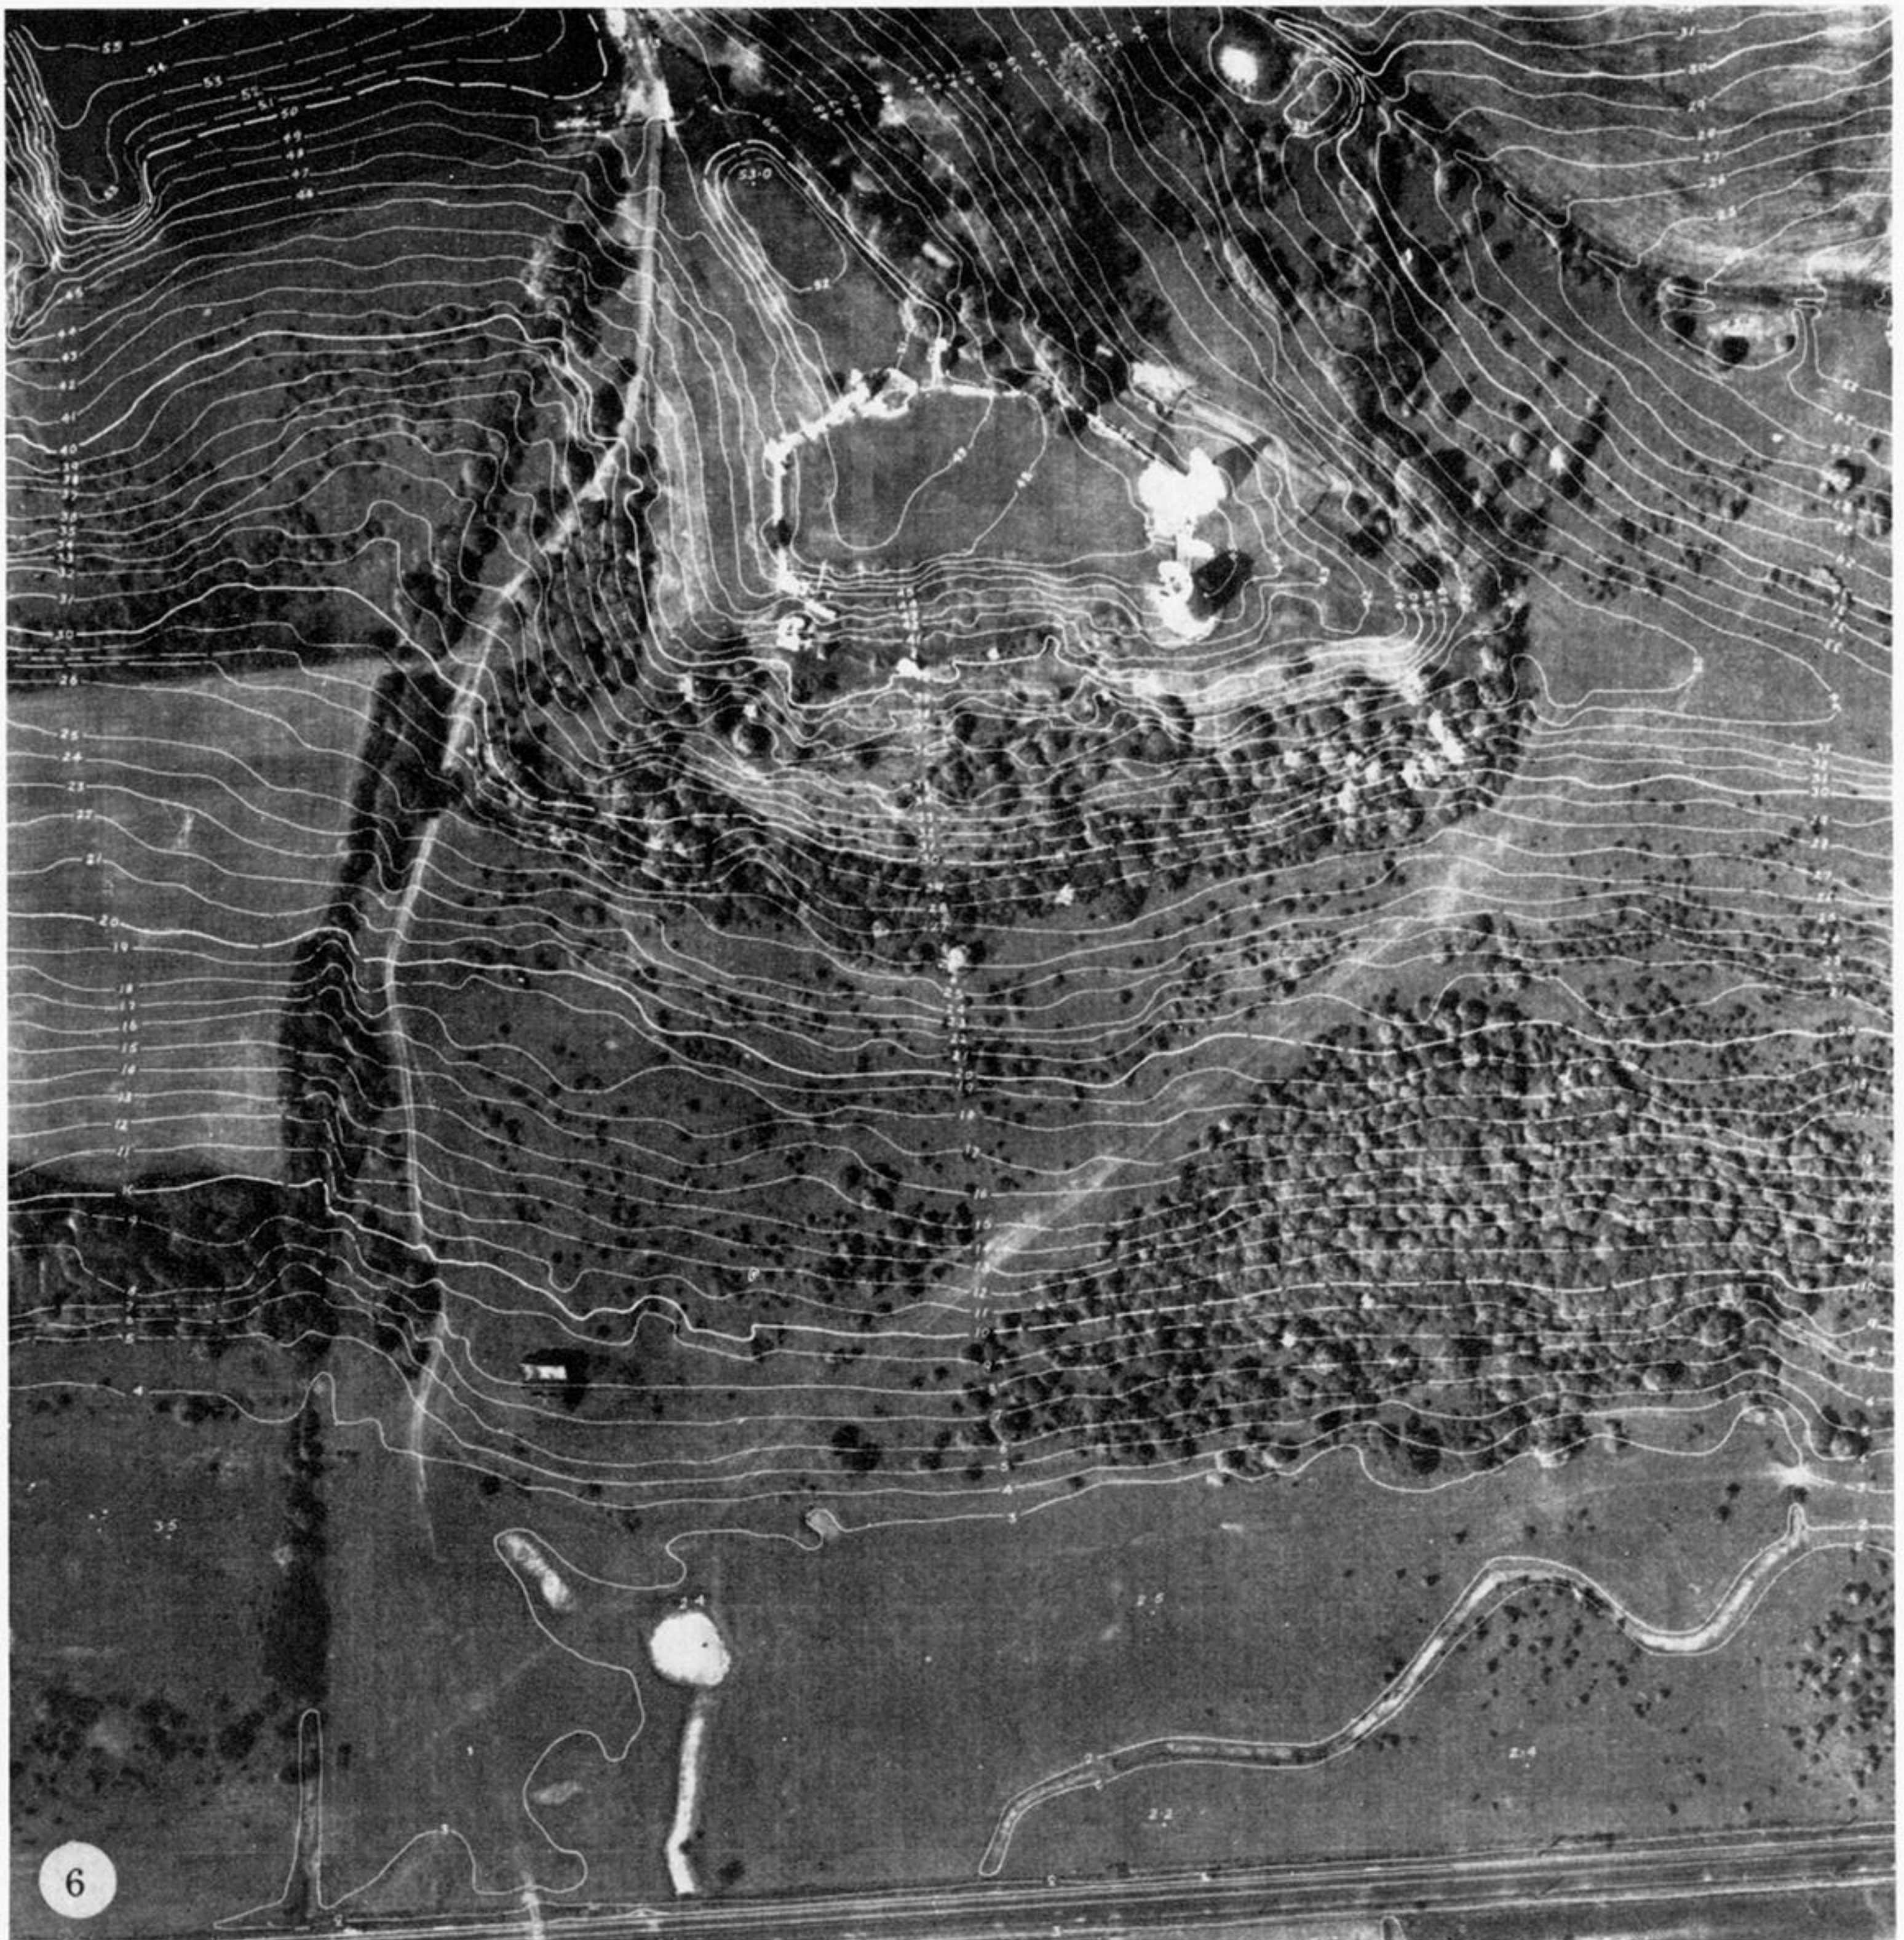
FIGURE 6. Orthophoto map of Hadleigh Cliff, with contours at 1 m vertical intervals (with acknowledgements to Fairey Surveys Ltd).

Hadleigh Castle occupies an isolated knoll of London Clay between the above-mentioned side valleys, and Hadleigh Cliff is the abandoned slope formed on its southern face. The topography of the site has been established partly by levelled sections and partly by aerial photogrammetry. By using vertical aerial photographic cover at a scale of 1:4800, taken in July 1967, an orthophoto map with a contour interval of 1 m was produced. A reduced version of this is given in figure 6, plate 8. This illustrates the nature of the castle site and of the abandoned cliff falling southwards from it to Hadleigh Marsh. The crest of the cliff has an elevation of about +47 m o.d.: its intersection with the marsh is at +3 m o.d. The southeasterly trending side valley to the northeast of the castle is shown and also part of the more complex valley to the west. The Tilbury to Southend railway line runs across the marsh to the south of the slope toe. The linear feature trending SW-NE across the abandoned slope is the track of a buried pipeline, constructed in September 1964.

A preliminary description of the morphology of the landslides occupying Hadleigh Cliff has been given by Hutchinson (1965, 1967*a*). A more detailed plan of these features, prepared from the orthophoto and a field examination, is given in figure 7. In broad terms a degradation zone in the upper cliff, inclined at an average angle of about 12°, can be recognized, fronted by a more gently inclined accumulation zone of about 8° average angle extending down to marsh level. The most prominent feature is the large rotational slip which occupies the uppermost part of the slope and has encroached upon the south curtain wall of the castle. Below this is an irregular zone of open tension cracks followed by fresh toe features in the lower part of the degradation zone, which extends down to about borehole N6. The smoother, more gently inclined accumulation zone, which extends from this point down to Hadleigh Marsh, shows little sign of recent movement except for a slight ridge in the alluvium just clear of the slip toe, which is believed to represent a passive heave. A fuller discussion of these features is deferred until later. The landslides on the adjacent length of abandoned cliff to the west, beneath Sandpit Hill and Round Hill, were noted by Whitaker (1889).

The knoll occupied by the Castle is bounded to the south by the fresh crest of the unstable abandoned cliff, and to the west and northeast by the subdued crests of the unstable, but less active, side-valley slopes (figures 6–8). The stable area available for the construction of the castle was therefore limited and, indeed, appears to have been inadequate for the size of structure built. As a result the western curtain wall and towers, from just northeast of tower G to tower F and probably tower E, were constructed below the crest of the unstable western side-valley slope and were thus founded almost certainly on old landslip material. It is not

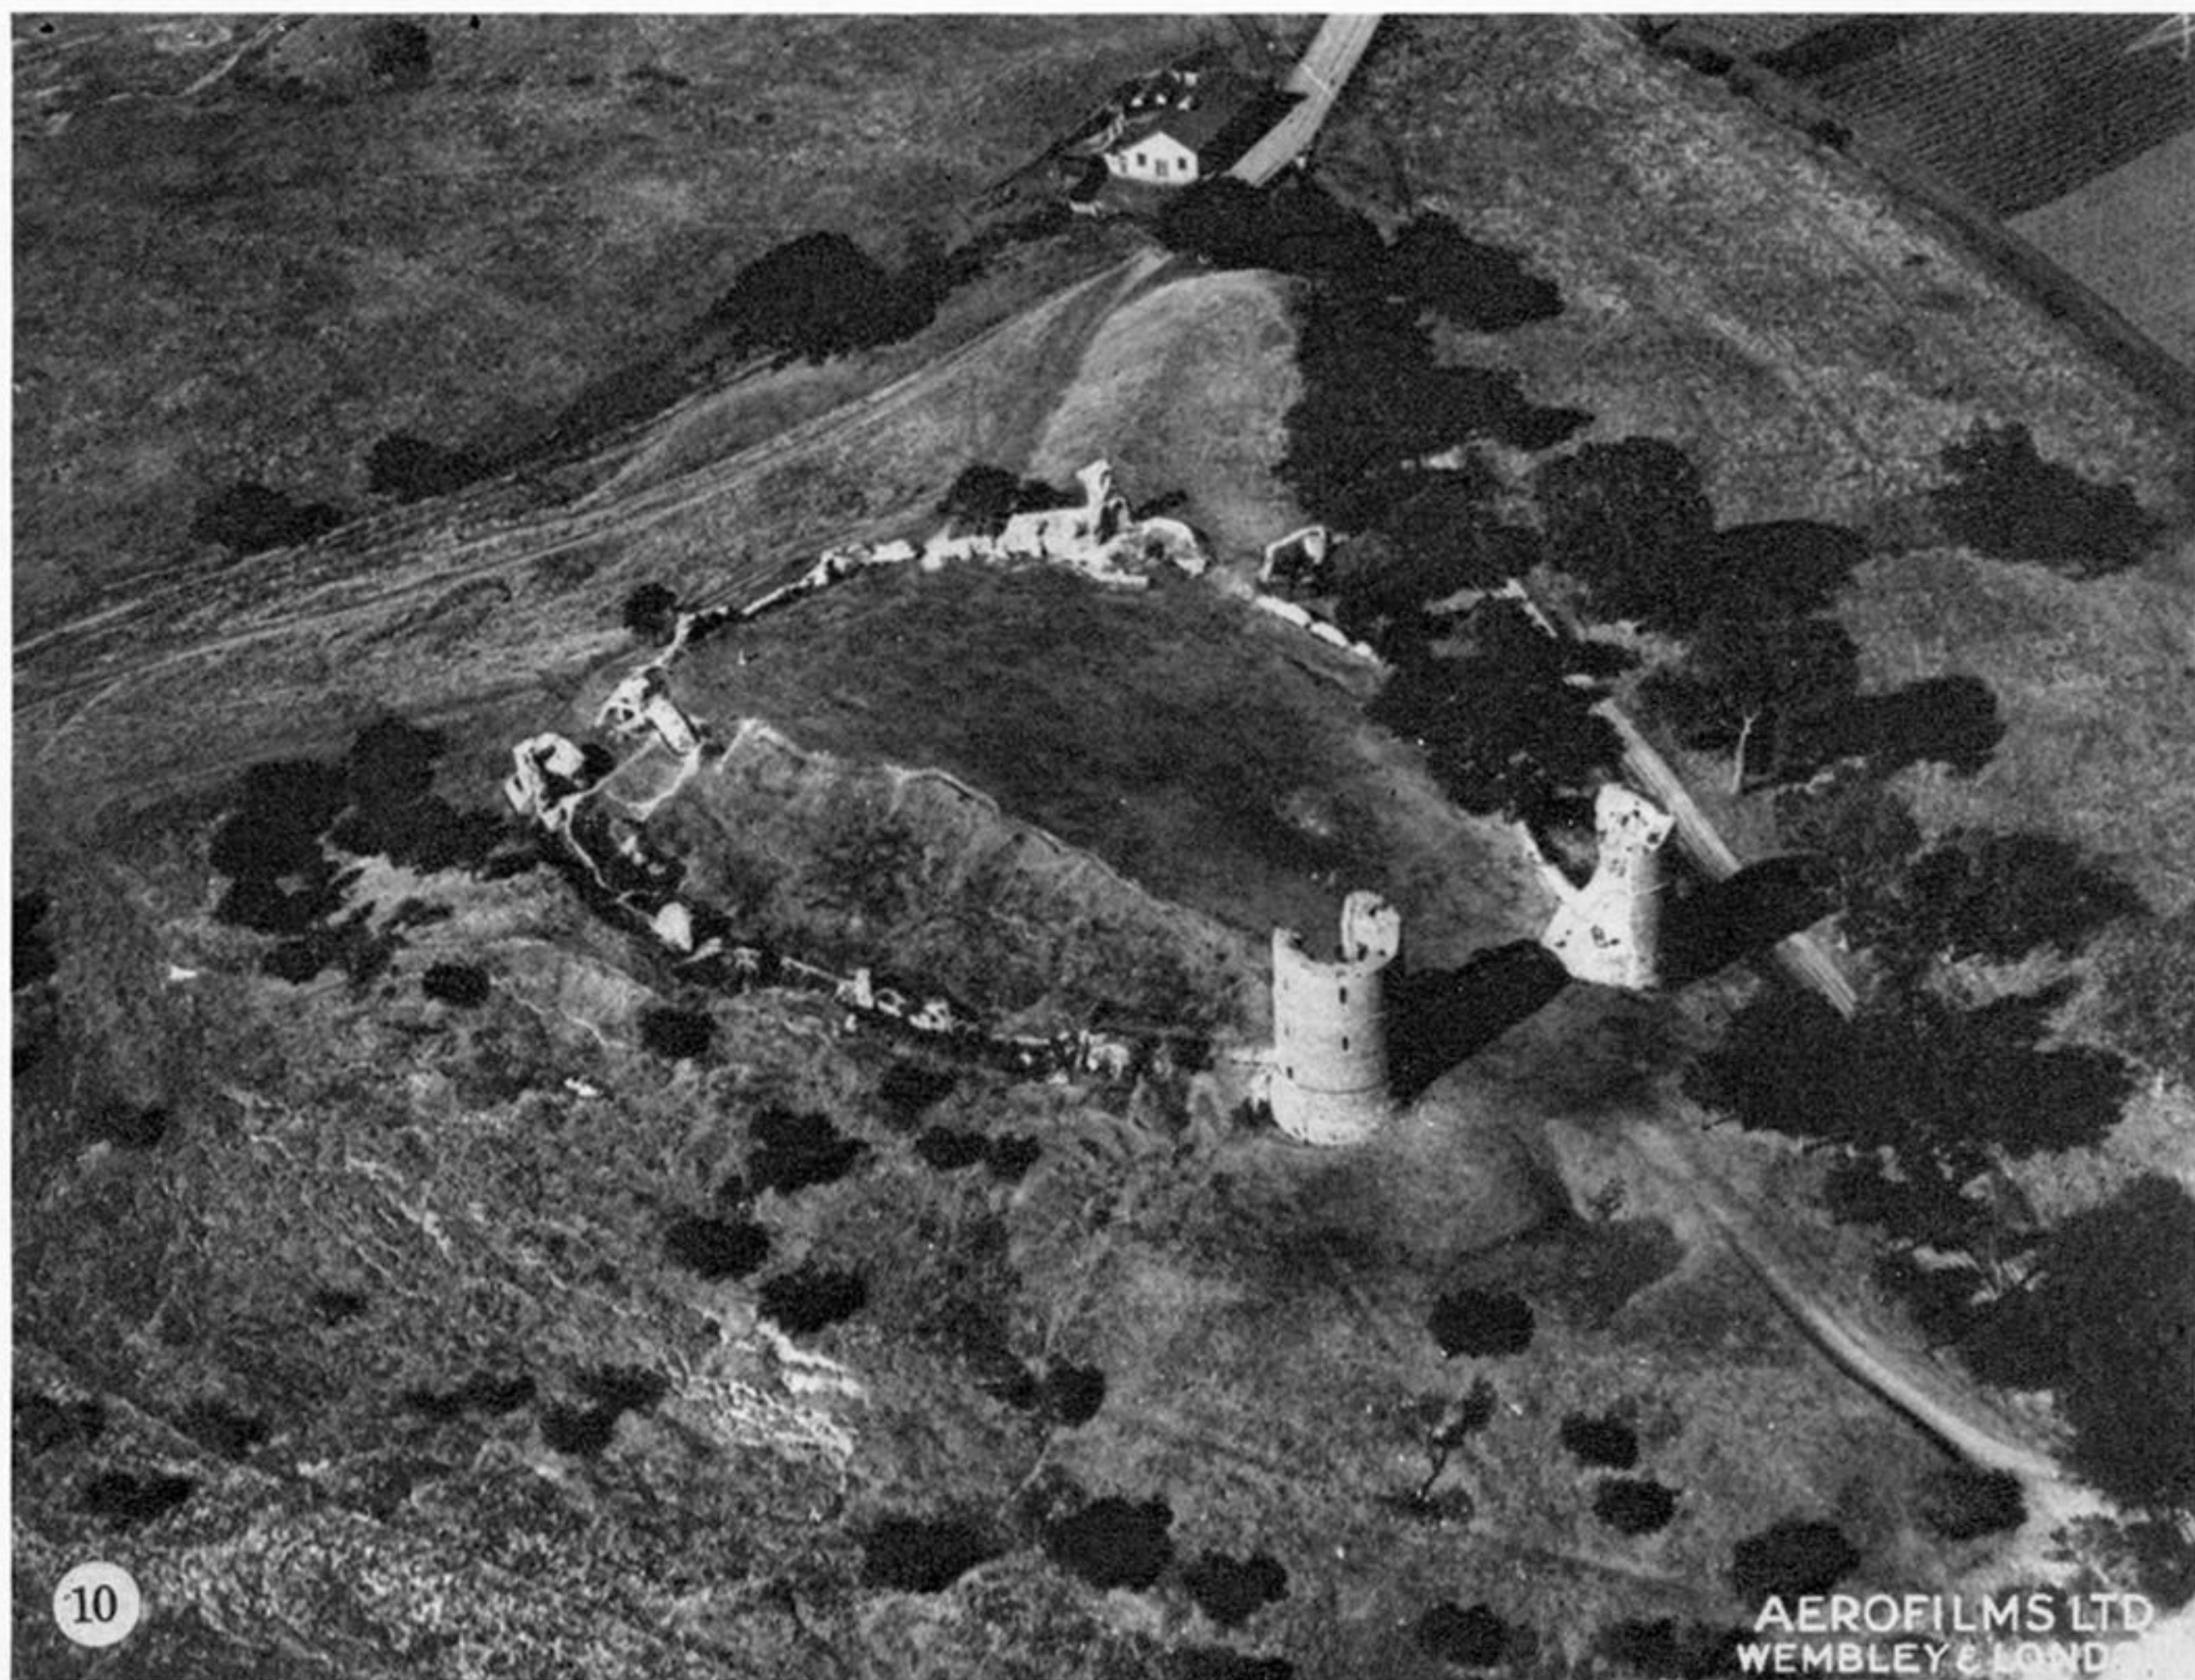
FIGURE 10. Oblique aerial photograph of Hadleigh Cliff, looking NW, taken 6 October 1928 (with acknowledgements to Aerofilms Ltd).
