## The development of an abandoned cliff in London Clay at Hadleigh, Essex

BY J. N. HUTCHINSON AND T. P. GOSTELOW

*Department of Civil Engineering, Imperial College, University of London*

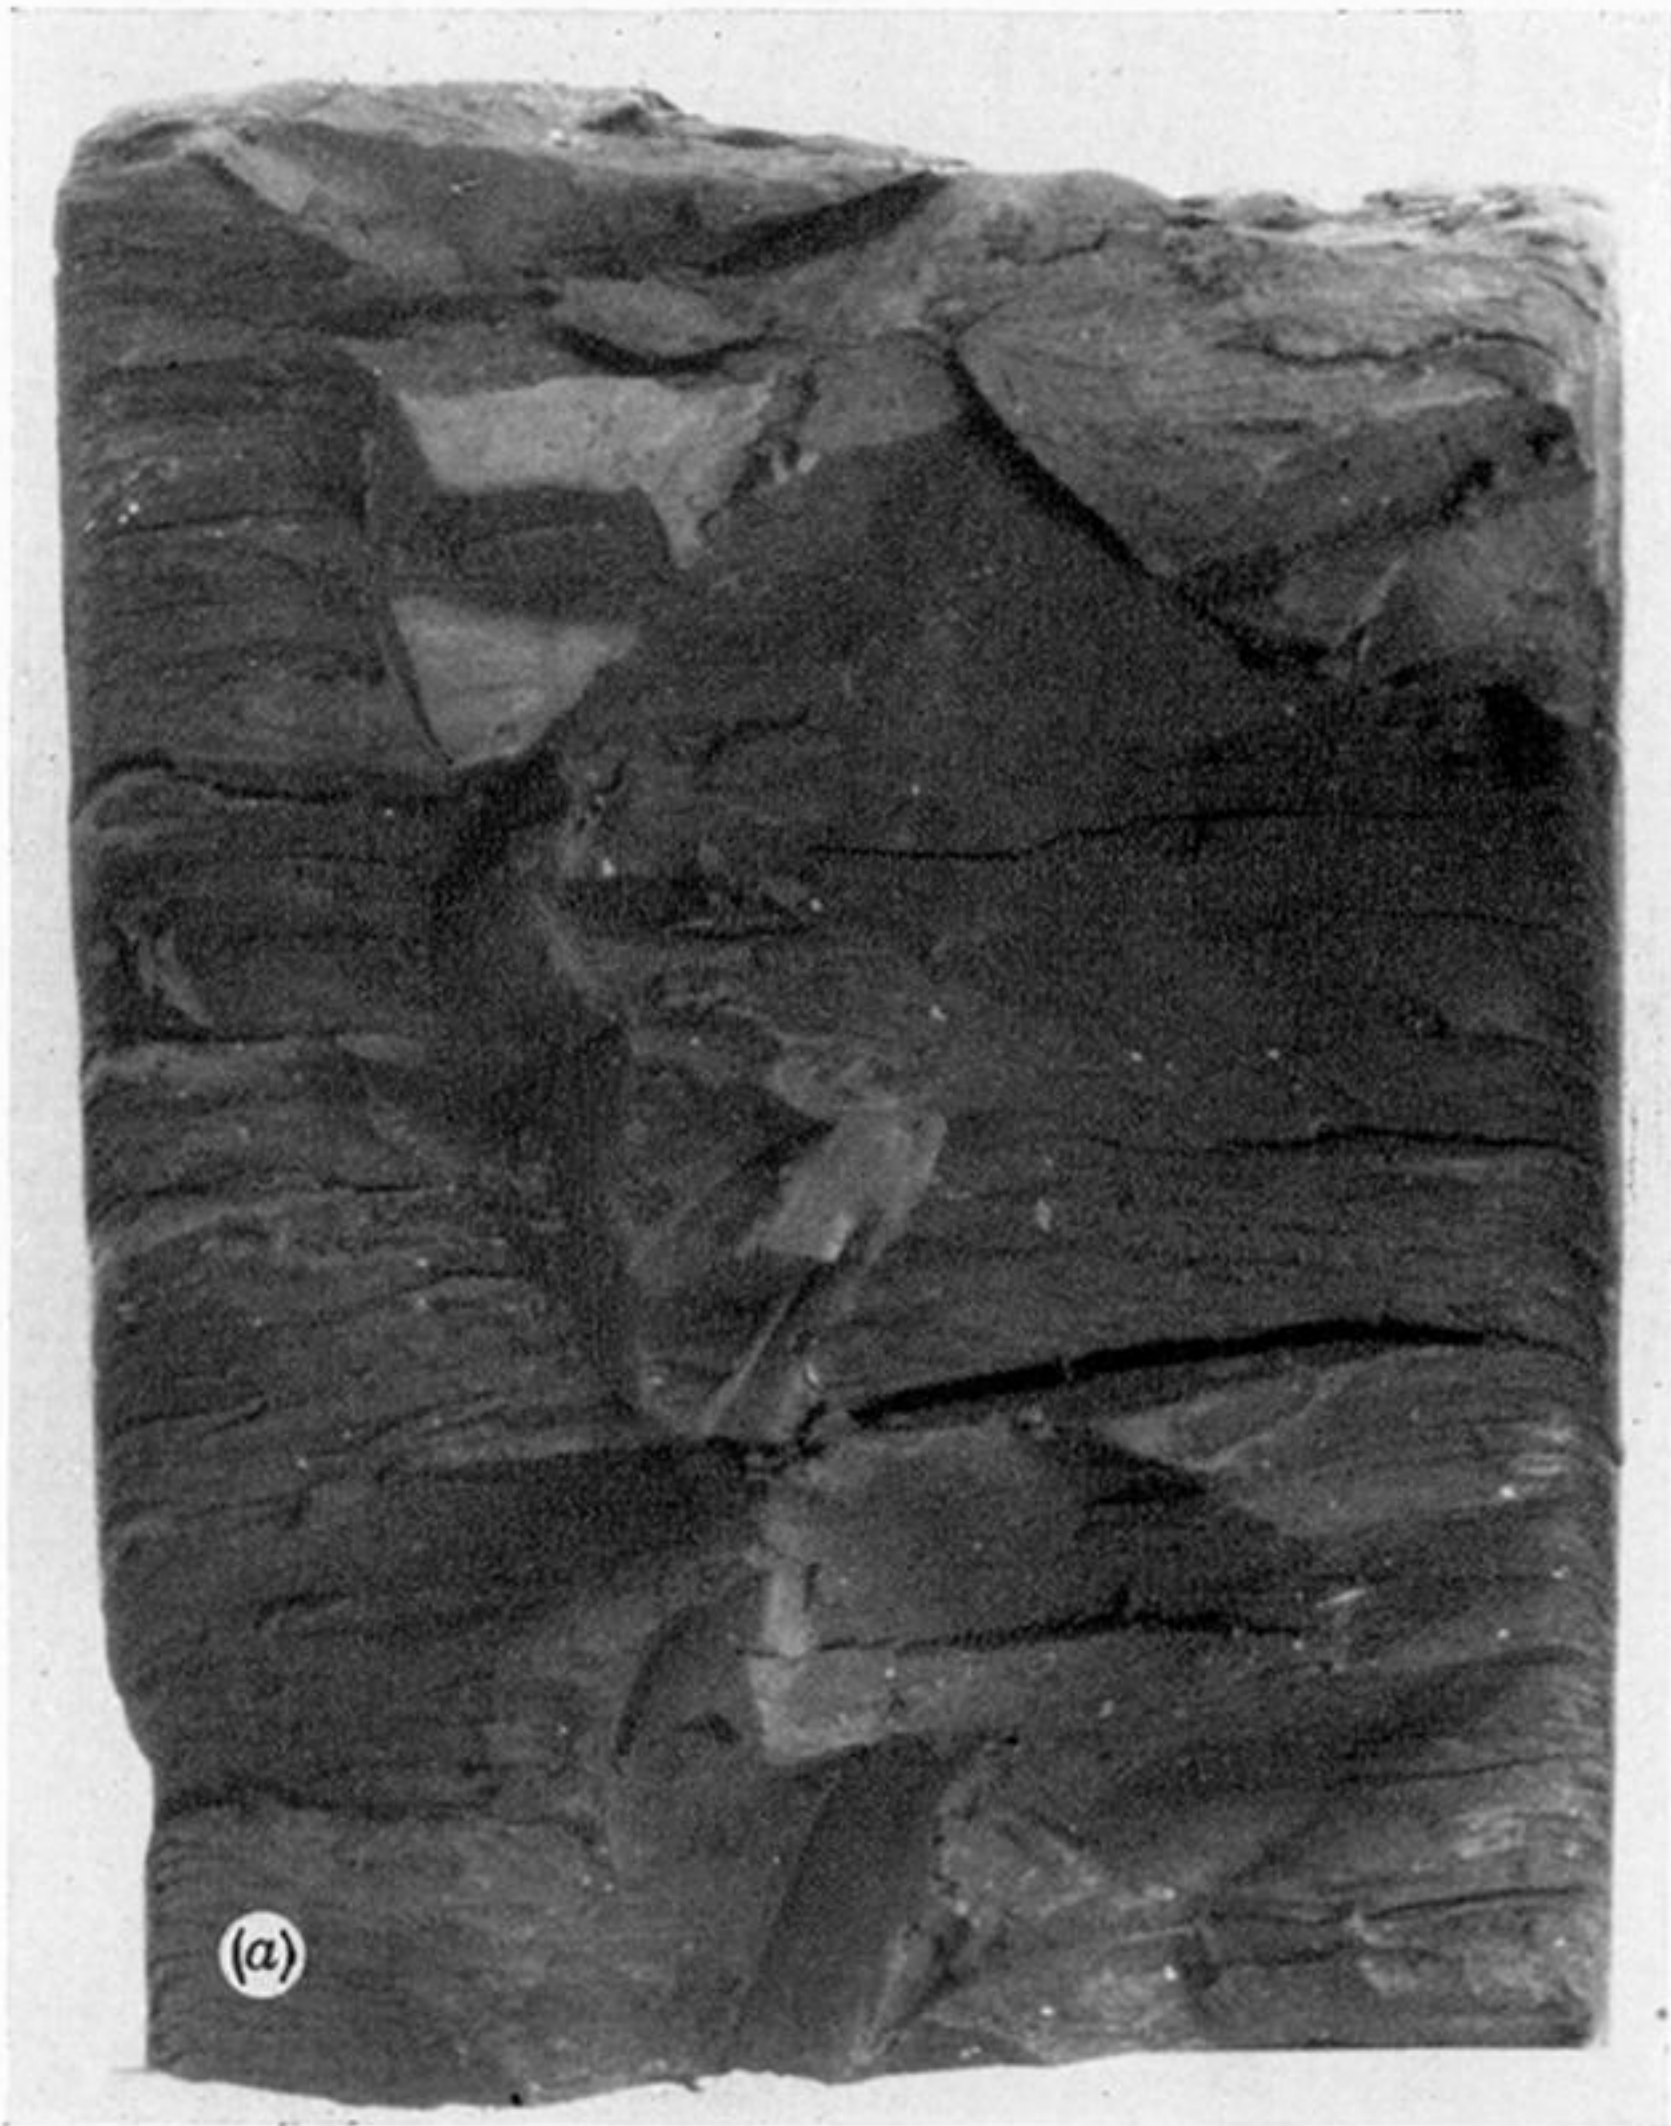
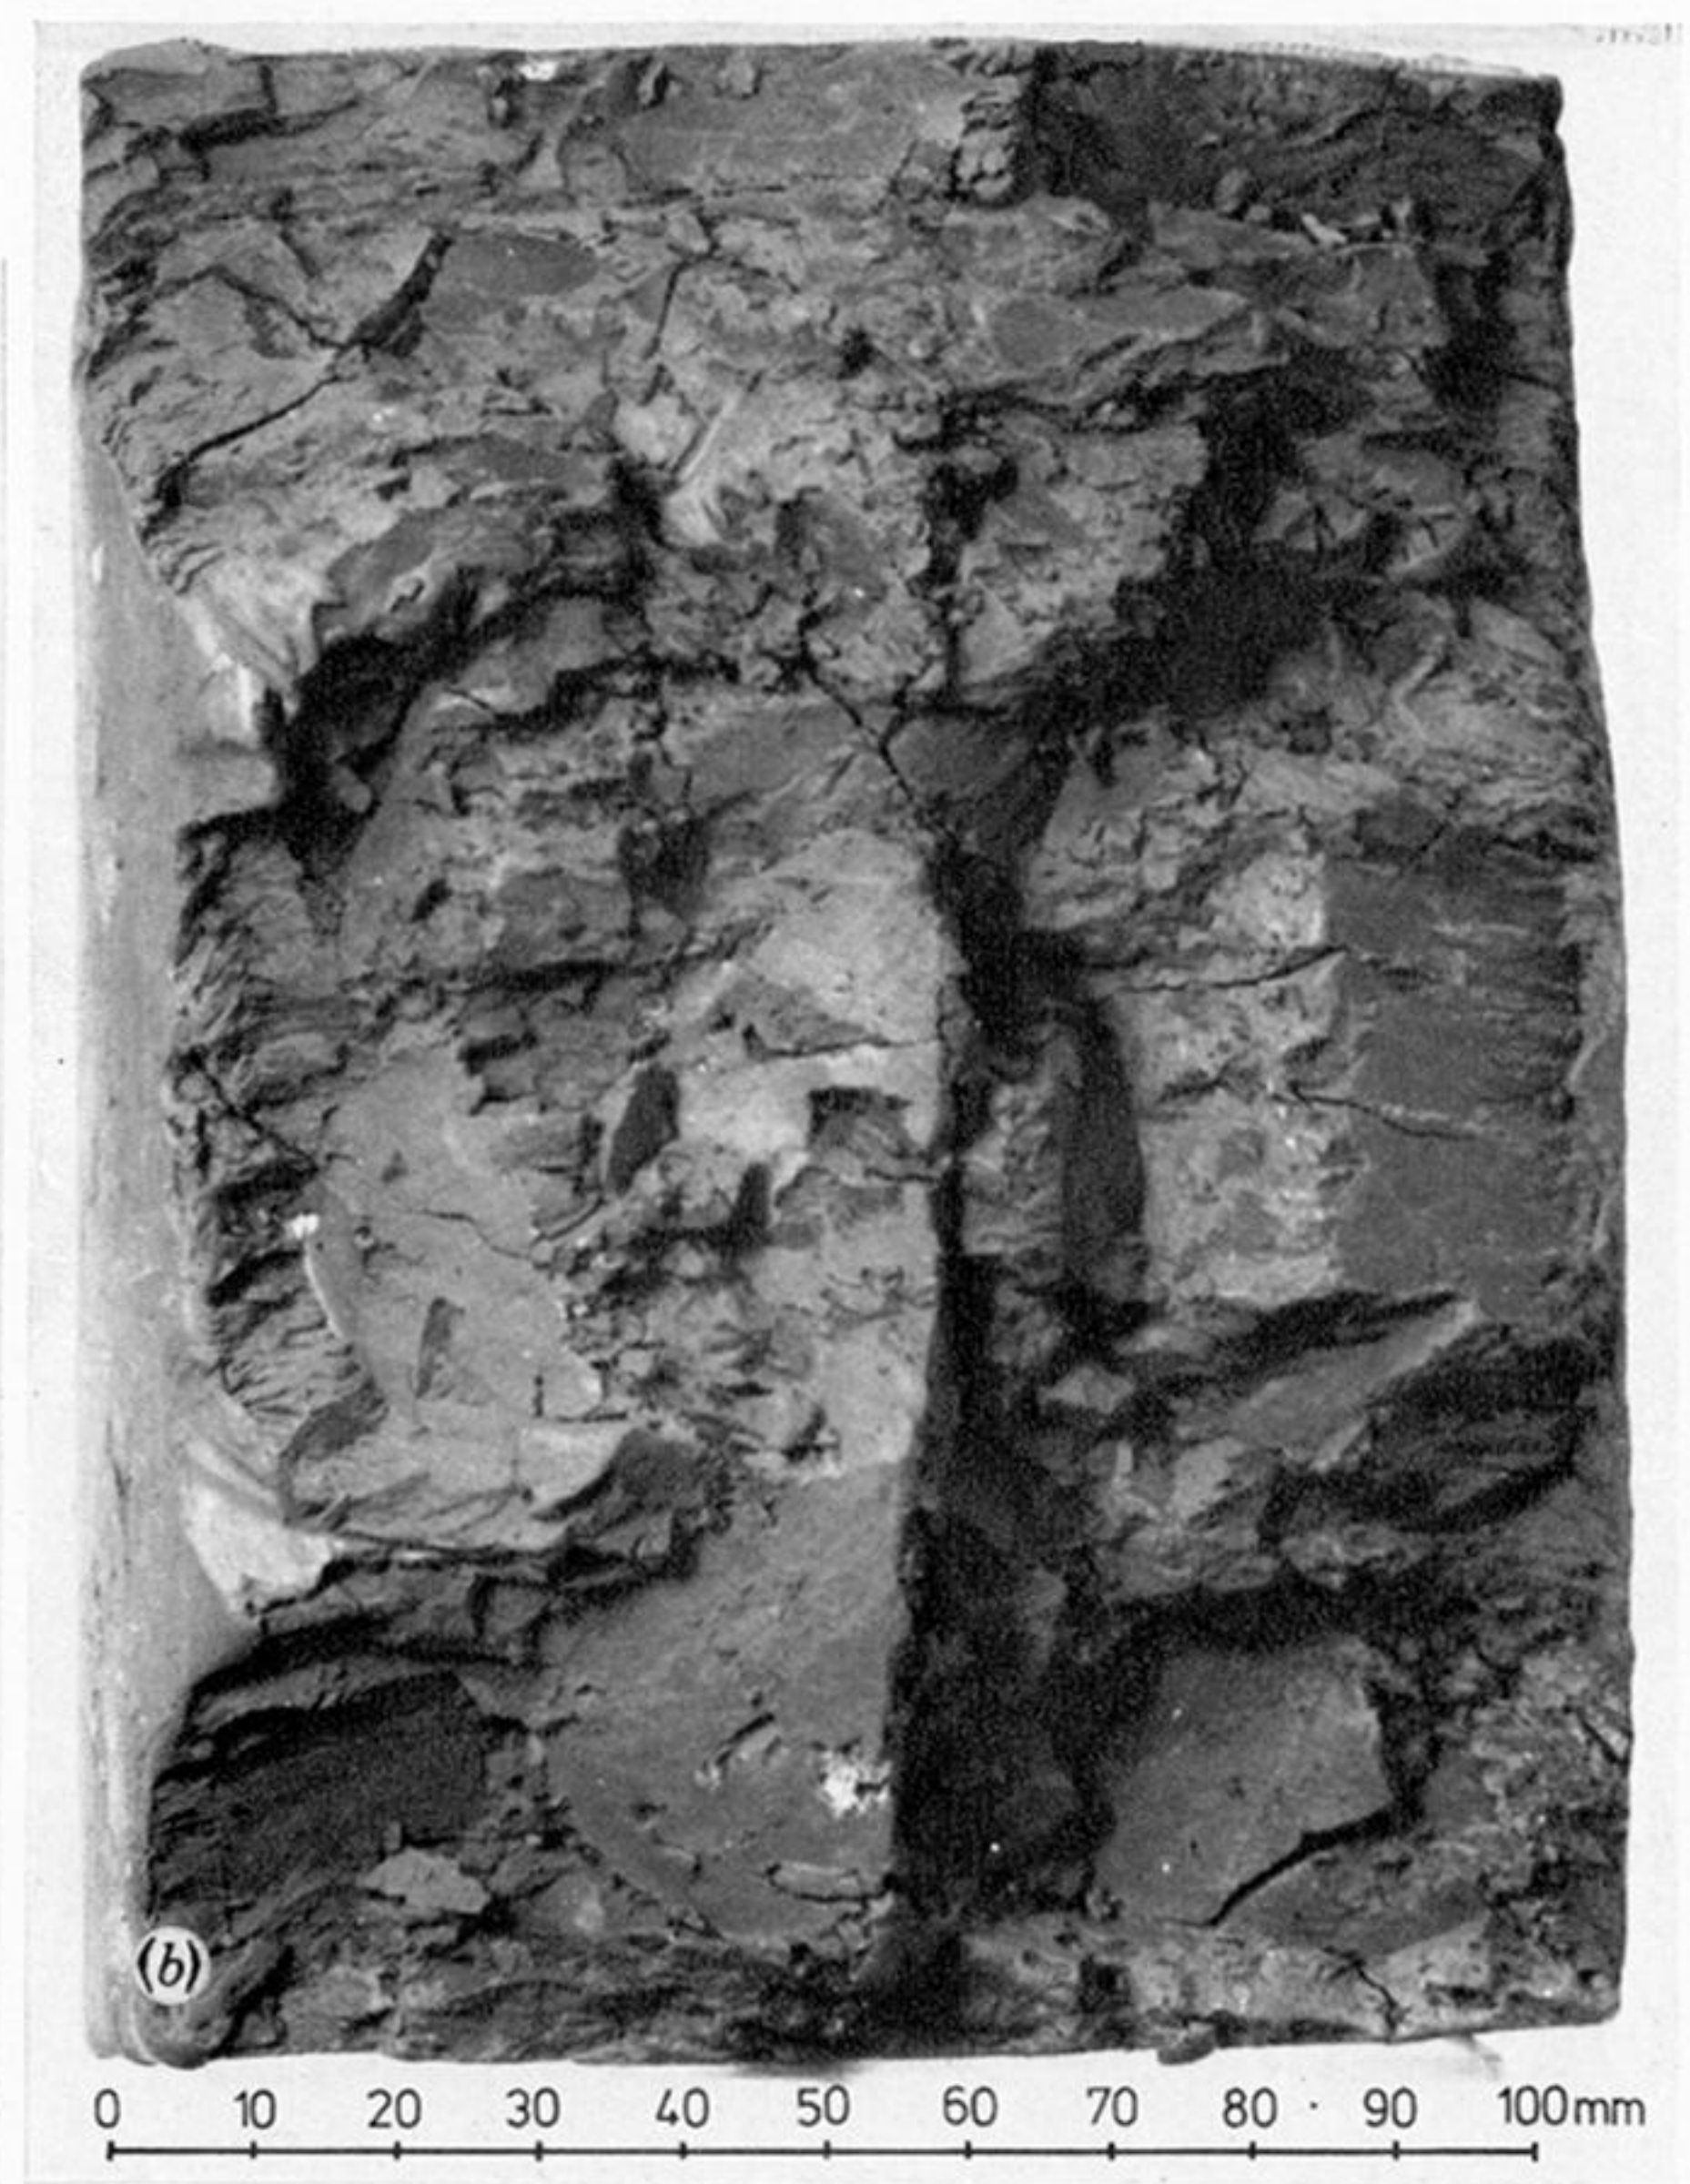
FIGURE 16. Photographs of hand specimens of different weathering zones of the London Clay.  
(a) Zone I (unweathered), (b) zone II and (c) zone IIIb.

of figures 5 and 15. Photographs of hand specimens of London Clay from weathering zones I, II and IIIb are shown in figure 16, plate 10.

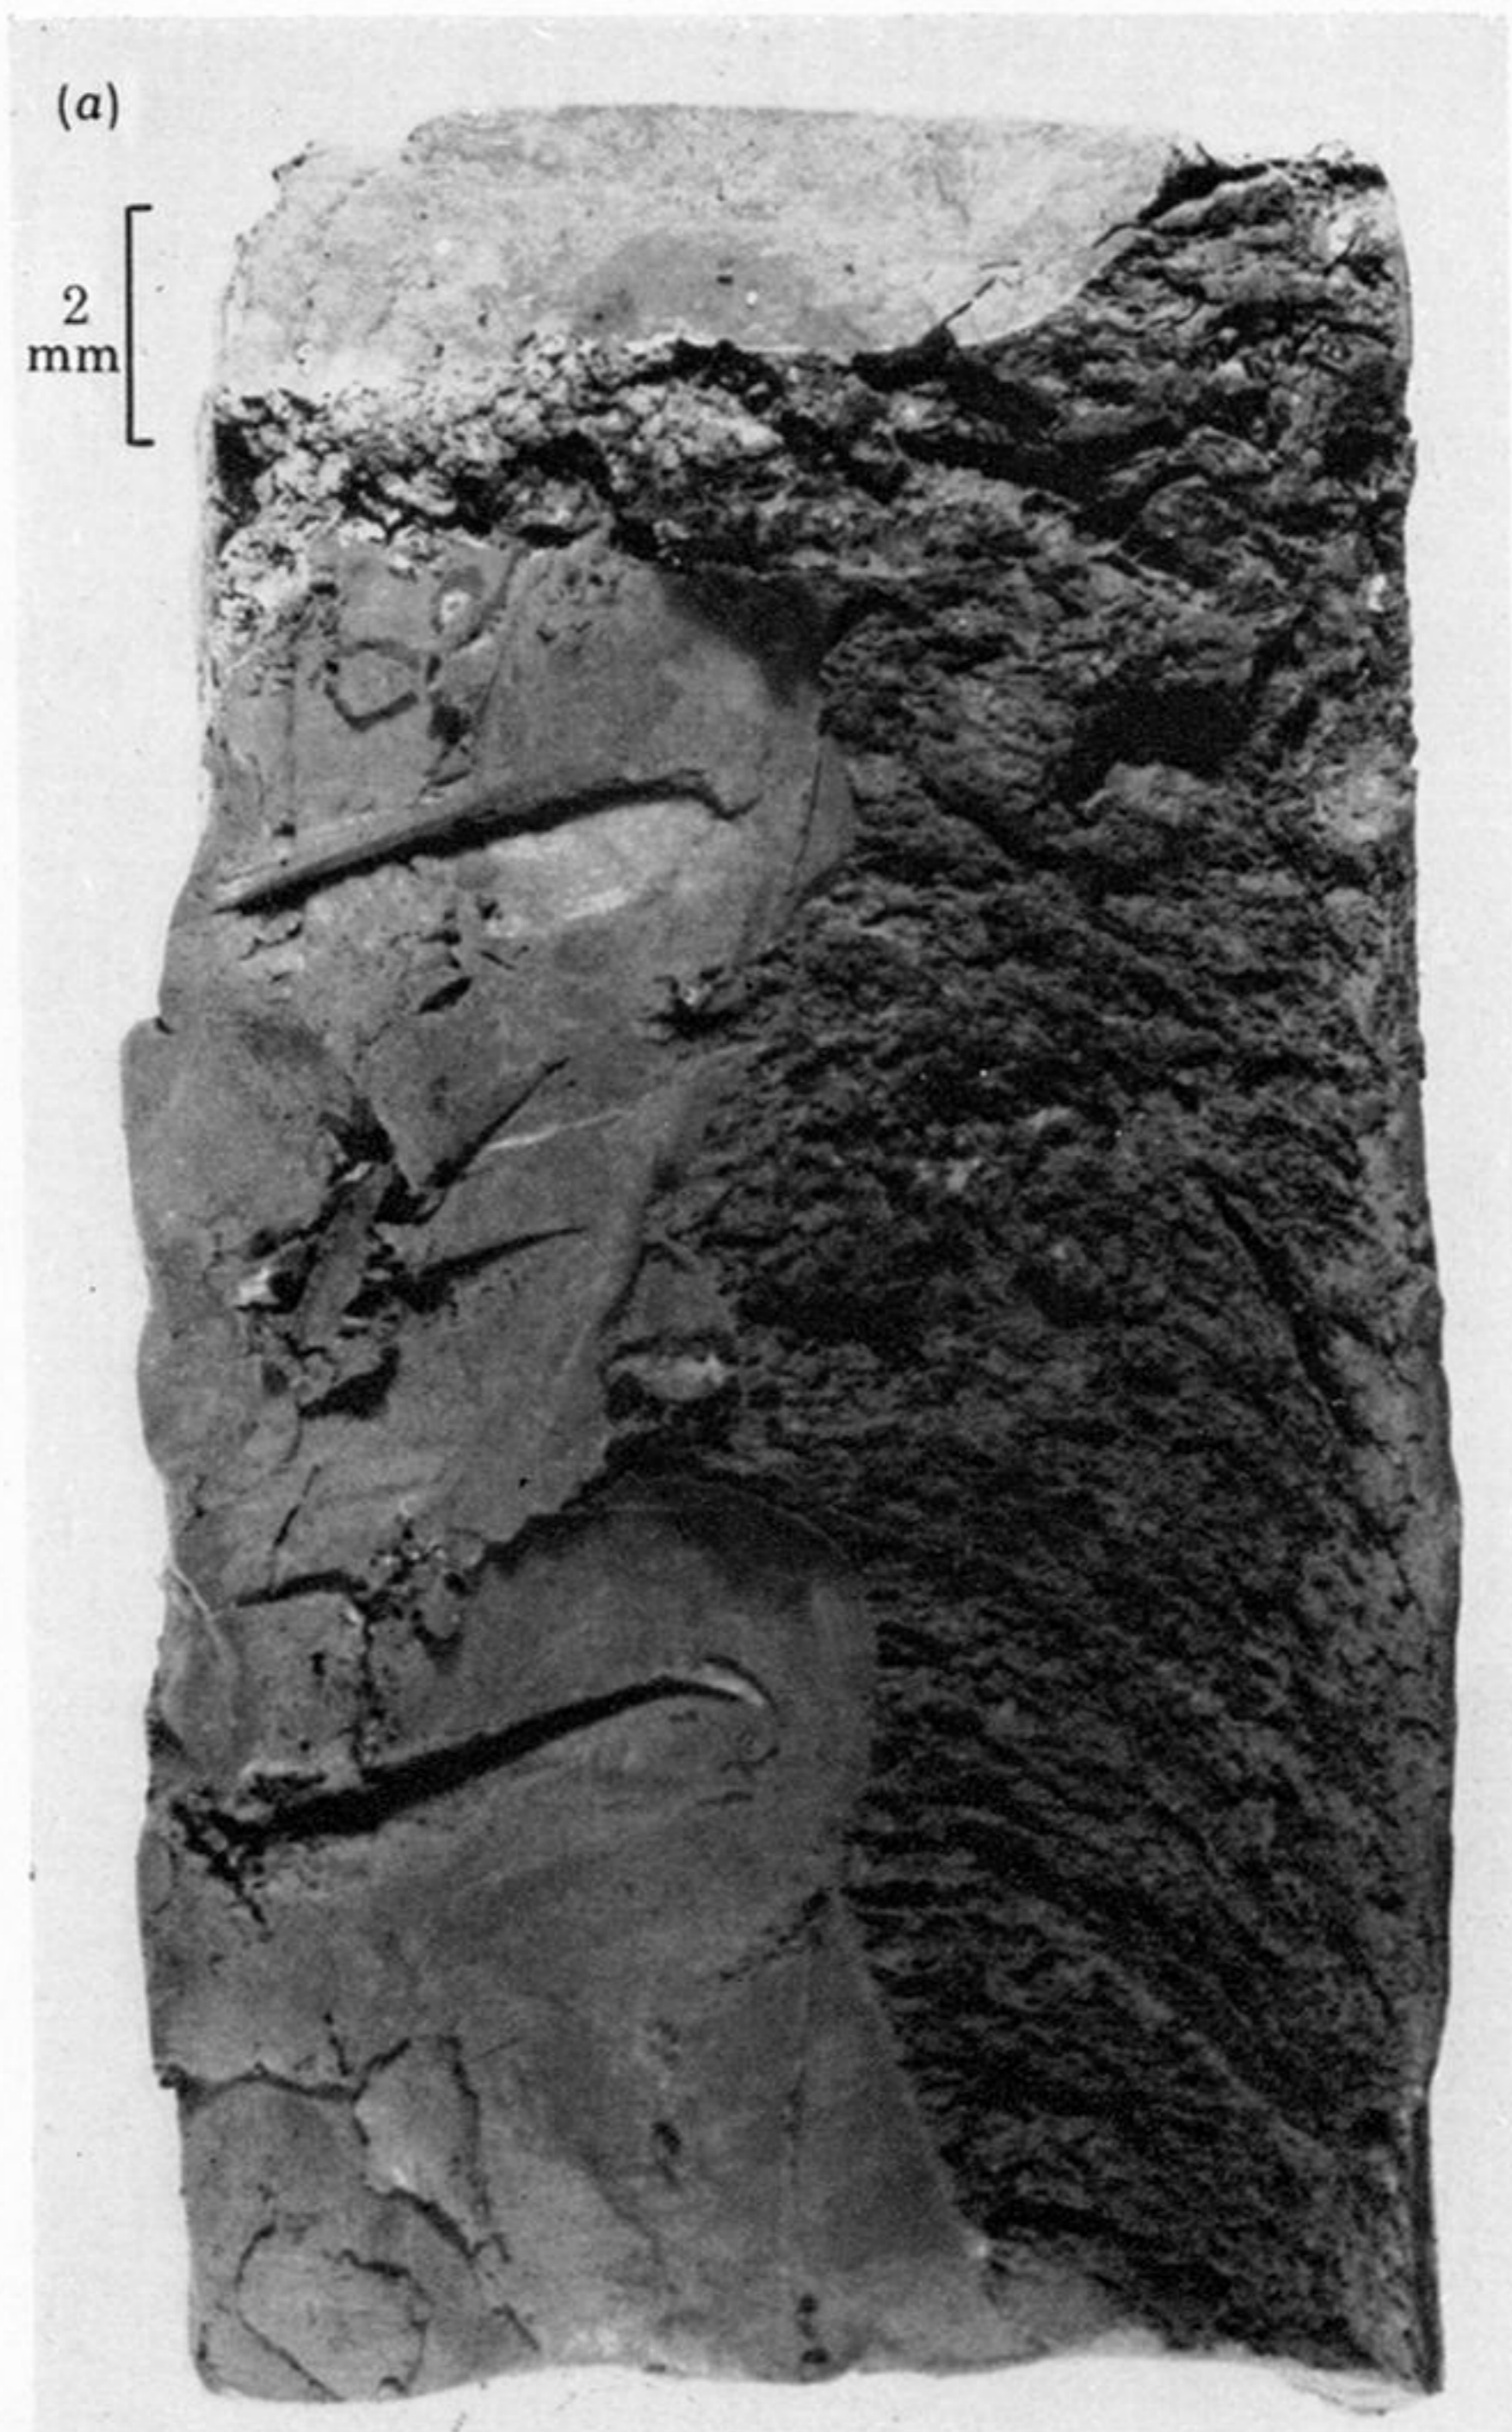
FIGURE 20. Photographs of the London Clay-derived colluvium of unit C3, (a) in hand specimen and (b) under the optical microscope. In the latter photograph the diamond-shaped light and dark areas indicate selenite crystals; the irregular light areas and lines represent intruded carbowax.

fissuring, in places slightly slickensided, with a spacing of about 0.15 m has developed, and sugary concentrations of selenite crystals are relatively common. Figures 20*a* and *b*, plate 11, show the appearance of the material in the hand specimen and under the optical microscope. Plastic and liquid limits are typically about 26 % (23–29) and 75 % (64–93) respectively, and the average water content, excluding dried crusts, is about 33 % (29–38), giving an average liquidity index of +0.14 (+0.04 to +0.15). The general consistency is firm to stiff. At present and former ground surfaces formed by this colluvium, dried crusts up to about 0.5 m thick are found, with prismatic structure, in which water contents down to 22 % have been measured.
