The Evolution of Landslide Slopes in Dorset [and Discussion]

D. Brunsten, D. K. C. Jones and Muriel A. Arber

Phil. Trans. R. Soc. Lond. A 1976 **283**, 605-631

The evolution of landslide slopes in Dorset

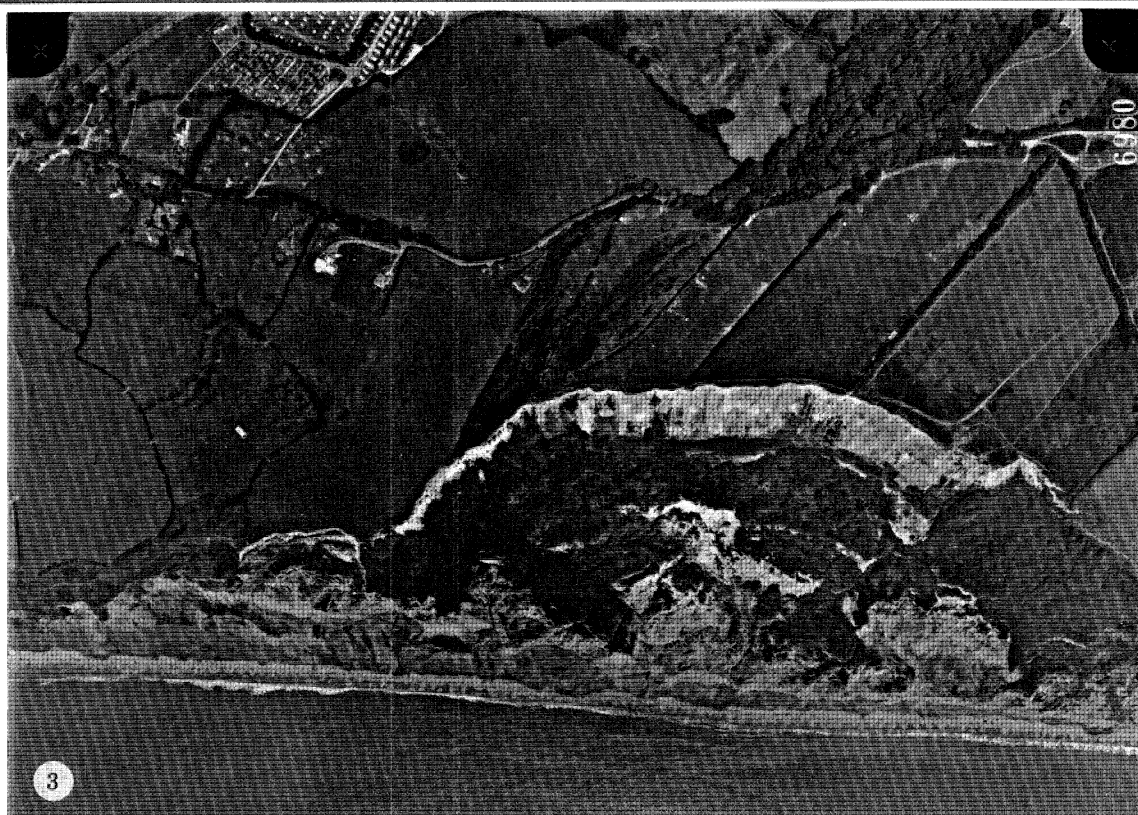
FIGURE 3. Vertical air photograph of Stonebarrow Hill, the Fairy Dell landslide complex and part of the degraded, inland landslide slopes described in an earlier paper (Brunsdon & Jones 1972) and compared with the active slopes in this paper. (Copyright D. Brunsdon, Fairey Aviation, 1969). Attention is drawn to the irregular topography near the houses to the west (left) of Fairy Dell and the areas of woodland which conceal the large landslide coombes at the head of the degraded slopes.

Second, vertical air photographs for 1946, 1948, 1958 and 1969 (figure 3, plate 12) are available at scales ranging from 1:4000 to 1:16000, together with oblique air photographs for 1946 and 1969. With the exception of the 1958 photograph, these are of good quality and allow the clear identification of such geomorphological features as landslide units, mudslides and gullies, as well as the accurate determination of the pattern of cliff retreat. The 1958 photograph is, unfortunately, rather heavily distorted and was therefore used only to obtain a rough guide of the evolutionary development during the period 1948–69.

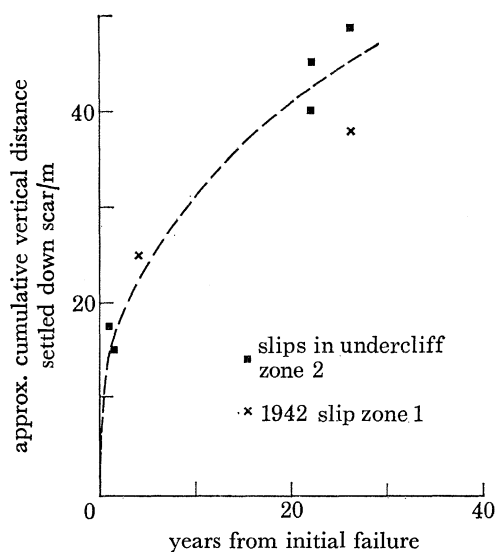
FIGURE 7. The approximate rate of settlement of landslide units in years from initial failure. The pecked line represents the generalized rate for zone 2 settlements.

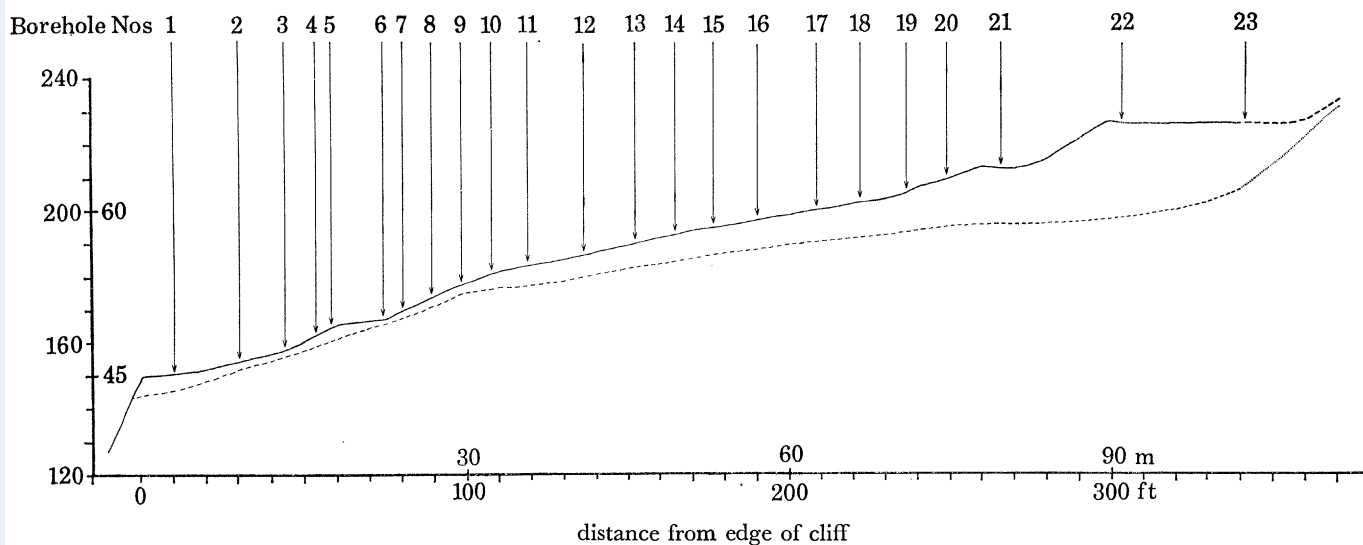
FIGURE 8. Section of a mudslide basin in the centre of the Fairy Dell complex (see figure 6). This illustrates the general morphometry of the Fairy Dell mudslides and especially the unloading of the toe by cliff retreat which leads to both recurrent and sudden movements. —, surface of mudslide; ---, base of mudslide.

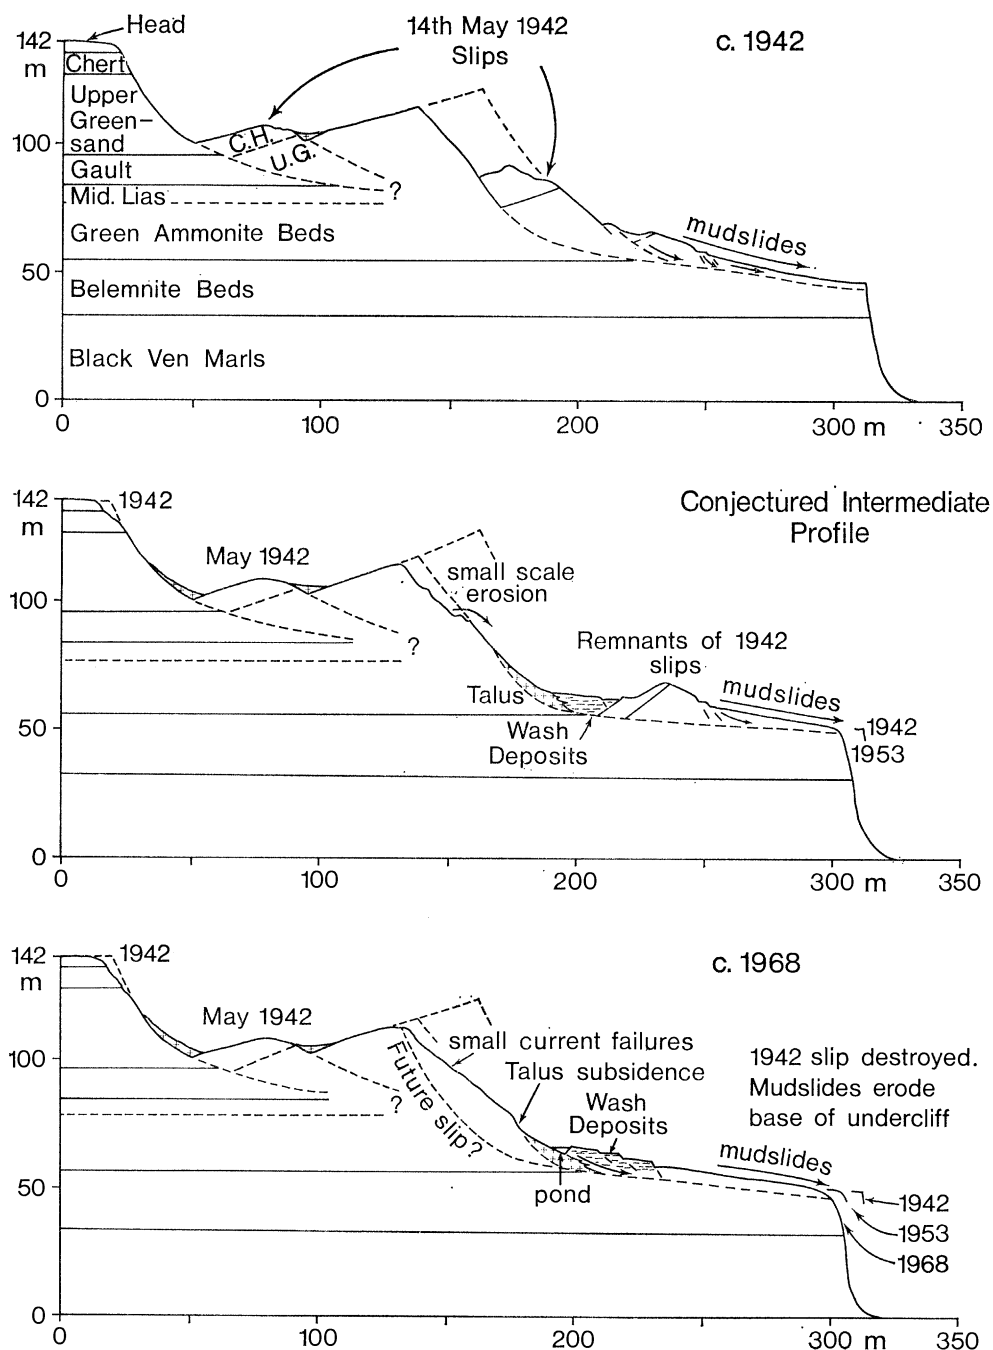
FIGURE 10. Schematic sections of Fairy Dell to illustrate the historical sequence of failures where mudslides operate in the lower areas of the landslide complex. Sources as for figure 9 and Brunsden (1974). The location in plan of these sections is approximately the same as for figure 12 (see figure 1).

and magnitude of landslide events for, while the largest slides occur in zone 1, the frequency of failures is greatest in zone 2. Second, there are differences in settlement rates (figure 7), photographic evidence indicating that the zone 2 blocks settle at a faster rate through time than those associated with the Upper Platform. Third, the throughput time for landslide debris appears to be different for each subsystem. Thus, the large blocks produced by the relatively infrequent zone 1 failures remain on the Upper Platform for periods of at least 100 years according to present evidence. By contrast, the more frequent smaller scale events in zone 2 produce blocks which are broken down and rapidly moved to the cliff edge, throughput time for these materials appearing to lie in the range 20–40 years, although it may be longer in the sediment accumulation areas (figure 9). It is important to note that this rapid movement and fragmentation in zone 2 is largely due to the continual removal of material along the margin of the blocks by mudslides (figure 10).

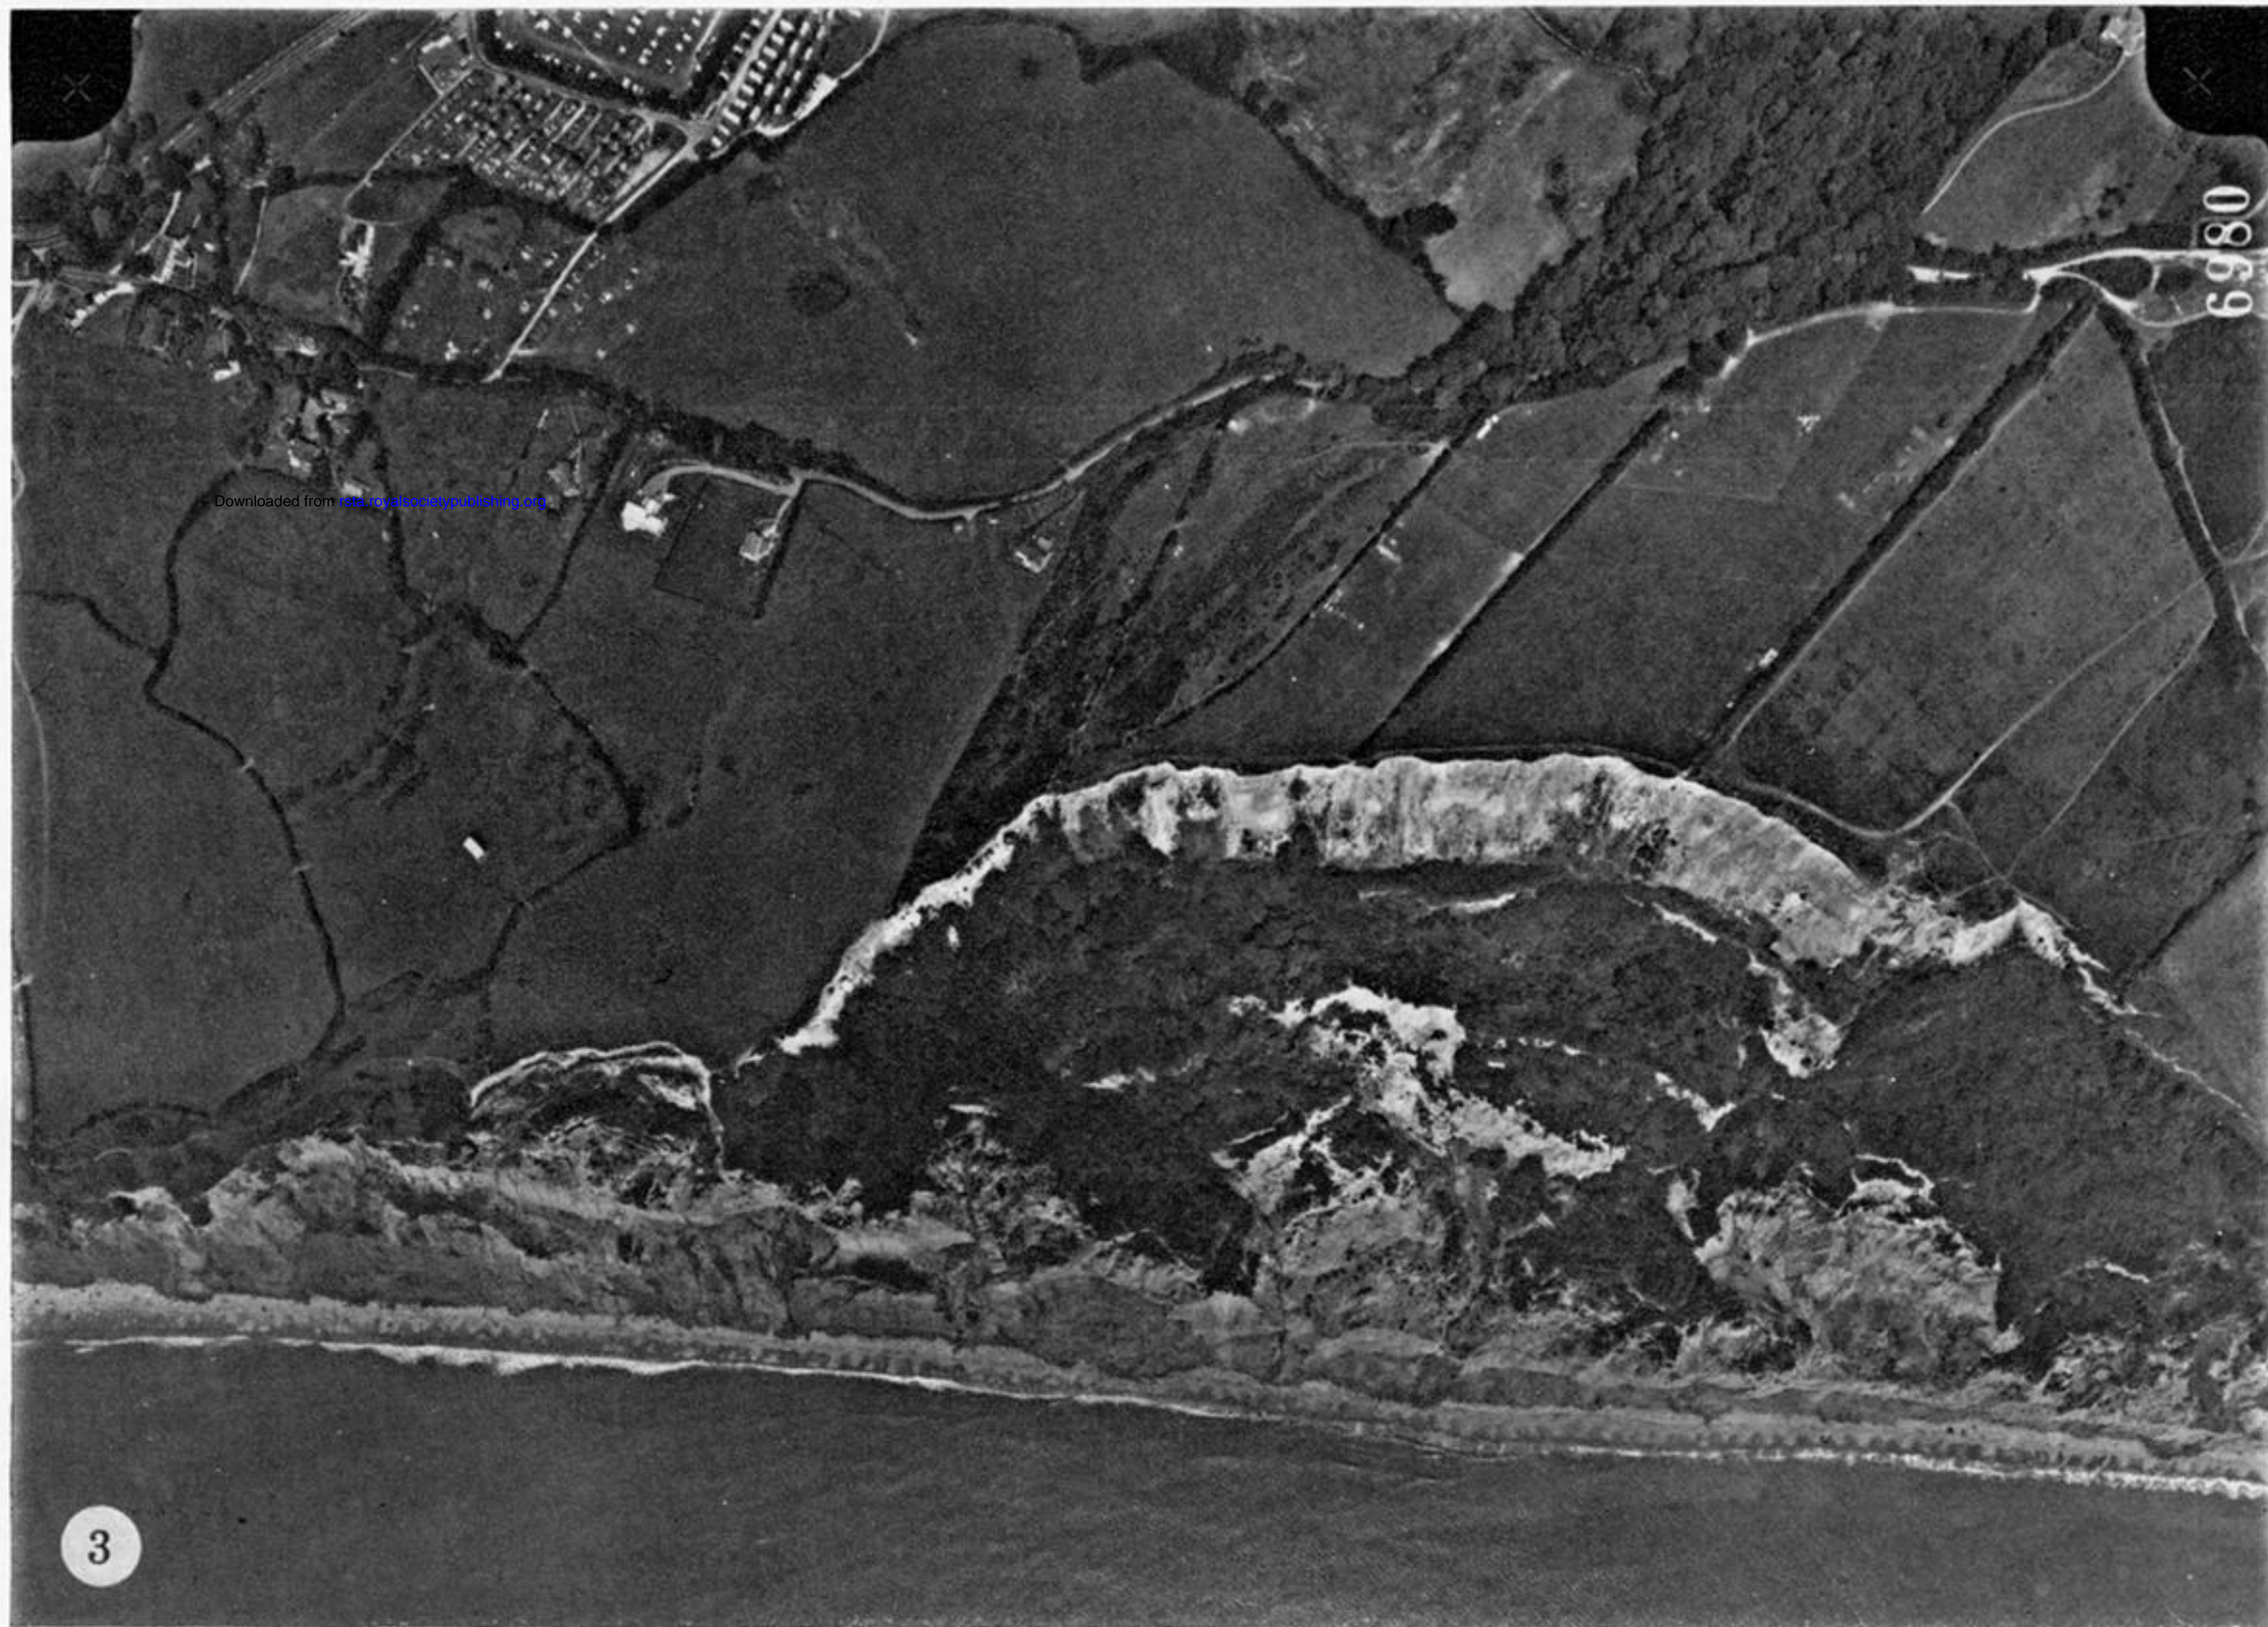
FIGURE 3. Vertical air photograph of Stonebarrow Hill, the Fairy Dell landslide complex and part of the degraded, inland landslide slopes described in an earlier paper (Brunsden & Jones 1972) and compared with the active slopes in this paper. (Copyright D. Brunsden, Fairey Aviation, 1969). Attention is drawn to the irregular topography near the houses to the west (left) of Fairy Dell and the areas of woodland which conceal the large landslide coombs at the head of the degraded slopes.
