The Interfacial Bond Strength in Glass Fibre-Polyester Resin Composite Systems

Part I. The Measurement of Bond Strength

J. B. SHORTALL and H. W. C. YIP

*Department of Metallurgy and Materials Science, The University of Liverpool,
P.O. Box 147, Liverpool, U.K.*

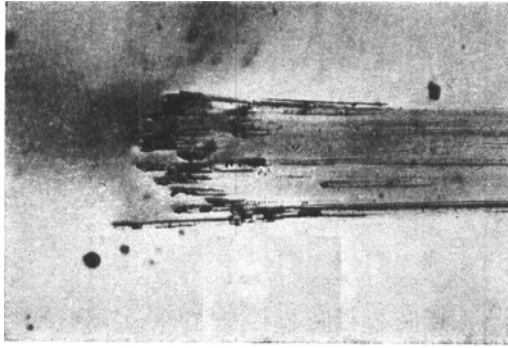
FIGURE 5 Stages of debonding and subsequent damage in a rectangular specimen containing a small number of fibres (Optical Microscope): (a) Onset of debonding near the end of a fibre bundle, (b) extension of cracks, (c) debonding and matrix failure.

end regions. The propagation of this crack sometimes did not start from the cracked interface but at a site with the highest stress concentration. This is not surprising as there was considerable difficulty in getting the inner fibres completely wetted by resin. A small number of specimens showed that the threshold debonding stress and σ_s all fell within the range of values reported in the single filament case, i.e. 38 to 60.5 MN m⁻². Figure 5(a), (b) and (c), shows the stages of debonding and subsequent damage to the composite in the multi-filament case.

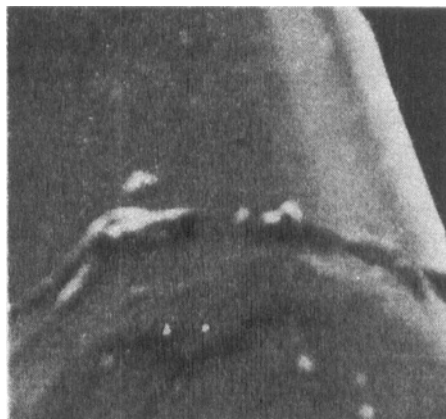
FIGURE 12 Scanning electron micrograph of portion of pulled out glass rod.

Figure 12 is a scanning electron micrograph of a pulled out rod at the breaking point of the resin sheath.
