The Adhesively Bonded Aluminium Joint: The Effect of Pretreatment on Durability†

The interface in aluminium bonded structures can be revealed by ultramicrotomy and subsequently studied by transmission electron microscopy. By these means, the more usual surface pretreatments encountered, have been characterised in depth.

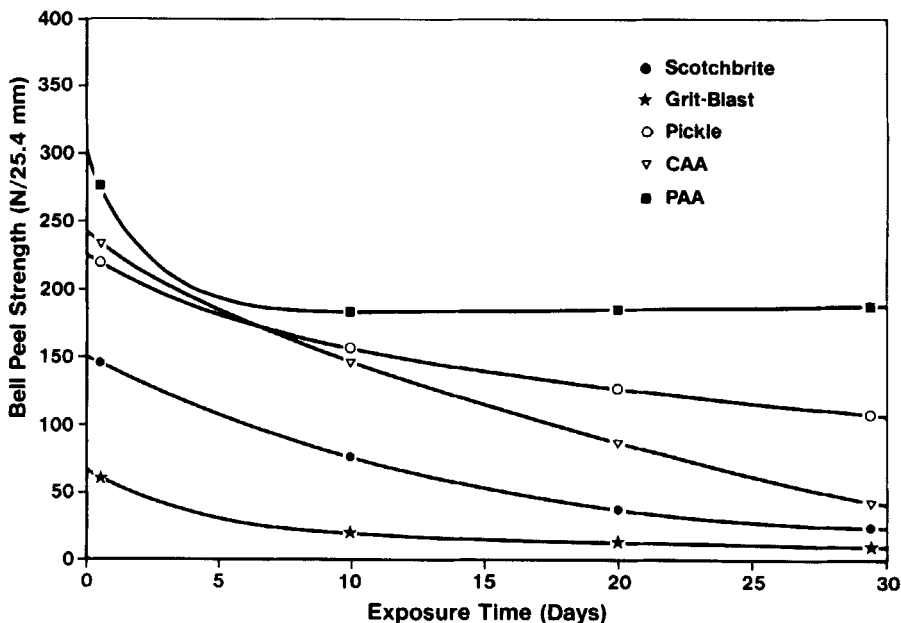
The peel profile for the exposed specimens is shown in Figure 2; this reveals the differences in the peel strengths of the control specimens and the reduction in peel properties after 30-days exposure. The full

FIGURE 2 Peel strength versus exposure time at 70°C and 85% R.H. for various substrate surface pretreatments used. [Maximum scatter for any set of joints: ± 15 N].

Controls: Figure 2 clearly shows that the peel values generated fall into two groups; those where the substrates had been abraded and those where chemical pretreatment had been used.

30-Day Exposure: At this time, the peel strength profile (Figure 2) indicates that the influence of substrate pretreatment on environmental exposure is much more varied than for the control experiments.

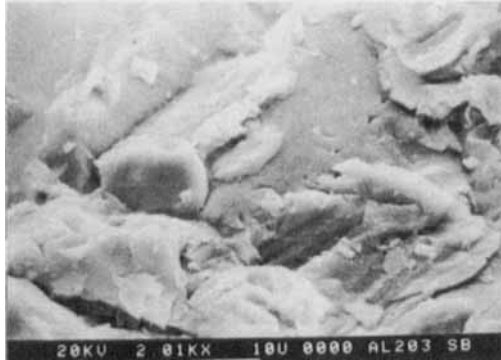
Characterisation of the abraded substrate surfaces by SEM.

FIGURE 3 Pretreatment: Alumina grit-blast.

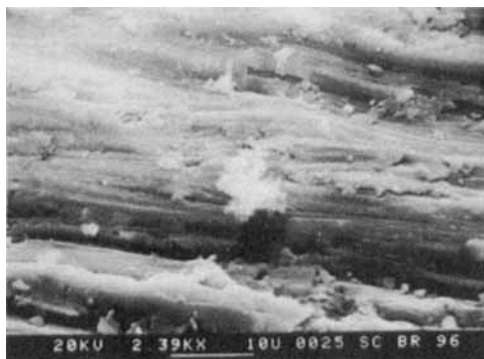
FIGURE 4 Pretreatment—Scotchbrite 96 abrasion.

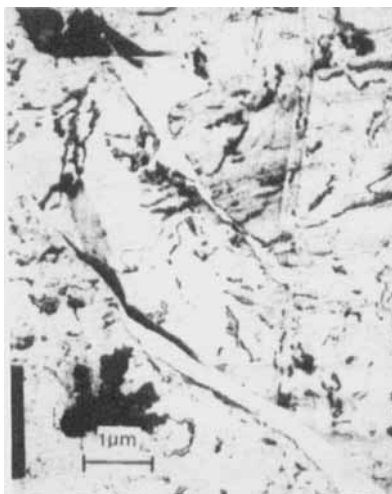
FIGURE 9 Transmission electron micrograph of a section through the aluminium substrate of a grit-blasted bonded joint; it shows the sub-surface cracking.

Figure 8 clearly shows the potential weakening effect on the *unruptured* joint by loosely-bound surface detritus. In addition, a crack is also evident, running through the substrate immediately below the pretreated surface. One of the many possible explanations for this sub-surface fracture, that must be given serious consideration, is that stress-cracking in the adherend is induced by the method of pretreatment itself—in this case, grit-blasting. Figure 9 gives a higher-resolution view of this phenomenon.

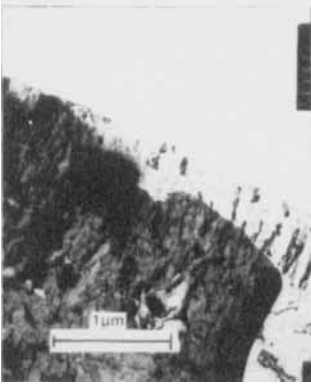
FIGURE 19 Scotchbrite abraded substrate. Essentially adhesive failure.

Transmission electron micrographs of sections through the peeling face of the ruptured peel specimen.

TEM examination of ultramicrotomed sections of the respective adhesive joints confirms the presence of extensive adhesive failure to the peeling face (Figures 19 and 20 are typical of all pretreatments); small areas of cohesive failure in the adhesive can be seen on the chemically pretreated substrates, whilst the abraded adherends appear to exhibit almost total adhesive failure.

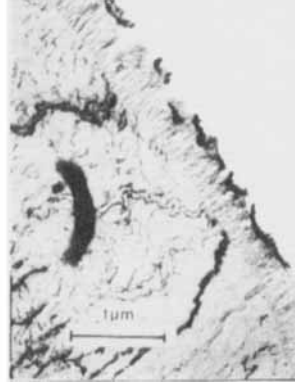
FIGURE 20 Phosphoric acid anodised substrate. Intermittent, cohesive failure.

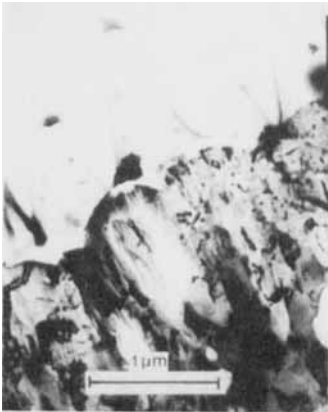
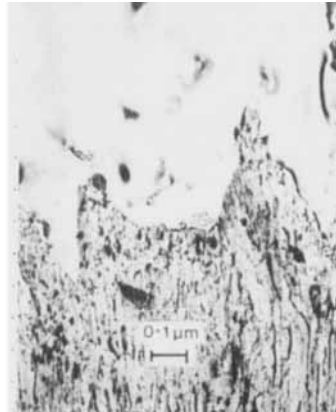
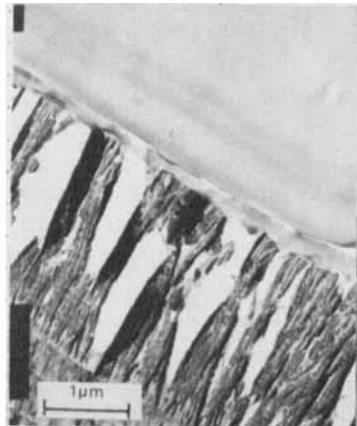
Characterisation of the environmentally exposed bonded joint. Transmission electron micrographs of sections through the unruptured bonded joint after 30 days environmental exposure.

FIGURE 21 Scotchbrite abraded.

FIGURE 22 Alumina grit-blasted.

FIGURE 23 Pickled to DTD 915b(ii).

FIGURE 24 Chromic acid anodised to DEF STAN 03-24/1.

FIGURE 25 Phosphoric acid anodised TO BAC 5555.

Specimens taken in advance of the crack tip (Figures 21–25) *i.e.* in the unruptured, supposedly unstressed area of the joint, show no

Figures 21–25 show little evidence of significant degradation at

the pre-rupture interface, or in the adherend immediately under the interface. It can, therefore, be postulated that the reduction in peel strength is due to an ingress of water either weakening or causing a debonding effect at or immediately adjacent to the adhesive/adherend interface.

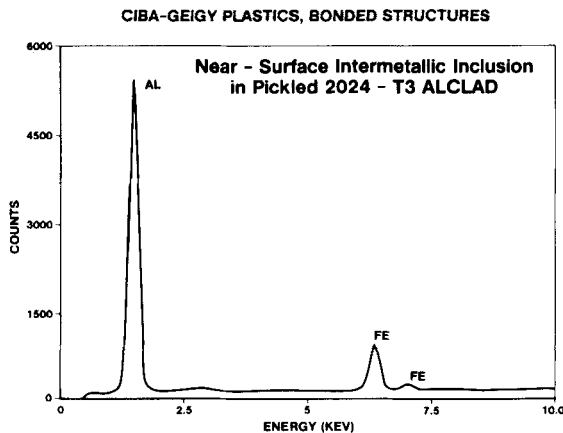
FIGURE 29 X-ray dispersive analysis of a typical metallic inclusion. This confirms the FeAl_3 structure.

If water, containing any dissolved electrolyte species, reaches the interface, then, as the intermetallics are essentially of the FeAl_3 type (Figure 29) the possibility of galvanic corrosion, with the adjacent aluminium matrix serving as the anode, must be considered. However, a further possible cause for this interfacial degradation could be weak (in the bonding sense), readily hydrolyseable films developing above the inclusion itself; as the interface recedes there is the possibility of new intermetallics being revealed and an easier environmental pathway being opened up to them.

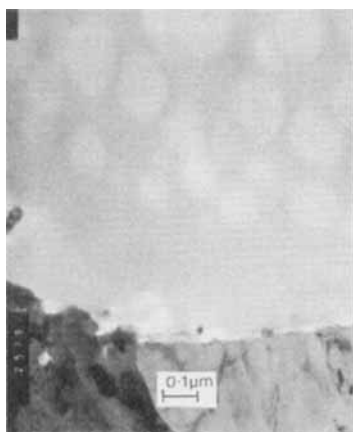
FIGURE 30 Scotchbrite abraded.

FIGURE 31 Alumina grit-blasted.

Both show better wetting-out of the substrate surface than for the unprimed case—air gaps can, however, still be seen.

Work has commenced on this examination and is already showing results of considerable interest. With abraded adherends, it appears that the primer wets and fills the smaller troughs and craters of the convoluted surface and assists in "fixing" some of the loosely-bound surface detritus (Figures 30 and 31).

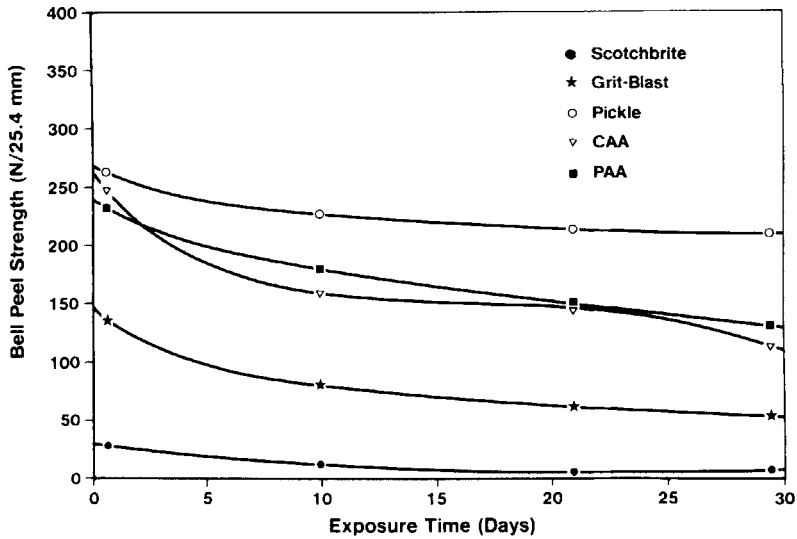
The peel strength profile (Figure 33) shows, once again, the marked difference between specimens prepared with abraded substrates and those using chemical pretreatments.

FIGURE 33 Peel strength versus exposure time at 70 Deg C and 85% R.H. for the various substrate surface pretreatments used; all adherends were primed prior to bonding.
