An Examination of Interfacial Failure in Adhesively Bonded Aluminum†

J. S. CROMPTON

Alcan International Limited, Banbury, Oxon OX16 7SP, U.K.

KEY WORDS Interfacial failure; bond interface structure; transitional regions; environmentally-assisted failure.

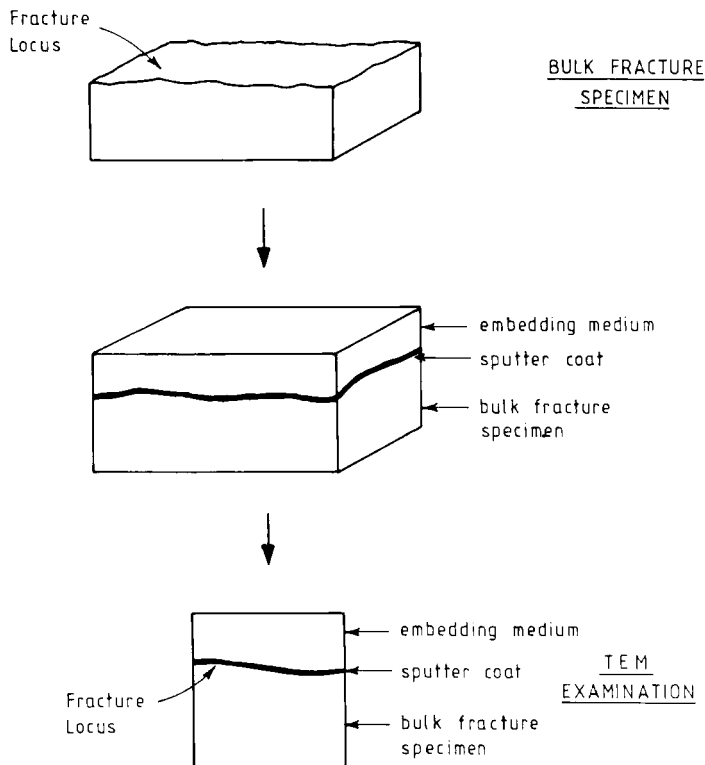
FIGURE 1 Schematic representation of method of examination of locus of failure.

After failure the fracture surfaces were examined using a high-resolution ISI DS130 SEM and JEOL 2000FX TEM examination of ultra-microtomed cross sections across the interface. To provide edge retention of the fracture surface during specimen preparation the surfaces of several specimens were sputter coated with an impervious layer of gold palladium and mounted in an embedding medium (Figure 1). This prevented damage of the fracture surface edge during specimen preparation and provided a clear indication of the locus of failure since it lay immediately adjacent to the sputter-coated layer. In all cases the features observed in the surface-sputter-coated specimens were also observed in specimens not subjected to sputter coating and embedding.

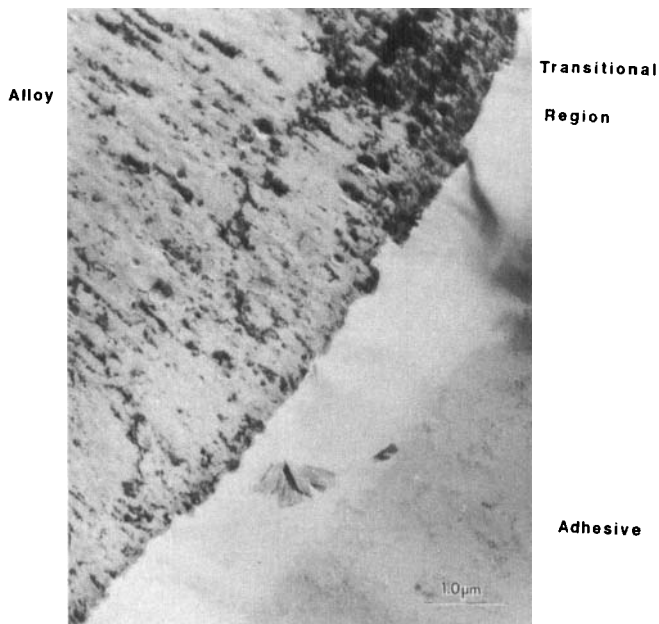
FIGURE 2 Interfacial region showing transition region at aluminium-epoxy interface.

The interfacial region of a bonded aluminium joint has been previously shown to contain local variations in chemistry and structure.^{6,8} When viewed as a cross section across the bonded joint these local variations are readily apparent (Figures 2 and 3). Figure 2 shows the transitional region at the interface of a bonded aluminium joint and Figure 3 illustrates that this may contain two transitional regions. Previous examinations of environmentally-induced failure in bonded aluminium have largely ignored the local interfacial variations. Consequently, studies have concentrated on examining either the stability of the substrate surface prior to bonding or the fracture surfaces after joint failure.

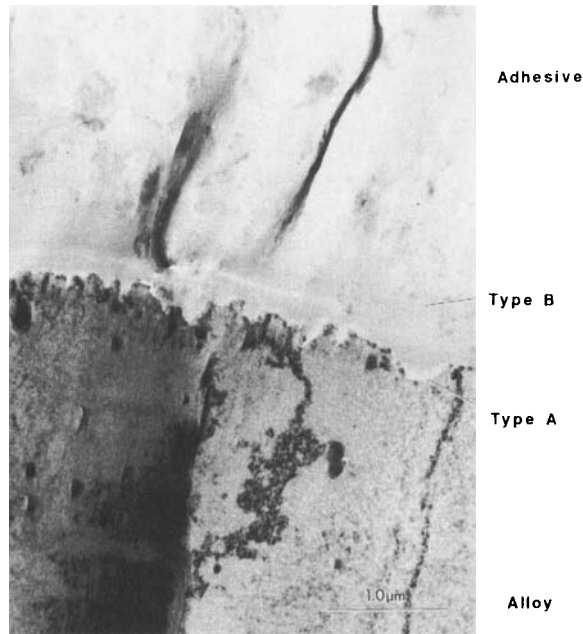
FIGURE 3 Transitional region of bonded interface showing two types of regions commonly observed.

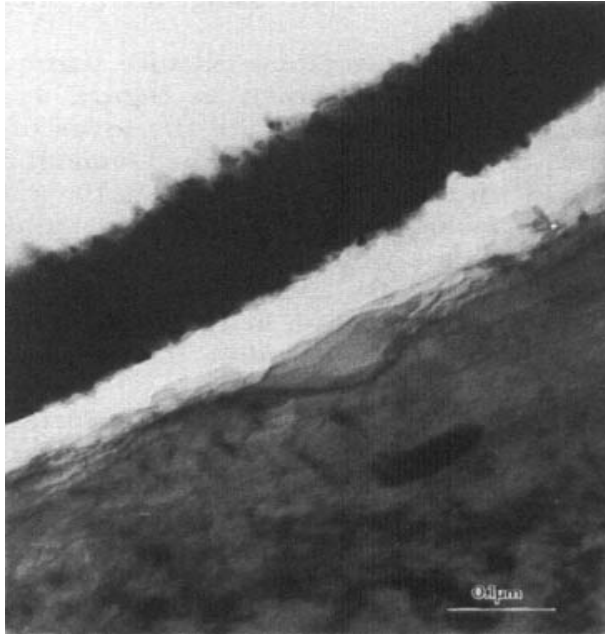
FIGURE 4 TEM micrograph of section through a fracture surface close to an aluminium surface etched prior to bonding.

A TEM micrograph of a sectioned interfacial fracture surface of a specimen which had been etched then bonded is shown in Figure 4. The aluminium substrate and sputter-coated layer are evident with the locus of failure immediately adjacent to the sputter-coated layer. At higher magnification it can be clearly seen that failure occurs within the adhesive close to the adhesive–substrate interface (Figure 5). For this surface condition this form of failure was observed to occur at a maximum of approximately 500 Å and a minimum of approximately 10–20 Å from the substrate surface. By examining sections from specimens interrupted at different stages of failure, a thin layer coverage of adhesive on the substrate was observed for locations corresponding to a range of crack growth rates from 10^{-7} mms^{-1} to 10^{-3} mms^{-1} .

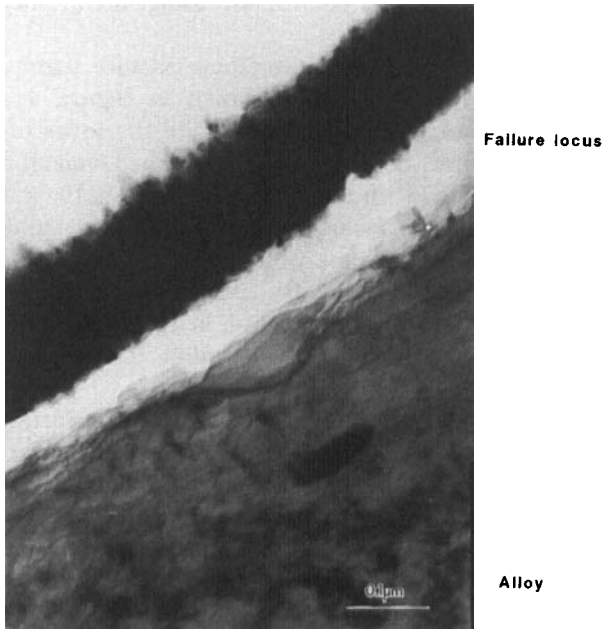
FIGURE 5 Failure of adhesive locally in a joint which had been etched prior to bonding.

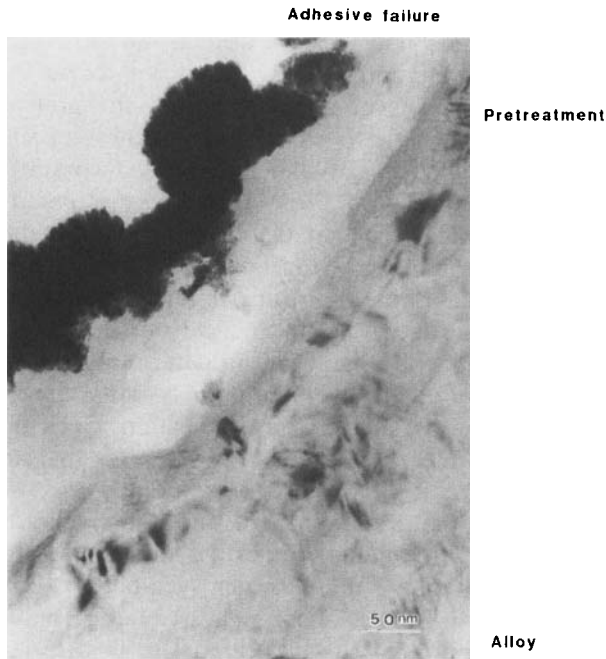
FIGURE 6 Section through a failure associated with an aluminium surface which had been pretreated prior to bonding.

A similar examination of environmentally-induced interfacial failure within a joint pretreated prior to bonding revealed identical features (Figure 6). The locus of failure was again observed to be within the local adhesive overlayer for a range of crack growth rates. Due to the penetration of the adhesive into the underlying porous pretreatment a thinner layer coverage of adhesive was generally observed. In this case values ranged from within 200 Å to within 20 Å of the pretreatment surface.
