The Durability of Adhesively-bonded Ti-6Al-4V*

RAJESH K. TIWARI and JOHN G. DILLARD[†]

The durability of chromic acid-anodized Ti-6Al-4V alloy, adhesively-bonded with FM-5 supported polyimide adhesive has been studied. The performance tests compared titanium samples that had been thermally treated and bonded, and samples that were bonded and thermally treated. Following the thermal treatment, the durability was examined (1) by immersing wedge-type specimens in boiling water and measuring the crack growth and (2) by measuring the lap shear strength for single lap specimens. In the wedge tests, failure occurs within the adhesive for specimens treated at temperatures below 371°C for less than one hour. For treatments at higher temperatures and for longer periods of time, failure occurs within the anodic oxide. From the lap shear tests, the principal finding is that the lap strength decreases with increasing treatment time at constant temperature and with increasing temperature at a fixed time. For the lap specimens, failure occurs to a greater extent within the oxide as the treatment time and temperature increase. Surface analysis results indicate the formation of an aluminum fluori

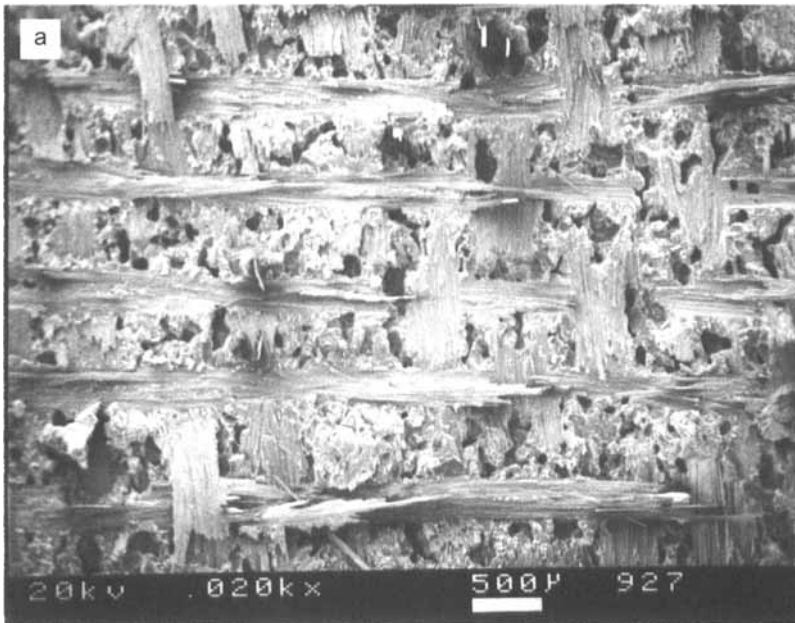
FIGURE 3 SEM photomicrographs of failure surfaces from wedge test specimens: (a) and (b) are side-A and side-B of the failure surfaces of samples that were thermally treated at 371°C for 3 hrs in air and then bonded; (c) and (d) are side-A and side-B of the failure surfaces of specimens that were bonded and thermally-treated at 371°C for 3 hrs in air.

The SEM photomicrographs of failure surfaces from the wedge specimens are shown in Figure 3. The SEMs in Figures 3a and 3b show the two different sides of the same sample. Since failure occurred (visual inspection) within the adhesive, it is not possible to designate the respective failure surfaces as “adherend” or “adhesive”. The

surfaces are labeled arbitrarily as "A" and "B". The weave-type features in the SEM photomicrographs (Figs. 3a and 3b) are characteristic of the pattern of the woven glass scrim cloth in the adhesive. That this pattern is observed on each failure surface indicates that failure occurred within the adhesive for specimens that were

covers the adhesive on the surface shown in Figure 3c and the imprint of the scrim cloth is evident in Figure 3d.

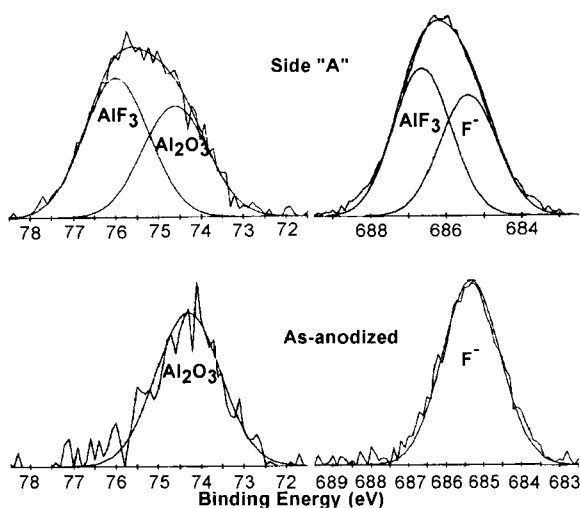
FIGURE 4 Curve-fit XPS analysis of fluorine 1s and aluminum 2p photopeaks for (a) A side failure surface for a specimen bonded and thermally-treated at 371°C for 3.0 hr in air and (b) an as-CAA-anodized Ti-6Al-4V alloy surface.

The curve fit XPS spectra in the aluminum 2p and fluorine 1s regions for an as-anodized titanium alloy surface and for the "A" side surface of the failed bond/heat sample (371°C for 3 hrs) are presented in Figure 4. The respective Al 2p and F 1s spectra for the as anodized, non-treated specimen exhibit only one photopeak. The binding energy for aluminum suggests the presence of an aluminum oxide or hydrated oxide, while the binding energy for fluorine indicates adsorbed fluoride ion. Adsorbed fluorine arises from HF that is added to the anodizing solution to control current density. From an XPS depth profile analysis of an as-anodized titanium-alloy sample (Tab. II), fluoride is present not only on the surface of the oxide coating but is also present within the oxide coating. The fluorine concentration increases from about 5 at.% at the surface to almost 10 at.% at a depth of 35 nm. The fluoride ion could be present as adsorbed anion [9] and/or fluoride could be located in the metal oxide lattice as a substitute for O^{2-} ions. Since F^- and O^{2-} anions have very similar ionic radii [10], the substitution of O^{2-} anions by fluoride ions in metal oxides is common

The aluminum 2p and the fluorine 1s photopeaks from XPS analysis of failure surfaces (side A) for bond/heat samples from wedge tests could each be resolved into two components. Each new component occurs at a binding energy that is higher than that for aluminum oxide or adsorbed fluoride. The binding energies for aluminum and fluorine as fluoride from the curve fit data were 76.1 eV and 686.7 eV,

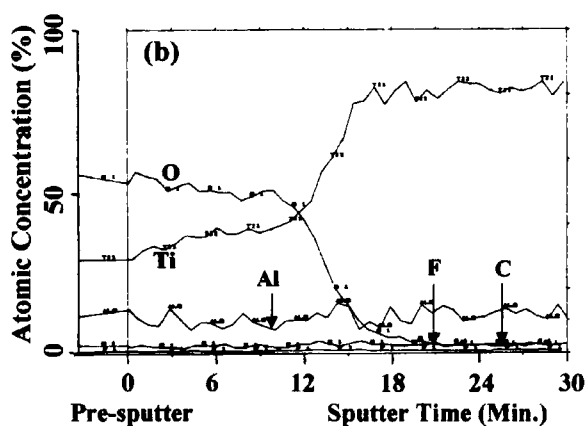
FIGURE 5 Auger sputter-depth profile of (a) as-anodized CAA Ti-6Al-4V alloy and (b) CAA Ti-6Al-4V alloy thermally-treated at 371°C for 3.0 hrs in air.

increase in the oxide thickness for the thermally-treated specimen due to thermal oxidation. The metal/oxide interface is sharp and no significant tail of the oxygen signal is observed for thermally-treated CAA Ti-6Al-4V alloy.

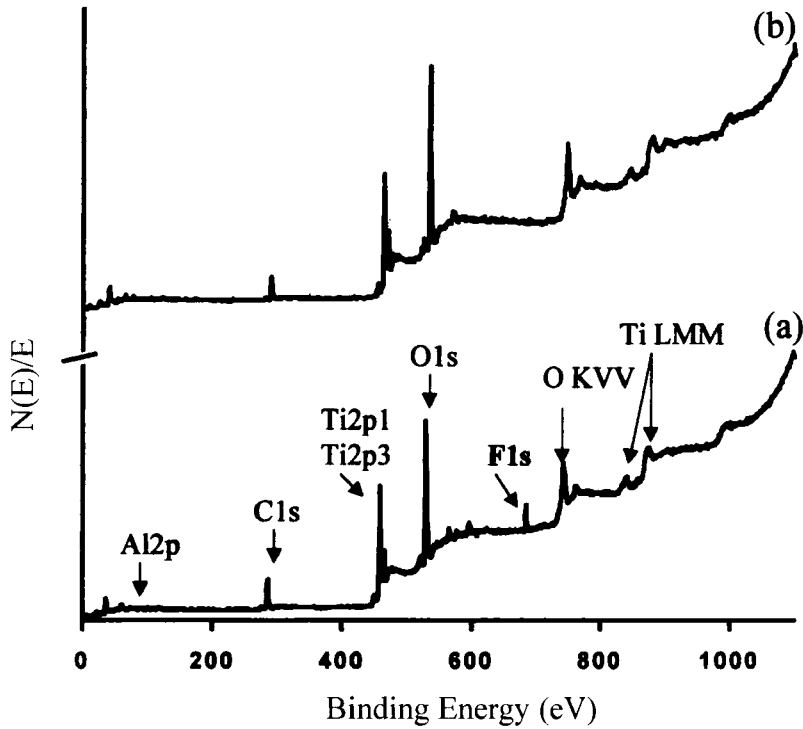
FIGURE 8 XPS wide scan spectra for (a) as-anodized CAA Ti-6Al-4V alloy and (b) CAA Ti-6Al-4V alloy thermally-treated at 371°C for 3.0 hrs in air.

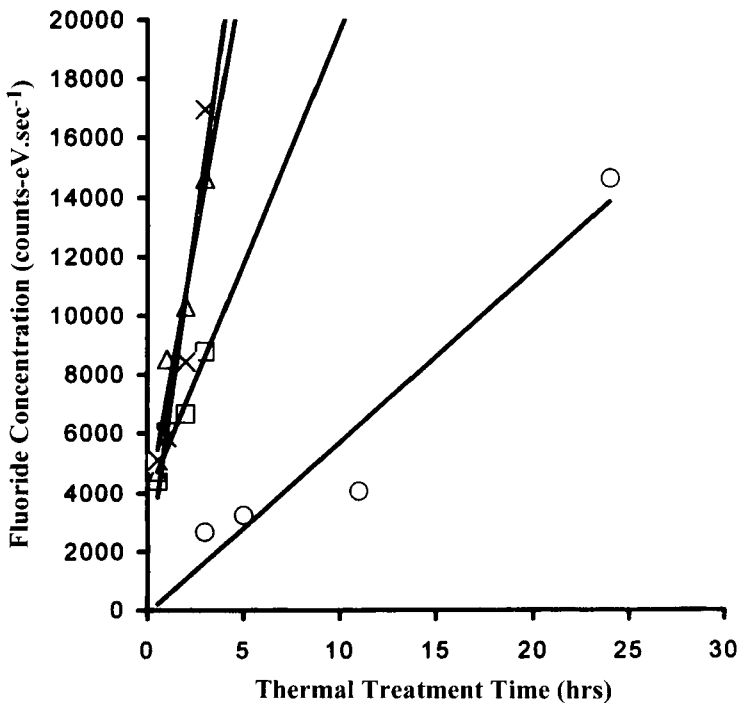
FIGURE 9 Concentration of fluorine, as fluoride, plotted vs. the thermal treatment time at various treatment temperatures: (o) 350°C, (□) 371°C, (Δ) 385°C and (X) 399°C; straight lines are the least-squares fits from the regression analyses.

rate data for the formation of aluminum fluoride species using fluorine as fingerprint element are shown in Figure 9. With just four data points at each temperature, it is difficult to determine, with a good degree of confidence, the rate law for the reaction. However, data for the formation of aluminum fluoride species fitted reasonably well ($R^2 = 90$) a linear reaction rate equation of the form $y = kt + c$, where y is the concentration of fluorine or aluminum as aluminum fluoride; k is the reaction rate constant; t is the elapsed time of the reaction (thermal treatment time); and c is a constant. The linear reaction rate constants, as determined from linear plots of aluminum and fluorine kinetics data at various temperatures, are listed in Table VII. The rate of aluminum fluoride formation as a function of treatment temperature in the form of an Arrhenius plot is shown in Figure 10.

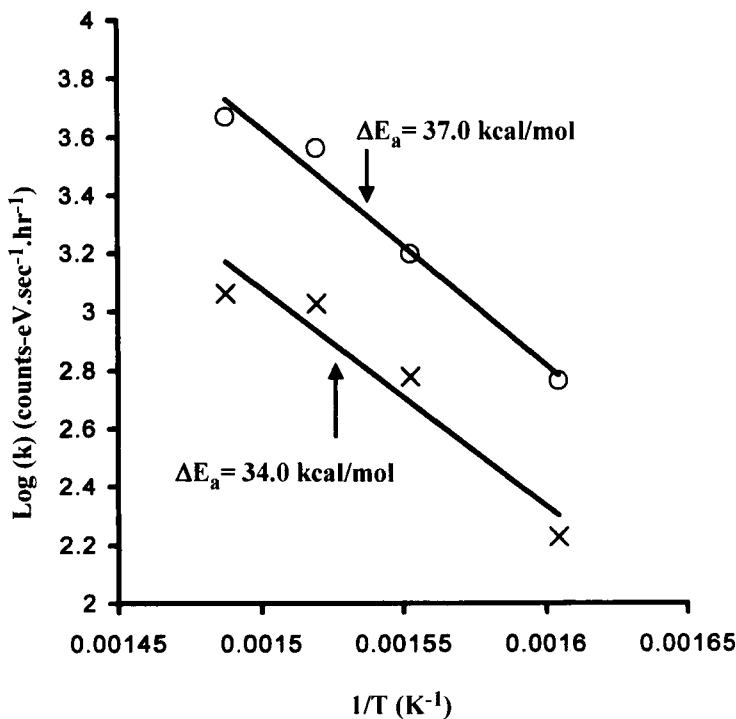
FIGURE 10 Arrhenius plot: rate of aluminum fluoride formation vs. $1/T$: (o) linear rate constants from fluorine kinetic data; (X) linear rate constants from aluminum kinetic data; straight lines are the least-squares fits from the regression analyses.

The activation energy values obtained from Arrhenius plots using aluminum and fluorine kinetic data are about the same. The average activation energy for the formation of aluminum fluoride species is approximately 36 kcal/mole. The high activation energy suggests that the rate of aluminum fluoride formation is substantial only at high temperatures.
