HEADQUARTERS
OGDEN AIR MATERIEL AREA
UNITED STATES AIR FORCE
Hill Air Force Base, Utan

OOAMA AIRMUNITIONS LETTER NO. 136-11-56H

SUBJECT: Advance Explosive Ordnamic Disposal Technical Information

NWI-61-3

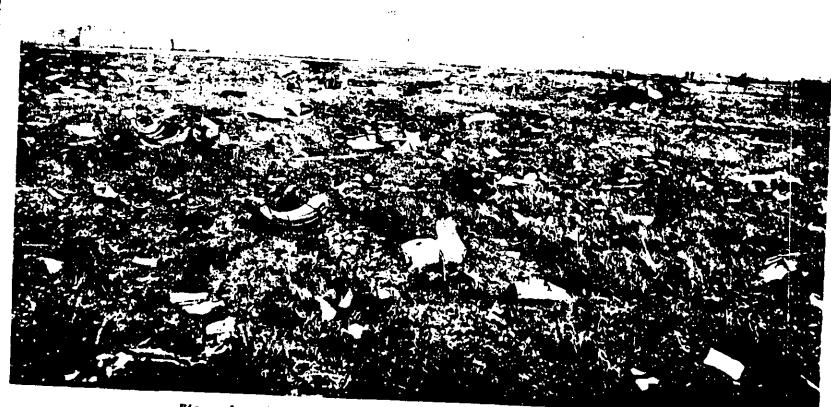
Figure 1. Aircraft wreckage - looking North from point of impact.

- b. An AMC EOD team was dispatched to the site and arrived there approximately four hours after initial notification. The following preliminary observations and findings were made:
- (1) Appropriate security of the impact area had been effected by Beale Air Force Base and the County Sheriff's Office personnel.
- results. (2) Radiation monitoring had been conducted with negative
- (3) The aircraft disintegrated upon impact and wreckage was strewn over a large area (Figures 1 and 2).

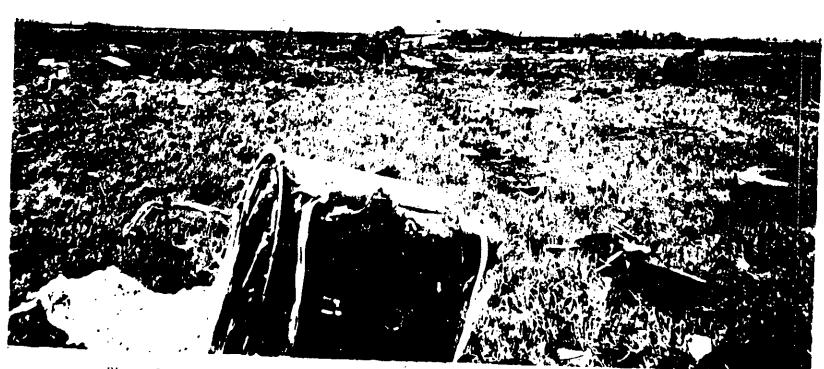
Figure 2. Aircraft wreckage - looking South. Bomb A Parachute assembly in foreground.
