PALOMARES SUMMARY REPORT

15 JANUARY 1975

The accident which occurred over Palomares, Spain on 17 January 1966 and its subsequent recovery operation attracted worldwide interest. This report is designed as a summary which collects the most pertinent data under one cover.

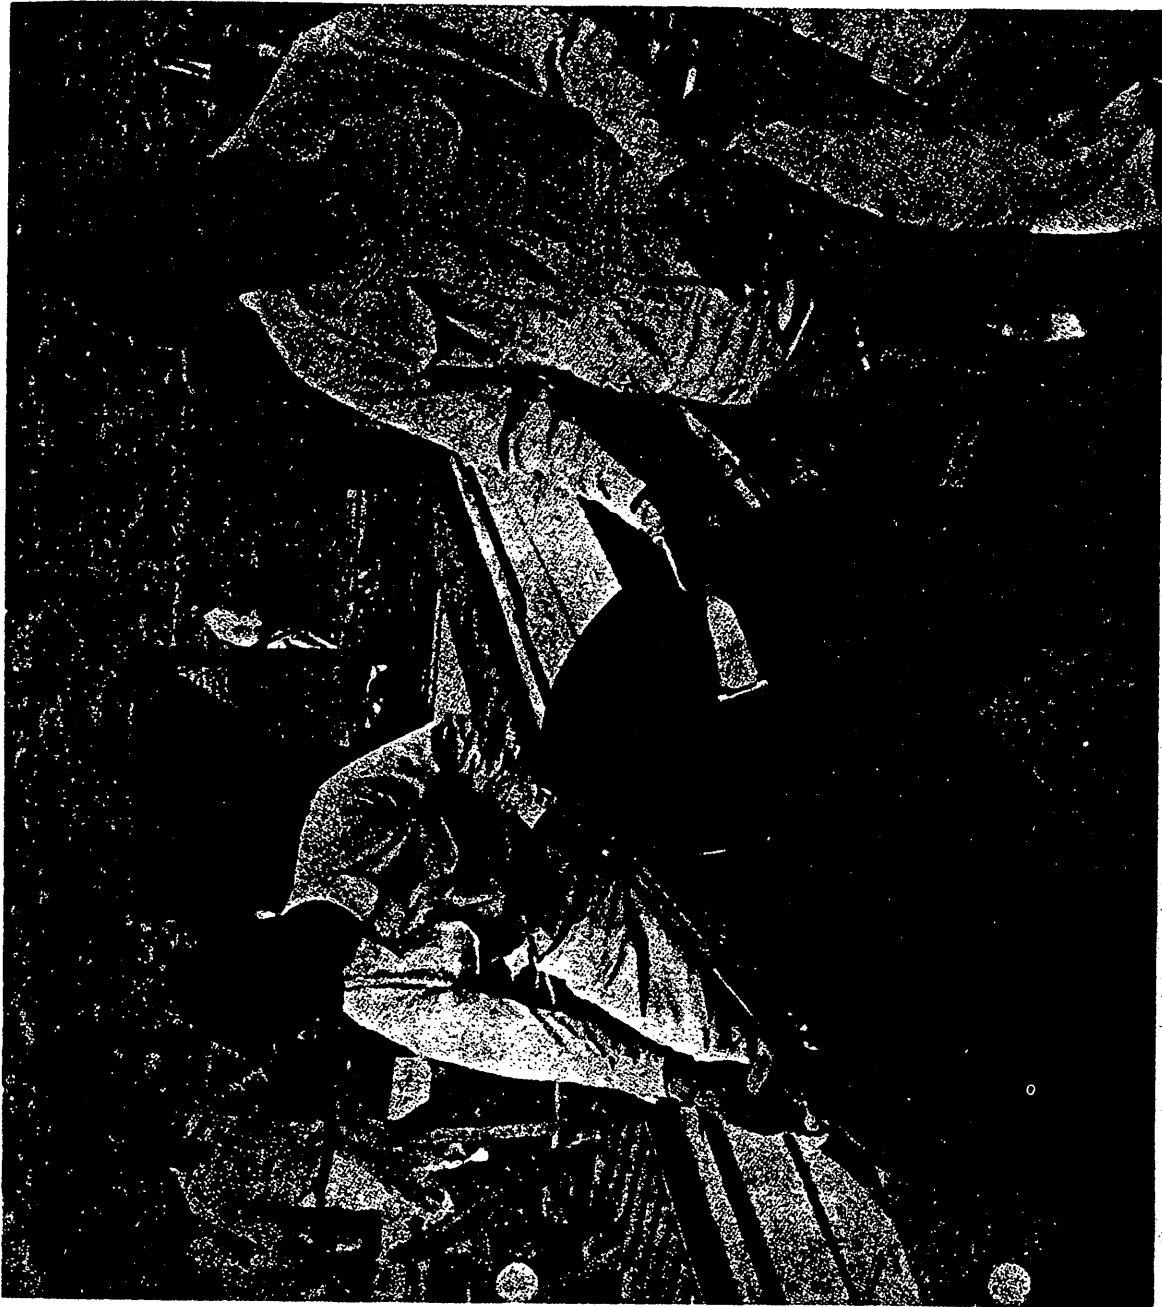
Figure 2-19 Monitoring Barrels

final 12 on the bottom, before the barrels left the filling area (Fig. 2-19). A flatbed transported them to the beach, where radiation was spot checked. A roller conveyor system was used to move the barrels to the ships, with a square of plywood under each to permit easier moving. The goal was to move one barrel off the assembly line each 40 seconds (Fig. 2-20). It was found that only a very brief contact of the PAC-1S was needed to show if contamination existed; thus, with two monitors working top and sides, and a third for the bottom readings, the goal could be accomplished.

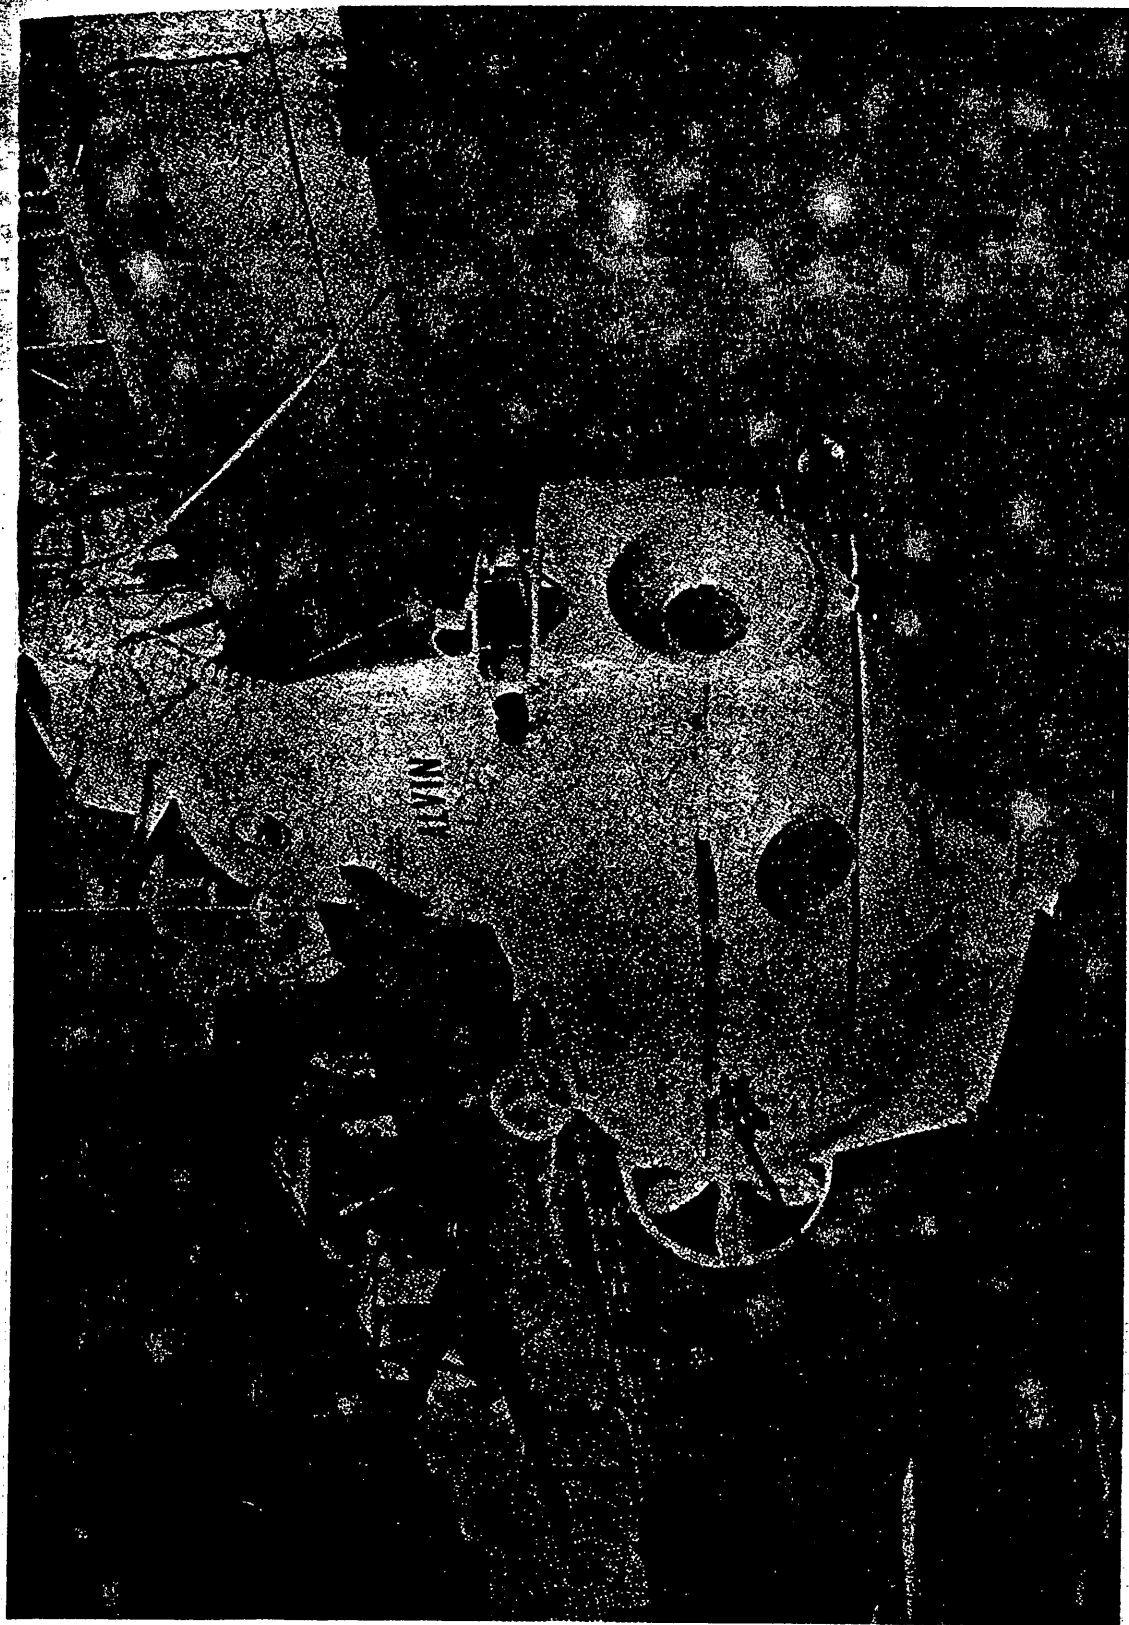
Figure 3-23 ALVIN Vehicle

ALVIN - Next in size and best in maneuverability and adaptability to rugged terrain, ALVIN (Fig. 3-23) spent 72 days on station and evaluated six contacts, three of which originated from the B-52/KC-135 collision. When compared to the box score of CUBMARINE, ALVIN's contact results are misleading. Employed almost exclusively in deep water at the extreme limit of the predicted debris pattern, ALVIN's opportunity for contact in either the search or identification mode was several orders of magnitudes less than that of CUBMARINE. It is probable that ALVIN would have performed as well as CUBMARINE, given the same area assignment. In spite of the fact that ALVIN found the illusive nuclear weapon, both times, and received its share of the glory, it was not without its shortcomings. To counteract its effectiveness in rugged submarine canyons, the limited endurance, about 8 1/2 hours, made searching large flat areas inefficient. Construction and crew habitually accentuated crew
