# **Field Service Report For**

**LM 2500 Repair**

**Facility: WG-Pratt & Whitney  
Unit: 481-642**

## REPAIR SUMMARY LM2500 481-642

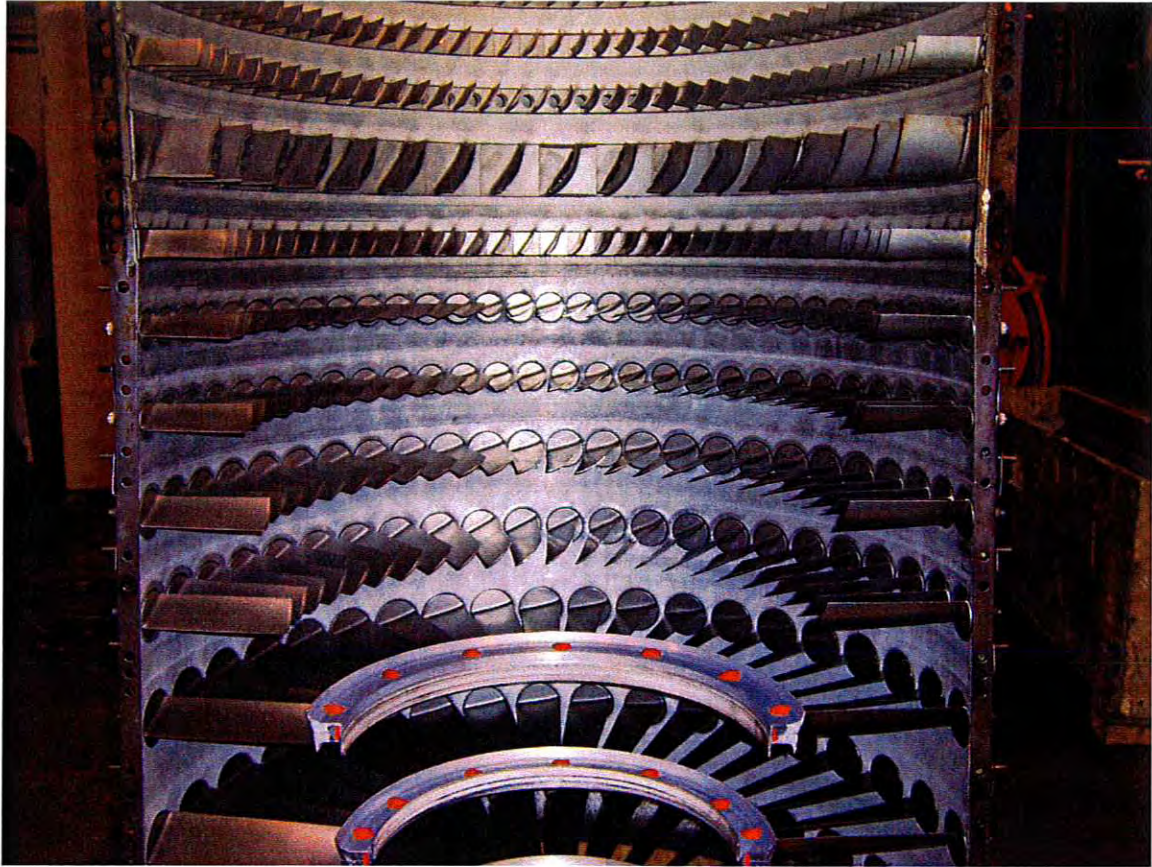
## HIGH PRESSURE COMPRESSOR CASE PRIOR TO CLEANING

**Starting with the high pressure compressor section of the unit. It has been opened and the following work performed: The rotor and all 16 stages of blades were inspected. The rotor and blades were then hand cleaned. Some repairs were performed such as blending of blades. The vanes were inspected and cleaned with no discrepancies noted; the variable stator vanes were inspected for integrity and were in good condition with no damage. Overall condition of the high pressure compressor is very good and as per the GE manual GEK 97310 inspection section all is in serviceable condition. Currently the compressor is being reassembled and should be completed by 06/03/09.**

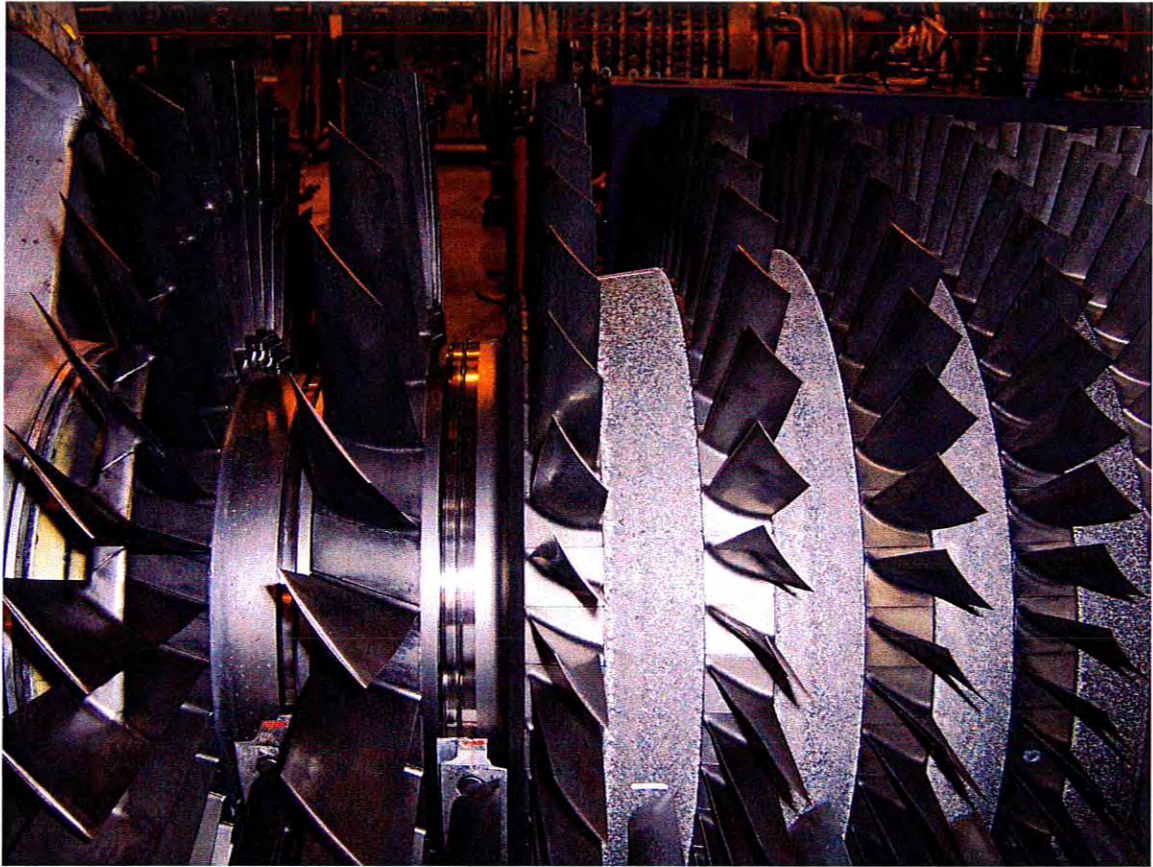
## FORWARD COMPRESSOR BLADES PRIOR TO CLEANING

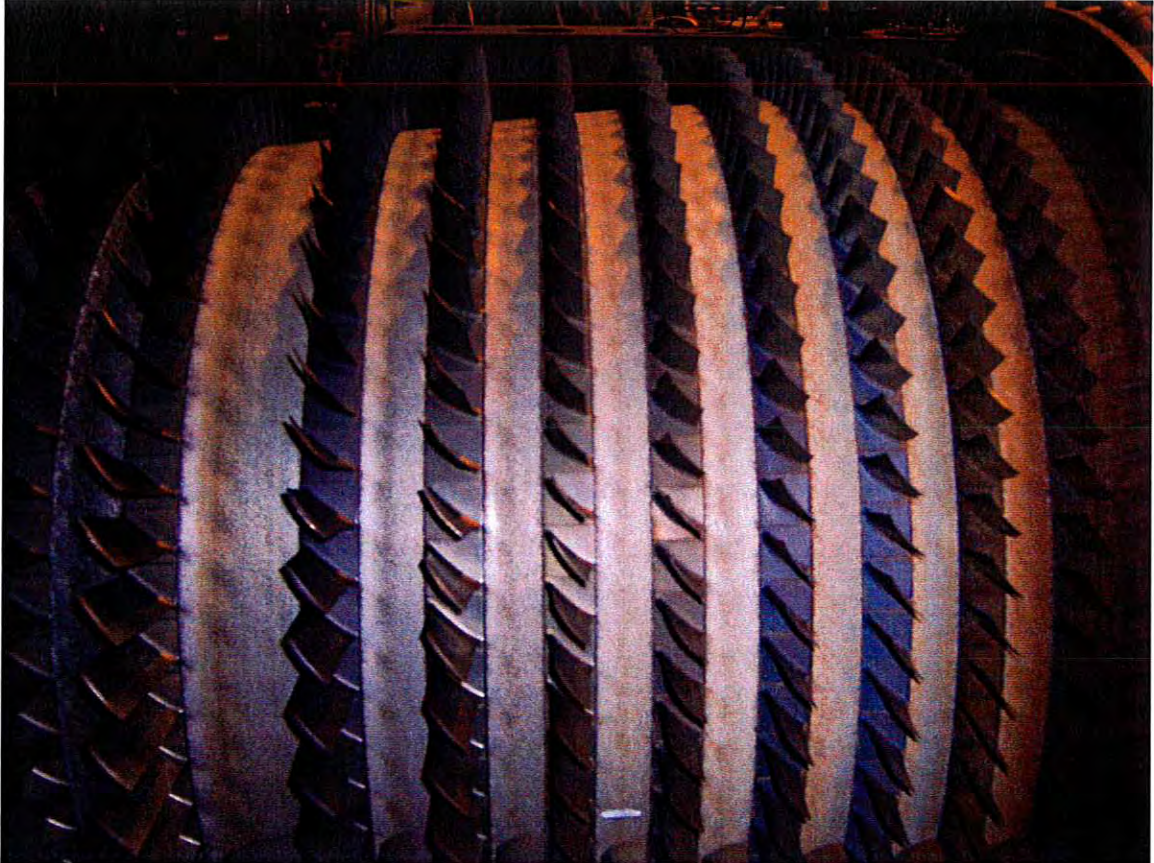
## **AFT COMPRESSOR STAGES PRIOR TO CLEANING**

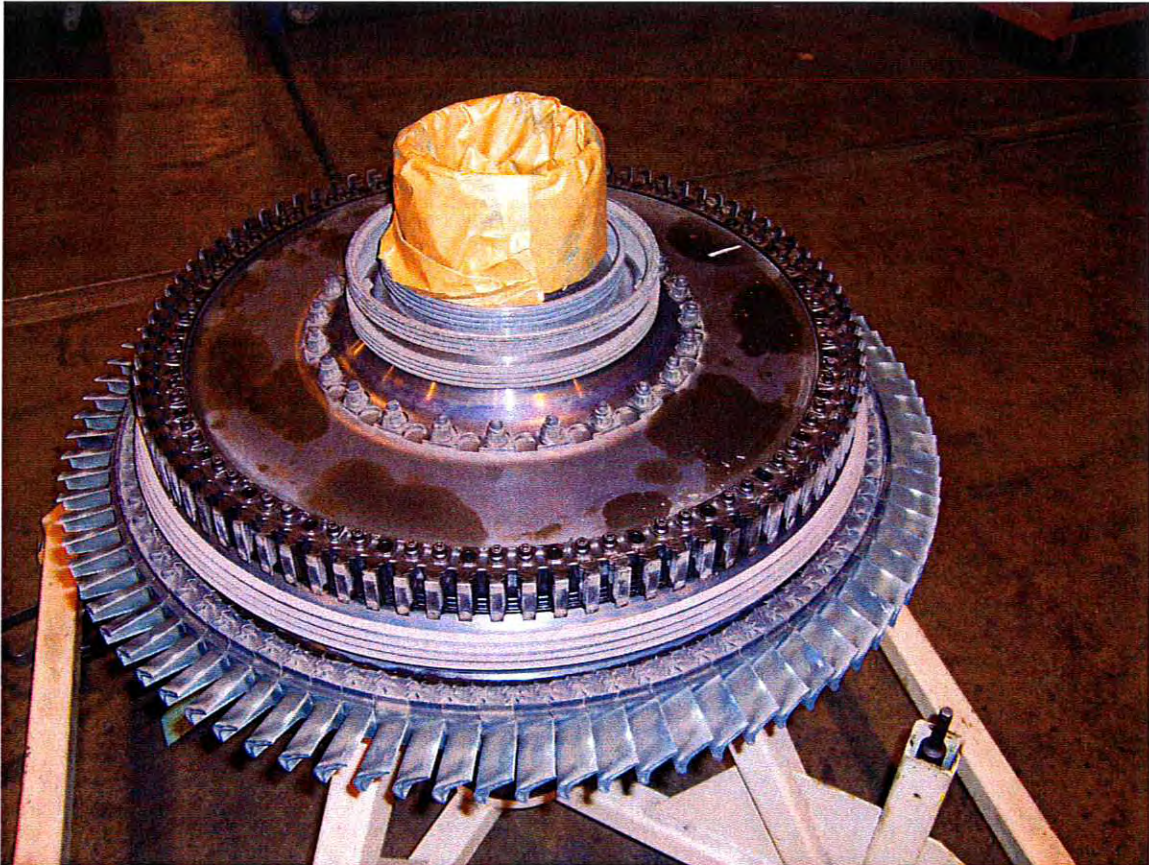
## HPT ROTOR PRIOR TO CLEANING AND REPAIR

**The high pressure turbine section has been removed and disassembled. The stage 1 nozzle is still in the unit and has been inspected with no damage noted. In order to inspect the shrouds stage 2 nozzle assembly was removed. The stage 1 blades were removed and inspected. The stage 1 blades are currently sent out for repair. Status of the repair is pending and we are trying to get it done as fast as we can. The stage 2 nozzle assembly has also been sent out for inspection and we are currently waiting for a report on its status. The stage 2 blades were removed and inspected and are in good serviceable condition as per the GE manual. The stage 2 blade shrouds were inspected and are in good condition. As soon as we get the Parts back from repair the unit will be reassembled and moved to a different area for proper external cleaning due to the facility set up. Please see pictures below.**

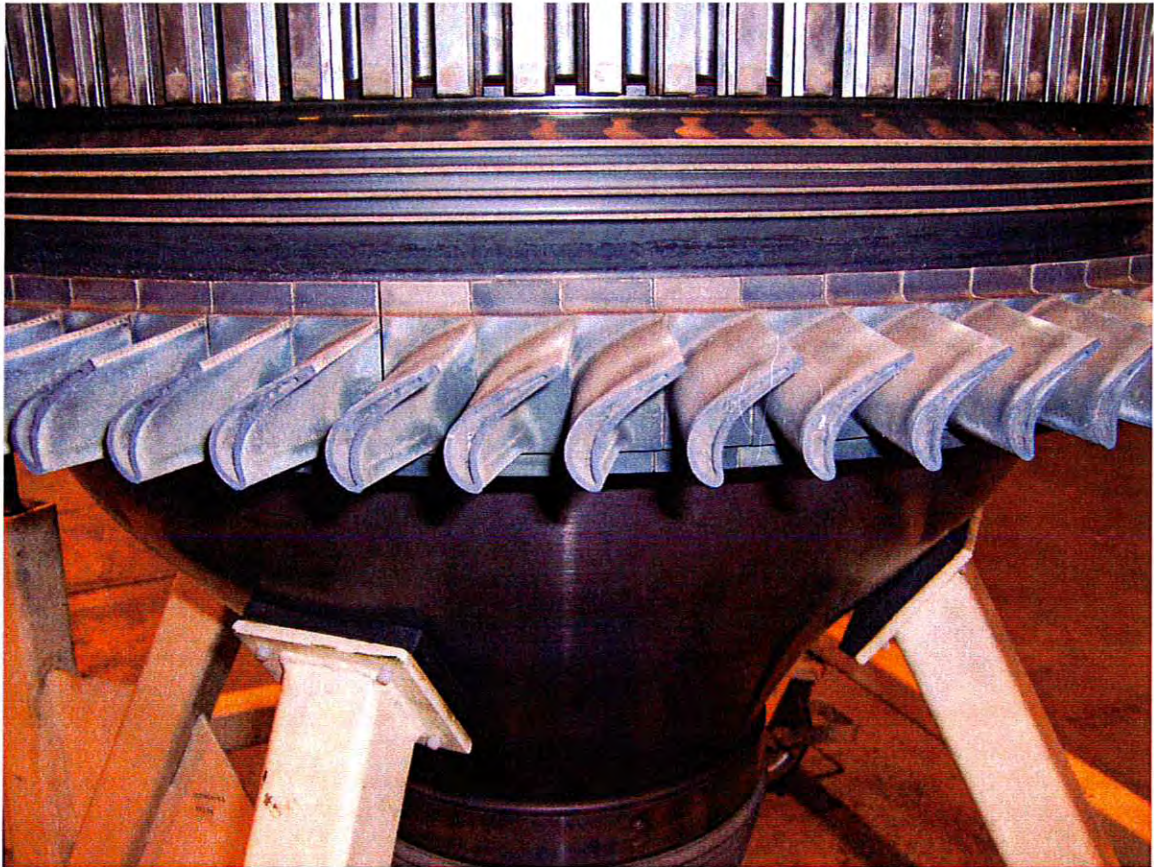
## HPT ROTOR STAGE 1 BLADES

**481-642: HPT blades and stage 2 nozzle has been sent of to Chromalloy. They will recoat the blades and inspect the stage 1 blade shrouds which according to GEK 93710 chapter 5 gives you the limit and as inspected are in serviceable condition. To make the shroud look better there is a possibility of recoating which will be determined upon price and time. HPC is being hand cleaned since the top case removal. Minor dents will be blended if necessary. The stage 1 HPC blade dampers show wear and missing material. This is not uncommon on units that operate at low and fluctuating loads. The condition was not mentioned in the second party inspection. Will determine the outcome after reviewing the BSI report. JTS has blades if necessary. FYI they will give us a quote for overhauled and one set that is serviceable. If the blades were not mentioned in the inspection report I would not replace them. Attached are some of the pictures from the JTS shop with recommendations. As we all know these are their recommendations and to benefit their profit. This unit will only need minor work since the inspection after tear down.**

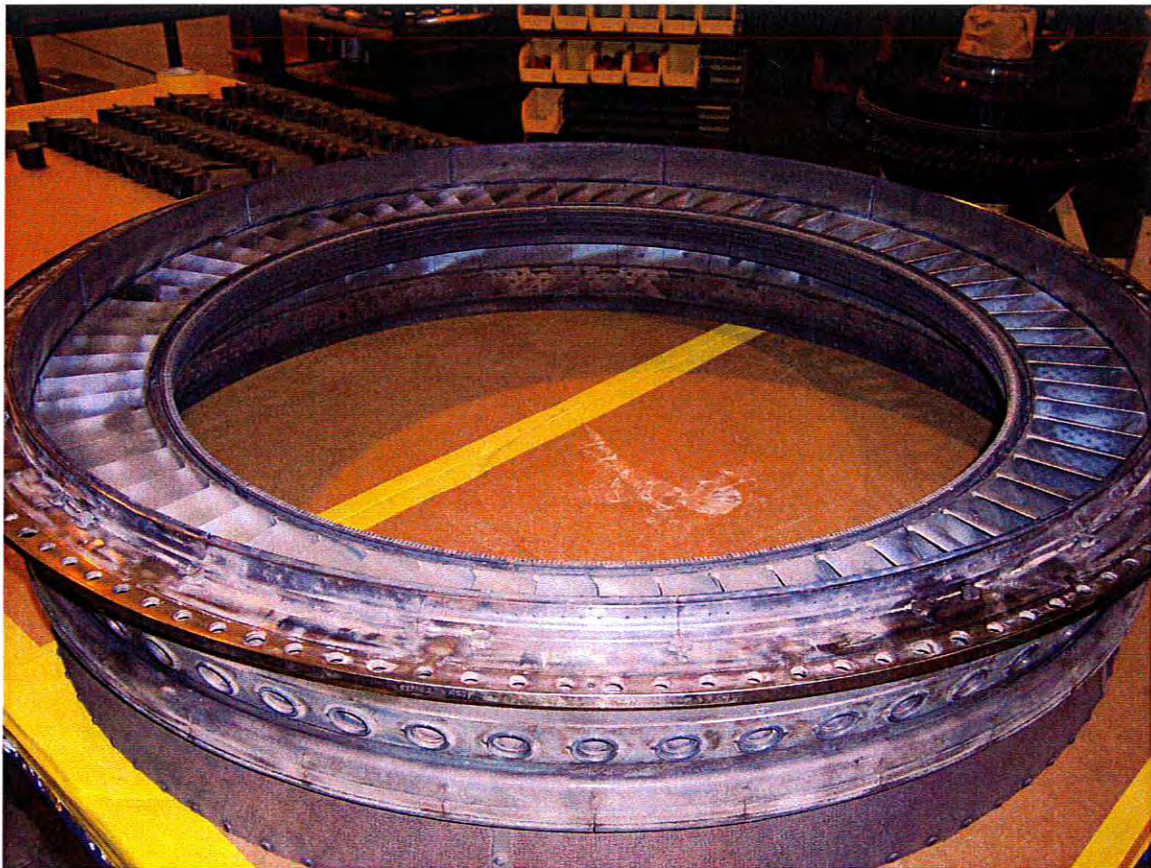
## STAGE 2 NOZZLE ASSEMBLY PRIOR TO CLEAN UP AND REPAIR

2. The stage 2 nozzle assembly is being disassembled today since it arrived from Chromalloy. It was shipped back due to no facility in the US. The damaged shrouds will be removed and replaced. This will take a few days. When finished the nozzle will need to ship out for grind. I forwarded Cost for this earlier but will attach it again. We have a few options on what shrouds to use and we should try and keep the cost down by using their Pratt parts. When the nozzle returns it will be reassembled and installed.

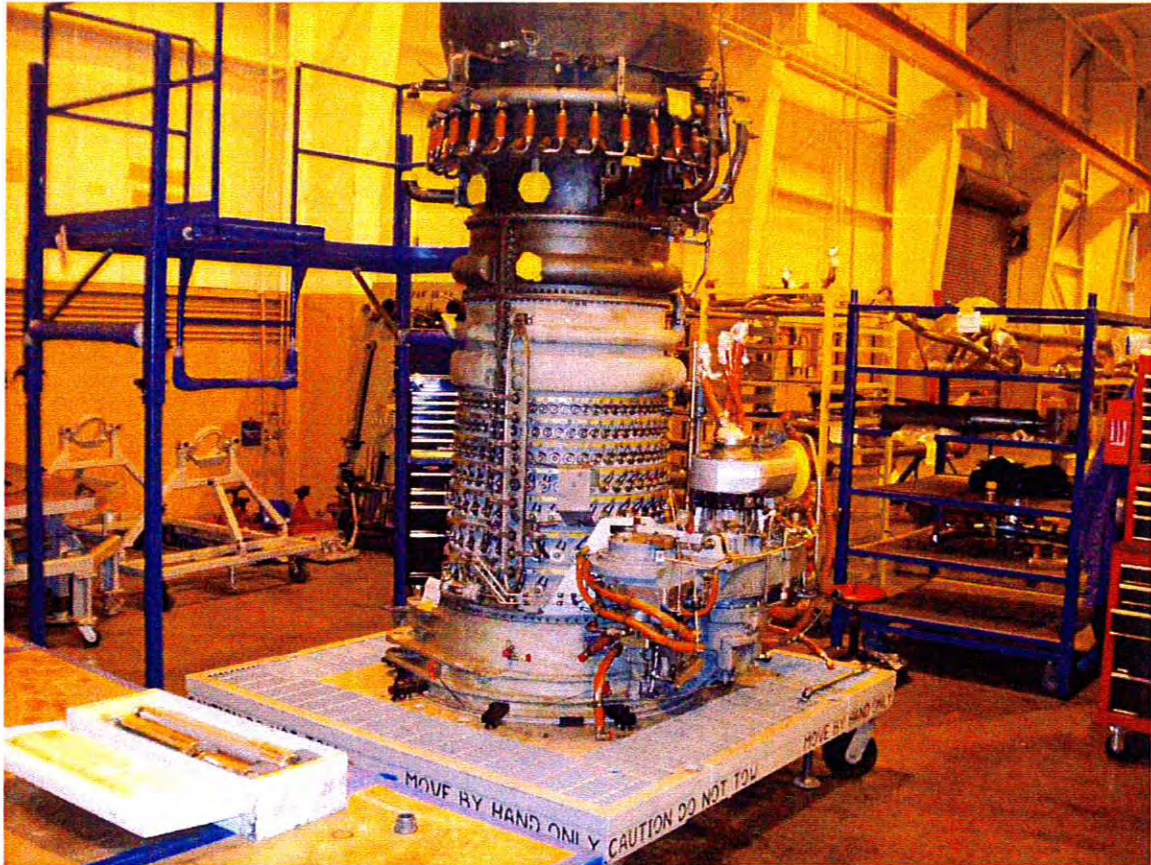
**UNIT VERTICAL READY FOR GEARBOX REMOVAL  
AND STATOR CASES**

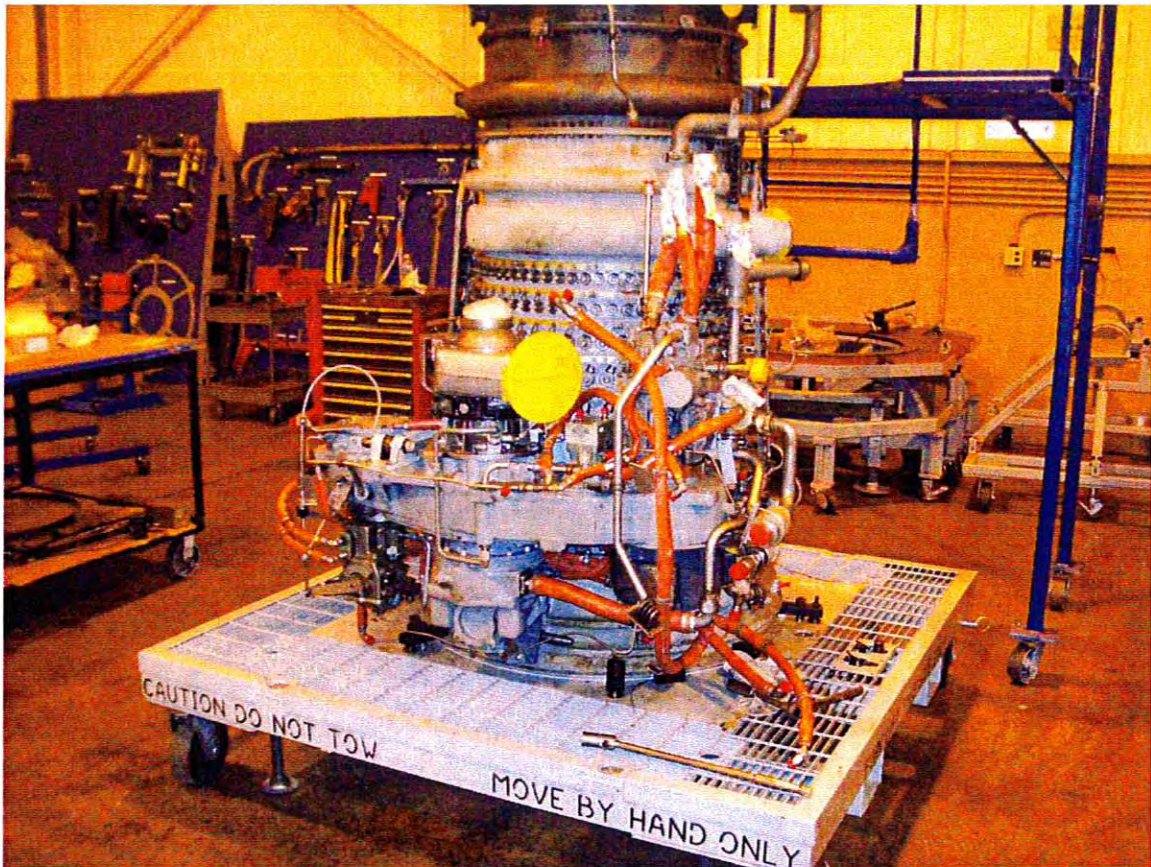
**UNIT PRIOR TO GEARBOX REMOVAL**

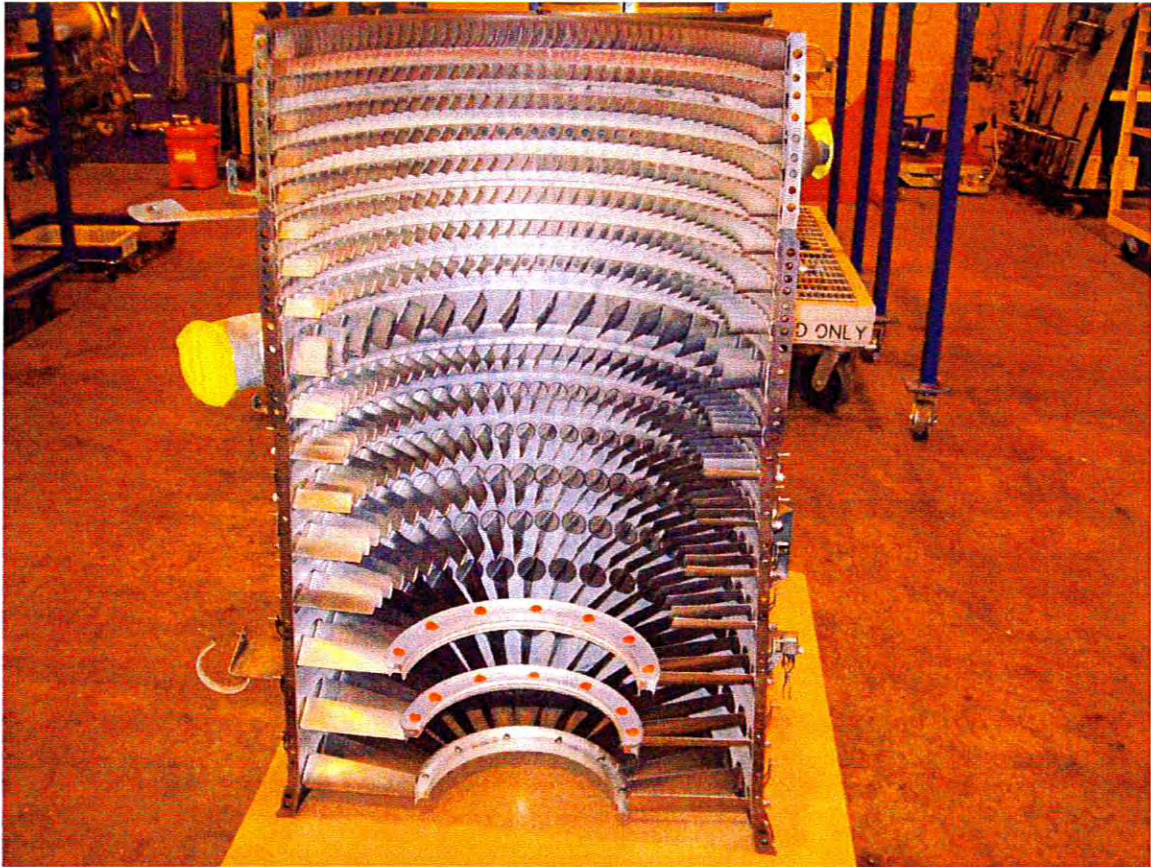
**UPPER COMPRESSOR CASE AFTER REMOVAL**

3. The compressor cases are being removed due to the case rub which is in serviceable limits. The reason for this is that Rolando and Neill brought this issue to attention for the customer. The plan for the cases is that we are going to try and clean it up. The risk of doing that is possible loss of performance due to opening the blade to case clearances. The only other option would be to rework the cases which is very costly and time consuming. We will measure before and after clearances to have an idea where we will be at after repair.

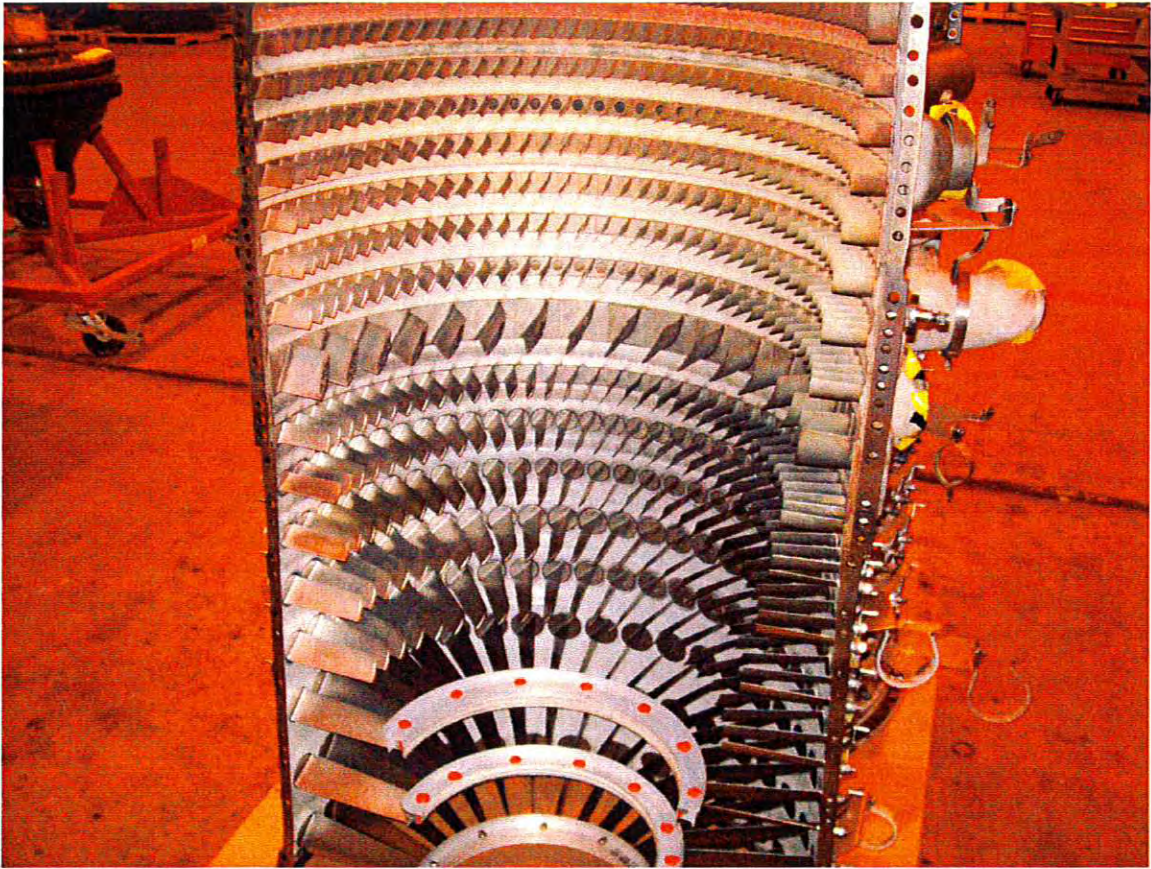
**LOWER COMPRESSOR CASE AFTER REMOVAL**

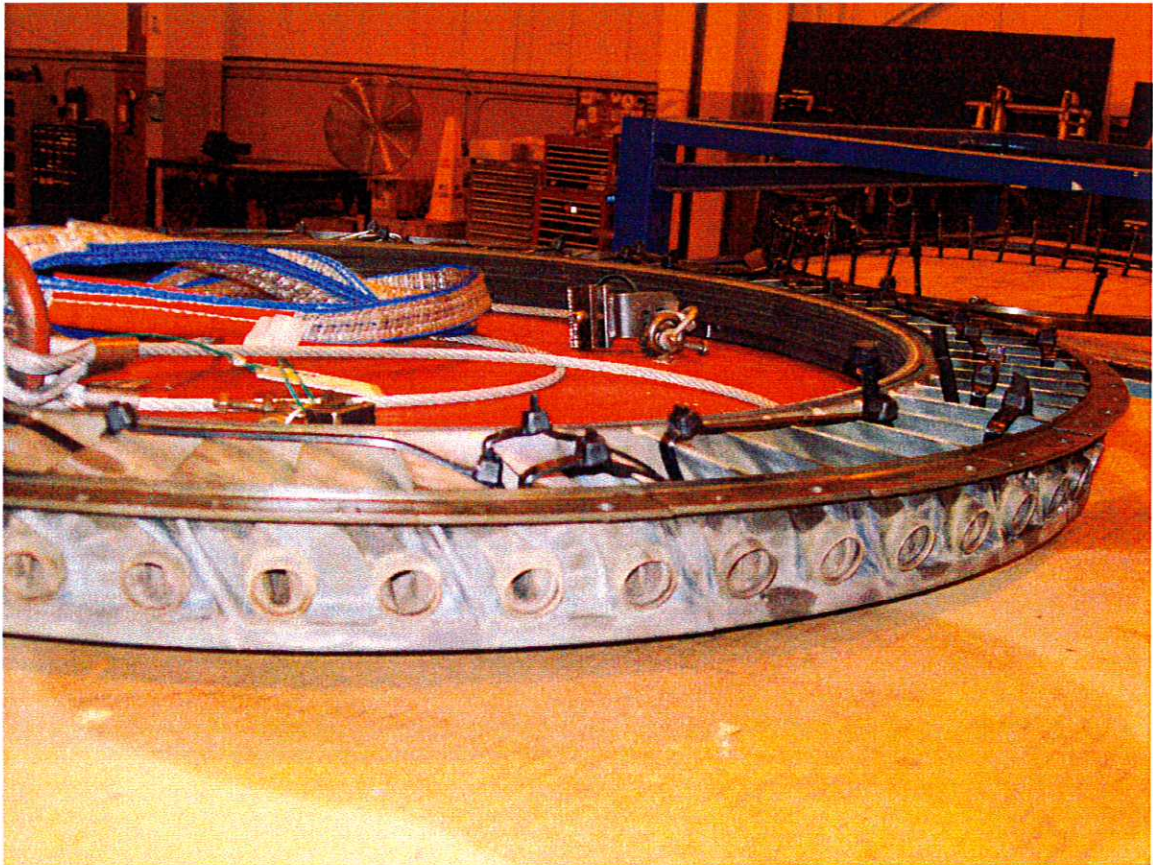
**STAGE 2 NOZZLE ASSEMBLY DISSASSEMBLED**

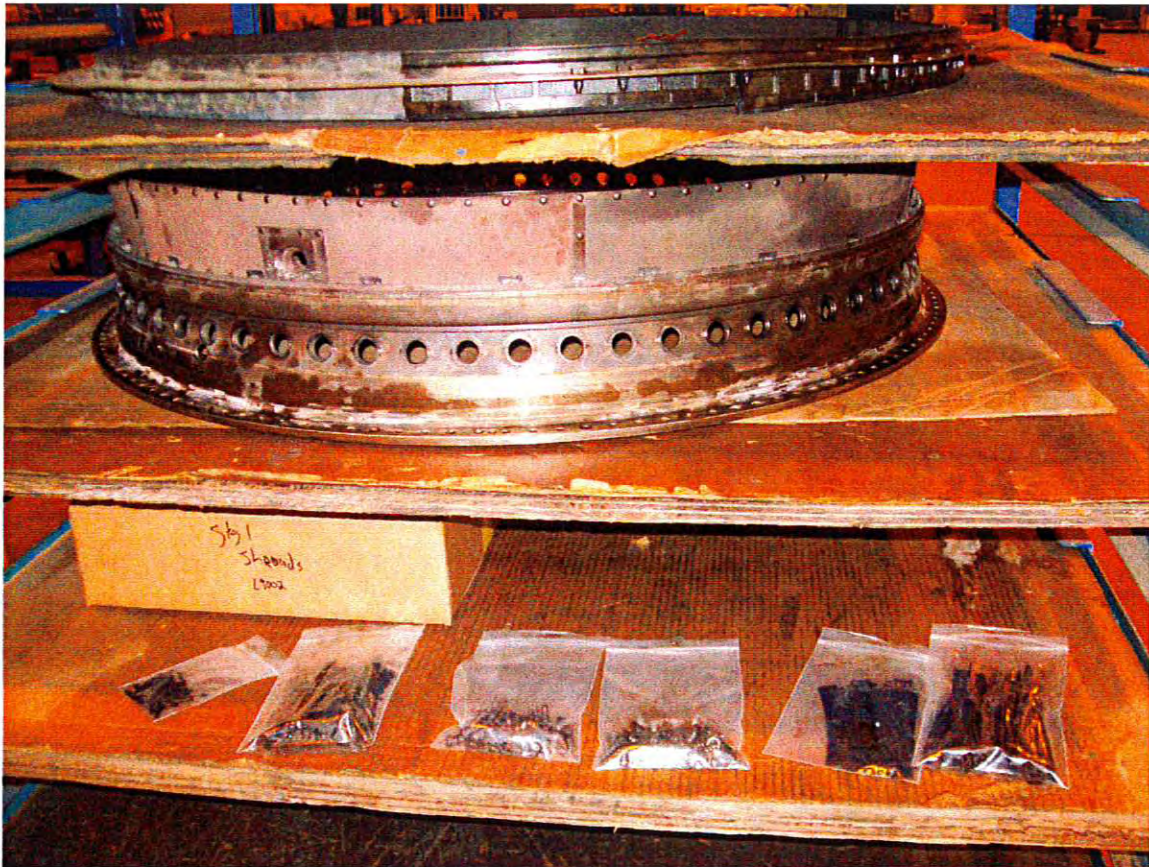
**STAGE 2 NOZZLE ASEMBLY SUPORT**

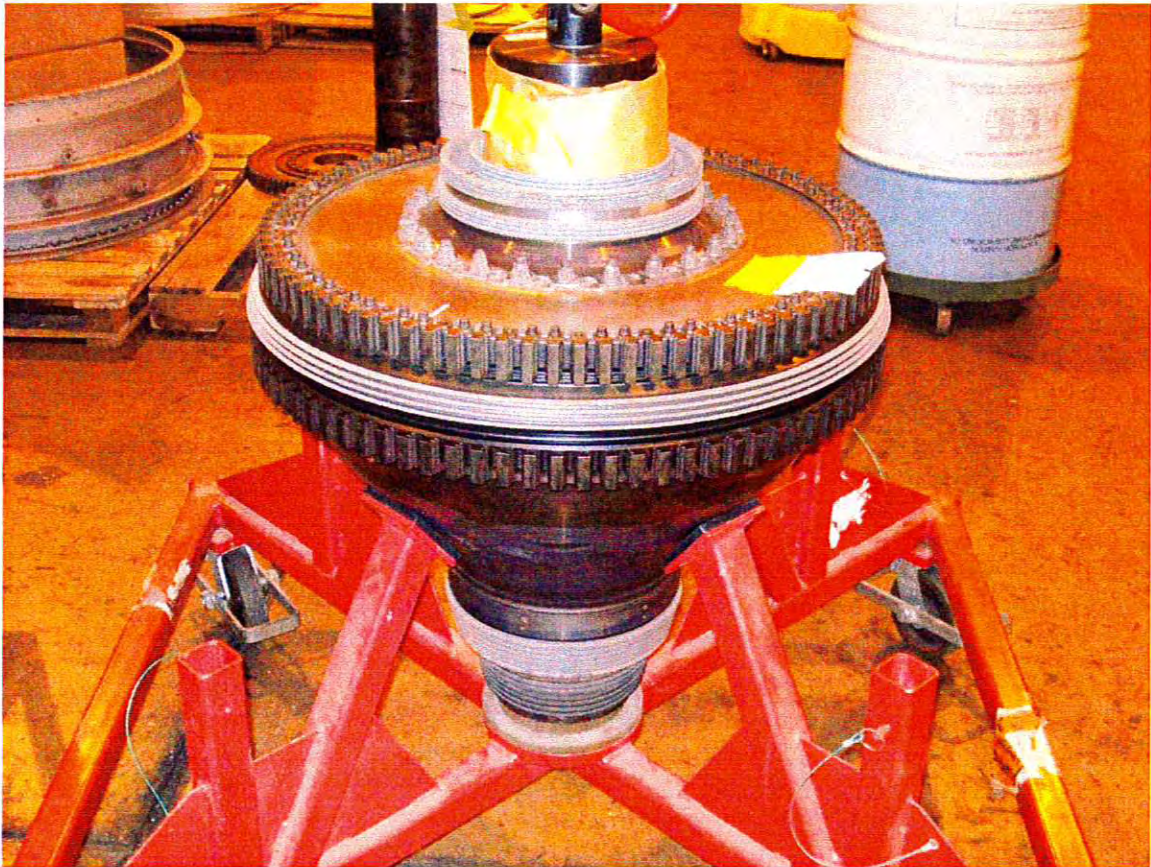
**DEBLADED HPT ROTOR WAITING FOR BLADES TO  
COME BACK FROM REPAIR**

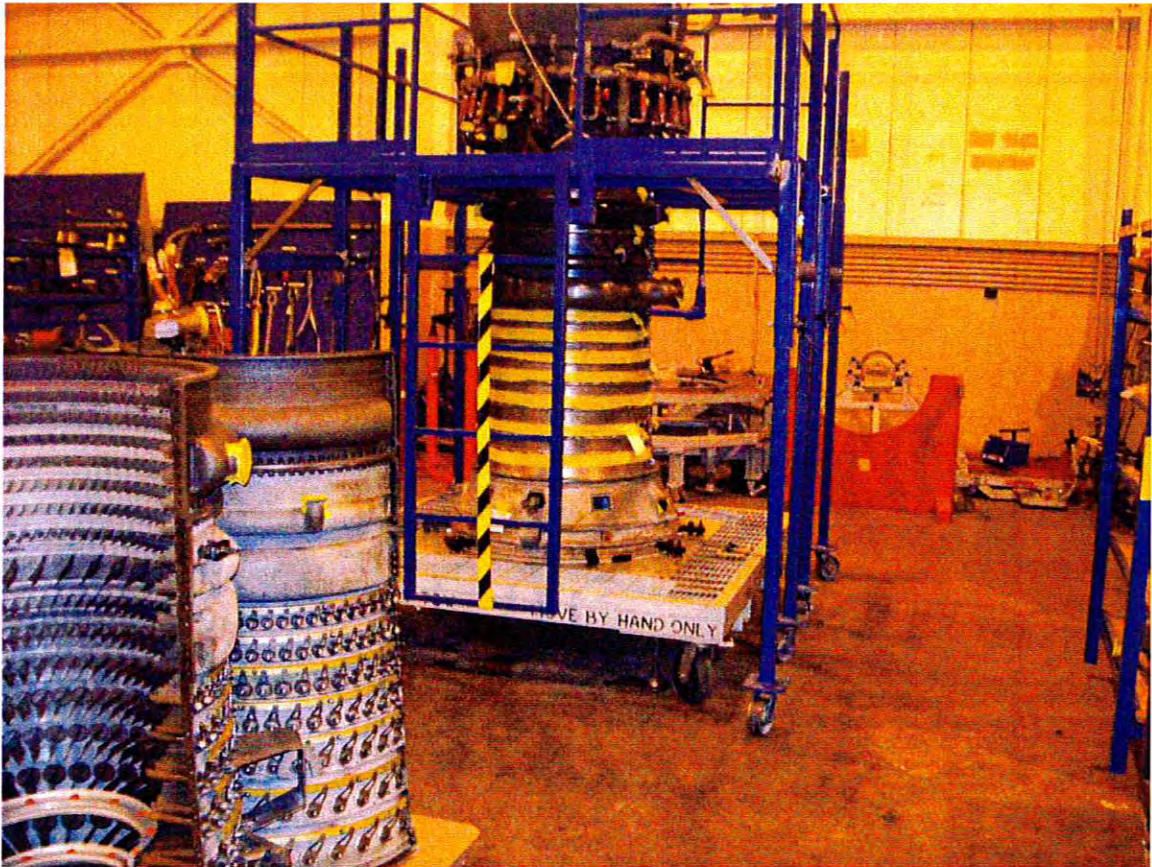
**ENGINE VERTICAL WITH STABILIZER CASES FOR PROTECTION**

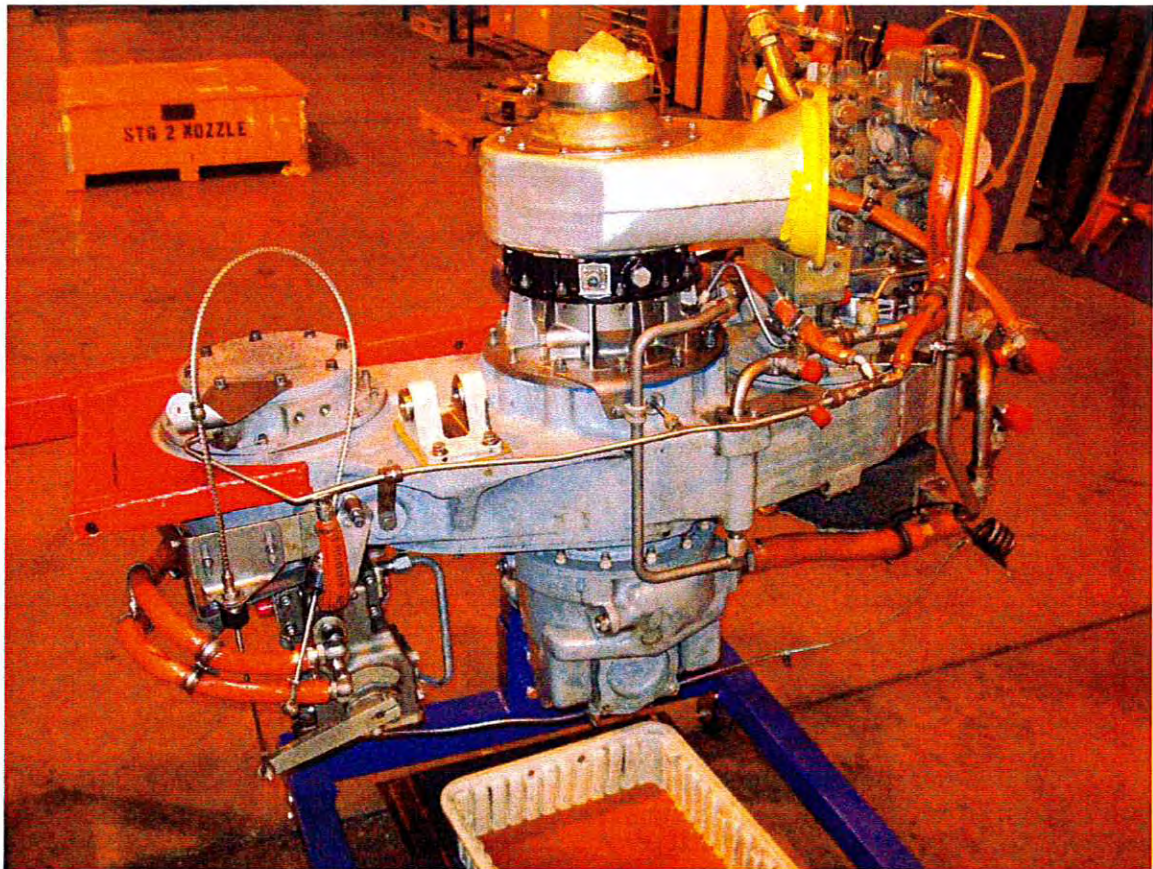
**THE REMOVED GEARBOX**

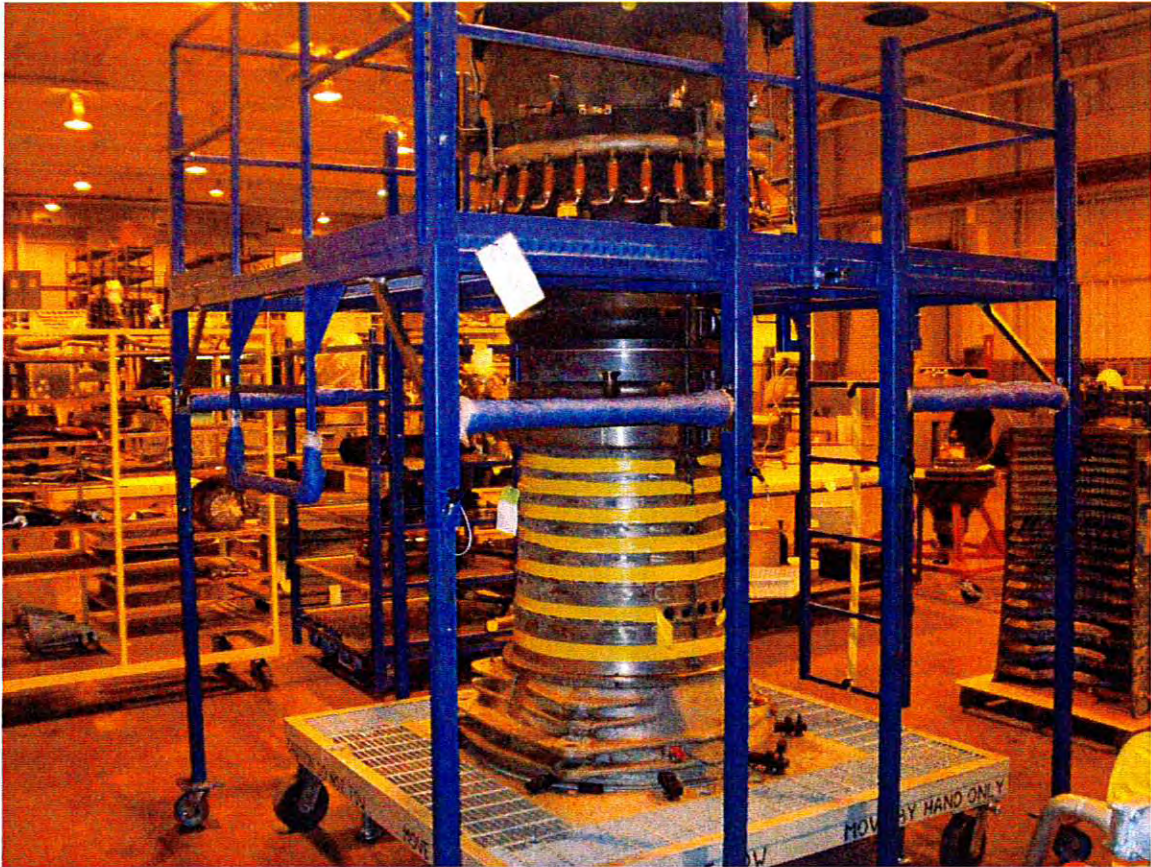
**ENGINE VERTICAL**

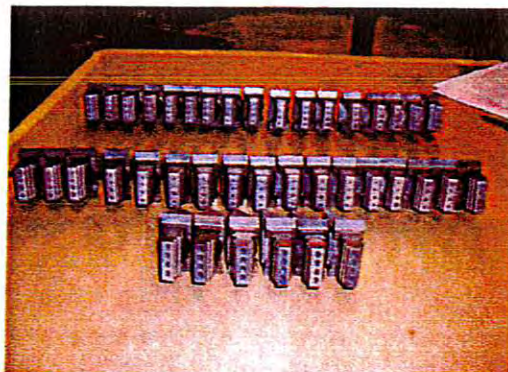
Discrepancy: Significant wear on Stage 1 HPT blade tips.			
Picture in Folder			
Corrective Action: Replaced stg 1 blades with 48 ea. From WGPW stock and 40 ea. CFM			
		Completed By: RM	Date:

Stage 1 Blades

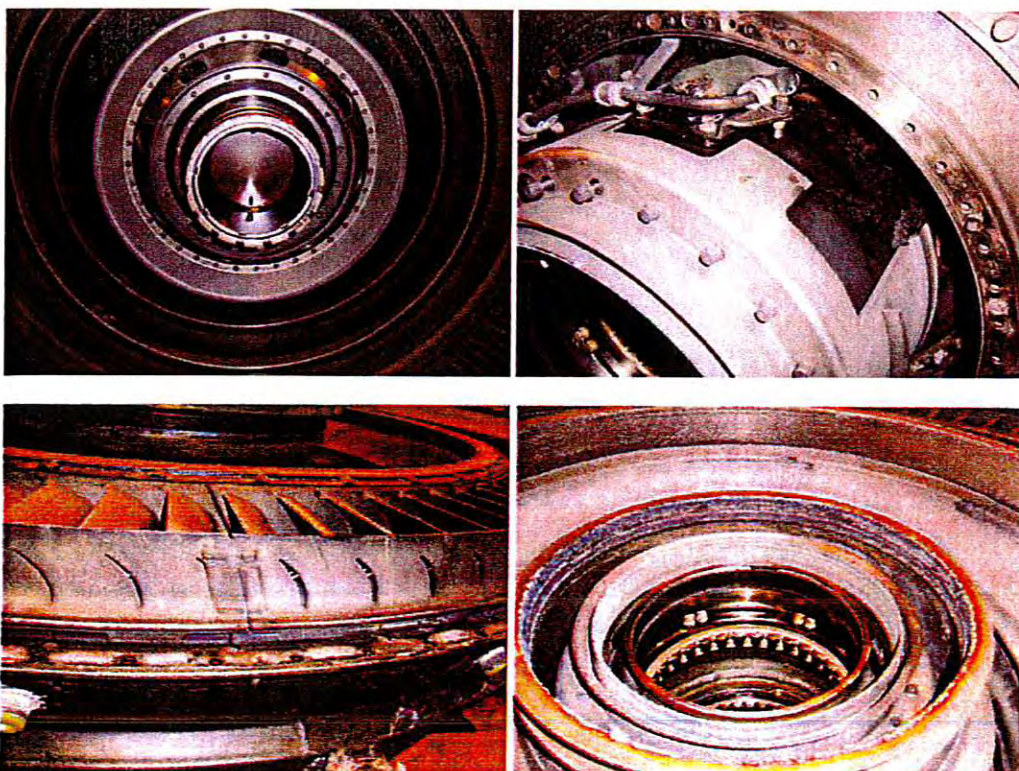
## SECTION 12.0 TMF PHOTOS

Additional inspections were carried out the all major components of the gas turbine. During the inspections there were several discoveries which were found and corrected. One of those was evidence of an oil leak in the Turbine Mid-Frame (TMF). The TMF was sent to Chromalloy in San Antonio Texas for in-depth inspection and repair. The leak turned out to be a very minor issue with a supply line gasket. The gasket was replaced, the TMF pressure checked and returned in serviceable condition.
