Over-the-Air Jamming and Spoofing Tests of GNSS Timing Devices

Summary—We present results of over-the-air jamming and spoofing interference tests against two types of commercial GNSS timing devices: a stand-alone GNSS timing receiver chip and a multi-source timeserver with an integrated GNSS disciplined (OCXO) clock. During jamming, the receiver chip showed poor and fluctuating timing, while the timeserver was protected by a high stability oscillator and eventually switched over to the external PPS input as the active sync source. During GPS L1 spoofing both devices maintained good timing as long as GLONASS signals were in use. With GLONASS disabled, the timeserver switched over to the spoofed time and position instead of selecting the available alternative sync source.

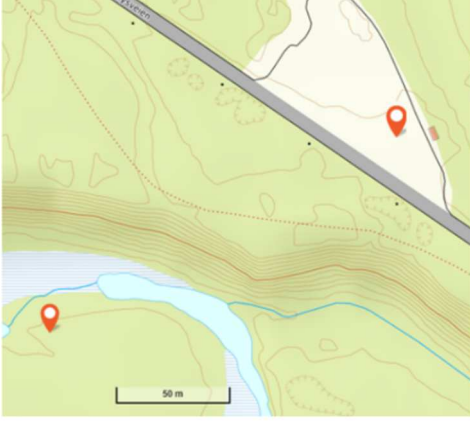
Fig. 3. Timeserver change of position during jamming represented on map. The signal degradation experienced by the timeserver during the jamming scenario caused the position reported by the timeserver to change by several hundred meters for as long as the interference persisted.

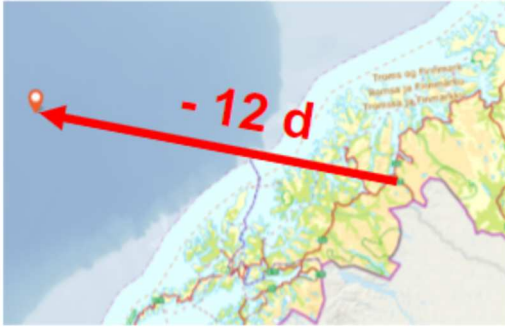
Fig. 6. Position change during spoofing. The position change that occurred during the spoofing scenario displayed on a map. The change in position is approximately 400 km.
