CAPTURED TANKS UNDER THE GERMAN FLAG

RUSSIAN BATTLE TANKS

DR. WERNER REGENBERG
HORST SCHEIBERT

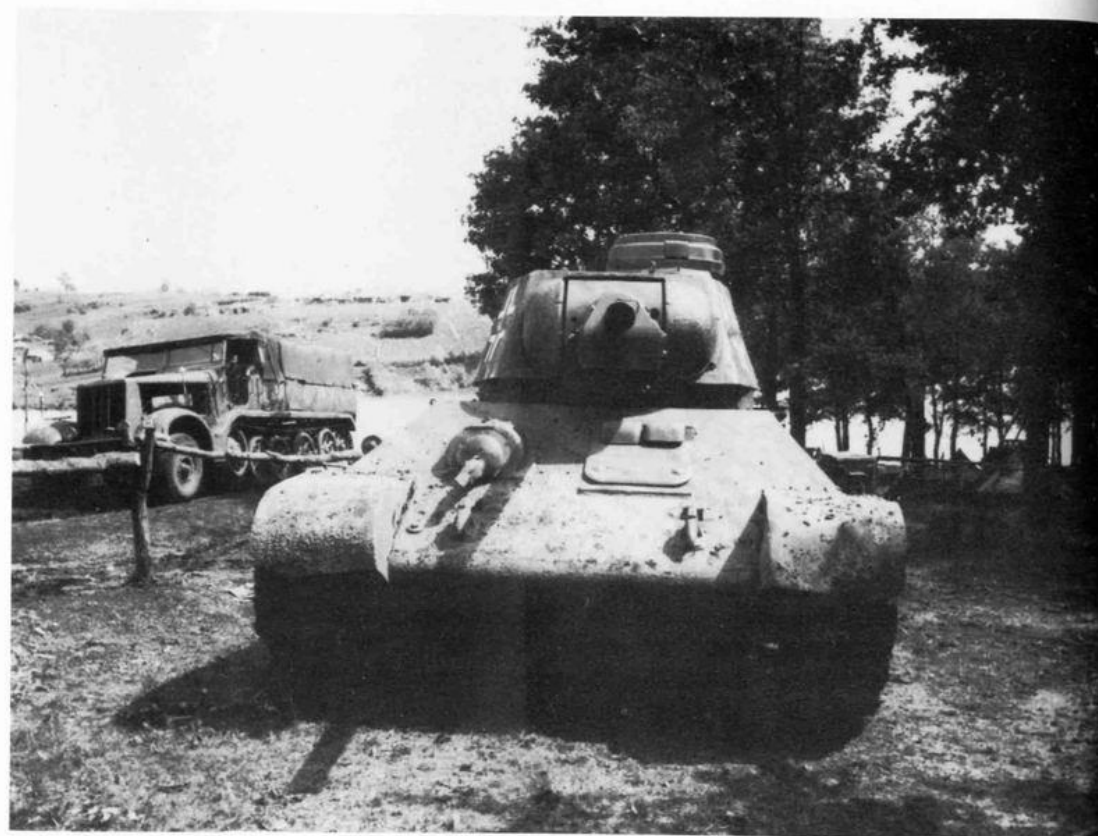
A T-34 (1943 model) in service with Company 7 of Armored Regiment 11 in 1943. A German commander's cupola was mounted on the tank. In the middle of the bow is the regimental marking "Op" (Regimental Commander von Oppeln-Bronikowski). It is the same tank as was shown on the inside front cover.

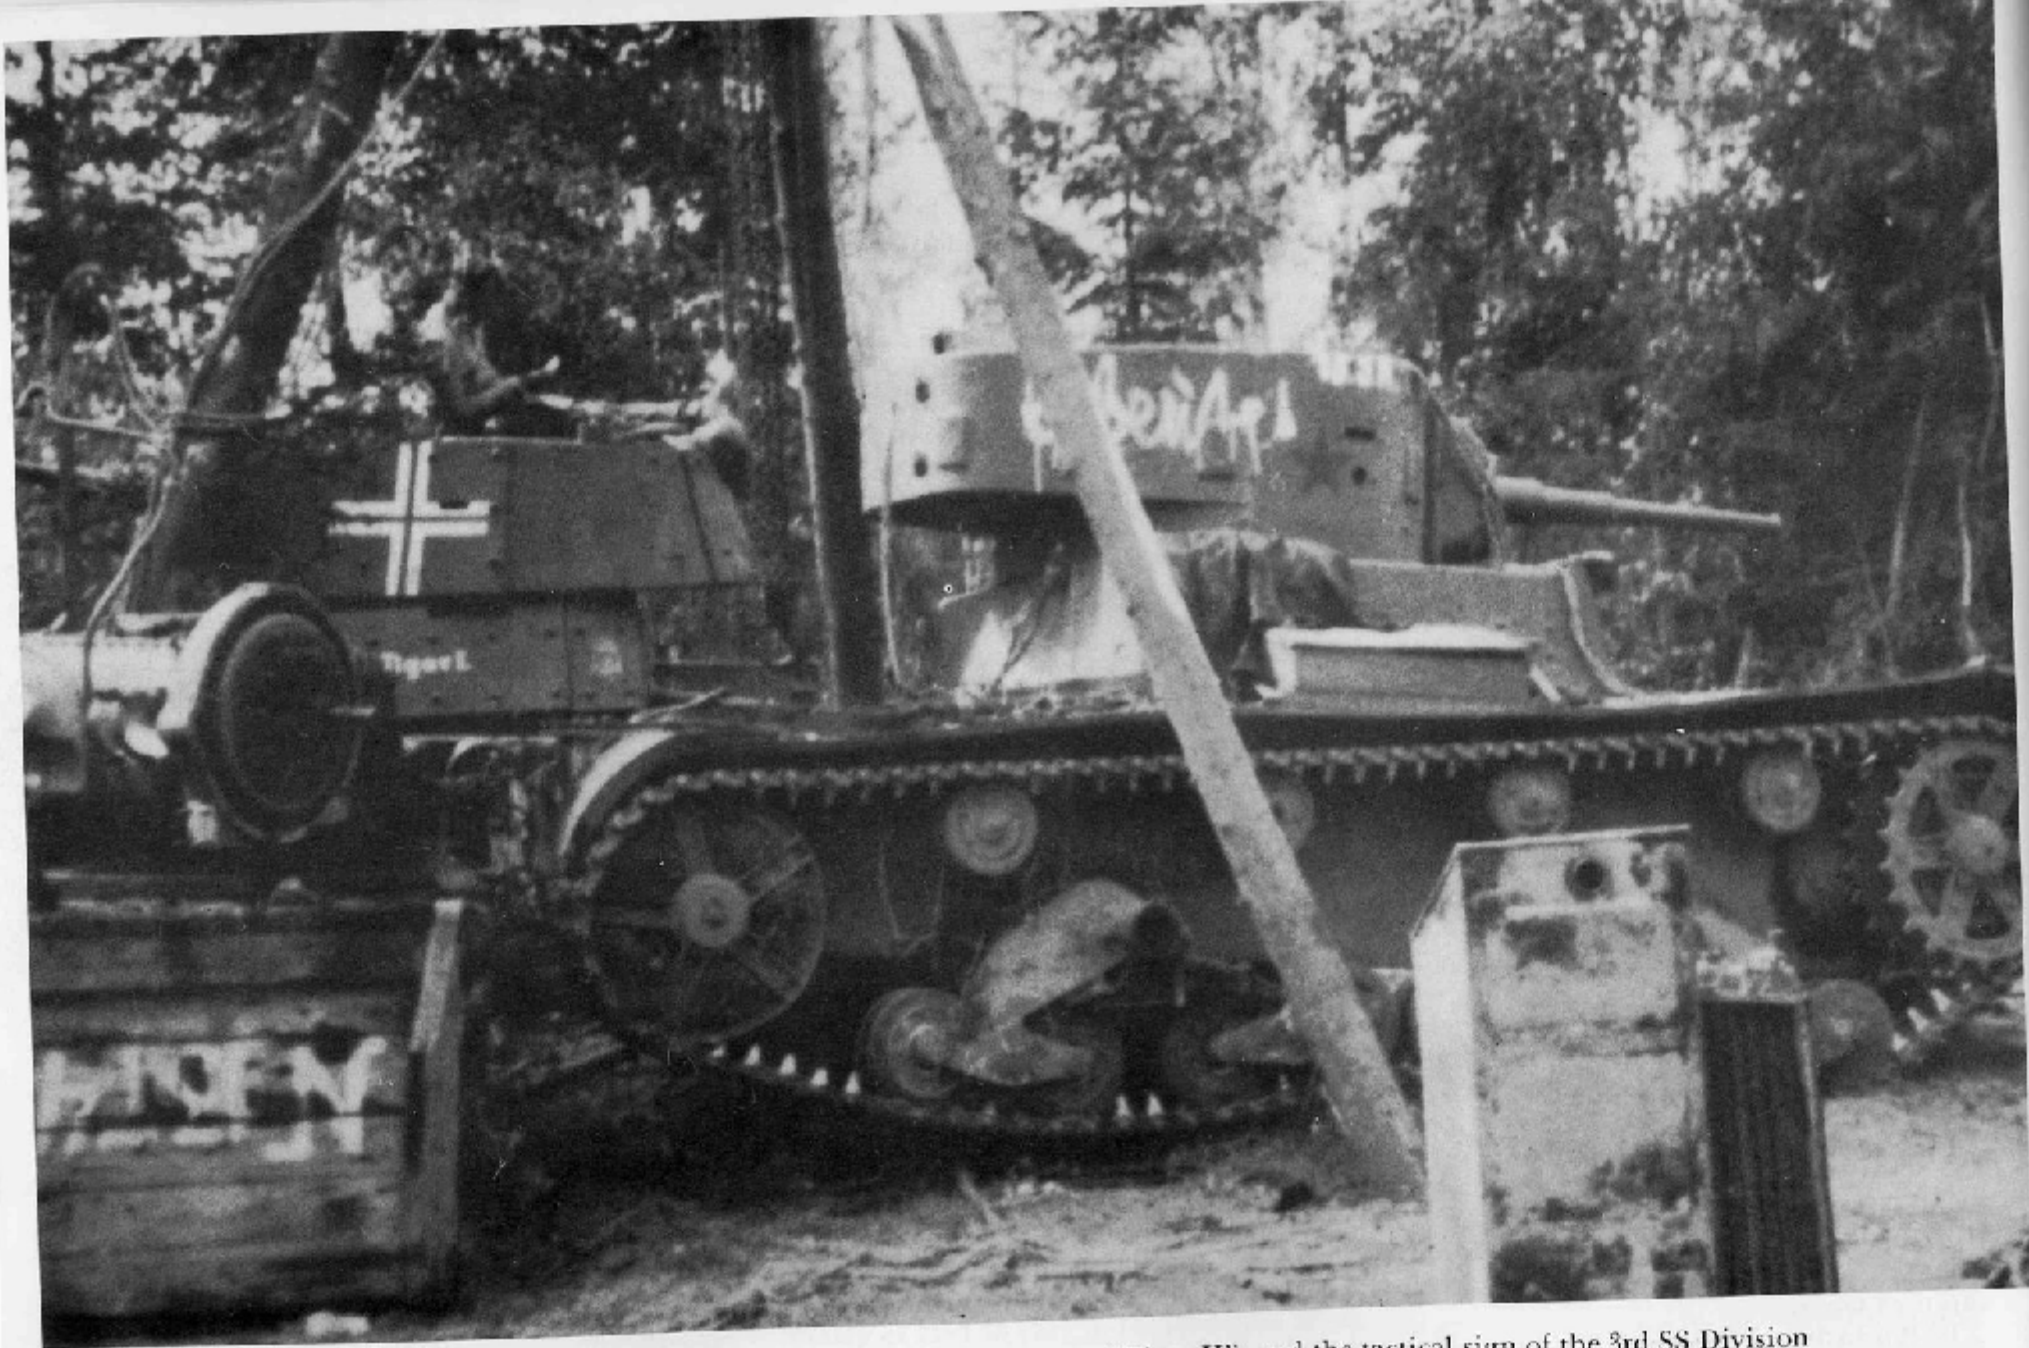
Two T-26 tanks in a field workshop. In front is a T-26 B (1933 model) with Russian emblem and the inscription "captured 15th I.R.". Behind it is a T-26 E with a German cross, the name

"Tiger II", and the tactical sign of the 3rd SS Division "Totenkopf". The T-26 E tanks were T-26 S types equipped with additional armor on the turret and body. (BA)

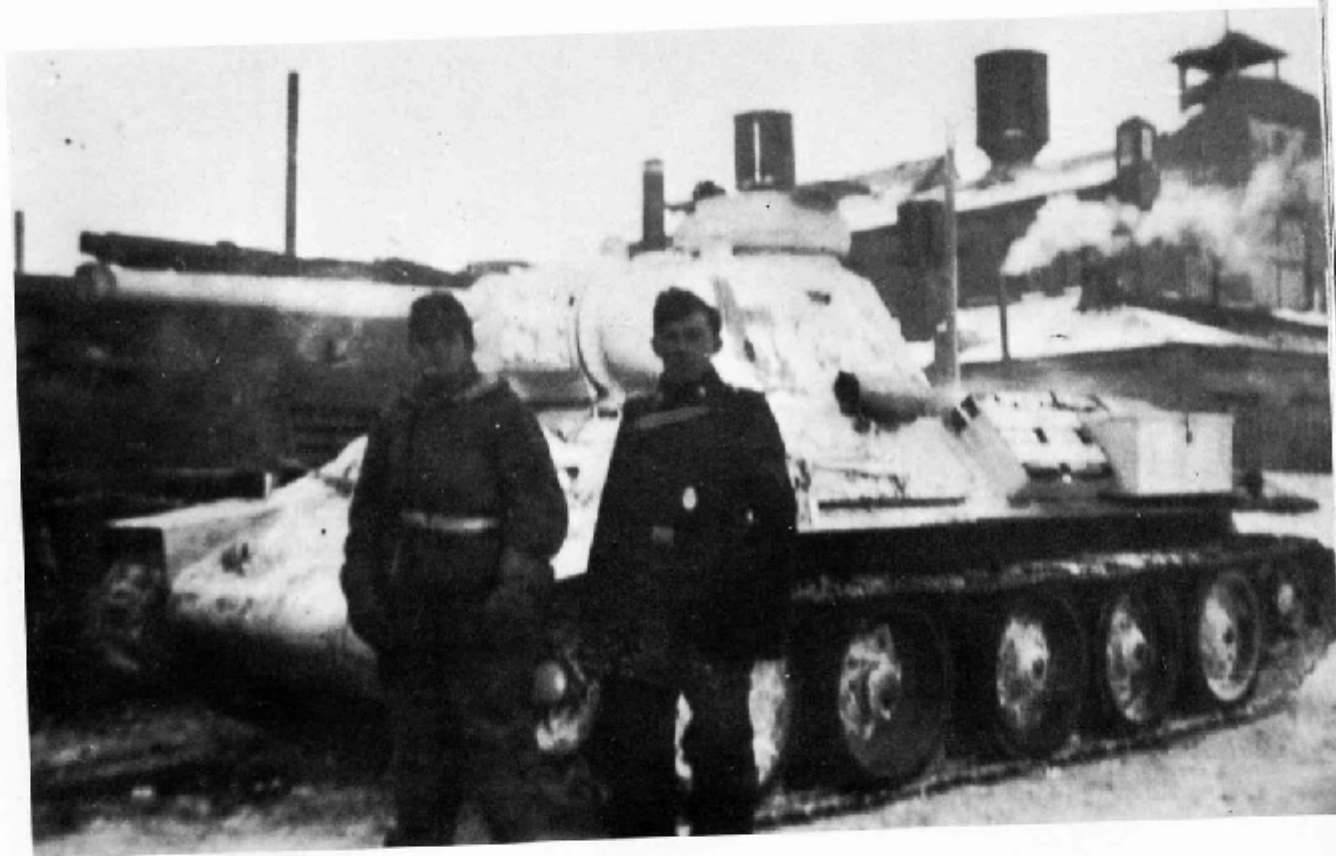
In the winter of 1943/44 this T-34 was captured. The T-34/76 has been painted with a simple German cross and equipped with a German commander's cupola.

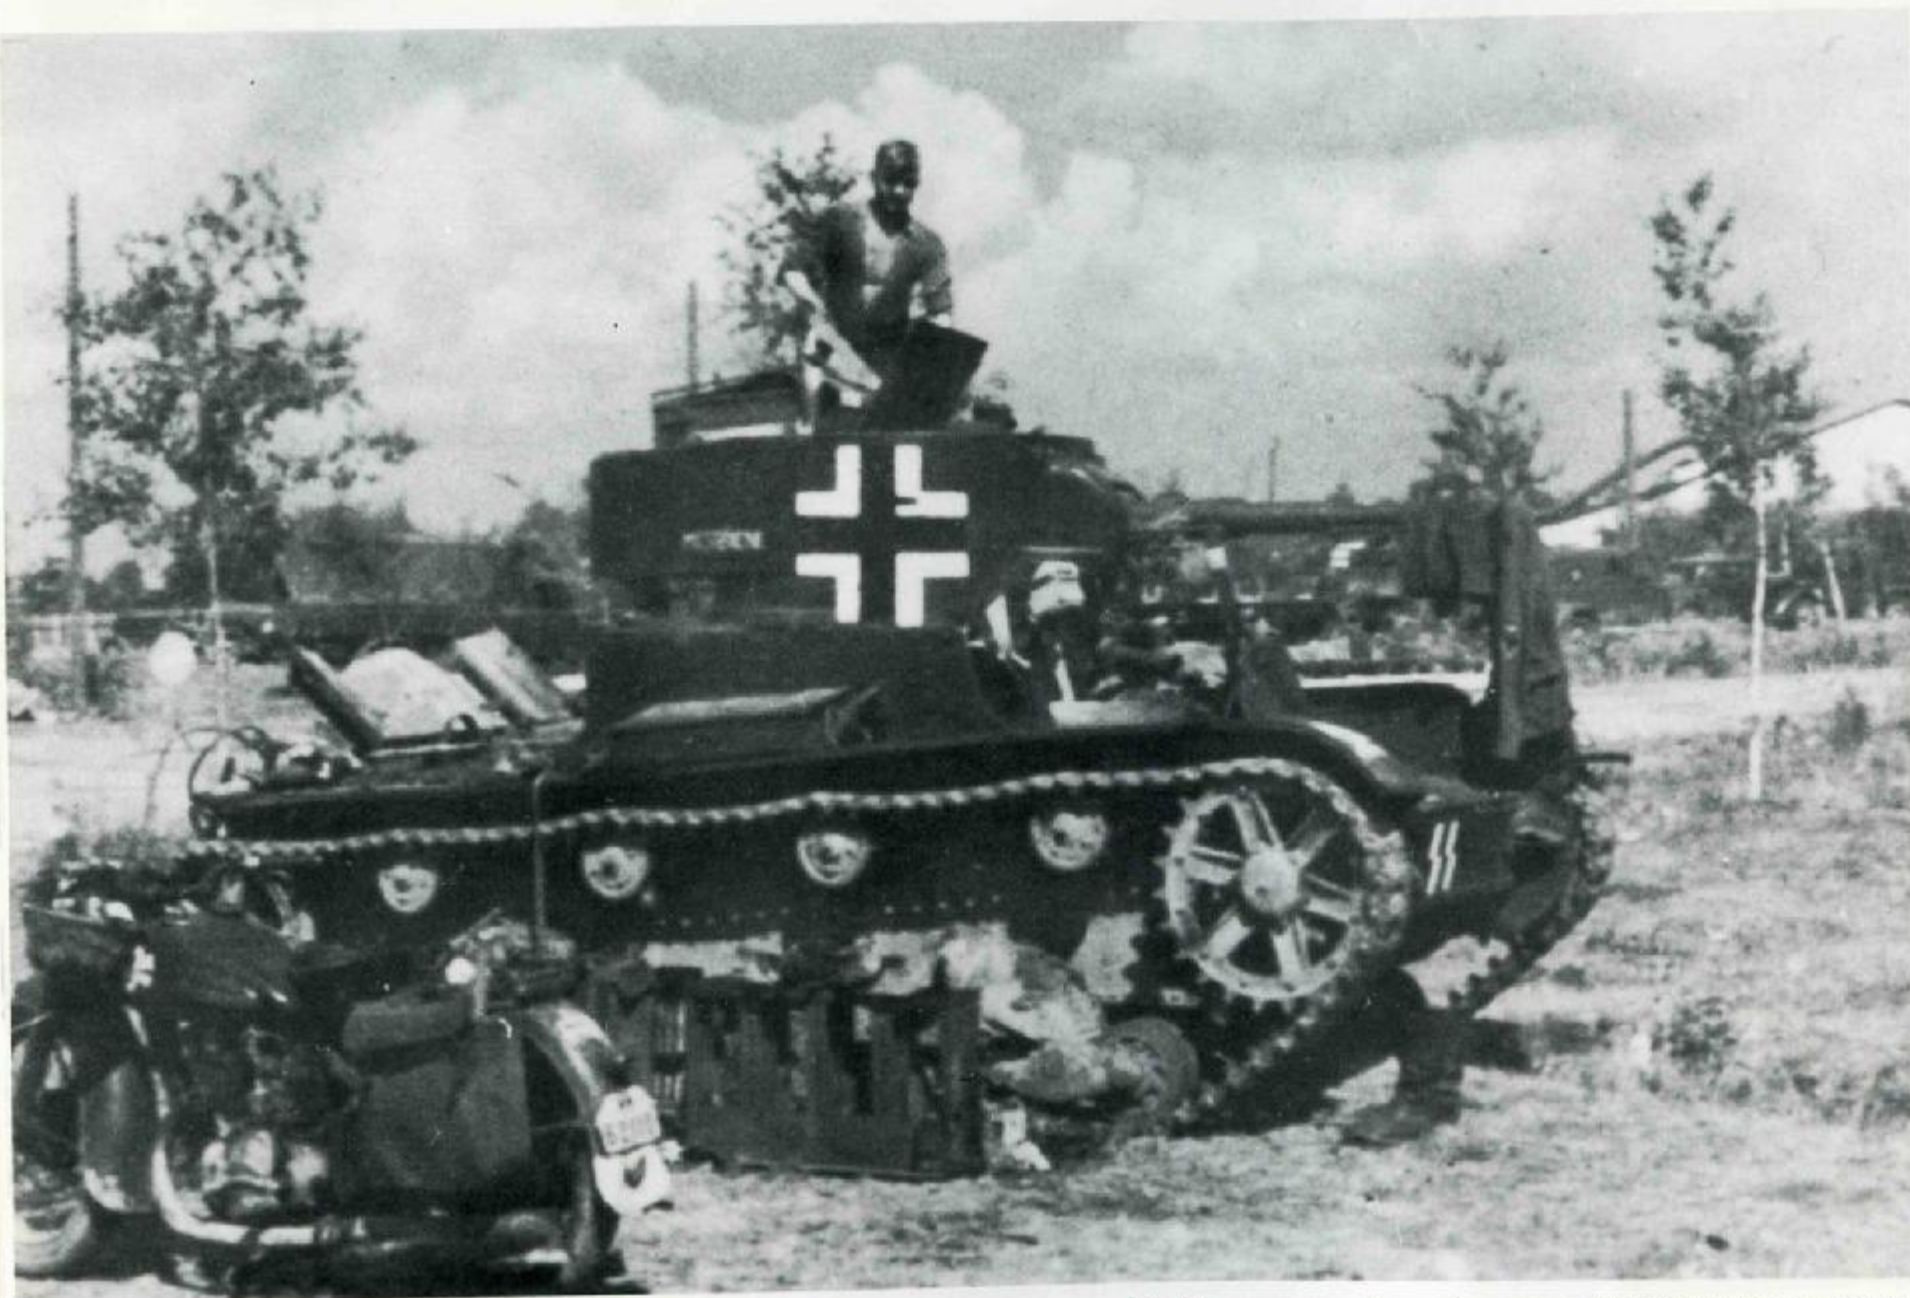
A light Russian T-26 (1933 model) in service with the 3rd SS Division "Totenkopf". The unit emblem, the death's-head, has been painted on the chain cover at the right front, and the SS runes are also added on the bow. The tank, with the strikingly

big German cross, bears the name "Mistbiene" (manure bee). The T-26 (1933 model) was designated by the German Army as Armored Battle Vehicle T-26 B 738(r). (BA)

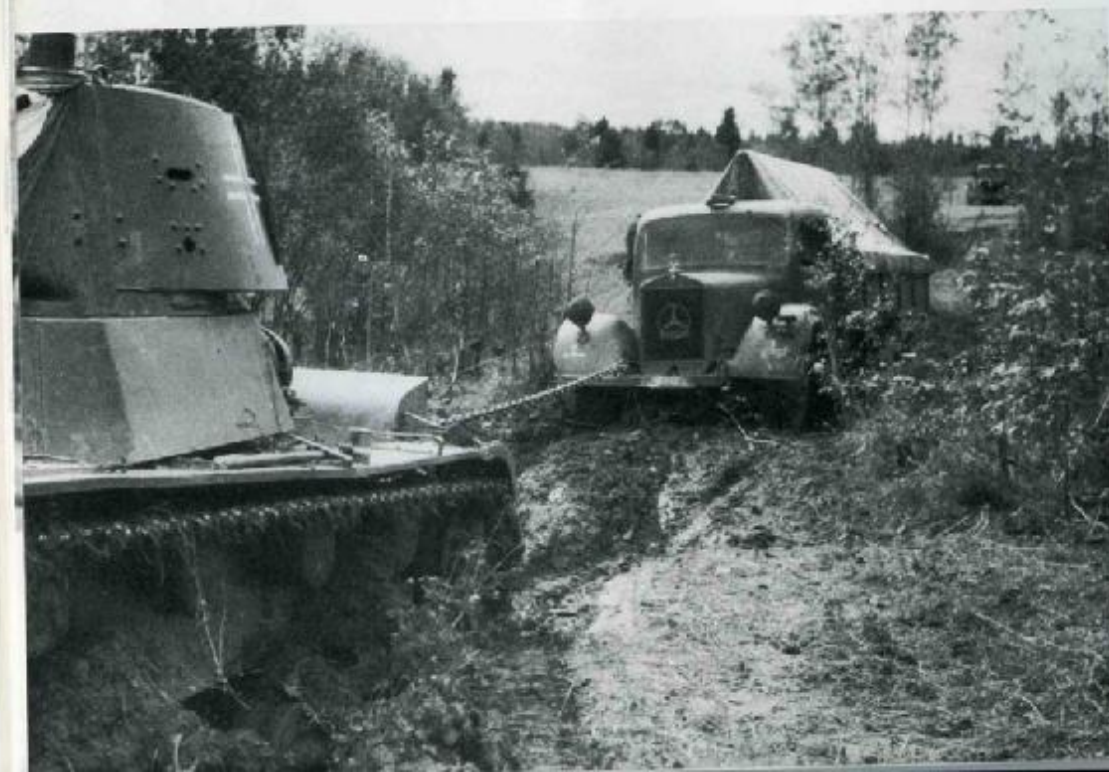
Here a T-26 C tows a 3-ton Mercedes truck along a muddy path. The tank is marked with a cross and a swastika flag on the turret. The observation slit and pistol loophole in the turret are easy to see. (BA)

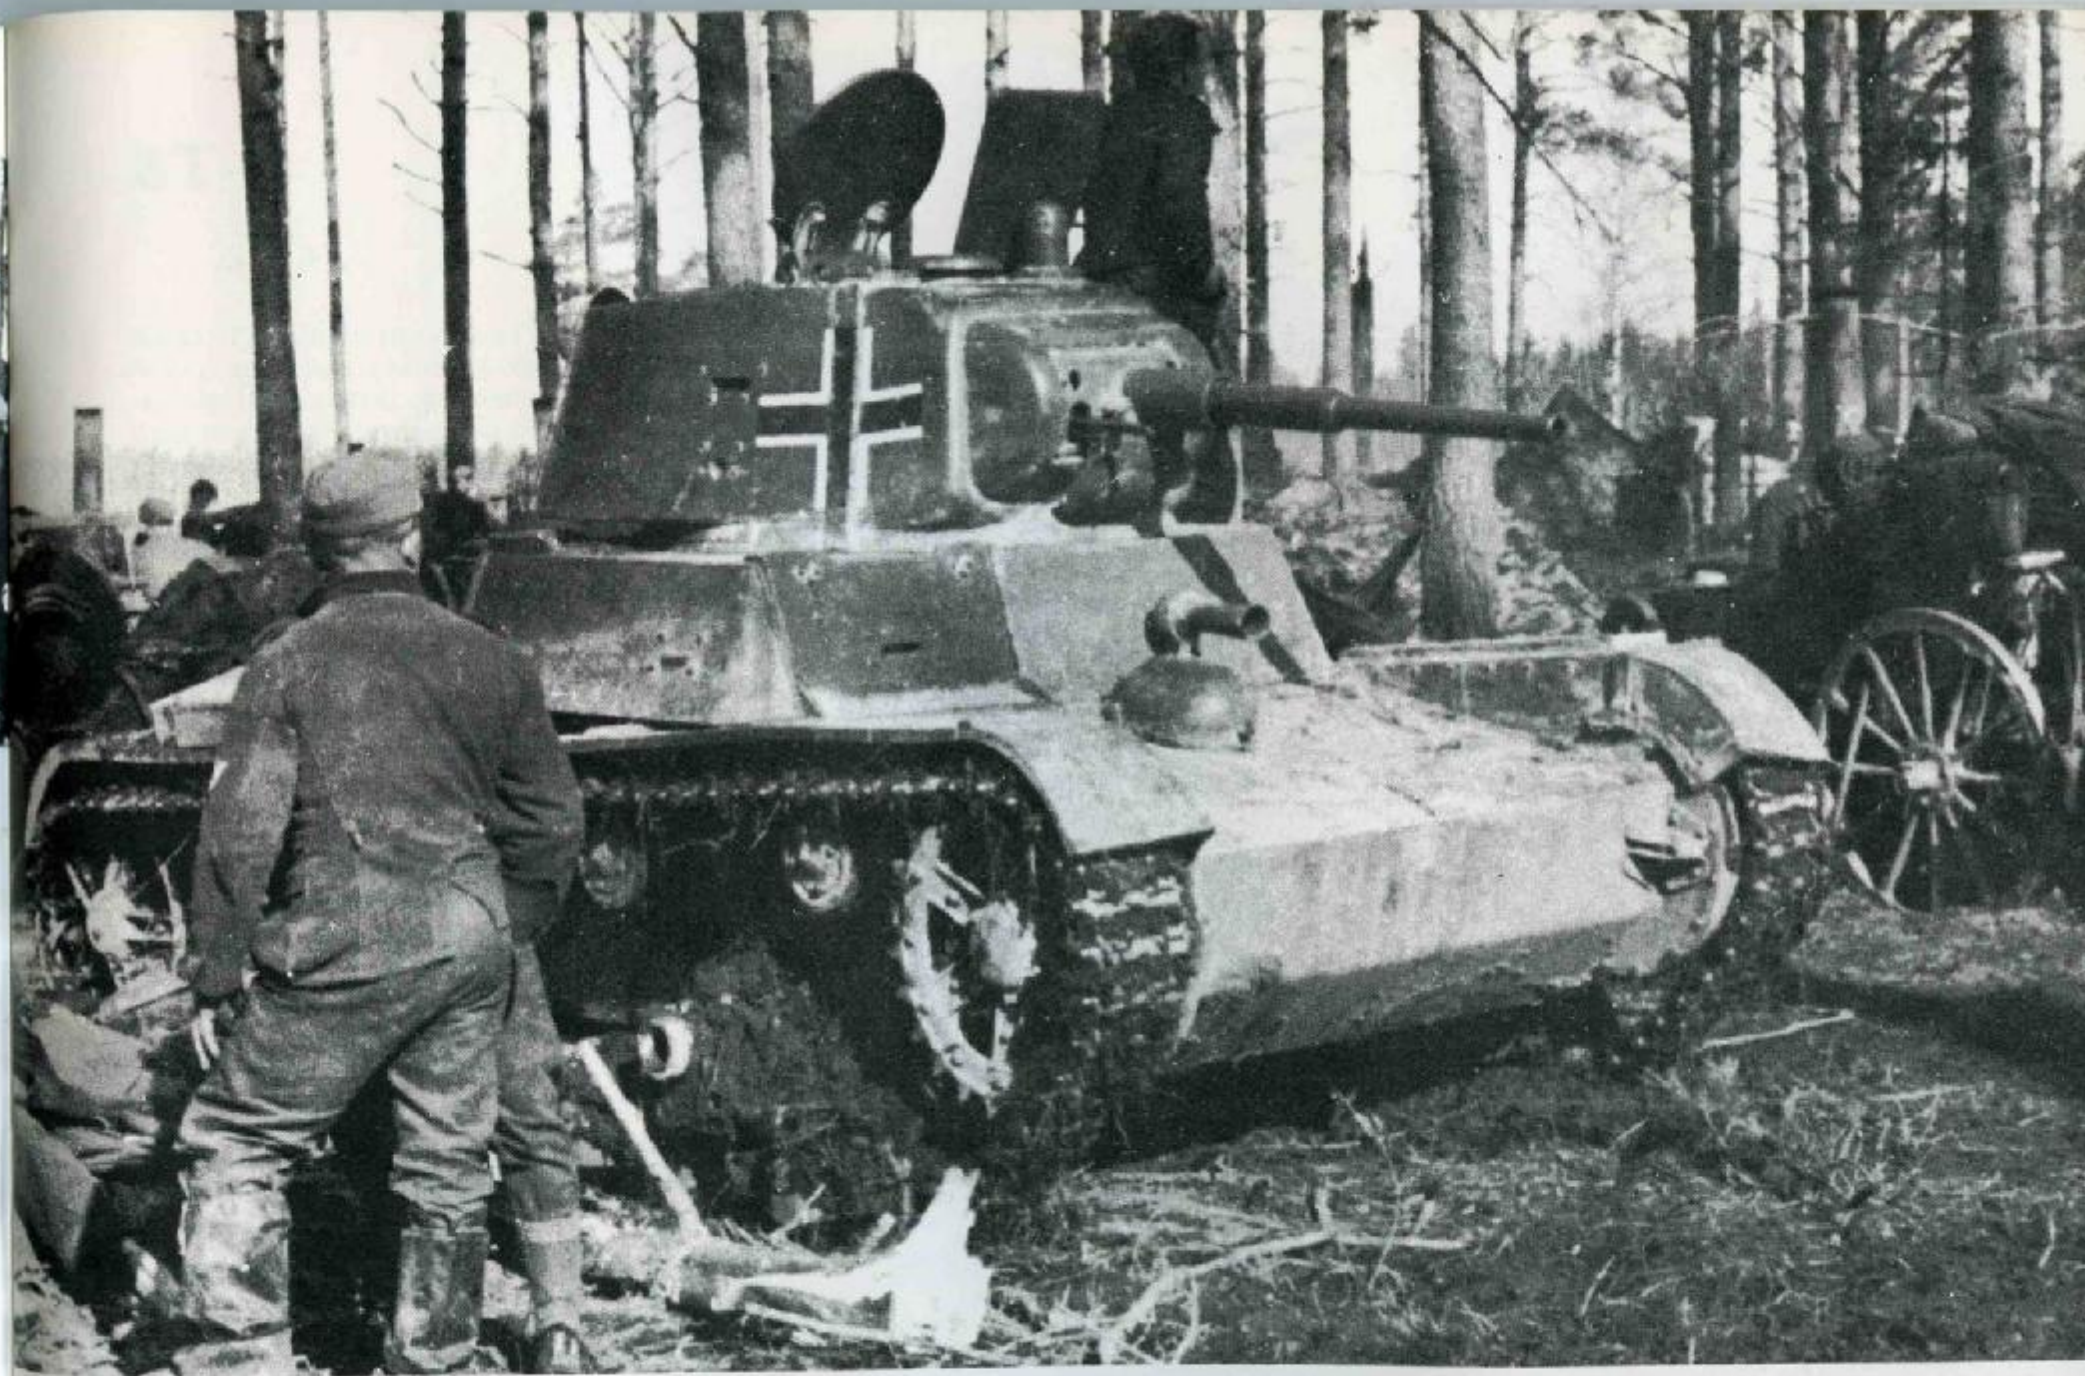
This T-26 S (1939 model) carries a big German cross on the turret and also a white number 3 on the left track cover.

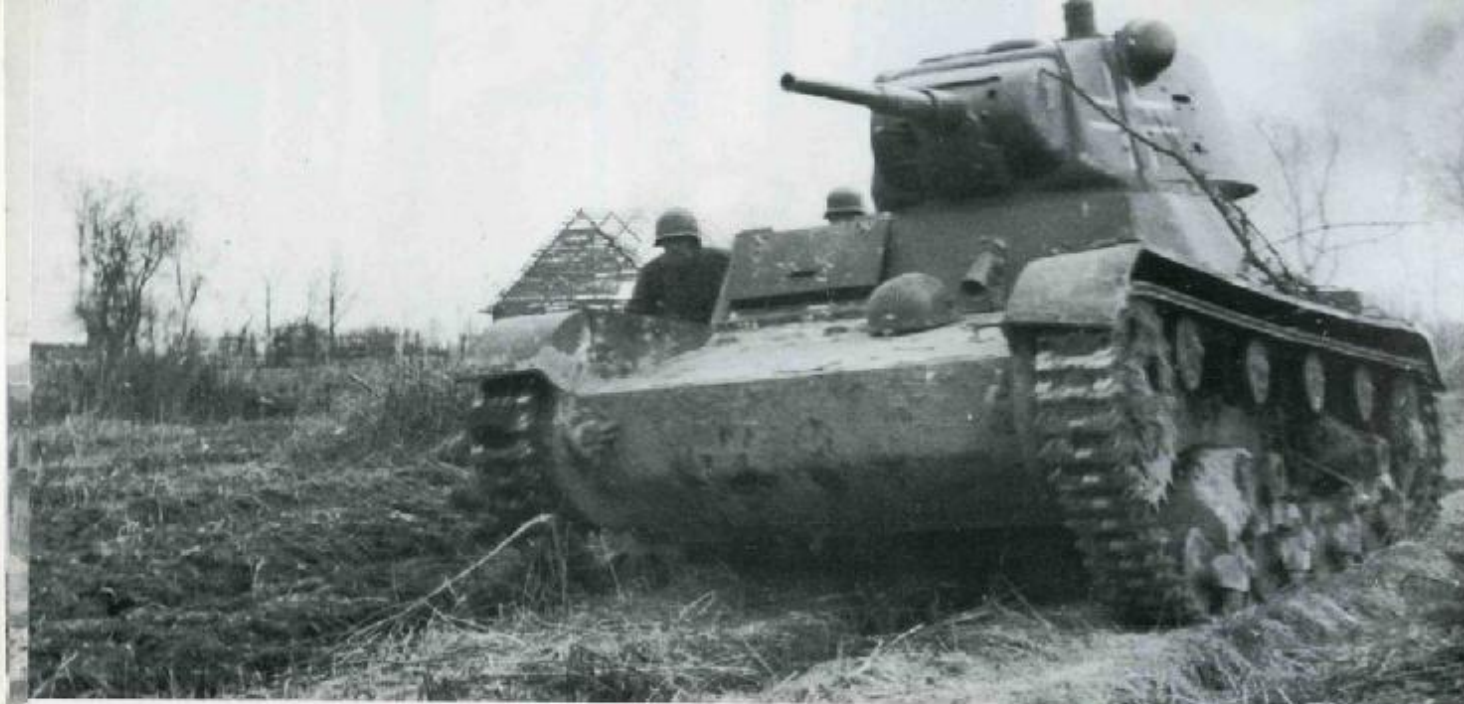
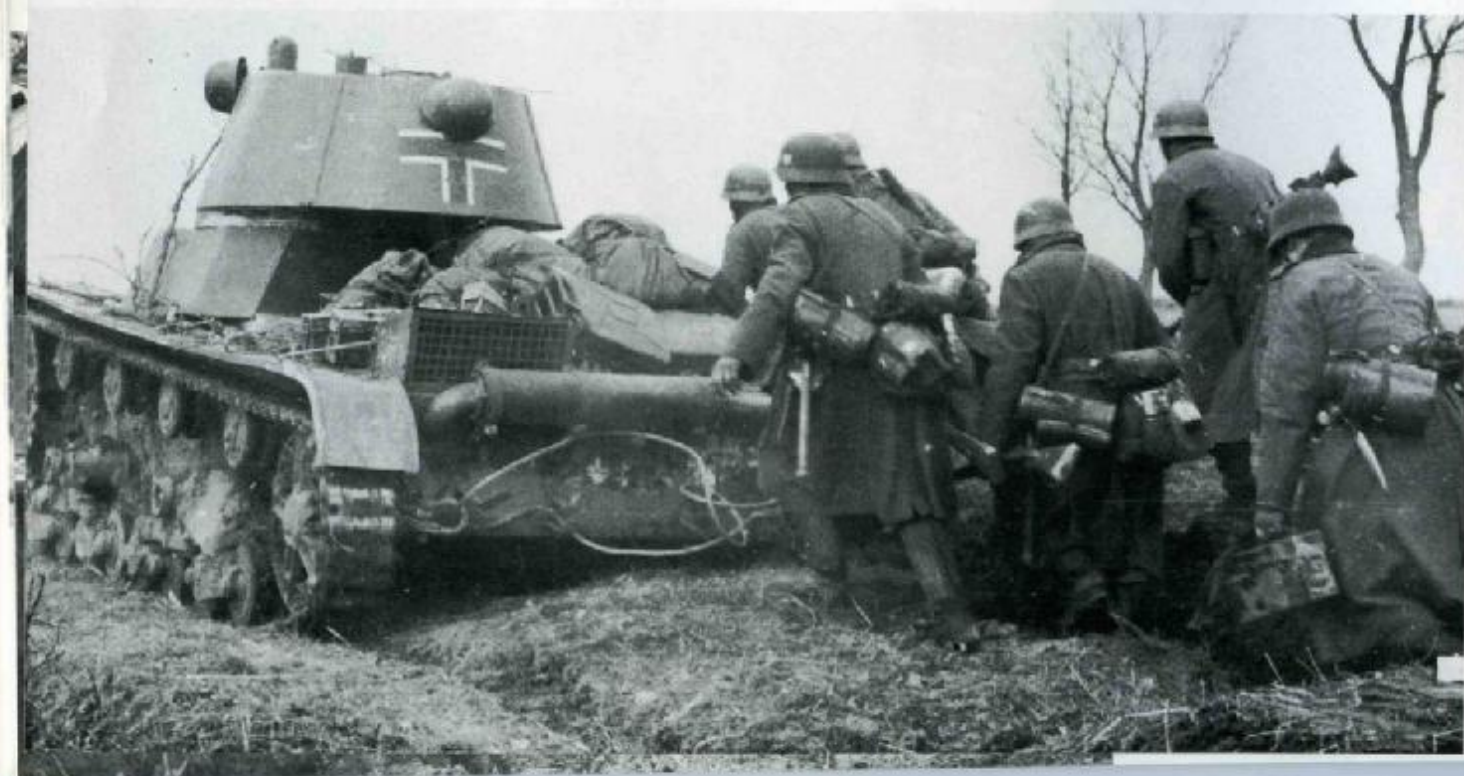
These two photos show the same Type T-26, also called Armored Battle Vehicle T-26 C 740(r) by the German Army, going into action with infantry following it. The lower picture shows that a cross has also been painted on the back of the turret. On the tail the crew's gear, ammunition boxes and fuel canisters have been stowed. (2 x BA)

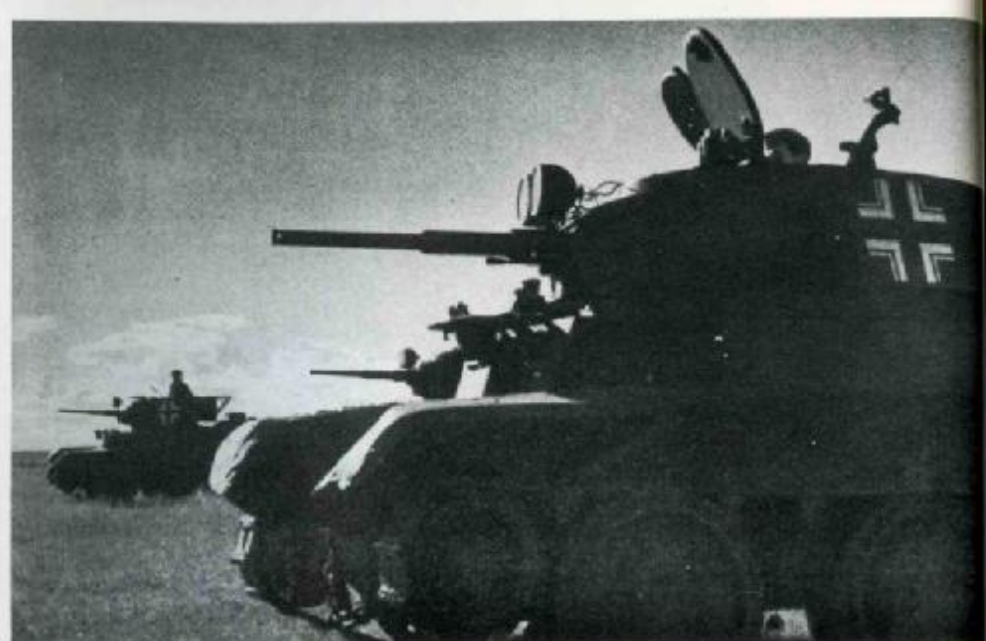
Three BT-7 tanks with very noticeable German crosses painted on. These were three different versions of the Type BT-7. In front in the picture, the last production type BT-7 M (also called BT-8) can be seen, with one oval and one round turret hatch as well as mountings for an anti-aircraft machine gun (1939 type). In the middle is the BT-7 (built in 1937), and at the rear a Type BT-7TU (built in 1935). The suffixed TU indicates that it is a command tank, thus it is equipped with a frame antenna. All three tanks have their original Russian shooting spotlights mounted. (Frank)

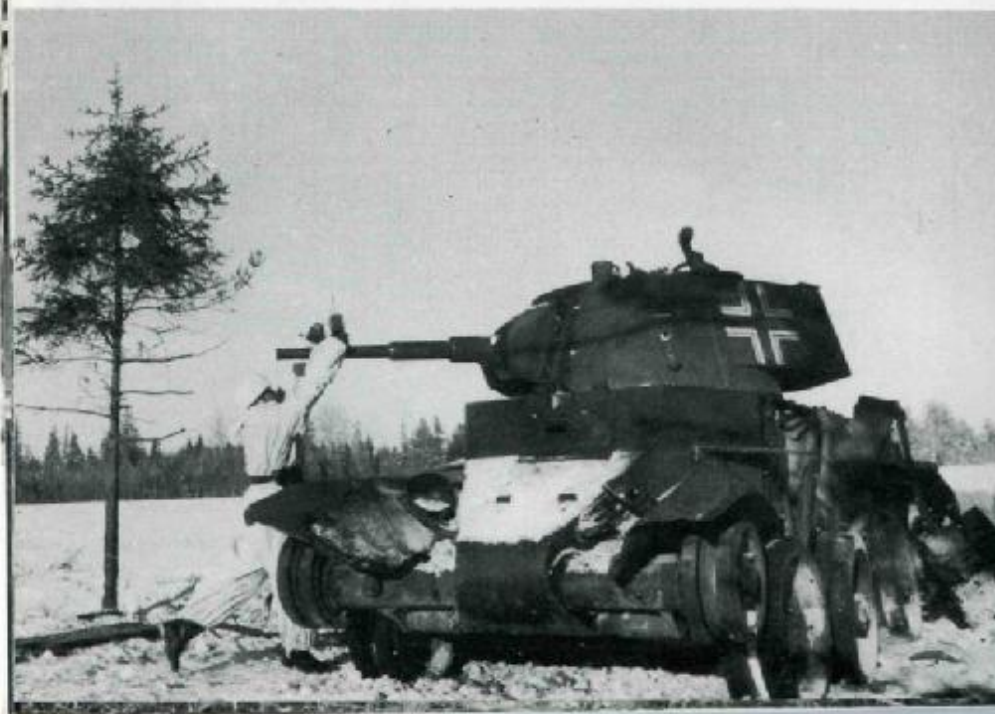
Left: This BT-742(r) is serving a final purpose. After seeing service on the German side, it serves now as a practice object for close-range tank fighting in an army school for paratroopers. The paratrooper is hanging two boxes of #24 explosive, connected by wire, on the barrel of the BT-7 M's gun. This operation, performed on an active tank, called for an ample portion of courage. (BA)

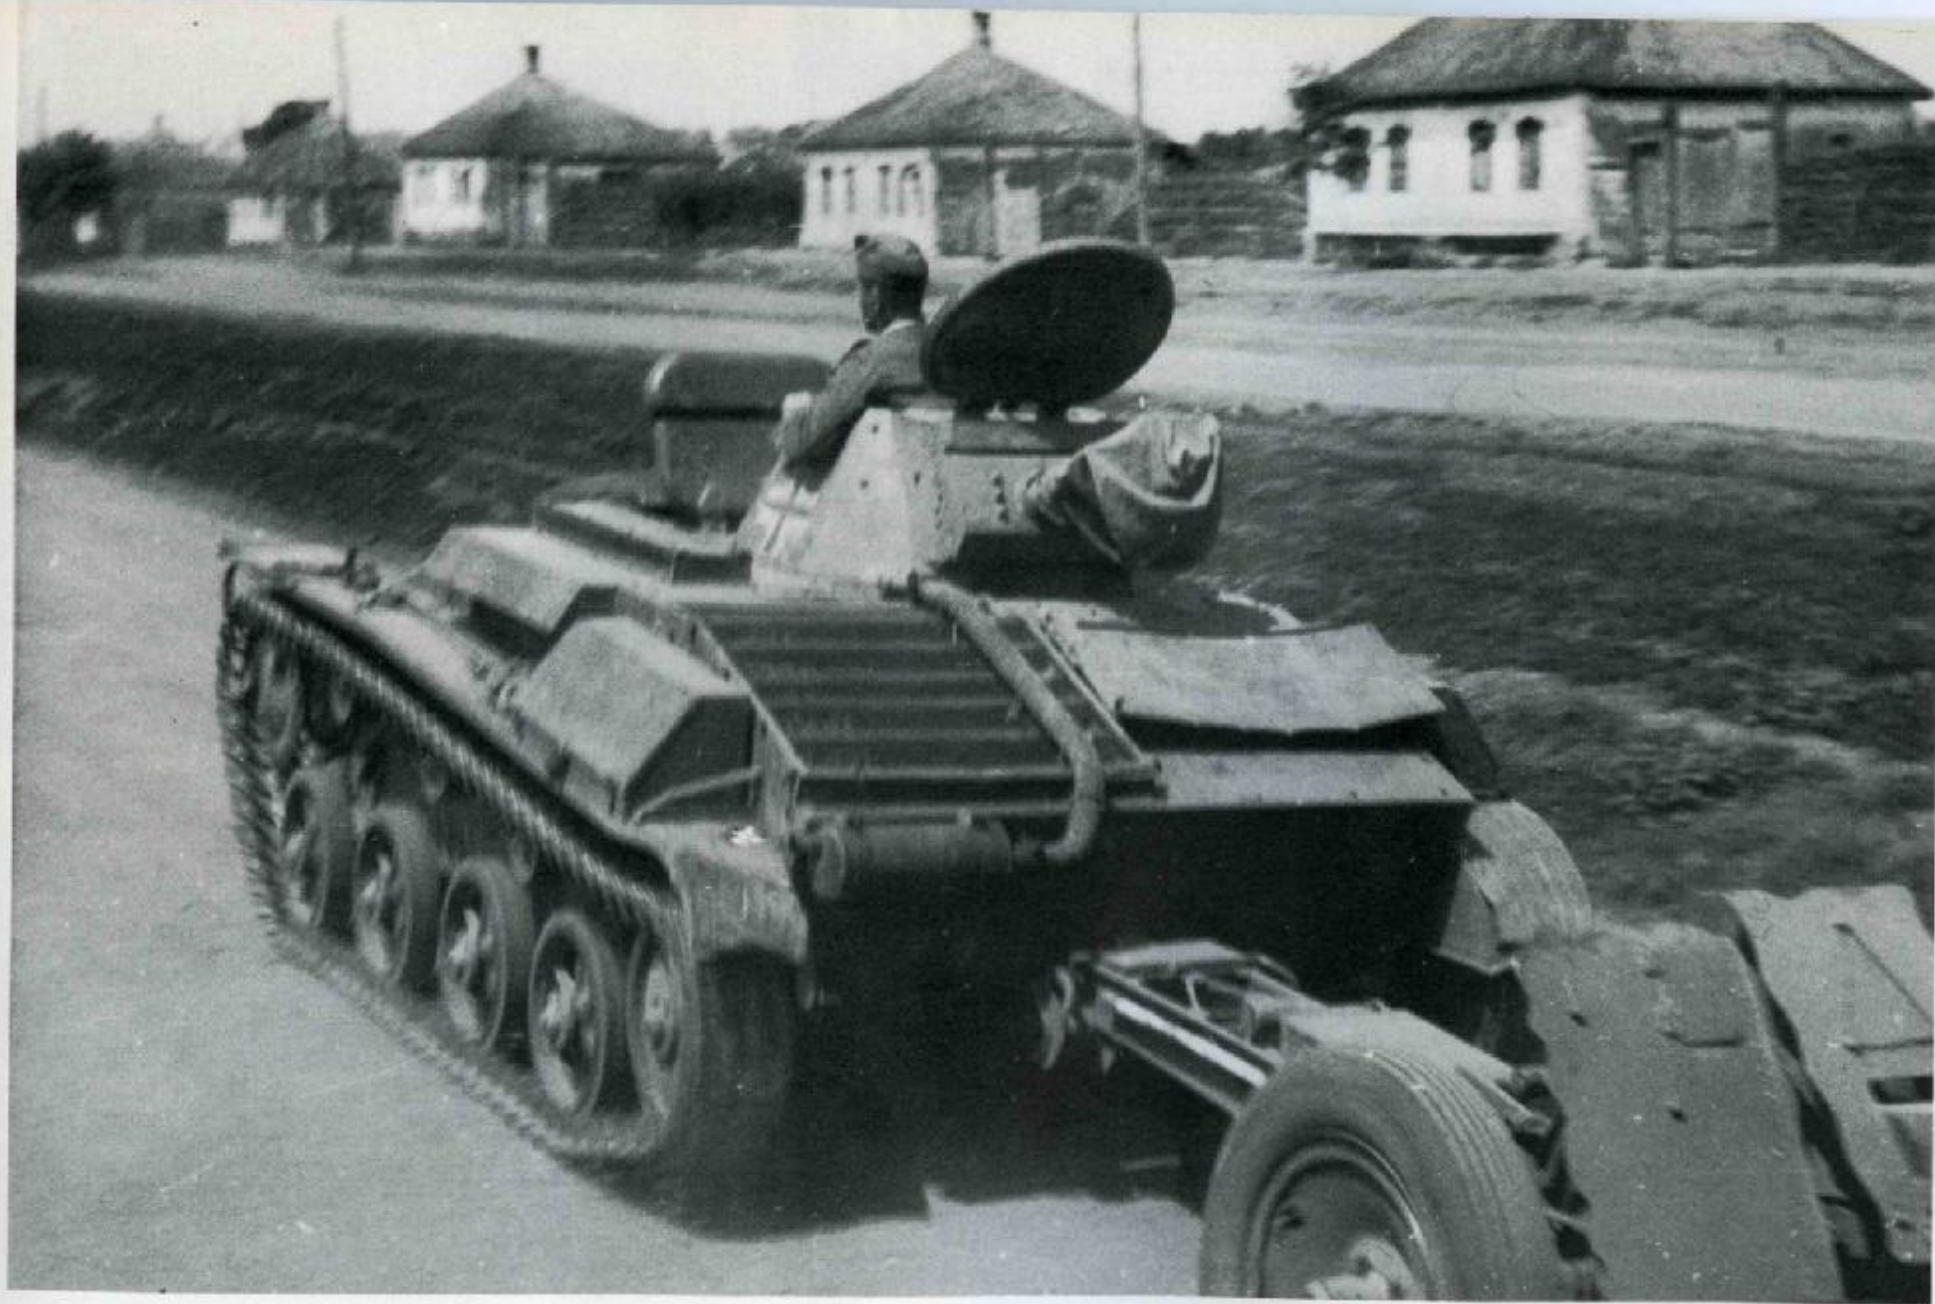
Captured T-60 tanks were seldom used as battle or reconnaissance vehicles in the German Army. Light tanks armed with machine guns or a 2-cm cannon were often rebuilt by the Wehrmacht as

tractors or self-propelled guns. Thus most T-60 tanks, like this one with a built-on 2-cm cannon and a 1.IG in tow, were used as towing tractors. (BA)

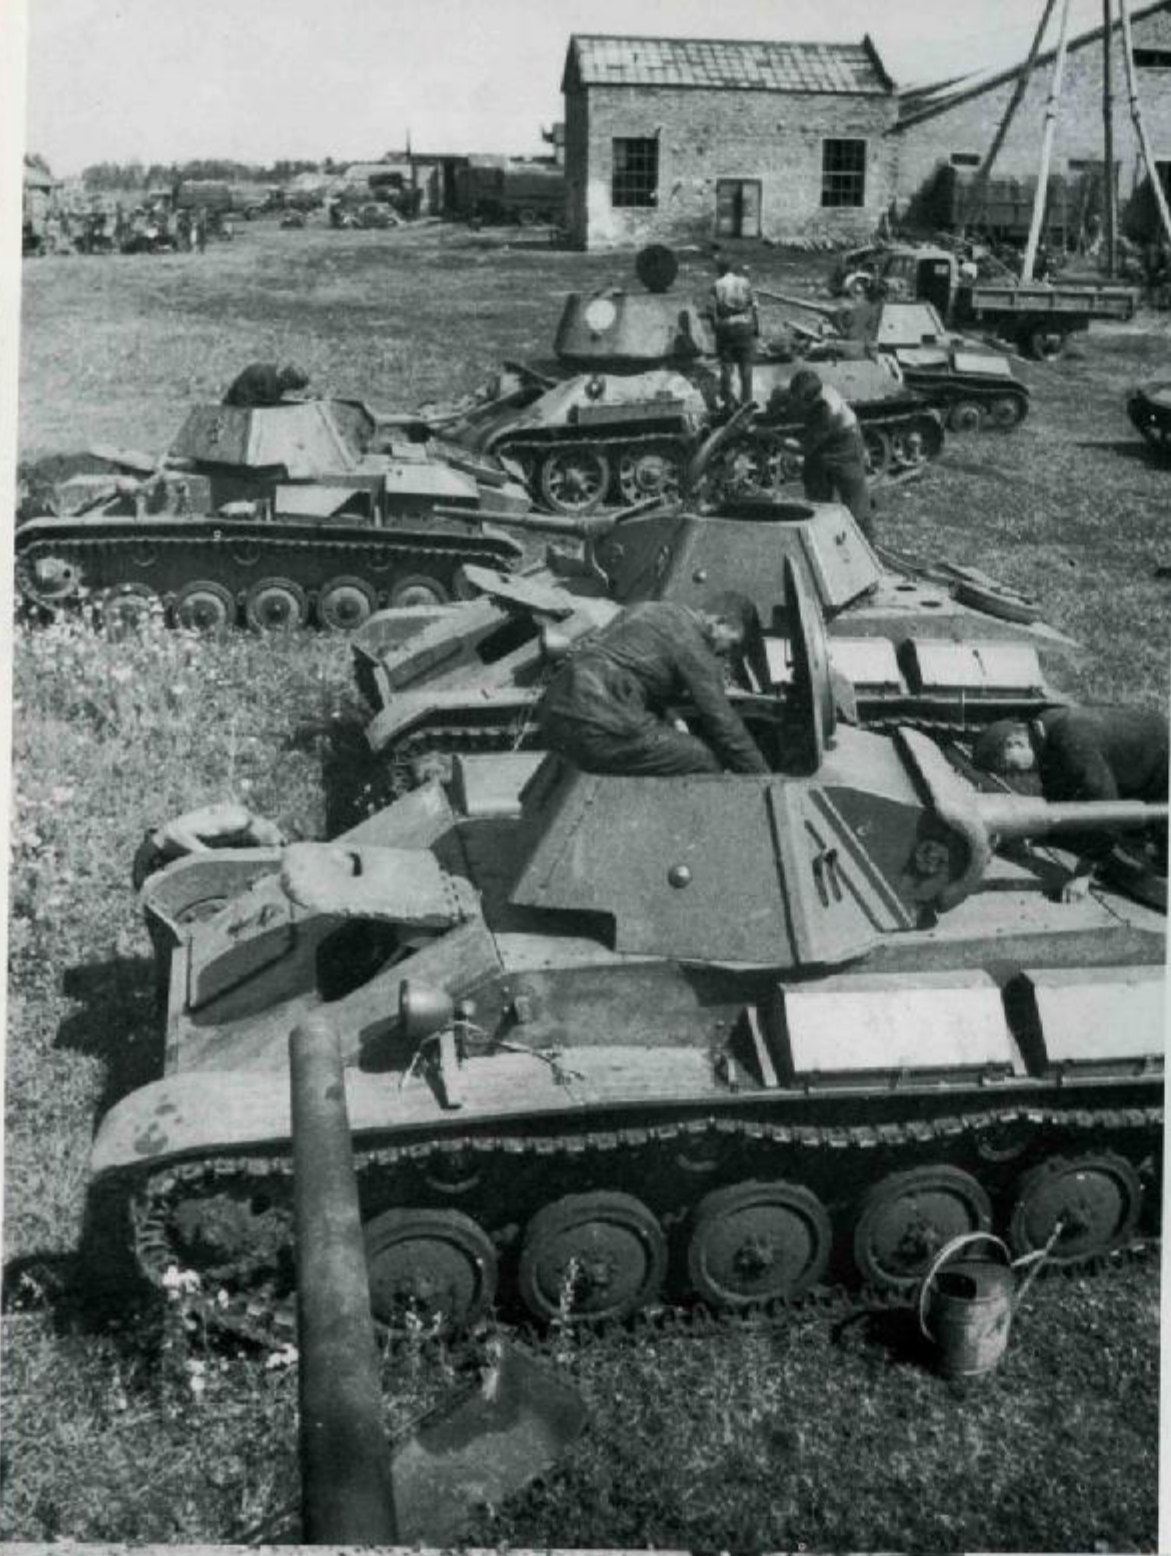
The workshop company of the 82nd Infantry Division is repairing several T-70 and T-34 tanks to make up a captured tank unit. (BA)

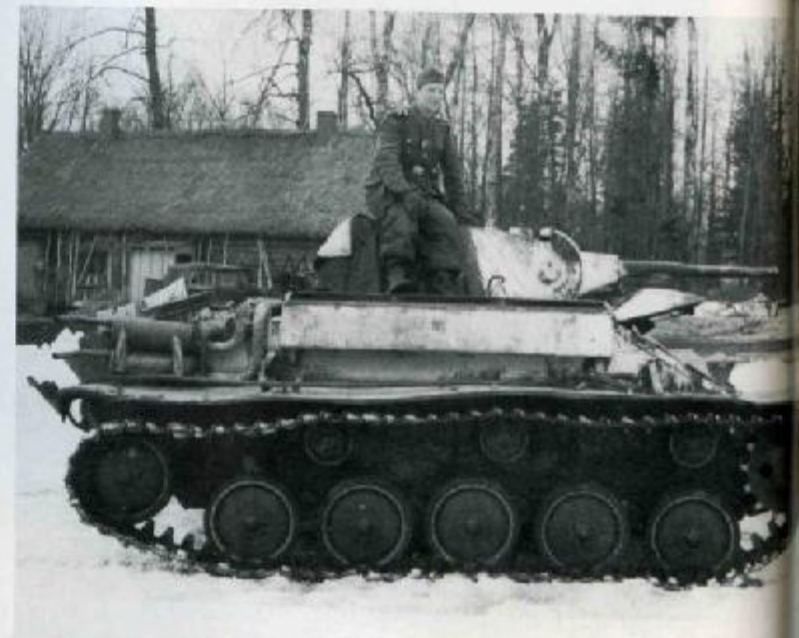
Captured T-70 tanks found greater use as battle tanks, as they had an acceptable armament with their 47-mm cannon. But a great disadvantage was the one-man turret. This T-70 was in service with the 98th Infantry Division. (BA)

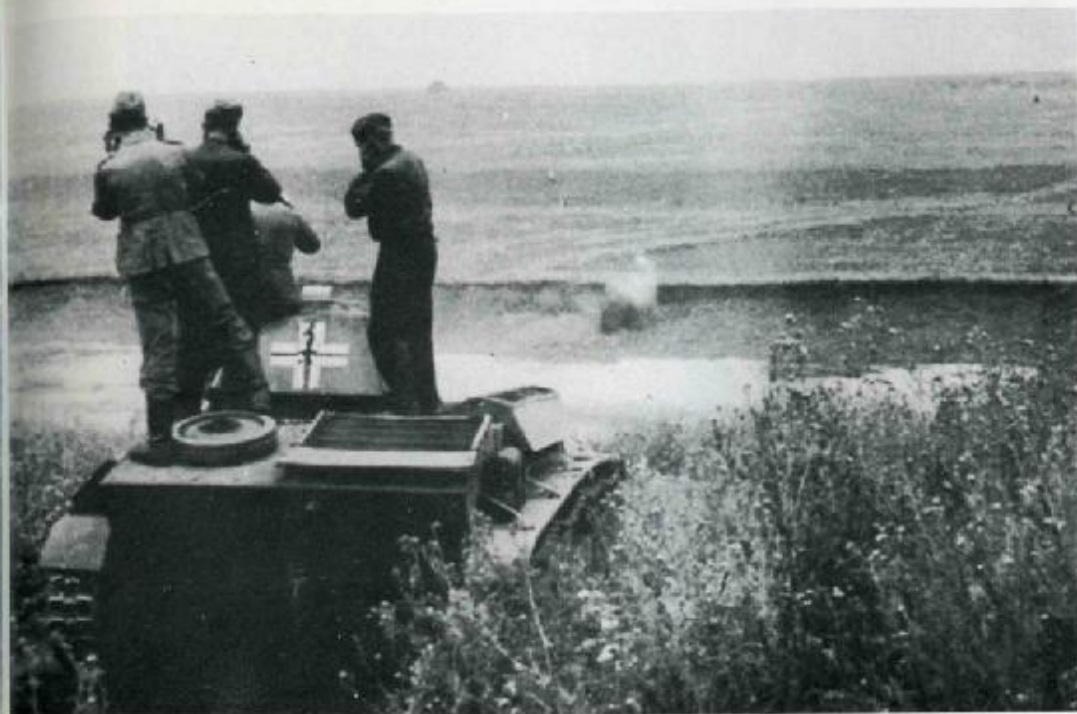
Above:
This T-70 is also in service with the 82nd
Infantry Division. Here the tank's weapon
is being tested or fired. (Strecker)

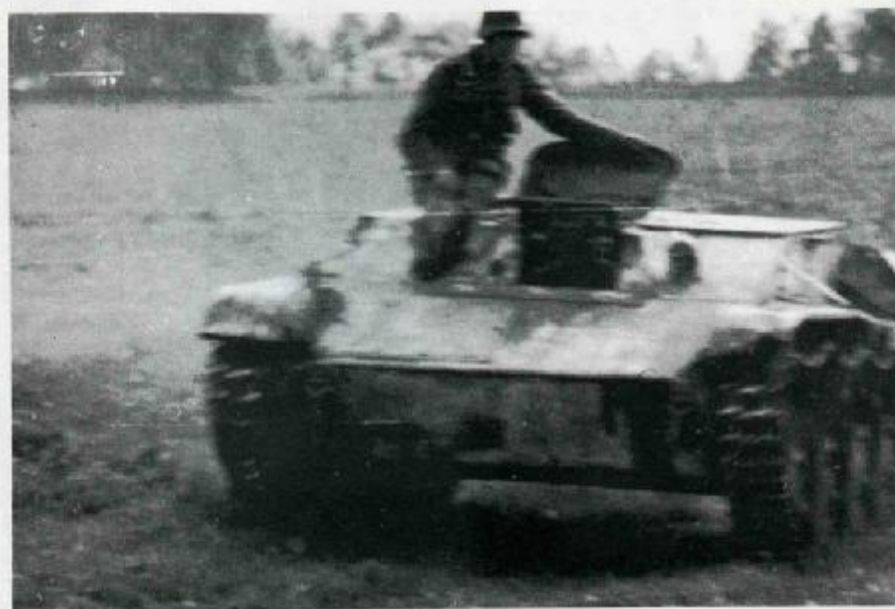
Upper right:
The T-70 as an ammunition tractor.

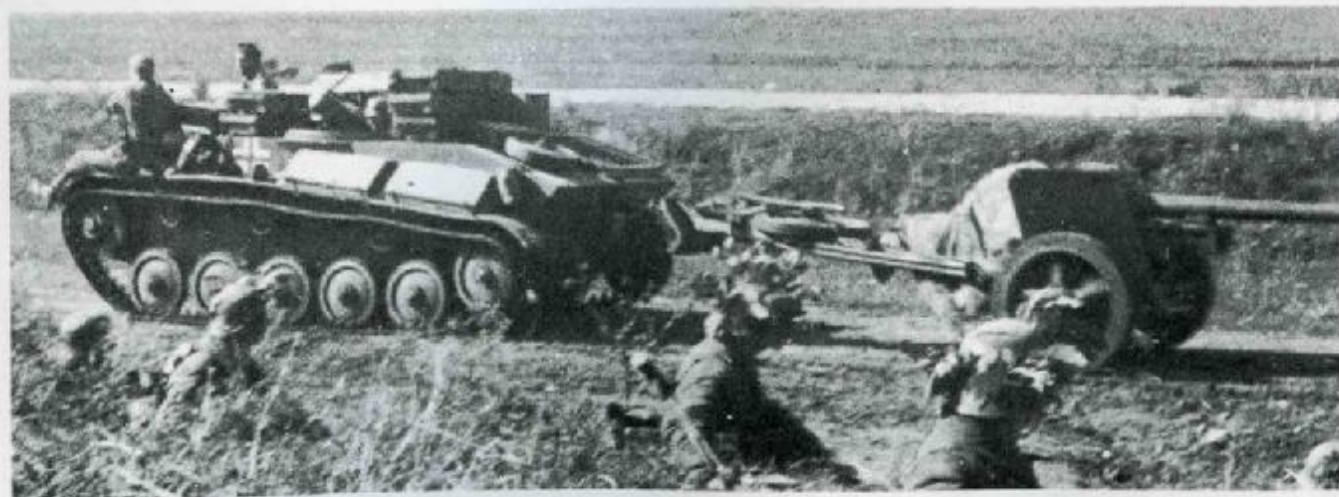
Right: Here a T-70 (without turret) is used
as a towing tractor for a 7.5-cm Pak 40
antitank gun.

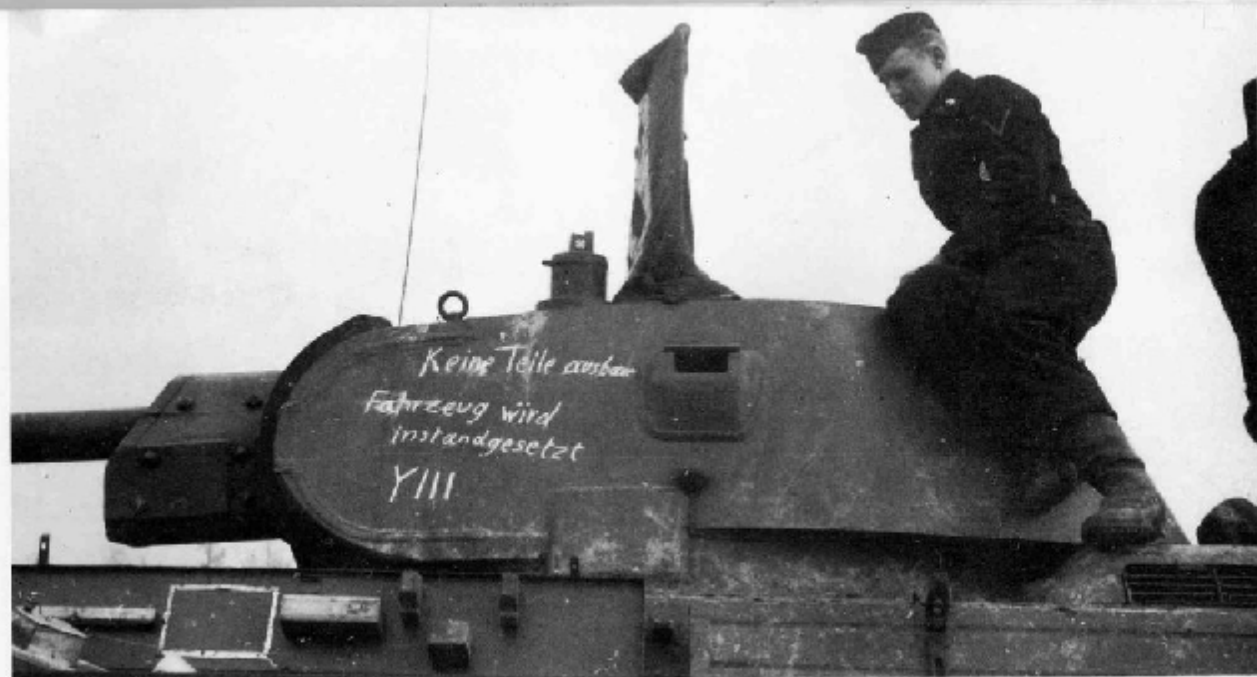
Tank "A" close-up. Here the antenna is folded backward. The mounting of the bow machine gun, the lights and the towing hook of this 1941 model are easy to see. (BA)
