CAPTURED TANKS UNDER THE GERMAN FLAG

RUSSIAN BATTLE TANKS

DR. WERNER REGENBERG
HORST SCHEIBERT

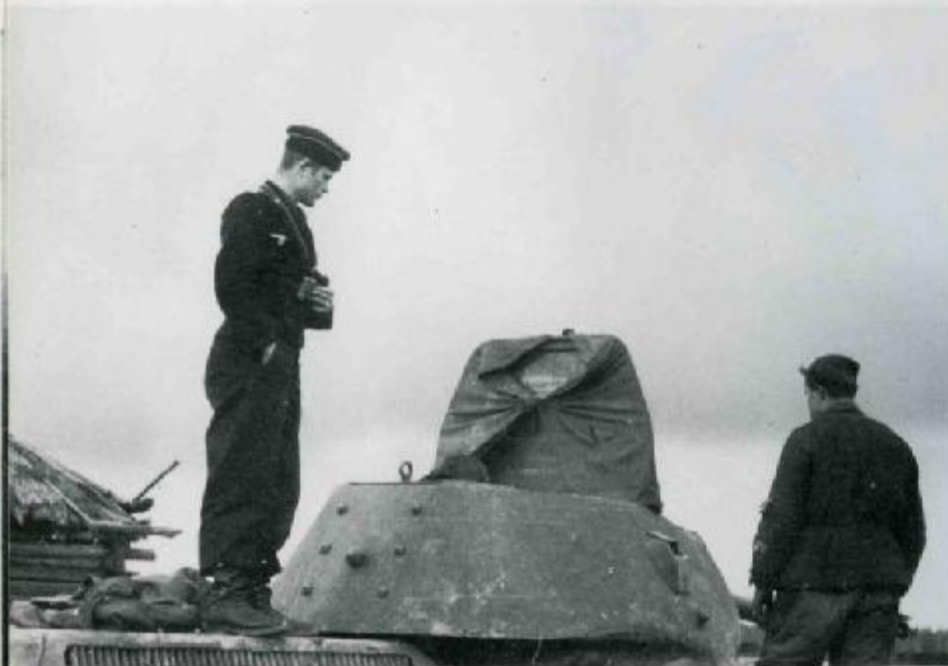
A swastika flag has been tied around the turret hatch here too. The cast turret (photo) had 52-mm armor, the welded version only 45 mm. (BA)

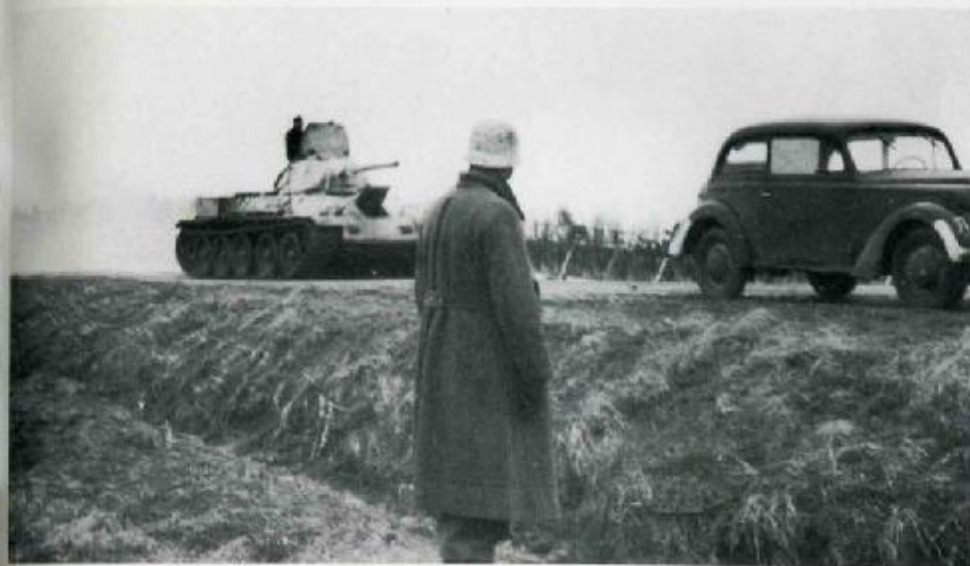
Another T-34 of the 98th Infantry Division. The tank is a 1941 type with welded turret, on which a German cross has been painted. (BA)

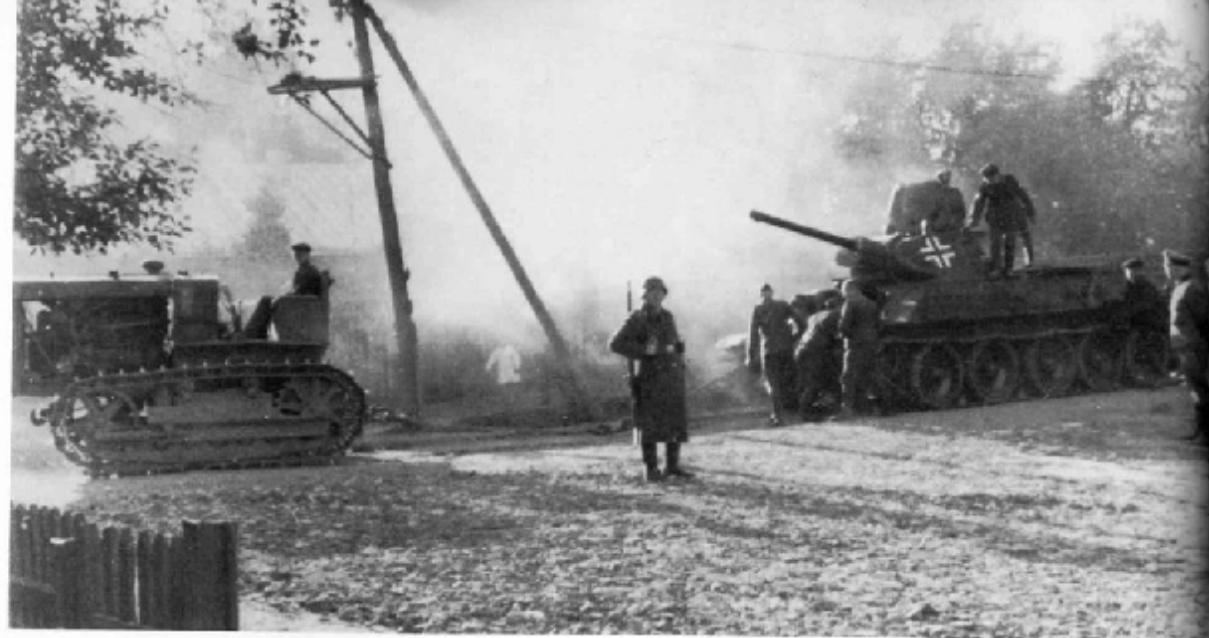
A T-34/76 of the 1942 production series in the Russian steppes. The 1942 model—also called T-34/76—can be recognized from behind by the round service hatch, which is rectangular on earlier models. The tank with the striking German cross appears to be stripped, as almost all built-on parts and even the exhaust pipes are missing.

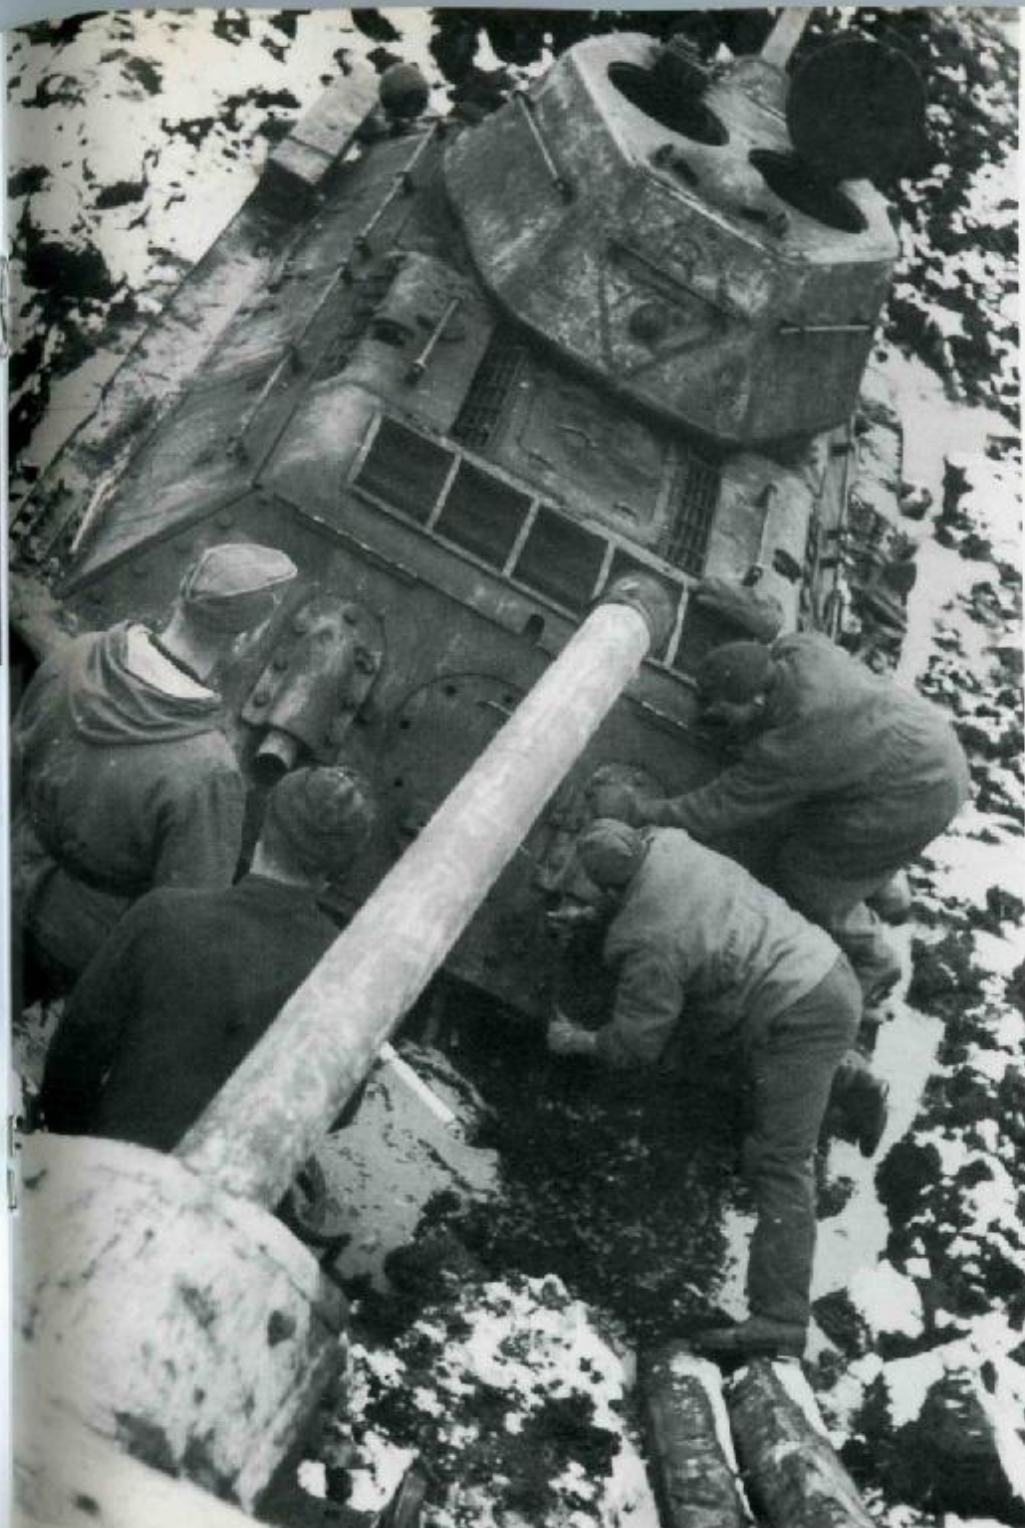
T-34/76 1943 Model

During the course of 1942, the 1943 model of the T-34 went into production. As Type D, it had a larger hexagonal turret with two turret hatches. The photos show details of the tail, engine cover and turret well. Here a towing procedure is shown.

After one tank is not sufficient, a second T-34 is applied to tow the valuable booty in. The two towing tanks are also newly captured and as yet bear no German markings. While the front and left tanks have the new type of bow machine-gun mount, the right one still has the old type (2 x BA)

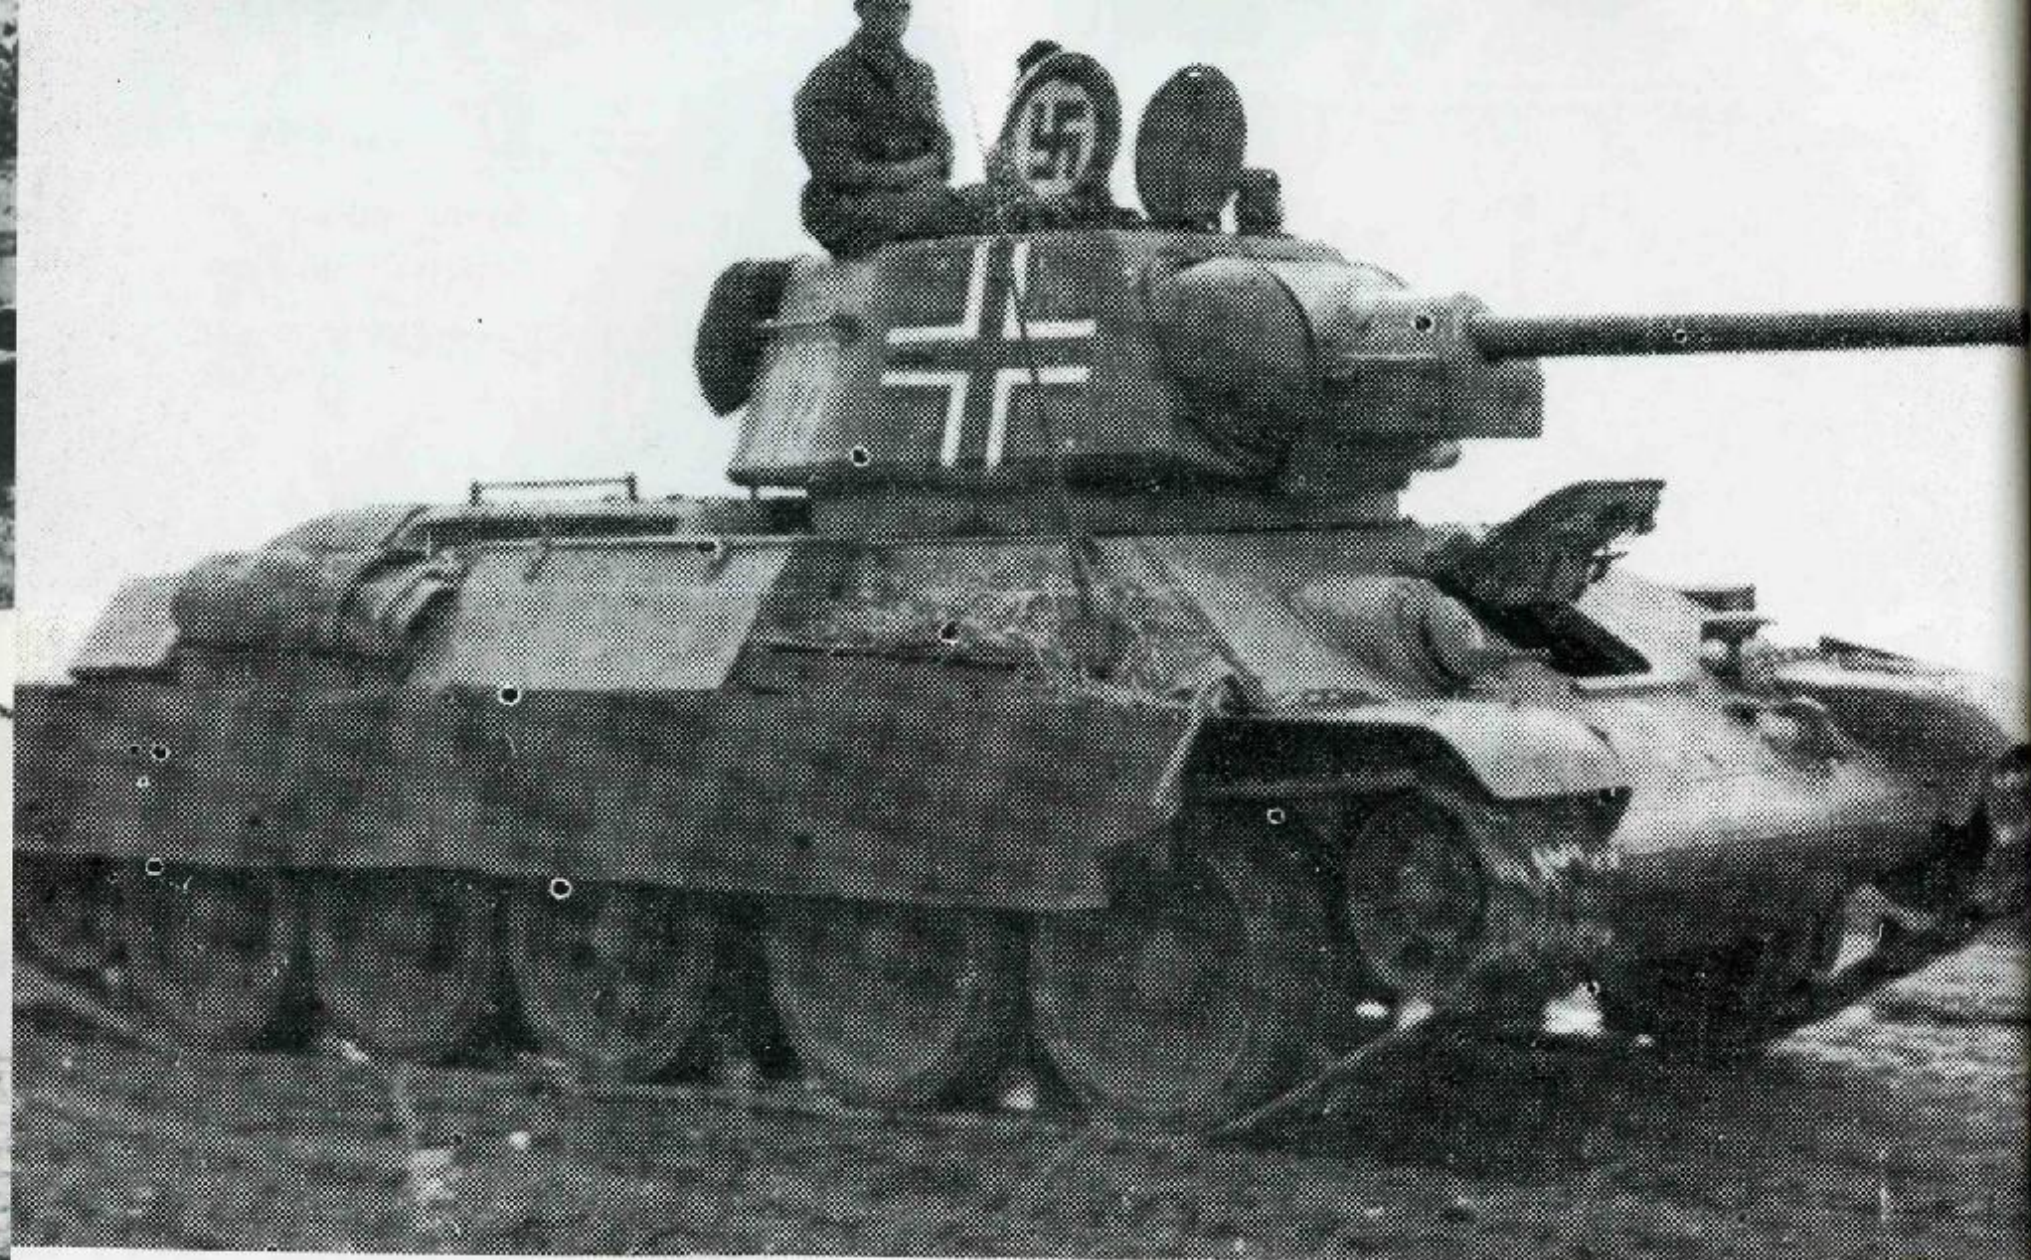
Another variation among captured T-34 tanks of the 2nd SS Division is shown by this tank, which was fitted with aprons like those of the German battle tanks. Along with the cross, the turret

number 1021 has been painted on, as well as a swastika on the turret hatch for recognition. This photo served as a model for the color drawing on the back cover.

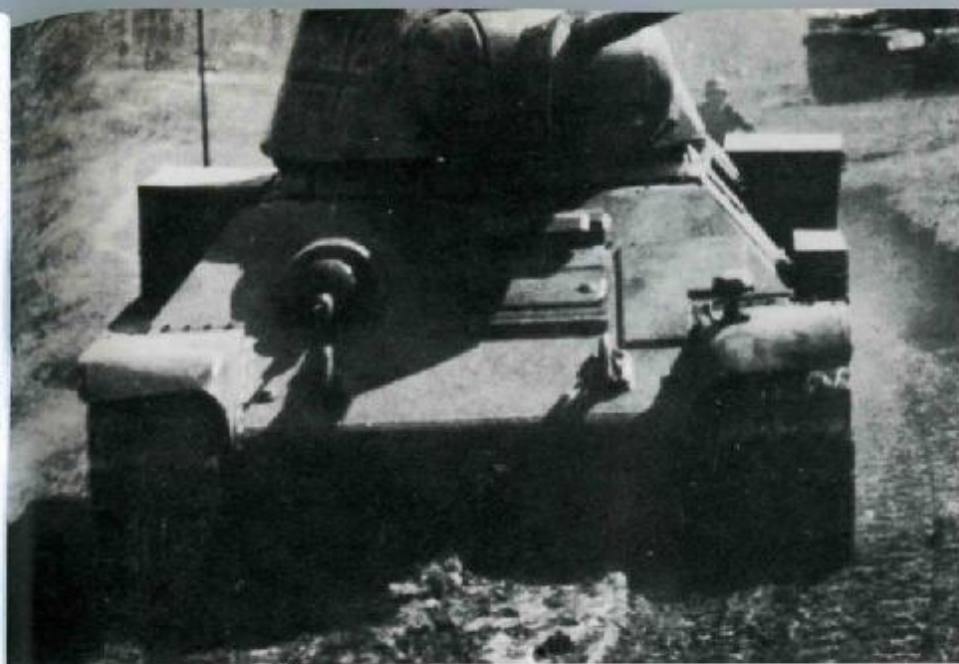
This T-34 took a direct hit at the right, next to the driver's hatch, and an armor plate was welded on there. The tank is equipped with a German Notek camouflage light. (BA)

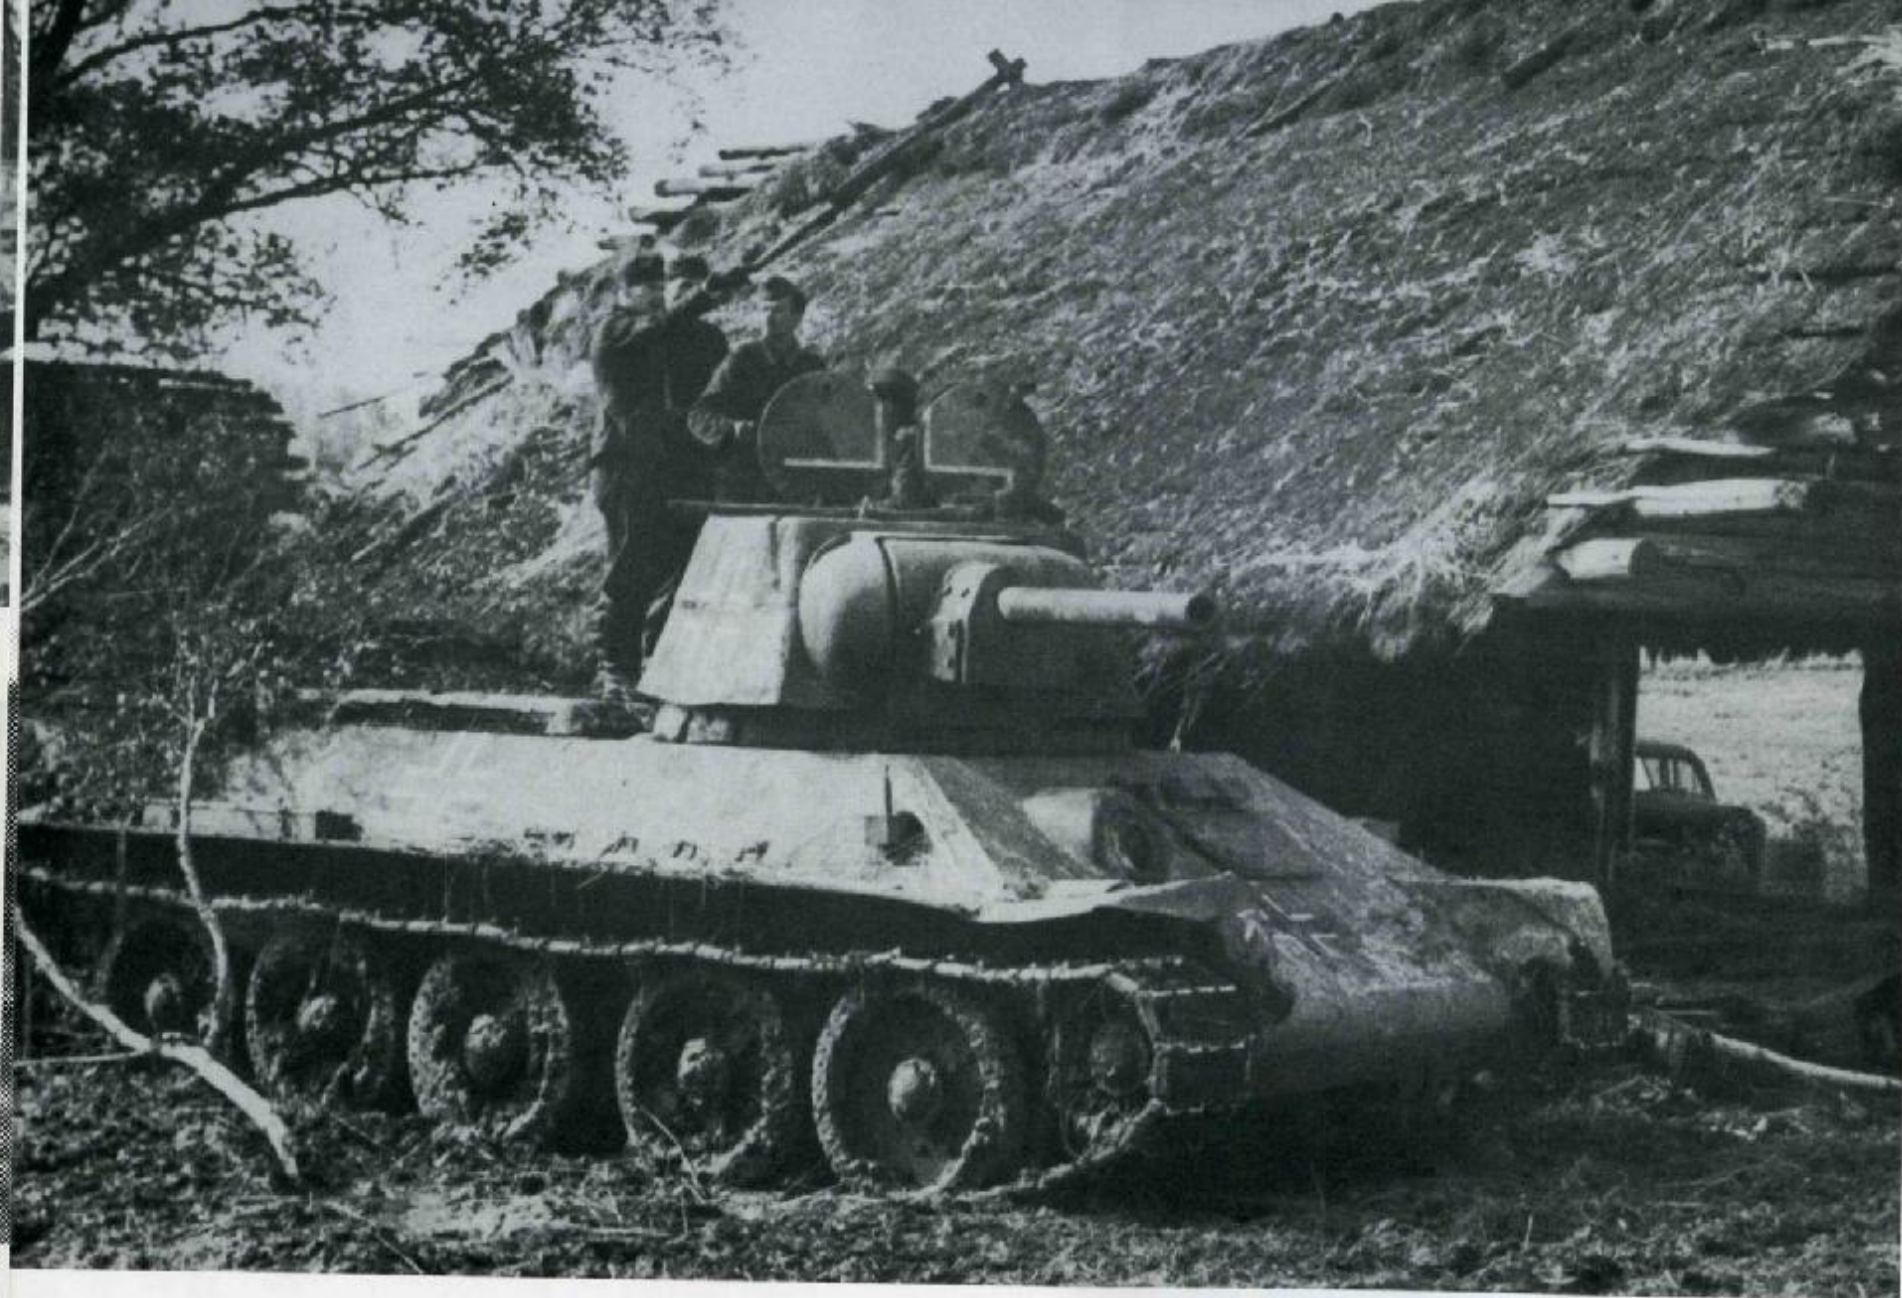
Liberally covered with recognition markings is this T-34. It has German crosses on the bow, the sides of the hull and turret, and—as the opened hatches show—a gigantic cross on the turret roof too. (BA)

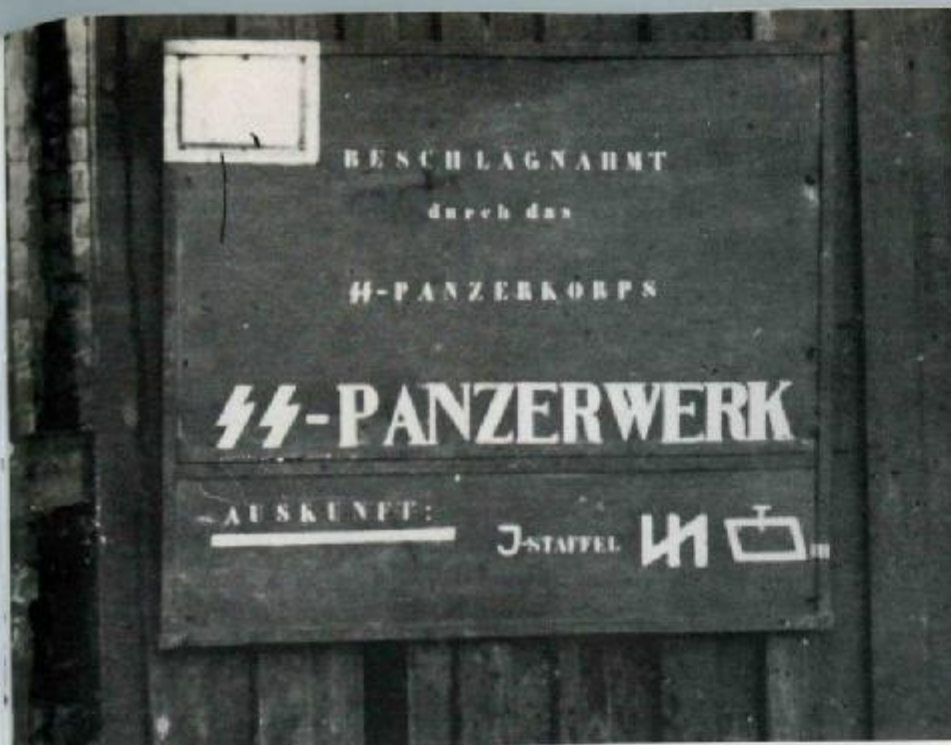
Sign reads: Confiscated by the SS Armored Corps, SS Tank Works. Information: J Squadron, plus 2 emblems.

In the spring of 1943 the SS Armored Corps confiscated a large building in recaptured Kharkov. There the Armored Pursuit Unit "Das Reich" repaired captured T-34 tanks and organized them into their own companies.

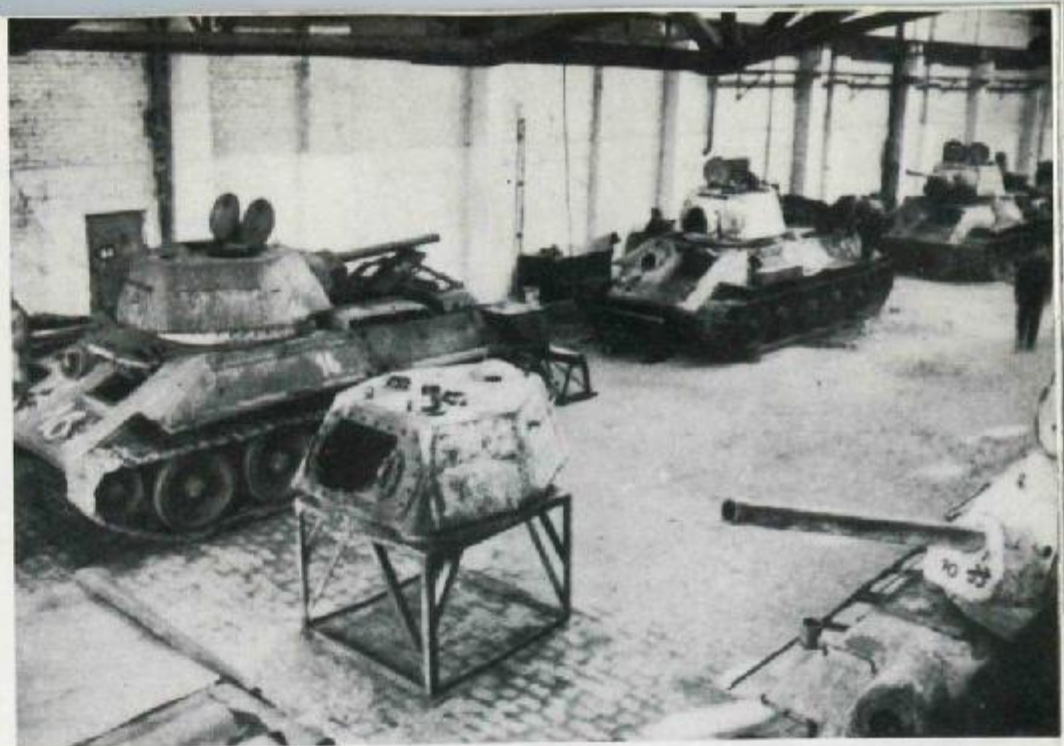
Upper right:
Captured T-34 tanks were completely dismantled there, overhauled and assembled again as if on an assembly line. So that the parts fitted together correctly, the tanks were numbered and the individual parts had these numbers applied. In back are four T-34 (1943 model) tanks, in the center a T-43 turret and in front a T-34 (1941 model).

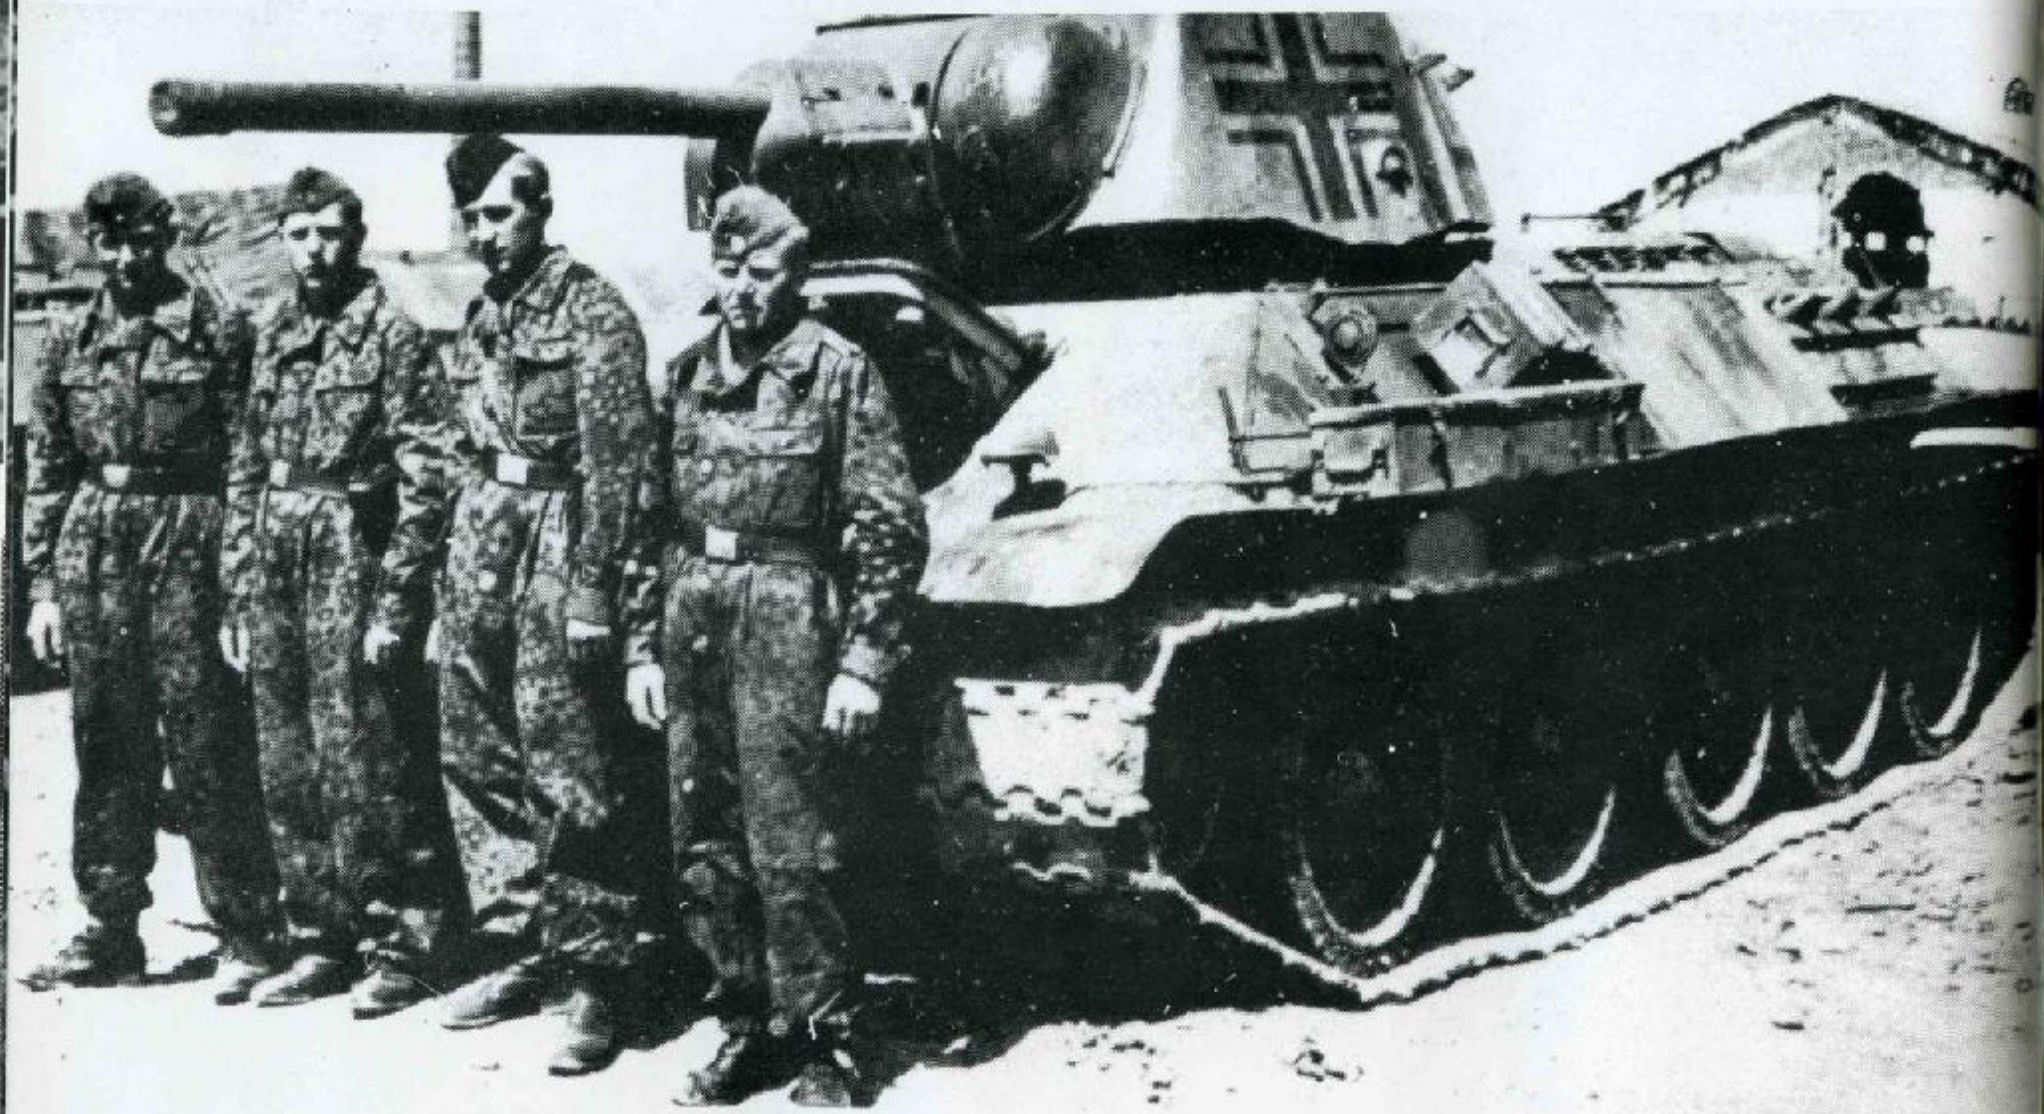
T-34 (1943 model) with its new crew. This tank also belonged to the SS Division "Das Reich". Since these tanks were prepared in

the "factory", they all had the same built-on parts and German Notek camouflage lights. (Munin)

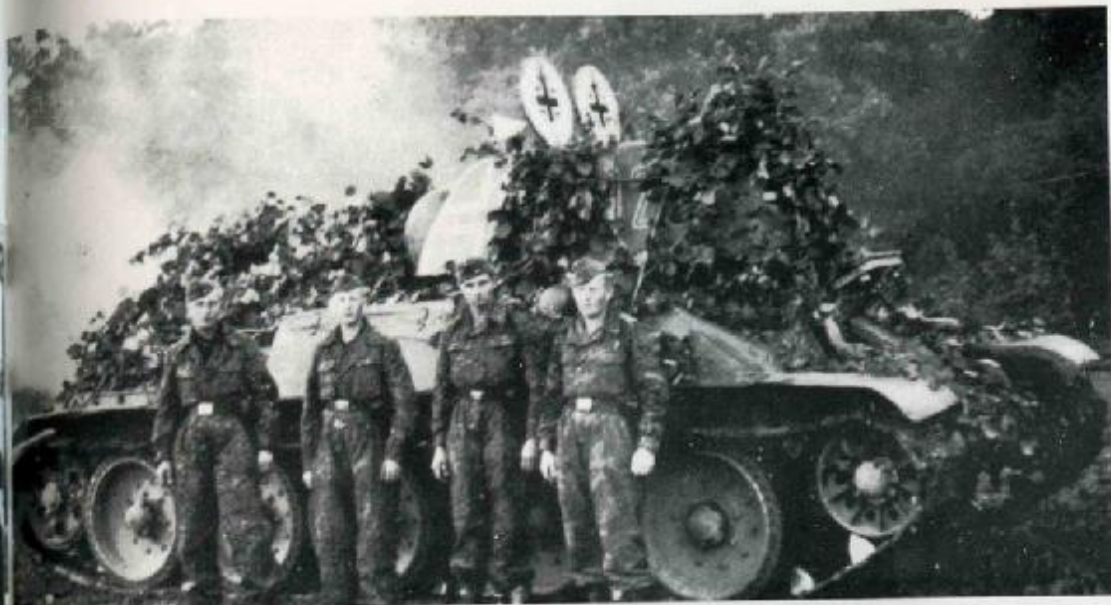
This T-34's markings can be seen despite its camouflage. Along with the crosses and numbers on the turret sides, the light-colored insides of the turret hatches are also painted with crosses. At the 6-o'clock turret position they serve, as here, as recognition signs from forward, and in an attack one can recognize one's own tank from the rear. (Munin)

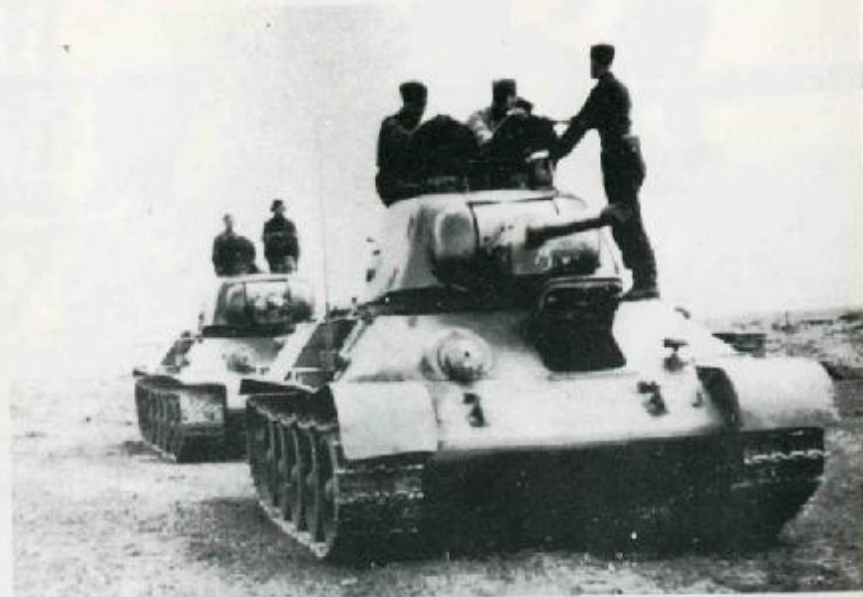
Again, four T-34 tanks of the Division "Das Reich", including 1943 models, easy to recognize by the turrets with the two round hatches. (Munin)

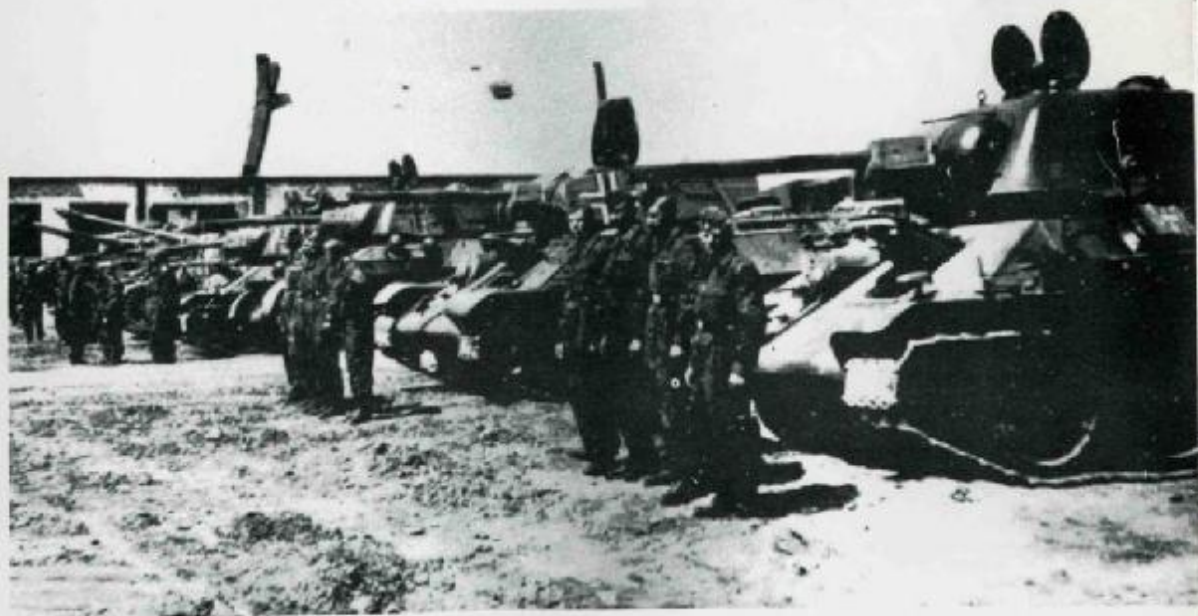
The SS Division "Das Reich" used the tanks in mixed companies with Tank IV units. Here, along with the German tanks, are four T-34's, including one 1941 and three 1943 models. (Munin)

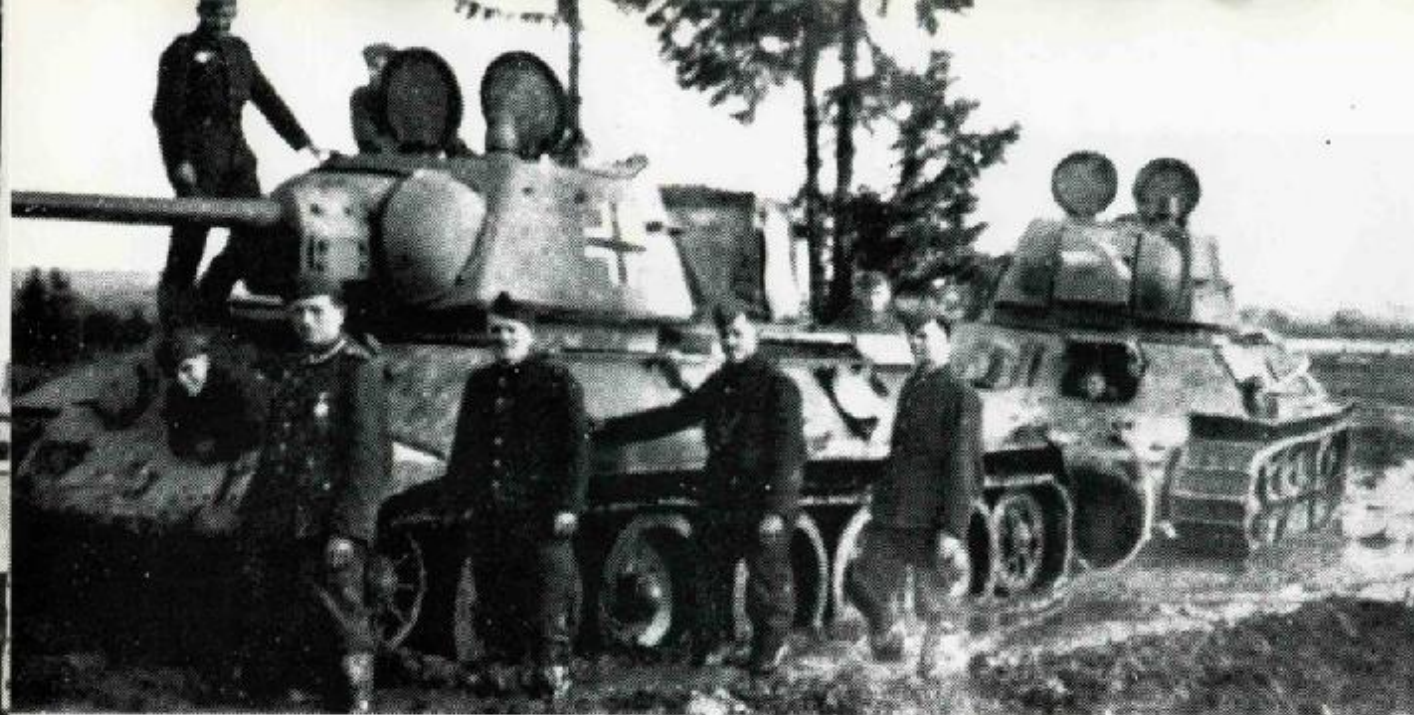
The Armored Pursuit Detachment 38 of the 2nd Armored Division used these two T-34 (Type D) tanks as "pursuit tanks". There were not so many problems with friend-for recognition when captured tanks were used as pursuit tanks.

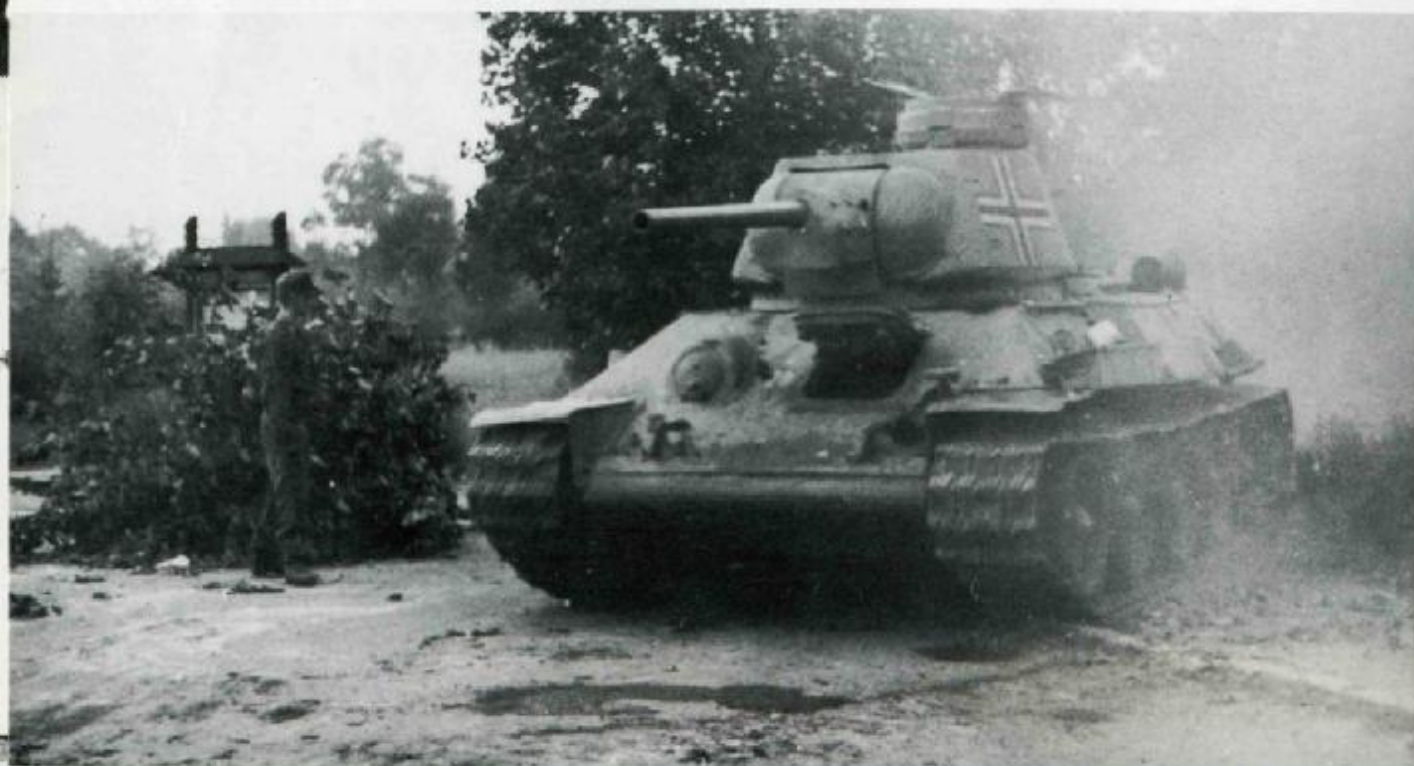
To give the commander a better panoramic view, the cupola of a German Panzer III or IV tank was built onto this T-34. In the middle of the bow armor, the number 20 can be seen. (BA)

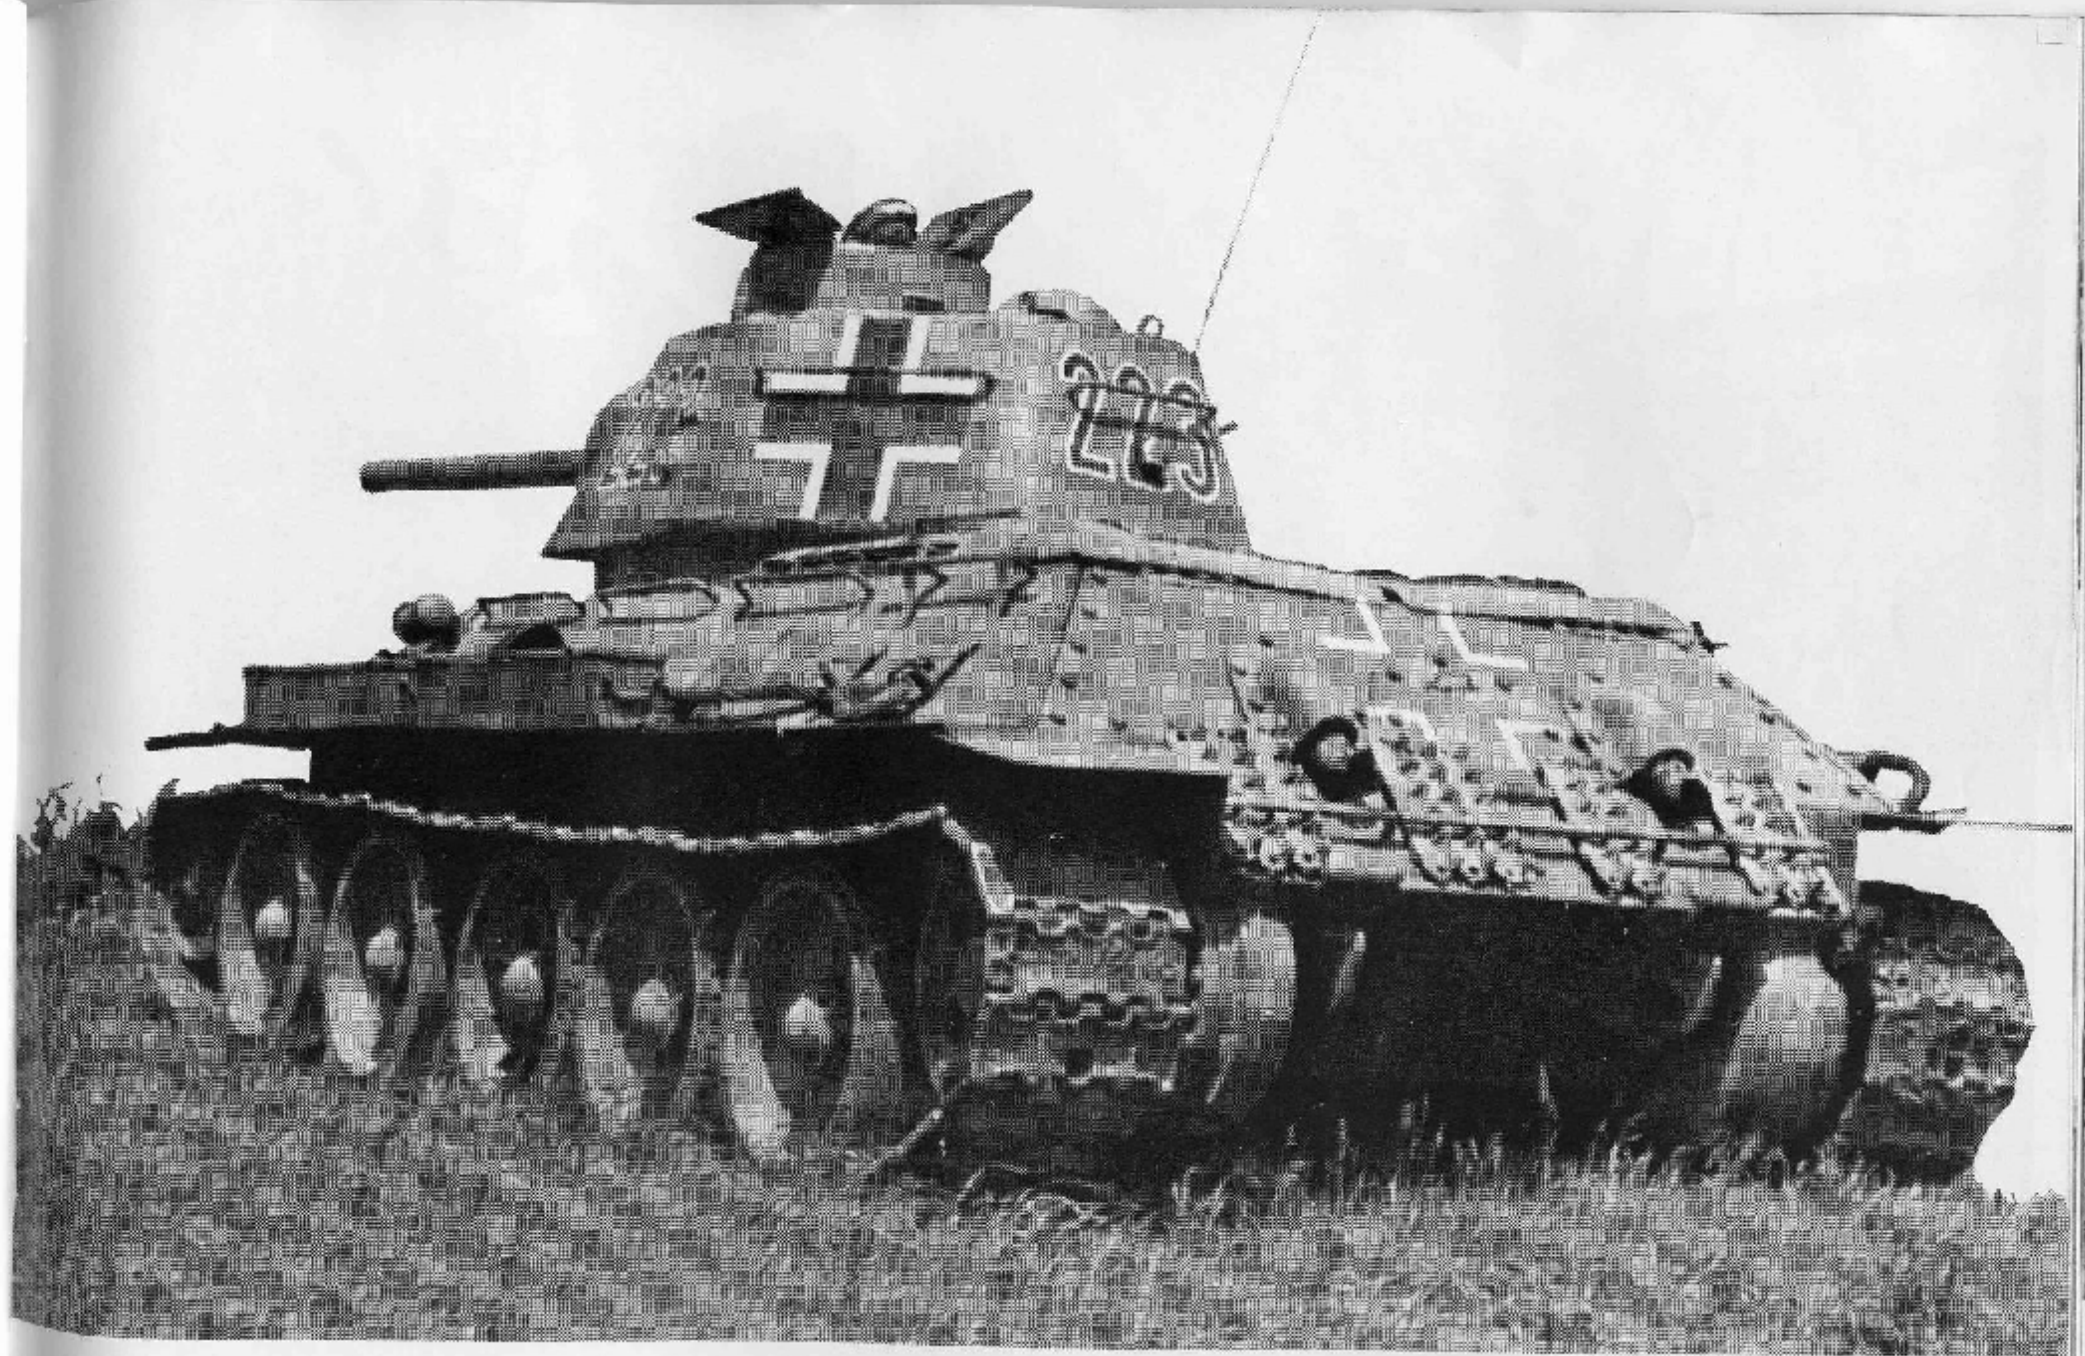
This T-34/76 (Type E) served as a model for our cover picture.

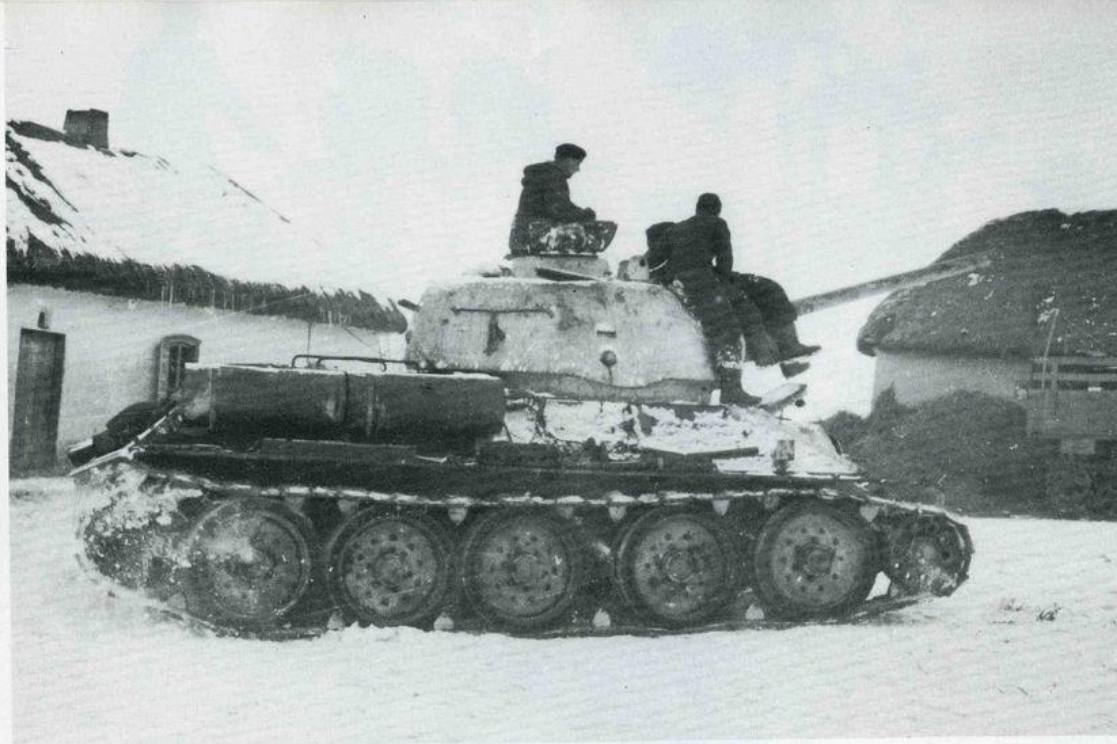
The later versions of the T-34 (1943 model) were equipped by the Russians with a simple commander's cupola. As with the earlier versions, there were either cast round or welded hexagonal turrets, depending on the factory in which they were made. (BA)

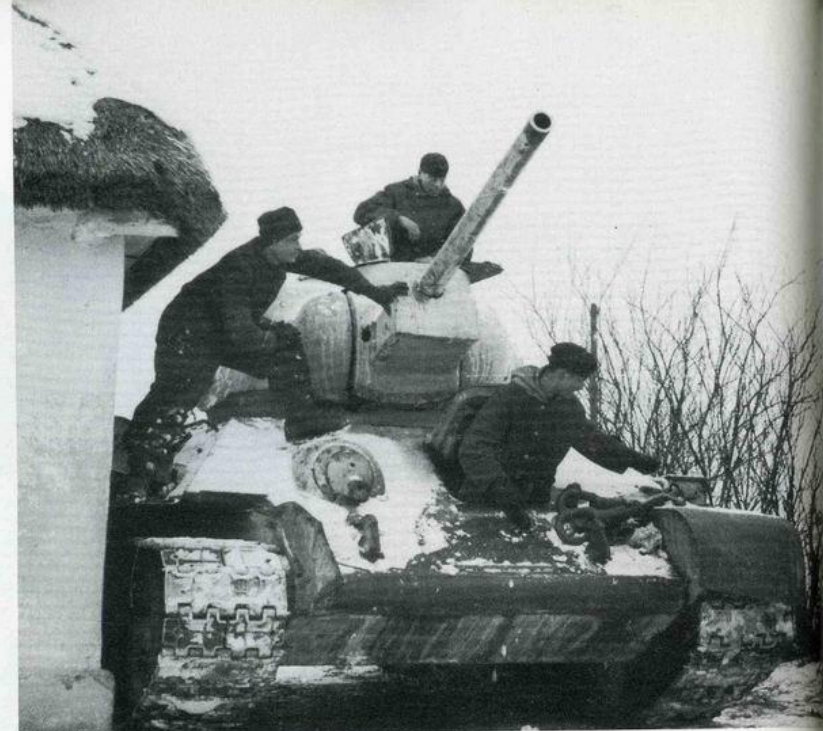
This T-34 has been captured intact by German troops and is now being tested. German markings have not yet been painted on. (BA)

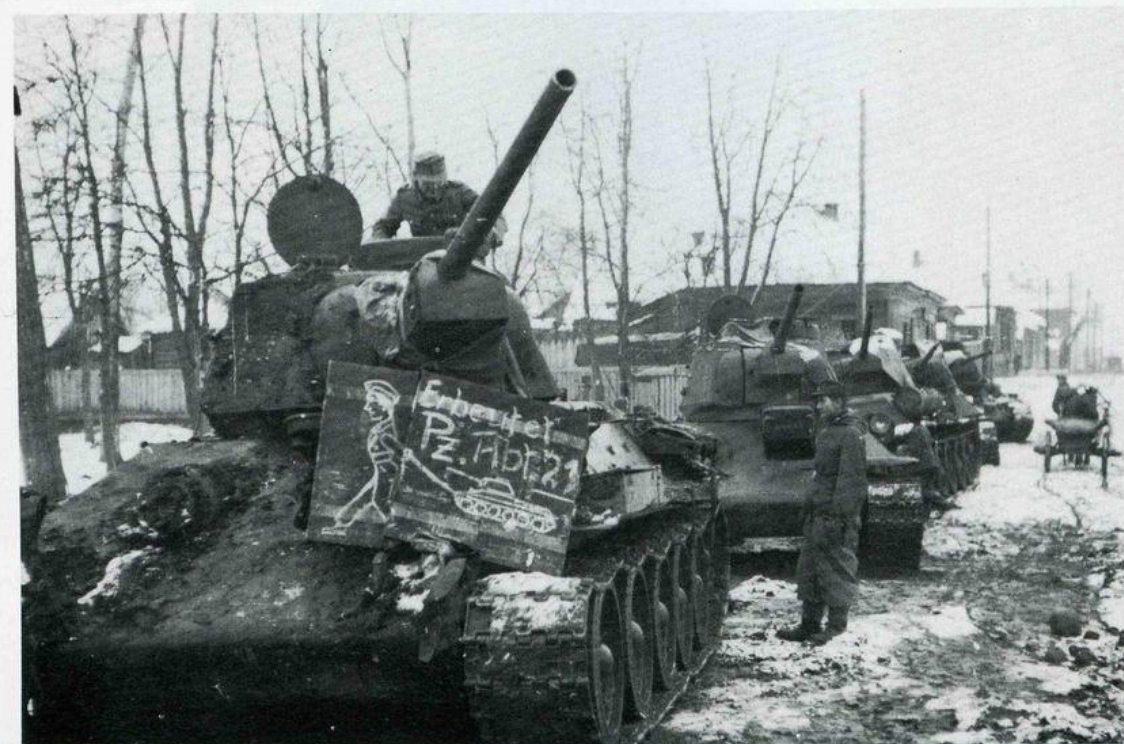
In the winter of 1943/44 Armored Detachment 21 of the 20th Armored Division was able to capture a large number of T-34 (1943 model) tanks. (BA)
