CAPTURED TANKS UNDER THE GERMAN FLAG

RUSSIAN BATTLE TANKS

DR. WERNER REGENBERG
HORST SCHEIBERT

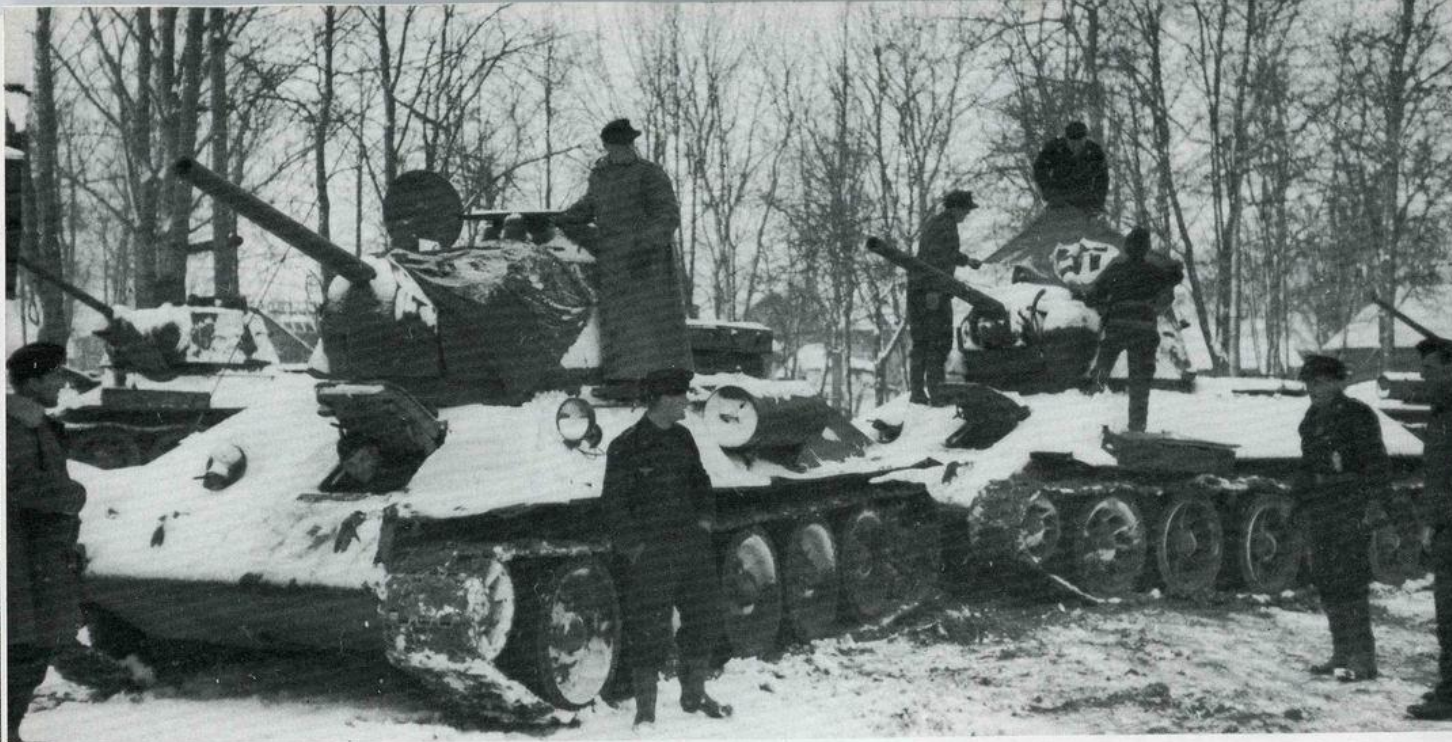
The T-34 tank with its 76-mm cannon was welcome booty. These were immediately marked as German tanks with air-identification cloths. The front tank has the old-type rubber-covered road wheels, the others have the newer type. (BA)

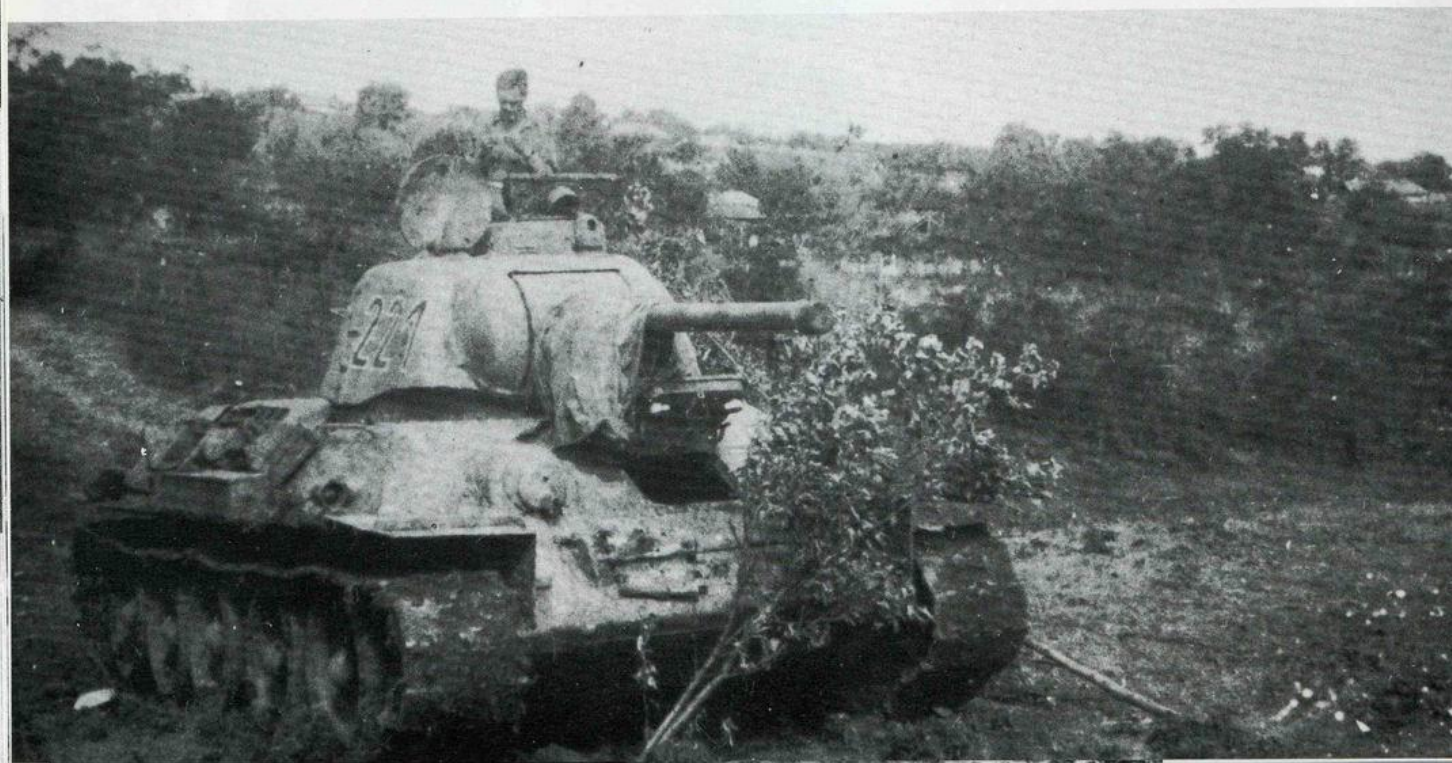
The leading tank of the 2nd Column, with turret number 221. To the right near the driver's hatch a German cross can be seen. Since these tanks were in service as pursuit tanks, the main identifying mark is on the rear. (Cutshorn)

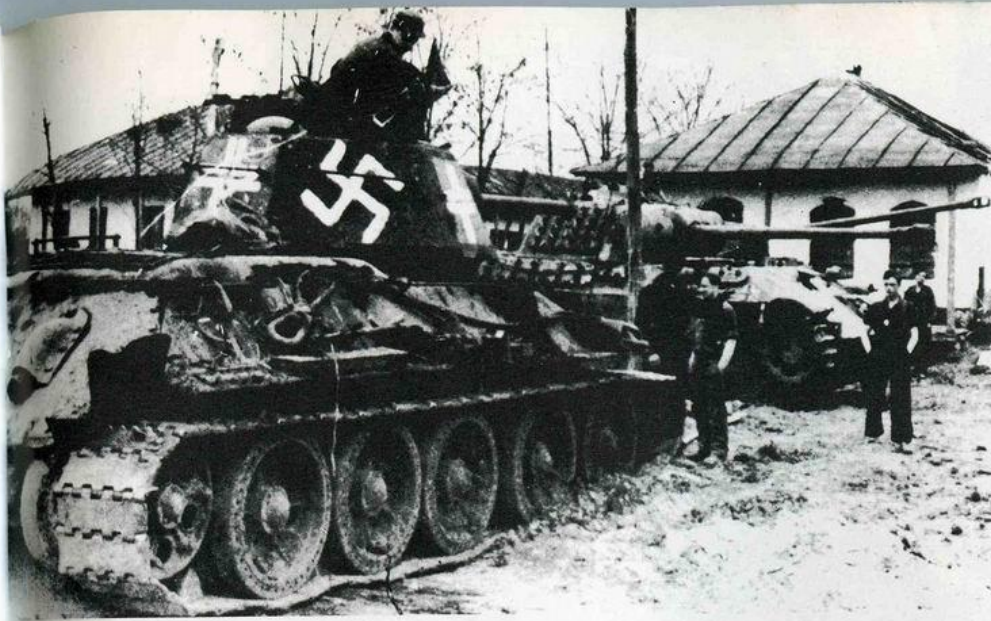
This tank was marked very clearly as a German vehicle. Around the turret, big white crosses alternate with swastikas. (BA)

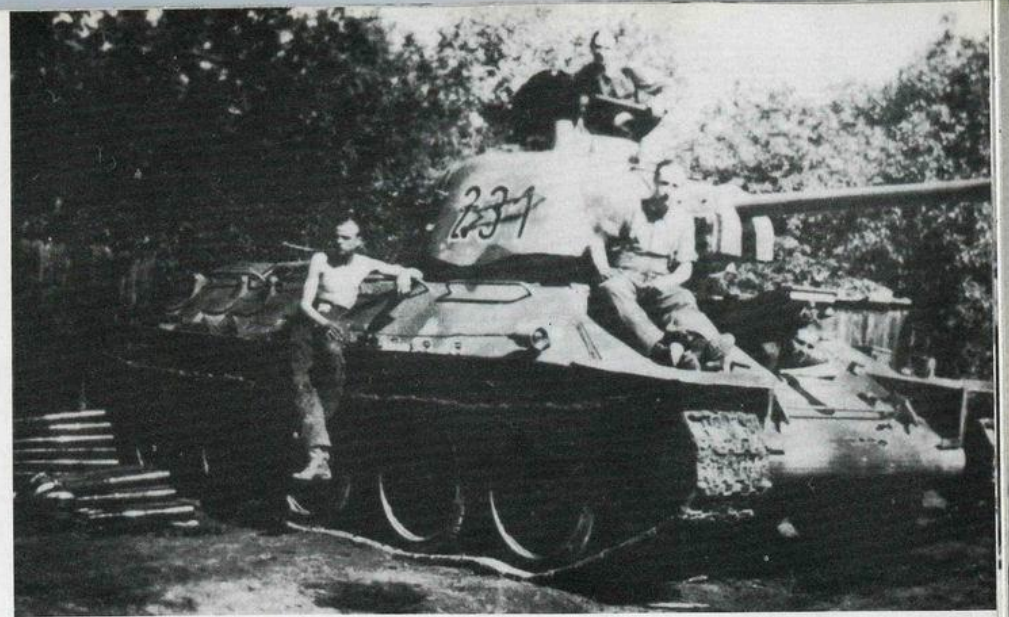
Ammunition is piled up next to Tank 231. Some 80 cartridges could be carried. (Weber)

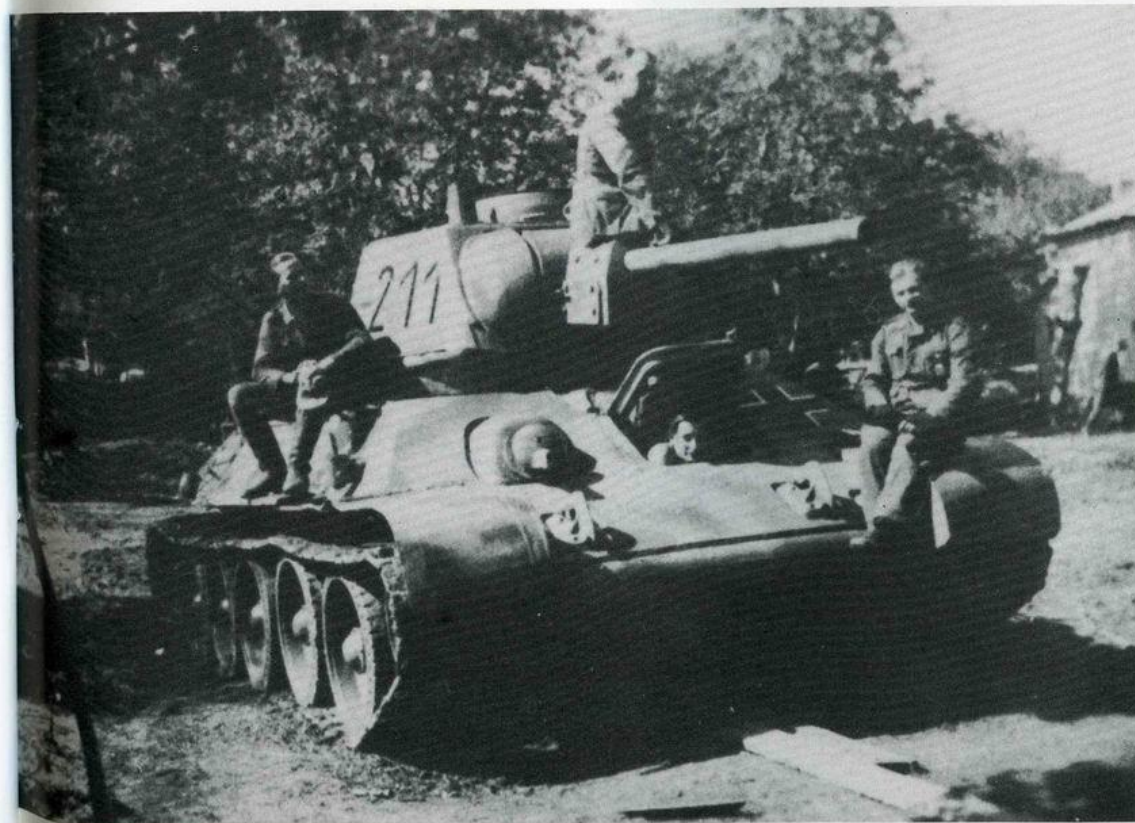
In addition to T-34's with cast turrets, there were also tanks with welded turrets in this unit, as here number 211. Some captured tanks were still in service with Armored Pursuit Detachment 128 in 1945. (Weber)

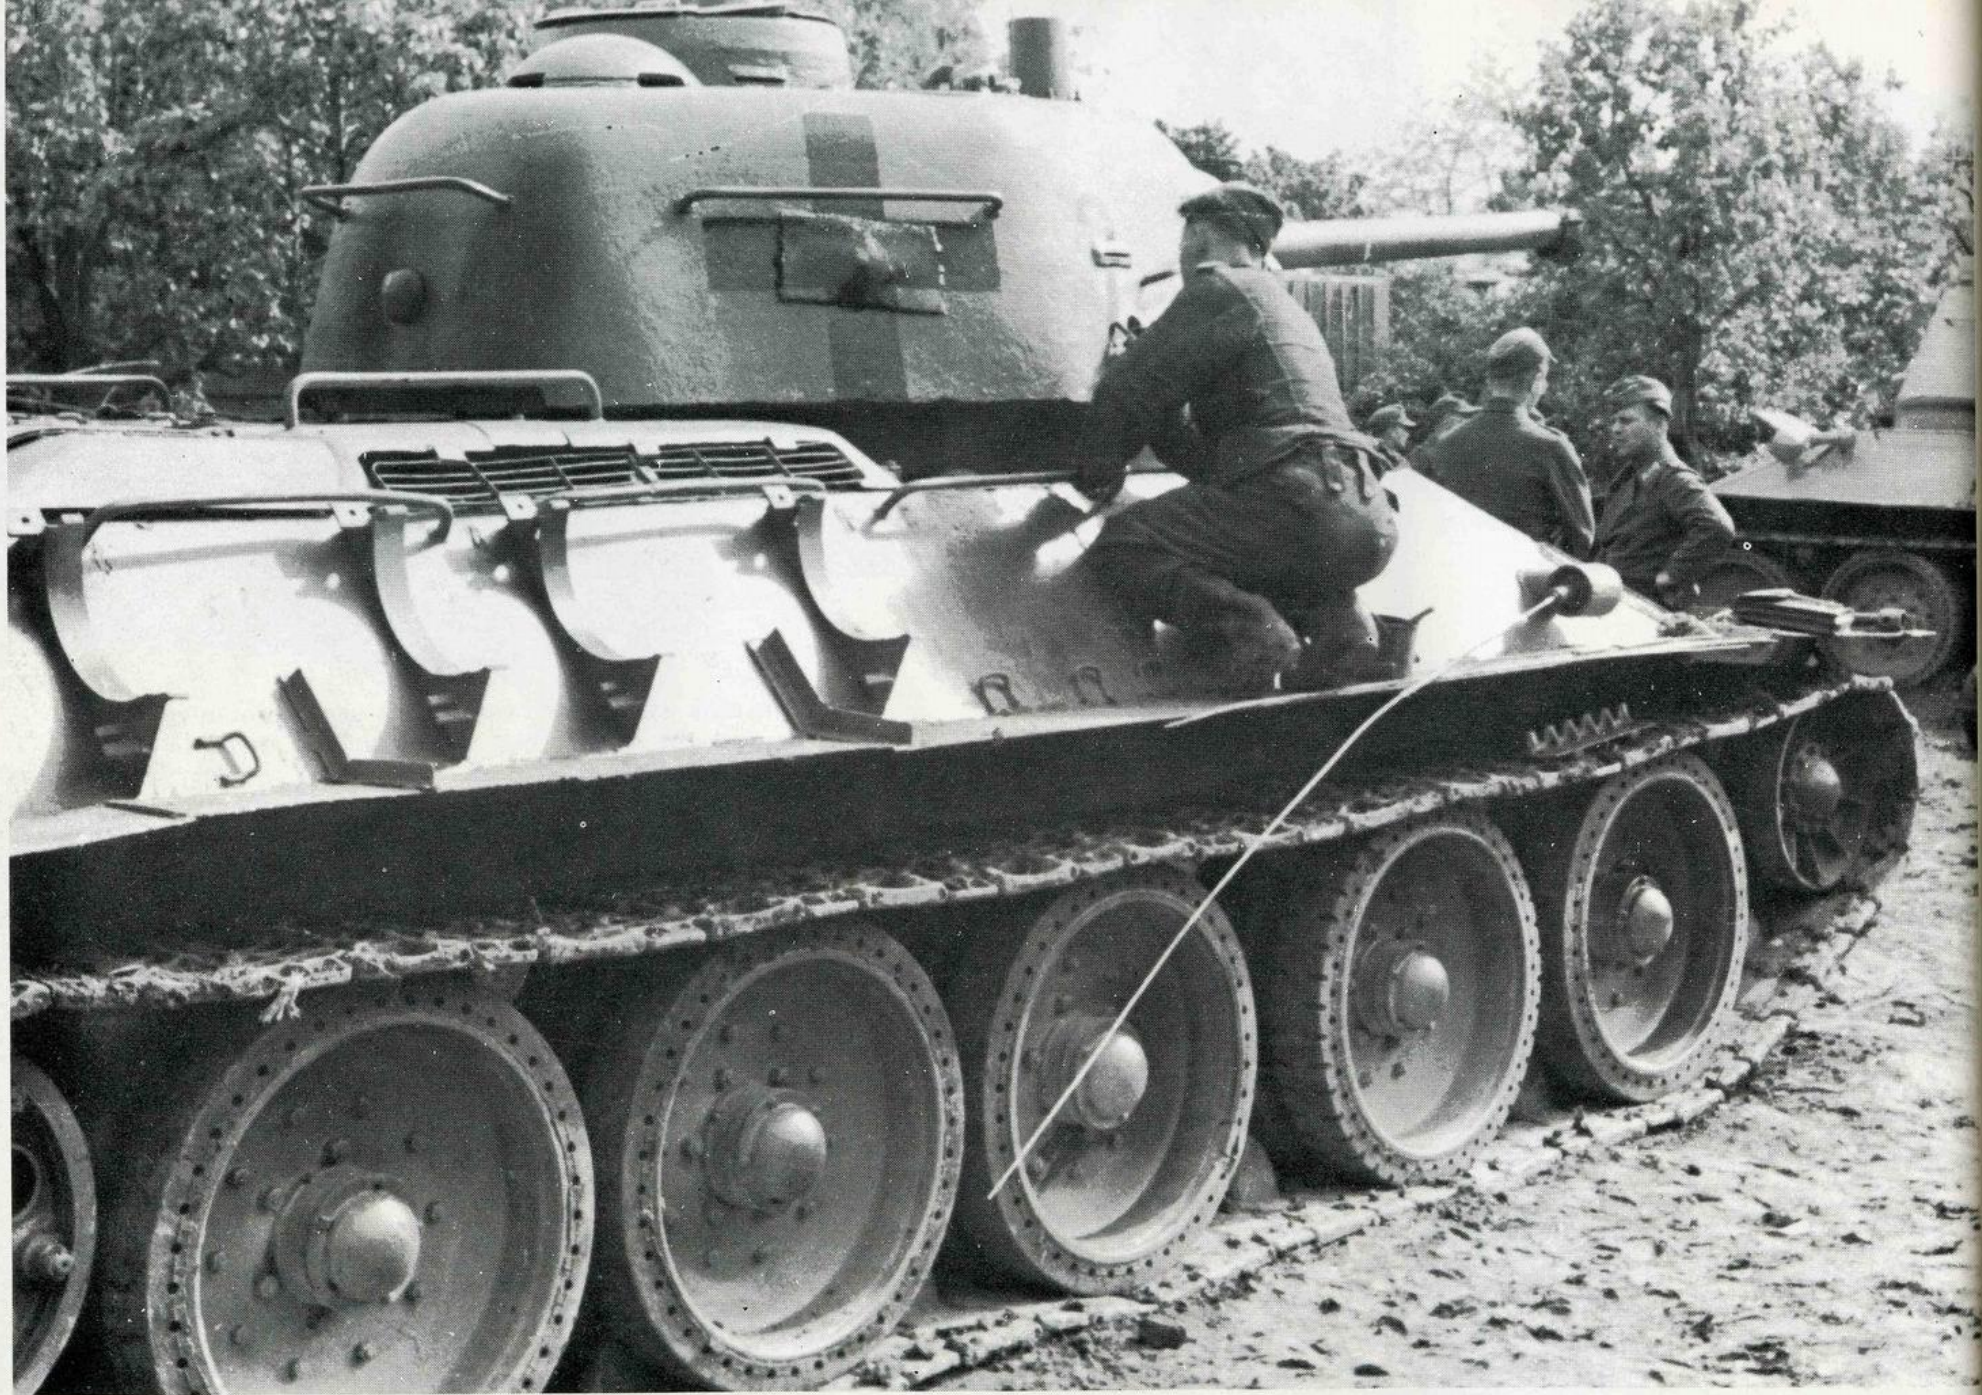
Captured and still usable Russian tanks—here a T-34 (E)—were prepared for service in German units by covering holes (note the armor plate in the middle of the black cross), being equipped with radios (antenna) and having sequential numbers painted on their turrets.

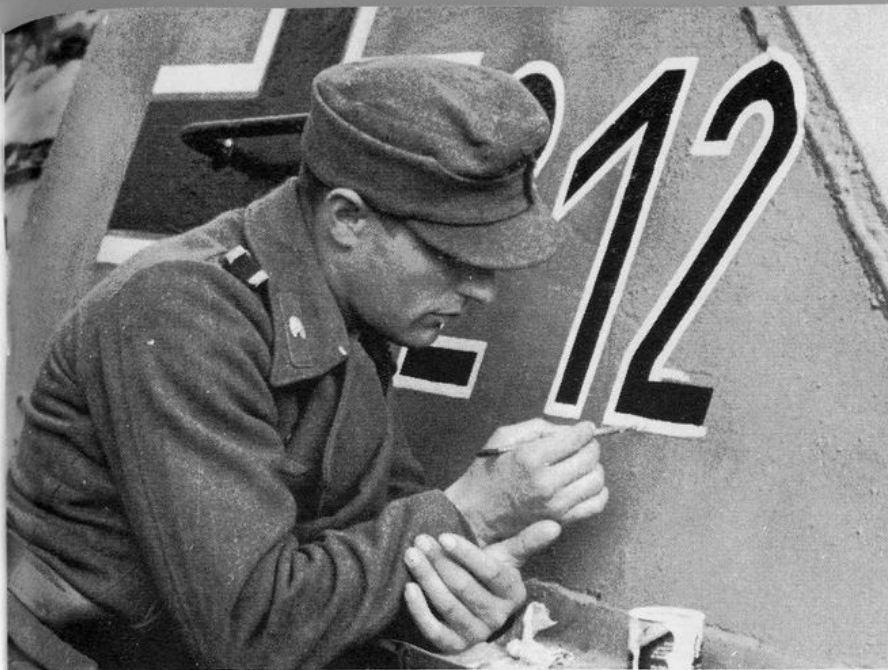
The big German crosses were painted carefully with stencils. The edges of the crosses were drawn on with chalk and then painted by hand.

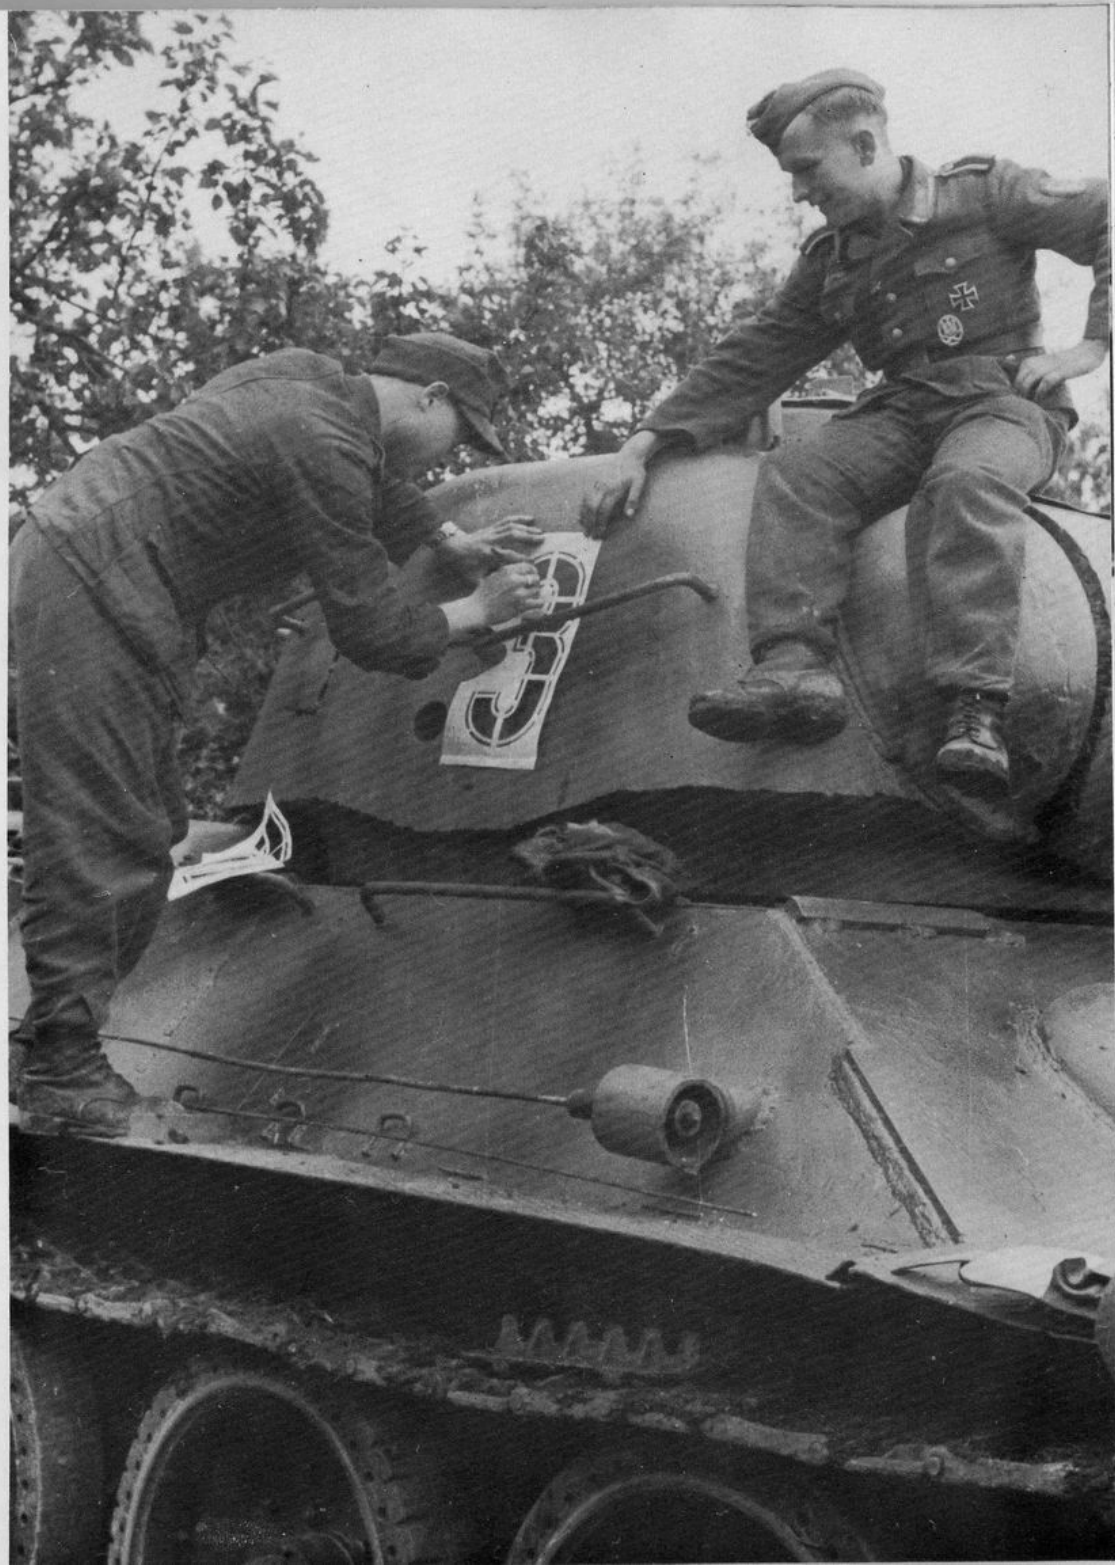
The tanks were given the three-color camouflage paint typical of the time (see front cover). The turret numbers were also painted on with stencils. (BA)

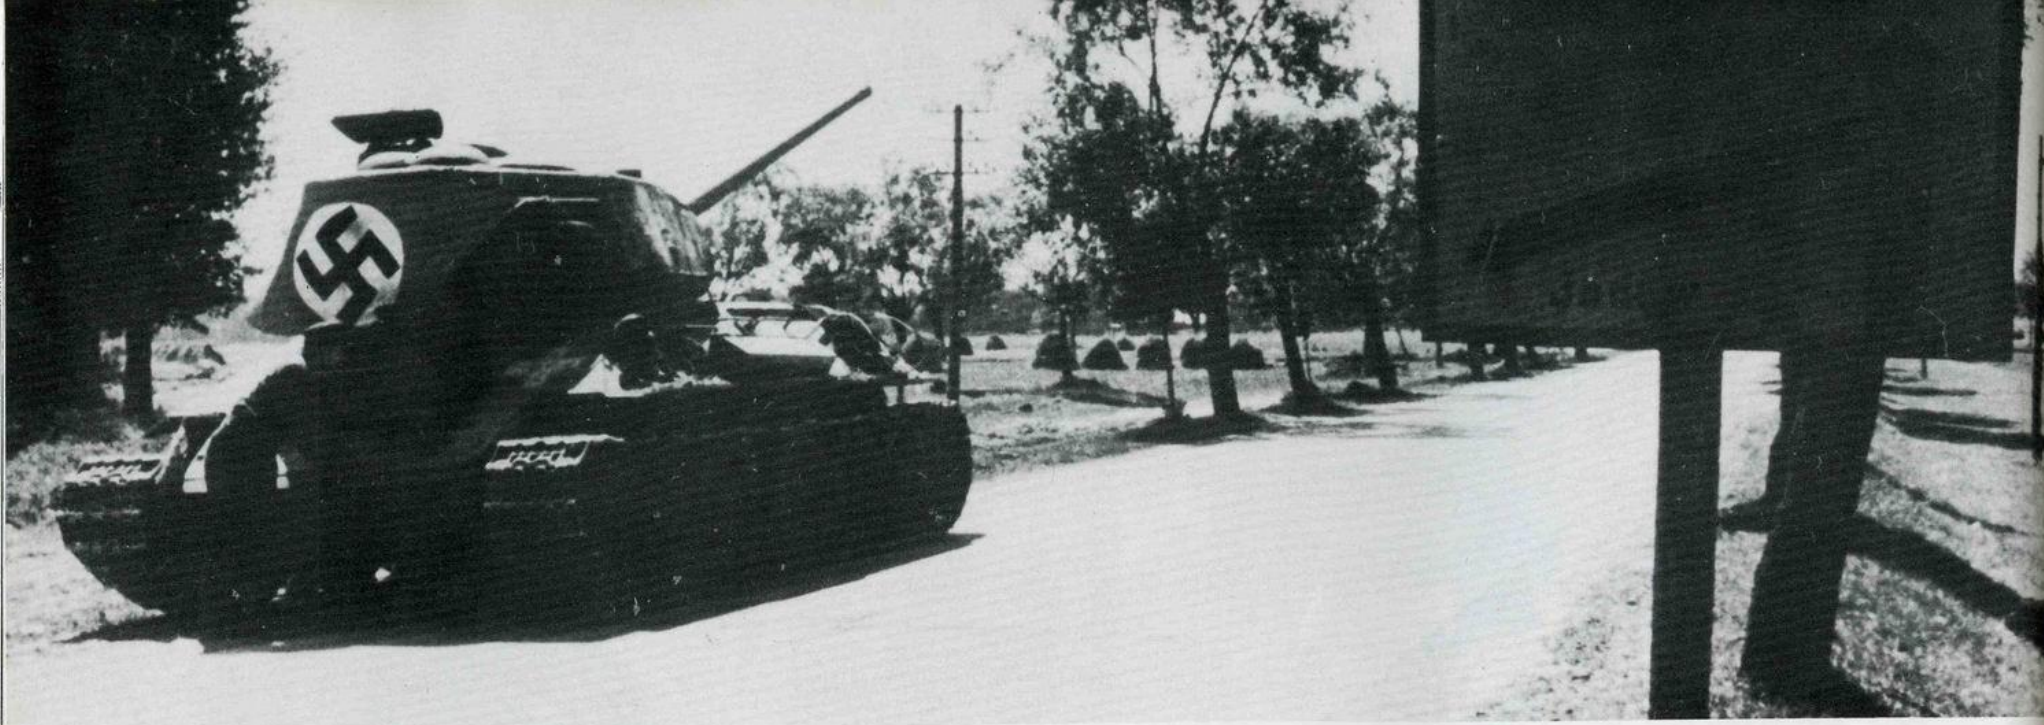
Built from the end of 1943 on, the new T-34/85 with a three-man turret and the new 85-mm cannon appeared at the front in 1944. This tank at the Warsaw-Jadow intersection shows a white German cross at right near the driver's hatch and a swastika flag. It was captured and put in service by the 5th SS Armored Division "Wiking" in 1944. (BA)

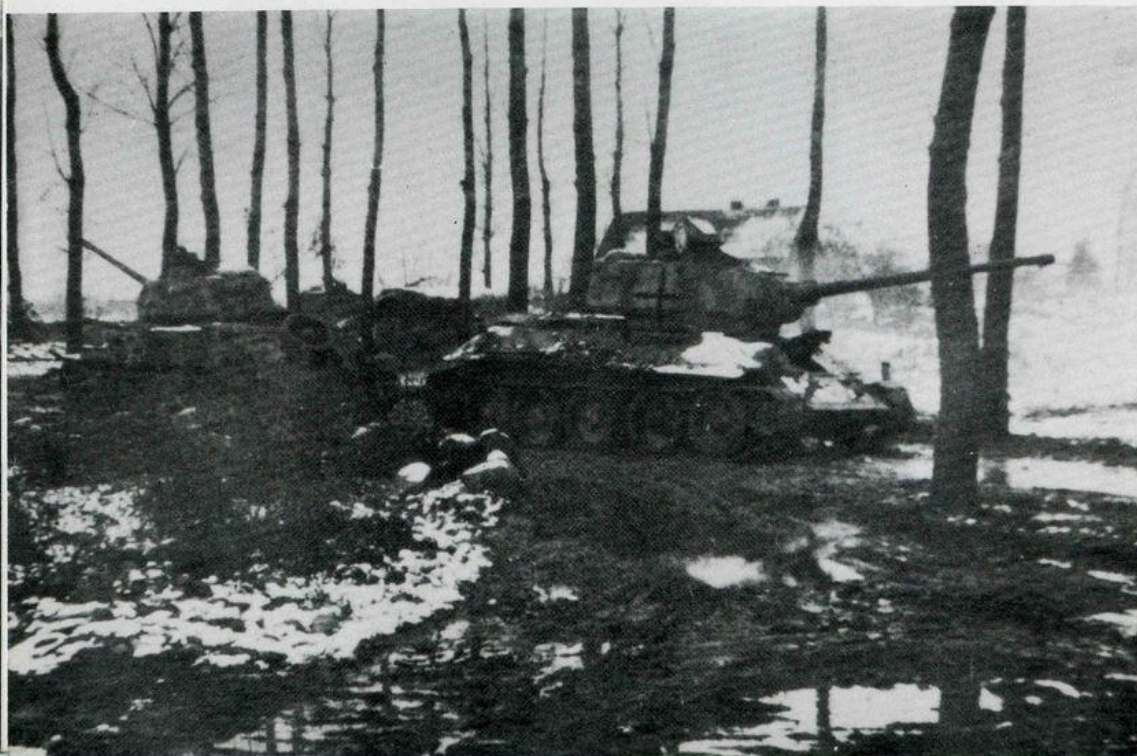
These two T-34/85 tanks were captured by the 252nd Infantry Division in East Prussia during 1944. The tanks were made recognizable as German vehicles with crude black crosses and put in service with Armored Pursuit Detachment 252. There were only a few captured T-34/85 tanks, since they appeared on the battlefield only at a time when the German troops were almost always retreating—and so few were captured.

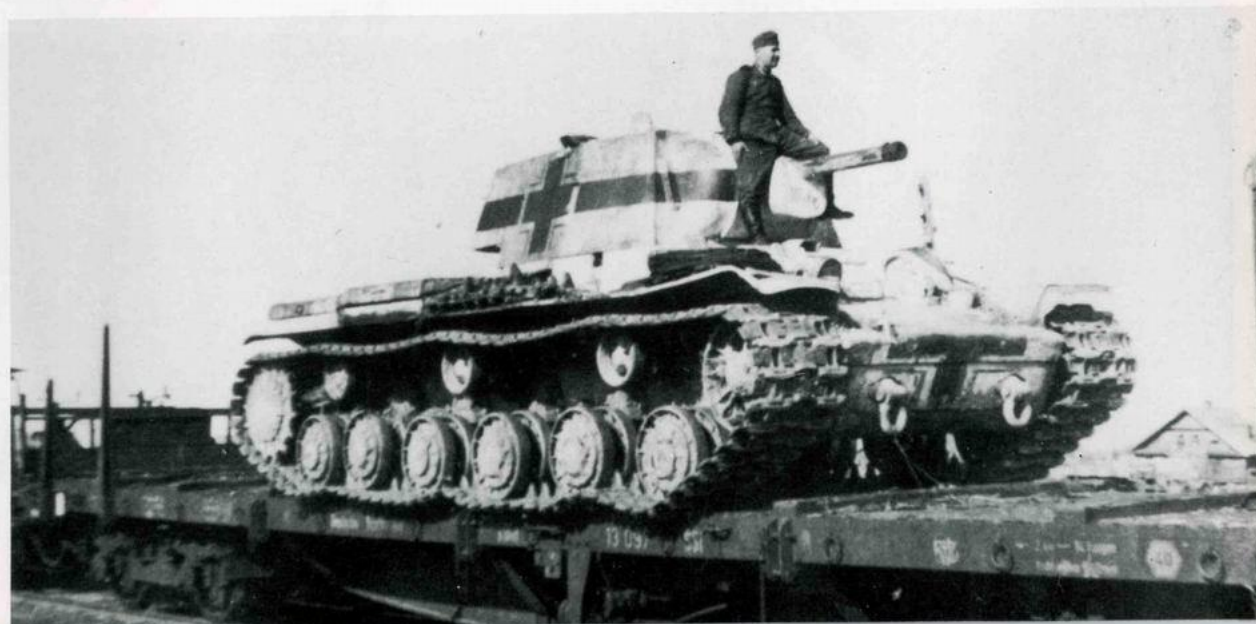
A KW-I of the first production batch (1939 model), with a 76-mm cannon, Machanov L-11. The vehicle bears only a small German cross and the noticeable number H 03. The tank has been equipped with a German commander's cupola. At the left front of the track cover is the typical German auto jack. This tank was put in service with Armored Regiment 1. (Riebenstahl)

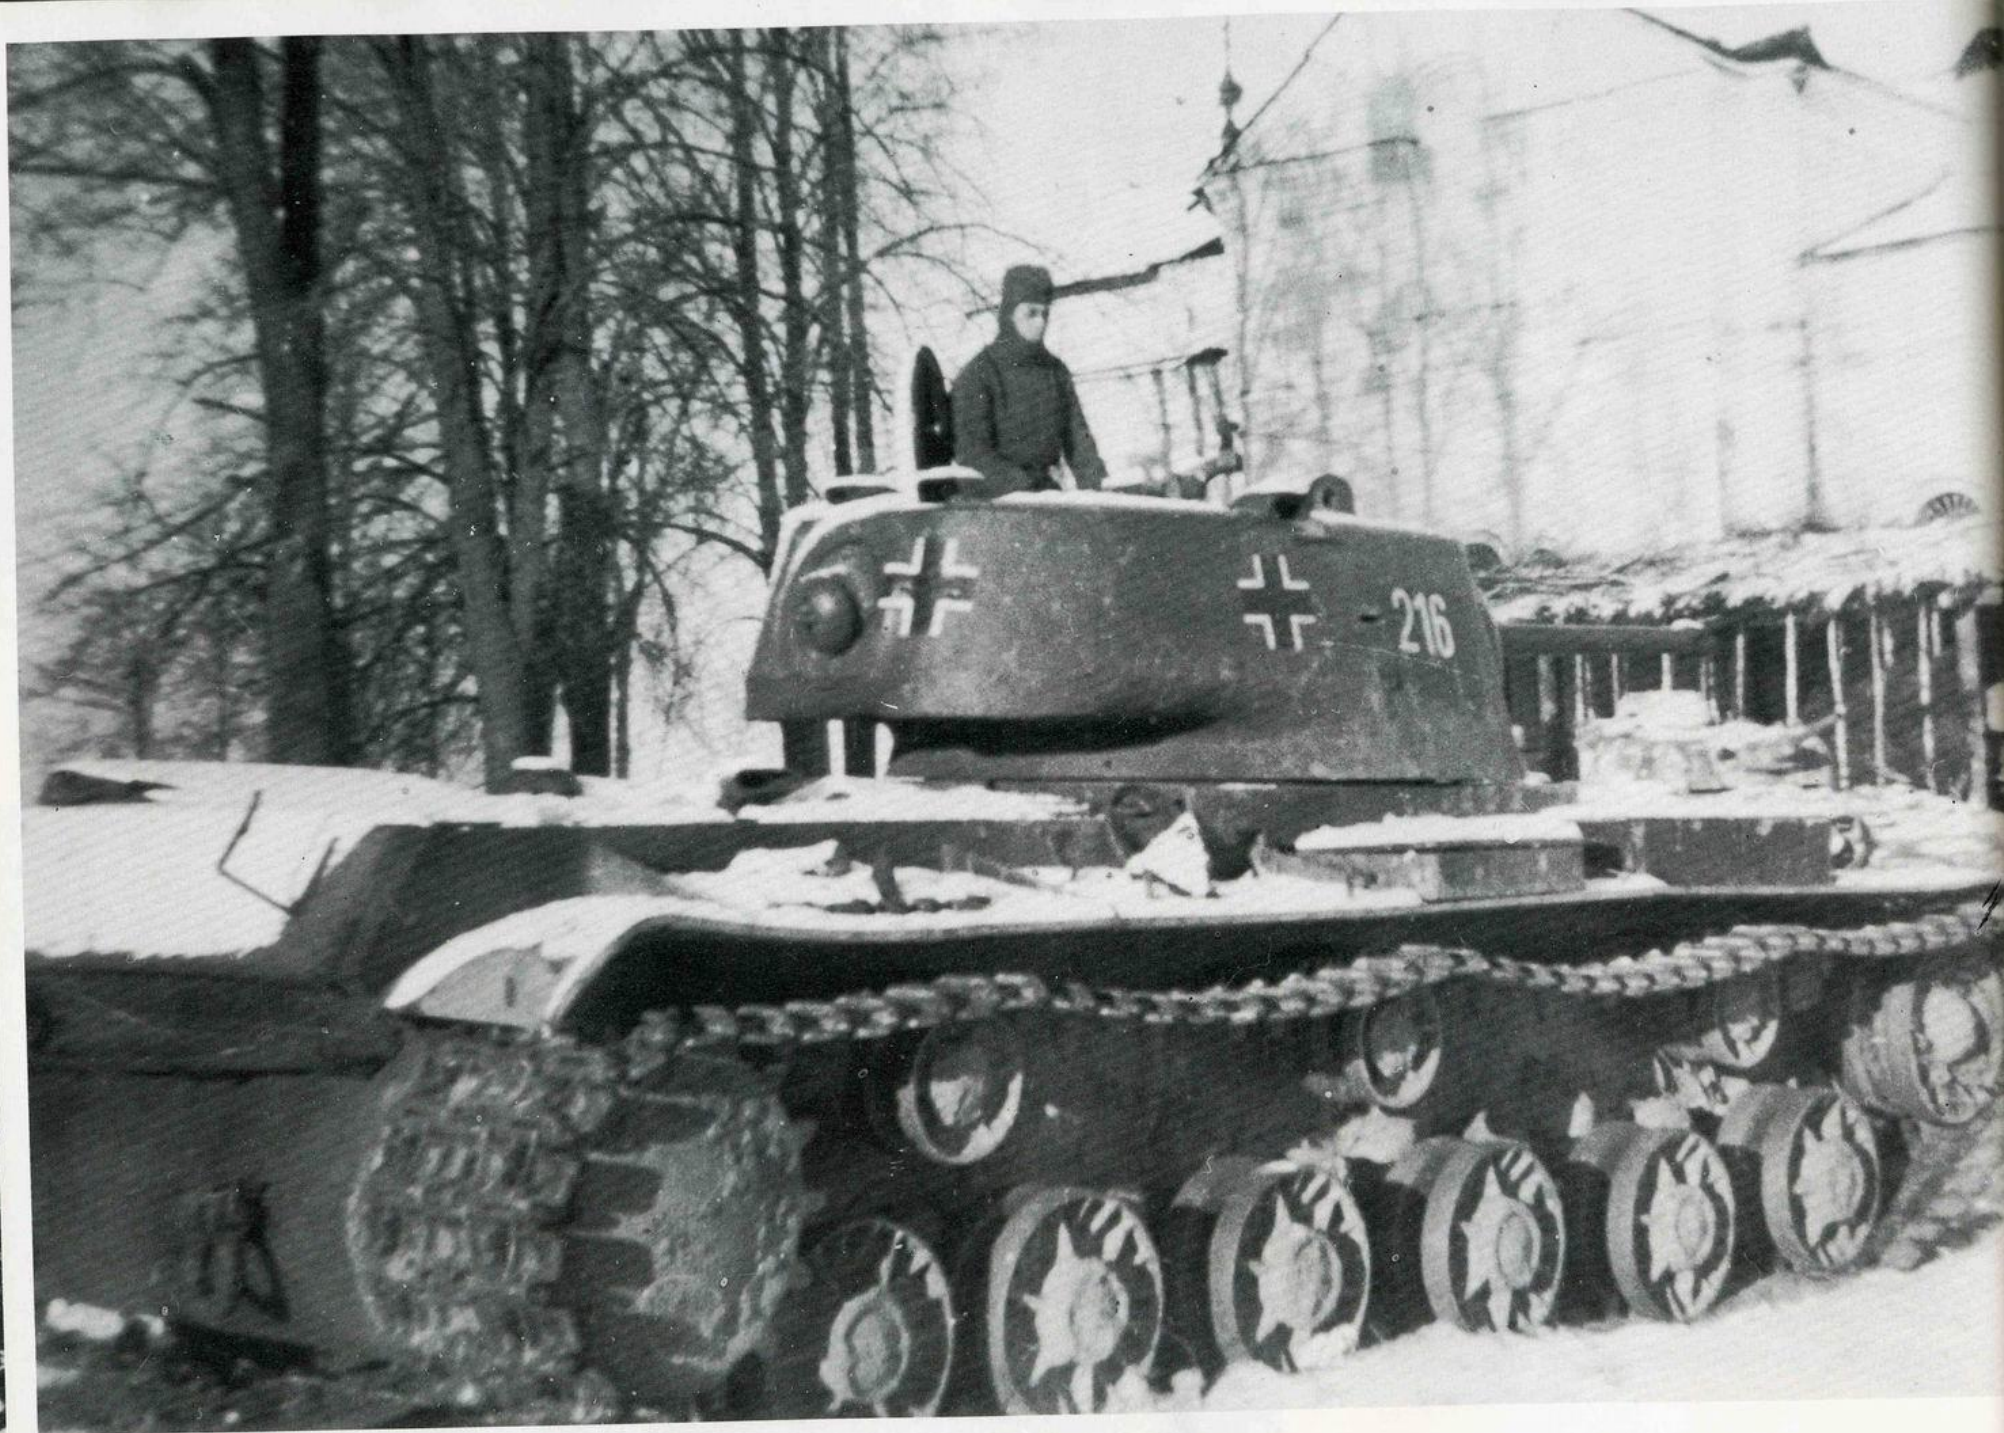
This KW-I (1942 model) was in service with the 1st Armored Division. The 1942 model was also equipped with a ZIS-5 cannon, but had only a cast turret. (Riebenstahl)

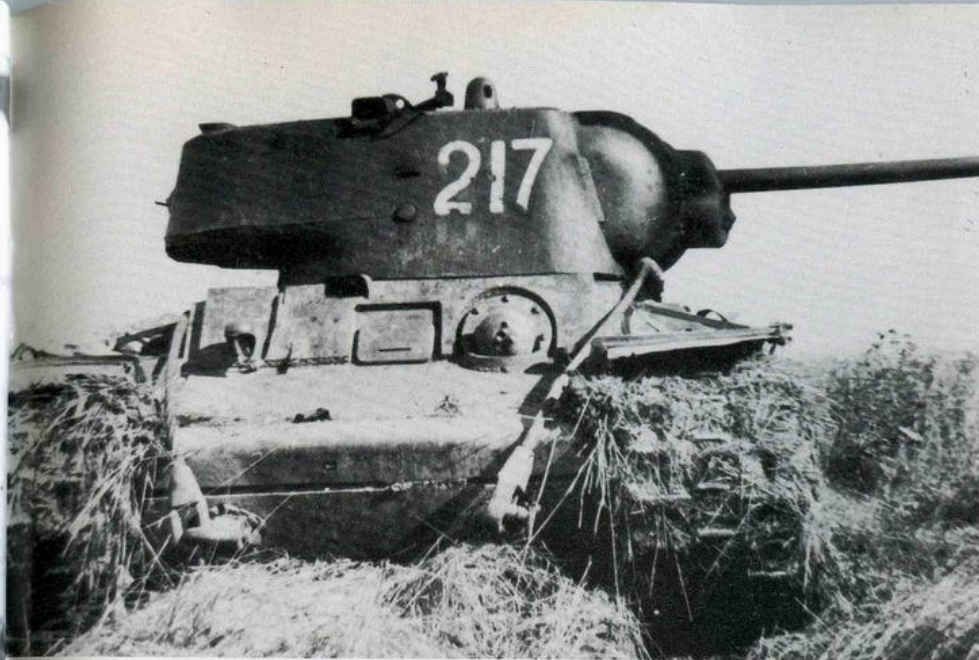
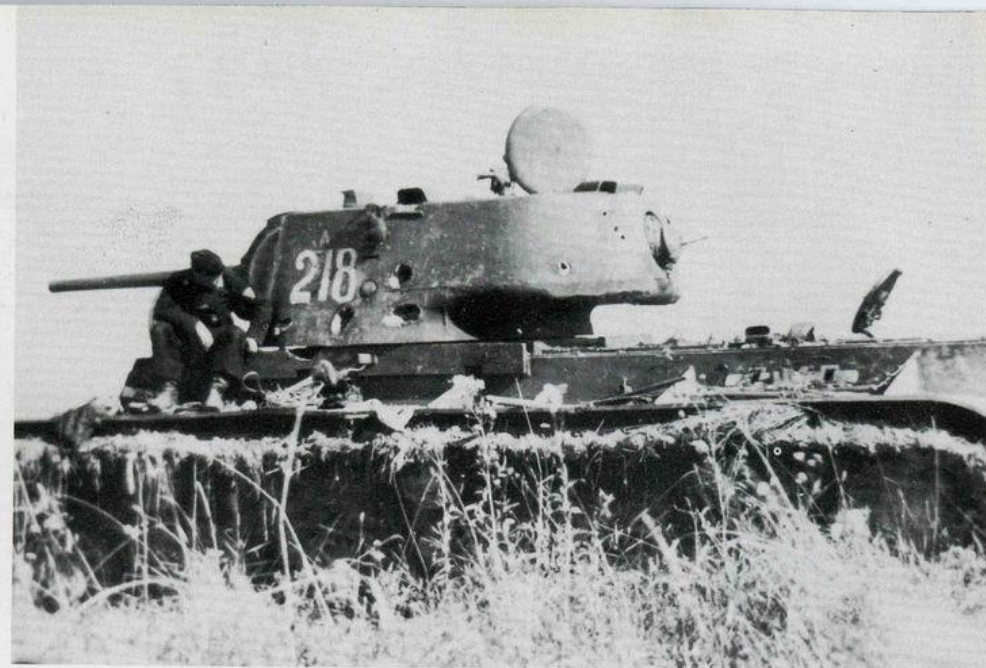
The three KW-I tanks shown on this page were also in service with Armored Regiment 1 of the 1st Armored Division—here still without German crosses. (Riebenstahl)

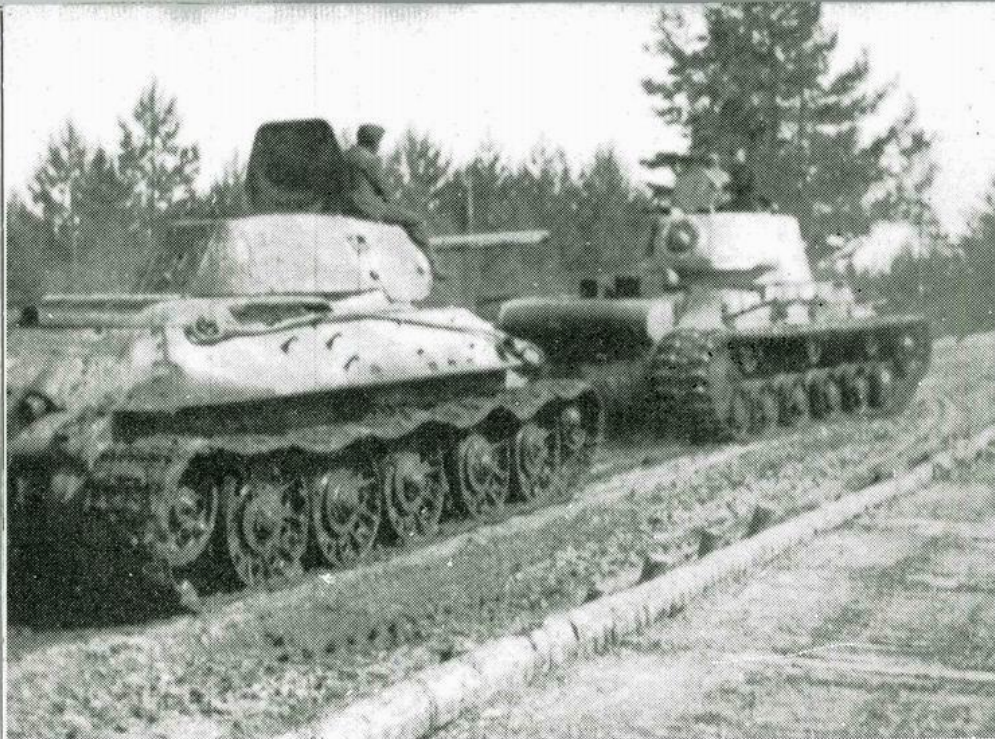
Here a T-34 is being towed by a KW-I (1942 model). The two tanks were captured by the 8th Armored Division but not yet marked with German crosses.

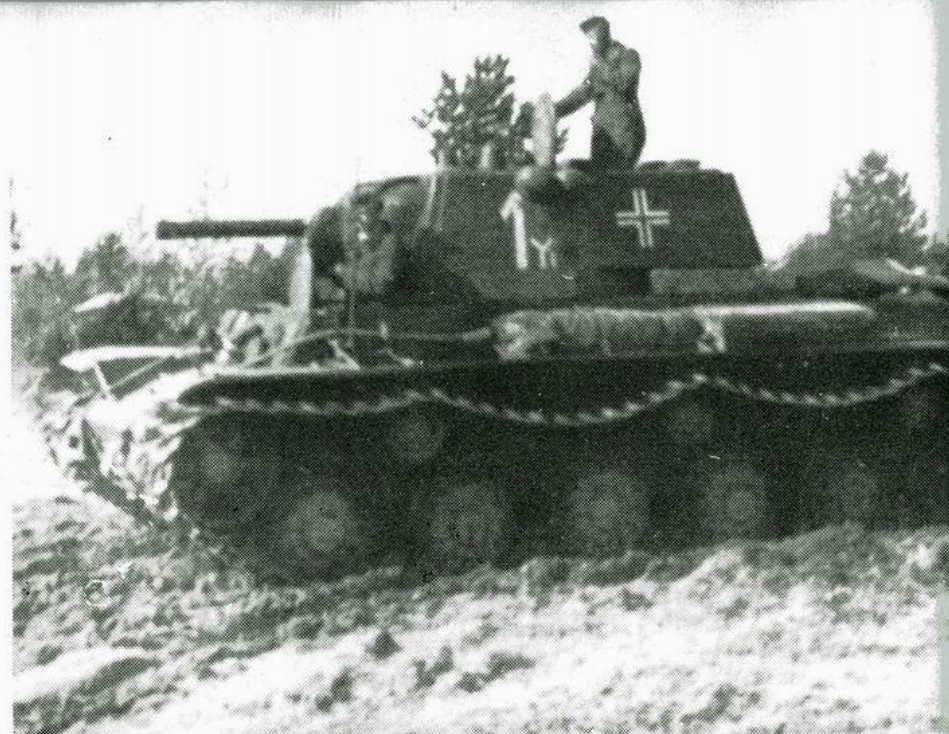
This KW-I (1940 model) was also in service with the 8th Armored Division. It belonged to the 1st Company of Armored Regiment 10. The 1940 model was armed with the 76-mm Grabin F-32 cannon. These tanks were used by the Germans under the designation "Armored Battle Vehicle IA 753(r)".

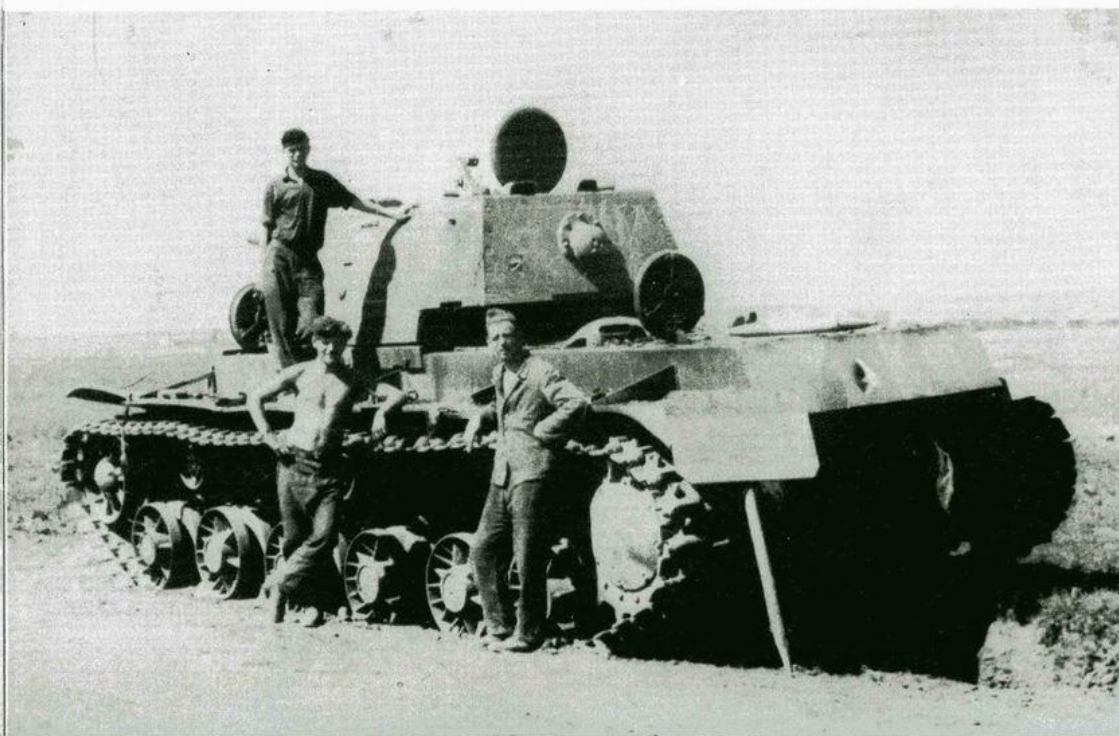
The Armored Regiment 204 of the 22nd Armored Division captured a KW-I (1941 model), with the longer ZIS-5 cannon, near Byelogrod at the end of 1943, and went to much trouble to rebuild the tank. (Brändlin)

From the KW-I shown at the bottom of the lefthand page there arose this KW-I with a German 7.5-cm L/43 cannon and German

commander's cupola. The armor was sprayed with German camouflage paint. (Brändlin)

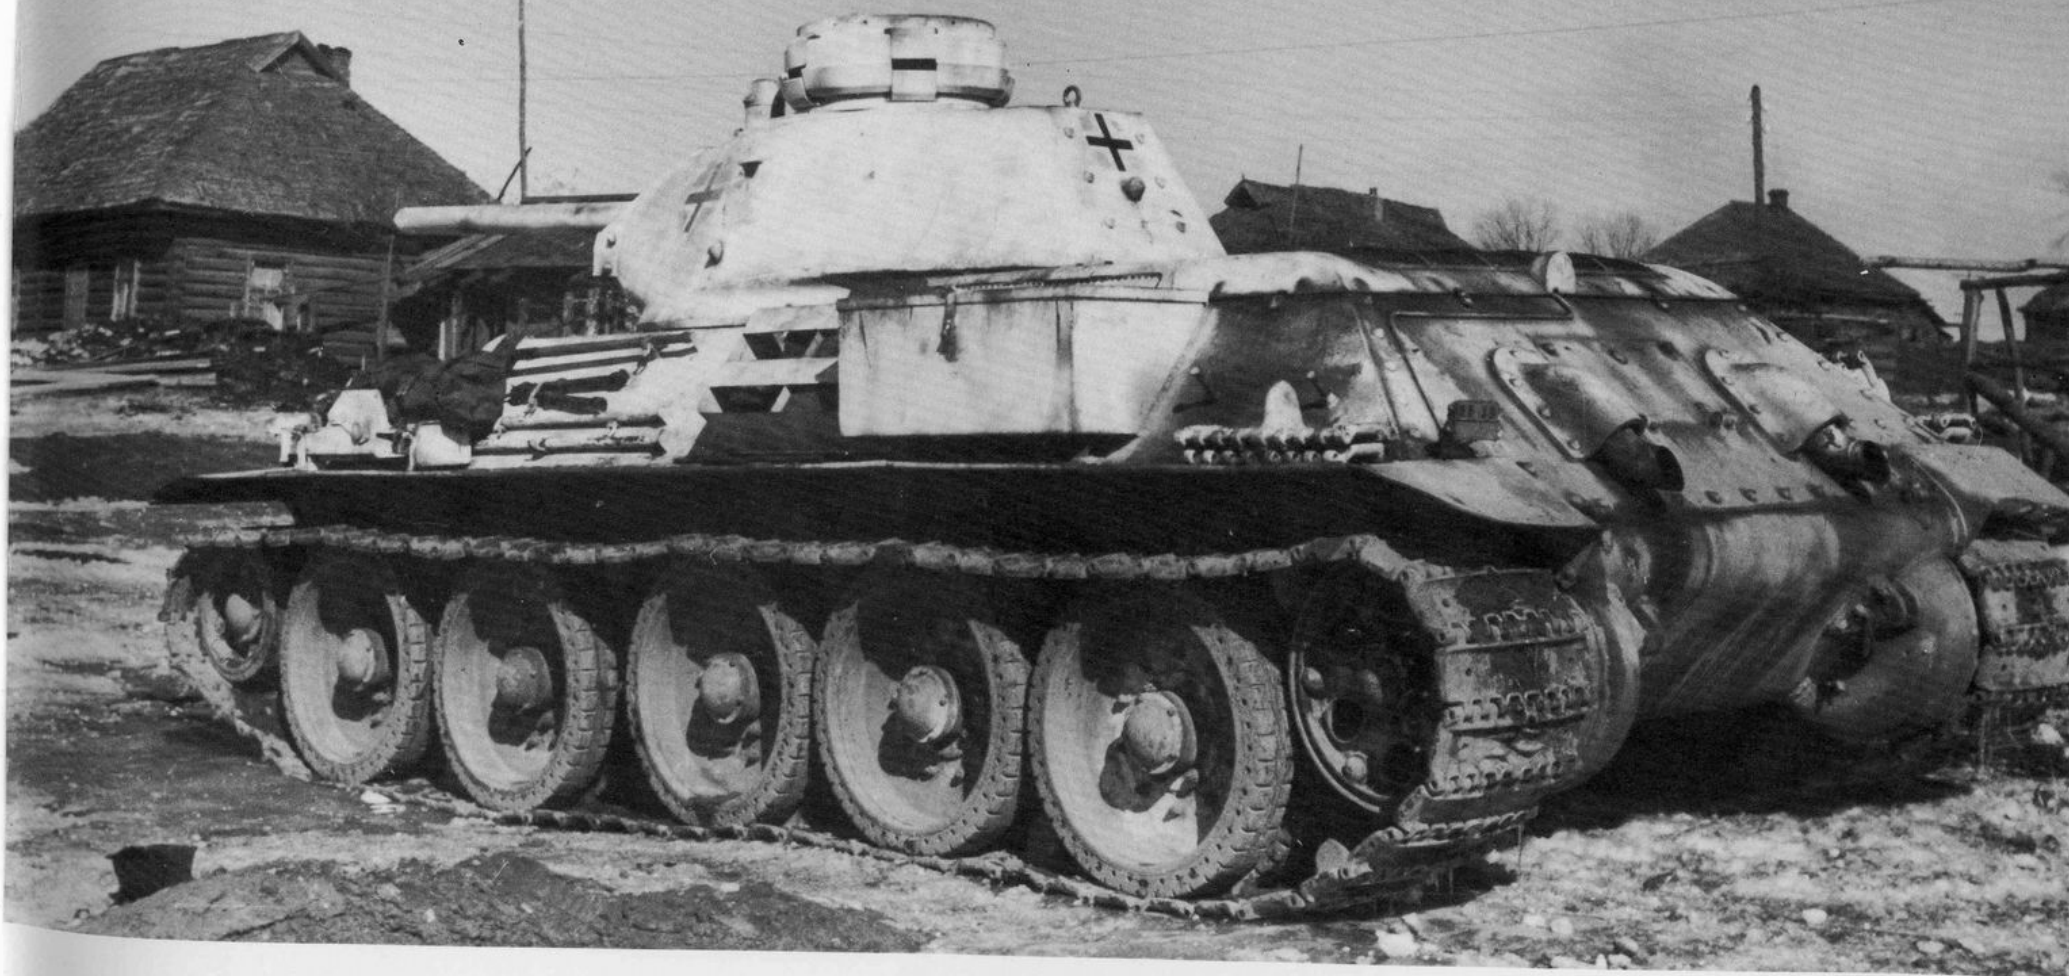
A T-34 (1941 model) with a German commander's cupola added, in use by the 98th Infantry Division. The tank is also equipped with German camouflage light, auto jack and tools. (BA)
