GERMANY'S

PANTHER

**TANK THE QUEST FOR
COMBAT SUPREMACY**

THE QUEST FOR COMBAT SUPREMACY
Development • Modifications • Rare Variants
Characteristics • Combat Accounts

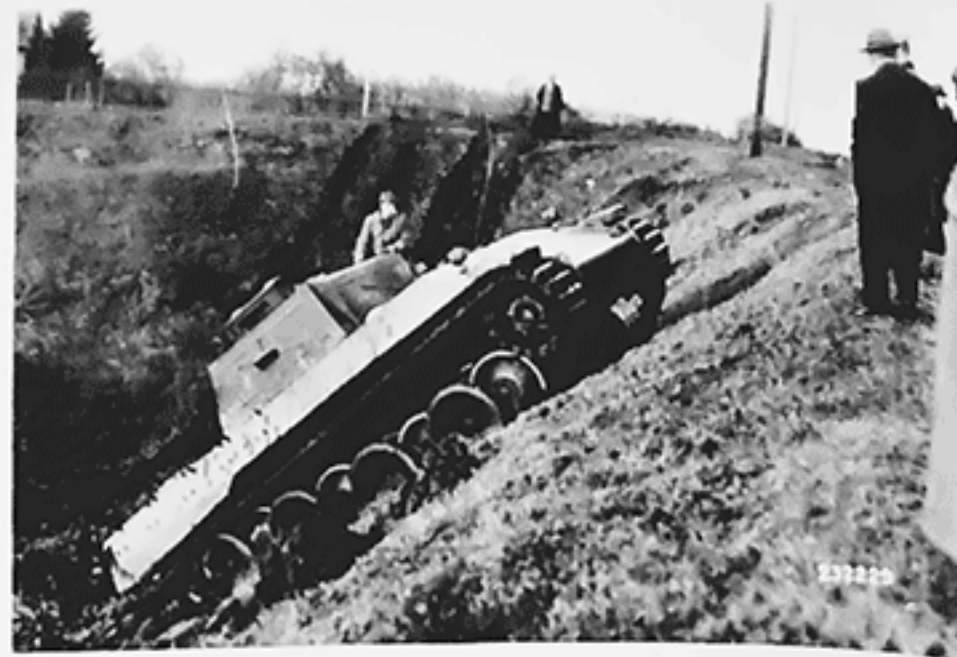
Versuchs-Panther (Fgst.Nr. V1) completed by M.A.N. by September 1942) did not have a turret but was tested with a **Belastungsgewicht** (test weight). The design of the drive sprocket wheels is unique to the two Versuchs-Panthers. (WJS)

M.A.N. completed these two **Versuchs-Panther (Fgst.Nr. V1 and V2)** in the Fall of 1943. **Fgst.Nr. V1** was only an experimental chassis without a turret. **Fgst.Nr. V2** was finished as a complete tank mounting a hexagonal turret with the characteristic bulge below the commander's cupola. Demonstrations for Speer and Wa Pruef 6 as well as driving trials were conducted at Berka near Eisenach from 8 through 14 November 1942. The delegation from M.A.N. stated that they were satisfied with the automotive performance of their **Versuchs-Panther**.

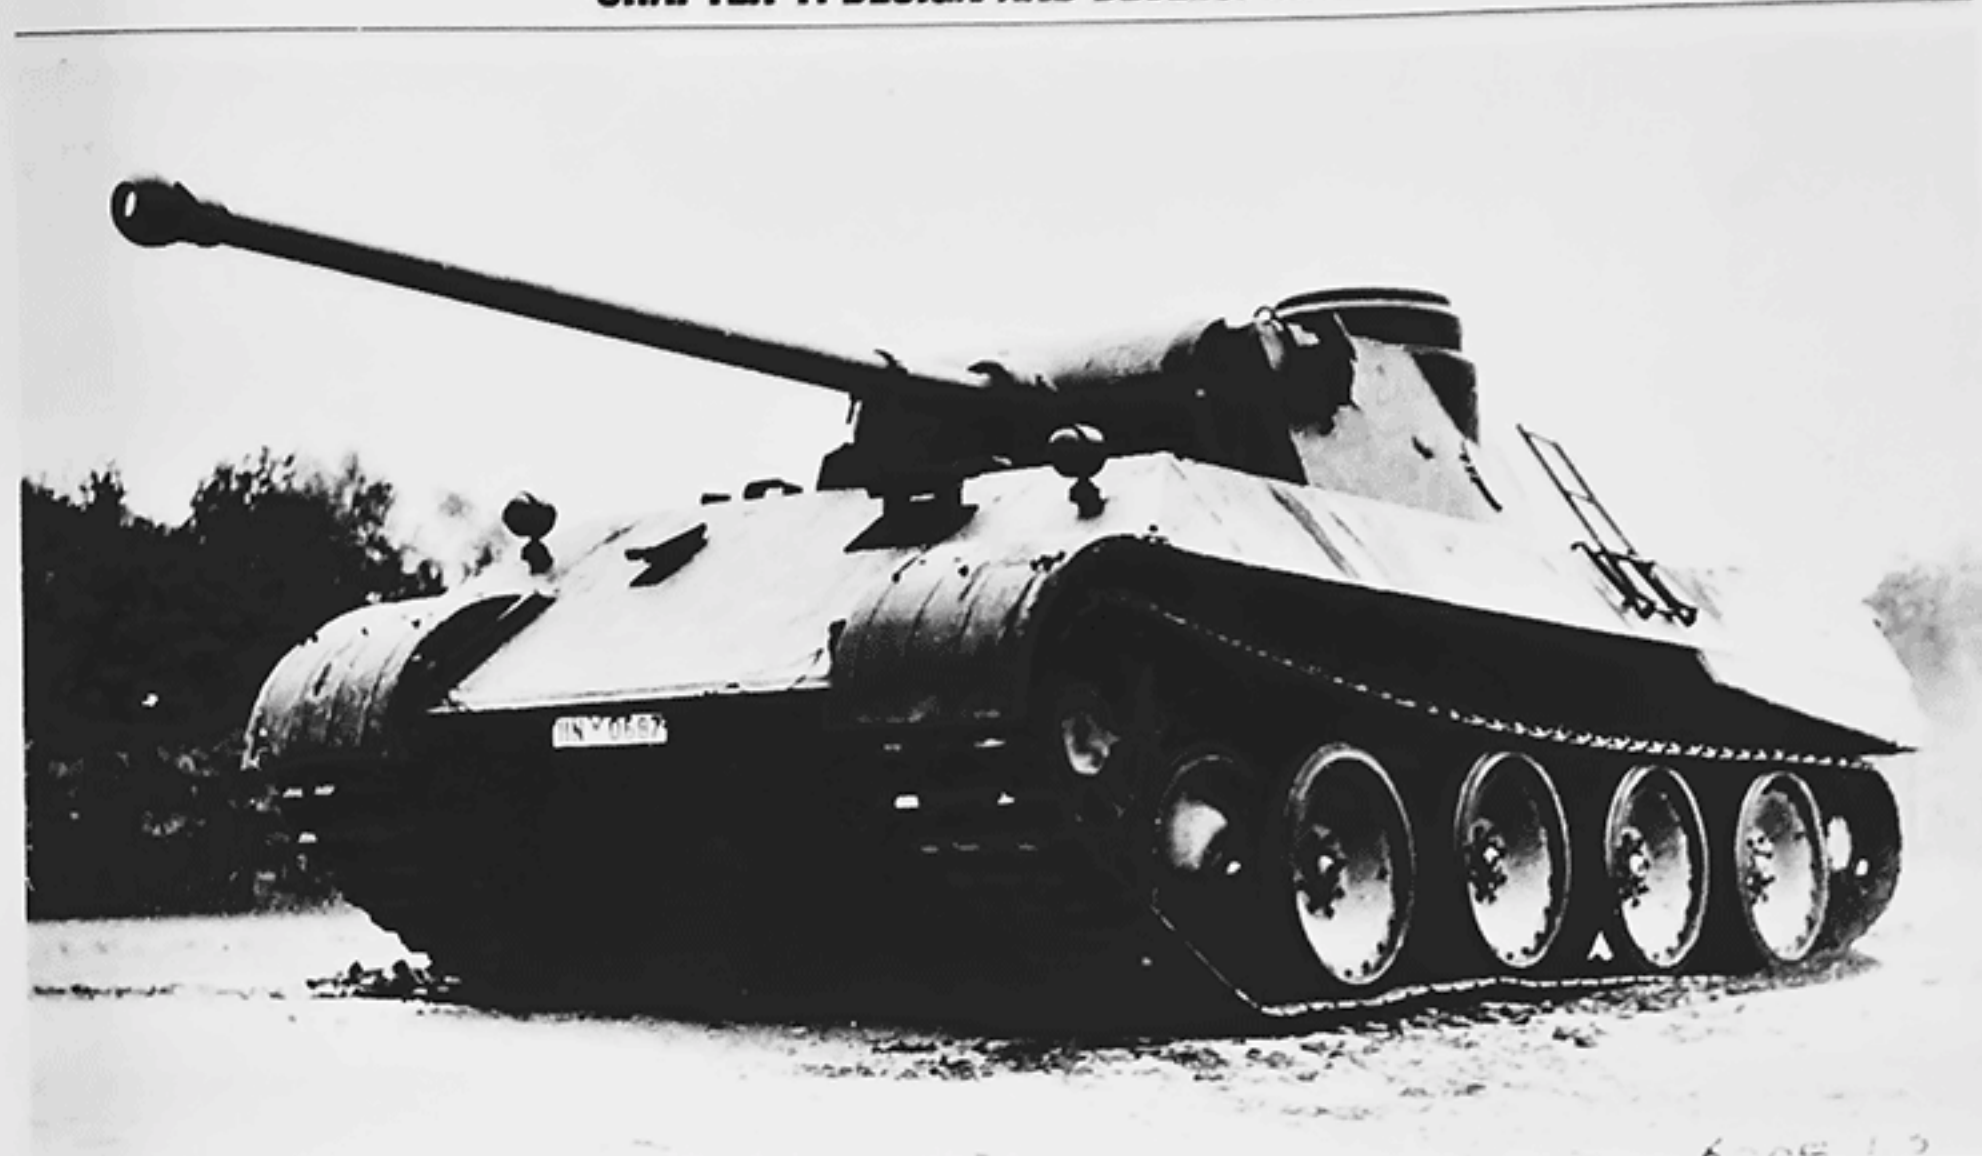
Versuchs-Panther (Fgst.Nr. V2) completed by M.A.N. in the Fall of 1942) was outfitted with a turret. The 7,5 cm Kw.K.42 L/70 still had the ball muzzle brake invented for the 7,5 cm Kw.K.40 L/43 in the Pz.Kpfw.IV Ausf.F2. (WJS)

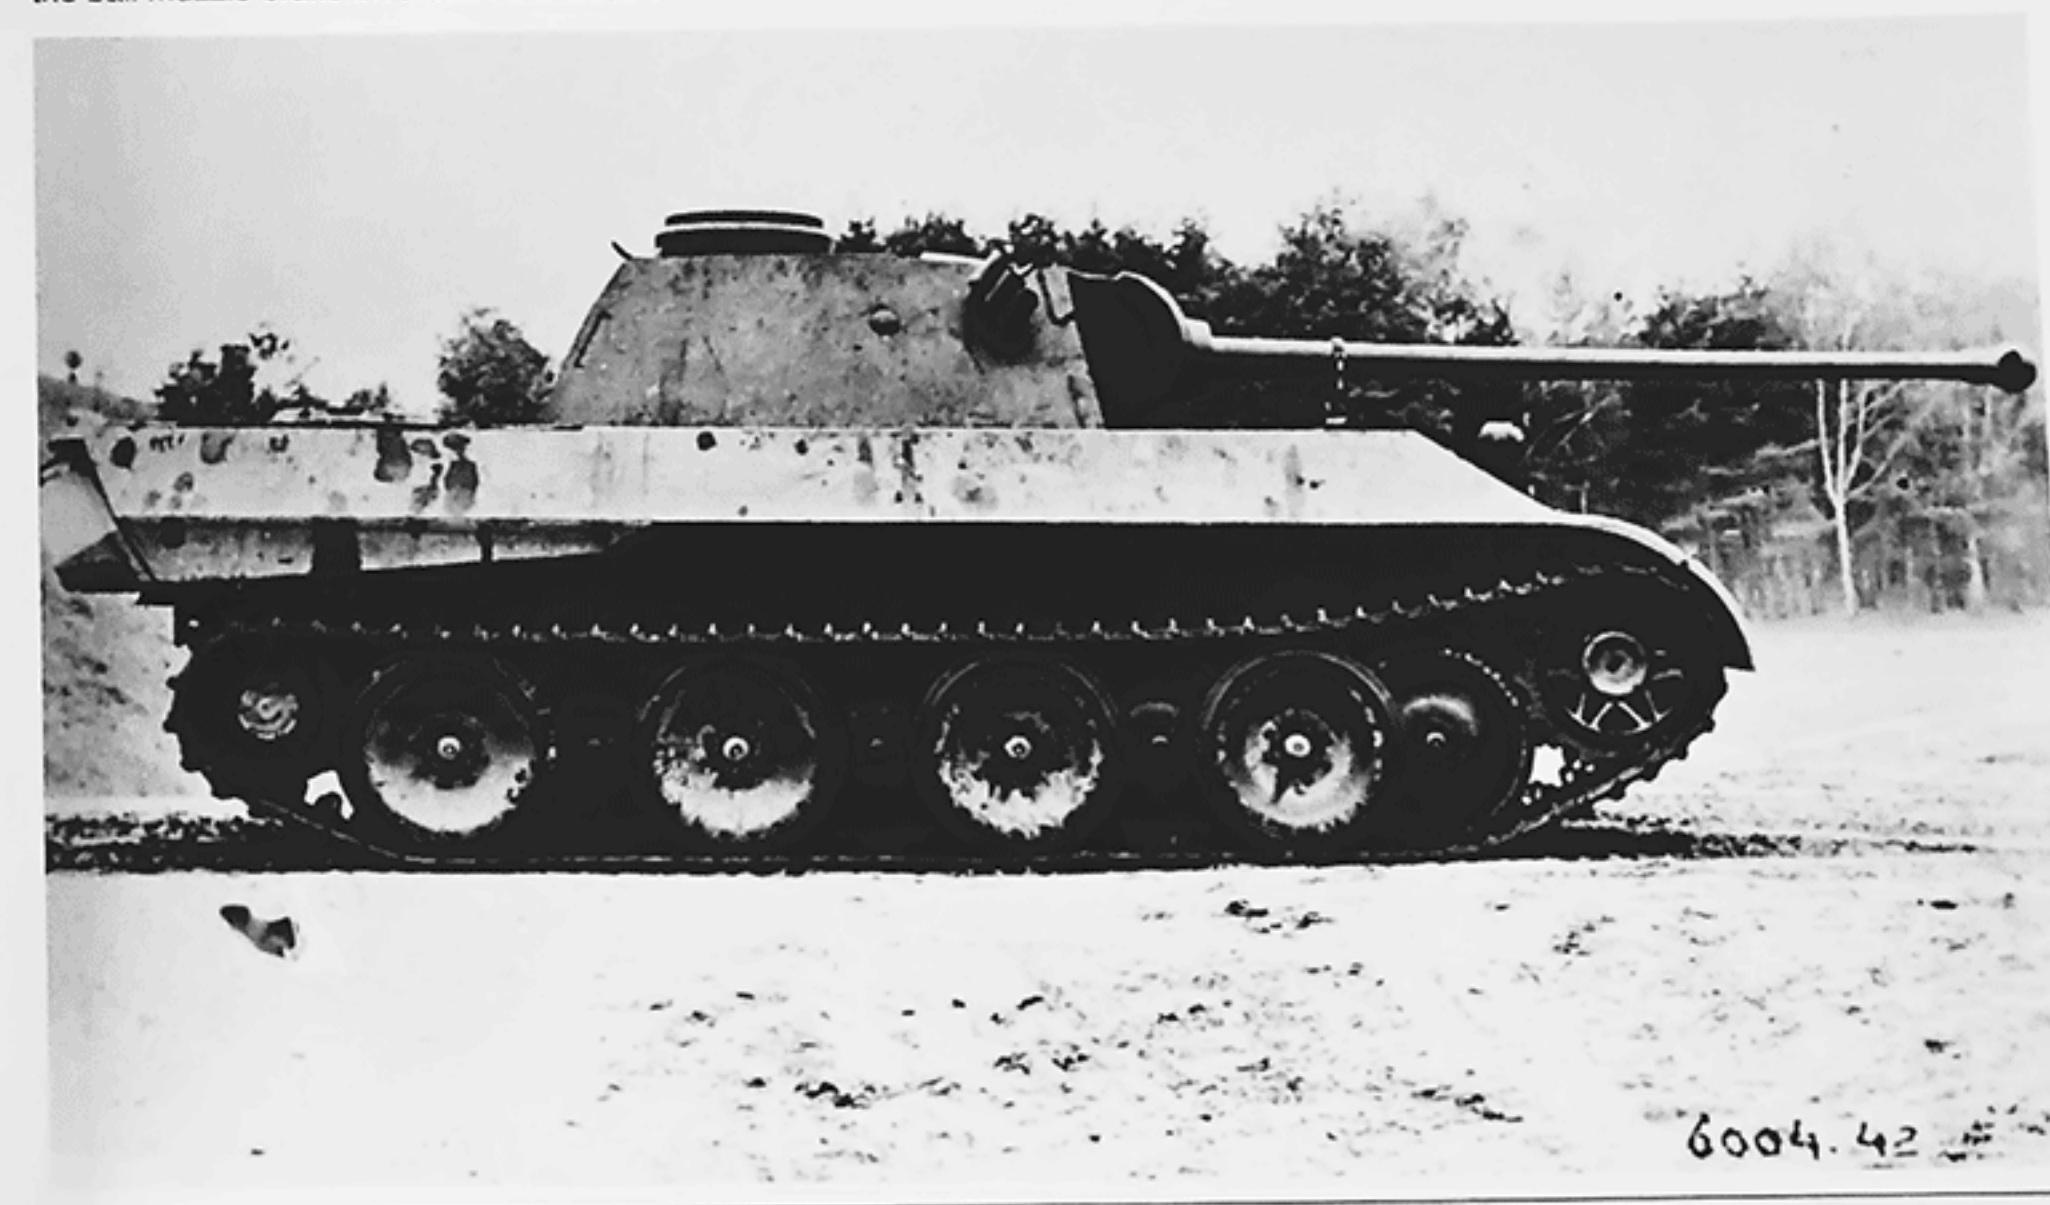
Versuchs-Panther (Fgst.Nr. V2) The hexagonal shape and the bulge in the side of the turret for the commander's cupola are unique to this **Versuchs-Turm** (experimental turret) and are not present on any production series Panther Ausf.D.

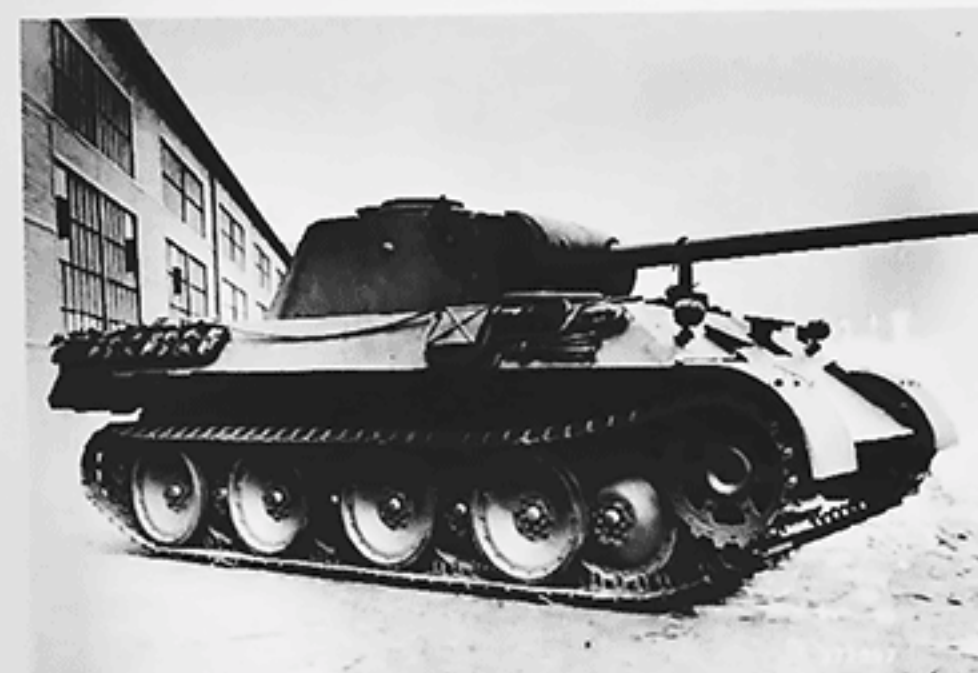
One of the first five Ausf.D Panthers that was assembled by M.A.N. in Nuernberg in January/February 1943. It has the original stowage arrangement for the tools, no rain guards, and no brackets for mounting Schuerzen. (WJS)

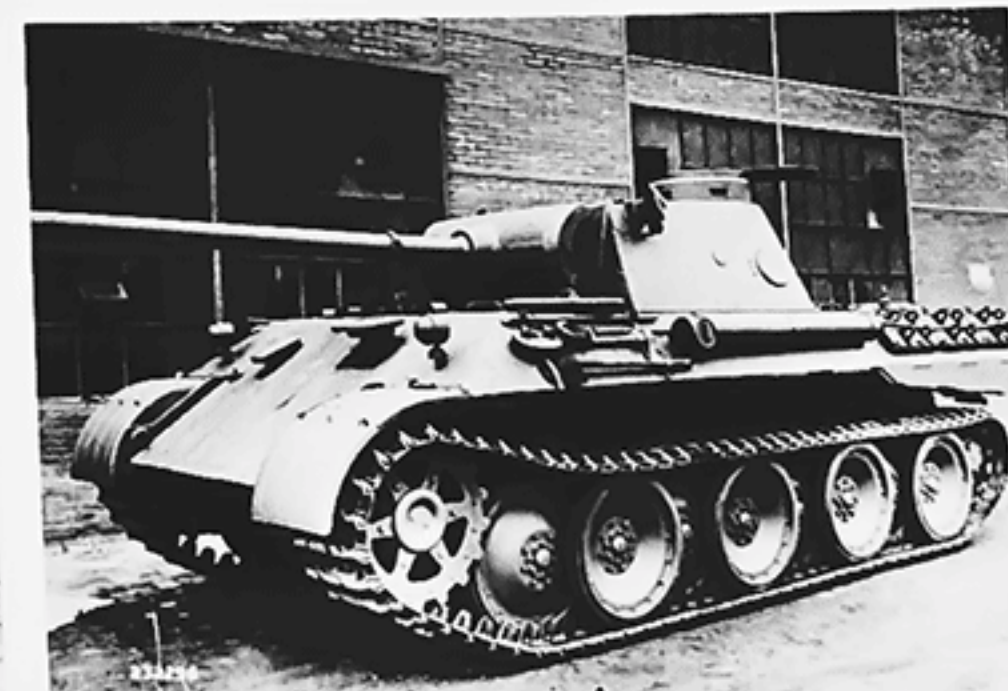
Panzerkampfwagen Panther (7.5 cm Kw.K.42 L/70) (Sd.Kfz.171)
Original **Ausführung D** as it was produced at M.A.N. in January 1943
before any modifications.

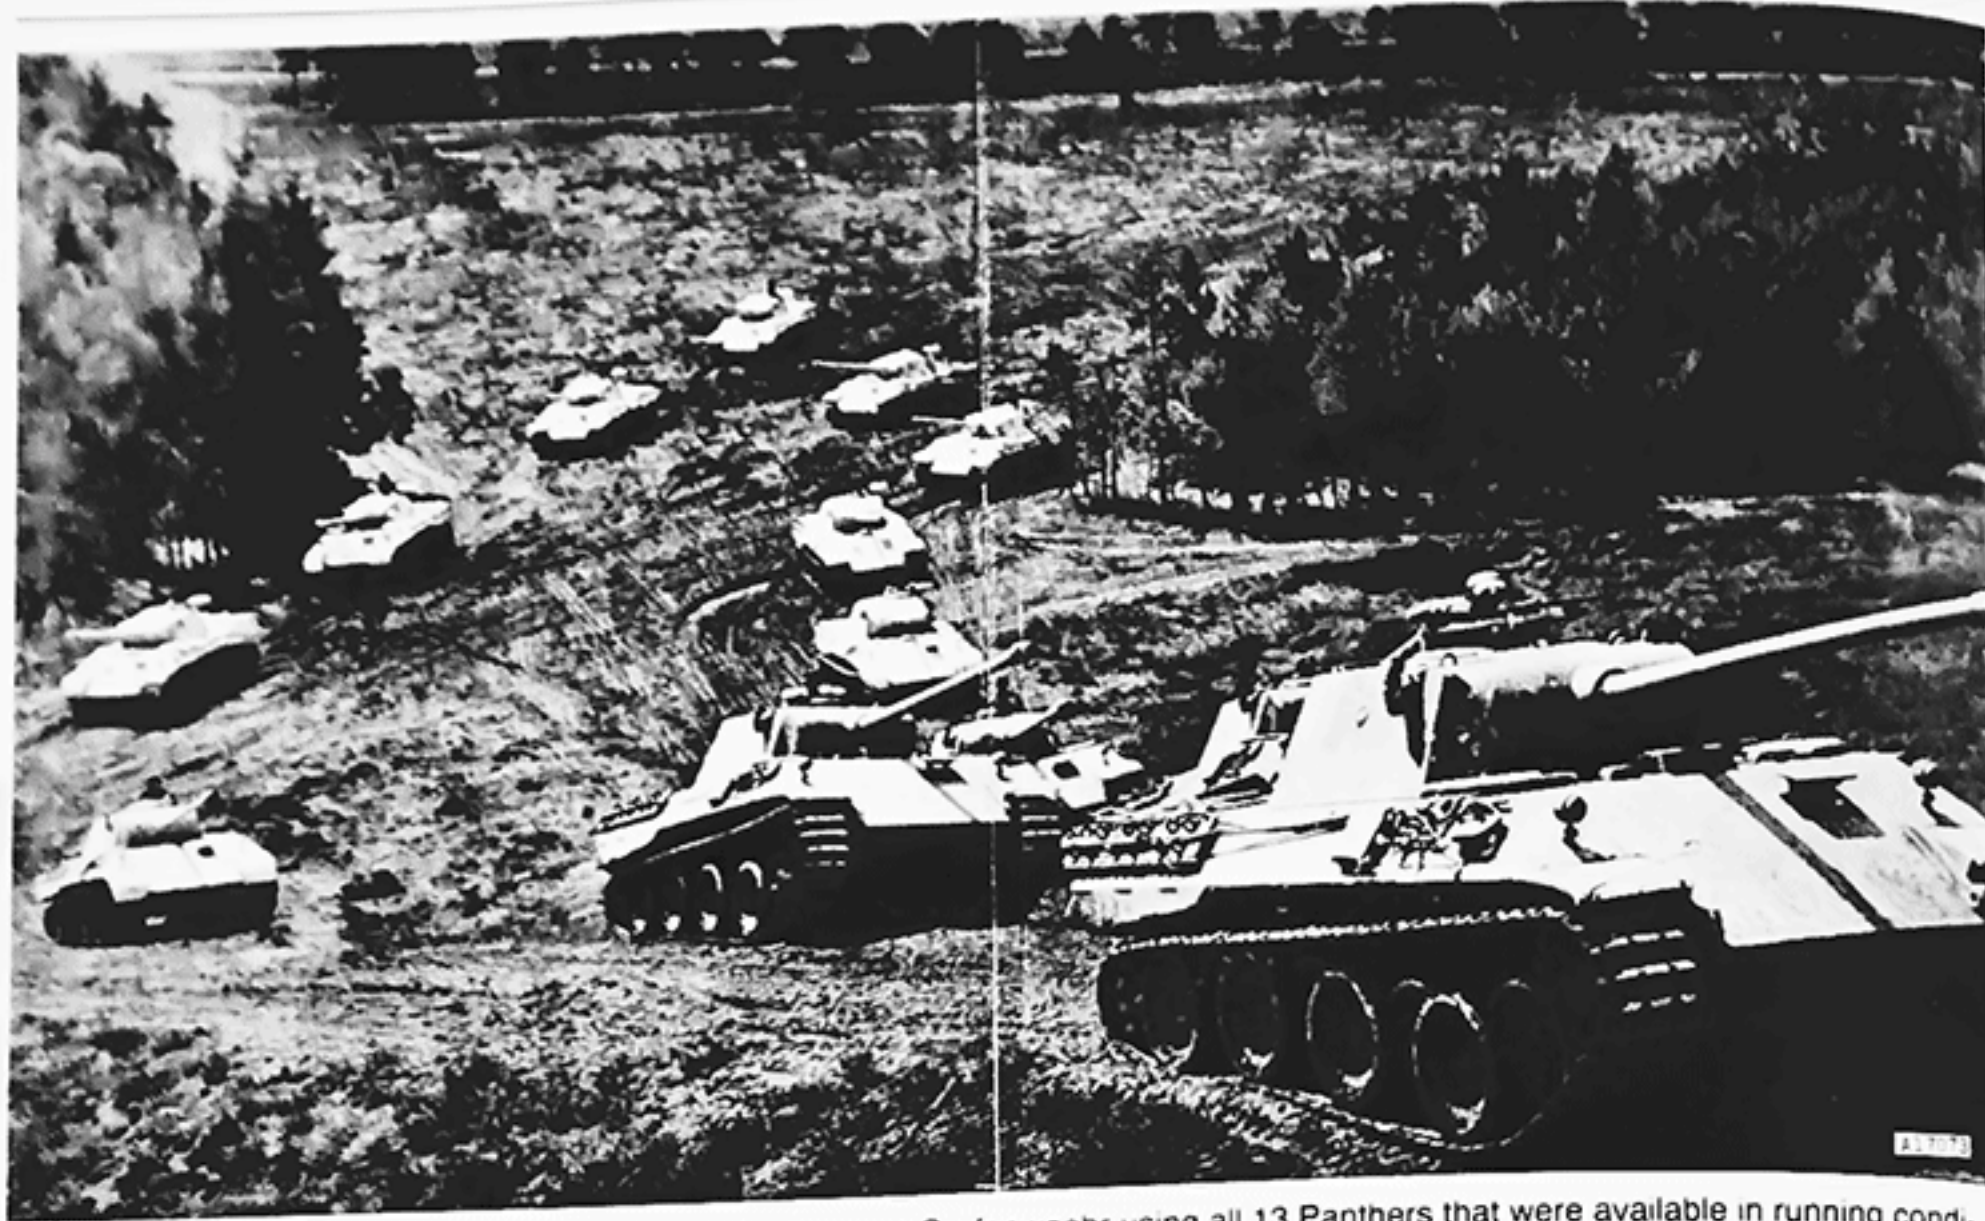
On 21 February 1943, a demonstration was held for Speer at Grafenwoehr using all 13 Panthers that were available in running condition. All of these Panthers had **Kupplungslenkgetriebe** (clutch-brake steering gears). (CHY)

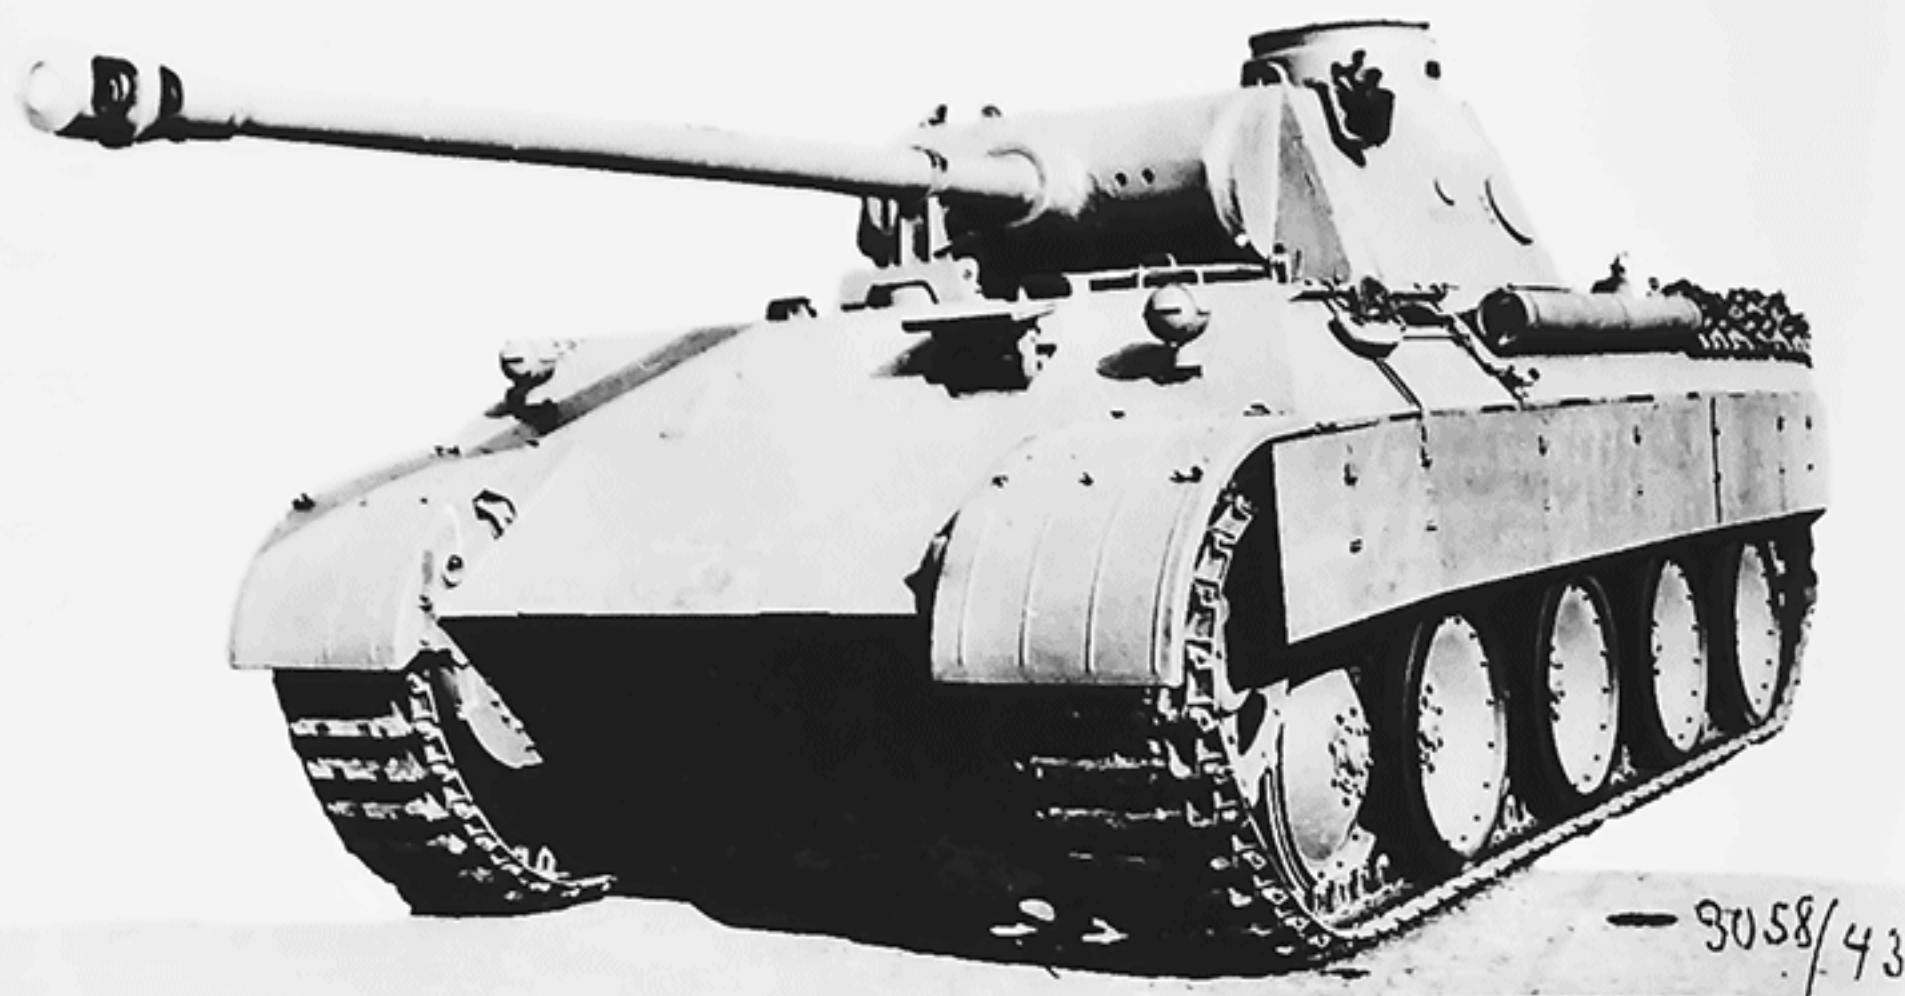
Starting in April 1943, **Schuerzen** (soft steel skirts) were mounted with brackets along the hull side. **Schuerzen** were designed to protect the hull side from hits at close range from Russian 14.5 mm anti-tank rifles. (WJS)

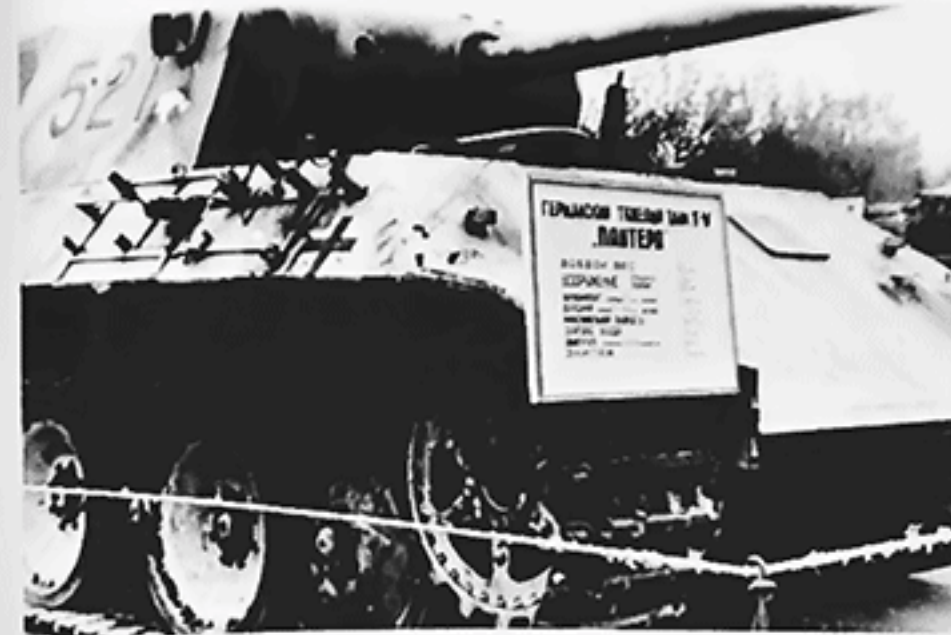
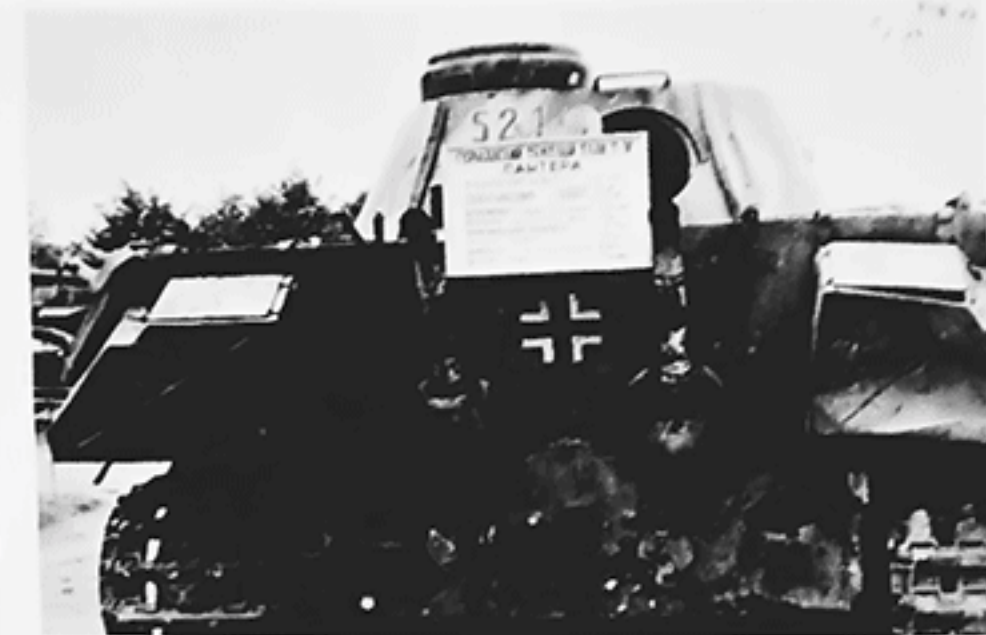
This page and two photos opposite below: Panther Ausf D, Tactical Nr. 521 (Fgst Nr. 210055 completed at M.A.N. in early May 1943) was issued to Panzer-Abteilung 52. It fought at Kursk before being captured and displayed by the Russians. It still had the **Nebelwurfgeraet** (smoke candle dischargers) on both sides of the turret. Rain guards had been welded over the **Verstärkungsoeffnung** (communications port) on the left turret side and over the access hatch on the turret rear. Tool stowage has been modified by reversing the axle on the left side and securing the jack block with a single bar across the middle on the right side. The engine access hatch is missing revealing a **Maybach HL 210 P30** engine and cylindrical air cleaners. The roadwheel next to the drive sprocket had 16 rim bolts while the roadwheel next to the idler wheel had 16 rim bolts reinforced with 16 rivets. (TTM)

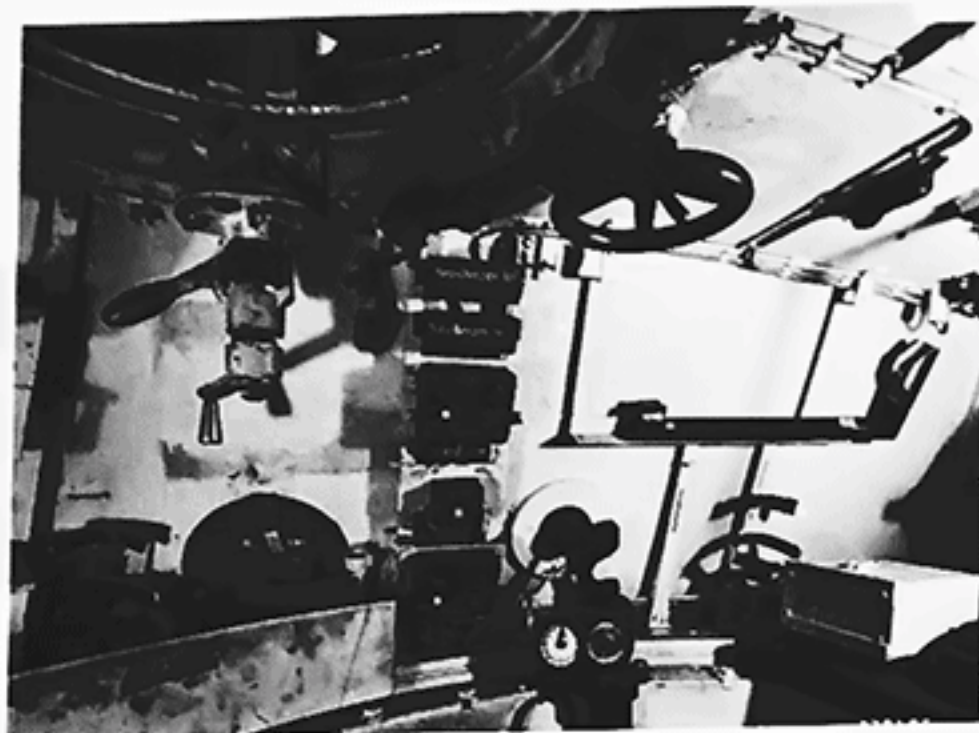
Interior views of a Befehls-Panther turret completed at M.A.N. in May 1943. It still had the **Verständigungsoeffnung** (communications port) in the left turret wall and smoke candle dischargers mounted on the turret sides. The commander's cupola has been modified and realigned so that the hand crank and lever for opening the hatch are mounted to the left of the commander. The FuG 5 (10 watt sender and receiver) radio set was mounted in the turret of the Befehls-Panther with its antenna on the right rear of the turret roof. (WJS)

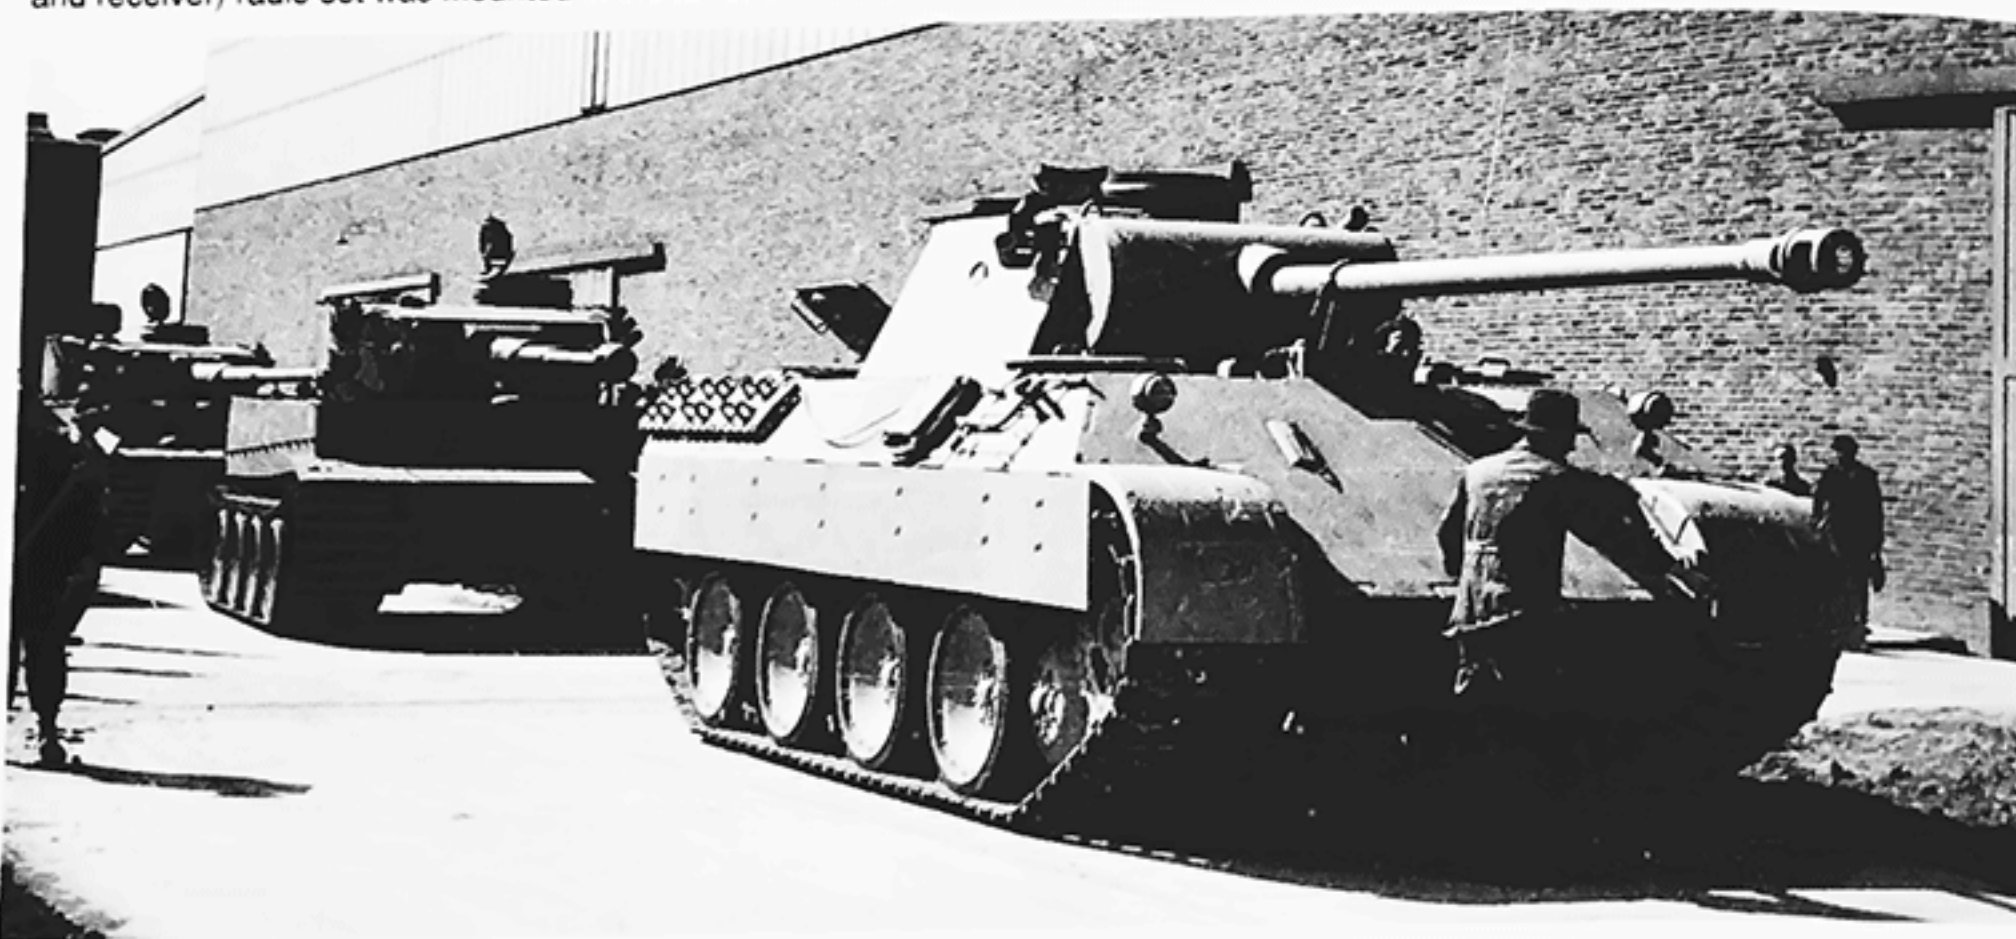
Above: Panther Ausf D (Fgst Nr. 210111 completed at M.A.N. in late May/early June 1943). **Nebelwurfgeraet** (smoke candle dischargers) are no longer mounted on the turret sides. The armor pot covering the telescoping air intake pipes is present on the rear deck. (WJS)

Starting in June 1943, the **Nebelwurfgeraet** (smoke candle dischargers) were no longer mounted on the right and left turret sides. During a reported action in February 1943, enemy small arms fire had set off the smoke candles resulting in the temporary incapacitation of the crew members.

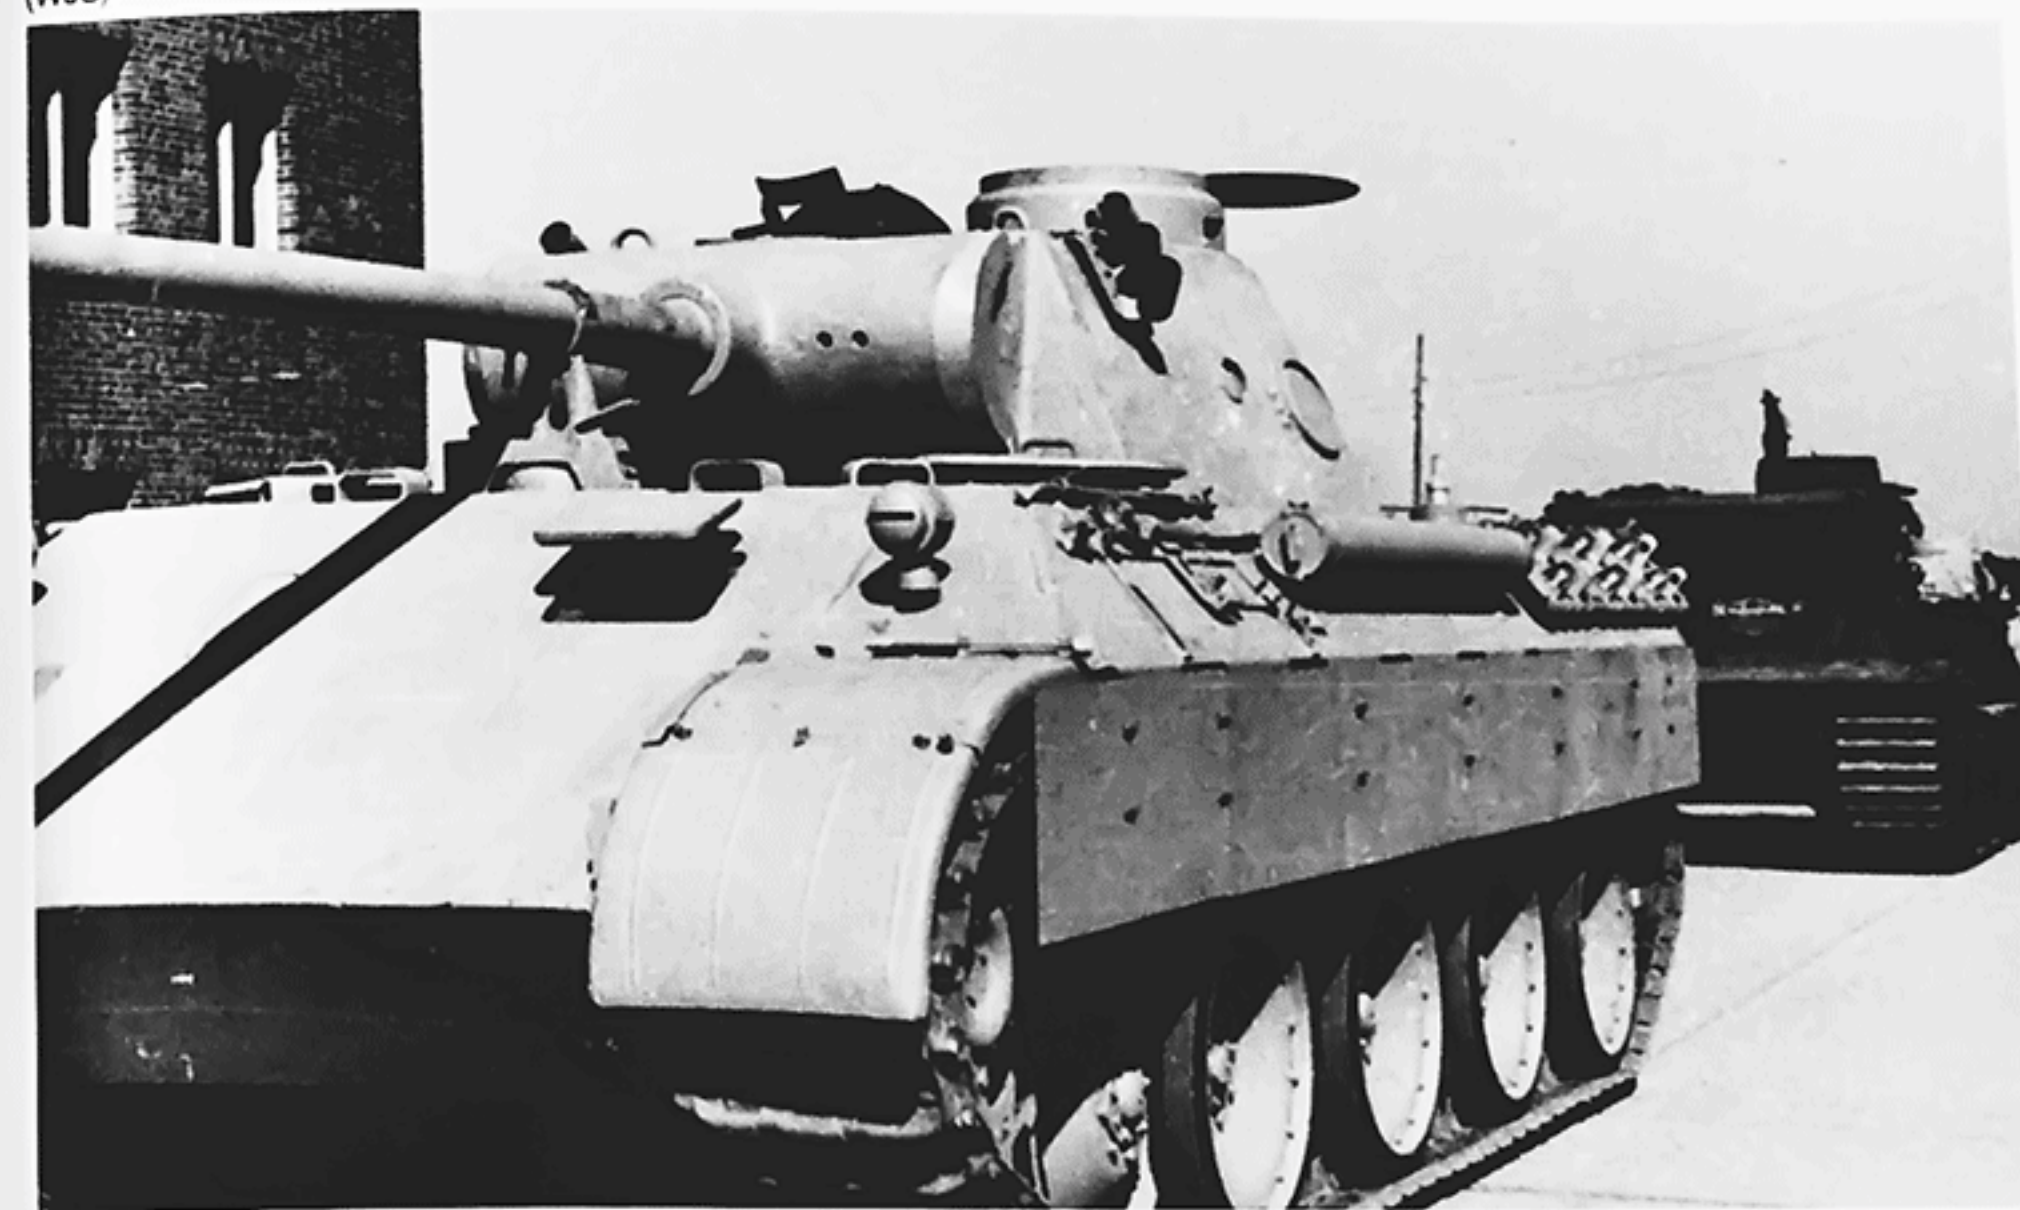
Opposite below and above: These Panther Ausf Ds were completed alongside Tigers at Henschel in early May 1943. They still have **Nebelwurfgeraet** (smoke candle dischargers) along with the banned rain guards over the pistol port plugs on the turret sides. The opened engine access hatch reveals the pattern used for Maybach HL 210 P30 engines. (HLD)

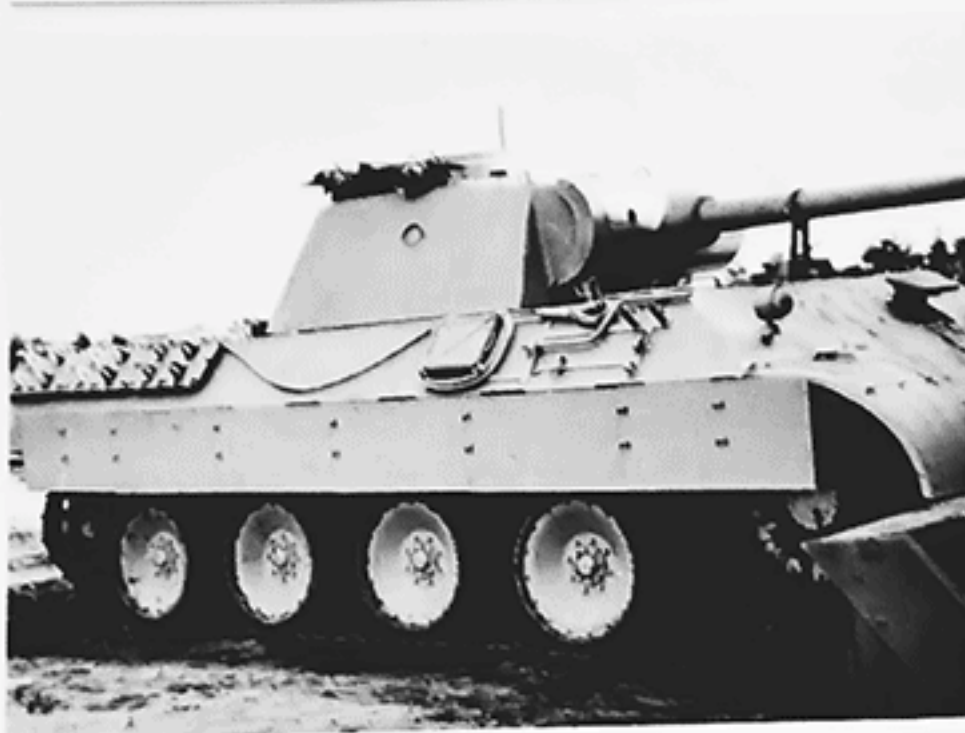
Panther Ausf D (Fgst.Nr. 212061 completed at Henschel in late May/early June 1943) was used in an experiment to test complete submersion. It still has the original stowage layout on the right side and a rain guard welded over the pistol port. (WJS)

Very few Panthers were completely outfitted with all of the equipment needed for complete submersion. Submersion tests, started on 18 July 1943 with Panther **Fgst.Nr.** 212061, had shown that there were numerous sources of leaks.

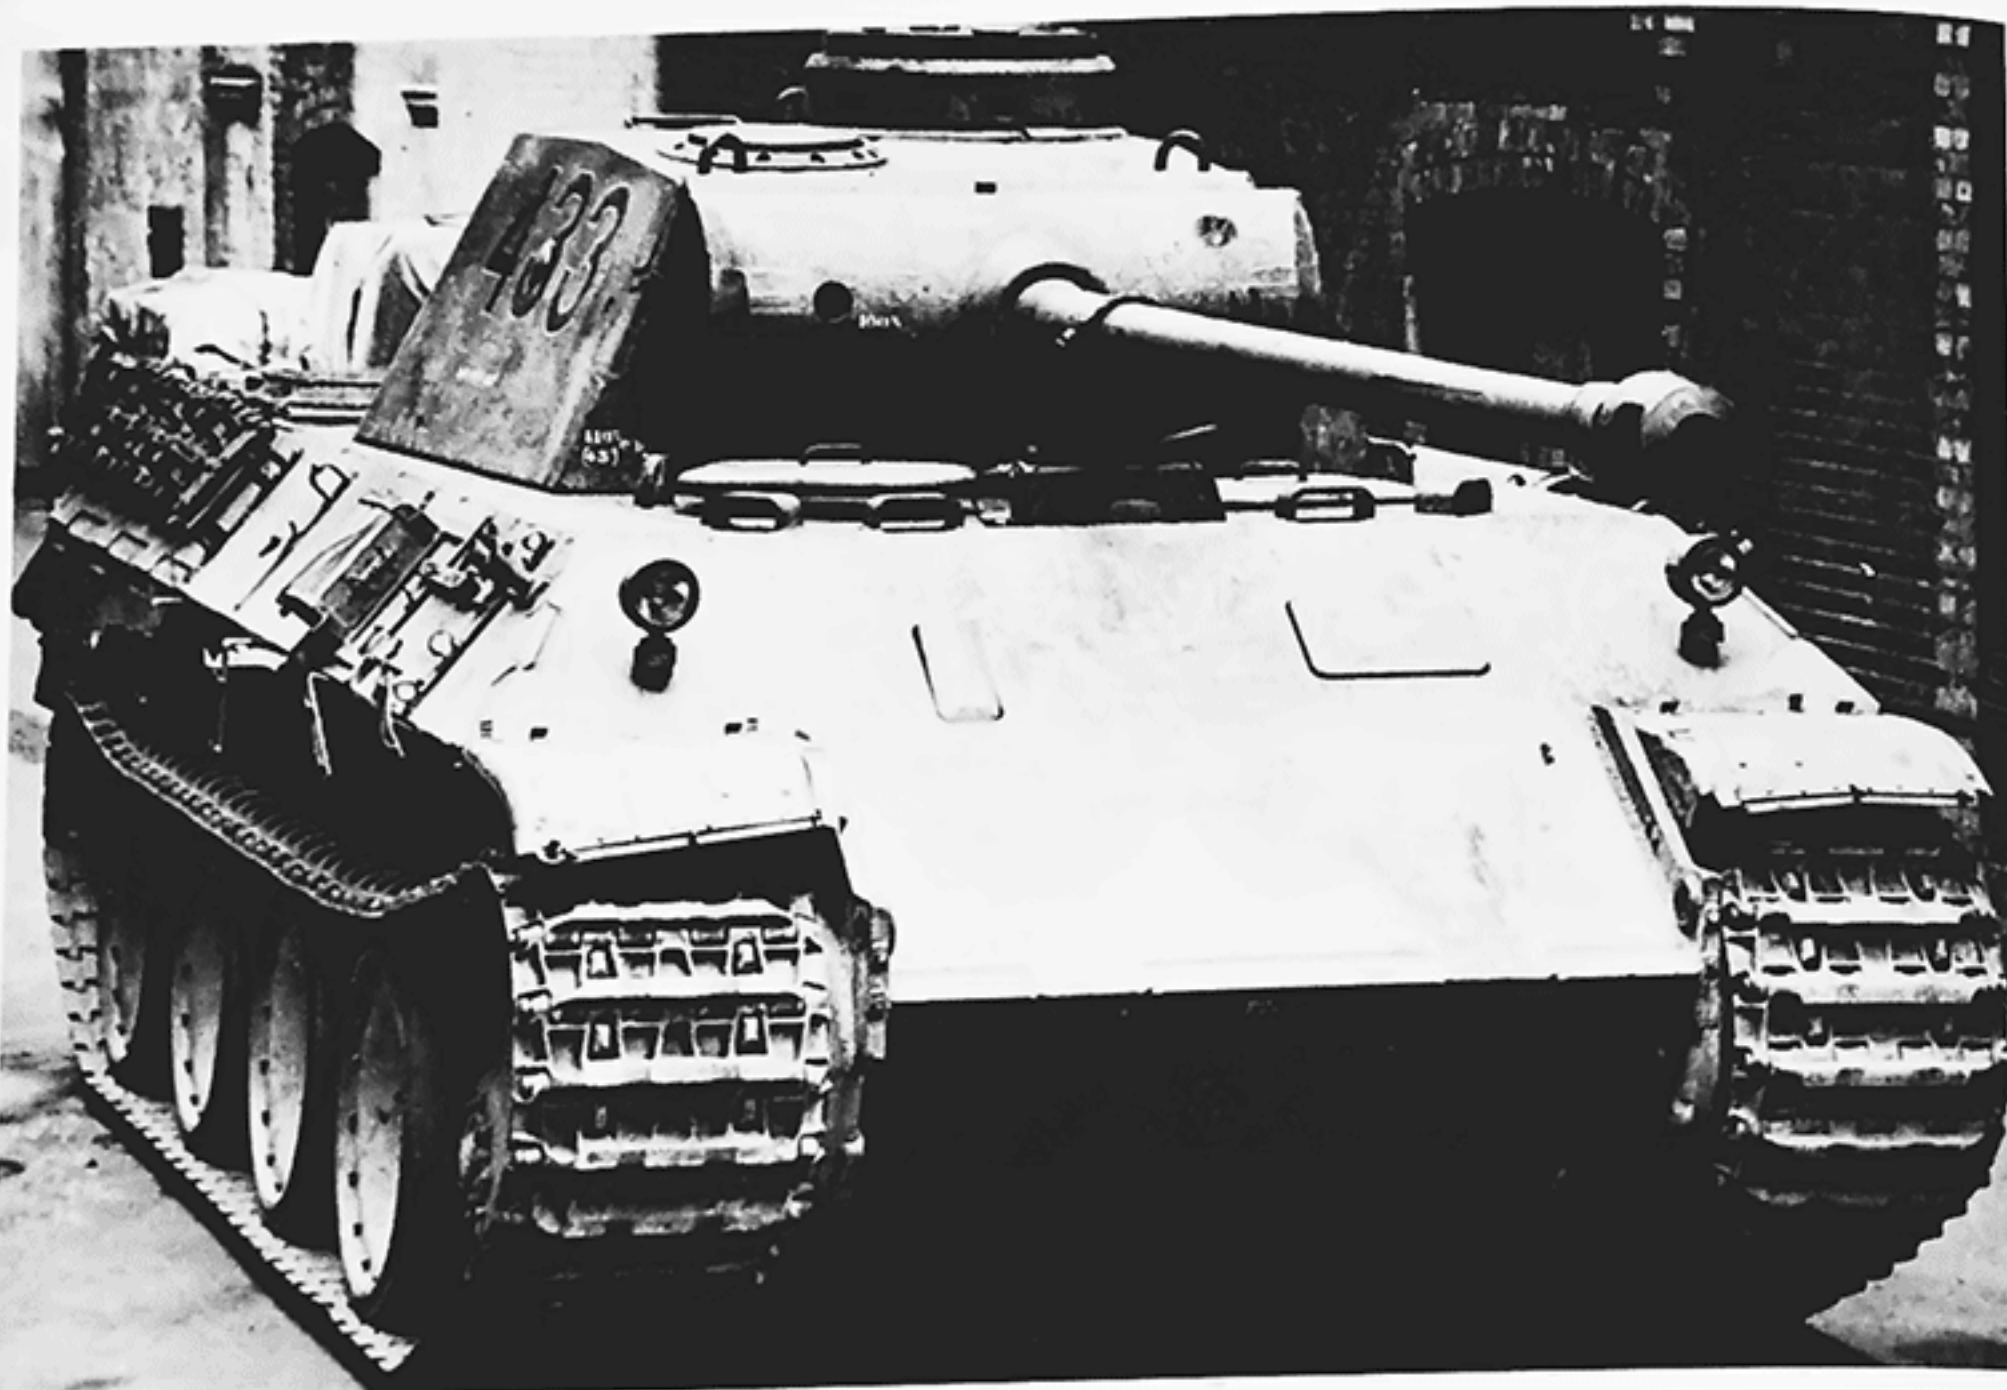
Above and below Panther Ausf D, Tactical Nr. 433 (Fgst.Nr. 213101 completed at M.N.H. in late May/early June 1943) was issued to Panzer-Abteilung 51. It fought at Kursk before being captured by the Russians and shipped to England for detailed examination. **Nebelwurfgeraet** (smoke candle dischargers) are no longer mounted on the turret sides. Mounting brackets for the track adjusting tool and a sledge hammer have been welded onto the right superstructure side but the jack block is still held by two crossing straps. (NA)

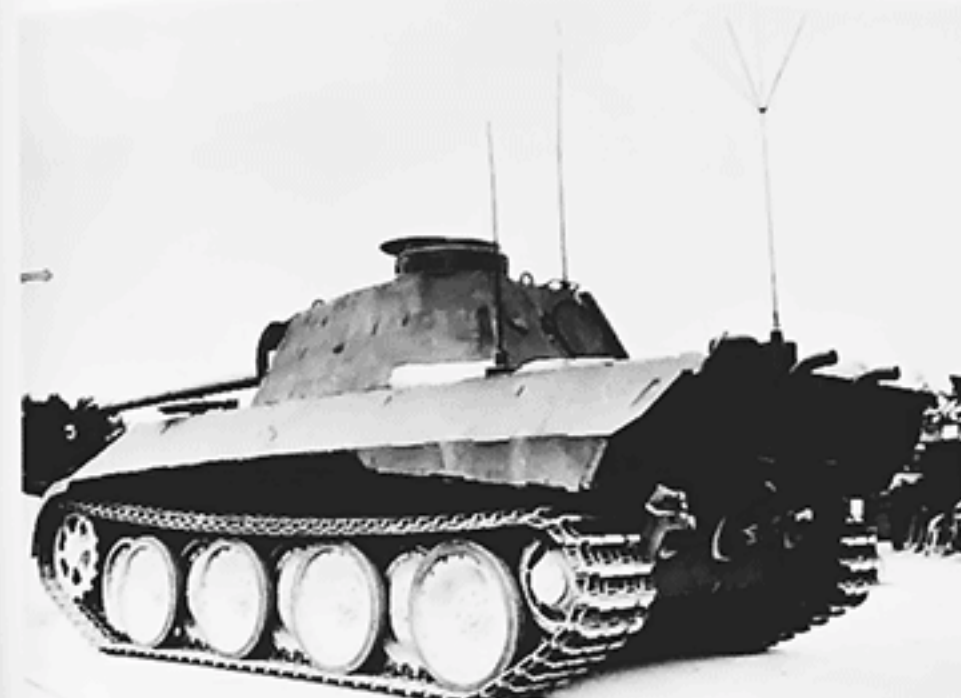
Starting in June 1943, road wheels were reinforced by adding a rivet between each of the 16 rim bolts. This modification was conducted at Weiden near the Grafenwoehr training area for all of the Panthers sent to the Eastern Front for operation "Zitadelle." Starting in August 1943, reinforced road wheels with 24 rim bolts were introduced.
