GERMANY'S

PANTHER

**TANK THE QUEST FOR
COMBAT SUPREMACY**

THE QUEST FOR COMBAT SUPREMACY
Development • Modifications • Rare Variants
Characteristics • Combat Accounts

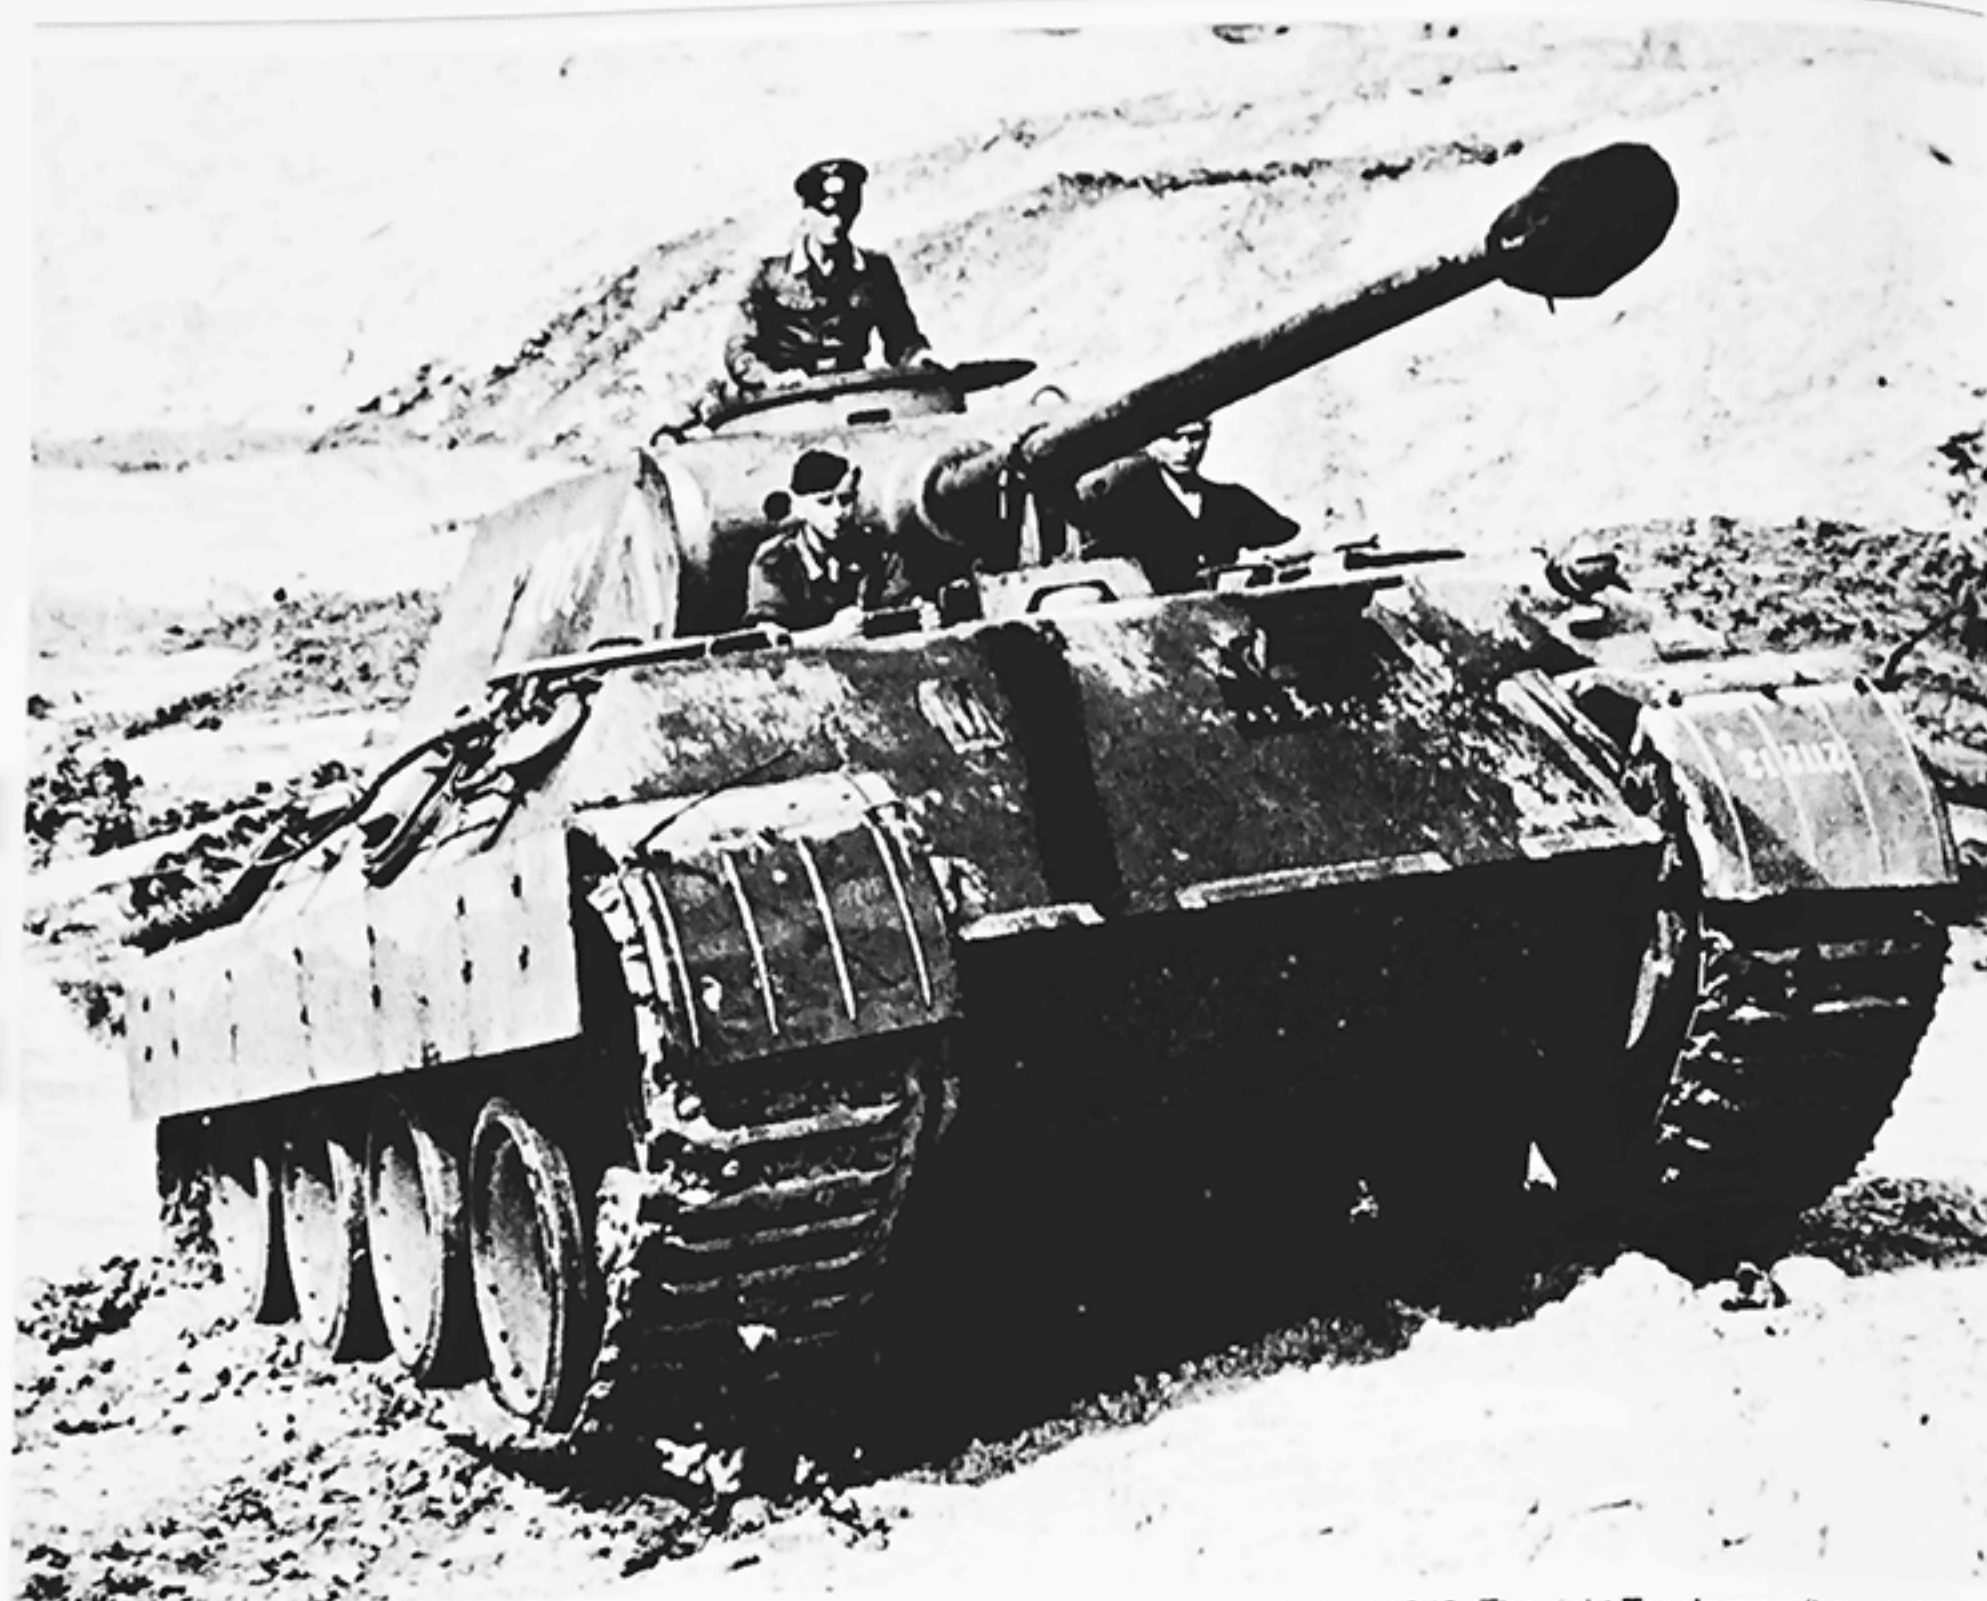
Panther Ausf D, Tactical Nr. 203 (Fgst Nr. 211213) was completed at Daimler-Benz in August 1943. The right **Tarnlampe** (headlight) has been dropped and a ring for the anti-aircraft M.G. mount was welded onto the commander's cupola. (TTM)

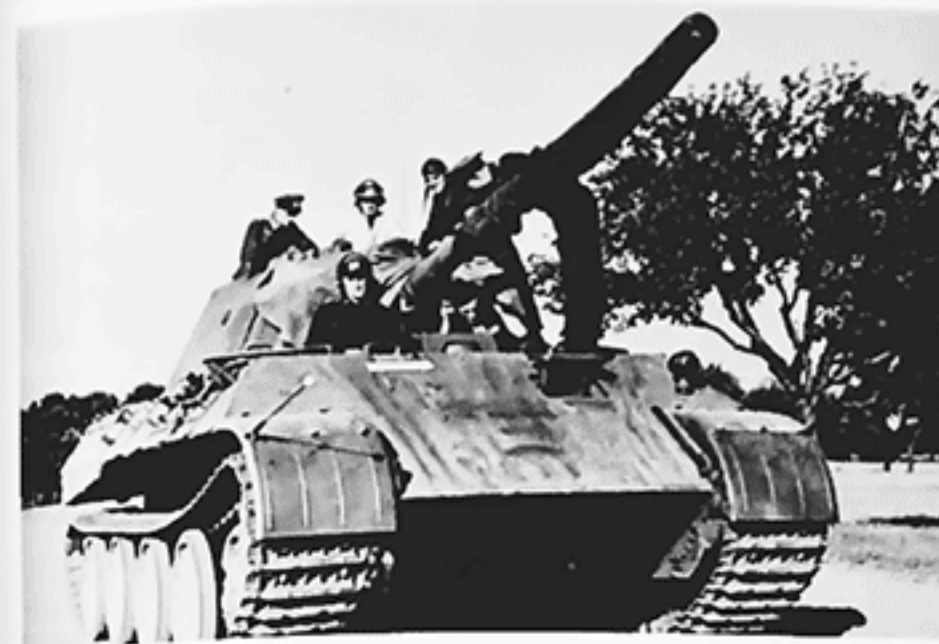
Above: This Panther Ausf D (License Nr. 1A-0805) shown during testing at a proving ground was produced after July 1943. The right **Tarnlampe** (headlight) and the **Verständigungsoeffnung** (communications port) in the left turret side had been dropped. A mounting ring for the anti-aircraft machinegun mount was welded onto the commander's cupola. (TTM)

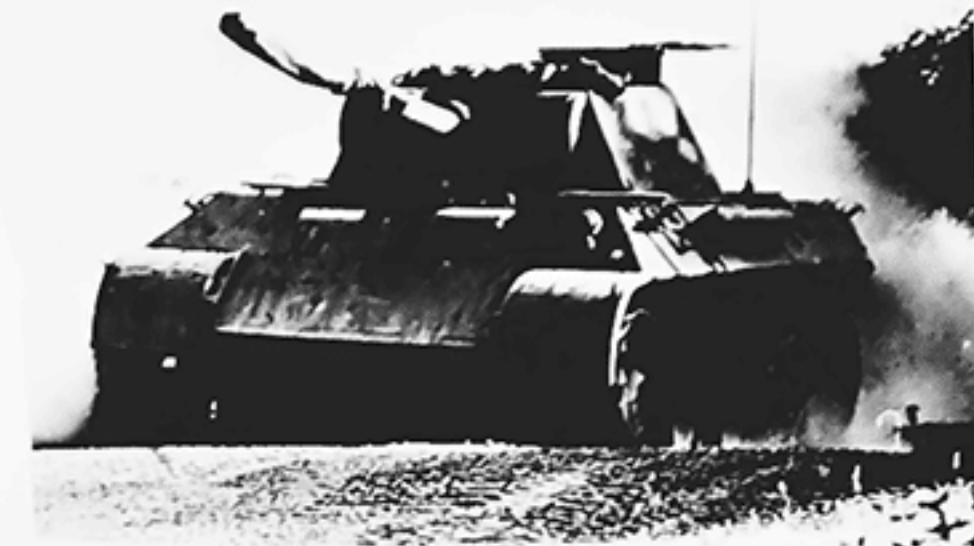
Above and below: Panthers were driven on a test track after assembly in automotive working order. The Panther was driven into a pool to check that seals and gaskets met leak tight specifications. The twin air intake covers on the engine access hatch have the U-shaped handles associated with Panthers with **Maybach HL 230 P30** engines. The armor pot covering the telescoping air intake pipes on the rear deck was hinged at the front and had a screened opening on top. (BA)

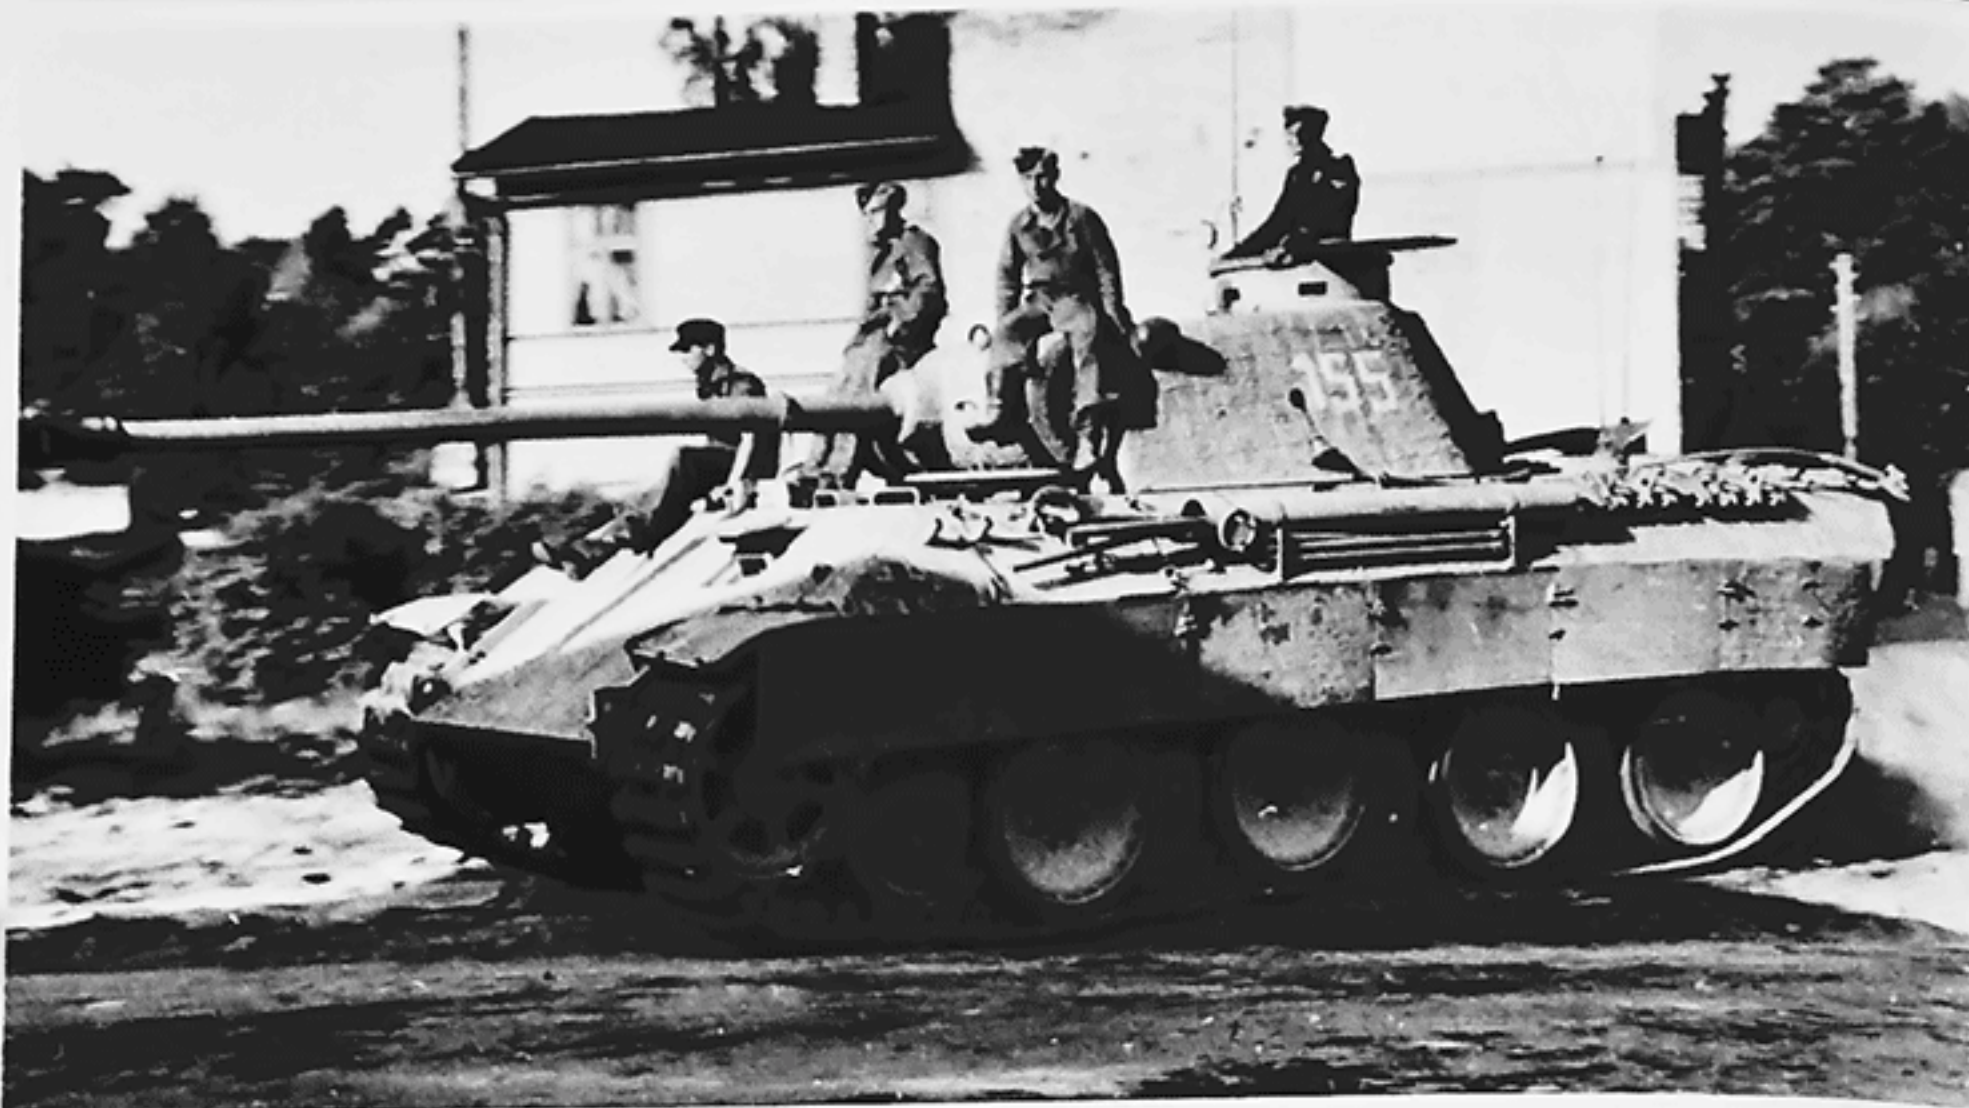
Befehls-Panther Ausf.D, Tactical Nr. 155, possessed the last changes made to Ausf.Ds during production. It had **Zimmerit** anti-magnetic coating, 24 bolt reinforced roadwheels, and a rain guard over gun sight apertures in the gun mantlet. Replacement antenna rods for the Befehls-Panther were stowed in tubes mounted on the left side below the canister for the gun cleaning rods. (BA)

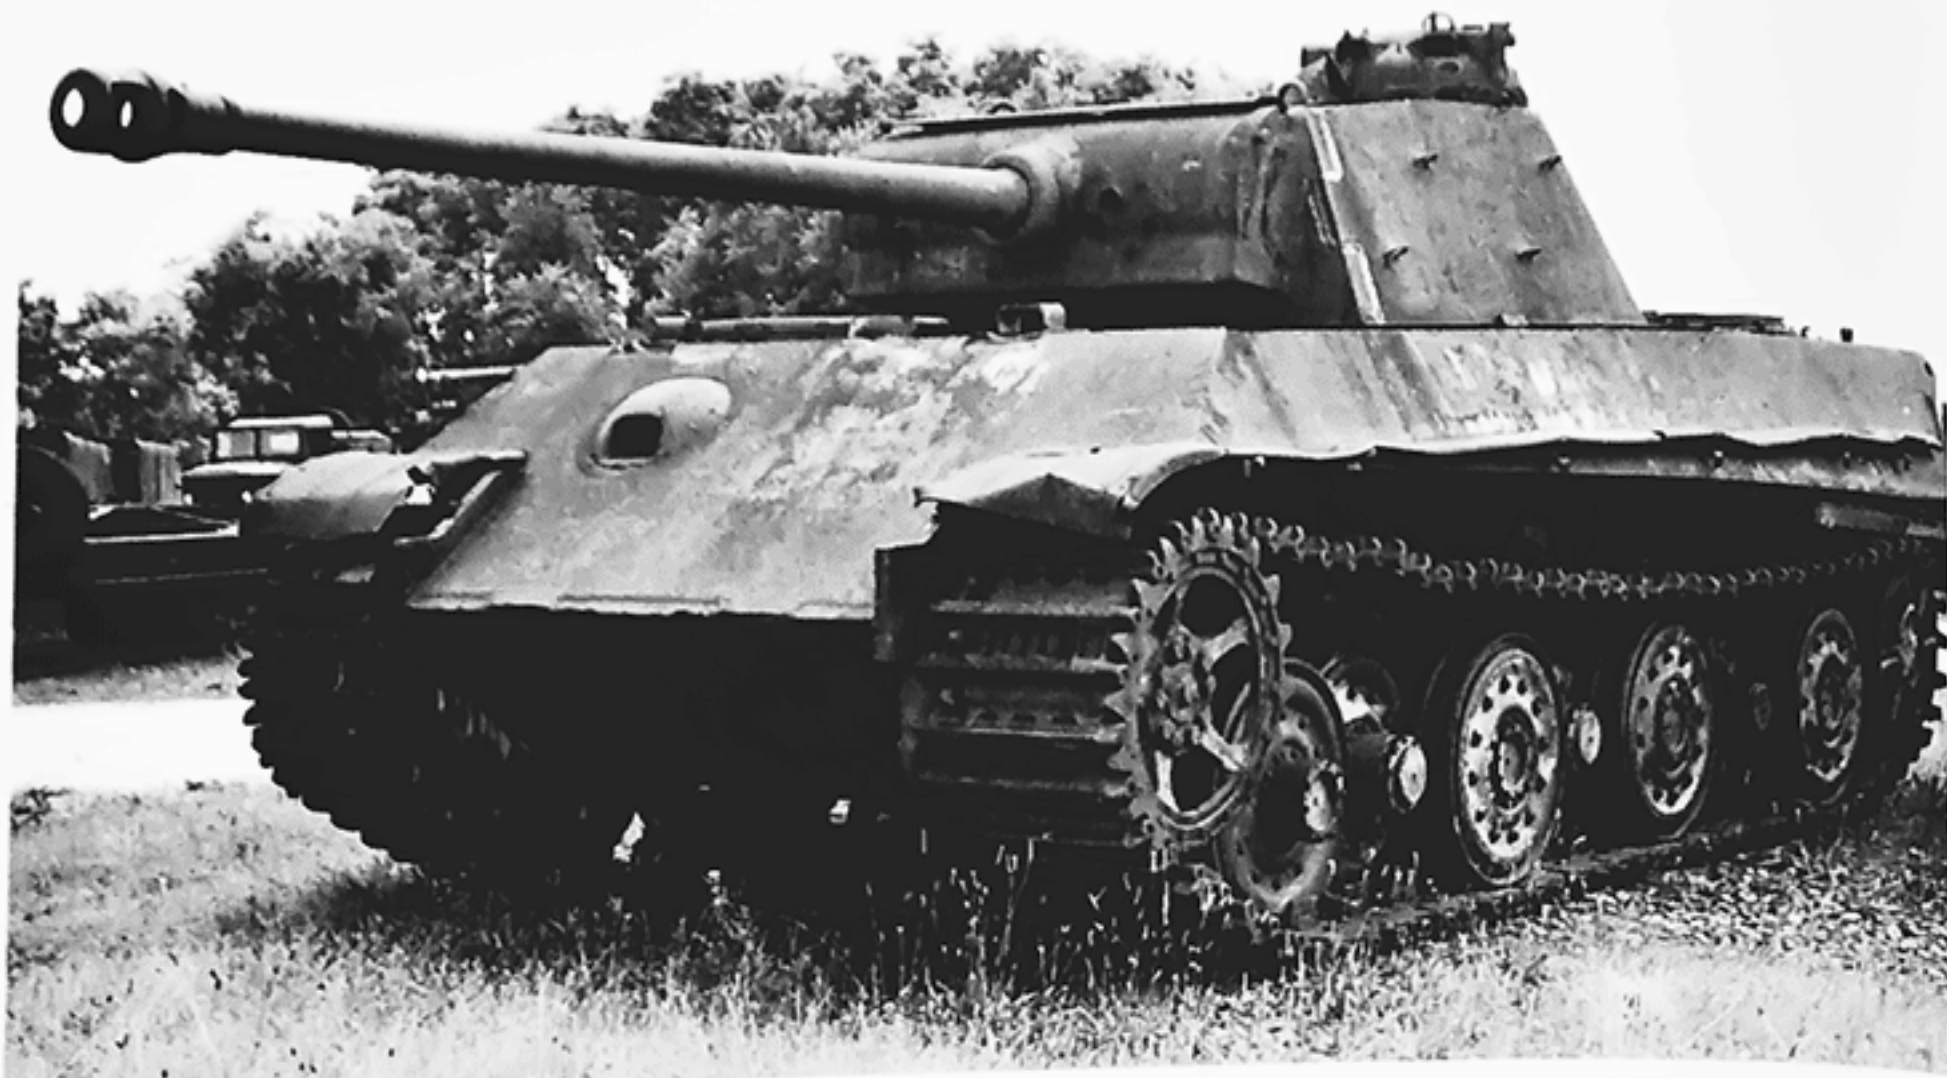
The only chassis completed for the **Versuchs-Panther II** was captured by the Americans and shipped to Aberdeen Proving Grounds. A Panther Ausf G turret (completed in April 1945) was mounted on the Panther II chassis. It is not known if the turret was mounted by the Germans in a last ditch effort at the end of the War or if Americans mounted an Ausf G turret on the Panther II chassis after it was captured. (CHY)

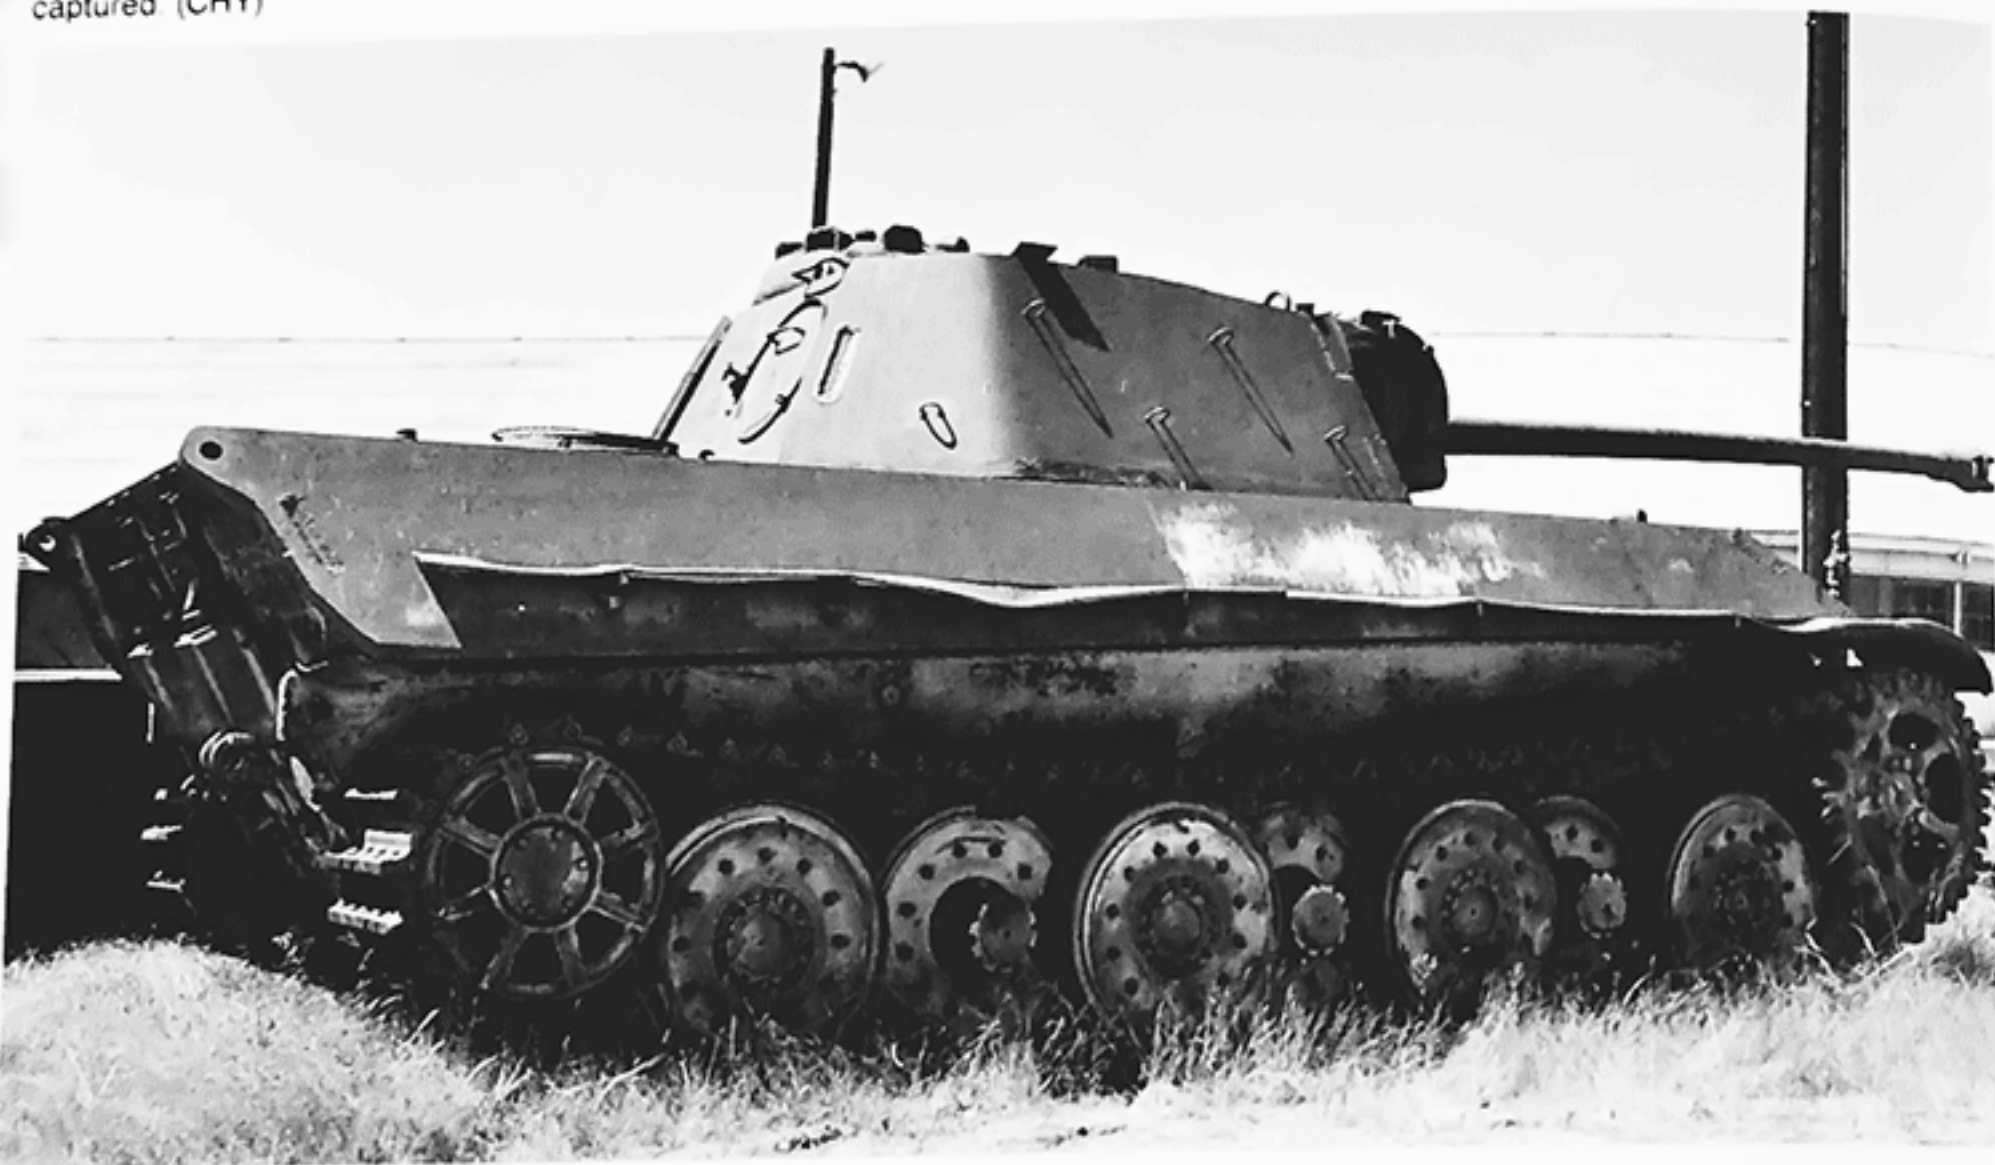
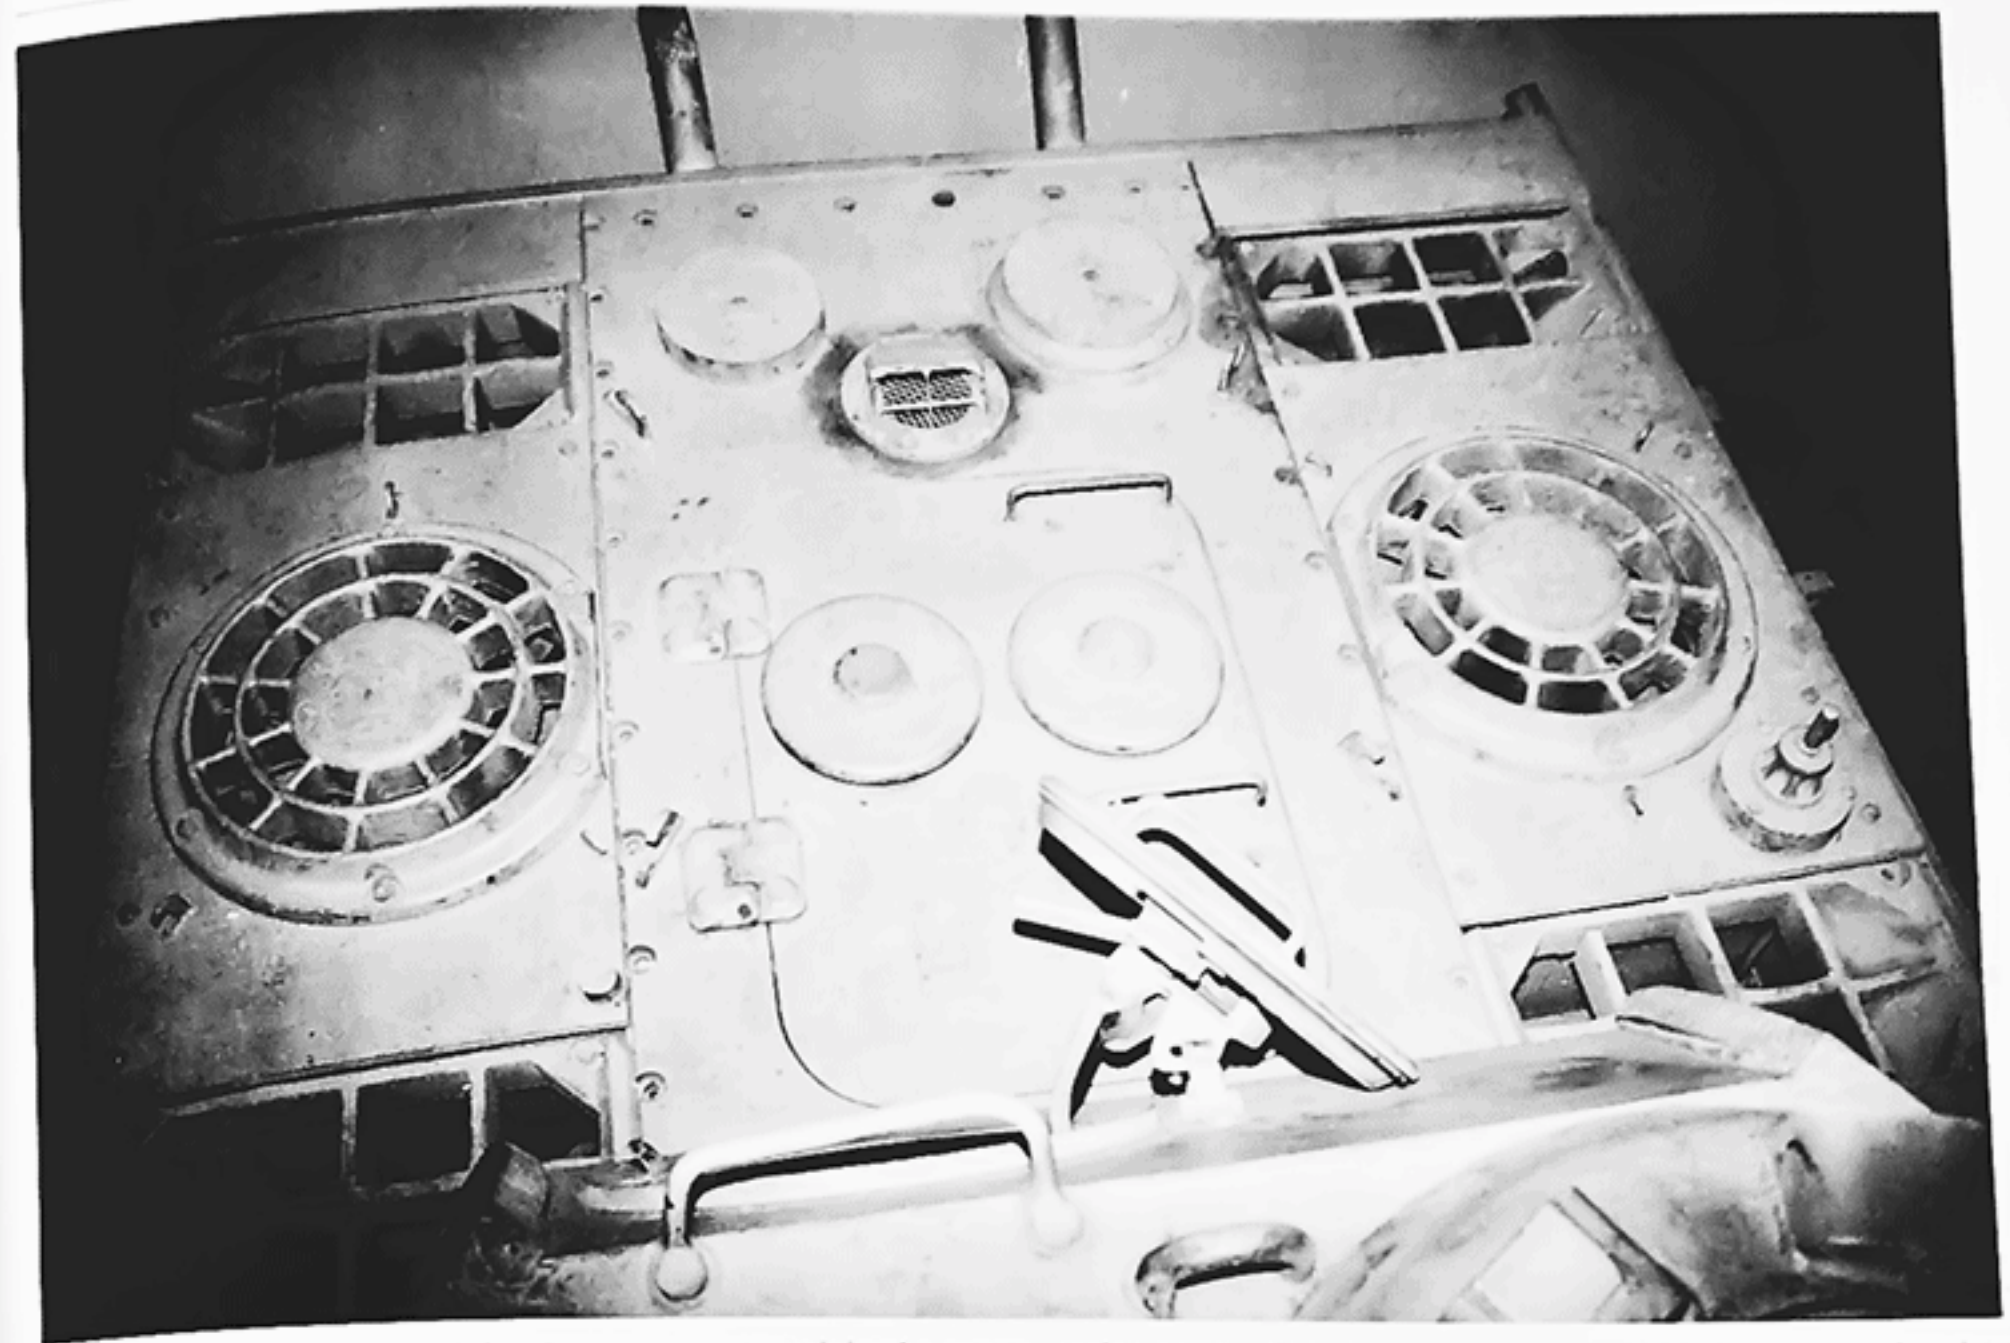
Components on the rear deck (engine compartment air intake scoop, engine combustion air intake covers, and the four rectangular air intake louvers) designed for the Panther II were later adopted into the Panther Ausf G design. The air exhaust louvers covering each fan are the same as those used on the Tiger II. (Patton Museum)

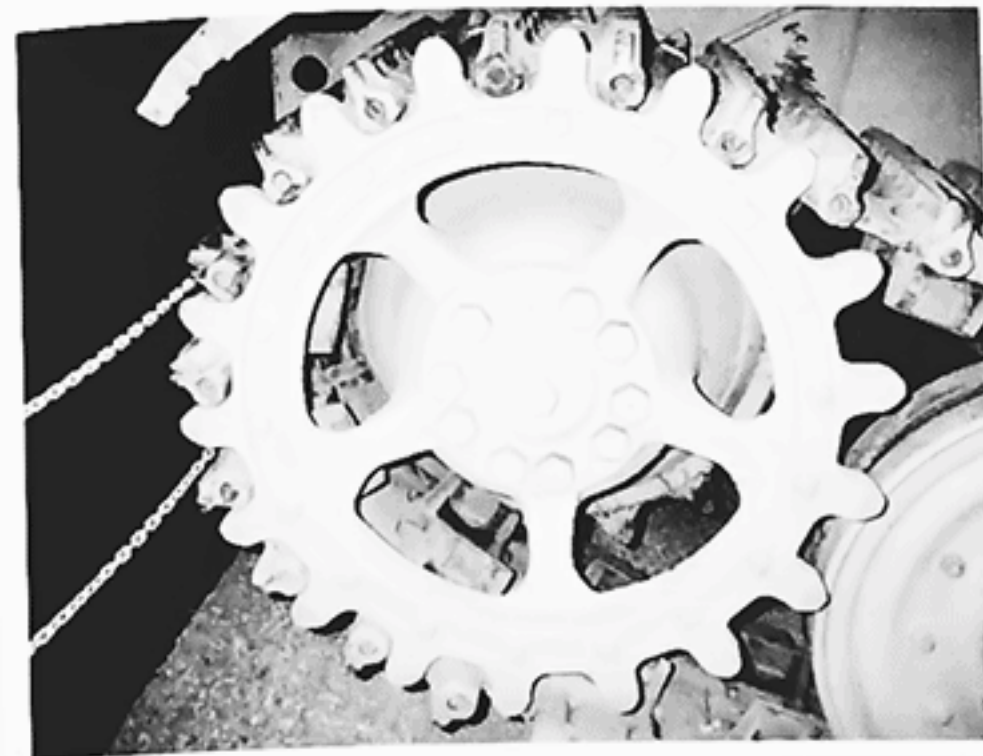
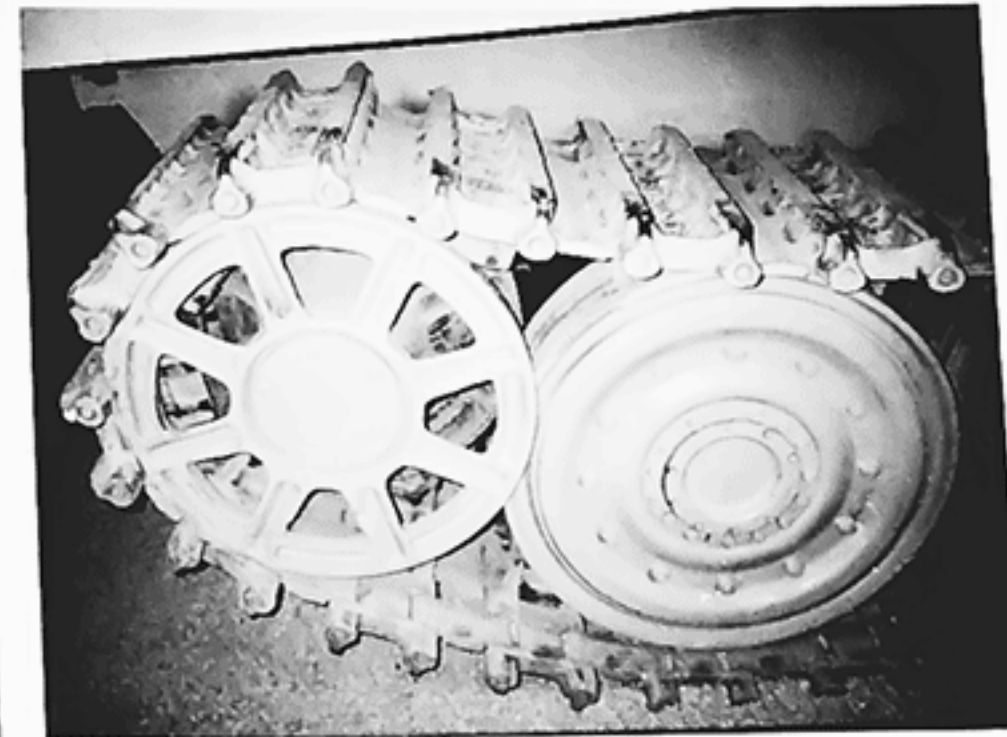
The 660 mm wide combat tracks for the Panther II were to be utilized as transport tracks for the Tiger II. The **Gummisparende Laufrollen** (Drawing No. 021 D 50204) steel tired, rubber-cushioned roadwheels were specifically designed for the Panther II as was the idler wheel with eight spokes. The drive sprocket was similar (but not identical) to the design used on the Tiger II Versuchs-Serie. (Patton Museum)

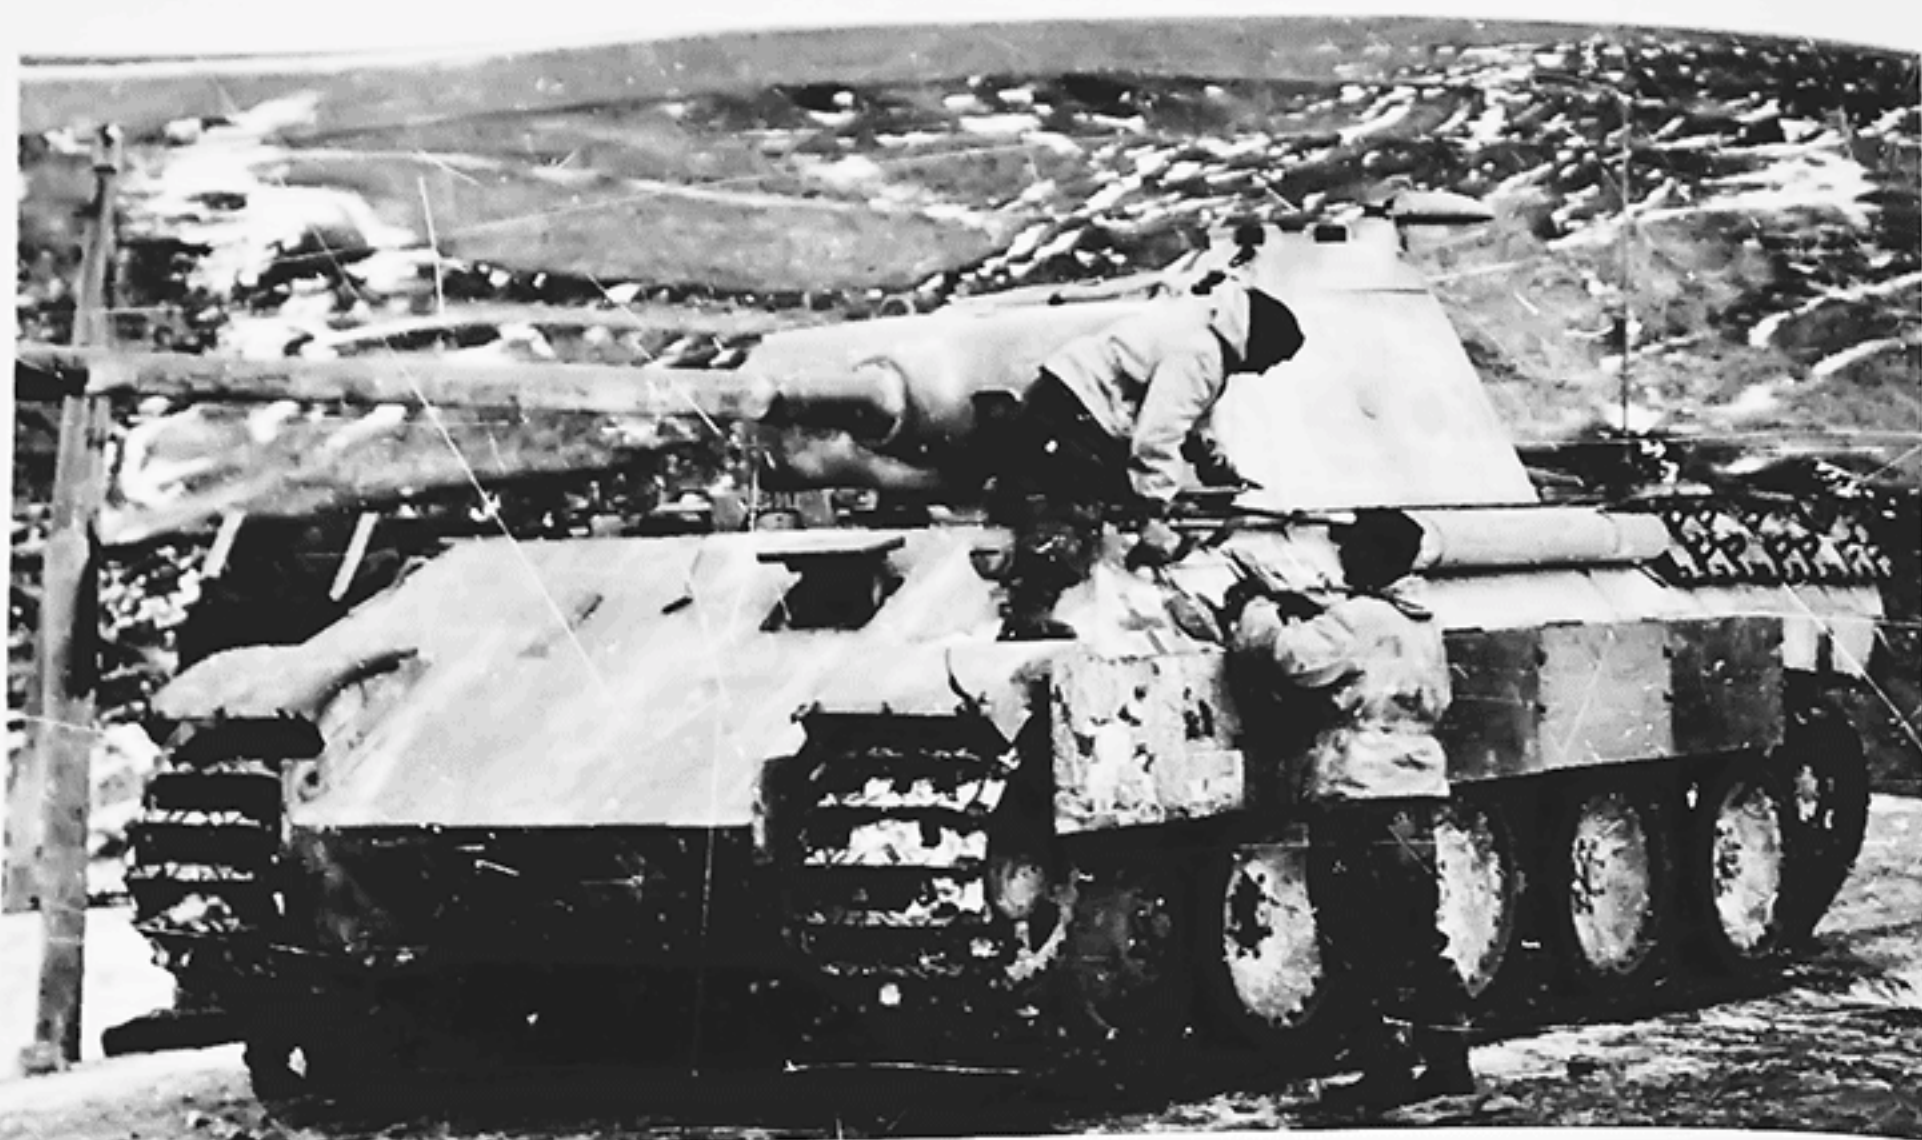
This Panther Ausf A (Fgst Nr. 151951 produced by Daimler-Benz on or about 1 October 1943) did not receive a coating of **Zimmerit** applied at the factory. It still has the binocular **T.Z.F.12** gun sight and "Letterbox" machinegun port in the glacis plate. Pistol ports are still present on the turret sides and the ring for the anti-aircraft machinegun mount is missing from the commander's cupola. All visible roadwheels have 24 rim bolts. (BA)

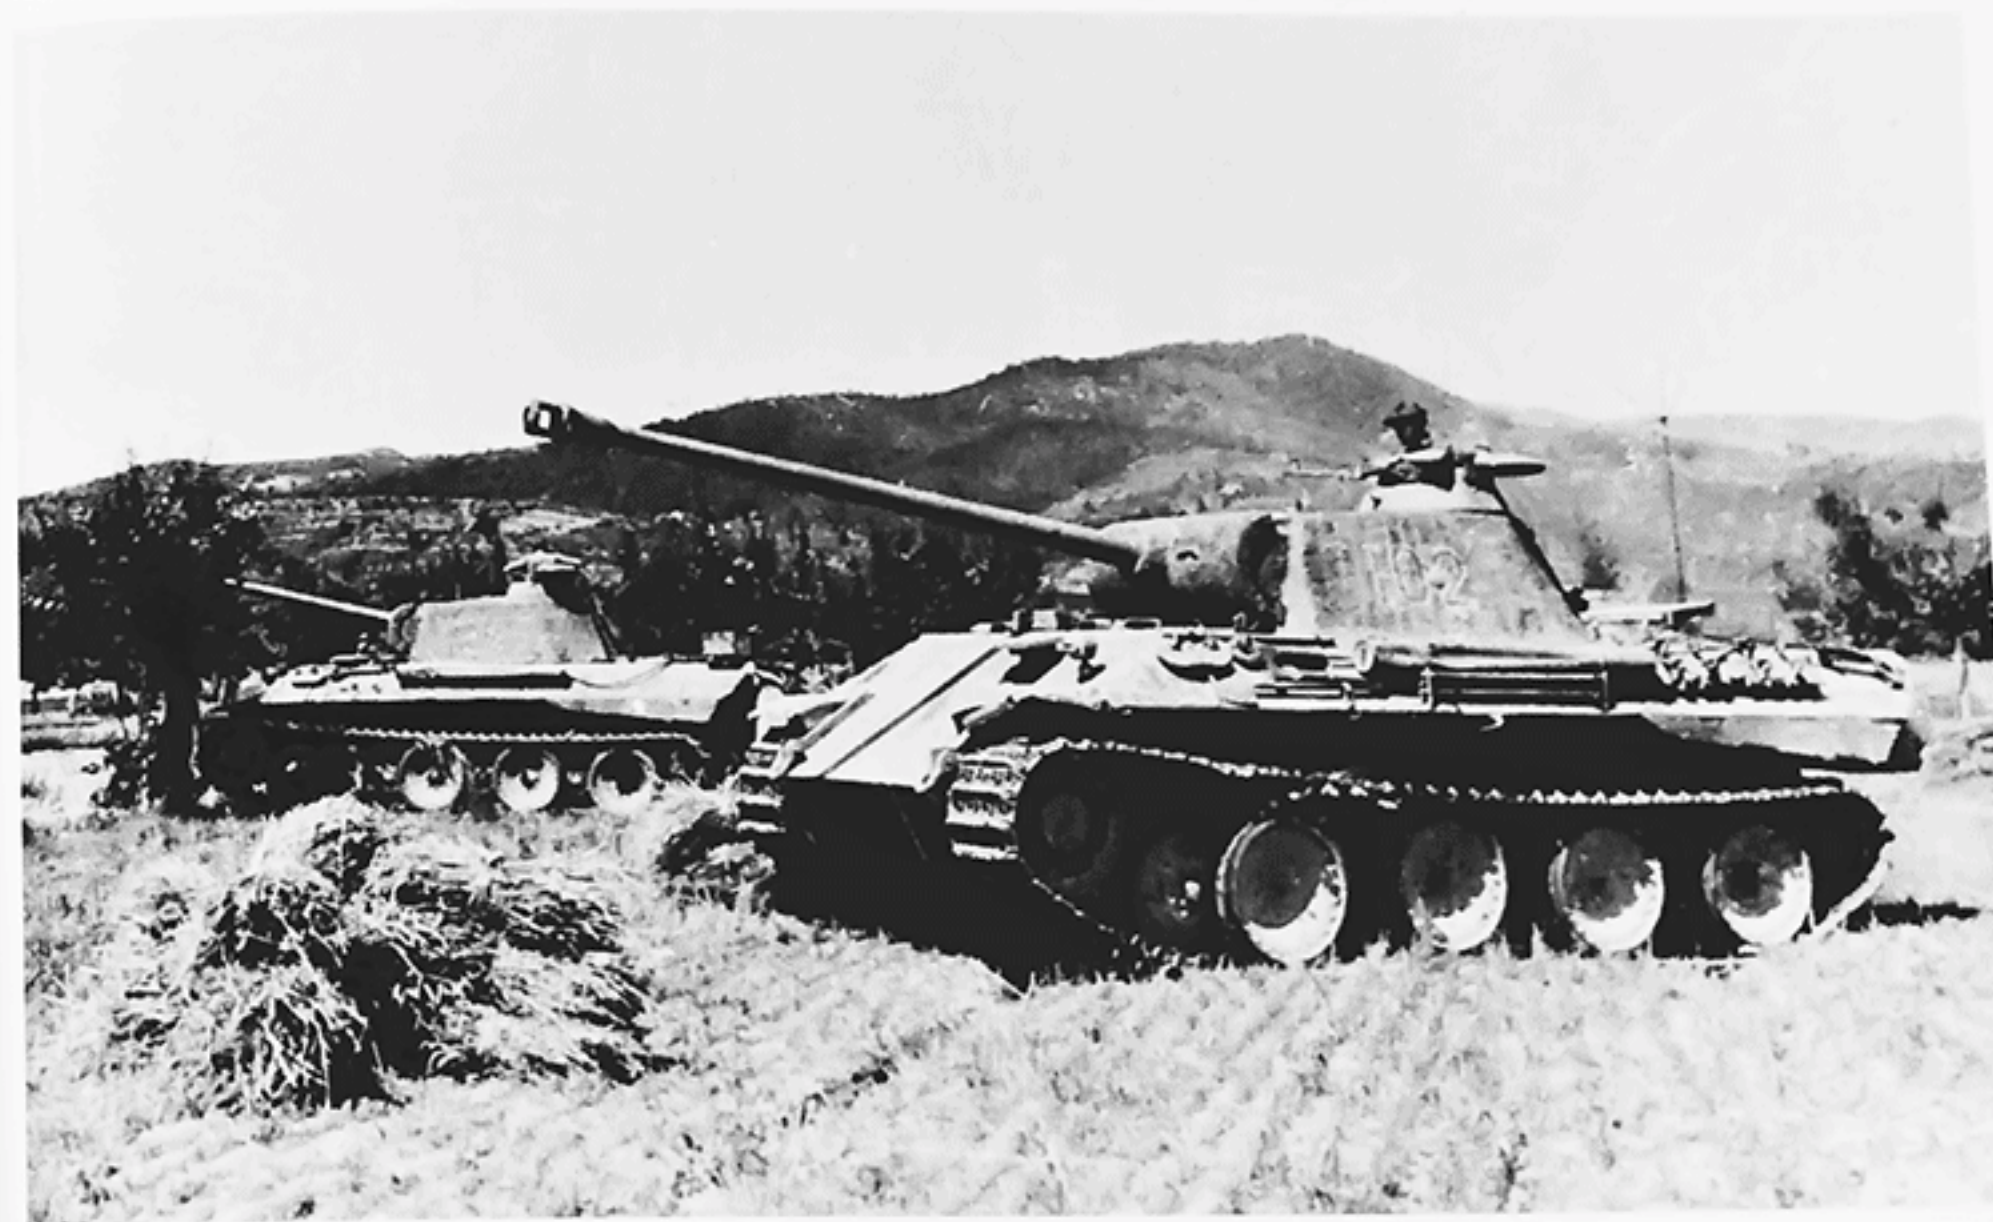
A Befehls-Panther Ausf A, Tactical No. 102, in Italy with the I. Abteilung/Panzer-Regiment 4, still has the **T.Z.F.12** binocular gun sight, "Letter Box" machinegun port on the glacis, and pistol ports on the turret sides. As in all Befehls-Panthers, the aperture for the coaxial machinegun was sealed with an armor plug and the spare antenna rods were stored in tubes mounted on the left side. (BA)

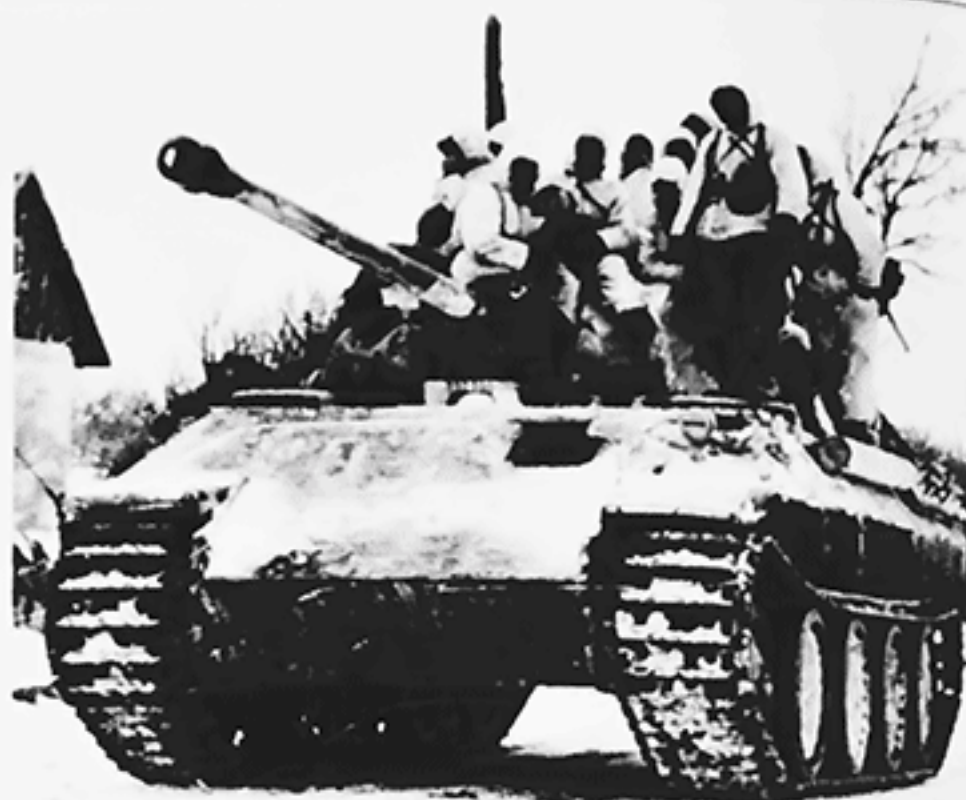
Panther Ausf A (Fgst Nr. 152151 produced by Daimler-Benz on or about 16 December 1943) still has a "Letterbox" machinegun port on the glacis plate. It has a **T.Z.F.12a** monocular gun sight with a single sight aperture under a wide rain guard. (BA)
