GERMANY'S

PANTHER

**TANK THE QUEST FOR
COMBAT SUPREMACY**

THE QUEST FOR COMBAT SUPREMACY
Development • Modifications • Rare Variants
Characteristics • Combat Accounts

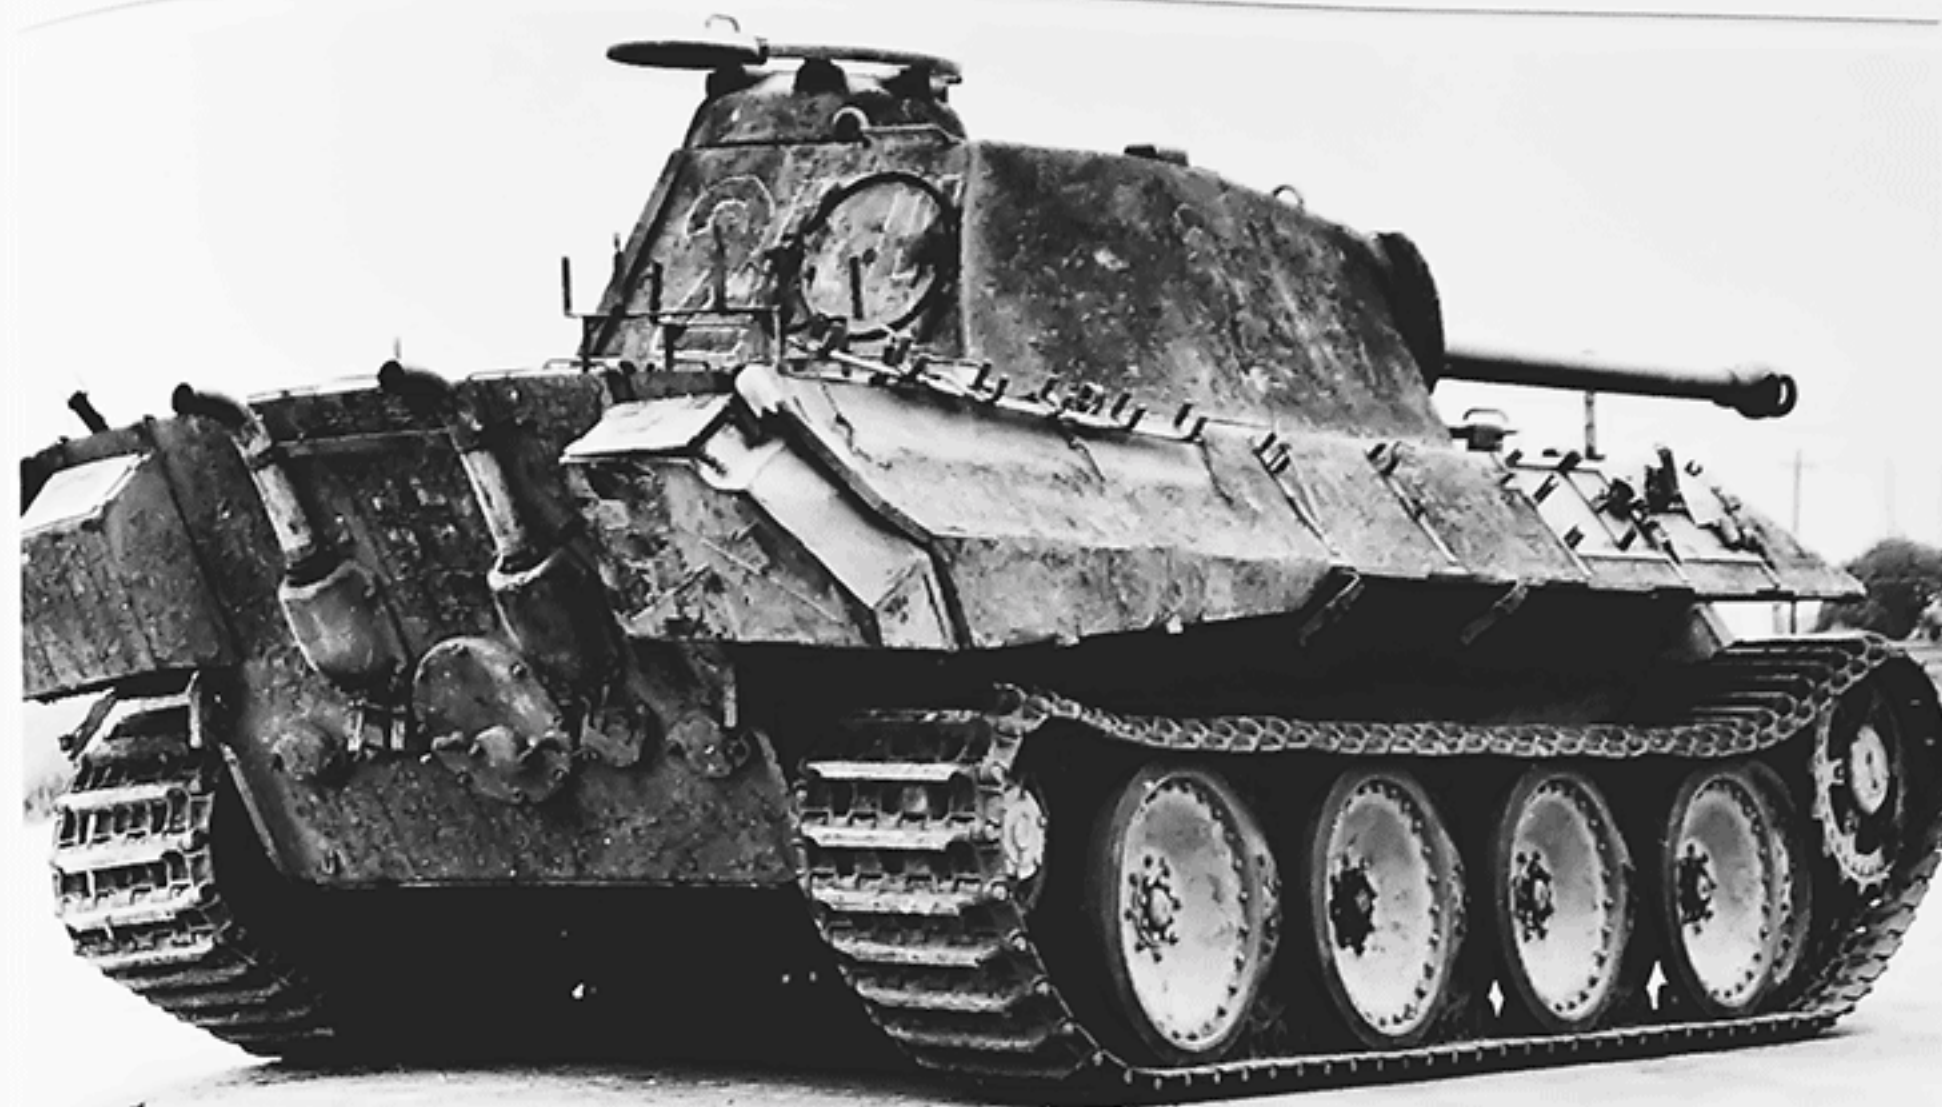
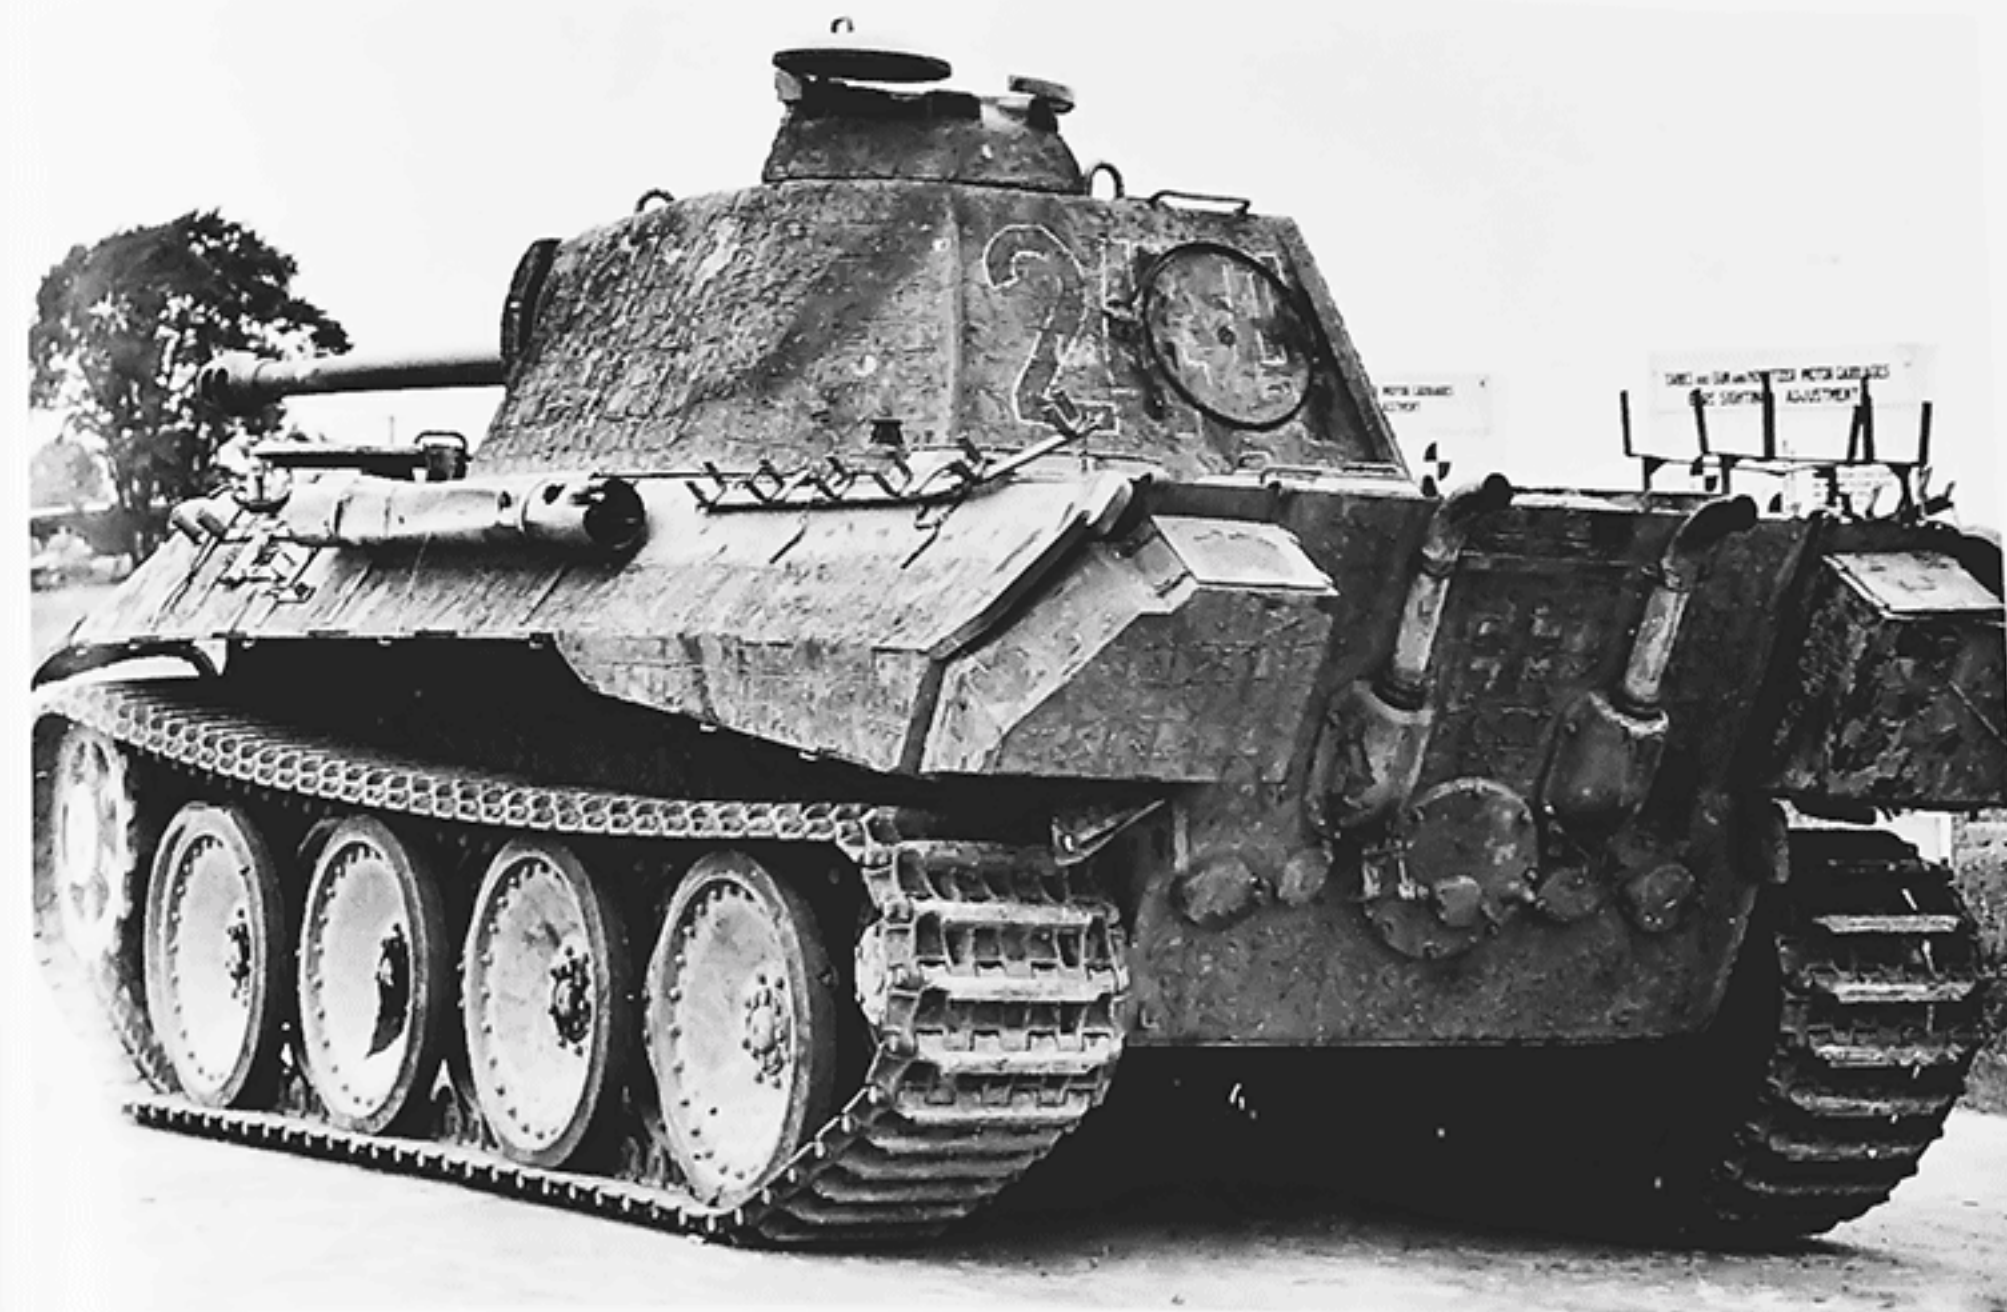
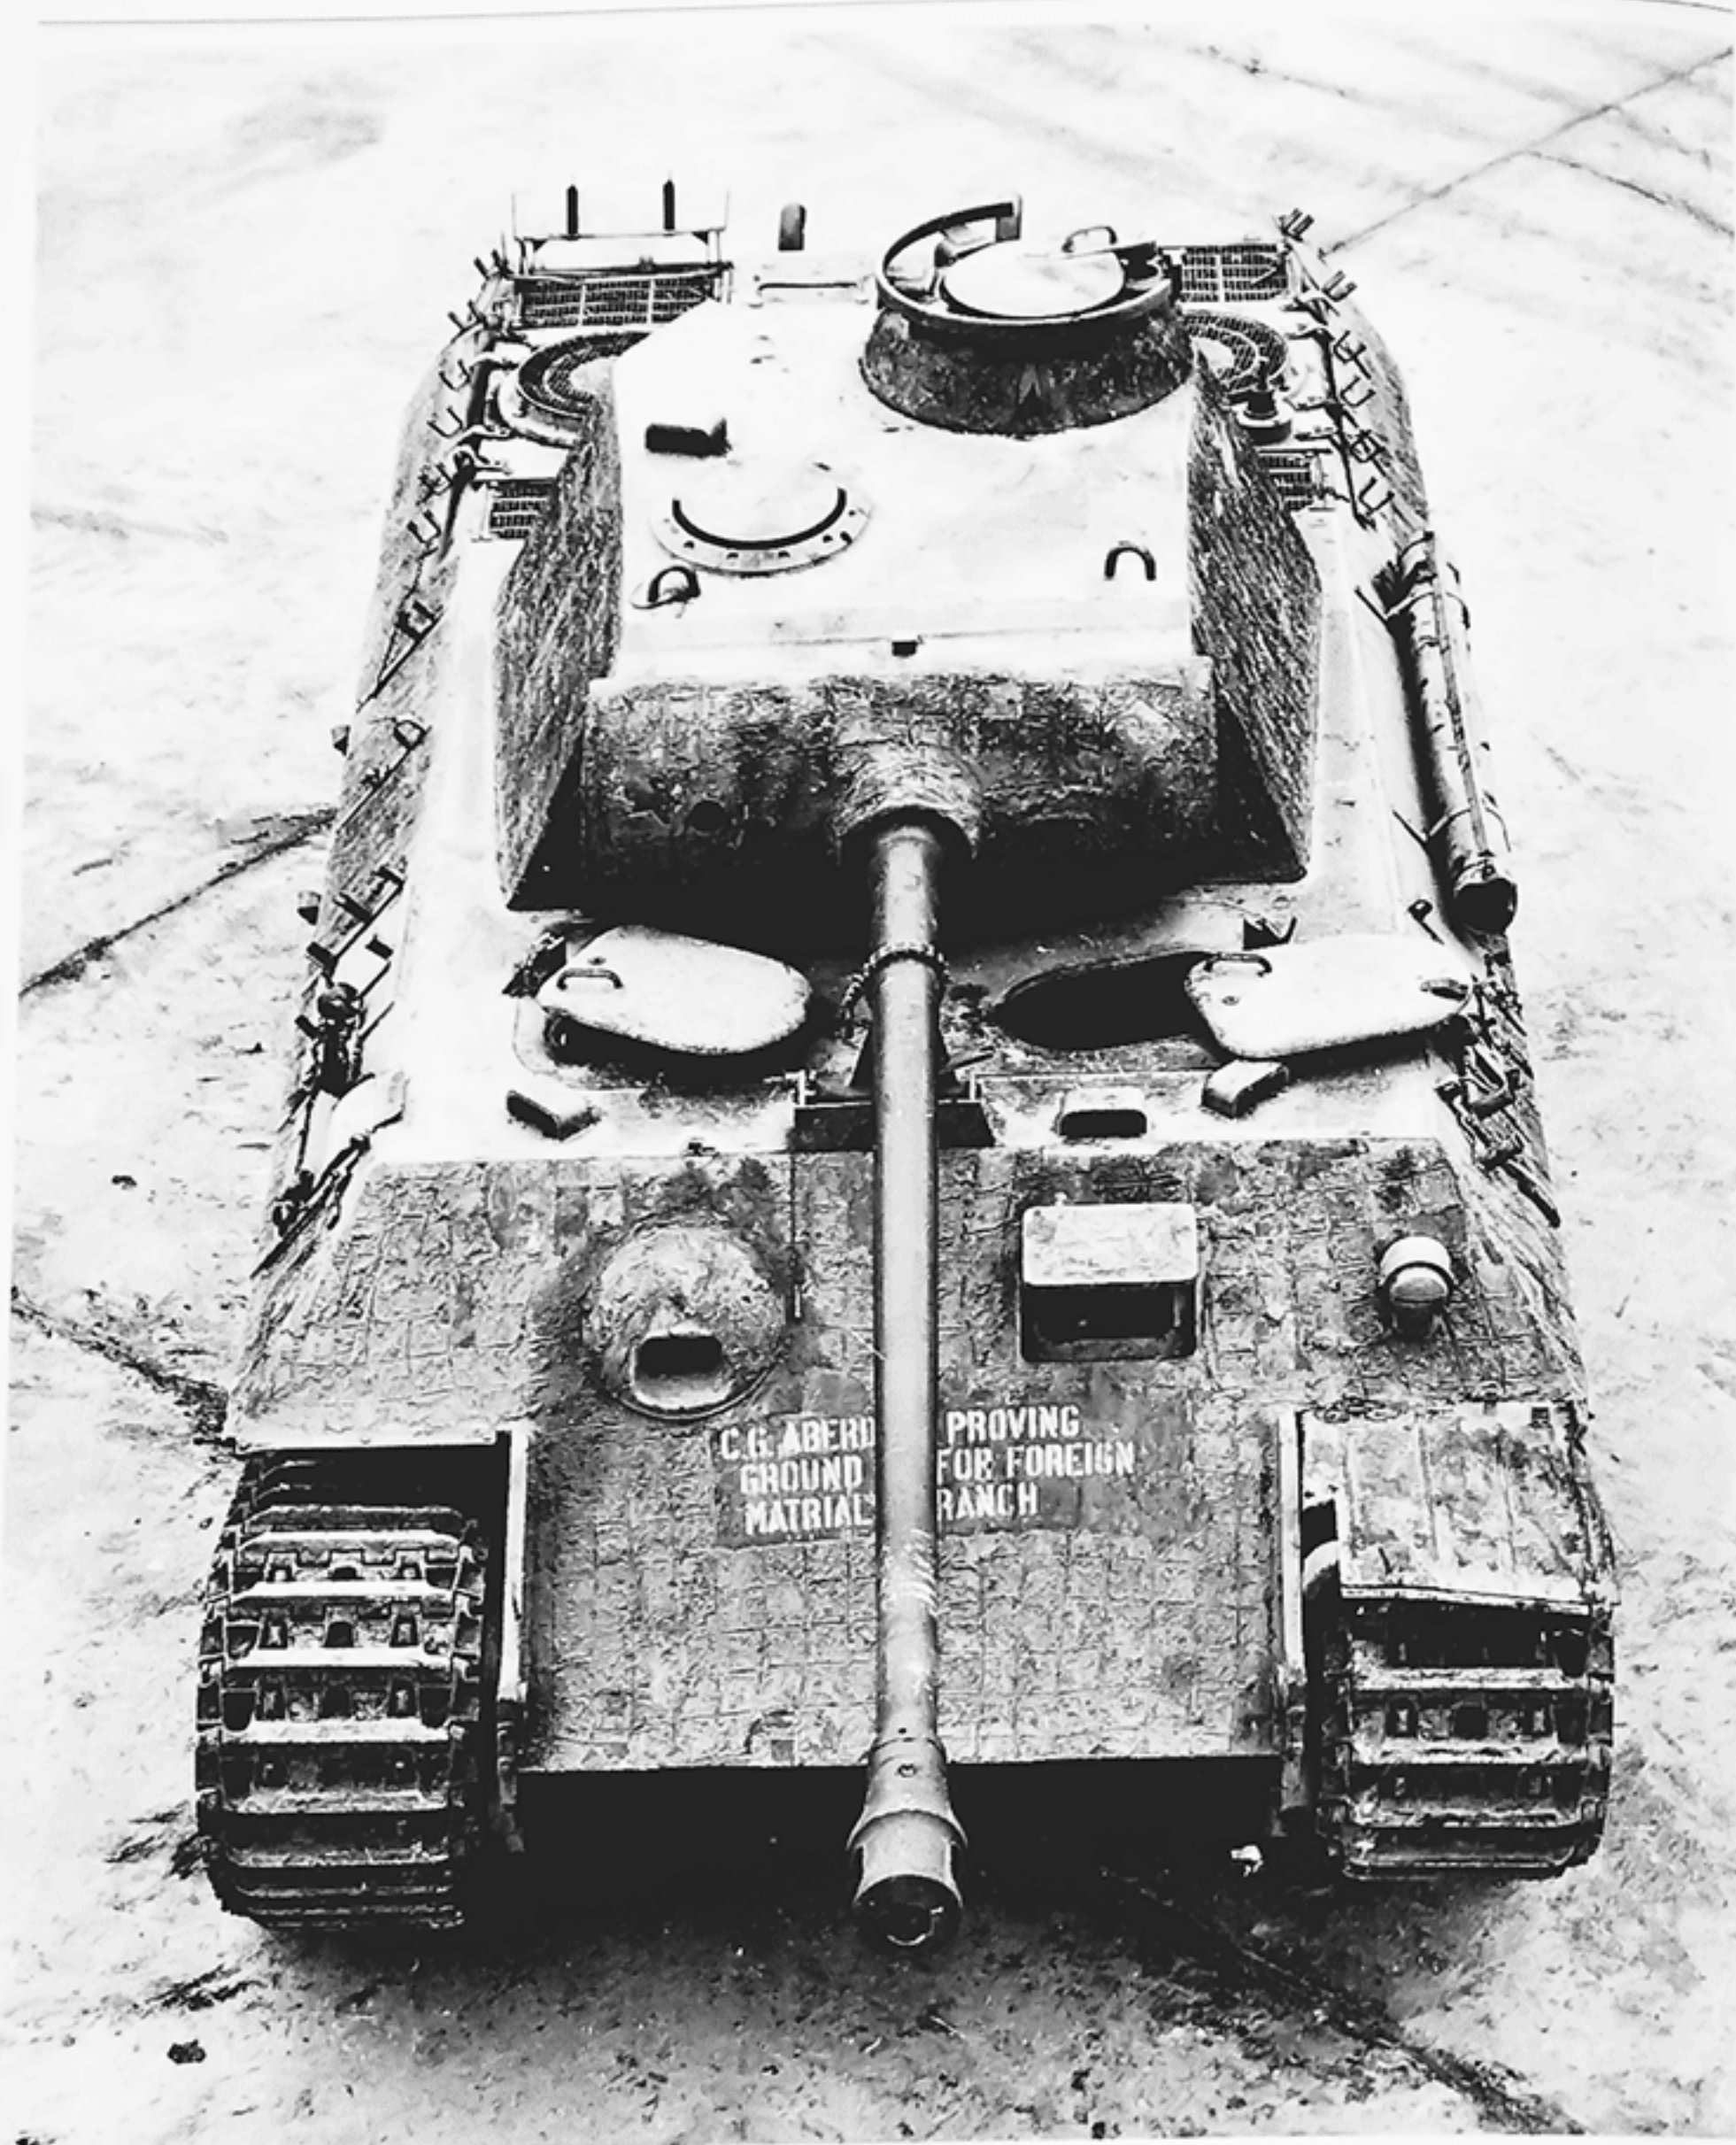
Opposite and next two pages: Panther Ausf A (Fgst Nr. 152158 completed by Daimler-Benz on or about 18 December 1943) had a **M.G.Kugelblende** (machinegun ball mount) and a **T.Z.F.12a** monocular gun sight with the second aperture in the gun mantlet plugged. It was issued to the I Abteilung/Panzer-Regiment 4 (Tactical No. 244) and sent to Italy. The rack for holding a stowage box on the right rear corner of the rear deck is a unique modification from this unit. Pistol ports are no longer present on the turret sides. The armor louvre over the right fan on the rear deck has a straight radial pattern instead of the spiral pattern. The Notek taillight is still mounted behind the left track. (CHY)

Starting in late November/early December 1943, the **Kugelblende** (ball mount) for the hull machinegun with a spherical armored guard was introduced. At the same time, the forward facing periscope on the hull roof for the radio operator was deleted. This periscope was no longer necessary since the radio operator was to use the **K.Z.F.2** sight provided with the machine gun mount for direct observation.

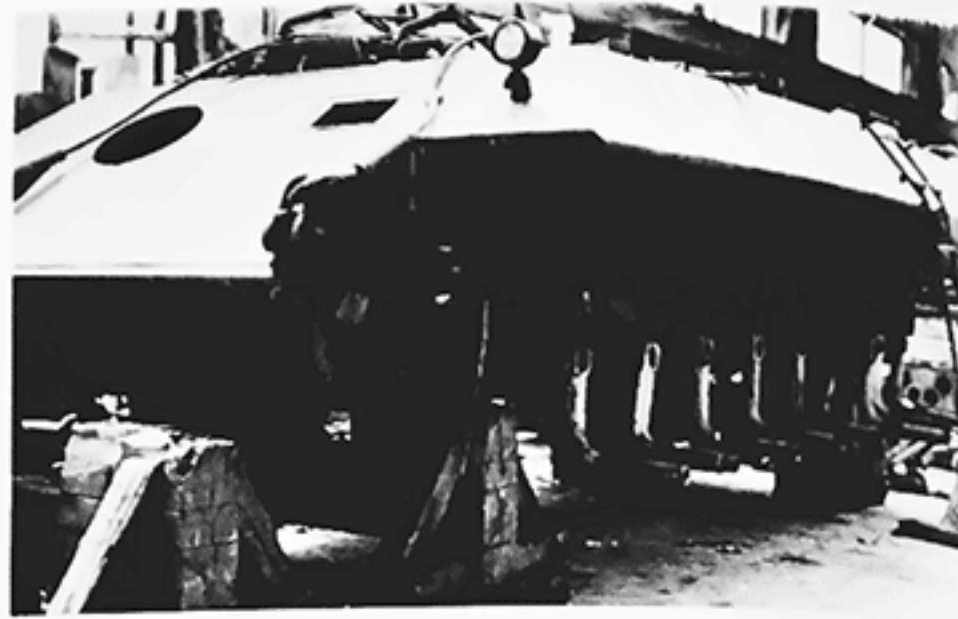
M.A.N. assembled a Panther Ausf A for testing that did not have interlocked armor for the front and side plates. (NA)

As shown on a drawing dated 1 May 1943, the hull roof plate was cut with straight sides and was no longer interlocked with the armor plates for the hull sides. Due to the lead times for delivering completed hulls to the assembly firms and cutting the armor plates prior to final hardening in the furnaces, such changes to the basic armor layout took a long time to appear on completed Panthers leaving the assembly plant. The earliest Panther Ausf A identified with a straight sided roof plate is December 1943. This modification was not introduced by all of the armor suppliers. Therefore, up to the end of the production series, Panther Ausf As with interlocked roof plates were completed side by side with others that had straight sided roof plates.

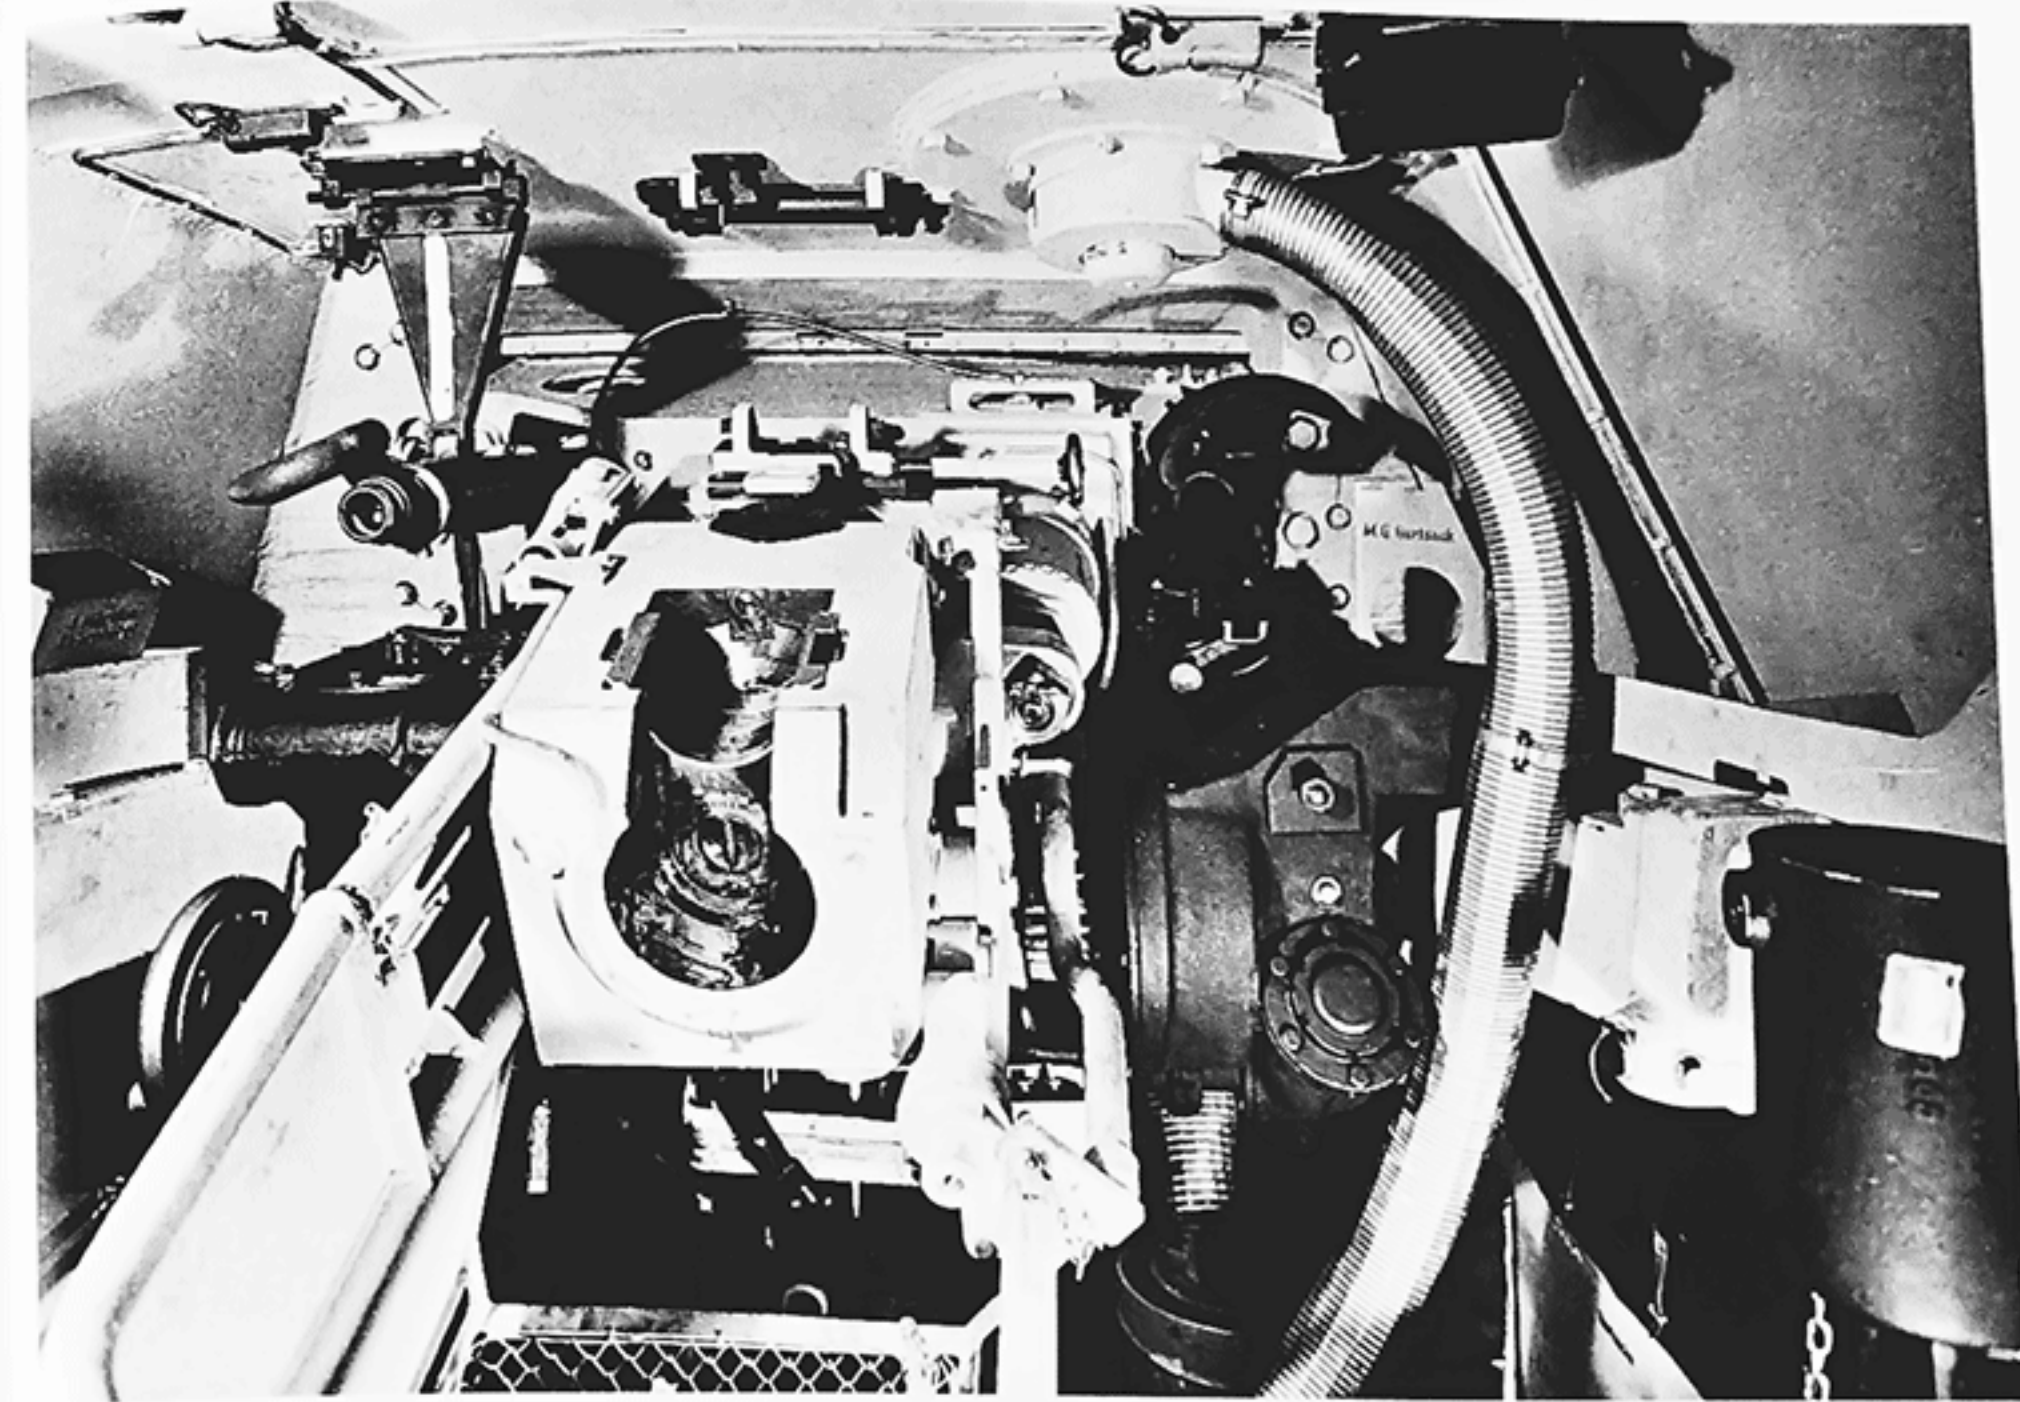
The interior of a Panther Ausf A turret completed in January 1944 with a coaxial machinegun and a T.Z.F.12a monocular gun sight. (WJS)

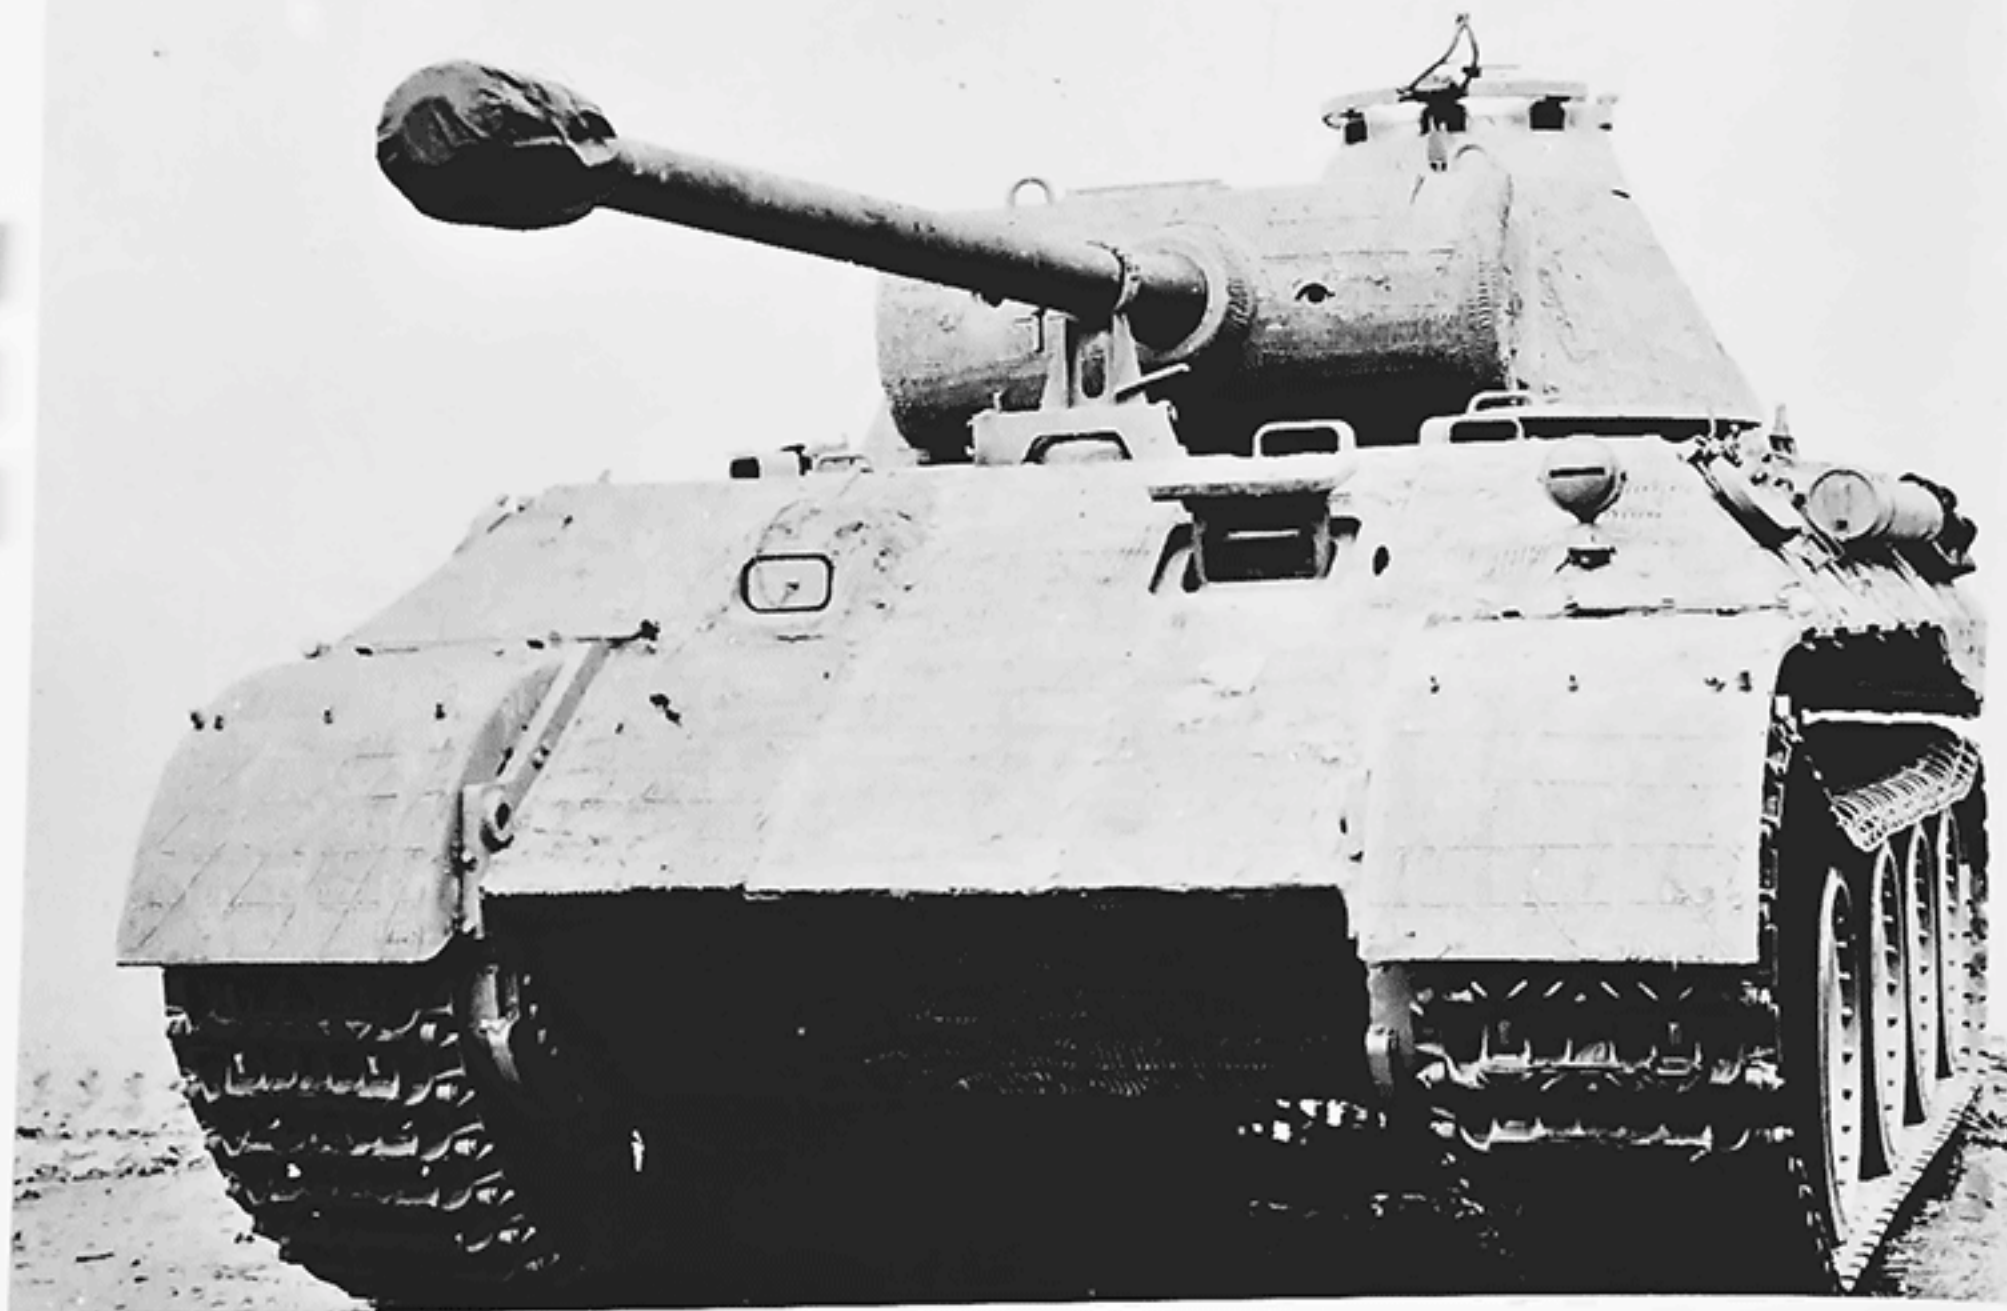
Above and opposite:
 Panther Ausf. A (Fgst.Nr. 210718 completed at M.A.N. in February 1944) with the monocular T.Z.F.12a gun sight. The taillight is mounted beside the left exhaust pipe armored guard, the guide for the starter crank is mounted below the right exhaust pipe armored guard, and the 20 t Winde (jack) is mounted between the exhaust pipes. (CHY)

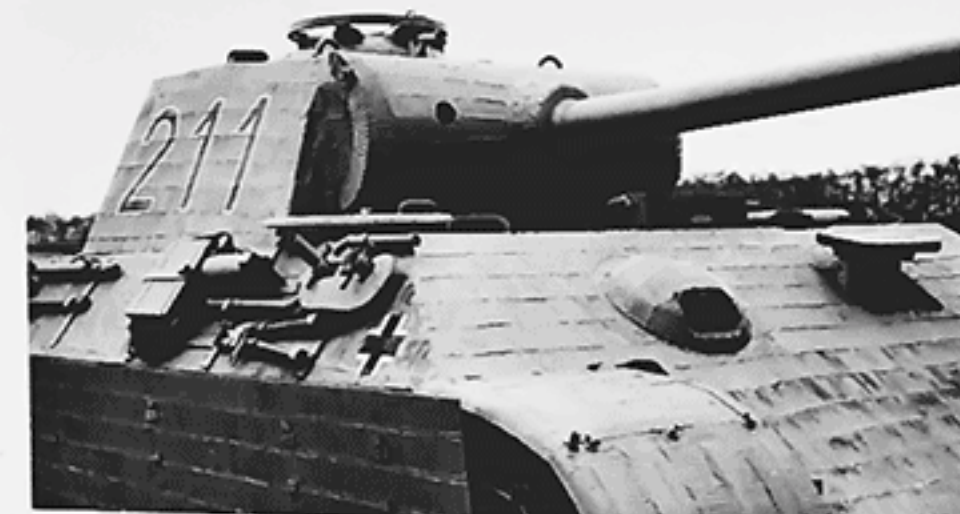
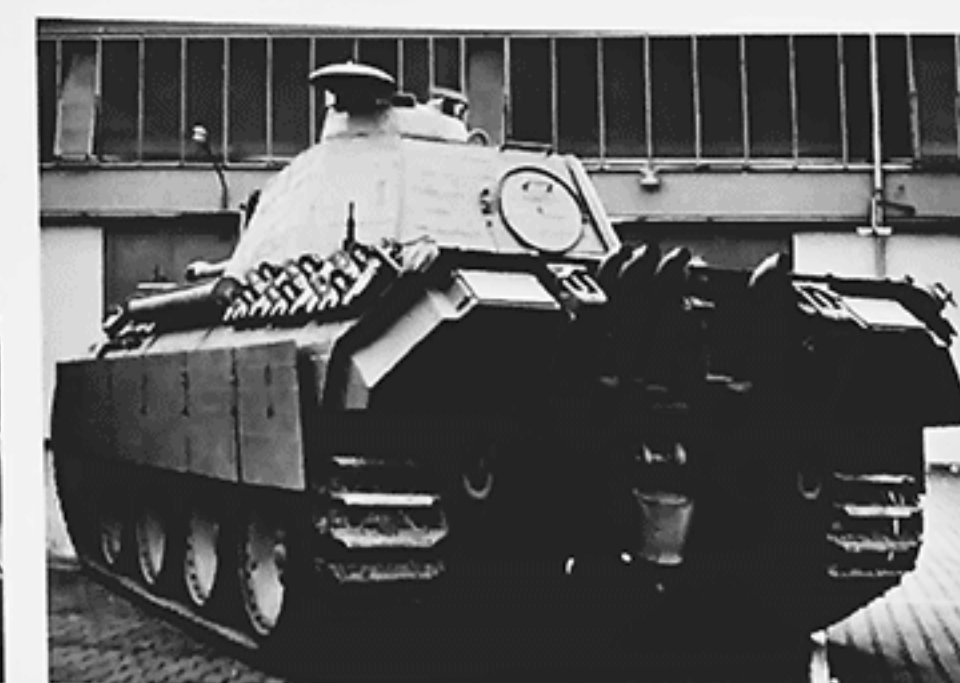
Panzerkampfwagen Panther (7.5 cm Kw.K.42 L/70) (Sd.Kfz.171)
An **Ausführung A** with all externally visible modifications in effect when the last one was produced by M.N.H. in July 1944.

On 20 March 1944, MNH reported that M.A.N. had already standardized mounts for two types of jacks, the **IW 20** and **RWS 20 Winden**. Because of this, MNH could begin installing the modifications for the **20 t Winde** and the motor hatch cover with the welded tow coupling earlier than planned. Starting with Fgst.Nr. 155341 (completed on 16 April 1944) the **RWS 20 Winde** (30 in stock) and then the **IW 20 Winde** (70 available) was to be mounted along with the central tow coupling on the motor hatch cover. The excess **15 t Schober-Winden** were not to be discarded but held in reserve since Wa Pruef 6 was in contact with M.A.N. to design a vertical mount for the 15 t jack. The old motor access hatch without the tow coupling was still to be fabricated by Ruhrstahl Hattingen for MNH Panthers up to Fgst.Nr. 155340 (completed on 16 April 1944).

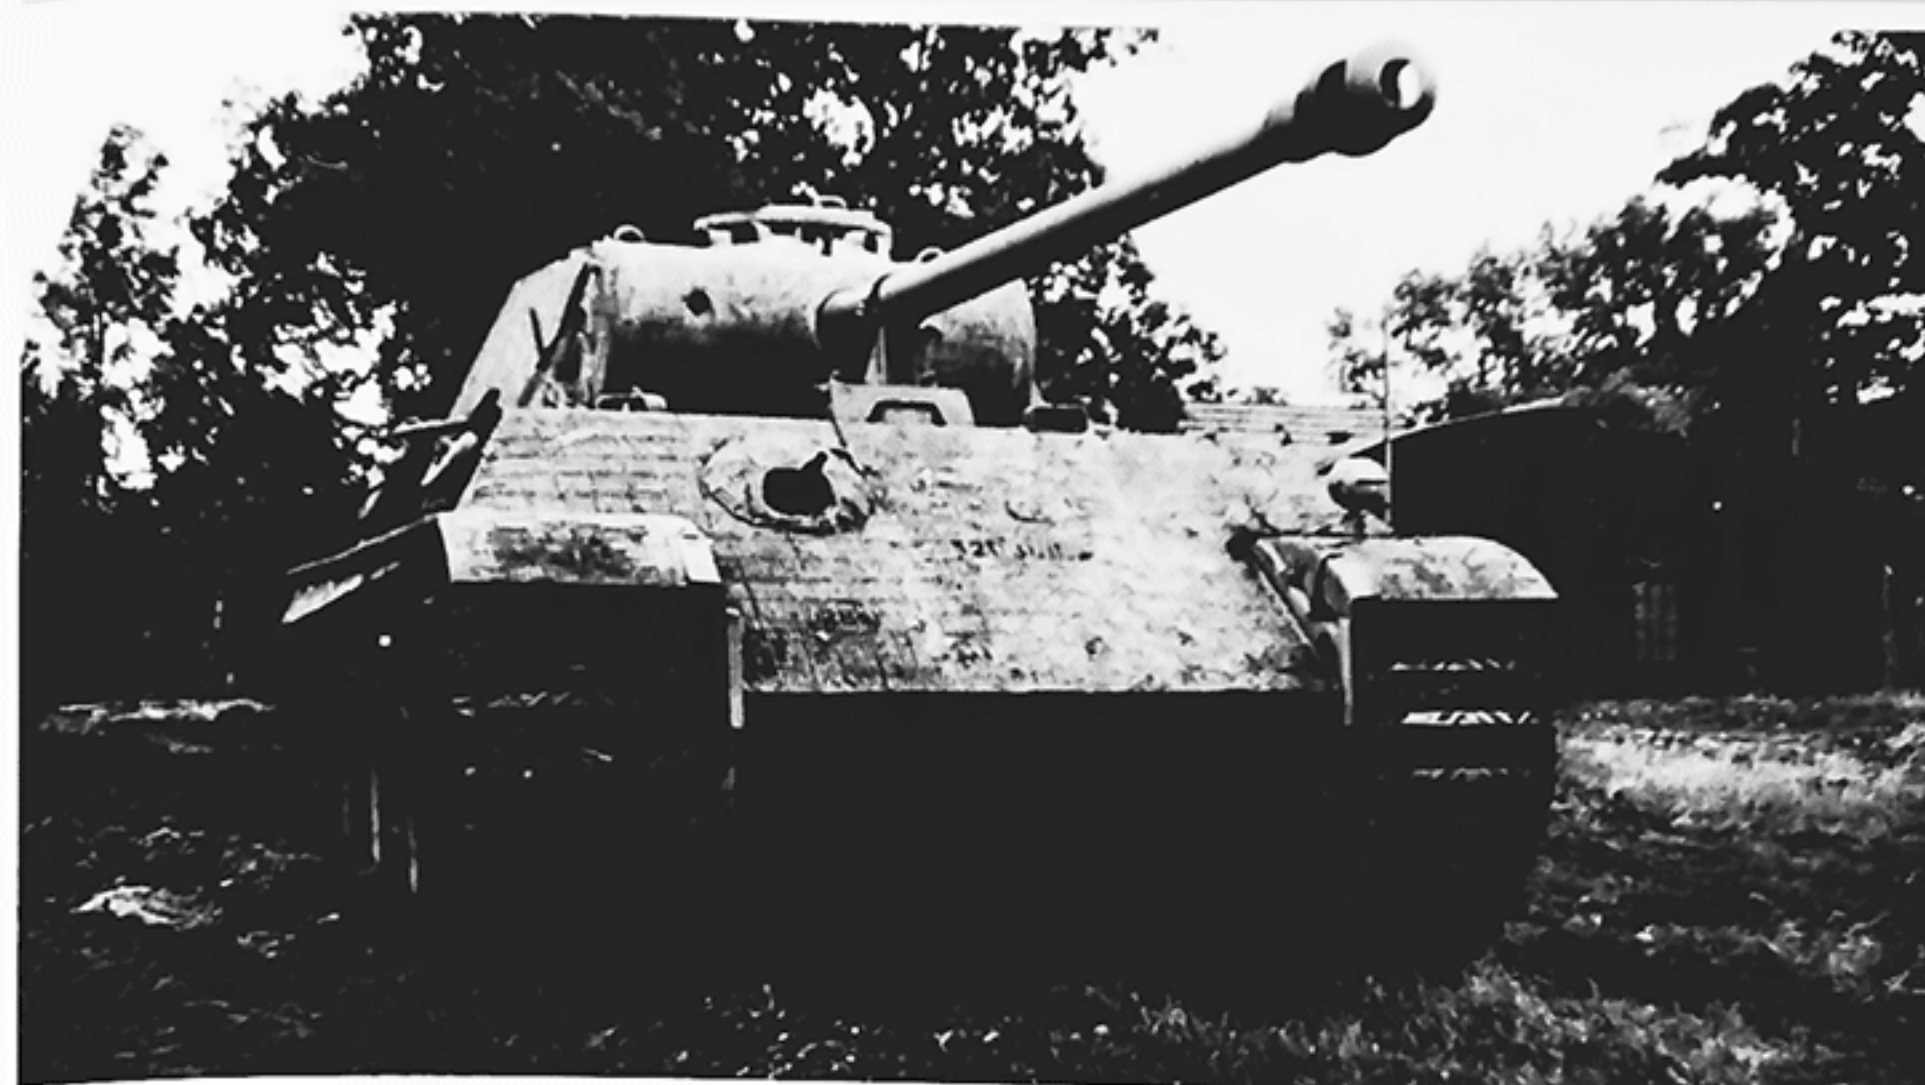
Opposite:
The front and rear view of Panther Ausf.G (Fgst.Nr.120303 completed by M.A.N. on or about 1 April 1944). On Ausf.Gs the **Tarnlampe** (headlight) was mounted directly above the left fender. The ends of the longer, thicker tow cables (32 mm diameter and 8.2 meters long for the Ausf.G instead of 27 mm diameter and 5 meters long for the Ausf.A and D) were secured by U-shaped holders on the rear deck. (BA)

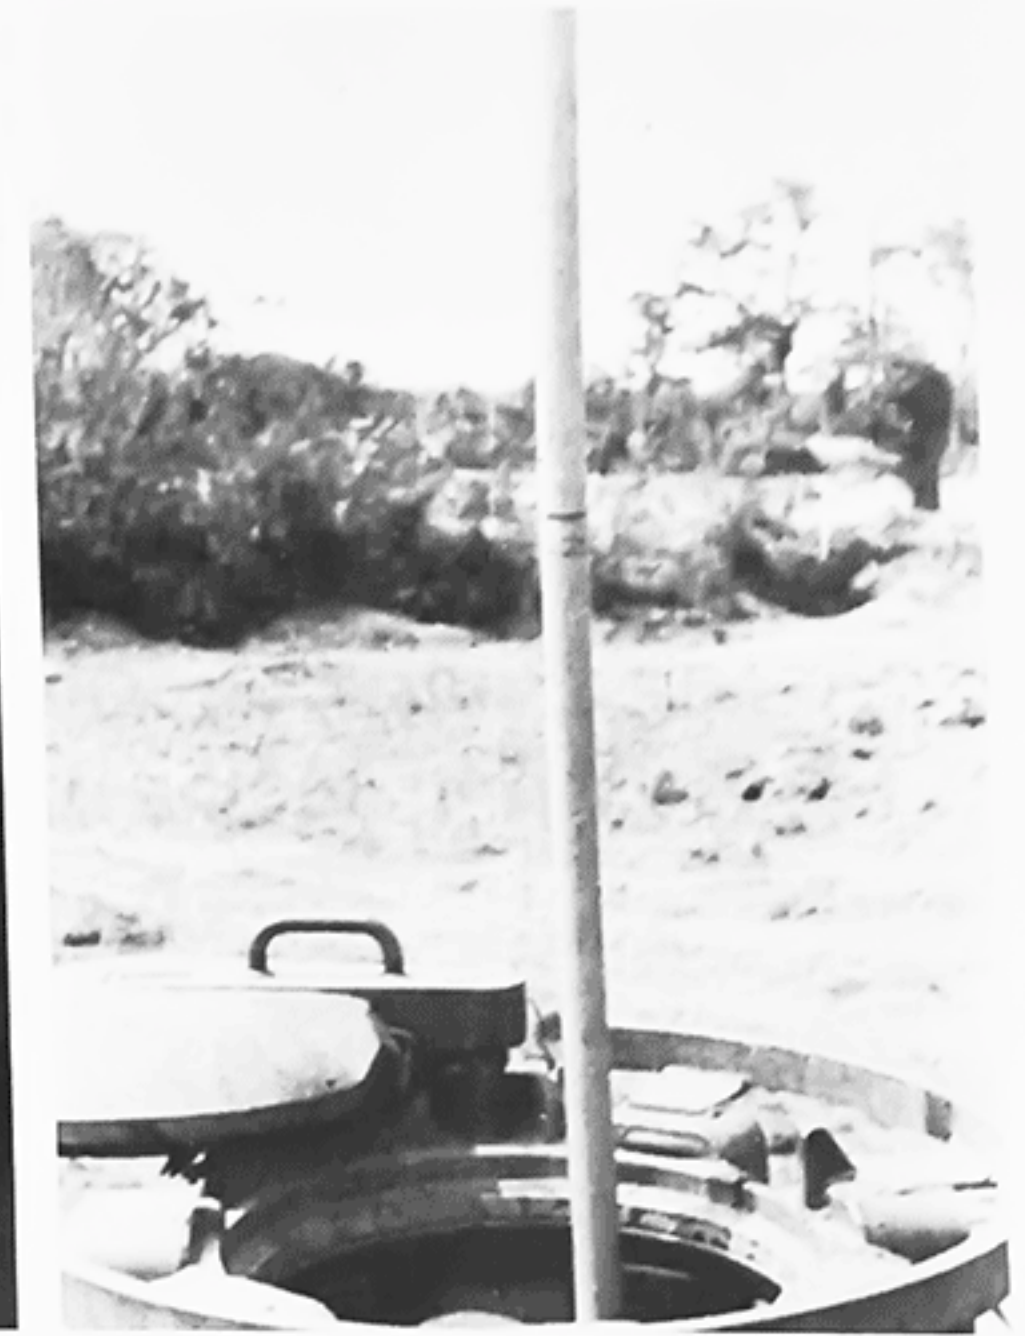
Starting in August 1944, Panthers had a sheet metal cover welded to the front of the turret roof to prevent foreign material from jamming in the gap behind the gun mantlet.

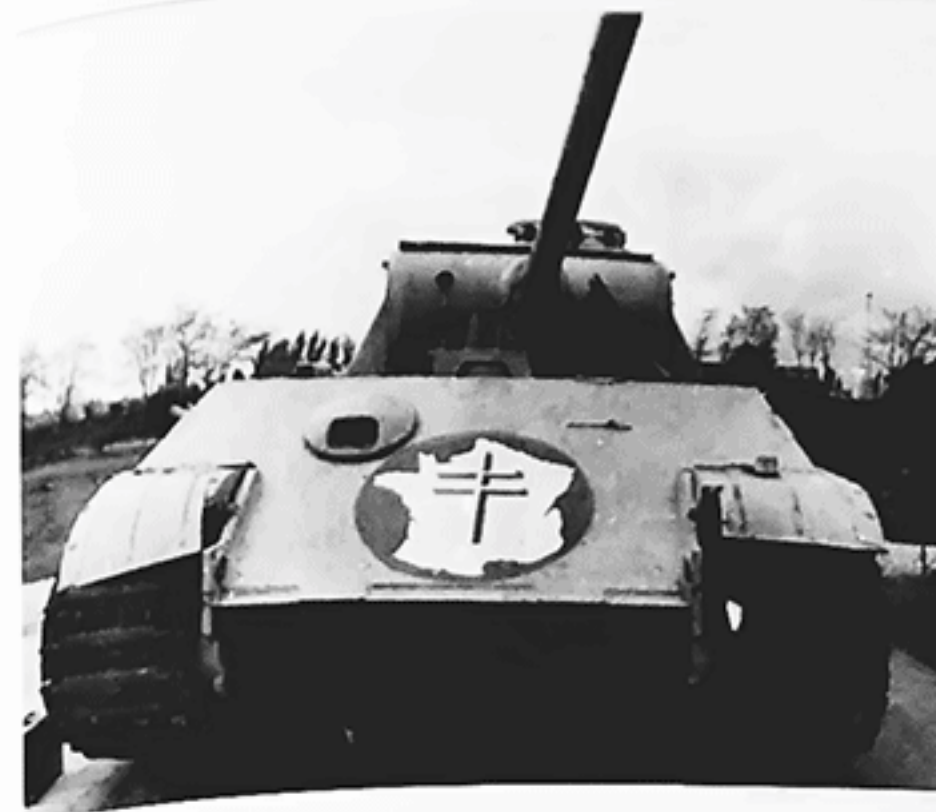
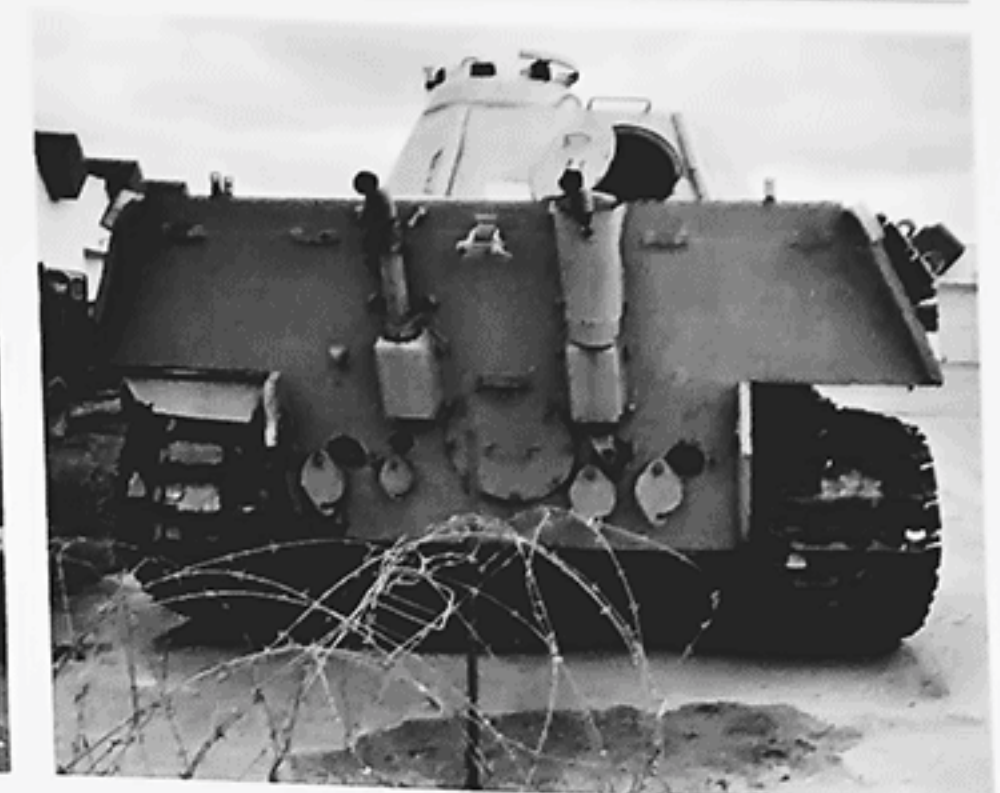
This page and opposite
Six views of the Panther Ausf. G (Fgst. Nr. 120790 completed by M.A.N. on or about 30 July 1944) preserved at the Musée Blindes in Saumur, France. A debris guard has been welded over the gap between the gun mantlet and the turret front. A handle was welded to the access hatch on the turret rear to aid opening and closing the hatch. Starting in May 1944, cast armor guards for the exhaust pipes were gradually replaced by welded armor guards. Starting in June 1944, sheet metal covers were introduced to hide the glow at night from heated exhaust pipes. (HLD)
