GERMANY'S

PANTHER

**TANK THE QUEST FOR
COMBAT SUPREMACY**

THE QUEST FOR COMBAT SUPREMACY
Development • Modifications • Rare Variants
Characteristics • Combat Accounts

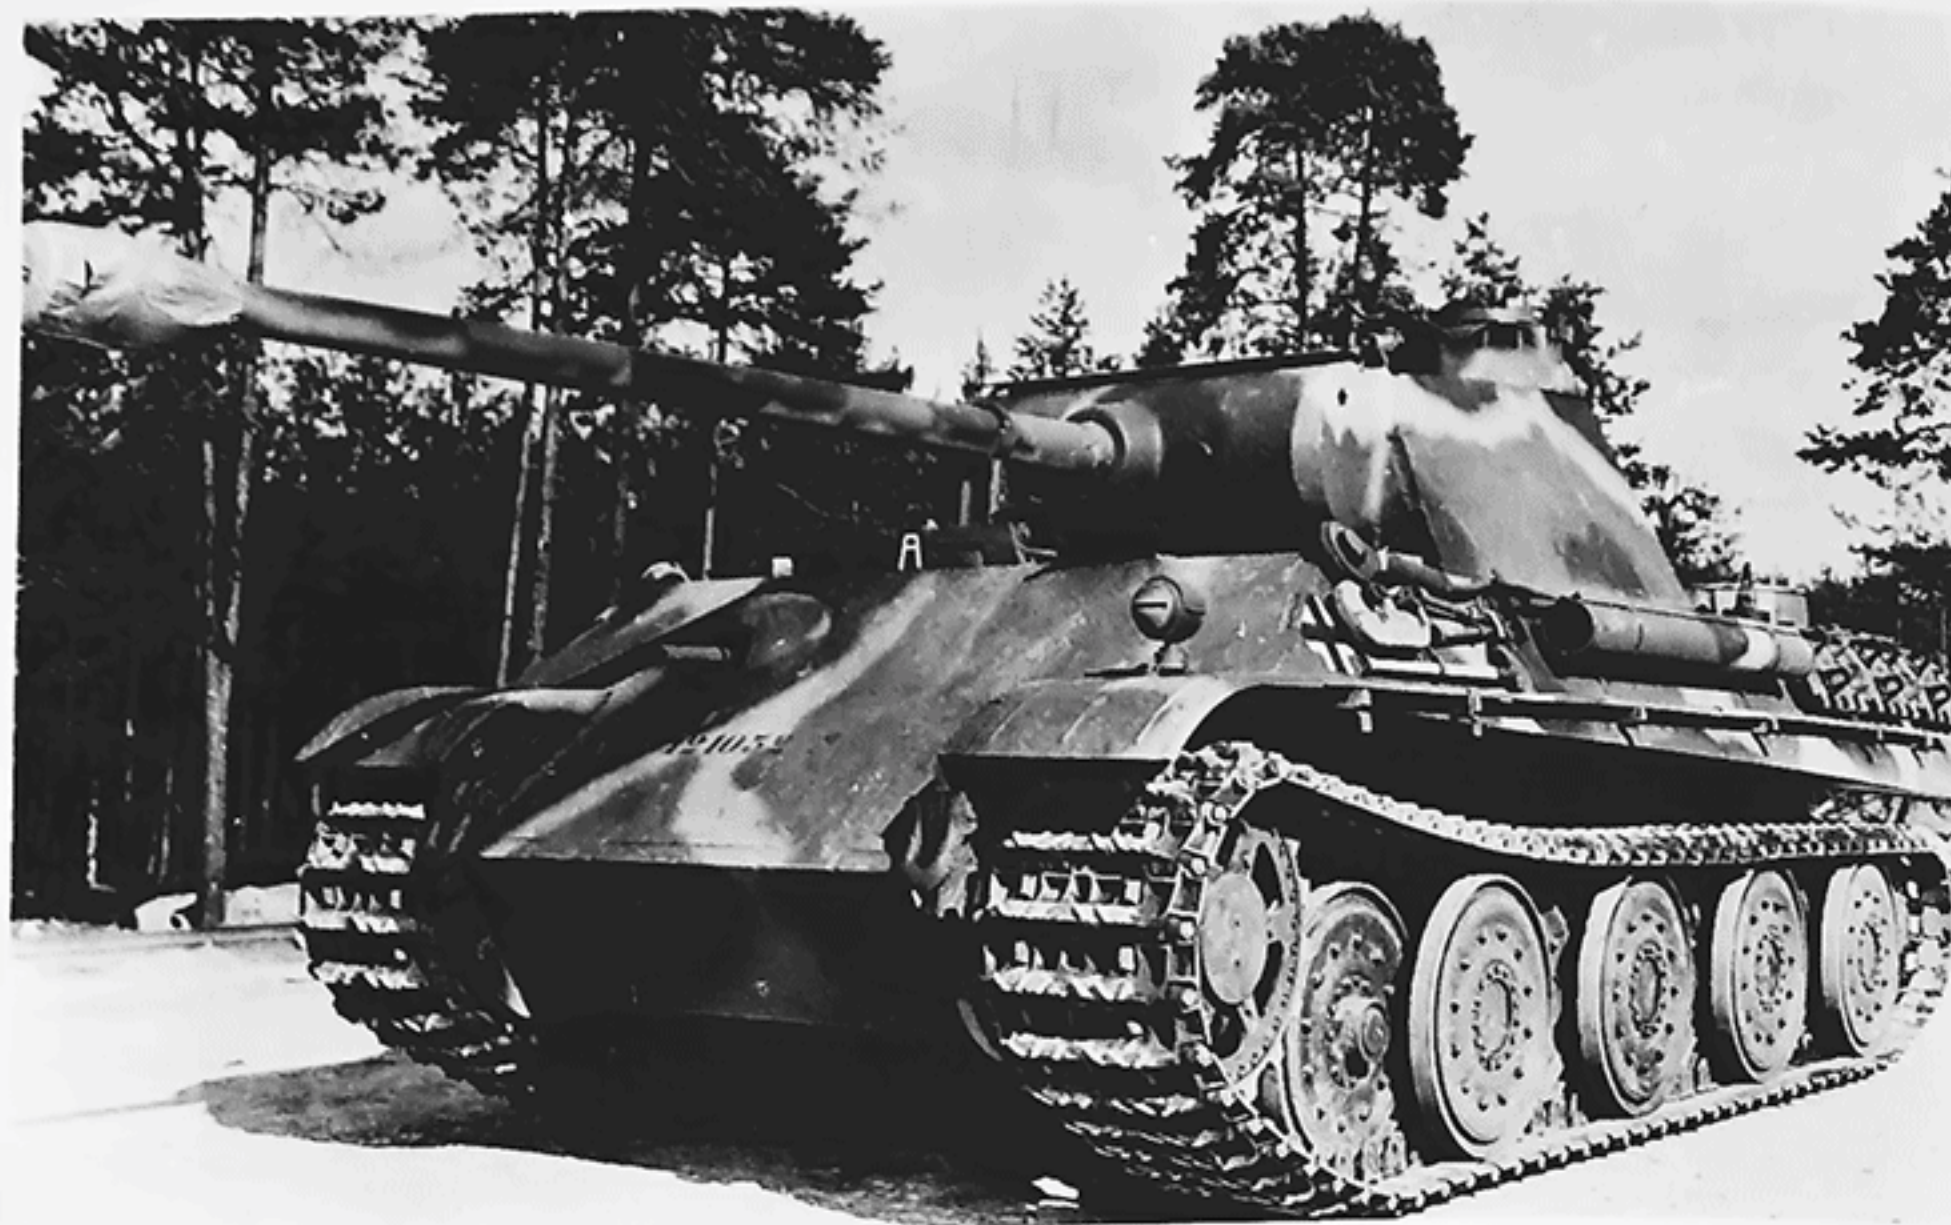
One of the small series of Panther Ausf. Gs (Fgst. Nr. 121052 completed by M.A.N. on or about 22 September 1944) outfitted with steel tyred roadwheels. These roadwheels were the same type used on the Tiger I and Tiger II but were mounted in the normal Panther pattern running on normal Panther tracks. By the time this Panther was completed Zimmerit anti-magnetic coating was no longer being applied. A rain guard has been fitted over the driver's visor. The fan tower on the rear deck was backfitted to this Panther. (NA)

Steel-tired roadwheels were mounted on the last station on several Panthers completed by M.A.N. in March/April 1945. It is not known if this was due to a shortage of rubber-tired roadwheels or installed as an attempt to reduce roadwheel failure.

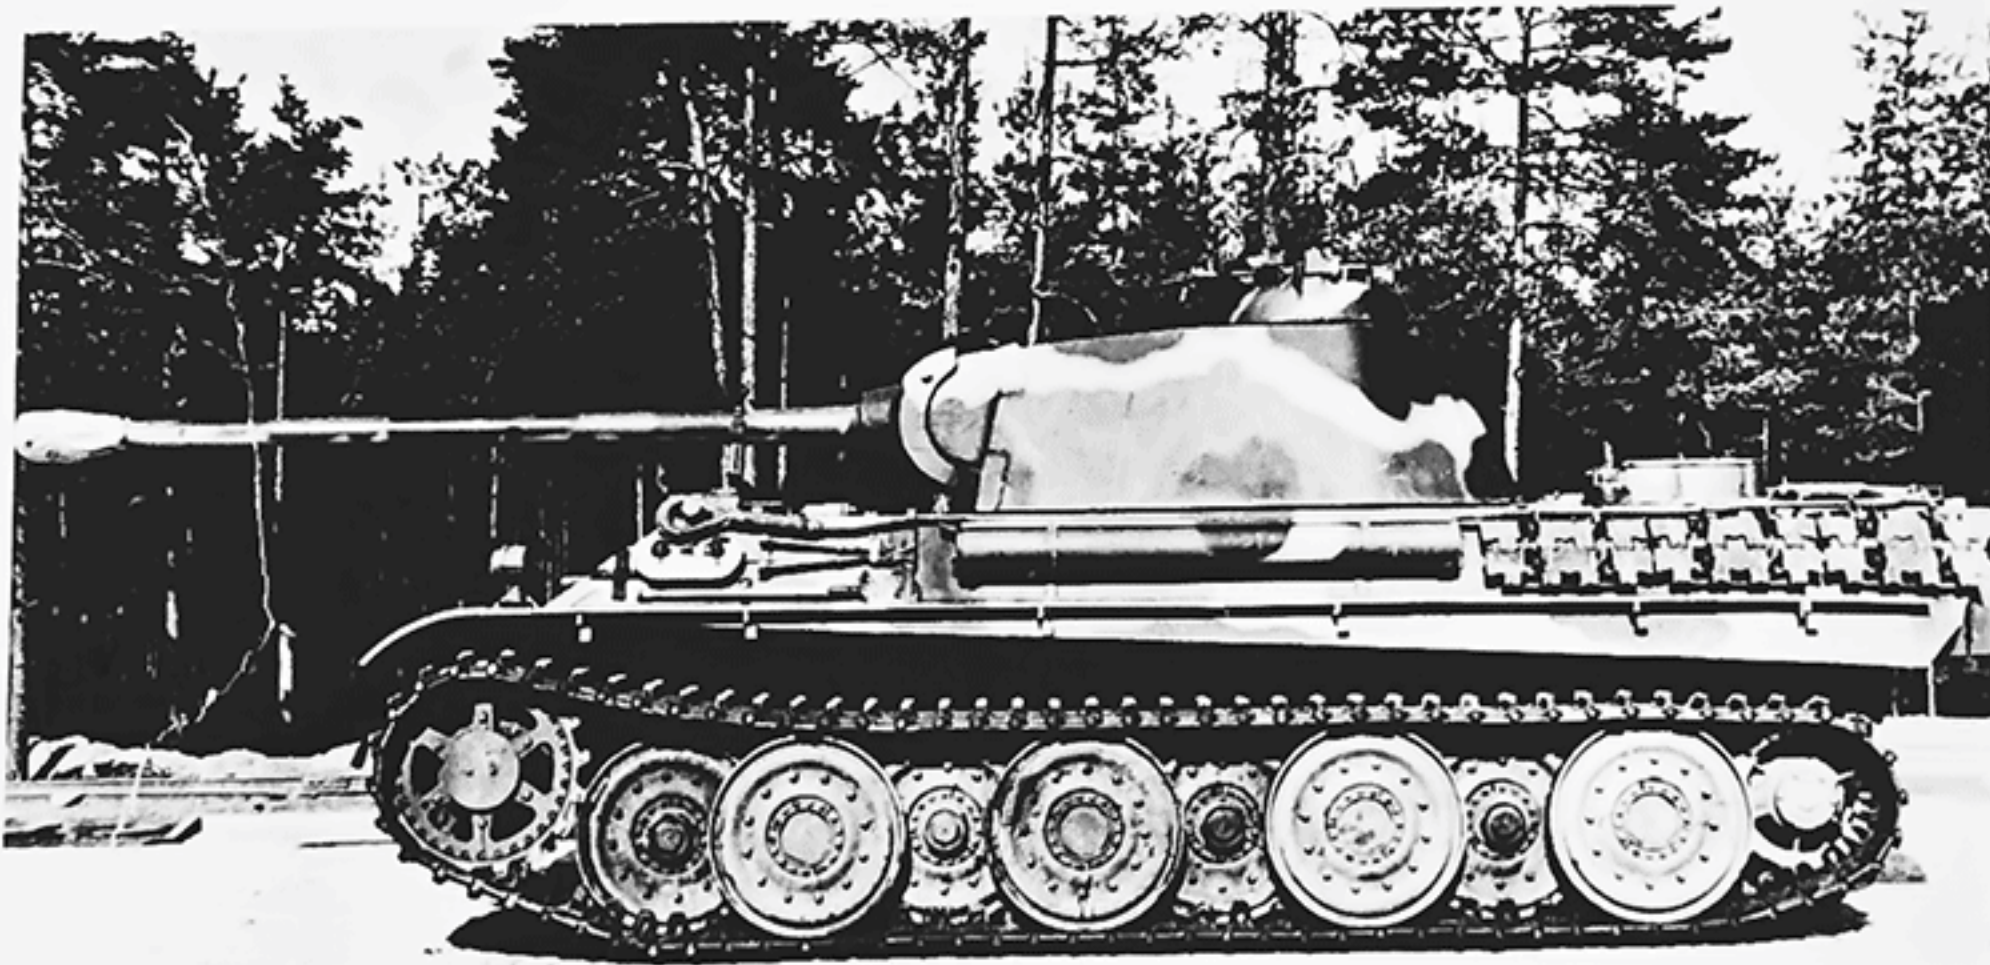
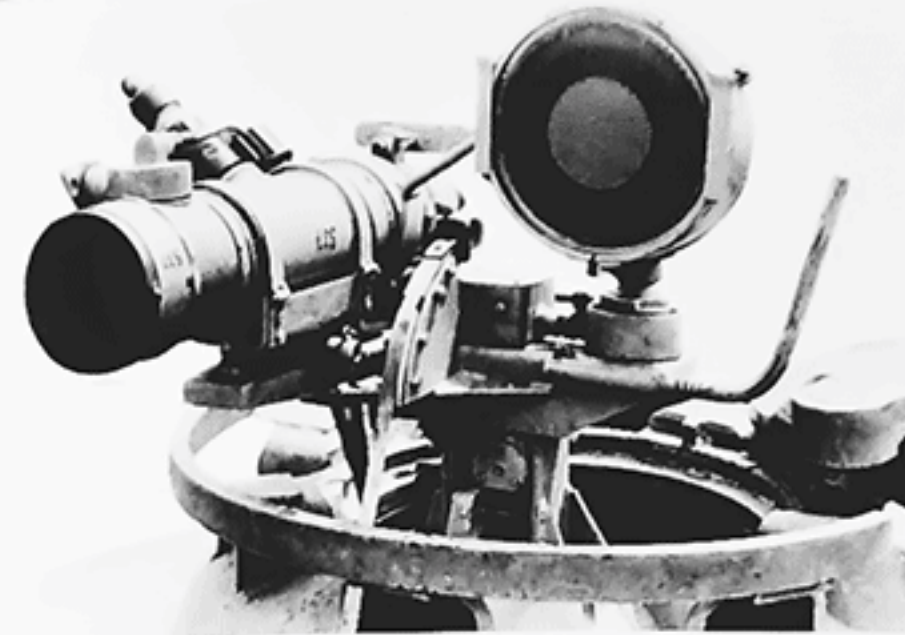
Above and right: The F.G. 1250 infrared searchlight and scope mounted on the commander's cupola of an Panther Ausf. G. The steel band was fed through a hole in the turret roof at the base of the cupola. This steel band, connected internally to an indicator, allowed the gunner to recognize when the elevation of the gun was on target (WJS)

5.3.15 INFRARED SEARCHLIGHT AND SCOPE

An aggressive program had been initiated to outfit Panthers and other armored vehicles with F.G.1250 infrared searchlights with scopes. Starting in June 1944, Leitz, Wetzlar had delivered significant numbers of F.G.1250. However, the desire to maintain secrecy prior to mass employment and the failures revealed in a major trial exercise, delayed the first combat test, involving a single company of Panthers, until March 1945.

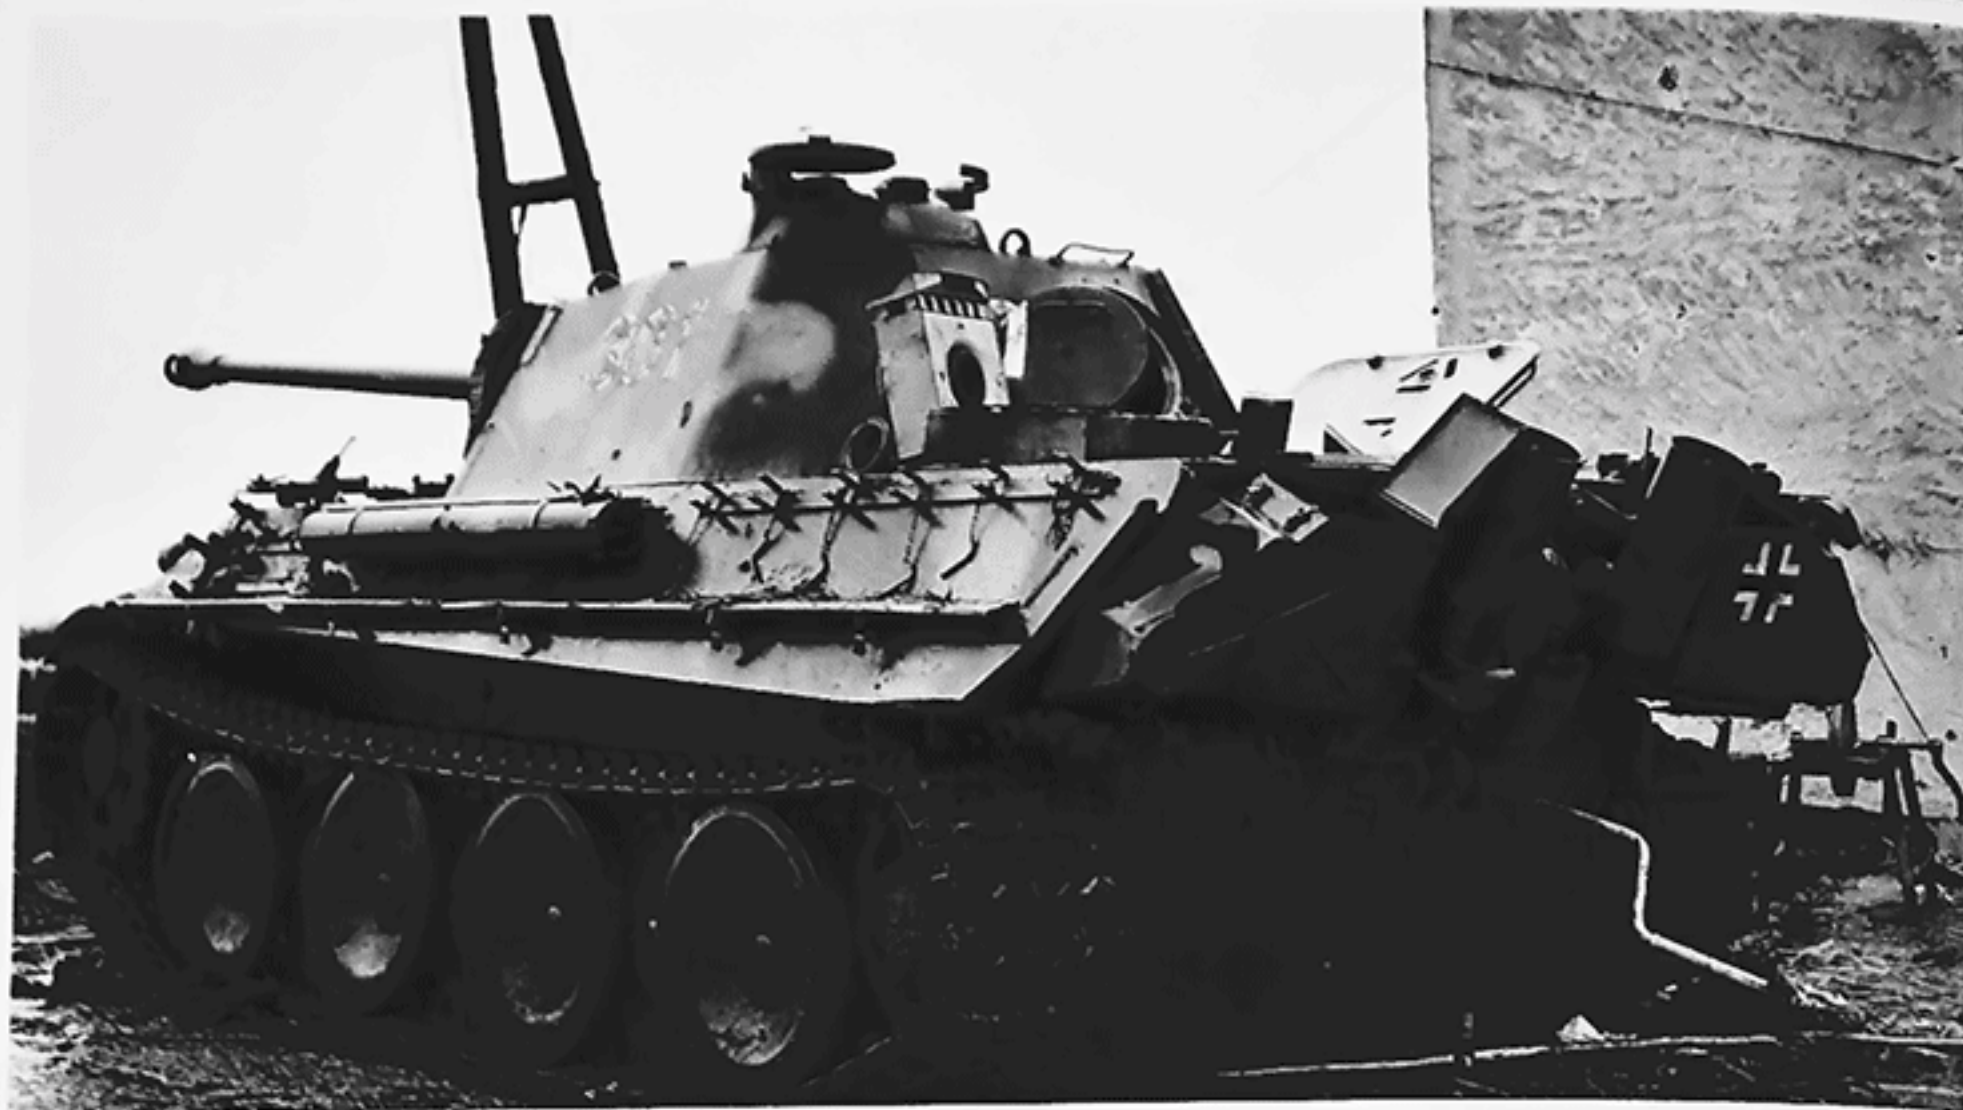
Panther Ausf. G, Tactical No. 301, with a "chin" gun mantlet, without Zimmerit, with Flammvernichter exhaust mufflers, a Kampf-raumheizung crew compartment heater, and larger diameter self-cleaning idler wheels. (NA)

Starting in October 1944, the temporary solution of sheet metal covers over the exhaust pipes was replaced by **Flammenvernichter** (flame suppressor) mufflers that prevented glowing and flaming exhausts at night. MNH first mounted the **Flammenvernichter** starting with Panther Ausf.G Fgst.Nr. 128875 (completed on 8 December 1944).

Starting in October 1944, a 650 mm diameter self-cleaning idler wheel replaced the smaller idler that had given problems through build-up of mud and ice. (TTM)

Above and below: Starting in October 1944, a fan tower for the **Kampfraumheizung** (crew compartment heater) was mounted over the right cooling air exhaust fan. Heated air was diverted into the crew compartment when six pie-shaped covers were installed to seal the top of the fan tower. (TLJ)

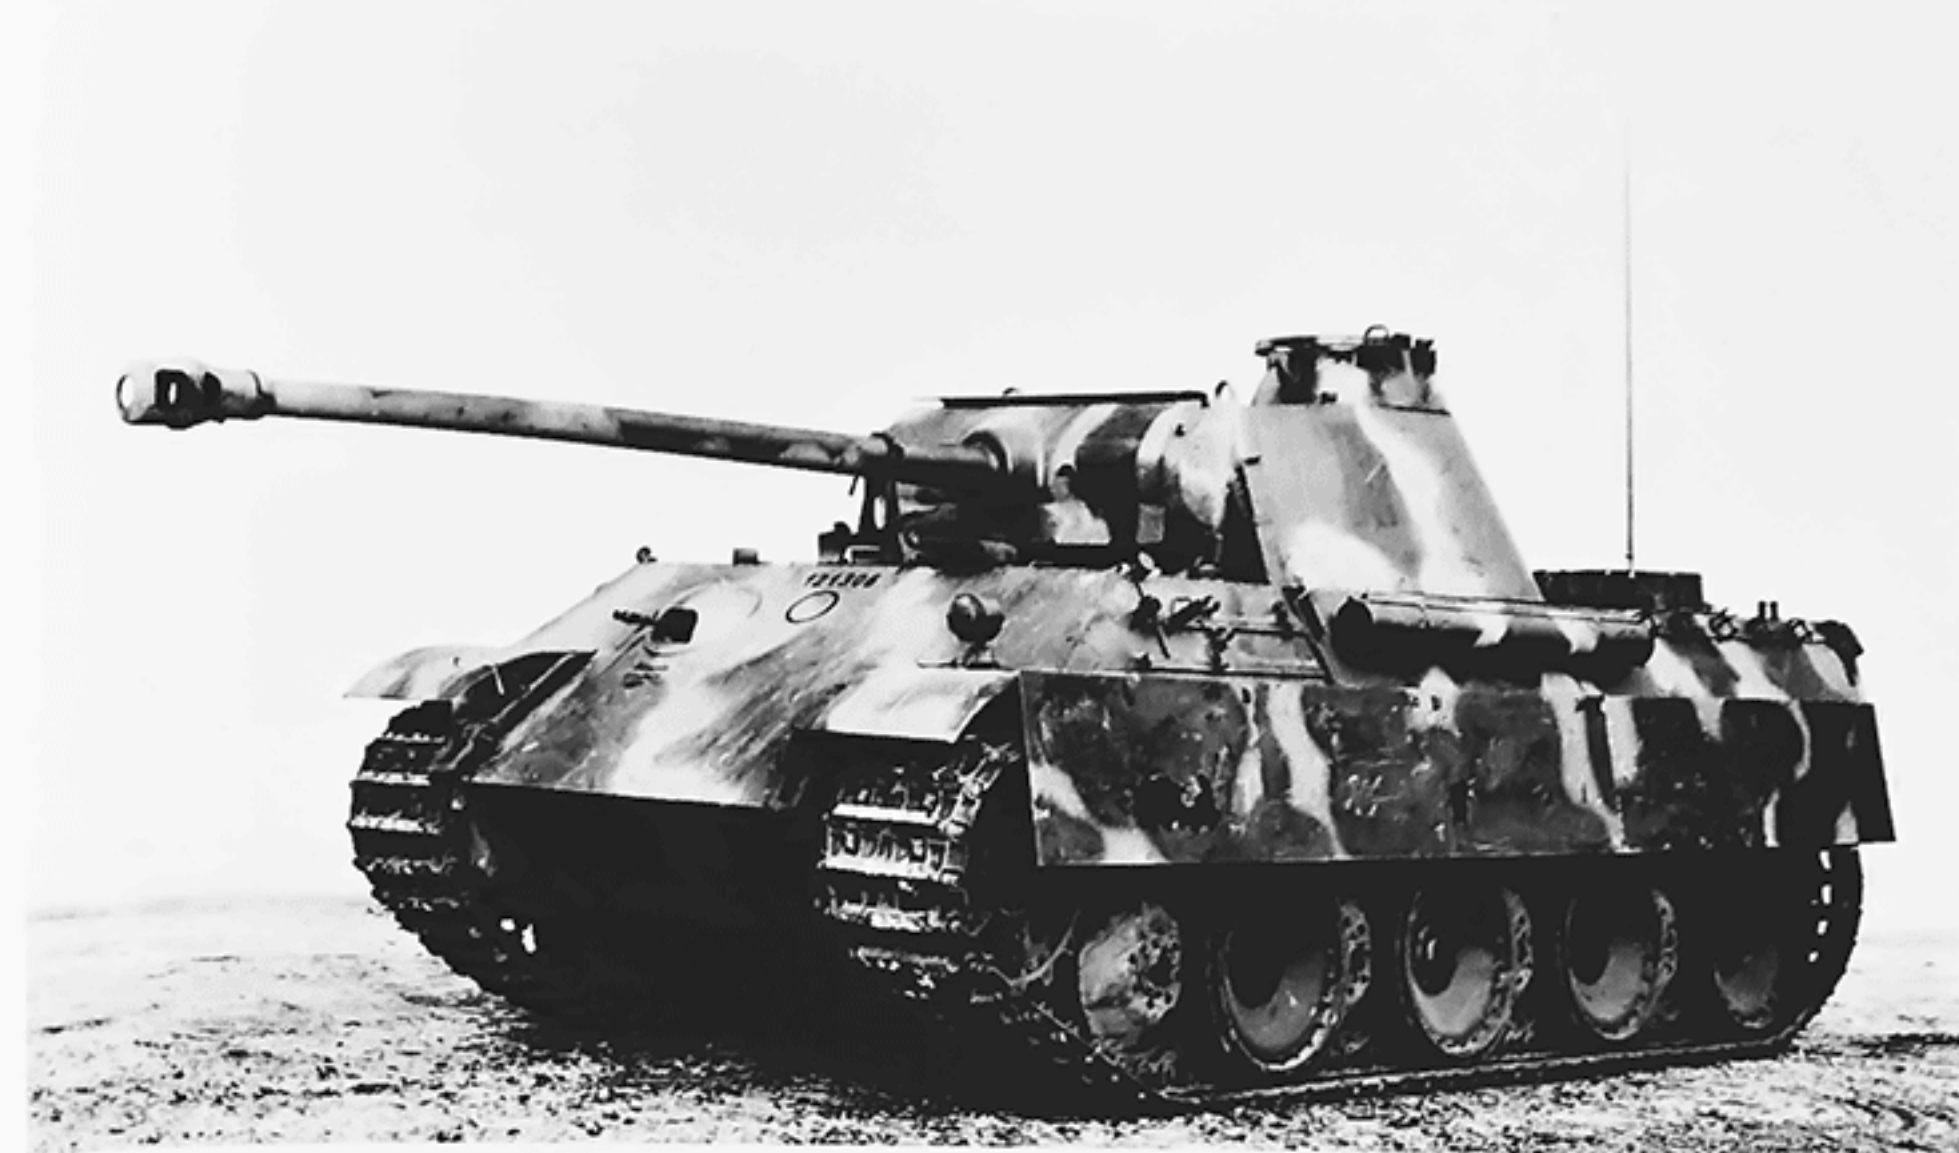
Panther Ausf. G (Fgst.Nr. 121306 completed by M.A.N. on or about 11 December 1944) was tested by Wa Pruef 6. It had a "Chin" gun mantlet and Kampf-raumheizung (crew compartment heater). The cylindrical canister for stowing the gun cleaning rods and spare antenna rods is still on the left superstructure side where it was fastened to all Panthers when they left the assembly plant. (WJS)

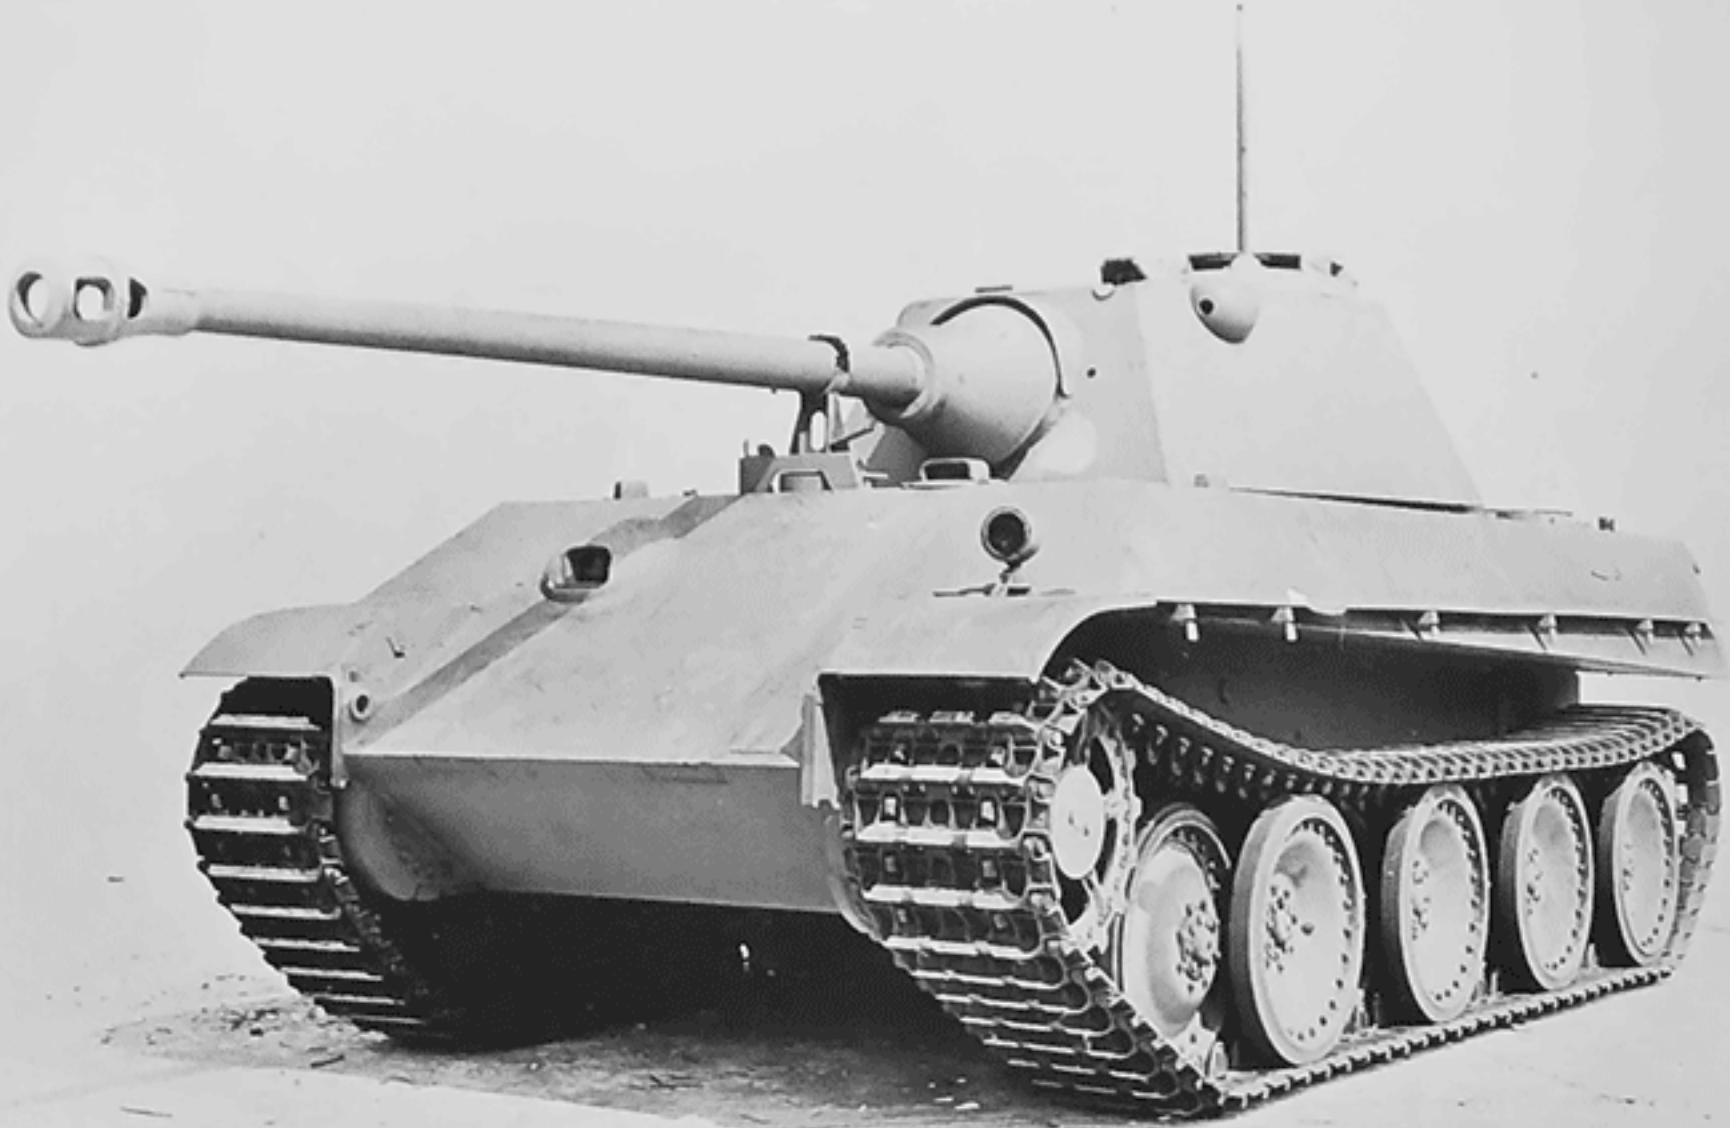
Above and opposite above: A **Versuchs-Schmalturm** (experimental narrow turret) mounted on a Panther Ausf.G chassis manufactured for Wa Pruef 6 (no tool or equipment stowage). These photographs dated 20 August 1944 reveal that experimental work had proceeded on the **Schmalturm** at a much earlier date than previously thought. An aperture for a "monocular" gun sight (not the binocular **T.Z.F.13**) has been drilled in the turret front. A periscopic gun sight is mounted in the left front turret roof. The redesigned commander's cupola had a hole for extending the **T.S.R.1** observation periscope without opening the hatch. (BA)

6.1.2 SCHMALTURM

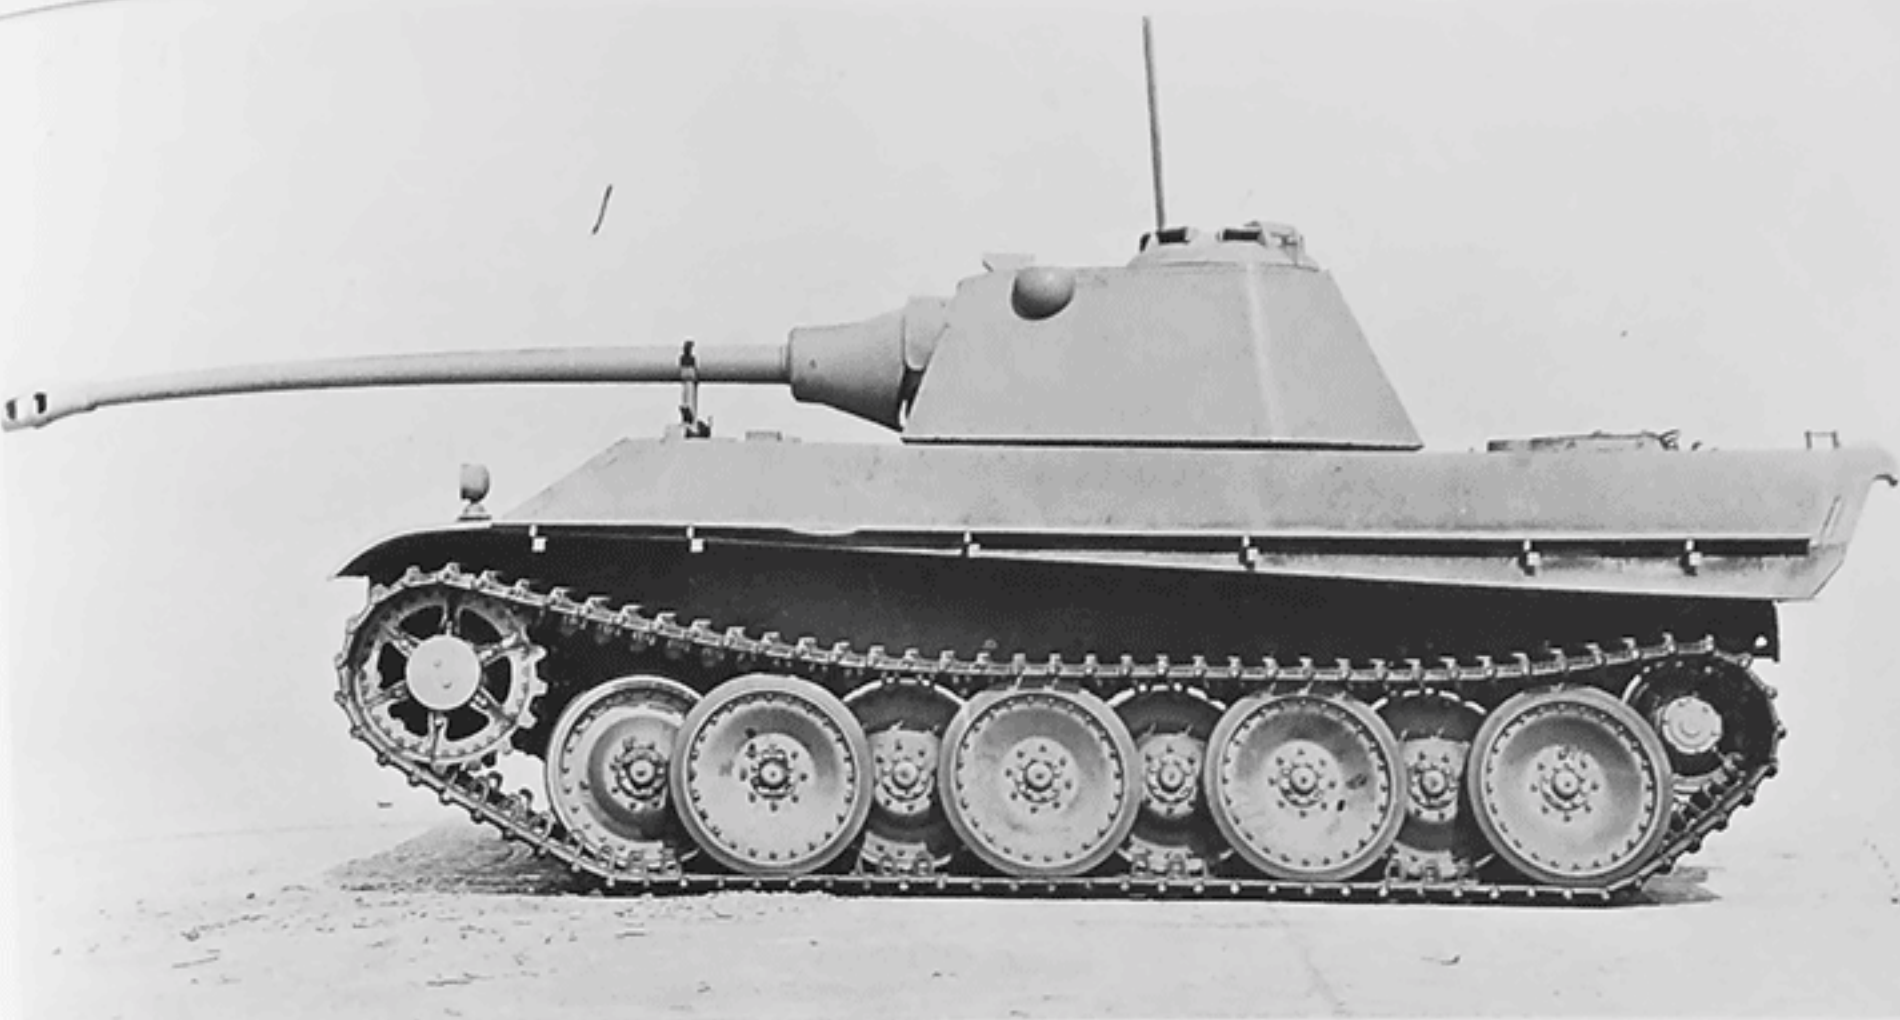
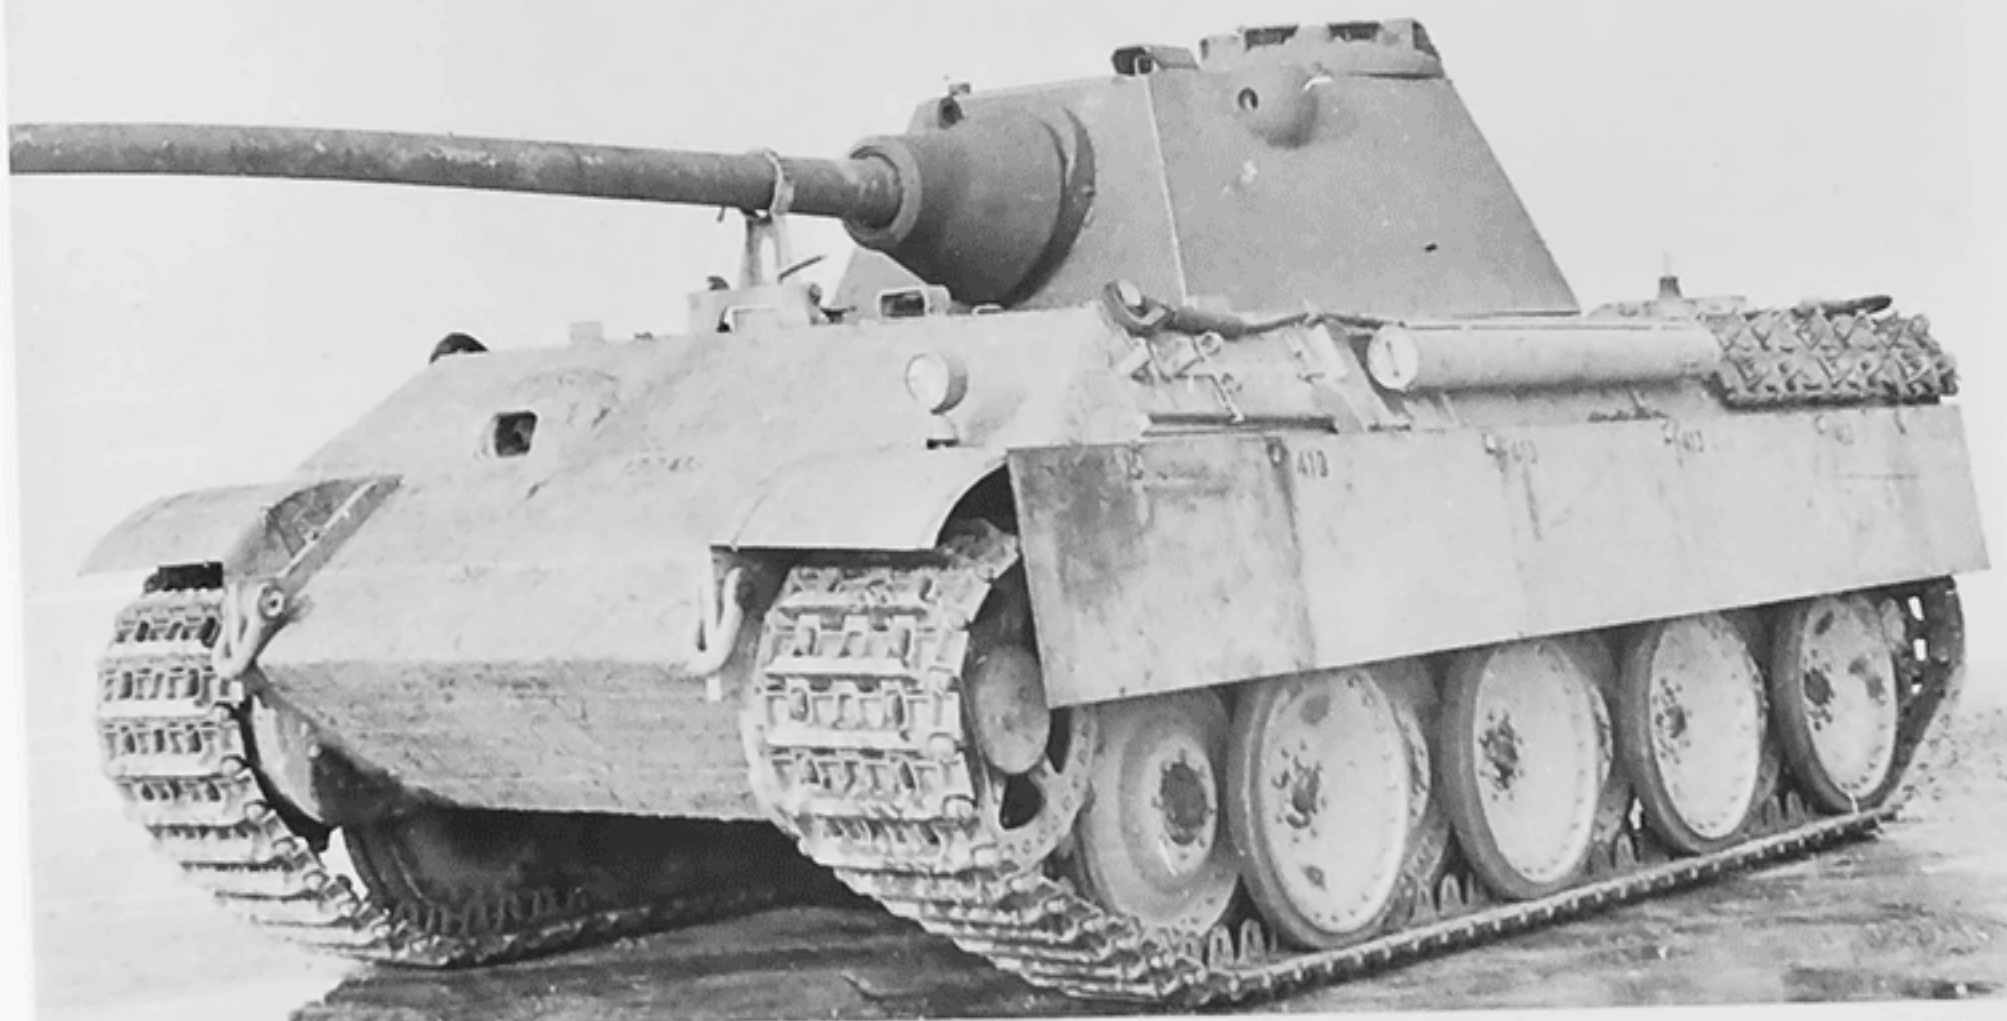
A second **Versuchs-Schmalturm** mounted on a Panther Ausf.G chassis. The chassis (Fgst.Nr.120413) was completed by M.A.N. for issue to the troops in early May 1944. No hole is evident for a telescopic gun sight in the turret front, only a periscope projecting through the turret roof. The sheet metal debris guard covering the gap between the gun mantlet and the turret front had not been welded on. (WJS)

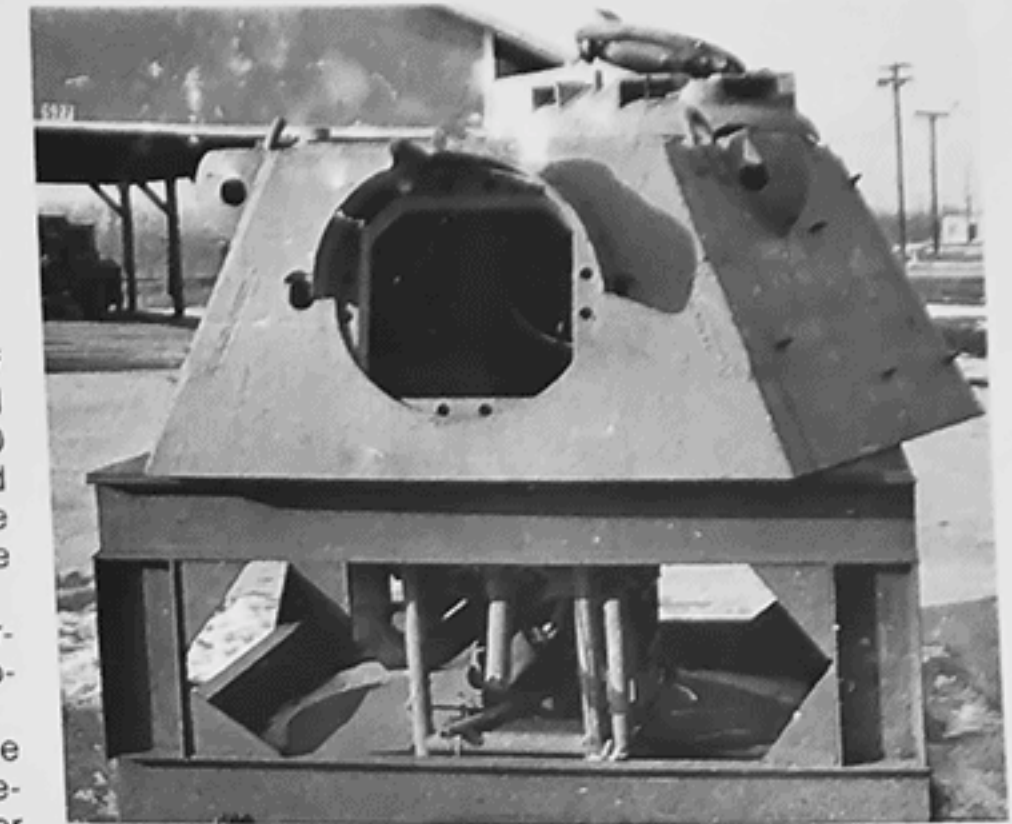
This **Schmalturm** shipped to Aberdeen Proving Grounds for examination is unique in that there is an aperture in the turret front for a telescopic sight but it does not have an aperture for a periscopic sight. The five rings welded to the turret side and the brackets for fastening the poison gas warning panels attest to the fact that this turret was being assembled in a normal production series. (TTM)

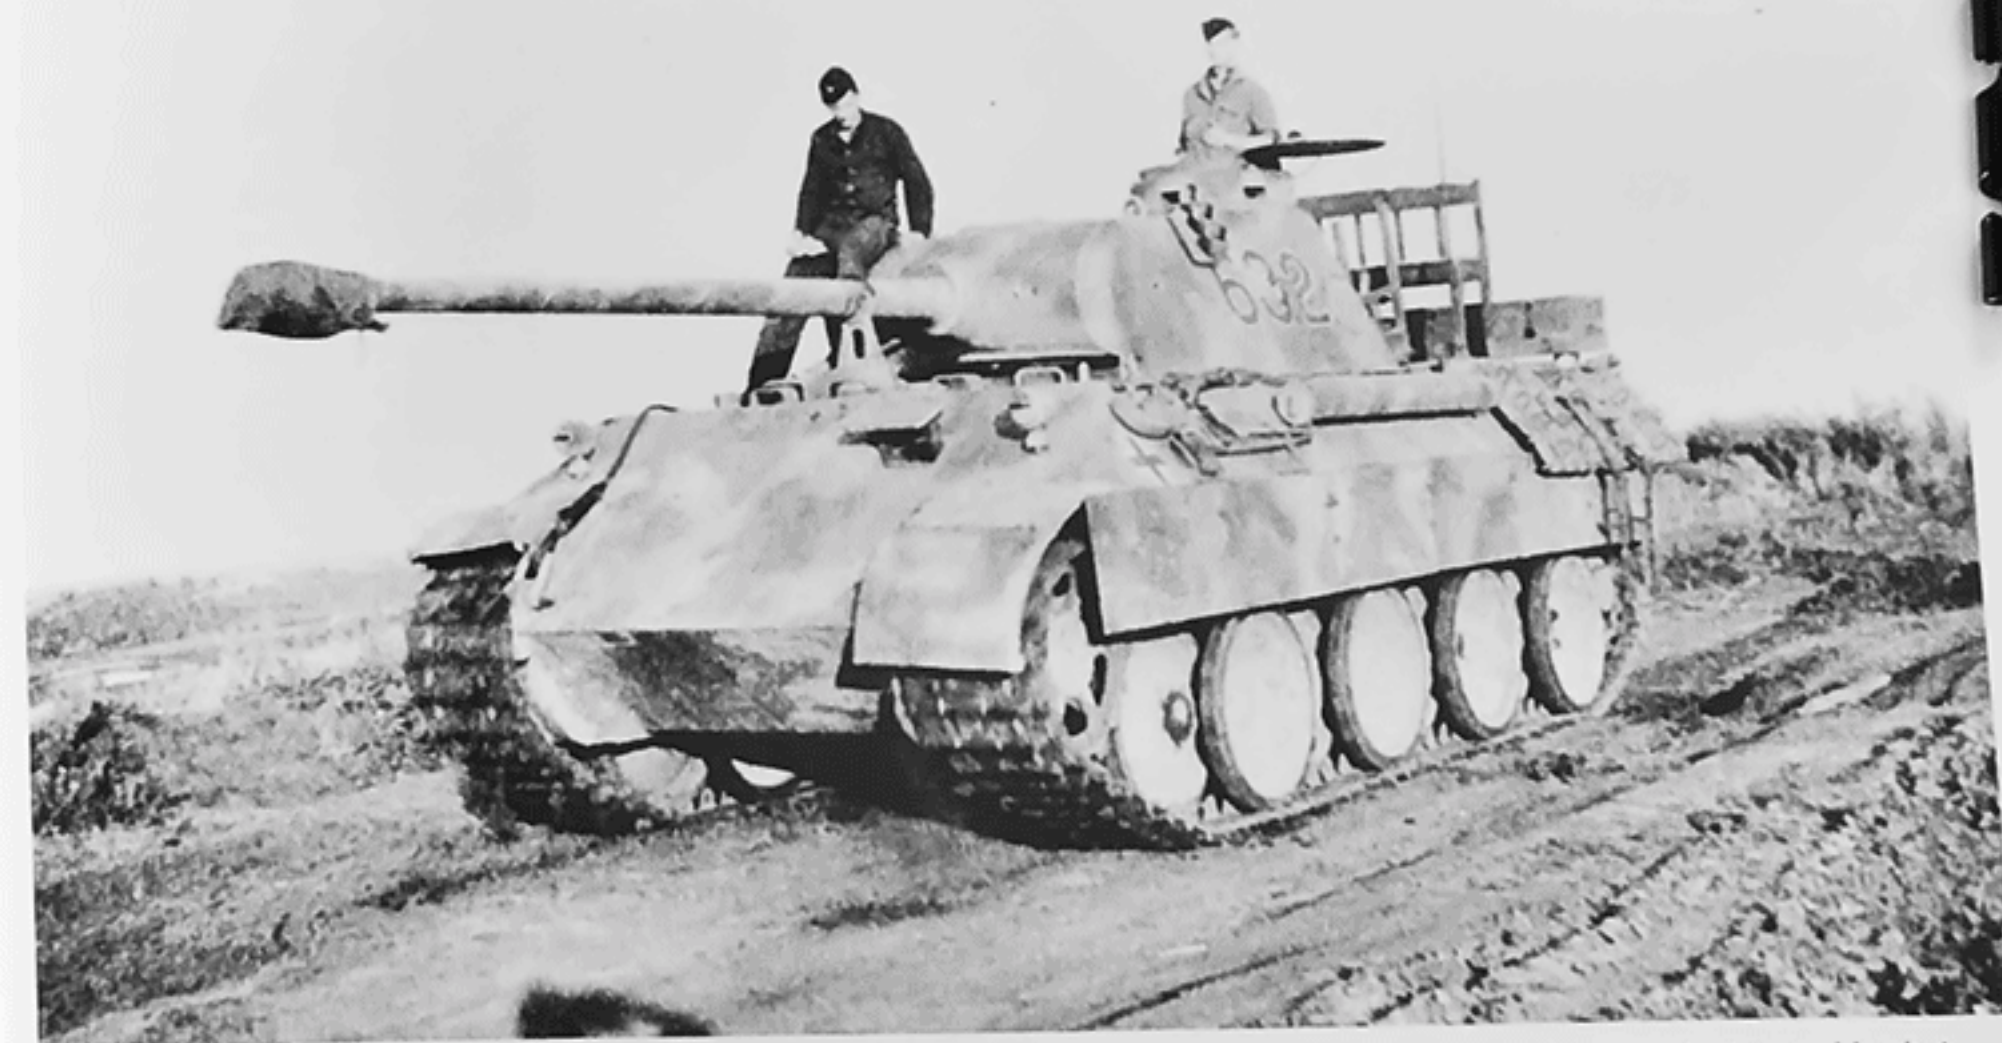
Panther Ausf.D (Tactical No. 632) with Panzer-Abteilung 52. The smoke candle dischargers are still mounted on the turret sides but they are empty. (KHM)

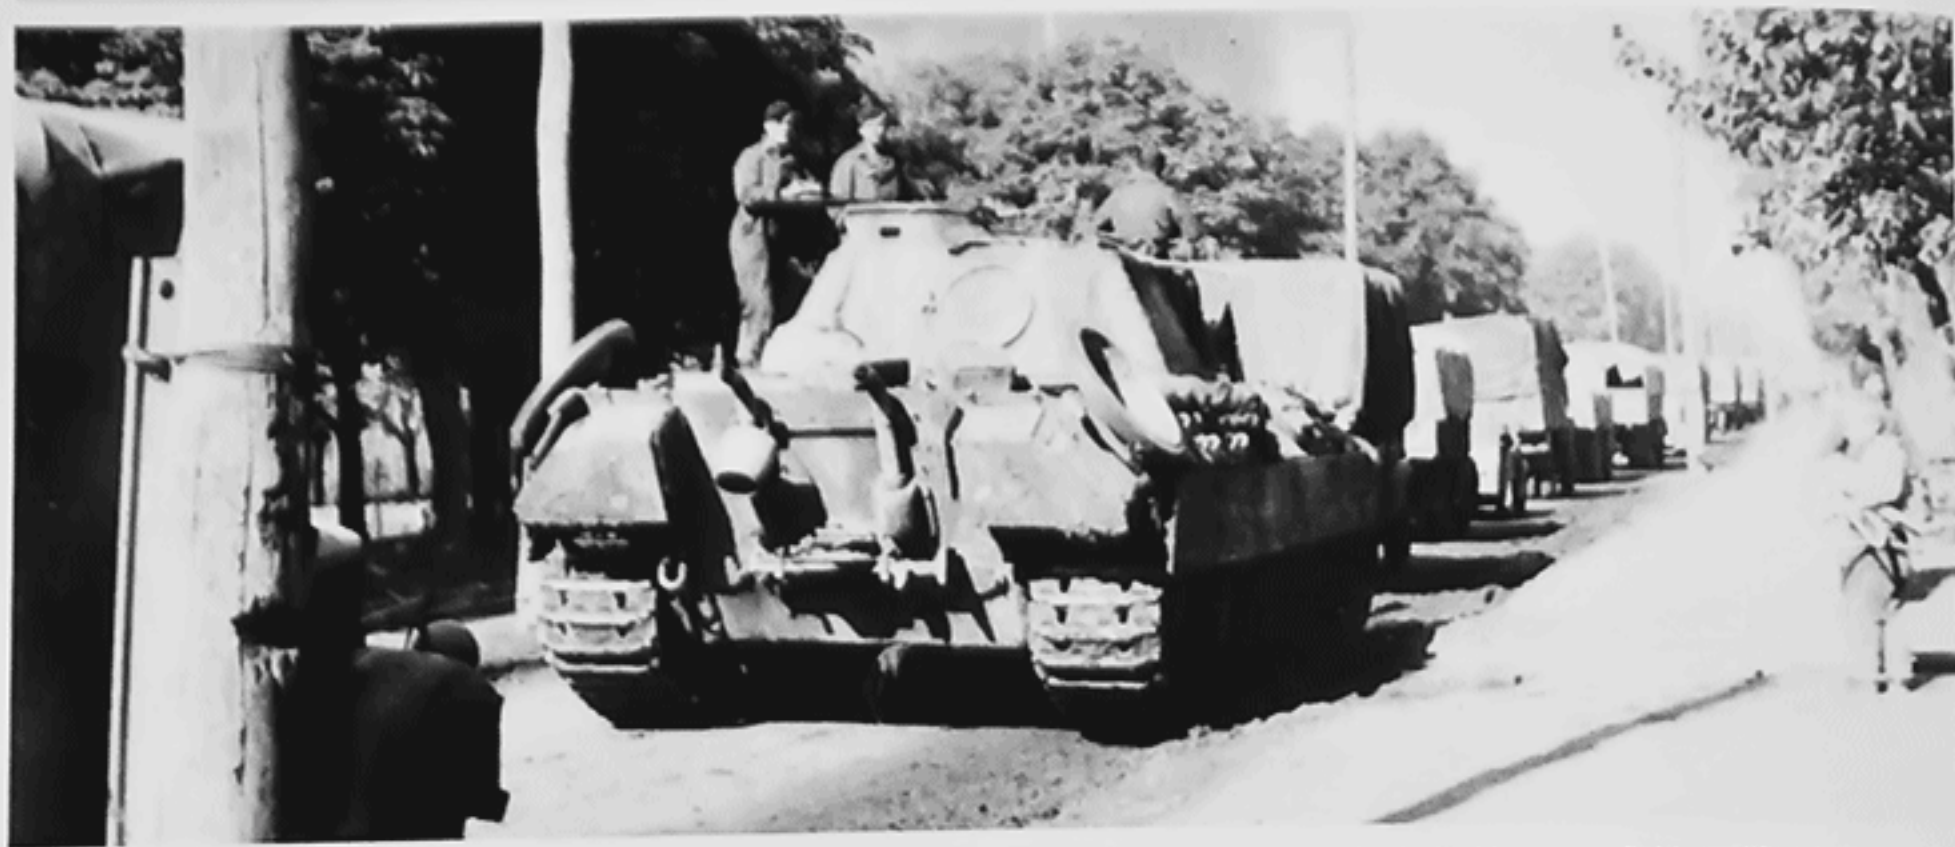
Panther Ausf.D in convoy near Poltova in September 1943. The spare roadwheels mounted on the hull sides are a field modification. (KHM)
