GERMANY'S

PANTHER

**TANK THE QUEST FOR
COMBAT SUPREMACY**

THE QUEST FOR COMBAT SUPREMACY
Development • Modifications • Rare Variants
Characteristics • Combat Accounts

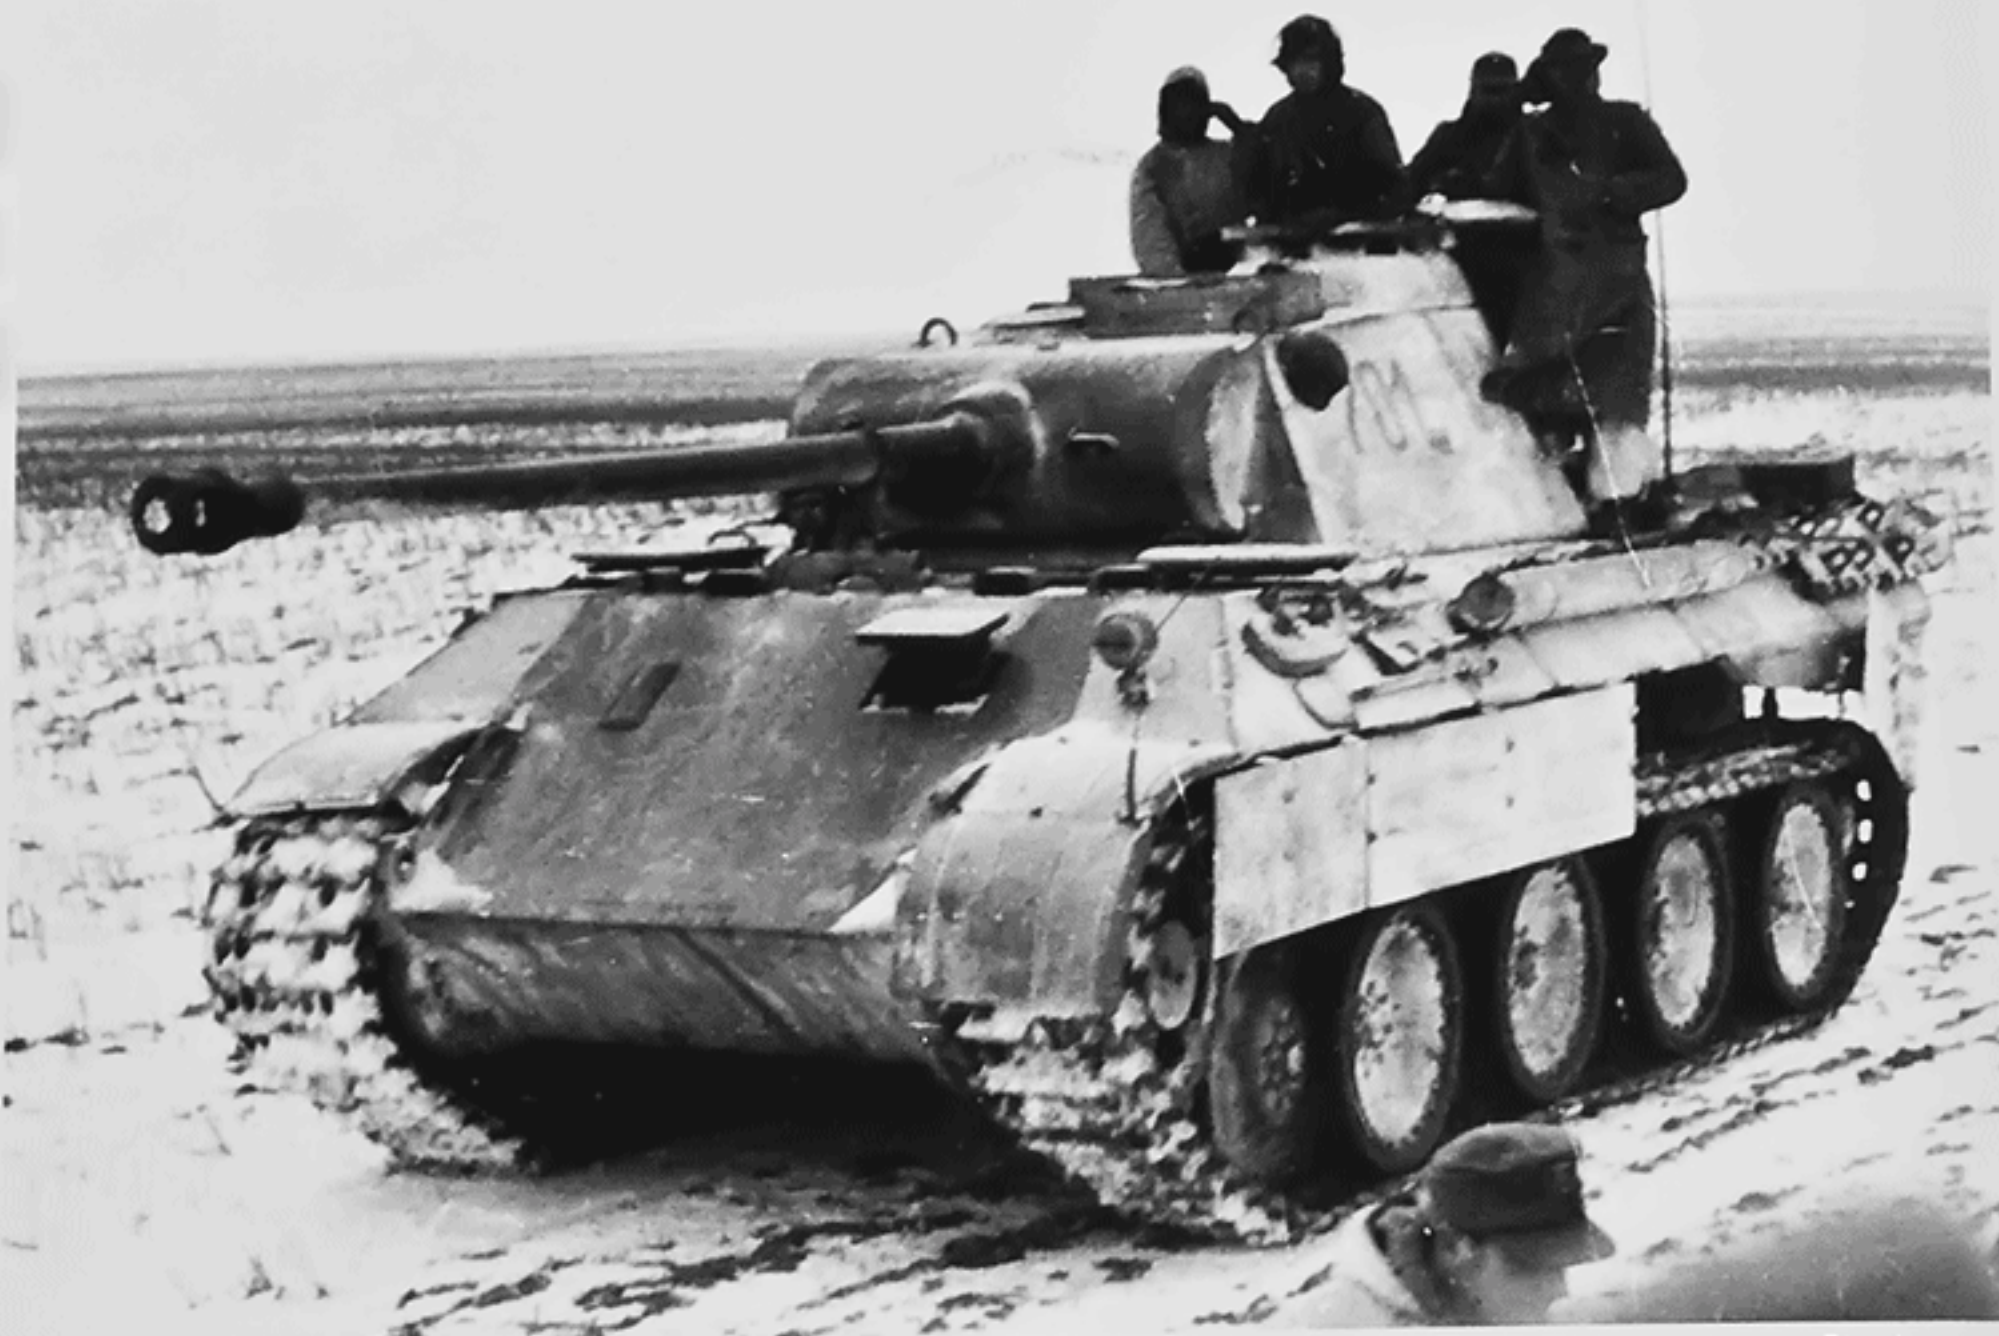
Some of the Ausf.As produced in August and September 1943 did not receive a coating of **Zimmerit** applied at the factory. Pistol ports are still present on the turret sides and rear along with the binocular **T.Z.F.12**. (BA)

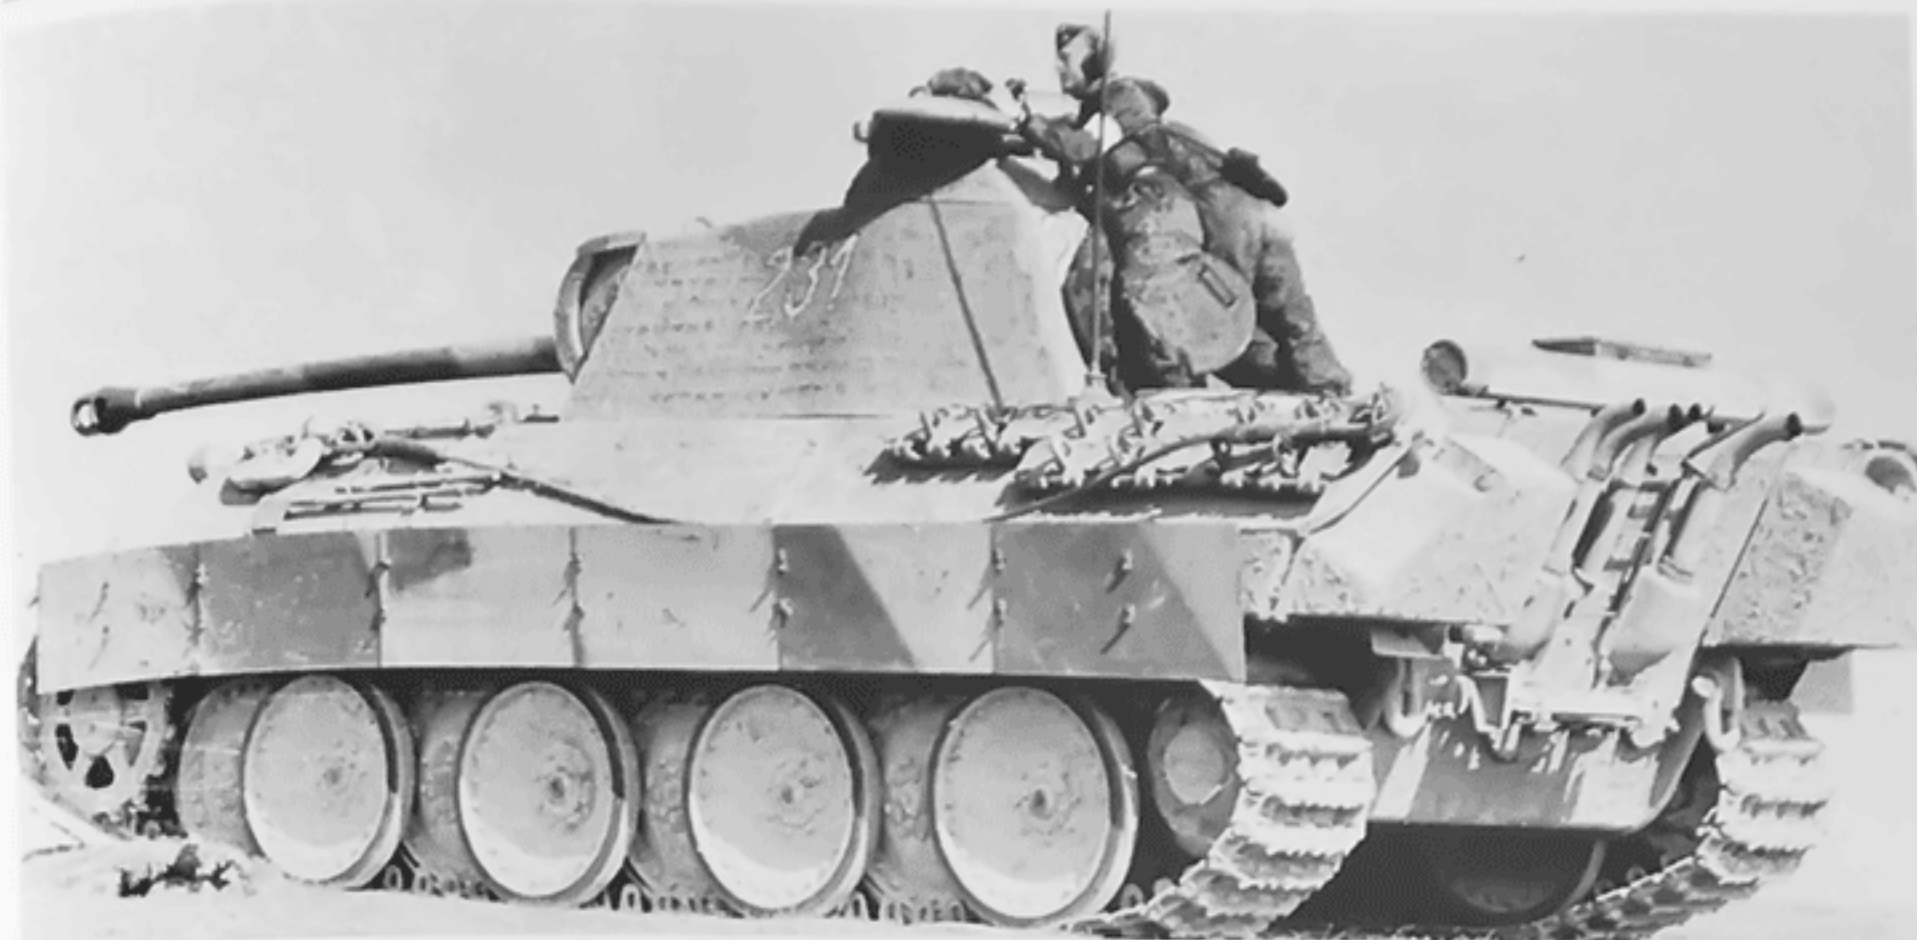
Panther Ausf. A (Tactical No. 231) with the twin pipes parallel to the left exhaust pipe and the jack still mounted horizontally across the engine access hatch. The cylindrical container for the gun cleaning rods has been relocated to a position across the hull rear by the field unit. (BA)

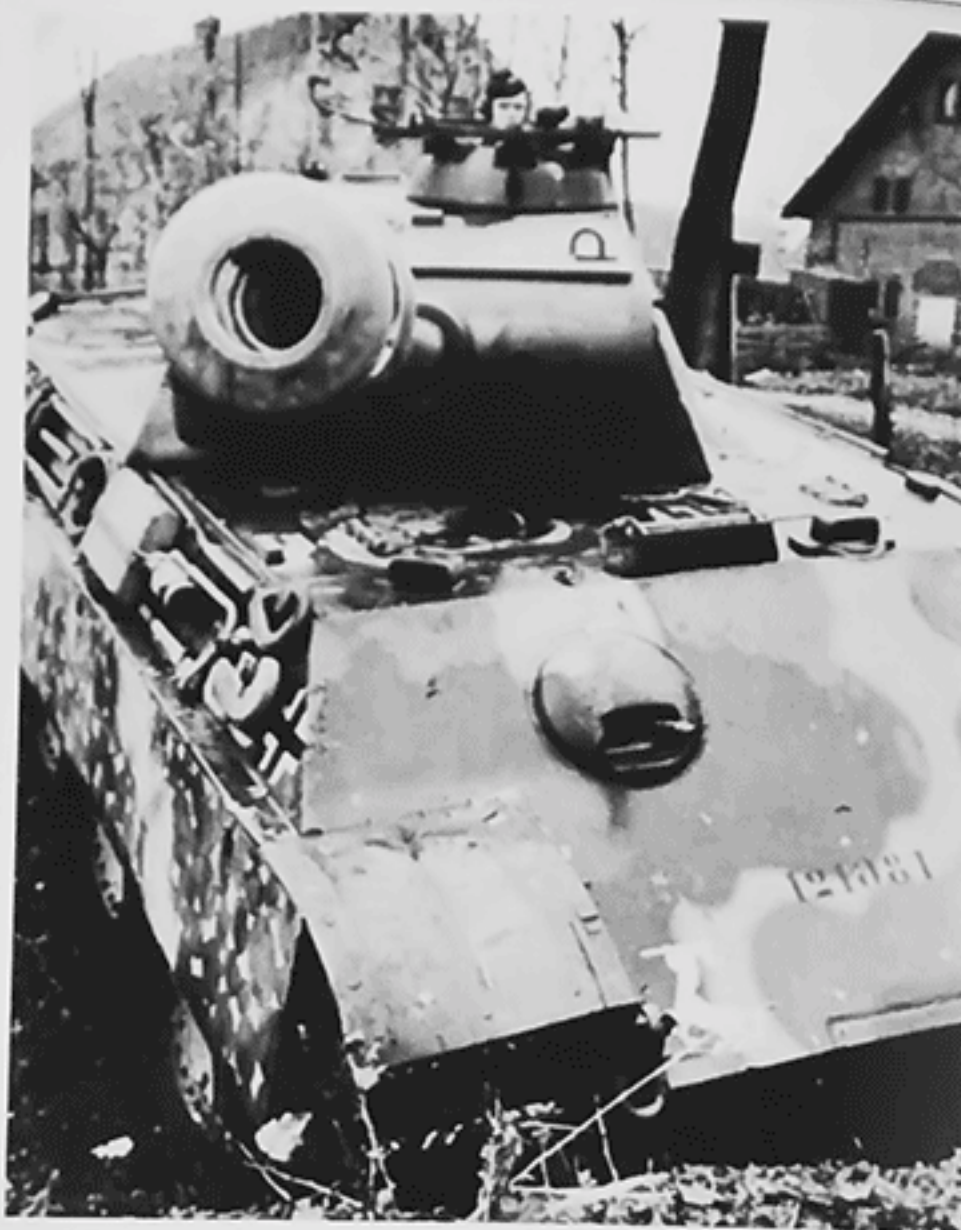
Panther Ausf. G (Fgst.Nr. 121081 completed at M.A.N. in late September 1944) was issued to I.Abteilung/Panzer-Regiment "Hermann Goering." Zimmerit was not applied and patches of camouflage paint were sparingly applied to the red oxide primer base coat. (JW)

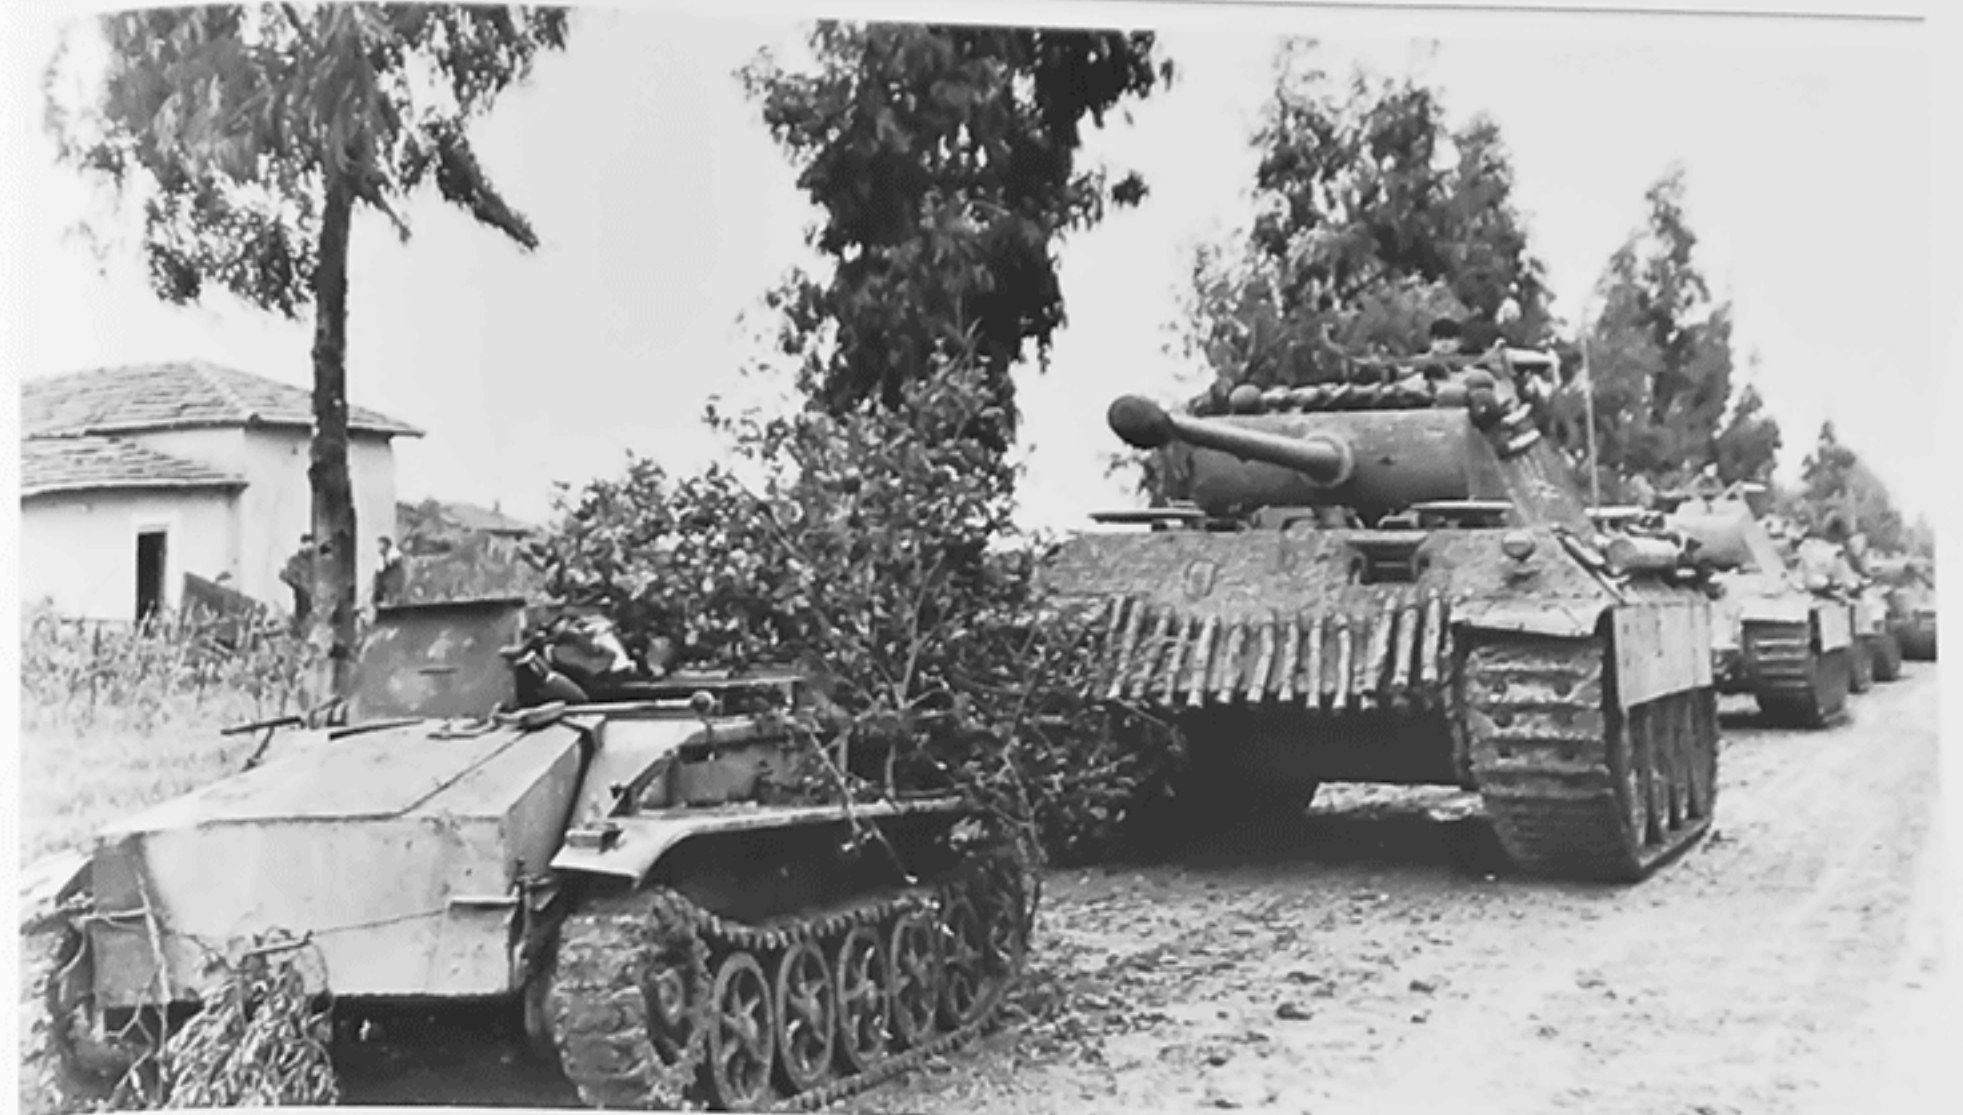
A column of Panthers with the I.Abteilung/Panzer-Regiment 4 waiting to attack at Anzio. Most of the Panthers were Ausf. A with a few Ausf. D. The lead Panther Ausf. A has a monocular T.Z.F.12a gun sight but still has the "Letterbox" machinegun port in the glacis plate. (BA)

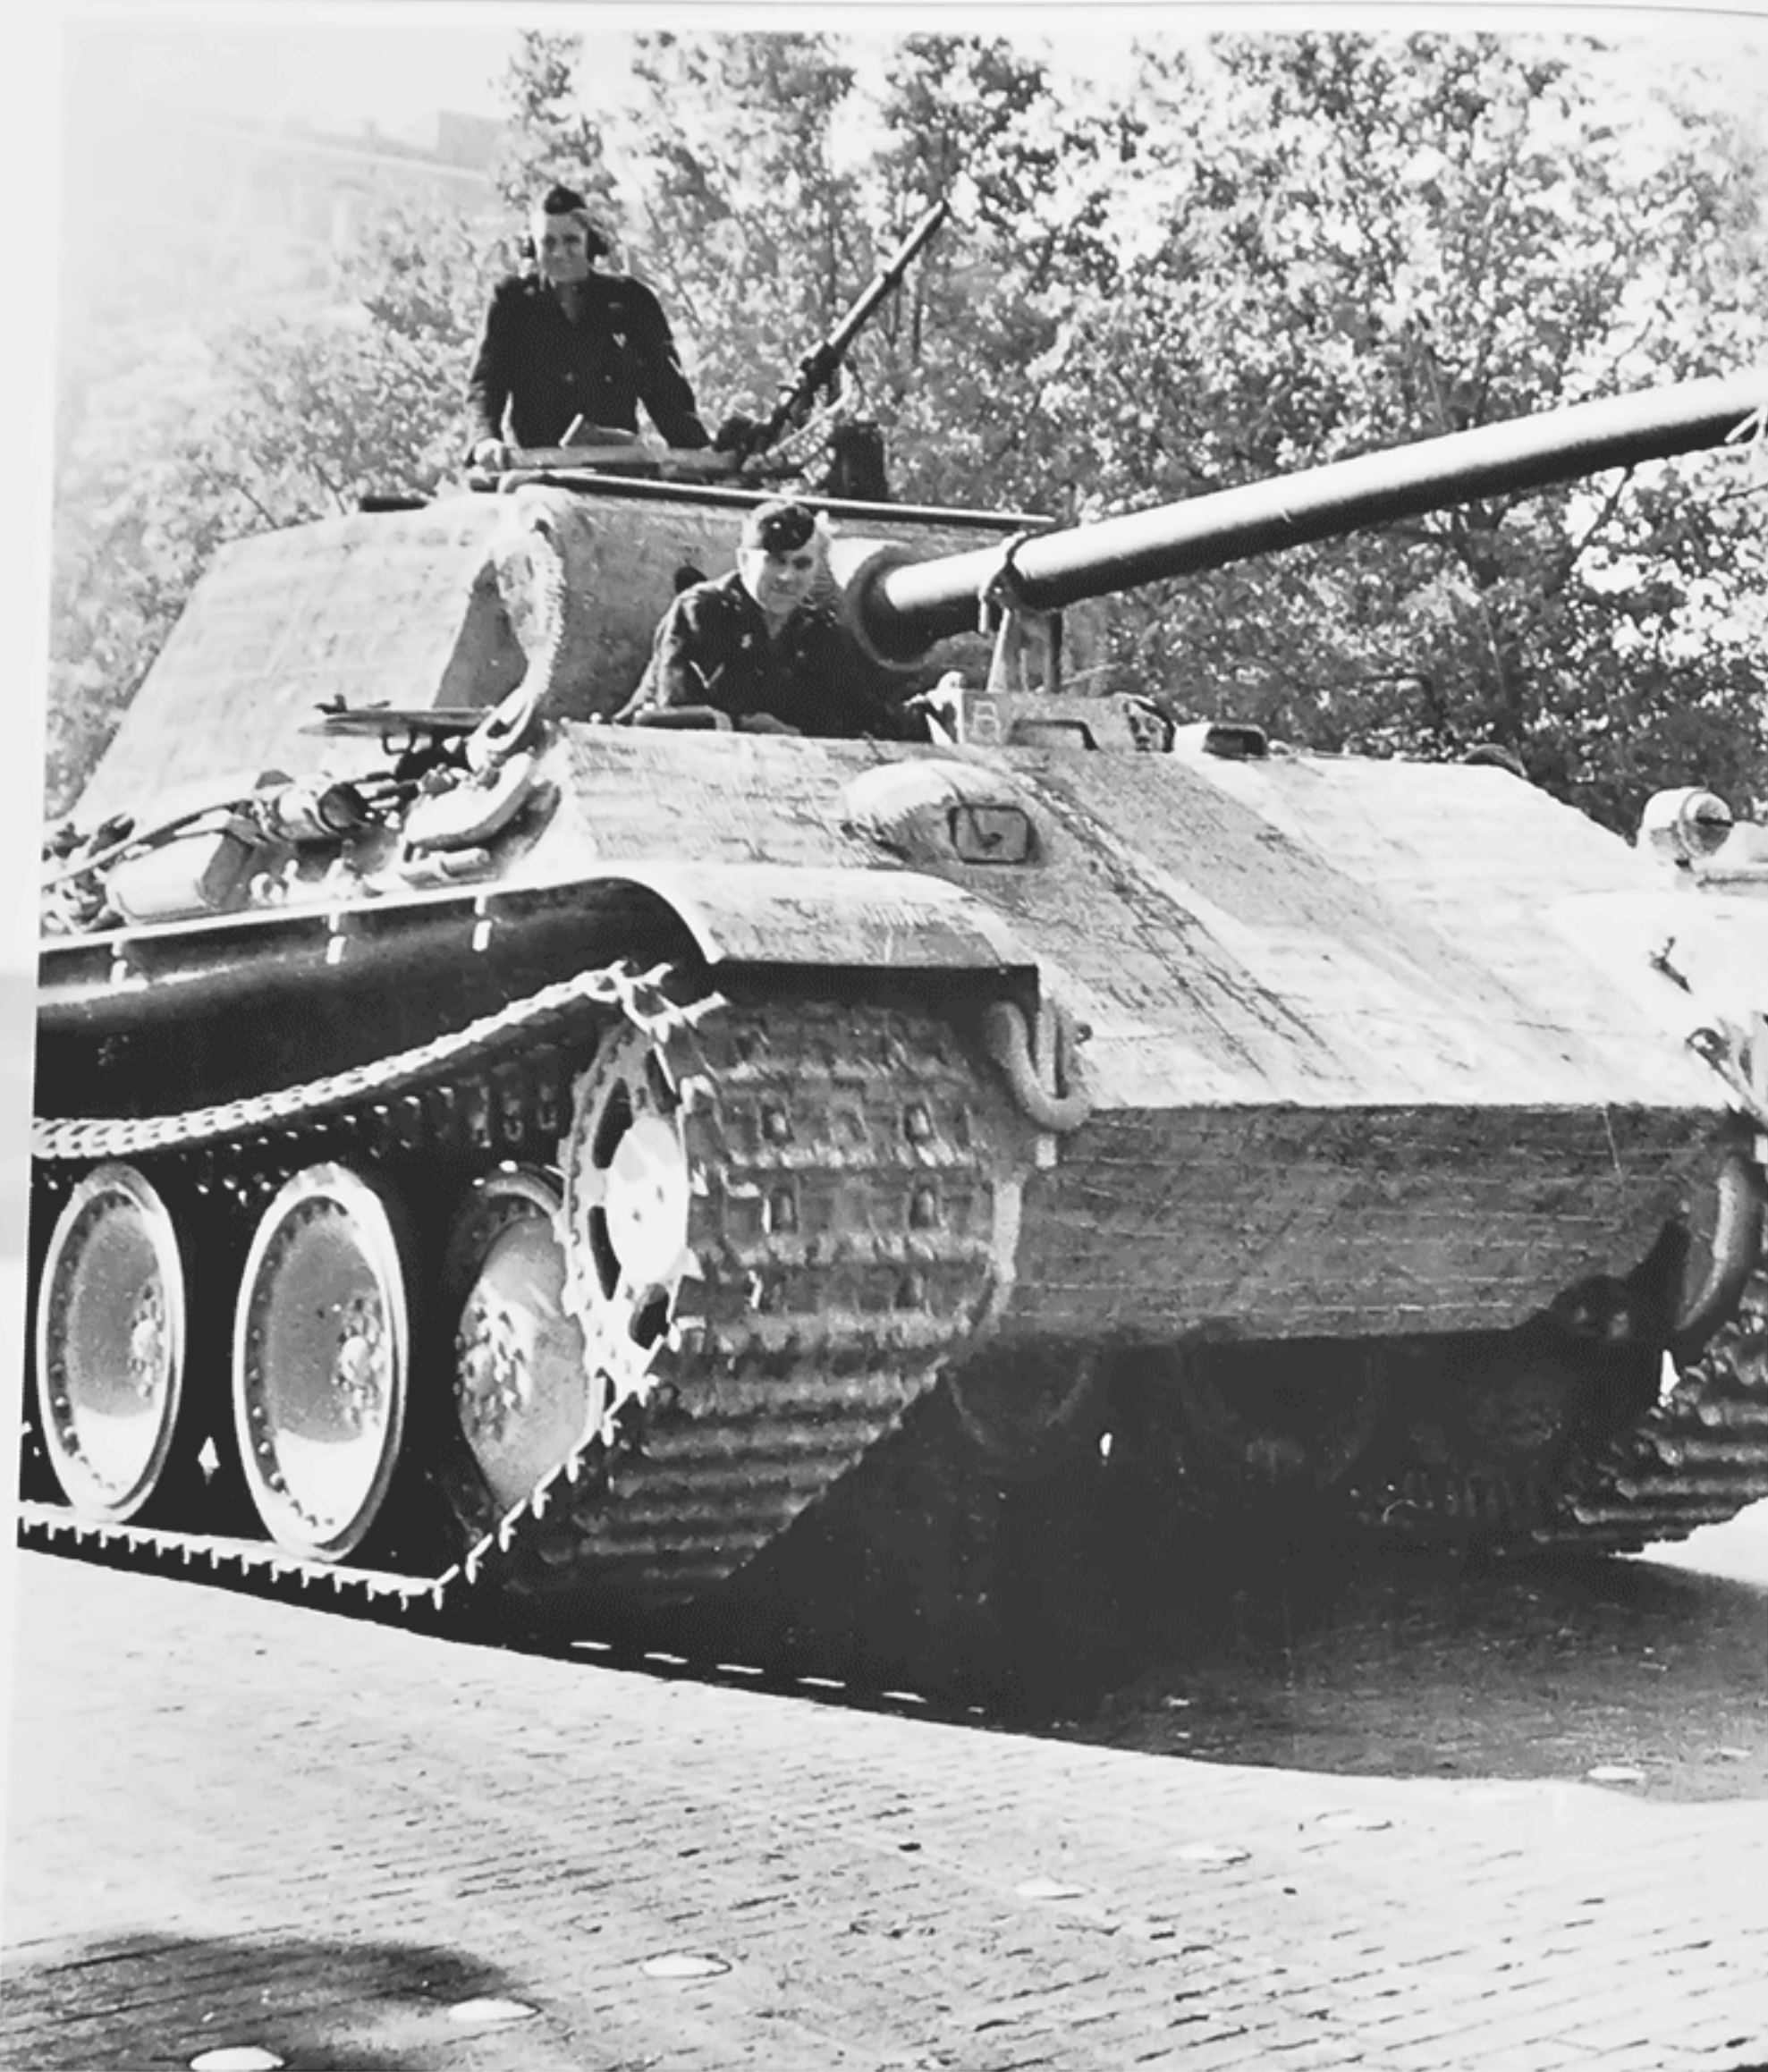
A Panther Ausf. G with the M.G.34 on the cupola prepared for anti-aircraft defense. The hull machinegun wasn't mounted. (BA)

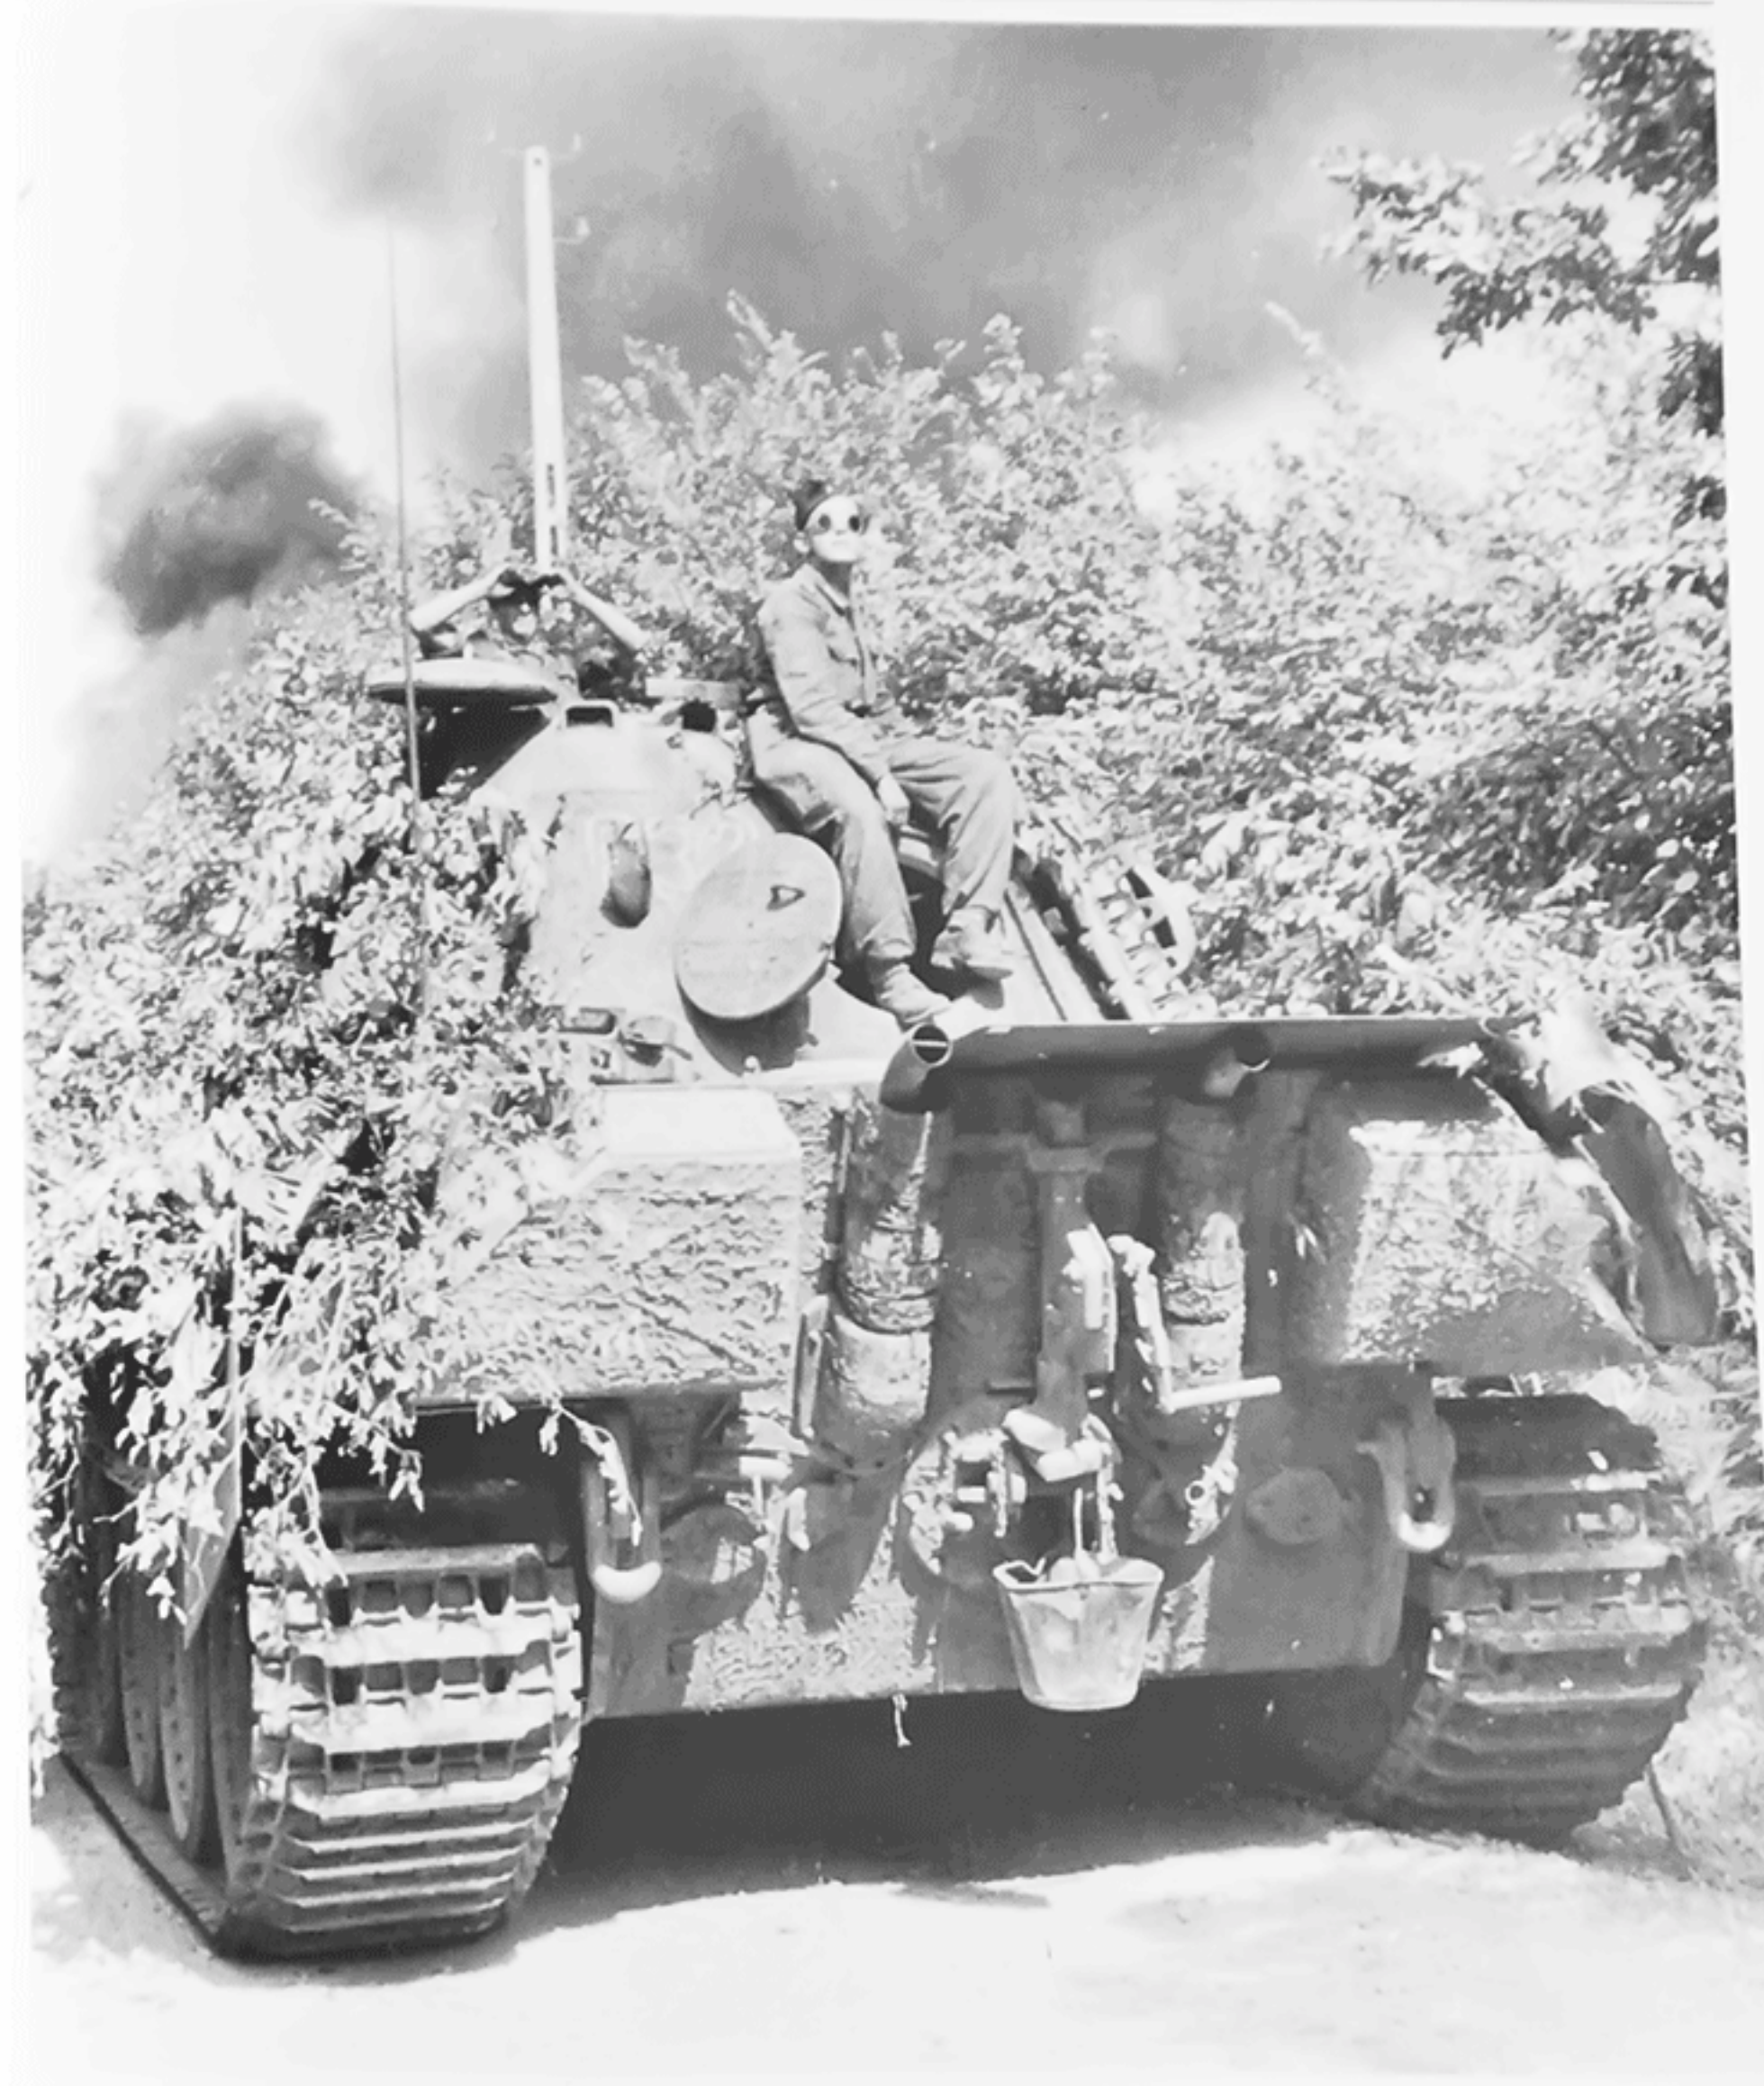
A heavily camouflaged Panther Ausf. G (Tactical No. 632) probably with the II. Abteilung/Panzer-Regiment 33. (BA)

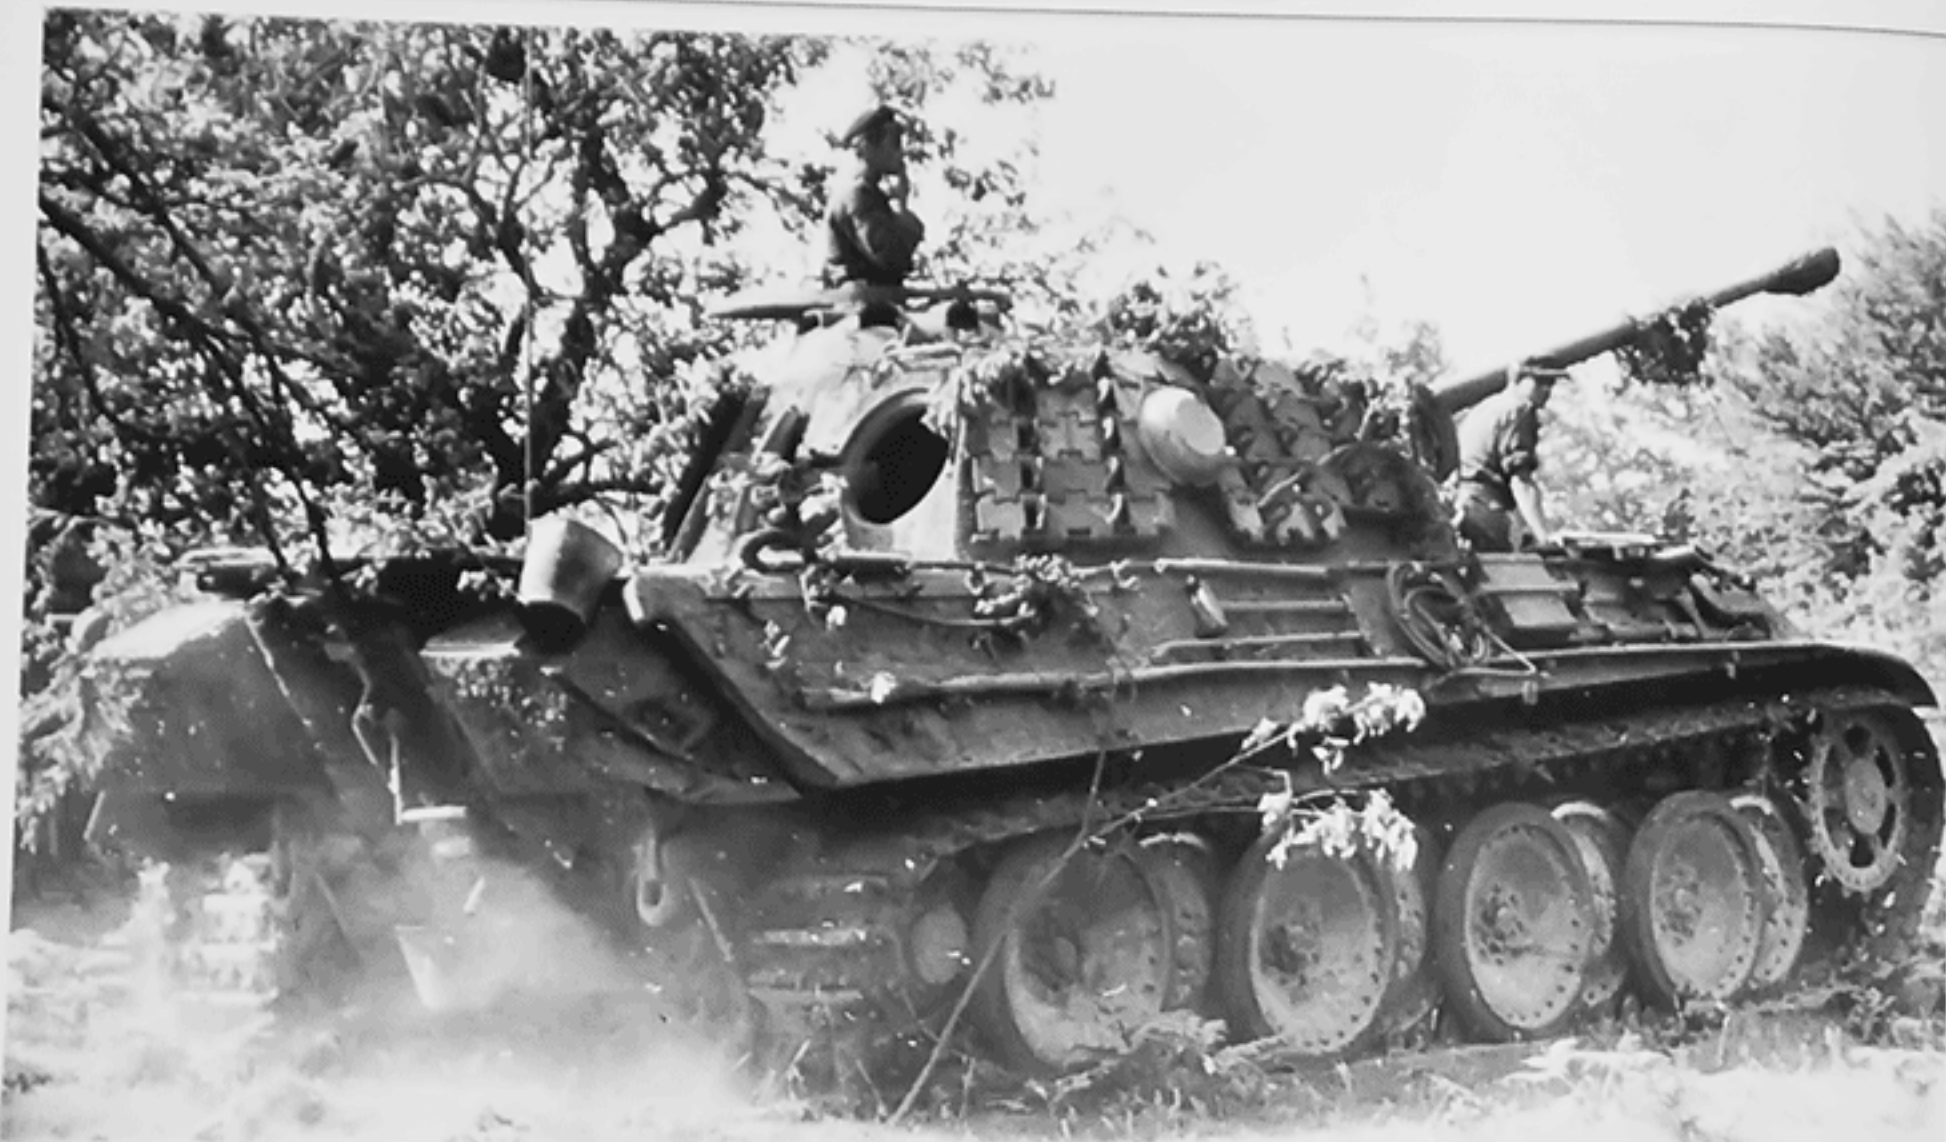
Spare track links have been hung from the turret sides of this Panther Ausf. G in an attempt to increase protection. (BA)

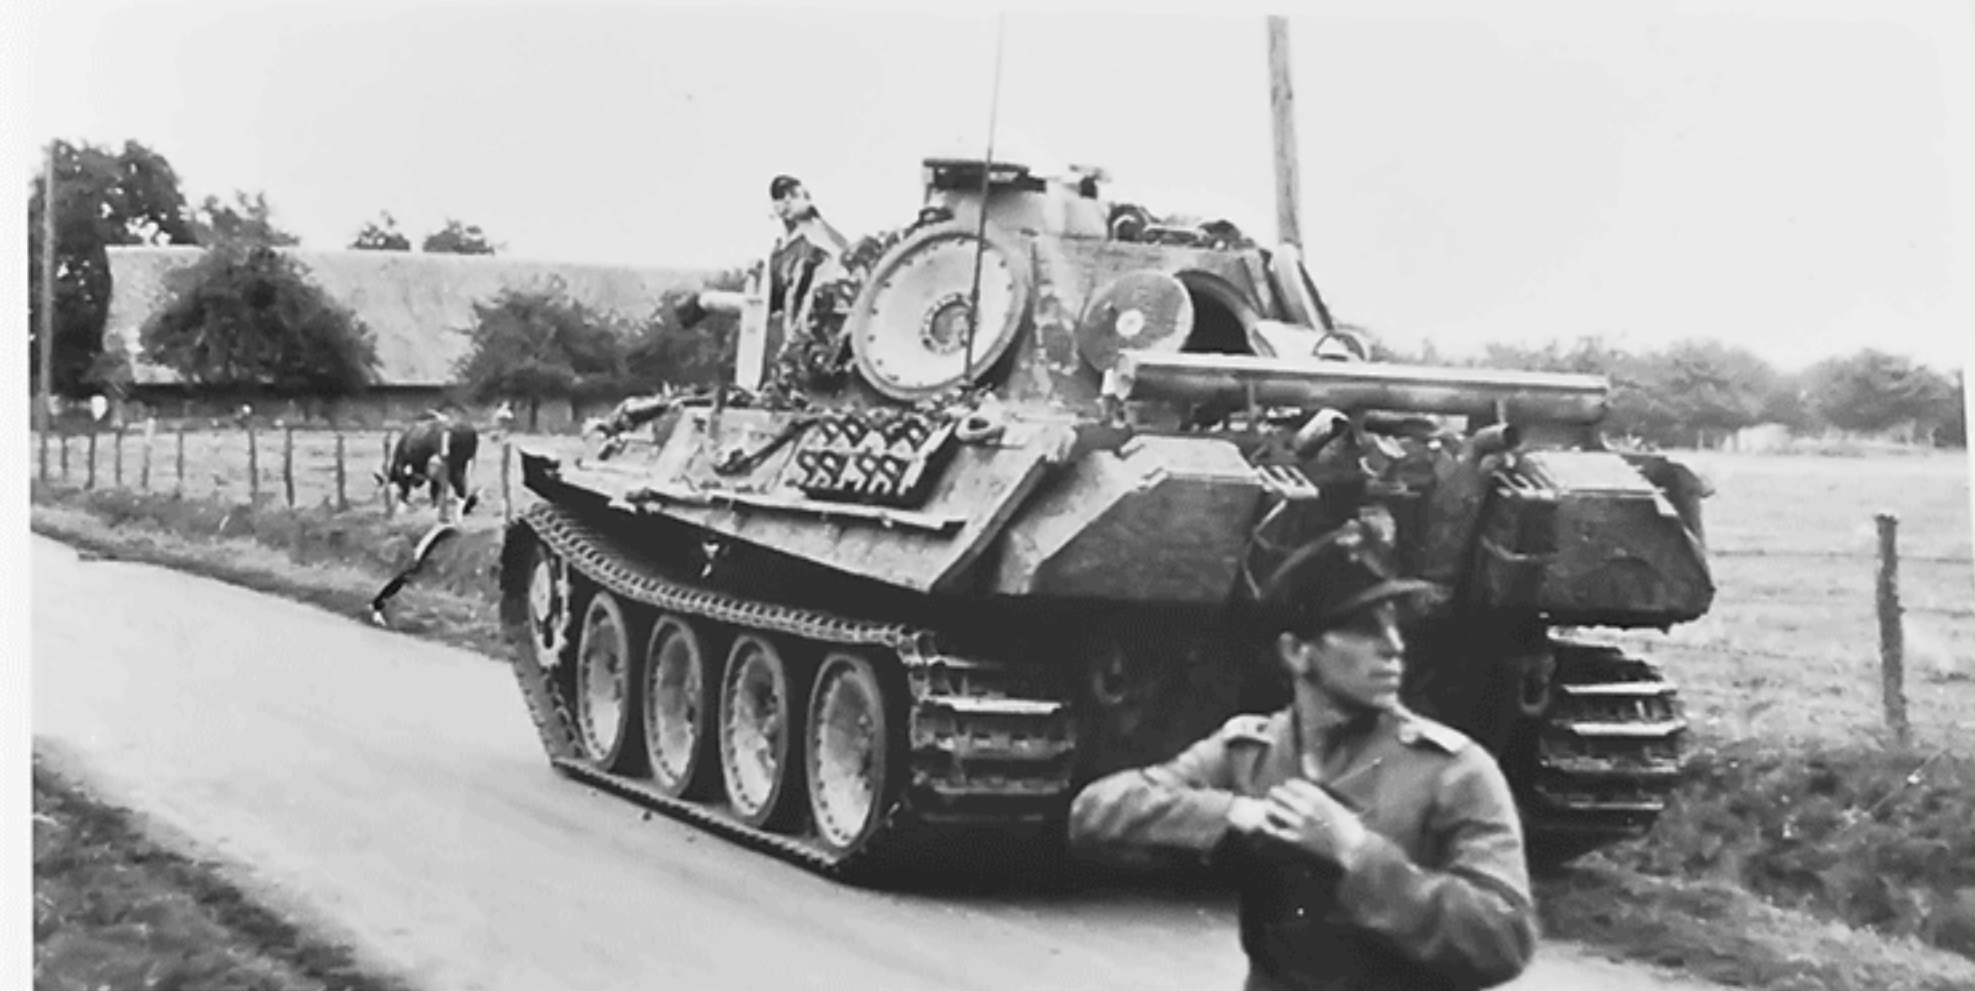
Below: Spare track and roadwheels were mounted on the turret of this Panther Ausf. G probably with the 6. Kompanie/Panzer-Regiment 33. The cylindrical container for the gun cleaning rods was relocated to a position across the rear deck by the field unit. (BA)

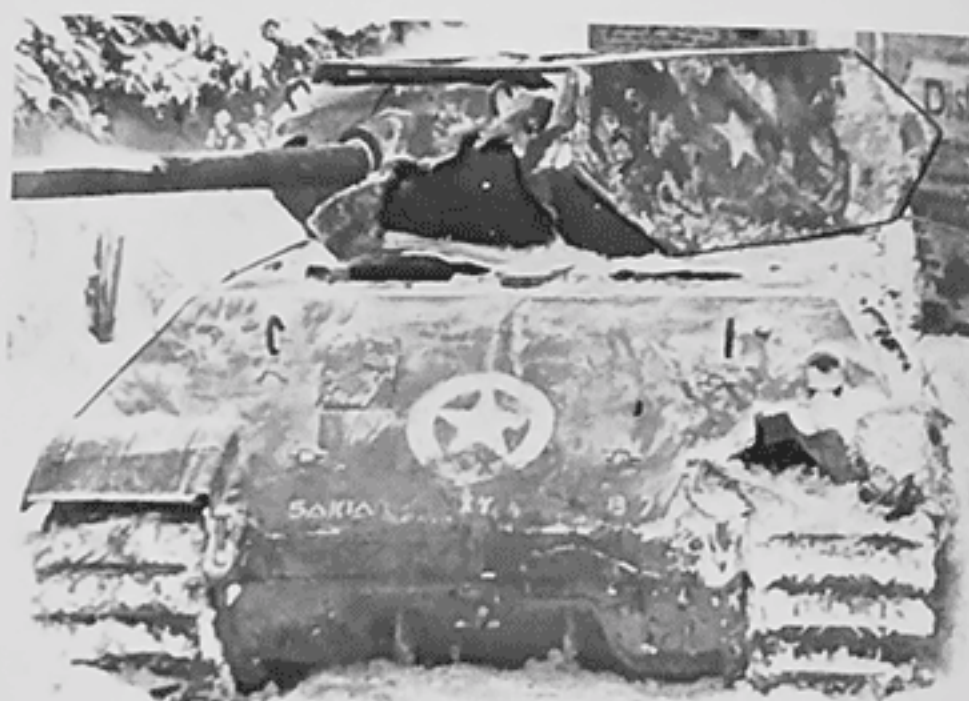
Above and opposite below: Five Ausf.G Panthers were disguised as American M-10 Tank Destroyers and issued to Panzer-Brigade 150 for the Ardennes Offensive. The M-10 silhouette was created by welding on sheet metal strips cut to shape. A flat-hinged two piece hatch replaced the commander's cupola. (CHY)
