GERMANY'S

PANTHER

**TANK THE QUEST FOR
COMBAT SUPREMACY**

THE QUEST FOR COMBAT SUPREMACY
Development • Modifications • Rare Variants
Characteristics • Combat Accounts

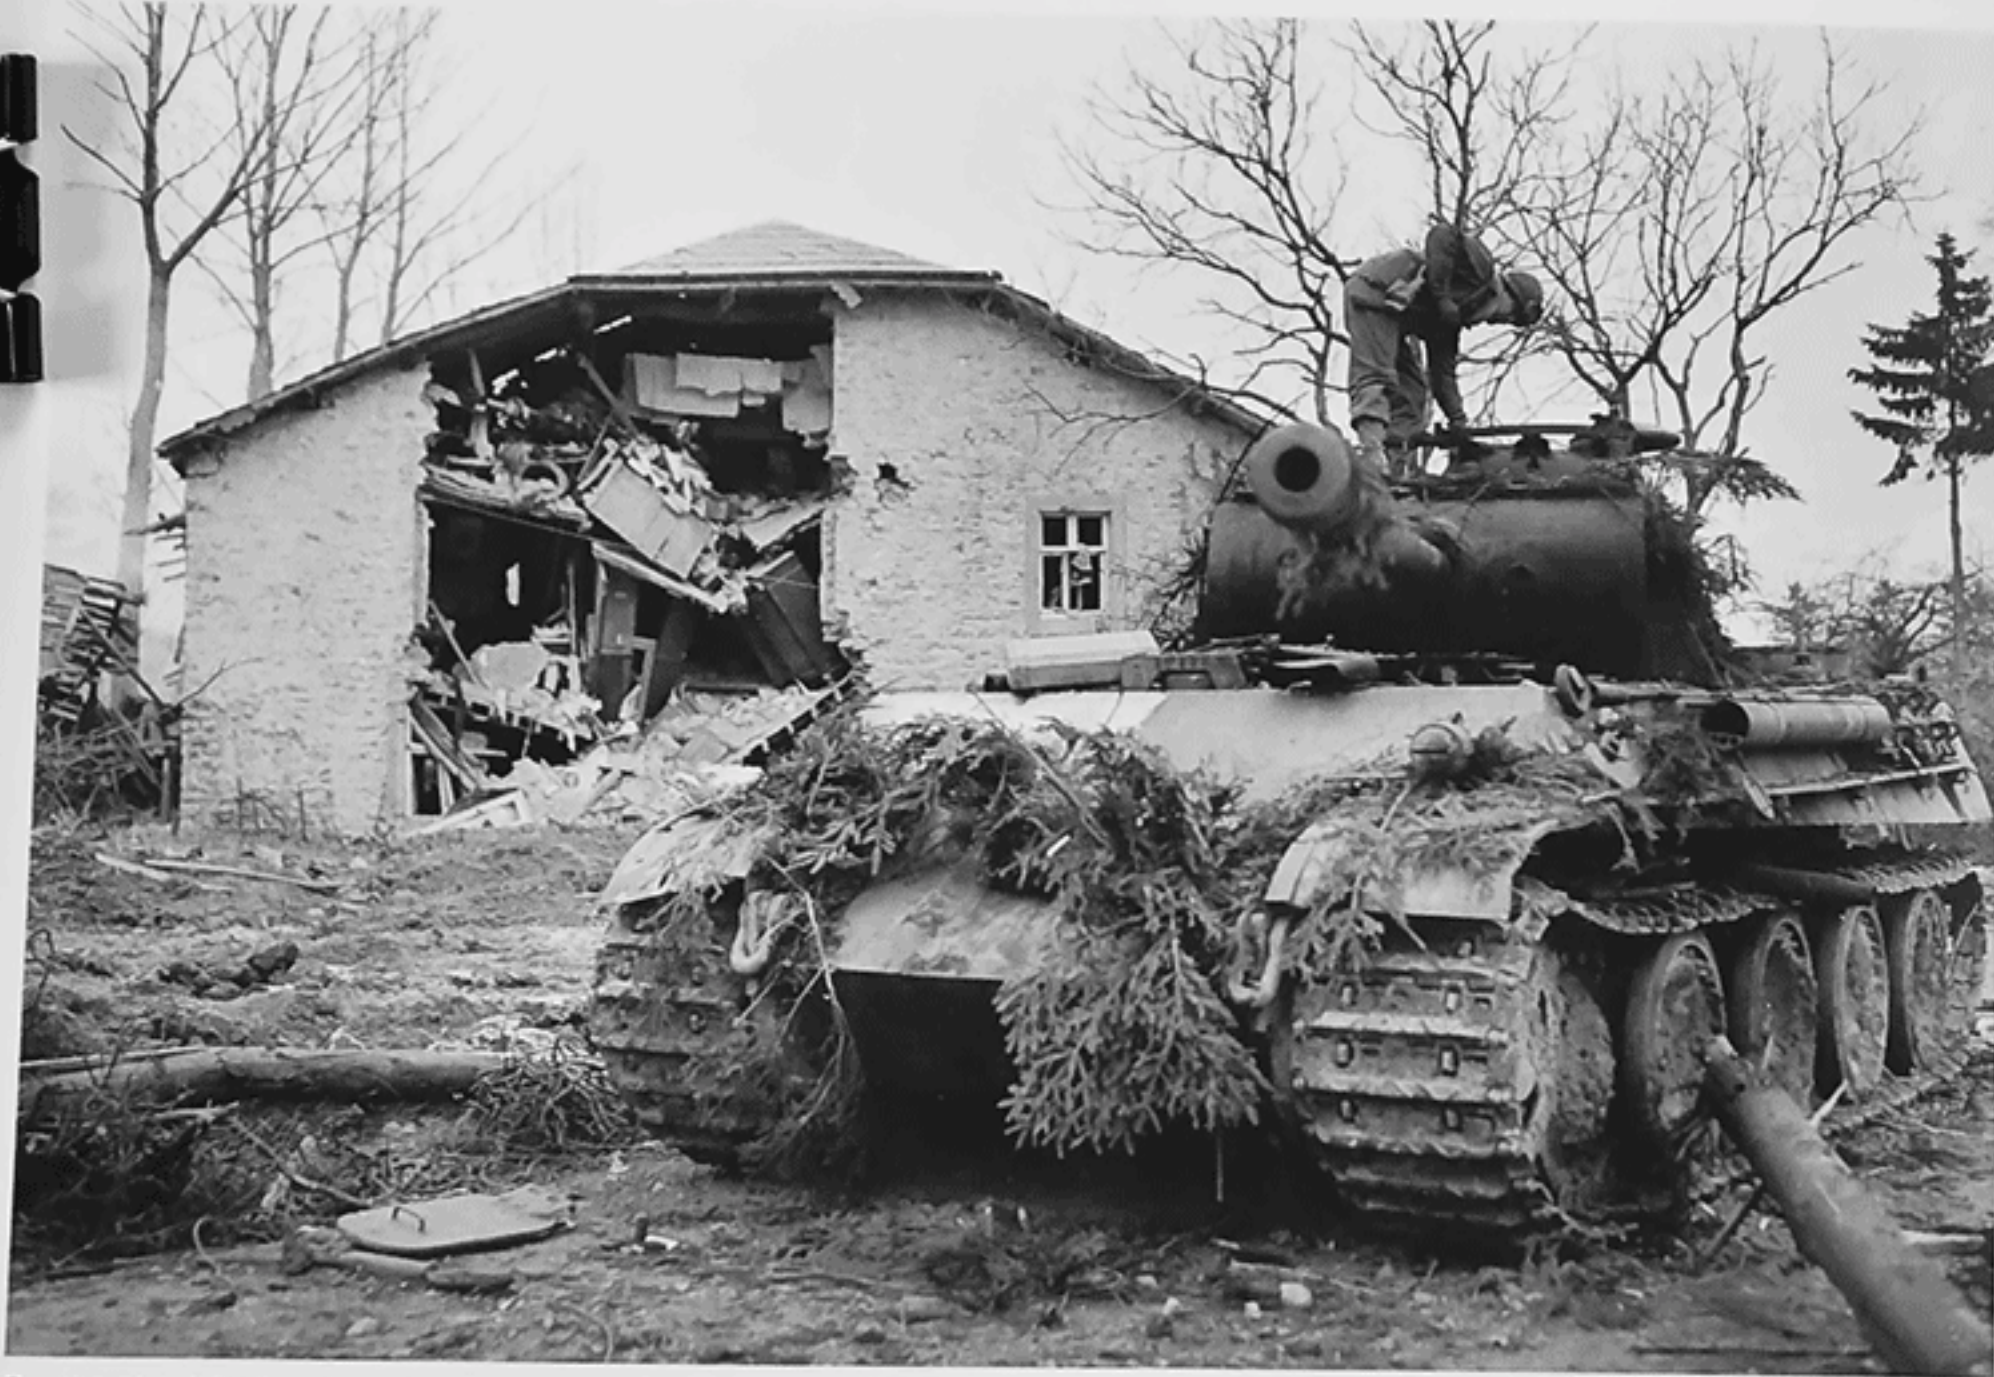
Panther Ausf.G (Fgst.Nr. 121163 completed at M.A.N. in late October 1944) was knocked out in Belgium during the "Battle of the Bulge" in December 1944. (NA)
