# **LUFTWAFFE CAMOUFLAGE AND MARKINGS 1933-1945**

## **Volume One**

**K.A. Merrick**  
with Jürgen Kiroff

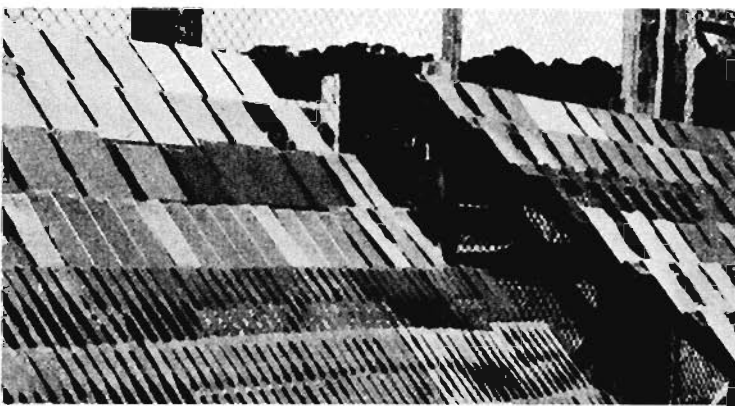
While of poor quality, this photograph shows the important test stage where lacquer samples were exposed on open-air racks to determine the effects of weather on various finishes and colours over a set, extended period of time.

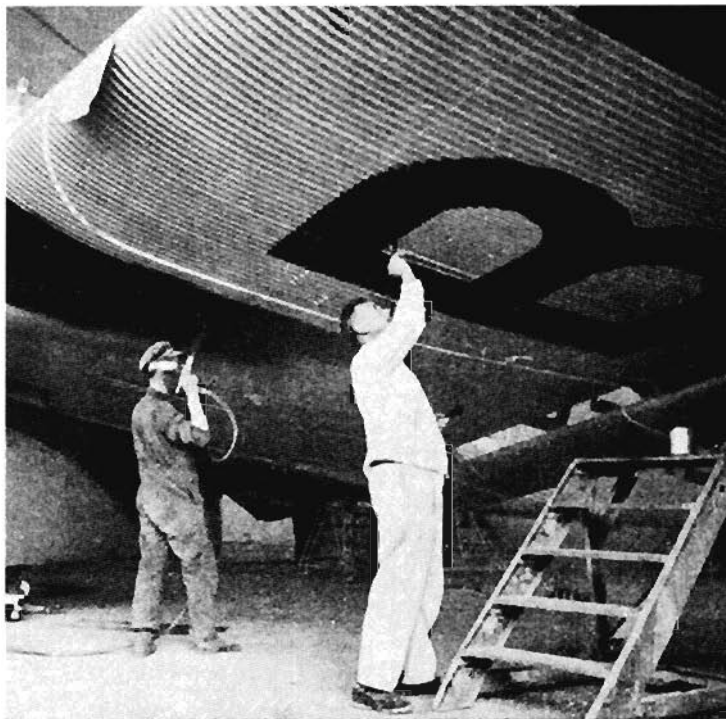
ABOVE: A factory worker sprays the base coat of translucent zinc chromate finish onto a Ju 86. In the foreground is the tank holding the 7102- lacquer that had a greenish tinge and prepared the metal surface for the following lacquers. This base coat was always heavily thinned out, up to a ratio of 10:1, which made it almost transparent. The holding tank incorporated a mechanical mixing device to keep paint from settling, and also ensuring consistent colour quality when used with O2, or any of the camouflage colours; it was pressurised by means of a compressed air line.

ABOVE AND ABOVE RIGHT: Compressed air supply was available in three forms. The large vertical static tank, seen in the photograph of the Ju 86 (see page 24) being sprayed, was one. The second was this mobile horizontal tank and compressor. The third type (ABOVE RIGHT) was much simpler and more mobile – a pair of compressed air cylinders on a wheeled frame; a type that was also used at unit-level for minor spray painting tasks on aircraft.

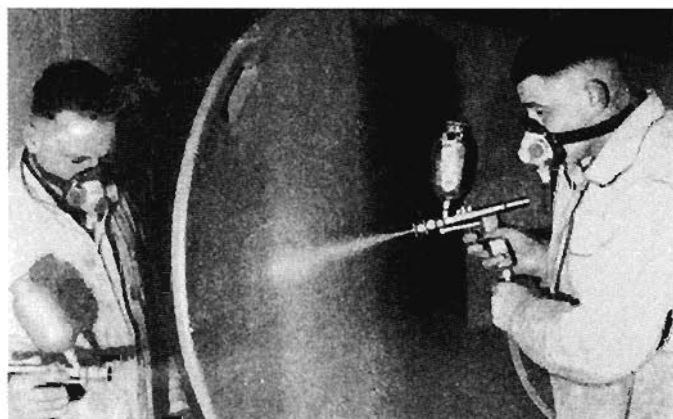
ABOVE: Spraying was done simultaneously on both sides of the wing.

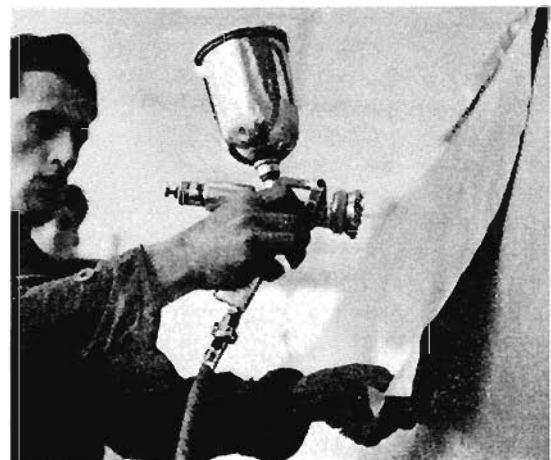
RIGHT: Blanking templates were used where areas were to be given different colouring. This man is using a 'Prea' brand spray gun. This firm supplied much of the range of spray equipment used by the aircraft industry but some imported equipment, such as the 'Superior' compressor, was also employed.

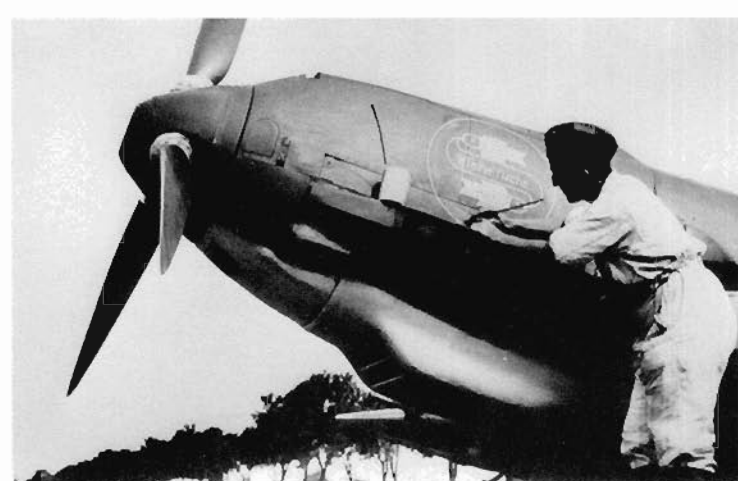
ABOVE: A range of painting equipment was issued to units for general minor maintenance and marking of such items as aircraft identification numbers and Staffel markings, etc. as seen here – a personal emblem of one of the JG 53's pilots being painted using a 1.25 litre tin, balanced on the exhaust stub shield, and one of the smaller of the round brushes. (Eric Mombeek)

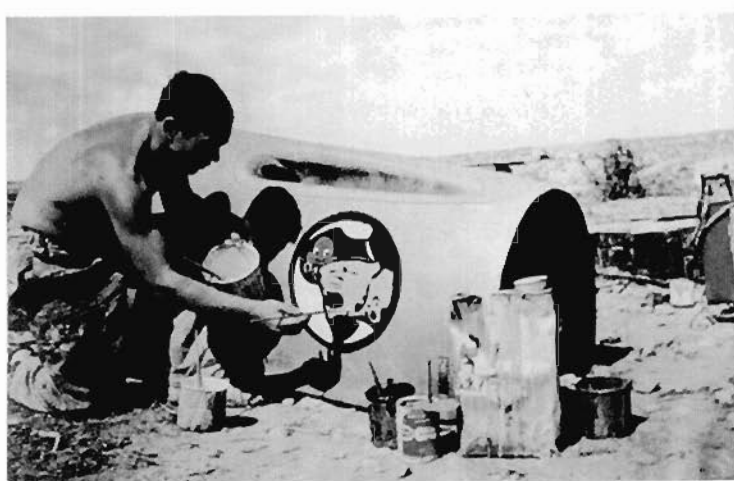
ABOVE: Conditions for painting in the field as opposed to those in a factory environment are illustrated by this desert setting of a ground staff member applying the final touches to a JG 27 emblem on a Bf 109 F cowling. Four of the standard issue paint tins are visible, plus a food tin used to wash the brushes out using benzine from the very battered fuel tin.

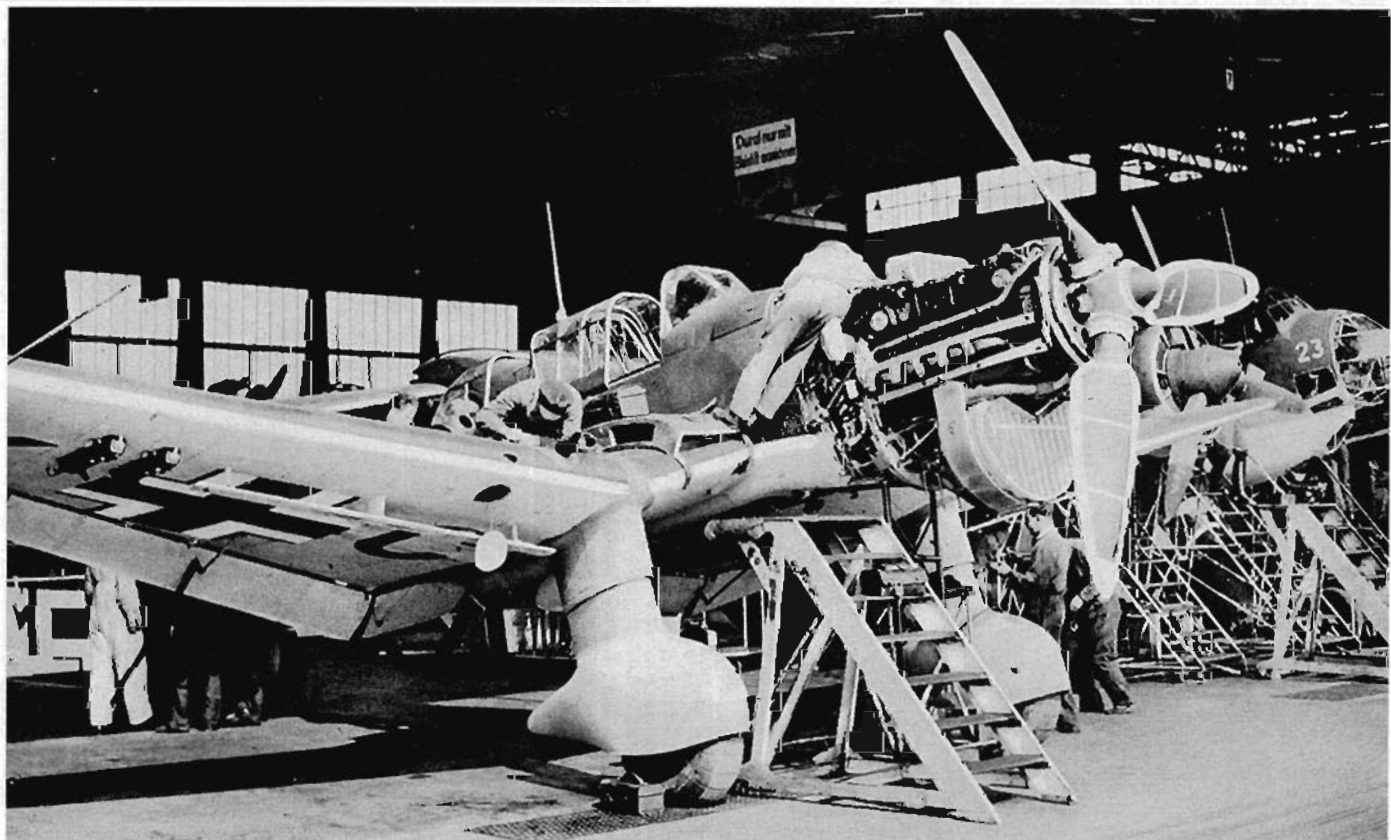
BELOW: The finished aircraft was rolled out for a final check of engine and ancillary services. The protective padding on the lower two propeller blades remained in place until the aircraft was ready for transfer for its factory acceptance test flight. The first two letters of the Stammkennzeichen on the machine were XO, and the size and positioning of the underwing Balkenkreuz marking indicate that this was probably part of the 1939/40 production cycle.

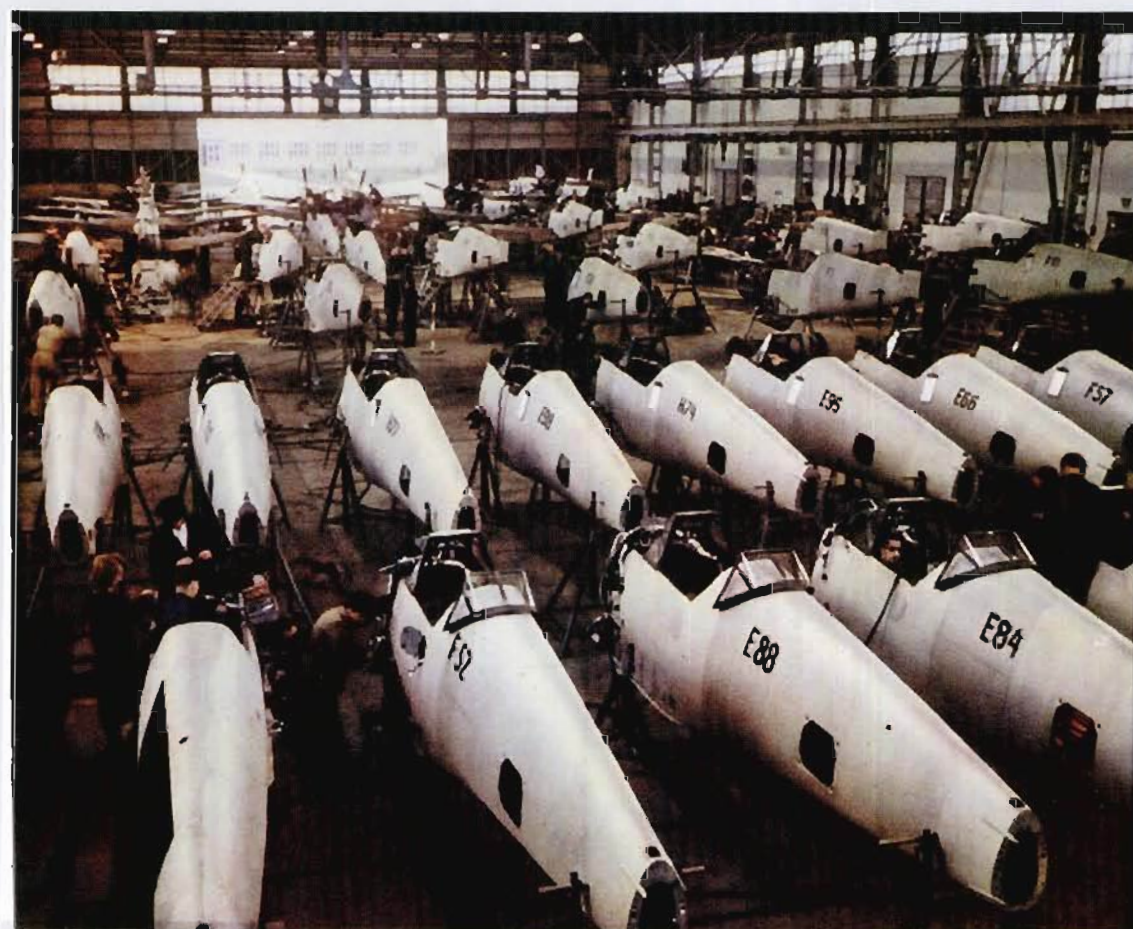
LEFT: Bf 109 airframes under construction, still in their 7102- zinc chromate metal primer finish. The 'E' and 'F' series of prefixed numbers marked on the airframes were production batch identification numbers that would eventually disappear beneath the final camouflage.

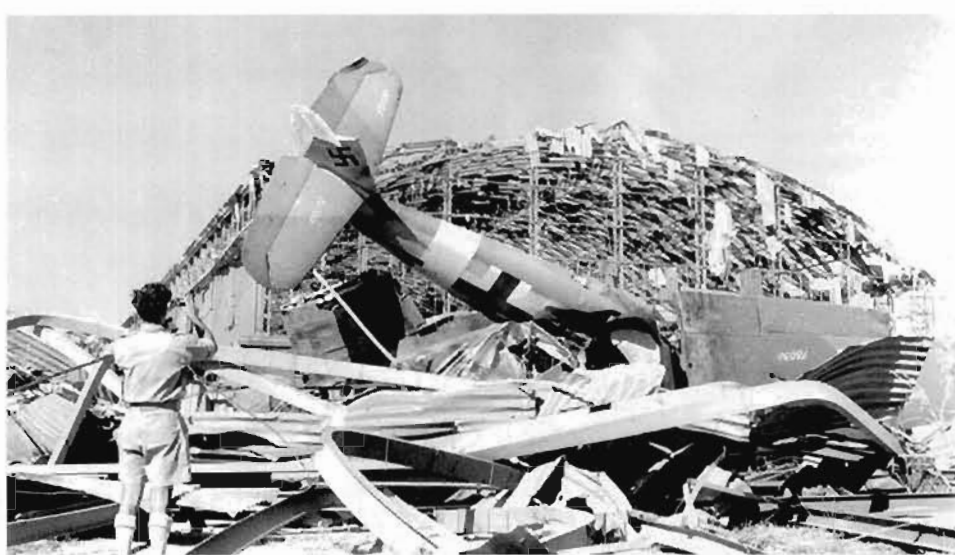
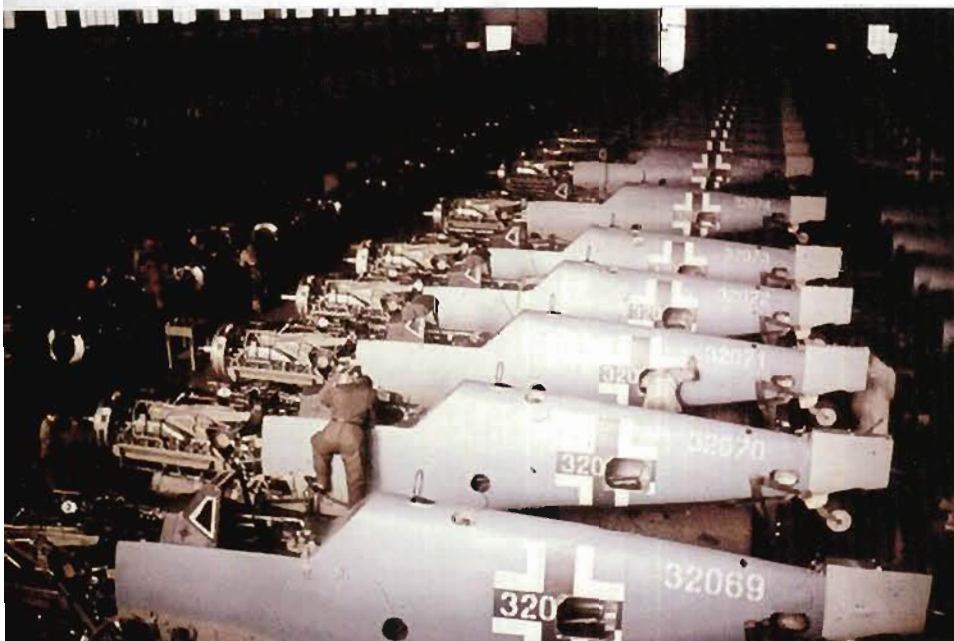
LEFT: Bf 109 G-6 production at Messerschmitt's Erla plant at Leipzig in the Autumn of 1943 shows fuselage structures painted in 76-overall with Balkenkreuz markings applied. Note the application by stencil of each airframe's Werknummer, in two places; the one across the Balkenkreuz required repainting of the black area of the marking later, but the other number would disappear beneath the upper surface camouflage greys of 74 and 75. The aft section, bolted to Frame 9, was a sub-contract component delivered in 02.

RIGHT: The chaotic conditions in the Me 262 parts storage facility at the Obertraubling plant were indicative of this industry as a whole. With the exception of the fuel tanks, the remaining items were all pre-painted in 76. Engine cowling parts, all undercoated in 02, are stacked on the left while to the right are leading edge slat units undercoated in 02. In the latter case this was required by the RLM as they were steel units and had to be given some anti-corrosion covering during storage and distribution though even that protection was eliminated in some instances. All were sub-contracted parts.

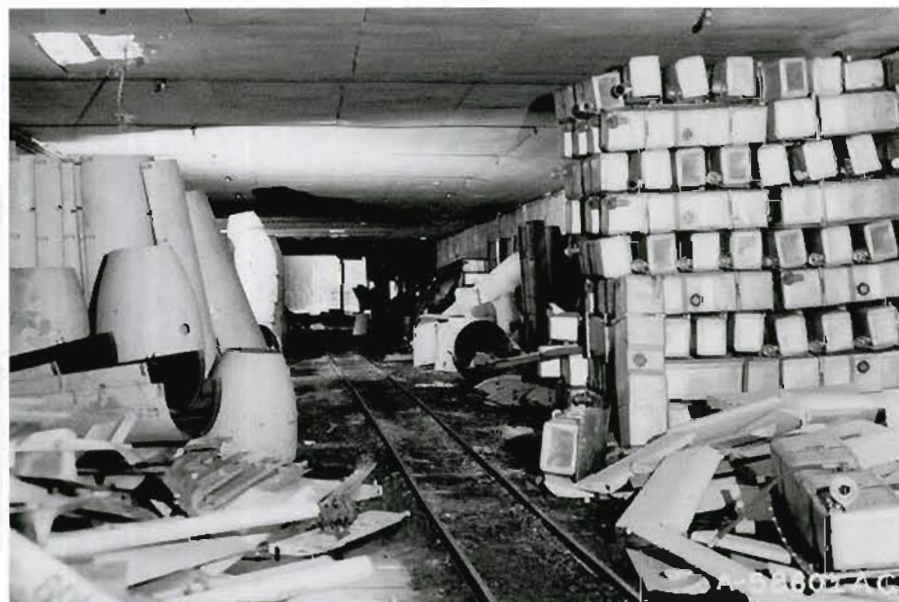
RIGHT: The use of several painters, preparing similar components and with no set pattern parameters, resulted in wide variation making each component's camouflage finish unique. These tail fins for late production Bf 109 G or K-4s, built by a sub-contractor, were found at a facility in February 1945 during the advance on the Second Belorussian Front. There are about 100, no two of which are identical. Behind is a stack of horizontal tail planes, the camouflage of which appears to be 81/82. At the rear, on the right are stacks of wings for a different type, while behind them is what appears to be an He 111 wing. (R. Michulec)

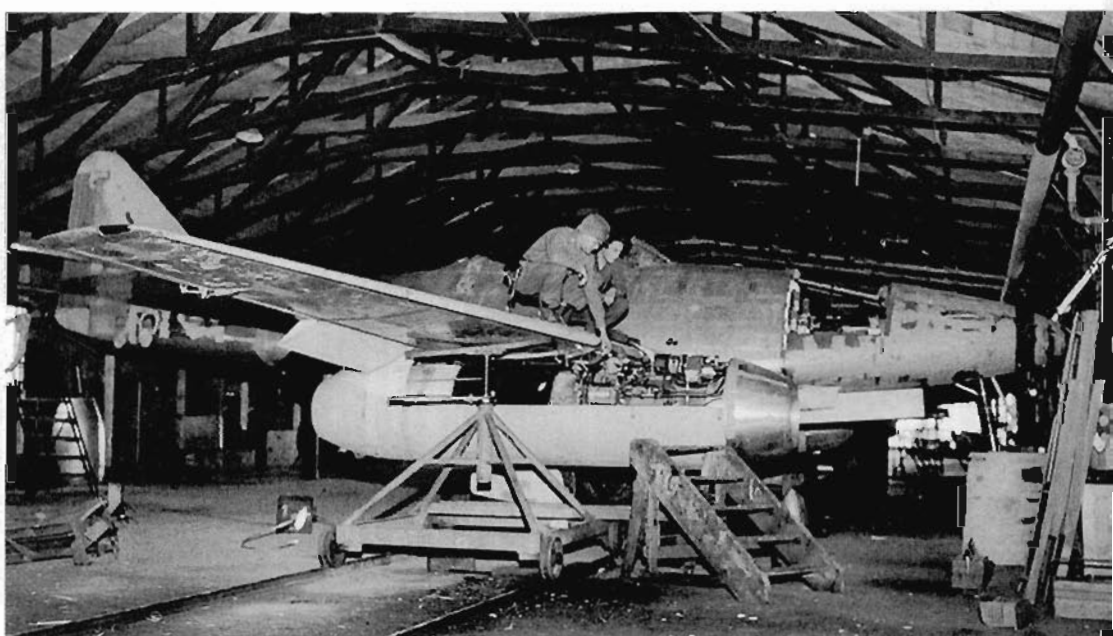
RIGHT: In the final stages of assembly, this Me 262 airframe illustrates well the minimal undercoating lacquer finish by then common across the entire aircraft industry. The nose section of the fuselage, the undercarriage doors (wooden), the upper section of the fin, the control surfaces, and all but the forward part of the engine cowlings are in O2, the only parts to receive any primer coat. The extensive use of Spachtel (filler) paste to smooth out the joints is clearly visible. This filler was originally silver in colour, but shortages of aluminium bronze (aluminium powder for colouring) had reduced the paste to a pale grey by this stage of the war. The rest of the airframe was left bare metal for the application of the thin coat of each colour of the camouflage paint.

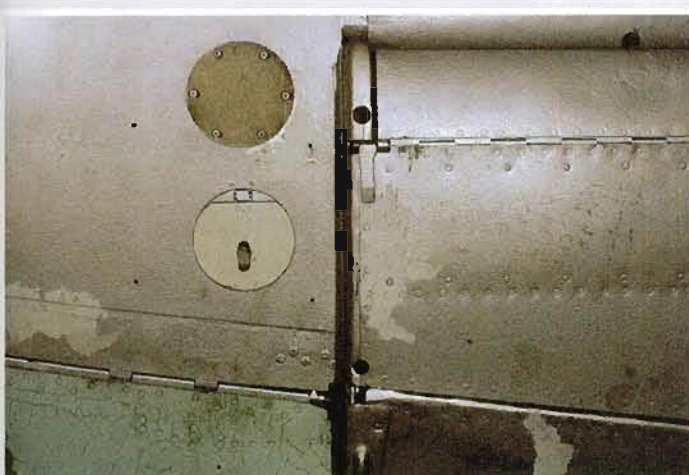
ABOVE: One of the problems facing the aircraft manufacturing industry, and especially the sub-contractors and repair facilities, were slipping standards with both the preparation and application of lacquer. This close-up of the under side of part of the wing structure of Bf 109 G, W.Nr. 163824, shows the crazed effect produce by using too much thinning agent for spray painting, (the silver colour is modern paint that had been sprayed over a plasticised film to disguise the original finish when an attempt had been made to ship the aircraft out of the country.) Note the sample of quite dark, late war O2 on the circular panel. Compare this with the green-blue colour of the affected paint section.

This change in marking colour meanings had been adopted across the recycle/rebuilding system. The Bf 109 G, W.Nr. 163824 held by the Australian War Memorial had been marked on the fuselage with a yellow triangle and date on completion of its re-build; individual components used in the process had red triangles, with earlier dates, marked on them. This parallels the changes to the engine overhaul marking system.

As the war situation worsened recycling and rebuilding produced some hybrid schemes as parts were matched for technical necessity rather than empathy of camouflage. The Australian War Memorial (AWM) Bf 109 G referred to above is still in its original finish and provides a unique record of this system of rebuilding and the mismatching of camouflage colouring in some instances, (see Chapter 6).

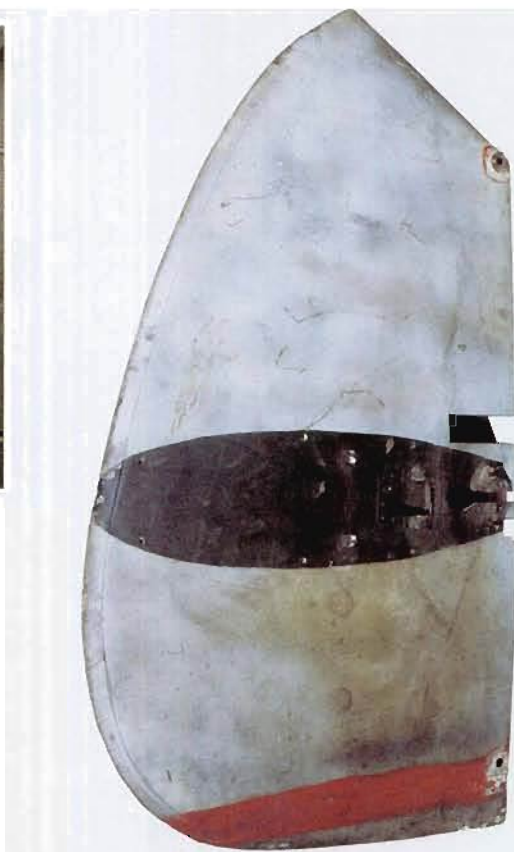
LEFT: The inside face of the starboard fin off Major Wolfgang Schnauffer's Bf 110 G of NJG 4 exhibits its colouring of 76 with thinned out O2 sprayed as a fine streaked mottle in places. The dark green underpainting where the fin and horizontal tail plane meet can be clearly seen. This unidentified non-camouflage colour was sometimes also used for wing root areas by Messerschmitt. It also has been found on some Bf 109s and matches the colouring on some internal equipment. (AWM)

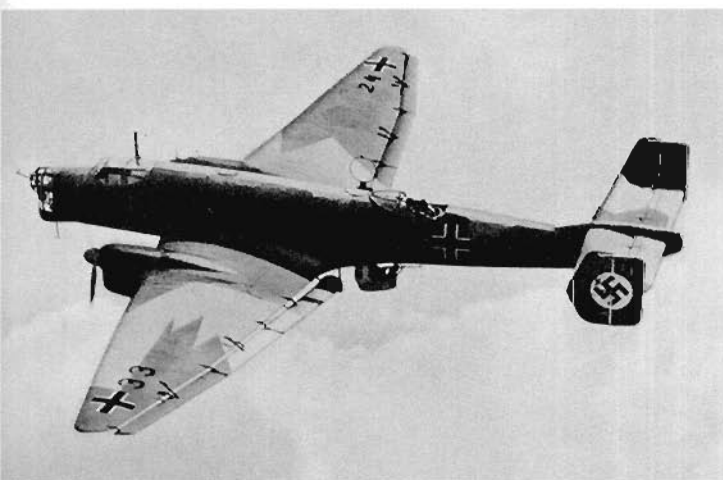
ABOVE: The Ju 86 was the first of the Luftwaffe's aircraft to wear the new three-colour camouflage. This machine, 33G+24 of 4./KG 253, was painted in the Sichtschutzschema A1 pattern with a slight modification to the pattern on the port wing tip. The 61-colouring had been taken straight forward to the leading edge of the wing, instead of angling back towards the fuselage; possibly because the area was so small, its application had been simplified. A check with the Do 17 grid patterns in this chapter will show how the more aft placement of the Ju 86 wing brought an entirely different section of the standard pattern layout into play.

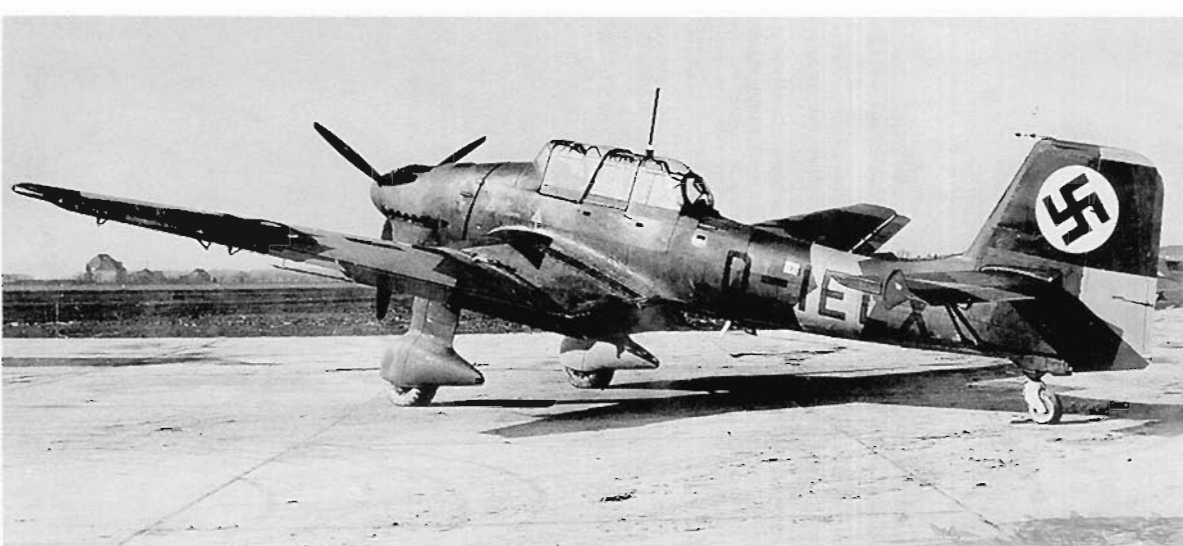
ABOVE, RIGHT AND BELOW: The twelfth production Ju 87 A, D-IEAU, and an early production B model, (ABOVE) D-IELX, demonstrate the apparent difference in camouflage pattern produced simply by transposition of colours. D-IELX had pattern A1, while D-IEAU had pattern B1; both patterns could also be mirror reversed, providing four alternatives in all.

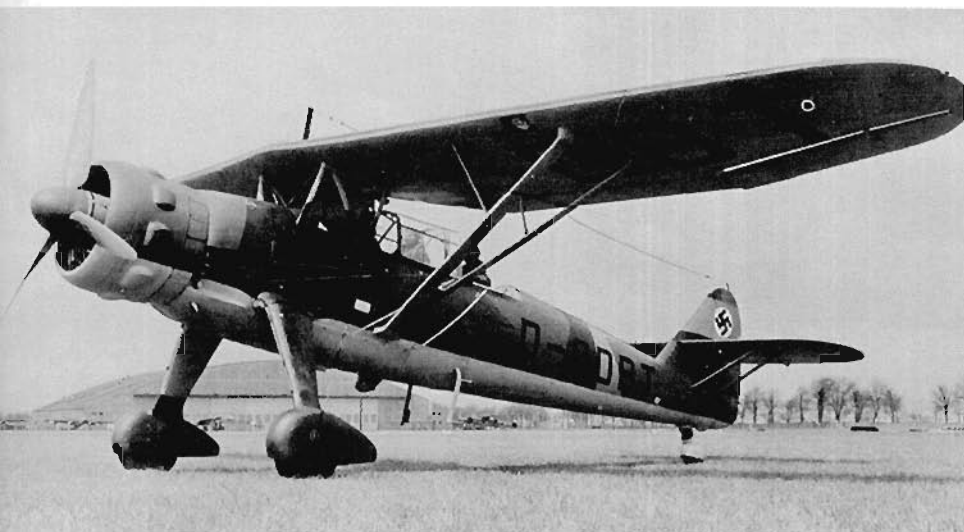
ABOVE: The Hs 123 was another of the new breed of aircraft to wear the three-colour splinter pattern. This brand new production example was finished in the A1 pattern. The absence of the red band and white disc behind the Hakenkreuz, (which however remains in its former central location) indicates that this aircraft was produced around December 1938, at which time the background markings were declared obsolete. If so, then the retention of the old 61/62/63 upper surface camouflage continued later than indicated by the shift to 70/71 on the larger production run aircraft of the period. This may simply have been a case of using up current stocks of the colours, the relatively small production run of Hs 123s not requiring the huge stock holdings of paints that were required at works like Junkers or Messerschmitt.

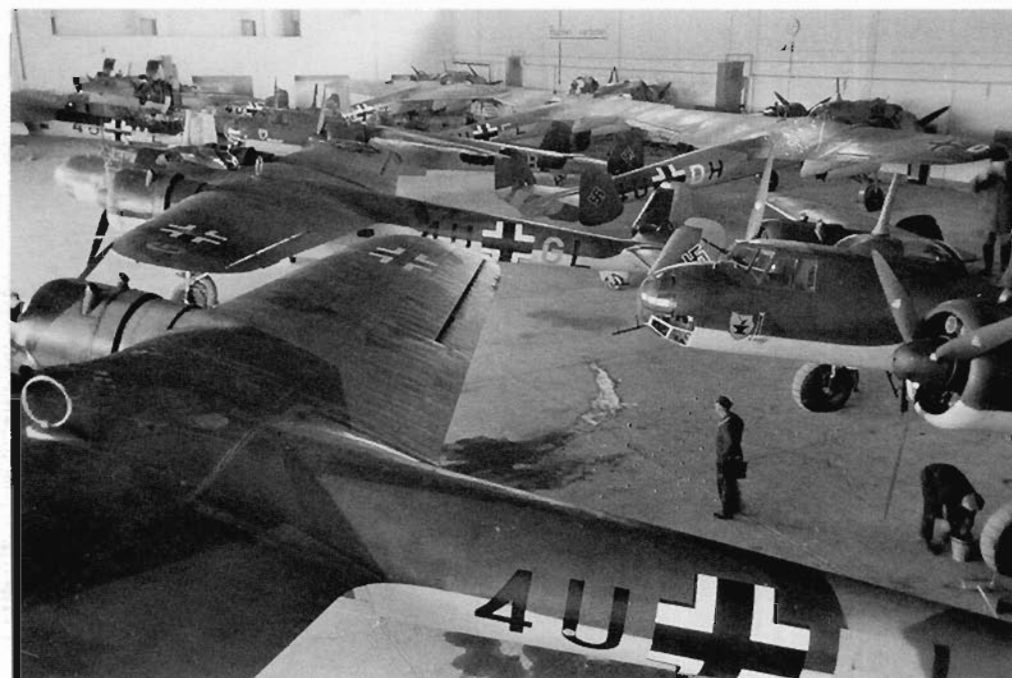
LEFT: This hangar scene of Do 17 Ps of 1. and 3.(F)/Aufkl.Gr. 123 provides good examples of the pattern changes possible with the 61/62/63/65 scheme, several variants being visible. The late date of retention of this form of camouflage is unusual, the four-letter code system having been introduced on 24 October 1939, while the 61/62/63/65 camouflage pattern had been superseded in 1938. None of the aircraft shows any sign of repainting where an original five-character military code would have been marked on them. Why this should have occurred is unexplained, but they may have been aircraft brought out of reserve stocks for use in the opening stage of the war. In which case, repainting of the camouflage would not have been carried out until their first major overhaul, some 1,500 flying hours or two years service hence.

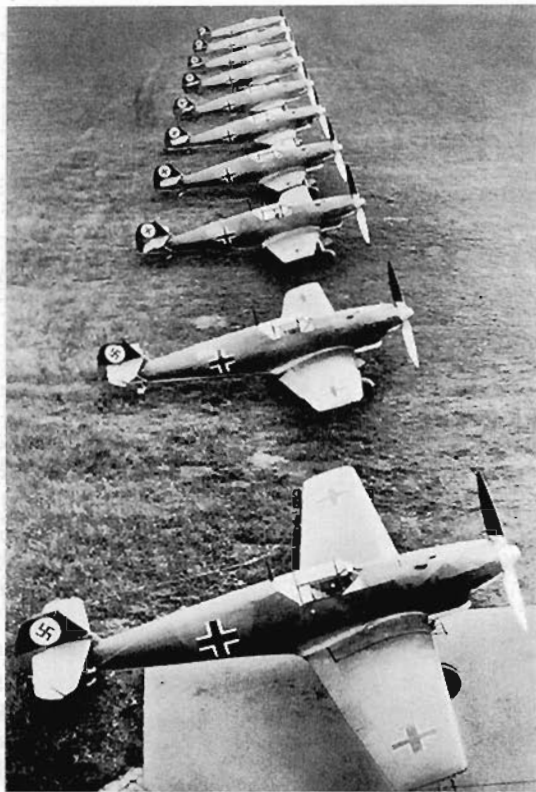
ABOVE: The introduction of the all-metal Bf 109 B-1 fighter into Luftwaffe service also heralded a major change in camouflage colouring and style. This line-up of very early production aircraft illustrates the conformity of the new design pattern in 70/71/65. The same general pattern was soon to be extended to the other categories of Luftwaffe front line service types. The second and third machines have their Werknummern, hand-painted in 02, marked in the upper left angle formed by the fuselage Balkenkreuz; the first is '1046', the second '1029'. At least one other machine in the line also carries its identity in this form.

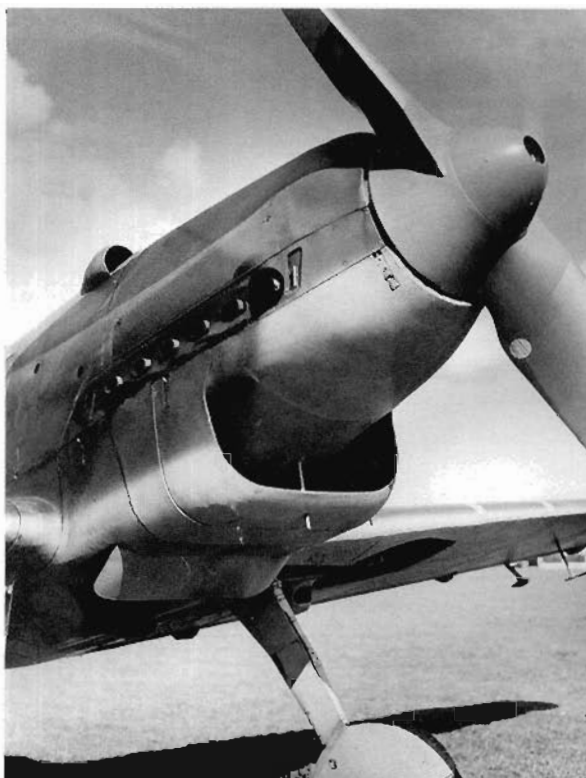
LEFT: This close-up photograph of the nose section of a Bf 109 B-1 shows how the camouflage colours were sprayed with a soft edge where they met the 65-colouring. The 65-colouring of the wing was also taken up the curve of the wing leading edge, something that was soon abandoned but then re-introduced with the 1940 wing pattern revisions for day fighters. The pale grey colouring of the hub section of the Heine fixed-pitch wooden propeller, and its red-edged white manufacturer's marking, can be seen.

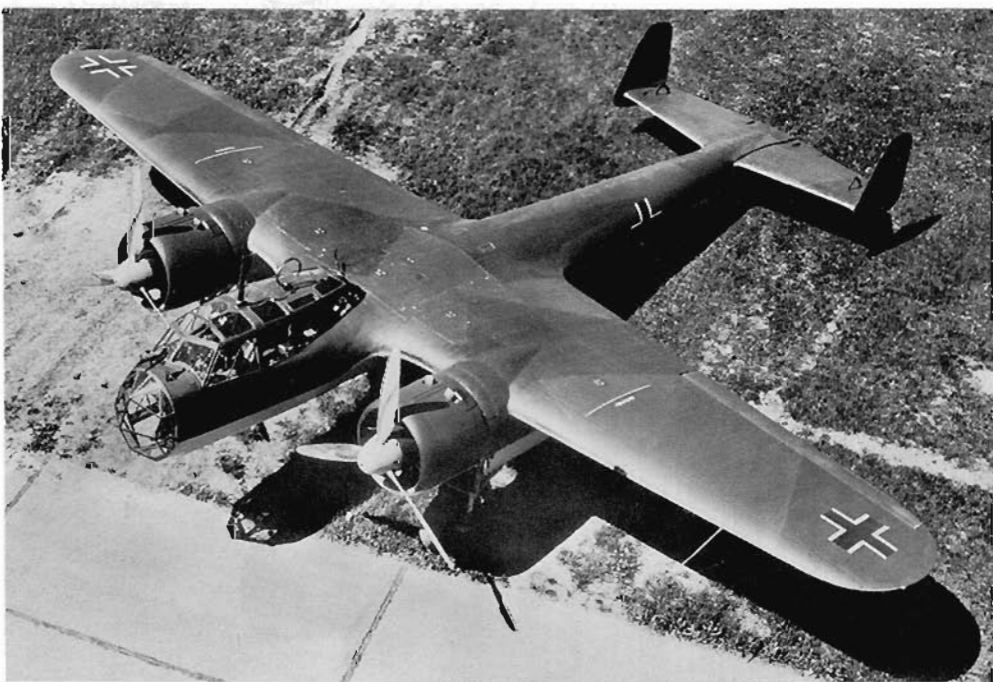
BELOW: A Do 17 Z-1 wearing the regulation standard factory finish 70/71/65 scheme of 1938. The main stencil markings on the wings were in yellow. Application of the pattern conforms completely to the RLM standard.

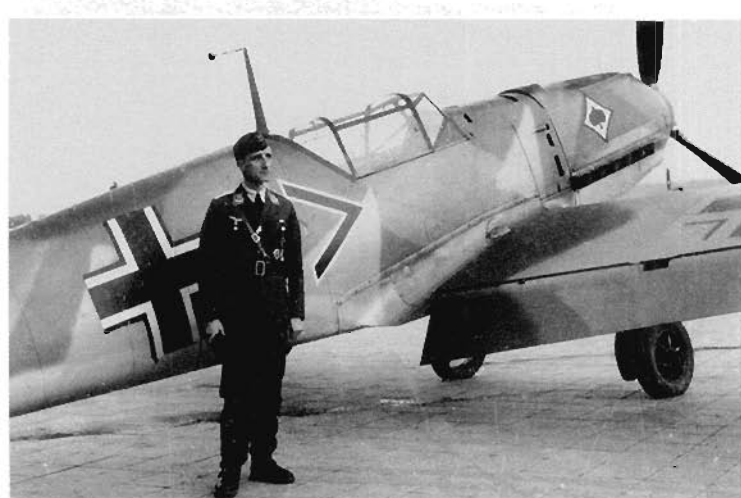
LEFT: The experimental camouflage schemes applied to JG 53's Bf 109s during 1939 were innovative, but ultimately proved too complex and time consuming to apply, offering no advantage over the revisions to the standard scheme introduced in November/December 1939. Photographed at Wiesbaden-Erbenheim in September 1939, colours 70, 71 and 02 were used on this machine in a mixture of straight, as well as flowing-edged segments, with 65 for the lower surfaces. The scheme varied widely though, no two aircraft showing any close similarity of pattern.

02. The latter had disappeared from the camouflage schedules of the Luftwaffe by then, but its value was obviously being reassessed. Some of the experiments revisited the use of multiple-coloured splinter patterns once more, something the Luftwaffe had favoured before moving to a more defensive form of camouflage. However, this phase of the testing evaluated a totally random series of patterns, possibly in an attempt to judge the most effective ratio of colour areas, no two aircraft involved having the same pattern, though the combination of colours remained constant.

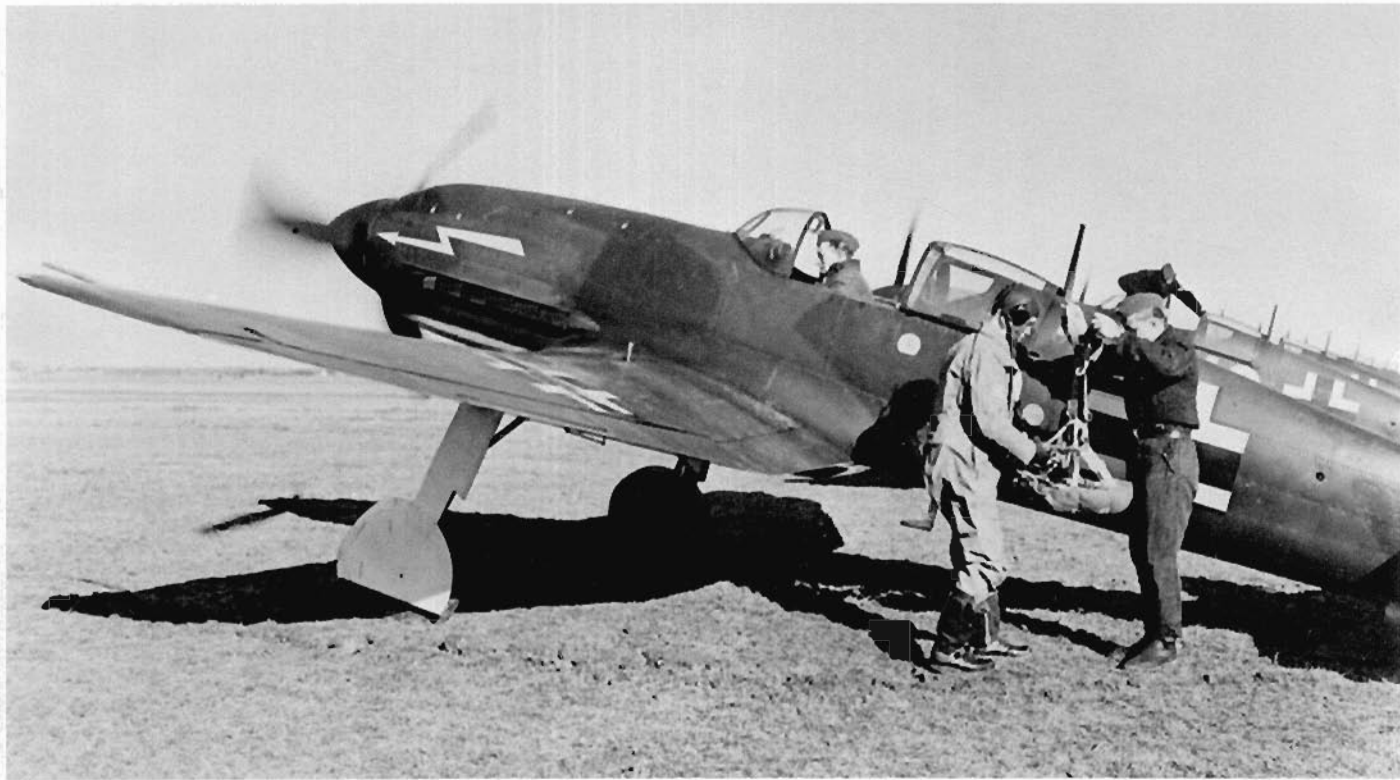
ABOVE: Part of the camouflage pattern adopted for this bogus 'production' fighter the He 100 D-1 can be seen clearly here. It was a one-off pattern that appears to have had no relationship to the standard patterns in use for the contemporary Bf 109, the only single-seat fighter in service at the time.

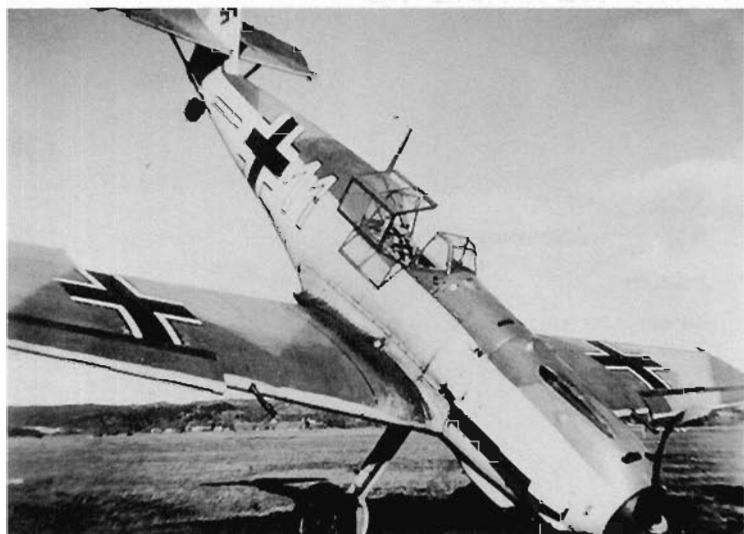
BELOW: A good example of the revised style and colouring that had been introduced at the end of 1939. This Bf 109 E-3 has 71/02 applied in the Type 5 pattern. Balkenkreuz and Hakenkreuz markings are of correct form and size, indicating that this was a 1940 production aircraft. Note also incorporation of the revision to the demarcation line along the leading edges of the wings, making them less obvious head-on.

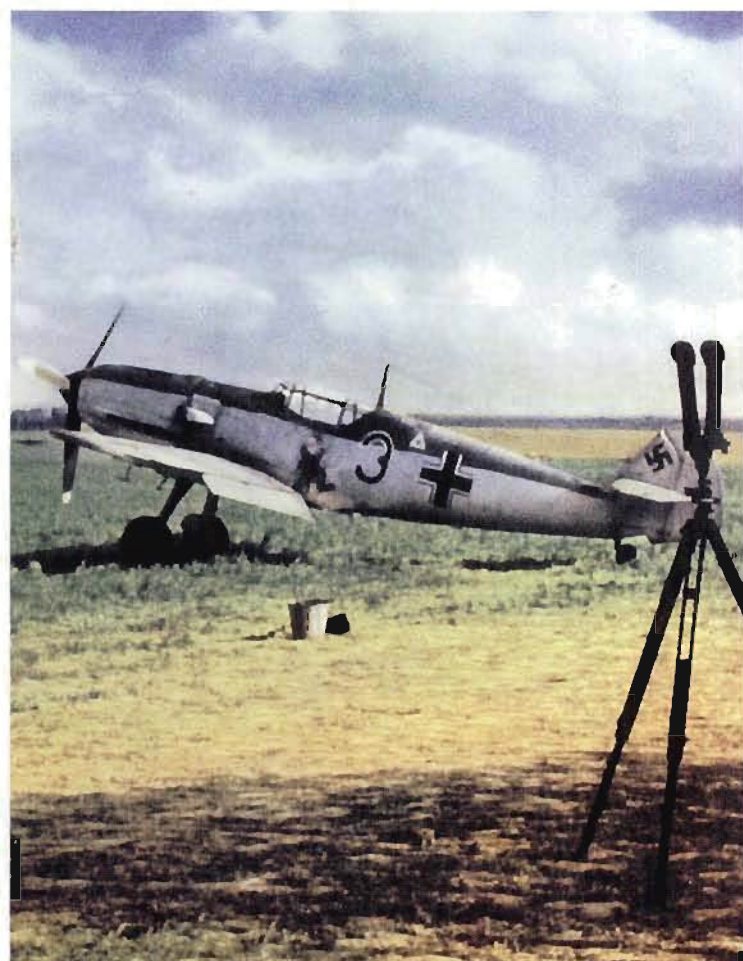
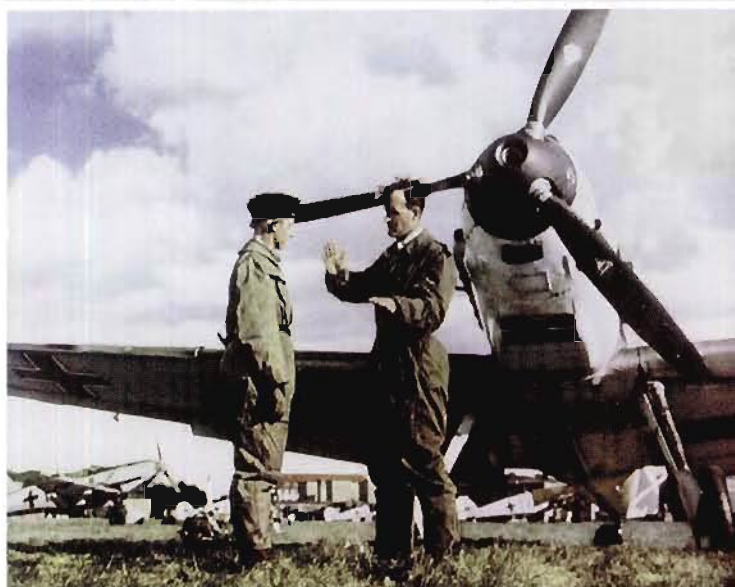
LEFT AND BELOW: The raised demarcation line between upper and lower surface camouflage, introduced in December 1939, was applied in two distinctive styles, one with the lower line taken down to the bottom edge of the cockpit (LEFT). In the photograph below, on the aircraft in the background, the 65 has been raised to a line that would still give an uninterrupted uppersurface splinter pattern plan view. Note the VDM company trademarks on each propeller blade of the aircraft in the foreground. (P. Hilt)

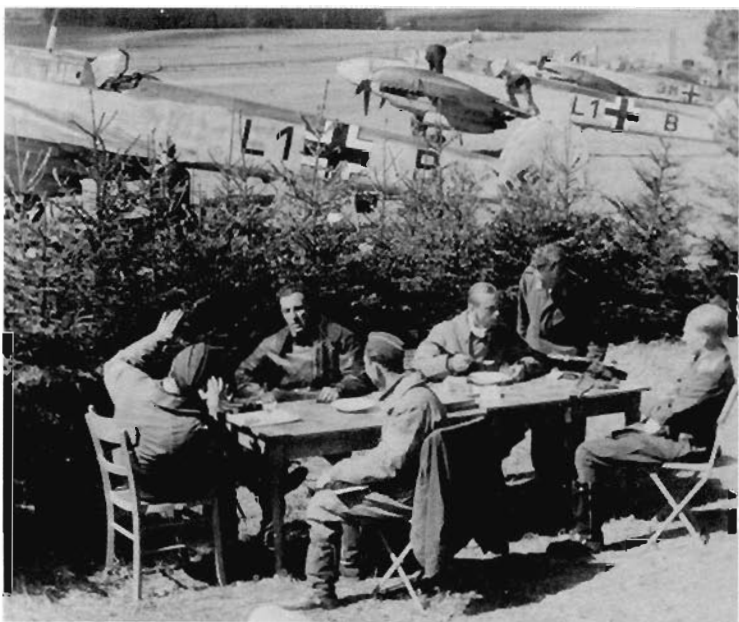
BELOW: A line-up of Bf 110 Cs, the first two from V.(Z)/LG 1, showing the revised form of camouflage introduced for Bf 110s in May 1940. The sides of the nearest machine, L1+XB, W.Nr. 3560, (brought down over England on 27 September 1940), have a pale mottle of 02. The aircraft behind, L1+YB, and 3M+AA, W.Nr. 2116 from the Stab of ZG 2, both wear the same style of camouflage though the latter appears to have had a soft sprayed application added to the upper surface 71/02 pattern – something that became more common as the air fighting over Britain developed.

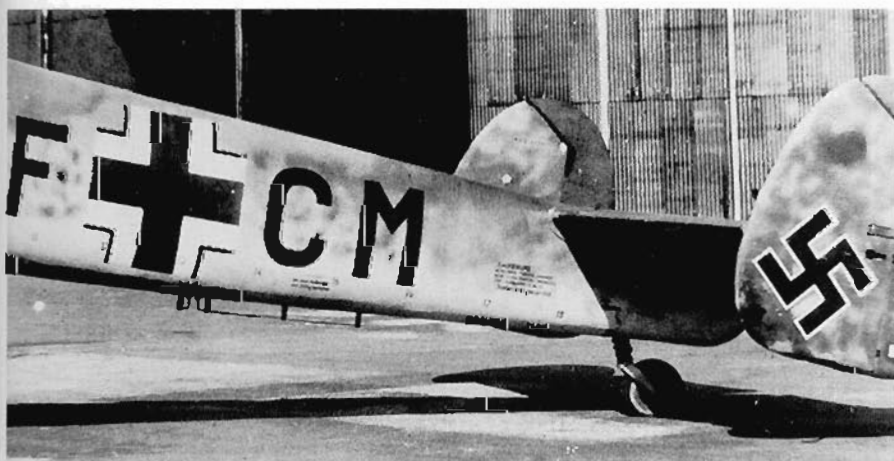
LEFT: A detail photograph of Bf 110 C-5, W.Nr. 2177, 5F+CM, of 4.(F)/14, which was forced down over England on 21 July 1940. It wears the factory finish of 71/02 on its upper surfaces with mottling in both colours on the 65-coloured side surfaces. The paint legend carrying the information on this new finish appears just forward of the tail plane. Under the letter 'C' the three lines (the top one very faint) of stencilling are maintenance markings which read: 'Hier anheben. Vor dem Aufbocken 300kg belasten' ('Lift here. Before jacking, ballast with 300 kg'). (R. Lutz)

The first example of a Bf 110 wearing the full camouflage revisions was captured intact on 21 July 1940; W.Nr. 2177, 5F+CM of 4.(F)/14, had been built by a sub-contractor, Gothaer Waggonfabrik AG, and its finish included mottling in both 71 and 02 on the raised 65-colouring of the side surfaces. This is an important time marker in establishing introduction of mottling at point of manufacture. The aircraft carried on the port side – just forward of the tail plane – the increasingly rare paint

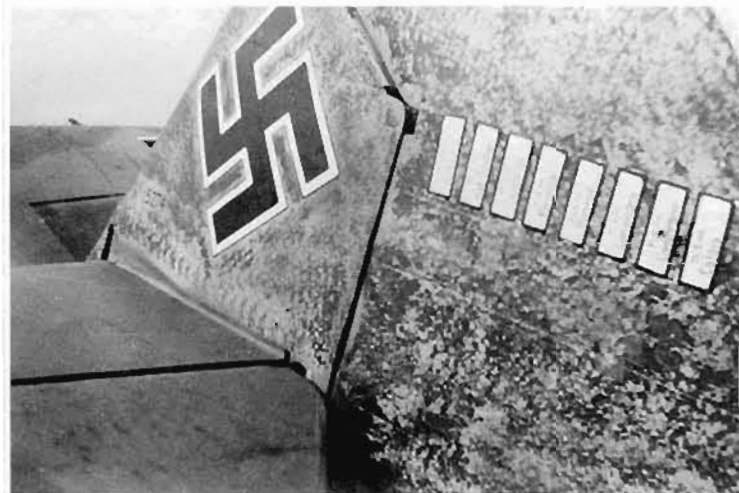
ABOVE: Close detail of the application method used by JG 2 for some of its aircraft. The stipple effect on W.Nr. 5274 was produced by using a 'stabbing' motion with one of the larger size brushes from the standard painter's kit issued as maintenance equipment. This style of finish has often been erroneously identified with use of sponges, an item that was not part of the standard kit. The series of repetitive near half circle shapes at the base of the fin show that the edge of a circular brush had been used. (E. Mombeek)

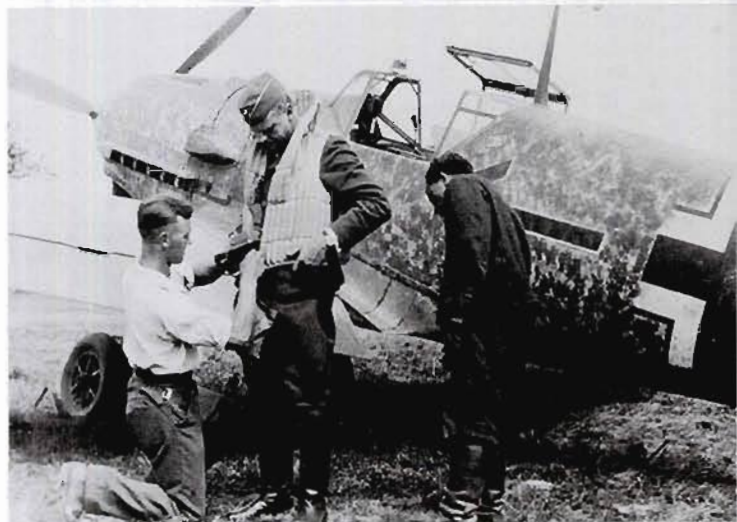
BELOW: This view of a Bf 109 E-3 of Oberstleutnant Harry von Bulow-Bothkamp, Geschwaderkommodore of JG 2, provides a more detailed example of the stippling style of application that illustrates that brushes were used, not sponges. Note the overlapping of the edges of the Balkenkreuz with the 71-colour, which was confined to the 65-coloured areas of the fuselage side surfaces. (E. Mombeek)

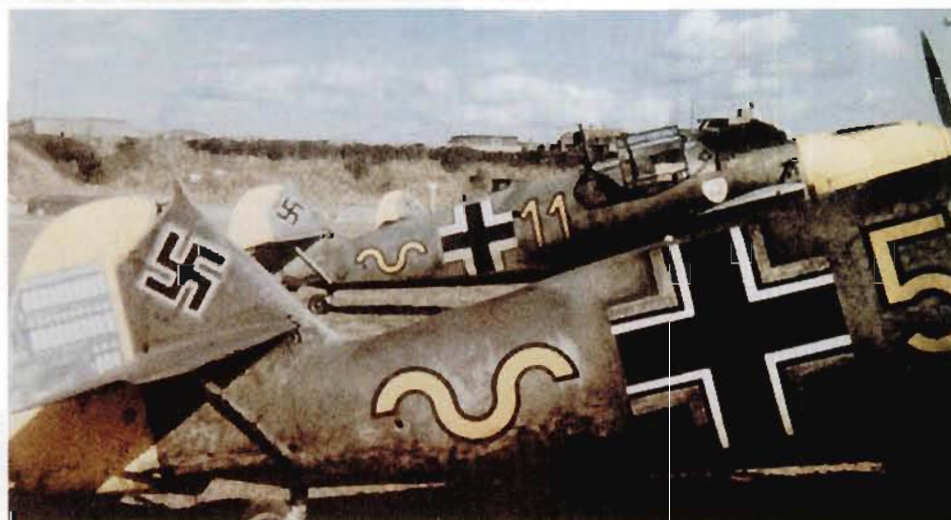
LEFT: The very intensive form of mottling used by JG 2 was sometimes enhanced by combining stippling with a soft-sprayed application. In this view of 'Yellow 5' of III./JG 2, the sprayed application of 71 had been done with thinned down colour on the upper part of the fuselage sides, and then enhanced with stippling in full strength 71 in other areas. Note that the Balkenkreuz marking had been reduced to the non-official, narrow-edged, style adopted by some other aircraft of JG 2 in a further attempt to increase the camouflage effect. The regulation style of marking can be seen on 'Yellow 11'. (M. Payne)

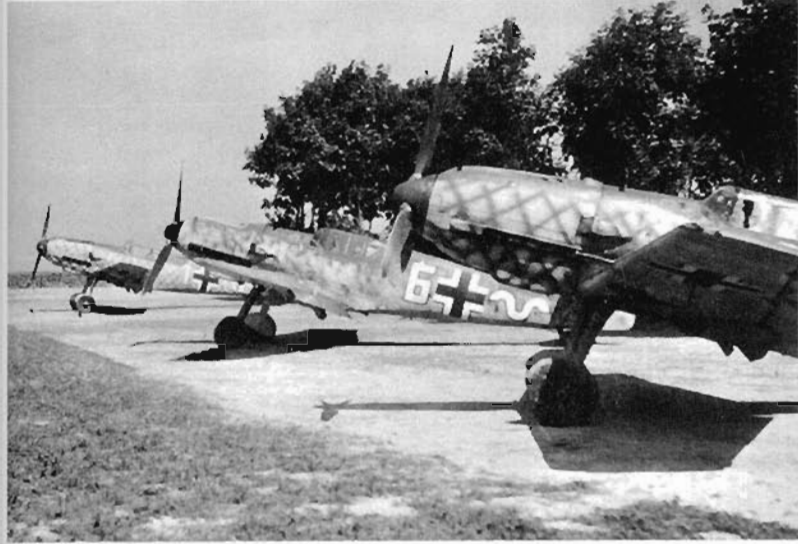
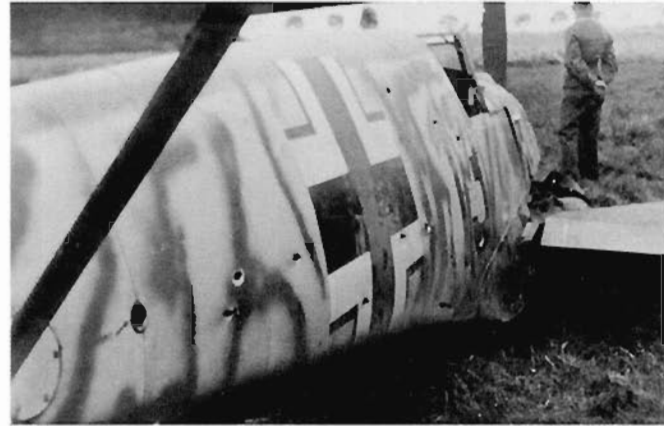
LEFT AND ABOVE: Two views of Bf 109 E-4, 'Yellow 13' of 9./JG 54 illustrate yet another distinctive style of application, this time using just 71, to break up the 65-colouring of the side surfaces. (E. Mombeek)

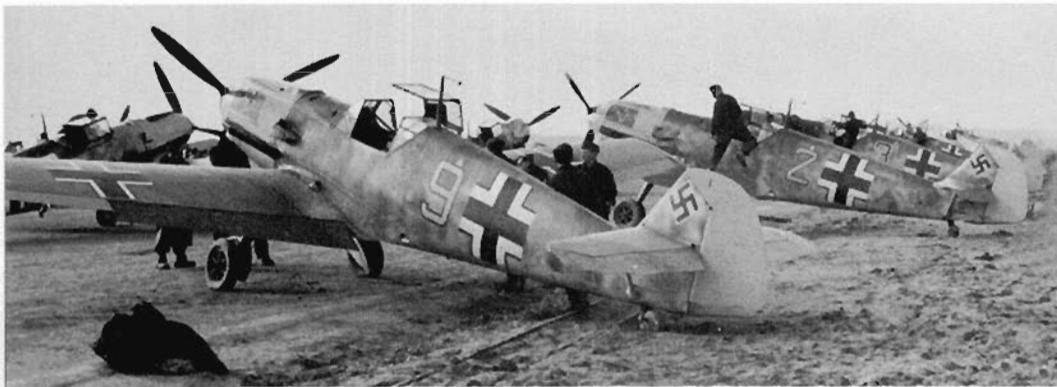
RIGHT: Not all modifications to the camouflage of Bf 109 Es during this period were so subtle. This example, a Bf 109 E-4 of 4./JG 26 photographed at Marquise in October 1940, records a very crude form of application indicating that it had been done at unit level. The 65-colouring of its flanks had been all but obliterated with a heavy streaking of 71. On either side of the area directly below the cockpit, the streaks of 71 had been sprayed over with 02. This took the general camouflage colouring back to the late 1939-style.
