# **LUFTWAFFE CAMOUFLAGE AND MARKINGS 1933-1945**

## **Volume One**

**K.A. Merrick**  
with Jürgen Kiroff

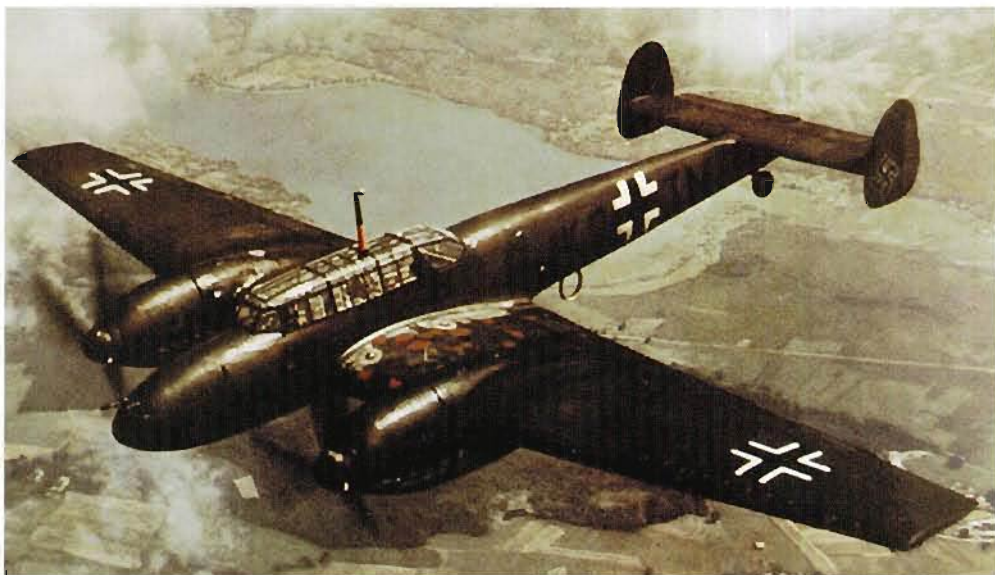
ABOVE: Bf 110 C W.Nr. 2143 KD+TM in factory-finished splinter camouflage of standard 70/71/65. Some small patches of red oxide primer can be seen on the wing root walk area. This aircraft was test flown on 17 May 1940.

Fritz Wendel had test flown W.Nr. 2143, KD+TM on 17 May 1940,<sup>4</sup> a little over two months before the loss of W.Nr. 2177, and a colour photograph of W.Nr. 2143 shows it wearing standard 70/71/65 camouflage. Given the production rate for that batch of aircraft, and a gap of only 34 aircraft between W.Nr. 2143 and W.Nr. 2177, it could be reasonably extrapolated that the latter aircraft had been produced somewhere around the end of May. It would be presumptuous to assume that it was the first to wear the revised colours and mottle but it must have been fairly close given, as noted, the special legend marked on its fuselage. Thus a date of late May would be a reasonable estimate for the introduction of the new scheme at production centres.

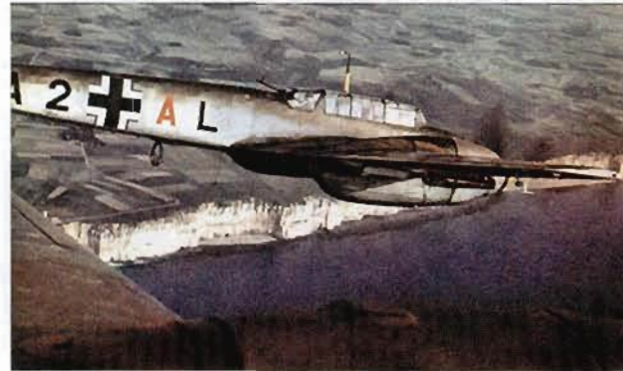
ABOVE: This in-flight view of a Bf 110 C of II./ZG 2, A2+AL, shows the application of a fine spray of 02 over part of the upper surface camouflage, markedly toning down the effect of the segmented 71/02 pattern along the spine of the fuselage.

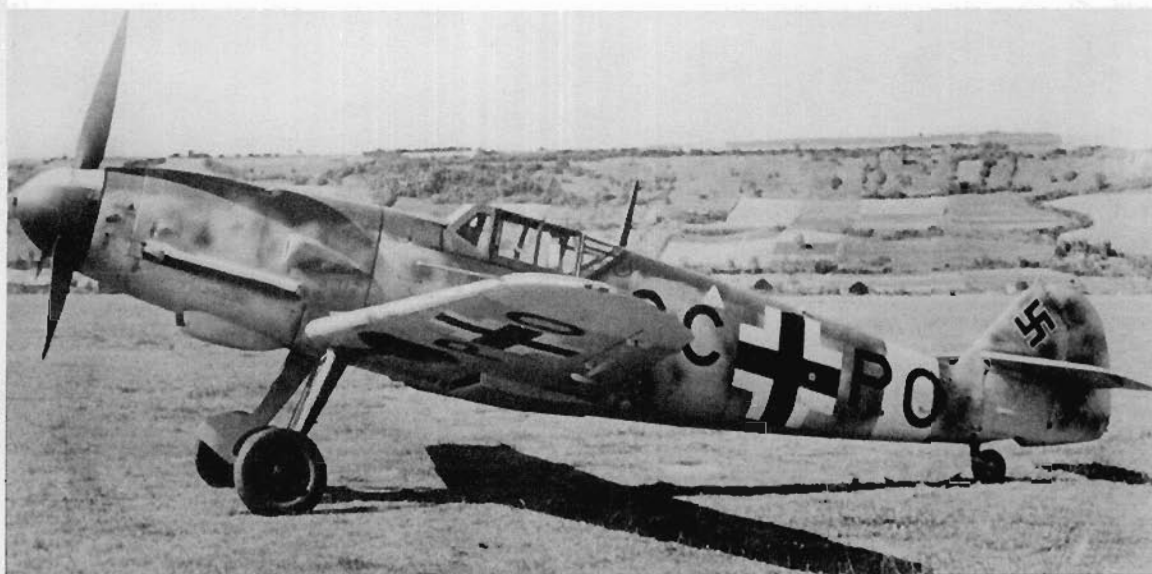
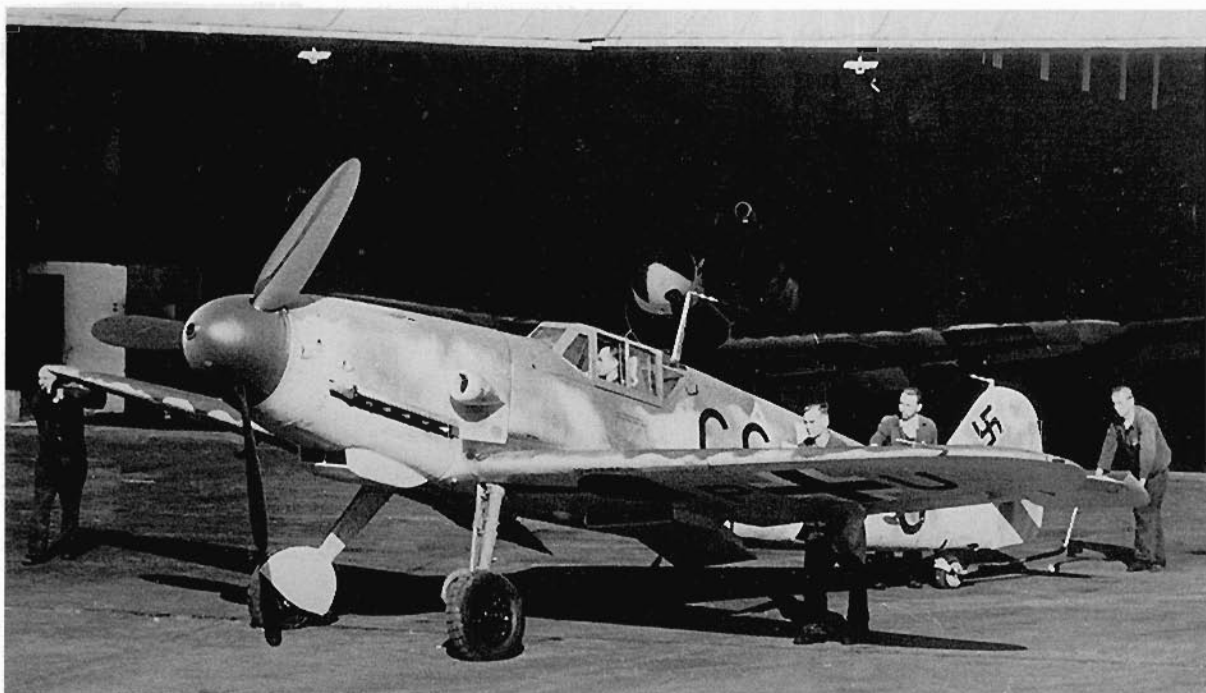
LEFT: Compare this photograph of CC+PU with the previous one of PC+PO. The style of camouflage application is identical, but both 74 and 75 had been used for the streaked 'mottling'. Consistency of style can sometimes = but not always - provide distinct clues as to where an aircraft had been produced as well as to specific production batches. (H.Obert)

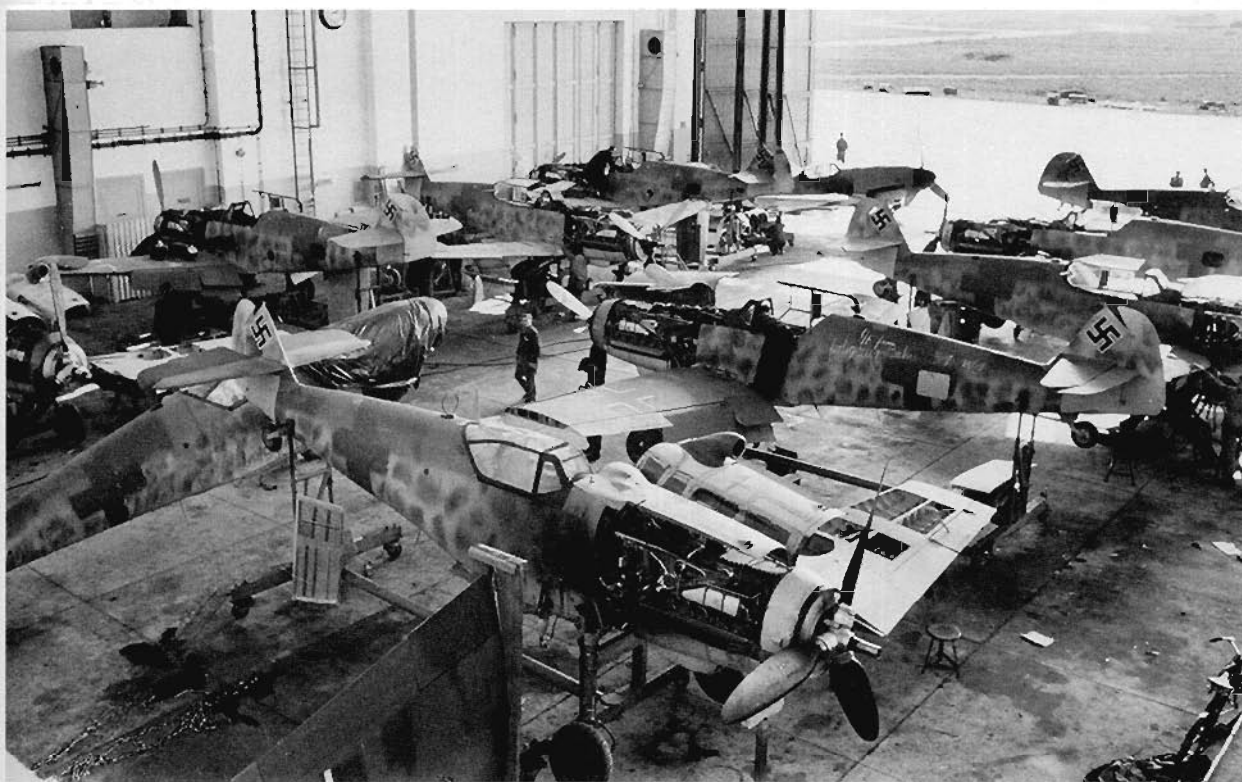
BELOW: A production batch, Bf 109 G-6/R6 aircraft, using the same standard camouflage pattern, as shown on the previous page, but with the downward streaking effect applied right along the fuselage in both 74 and 75. Note the development of a scalloped-edge effect to the division of the upper and side surface colour areas. The style and density of mottling to the vertical tail surfaces had remained consistent through the F and G series to this point.

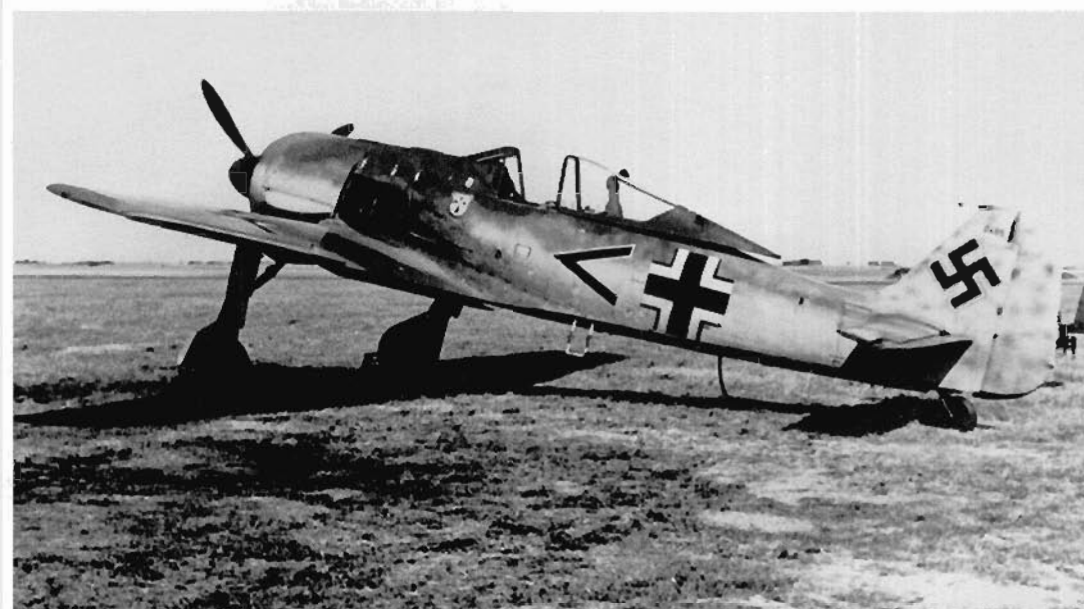
LEFT: Compare the camouflage on this Fw 190 A-2, W.Nr. 0485, just 14 aircraft later in the same production block, with the previous photograph. The 74-segment on the nose section has been taken a little further onto the engine cowlings this time, while the upper surface camouflage colours have been extended further down the sides to the horizontal line of the cross arm of the Balkenkreuz. There is evidence that the painting out of the Stammkennzeichen with 76 had removed some of the side surface mottling from the inside point of the Gruppenadjutant's Stab marking afterwards. Note that forward of the marking the upper surface colours were blended into the 76 with an almost solid, but much thinner application of 74 and 75. The style and density of mottling on the fin and rudder is about the same in both photographs. (E. Mombeek)

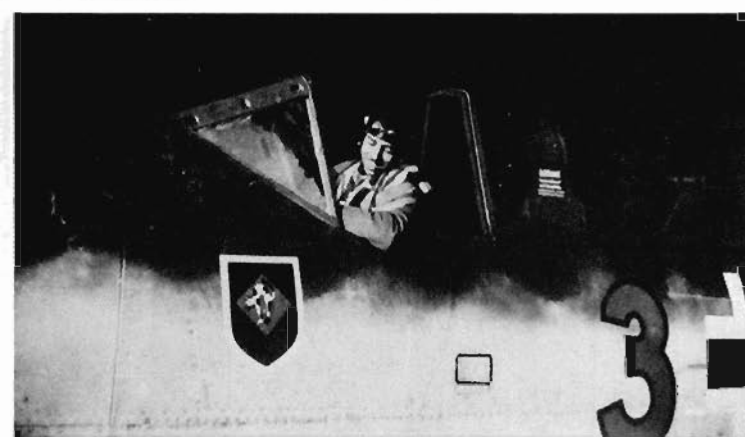
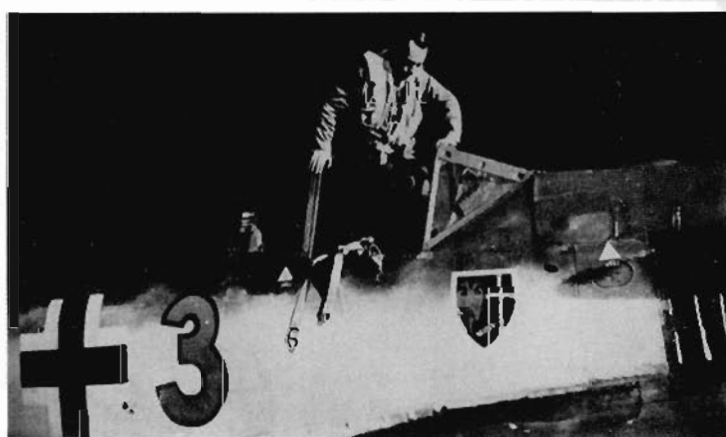
ABOVE LEFT AND RIGHT: These two close-up photographs of the fuselage of Uffz. Rudolf Rauhaus's Fw 190 A, 'Red 3' of JG 1 show the style of blending between the upper surface camouflage pattern and the 76-coloured side surfaces. The main colours have a scalloped bottom edge that had received only a narrow, thinly sprayed application of 74 and 75. This was a very conservative interpretation of the mottling requirement laid down by the RLM.

The two emblems represent Rauhaus's personal one, (the coat of arms of his home town Neuss) on the starboard side, with the 6. Staffel emblem on the port side. This close similarity of style of transition colouring points to this aircraft having been produced at the same production centre as the one shown in the photograph above. (E. Mombeek)

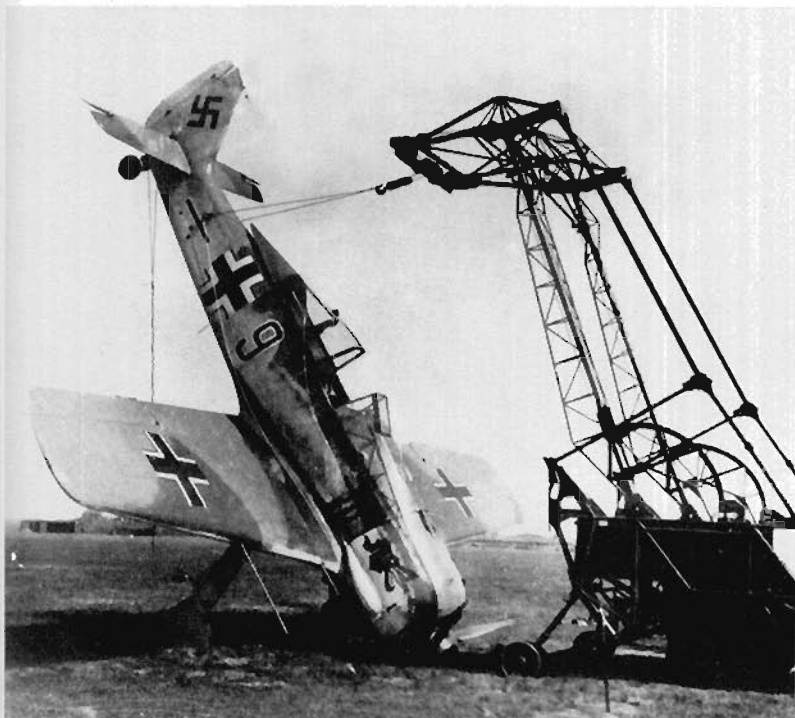
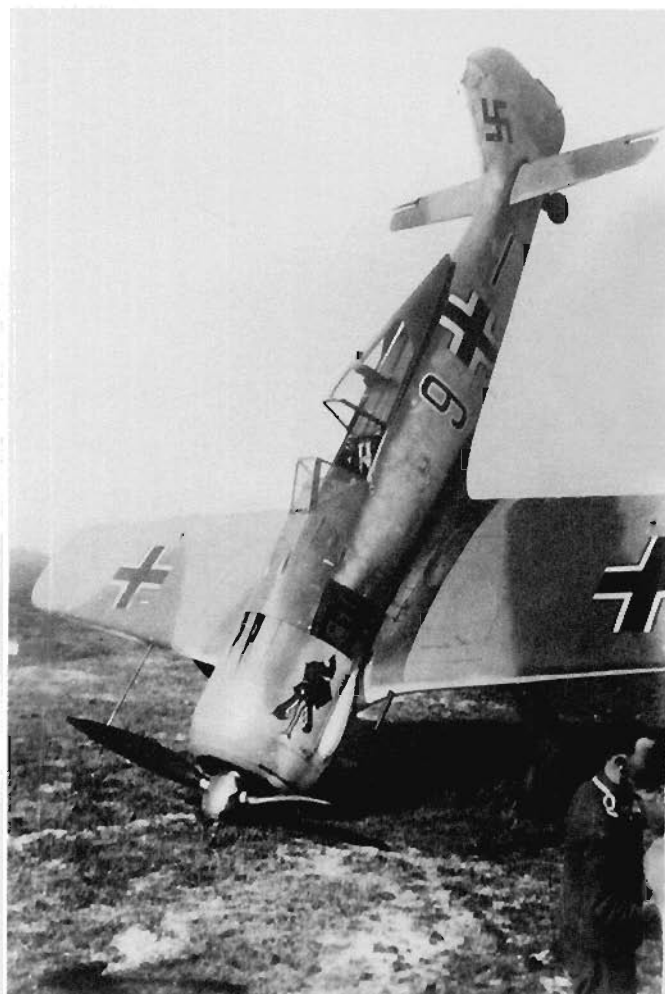
THIS PAGE: Three views of Fw 190 A-2, 'Black 9' of 5./JG 1 taken in 1942, they show clearly the standard RLM approved type 5 camouflage pattern of 74/75/76 approved for single-engine fighter aircraft, but incorporating the soft, curved-edged pattern characteristic of Focke-Wulf aircraft. However, mottling of the side surfaces has been done lightly to the point of being almost non-existent. The leading edge of each wing has been left in the lower surface colouring of 76, reducing head-on visibility. Note also the dark wing walkway strip carried through the camouflage on the inboard section of both wings. The unit badge is marked in the 2. Staffel colour of red. (E. Mombeek)

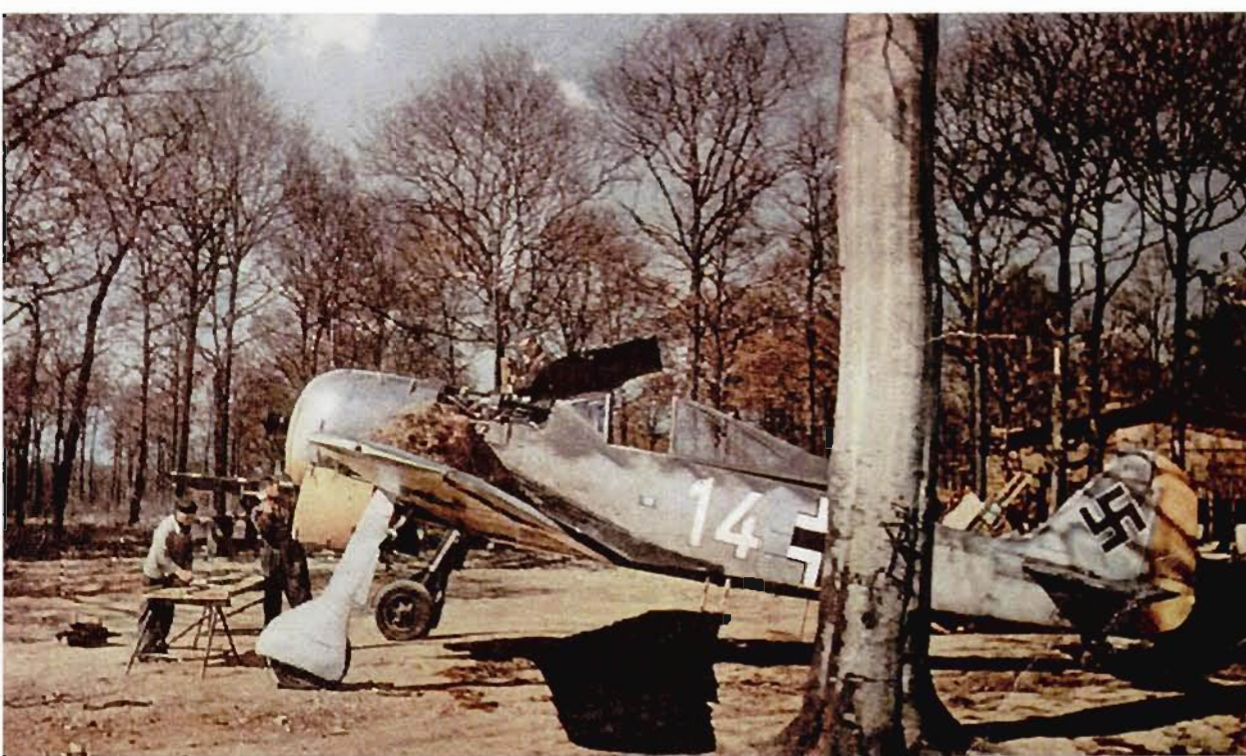
LEFT: A Fw 190 A-3, W.Nr. 1033 'White 14', finished in 74/75/76 camouflage with full 04 tactical markings. Again the side mottling had been reduced to a transition between upper and side surface colouring by means of a ragged, wavy application to the edge of the top surface colours. Location appears to be France.

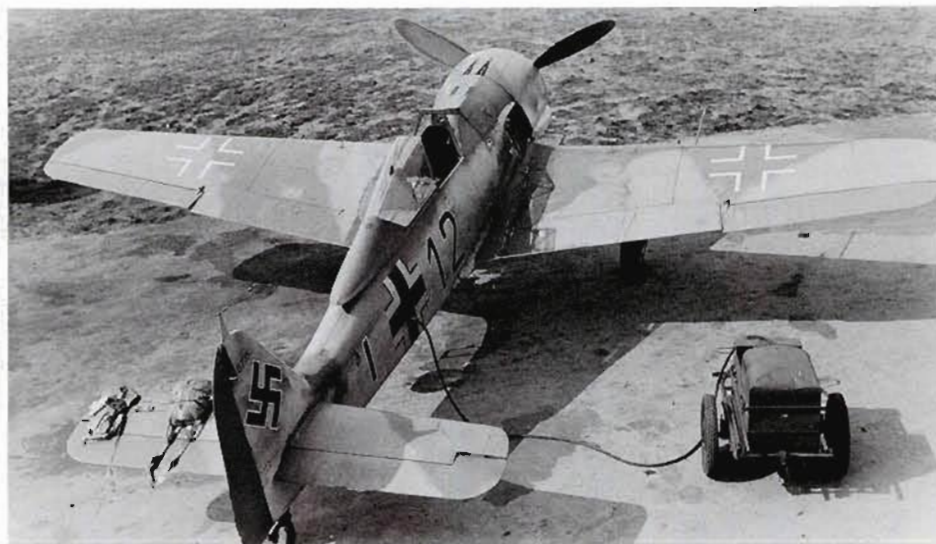
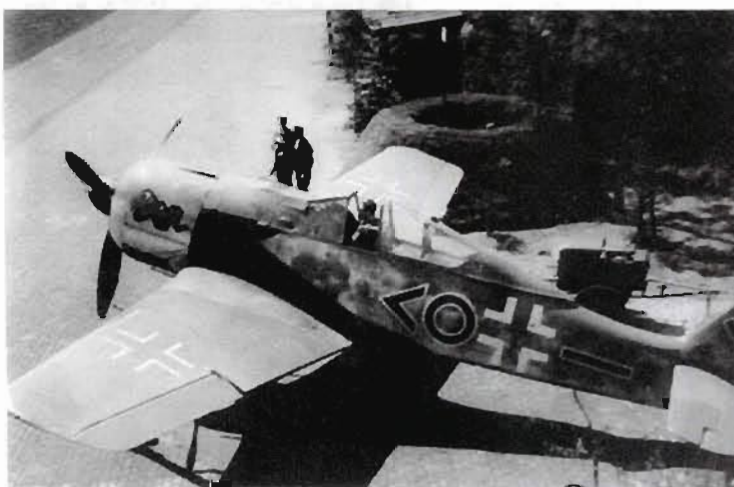
RIGHT: This rear view of Fw 190 A-4, W.Nr. 6735, 'Black 12' of 8./JG 2 provides an interesting comparison with the three views of 'Black 9' on the previous page. The application of the pattern is almost identical, but there are subtle variations. The starboard tailplane has the darker colour extended further inboard.

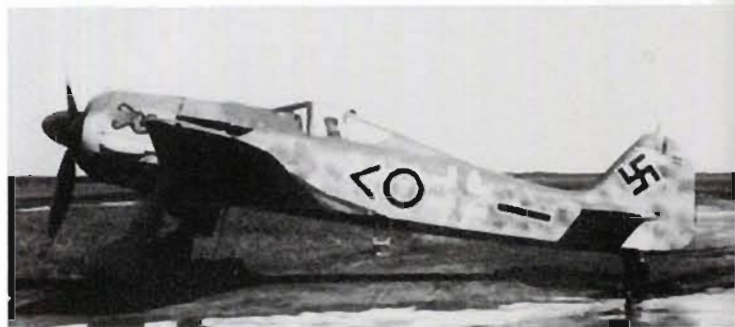
LEFT AND BELOW: Two views of an Fw 190 A-5, the mount of Lt. Rüdiger von Kirchmayr, Technical Officer of II./JG 1. The upper surface camouflage had again been modified on the section forward of the cockpit, the 74-coloured segment being significantly reduced. Note also the very heavy style of mottling on the side surfaces. (E. Mombeek)

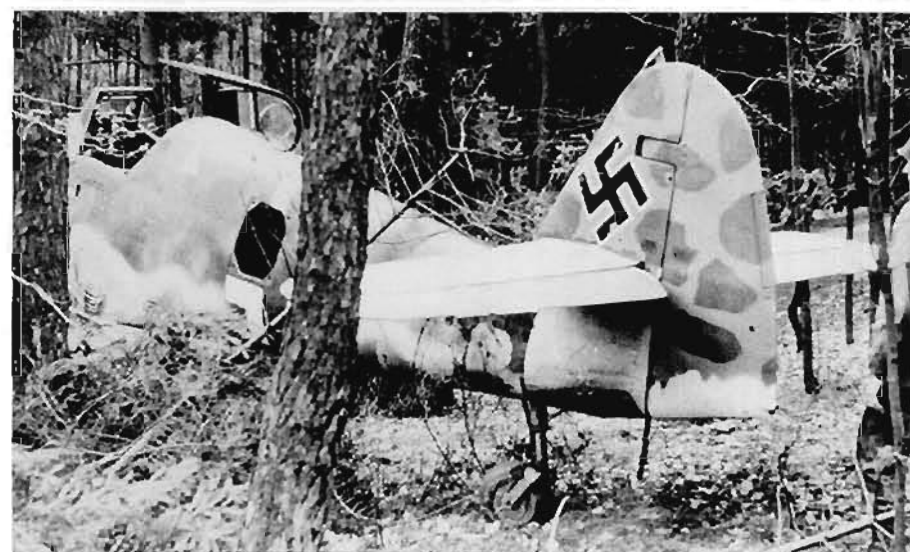
LEFT: As the war progressed to its final stages, standards were eroded, but manufacturers of sub-components seemed best able to retain some standard of conformity of style longer than the main assembly plants, though in the end they too failed to some degree. This Bf 109 K had a finish of 82/83 on its vertical and horizontal tail surfaces with upper surface colouring taken right down the sides of the fuselage, a narrow wavy band of 76 dividing it horizontally. This distinctive style of camouflage application is similar to that seen on the W.Nr. 330200 batch built by Messerschmitt at its Regensburg plant. However, continuation of the 76-wavy line forward of the Balkenkreuz is different. The area below the fixed horizontal tail surfaces is bare metal, as is the access panel just forward of it – the result of the last stages of the austerity directives. These were part of the tail assembly parts supplied by a sub-contractor. The under surfaces of the fixed section of the horizontal tail plane were probably also left in bare metal.

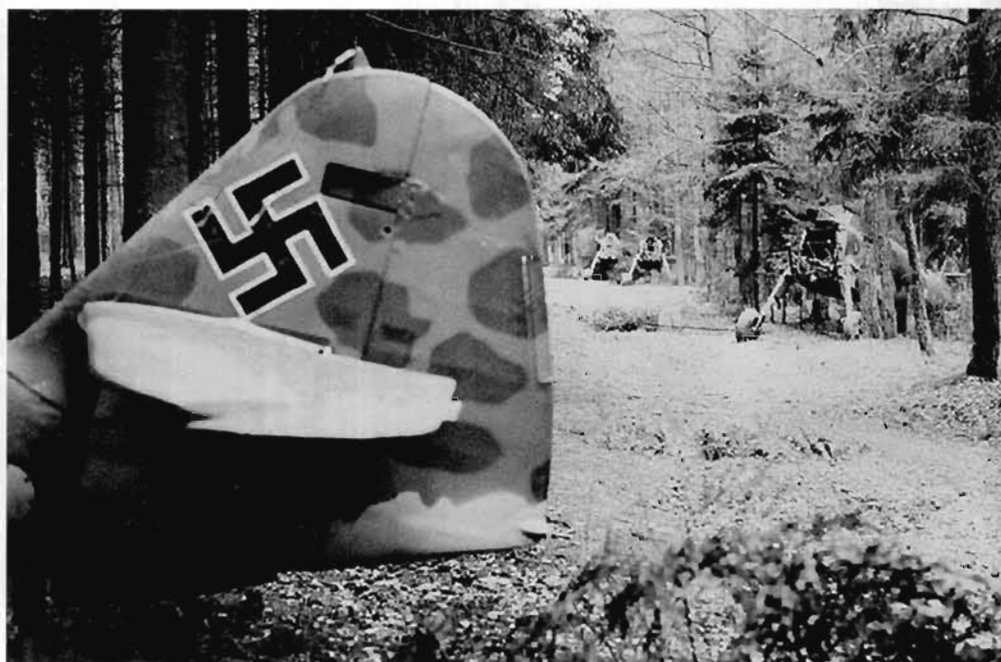
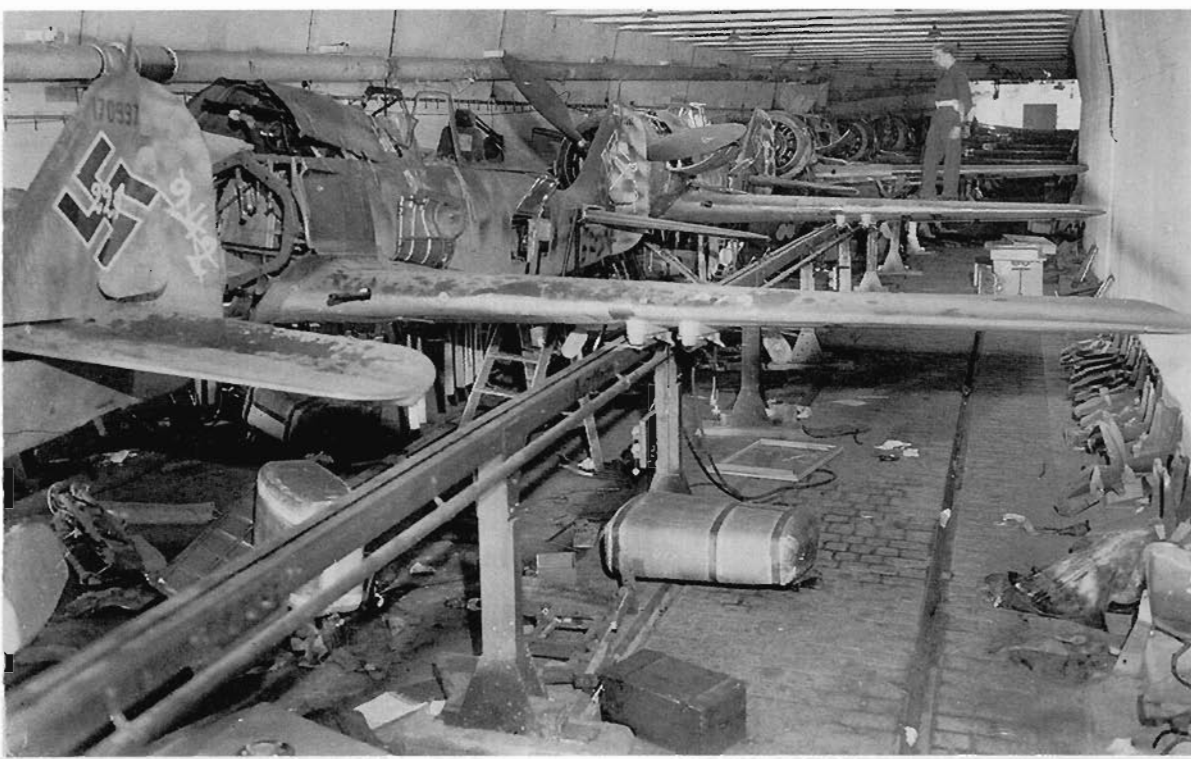
RIGHT: Not the same aircraft as in the previous photograph as close examination of the positioning of the spots of 83-colouring show (see the lower rearmost spot of 83). These aircraft were all found near Wertheim. The near consistency of their shapes and the bottom colour division line makes it clear that a stencil had been used. The unpainted area below the fixed horizontal tail surfaces and bare metal rear access panel can also be seen. However, note the dark 81-coloured rear section of the fuselage with that colour taken up over the fin fairing. The remainder of the fuselage was 82/83. Compare these two photographs with that on page 42 of the stockpile of Bf 109 fins that had free-hand applied camouflage.

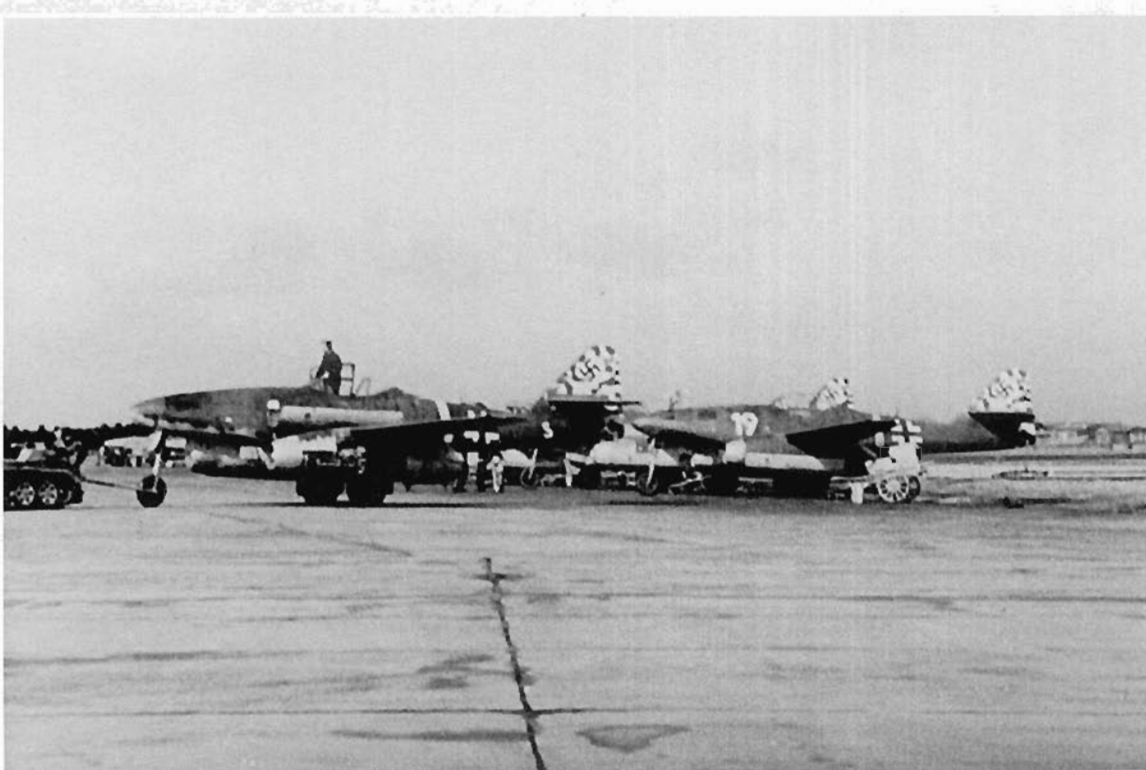
LEFT: Me 262s of Kommando Nowotny, showing the distinctive stencilled mottle used by the sub-manufacturer who supplied fin and rudder assemblies to the particular production centre. The 81 (or possibly 83) patches contrast strongly with the very pale 76 colouring. The very dark camouflage colouring of the two aircraft in the foreground contrasts with other machines used by this unit, marking the transition between the earlier 74/75/76 scheme to the late war colours of 81/82/76. 'White 1' had the 81 and 82 pattern taken right down the fuselage side surfaces, but 'White 19' appears to have retained its original high demarcation 81/82 pattern, with the side surfaces sprayed over in just 82. Both aircraft have bare metal nacelles at the front of the engines, a consequence of the short life of engines at that time, resulting in constant engine changes. The forward cowling on the Jumo 004 engine was integral with the engine, containing the fuel tank for the Riedel starter motor, and was not painted prior to factory fitting. At unit level, it was obviously not considered worthwhile doing so. All the aircraft wear the distinctive narrow O4-coloured fuselage band, and 'White 1' in the foreground also has a white 'S' marked below the tail plane, identifying it as a training (Schulflugzeug) machine for the unit.

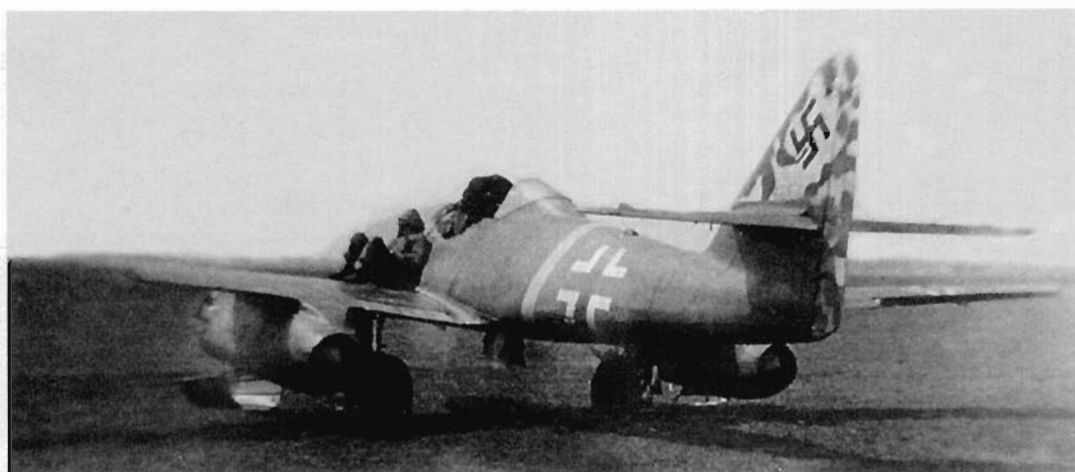
ABOVE: This view of 'White 7', W.Nr. 110376 belonging to III./EJG 2 taken at Neubiberg in May 1945, shows the sharp-edged pattern of 81 on the fin and rudder surfaces. The exact repeat of this pattern on each aircraft was accomplished by using a stencil.

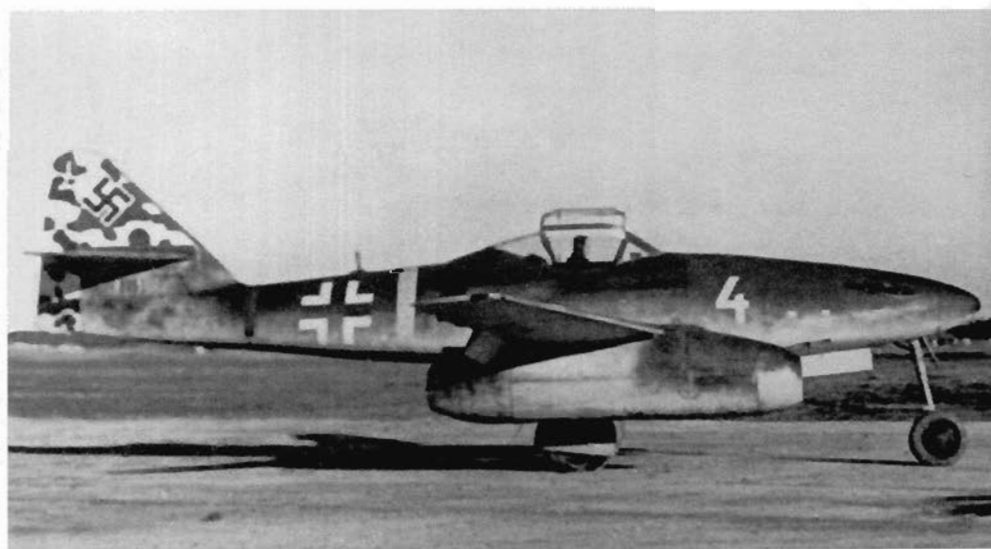
RIGHT: The other side of the fin and rudder pattern is seen here on 'White 4' of Kommando Nowotny. The contrast between the pale 76-shade on the fin and that of the lightly oversprayed 76 seen on the lower parts of the aircraft can be seen. The rear vertical joint between the tail unit and the fuselage was covered with a doped fabric strip, and it appears that this one had been replaced and hand-painted with the darkest of the camouflage colours. The narrow yellow band was in O4.

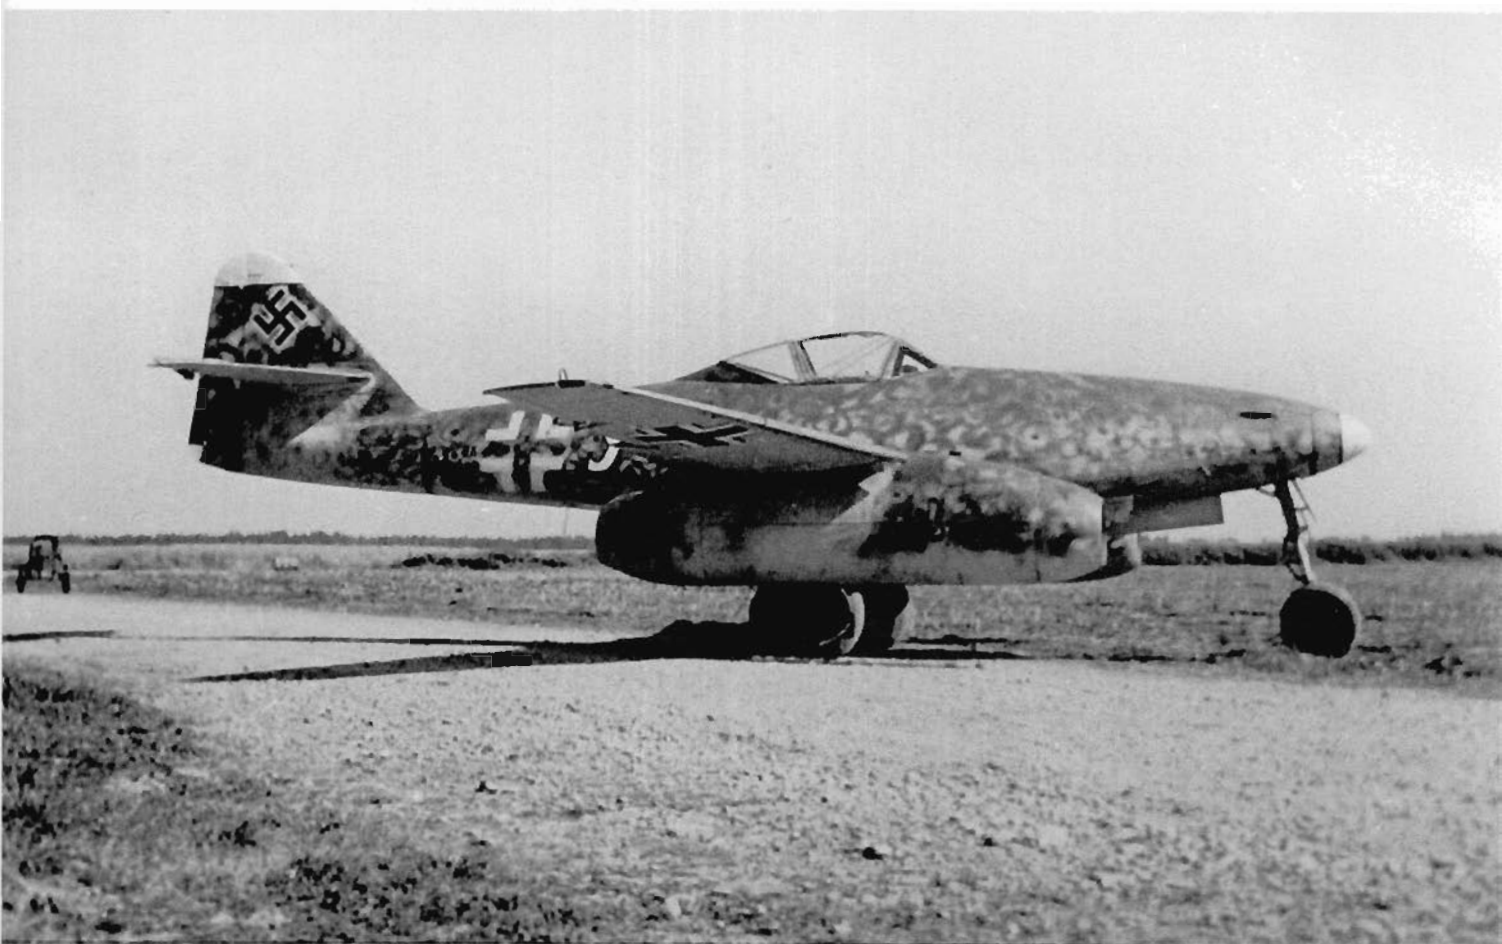
ABOVE AND BELOW: Three photographs of Me 262 A-2, 9K+YH, of 1./KG 51, showing the difference in style of the two production line painters who had camouflaged the aircraft. The port side had soft mottles while the starboard side had a more linear form of application. The nose cone was white, the Staffel colour, the same colour being added to the tip area of the fin and rudder. The style of the aircraft letter 'Y' was most unusual, having a cursive form with a curved lower stroke. Overall camouflage was 81/82/76.

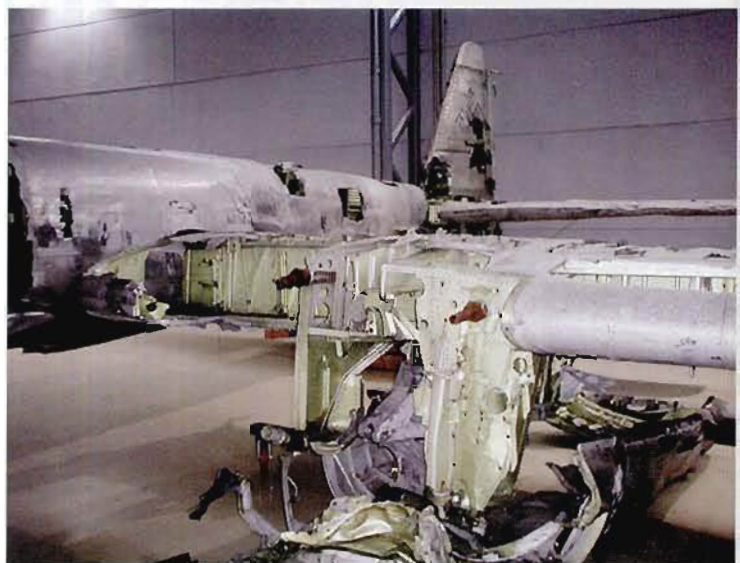
ABOVE: The same anodised finish was used for the Ju 88 and testimony to its durability is this photograph of a Ju 88, recovered from the sea in only recent years. It is now on display in the Flymuseet in Norway. The resistance to corrosion of this finish is evident. (Flymuseet)

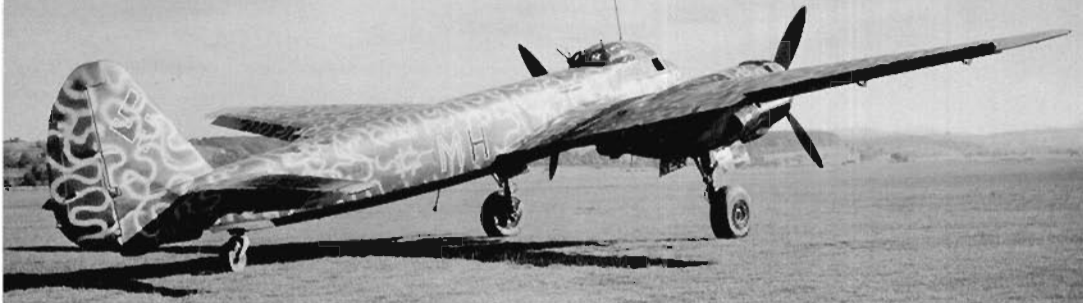
LEFT: The Ju 88 A-4 of 1./KG 54, W.Nr. 550396 coded B3+MH, which landed at Dübendorf airfield on 21 October 1943. It wore a most unusual colour scheme as explained in the main text. The reduced form of Balkenkreuz, half size, was marked only by the white angles, dulled to an off-white colour. The original, full size marking could just be detected where it had been painted over. The Balkenkreuz markings on the wing upper surfaces were full size but shown only as narrow, off-white, outlines. Note also the yellow wing tip markings, something omitted from the Intelligence Officer's report. What appears to be two shades of base colouring is actually a single overall blue colour with lines of permanent black sprayed in snaking lines (Arabesken). The snaking lines of pale sand colouring were marked over the entire upper and side surface finish. The aircraft letter was in yellow, outlined in white, an oddity, as both Staffel and Gruppe colouring were white. Flame dampers had been fitted for night operations. (Flieger Flap Museum)

Late in the evening of 21 October 1943, a Ju 88 A-4/trop landed at Dübendorf airfield in Switzerland. En route from Germany to its 1./KG 54 base at Bergamo, in Northern Italy, the crew had become lost and with failing fuel reserves they landed. The main feature of B3+MH W.Nr. 550396, was its unique camouflage, described by the Swiss Intelligence report of 23 October as '*Farbe: Oberseite Wasser - und Wüstentarnung, Unterseite Schwarz*', (Colour: upper surface water - and desert camouflage, underside black). The choice of colour descriptions was unique, water and desert (sand). The report failed to mention the black snaking lines also present over the entire upper and side surfaces, beneath the snaking lines of sand colouring. The term 'water' was meant to describe a shade of blue, but in studying the photographs of the machine, and comparing the colour with the 79-coloured lines, this was a much darker shade of blue than regulation 65 or 78 that subsequently came into use, either of which might otherwise have been applicable.

As noted above, the overall dark blue colour had snaking lines of permanent black over which pale sand coloured lines had been added. Undersurfaces were finished in permanent black, though the engine cowlings had only part of their lower surfaces sprayed solid black, snaking lines of the same colour being used in some areas.

1./KG 54 had moved to Sicily in December 1941 where it came under the command of X. Fliegerkorps. It had then moved to Crete in June 1942, but was back at Catania, in Sicily, at the beginning of 1943. Its operational deployment had been over water for most of that period which might explain further the reason for adopting the unique 'sea' camouflage. The few other photographs of aircraft from this unit show the same snaking lines over a darkish camouflage, with dark snaking lines on the pale under surfaces, something found on B3+MH, but obscured in parts by the more solid application of night camouflage.

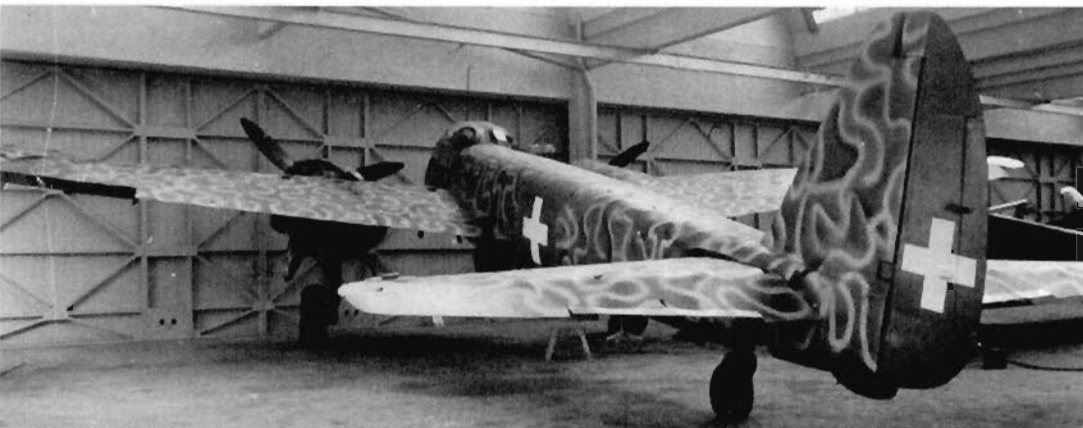
ABOVE: Taken after Swiss markings had been applied over the original German markings, the combination a snaking black and pale sand-coloured lines can be seen more clearly on the rear section of the fuselage and the fin assembly. (Flieger Flap Museum)

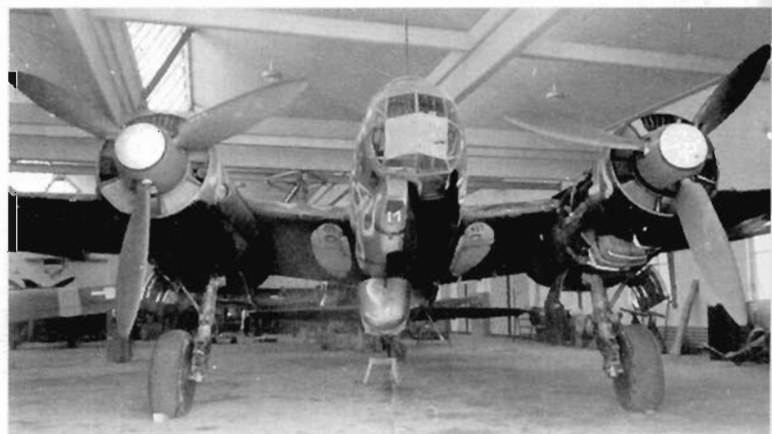
RIGHT: The front view reveals that the permanent black spray on the undersurfaces was not applied to all sections; the gondola has black only on the inboard half, and the engine cowlings have the black confined to their lowest sections. Where the bomb shackles have been removed, the original O2-primed wing surfaces are visible. The Balkenkreuz markings on the wing under surface had been reduced to half size and marked only with the white angle sections. (Flieger Flap Museum)

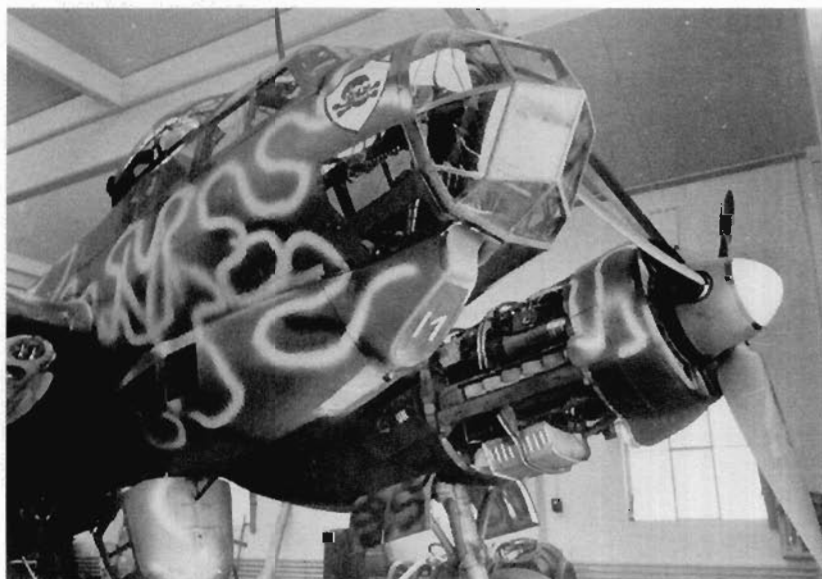
LEFT: The marking on the bomb aimer's window is the letter 'M', applied in what seems to have been tape, with one section having peeled away. It was repeated in white on the opening section of the crew entry hatch, but the sweeping line of sand colouring obscured part of it. Note that the overall blue finish extended to the lower surfaces, as shown by the open section of the crew entry hatch. The black lines can be clearly seen on the gondola and the undercarriage door. The flame damper extension to the port engine has 'UK' marked in white, with a fainter 'G' aft of it, and what appears to be part of a W.Nr. 1741 on the top curve - a part recycled or borrowed from another of the unit's Ju 88s. The unit emblem appears in a form not usually seen; instead of being stencilled directly onto the camouflage it is presented on a shield, the colour of which appears to be yellow with black edging. There is also a ribbon marking across the top right hand corner. Close examination shows the emblem had, as usual, been applied using stencils. The spinner tips were white, marked off with a thin black line. (Flieger Flap Museum)

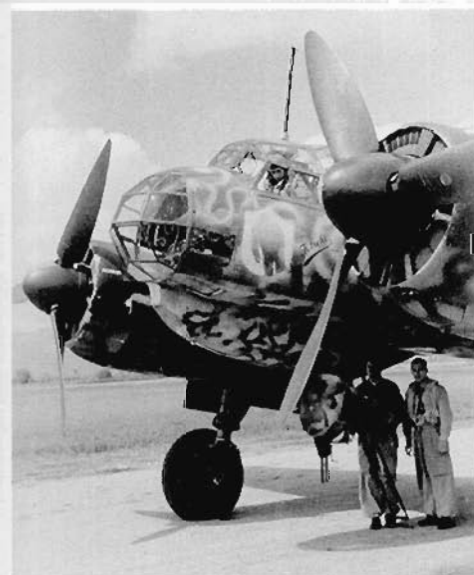
RIGHT BELOW: While this Ju 88, also photographed in Italy, exhibits a similar type of modified base camouflage, the style and sharpness of the continuous network of 79-coloured snaking lines is distinctly different, indicating that it had had its camouflage modified at a different depot from that of the previous three examples. There also appear to be no black lines. The difficulty in assessing the base camouflage colouring of these Ju 88s operating in Italy will be apparent from these examples. Superficially, they all appear to be just modified standard camouflage finishes of 70/71/65, but the details given in the text, and the examples shown here, highlight the traps when assessing photographs.

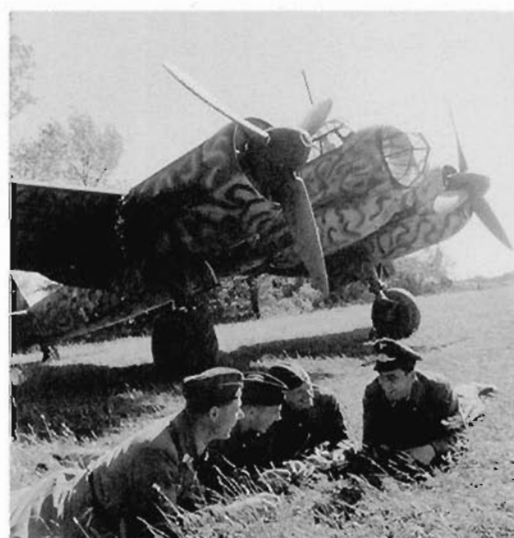
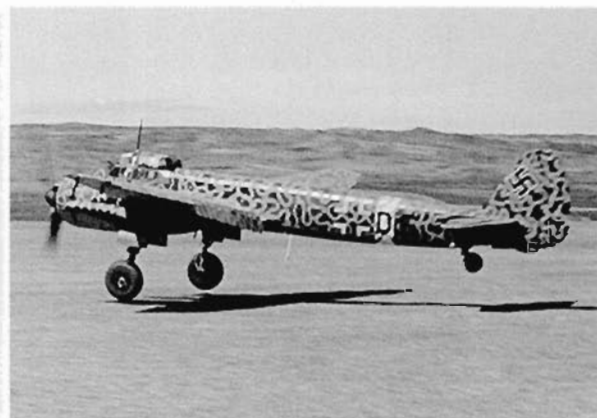
LEFT: The depth of the colours, 78 and 79 in particular, may be judged from this wartime colour photograph. While such resources are not suitable for establishing exact shades of colours, the tonal differences shown here give some idea of the relative shades of the original 78 and 79.

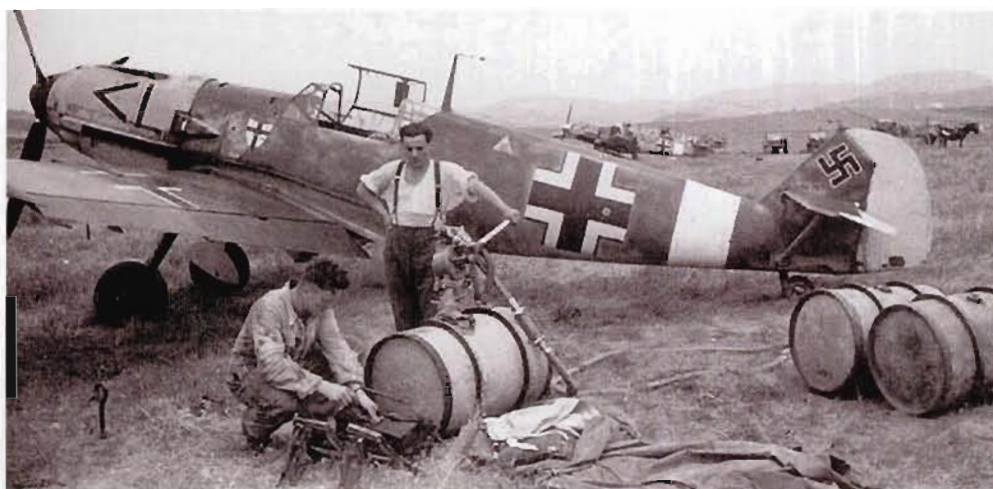
LEFT: Taken in Sicily during the period when the Luftwaffe was making some rapid re-deployments for the opening phase of the Balkan campaign, this photograph caught two of I./JG 27's Bf 109 Es in the background in their new 78/79/80 finish. The disruptive pattern of the 80-coloured spots could be seen even at reasonable distance. The aircraft in the foreground, Bf 109 E-4, W.Nr. 785, from Stab III./JG 27 was still in its 71/02 finish with a heavy mottling of the darker colours on its flanks, and yellow tactical colouring on the engine cowl and rudder, to which had been added the Mediterranean tactical marking of a white band around the rear of the fuselage. (R. Michulec)

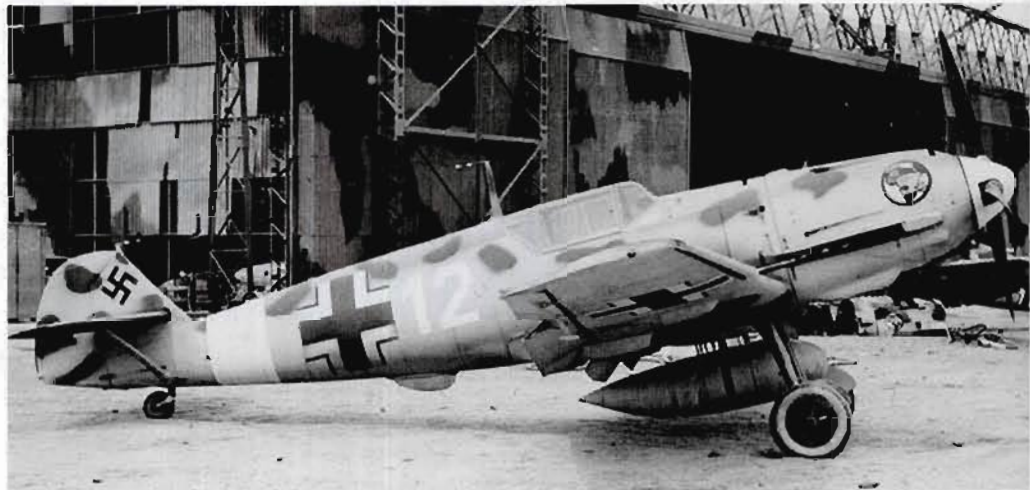
RIGHT: The repainting in tropical colours scheduled for JG 27's Bf 109 Es was tempered by the current battle conditions. The work was carried out in Sicily and this machine, 'White 12', had just been completed when photographed. The distinctive style of the dark green 80-coloured 'spots' was limited to the first batch of aircraft, subsequent Bf 109 Es exhibiting a different style of mottling application. This particular Bf 109 E was one of several reputed to have served with 10./NJG 1, in Holland in 1941. The Perspex bulge below the fuselage held direction-finding equipment used in a series of night-fighting experiments during early morning and late evening patrols. When those had been completed the aircraft were dispersed to other units.

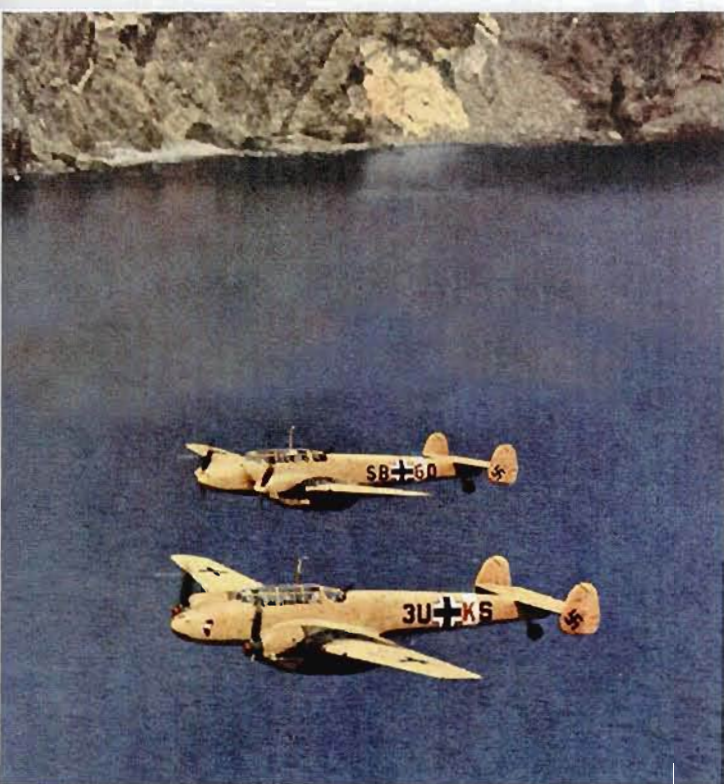
ABOVE: These two Bf 110s of ZG 26 flying over the Mediterranean clearly show how RLM 79 Sandgelb alone stood out against the blue water.
