# **LUFTWAFFE CAMOUFLAGE AND MARKINGS 1933-1945**

## **Volume One**

**K.A. Merrick**  
with Jürgen Kiroff

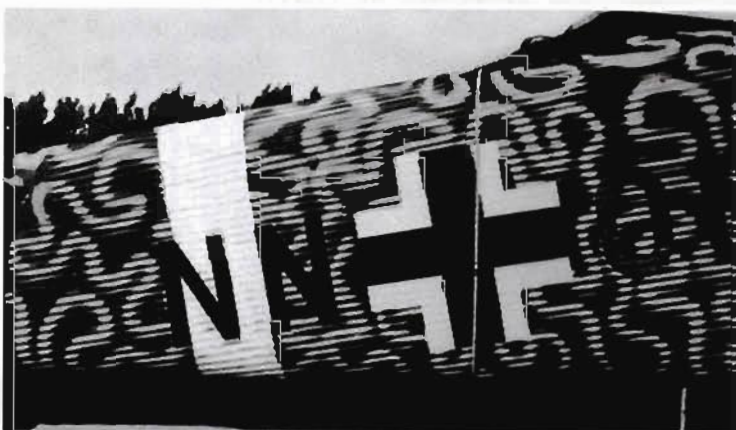
ABOVE: The photograph of Ju 52, NN+00 was attached to the report on camouflage changes for aircraft for delivery flights to the Mediterranean. The base camouflage remains standard European 70/76/65, 'Arabesken' lines of 79 added. The density of the latter shows that breaking up the dark background colour into small areas was necessary to be effective.

A final small window into the combination of tropical and European colours makes an interesting addendum. In a portion of an RLM report (unfortunately not identified from these fragments taken from it) concerning problems associated with the Mediterranean area, Item 13 included a photograph (shown here) showing part of a Ju 52 with Stammkennzeichen 'NN+00'. The caption contained in the original report stated:<sup>5</sup>

*"The standard camouflage for flying over water in the European theatre is satisfactory, but for aircraft flying to Africa on delivery flights it was found that the use of sprayed 'yellow lines' (Arabesken), but not bright yellow was most effective."*

This is very informative. The 'yellow' referred to was the 79-finish applied to all aircraft operating in that area. The remark that the sea was blue, but painting *all* aircraft that colour was impractical, lends some support to the details given earlier in this chapter regarding Ju 88s. Those aircraft appear to have received priority in terms of a more suitable over-water scheme because of the nature of their operations.

The report used the term *Arabeske* to describe the pattern of 79-colouring, (in English arabesques), meaning scrollwork or fanciful intertwining of a linear form, a very good description of the weaving lines of 79. This form of addition to the basic camouflage would become more widespread in the ensuing years, and sometimes referred to in some writings as *Wellenmuster* (wave pattern).

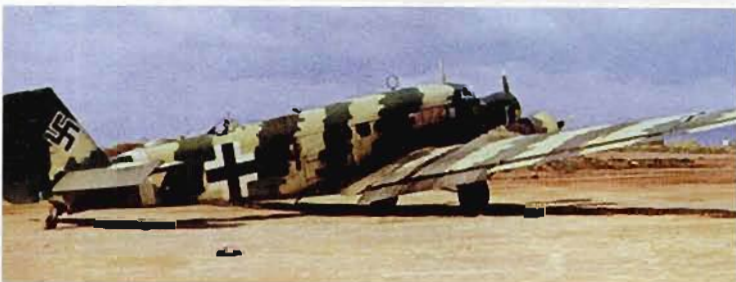
ABOVE: The break-up using 79-colouring to the dark greens of the European camouflage for flying over water is shown here to good effect; the ragged edges adding to the effectiveness of the camouflage. The background colour appears to be a single shade of brownish-green, but closer examination, particularly of the elevator, shows it to be standard 70/71 finish. The narrow 'white' band around the fuselage was the tactical marking for Luftwaffe forces based in the Mediterranean area and the narrowness may have been the strict interpretation of the 50 cm dimension set for the Bf 109 units. Ju 52 4U+NH was a unit hack operated by 1.(F)/123 in support of its Ju 88 force.

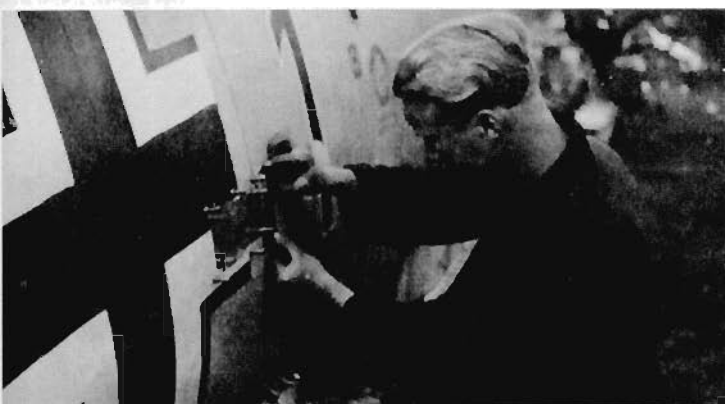
ABOVE: The amount of repair work able to be carried out at front line-level was relatively limited. Here, a ground staff member of III./JG 26 was photographed while applying a metal patch to the inside surface of the fuselage of a Bf 109 E, having already carefully removed a rectangular section of damaged metal. The pressure clamps further out from the hole define the real size of the metal patch.

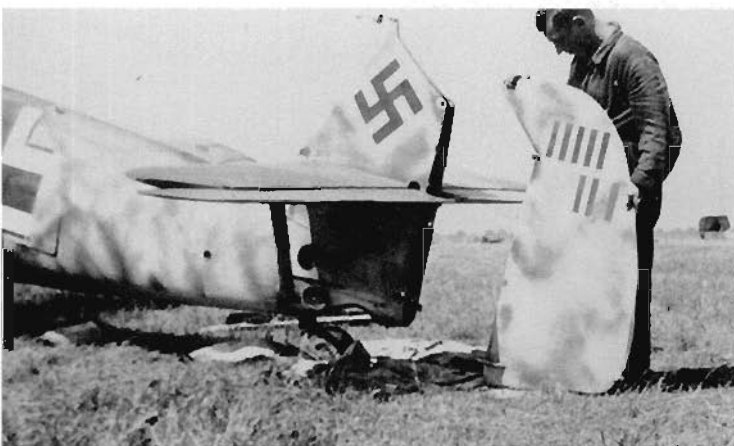
BELOW: Among the other forms of common front line repair work was replacement of control surfaces, such as this rudder, which appears to have been removed to provide access to the internal area of the fin as there is no evidence of major damage to the rudder itself. The Bf 109 belonged to II./JG 54, whose style of camouflaging of the 65-coloured areas was done using a loose pattern of short strokes in both 71 and 02. The eight kills on the rudder of 'White 1' recorded the score of Oblt. Hans Philipp. Replacing, or even swapping cannibalised parts did sometimes lead to mis-matched colour schemes or patterns.

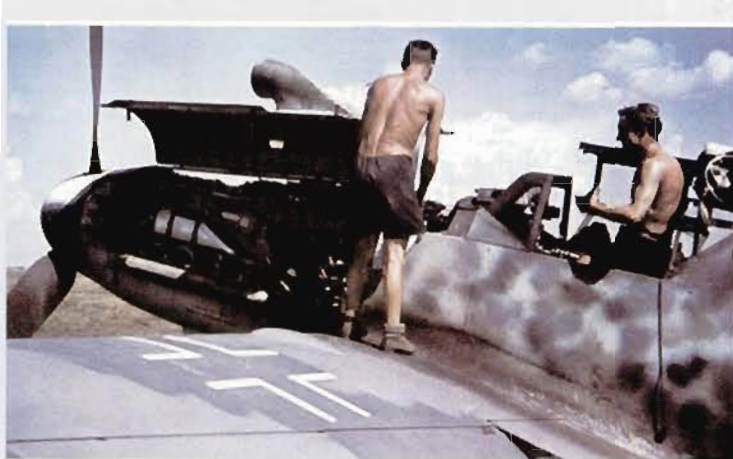
ABOVE: This Erla-built Bf 109 G-6, 'White 10', W.Nr. 19881, flown by Lt. Willmans of 1./JG 52, shows the mix of mottle colouring to the fuselage side surface in colours 74, 75 and 02. (M. Jessen)

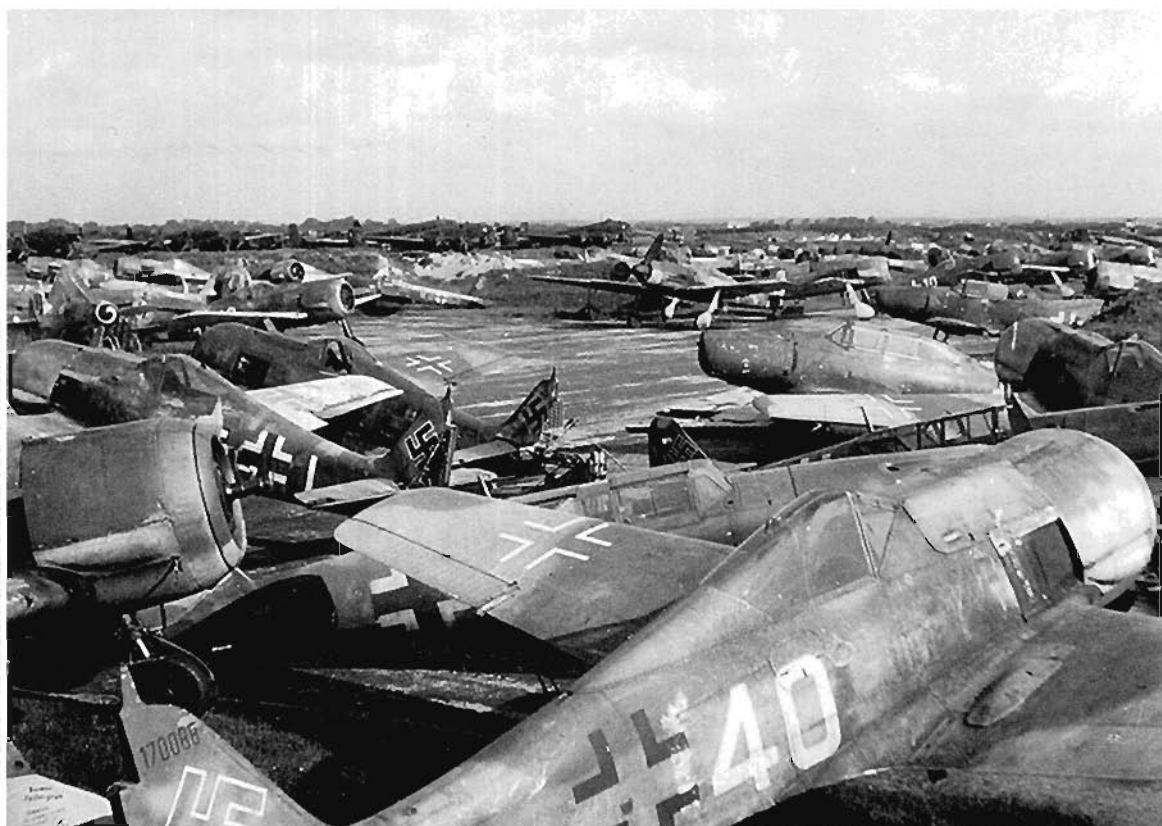
RIGHT: This collection of aircraft provides a rich source of comparative schemes. In the foreground is Fw 190.

W.Nr. 170088 'White 40', (note the faded '1') camouflaged 75/82, the marked contrast level being seen on the port wing, which is in full sunlight. Compare the lighter colour with the small area of 76 on the cowlings, and the darker colour with the black of Balkenkreuz marking. Behind is a Bf 109 G two-seat trainer; the small amount visible shows a 75/82 finish on the rear section of the fuselage and the horizontal tail surfaces with some heavy mottling of 81 aft of the Balkenkreuz. The 7. Staffel Fw 190, 'White 5' W.Nr. 750125, has patches of 81 applied along the spine of the fuselage and onto the fin area, as large, crisp edged areas over the 75/82 colour, creating a three colour mix. This can be seen on the horizontal and vertical tail surfaces. In contrast, forward of

the Balkenkreuz marking, the fuselage has a soft application of 82/83 with a haze of both over the very pale 76-side surfaces. The starboard wing has what appears to be a rough repainting in 76 with an area of 82/83 showing along the aileron and adjoining wing section. Compare it with the wing of the next aircraft, which was in the same direct lighting conditions. This appears to be an older aircraft that had been repaired. The Fw 190 next to it had a dark camouflage that matches the general colouration of 'White 40'. Directly to the right, on the edge of the photograph is another Fw 190 finished in 75/82. In the centre is a Fw 190 D-9 marked with a IV. Gruppe emblem over what appears to be a band of colour, darker than the 76, stretching from the Balkenkreuz marking to the tail unit, and obscuring the white edges to the rear half of the marking. To the right is a Fw 190, 'White 10', in a very dark, low contrast finish of what appears to be 81/83.

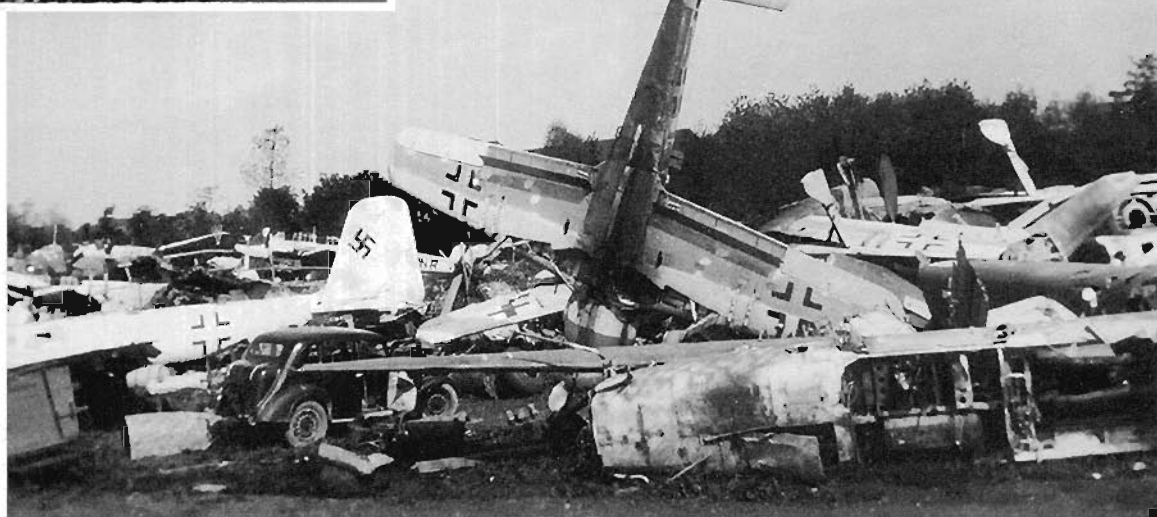
BELOW: Following operational experience with bare metal under surfaces, colouring was restored to the front section of the wing lower surfaces on Fw 190s, usual back as far as the main spar line and including the oleo fairings, in order to prevent glare at low sun angles when the aircraft were at dispersal. The colouring used was usually 76, or the green-blue where that occurred on the main airframe. This example, 'Yellow 12' of an unidentified III. Gruppe, used 76, the same colouring appearing on the ailerons, but the fabric of the elevators appears to be in red-oxide primer. The nose section has a 04-coloured tactical band marking around the front portion. (J. Crow)

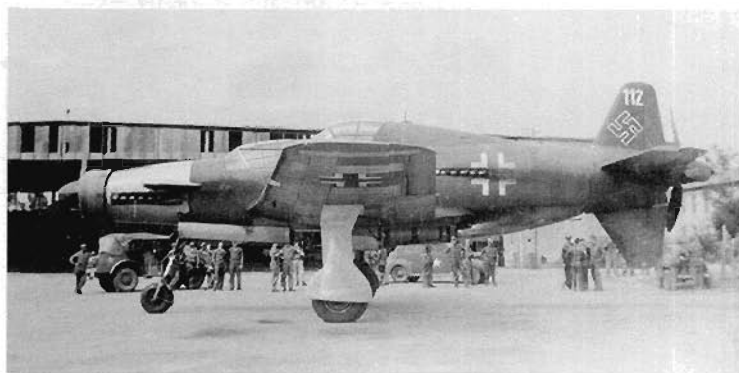
ABOVE: The Do 335 A-12, W.Nr. 240112, the second two-seat trainer prototype as found at Oberpfaffenhofen at the end of the war. Although allocated the Stammkennzeichen RP+UB, but in accord with the last change to the regulations on such markings promulgated in July 1944 this had not been marked on the airframe. Only the Werknummer was to be displayed across both vertical tail surfaces, but Dornier, like some other manufacturers, chose to use just the last three digits for most of its Do 335 aircraft. Camouflage was shown on the works drawings as 81/82/76, but the very low contrast scheme seen here was more likely to have been 70/82 – the same mix found on the Do 335 A-02, W.Nr. 240102, during its 1975 restoration. Dornier, as a manufacturer of bomber aircraft, had a surplus of 70 and 71 colours and was allowed, under the transitional provisions of the change in camouflage colours, to use that combination. The lower surfaces of wings were left in bare metal, only ailerons and flaps being coated with 02-primer, indicating that the airframe had been finished after September 1944. The engine cowlings were still in bare metal but would have received camouflage had the construction programme continued.

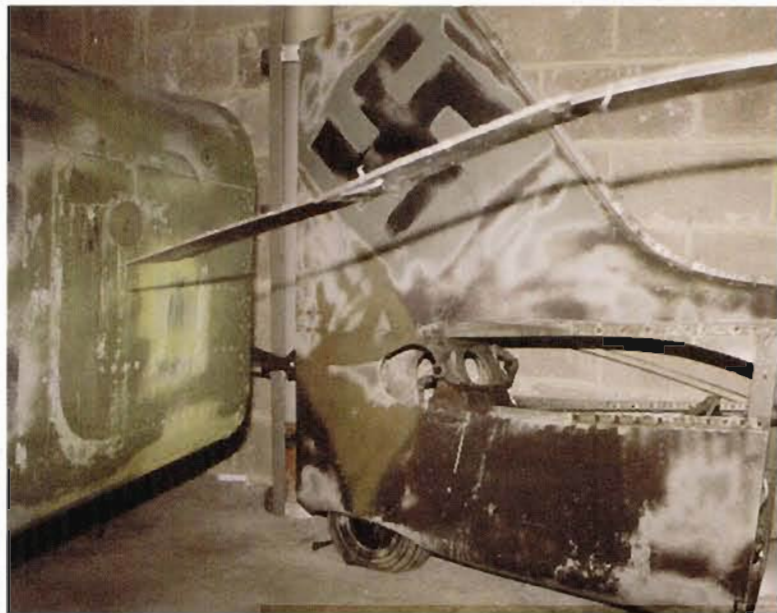
RIGHT: Recovered sections from an Fw 190 A-5 of 4./JG 54 that crash-landed in July 1943 still clearly show the colours of its non-standard camouflage, confirming that JG 54 had been used to test the re-introduction of the pre-war camouflage colours. On the left can be seen the rear section of the fuselage, finished in 62-green; the yellowish areas are where the green colour had been sprayed over the original 04 yellow tactical band marking. Positioning of the yellow tactical marking varied, but in mid-1942 it was standardized behind the Balkenkreuz. The full yellow rudder marking had been reduced at the same time, making both markings less compromising to the camouflage, a direct result of the increased intensity of the fighting. The fin and rudder assembly on the right has clear evidence of its base colouring of 61 that had been sprayed over most of the port side. To that had been added a segment of 79-sand brown that extended up the rear section of the fin and around the trailing edge portion of the Hakenkreuz marking; the latter has a square of 02 behind it. At the time, JG 54 was involved in ground-attack work and this form of camouflage would have worked well. The month after this aircraft crashed, an RLM instruction was issued stating that colours 81 and 82 were ready for reintroduction into the main manufacturing cycle. JG 54 had received its first Fw 190s, complete with the non-regulation camouflage, in late December 1942, undoubtedly as part of the field-testing of the revised camouflage colours. (M. Sheppard)

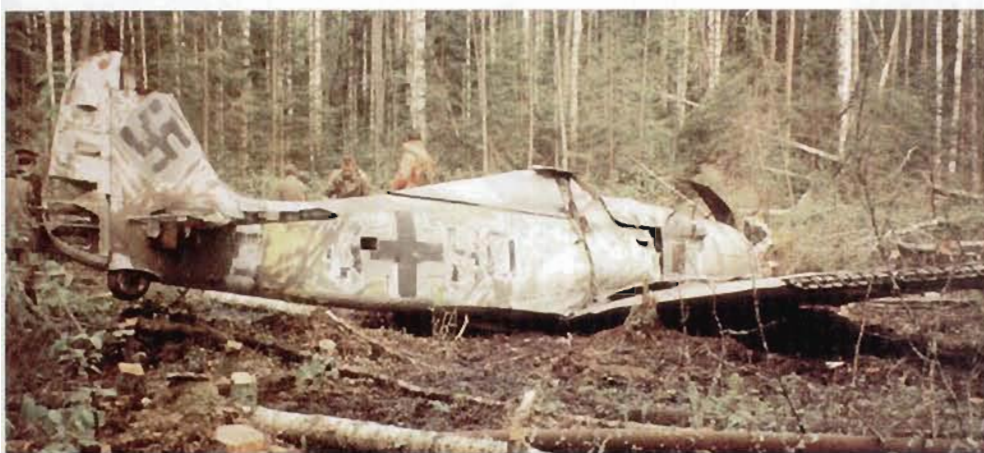
LEFT: This overall view of the aircraft, as it was discovered, shows its remarkable state of preservation. The area of 02-colouring behind the Hakenkreuz, seen in close-up in the previous photograph, can be seen to be original. The red areas of fabric primer can be seen in the torn areas on the tail section. This exotic form of camouflage began to disappear from aircraft of JG 54 around the late summer of 1943 and had gone entirely by mid- to late 1944, when the last surviving examples had been lost in action. By then the RLM had reintroduced the pre-war colours of 61 (RLM 81), 62 (RLM 82) and 64 (RLM 83). (M. Sheppard)

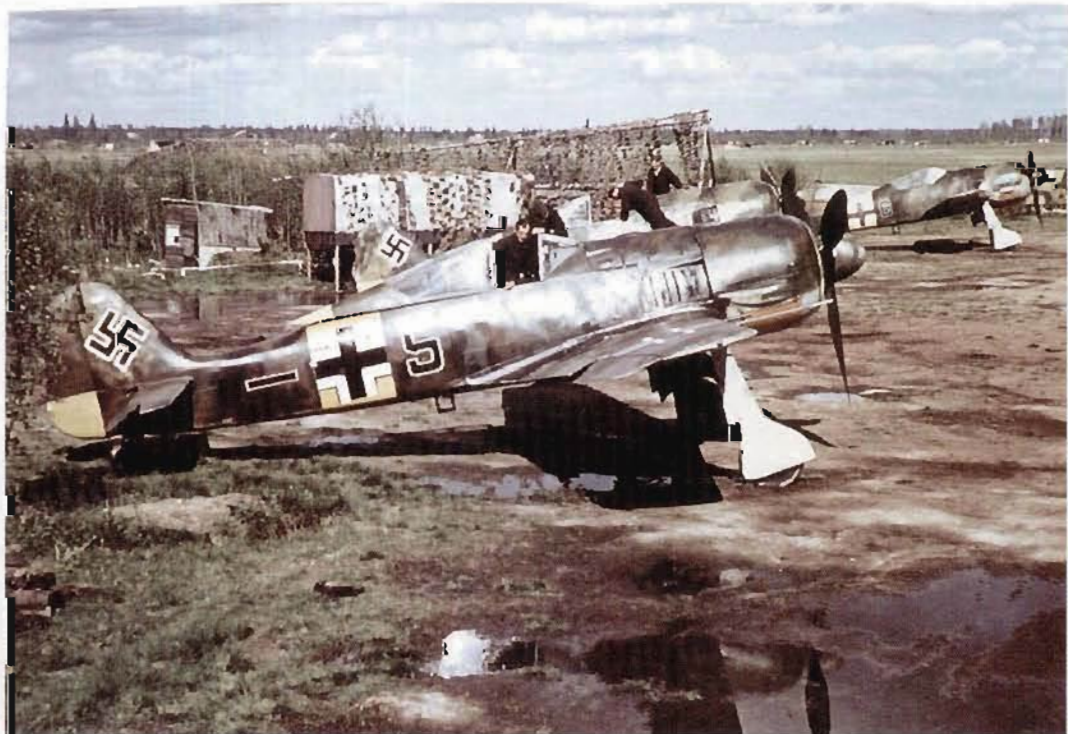
RIGHT: The random nature with which the mixture of colours was applied to Fw 190s of JG 54 also may be judged from this photograph. 'Black 5' has large areas of 81 (61) and 82 (62), 79 and 02 in a very random patchwork of colours that blend into each other, leaving just traces of the original 76 side surface colouring in one or two places. Even the spinner had been given a mixture of colours. The aircraft immediately behind has a less eclectic pattern of colours, though the 81 (61) and 82 (62) colours can still clearly be seen, but mixed with large segments of 02; the same colours being used, in similar style on 'Black 6' to the rear. Note the difference in shade of yellow used for the tactical marking on rudder and around the fuselage compared with beneath the engine cowling. The deeper colour beneath the engine cowling may have arisen from heat factors, though that is not consistent with the colour stability in the same place on many other Fw 190s. The under surface colouring was 76 in each instance. (M. Sheppard)

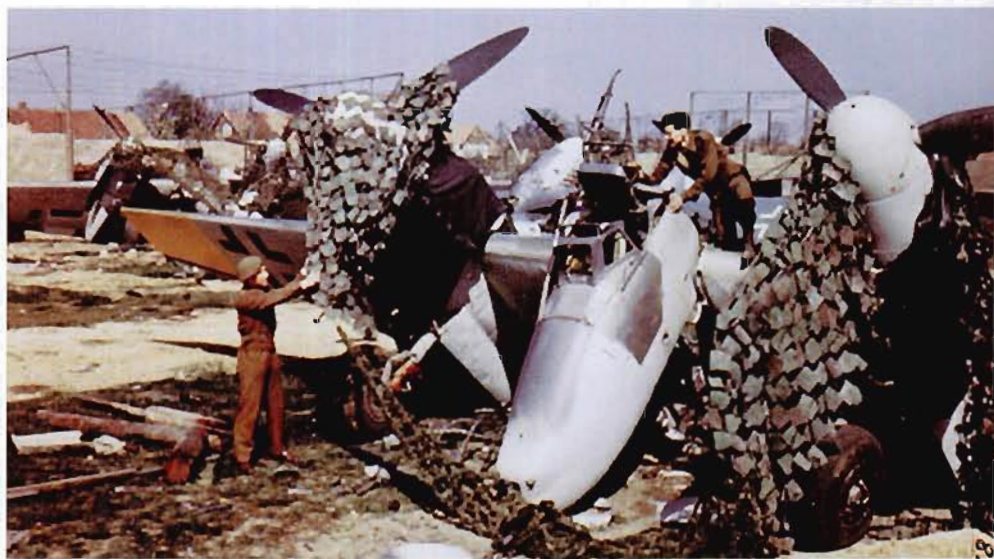
RIGHT: Destroyed at the Luther factory at Braunschweig-Waggum by the retreating Germans, these Bf 110 G-4/R-3s wore the simplified night fighter scheme of 75 over 76 introduced in 1944. However, unlike other night fighter types of the time, the 75 had been applied as a solid coat on the strict plan form view, a style of application favoured at some production centres. All four Bf 110s found, (from Werknummer block 160786 to 160790) wore a yellow tactical band marking around the rear of the fuselage as well as yellow under the wing tips, indicating that they had been intended for issue to a unit, or units operating on the shrinking 'eastern' perimeter of the Axis-held territories.

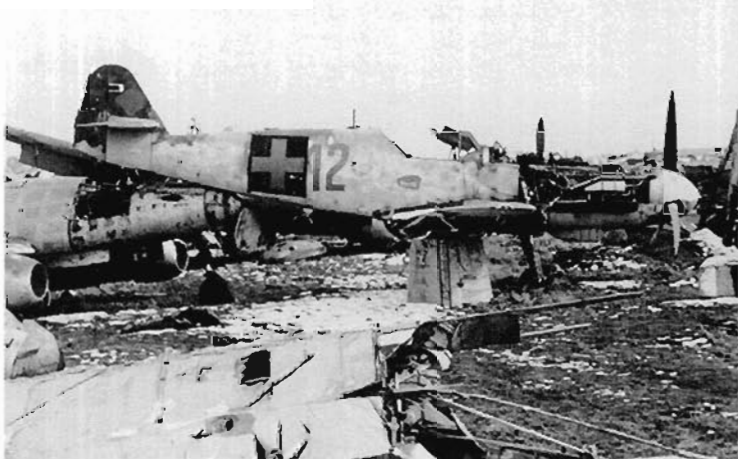
ABOVE: Mismatching between pre-painted parts supplied by sub-contractors to the main assembly plants began to appear more frequently in the closing months of the war as supply and demand were torn in different directions. This Bf 109 K-4, 'Red 12' of a Hungarian unit, had camouflage of what appears to be 75/82 for the main airframe, but the entire tail unit was in 81 with only small patches of 82 showing through, the same style seen on the prototype Bf 109 K-4. Note that the lower half of the fin assembly, beneath the fixed tail surfaces, was finished in a richer shade of 76 than that of the main airframe. The engine cowling can be seen beneath the engine section and appears to have been in plain 76, possibly coinciding with the main 76-camouflage segment forward on the engine section. (J. Crow)

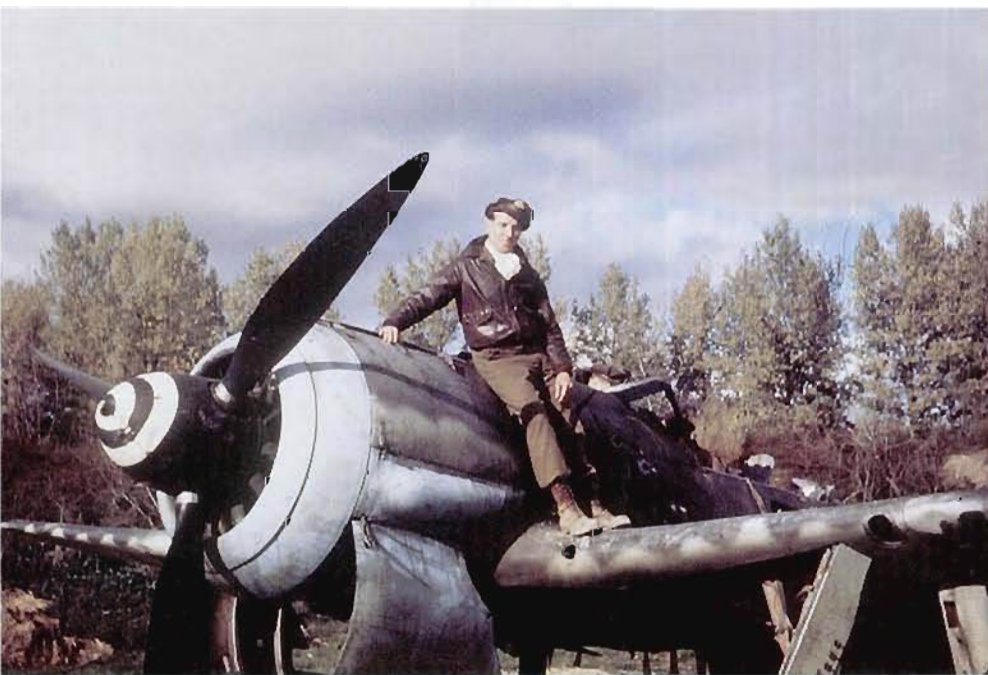
LEFT: A clear example of the distinction between 76 and the unidentified green-blue colour. Upper surface camouflage was 81/82, and is identifiable from the sections of colour along the leading edge of the wings. The side surfaces were in 76 but the lower surfaces of the engine cowling and forward section of the wings, including the undercarriage fairings, had been painted in green-blue. The addition of a different colour than 76 to these areas points very strongly to this Fw 190 having been produced originally with bare metal lower surfaces, and then having had specific areas painted after leaving the factory facility. Following field-testing of the fifty aircraft around August/September 1944, the bare metal finish was modified on later production aircraft to incorporate some form of colouring beneath the engine and along the leading section of the wings, including the undercarriage fairings. In this instance, the additional colouring was done after production (as shown by the over-spray of the green-blue on the 76-colouring in places), indicating that this aircraft might have been one of the initial batch of fifty airframes. (J. Crow)

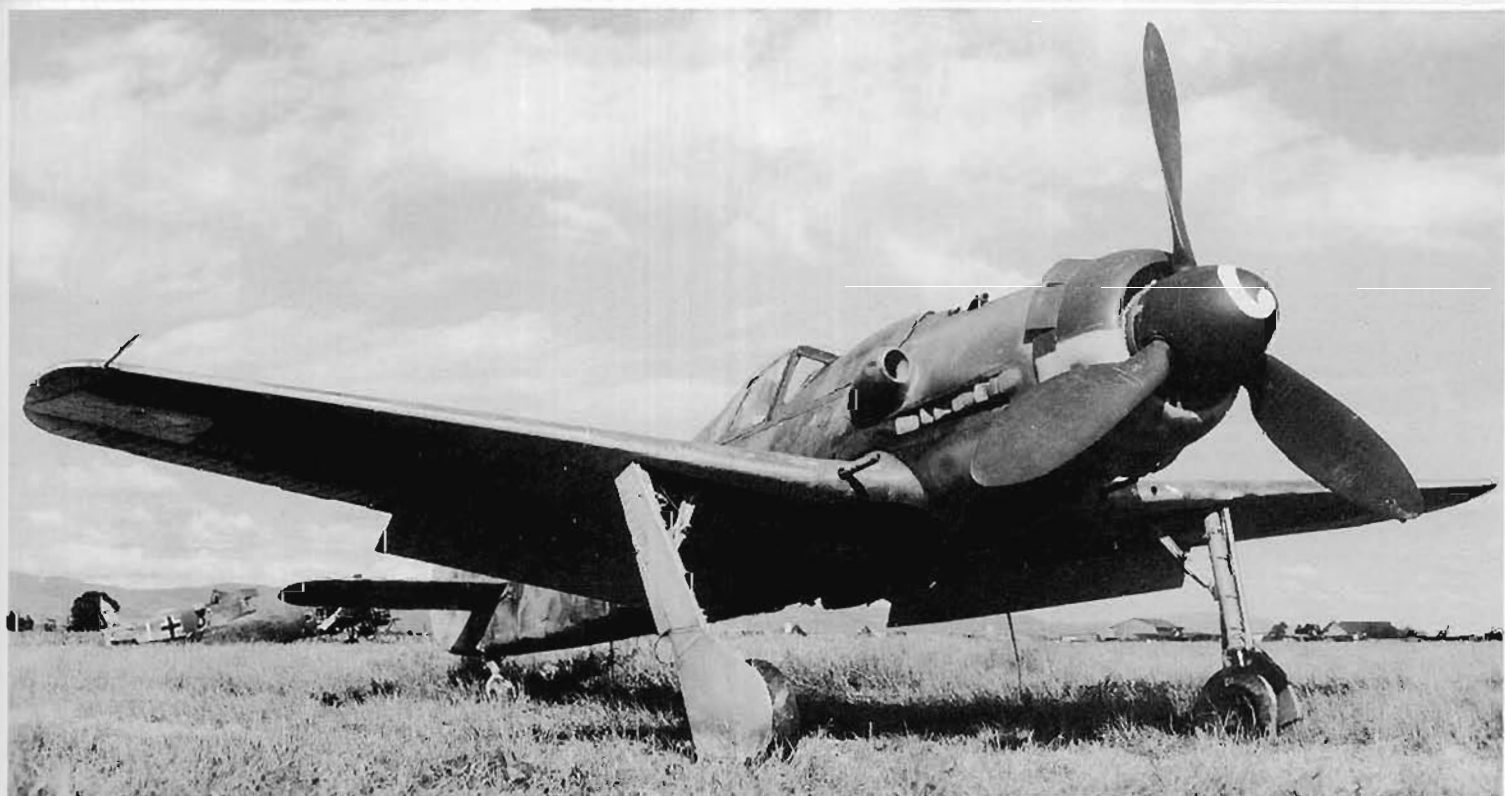
BELOW: Engines for Fw 190 Ds were delivered as a power pod, complete with cowlings, from the engine manufacturer. The panels were usually finished in a solid upper surface colour of 82 with the lower sections in green-blue. Most existing black and white photographs show a distinctly warm tonal shade for the lower colour, as seen here – the same colour as seen on the undercarriage fairings and leading edge of both wings where the lower surface colour curves round. The port undercarriage oleo and the inside face of the wheel fairing were both in 02, which by that stage of the war, no longer conformed to a precise colour for such non-camouflage applications. Its colour varied slightly, but was always a warm shade of greenish-greyish yellow, producing a tone similar to that of the green-blue in black and white photographs. (J. Crow)

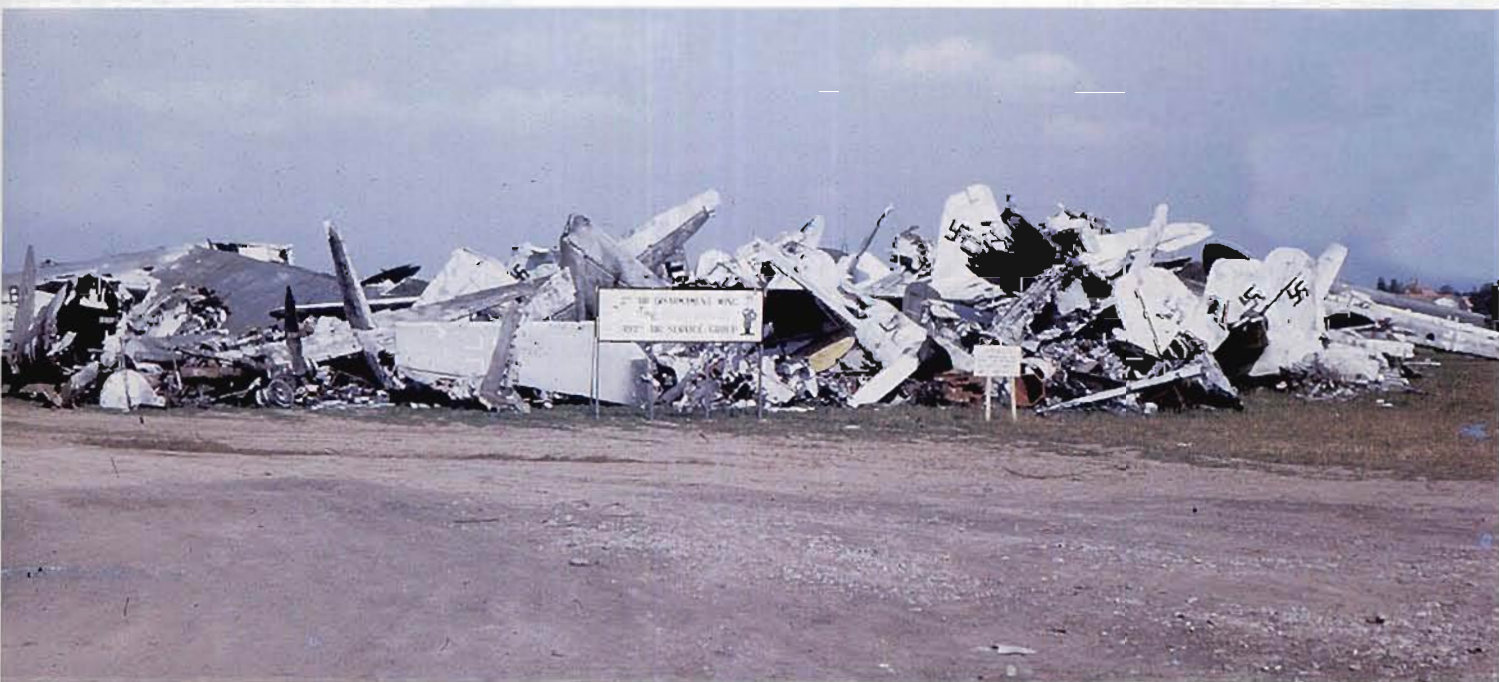
BELOW: As the sign states, the '27th Air Disarmament Wing of the 192nd Air Service Group' were in control of this massive dump of aircraft and parts, consisting mainly of Ju 88 night fighters. There were a few other types present as well, such as an He 111 on the left and an Me 410 on the far right. But the overwhelming impression was one of stark pale grey colouring – a sea of 76 in effect, relieved only by tiny fragments of colour, such as the occasional red gust lock or yellowish-green painted wooden part, or the 70/71 greens of the He 111, or the solid 75 colouring of a large wing section. This gives a good visual impression of the washed-out shade of the final RLM standard for colour 76. (J. Crow)

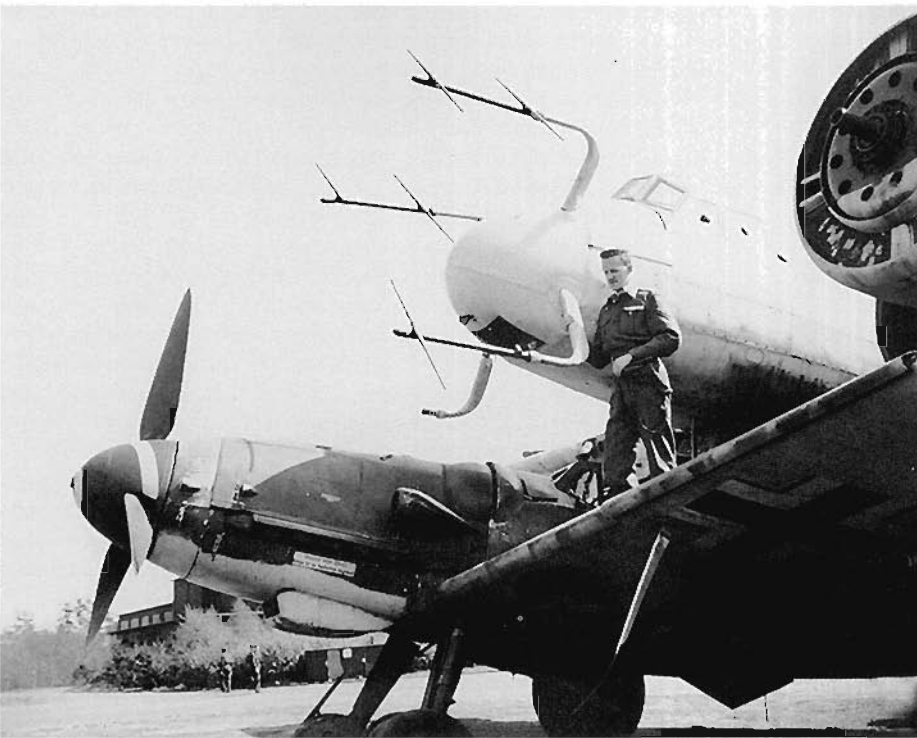
ABOVE: The distinct contrast between the dark, low contrast 81/82 camouflage of this Bf 109 G's upper and side surfaces and the cold tonal quality of the 76 on the lower section of the engine cowling, is quite clear in this photograph. (The nose section of the Ju 88 nightfighter looming above provides a good 76-colour match). The lower engine cowling appears to have been a replacement that had been painted, rather roughly by hand, leaving a sharp edge between the two colour areas. Note the much warmer tone of the colouring along the leading edge of the latter – possibly green-blue, the same colour that can be seen where the wing meets the fuselage lower surface. This appears to be a Bf 109 G-14 fitted with FuG 16Z antenna more usually associated with the Bf 109 G-14/AS. (S.Coates)

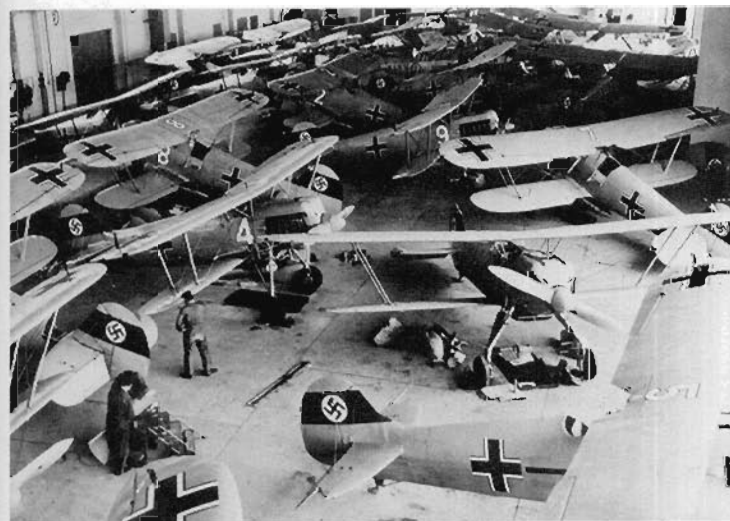
ABOVE: The He 51 was the standard fighter of the new Luftwaffe. This collection of 2. Staffel (front) and 3. Staffel machines (rear) of I./JG 132 illustrates the 63 overall finish with its glossy sheen. The nearest aircraft, 'White 5', is W.Nr. 1094. In the background are several He 46 Es in the same 63-overall finish, two of which wear codes 60+V42 and 60+W42, identifying them as machines of 4. Staffel of II./Kü.Fl.Gr. 406. Amidst aircraft at the rear is Fw 44 C, D-ELYV, wearing the same overall colour and marked 'Yellow 1', outlined in red, in a black circle. (R. Harrison)

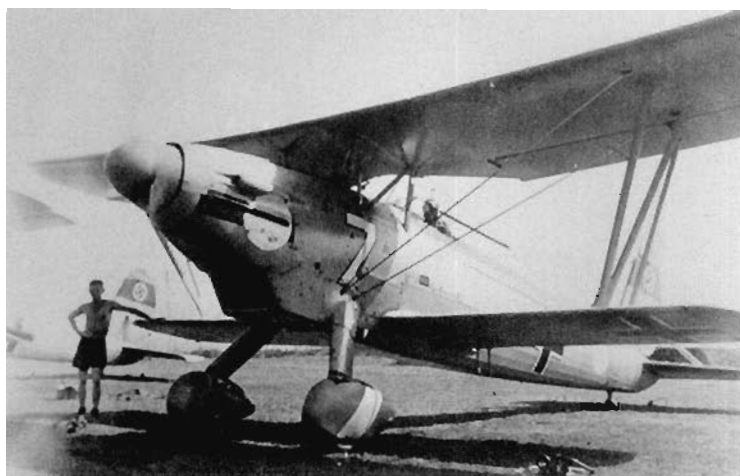
ABOVE: In Germany, prior to the appearance of the Bf 109 Bs, Ar 68 F-1 fighters had replaced He 51s, initially retaining the contemporary 63-overall colour scheme as seen here on this 3./JG 134 aircraft. Upper decking of the fuselage was in mid-range colour, possibly RLM 24. 'White 7' was the mount of Otto Hintze. (Hintze via J.Vasco)

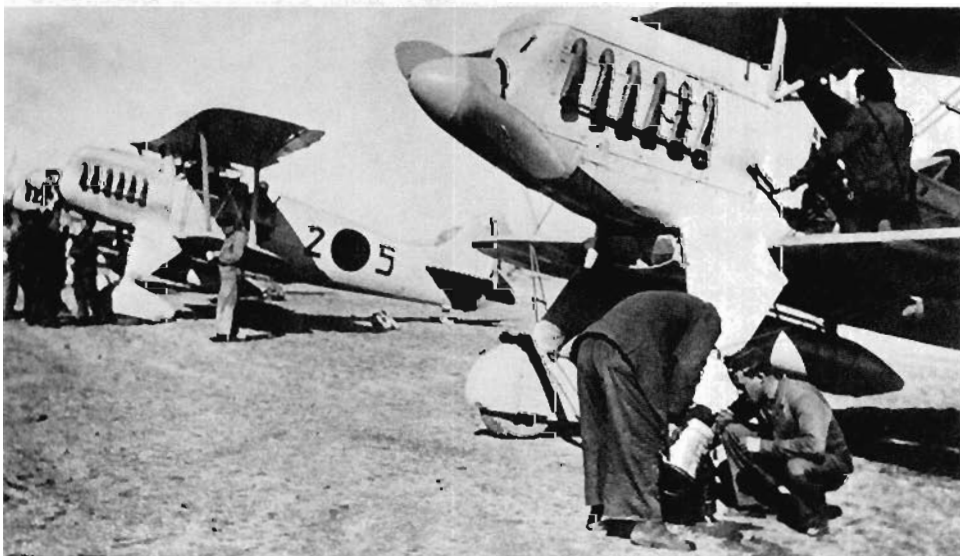
ABOVE: The He 51 was the first fighter type to be sent to Spain with the German 'volunteer' forces. Finished 63-overall, they were marked with a simple system of codes that integrated with the existing system of General Franco's Nationalist forces in general, and Gruppo 2 in particular which was already using the same type. The OKL wanted its forces to appear as part of that force. The numeral '2' identified 1./J 88, while the individual aircraft number was marked aft of the black disc. The style of the marking however would change within a short time. 1. Staffel was later redesignated 4./J 88 and eventually disbanded in March 1937.

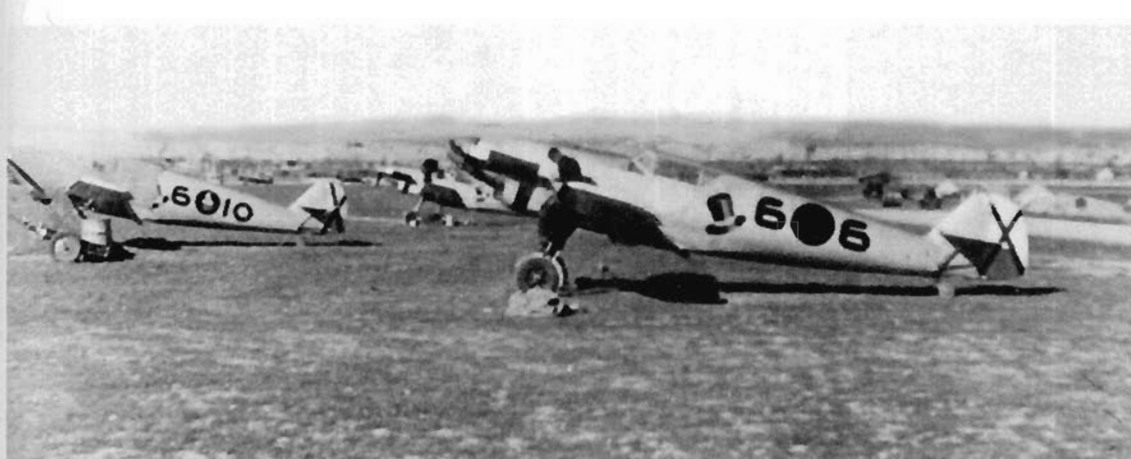
LEFT: The original form of code marking for the Bf 109 force (deliveries of which had commenced in March 1937) is seen here at Escraton airfield, the number '6' having been allocated to the type. A smaller, more angular form would soon replace the cursive style; placement would also alter.

RIGHT: The same Bf 109 B-1 in the foreground of the previous photograph illustrates the revised style of code marking and the fact that existing markings had been retrospectively changed. The unit badge of a top hat, seen in the previous photograph, was marked only on the port side of the aircraft.

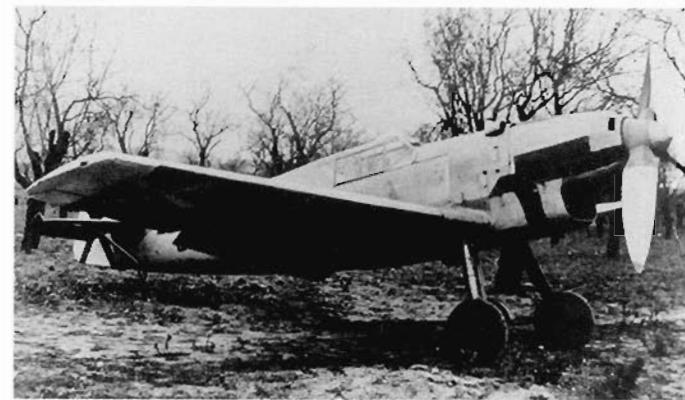
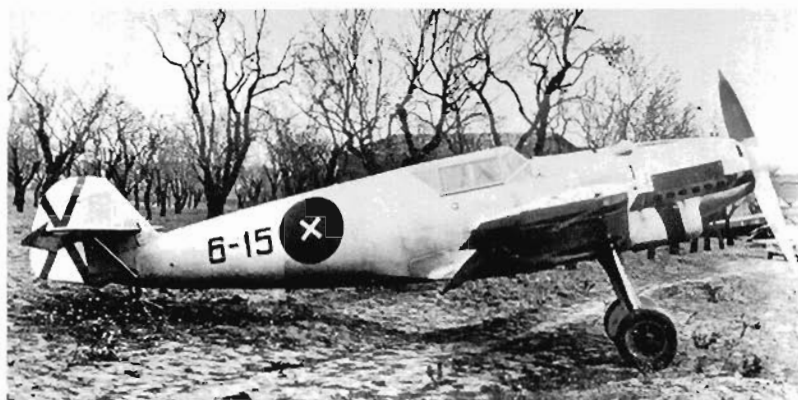
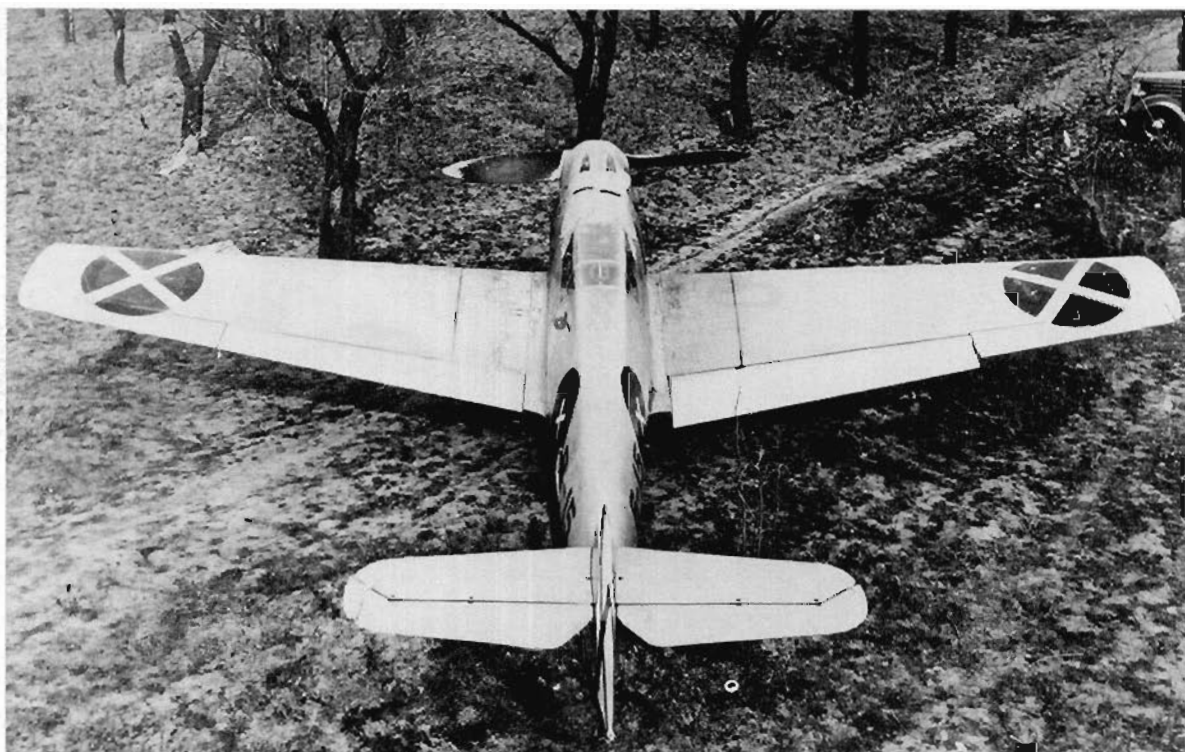
ABOVE. ABOVE RIGHT AND RIGHT: These photographs illustrate placement of the black disc markings and the white cross symbol, the latter having been adopted for extra identification. The original disc size did not overlap the ailerons and on the original print the additional ring of black added to enlarge the disc marking, is just visible. Note alignment of the 'X'-marking was not the same above and below the wing; below, the tip of the inboard white stroke being closest to the wing leading edge. Wing tips had been painted white to a point approximately 50 cm inboard. This was the aircraft captured and later transferred to Russia for detailed examination.

When Feldwebel Otto Polenz was forced to land his Bf 109 B-1 (coded '6015') behind Republican lines it was closely examined by the French Intelligence Mission and later by the Russians, the aircraft being transferred to the Soviet Union for detailed testing along with an He 111.

The subsequent Russian photographic record of it has now been published and reveals that what appears to be bare metal finish is actually a very thin coat of a colour that matches closely the 02 colouring of the interior parts. Heydrich's description of a "silvery grey finish/greenish-grey" matches well with the usual initial, very thin coat of zinc chromate metal preservative, applied before the usual undercoat and camouflage colouring. The 7102- zinc chromate was manufactured by Warnecke & Böhm under the company designation of Ikarol light metal base coat green 201. This was a relatively transparent finish with

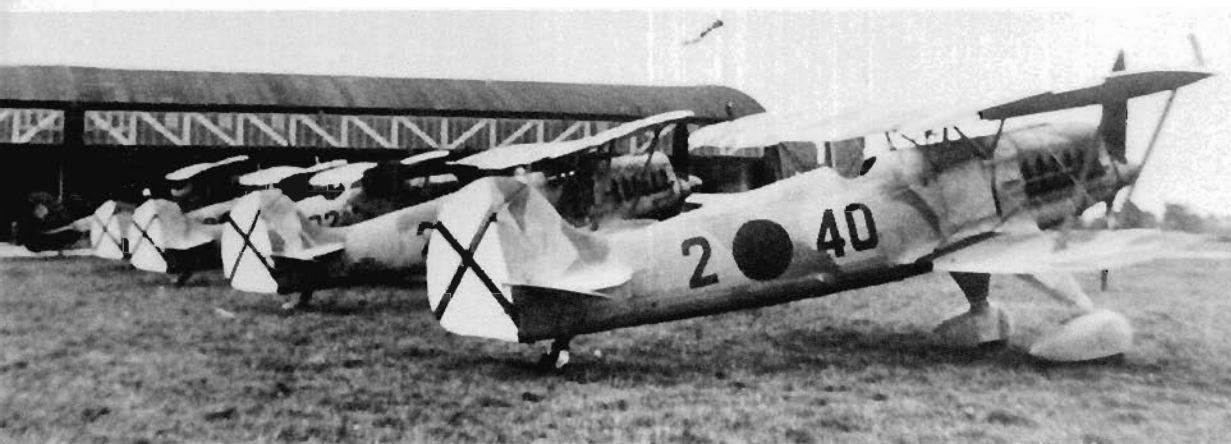
LEFT: This line-up of He 51s shows the random nature of the application of 61 and 62 to the base colouring of 63.

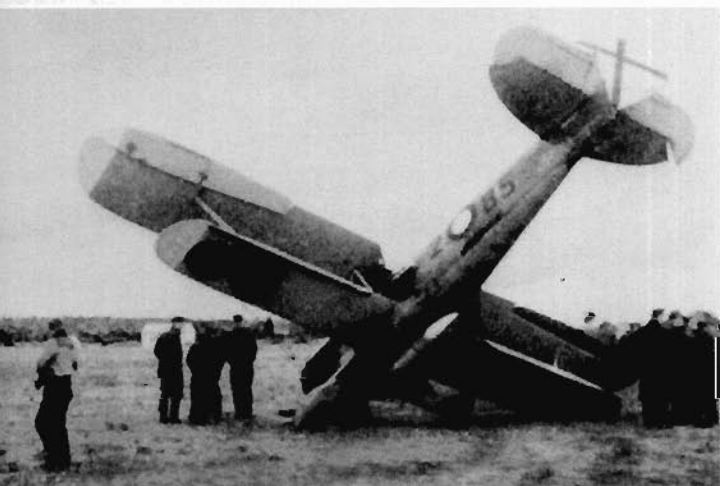
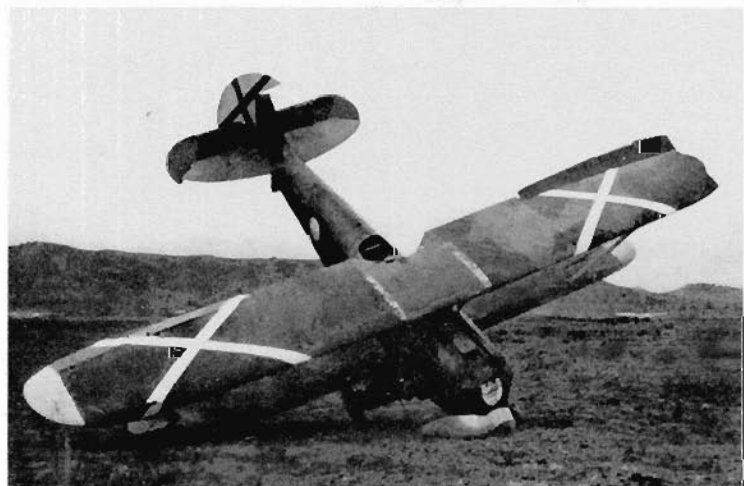
BELOW LEFT AND RIGHT: Two photographs of 2●85, taken on 5 December 1937, illustrate the extent of the additional white markings that had been added to the Legion's aircraft to help identify them. The eclectic mixture of aircraft types operated by both sides was found to be dangerously confusing during air fighting. Perhaps more significantly, the He 51s needed quick recognition for their ground-attack duties to save them from friendly fire. While not easy to see here, the upper surfaces of the top wing also had two black discs on each wing in addition to the large white cross marking and white wing tips. The underside of the bottom wing shows more clearly the double black disc marking, (the two pale strips on the centre section appear to have been replacement wing joint tapes.) The white centre to the fuselage black disc marking was a personal addition, that part of the identification markings proving popular for such additions. An heraldic-style shield had been painted on the front of the engine cowling, possibly the coat of arms of a German town. Camouflage was a mixture of 61 and 62 over the original 63-overall finish, with what appears to have been 65 for the undersides. The external fuel tank had been left in bare metal.

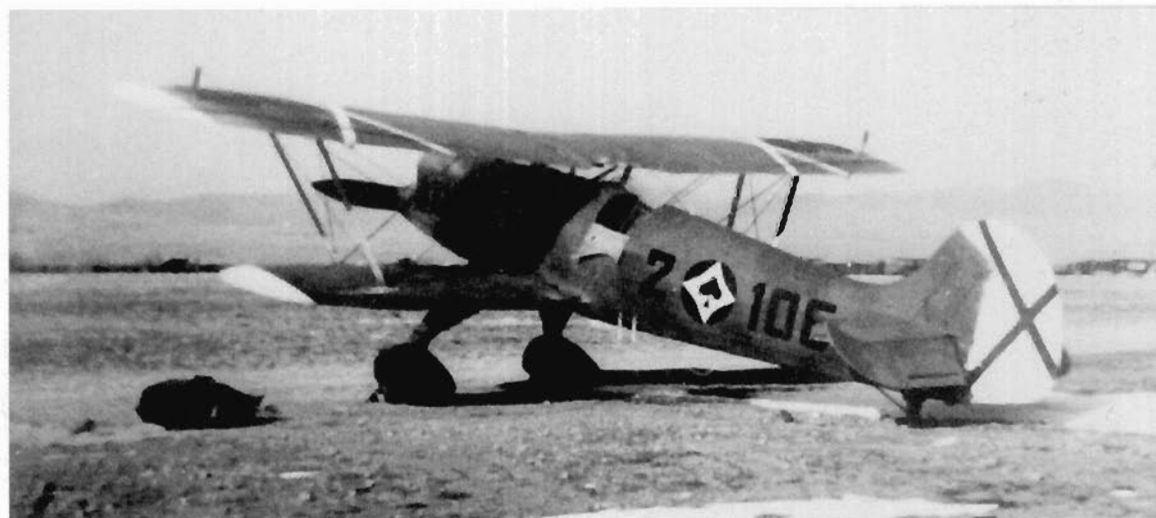
BELOW: This He 51 B-1, 2●106, of 4./J 88, illustrates the progressive shift to very dark camouflage for the type, which operated at low-level for much of the time in the ground-attack role. Upper and side surface colouring appears to have been 61 sprayed over a base colouring of 62, (this combination would be resurrected in 1944, but under revised RLM designations 81 and 82). In terms of visibility, the advantage of the tactical white markings is apparent.

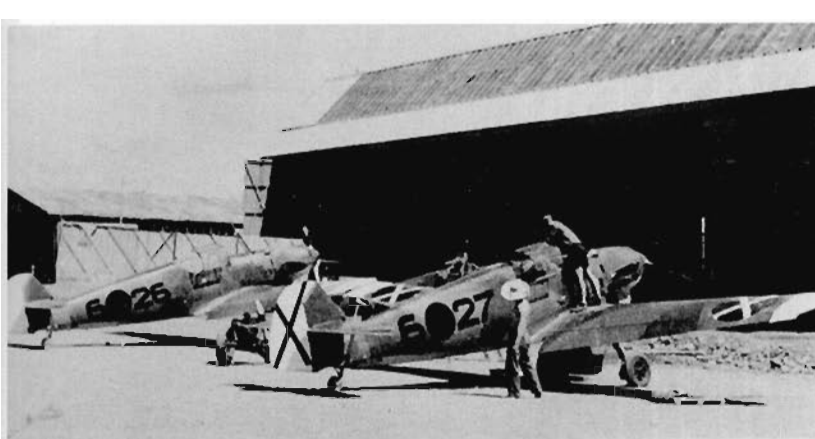
ABOVE: This pair of Bf 109 B-2s, 6026 and 6027, delivered in the autumn of 1937, retained full contemporary Luftwaffe camouflage of 70/71/65 in the Type 2 pattern. The complete complement of Nationalist markings had not been finished when this photograph was taken, 6026 still lacking its black cross marking for the rudder. The size of the wing black disc marking had been increased by that time, overlapping the aileron.

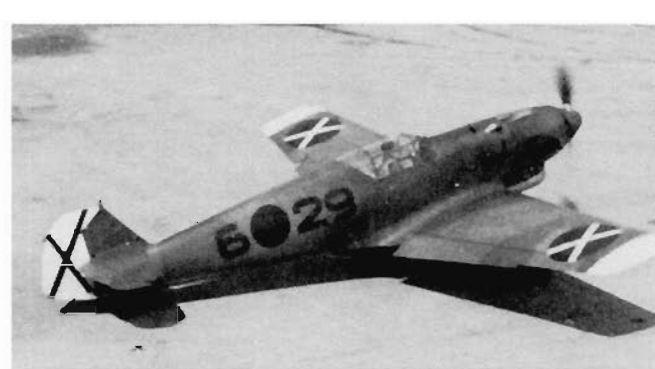
ABOVE: This elevated view of 6029, shows more clearly the standard Luftwaffe Type 2 camouflage pattern.

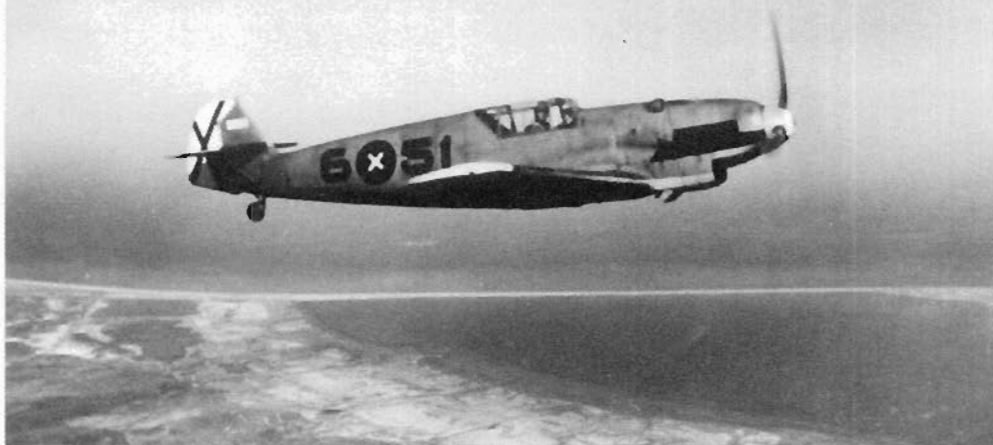
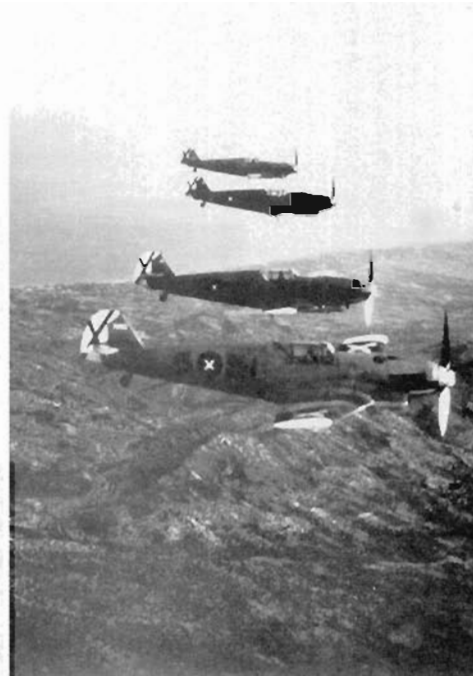
ABOVE AND RIGHT: Two photographs of Bf 109 D-1, 6051, finished in 62/65 colouring. However, close examination shows the original 70/71 camouflage beneath the thin 62 coating. The darker segments on the wings appear to be part of the original colours, retained as a rudimentary disruptive pattern, the section near the wing root being identical, though a larger segment appears to have been left inboard of the disc marking. The spinner was white, as were the six kill markings shown on the fin. The latter were those of its regular pilot, Hptm. Wolfgang Schellmann, who, with 12 kills, became the second highest scoring German pilot in the Spanish conflict.

One oddity was Bf 109 D-1, 6051, photographed wearing a combination of 61 and 62 on the wings and horizontal tail surfaces. Careful examination of the two extant photographs of this particular aircraft show that originally it had standard Luftwaffe Bf 109 pattern camouflage of 70/71/65 - just like the Bf 109 Cs that had been delivered. The all-green finish appears to have been of less camouflage use than the colours already adopted for the He 51s and other types operated by the Legion Condor for land operations. As a result, 6051 had been re-sprayed with a coat of 62 on all upper and side surfaces, leaving large segments of the original 70 and 71 finished surfaces to wing and horizontal tail surfaces in a rough approximation of the original standard pattern. The 62-colouring had been very thinly applied, and on the upper and side surfaces of the fuselage the original segmented pattern could still be detected. The lower surfaces retained the existing 65-colouring. (This aircraft survived the war, was handed over to the Nationalists, and was again re-sprayed, this time with the standard 62/65 finish adopted post-war). Some, or possibly all, of the other Bf 109 Ds delivered were also re-sprayed in 62, over the original 70 and 71 finish.
