# **LUFTWAFFE CAMOUFLAGE AND MARKINGS 1933-1945**

## **Volume One**

**K.A. Merrick**  
with Jürgen Kiroff

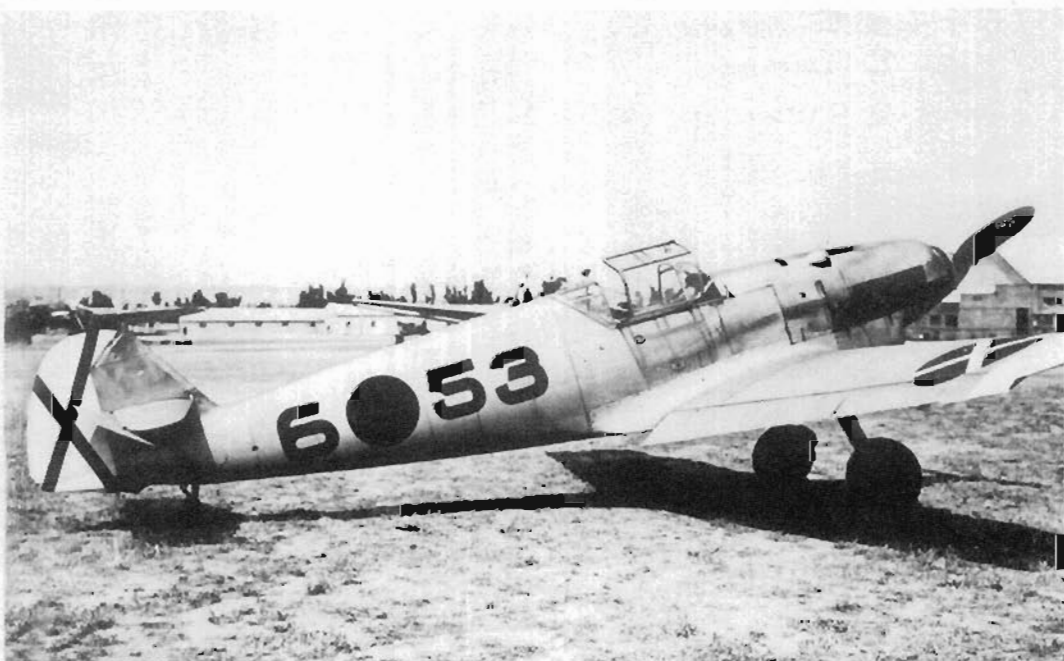
RIGHT: This photograph of 6053, taken in the summer of 1938, has appeared many times before and been subject of much speculation as to its colouring. In view of what is now known of Bf 109 D-1 deliveries, and 6051 and its colouring, the contention can now be resolved. The third D model to be delivered, 6053 also arrived in full 70/71/65 camouflage, which had then been oversprayed with 62. The thin nature of the 62 re-spray finish can be detected on the fin where the original darker colouring shows through in patches, and on the starboard wing root area where the 70-coloured segment can still be detected. This move to a 62/65 finish was in keeping with the dominance by that time of Nationalist air power.

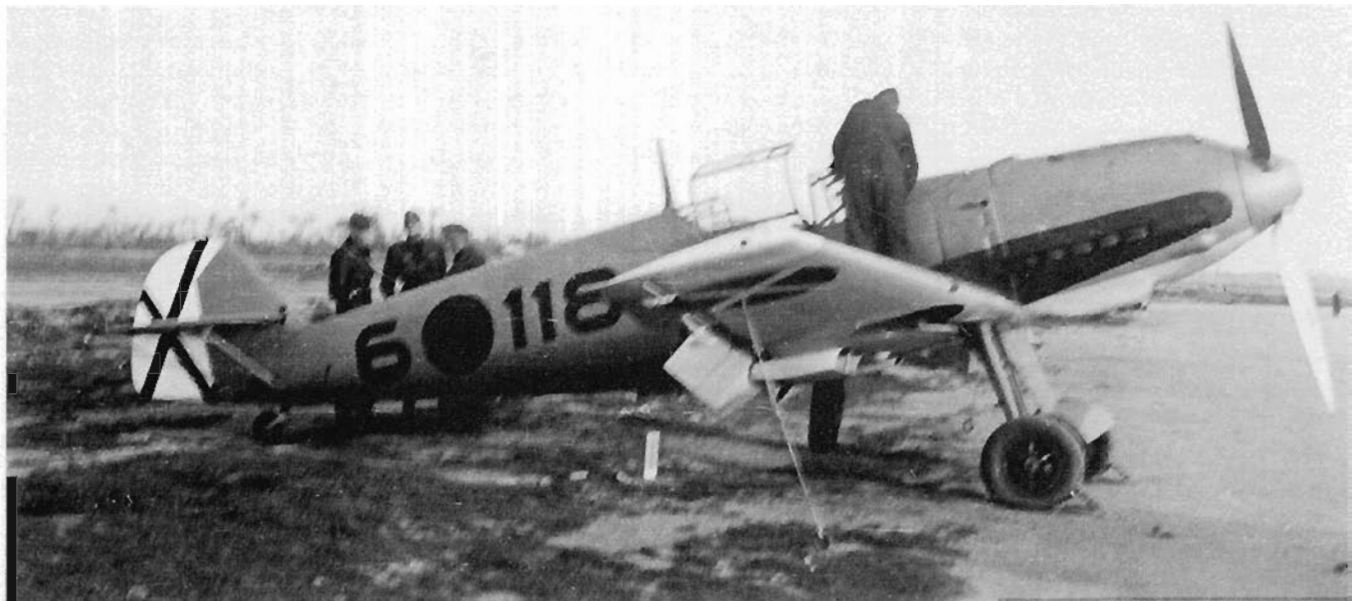
ABOVE: Bf 109 E-1, 6-118, one of 45 delivered to Spain, photographed in 1938, illustrates the universal 62/65 camouflage that had been adopted for the Bf 109 force by late 1937. Use of stylised black trim for the exhaust area and wing root fillet was a feature introduced with deliveries of the 'E' variant.

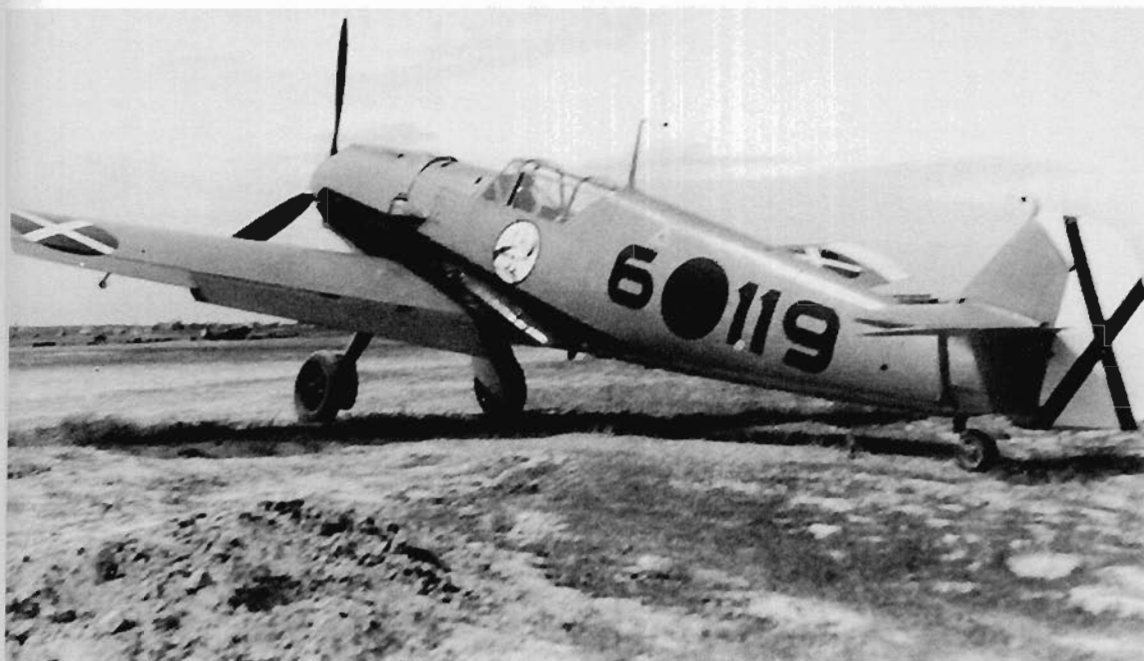
ABOVE: This rear angle view of Bf 109 E, 6-119 shows the full extent of the black trim marking introduced to screen the dark stains from the engine exhausts on the 62-green of the upper surface camouflage. This was the mount of the last Staffelführer of 1./J 88, Hptm. Siebert Rents, and was amongst the batch of Bf 109 Es handed over to the Spanish Air Force at the end of hostilities in Spain.

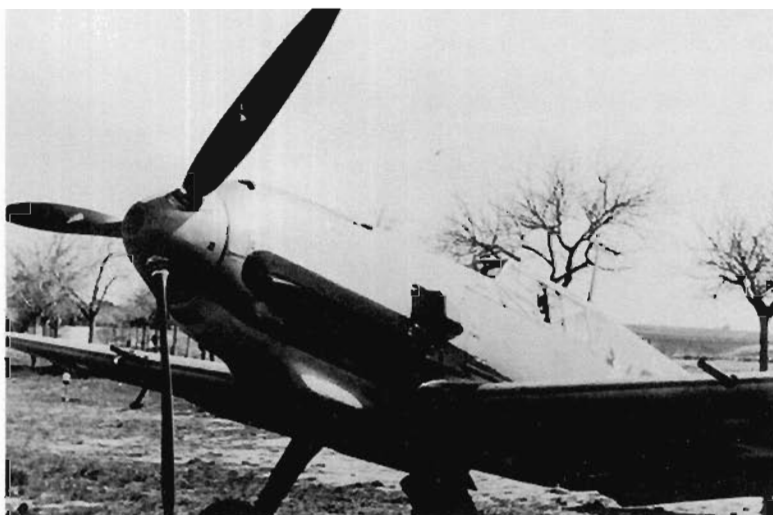
LEFT: A Bf 109 E-3 bearing the Mickey Mouse emblem of 3./J 88 and camouflaged 62/65. Note the crisp division between upper and lower surface colours visible below the engine exhausts and on the wing leading edges. (D. Vincent)

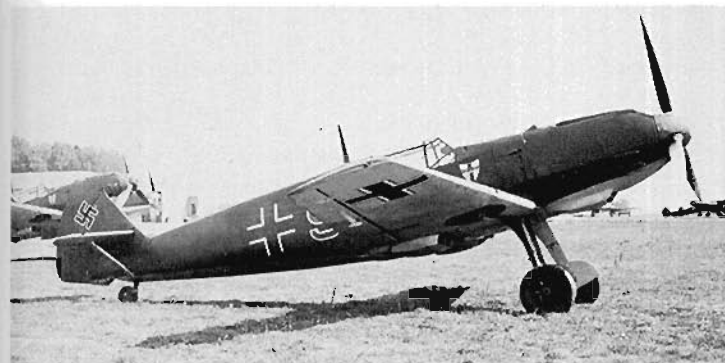
ABOVE: Controversy remains about the alleged evidence of a monochromatic finish for some Bf 109s in the period before the war. This photograph of 'Red 9' of 2./JG 1 appears to show just such a monochromatic green finish, in either 70 or 71. There are others that show a similar effect, but often the two-tone camouflage can be detected on parts of the aircraft.

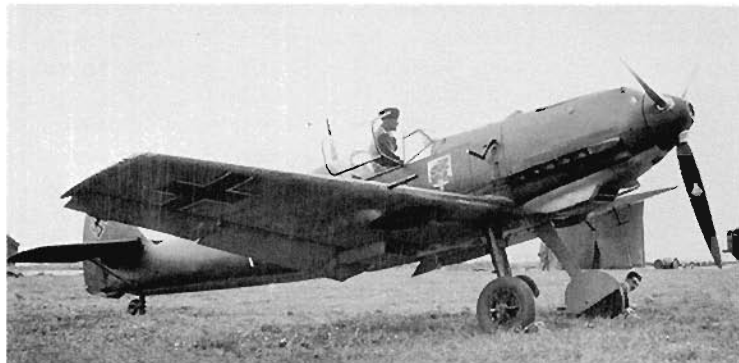
ABOVE: This Bf 109 E-3 of I./JG 76 (later II./JG 54) also appears to have a monochromatic finish. However, careful examination of the wing leading edge reveals the presence of a two-tone pattern with segments that correspond to a Type 2 pattern. The style and positioning of national markings and the Hakenkreuz clearly date this photograph to post-January 1939.

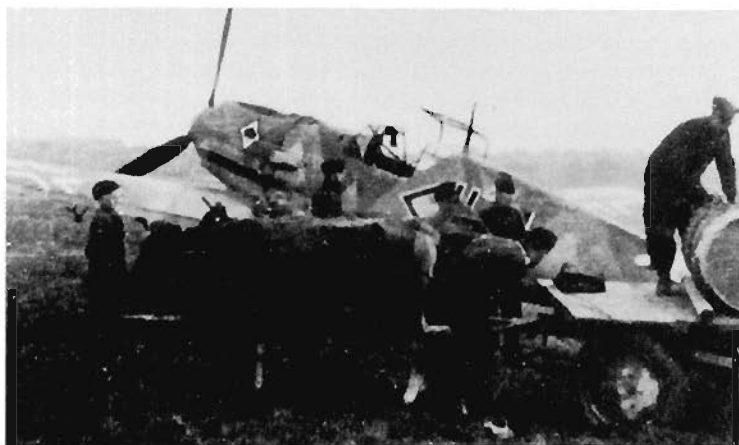
ABOVE: Taken in November 1939 at Kirchberg, another of JG 53's unique camouflage schemes is shown here. While of questionable quality it shows the same combination of colours 70, 71 and 02 used in a different manner, with a mixture of hard-edge splinter pattern forward and wavy line demarcation on the rear part of the fuselage.

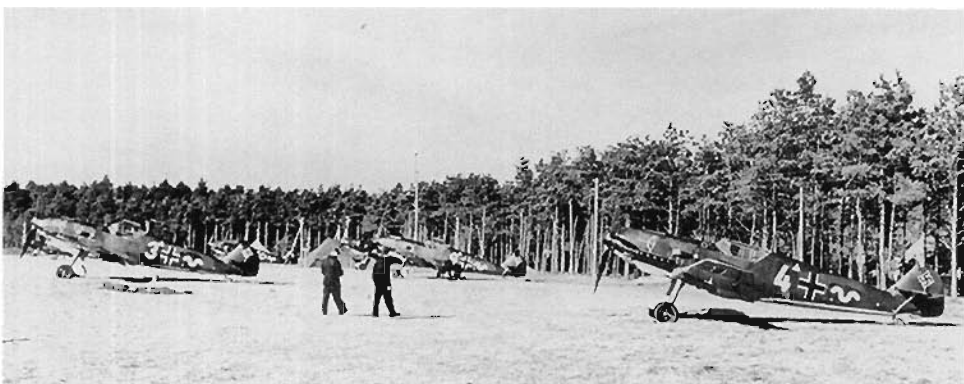
BELOW: Despite having the III. Gruppe marking aft of the Balkenkreuz, these Bf 109 E-3s, photographed in late September 1939, belonged to I./JG 20. Reputedly the Gruppe was not re-designated III./JG 51 until July 1940, making use of the III. Gruppe marking unexplained. The nearest two aircraft each had areas of their fuselage overpainted in 70 to eliminate the original aircraft number and what by its shape was a II. Gruppe horizontal bar which adds to the mystery. The camouflage of 70/71/65 and style reinforce the date of this photograph prior to the opening offensive against Poland on 1 September.

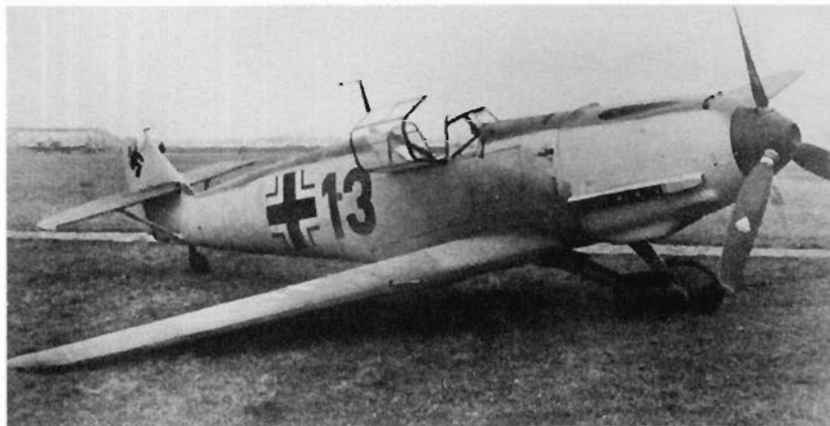
RIGHT: Following the Polish campaign, camouflage for subsequent production single-seat fighter aircraft was revised, resulting in a raised demarcation line between upper and lower surfaces; a revision implemented by modifying some, but not all, aircraft already in service. This Bf 109 E-3, in addition to revised side surfaces, had had its Type 4 (B pattern reversed colours), upper surface camouflage changed to the simplified one being introduced for production aircraft. Positioning of the Hakenkreuz marking, still centred over fin and rudder, confirms this was a post-production modified scheme. Despite the incorrect positioning, the fuselage Balkenkreuz had been increased to approximately the revised proportions, but in doing so the demarcation line had been lifted slightly to clear the top of it. Upper surface colours were 71/02. These revisions and the background indicate a date of early spring of 1940. (B. Robertson)

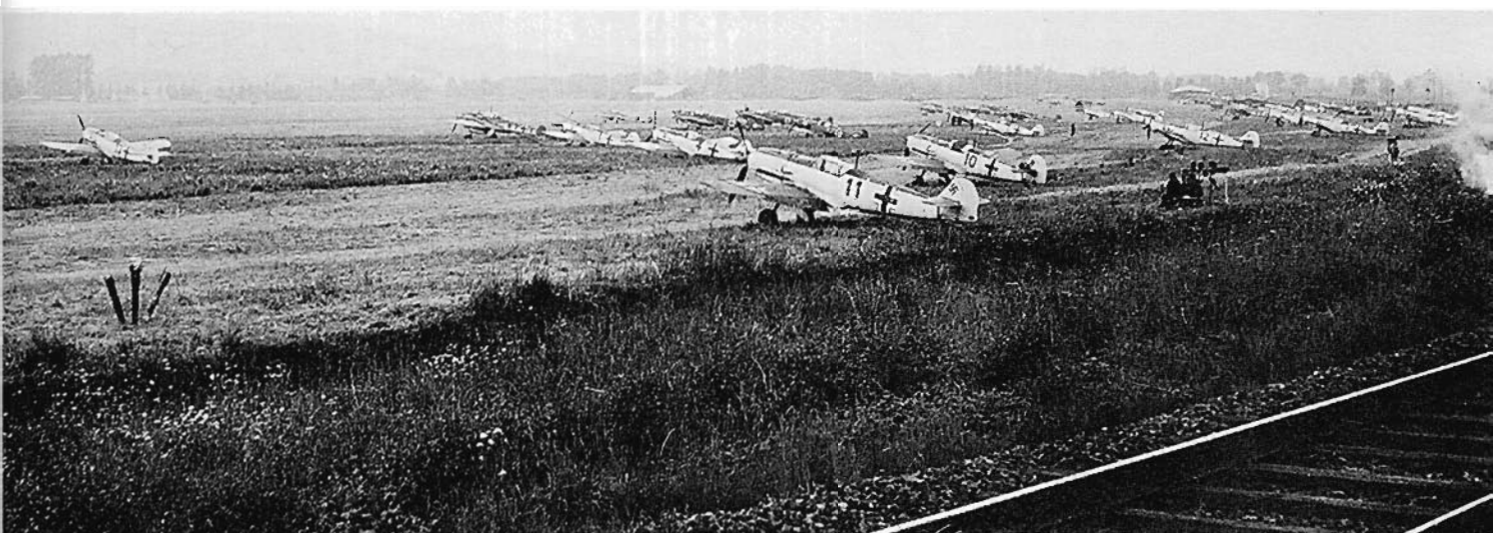
ABOVE: Bf 109 Es of JG 52, sharing a mist-laden airfield with Bf 110s of II./ZG 2, provide an interesting study in camouflage transition. The bold 65-coloured side surfaces makes the Bf 109 Es stand out against the background. In contrast a Bf 109 E, 'Yellow 17', in 70/71 camouflage (immediately in line of sight over the canopy of the Bf 109 E marked 'Black 11') is difficult to detect. This illustrates well the shift from a ground defensive to an air defensive camouflage scheme for the Bf 109 E. The Bf 110s scattered across the entire photograph also exhibited old and new schemes. Immediately right of the lone Bf 109 E 'Black 13', on the left of the photograph, is a machine marked A2+K(?); it has revised camouflage with 65-coloured side surfaces and 02-mottling, dating the photograph to around May/June 1940. A lone Ju 52 in 70/71/65 is difficult to detect, and there are more Bf 110s in the new style of camouflage, plus another Bf 109 E in old style, to the right of the photograph. This mixture of camouflage schemes well after the introduction date for the Bf 109 change, illustrates the slowness that sometimes occurred in getting older machines repainted. (D. Vincent)

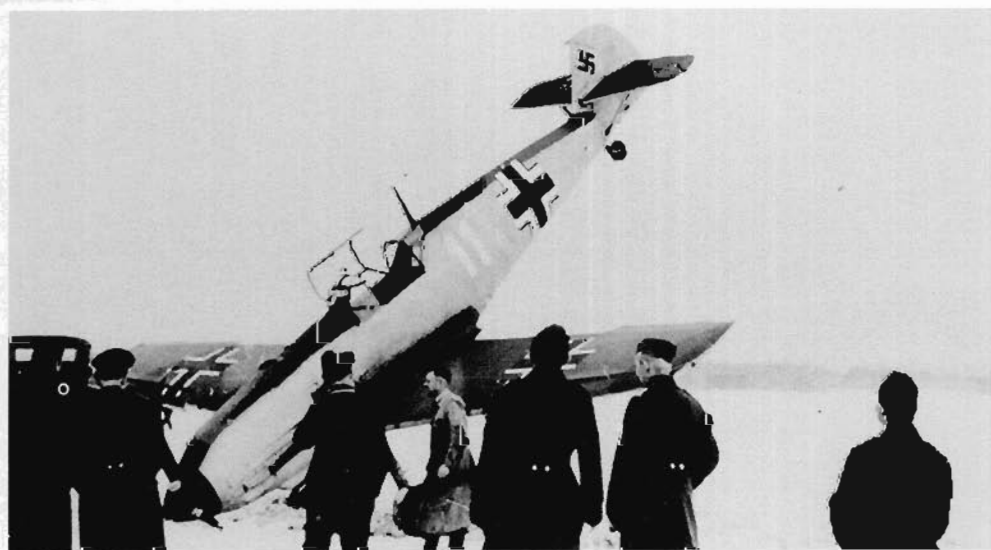
LEFT: Photographed during the winter of 1939/40, this Bf 109 E-1, was a production aircraft delivered in the revised, Type 5 camouflage pattern introduced into manufacturing centres following changes resulting from the Polish campaign. The raised demarcation line of the 65 colouring and its slightly ragged edge is indicative of a post-production change to its camouflage, indicating that early deliveries of aircraft in production Type 5 pattern may have had full camouflage in 71/02 that was then revised in December, something supported by the fact that the Hakenkreuz and Balkenkreuz markings were in the revised dimensions and positions introduced in October 1939. (D. Vincent)

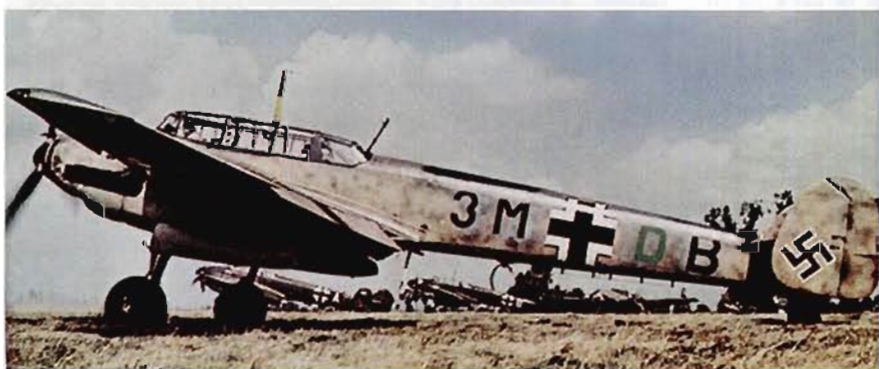
ABOVE: The 70/71 upper surface finish for Bf 110s had been phased out in May 1940, production centres changing over to the 71/02/65. This Bf 110 D, 3M+DB of Stab/ZG 2, was photographed during the transition period and wore the revised factory-applied scheme with side surfaces mottled in 02. The older Bf 110 C-4s behind retained their 70/71/65 finish.

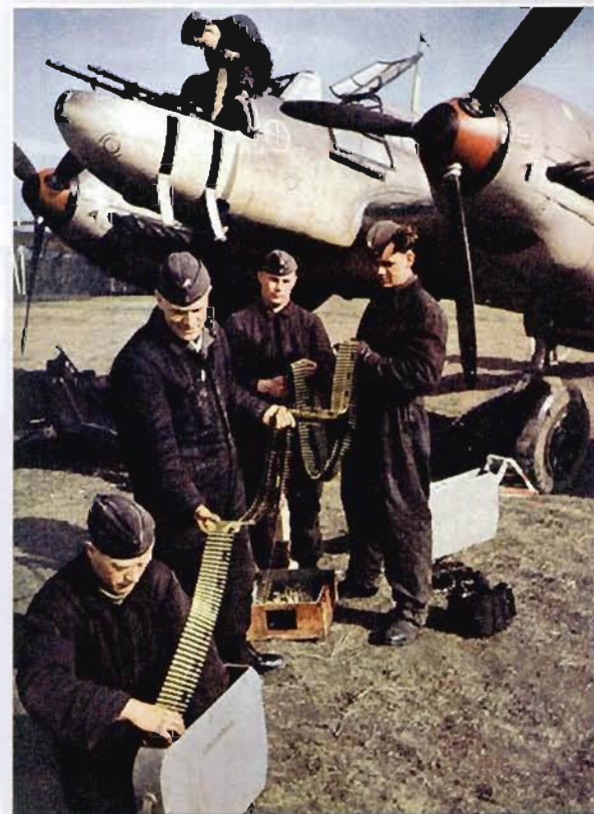
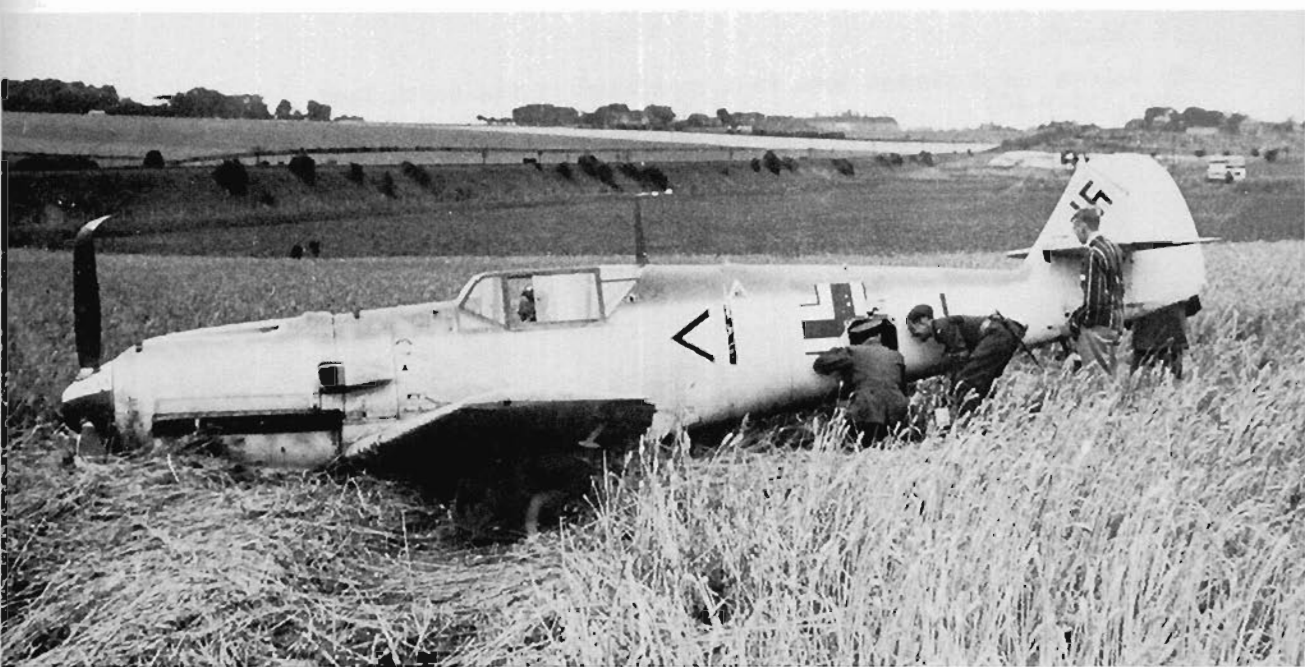
ABOVE AND RIGHT: Oblt. Werner Bartel's Bf 109 E-1, W.Nr. 6296F from the Stab of III./JG 26, brought down on 24 July 1940, displayed the first tentative changes to the camouflage revisions that had been introduced at the end of 1939. Upper surfaces were 71/02 but with transition to the 65-sides applied with a soft sprayed application along the engine cowling to produce a ragged effect. Very soft traces of mottling, in both colours, had been added to the engine cowling, down to below the exhaust stubs. The gun troughs were a pale colour, something still seen fairly often at that period of the war. Judging from other photographs, the colour was probably 65, not yellow or white as has sometimes been suggested. Note the tonal contrast between the 70 of the propeller blades and the darkest upper surface colouring. The spinner was black with a one-third white segment, another recently introduced change to fighter aircraft. The suffix 'F' (Flugklar) to the Werknummer indicated that it was a repaired aircraft (apparently also upgraded from original E-1 configuration, probably at the same time), which probably accounts for the additional camouflage revision. This form of suffix to the Werknummer did not continue much beyond this date as the Luftwaffe revised its system of repair codes and symbols. The illusion of a very pale rudder colour was produced by the angle of the rudder to the sun, something confirmed from the head-on view.

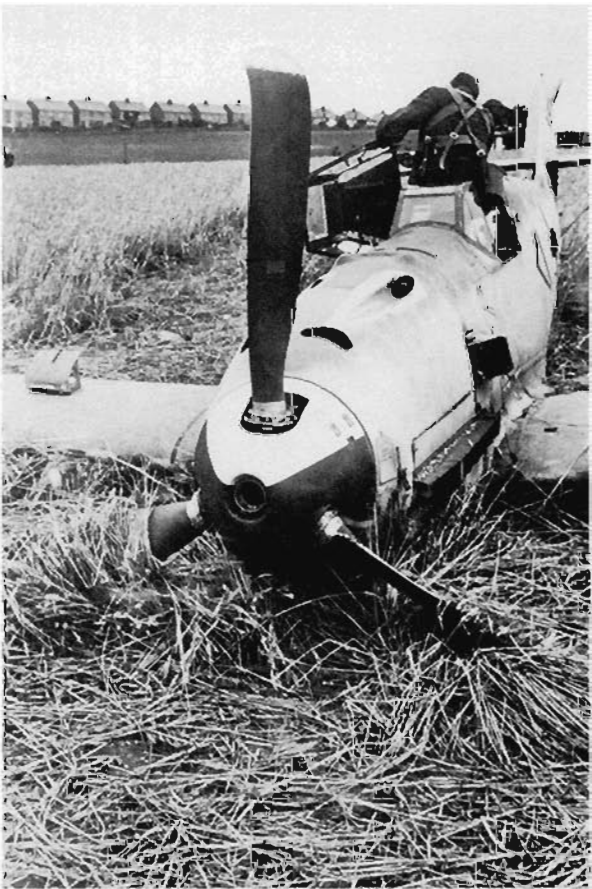
LEFT: Oblt. Daig's Bf 109 E-1, W.Nr. 3488, 'Red 13' of II./JG 27, which was shot down near London on 9 September 1940; the cowling and rudder were finished in temporary yellow. It wore the Type 5 camouflage pattern in 71/02 on upper surfaces, but that had been heavily oversprayed with a dense soft mottle of a medium toned colour, possibly 02. The spinner was described as being divided two-thirds dark and one-third 'pale'. (D. Carrick)

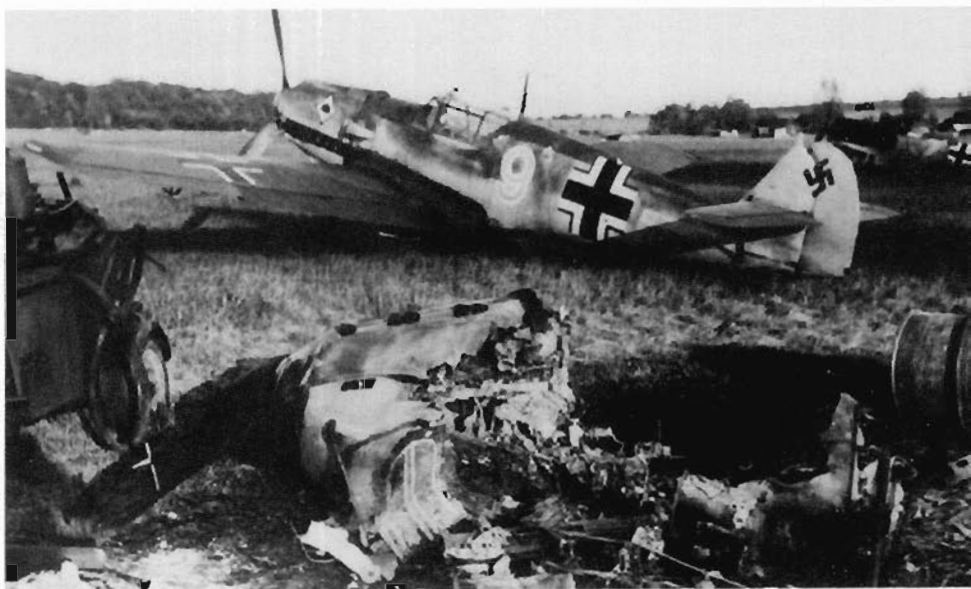
RIGHT: From the same unit, and taken in the same month, this Bf 109 E of 5./JG 53 wears a similar form of disruptive mottling, taking the upper surface camouflage back down to the horizontal mid-line of the aircraft. This may have been initiated as a more defensive measure, the pale blue-grey colouring of the 65 sides not then outlining the fuselage in an oblique view. This may have resulted from some of the unit's aircraft having had their 65-side colouring aft of the cockpit raised to the high position when the change to the old scheme was initiated in December 1939. Two distinct variations had resulted, one with the upper surface colour line taken up to a point level with the top frame of the cockpit (as here); or to a point level with the bottom line of the cockpit (as in the previous photograph). This particular machine was taken on charge before the removal of the old red banner and white disc marking, which left the Hakenkreuz centrally located, spanning fin and rudder.

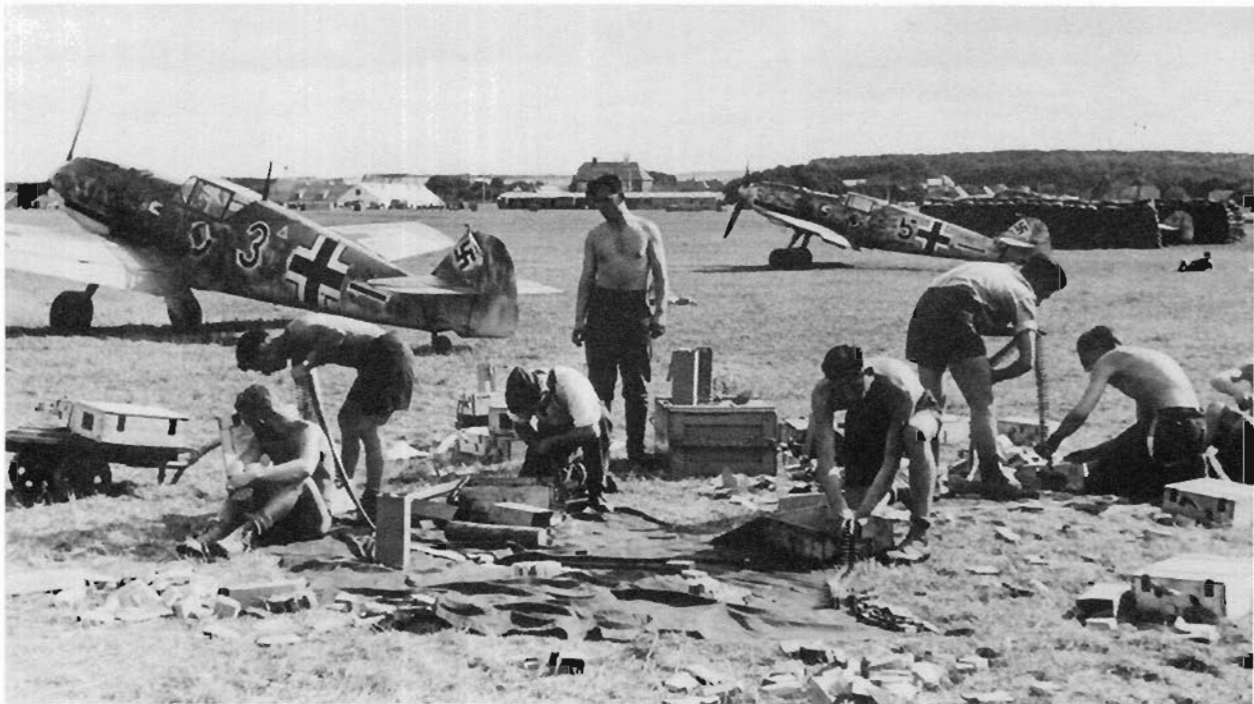
LEFT: A similar style of application had been applied to this Bf 109 E-4, 'Yellow 5', camouflaged in standard 71/02. In this case 71 appears to have been used as short dashes of colour over a very thinly sprayed finish of 02 on the fuselage side surfaces; some of the 02 had also been applied over the spine of the aircraft. Note the high contrast around the square of the Hakenkreuz marking, part of the original standard 65-background. Wing and horizontal tail surfaces however remained in plain 71/02 finish. The rudder was finished in white, indicating that the photograph was in September 1940. (F. Kovács.)

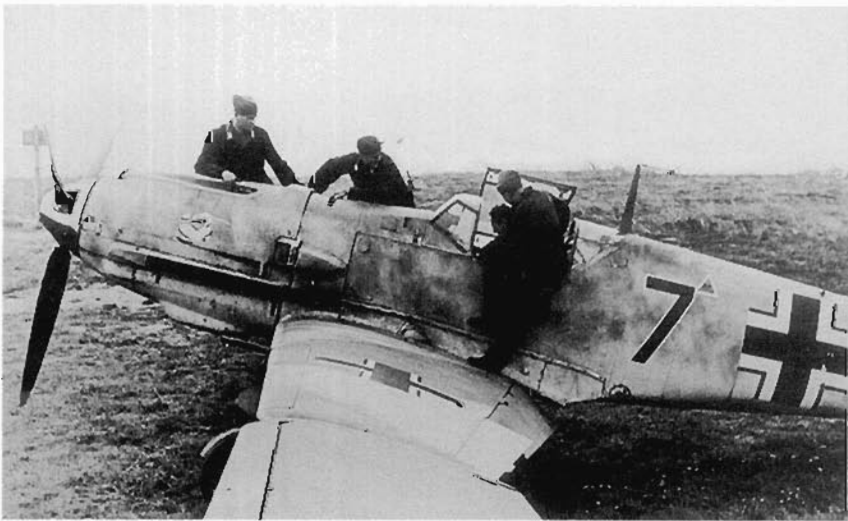
RIGHT: A Bf 109 E-3 of 2./JG 77 wearing the Type 5 camouflage pattern using 71/02 on wings and fuselage upper surfaces. Fuselage side surfaces had been densely sprayed with 71 and 02, the 71 having been extended to give a dark background to the white-edged, 'Black 7' marking. The high contrast camouflage finish is clearly visible on the wing. (F. Kovács.)

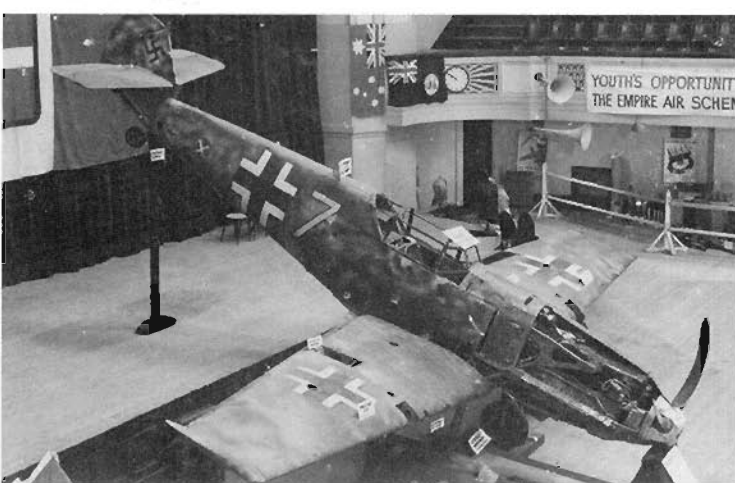
ABOVE: A more radical change is seen here. Displayed in Australia for fund raising and recruitment at Horsham Town Hall, in Victoria in 1943, Uffz. Grabow's Bf 109 E-4, W.Nr. 0750, 'Yellow 7' of 3./JG 3, had been shot down on 5 September 1940. The intelligence report stated that it was mottled with dark and light green, and grey. The darker colour was possibly 70 with thinner sprayed applications of 71, the 'lighter' green, and 02, probably the grey. Close examination reveals the Type 5 camouflage pattern, as the original finish. The 65-coloured side surfaces had been heavily sprayed with dark and light mottles, the former predominating. While the wings had been given similar treatment, almost obscuring the original splinter pattern, the horizontal tail plane had retained its original 71/02 pattern. This was a common feature of these modified camouflage schemes, presumably the small surface area involved not being considered significant, or more probably indicating a reluctance to add weight to the control surfaces. Lack of the original white tactical markings on the engine cowling and rudder was a result of the time span involved, the temporary finish having long since powdered away. The rudder was the original one as the pattern of mottling shows. The black disc and white cross marking appeared only on the starboard side, probably a connection with the Spanish conflict as this was also seen on some aircraft of other units. (N. Paterson)

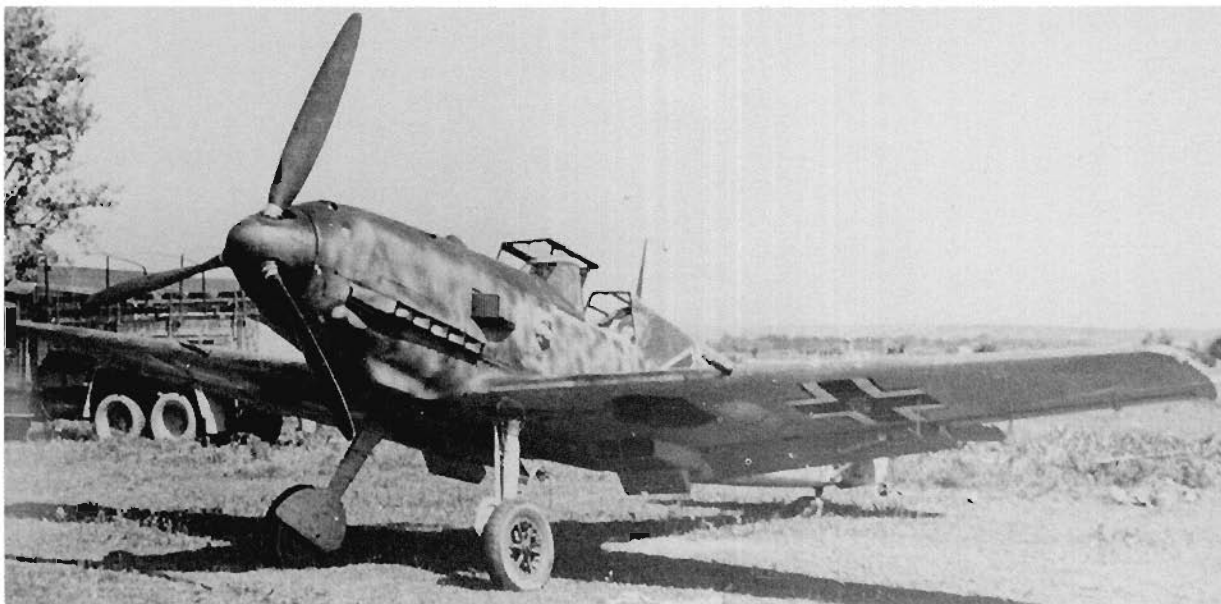
BELOW: A Bf 109 E-4 of II./JG 77, possibly the Gruppen Adjutant's aircraft, finished in 71/02 with mottling of the side surfaces in both upper surface colours and extending to the oil cooler beneath the engine cowling. The rudder was in 04. (F. Smith)

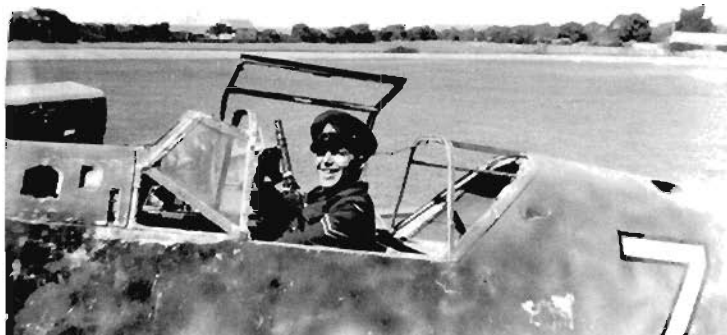
ABOVE: This close-up of the fuselage area of W.Nr. 0750, taken during the fund raising tour in Australia, shows how the dark and light green had been applied, the darker over the lighter one, using short bursts of spray closely linked together in places, but more widely spread in others. The visual result of such a simple technique over the 71/02 base finish was quite effective. (A. Paterson via D. Vincent)

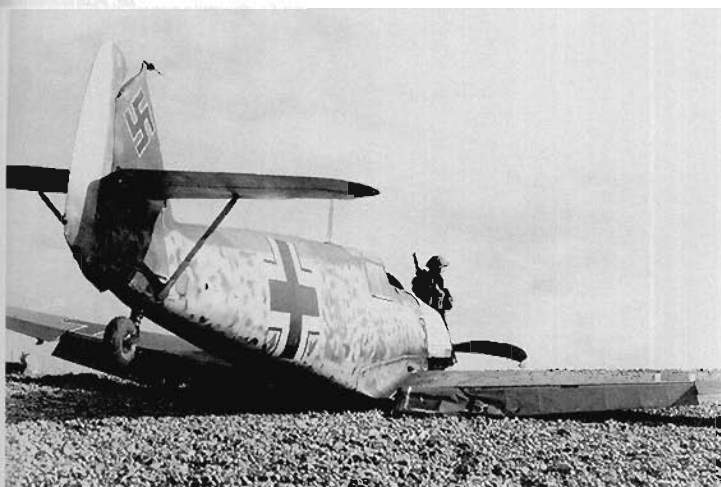
BELOW AND RIGHT: The finish on Uffz. Arno Zimmermann's Bf 109 E-1, W.Nr. 3576, of 7./JG 54, brought down on 27 October 1940, is often raised in the conjecture about the introduction of 74 and 75 into Luftwaffe front line service. Upper surface colours were 71/02 on the fuselage spine, but the wings, according to the intelligence report on the aircraft, were darkish grey except for a large triangular area of dirty light blue colouring (Type 4 pattern). The fuselage side colouring was also described as a dirty light blue dappled with grey. Careful examination of the photographs shows that the dappling in grey follows the projected angles of the upper 71-coloured areas. Where dapples overlapped the 71, they appear darker which might indicate that the grey used was either 66 or a mix of 66 and 22. Engine cowling and rudder were in 04, the latter colouring on being confined to the rear two thirds.

The only serious contender amongst those oft-quoted as wearing a 74/75/76 scheme was the 7./JG 54 Bf 109 E-1, W.Nr. 3576, 'White 13', brought down on 27 October 1940. The range of colours described in the intelligence report seem to support use of the three colours, lower surface colouring being covered in the description of a 'dirty light blue' applied to the side surfaces. However, this is the same colour description used for the 'triangle formed from wing root at trailing edge to a point half way along leading edge.' The triangle is the paler area of colour seen in the Type 4 camouflage pattern in which this aircraft was finished.

production of which sub-type had ceased by the autumn of 1939. Its retention of the original E-1 style of canopy and lack of head armour indicates that it had not been upgraded, and its original 70/71 camouflage had been repainted, not at a factory but at a field maintenance unit. When the three greys 74, 75 and 76 were introduced, they were done so at the factory, not at maintenance unit-level.

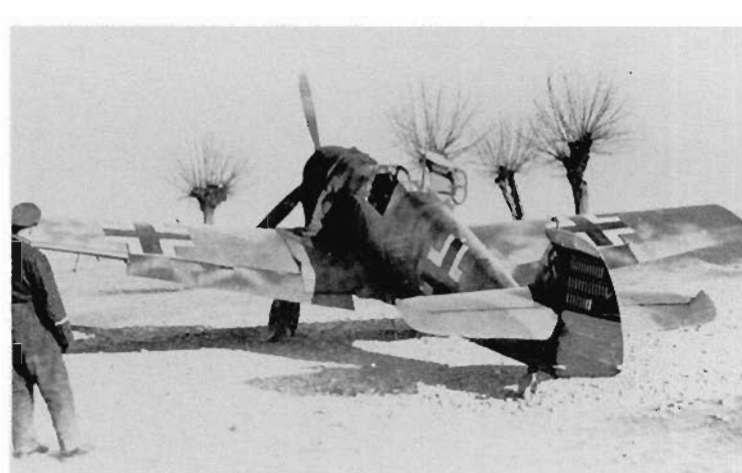
LEFT: The highly individualistic camouflage schemes adopted by various Bf 109 Es during the air battle over Britain remained in use until aircraft were replaced. This Bf 109 E-3, the mount of Kdr. Herbert Ihlefeld, commander of I./LG 2, was based at Calais-Març when this photograph was taken on 31 March 1941. The 71/02 type camouflage had been retained untouched on the horizontal tail plane, but the wings had been oversprayed with random patches and wedge shapes of a colour darker than the 71, possibly 70, and fuselage side surfaces had also been mottled with the same colour. The rudder was painted 04 other than for a patch of the dark colouring probably 70 on which 32 kill markings were displayed. Note the pale square of original 65-colouring surrounding the Hakenkreuz on the 70 painted fin. (F. Smith)

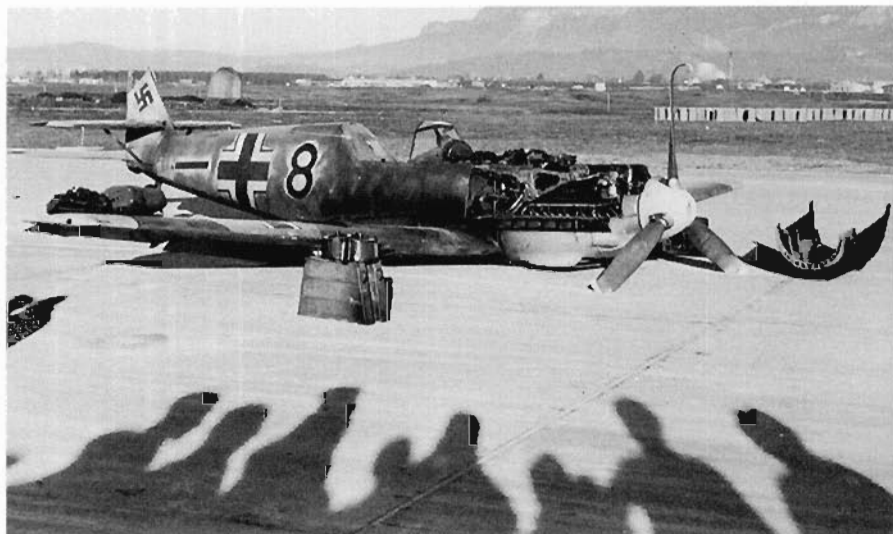
RIGHT: JG 77 had continued to employ very dense forms of mottling during its deployment in Norway. This photograph of 'Black 8', W.Nr. 5011 of I./JG 77 was taken after a forced landing at Stavanger-Sola on 10 May 1941. The very dark mottling, with extensive use of 71, was an advantage over the dark waters and dense pine forests of the Norwegian region, taking the general camouflage back more to its 1939 form.

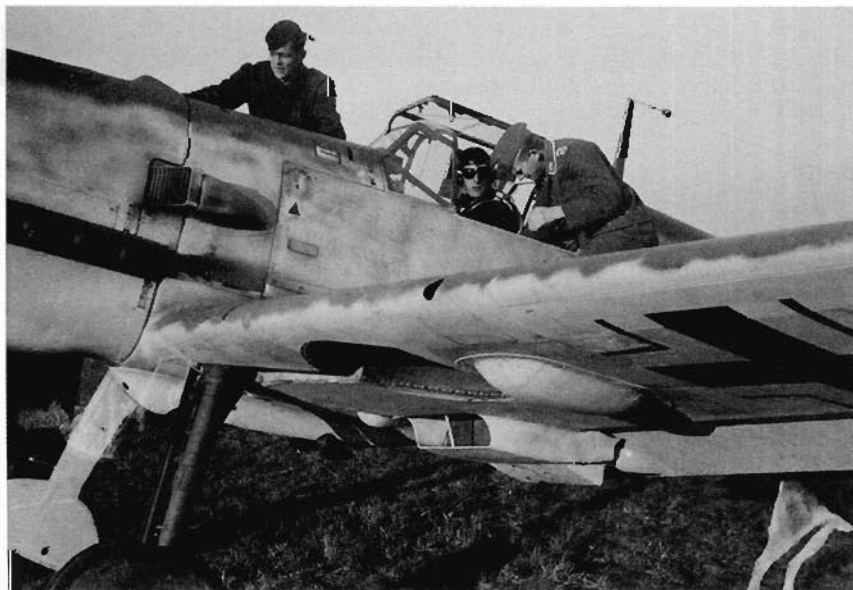
LEFT: Following the success of fighter-bomber tactics developed by the Bf 109 E-equipped 3./Erprobungsgruppe 210, the RLM had ordered that every Jagdgeschwader was to have a 'Jabo' Staffel. This Bf 109 E-4/B of III./JG 77 was fitted with an ETC 250 bomb rack for a 250 kg bomb and had had its wing-mounted MG FF cannon removed. Camouflage was 71/02 with mottling in 02. Note the finish of the upper surface wing camouflage along the wing leading edge. The undercarriage oleos were painted in 66, and the lacing of the canvas liner for the wheel well is just visible.

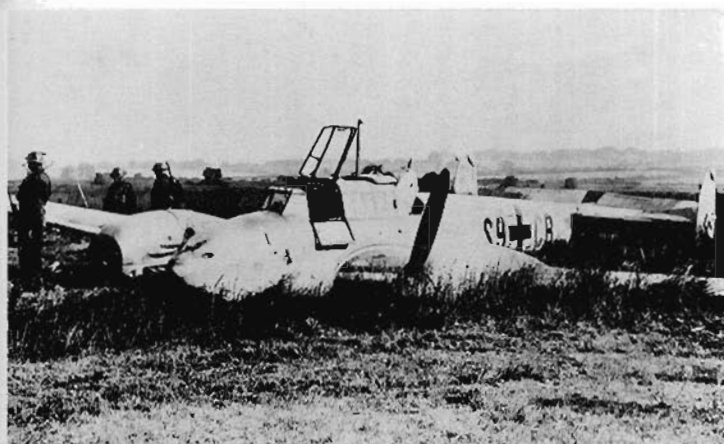
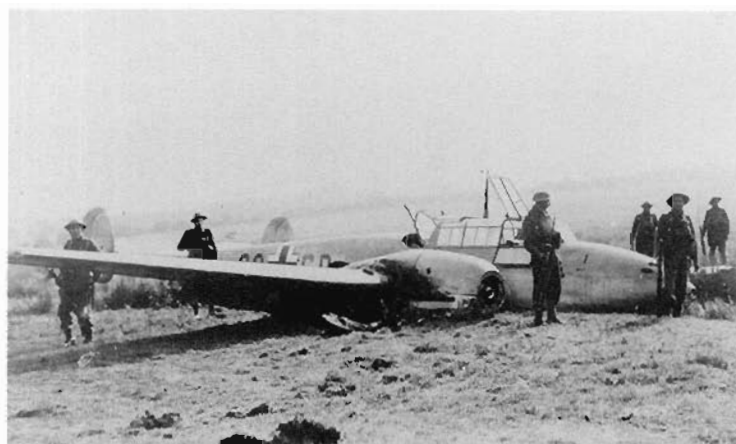
ABOVE LEFT AND ABOVE: Fighter-bombers were in the thick of the heavy fighting over Britain in July 1940 and Lt. Koch's Bf 110 D, W.Nr. 3339, S9+CB of Stab Erprobungsgruppe 210, had been shot down after the raid on Croydon on 15 August. The very pale finish had been produced by using a thin spray of O2 over the upper surface camouflage of 71/02 on the fuselage and engine cowlings; however, the wings retained their 71/02 finish without any O2 spray. The elevators were discoloured with engine exhaust stains. (P. Cornwall via J.Vasco)

LEFT: Close up, the nose section of Koch's aircraft shows how the extra spray of O2 had subdued the original two-tone camouflage. A high demarcation line between side and upper surface colouring was also being recorded on later model Bf 110s by this time. (P. Burgess via J.Vasco)

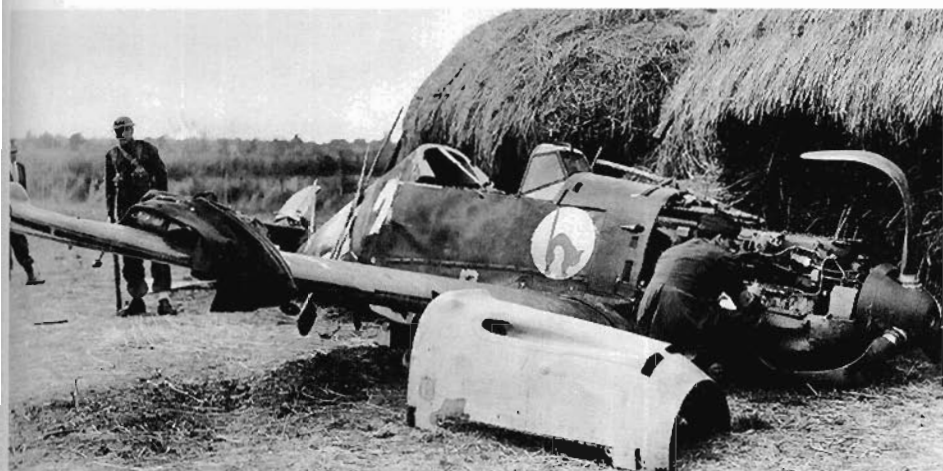
LEFT AND BELOW: Even as late as October 1940, some Bf 109 Es were still operating in the old full 70/71/65 scheme. This usually resulted from the need to bring reserve aircraft into action, and losses during the Battle of Britain placed heavy pressure on such resources. Fw. Boche's Bf 109 E-1, W.Nr. 3465, of 4./JG 52 had been brought down during a raid on London on 8 October, the aircraft breaking in two. Apart from the 04-coloured cowling and rudder, and white figure '2', the aircraft's dark 70/71 colouring was relieved only by the red cat emblem. The Intelligence Officer with the notebook wears his identifying 'IO' armband.

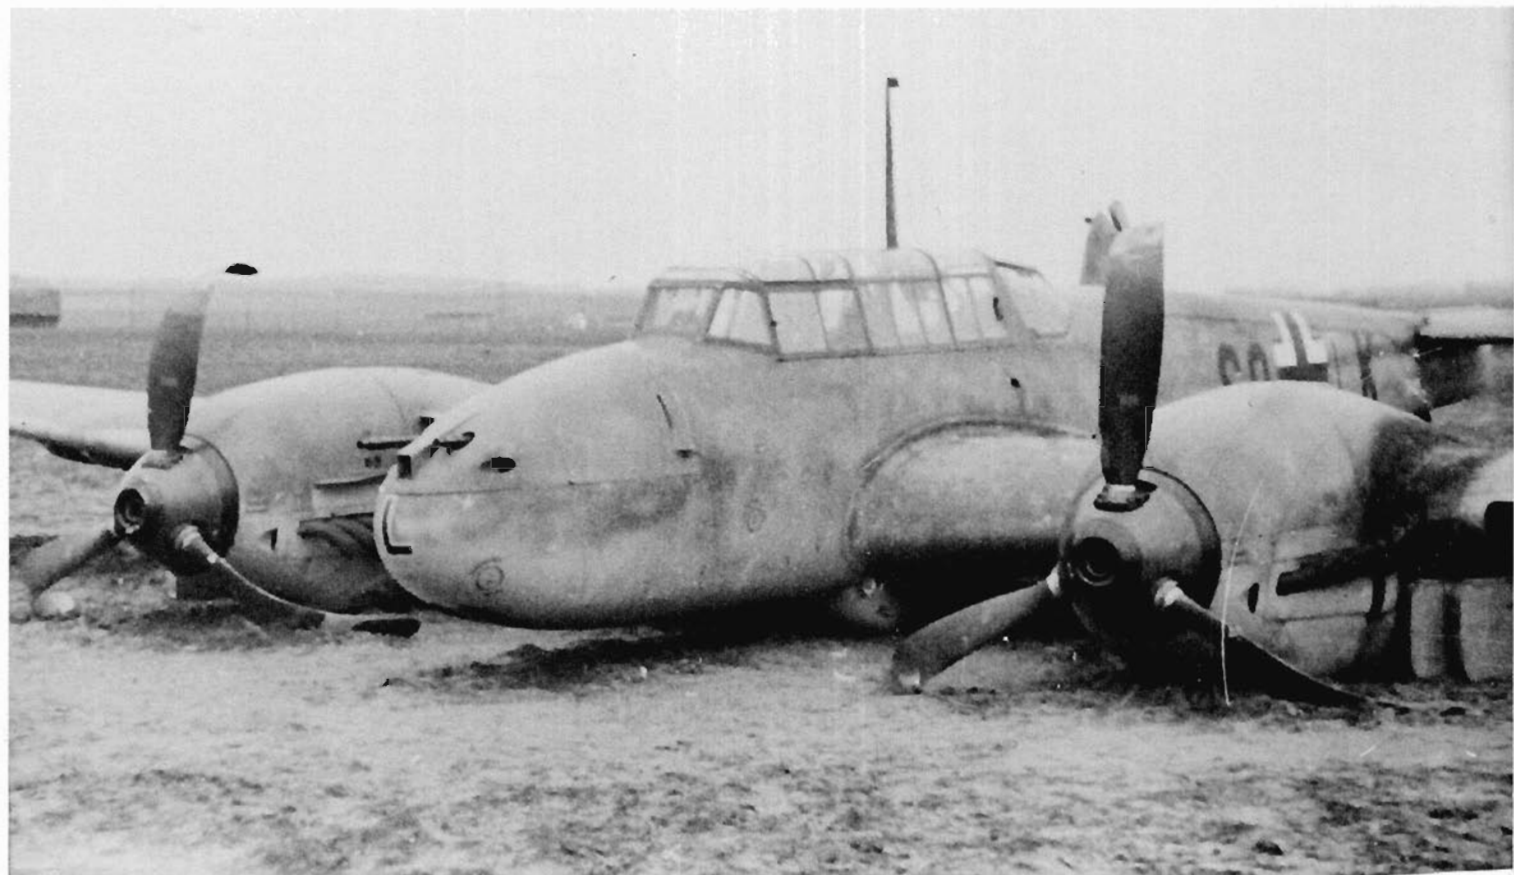
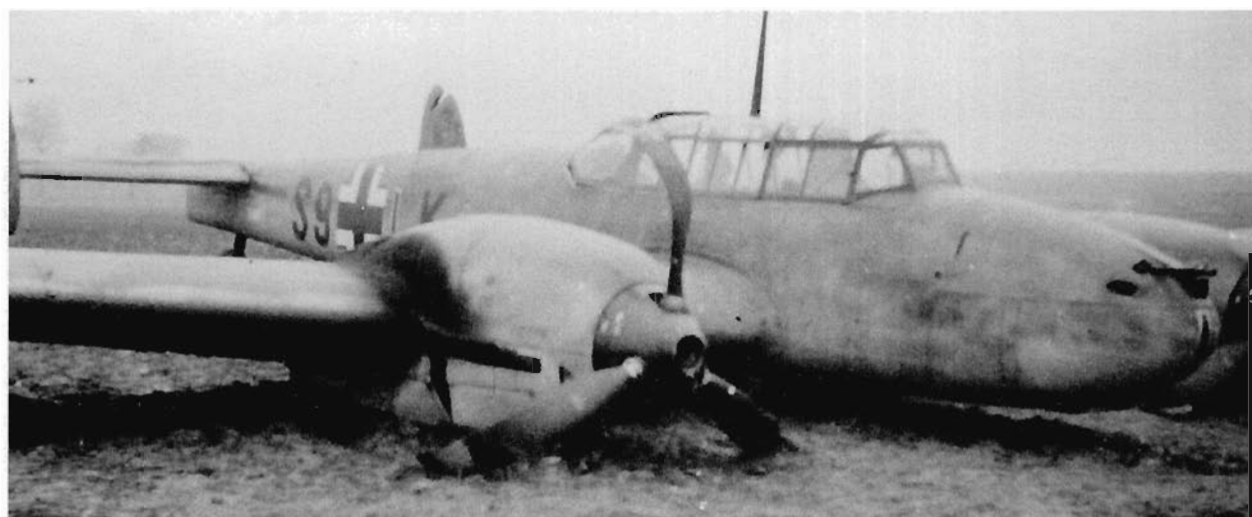
ABOVE AND LEFT:  
Uffz. Artez' Bf 110 D,  
S9+LK, of  
2./Erprobungsgruppe  
210 photographed  
after a forced-landing  
on 21 March 1941,  
following a night  
bombing attack.  
Camouflage was still  
71/02/65 with a thin  
spray of 02 over the  
camouflage of the  
fuselage and engines.  
The extended tail cone  
housed a dinghy.  
(J.Vasco)

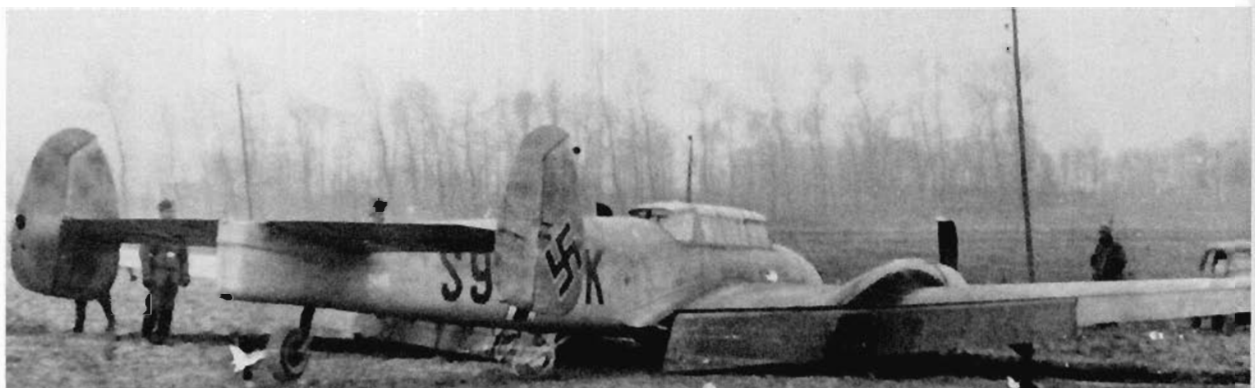
RIGHT: In this view the  
darker camouflage of  
the wing upper  
surfaces can be seen,  
the 71/02 finish  
being left without an  
over-spray of 02.  
(J.Vasco)

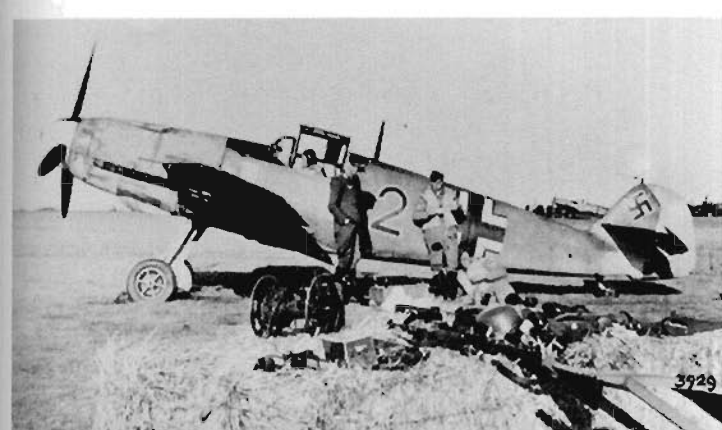
ABOVE: Early deliveries of the improved Bf 109 F series in September 1940 carried standard 71/02 with mottling applied to the fuselage side surfaces. This aircraft had its side surfaces almost covered with a light spray of 02 taken right down to the lowest point. Based on the French coast, yellow tactical markings have been retained for engine cowling and rudder. The temporary yellow on the engine cowling tended to deteriorate more quickly than that applied to the rudder, heat from the engine no doubt hastening the process sometimes producing a deeper shade of colour.

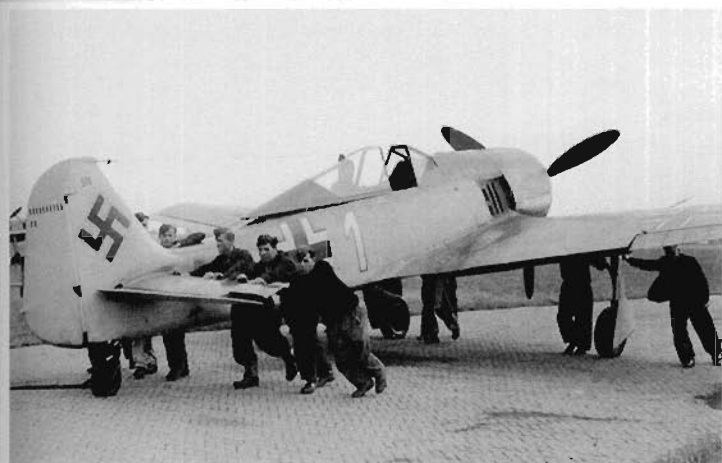
ABOVE: Fw. Friedrich Eberle's Fw 190 A-3, W.Nr. 518 'Yellow 1' of 10./JG 1, displayed the revised colours for European-based fighter aircraft 74/75/76. Initial production Fw 190s used very little side mottling despite the general order to use a mixture of both upper surface colours to blend the upper surface camouflage into the pale side surface areas. The rudder carried twelve kill markings. (E. Mombeek)

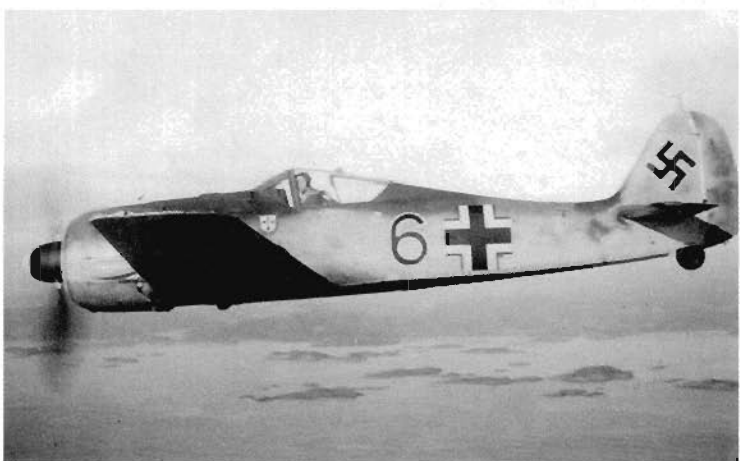
ABOVE: Uffz. Alois Job's Fw 190 A-4, 'Black 6' of 8./JG 1, illustrates the very restricted form of side surface mottling. Job shot down a Spitfire using this aircraft on 12 January 1943. (E. Mombeek)
