# **LUFTWAFFE CAMOUFLAGE AND MARKINGS 1933-1945**

## **Volume One**

**K.A. Merrick**  
with Jürgen Kiroff

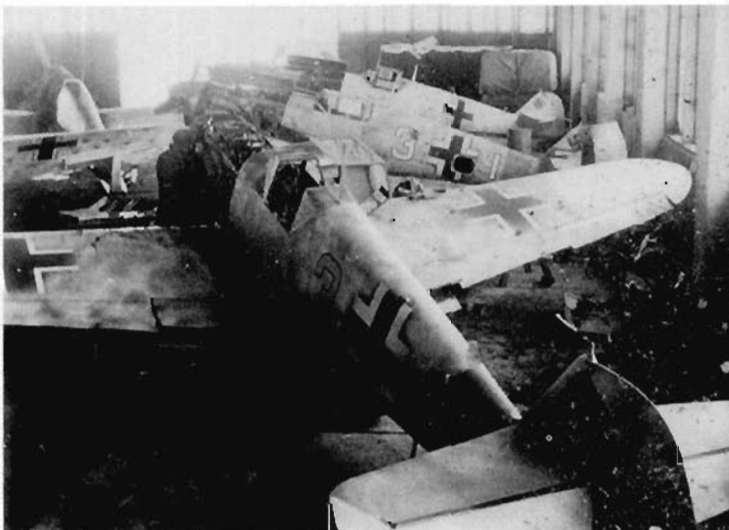
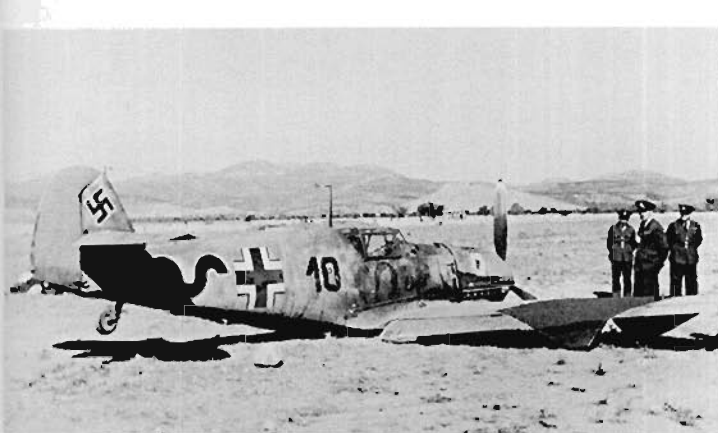
ABOVE: A Bf 109 E-3 of III./JG 77 brought down during the Balkans campaign. Camouflage was 71/02 with fuselage side surfaces mottled with softly sprayed 71 and 02 that almost obscured the 65-colouring in many places. Note the stronger contrast between the 71 and 02 on the section of the wing outboard of the cloth draped over the Balkenkreuz marking. Tactical markings were 04 on rudder and engine cowling. The 9. Staffel badge below the cockpit had been discoloured by the engine exhaust, but the III. Gruppe marking on the cowling is clearly visible; note the latter large style. The aircraft retained the 1939-size Balkenkreuz marking and smaller code application, the numeral size being based on the proportions of the Balkenkreuz.

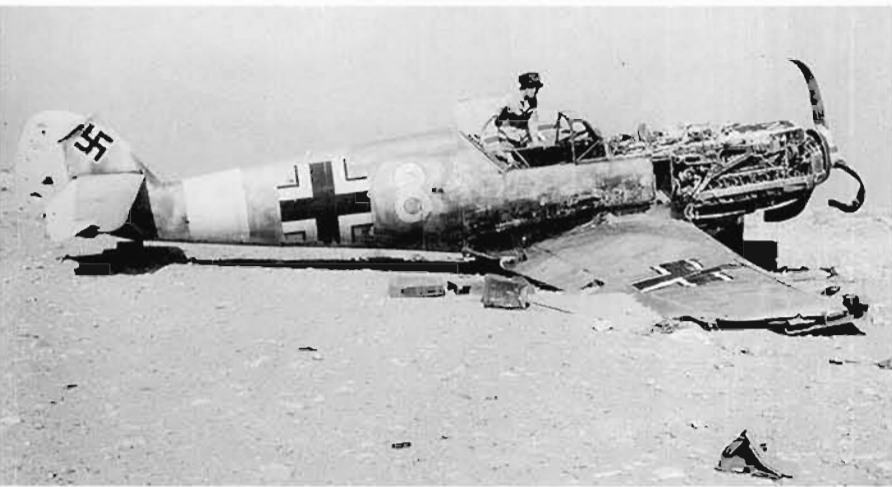
LEFT: In 1941, the Luftwaffe was drawn into the battle in North Africa. Initially, the Bf 109 Es of JG 27, which had begun arriving in April 1941, were forced to fight wearing their European camouflage as seen on this wrecked Bf 109 E-4, victim of the first Libyan offensive. It retained the extremely unsuitable 71/02 scheme on its upper surfaces with side surfaces sprayed with a very thin application of 02, over which an equally thin application of 71 had been applied as a vague mottle. It also retained its 04-coloured rudder from the previous theatre of operations despite the North African tactical white band marking having been added. The 'Yellow 8' marking replaced an earlier number that had been painted out.

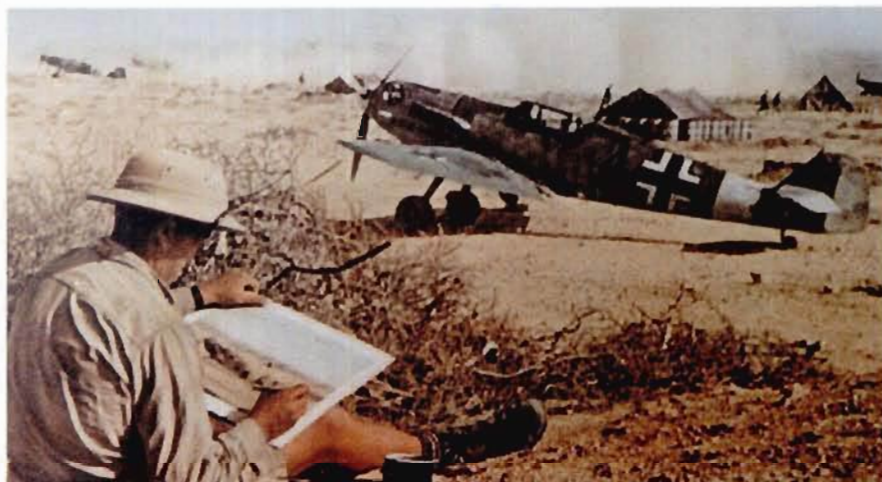
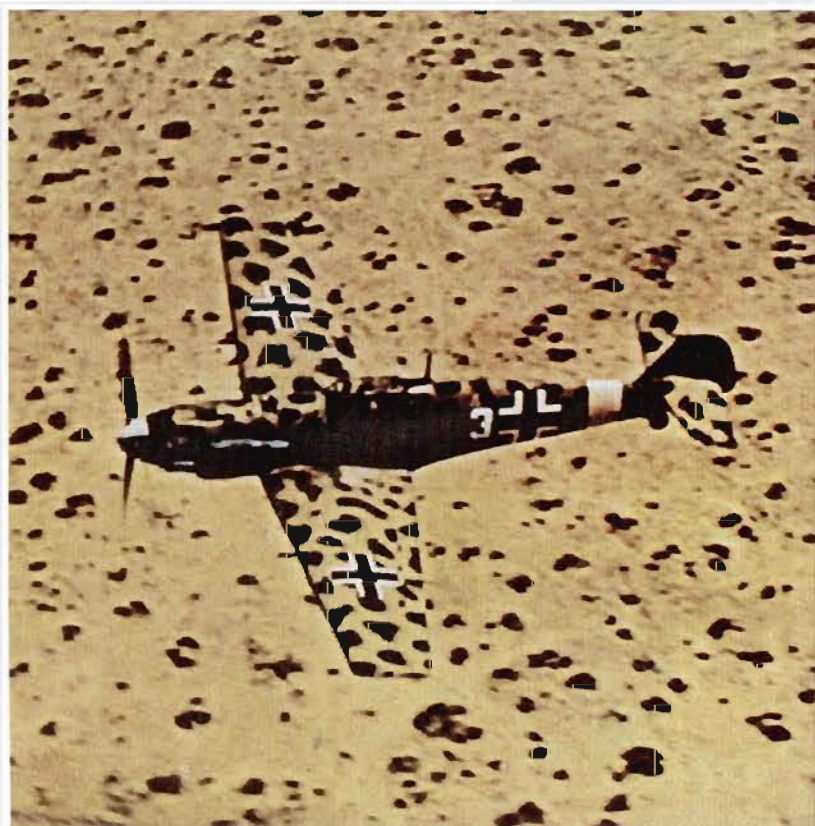
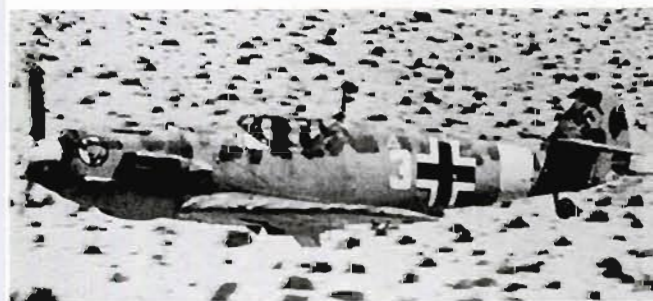
LEFT AND ABOVE: Unprepared for such a theatre of operations, initially the Luftwaffe had employed three new tropical colours – a sand yellow, which matched exactly the shade of the North African sand, a deep blue for under surfaces, with a third colour, olive green, for mottling. Eventually, the first two had been replaced with a deeper sand colour and a paler blue. These photographs of Bf 109 E-4 trop, 'White 3' of 1./JG 27, provide a unique opportunity to examine the earlier form of camouflage colours as well as the random pattern of mottles. Repainting was carried out in Sicily, with aircraft being rotated from the battlefield as conditions allowed. Careful examination of the wings show the distinct difference in application, the port one having mottles applied in a line roughly parallel to the leading edge. The starboard wing applications were more random – the result of the usual practice of having two painters working at the same time, one each side of the aircraft. The horizontal tail plane surfaces also have different styles of mottle. (F. Smith)

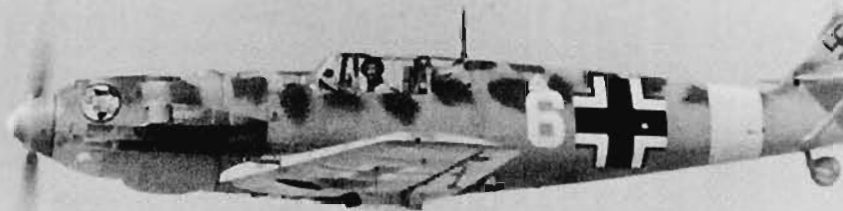
ABOVE AND RIGHT: In these two views, one of 'White 6', the other of 'Black 8' of 2./JG 27, the differences are again apparent. On the latter aircraft, the upper surface mottle had been carried down to the mid-line of the fuselage. The style of mottling on each aircraft was different.

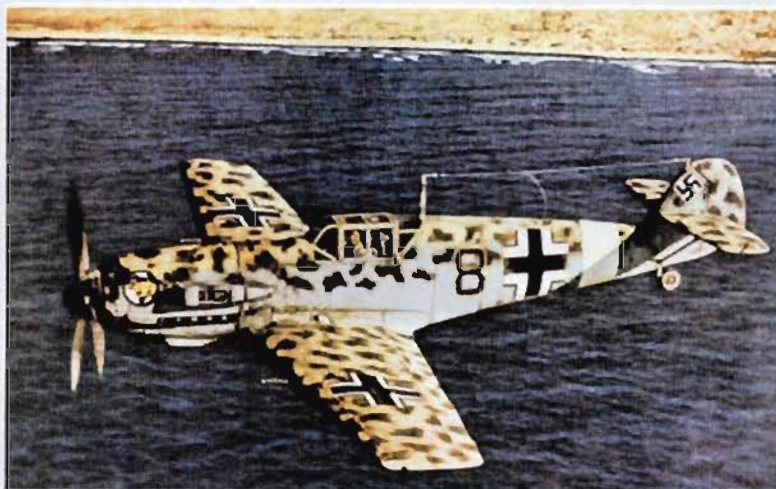
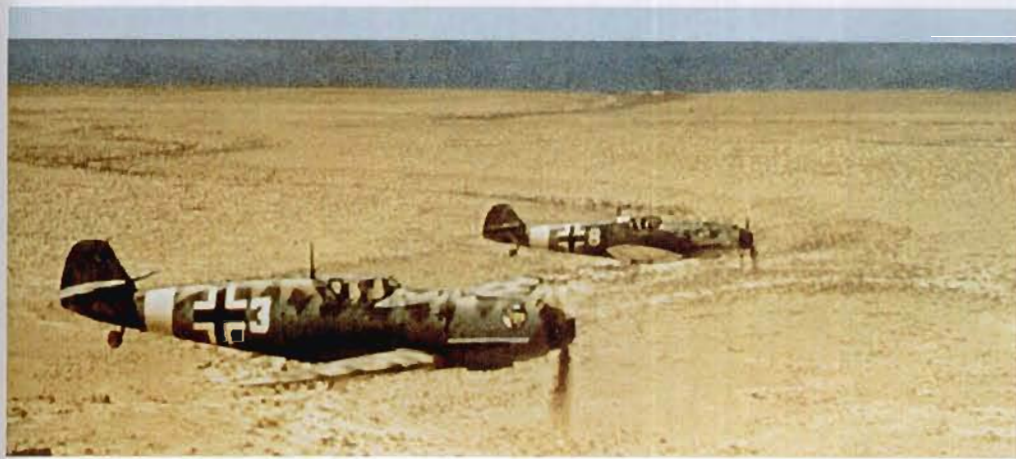
ABOVE: This view of 'White 3' and 'White 8' of 1./JG 27 illustrates the process of repainting on rotation. The nearer one is in full tropical camouflage while the other still retains its European scheme.

RIGHT: This photograph of a Bf 109 E-3, 'Yellow 4' is one of the relatively very few to show the first style of application of tropical colours to the machines of JG 27. The distinctive shape of the patches of the 80-colouring and the high demarcation line of the 78/79 division are clearly illustrated. Note the mint condition of the camouflage but worn propeller paintwork, the latter not having been repainted.

The first examples of desert camouflaged Bf 109s are unlikely then to have been seen before early May. The well known photographs of 'Yellow 4', photographed in colour with the service standard and often used in conjunction with the comment that it was taken in April, shows an aircraft in mint condition but with propeller blades that have heavy wear on them. Just when this photograph was taken is not known for certain, but given the state of operational flying in April it is most likely that this was taken in May during the relative lull in fighting.

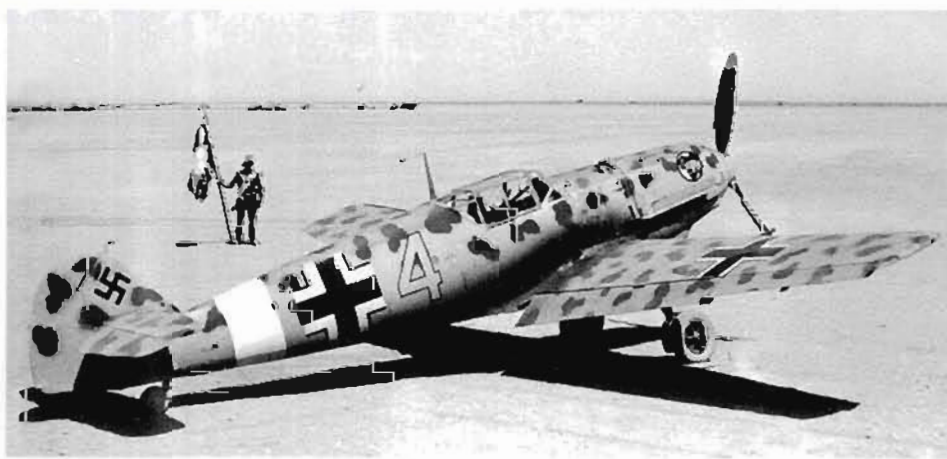
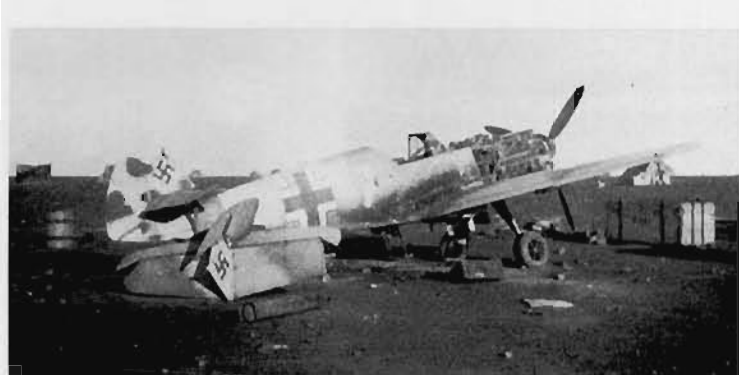
ABOVE: The practice of changing major components to keep aircraft serviceable without having to send them back to a repair facility was essential for JG 27 during its early period of deployment to North Africa. This Bf 109 E, 'White 7', had its entire empennage replaced with one taken from an aircraft that had already been repainted in the tropical colours of 79/80. The style of large patches of 80 was limited to the first Bf 109 Es sent for repainting in Sicily. This process of exchanging parts often produced hybrid colour schemes. (K. Smith via D. Vincent)

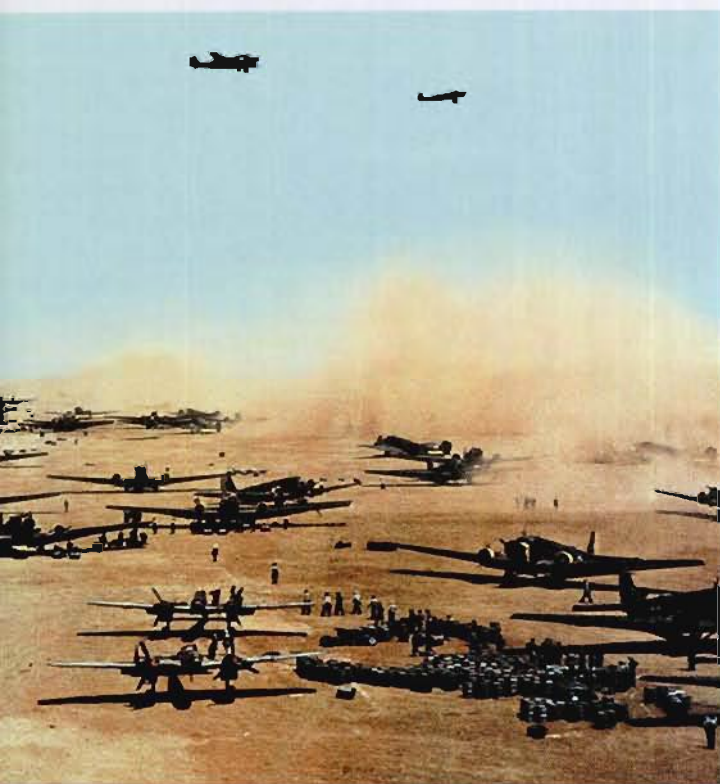
LEFT: The total unsuitability of European camouflage seen against the stark background of the desert is well illustrated in this photograph. While detail remained poor at such distances, the visual difference of the 70/71/65 finish of the Ju 52s and the distinct blue-greys of the Bf 110s of ZG 26 (one of the later arrivals in the new fighter colours of 74/75/76) is immediately apparent, just as it would appear to an Allied aircraft approaching the area.

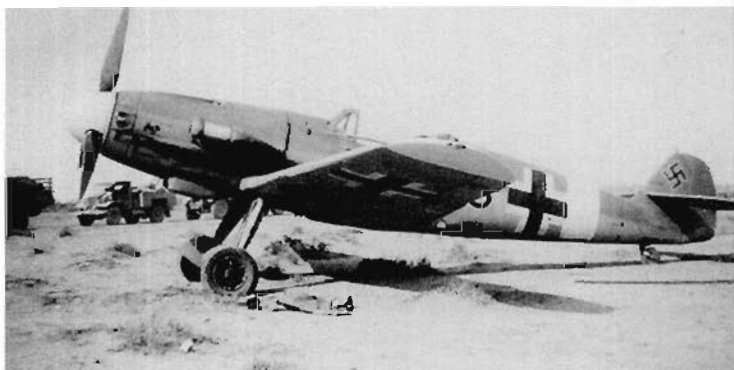
RIGHT: A Prix de Guerre of the US Air Force in Tunisia. The airframe had been repainted in red by the Americans, with yellow leading edge to the horizontal tail plane and wings, but taken right through to the line of the main spar on the latter (in the same style as would be seen on Luftwaffe Fw 190s, with bare metal wing surfaces, in 1944/1945). A broad yellow band was also used to delete each Balkenkreuz marking on the fuselage. (J. Crow)

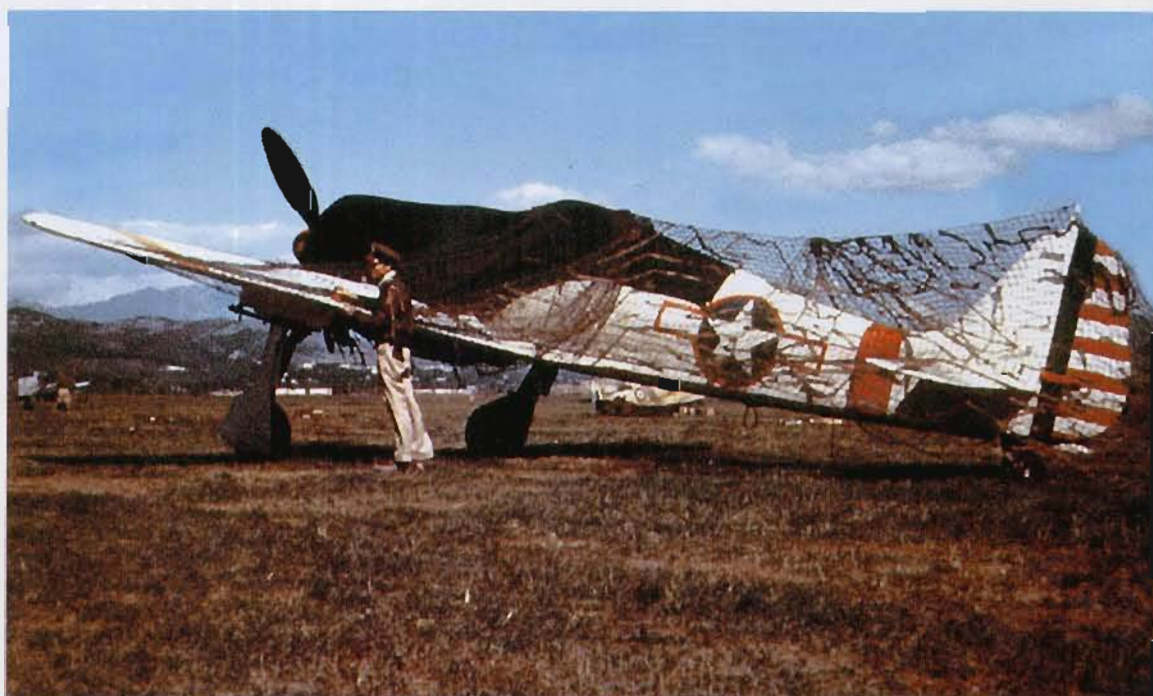
RIGHT: German aircraft captured by the RAF were less flamboyantly treated. This Bf 109 F-4 Z Trop, 'Yellow 2' of an unidentified III. Gruppe, retained its 78/79 finish with just its national markings painted out and replaced by RAF roundels and fin flash.

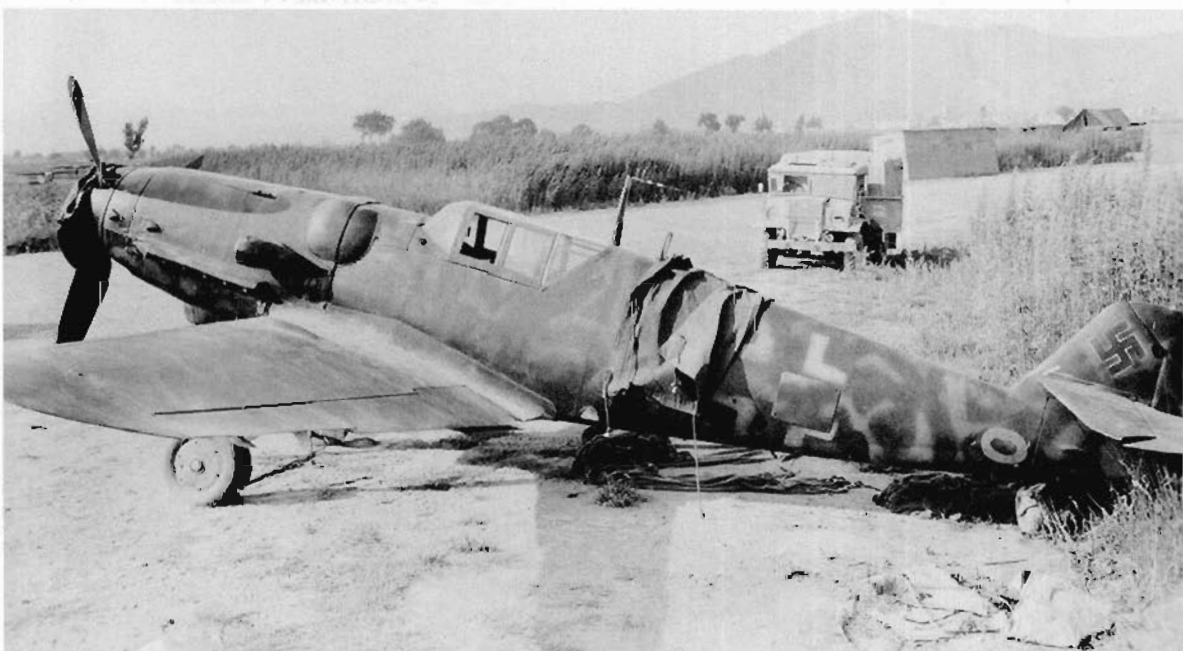
LEFT: Uffz. Dubois' Bf 109 G-6/R3, W.Nr. 160756, 'Yellow 4' of 3./JG 4, at Santa Maria landing ground in Italy in late July 1944. Note the Italian style of camouflage, with the fuselage Balkenkreuz and the Hakenkreuz markings partly painted out and the wing upper surface marking almost undetectable. The circle of fresh 02 around the removable panel at the rear of the fuselage provides a good colour indicator. The small black numbers were marked on the original negative by the intelligence assessment team. (NASM via Dr. J. H. Kitchens & J. R. Beaman)

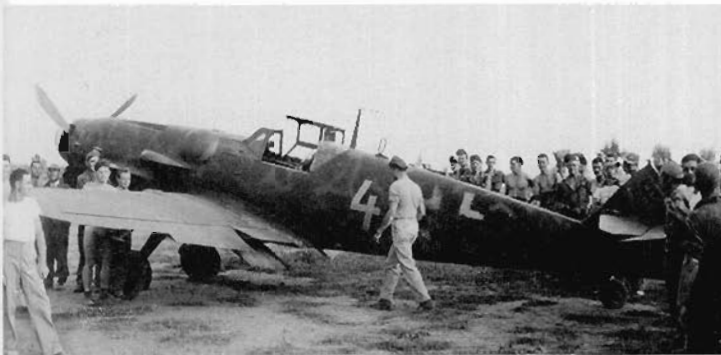
ABOVE: Taken moments after its pilot surrendered it on 25 July 1944, the style and positioning of the 'Yellow 4' marking can be seen. The relative brightness of that marking was in sharp contrast with the dark camouflage colouring. (NASM via Dr. J. H. Kitchens & J. R. Beaman)

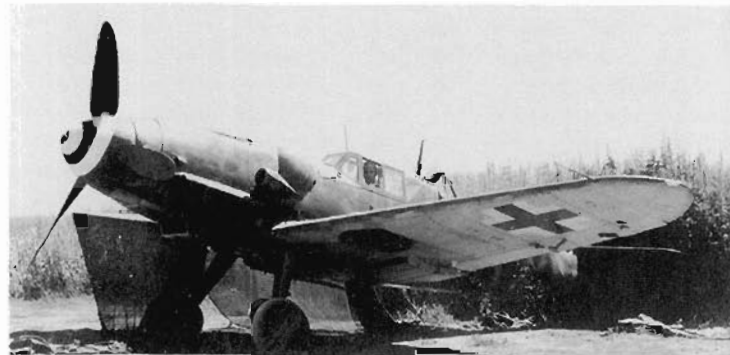
ABOVE: The positioning of the underwing Balkenkreuz was slightly further outboard as noted, but the undisturbed background paint, indicates that the original 76-colouring had been retained. (NASM via Dr. J. H. Kitchens & J. R. Beaman)

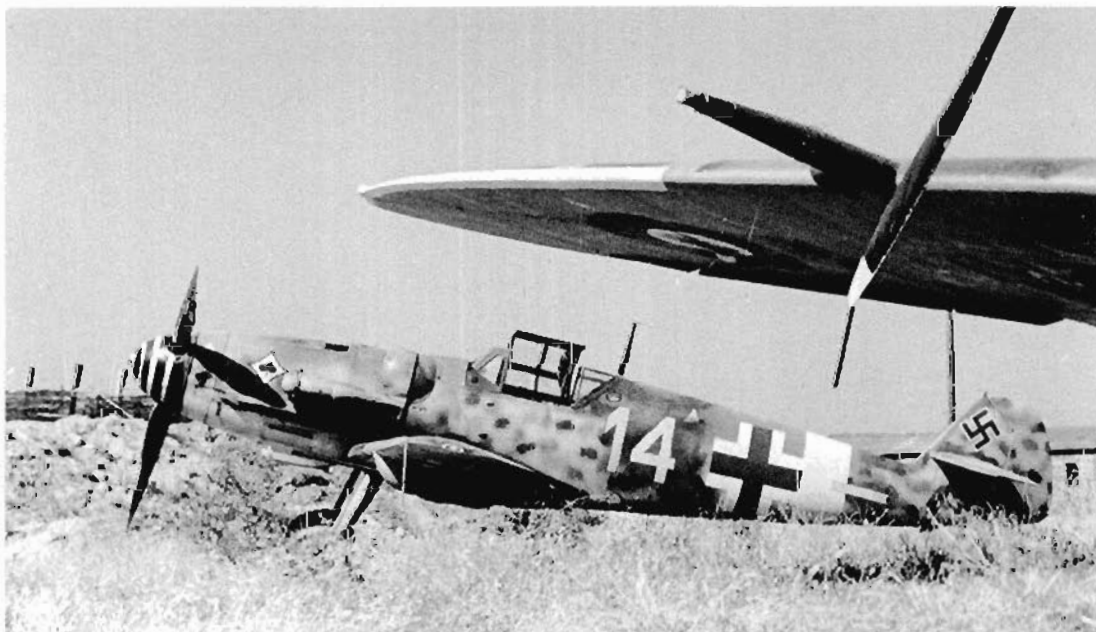
LEFT: On the Italian front, fighters either wore desert colours or, more usually, retained standard 74/75/76 finish. This Erla-built Bf 109 G-2/R6 trop. W.Nr. 10639, 'Yellow 14' of III./JG 53, was captured in Sicily in late 1943. It wore an almost textbook finish of the latter colours, with alternate mottles of 74 and 75 on its side surfaces. Only behind the aircraft number had the colouring been intensified to present a darker background.

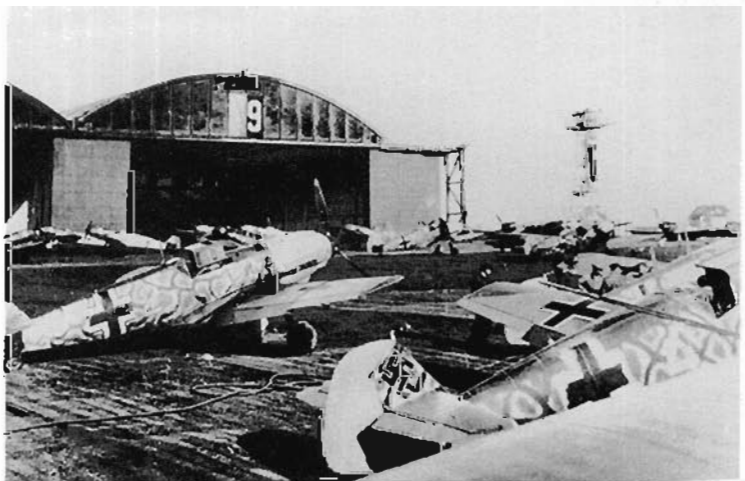
ABOVE: Units transferring to the Eastern Front in 1941 had retained their existing camouflage, though some had soon introduced their own modifications. These Bf 109 E-3s and -4s of II./JG 54 retained the unit's distinctive 'garden wall' side surface pattern. Upper surfaces were in 71/02 and those two colours had been used to produce the unique pattern. 71-colouring was used for the 'seams' with the central area of 65 broken by a patch of 02. Note the fuselage Balkenkreuz marking on the nearest aircraft that was in the process of being remarked. Rudder and cowlings tactical colouring was 04.

II./JG 54 retained its well established 'stone wall' design in 71/02/65 for its Bf 109 F-2s. This novel form of camouflage, which appears to have been a development from the distinctive cross hatching strokes of 71 used during the Battle of Britain on its Bf 109 Es, gradually disappeared as the Bf 109 F-4 began to replace the F-2, and was used only by II. Gruppe.

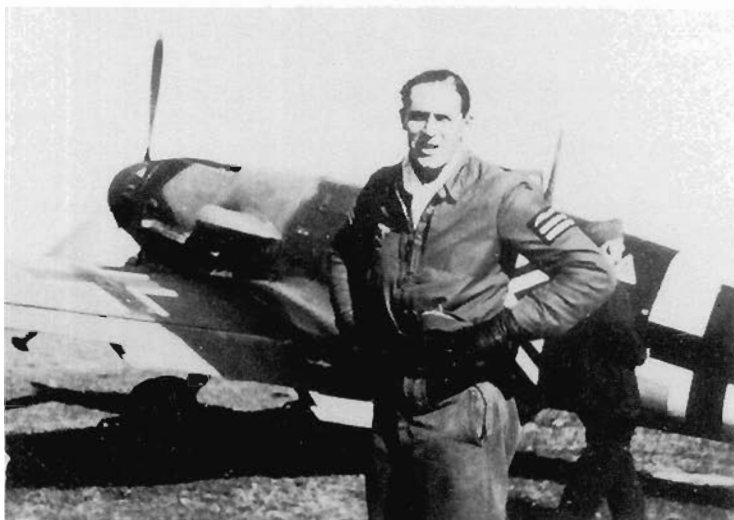
ABOVE: JG 54 was renowned for displaying individual camouflage schemes. Here Major Hannes Trautloft stands in front of his Bf 109 G-2 at Siwerskaja; it wore what appears to be an extremely dark overall finish (possibly 80) segmented with a lighter colour that tonally appears to be 02. Examination of the photograph shows that the lighter segments had been sprayed over the underlying dark colour. The camouflage pattern was composed of much larger segments than normal, with sharp delineation between them.

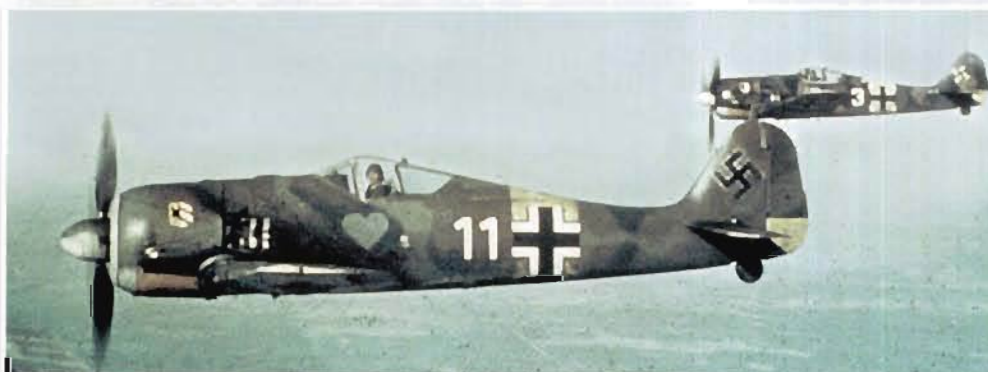
ABOVE: A pair of Fw 190s of 1./JG 54 display their unique camouflage style and colouring. The original photograph was distinctly deficient in yellow but careful examination reveals a mixture of a dark green, a paler green and patches of a mid-tone brown. Traces of the latter colour can be detected on the tip of the fin and rudder, along the spine of the aft section of the fuselage and below the cockpit, and in two areas on top of the fuselage forward of the cockpit. The aircraft behind more clearly shows areas of brown at the tip of the rudder, below the Hakenkreuz marking, on the rear of the fuselage, the rear of the canopy fairing, below the cockpit and on the top of the engine cowlings. Compare the solid white square behind the Hakenkreuz of the rear aircraft with the one on the nearer aircraft that had had its white border partly painted out. The two greens on the nearer aircraft were 62 (82) and 64 (83) while the brown appears to be 61 (81). The aircraft behind has areas of what looks more like 79 (below cockpit and on rear section of fuselage) in combination with 62 and 64.

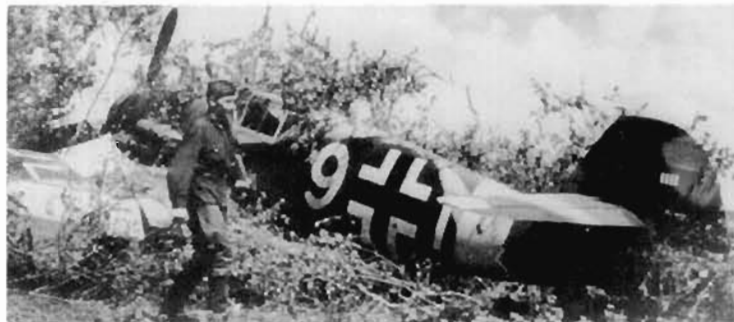
ABOVE: One of JG 3's Bf 109 F-4s painted in the unusual combination of colours in which the unit had received its new aircraft on formation at Wiesbaden-Erbenheim. This aircraft was captured by the Russians after it had force-landed. The three colour combination is particularly noticeable on the horizontal tail surfaces.

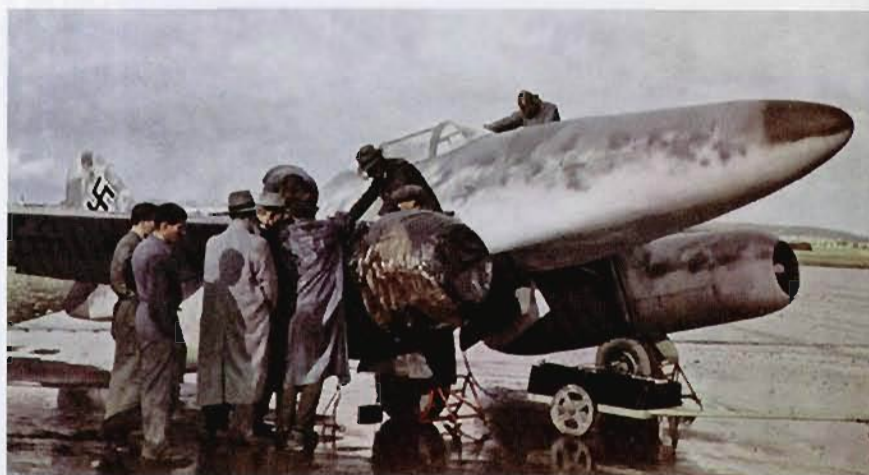
ABOVE: The Me 262 V-3 was first flown in early 1942 and as such carried standard fighter camouflage for the period – 74/75 with a slight mottling in both colours applied to blend upper and side surface colour transition. The nose cone was finished in 70, probably to give the impression of a conventional spinner to prying eyes. The engine cover was finished in ground defensive camouflage of brown and black, the same RAL colours used for the wheel covers.

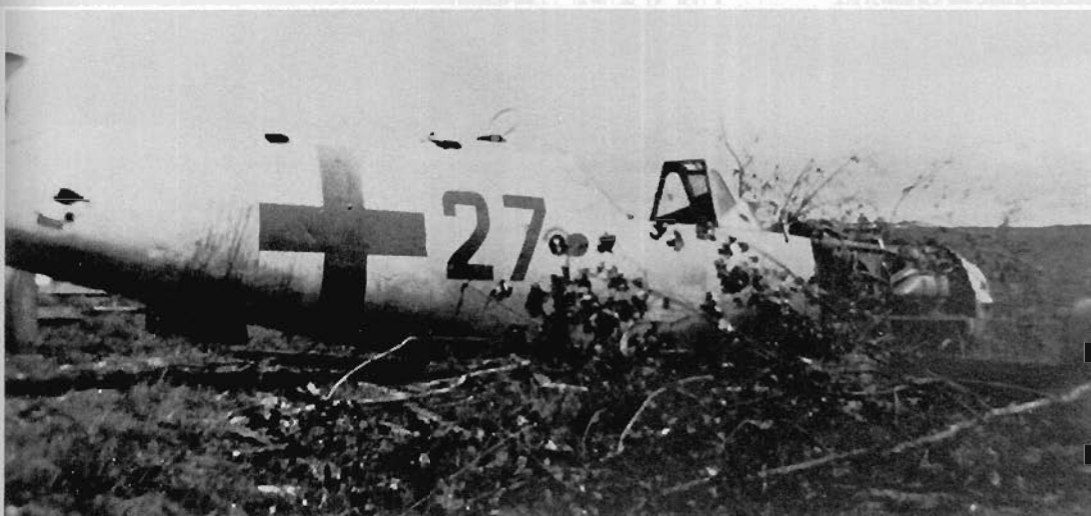
LEFT: Remains of 'Black 27', probably a Bf 109 G-6/AS, brought down in the late spring of 1944. It wore the overall high-altitude grey colouring of 77. Several Jagdgeschwadern had Staffeln dedicated to these duties. (M. Payne via J. Prien)

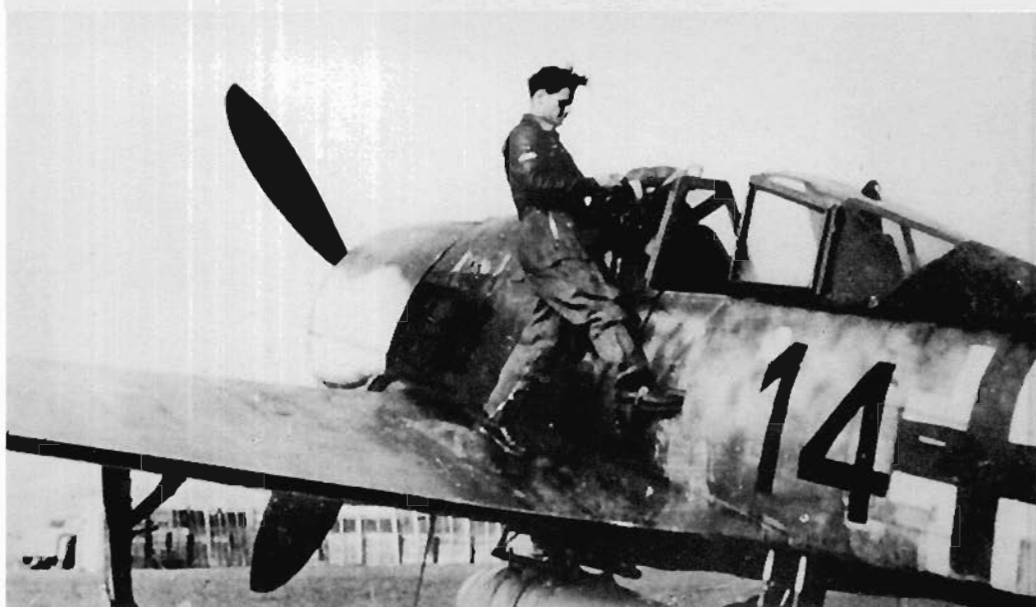
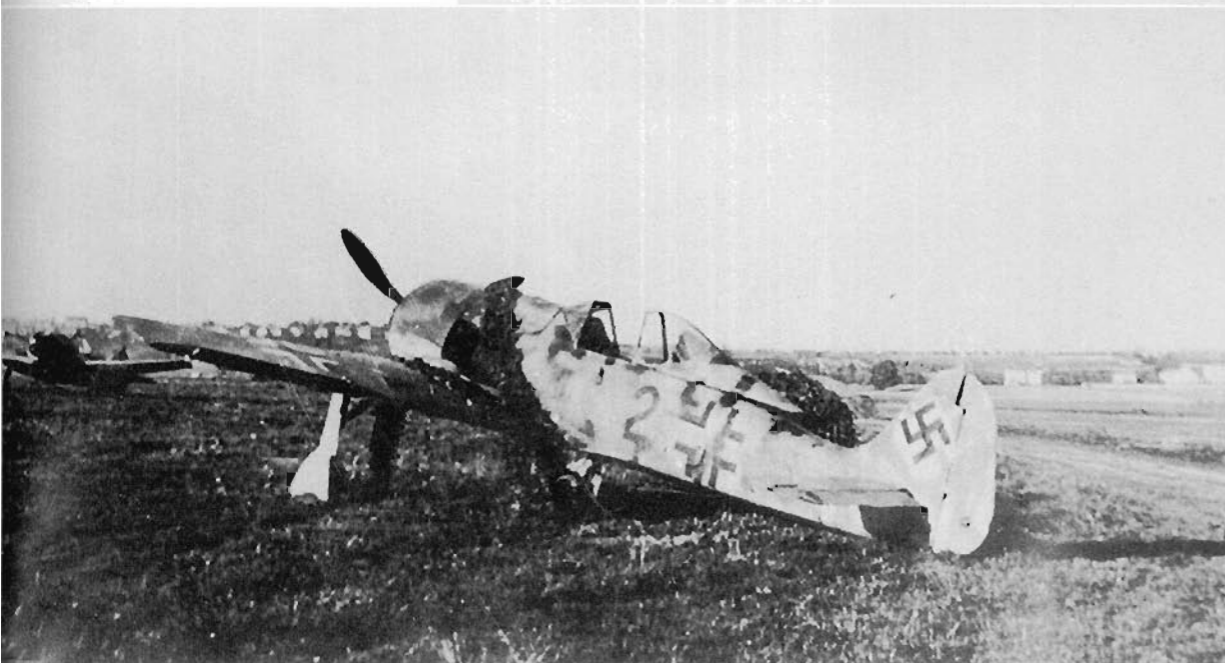
LEFT: A most unusually modified camouflage. The fuselage of the Fw 190 appears to be finished in a base coat of 82 with long thin patches of 81 added in semi-linear fashion. The fin and rudder lack anything but the 82-colouring, but around the Hakenkreuz the original 76 can still be detected. In contrast the wings and engine cowlings appear to be in very dark colours; possibly a much denser application of 81 and 82. (J. Crow)

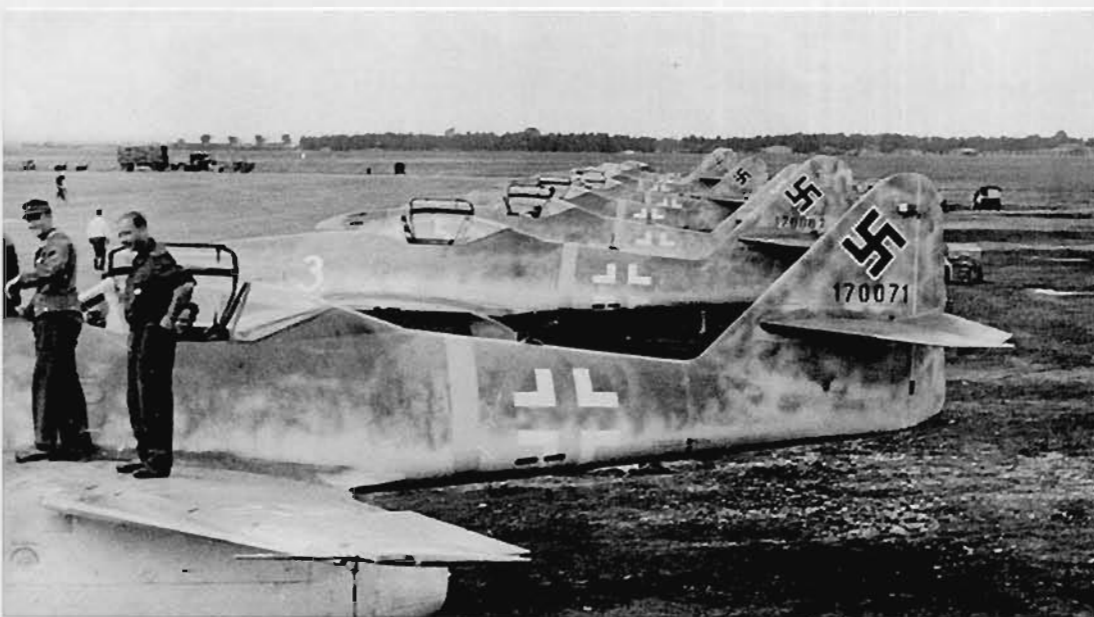
LEFT: A line-up of Me 262 A-1a's of Erprobungskommando 262 at Lechfeld in 1944, illustrating the close conformity of style of application of the 74/75/76-colouring, with soft mottling between the upper solid camouflage and the side surfaces. There are two patterns present, the A and B form mirror images of each other; the first and third aircraft have one form, the second and fourth the other (detail is too poor to determine what the remainder wore). This was normal, RLM approved practice at some production centres. The first two aircraft were W.Nr. 1700071 and 170067; all wore the narrow yellow 04-coloured fuselage band marking common to the unit's aircraft.

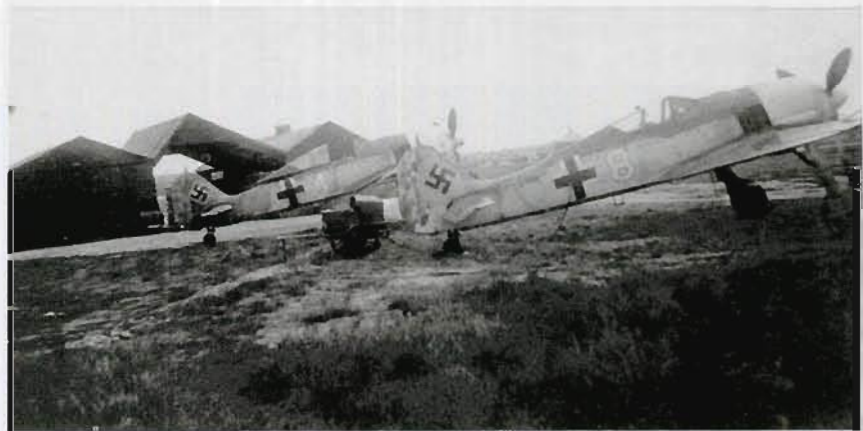
RIGHT: Found abandoned at a production centre, this Fw 190 A was finished in standard 74/75/76. The presence of the Stammkennzeichen marking, BG+KQ, dates the aircraft's construction to around July/August 1944, the regulation withdrawing the use of those markings having been promulgated in the Sammelmitteilung of 1 July 1944 and there was usually a two month grace period for adoption of the requirements listed.

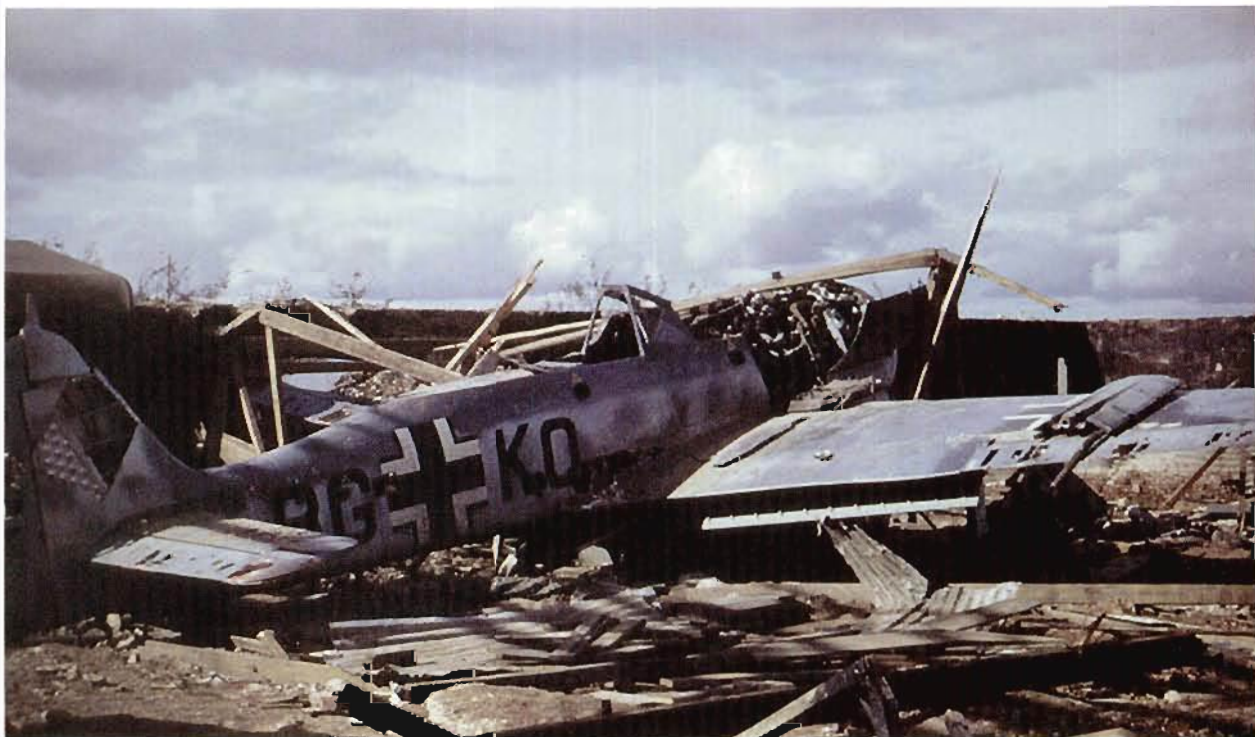
ABOVE: An Fw 190 photographed at its production facility, marked with Stammkennzeichen DN+FY and prepainted with its tactical band marking for deployment to the Mediterranean theatre of operations. Camouflage was standard 74/75/76 with mottling in the two upper surface colours.

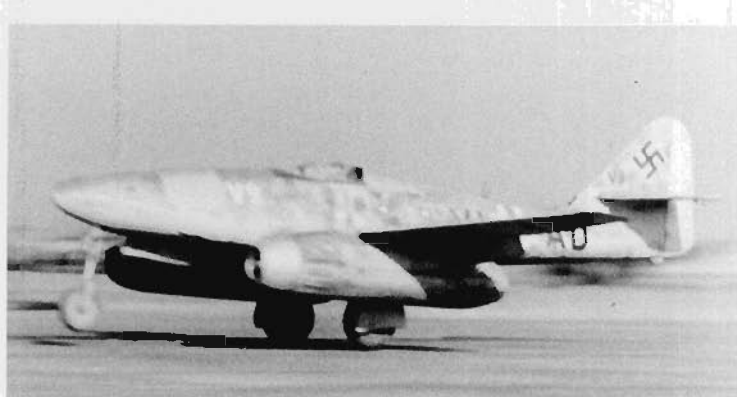
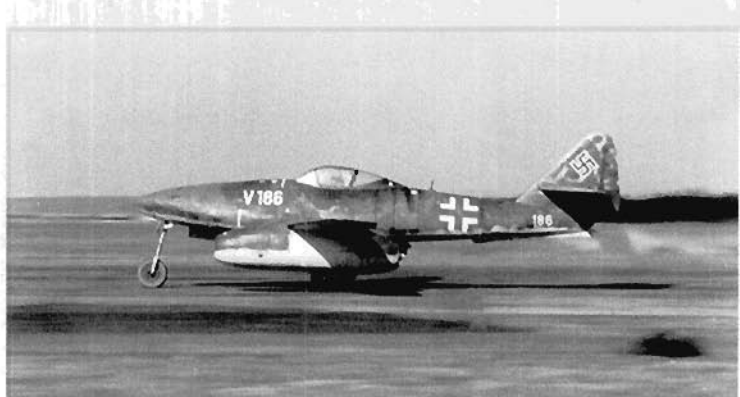
ABOVE AND ABOVE RIGHT: The Me 262 V 9, W.Nr. 130004 and Me 262 C-1a V 186, W.Nr. 130186, demonstrate the stark difference between mid and late-war camouflage colouring. The V 9 wore standard 74/75/76, finish while V 186 had a dense camouflage of 81/82/76. Note the reversal of fuselage Balkenkreuz marking colouring between the two colour schemes. The change to the defensive colouring on the V 186 is interesting given that, W.Nr. 130179, serving with Kommando Schenk, had the old 74/75/76 scheme. This points to re-camouflaging at least of some test aircraft with 81/82/76.

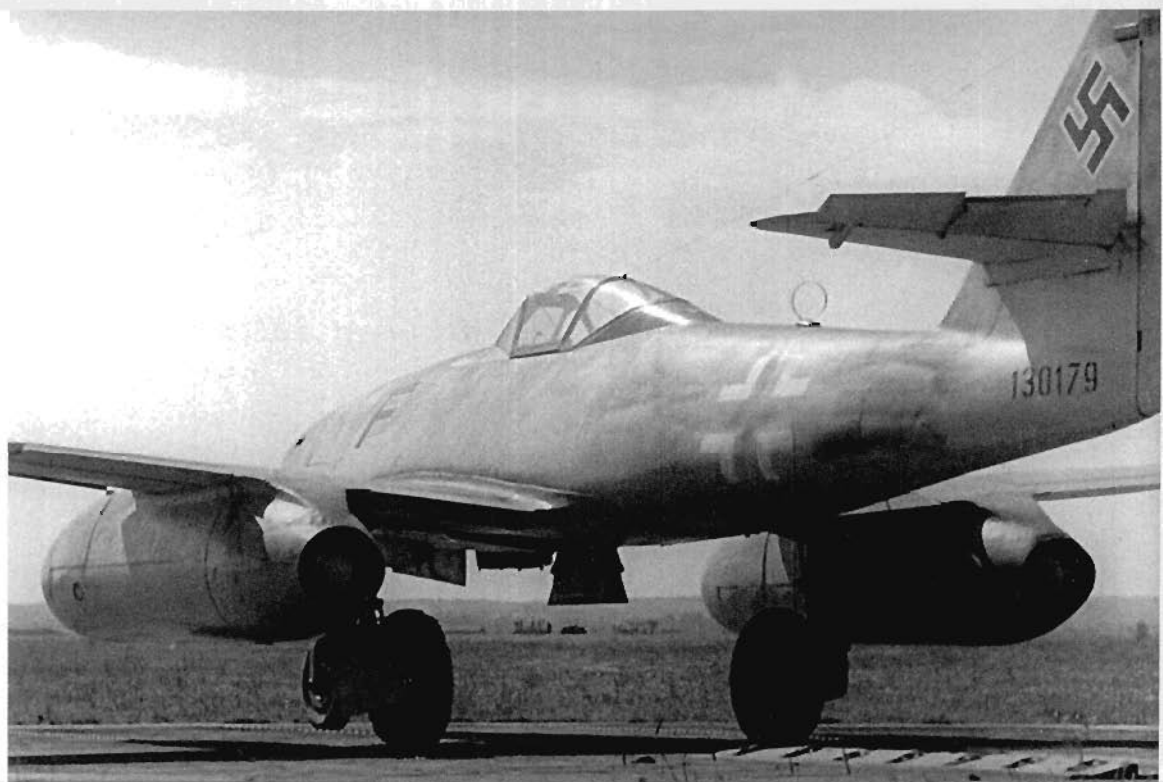
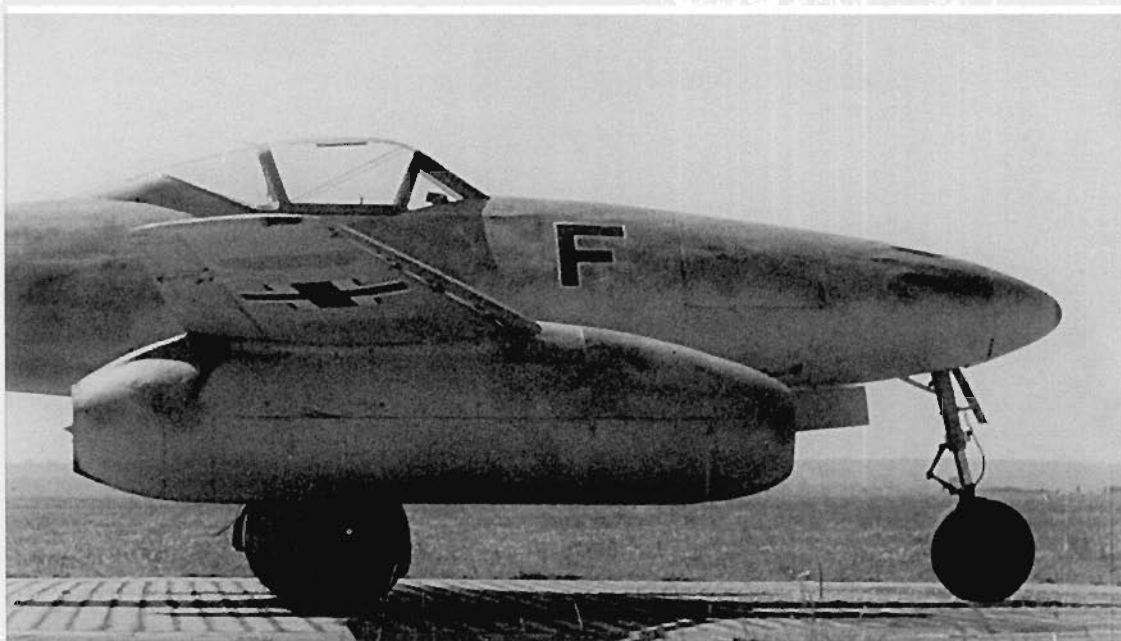
LEFT AND ABOVE: W.Nr. 130179, marked with a 'Black F' thinly outlined in white, photographed in July 1944 while serving with Kommando Schenk. The stark difference in colouring with that of the V 186 is evident, yet only seven aircraft separate the two.

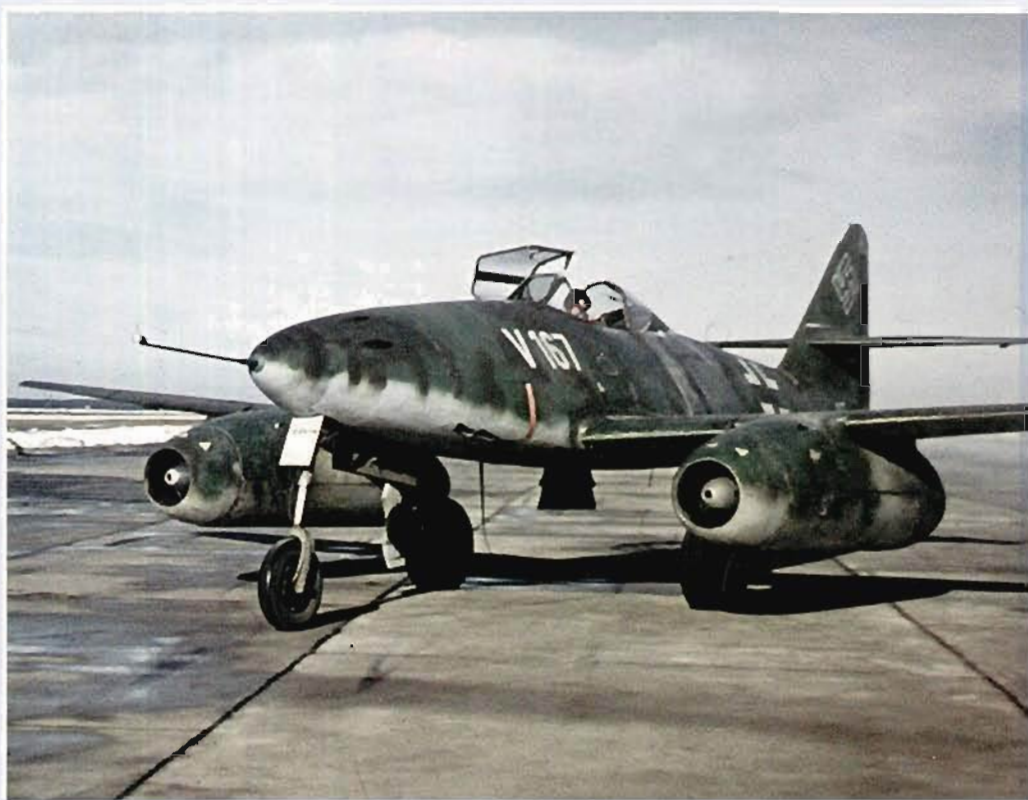
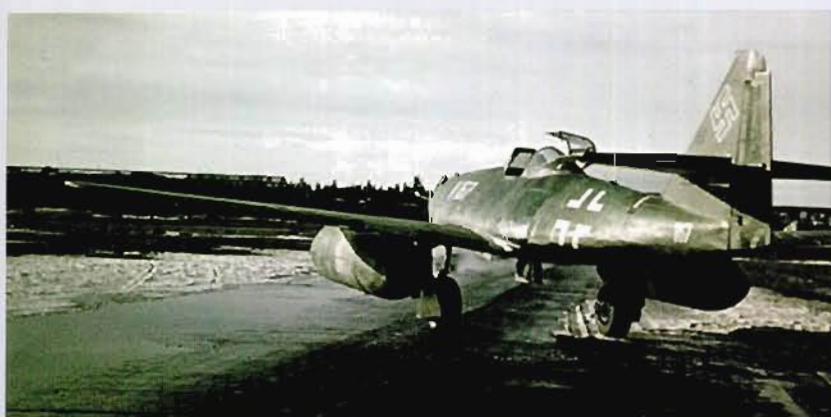
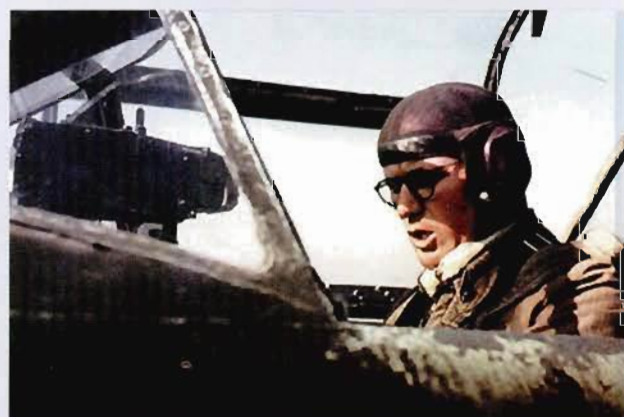
ABOVE: The durability of the camouflage lacquers was tested by the much higher speeds achieved by the Me 262. The extensive test regime (some 300 flights) completed by the V167 produced clear evidence of wear and tear, not just to the cockpit rim, which received damage from feet, but also to the framework of the canopy's fixed section. The Messerschmitt veteran company test pilot Karl Baur is in the cockpit.

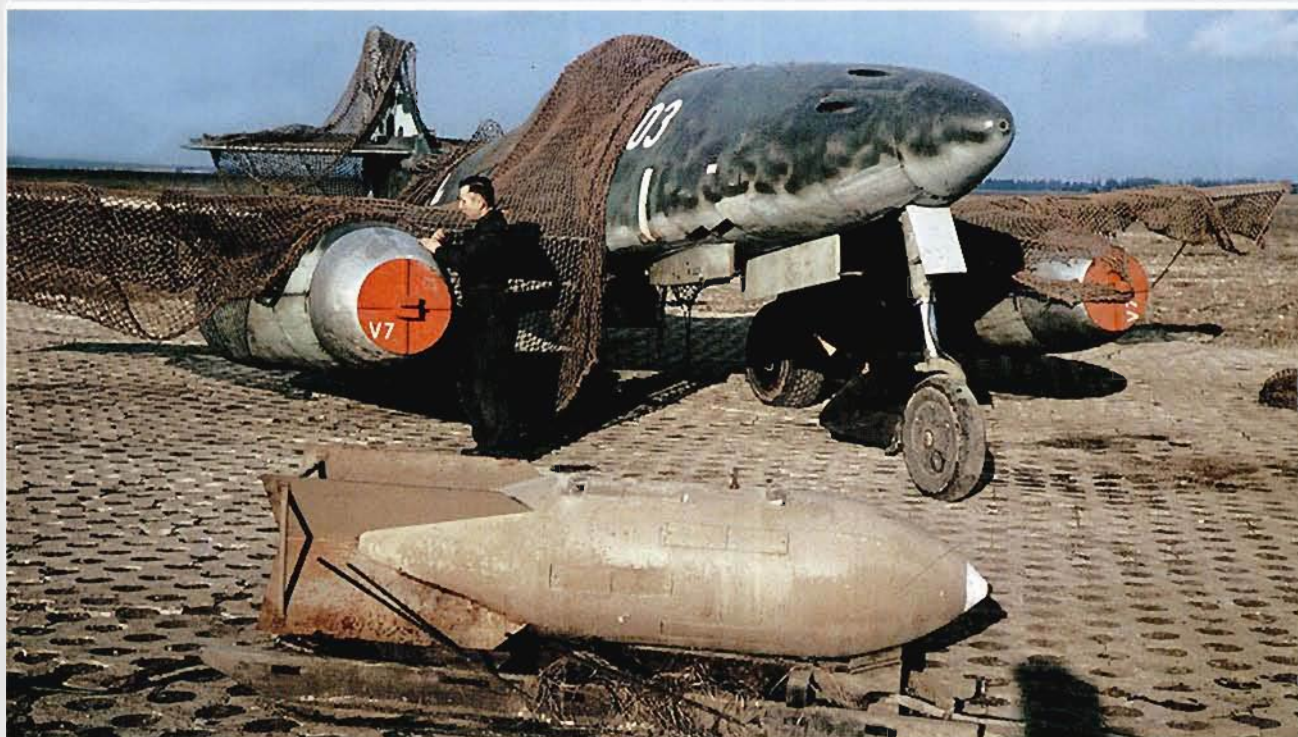
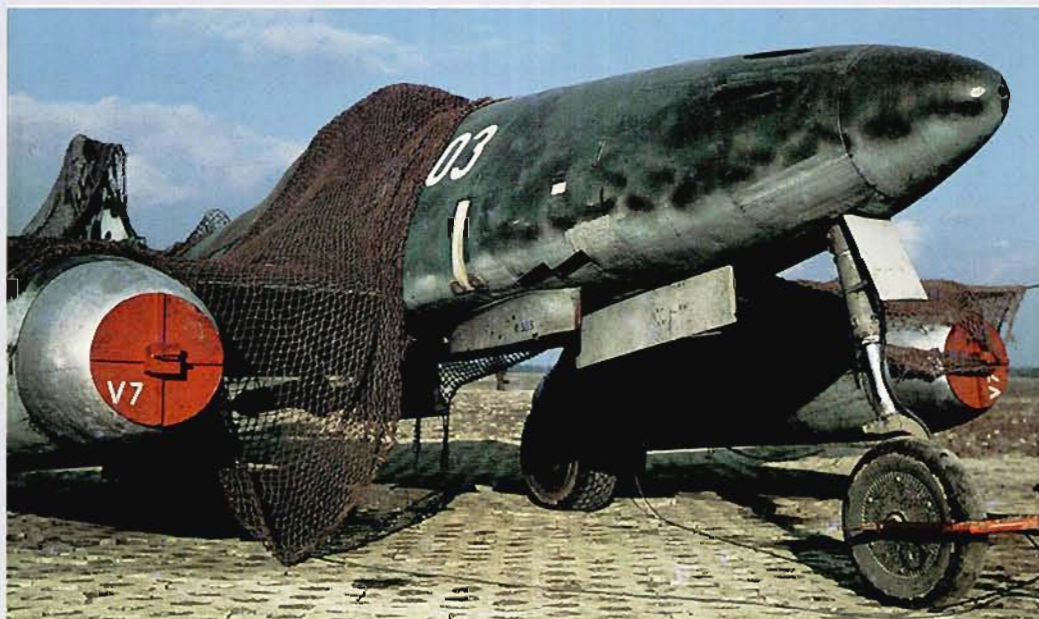
THIS PAGE: This series of three colour photographs of the replacement V 7 aircraft, W.Nr. 170303, shows the dense mottling of the 81/82 camouflage, brought right down the sides of the fuselage for better static concealment. The Wikingerschiff bomb racks were left in bare metal with the last three digits of the airframe Werknummer marked on them. The starboard rack has '8303' stencilled in black on it, ('8' denoting Messerschmitt in RLM documentation). The fin and rudder colouring of very pale 76 is in stark contrast to the rest of the airframe. Note also that the distinctive pattern on the fin and rudder would indicate that this aircraft was at one time attached to Kommando Nowotny before being returned to Messerschmitt as a test aircraft.
