# **LUFTWAFFE CAMOUFLAGE AND MARKINGS 1933-1945**

## **Volume One**

**K.A. Merrick**  
with Jürgen Kiroff

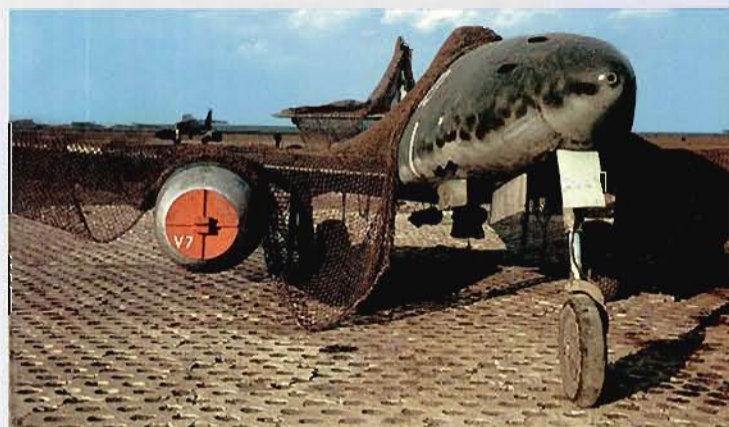
ABOVE: Me 262 A, W.Nr. 110813, had been used as a development aircraft for bomb trials in mid-1944. The two 250 kg bombs are mounted on Wikingerschiff bomb racks. Later, the aircraft served with Kommando Nowotny as 'Green 3'. Camouflage is 74/75/76, with a high demarcation line between upper and side surface colouring.

ABOVE: W.Nr. 110813 as 'Green 3' in service with Kommando Nowotny. Note that by then both engines had been replaced with the front section of each engine, which formed part of the engine as delivered, being left in bare metal finish.

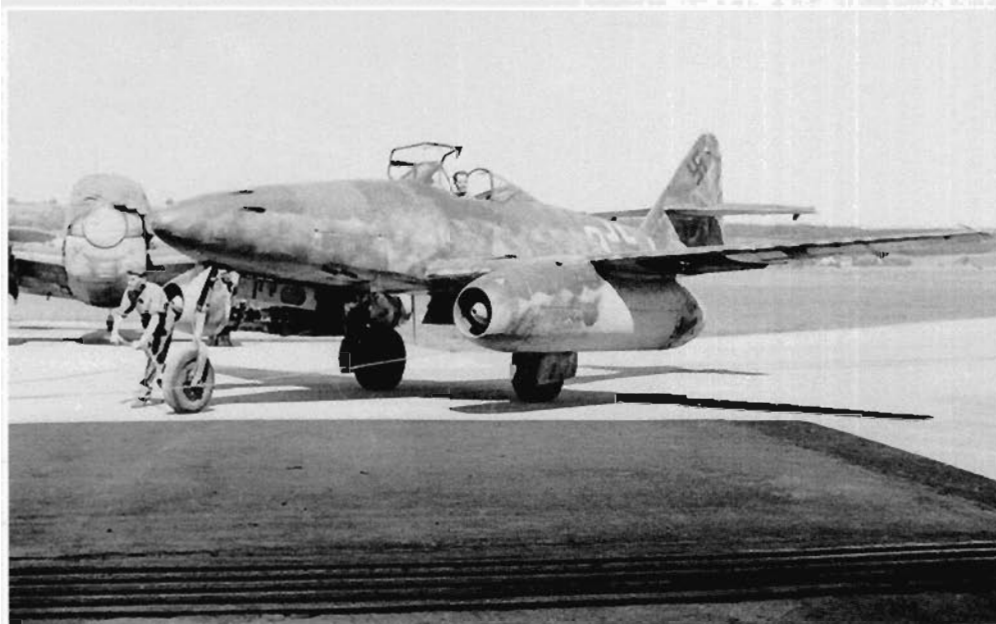
ABOVE AND RIGHT: Two views of Me 262 W.Nr. 500071, 'White 3' of 9./JG 7, which landed at Dübendorf airfield in Switzerland on 25 April 1945. The camouflage of this aircraft is particularly significant – 82/83/76 – as described in the text. The blue and red Reichsverteidigung band markings of JG 7 are painted around the rear section of the fuselage. The white wing and fuselage Balkenkreuz were of correct form, but the underwing markings were simple solid black crosses on the bare metal wing surfaces. The misalignment of the fuselage marking resulted from use of a replacement access hatch door. The '3+1' markings were in white, with the '3' repeated on the nose wheel door.

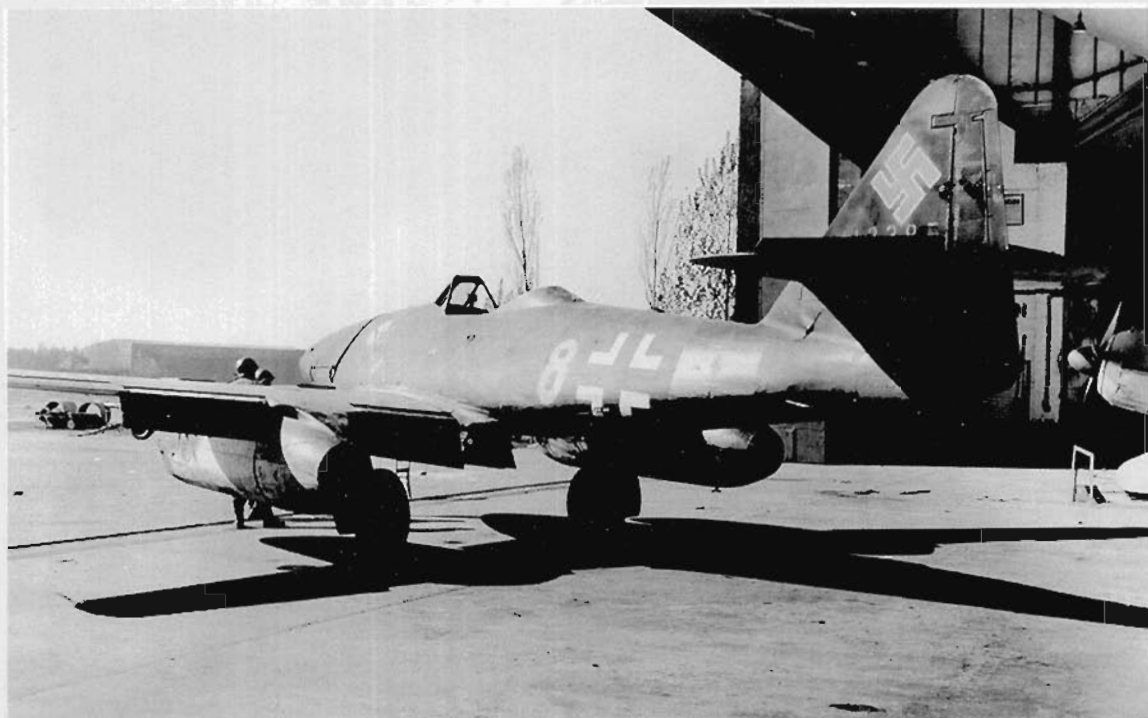
LEFT: In this view, the light shows up a little more contrast between the two upper surface colours of 81 and 83. The lower section of the nose cone and the engine cowlings were painted in 76, but the remainder of the under surfaces were in bare metal. The sealing filler paste lines below the wings can just be determined. The filler was a pale grey colour in its natural state, lacking the aluminium bronze content of earlier years which gave it a better matching metallic look.

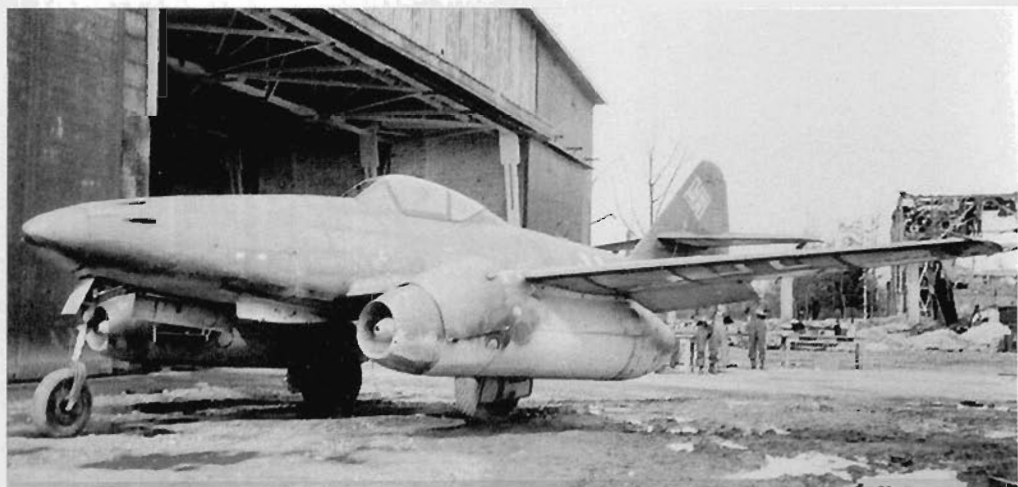
RIGHT: Me 262 A-1a, W.Nr. 500210, one of five belonging to Gefechtsverband Hogeback which surrendered at Fassberg on 8 May 1945. This was from the same production batch as the Me 262 A-1a W.Nr. 500200, now held by the Australian War Memorial, and used the same type of camouflage; first a coat of 81 over upper surfaces with 82 employed over that to produce a slightly lower contrast colour scheme. The dull lighting at the time that the photograph was taken makes the finish appear to have even less colour contrasts. Only the lower section of the nose cone and the engine panels were camouflaged, possibly with the same green-blue colouring found on the W.Nr. 500200, the rest of the under surfaces being left in bare metal.

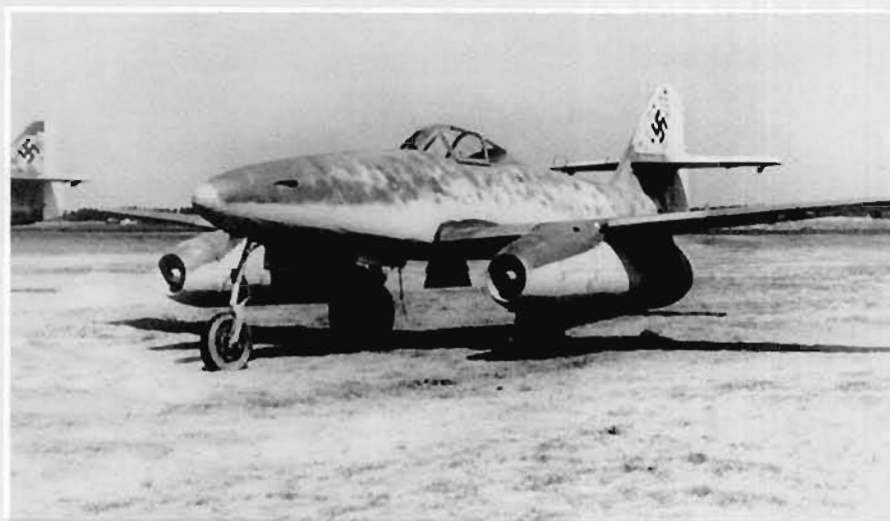
LEFT: This Me 262 A-2a of III./KG 51 wore 81/82 camouflage with either 76 or the green-blue colouring on the sides and part of the lower surfaces. The very dark 81-colouring can be seen on the wing root and upper forward section of the port engine nacelle. Discernible sections of the wing upper surface camouflage identify this scheme as prior to the revisions introduced on 23 February 1945. The rudder, and that of the aircraft on the left, was yellow, as was the tip of the nose cone. Note how the general camouflage pattern had been raised up the sides of the fuselage, producing pale side surfaces aft of the wing. The white outline Balkenkreuz marking was almost indiscernible. (H. Fröhlich)

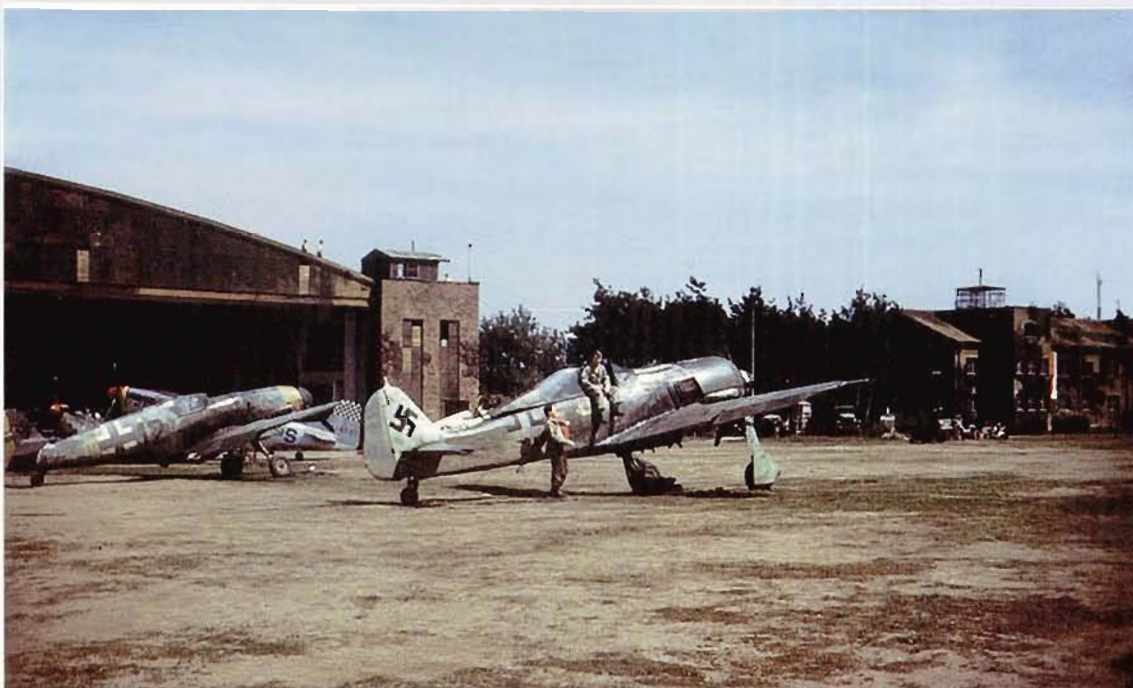
LEFT: Bf 109 G-10/R2 W.Nr. 770269, 5F+12, and Fw 190 A-9, 'Red 5', which surrendered at Fürth in May 1945. The Fw 190 had a relatively light camouflage using 81 and 82 on the wings, tail plane and forward area of the fuselage, but relying on just 82 and a soft overspray of 02 for the rear half. The original 76 colouring can be seen in places on the fin and rudder, particularly around the area of the Hakenkreuz. The 02 spray had also been used on the undercarriage fairing, toning down the brighter colouring of the 76 to produce a better ground defensive camouflage.

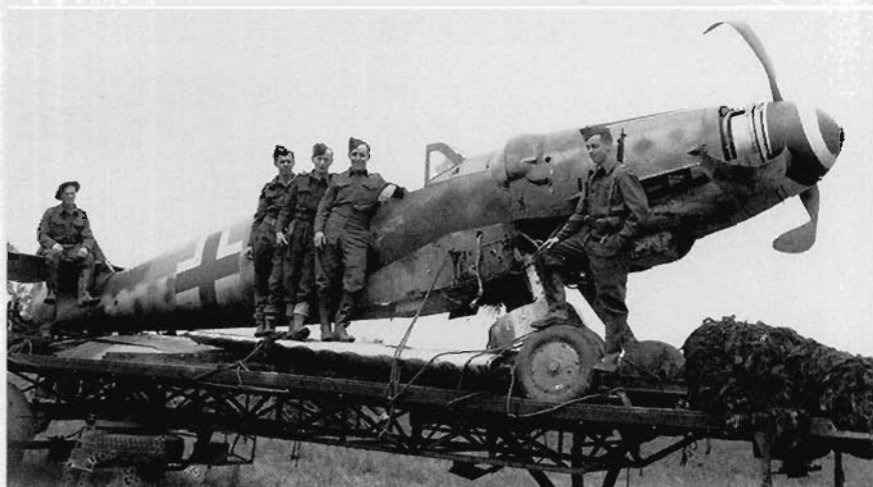
RIGHT: British troops stand on a flat car bearing a Bf 109 G-6 that had been captured in transit, salvaged for repair. The style of camouflage, with crisp division between upper and lower surface colours, and a very round style of mottles, was characteristic of two production centres, Erla and WNF, Erla's 411000-412000 and WNF's 440000-441000 production blocks both showing this style of finish. Photographs of Bf 109s wearing this distinctive style of 74/75/76 finish all seem to date from around the early part of 1944.

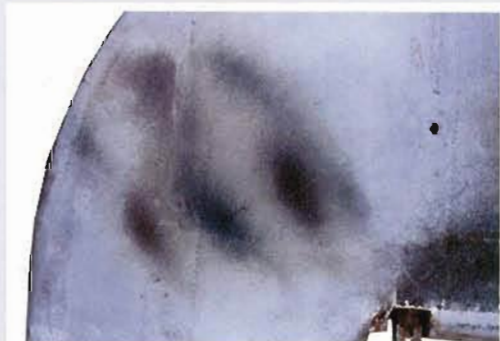
ABOVE: A close-up detail of the sprayed 83 on the rudder showing the coarse application caused by using too low a pressure with the spray gun.

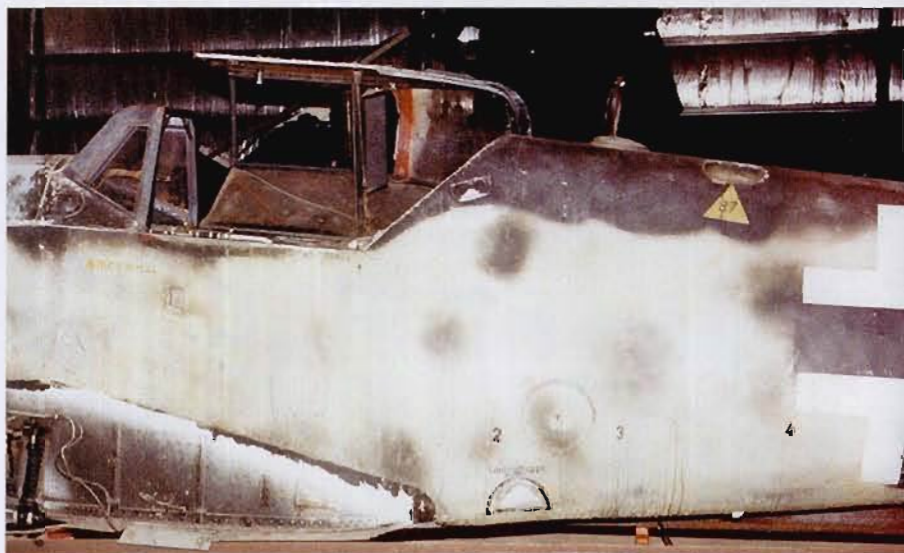
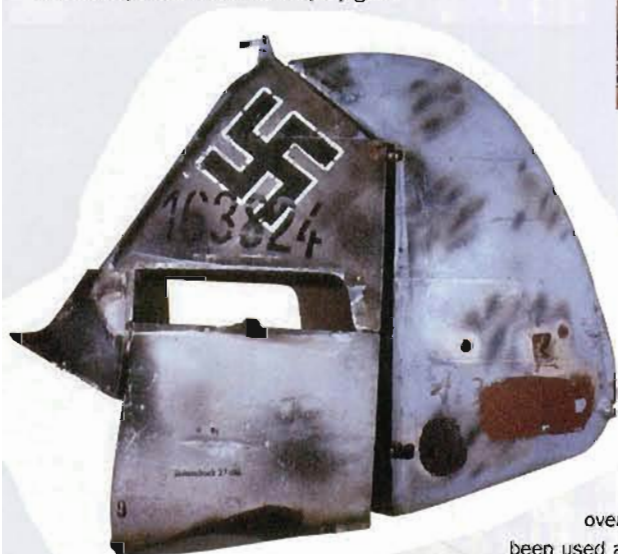
LEFT AND RIGHT: The tail unit, a complete sub-component, in this case a recycled one from a Bf 109 F, and a recycled rudder. A strong overspray of 02 had been used as camouflage above

the tail plane with the unidentified black-grey colouring added to the fin boot. The latter colouring also had been applied along the lower section of the leading edge of the fin. The rudder is in 76 with 83 used as short, sprayed stripes. The rather crude fabric repair on the starboard side had been roughly brush painted with 76. The repair on the port side had been primed with red-oxide coloured lacquer obscuring the last three hand-painted digits of the Werknummer, only 163 being just discernible. The incorrect style Hakenkreuz marking and Werknummer had been applied by stencil. Note particularly the strong colour difference between the 02 above the tail plane and the lower colouring and the original shade of 76 of the rudder.

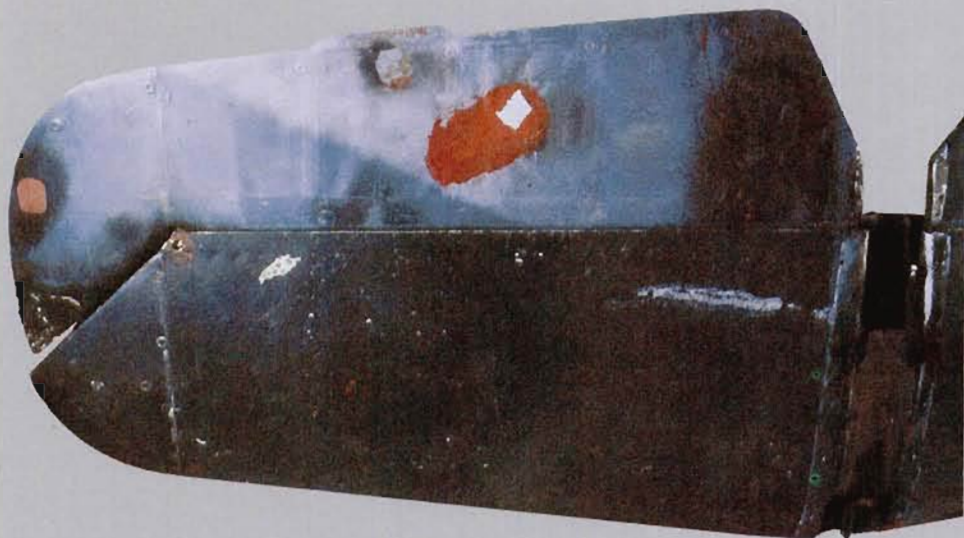
LEFT: The starboard tail plane upper surfaces with low contrast 81/83 finish on the fixed stabiliser and 74/75 on the recycled elevator. Note the crude repairs using the unidentified black-grey colour.

RIGHT: The port tail plane upper surfaces with 81/83 finish on the stabiliser and the recycled elevator in 75/82.

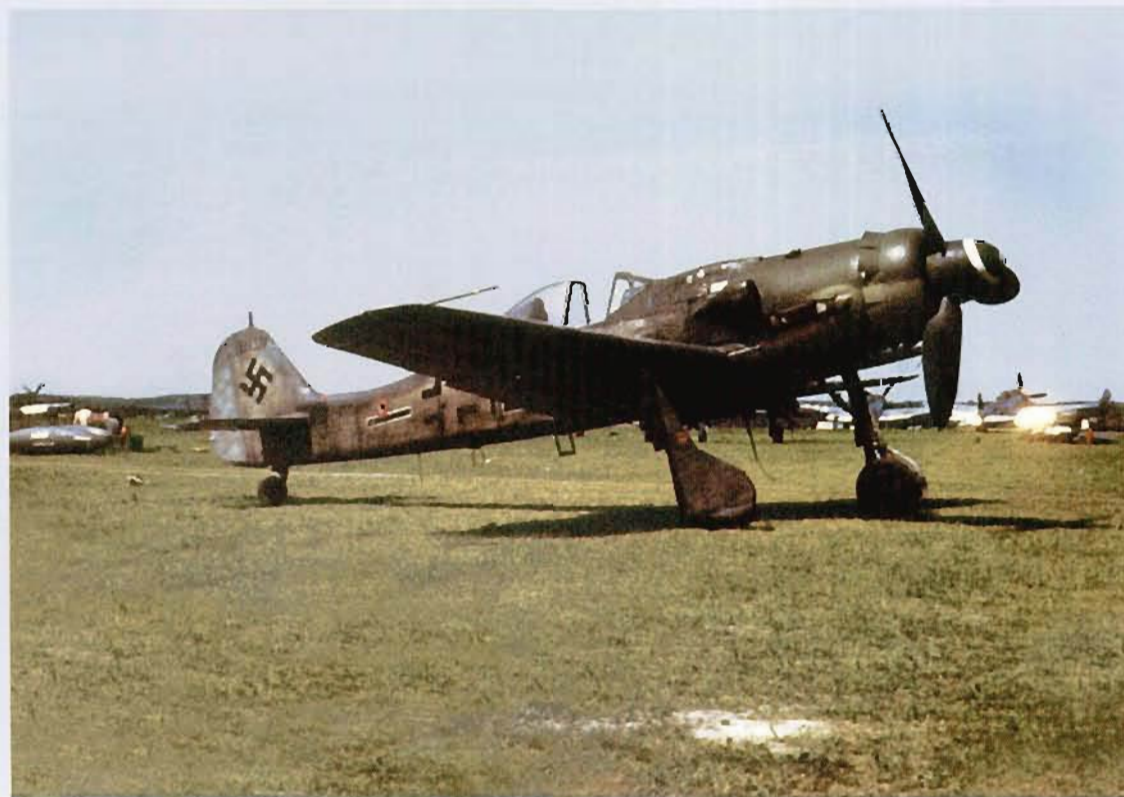
LEFT: Fw 190 D-9, W.Nr. 500571, 'Black 12' at Fürth at the end of the war. The main airframe was camouflaged in 81/82/76, but the 76 side surfaces had been toned down with a thin, sprayed coating of 02. The engine cowlings, which were supplied with the engine as part of the complete power unit, had a solid application of 82 on the upper surface and the unidentified green-blue colouring on side and lower surfaces. The colour difference is best assessed by comparing the 76 of the rudder with the area around the exhaust stubs on the engine cowling. While some aspects of the chemistry in 76 changed with a partial shift to use of Hansa blue in place of Cobalt blue very late in the war, it required long exposure to produce a greenish tinge to the colour – and the attrition rate did not favour such a time factor in many cases.

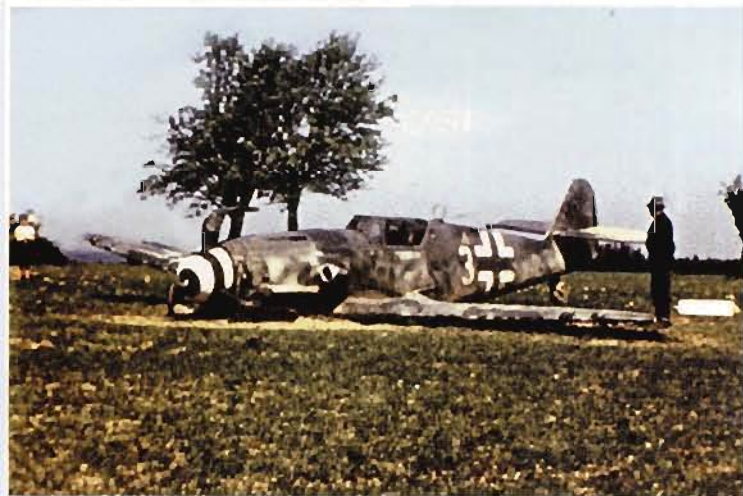
ABOVE: 'White 3', a late production Bf 109 – either a G-10 or a G-14/AS belonging to the 1. Staffel of an unidentified Jagdgeschwader – one of two that crash-landed behind Allied lines at the end of the war. The camouflage was 83/75/76, with a soft-sprayed application of 02 over the side surfaces to tone down the 76-colouring. The 'yellow' elevator was, in fact, just the yellowish-muddy spray that had been thrown up during the belly-landing. The Balkenkreuz and Hakenkreuz markings were of correct style. The presence of just a spiral spinner marking, and no yellow tactical markings, indicates that the aircraft had been serving with a unit on the Western Front, yet it lacked any Reichsverteidigung band markings, something that became more frequent in the closing weeks of the war. (J. Crow)

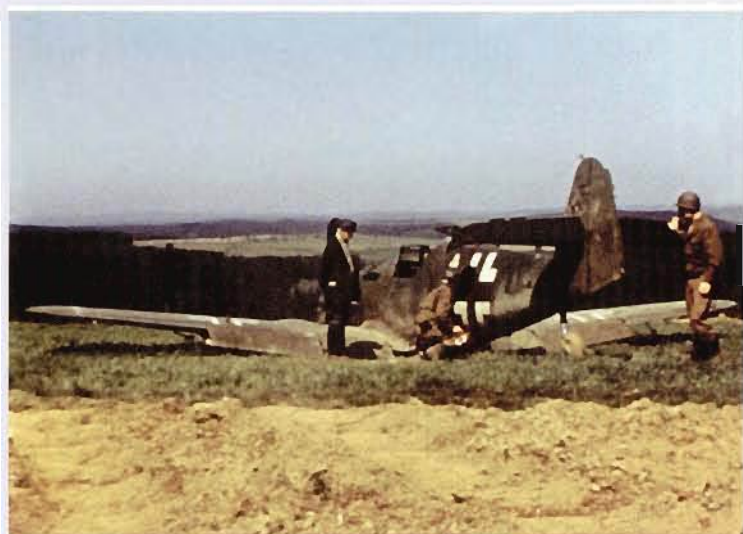
BELOW: The second aircraft to crash-land was 'White 8', also a 1. Staffel machine, and presumably from the same Jagdgeschwader. A Bf 109 K-4, it had a camouflage that appears to be of darker combination, possibly 81/83. The lower side surfaces of the fuselage were 76, but again the yellowish mud thrown up during the belly-landing has added a yellowish colour to the undersides. Again the aircraft lacked any Reichsverteidigung markings. (J. Crow)

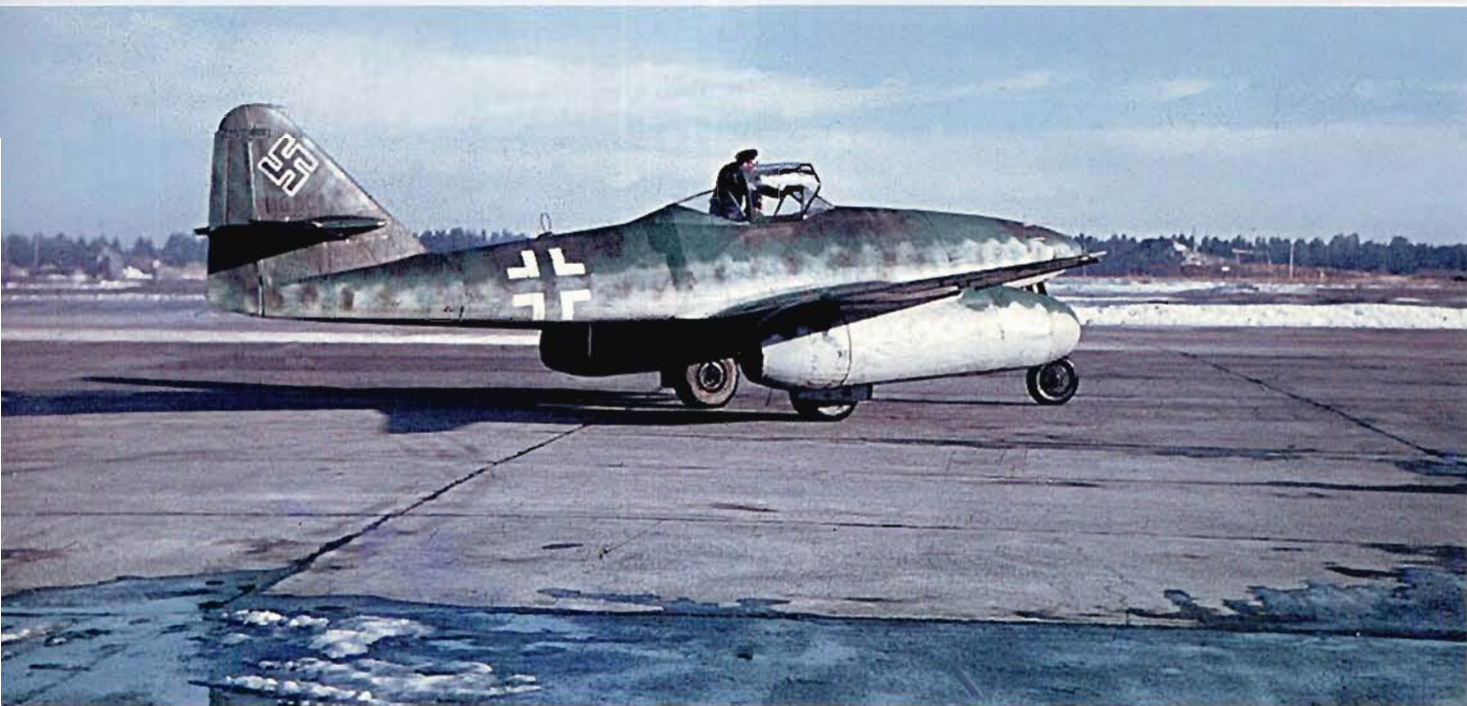
ABOVE AND LEFT: Two photographs of Me 262 W.Nr. 110604. The camouflage of 81/82/76 can be seen more clearly in these photographs, taken during routine production acceptance testing at Lechfeld. After completion of its acceptance flight, this aircraft had been marked with a red '1' number in preparation for its transfer to 11./EJG 2.

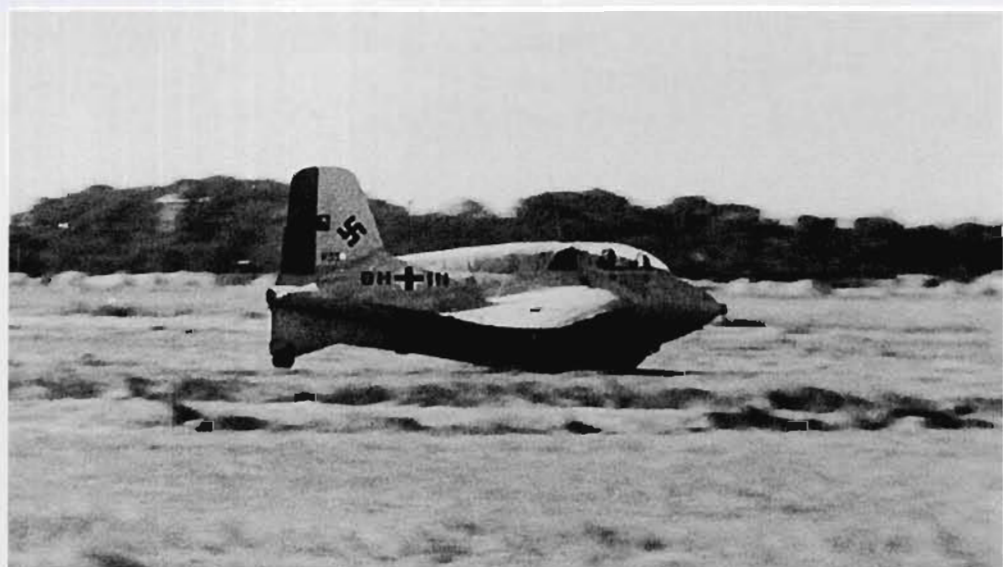
RIGHT: The prototype aircraft of the Me 163 B series retained their overall 76-finish until August 1944, by which time camouflage was considered essential. Seen here is the V 35, W.Nr. 163 10044, GH+IN. The rudder was a replacement, still in dark red-brown fabric primer.

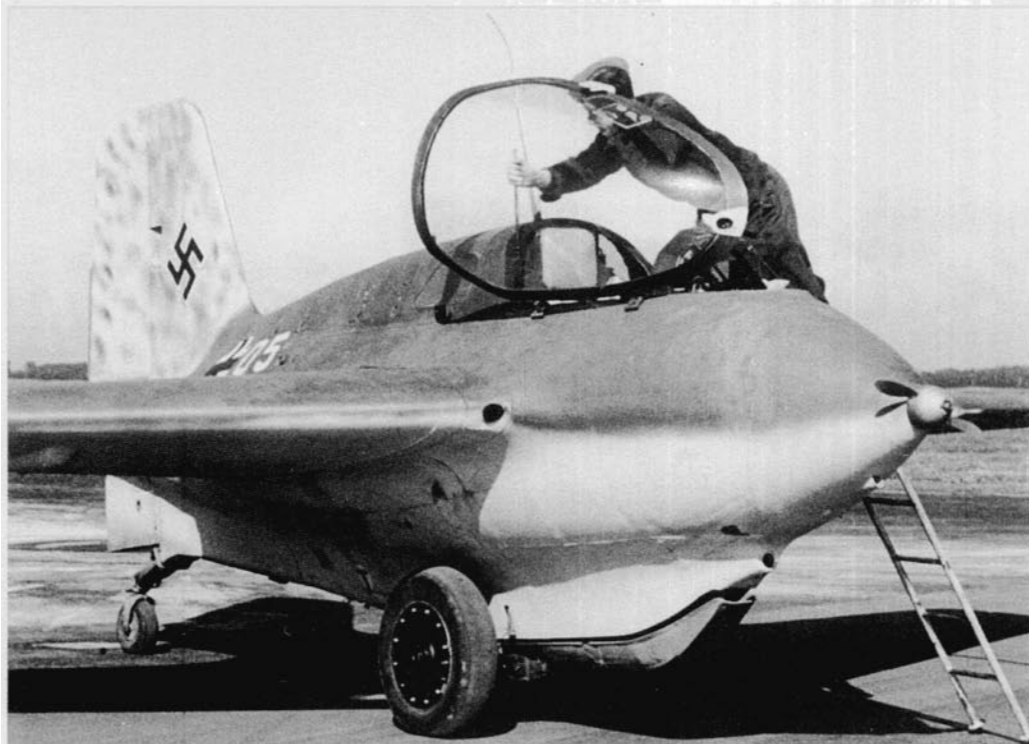
LEFT AND BELOW: Two photographs of the Me 163 V 45, W.Nr. 163 100 54, which carried the Stammkennzeichen PK+QP until all the test series aircraft had been allocated a new form of identification; 'C1' followed by a two-digit number sequence and PK+QP had become C1+05. The 'C1' code was marked in black, one quarter the size of the individual code, as per the new regulations, while the two-digit number was marked in white on each aircraft. The camouflage was 81/82/76, the tall tail surfaces mottled with both colours.

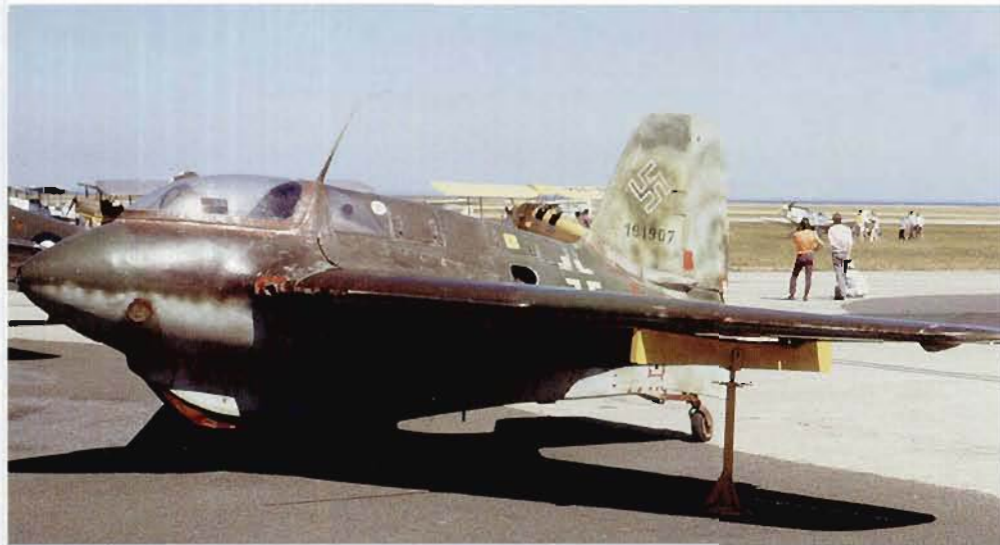
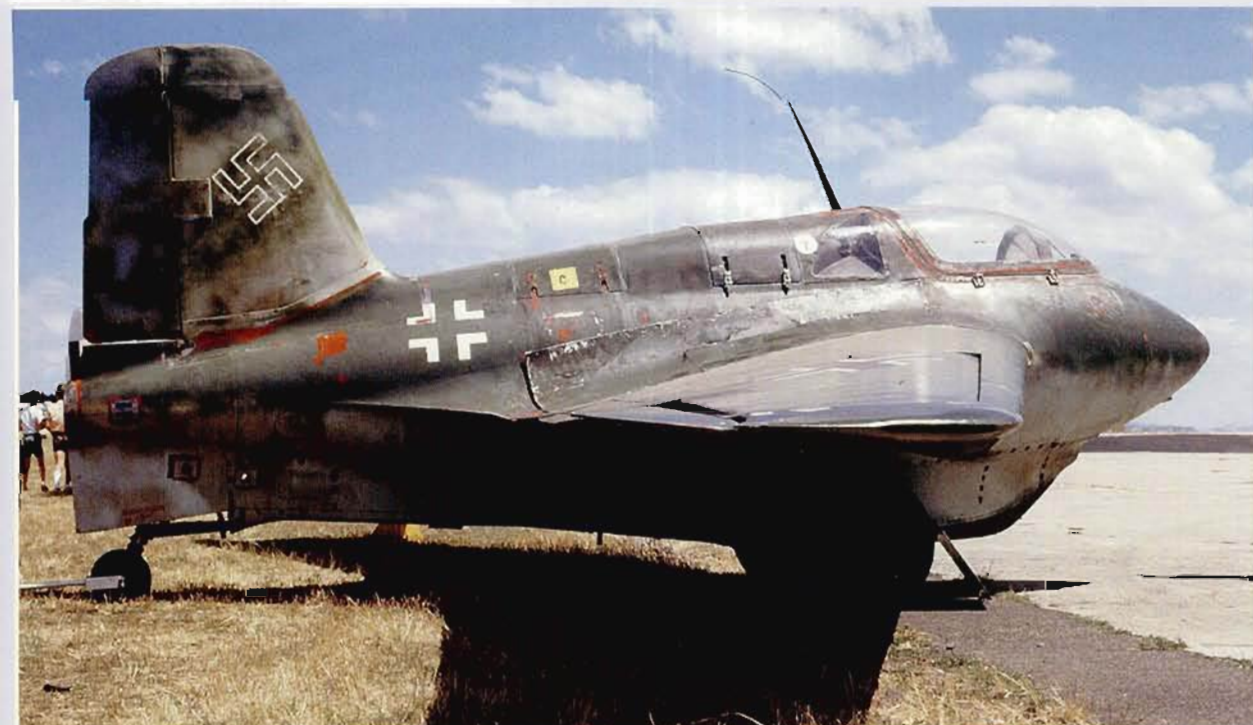
RIGHT AND BELOW: Me 163 B, W.Nr. 191907, formerly on the strength of JG 400, camouflaged in 81/82 to the RLM stipulated standard pattern. The starboard side of the fin and rudder had a dense mottle of full strength 82 (bottom left and top right) with some very thinned out 82 in the centre over the green-blue base colouring, and just a touch of very weak strength 81 at the centre of the fin. On the port side, the 82 was confined to a solid mass at the tip of the fin, with a very thinned out application used as a mottle on the remainder of it. The rudder had been sprayed with a similar combination to that used on the starboard side, very thinned out 82 at top and bottom with weak strength 81 in the centre, but applied in more linear form. This unmatched style of application and colour density illustrates differences resulting from the common practice of two men painting an airframe simultaneously, one each side. (G. Bell and N. Daw)

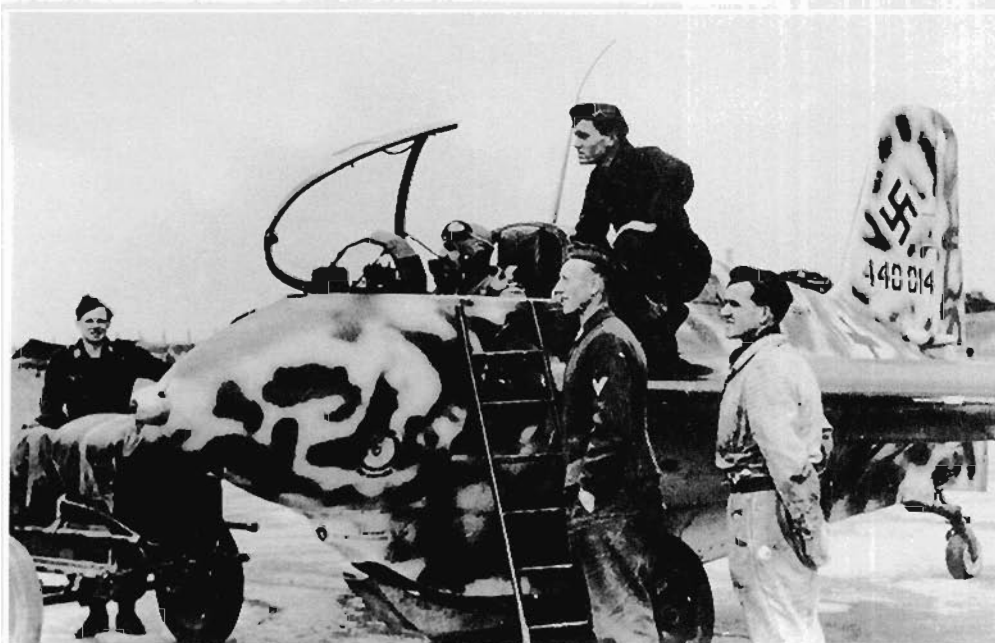
ABOVE: Me 163 B W.Nr. 440014 of 2./JG 400 was a Klemm-manufactured aircraft, its style of camouflage being very similar to that shown in the photograph of W.Nr. 440165. However, as Werknummer blocks were not issued sequentially, for security reasons, it is not possible to determine how closely together the two aircraft were manufactured. The unit records indicate that 2./JG 400 had been equipped with some Klemm-built Me 163 Bs by mid-year, prior to the change to 81/82/76 for fighter camouflage. The very dark mottles on these early machines were a solid application of 74, which contrasted strongly with the pale washed out 76-coloured background. An area of 75 can be seen just in front of the cockpit.

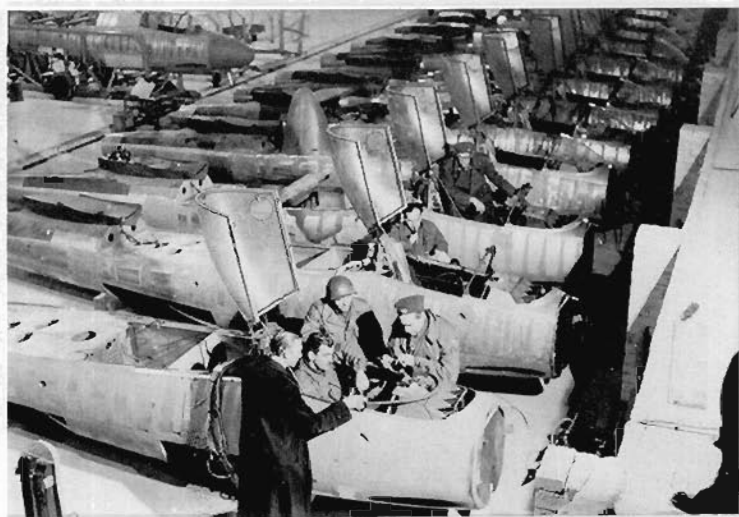
THIS PAGE: This underground production plant in a salt mine at Egein in Austria, held approximately 40 He 162 A airframes under construction when the site was captured in April 1945. The neutral coloured plasticised sealing paste, applied to the rivet and nail heads along frame lines, can be seen. Applied with a spatula, it was then sanded back to a smooth finish. The metal rear fuselage section on the nearest aircraft had line after line of the black identifying code numbers (RIGHT) for the grade of aluminium sheet used. Under certain lighting conditions marks such as this tended to show through the very thin, single-coat lacquer finish of the final camouflage. Internally the airframe was left unpainted.

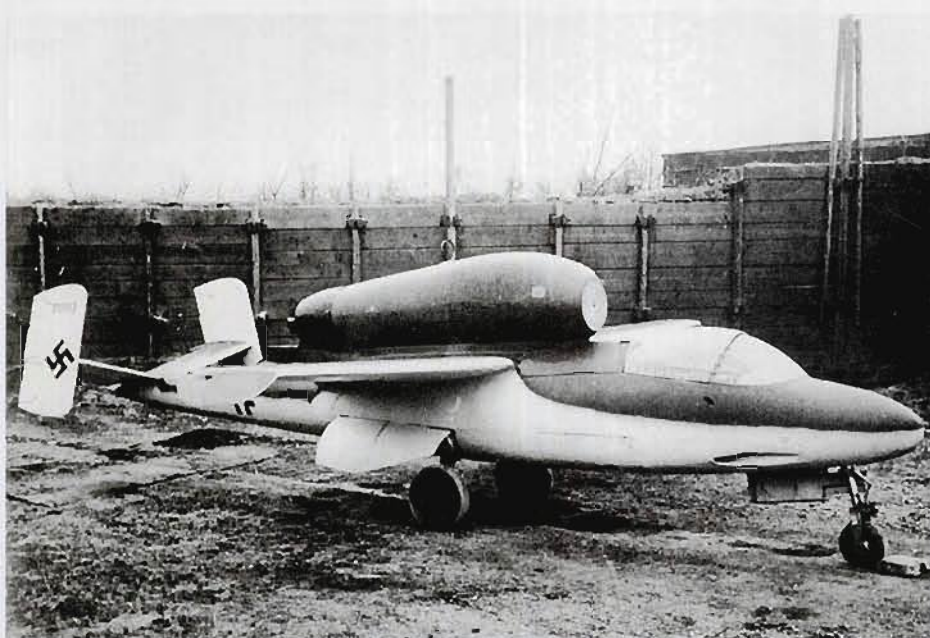
LEFT: The third Junkers-built He 162 A-2, W.Nr. 310003, produced in late February/early March 1945, and armed with two MK 108 30 mm cannon. The diminutive airframe of mixed wood and metal construction resulted in the type being camouflaged on all surfaces despite austerity measures then in force. Although the official painting schedule for the type called for an 81/82/76 scheme, upper surface camouflage here was the low contrast 81/83, with possibly green-blue lower surfaces.

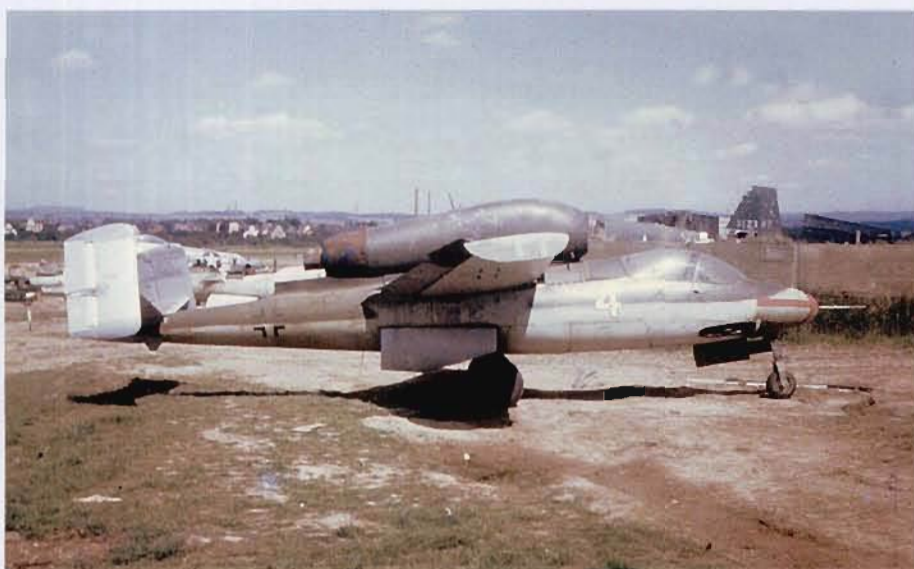
RIGHT: A rare colour photograph of an He 162, 'Yellow 4', W.Nr. 120067, of 1./JG 1 showing the 81/82/76 scheme. The final painting instruction for this type had set down a system of component colouring, rather than the usual random shape pattern in the two upper surface colours. However, close examination of this photograph, and also a black and white photograph of the same aircraft, taken at Leck in May 1945, show that the 81 and 82 had been applied in the old standard style. The entire tail plane section had been replaced, the original one, bearing the Werknummer in white and a white outline-style Hakenkreuz, had both surfaces of the fin and rudder assemblies in full camouflage. Note the large area of red oxide metal primer on the tail cone of the engine, showing the poor adhesion of the baked black stoving enamel finish used for this heat sensitive component. (S.Coates)

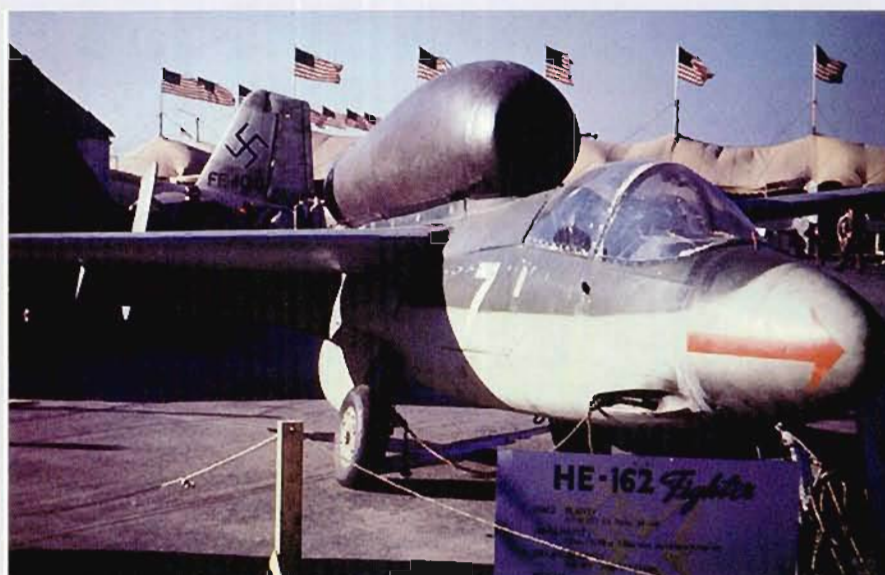
RIGHT: Another well colour balanced photograph of an He 162 A-2 on display post-war. The 81/82 upper surface colours can be determined as well as the green-blue lower surface colouring. Compare the latter with the intense blue of the sky. By the time this aircraft had been built, 76-colouring had been reduced to a greyish-white colour with only a touch of blue in it.

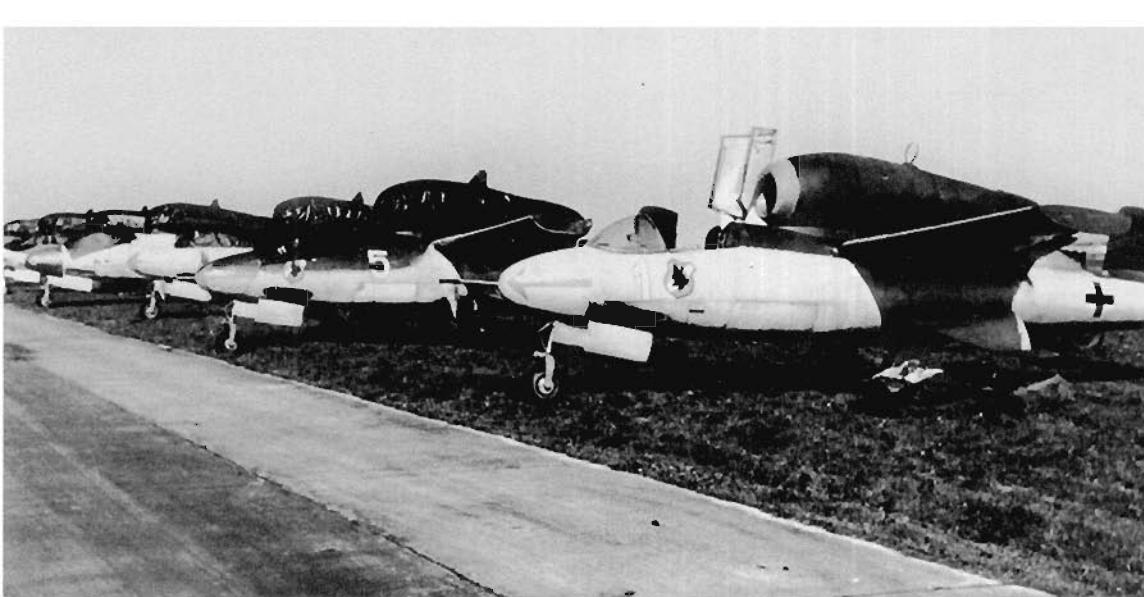
LEFT: In this line-up of aircraft of 1./JG 1, the variation in demarcation between upper and side surface camouflage can be seen. Positioning of the unit emblem and aircraft identification numeral also varied. Note also the anachronistic Balkenkreuz marking on the fuselage of the nearest aircraft.

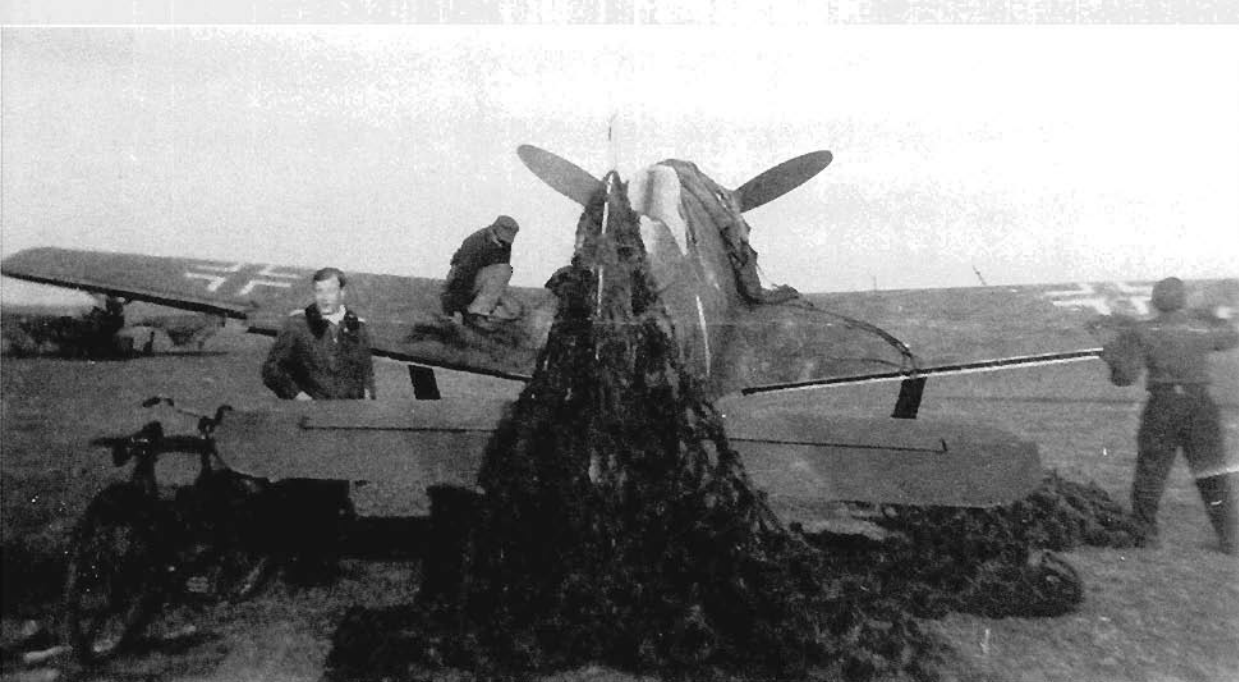
LEFT: In complete contrast with the more often seen standard form of camouflage, this Fw 190 A-8, of II./JG 1, had an intense mottle of 81 over the basic camouflage of 82/83, producing a strong ground defensive camouflage. The original camouflage scheme segments can just be discerned on the wings but, as usual, the horizontal tail surfaces had been left untouched, retaining their plain 82/83 finish. (E. Mombeek).

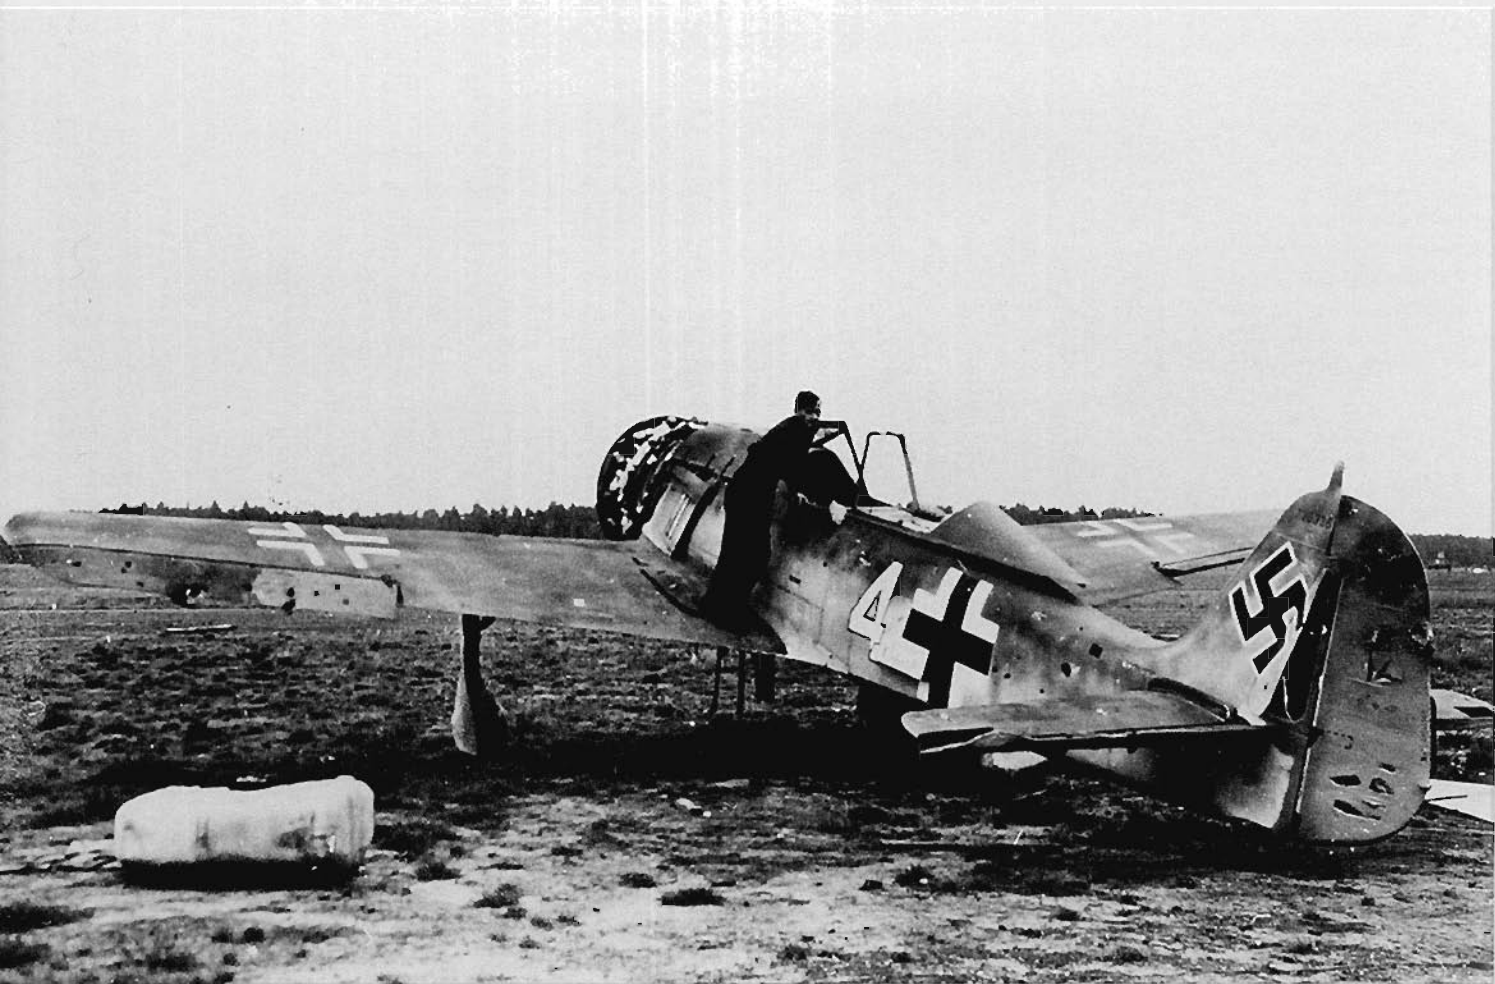
BELOW: Another Fw 190 A-8, W.Nr. 736336, 'Yellow 4' photographed at Fassberg, had camouflage of 82/83 with mottling in both colours. The 83-colouring predominated along the fuselage spine, mottling over the small areas of 82 and toning down the latter. Again, mottling and soft spraying with 83 on wing upper surfaces had almost obliterated the soft-edged segmented pattern, but the paler 82-colouring could still be seen as lighter coloured areas (note the inboard section of the port aileron). Side surfaces were in 76. (D. Vincent)

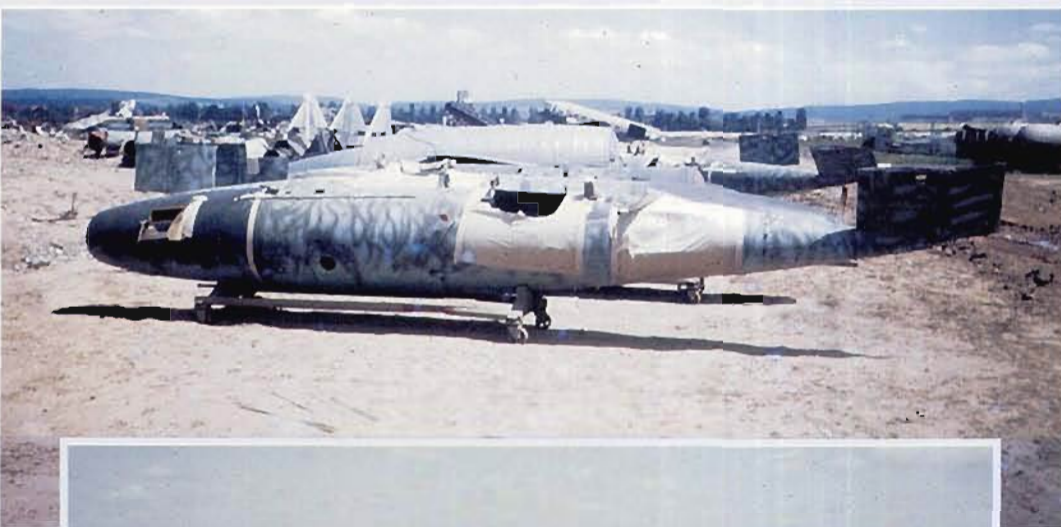
LEFT: A group of Fi 103 Re 4s, the piloted version of the flying bomb, gathered at a dump at war's end, possibly at Kassel where specific aircraft of interest were brought for possible onward shipment to the USA and the UK. Several styles of camouflage were used for the Fi 103, the earliest production machines using just a straight-line division between upper and lower surface colouring along the fuselage central horizontal datum. Later production batches showed a more varied form of camouflage, from dense mottling to the more minimalist style shown here. Often, mismatching of wings and horizontal tail surface and fuselage components produced some hybrid schemes, but it was of little consequence given the expendable nature of the weapon. While the piloted version of the weapon had all been produced at Dannenburg, even there different production batches displayed specific camouflage styles. These machines were late production weapons. Note the dense colouring used on the nose cone, a sub-component added after assembly of the remainder of the airframe. The camouflage was 76 with thin lines of 82 in a scribble pattern. The darker colouring of the nose cone appears to be 83 rather than 81. (S. Coates)

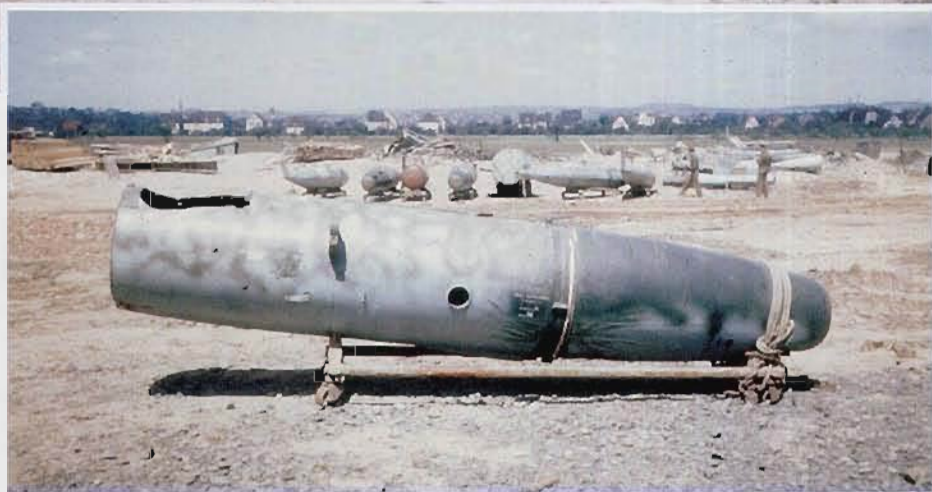
ABOVE: From the same batch, this part airframe shows the centre section and nose sections with their different camouflaging. The solid 83-colouring of the nose section had streaks of 82 added to roughly blend the upper and lower surface colours. The centre section had the same minimalist random lines of 82 over 76 as seen in the previous photograph. (S. Coates)
