# **LUFTWAFFE CAMOUFLAGE AND MARKINGS 1933-1945**

## **Volume One**

**K.A. Merrick**  
with Jürgen Kiroff

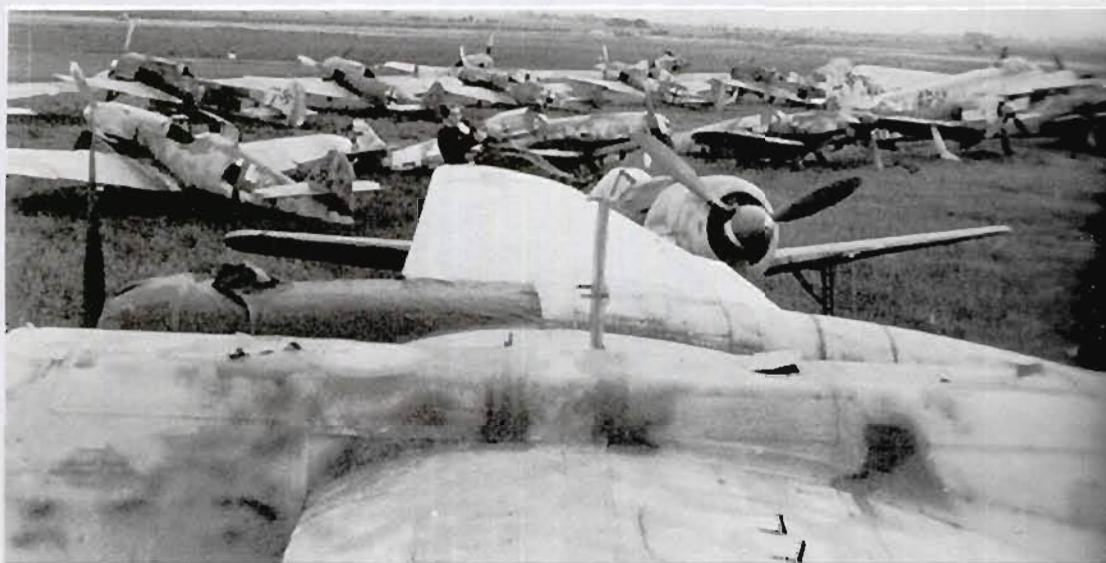
ABOVE: On the far left of this view of a group of surrendered aircraft is Bf 109 K-4, W.Nr. 334183 (marked on the fin tip, and in larger numerals at the base of the rudder), the seventh produced. Note the distinct variation in camouflage style with the fuselage lower surface colouring, brought right up to a very high demarcation line with a sharp edged division. Richness of tone of the side surface colouring indicates green-blue rather than the colder 76, while upper surface colours were 82/83. The fin and rudder of both machines wear identical forms of camouflage; they are sub-components produced with a stencil, painted before delivery to the final assembly plant. However, in this case the fin, while colour-matched to the rudder, was not from the same batch; the mottle did not match up, an anomaly occasionally seen on other Bf 109 Ks. The last three digits of the Werknummer, '183', had been hand-painted on the rear of the fuselage, at about the same angle and in similar style to that on Uffz. Deskau's machine, reinforcing the fact that they had originated from the same production centre. The He 219 airframe in the foreground had a 76 overall finish lightly mottled with 75 as did the Ju 88 G night fighter on the far right. (S. Haggard)

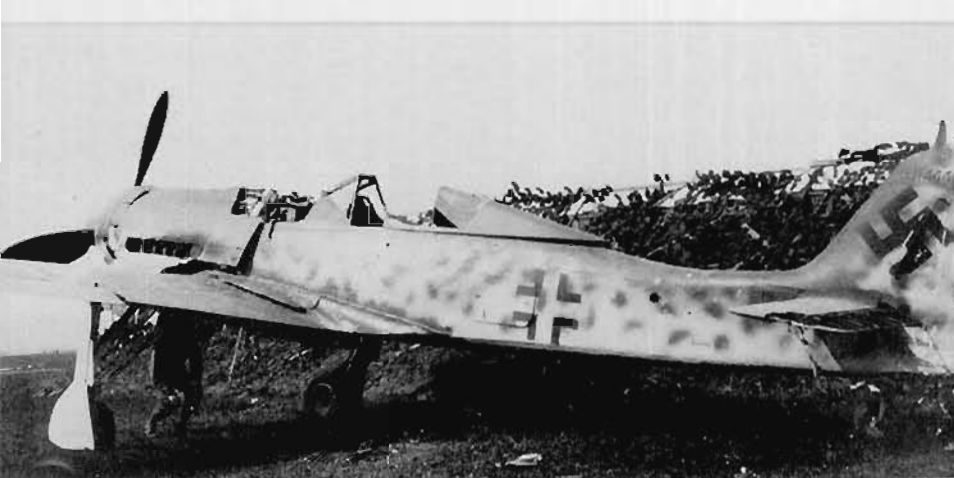
LEFT: Somewhat more consistent with camouflage patterns, if not always the colours used, were the late war piston engine fighters. Fw 190 D-9, W.Nr. 601444, had standard 74/75/76 finish with a solid application of the darkest colour forward of the canopy. The shattered canopy has exposed the 66-coloured, elongated headrest.  
(P. Miller via M. Olmstead)

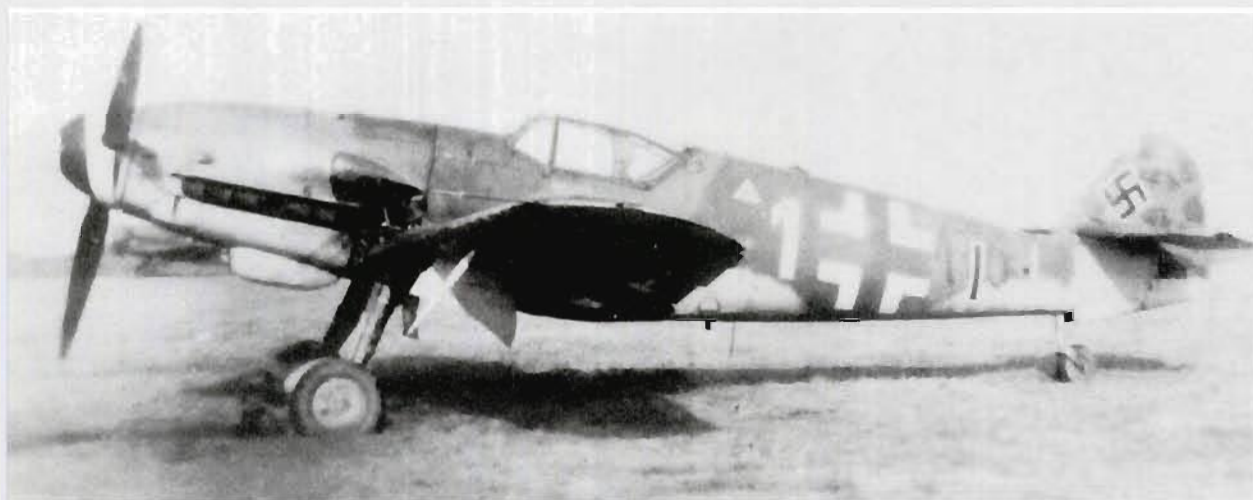
ABOVE: Bf 109 K-4, W.Nr. 334176, 'Yellow 1' of 11./JG 3. Photographed at Pasewalk in April 1945, it was camouflaged in 75/82/76 on upper and side surfaces, with the darker camouflage brought down the fuselage side behind the white outline form of the Balkenkreuz marking to provide a dark background. The last three digits, '176', of the Werknummer, had been roughly painted aft of the marking, an incorrect practice that became common at some Messerschmitt Bf 109 production centres after July 1944 when Stammkennzeichen markings were deleted for security reasons. The order required only the full Werknummer to be marked, on either side of the vertical tail surfaces, but this was increasingly implemented as shown here, stencilled in black at the base of the rudder, where the 76 camouflage ended. The use of three digits as quick identification had long been an 'in-house' production practice for Messerschmitt factories, but the marking was normally lost beneath the final camouflage. Retaining this form of identification as a permanent feature was peculiar to Bf 109s. The underwing Balkenkreuz marking was the simplified, but incorrect form, using only the black central cross section. The Hakenkreuz was also incorrect for the period, it being the obsolete earlier form. The pale white vertical stripe next to the tie down hole at Frame 8 was not part of the unit markings. Its purpose is unknown but it may have been a trestle support point marking – if so, it was unique. (Martin Deskau)

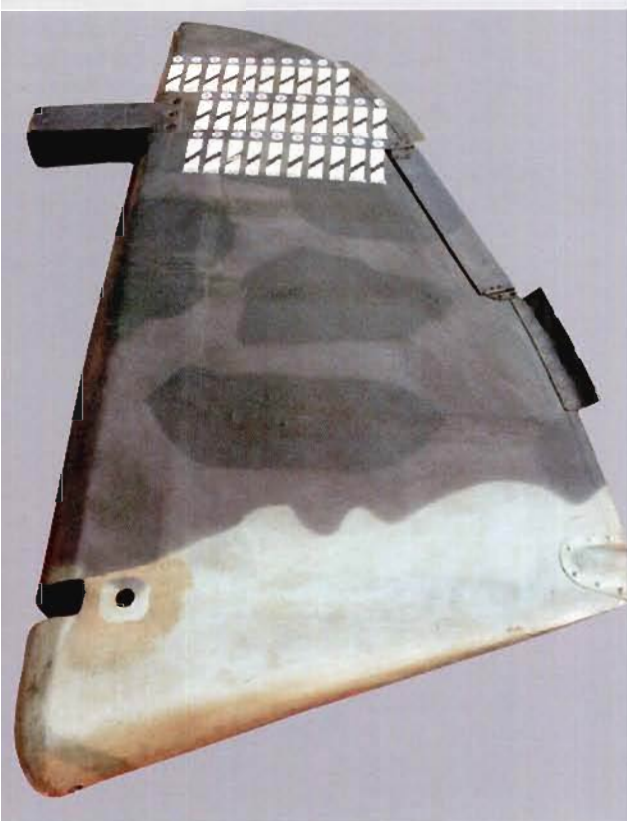
LEFT: Proof positive of at least one of the late war camouflage colour combinations used on Bf 109s. The rudder from Hptm. Müller's late-model Bf 109, either a G-10 or K-4 variant, showing the base colour of 75 with stencil applied patches of 82. The pilot was the commander of I./NJG 11 at the time that he was flying this aircraft and the rudder was removed from it on 27 April 1945. Previous illustrations of this rudder sometimes have been misinterpreted as showing 81/82, the result of having been photographed in late afternoon sunlight, rich in orange light. The yellowish stain along the bottom edge is caused by deterioration of the lacquer film used in this paint. (via JaPo Publications)

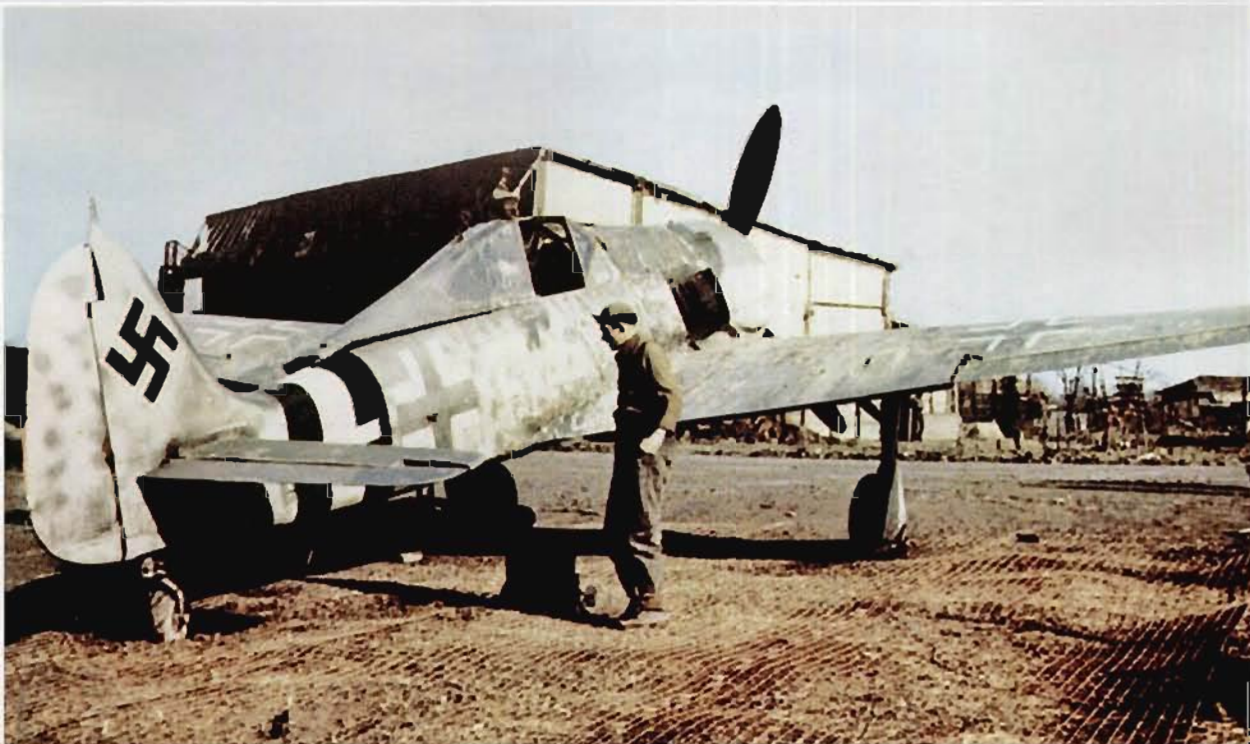
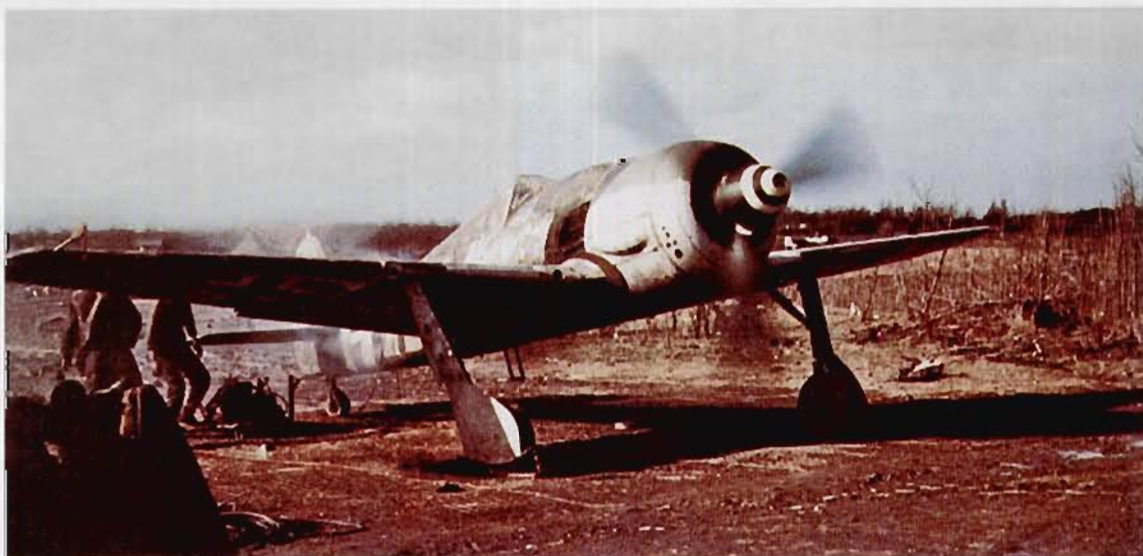
LEFT AND BELOW: These two colour photographs of the same aircraft help illustrate the overall finish of W.Nr. 681437. Note the starboard side of the engine cowling retains its original panel. This swapping of parts could produce some unusual camouflage effects. The black/white/black Reichsverteidigung markings were 900 mm wide. (Col. Leo C. Moon)

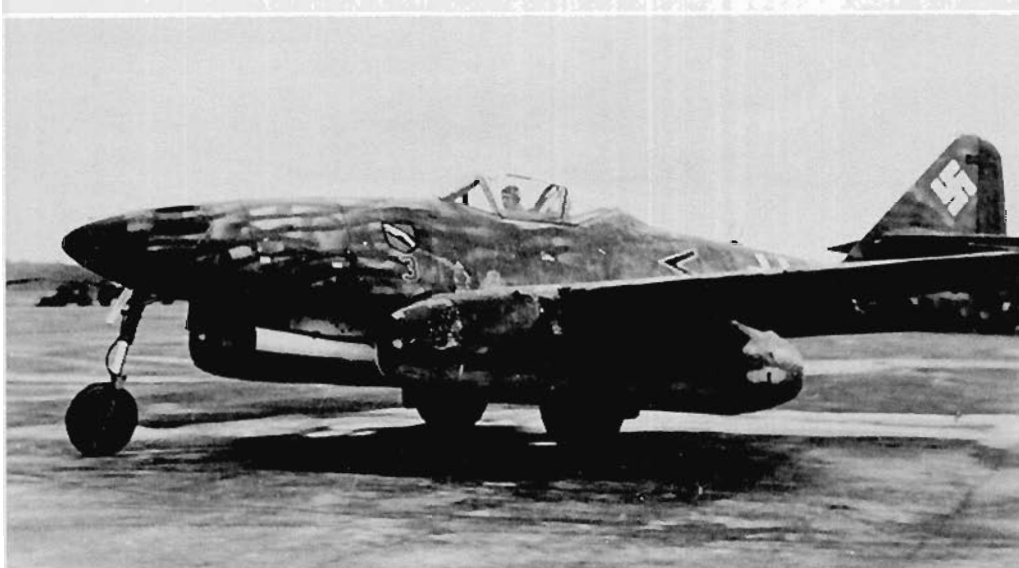
LEFT: Some of the more radical camouflage schemes seen on Me 262s were simply looser applications of standard colours. This machine of the Stab JG 7 had had its original high demarcation pattern and softer, side mottling overpainted with streaks of 82 and then 81 to break up the pale side surfaces. Close examination of the fin shows where 82 had been sprayed in a block and then streaked with 81 to almost eliminate the original 76 colouring. This appears to have been a late war conversion to improve static camouflage. The Hakenkreuz marking had probably also been repainted in white in the process. A '3' outlined in white was marked beneath the unit badge. The unit's blue and red Reichsverteidigung band was marked around the rear of the fuselage.

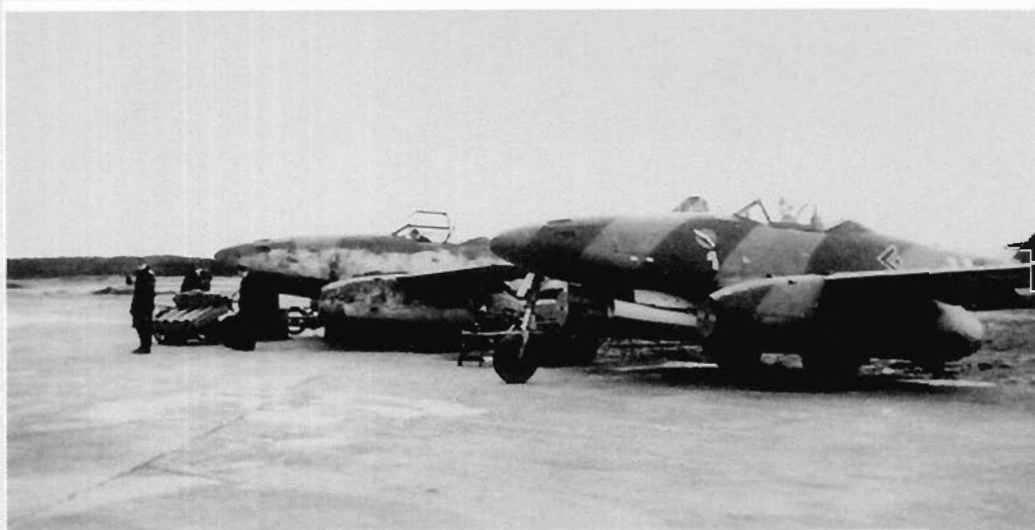
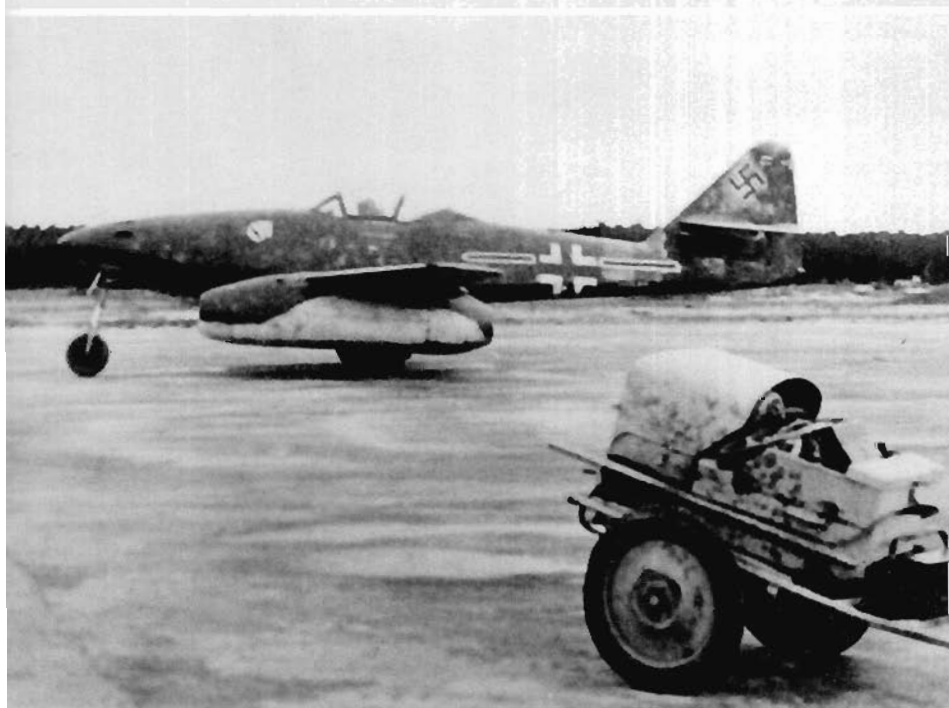
RIGHT: The two contrasting camouflage schemes seen here on these Me 262 A-1a aircraft of JG 7 illustrate the growing proliferation of modified camouflage styles that marked the closing months of the war. The aircraft in the background had an 81/82/76 scheme, with some mottling in both colours to soften the stark whitish-grey colouring of the late war 76. The nearer aircraft utilised the same colours, but applied both as solid applications, the contrast between the 81 and 82 being more readily seen than in more usual camouflage applications to the type. The bands of 81 were extensions of the main blocks of that regulation camouflage pattern colour. (P. Petrick)

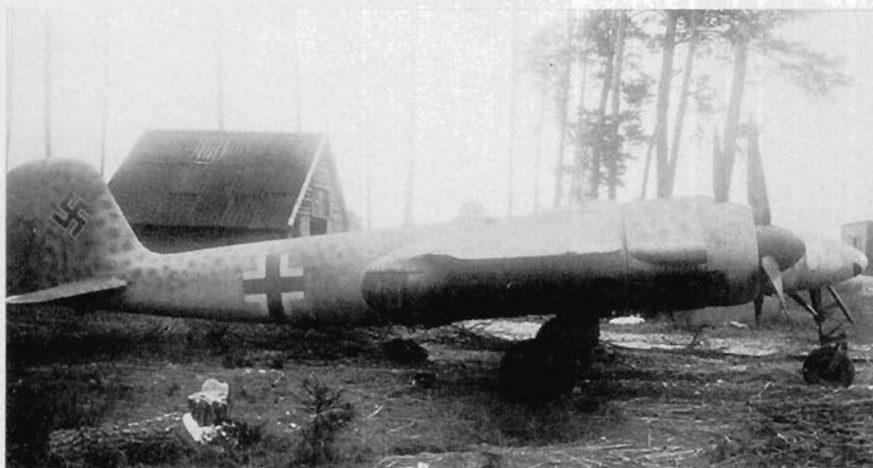
LEFT: Another JG 7 Me 262 A-1a, camouflaged in a similar style to the previous JG 7 example. The mount is that of the Geschwaderkommodore, marked with white-edged black rank markings and with a pale outlined small '4' below the unit badge. It had had its basic 81/82 camouflage heavily modified by adding a dense mottle of 81 to most of the airframe sides and upper surfaces. The Hakenkreuz is backed by an area of 82, no doubt being left to frame the marking. Two darker shades can be detected on the rudder so 83 might also have been employed in the scheme, and that would account for the near monochromatic effect of the general camouflage. Close examination does reveal that the very darkest areas on parts of the fuselage are in fact composed of two dark shades of colour. The side area of the engine is in 76 but lower surfaces were most likely bare metal, other than for the nose section. The blue and red Reichsverteidigung marking has a ragged line of pale colour just aft of its trailing edge, possibly 76, with a small area of 82 at the base of the fin. Why this odd combination was used is unknown, as it could have had little value with regard to the overall camouflage finish.

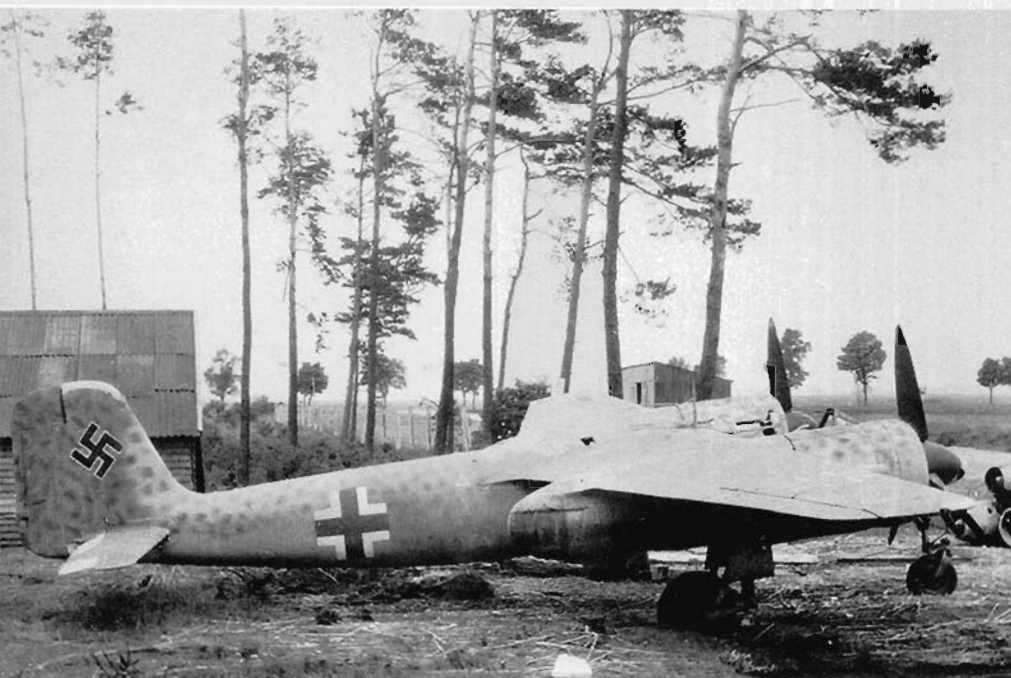
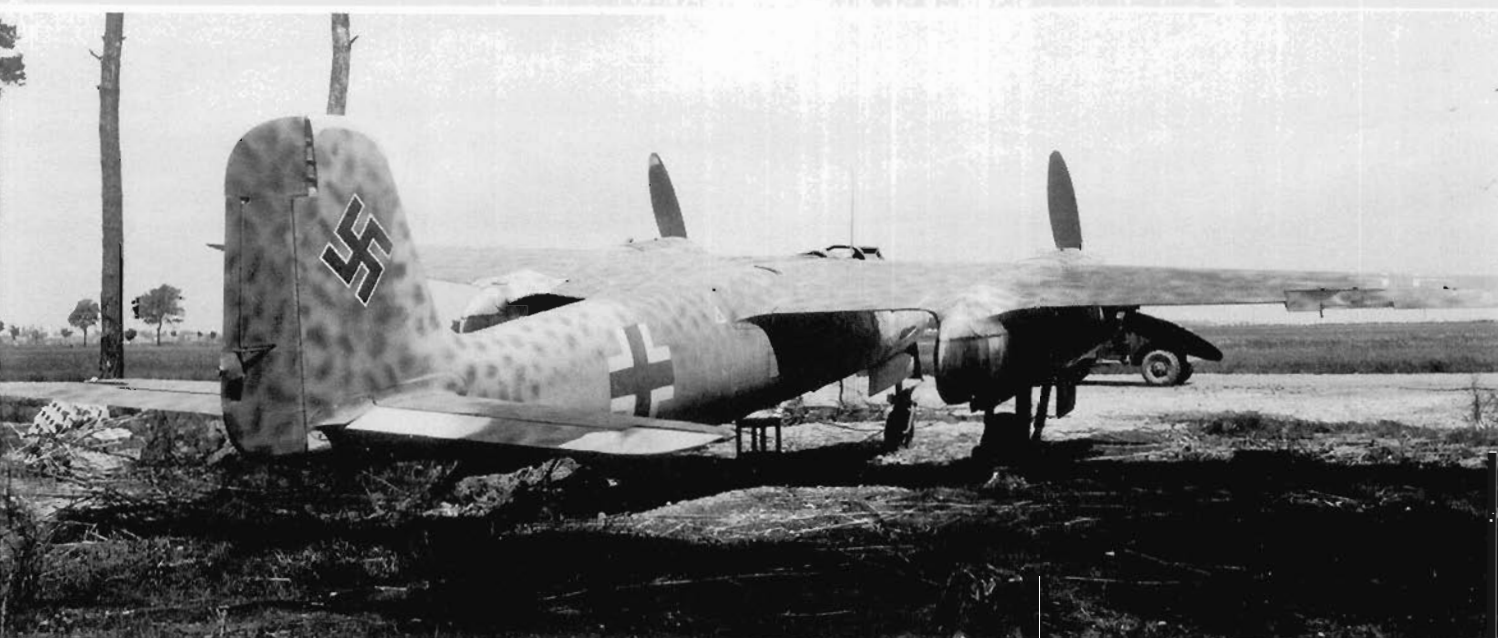
THIS PAGE AND OPPOSITE TOP: Fated never to enter service in numbers, the Ta 154 however had had some minor operational service during field-testing. This Ta 154 A-1/R1 day fighter, W.Nr. 320003, found abandoned, had camouflage of what appears to have been 76 closely mottled with 83. Note that the engine cowlings had a much paler mottle of 83 while the nose section of the airframe was in 76 with only patches of 02 primer. Over the 83 mottle, a spray of two other colours had been applied to various major sections of the wing, fuselage and tail plane. The deliberate omission of a small area of 76 on the leading section of the fin may have been intended to break up the outline of that large element of the airframe. Close examination of the wings shows that the lighter of the two other colours had been applied over much of it, with the same colour taken right down the starboard, but not the port side of the fuselage, which remained in 76. This was probably 82 because the darker mottle shows through it. The distinctly darker section on both the starboard wing and horizontal tail surfaces was probably 81. Examination of the horizontal tail plane shows the port side had a mottle of 83 with 82 sprayed over it, while the starboard side fixed section had the same colouring, plus a dark section of 81. Paradoxically, the elevator had a large section of its base 76 colour showing with no mottling, only a segment of 81 across it. The fact that that segment does not line up with the same colour on the fixed section indicates that it was a replacement item, probably from another airframe. The trailing edge wing/engine fairings had also been cannibalized from another machine. The consistency of colour combinations on those other parts points to a general adoption of this combination of 81/82/83/76 for the type. (D. Wadman)

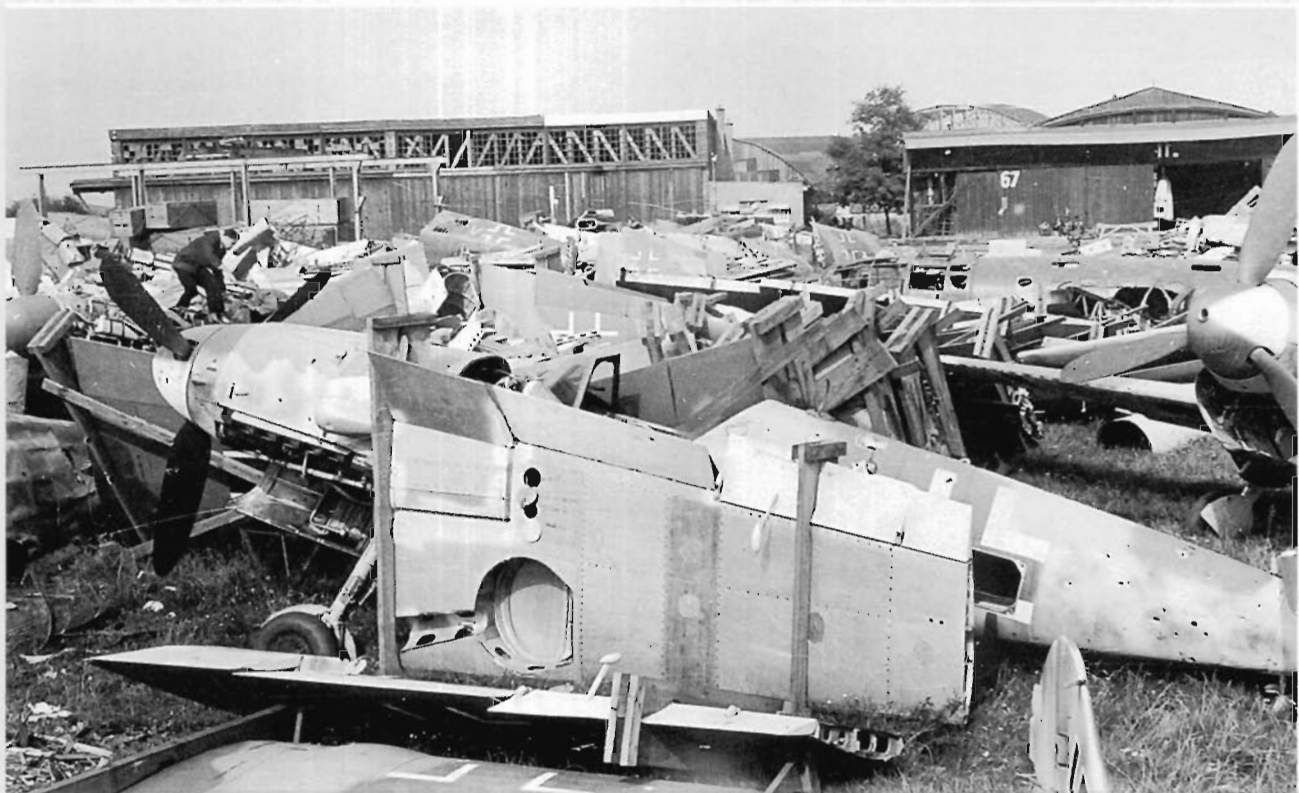
BELOW: A clear example that late production Bf 109s were also appearing with bare metal under surfaces to their wings. Part of a production batch of Bf 109 G-10s from the WNF factory, the airframe closest to the camera provides clear detail of the pre-painted aileron and elevator components, in very pale, almost off-white 76, and the bare metal surfaces of the remainder of the wing. Note the use of 76 sprayed as a rough border to the wing radiator fitting, possibly as a very crude form of sealing the joint between the two surfaces from excess moisture. The circular open hatches beside the radiator have their inside surfaces painted in 02 (the form that did not require precise colour matching). The other apparent 'colours' on the metal surfaces were simply produced by the different surface texture of each section. The overall camouflage of the aircraft was 75/82/76. Note the retention of the one-quarter to three-quarters white to black, spinner colouring on this and the aircraft to the right. The aircraft was photographed at Letnany airfield, in Czechoslovakia at war's end. (JaPo Publications)

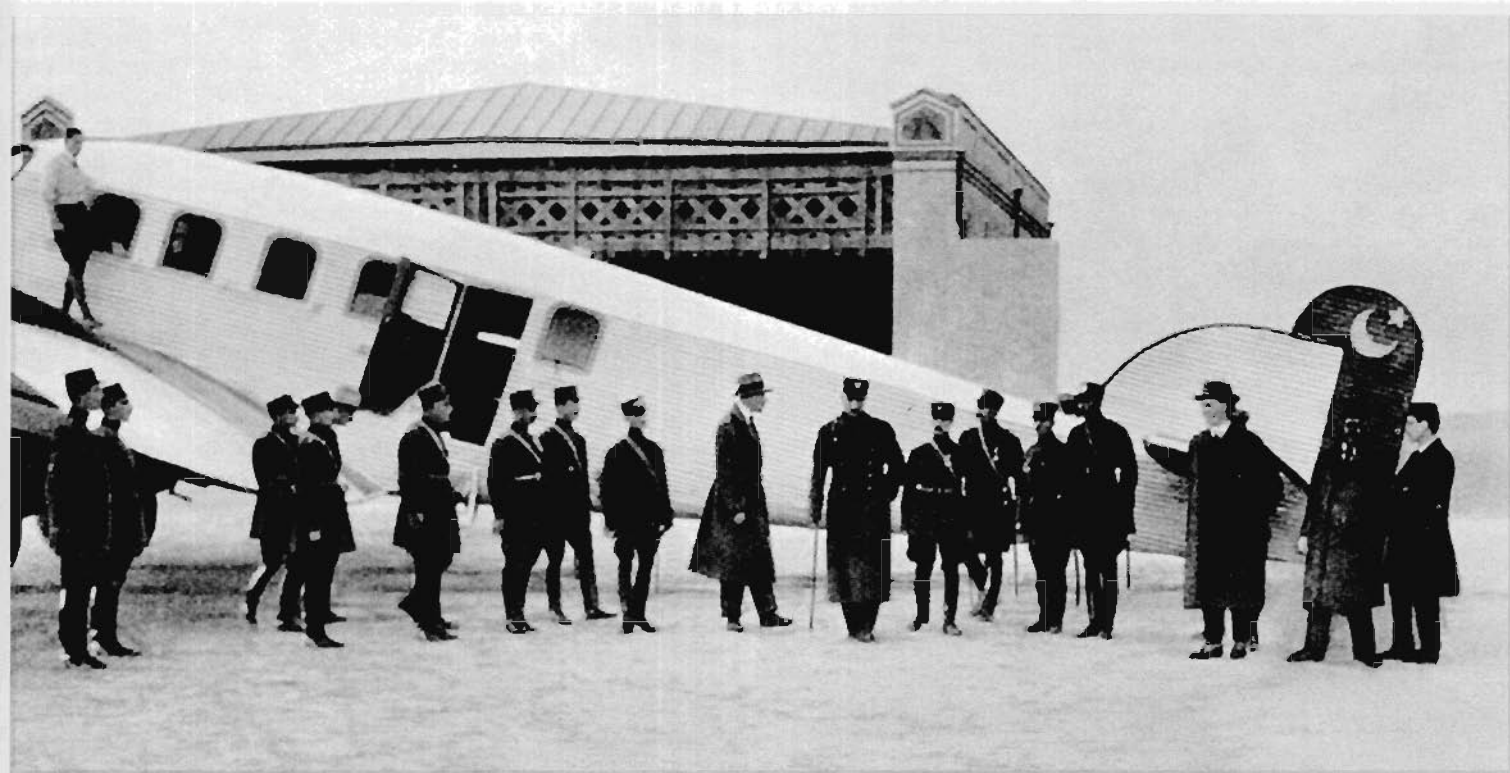
BELOW: Turkey also bought the CH 132 for its domestic airline needs. Again the overall finish was identical, pale grey with black trim, the rudder being used in similar style to that of the Swiss to display the national identity, in this instance with the star and crescent national emblem of Turkey. The rudder colouring was red.

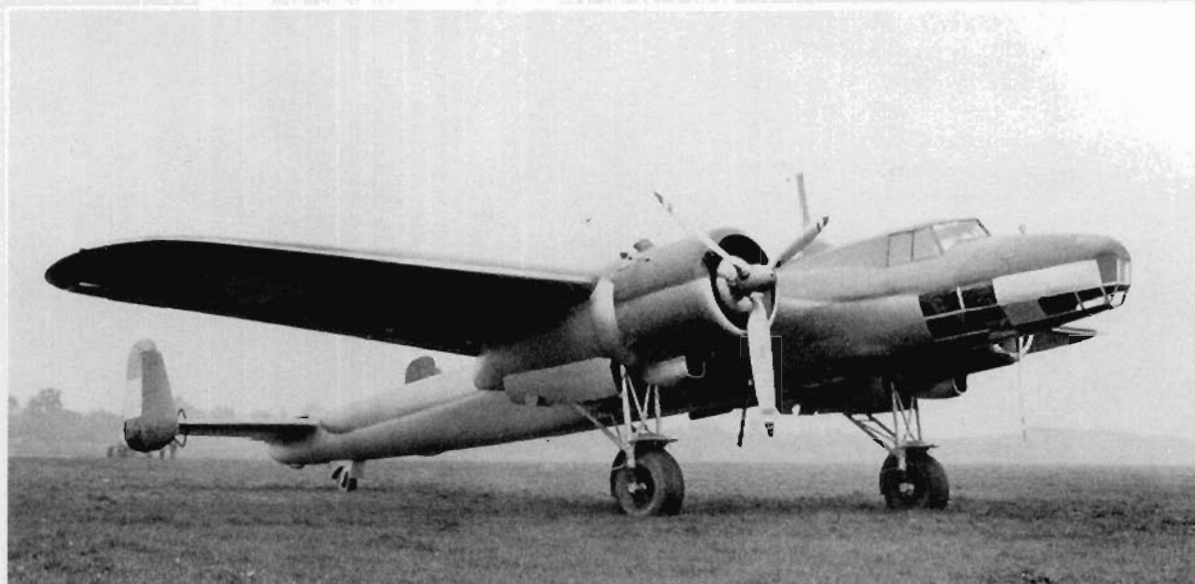
RIGHT: The Do 17 K was manufactured as an export model built in conjunction with the Luftwaffe Do 17 M variant. Twenty aircraft had been ordered in mid-1937 and the airframes were fitted with licence-built Gnôme-Rhône 14 N1/2 engines manufactured in Rakovica, near Belgrade. The early deliveries retained standard Luftwaffe 61/62/63/65 camouflage. (J.Radziwill)

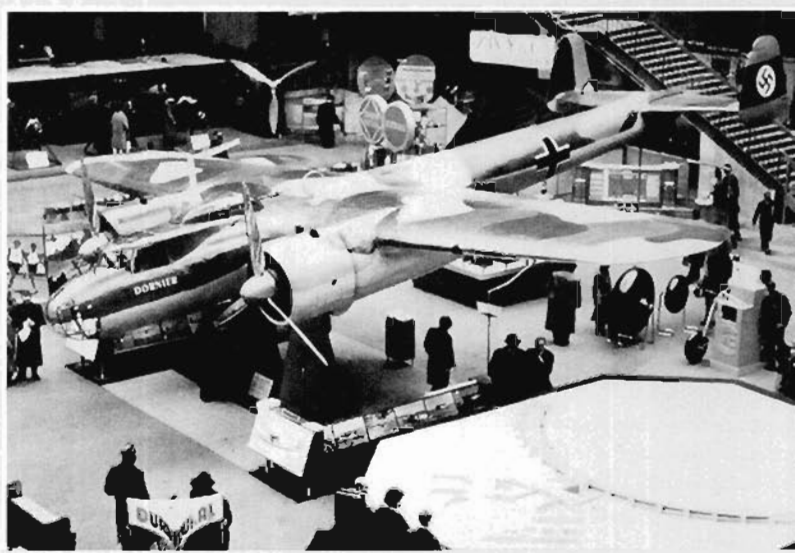
RIGHT AND BELOW: These two photographs of the Do 17 P, displayed at the XVIe Salon de l'Aviation in Paris in November 1938, illustrate the continued use of colours 61, 62, 63 and 65, but in a pattern that owed little to the superseded Luftwaffe geometric patterns. The two views allow comparison of the entire scheme with the one shown in the next photograph.

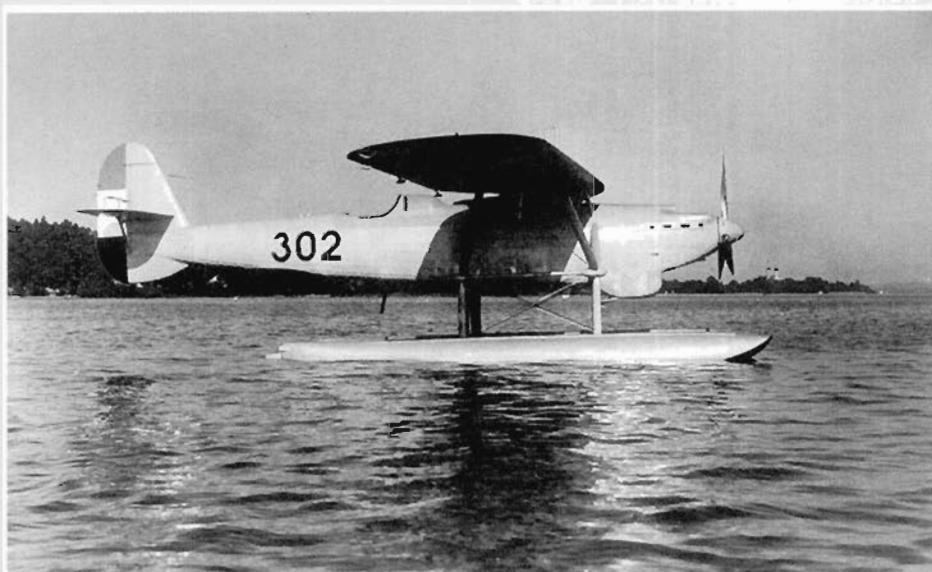
RIGHT AND BELOW: The first 12 Do 22 Kj floatplanes (the 'j' in the designation indicating Yugoslavia) were ordered by the Royal Yugoslav Naval Air Service and deliveries commenced in 1938. Manufactured at Friedrichshafen, further orders were placed by Greece (Do 22 Kg) and Latvia (Do 22 Kl). Overall colouring of the Do 22 Kj variant was standard RLM 02 with the addition of the Yugoslavian national colours. The black '302' marking was the Royal Yugoslav Air service code allocation. (J. Radziwill)

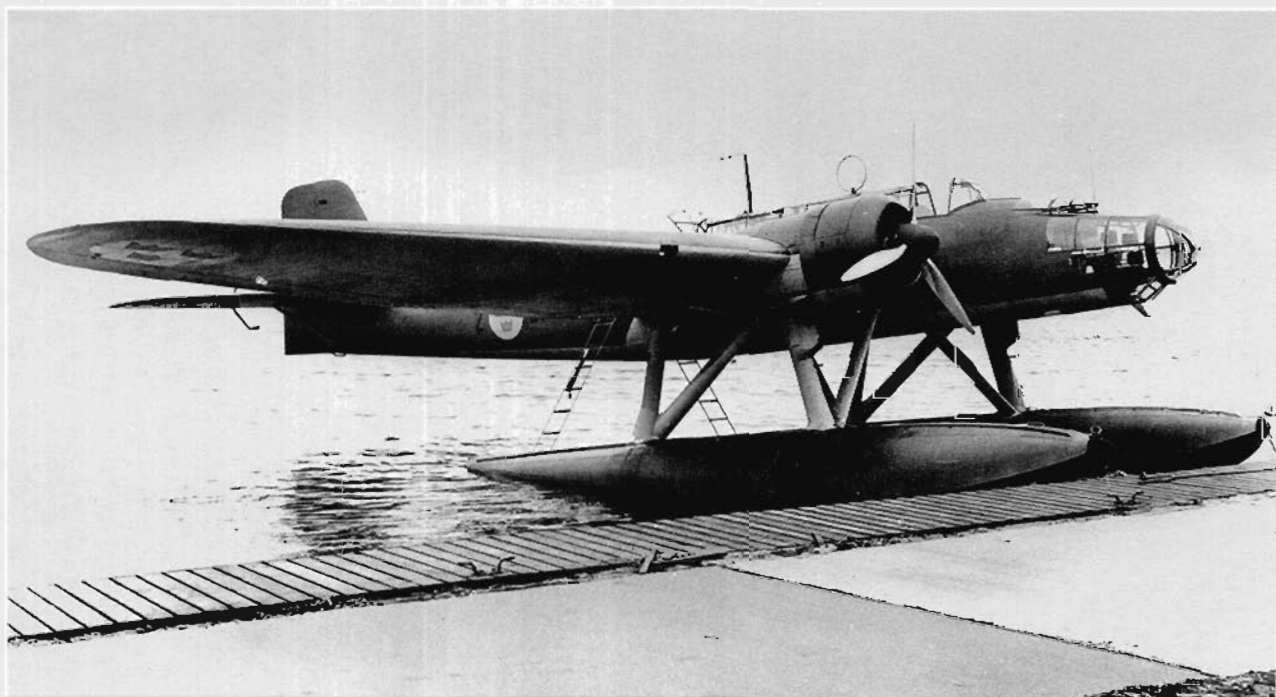
BELOW: The Swedish Government ordered several examples of the He 115 A-2. This aircraft, the first to be delivered, had a finish of 62 for upper surfaces and 65 for lower surfaces. The Swedes had favoured a brown-grey colour, but using 62 made it compatible with the colours already in use on its Ju 86s. The preferred colour raises an interesting point. The Dutch Do 24 Ks wore a grey that is described by people who were present at Broome, when some of the aircraft arrived packed with civilians, as "mud and cream". Taken in isolation the term appears incongruous, and hardly seems to accord with the usual meaning of 'grey', until one examines the stated colour preference of the Swedes for a 'brown-grey'. In that context, the description makes more sense.

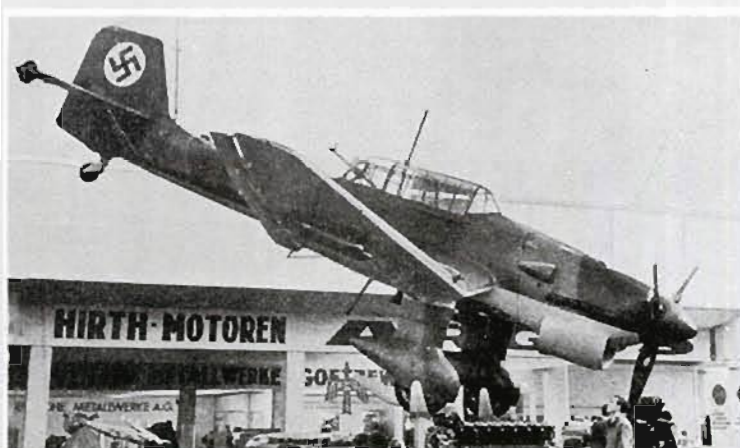
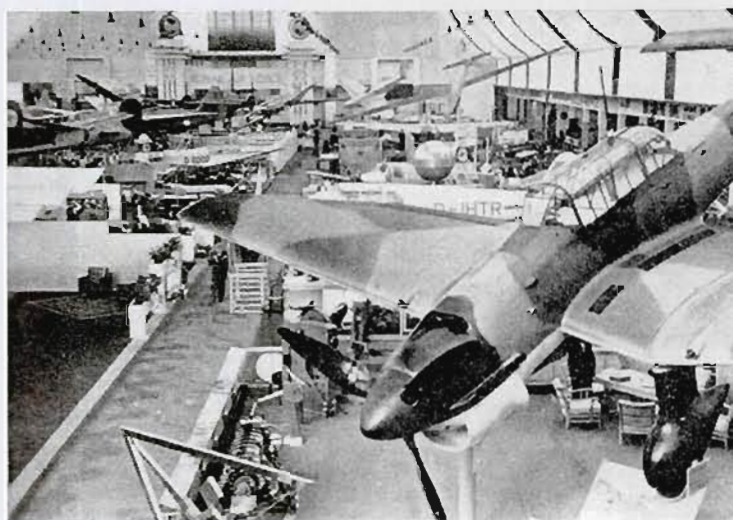
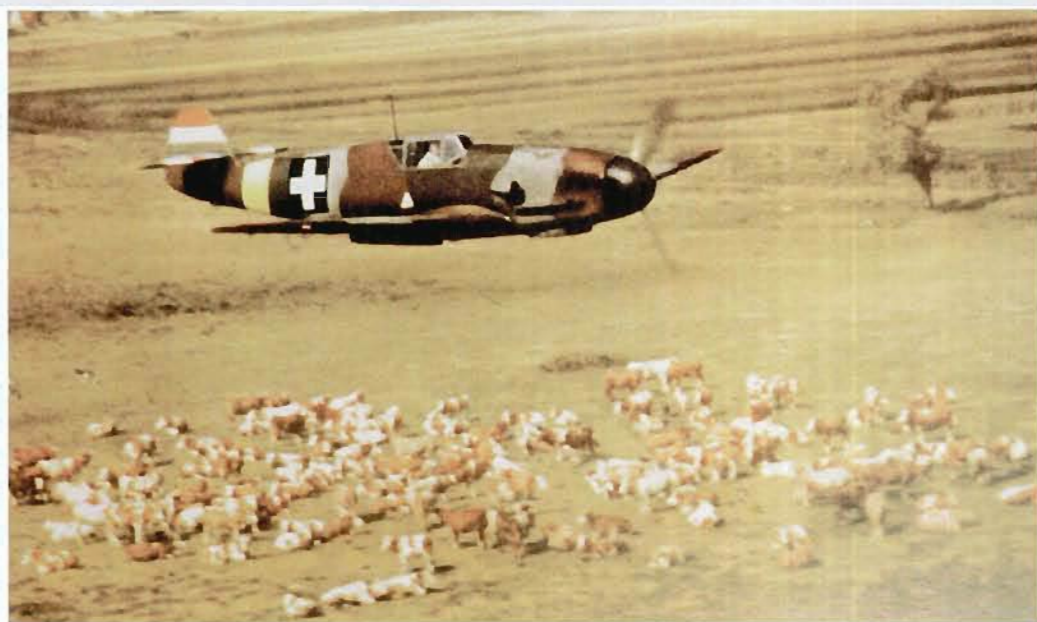
ABOVE AND RIGHT: Two views of the Ju 87 B displayed at the Brussels Air Show in 1939. The colours were 61, 62, 63 for upper and side surfaces with 65 for the under sides. The pattern used was quite unique, using soft and in places, slightly curved, lines of demarcation. The undercarriage spats were 'split' vertically with 61 at the leading edge and 62 for the rear half. This was the first time the type had been publicly displayed at one of the major Western air shows of the period, but examples had already been sold to pro-German allies to the east.

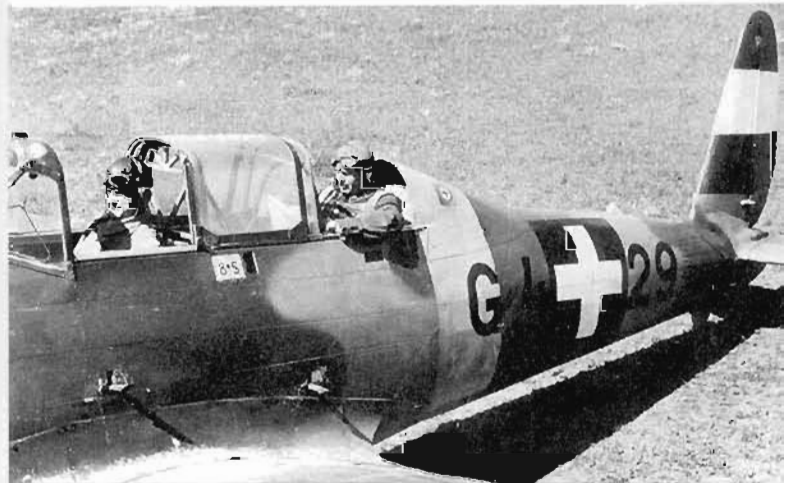
RIGHT: The Ar 96 A aircraft operated by the Royal Hungarian Air Force wore the same four colours (61, 62, 63 and 65) used on their other aircraft purchased from Germany. On each type, the style of application was very similar, with soft wavy-edged demarcation between the three upper surface colours, as shown here. The horizontal band markings were red, white and green. This aircraft was part of the force fighting on the Don Front in September 1942 and carries the yellow band marking for the Eastern Front Axis forces supporting the Luftwaffe. The presence of the old style aircraft maintenance schedule record, stencilled in black on the rear section of the fuselage, was probably one of the last times this form of marking was seen on front line aircraft.

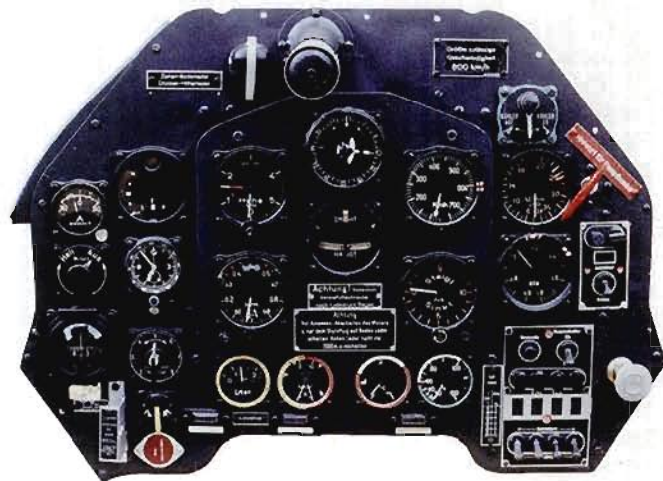
ABOVE: A restored Ju 87 B-1 instrument panel with instruments, placards and fittings in original condition, showing the overall RLM 66 background colouring, black instrument bezels and added colour to the rim of selected instruments. The four instruments below the blind flying panel are (left to right), fuel, combined fuel/oil pressure, oil temperature and coolant temperature gauges, each of which has its relevant DIN L5 colour marking around the rim. The red delineated white portions on the two right hand gauges mark the optimum operating range for each. The radiator flap selector, top right, was also painted with its relevant colour of green. Other than for these small islands of colour, instrument panels and instrumentation were a sombre combination of RLM 66 or black. (P. Cohausz)

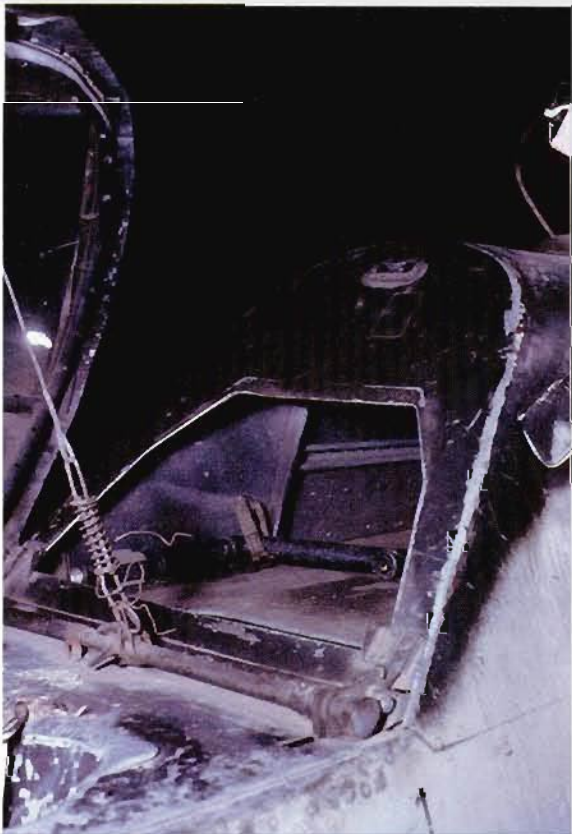
ABOVE: The rear section of the cockpit of Bf 109 G, W.Nr. 163824, showing the external non-standard black-grey camouflage colour which however substituted reasonably well for the regulation 66 in this instance. A very thin, roughly sprayed coat of the dark colouring had also been used inside the locker space.

Austerity measures and general shortages in the last few months of the war also lead to some non-standard finishes being employed. The AWM Bf 109 G, W.Nr. 163824, has the back of the pilot's seat sprayed with a very thin coat of black nitro-cellulose lacquer which has a definite low sheen finish; possibly 7160.22. From frame 7 aft, the interior metal of the fuselage is bare other than for frame 8, a replacement still in 02. Forward of frame 7 the lower sides of the fuselage were sprayed with a thin, coarse coat of a pale greenish-blue colour up to the stringer line running along the top edge of the radio access hatch. Between frames 5 and 6 the colour had only been applied to the starboard side, i.e., the area directly opposite the radio access hatch opening. This thin spray appears to have been highly dilute colour, possibly done when spraying of the green-blue colouring to parts of the fuselage were completed, simply utilising the last dregs of paint, when cleaning out the spray gun - a crude form of anti-corrosion protection in the lower areas where moisture usually gathered.
