Panzer-Division 1935-1945

(2) The Eastern Front 1941-1943

Robert Michulec

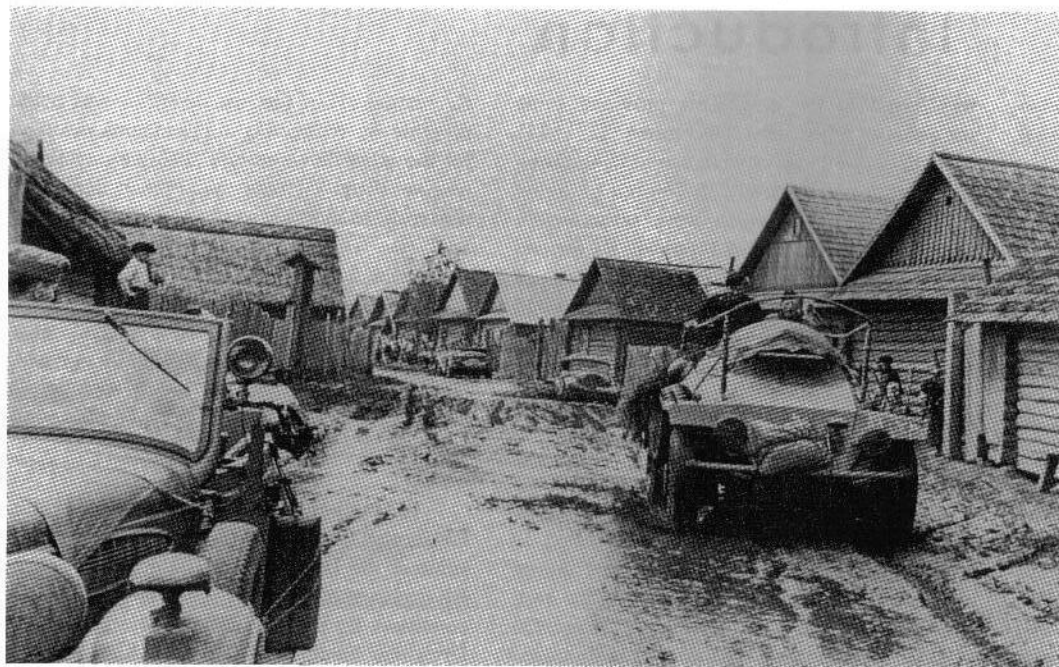
Vehicles of a divisional reconnaissance troop struggle down a muddy road through a Russian village in July, 1941. The armored car on the right is an early version of the kleine Panzerfunkwagen (Sd.Kfz.261). This one is a standard Sd.Kfz.221 that has been fitted with a frame antenna and additional radio equipment and still carries the standard MG34 armament. Later versions were built on the chassis of the Sd.Kfz.223 and were unarmed. Markings on the left mudguard indicate it belongs to 8.Panzer-Division. The vehicle on the left is a BMW 326 two-door convertible, one of many types of civilian cars utilized by the Wehrmacht.

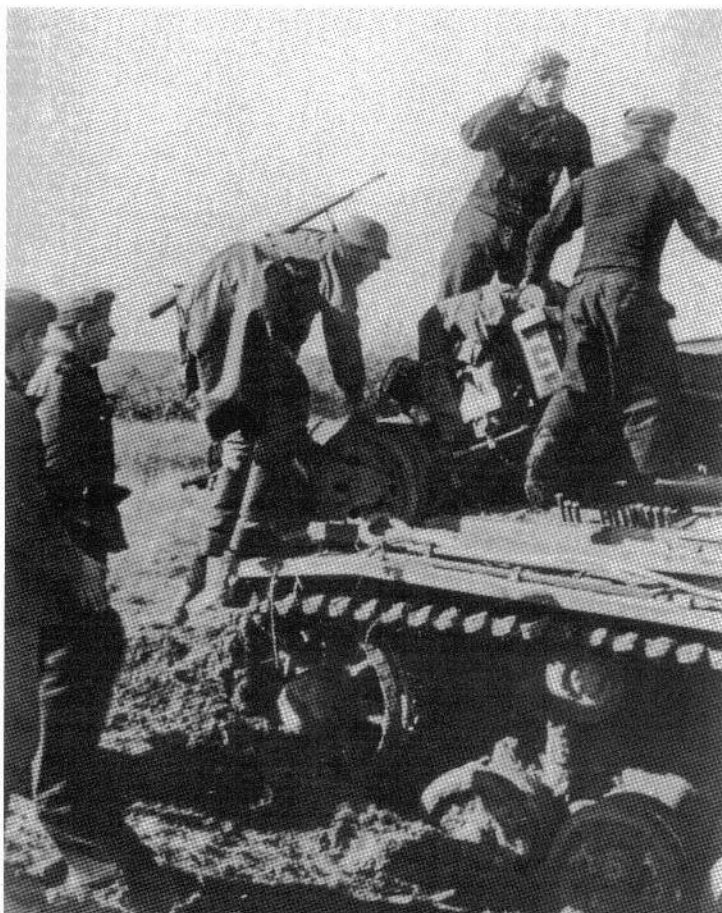
An NSU type 251 OS motorcycle is loaded onto the engine deck of a Pz.Kpfw.III during a period of muddy weather conditions in Russia, late summer 1941. The white letter 'G' painted on the dispatch case indicates it belongs to one of the five Panzer-Divisions under the command of Panzer-Gruppe Guderian.

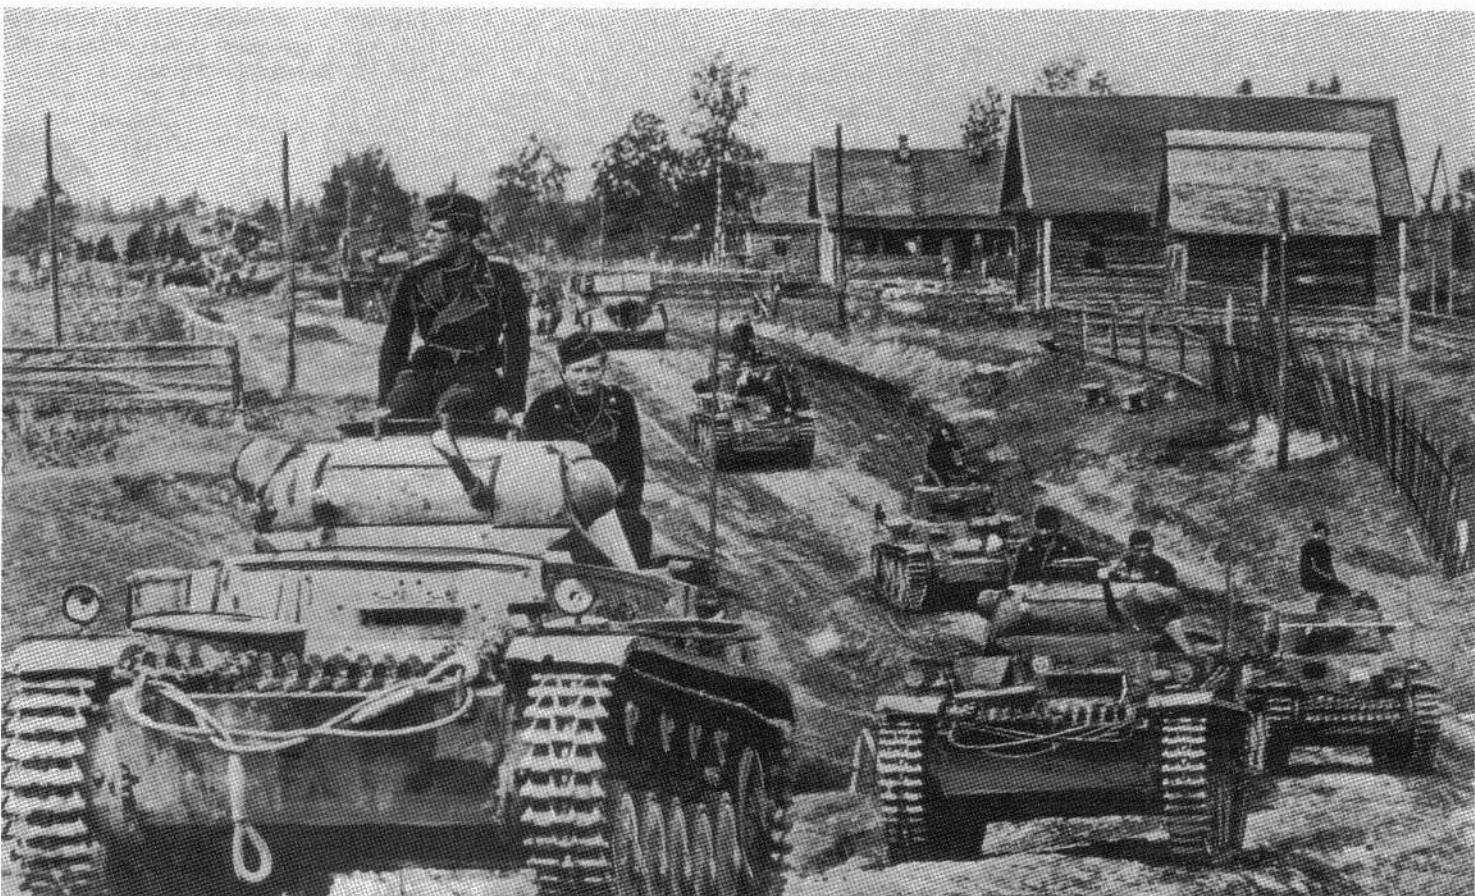
A column of armored and soft-skinned vehicles march through a Russian village in the summer of 1941. The two vehicles in the lead are Pz.Kpfw.II Ausf.A-C, the second of which carries the divisional emblem of 12.Panzer-Division, followed by three Pz.Kpfw.38(t). 12.Panzer-Division was part of LVII.Pz.K. which fought with Pz.Gr.3, taking part in the battles for Minsk and then Smolensk. Up to September, the division had lost 101 tanks including almost all of their Pz.Kpfw.I and half their Pz.Kpfw.38(t), which formed the majority of their strength. On the other hand, only 4 Pz.Kpfw.II and 8 Pz.Kpfw.IV were lost during the same time. Unusually, the leading Pz.Kpfw.II seems to have been painted in a very light color or possibly camouflaged with mud.

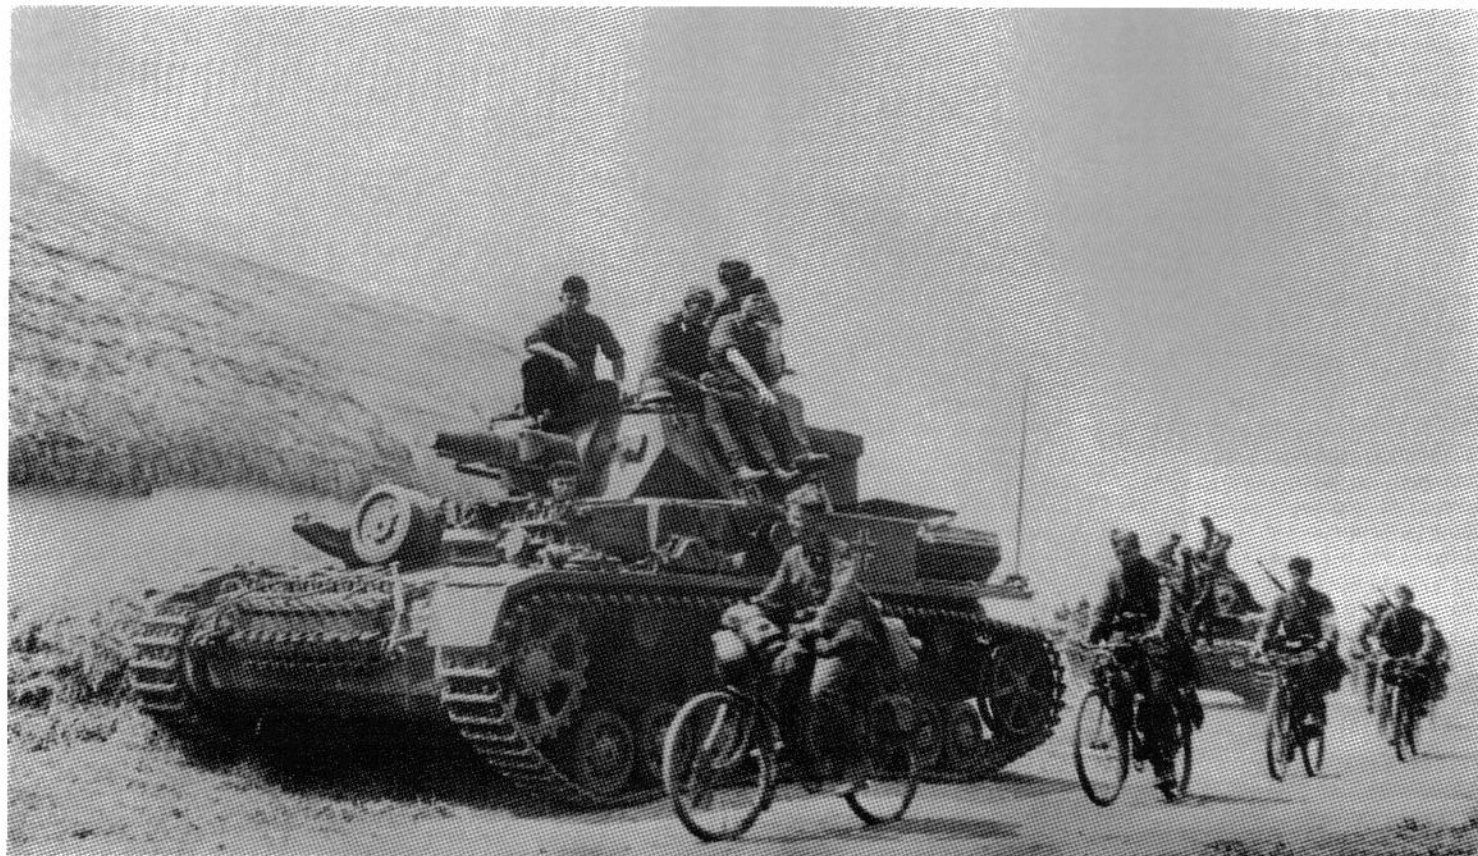
A Pz.Kpfw.IV Ausf.F1 is passed by a group of infantry equipped with bicycles. Armed with the 7.5cm KwK37 L/24, it was only capable of dealing with the Soviet KV-1 and T-34 at short ranges. The introduction of the Pz.Kpfw.IV Ausf.F2, seen behind, armed with the 7.5cm KwK40 L/43, finally gave the Germans a technical superiority. Interestingly, the antenna has been field mounted on the rear of the left mudguard.

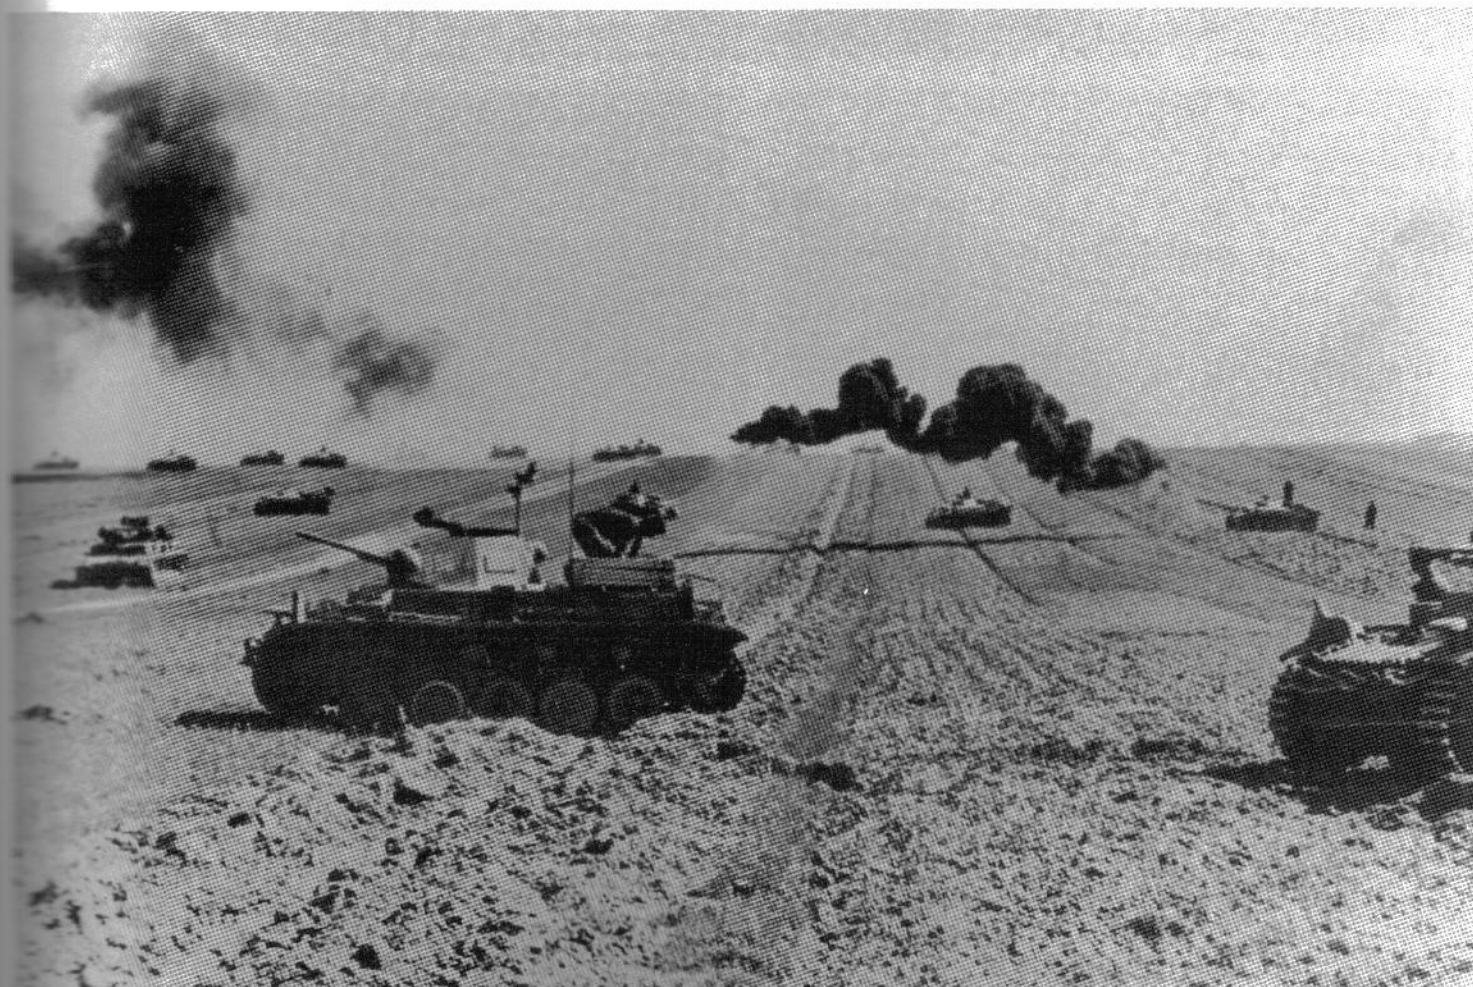
Two Pz.Kpfw.IIs, several Pz.Kpfw.II Flamm and at least one Pz.Kpfw.IV pause during their advance across a Russian field in September 1941. In the background, one of the Pz.Kpfw.II Flamm has just released a jet of fuel leaving a cloud of black, oily smoke hanging in the air. A total of 155 Pz.Kpfw.II Flamm were built on the chassis of the Pz.Kpfw.II Ausf.D and E and were used for the first time during Operation 'Barbarossa' in June 1941. They were all assigned to Panzer-Abteilung (Flamm) 100 and 101.

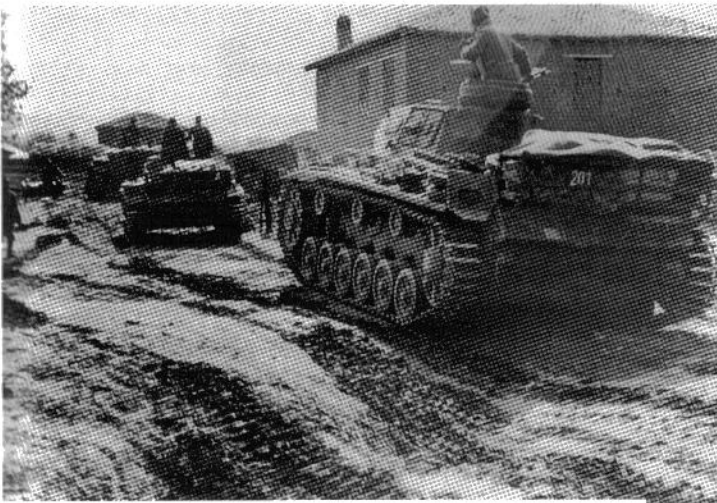
Heavily stowed Pz.Kpfw.III's move through a Russian village in the autumn of 1941. The nearest vehicle is an early Pz.Kpfw.III Ausf.G which has been fitted with a late cupola and still retains the early style of tactical numbering, white painted numbers on a black rhomboid shaped metal plate. The tactical sign for a Panzer-Division is painted in white on the rear plate as well with the company number painted beside it.

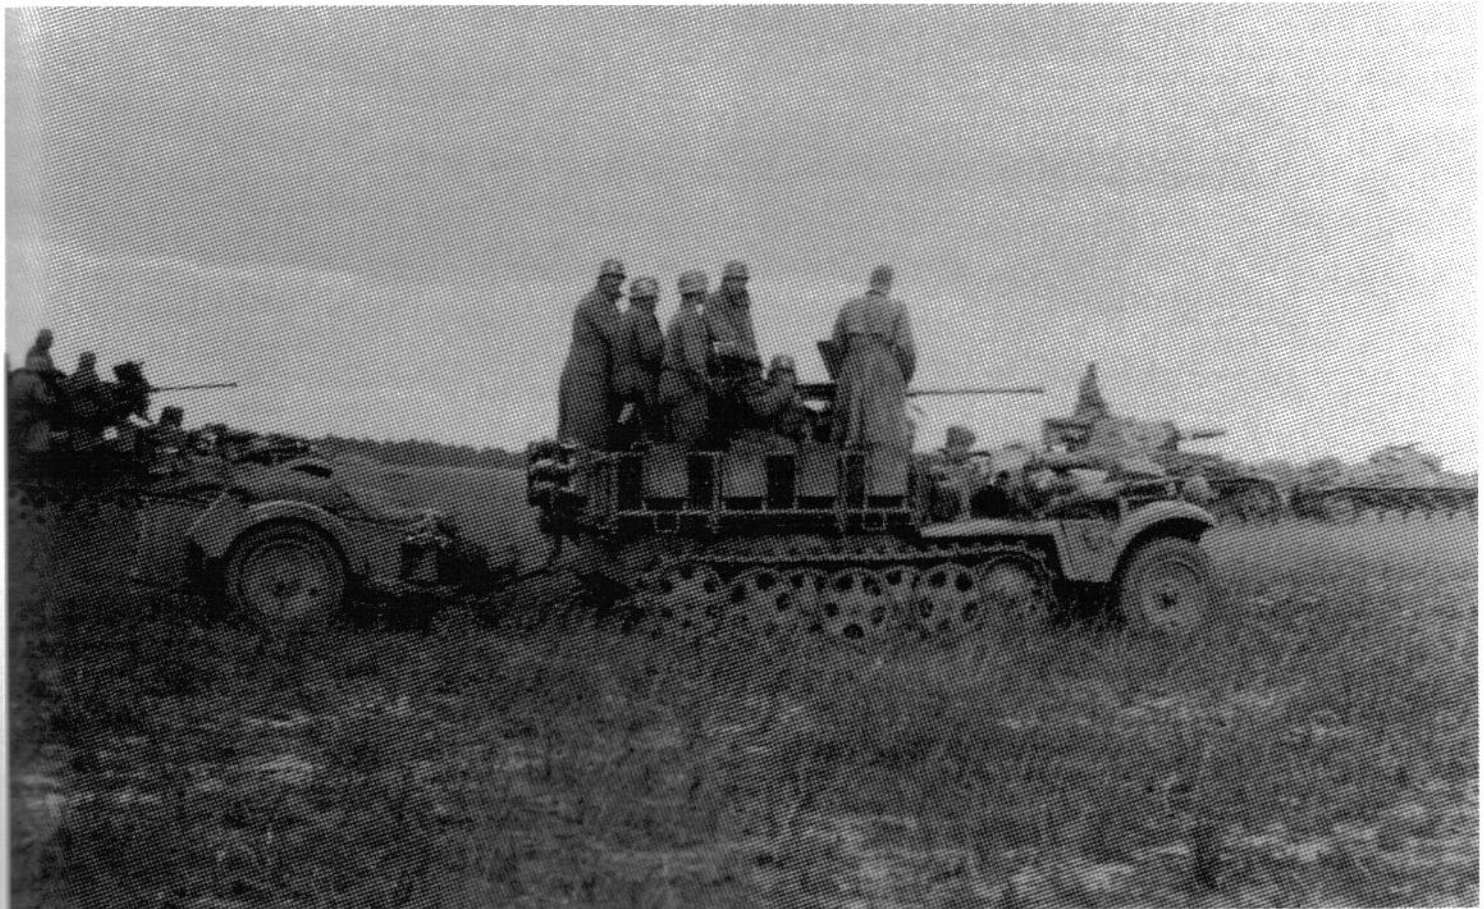
A pair of Sd.Kfz.10/4 half-tracks armed with 2cm FlaK38 anti-aircraft guns provide support to one of the Panzer-Divisions during their advance into Russia. With a crew of 7, space was at a premium, which can be easily seen here. In action, the sides of the gun platform could be folded down to provide additional space for the crew to maneuver around the gun. Magazines for the gun were carried in ready racks on the folding sides of the platform and usually, a single axle trailer was towed, carrying additional ammunition. A Pz.Kpfw.II and a Pz.Kpfw.IV Ausf.D can be seen in the background.

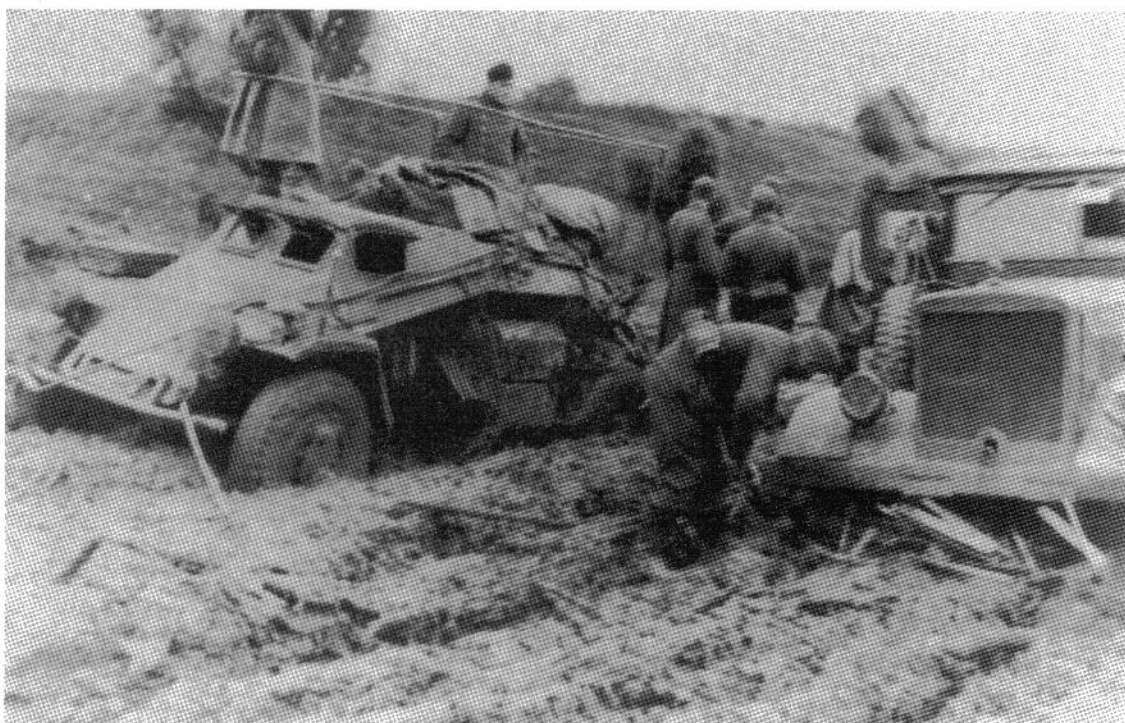
A leichte Panzerspähwagen (Fu) (Sd.Kfz.223) and a Borgward 3-ton truck bogged down in a muddy Russian field. Conditions such as this put a severe strain on both men and machines.

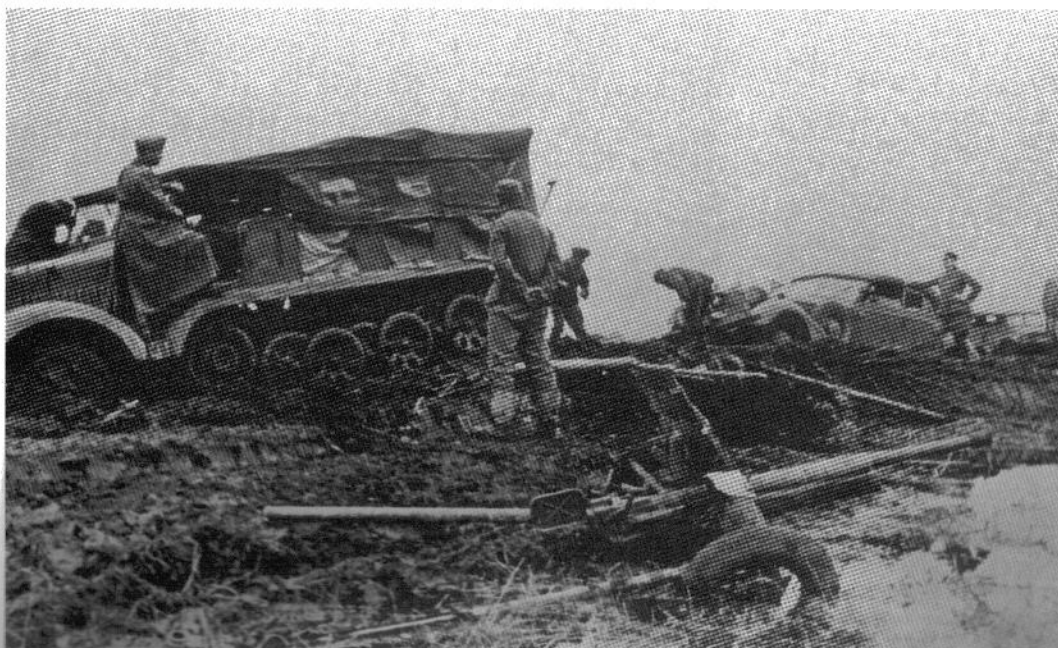
An Sd.Kfz.6 5-ton half-track prime mover being used to tow a staff car bearing a General's rank pennant. Normally, the rank pennant was carried on the right mudguard and the command pennant was carried on the left. When the rank pennant was on the left mudguard, this indicated the officer was not authorized to carry a command pennant. In the foreground is a Soviet 45mm Model 1932 anti-tank gun that has been abandoned by the retreating Russian Army.

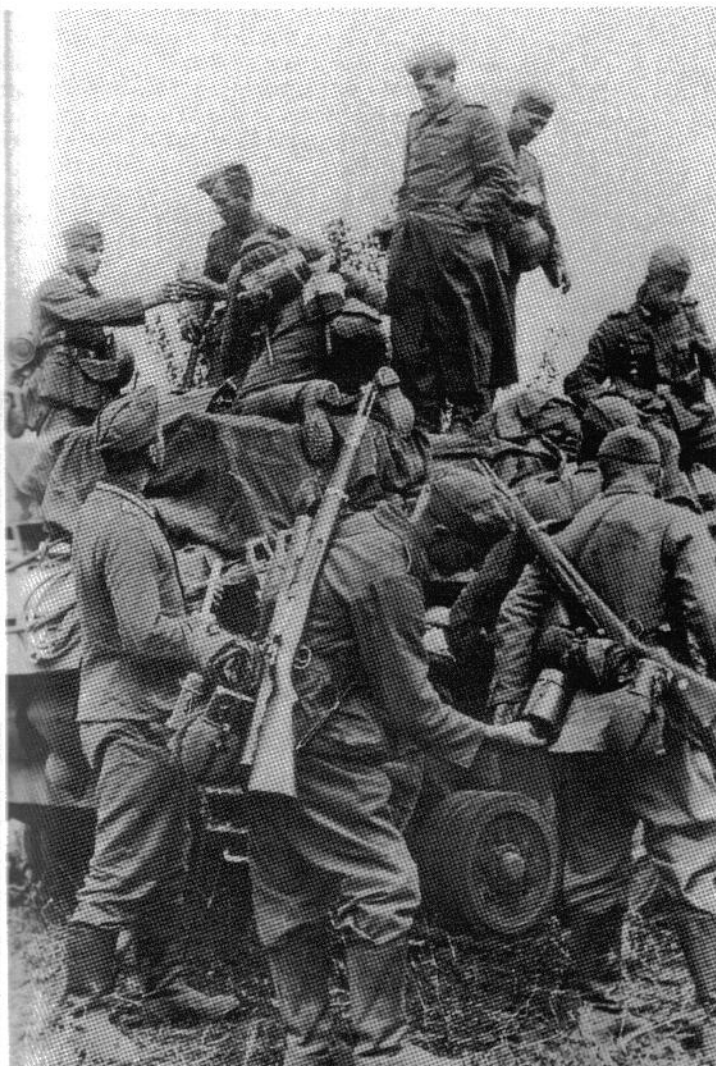
German troops climb aboard a StuG.III Ausf.A-B from an unknown unit in the autumn of 1941. On April 18, 1941, Sturmgeschütz Abteilung were organized with 3 batteries of 6 Sturmgeschütz each plus 1 for the battery commander. This was subsequently revised in November 1942 to add 3 more vehicles to each battery. At this time, their role was still that of self-propelled artillery for infantry support.

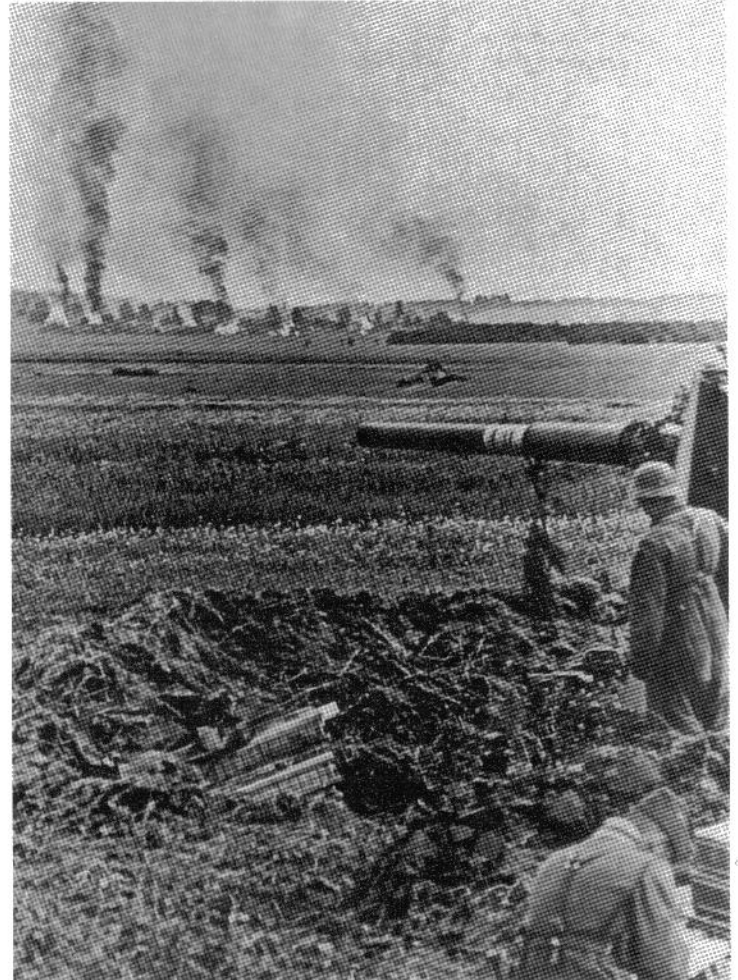
An 8.8cm FlaK18 from the same unit fires high explosive rounds at a village occupied by Soviet troops in late September, 1941. Manned by another highly successful crew, this gun has 13 kill rings painted in white around the barrel.

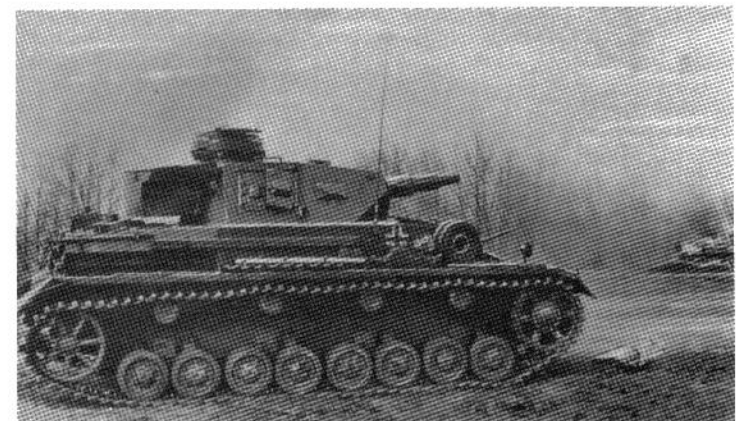
A Pz.Kpfw.IV Ausf.F1 of an unidentified Panzer-Division, engages Soviet troops on the edge of a forest in late autumn, 1941. Quite unusually, the three digit tactical number on the side of the turret, '532', is painted in black with the first two numbers being slightly smaller than the last.

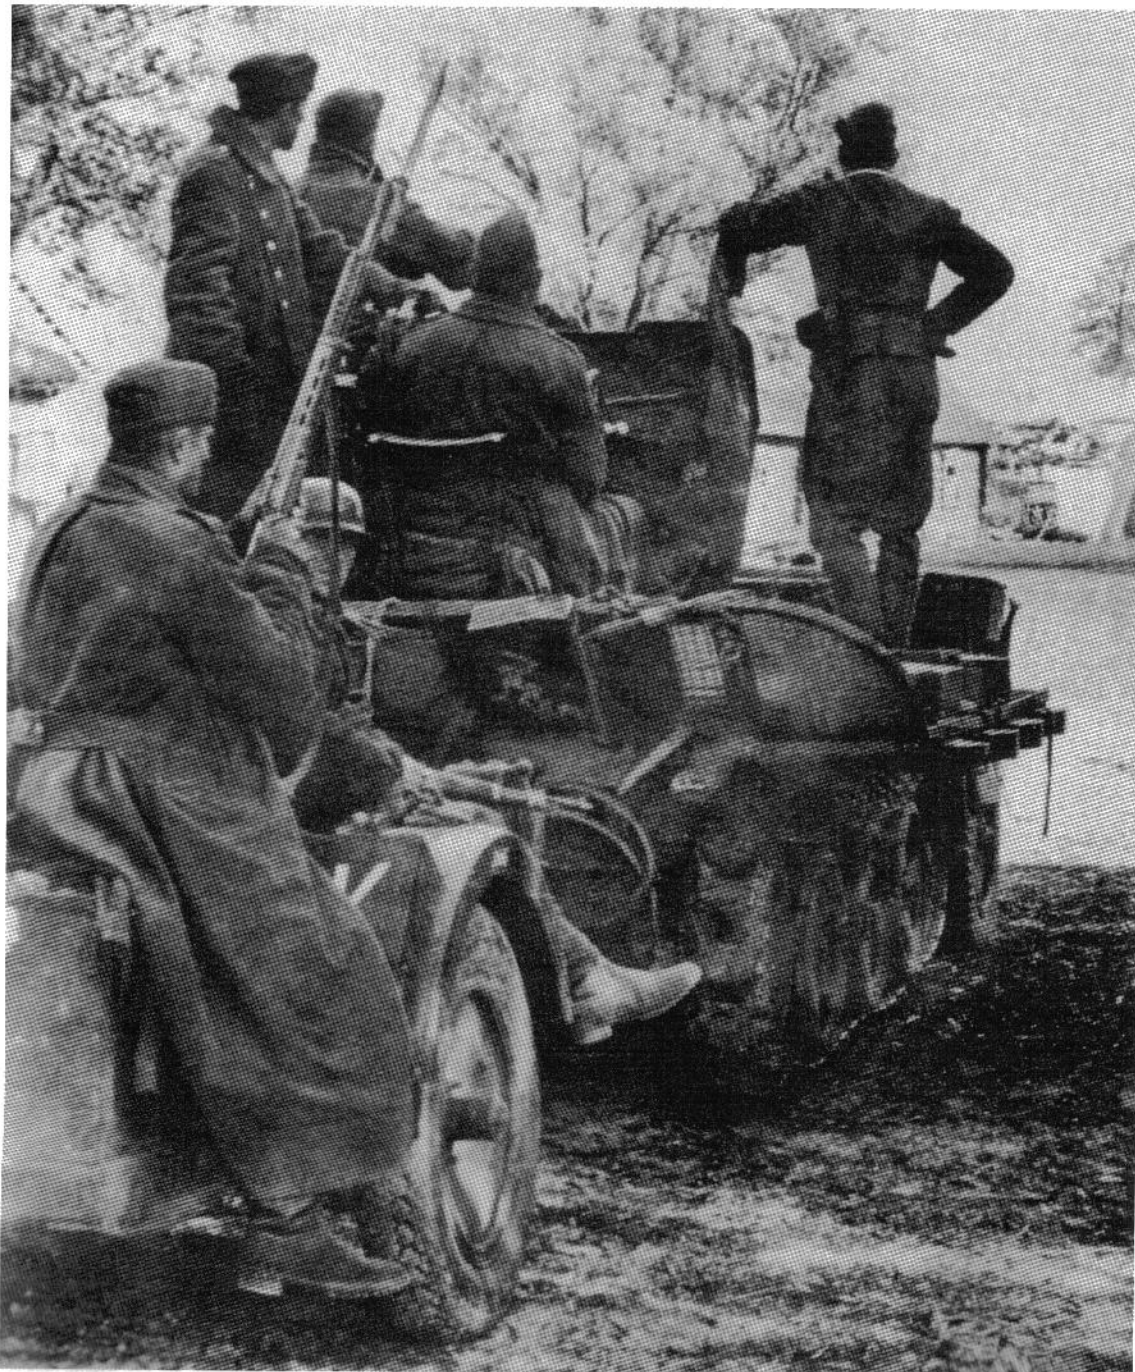
An Sd.Kfz.10/4 half-track armed with a 2cm FlaK30/38 anti-aircraft gun guards a village in Russia at the end of October, 1941. The divisional emblem of 11.Panzer-Division, the famous 'Ghost Division', is painted in white on the back of the vehicle. Also visible is the white letter 'K' painted on the ammunition trailer, the sign of Panzer-Gruppe von Kleist. The soldier seated on the trailer is handling a captured Soviet Tokarev STV-40 automatic rifle with a bayonet attached.

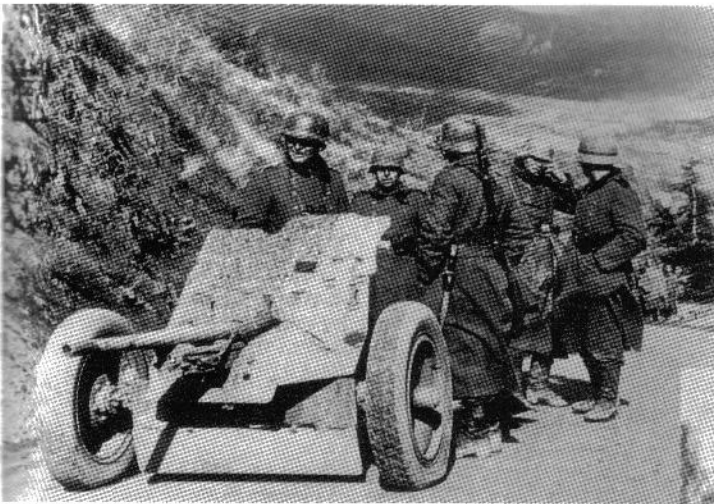
A mud spattered 3.7cm PaK35/36 anti-tank gun blocks a road in the Crimean Peninsula in November, 1941. This gun was often used in an infantry support role as it was incapable of dealing with the heavier tanks of the Red Army now being encountered in greater numbers.

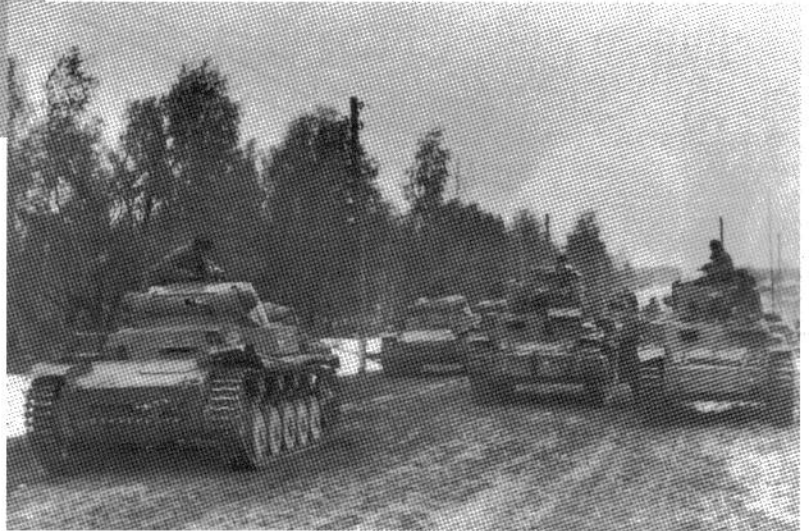
Two Pz.Kpfw.II Ausf.A-C, a Pz.Kpfw.38(t) Ausf.G and a Pz.Bef.Wg.38(t) Ausf.G on a dirt road. After Operation 'Typhoon', the failed assault on Moscow, the Panzerwaffe reported the complete loss of 86% of the Pz.Kpfw.35(t) and 38(t) and 40% of the Pz.Kpfw.II it had started the campaign with in June.

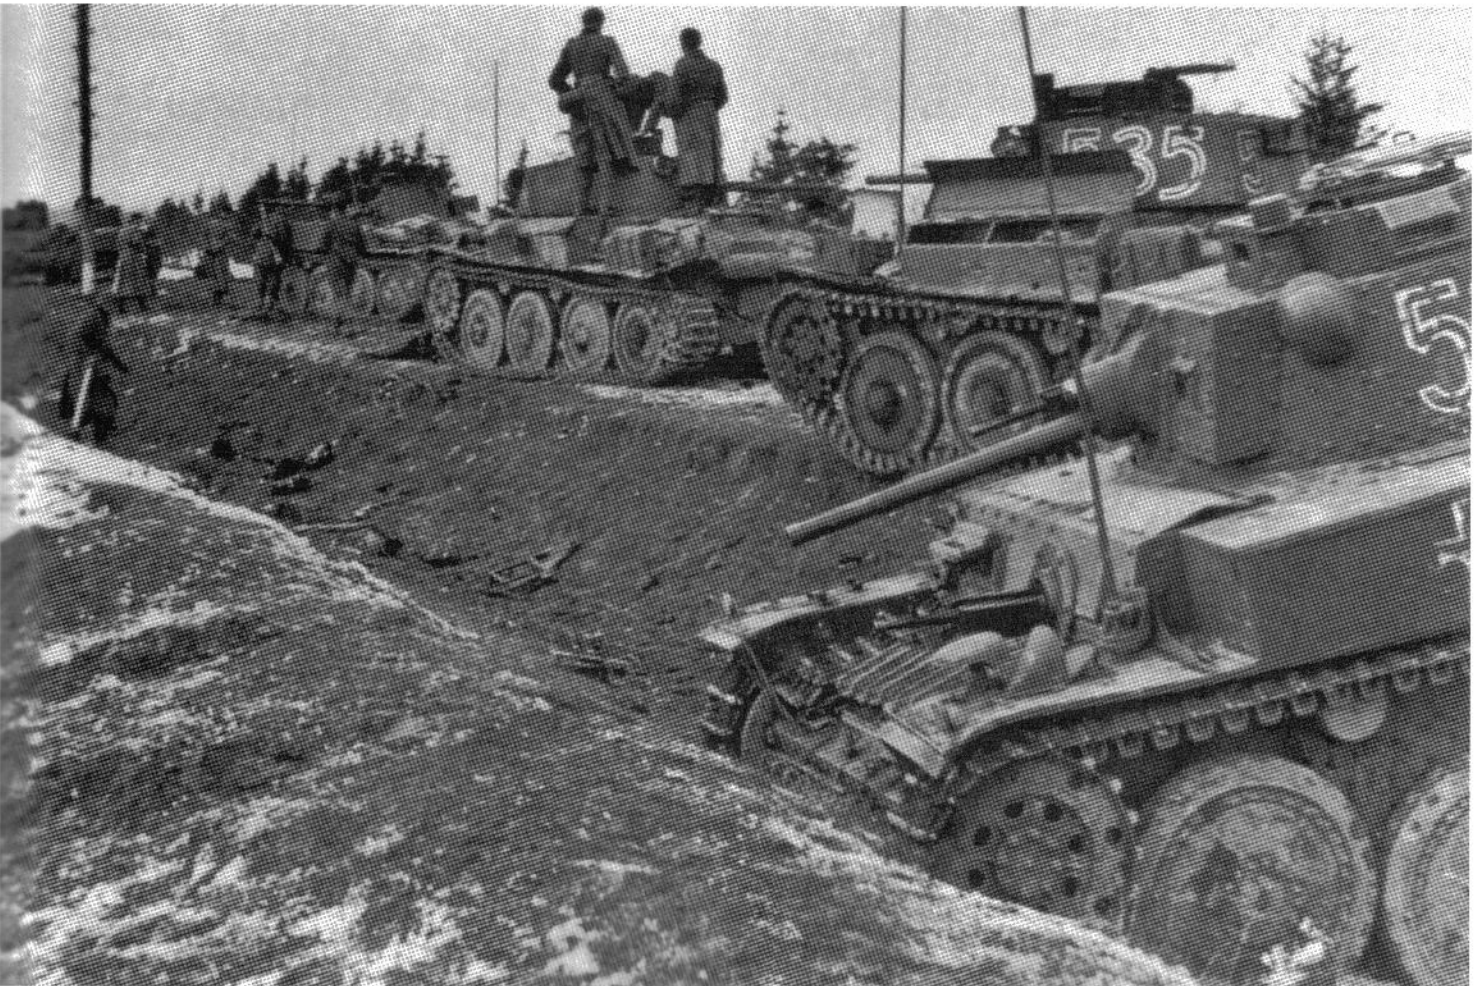
A group of Pz.Kpfw.38(t) Ausf.Ds of 7.Panzer-Division stopped along the road to Moscow in November, 1941. The white outline tactical numbers indicate that vehicles from 1.,2. and 3.Kompanie are present here. Note the two different styles which the number '5' is painted on the side and rear of '535'.

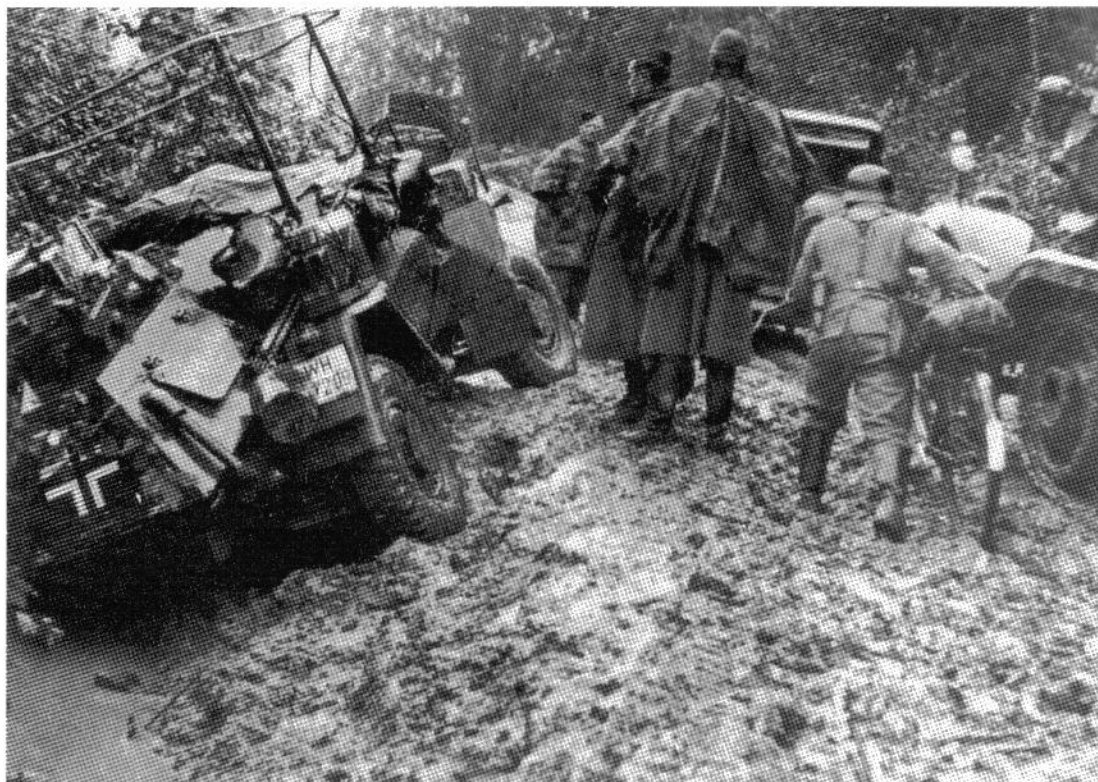
Prolonged poor weather conditions in November 1941 created impassable roads for most wheeled as well as tracked vehicle traffic in the Soviet Union. This leichte Panzerspähwagen (Fu) (Sd.Kfz.223) or kleine Panzerfunkwagen (Sd.Kfz.261) has slid into a ditch and awaits help from the Sd.Kfz.6 half-track prime mover coming along beside it. The name 'Weissenburg' is painted in white script on the engine access hatch.

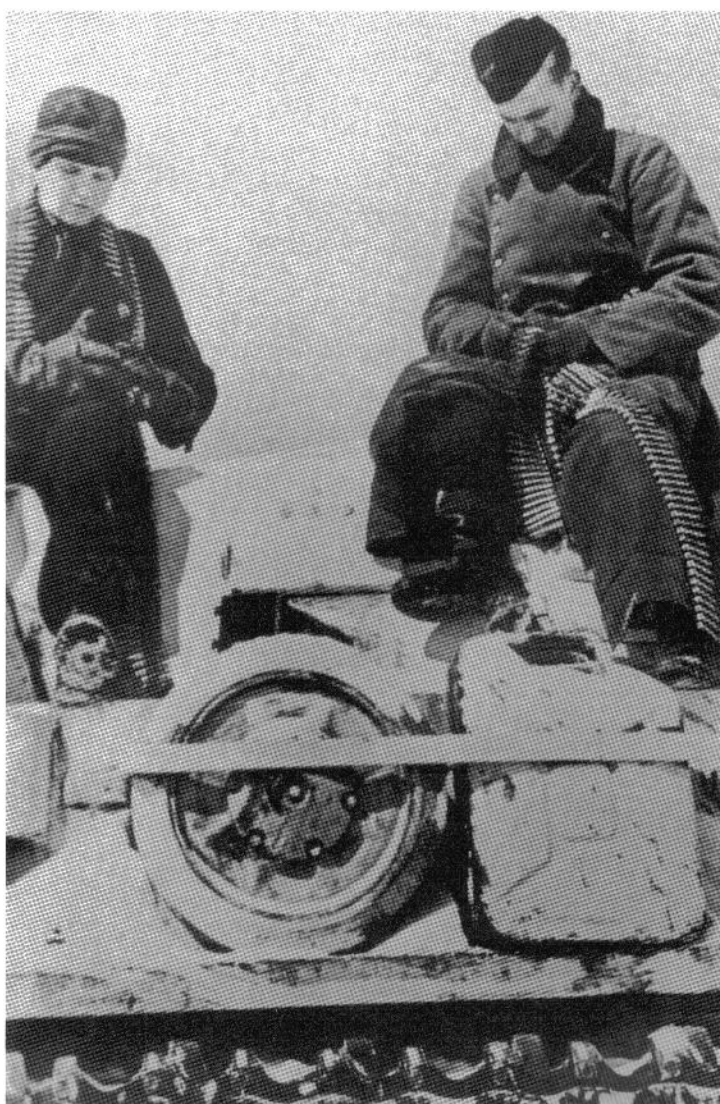
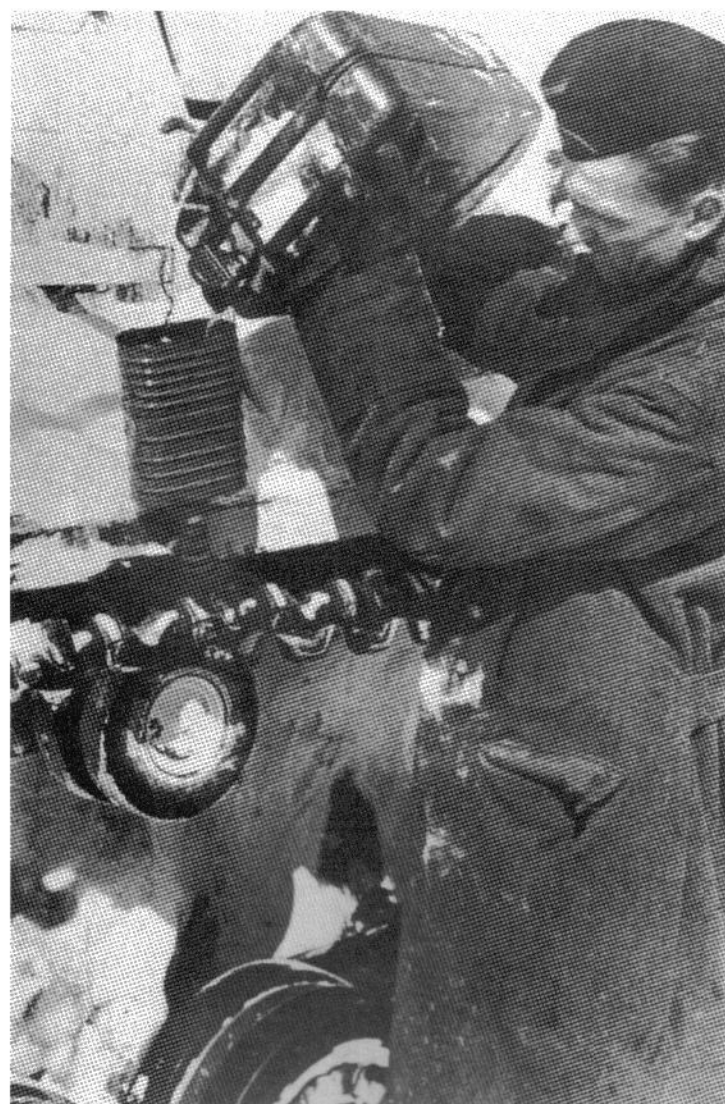
Two photos of a winter whitewashed Pz.Kpfw.IV Ausf.F1 being refueled and having its MG ammunition replenished during the winter of 1941-42. This enterprising crewman is utilizing a captured Soviet gas mask filter canister and hose as funnel to assist in the refueling process.

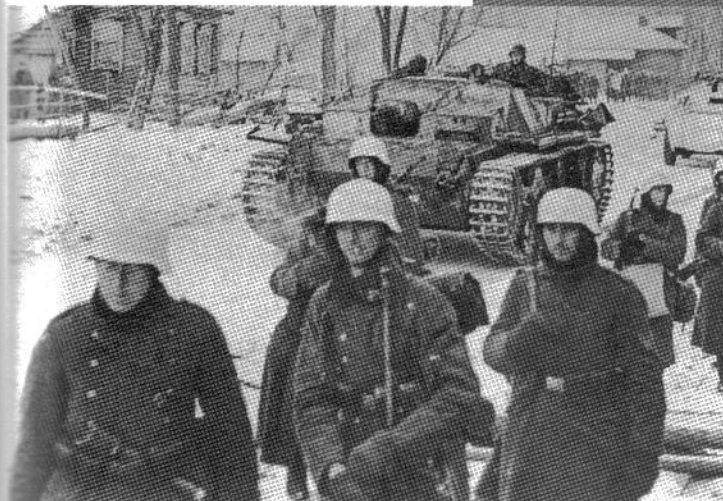
A StuG.III Ausf.C/D, which has a light covering of snow on it, heads a column of winter camouflaged armored cars through a Russian village in the winter of 1941-42. The armored car behind it is a leichte Panzerspähwagen (Sd.Kfz.222) which has had a white sheet draped over the front to improve the camouflage effect. The severe weather reduced the capabilities of the troops as well as put a strain on the vehicles themselves. The attack on Moscow would be the first major defeat for the German Army during which they lost large numbers of men and heavy equipment.

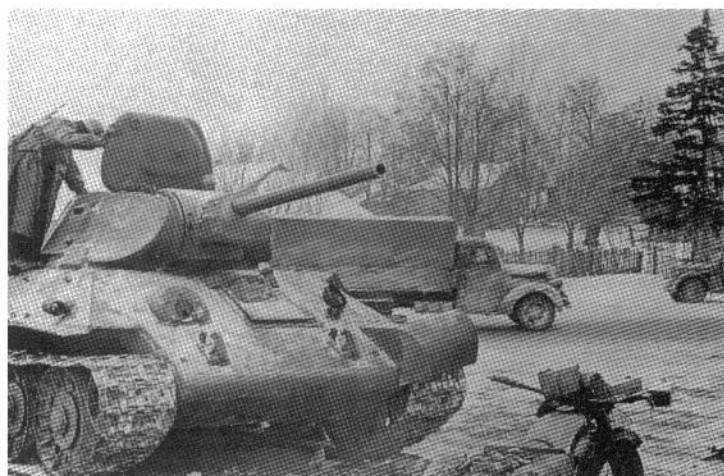
A German motorcyclist inspects the interior of a T-34/76 Model 1941, fitted with the later waffle pattern tracks and steel wheels, abandoned near Moscow in December 1941. Note the unusual marking on the mudguard of the motorcycle - a white outline square with the number '7' inside. It has a standard number plate also attached to the front mudguard with the number 'WH-210502'. The lorry and Horch car in the background have both received a thin coat of white camouflage paint.

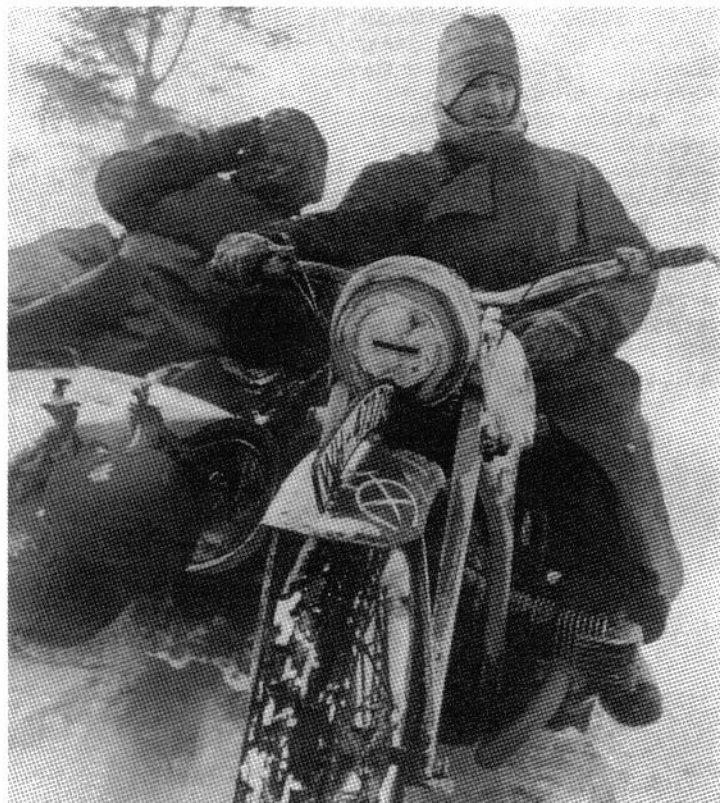
It is difficult to imagine the brutal conditions that the men on both sides endured in the winter of 1941-42, as can be seen in this photograph taken near Kalinin during December. The tactical marking on the mudguard indicates they are from the first company of a motorcycle reconnaissance battalion. The machine is a Zündapp KS600 with the license number 'WH-473719'.

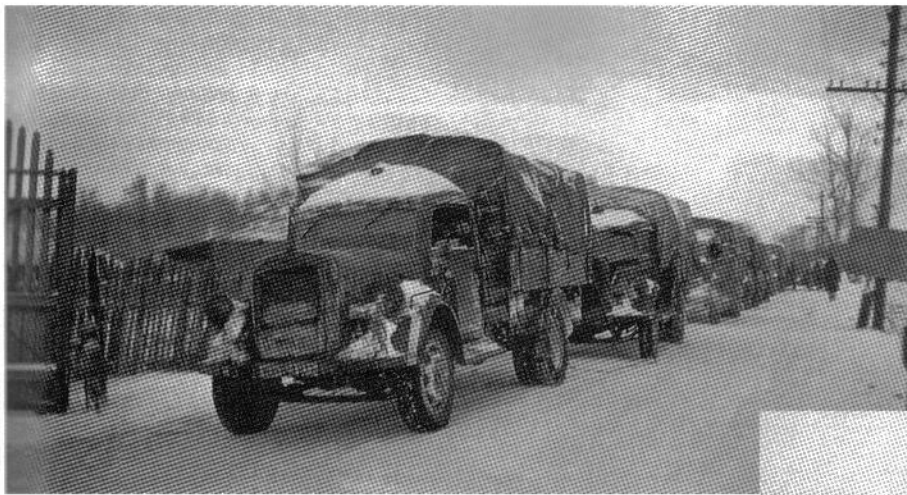
A snow covered German supply column halted on a road through a Russian village in the winter of 1941-42. The vehicles are equipped with chains on the rear wheels to improve traction on the frozen ground. Part of a tactical sign can be made out under the snow on the right mudguard of the nearest truck along with white width markings and the standard Wehrmacht number plate 'WH-629 977' on the front bumper.

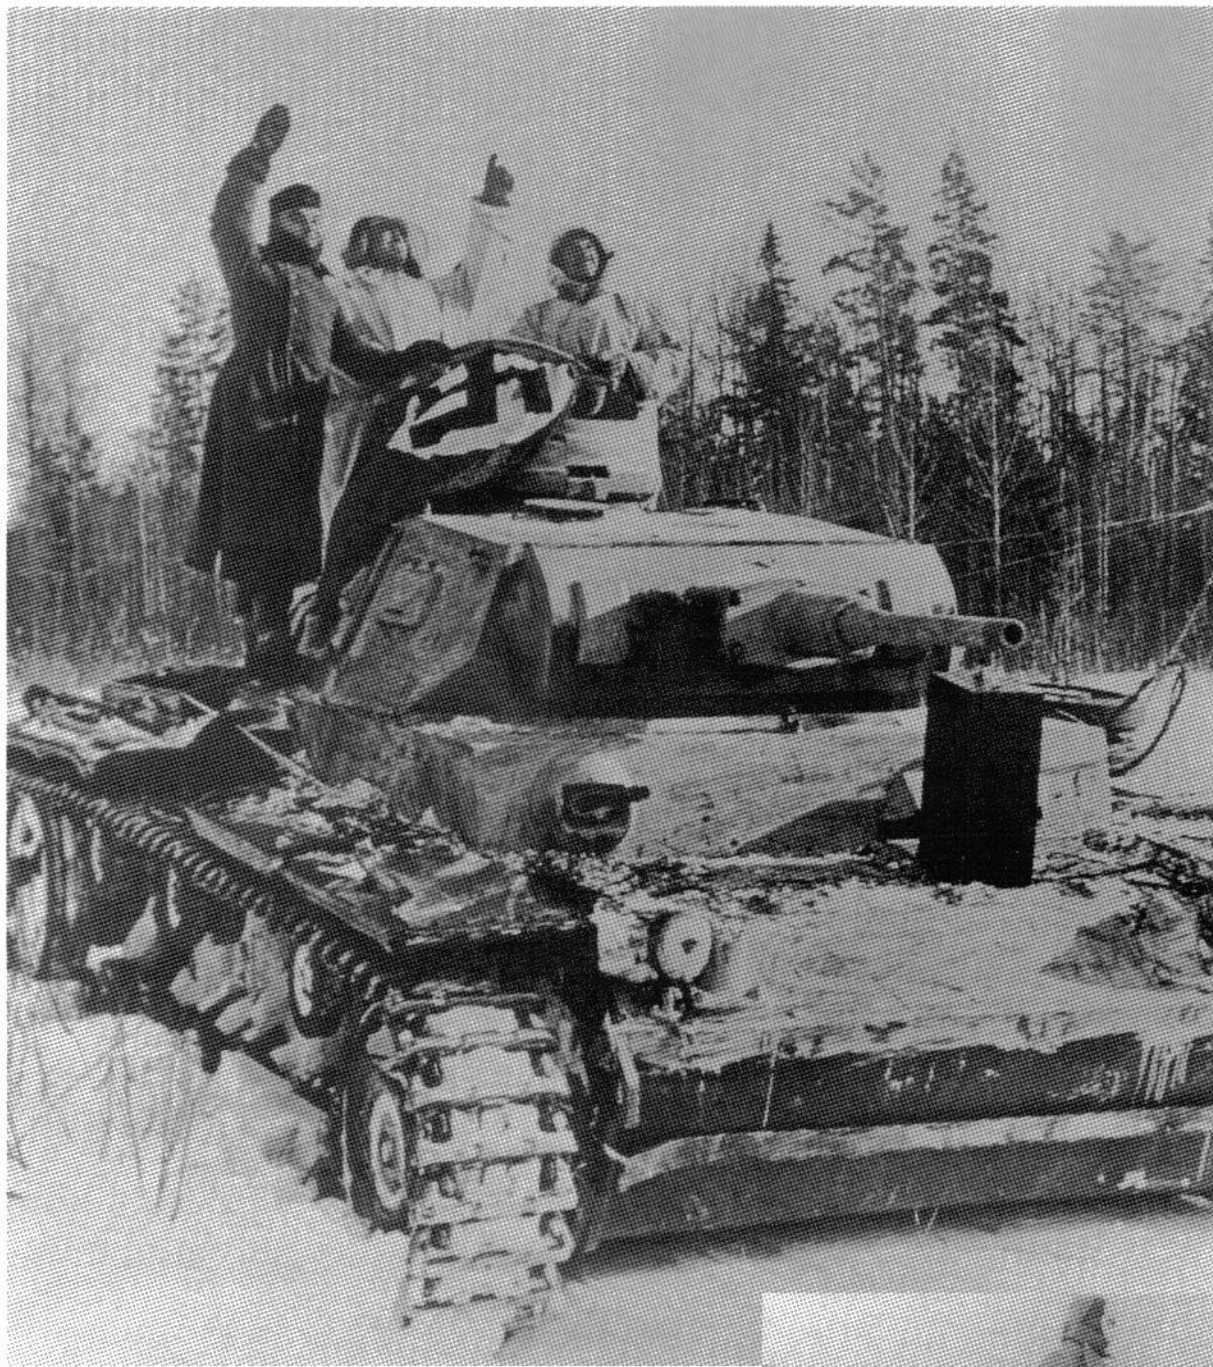
The crew of this Pz.Kpfw.III Ausf.J are waiting for another air supply drop in early 1942. The tank is completely covered with a thinly applied coat of whitewash painted on with a brush. Only the end of the gun barrel and front of the hull are left exposed because of the muzzle cover and spare track links normally carried in this position.

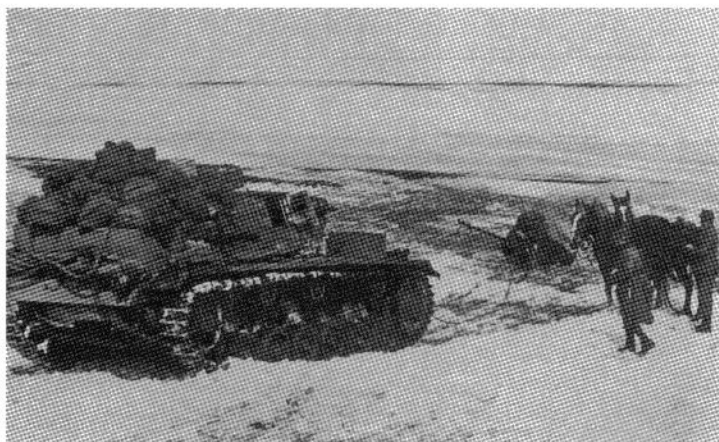
As losses of transport vehicles mounted, the German Army was often forced to rely on armored vehicles to move stores and equipment from place to place. Here, a heavily laden Pz.Kpfw.III Ausf.J helps retrieve a horse drawn supply cart that has broken through the ice of a small river in March, 1942.
