Panzer-Division 1935-1945

(2) The Eastern Front 1941-1943

Robert Michulec

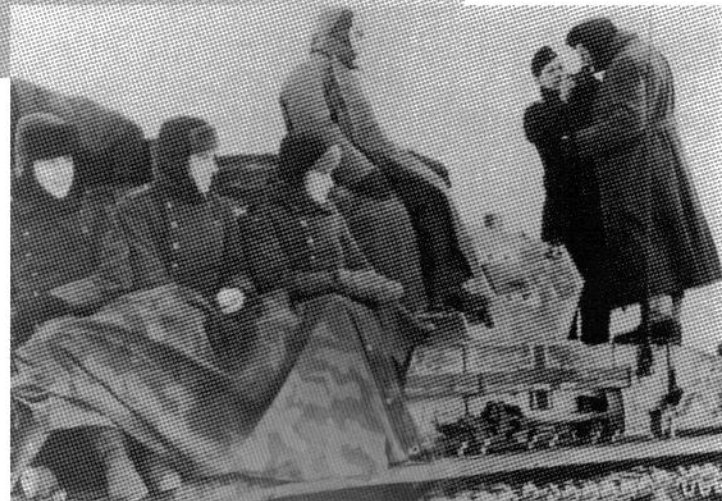
A Pz.Kpfw.IV Ausf.F1 provides transport for a group of men and equipment in February, 1942. The men are all warmly bundled against the cold and the three men sitting on the engine deck are using a Zeltbahn splinter pattern camouflage shelter quarter to cover their legs. Note the white outline national cross, part of which has been painted on the antenna trough. The winter camouflage paint has largely worn off most of the tank after prolonged exposure.

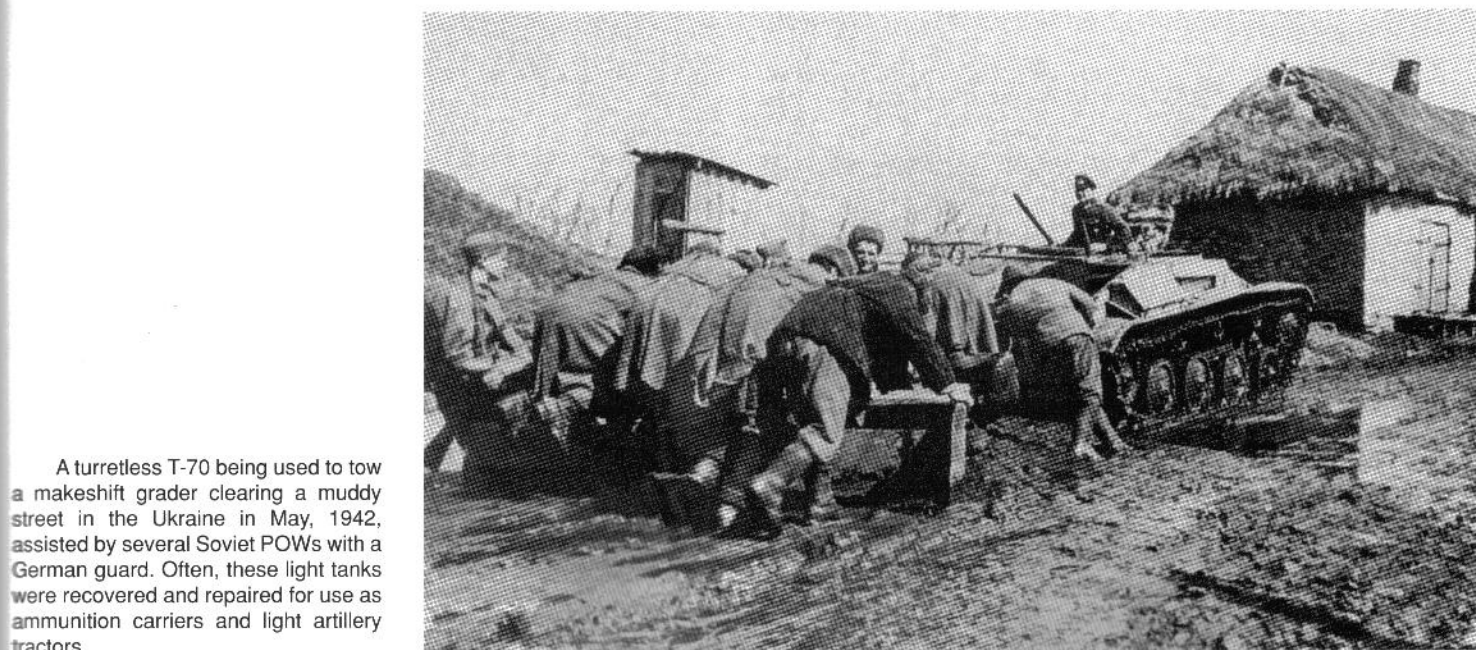
A turretleless T-70 being used to tow a makeshift grader clearing a muddy street in the Ukraine in May, 1942, assisted by several Soviet POWs with a German guard. Often, these light tanks were recovered and repaired for use as ammunition carriers and light artillery tractors.

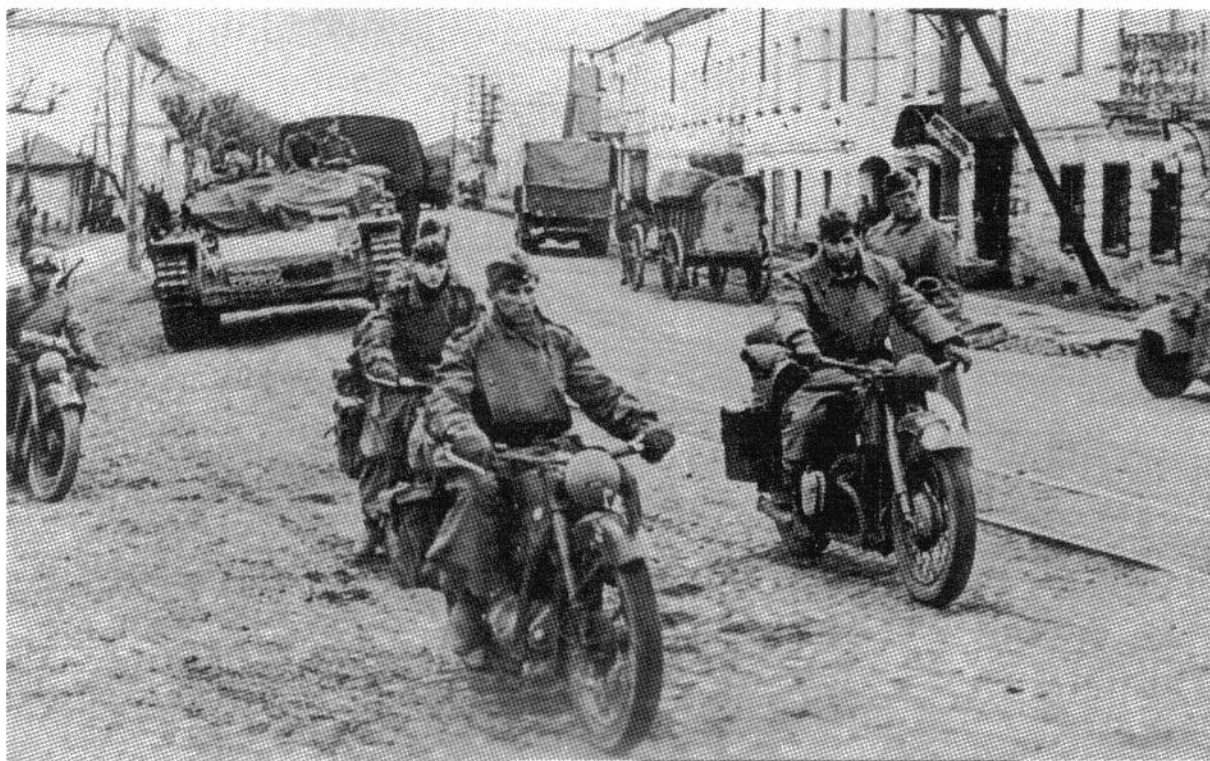
A BMW R35 and BMW R12 motorcycle lead the way through a Russian city in early 1942. Behind them is a StuG.III Ausf.E with a large canvas tarp over the front of the fighting compartment. Camouflage white paint covers the vehicle and some of the spare track links carried on the front of the hull. A section of new track links has been added beside them that has not been camouflaged.

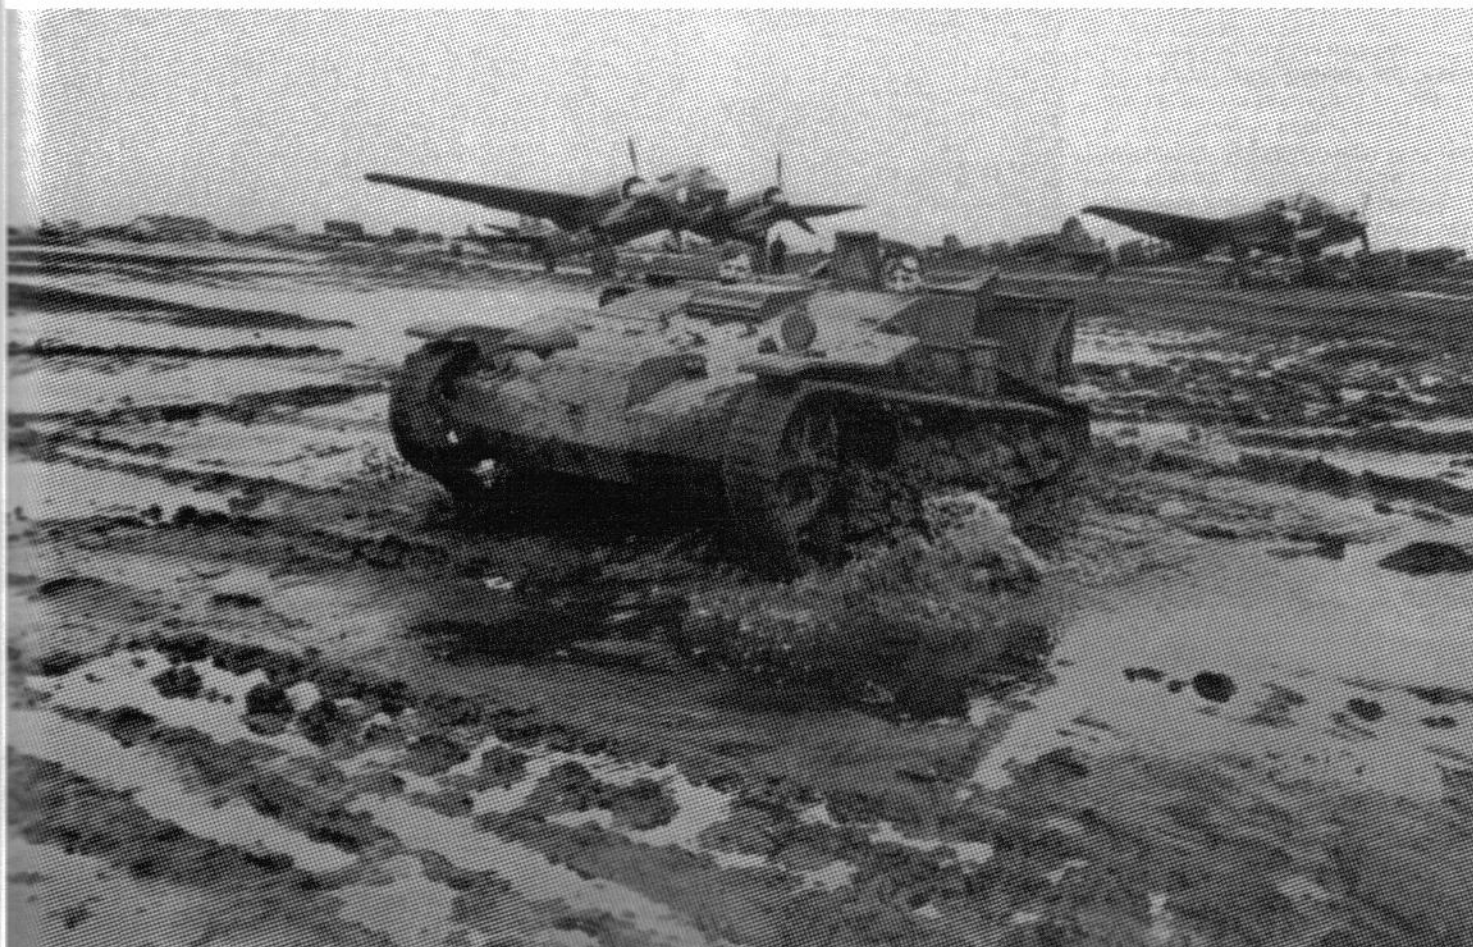
Many were used by the Luftwaffe for security and general duties, like this one photographed in Russia in April, 1942. They were able to carry a load of up to 500kg in the rear cargo compartment. In the background are two Junkers Ju88 bombers and a Ju52 transport.

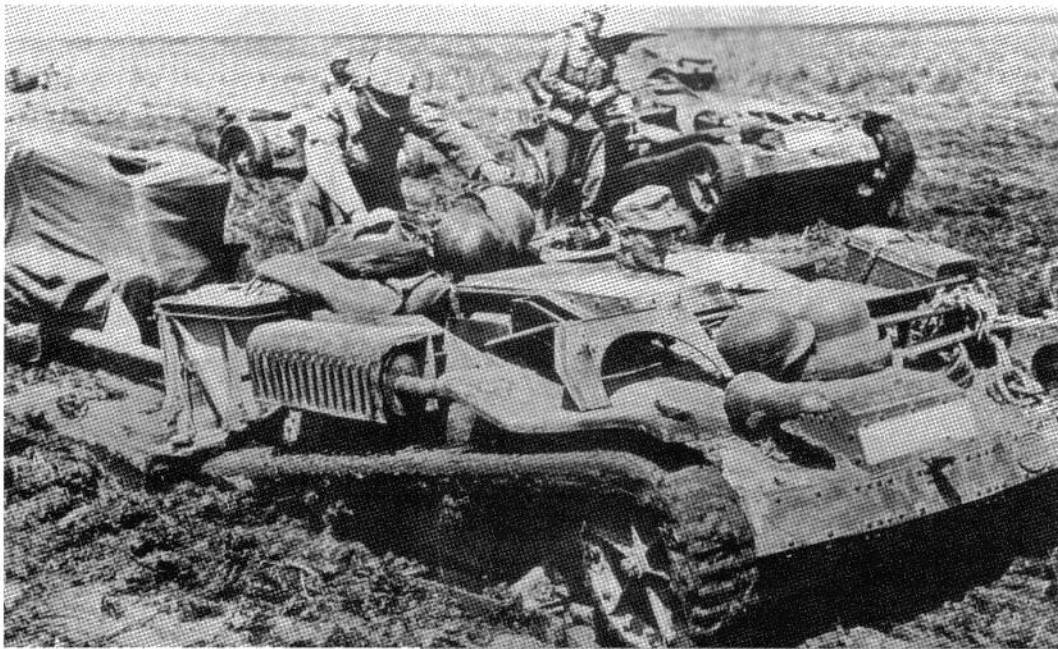
A pair of Renault UE tractors plow their way across the muddy Russian steppe after a rain storm in the spring of 1942. They normally had a crew of two men and had a large, open tray in the rear for carrying a load. Officially incorporated into the Wehrmacht, they were assigned a standard license number that would have been painted in the white rectangle on the front of the hull. It would appear that these two have not yet had their numbers assigned.

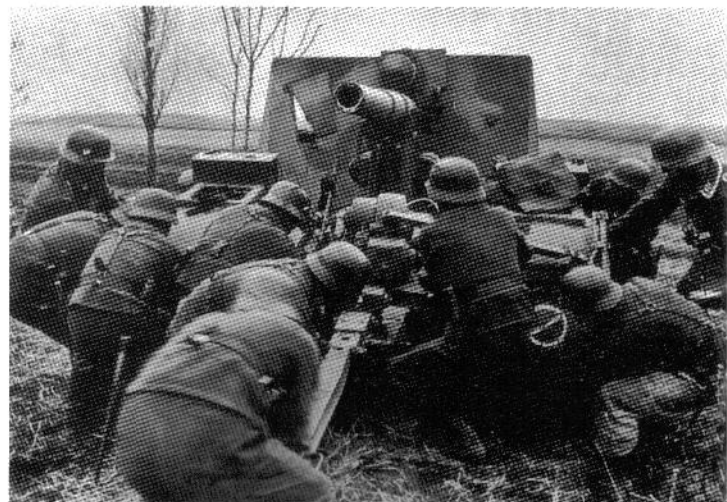
Luftwaffe troops struggle to remove the front carriage from their 8.8cm FlaK18 anti-aircraft gun in the Kharkov area in late May, 1942. The gun appears to have a two color camouflage scheme applied to the shield, the revival of a pre-war practice, and is likely green over the original dark gray base. The tactical marking on the mudguard frequently appears in photographs though the exact meaning is unclear.

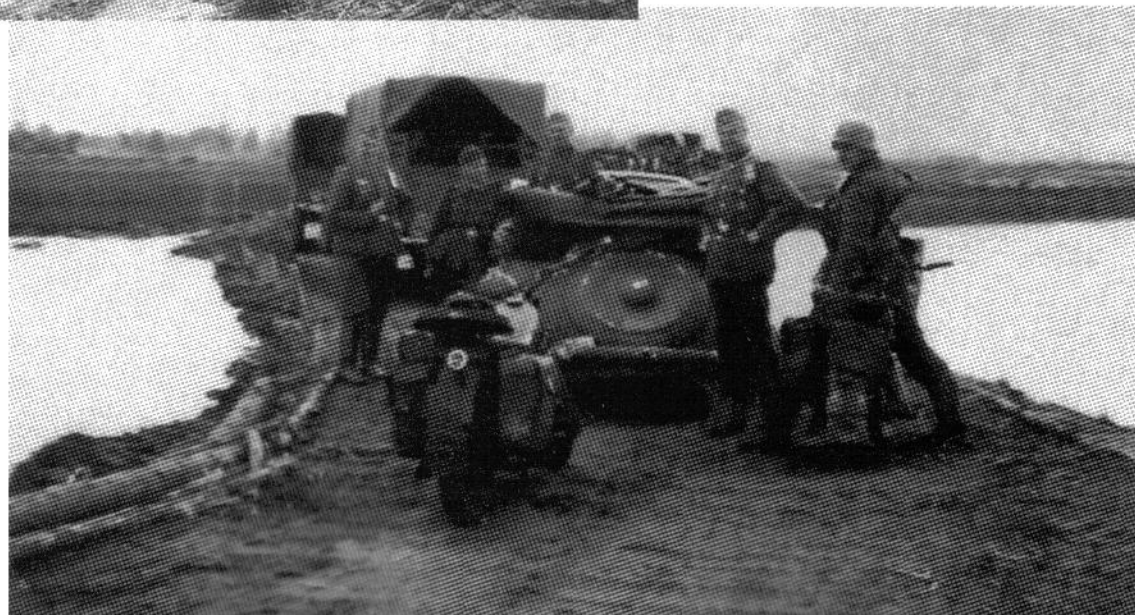
Another Horch Kfz.12 medium cross country car with a 3.7cm PaK35/36 in tow and gun crew posing for a photo to send to the folks back home. Again, the vehicle is fitted with a command flag frame on the left mudguard. The two soldiers on the right are wearing the special leather bandoleer used by artillery crews for manhandling their guns.

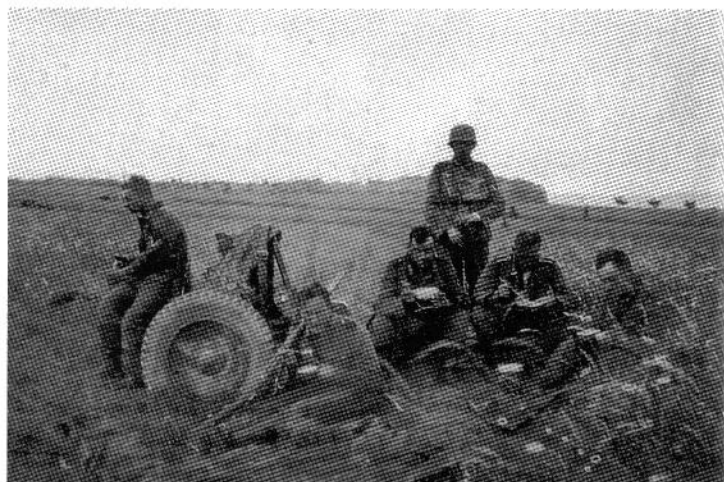
The crew of this 3.7cm PaK35/36 pause for a meal at their post in an open field. Though one of the best anti-tank guns of its day, its small size and limited protection could not have inspired much confidence in the men assigned to it.

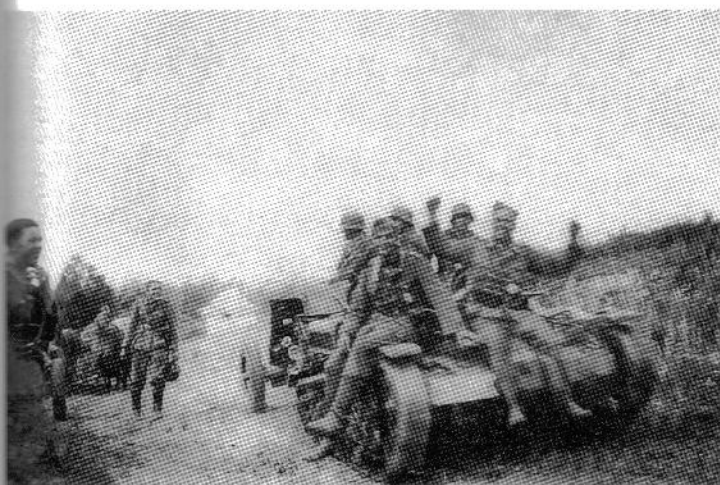
Another 3.7cm PaK35/36 gun crew enjoy a ride on a Renault UE 630(f) being utilized as a gun tractor. This little vehicle was perfect for short distance moves but would have been extremely uncomfortable on a long march.

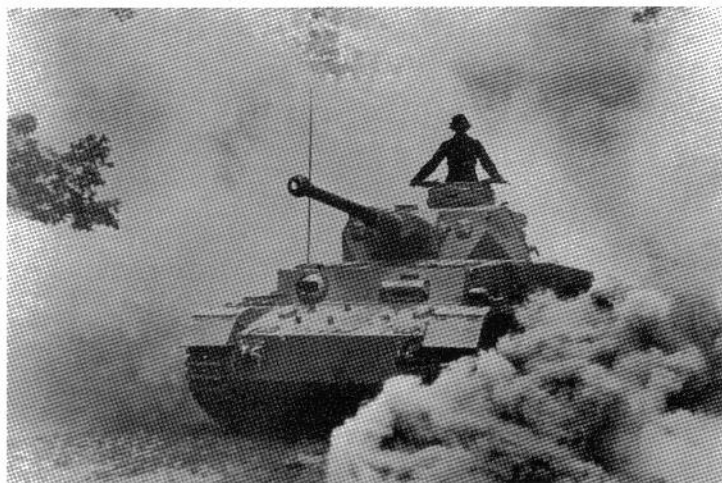
A new, very early Pz.Kpfw.IV Ausf.G. featuring the additional 30mm armor plates welded to the front of the hull and superstructure. The side vision flaps on the turret have been deleted, however, the loader's front vision flap is still fitted as is the early, globular muzzle brake normally associated with the Ausf.F2. The introduction of the 7.5cm KwK40 L/43 gun on the Ausf.F2 gave the German tank crews a new superiority over the better armed Soviet KV-1 and T-34 tanks. It is painted with the standard dark gray base which has been lightened by a coat of dust.

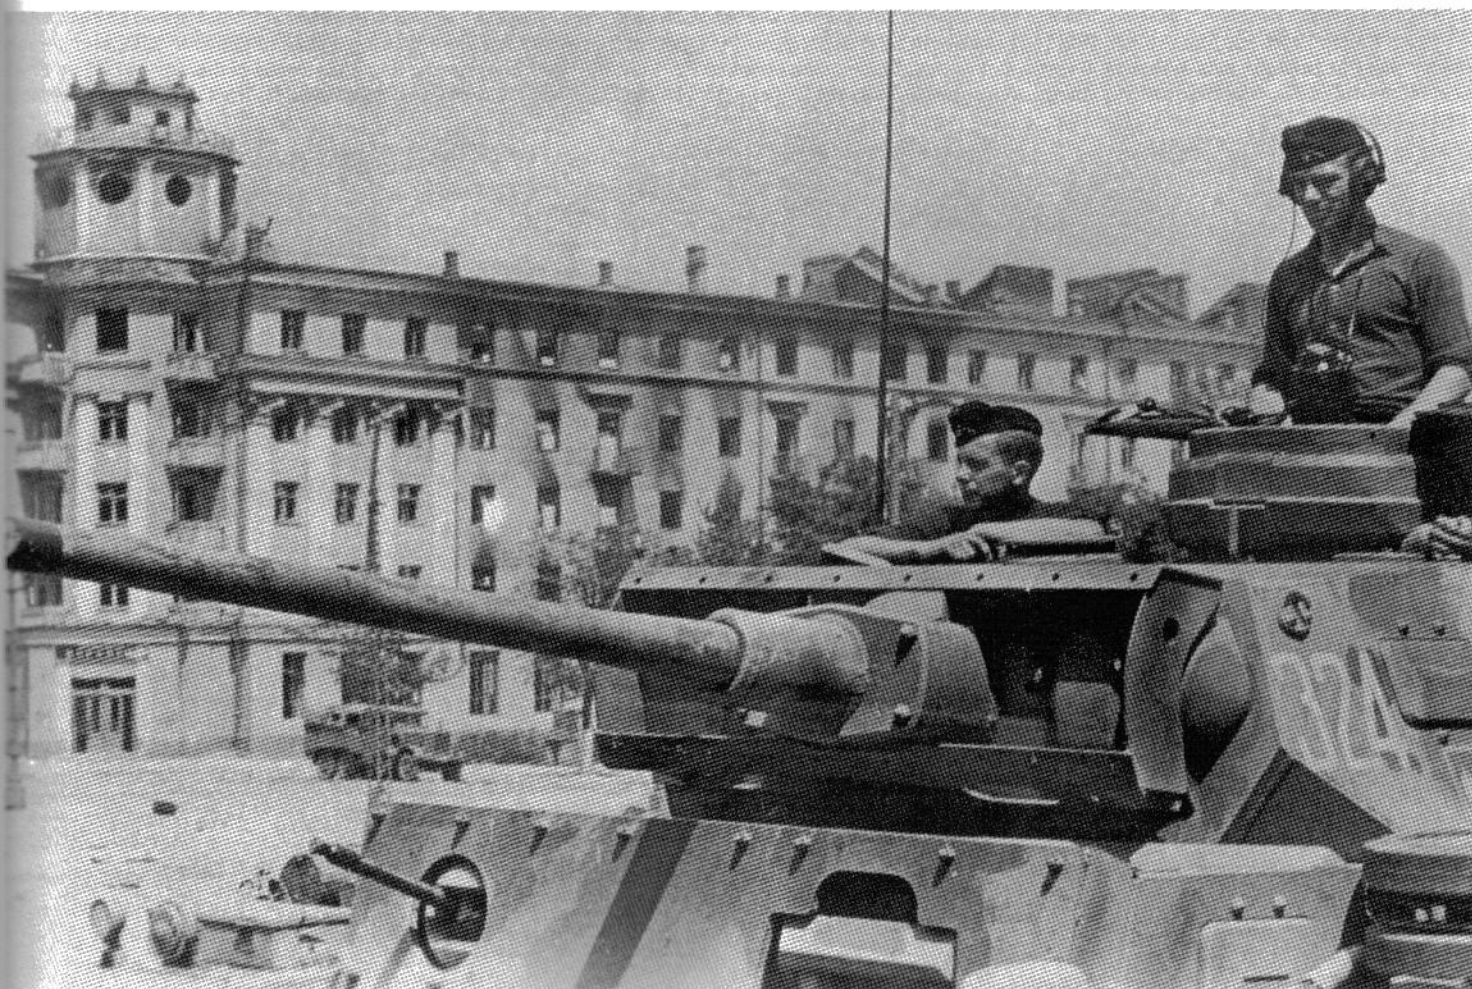
A closeup of a late Pz.Kpfw.III Ausf.J equipped with the 5cm KwK 39 L/60 gun, traveling through the city of Voronezh in late June or early July, 1942. It has been fitted with the 20mm spaced armor hull plate introduced on the Ausf.L and although the mounting plates on the mantlet have been installed, the 20mm plate is yet to be fitted here. The vehicle is finished in dusty coat of dark gray with a camouflage pattern of large, green irregular spots. The tactical number '324' is painted on the side of the turret in white along with a white outline square below the vision flap.

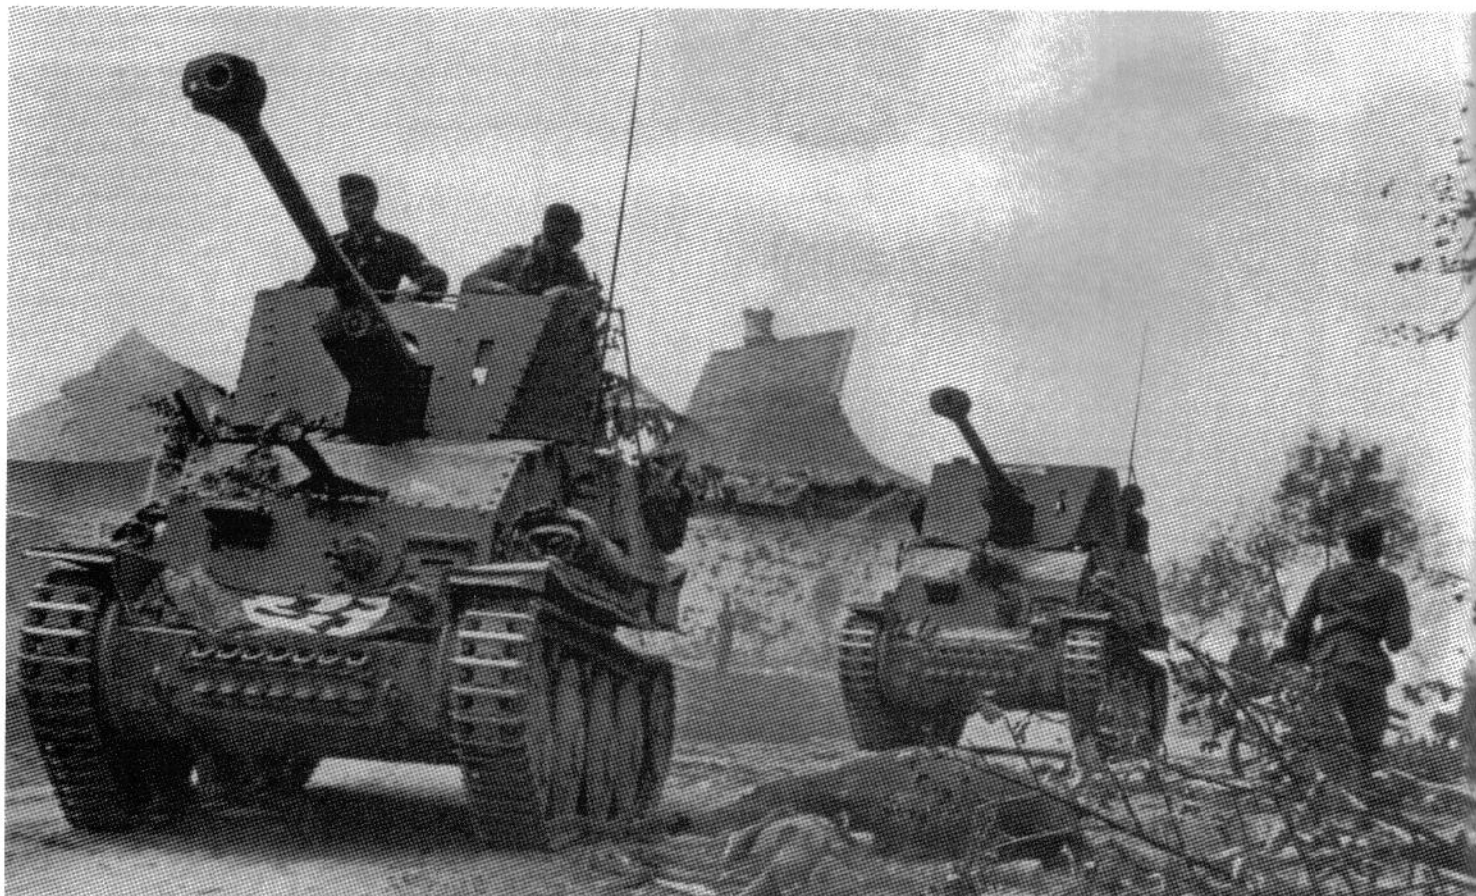
Two Panzerjäger 38(t) für 7.62cm PaK36(r) Marder III tank destroyers. Over 350 of these vehicles were built from April to October 1942 and served mainly with Panzerjäger units in Russia. It was a simple adaptation of the obsolete Pz.Kpfw.38(t) tank chassis and captured stocks of the Soviet 7.62cm Field Gun Model 1936. The barrel was rechambered to accept a 7.5cm PaK40 cartridge. Note the German national flag draped over the front of the leading vehicle for air recognition.

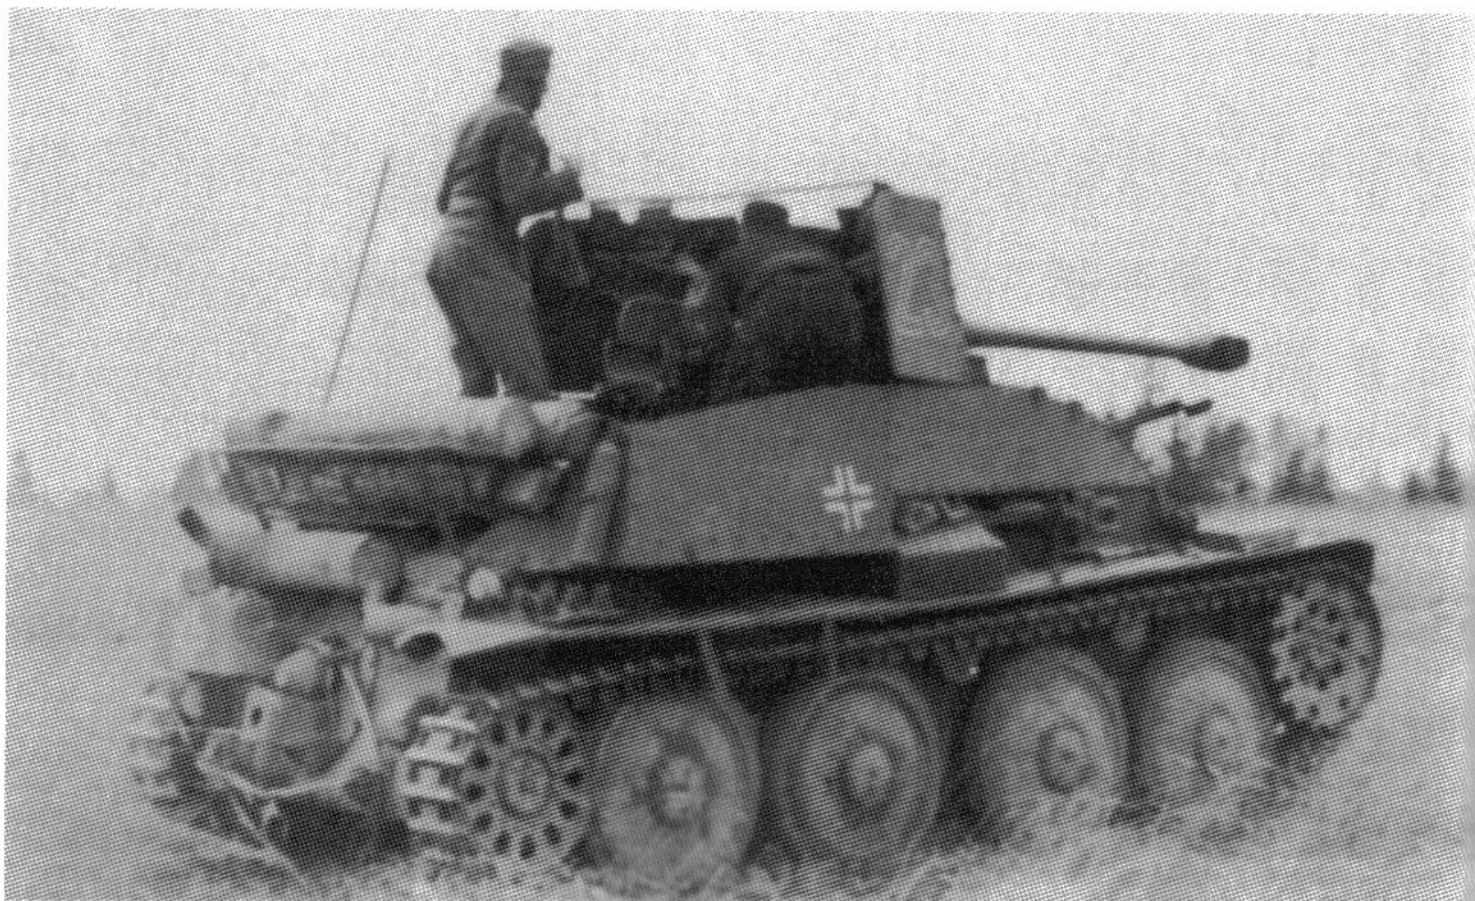
Another photo of a Marder III in action during the summer of 1942. It is obvious the space within the crew compartment was very limited and only provided partial protection against enemy small arms fire and shell splinters.

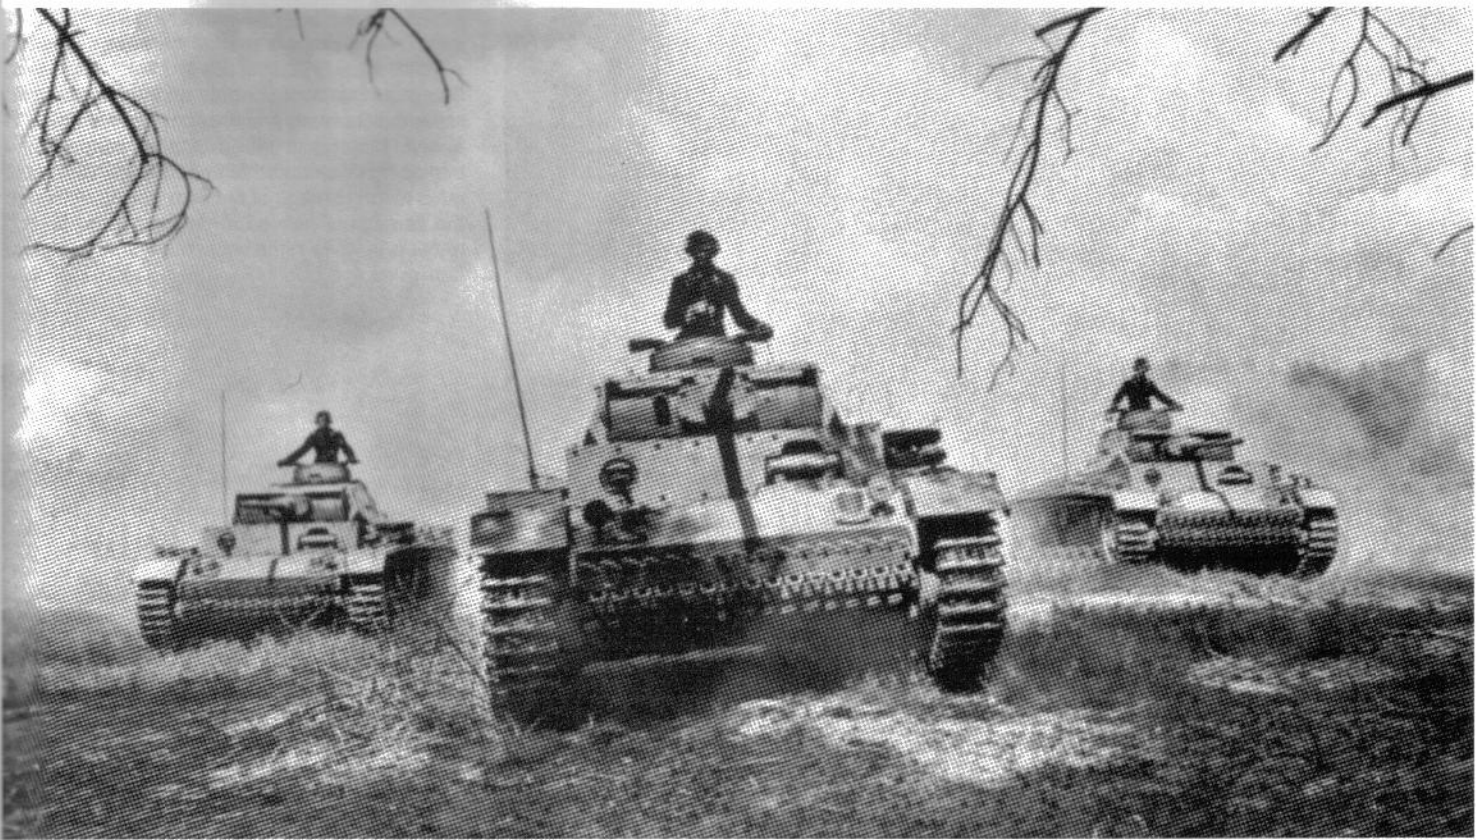
Three Pz.Kpfw.III Ausf.L in what appears to be a propaganda photo of charging Panzers. The 5cm KwK39 L/60 gun was introduced in the Pz.Kpfw.III Ausf.J in December 1941 and continued with the Ausf.L until December 1942. Their armored protection was upgraded by the addition of 20mm spaced armor plates on the upper hull and mantlet, however, due to the late delivery of a new torsion bar counter-balance for the main gun, many did not receive the mantlet armor.

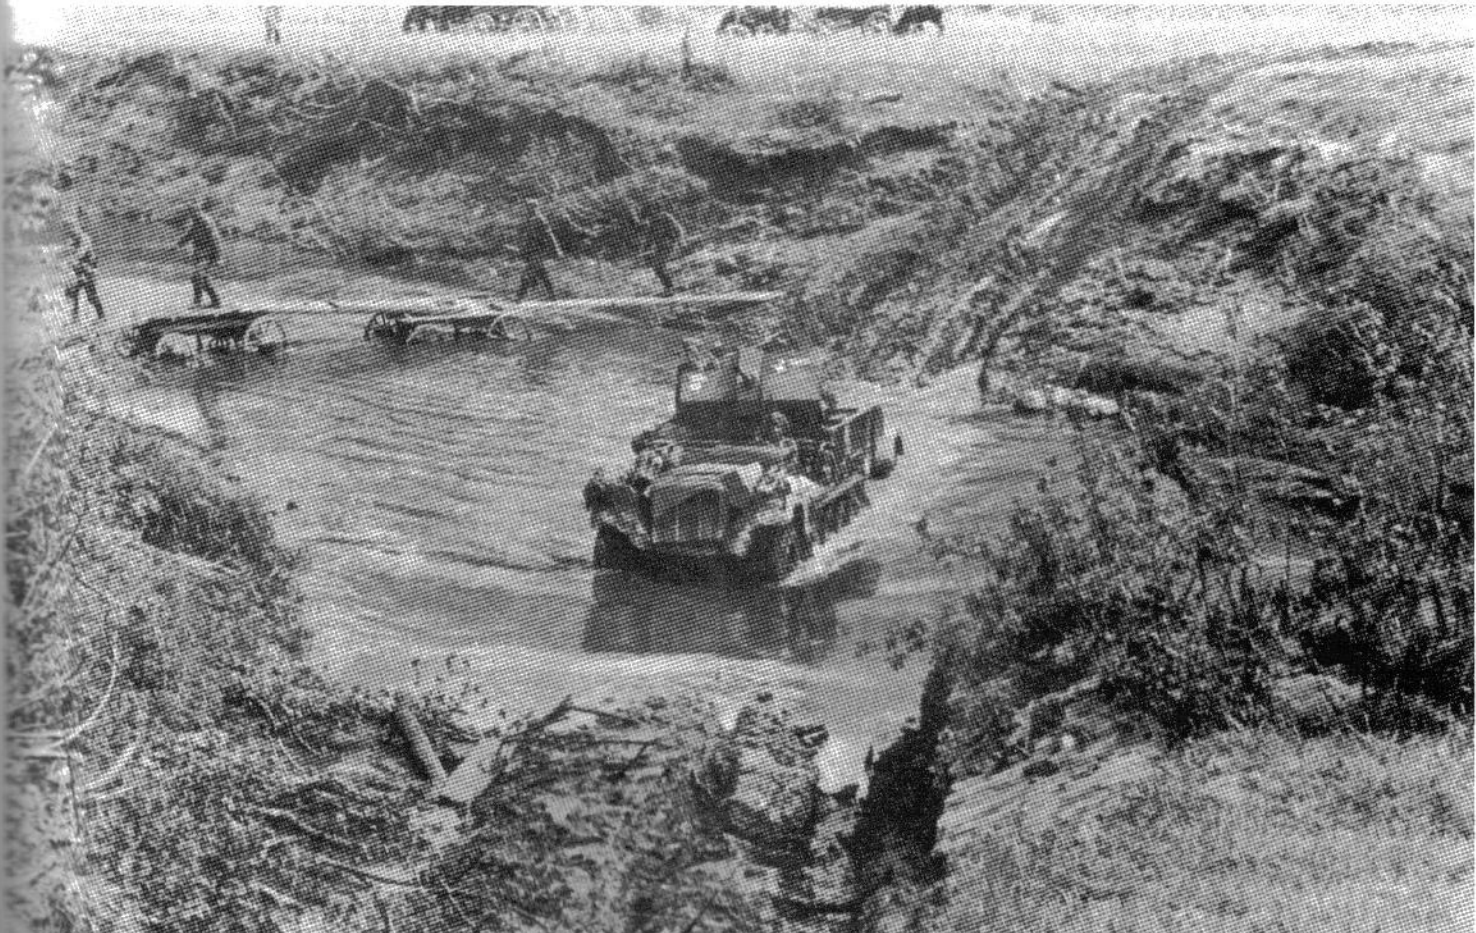
An Sd.Kfz.10/4 half-track armed with a 2cm FlaK30 anti-aircraft gun fording a shallow river somewhere in the steppes of Russia between Rostov and Voronezh in early July, 1942. The vehicle has seen some heavy action judging by the kill markings painted on the gunshield. There are no less than 8 aircraft shot down and 5-6 light armored vehicles destroyed. On the left mudguard, a white circle has been painted with an illegible marking inside.

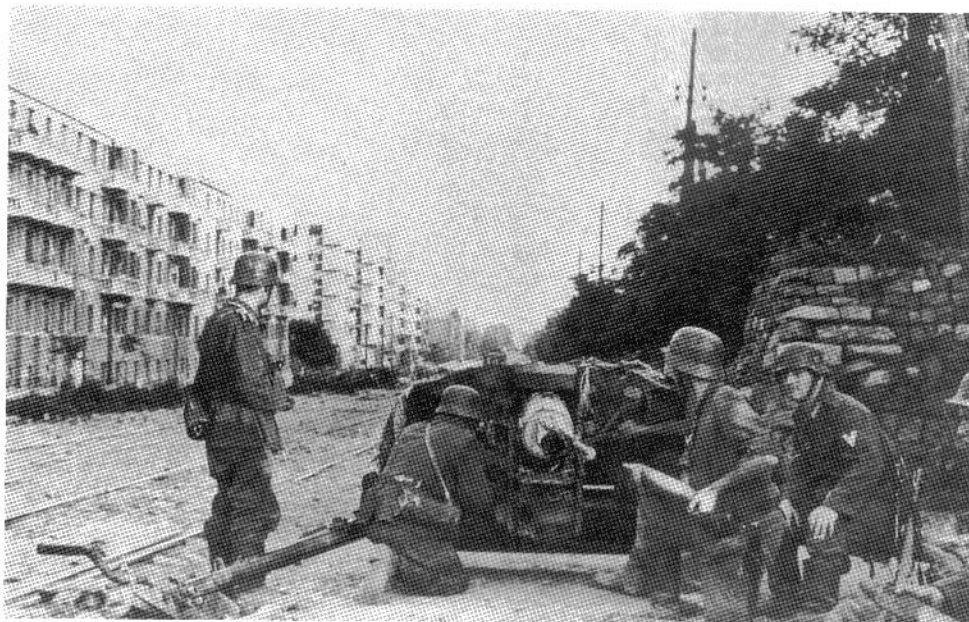
A 7.5cm PaK97/38 anti-tank gun and its six-man crew guard a street in the newly captured city of Rostov on Don in the middle of July, 1942. The gun was introduced as an interim measure when the Germans first encountered the new KV-1 and T-34 tanks in Russia, by adapting the barrels from captured French Model 1897 field guns to the carriage of the 5cm PaK38. Although the carriage is painted in dark gray, the breech remains in white in the same manner as standard tank guns.

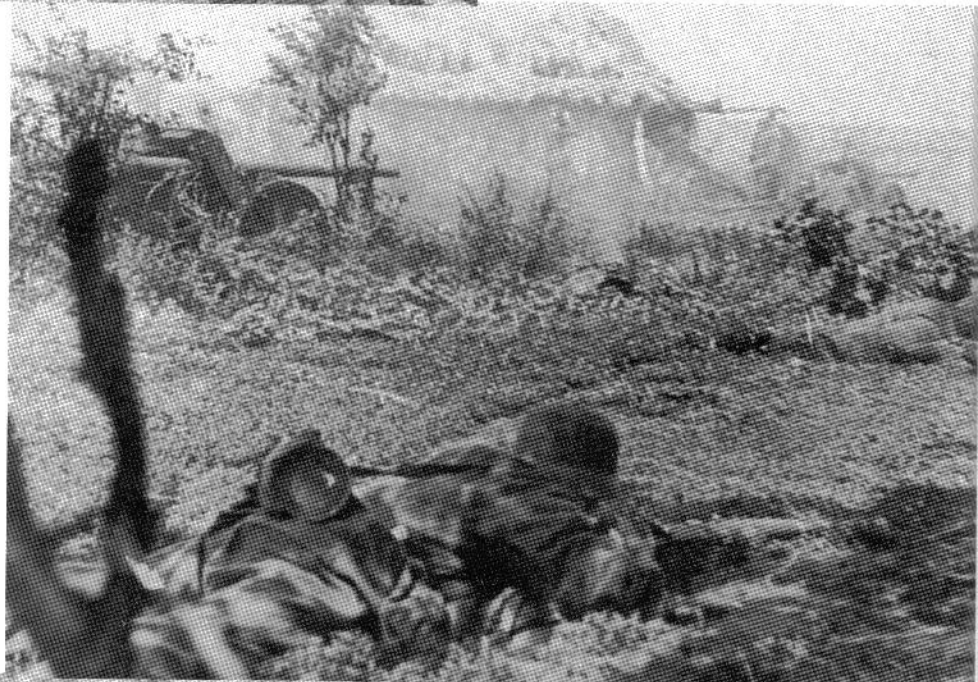
Two anti-tank guns photographed in the heat of battle in late July or early August, 1942. They are 5cm PaK38 which entered service in late 1940 and during 1941 and early 1942, was the only anti-tank gun in the German arsenal that could defeat the T-34 until sufficient supplies of its successor, the 7.5cm PaK40 were available. The muzzle brake on the nearest gun has been removed by the censor.

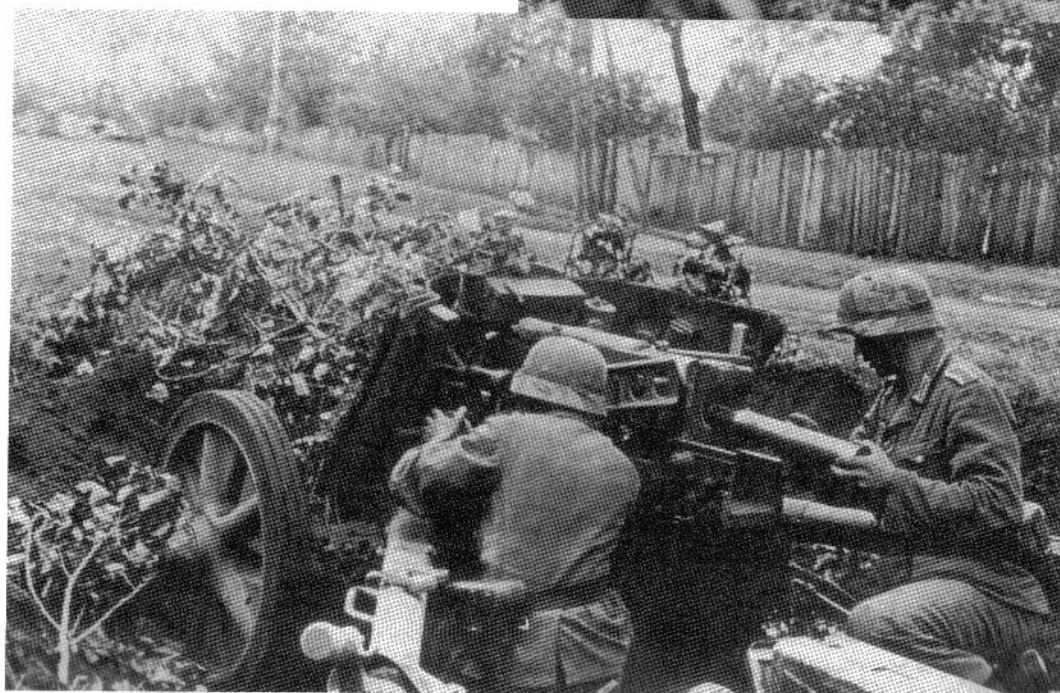
Few Soviet tanks were safe at ranges below 500m when they appeared in the sights of the 5cm PaK38, especially when using the powerful, but uncommon, Pzgr.Patr.40, capable of penetrating 116mm of armor plate at that distance. This was drastically reduced to 72mm at a range of 1000m. Here we can see one of these guns in action on the outskirts of a Russian village near Achtyrka. As well as camouflaging their gun, the crew have also camouflaged their helmets, probably with mud.

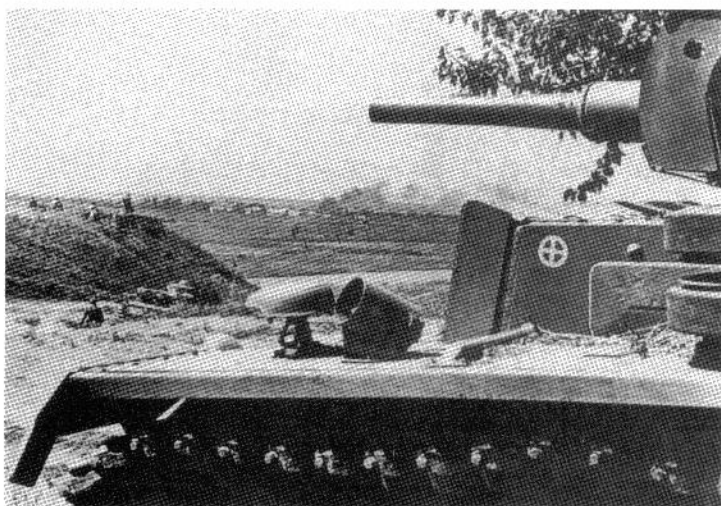
An early Pz.Kpfw.III Ausf.J with the 5cm KwK L/42 gun which has been backfitted with a 20mm spaced armor plate on the front of the upper hull and brackets for a 20mm plate on the mantlet. The tactical sign for 13.Panzer-Division is clearly seen painted in yellow on the side of the hull. Of special interest is the installation of the S-Minenwerfer on the mudguard otherwise only seen on the Tiger I. This photo was taken in the Kuban during the summer of 1942.

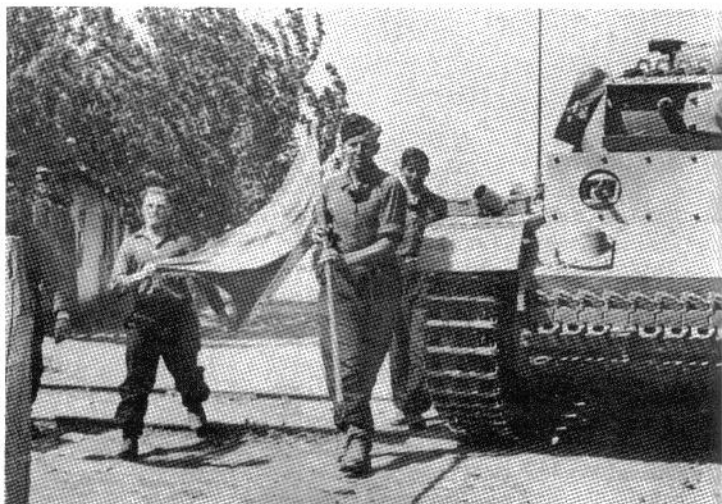
Pz.Kpfw.III Ausf.H, II./Pz.Rgt.18, 18.Panzer-Division, Russia, September 1941

This tank is finished in overall dark gray and carries the divisional emblem, a white skull over ripples of water within a white outlined black shield, painted on the rear of the turret stowage bin. The emblem recalls its formation from one of the original Tauch-Panzer-Abteilungen in the summer of 1940, although this vehicle is not one of those specially equipped tanks. The tactical sign of 18.Panzer-Division, a yellow 'Y' with three horizontal bars through it, is painted on the sides of the turret in front of the white, three digit tactical number, both of which are also repeated on the rear of the bin. The tactical sign appears on the front plate beside the driver's visor as well. Two white victory markings have been painted on the end of the gun barrel.

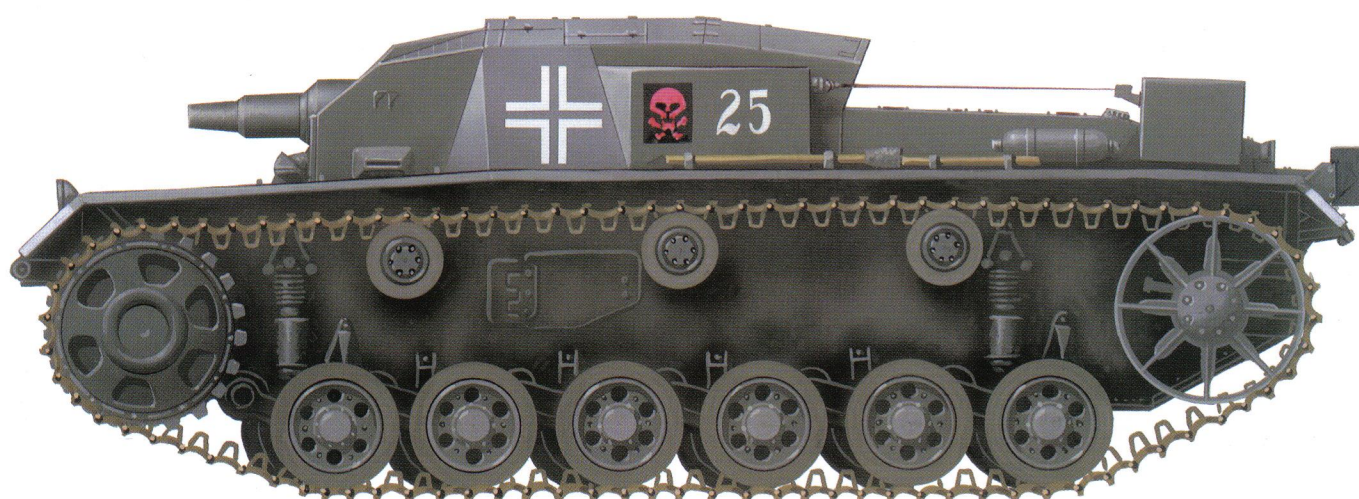
StuG.III Ausf.B, 1./StuG.Abt.192, Russia, summer 1941

The vehicles of StuG.Abt.192 carried their 'Totenkopf' unit emblem prominently displayed on the front plate beside the gun, both sides of the vehicle and on the rear of the smoke candle rack housing. The emblem was painted a different color in each battery, red in first battery, yellow in second battery and green in third battery, all in a black rectangle. They used a two digit tactical number system that was painted in white beside the unit emblem, except on the front, where they were painted above the emblem on the Ausf.Bs and beside on the later versions. Some also had the tactical sign for a self-propelled gun unit painted in yellow on the front of the hull with the battery and the unit number, '1/192', painted inside. Both the early and later style national crosses were seen. A number of them also carried white road width markings on their front and rear mudguards.

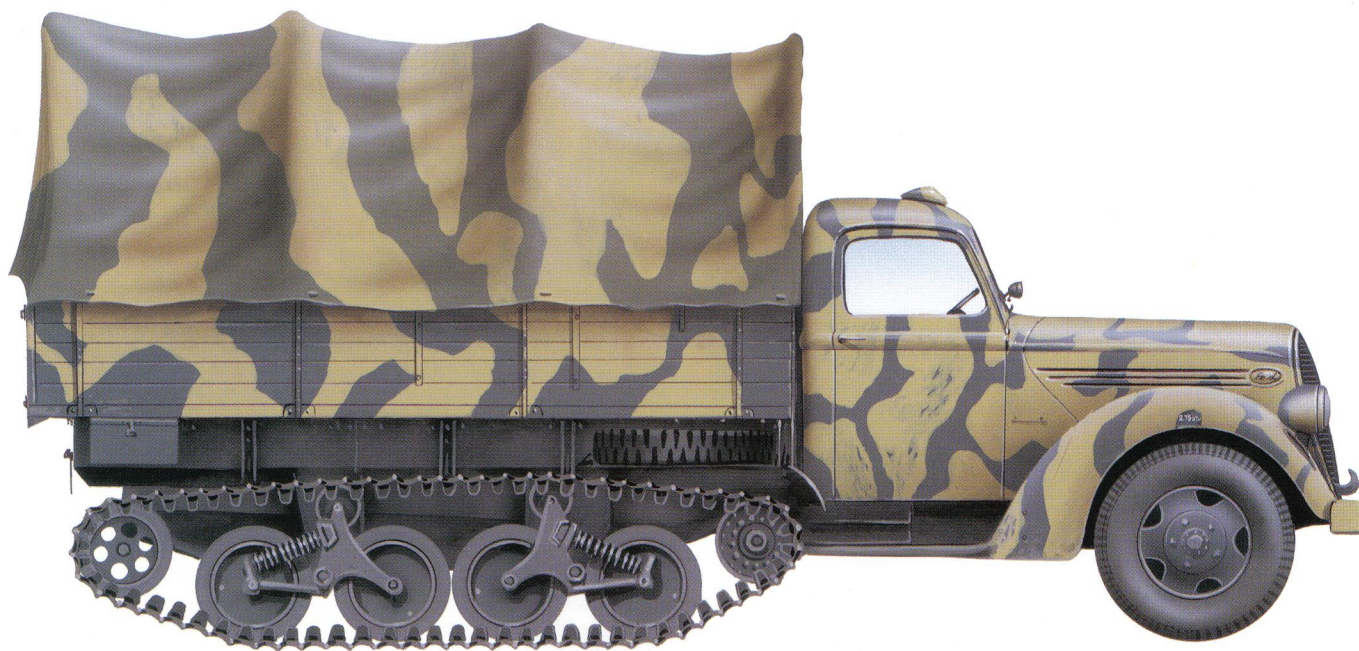
Ford G917T 'Maultier', unknown Infanterie-Division, Russia, summer 1943

This new Ford 'Maultier' (Mule) is finished in overall dark gray with a bold camouflage pattern of dark sand patches. Markings include the tactical sign for a motorized infantry division painted in white on the left rear of the cargo compartment and on the left front mudguard along with the vehicle number plate on the rear only. Tire pressure markings are also painted on the sides of the front mudguards.

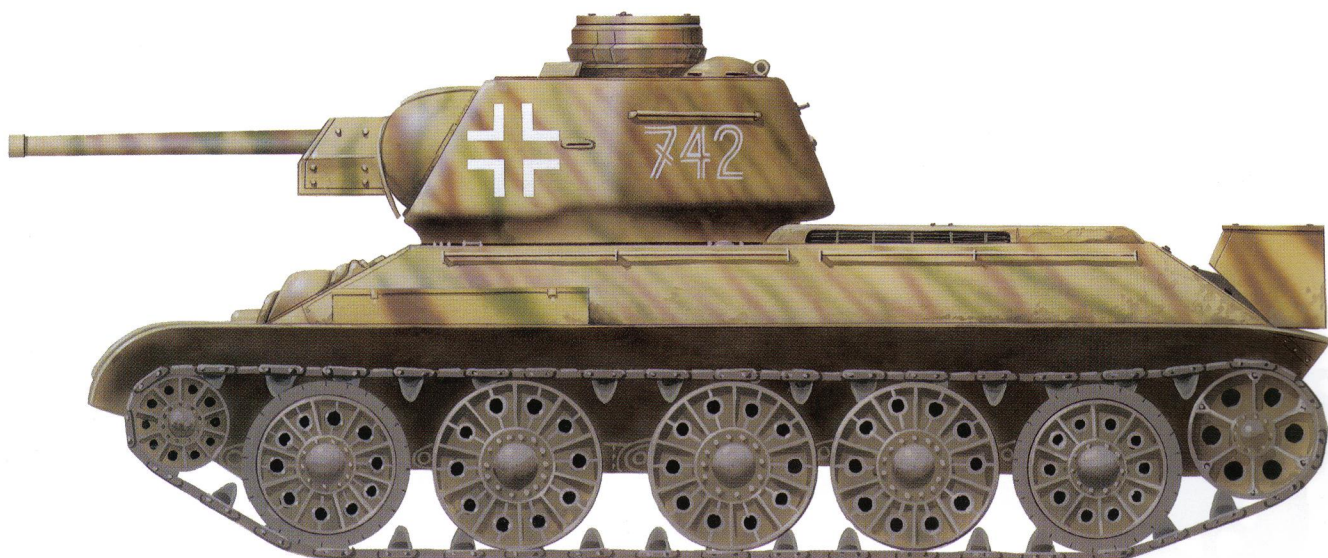
T-34/76 Model 1943, Pz.Rgt.11, 6.Panzer-Division, Russia, summer 1943

This captured Russian T-34/76 Model 1943 has been repainted by the Germans in dark sand with a camouflage scheme of light green and brown lines painted in a diagonal stripe pattern. An oversize white outline national cross has been prominently applied to the turret to identify it to German gunners along with a white outline three digit tactical number, '742', indicating the second vehicle in the fourth platoon of the seventh company. On the front plate, a white 'Op' was painted which signified the commander of Pz.Rgt.11, Oberst Herman von Oppeln-Bronokowski. The vehicle has been fitted with a cupola taken from a damaged Pz.Kpfw.III or Pz.Kpfw.IV.

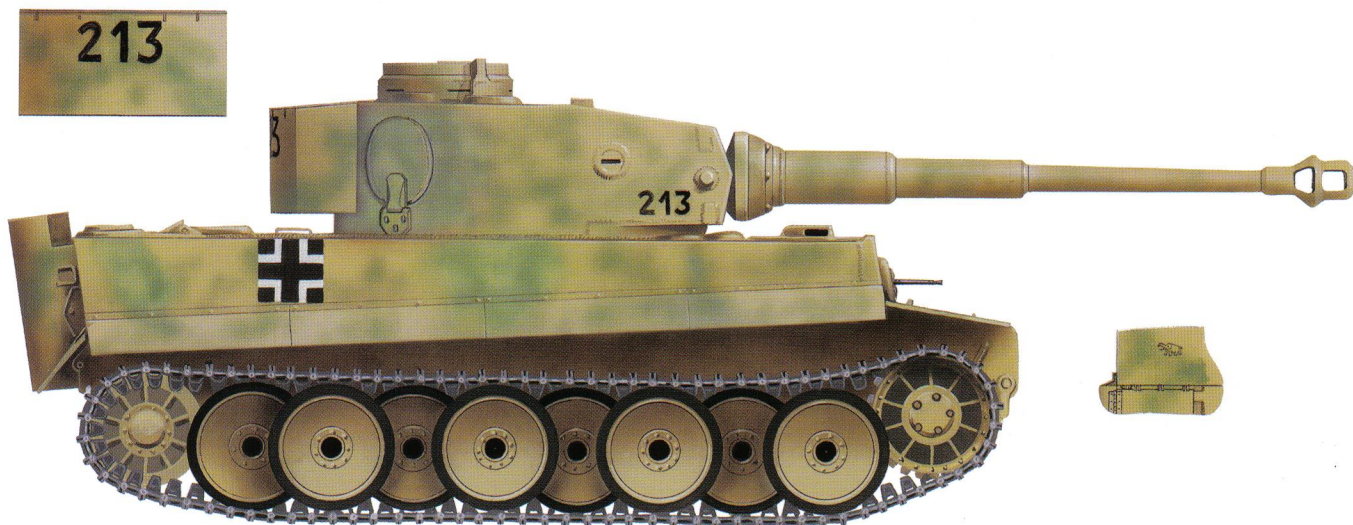
Pz. Kpfw. VI Tiger I Ausf. E, 2./s. Pz. Abt. 502, Russia, summer 1943

This early model Tiger I is painted in overall dark sand with a very light camouflage pattern of green patches. Tigers of 2. Kompanie carried a large national cross painted within a black square, located above the 7th and 8th roadwheel on each side of the hull. The three digit tactical number, also in black, is painted on the lower front side of the turret and has been repeated on the rear of the turret stowage bin as well. A small black outline mammoth, the unit's emblem, is painted on the front of the hull to the right of the machine gun ball mount.
