Panzer-Division 1935-1945

(2) The Eastern Front 1941-1943

Robert Michulec

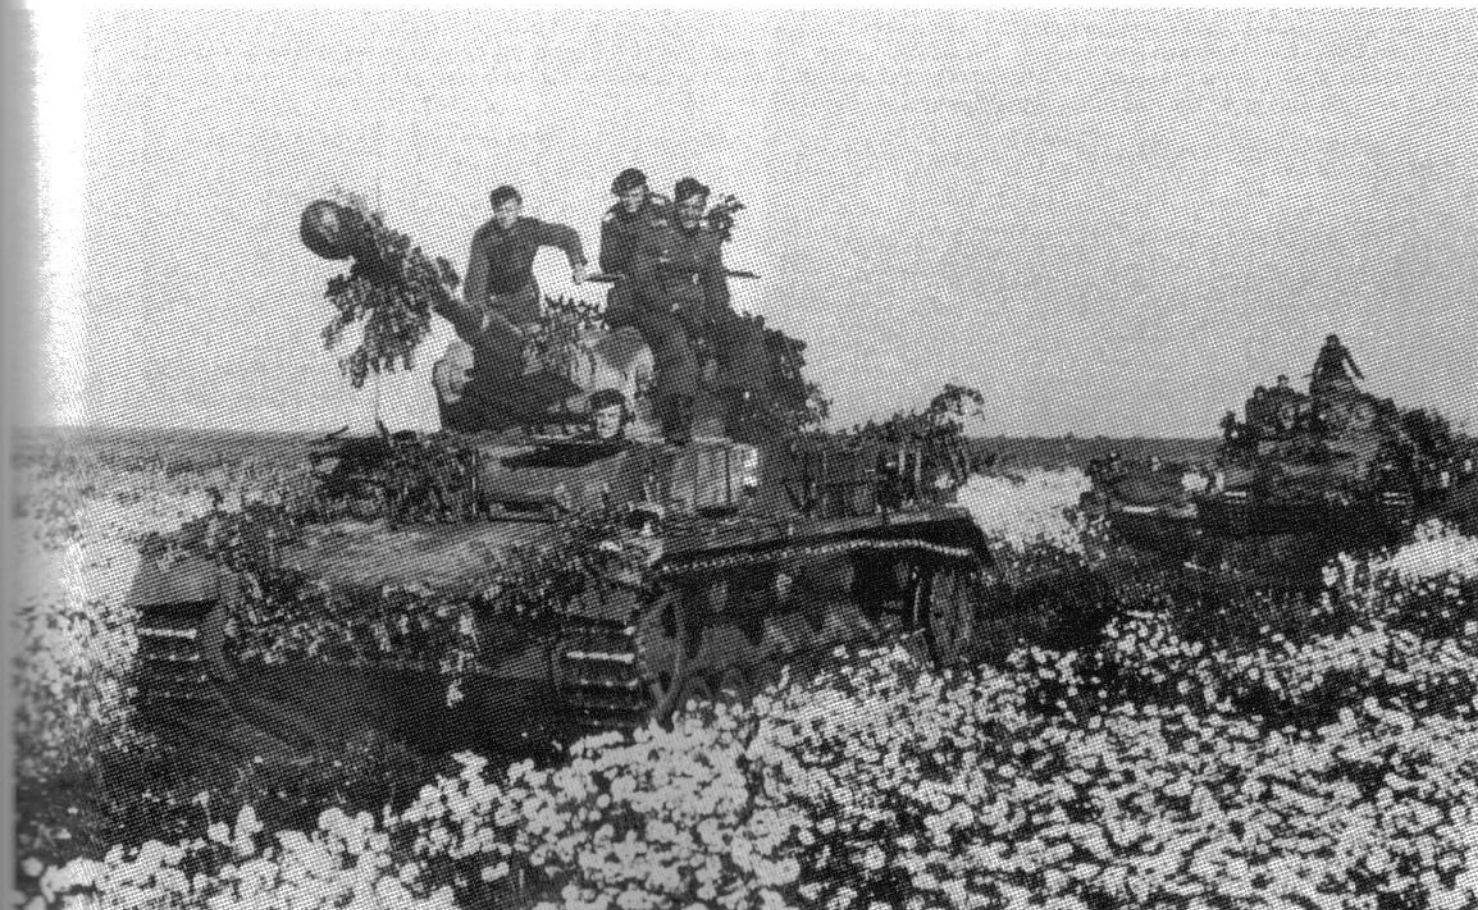
Two new Pz.Kpfw.IV Ausf.F2 of Panzer-Grenadier-Division 'Großdeutschland' march across the Russian steppes in the Don bend, August, 1942. They are painted in dark gray with sand colored spots sprayed on randomly and have foliage added to break up the shape of the vehicle. Armed with the 7.5cm KwK40 L/43, the Pz.Kpfw.IV Ausf.F2 finally gave the German Army superiority over the Russian KV-1 and T-34.

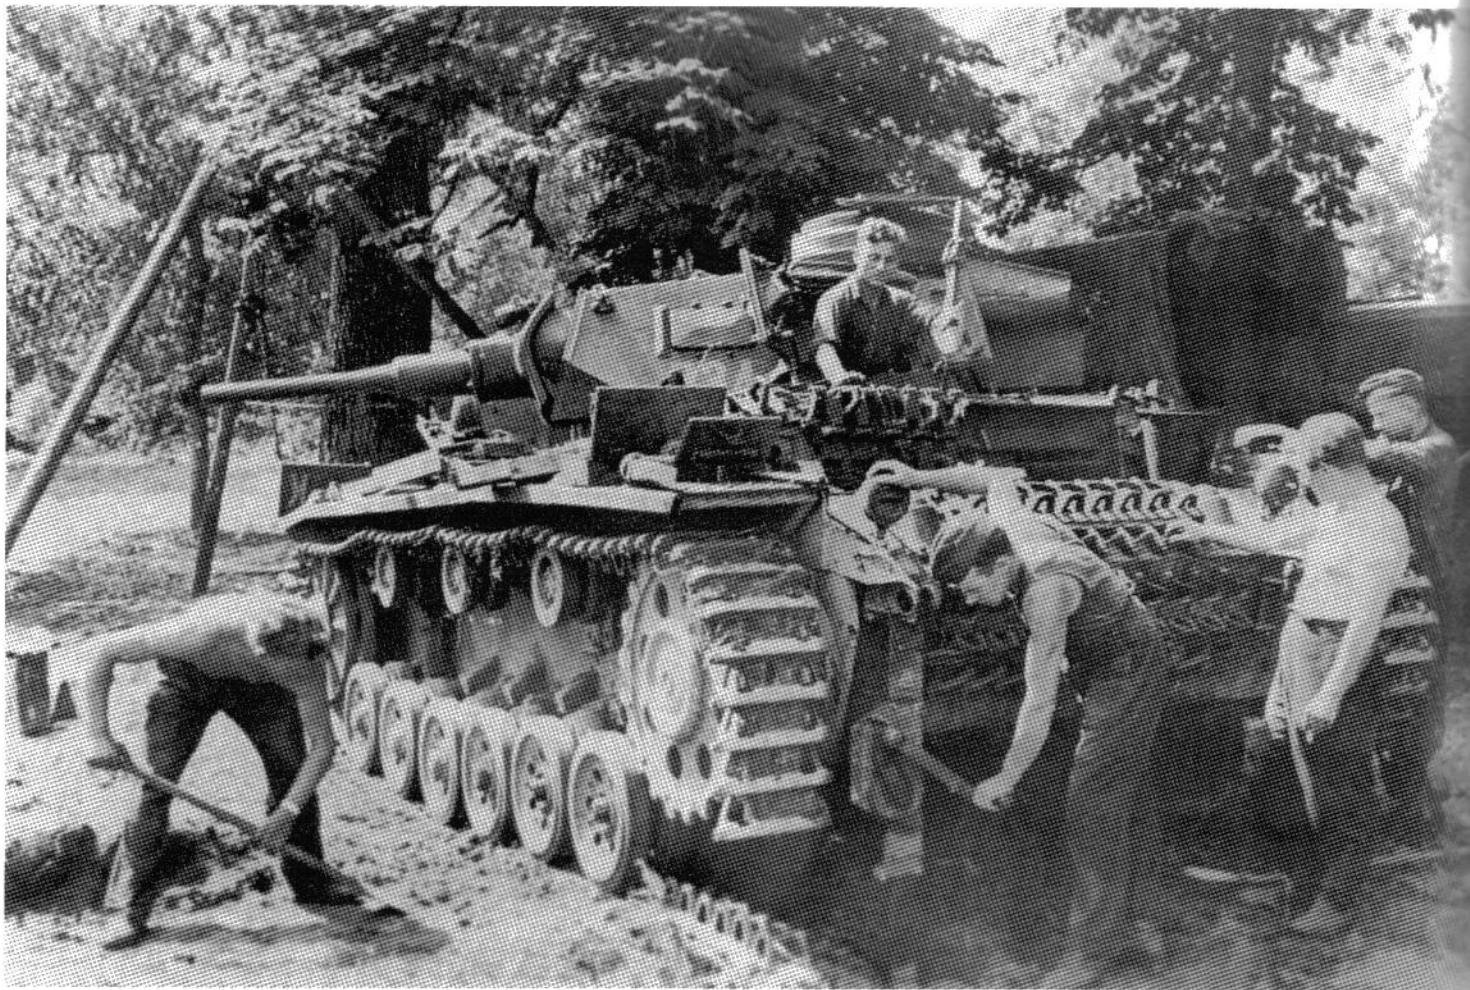
The crew of this Pz.Kpfw.III Ausf.F perform track maintenance during a lull in the fighting. It has been refitted with a 5cm KwK L/42, in place of its original 3.7cm KwK L/46.5 gun, along with a later cupola. The tactical number '334' appears on the sides of the turret in yellow along with a white letter 'K' on the rear mudguard. During July and August, at the height of the summer offensive in the central and southern part of the Eastern Front, the Germans lost 396 tanks of this type. During the same time, 462 replacements were produced.

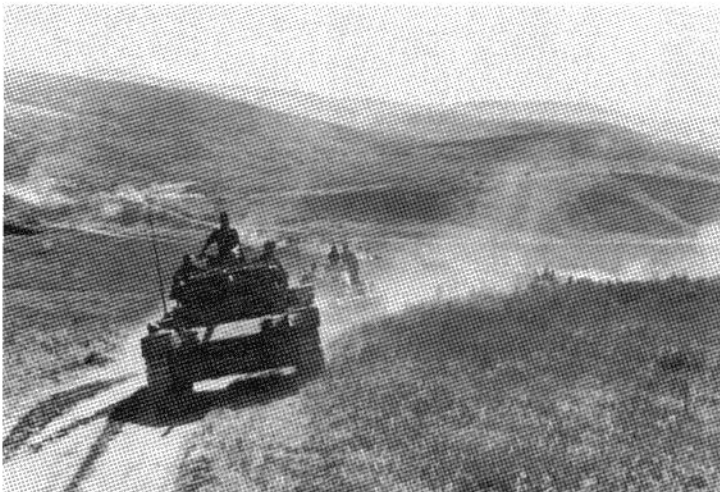
A column of Pz.Kpfw.III advancing through the foothills of the Caucasus Mountains in August, 1942. The armored units of H.Gr.Sud., despite their weakness, played a major role in the campaign to capture the Russian oilfields, striking quickly into the region against light defenses. In early November, 1942, 13.Panzer-Division advanced almost to Ordzhonikidze before being turned back by a Soviet counter-attack.

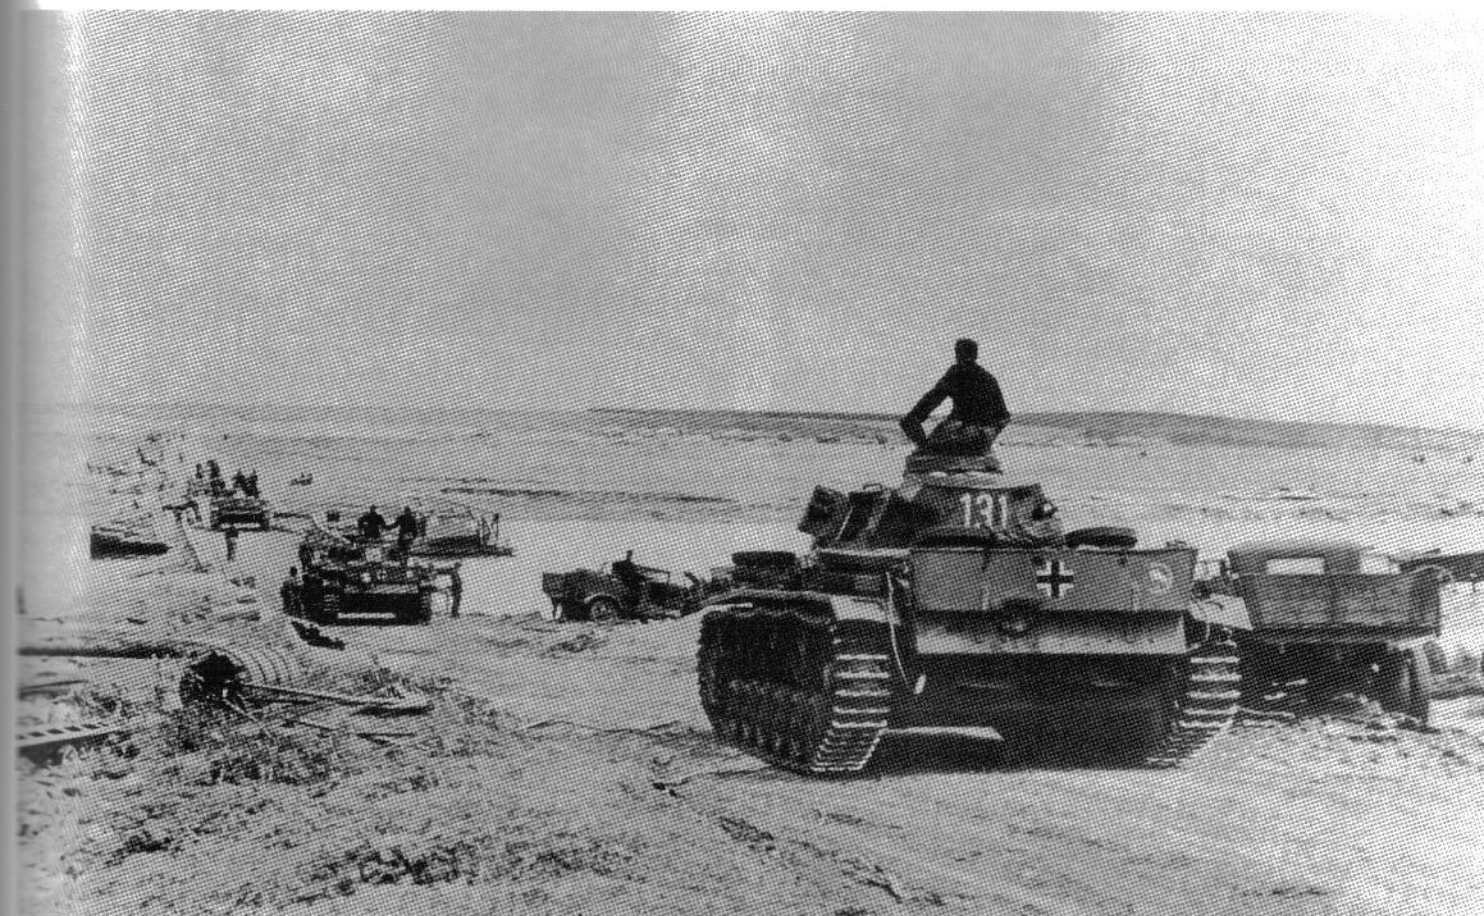
Pz.Kpfw.III Ausf.J tanks of 24.Panzer-Division crossing a German engineer's bridge over the Don River during the drive to Stalingrad in August, 1942. The stowage box fixed to the rear of these vehicles was typical for the Pz.Kpfw.III of the Division. A white outline black national cross is painted on the back of the box along with the emblem of 24.Panzer-Division, a rider on horseback jumping through a half circle, painted in yellow. This emblem was originally used by 1.Kavallerie-Division which had been reorganized as 24.Panzer-Division on November 28, 1941. The vehicles are finished in the standard dark gray paint.

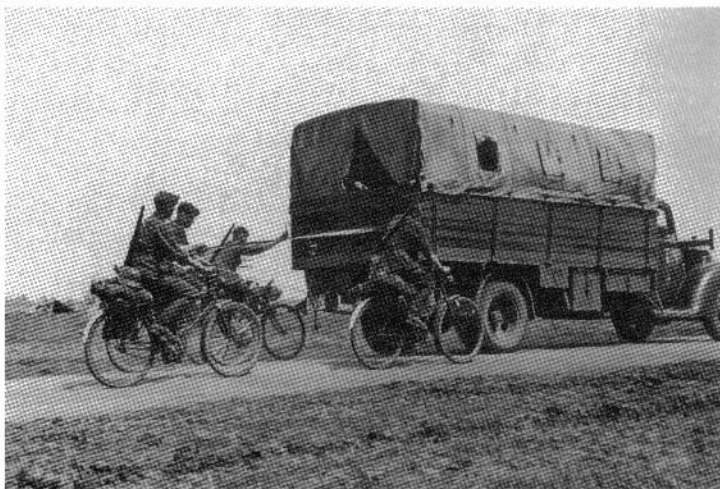
Luftwaffe troops on bicycles are towed along by a Ford V3000S truck near Stalingrad in late August 1942. The truck belongs to a RAD (Reichsarbeitsdienst) unit and carries this designation on its license plate, 'RAD 51187', and again, on the side of the door.

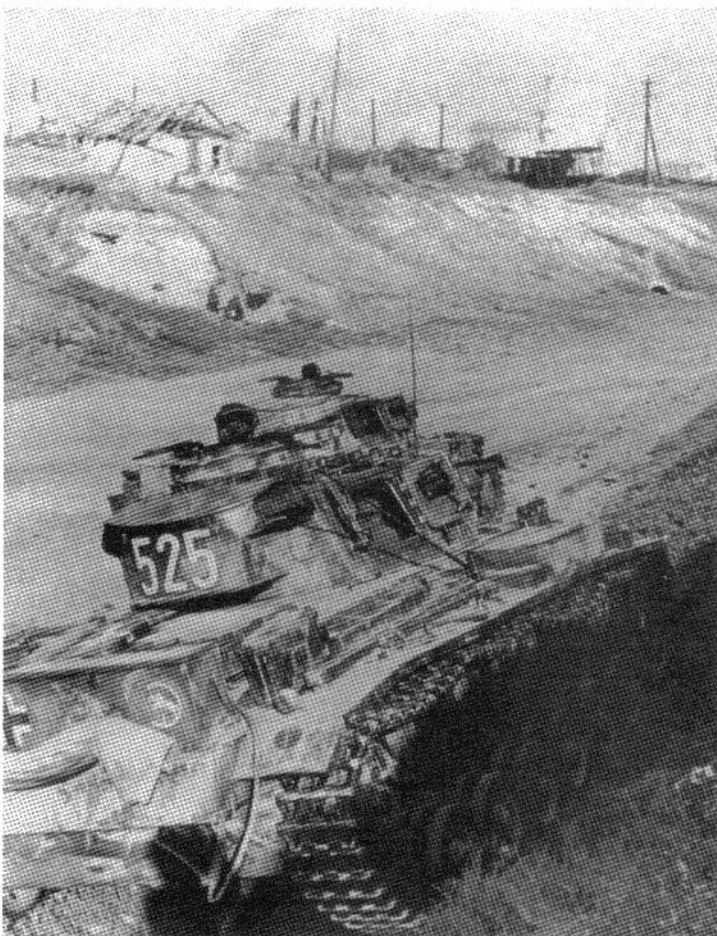
Two Pz.Kpfw.III Ausf.J of 24.Panzer-Division enter Stalingrad through the southern, older part of the city in August 1942. Both vehicles are from the same company and display their three digit tactical numbers in red with a white outline on the rear of the turret storage bin and again, in a smaller size, on the side of the turret. The one closest to the camera is '525' while the one beyond is '524'. The jumping horse emblem is clearly visible on the rear of the special storage bin attached to the engine deck that was peculiar to this division, along with a white outlined black national cross. They are finished in their original dark gray color.

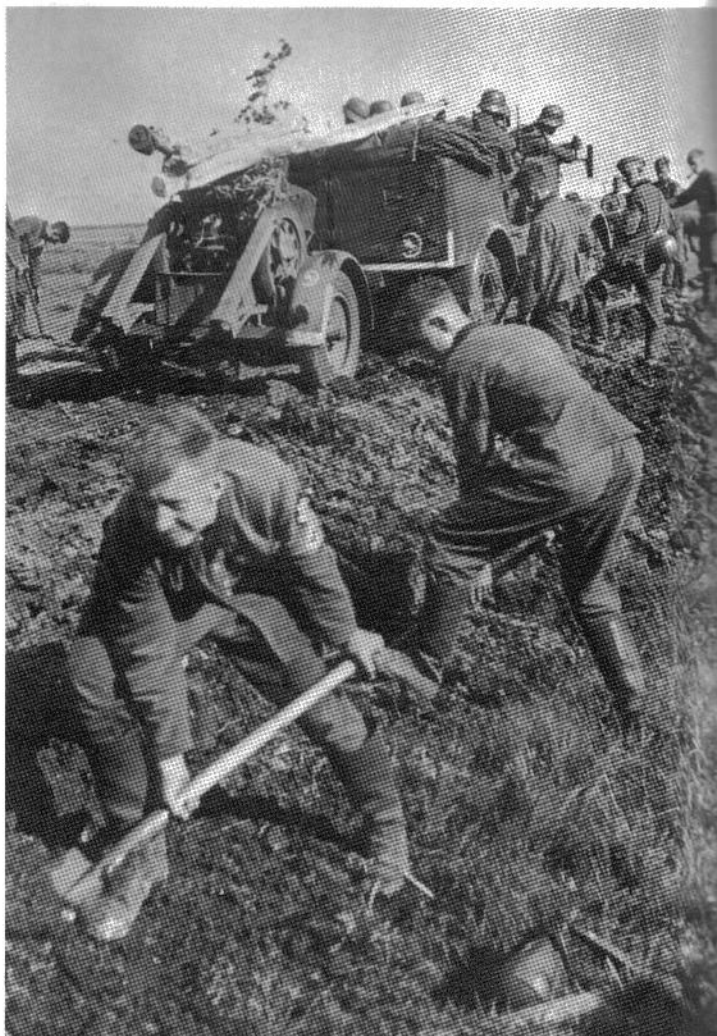
RAD men repair a road for vehicles of 24.Panzer-Division in August 1942. The vehicle is a Mercedes-Benz L1500A and is towing a small trailer carrying an 8.8cm Raketenwerfer 43, or 'Püppchen' as it was known. The stylized emblem of 24.Panzer-Division, a mounted rider jumping through a partial circle, can be seen painted on the rear of the car as well as on the mudguard of the trailer. It is easy to see how inefficient the German Army was in this regard when compared to a fully mechanized U.S. Army, dependent on machines instead of muscle power.

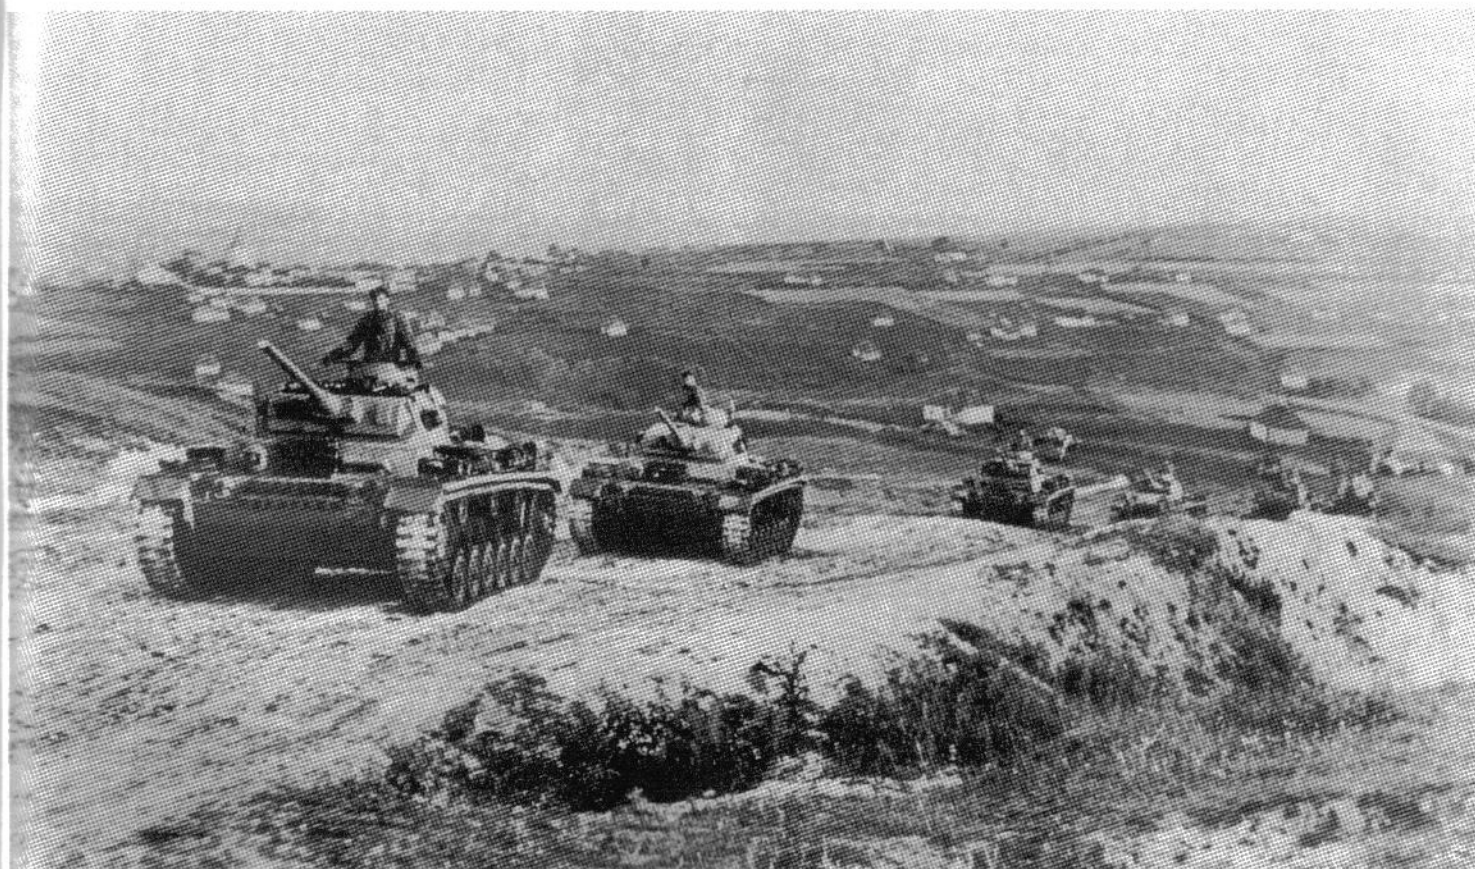
One of the units held in reserve for Operation 'Blue', was 2.Panzer-Division. The colorful winged dragon markings displayed on the turret of this Pz.Kpfw.III Ausf.J appear to have been limited to 6.Kompanie vehicles. Headquarters vehicles, '601' shown here and '602', had the emblem painted in a shield, while 2.Zug (platoon) used a diamond and 3.Zug used a triangle. The other two platoons used a circle and a square but it is not known for sure which each one used. Other markings included a yellow Panzer rhomboid painted on the side hull vision flaps and rear plate with a small '6' beside it along with a small, white tactical number and white outlined black national cross. The tactical emblem for 2.Panzer-Division, an inverted 'Y' with a short, single vertical bar to its right was also painted in yellow on both hull sides and rear plate.

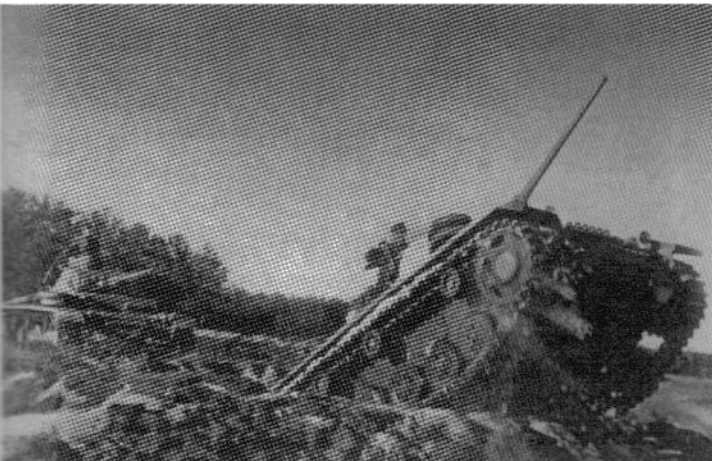
An early Pz.Kpfw.IV Ausf.G from one of the SS-Panzer-Grenadier-Divisions employed during the German counteroffensive to retake Kharkov in February and March, 1943, when General von Mansteins counter-attack led to the recapture of the city. A great German victory, it saved the whole southern sector of the Eastern Front. The tank is fitted with 'Winterketten', a special wide track that reduced the ground pressure and provided for greater mobility on soft ground. It is finished with a dirty coat of white winter camouflage paint.

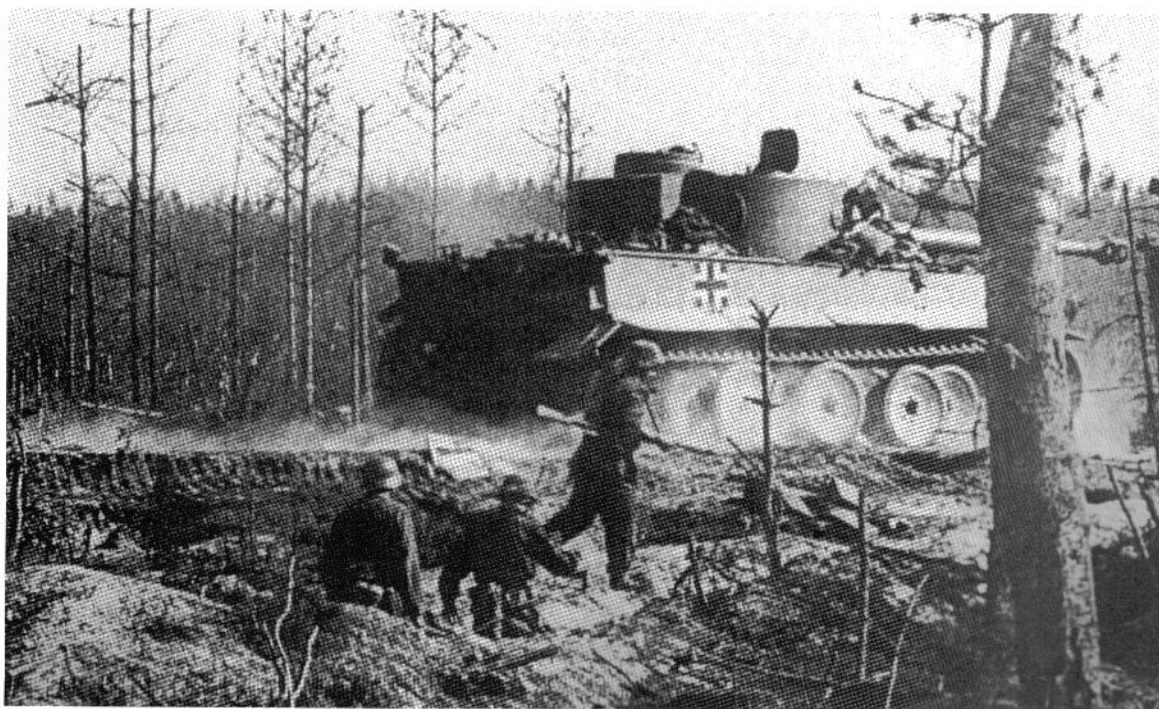
The Tigers of s.Pz.Abt.502 fought their first battles in the forests around Leningrad during the fall of 1942, in terrain that was unsuitable for tank combat tactics. Despite the very difficult conditions, the crews of s.Pz.Abt.502 fought well and were responsible for the destruction of over 125 Soviet tanks by the summer of 1943. This photo was taken that summer and shows one of their Tigers ploughing through the soft ground typical of that region. This tank was fitted with the turret mounted smoke candle dischargers which the censor has removed along with the rear part of the turret.

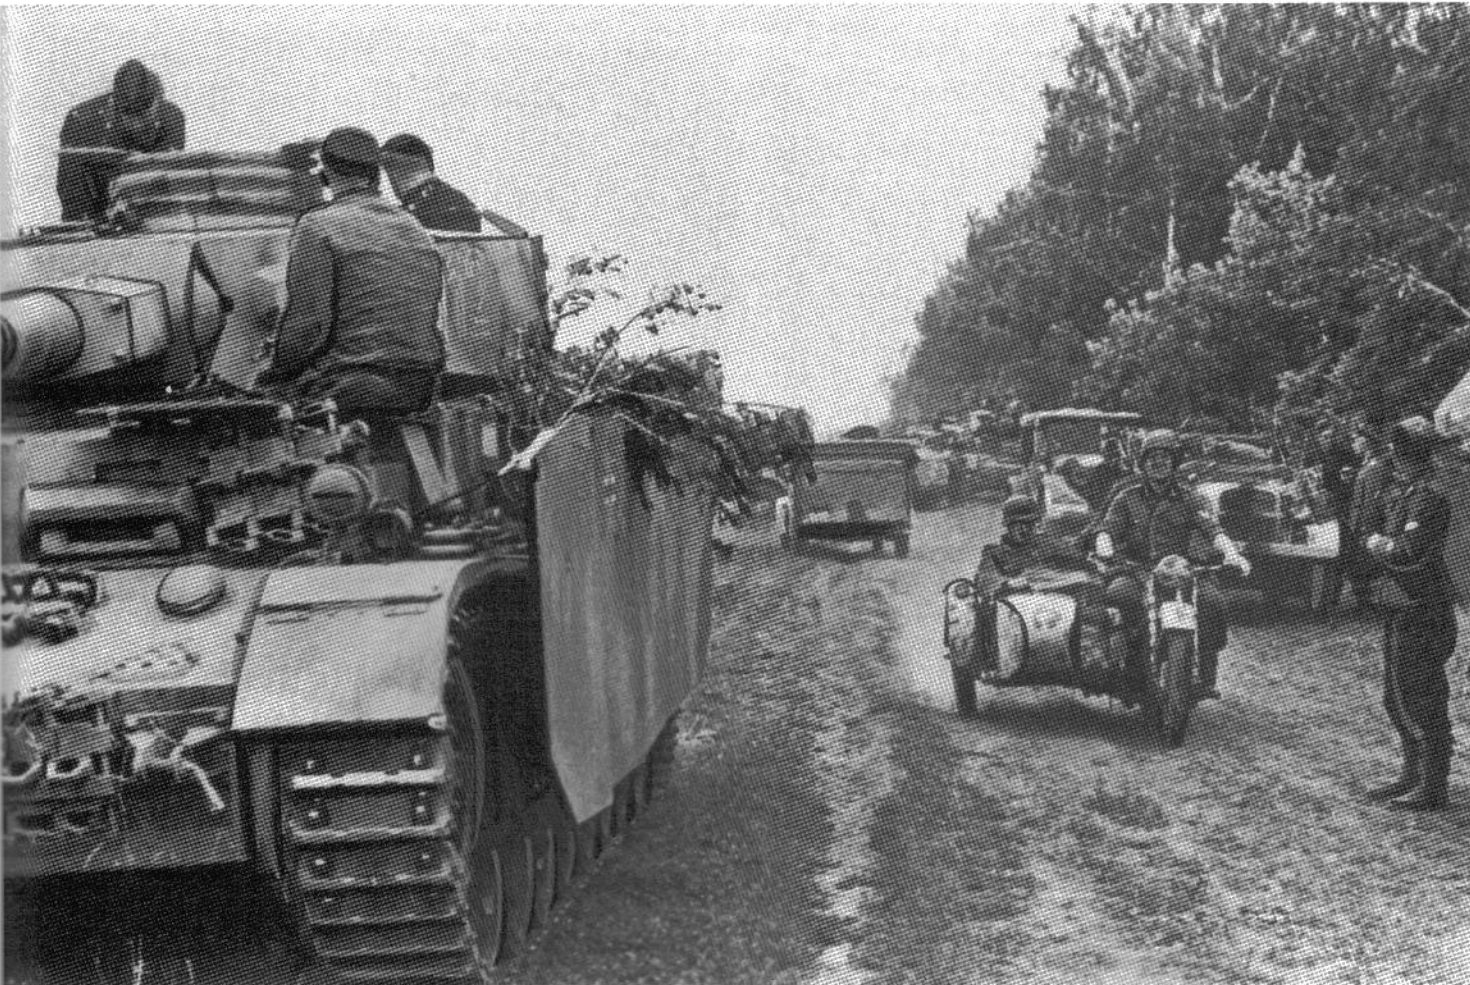
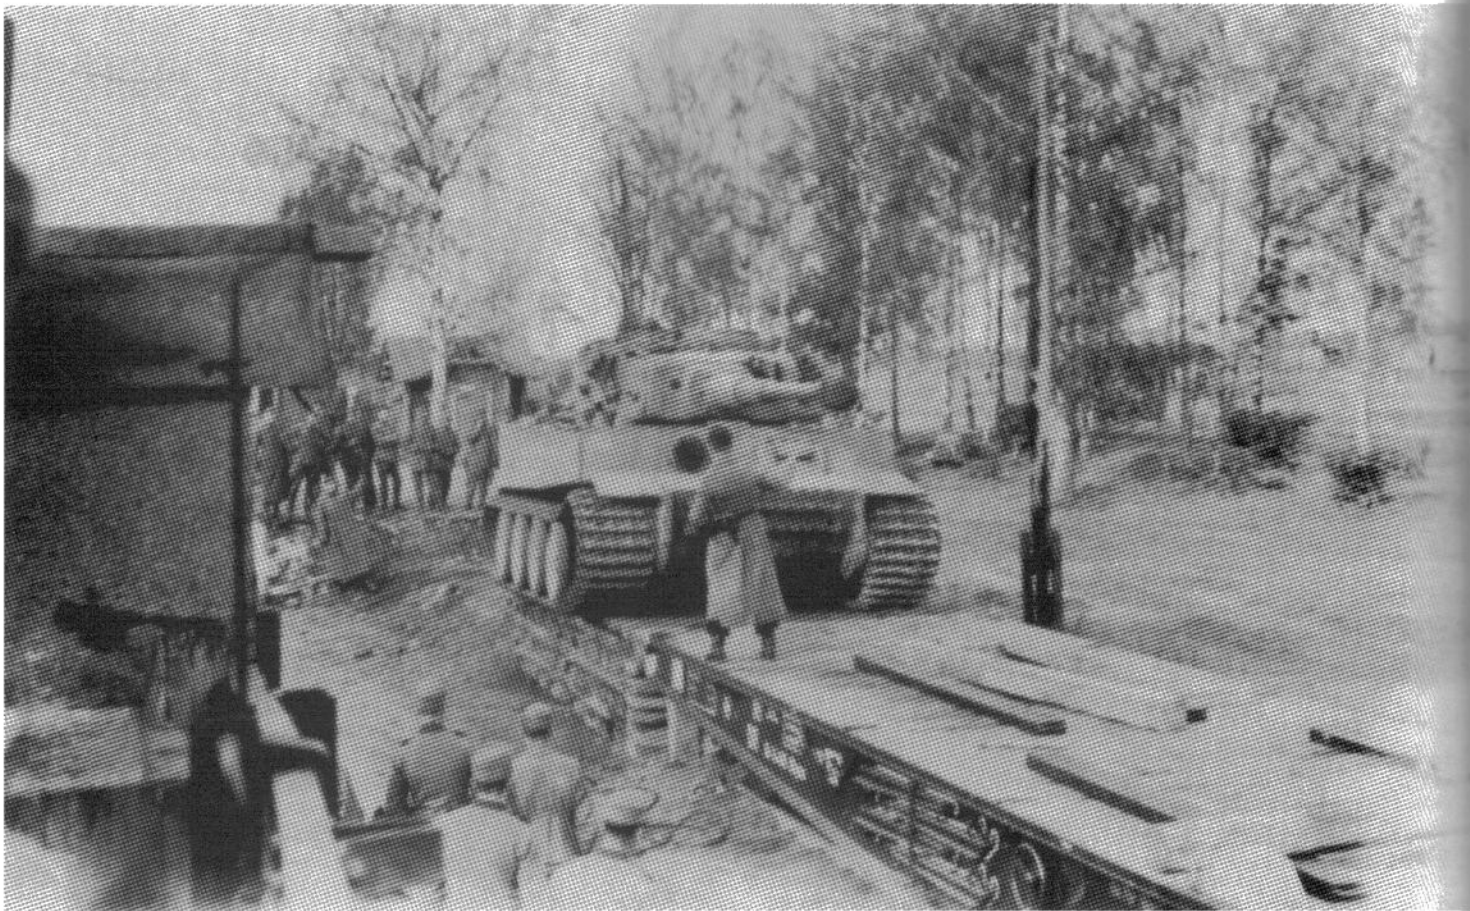
Two photographs of one of the first nine Tigers of s.Pz.Abt.502 being unloaded from a railroad flatcar at its destination in Russia in the late autumn of 1942. It was produced in early November 1942 as it is fitted with the new standard track but still has not been fitted with the side track guards. Not visible in the photos is the Pz.Kpfw.III stowage bin carried on the rear of the turret. The tactical number '102' has been painted in white outline on the side of the turret along with a large white outline Balkenkreuz on the side of the hull just ahead of the last outside roadwheel and the emblem of s.Pz.Abt.502, a white outline 'Mammut', on the front plate. Though it appears a light color, it is still in its original dark gray paint with a heavy coating of dust.

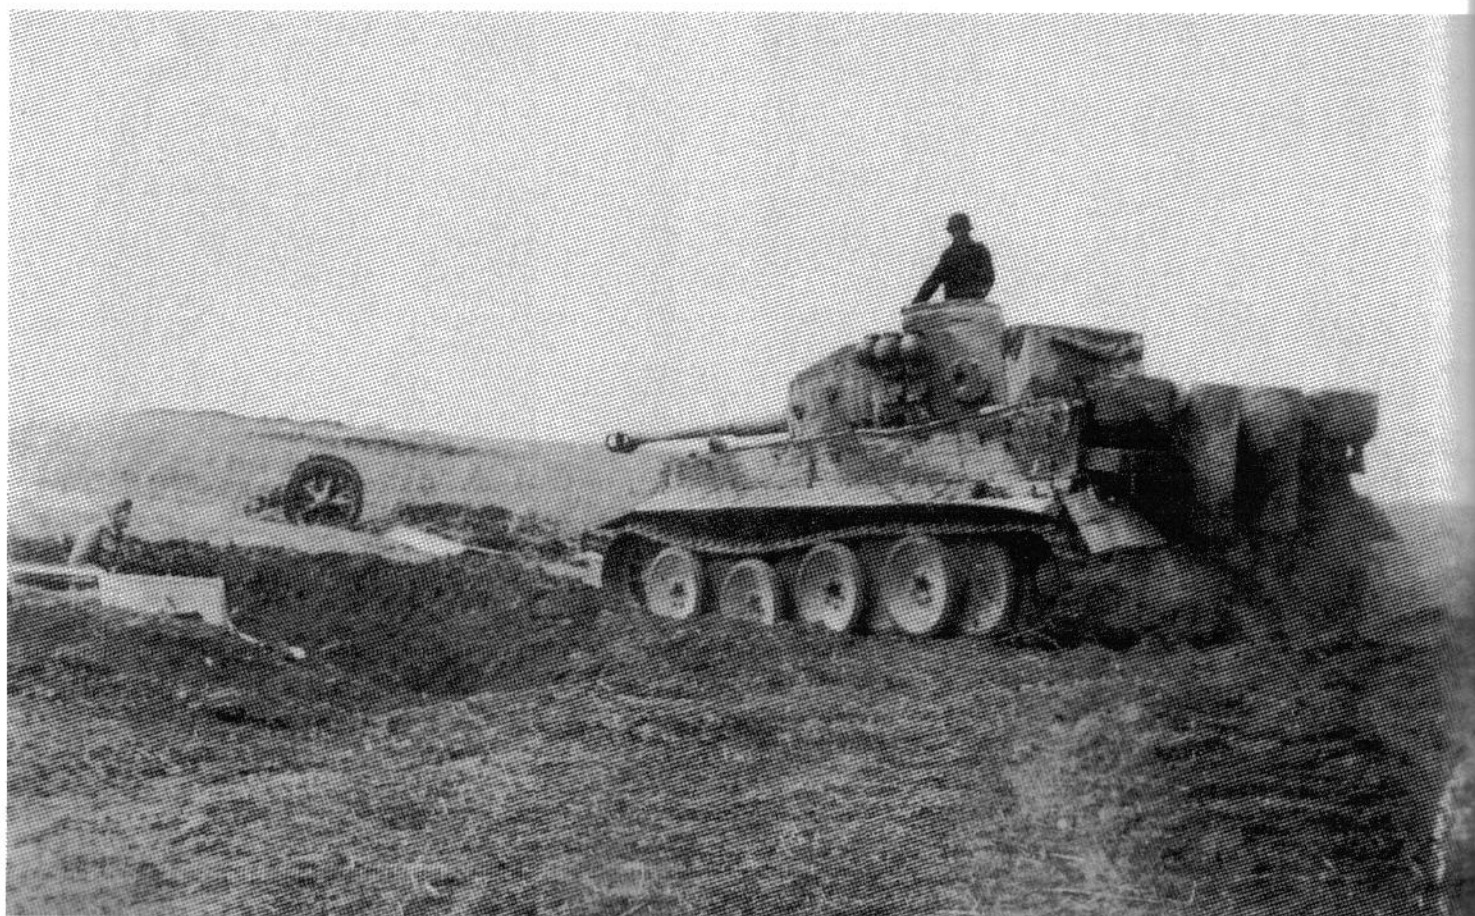
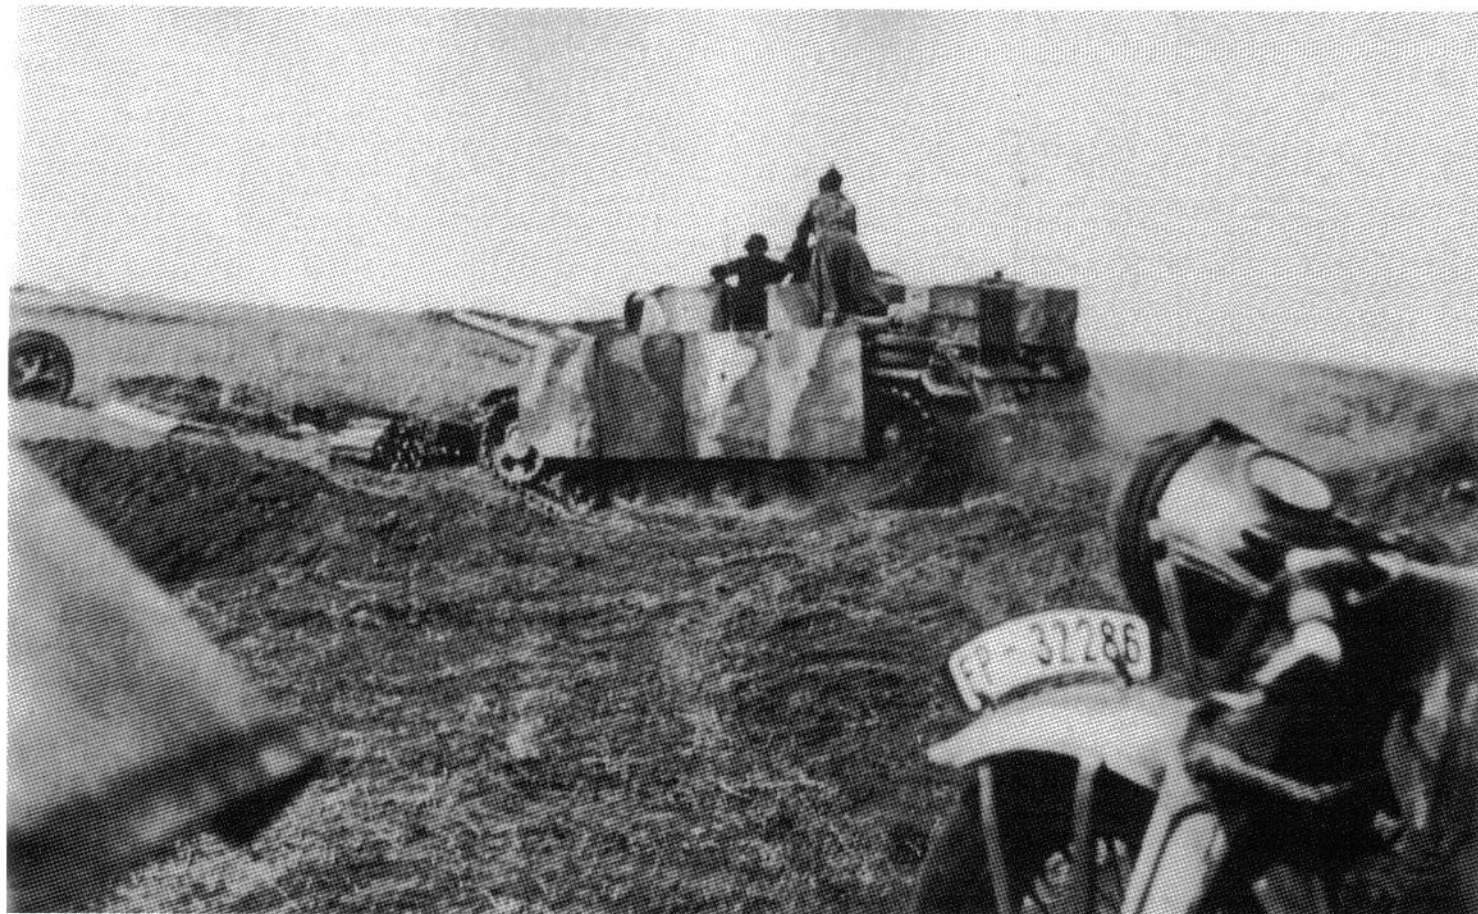
Two photos of Tigers employed by s.Pz.Abt.505 for Operation 'Citadel' in the northern sector during July 1943. Both vehicles are finished in the same way with a green or brown wavy camouflage pattern over the sand yellow base and barbed wire strung along the sides of the tank to discourage Soviet infantry from boarding. They are from the early production series, still with the Feifel air cleaners but without the turret mounted smoke candle dischargers that were discontinued in June 1943. White outline tactical numbers have been painted on the side of the turret.

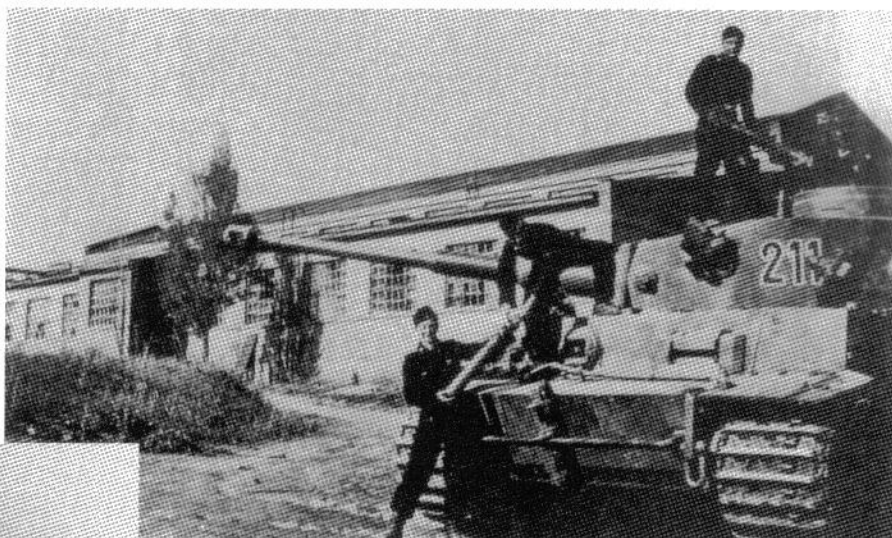
The crew of Tiger '211' from s.Pz.Abt.503 replenishing ammunition in preparation for the next battle. Numbering within the heavy tank battalions usually followed that of the Panzer-Divisions, in this case, the first tank in the first platoon of the second company. Whereas the standard organization of a Panzer-Division normally had four companies of twenty-two tanks at that time, the heavy tank battalion was equipped with three companies of fourteen tanks each.

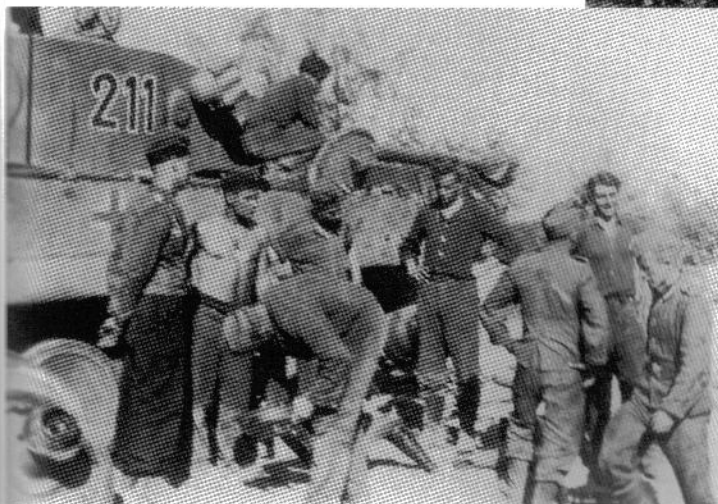
The battalion Werkstatt-Kompanie carries out repairs to the suspension of Tiger '211' after it has been damaged during a battle. Newly painted tactical numbers on the turret stand out in contrast to the Balkenkreuz painted on the side of the hull. The interleaved suspension of the Tiger usually required several wheels to be removed to gain access to an inside roadwheel, a very time consuming task.

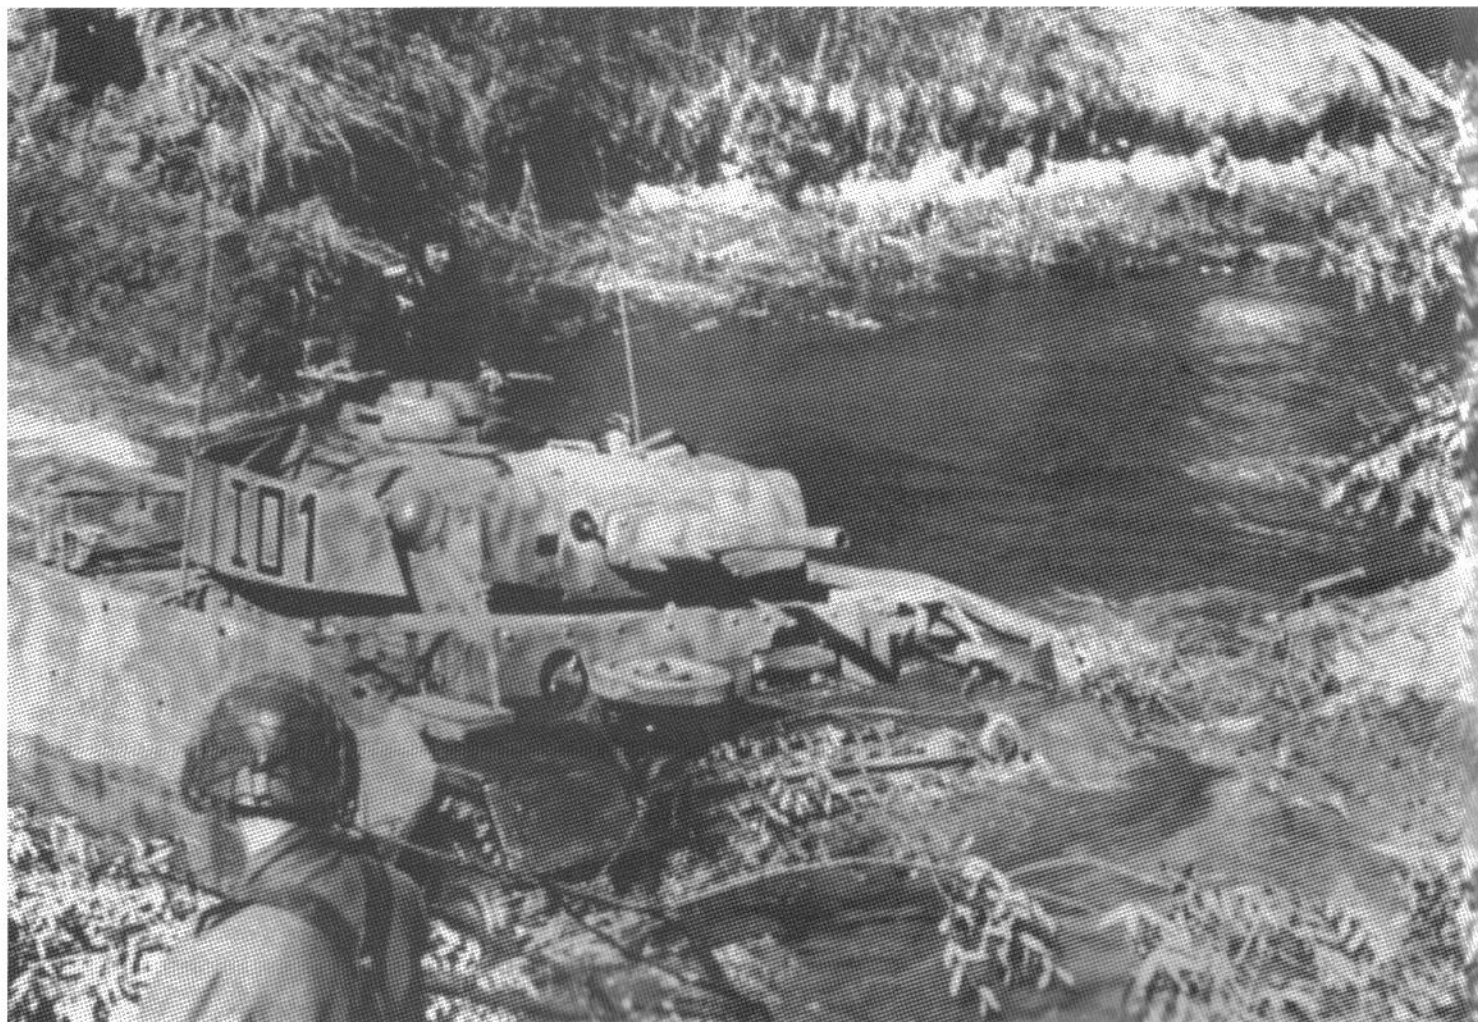
A Pz.Bef.Wg.III Ausf.J assigned to the I.Bataillon commander, Pz.Rgt.25, crosses a small stream near Kursk in July 1943. It has been fitted with the additional 20mm spaced armor plates to the front of the hull and gun mantlet as well as a complete set of schürzen around the turret and sides of the hull. A textbook camouflage pattern of light green and brown has been sprayed over the dark sand base color and new tactical markings, '102', have been painted in black with a white outline on the turret schürzen. The new black inverted 'T' insignia of 7.Panzer-Division is visible on the front plate beside the driver's visor.

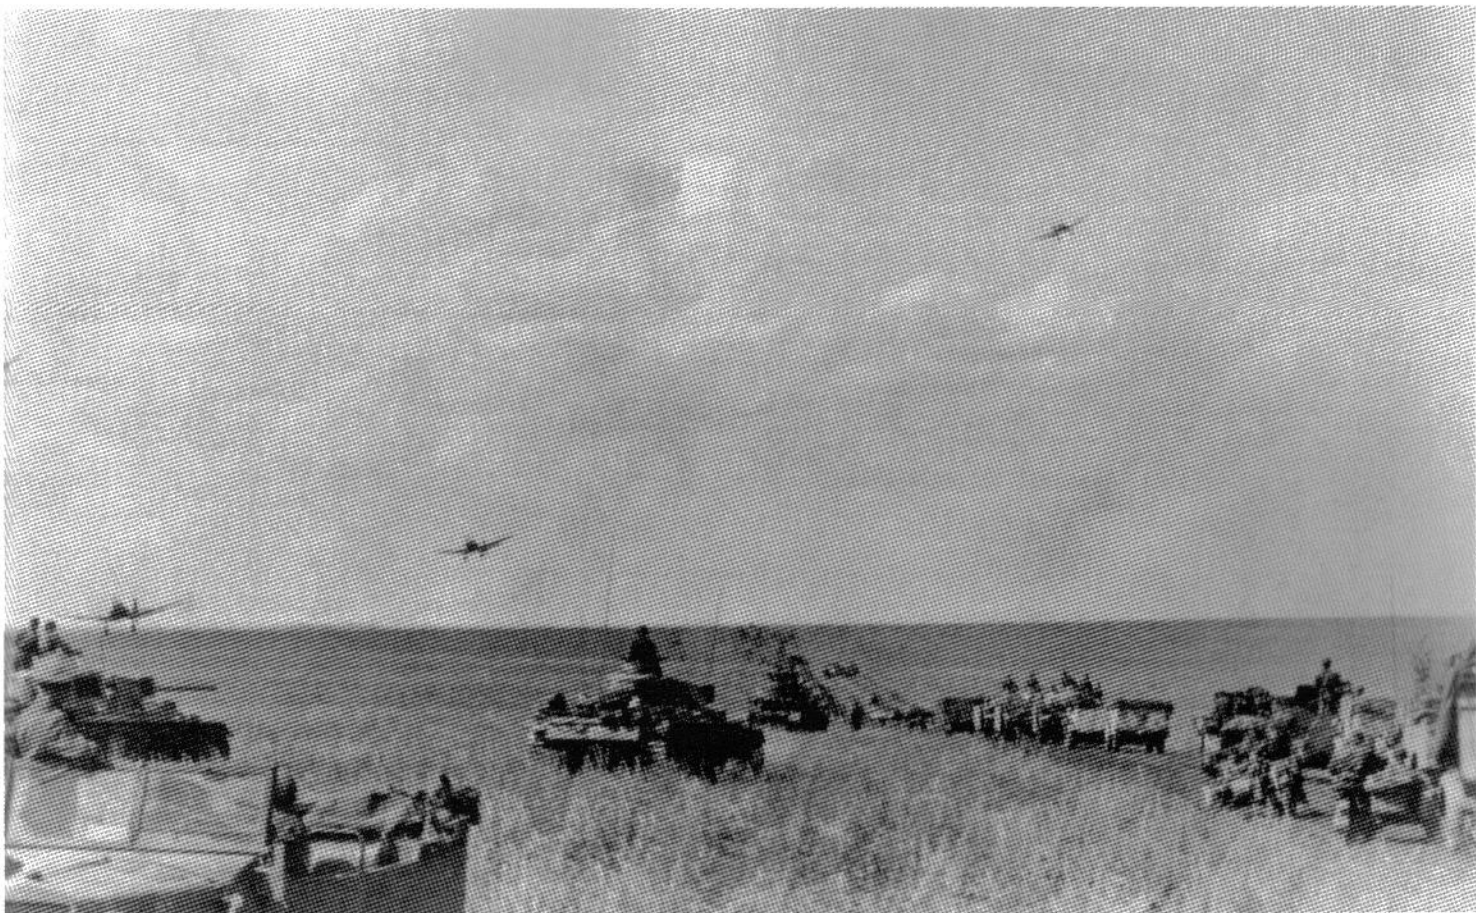
A Pz.Bef.Wg.III Ausf.J, fitted with the 5cm KwK L/42 and a full set of schürzen, photographed in the Bjelgorod area in late July 1943. It has also been uparmored with the additional 20mm spaced armor plate on the mantlet and, probably, on the front of the hull as well. Barely visible on the original print is the star antenna mounted on the rear of the engine deck. The white outline tactical number 'R02' indicates this vehicle is assigned to the Regimental Adjutant.

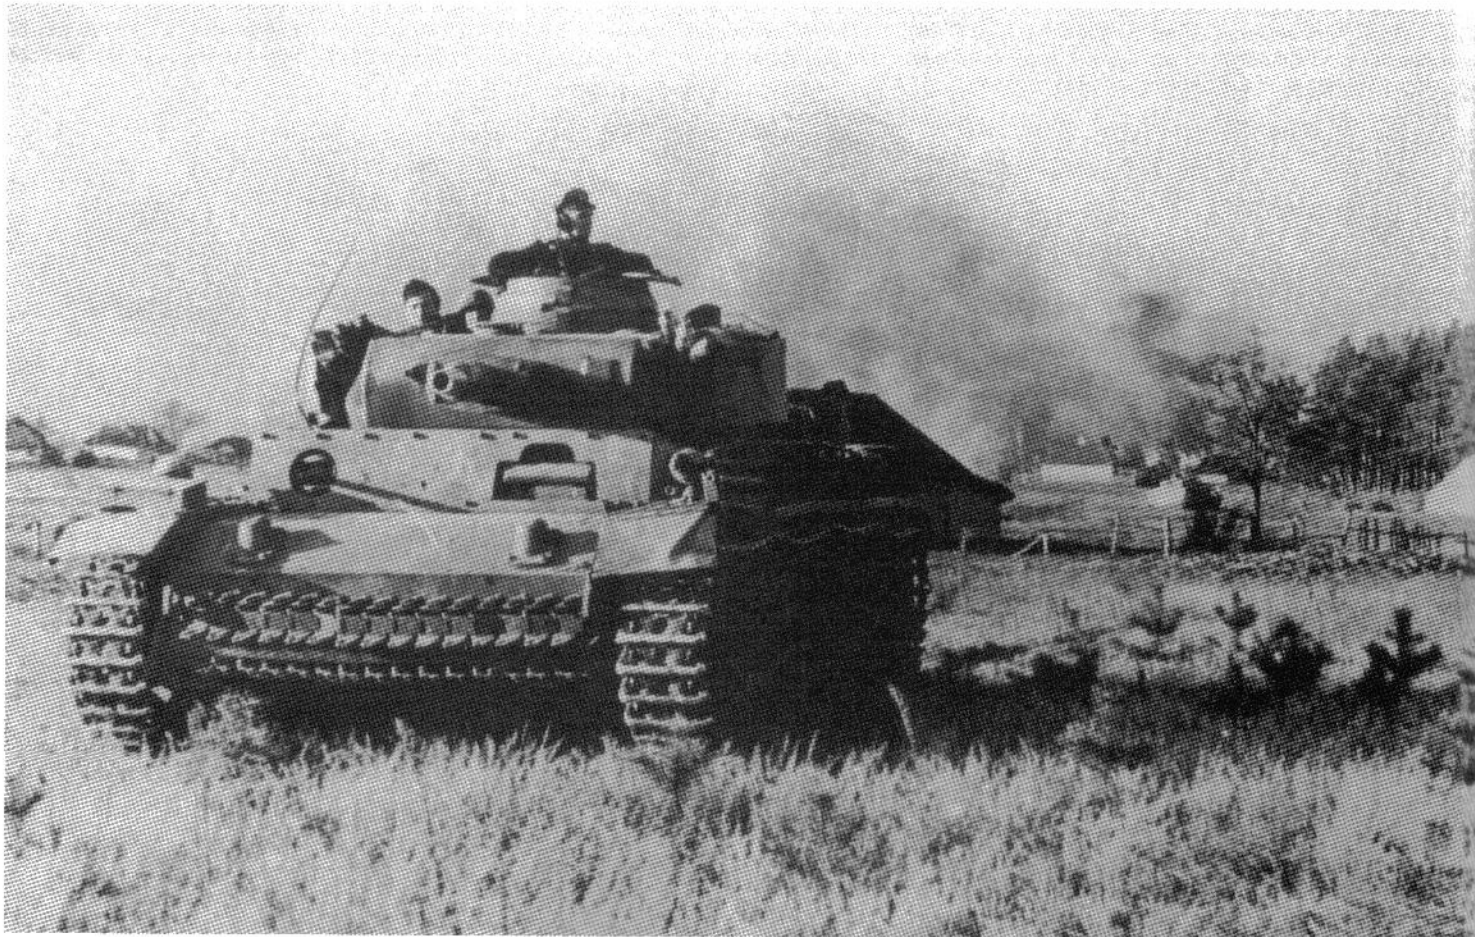
Three Pz.Kpfw.III Ausf.M, a Pz.Kpfw.IV Ausf.G or H and a new Pz.Kpfw.V Panther Ausf.D taken during the fighting around Kursk in July 1943. Only one of the Pz.Kpfw.III is fitted with the new schürzen armor plates which had begun to be installed in the spring of that year, all of which have been lost on the right side.

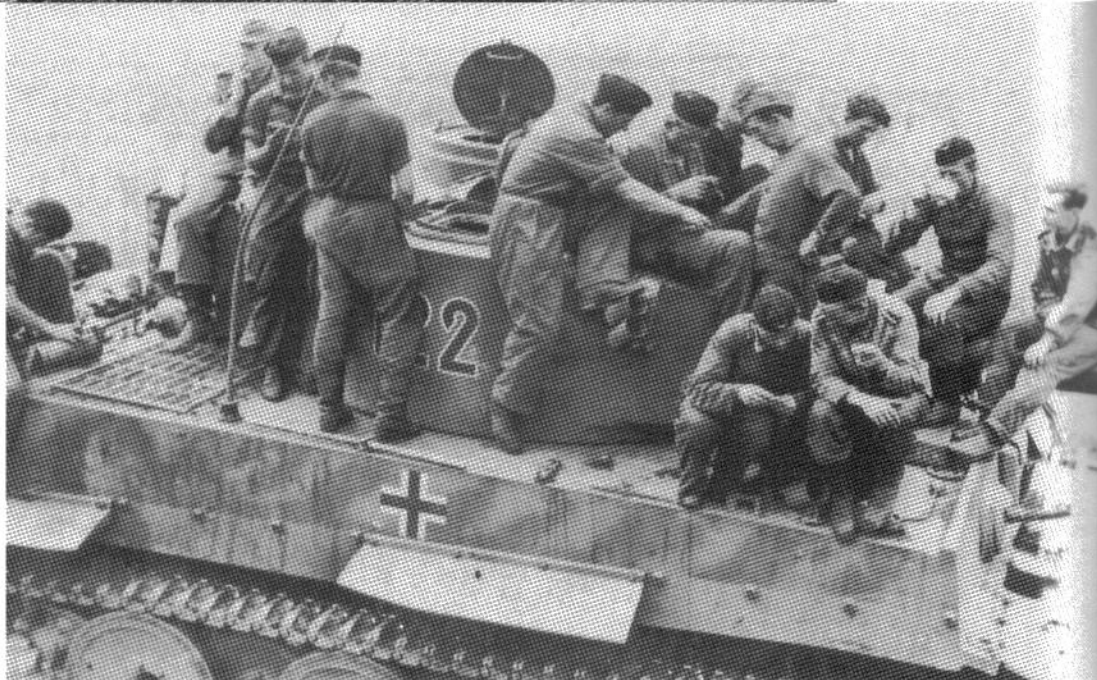
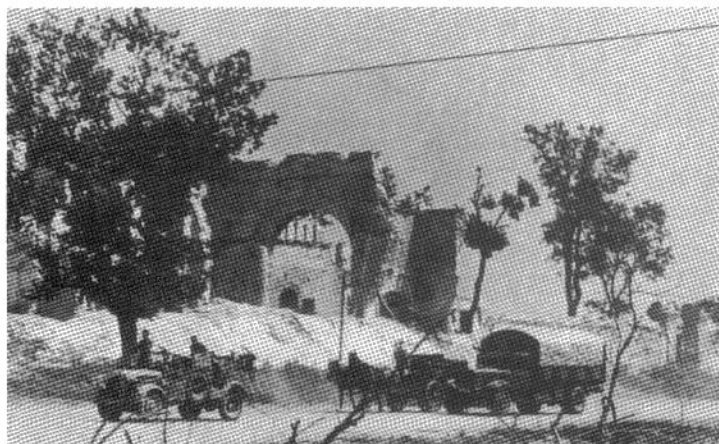
Two photographs of Tiger '122' from s.Pz.Abt.503 in the middle of August 1943. In the lower photo, the crew and mechanics are taking a break. The tank displays many signs of combat it has seen; missing mudguards and tools, a missing smoke candle discharger, a damaged roadwheel and a bent antenna. The missing mudguards also provide some insight on how the camouflage paint has been applied.
