Panzer-Division 1935-1945

(2) The Eastern Front 1941-1943

Robert Michulec

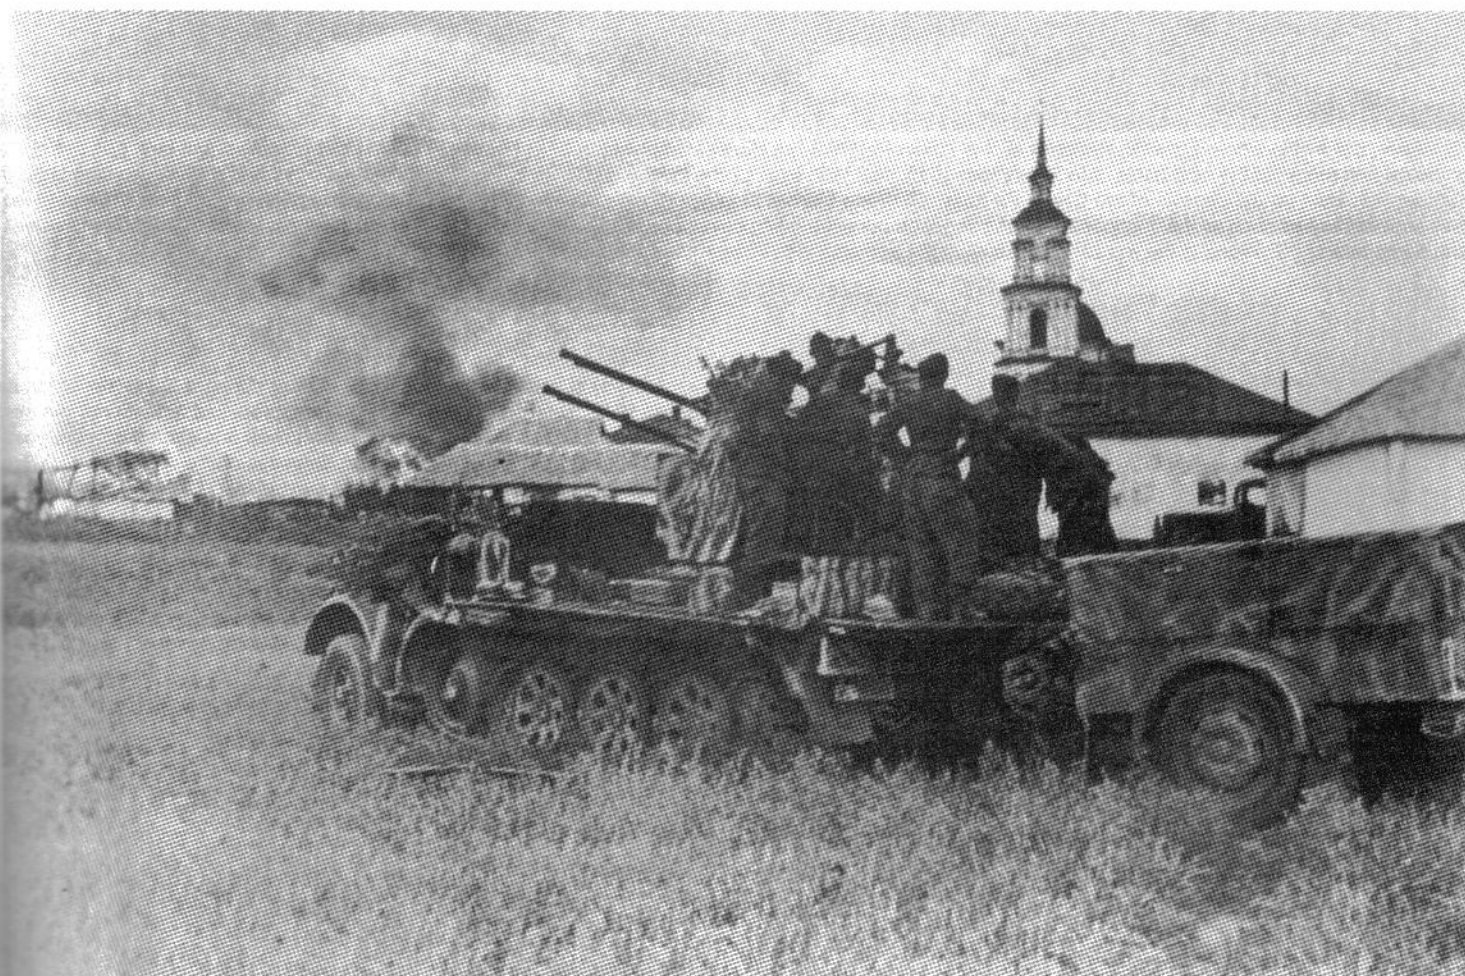
An Sd.Kfz.7/1 self-propelled anti-aircraft gun armed with the 2cm Flakvierling 38 engages Soviet aircraft in August 1943. It was employed in greater numbers than the Sd.Kfz.7/2 with 319 vehicles produced from late 1941 to 1944. In contrast to the vehicle in the above photo, this one has a more subtle camouflage scheme of dark sand wavy lines applied over the whole vehicle and ammunition trailer. The 'WL' designation can be seen on the license plate on the rear of the half-track, although the rest of the numbers are illegible.

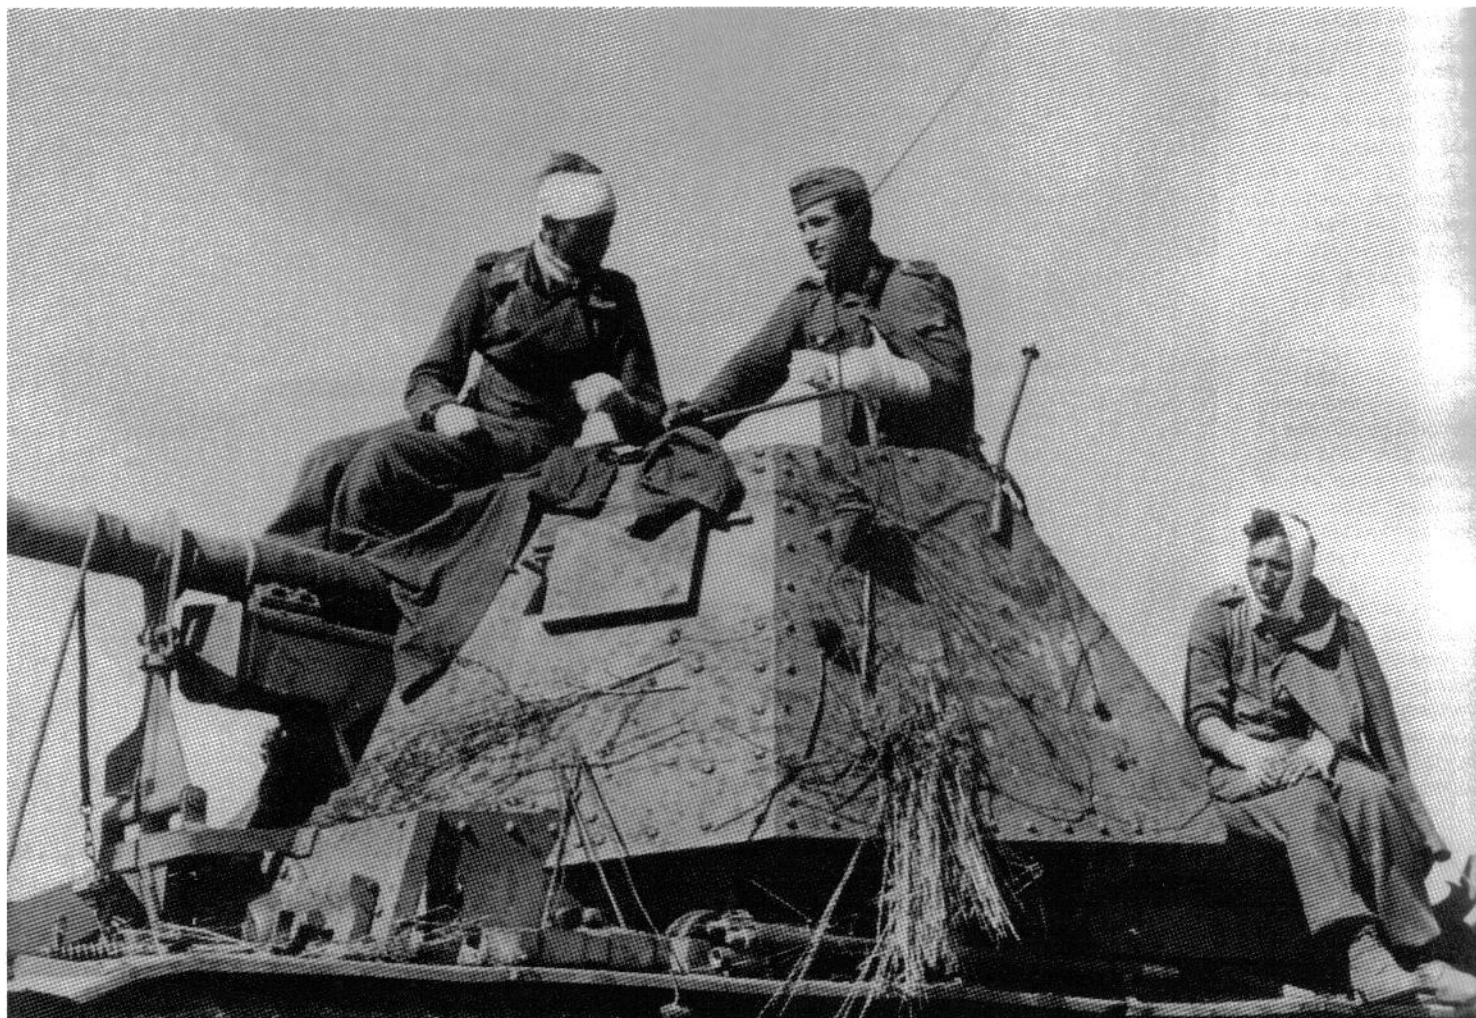
Alive, but a little worse for wear, the crew of this 7.5cm PaK40/3 auf Panzerkampfwagen 38(t) Marder III Ausf.H self-propelled anti-tank gun are back on board and ready for the next battle, late September 1943. Just visible under the foliage is a white outline black national cross and a white two digit tactical number '12'. Built on the chassis of the Czech Pz.Kpfw. 38(t), the Marder III series of self-propelled anti-tank guns were an interim solution while purpose built tank destroyers such as the Jagdpanzer IV and Jagdpanther were being developed. They served with the Panzer-Divisions, Panzer-Grenadier-Divisions and some Infantry Divisions in the Panzerjäger Abteilungen and also with independent Panzerjäger units.
