STURMTIGER and STURMPANZER in COMBAT

Sturmtiger and Sturmpanzer in Combat

Katowice – Speyer 2008

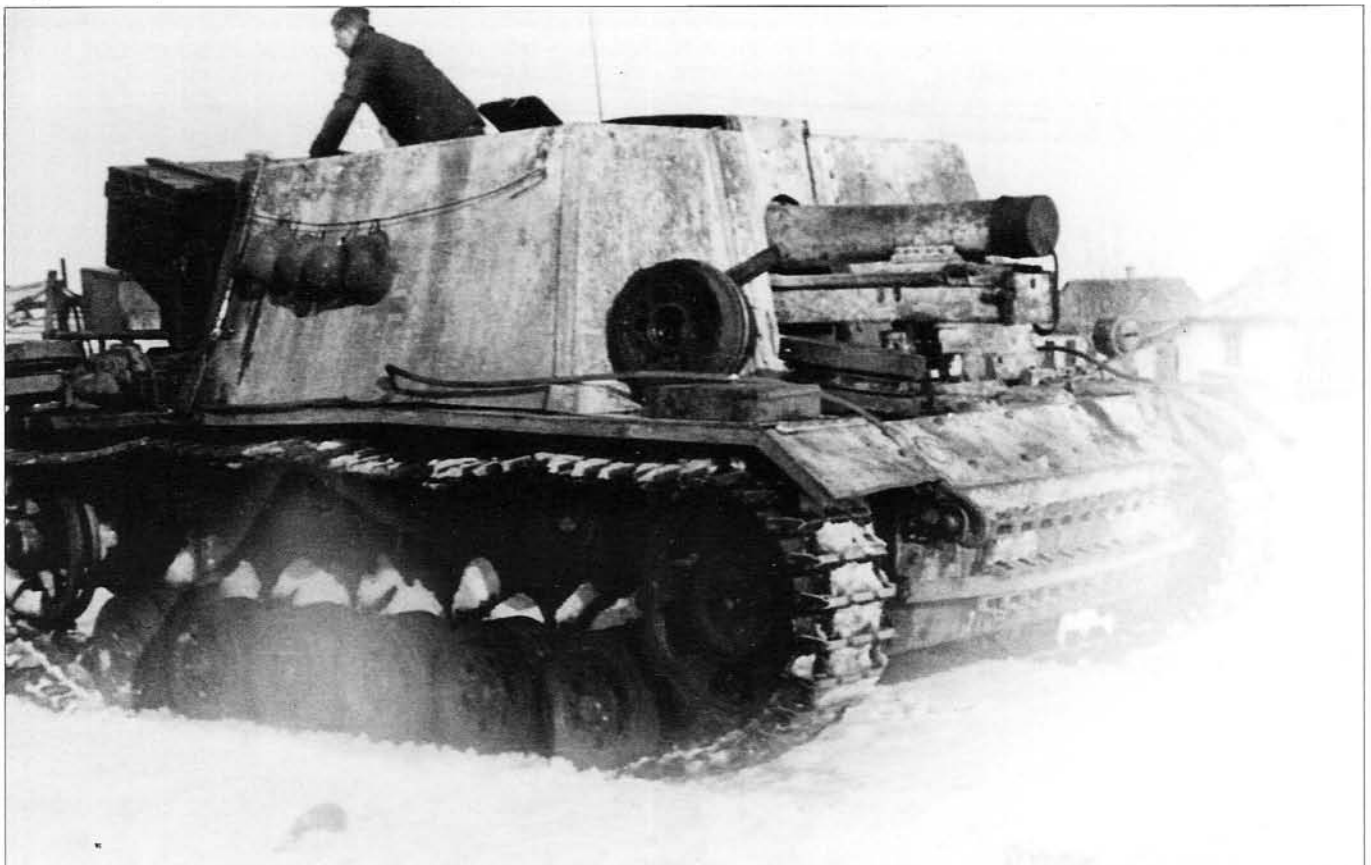
The crew of this vehicle has provisionally mounted replacement roadwheels in front of the superstructure. The rear roadwheel is missing its rubber rim. • Die Besatzung dieses Fahrzeuges hat einige Ersatzlaufrollen provisorisch vor dem Aufbau untergebracht. Bei der hinteren Laufrolle fehlen die Gummibandagen.

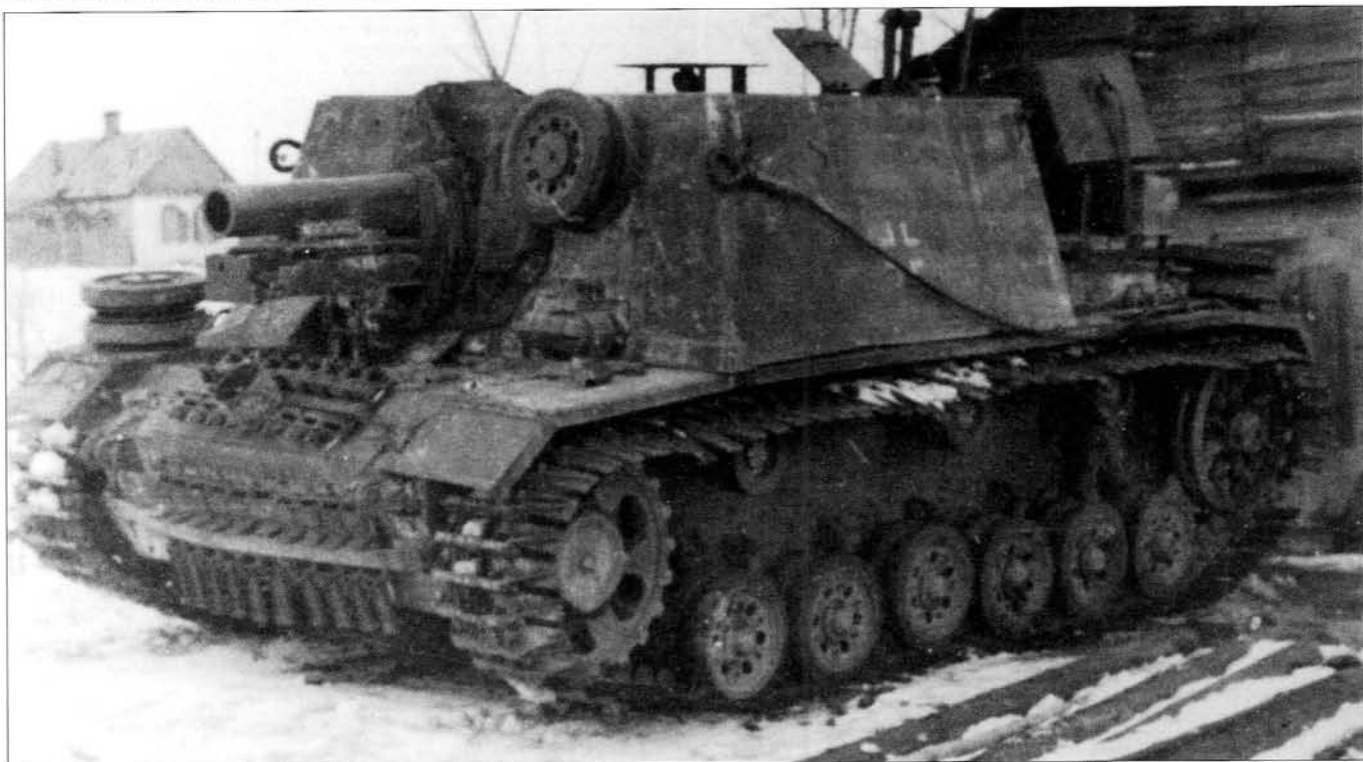
The crew of this vehicle added roadwheel mounts on its own initiative. *Sturm-Infanterie-Geschütz-Lehr-Bataillon XVII* had been assigned to the *22. Panzer-Division* in the meantime. • Bei diesem Geschütz hat die Bestzung bereits in eigener Zuständigkeit Laufrollenhalterungen angebracht. Die Sturm-IG-Batterie - Lehr-Bataillon XVII wurde zwischenzeitig in die 22.Panzerdivision überführt. [KHM]

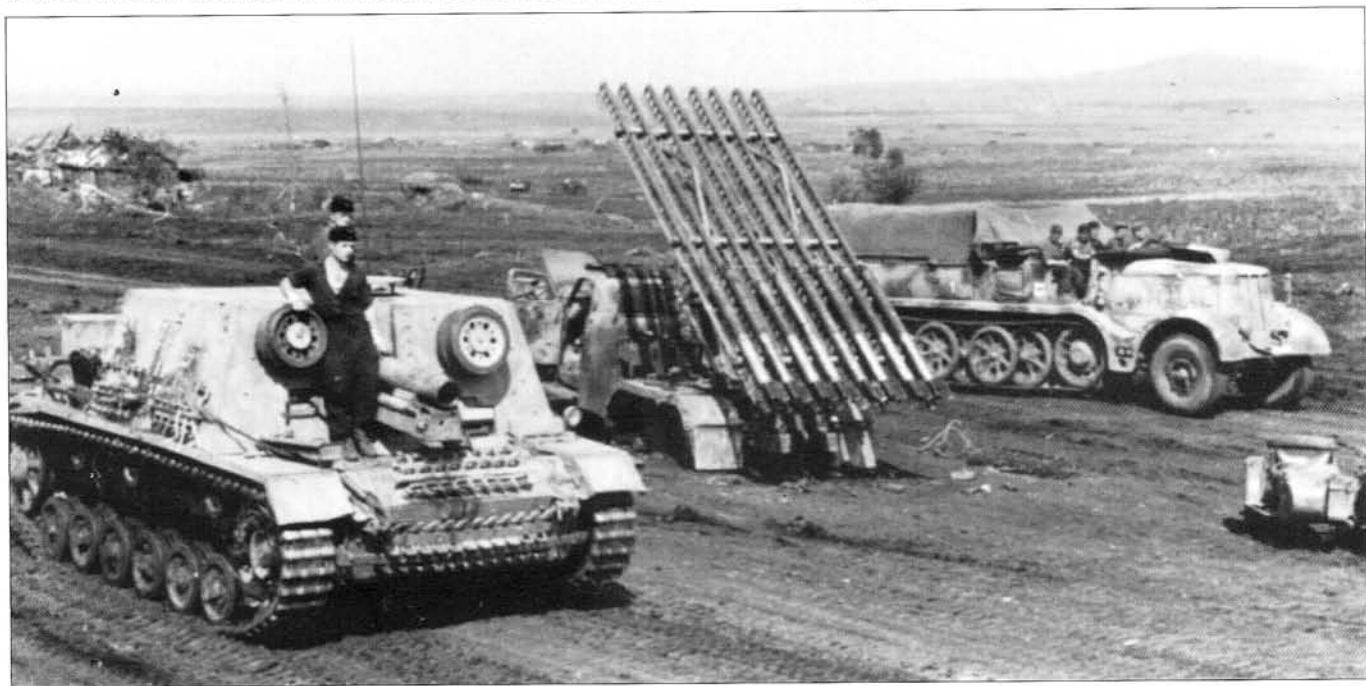
After the 22. Panzer-Division was consolidated with the 23. Panzer-Division, the remaining Sturm-Infanterie-Geschütze were also consolidated into the division. Note the replacement roadwheels on the left and right of the superstructure. • Nach der Verschmelzung der 22. und 23. Panzerdivision werden auch die verbliebenen Sturm-Infanteriegeschütze in den Verband übernommen. Man beachte die Ersatzlaufrollen rechts und links am Fahrzeugaufbau.

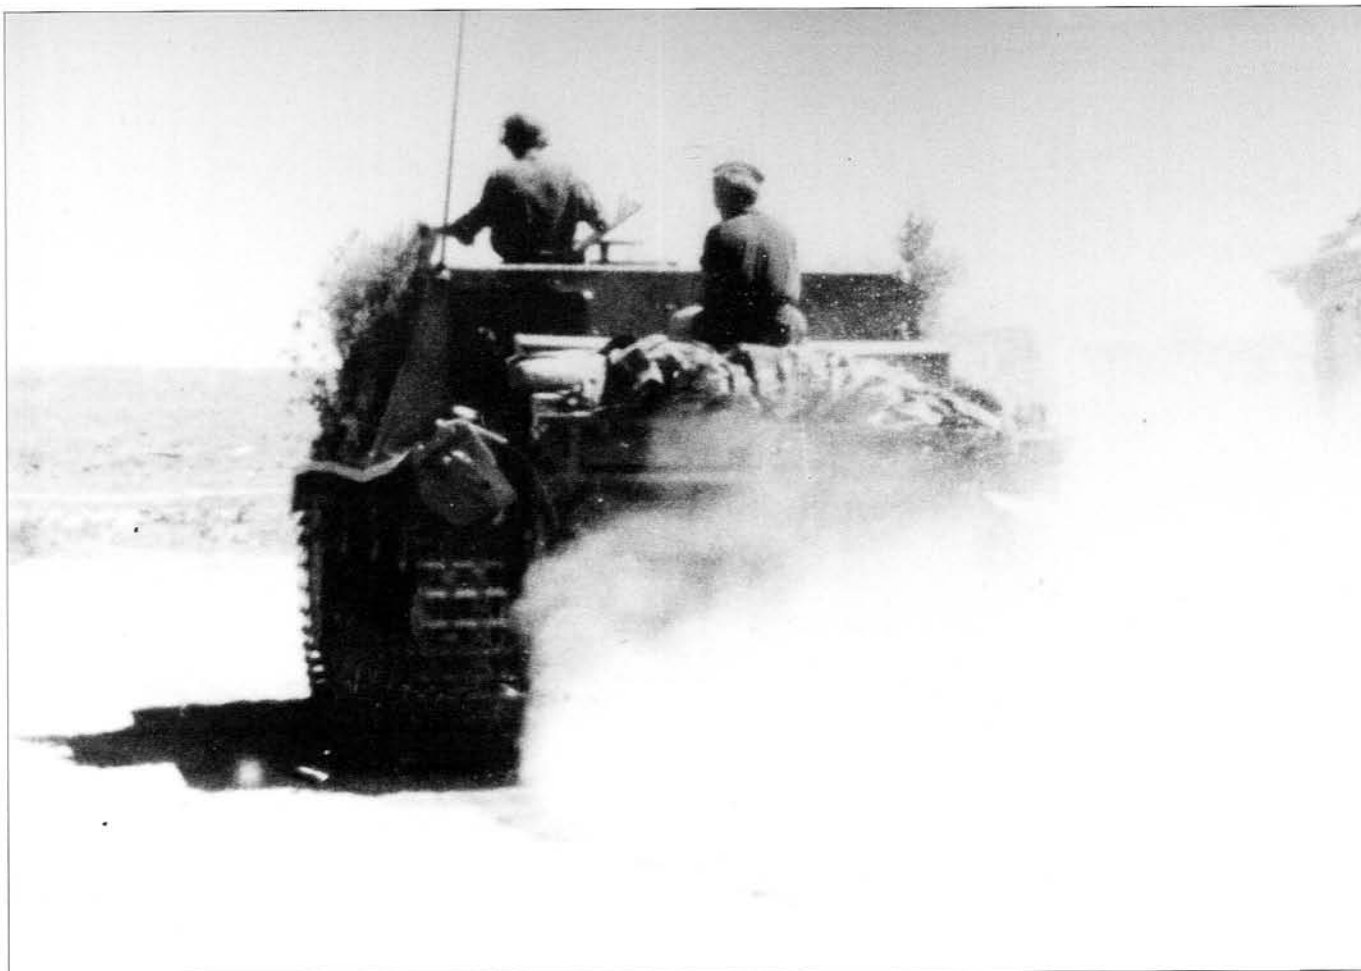
A rear view of a *Sturm-Infanterie-Geschütz*. The left mudguard has already been heavily damaged. • Rückansicht eines Sturm-Infanteriegeschützes. Die linke Kettenabdeckung ist bereits schon stark beschädigt.

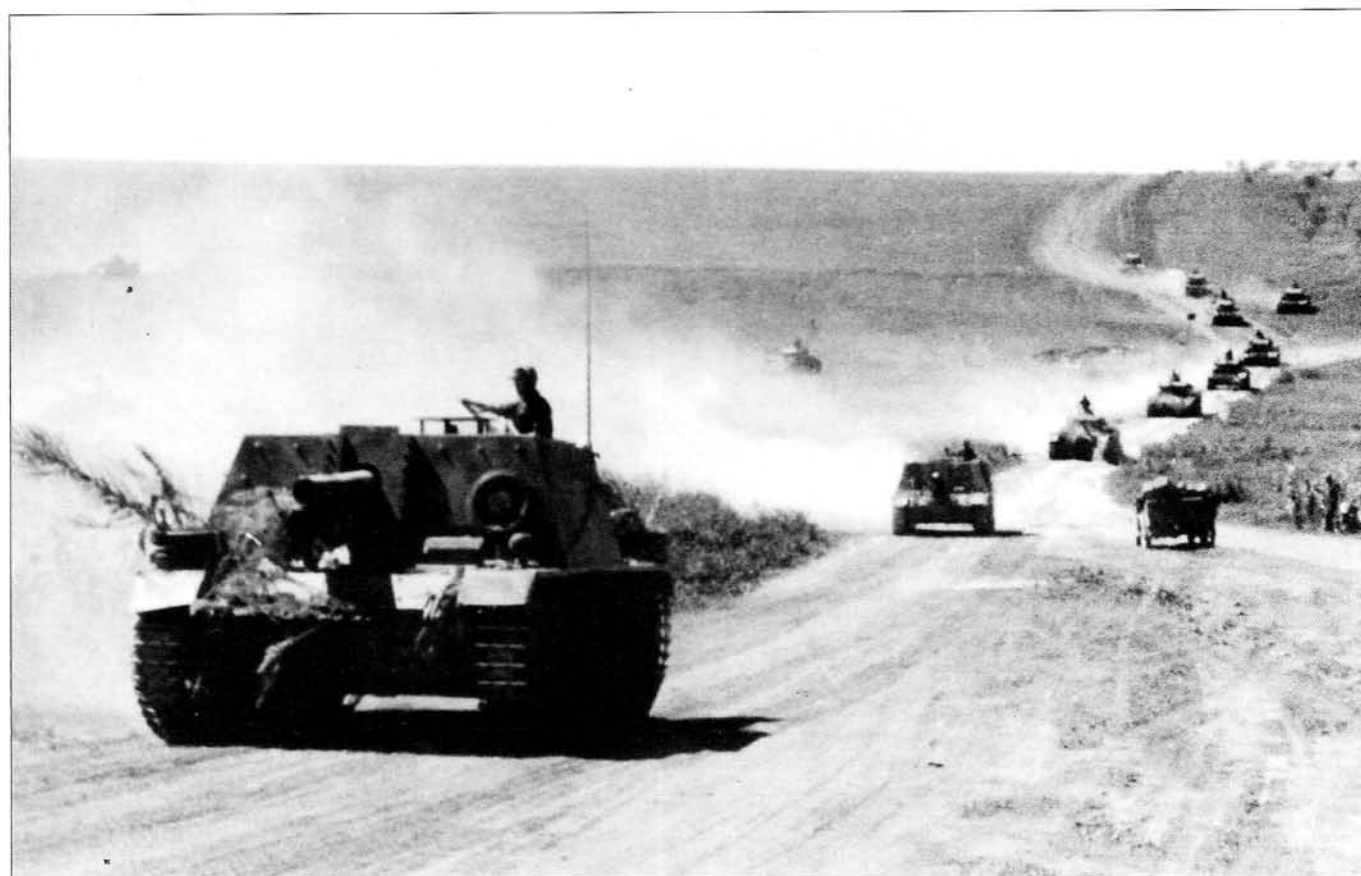
This gun also used the hull of a *Sturmgeschütz III* (Models B through D) as its starting point. • Auch dieses Sturm-Infanterigeschütz basiert auf der Wanne eines Sturmgeschützes Ausführung B bis D. [KHM]

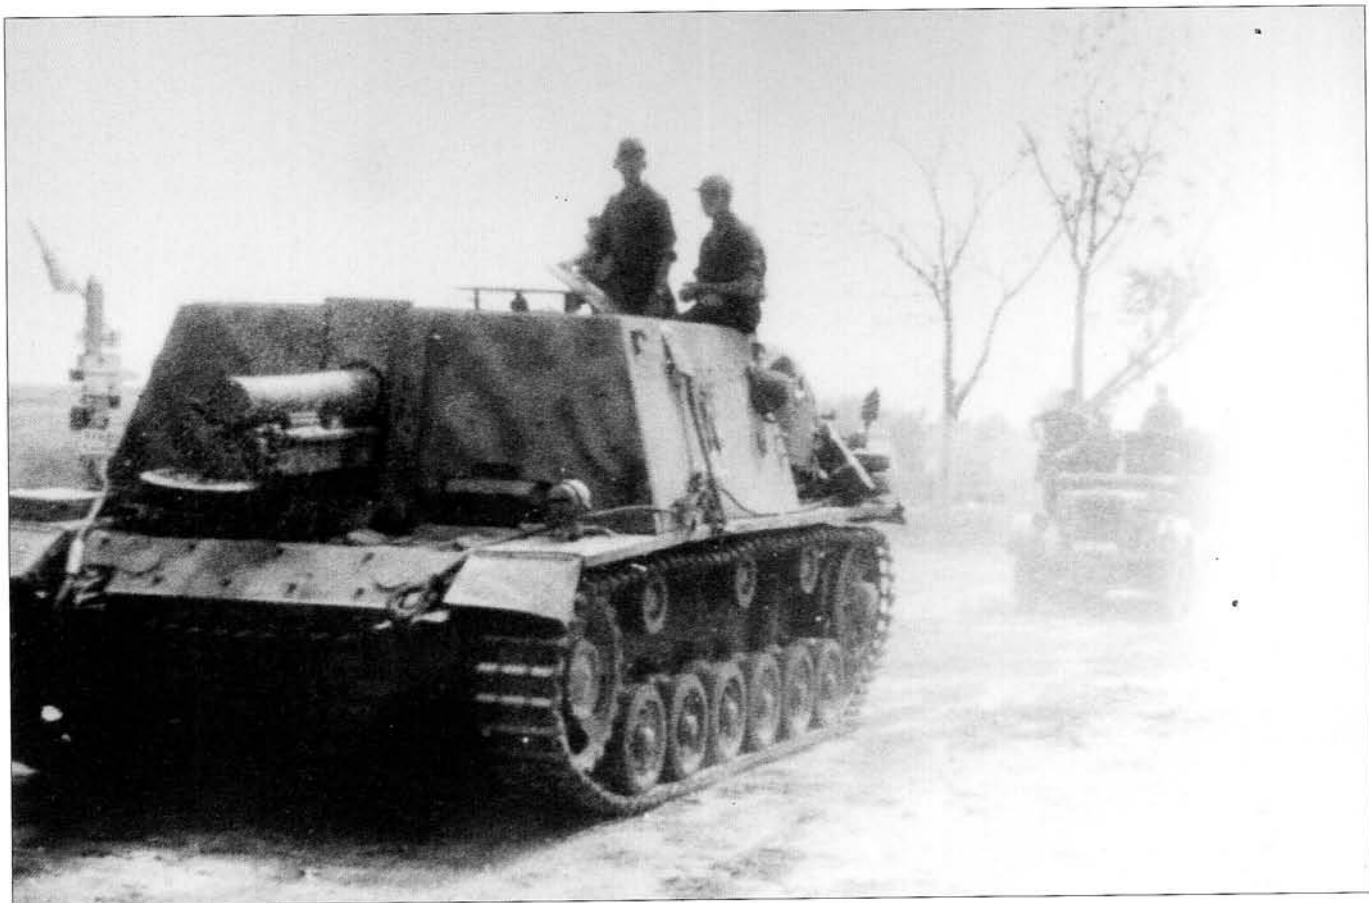
Moving forward on dusty roads. Neither sideskirt mounts nor *Zimmerit* were added to these vehicles. • Voran auf staubigen Straßen. An den Sturm-Infanteriegeschützen wurde weder ein Zimmeritanstrich noch Schürzenhalterungen angebracht

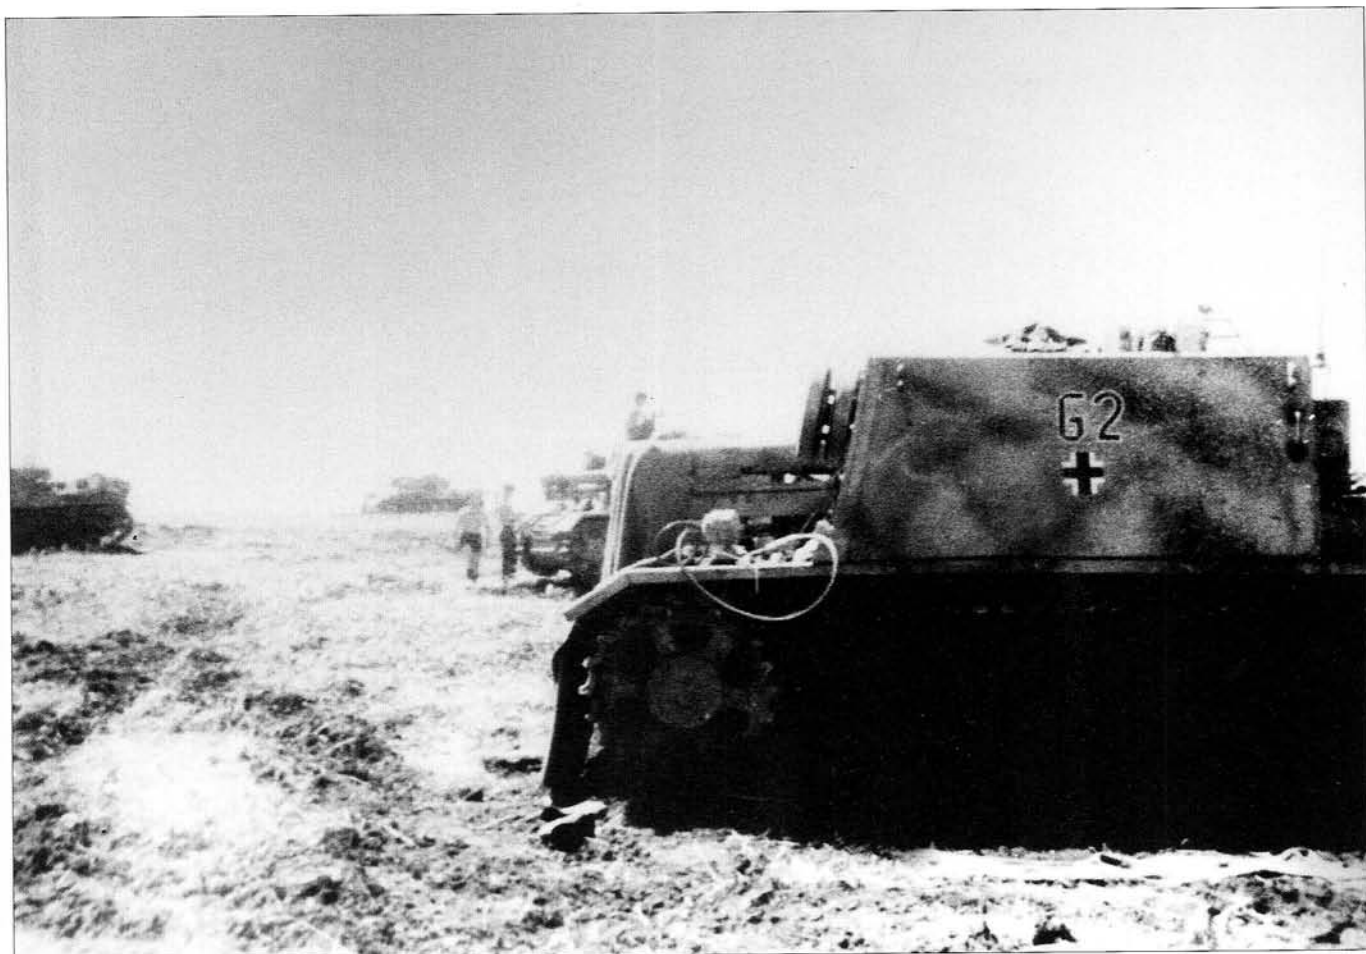
G2 has taken up its position. The 15-centimeter heavy infantry gun has been covered with a tarpaulin. • Sturm-Infanterietank "G 2" hat Position bezogen. Das 15 cm sIG wurde mit einer Plane abgedeckt.

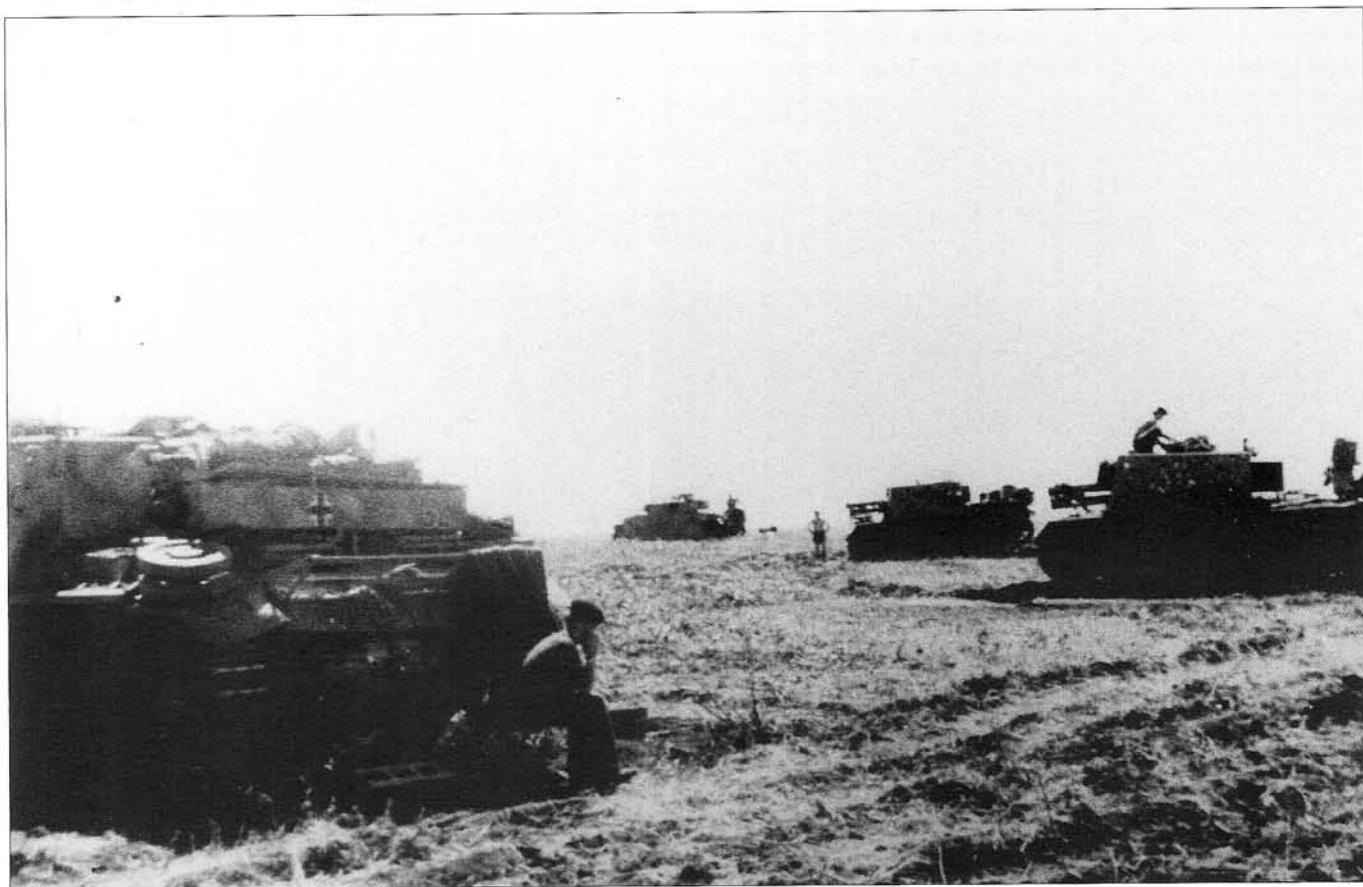
G2 has also been painted on the baggage stowage bin on the rear of the vehicle. • Die Kennzeichnung "G2" wurde auch auf der Gepäckkiste am Fahrzeugheck aufgemalt. [2xKHM]

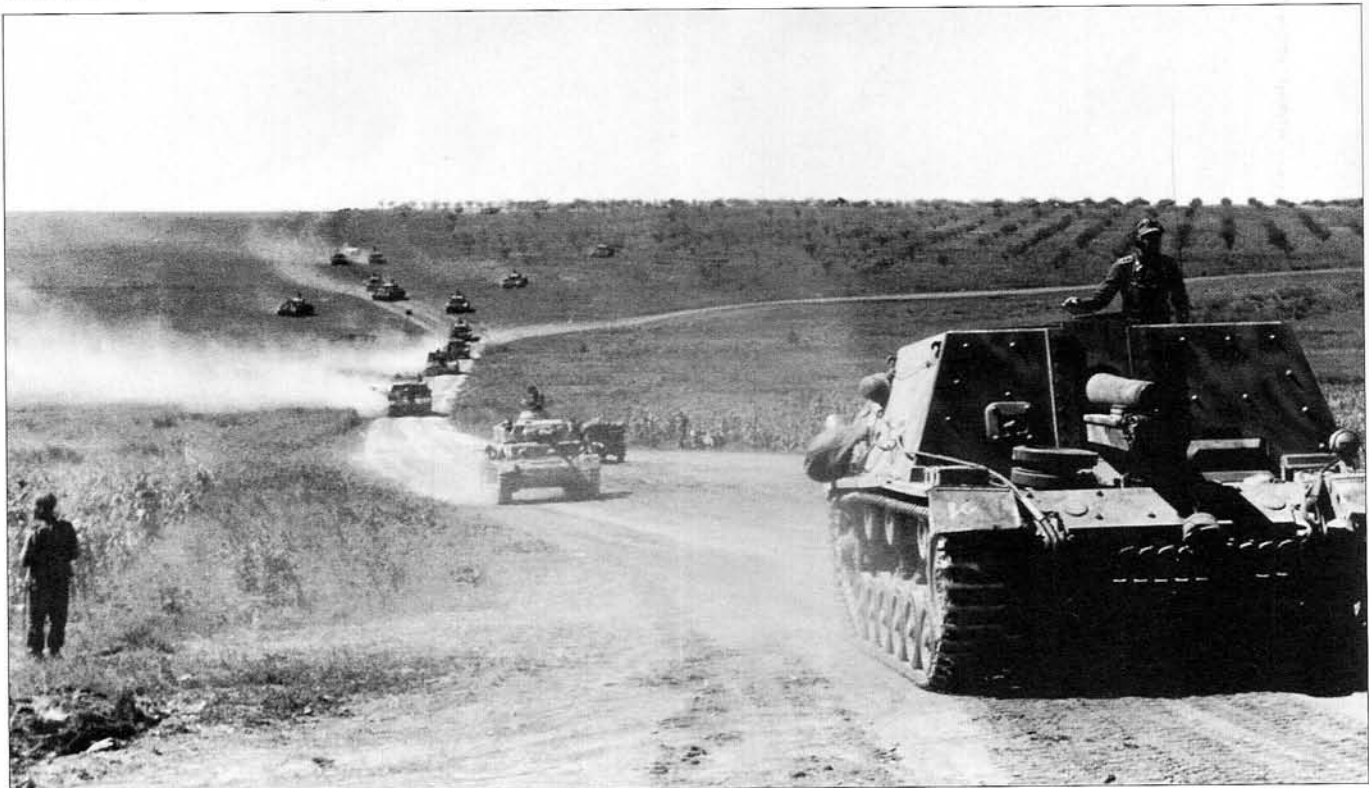
Rear view of G3. The gun is also carrying a 200-liter fuel drum with it to extend its range. • Rückansicht von Geschütz "G 3". Es führt zusätzlich ein 200 Liter mit Betriebsstoff mit sich

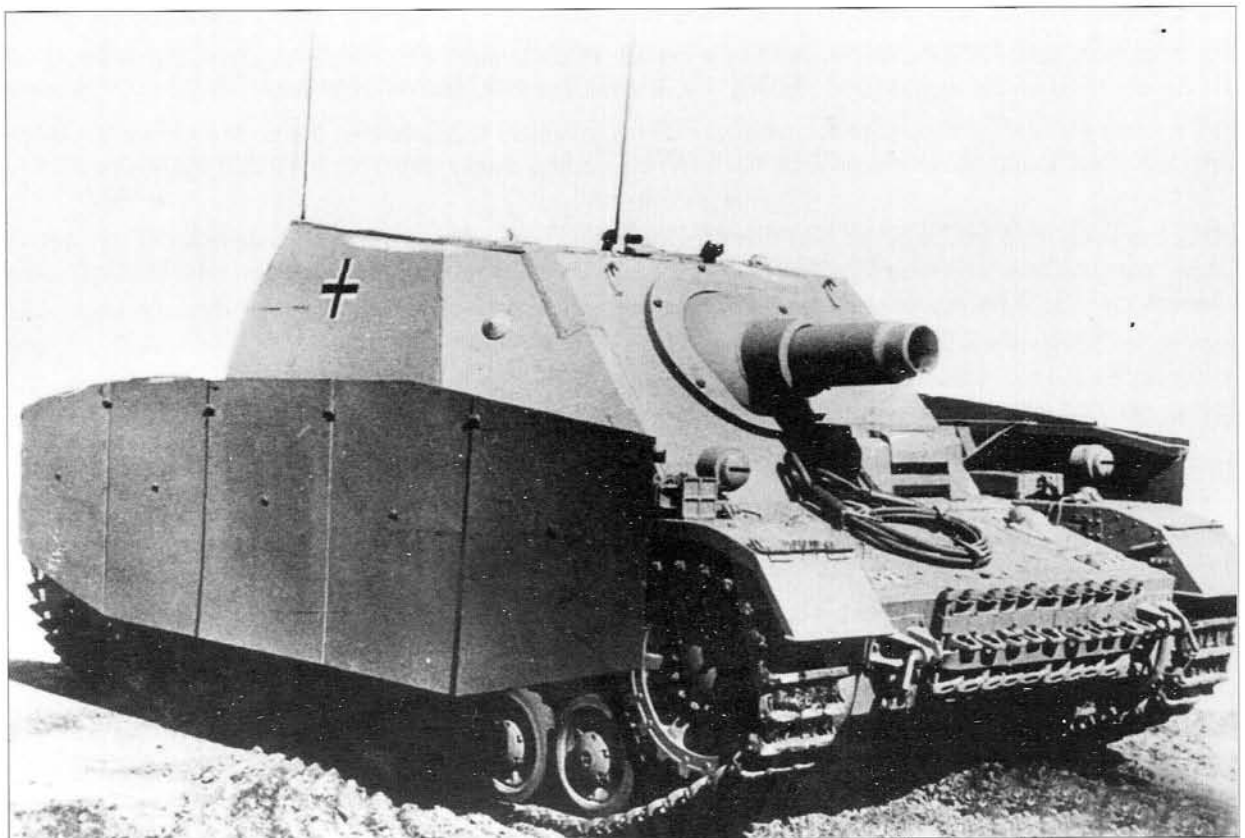
This vehicle has already had the sideskirts installed. Additional track links have been affixed to the front of the hull. • Beim diesem Fahrzeug sind bereits die seitlichen Schürzen montiert und zusätzlich Ersatzkettenglieder am Wannenbug befestigt.

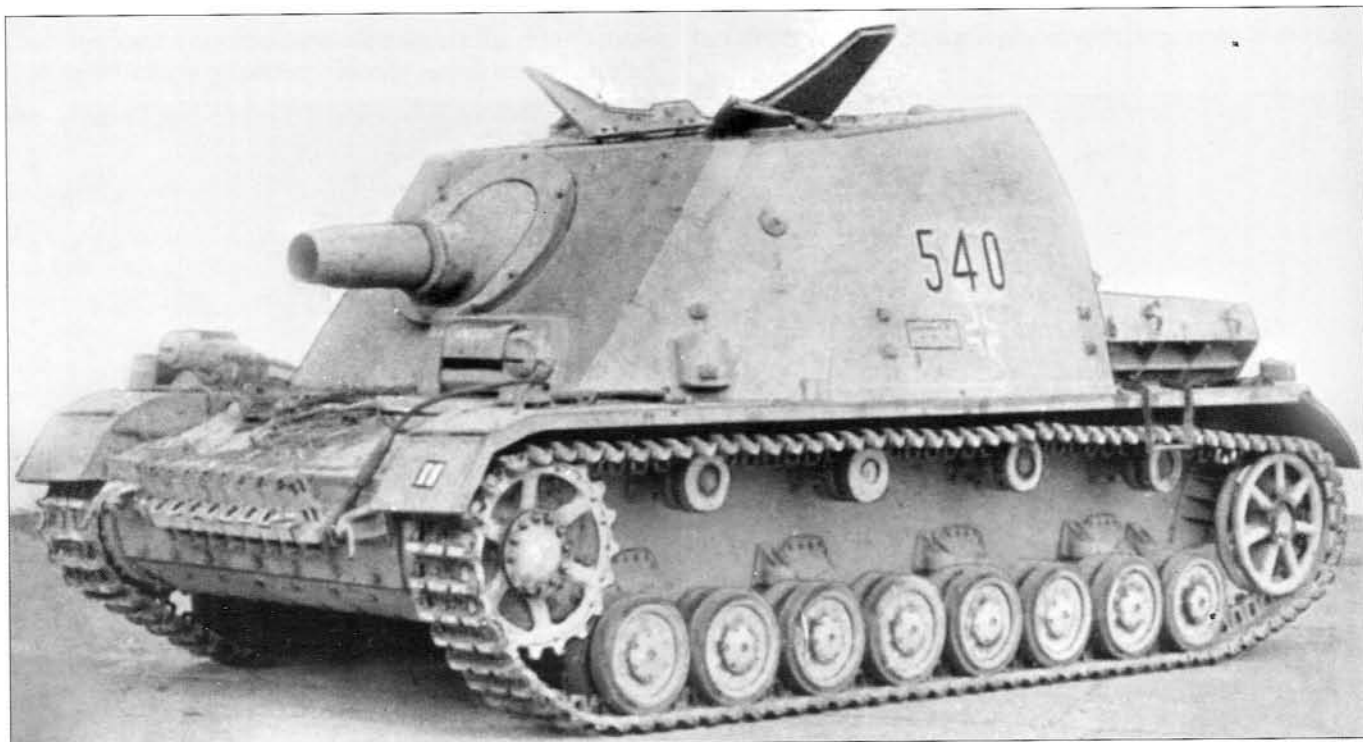
One of the first assault tanks using the chassis of the F model of the *Panzer IV* as its starting point. Note the shape of the first 15-centimeter Model 43 assault howitzer. Additional armor plating has been bolted to the front of the hull. • Einer der ersten produzierten Sturmpanzer auf Basis des Fahrgestelles des Panzerkampfwagen IV Ausführung F. Man beachte die Form der ersten 15 cm Sturmhaubitze 43. Am Wannenbug ist eine zusätzliche Panzerplatte angeschraubt.

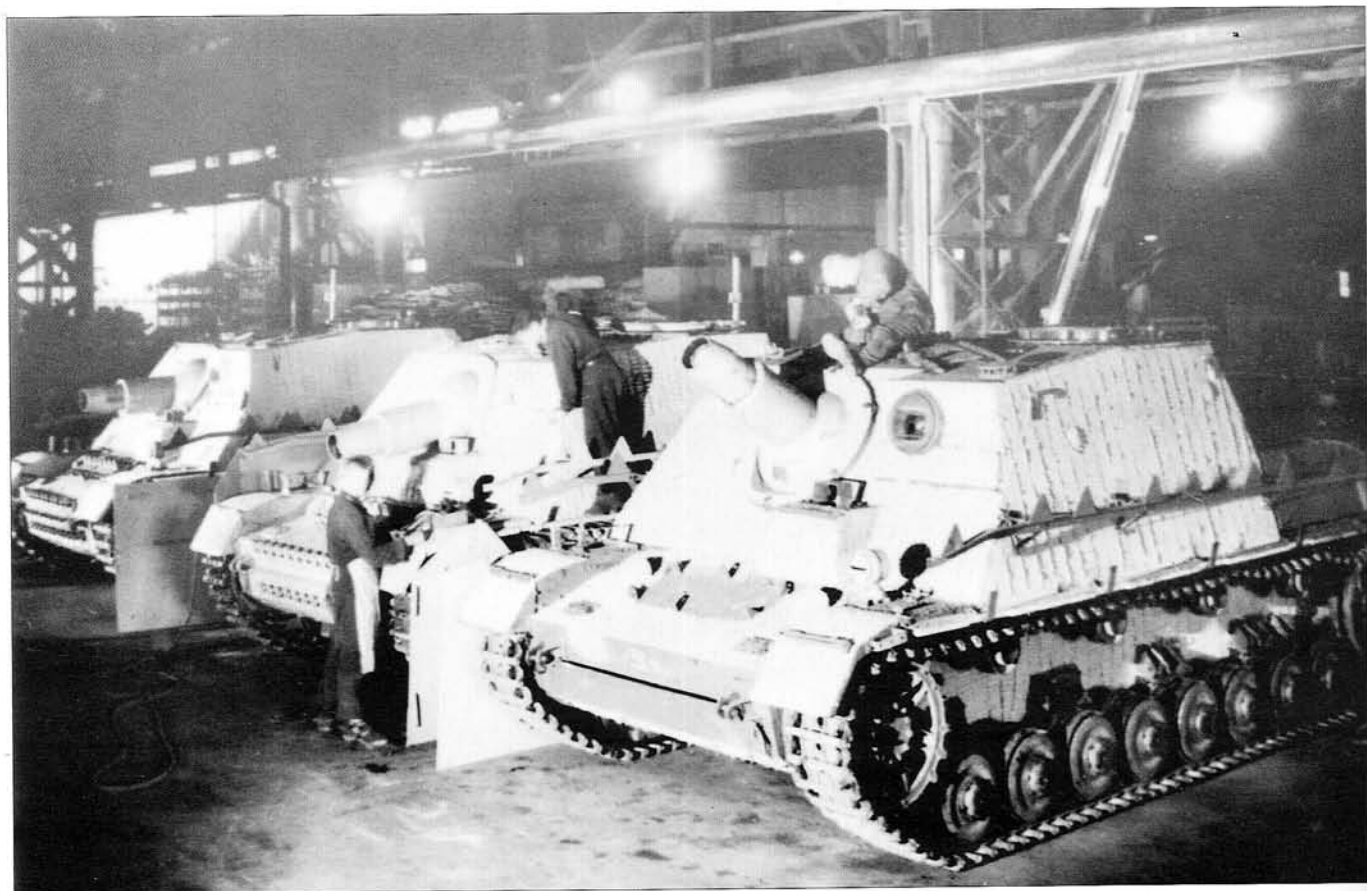
In the final production bay, the sideskirts have been set aside for mounting on the vehicles, and the next 4 pages • In der Halle der Endabnahme werden bereits die Schürzen an den Fahrzeugen bereitgestellt. und weitere 4 Seiten.

The *Zimmerit* coating has not only been applied to the superstructure but also to the mudguards. Only the area of the vehicle's hull has been spared. • Die *Zimmerit*beschichtung ist nicht nur an den Aufbauten angebracht sondern auch auf den Kettenabdeckungen. Nur der Bereich am Fahrzeugbug ist ausgespart.

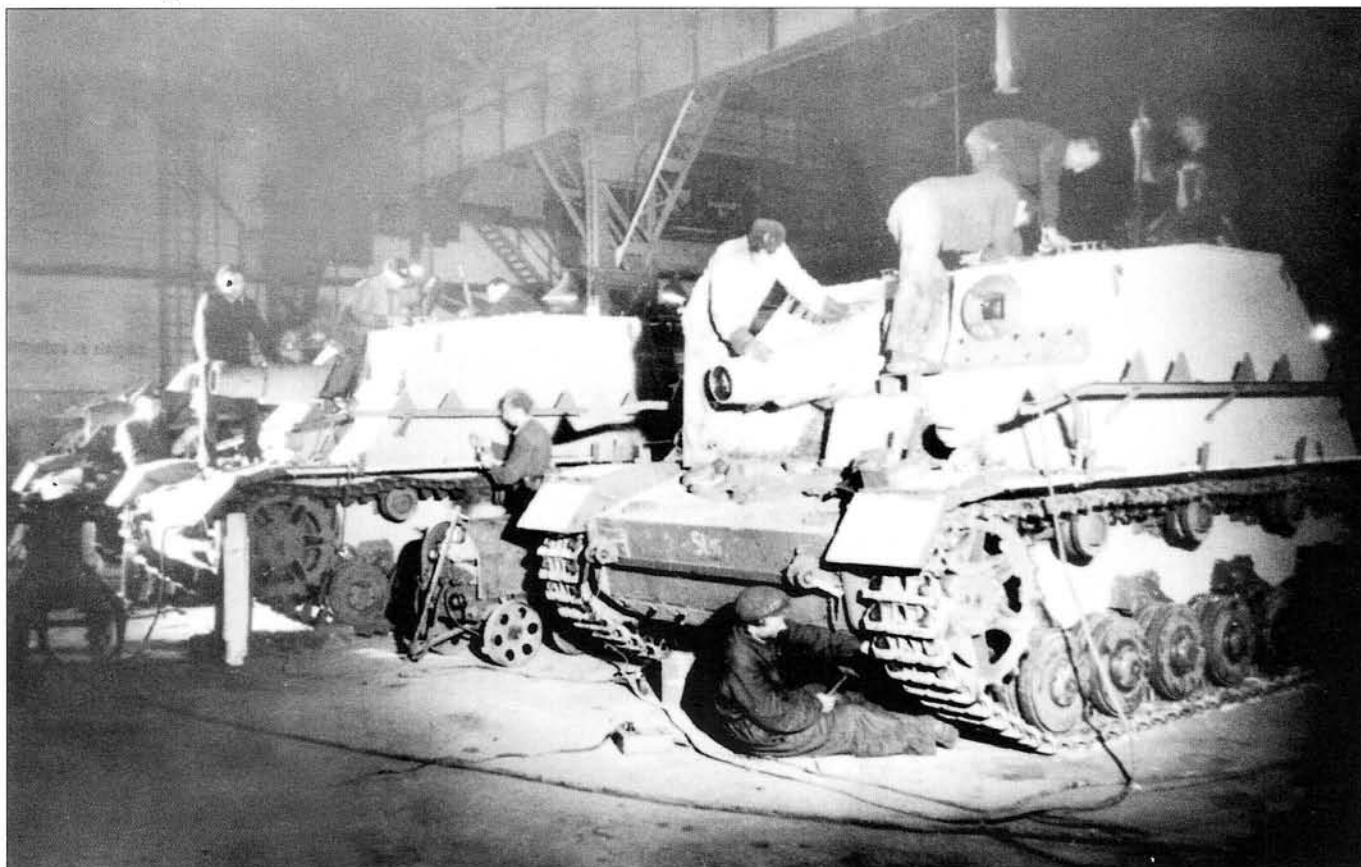
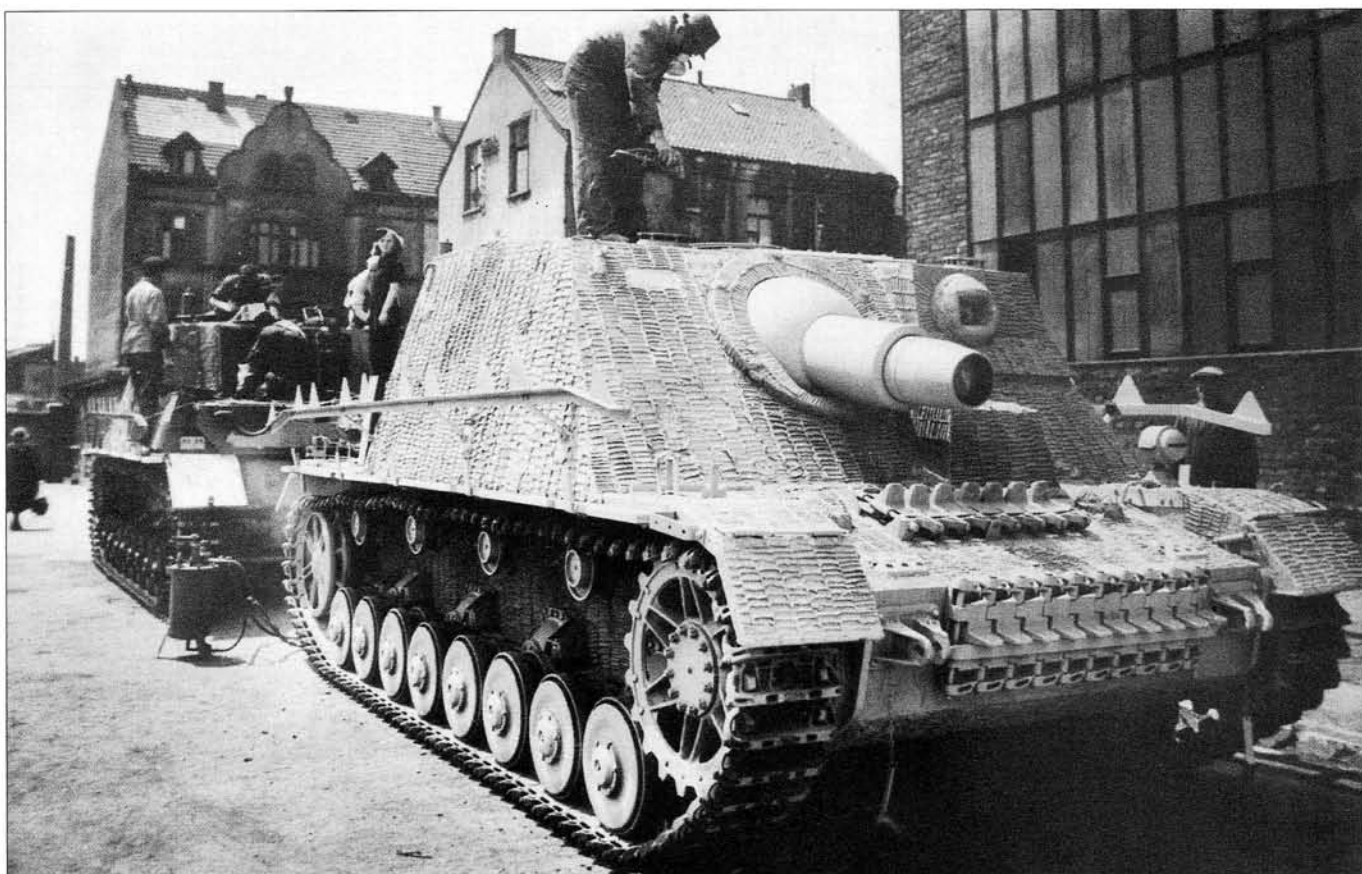
Montage der der Ausführung IV des Sturmpanzers bei den Deutschen Eisenwerken in Duisburg. • Montage der der Ausführung IV des Sturmpanzers bei den Deutschen Eisenwerken in Duisburg.

A coat of *Zimmerit* was applied at the factory. On the second vehicle, the MG 34 has not been mounted in its ball mount.
 • Die Zimmeritbeschichtung ist bereits werksseitig angebracht. Beim zweiten Fahrzeug ist das MG 34 in der Kugellafette noch nicht eingebaut.

Outside, the vehicles were sprayed with a uniform coat of sand-yellow camouflage. • Im Außengelände wird einheitlich der sandgelbe Grundtarnanstrich aufgesprüht.

The late-style cast iron idler wheel was mounted. Basic issue items, such as tools, were provided later on by the Army Procurement Agency. • Als Heckrad wurde das späte gusseiserne Modell montiert. Sonstige Ausrüstungsgegenstände, wie das Werkzeug etc. wurden erst vom Heereszeugamt befestigt.

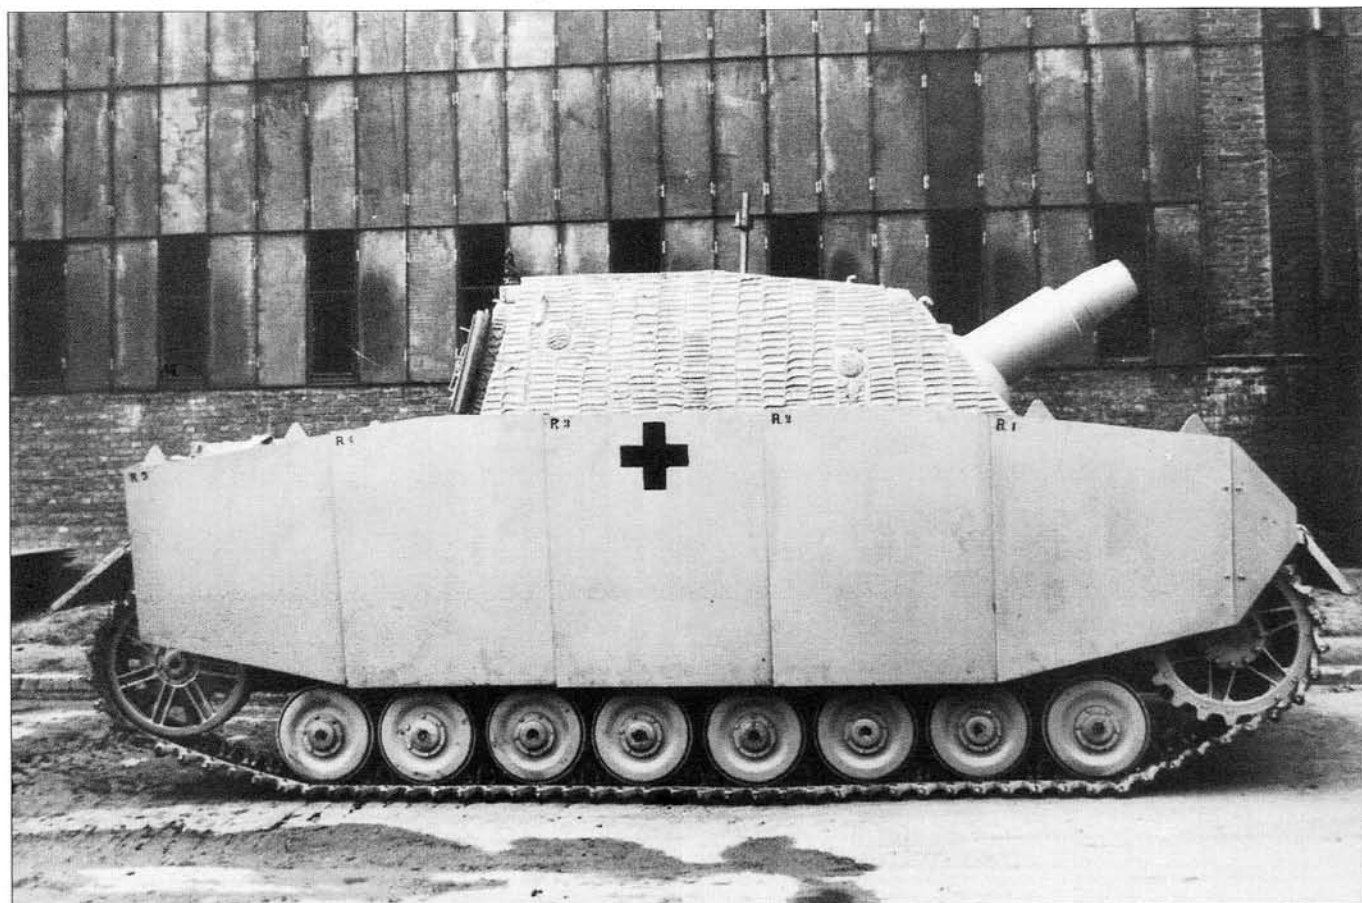
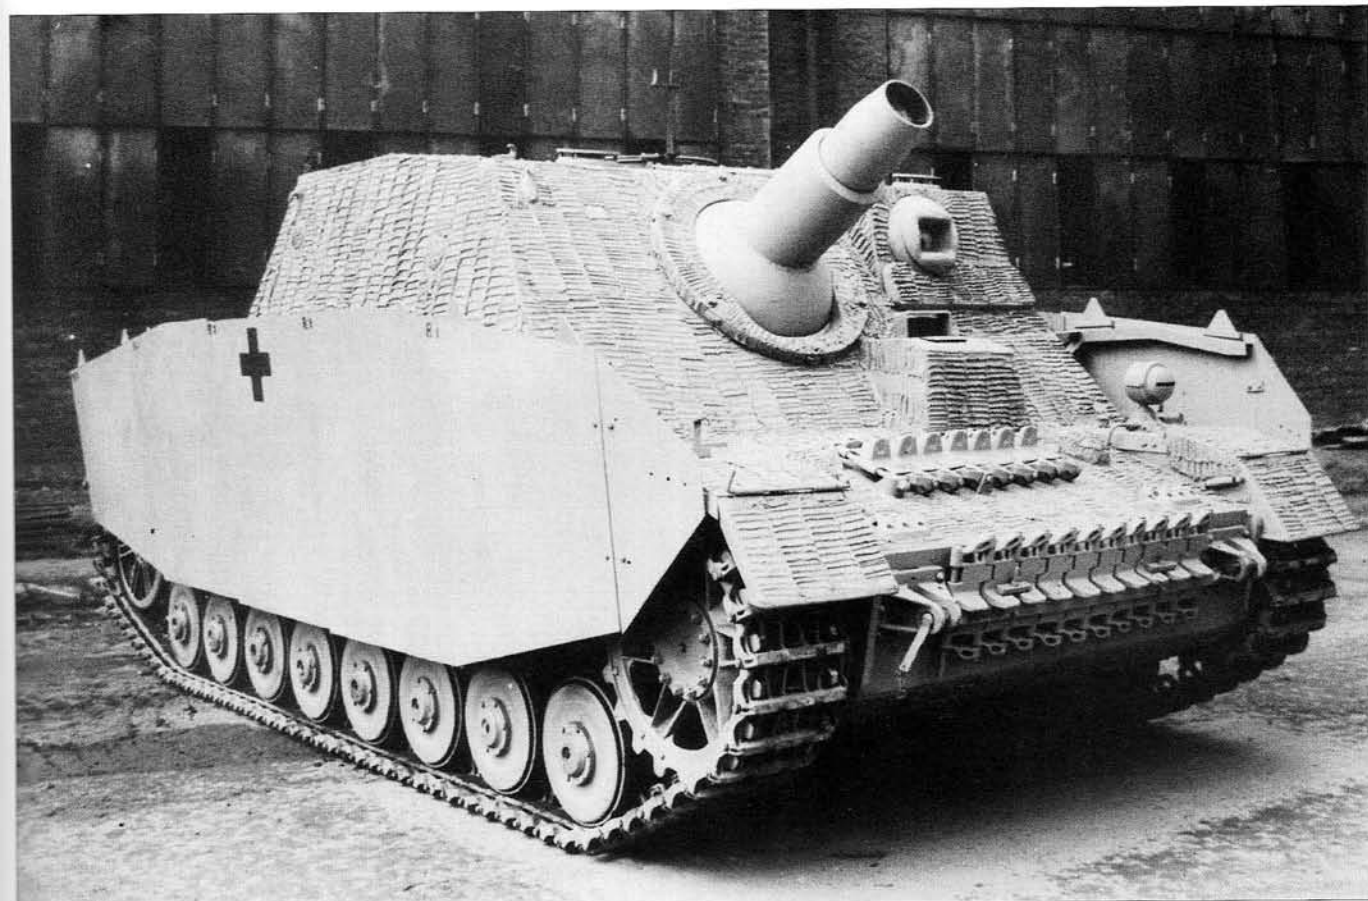
With this production batch, the factory installed eight steel roadwheels per side. • Bei dieser Serie wurden bereits werksseitig acht Stahllaufrollen pro Seite montiert

Following that, the sideskirts were mounted and the necessary markings and insignia, such as the *Balkenkreuz*, were added.
• Danach wurden die Schürzen am Fahrzeug befestigt und die notwendigen Beschriftungen und Kennzeichnungen, wie das Balkenkreuz, angebracht

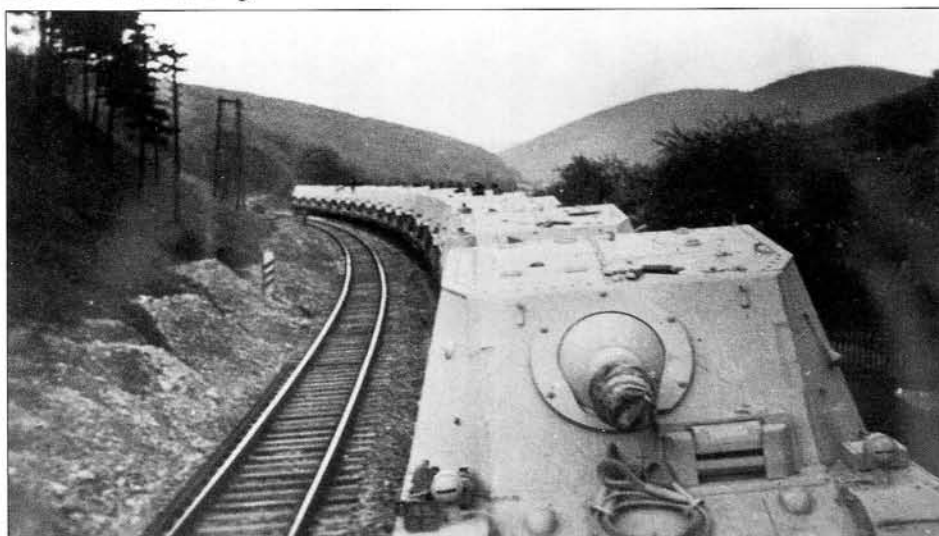
In May 1943, the factory-new assault tanks were issued to *Sturmpanzer-Abteilung 216* in the Amiens area. The mounting brackets for the sideskirts are not yet present on the vehicles. • Im Mai 1943 werden die fabrikneuen Sturmpanzer der im Raum Amiens liegenden Sturmpanzer-Abteilung 216 zugeführt. An den Fahrzeugen befinden sich noch keine Halterungen für die Schürzen

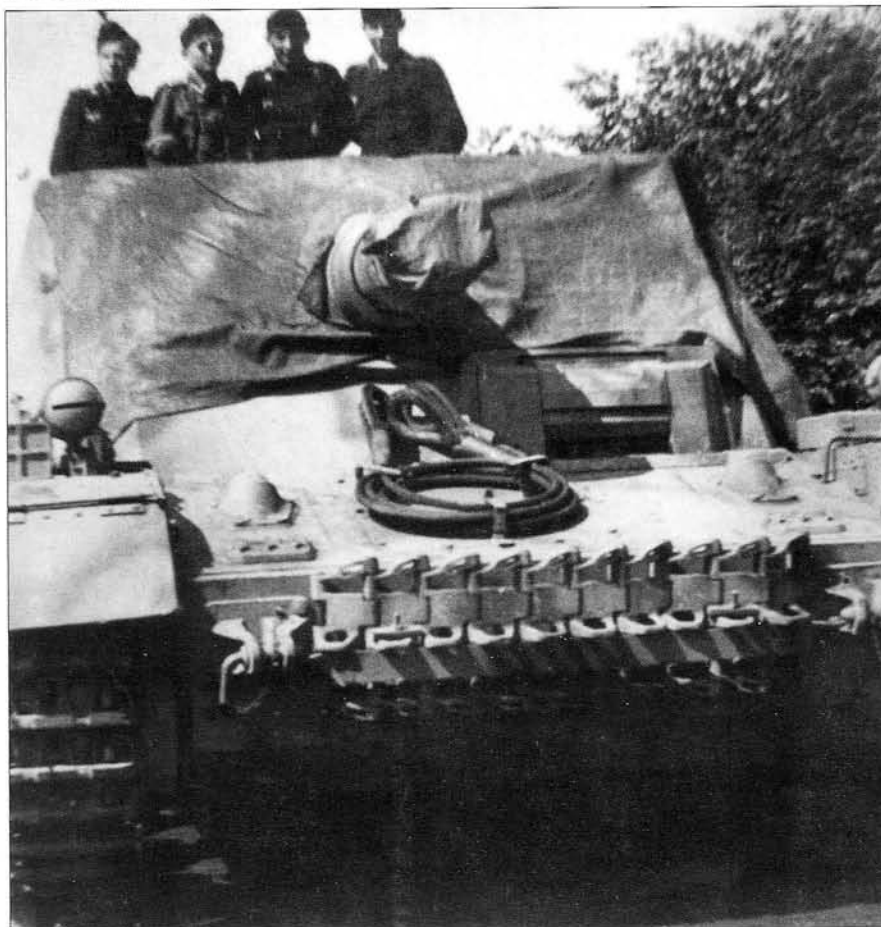
An assault tank converted from the E model of the Panzer IV. Note the air intakes of a Panzer III, which were screwed on to the old steering brake maintenance access panels. • Ein auf Basis eines Pz.Kpfw.IV Ausf. E aufgebauter Sturmpanzer. Man beachte die Lufteinlässe des Pz.Kpfw. III, die auf den alten Lenkbremsen-Wartungsluken angeschraubt sind.

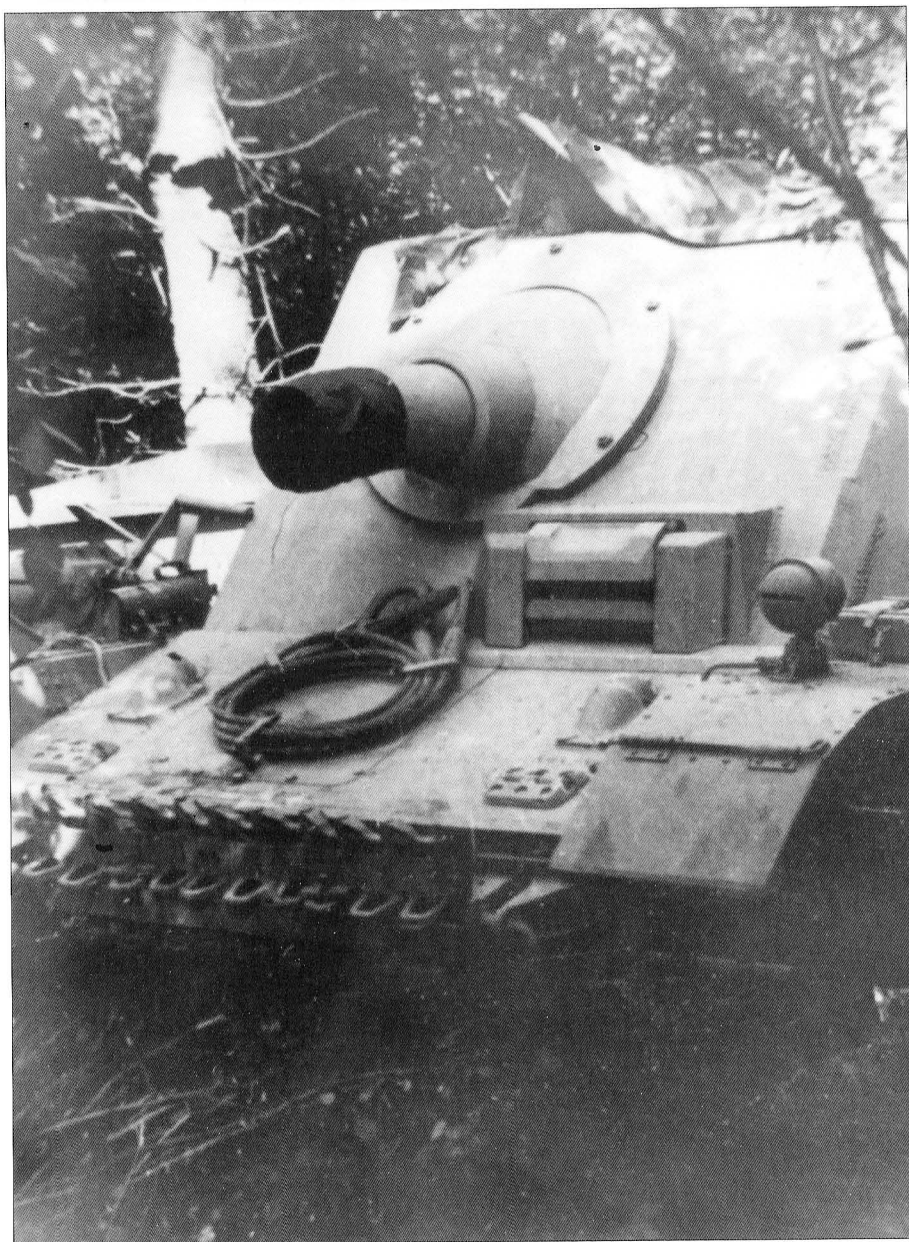
In an assembly area. The vehicles do not have a coating of *Zimmerit* yet. In this instance, these vehicles also have the *Panzer III*-style air intakes. • In Bereitstellung. Die Fahrzeuge haben noch keinen Zimmeritanstrich. Auch hier sind auf den Lenkbremsen-Wartungsluken Pz.Kpfw. III Lufteinlässe montiert.
