STURMTIGER and STURMPANZER in COMBAT

Sturmtiger and Sturmpanzer in Combat

Katowice – Speyer 2008

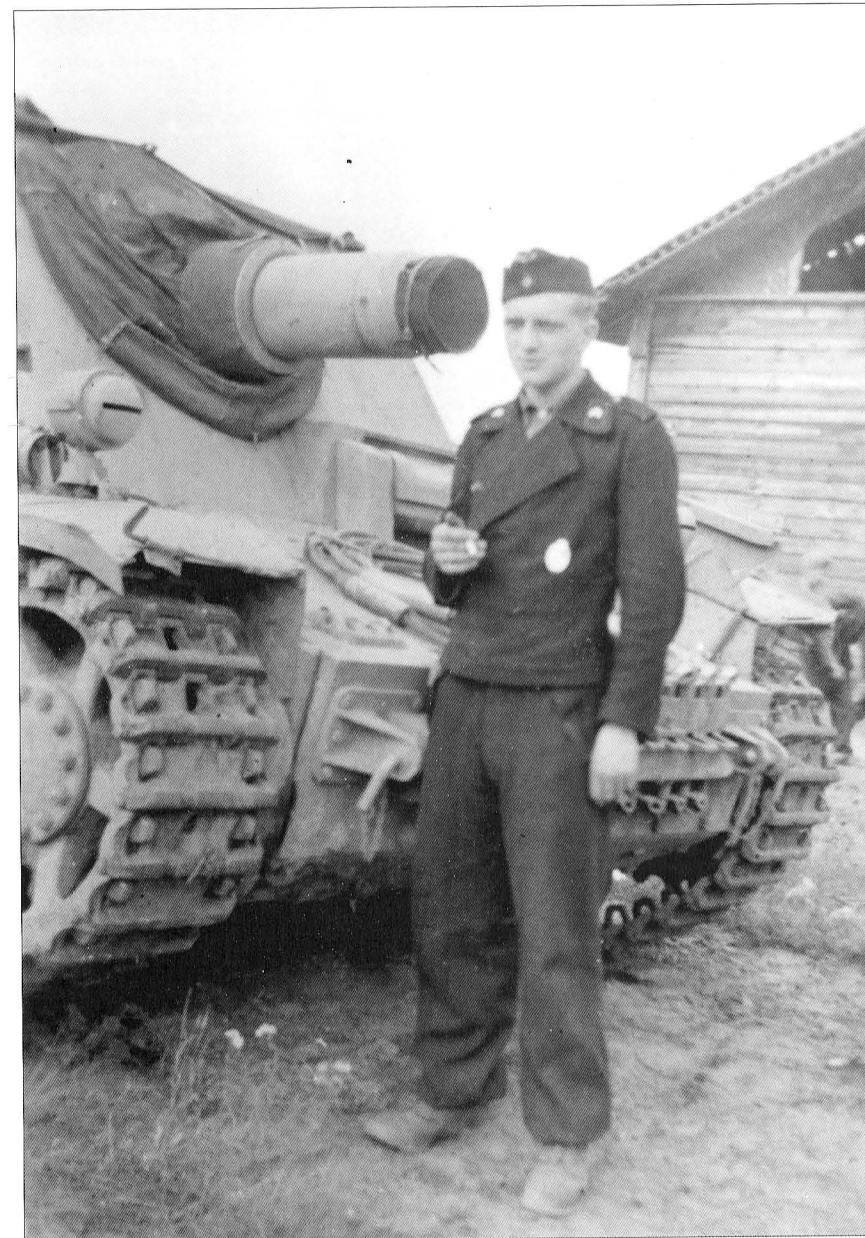
Supplemental armor plate has been added to the front of the hull. • Am Wannenbug ist zur Verstärkung eine Panzerplatte angebracht.

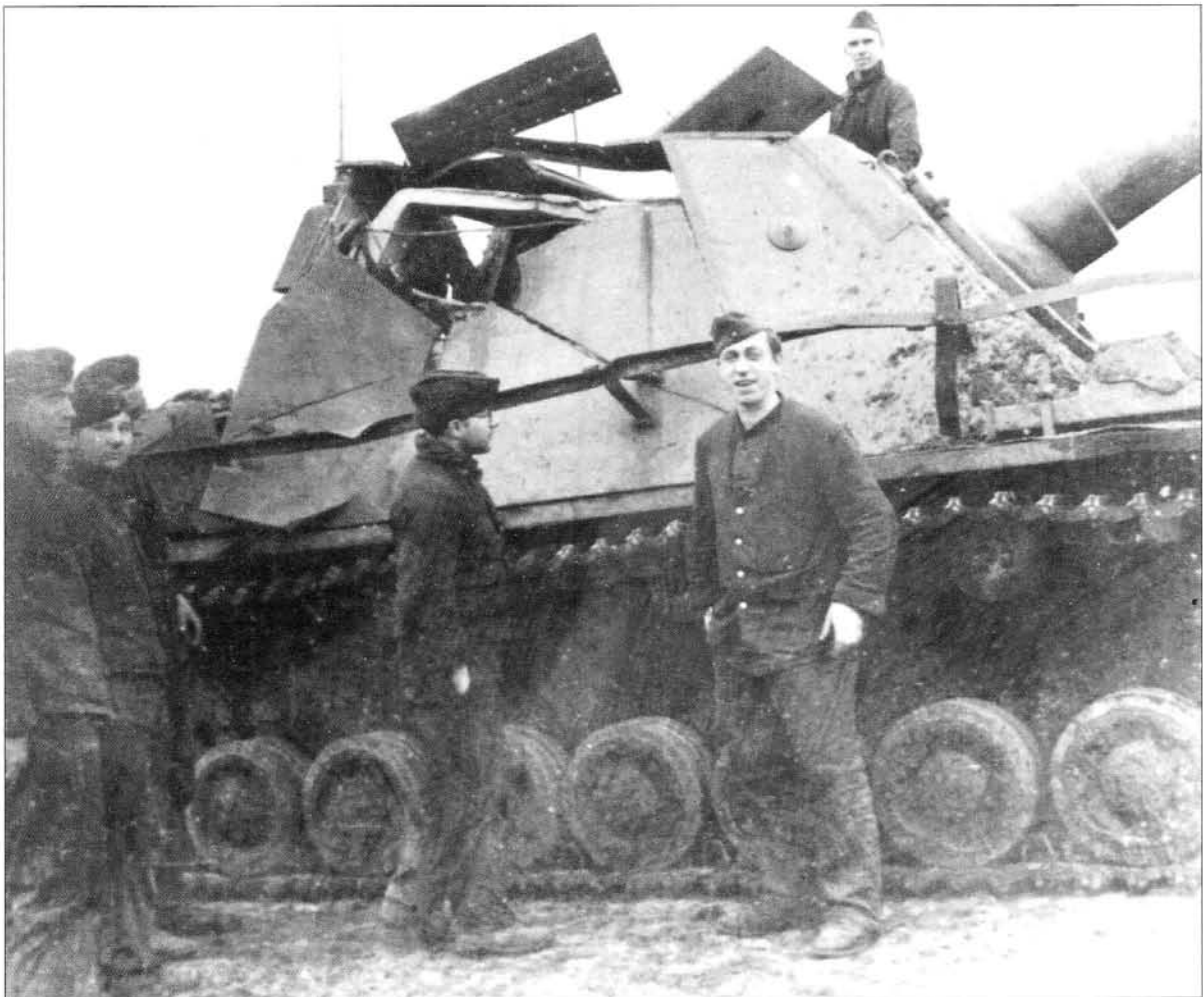
A total loss. This assault tank was destroyed on the right-hand side by an artillery round. • Totalschaden. Der Sturmpanzer wurde durch einen Artillerietreffer auf der rechten Aufbauseite zerstört.

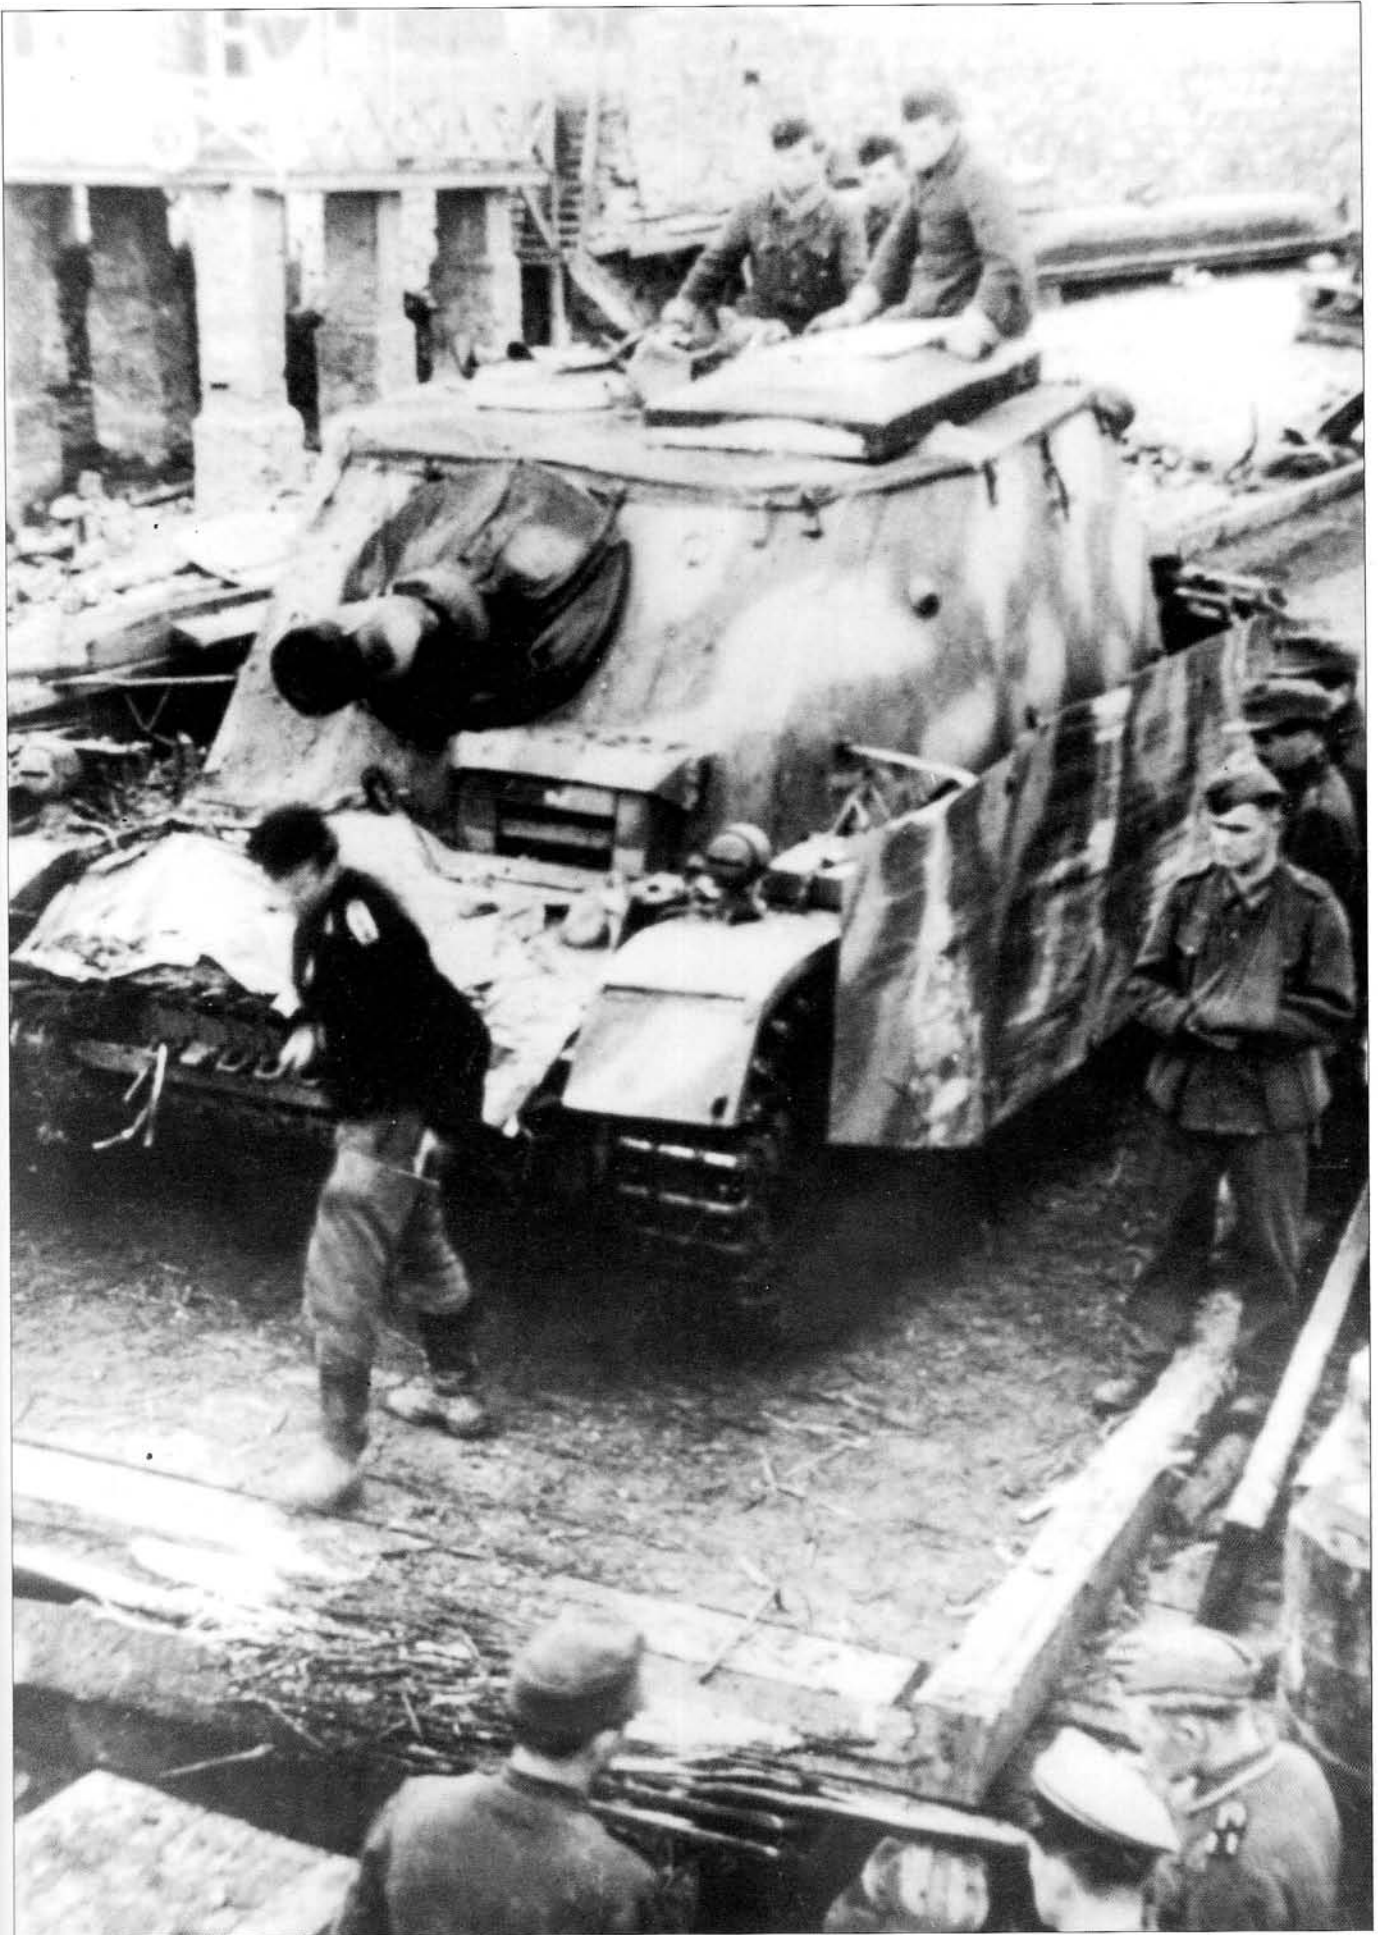
A provisional rain guard has been affixed above the *Fahrersehklappe 80* of this assault tank. • Über der Fahrersehklappe 80 dieses Sturmpanzers ist ein provisorischer Regenschutz befestigt.

There were some modifications in the area of the driver's station. The *Fahrersehklappe 80* was replaced with periscopes. In the case of some vehicles, a protective covering against rain was added.

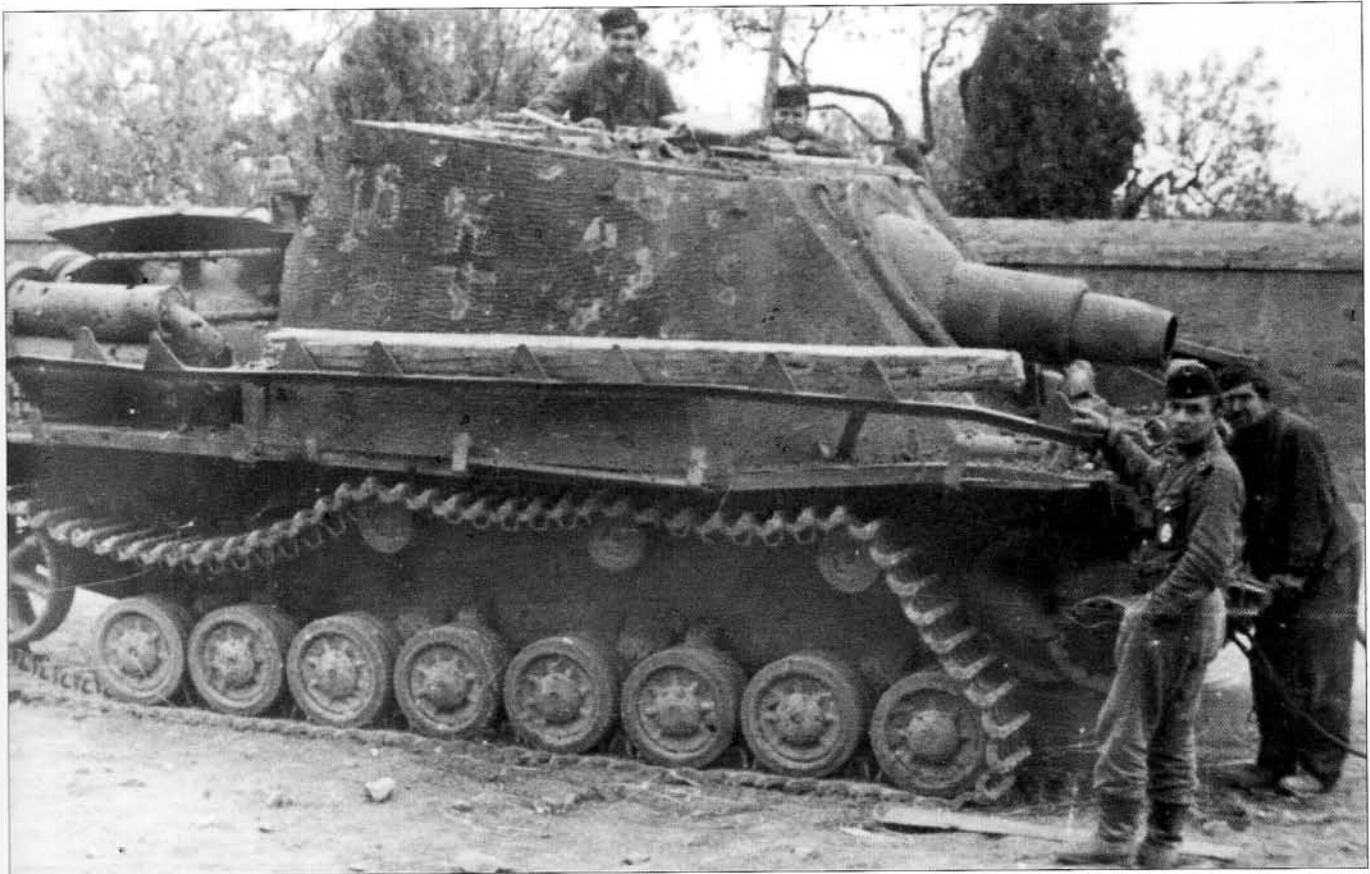
After damage to the differentials, the drive sprocket was completely removed and the track "detoured". Note the additional filter system. • Nach einem Schaden im Vorgelege, wird der Antrieb vollständig ausgebaut und die Kette "umgelenkt"- Man beachte die zusätzliche Filteranlage.

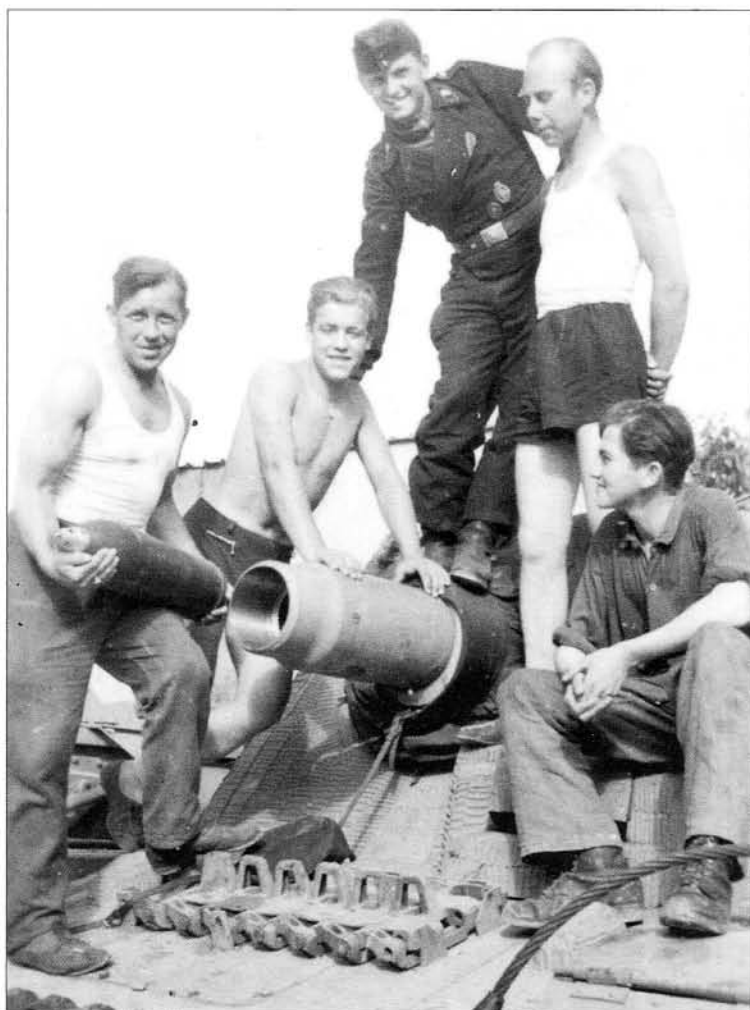
Souvenir photo. This photograph demonstrates the large size of the round. • Erinnerungsfoto. Diese Aufnahme verdeutlicht die Größe des Geschosses.

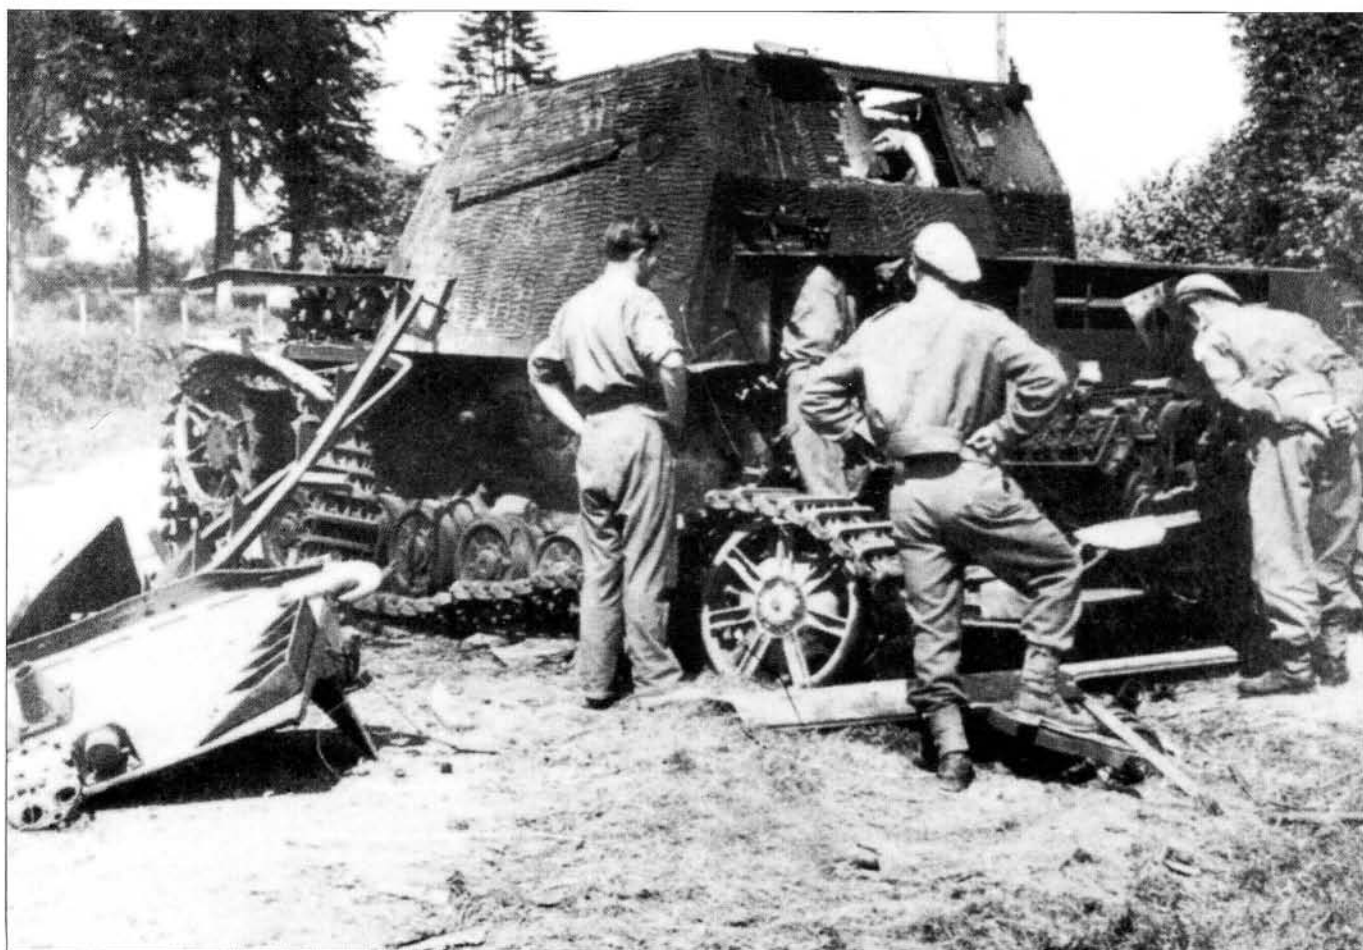
This assault tank was totally destroyed by an explosion in the vehicle's interior. A few Allied soldiers inspect the wreck of this vehicle, which was not frequently encountered in Normandy. • Dieser Sturmpanzer wurde durch eine Explosion im Fahrzeuginnern total zerstört. Einige alliierte Soldaten begutachten das Wrack dieses nicht zu häufig an der Normandiefrent gesehenen Geräts.

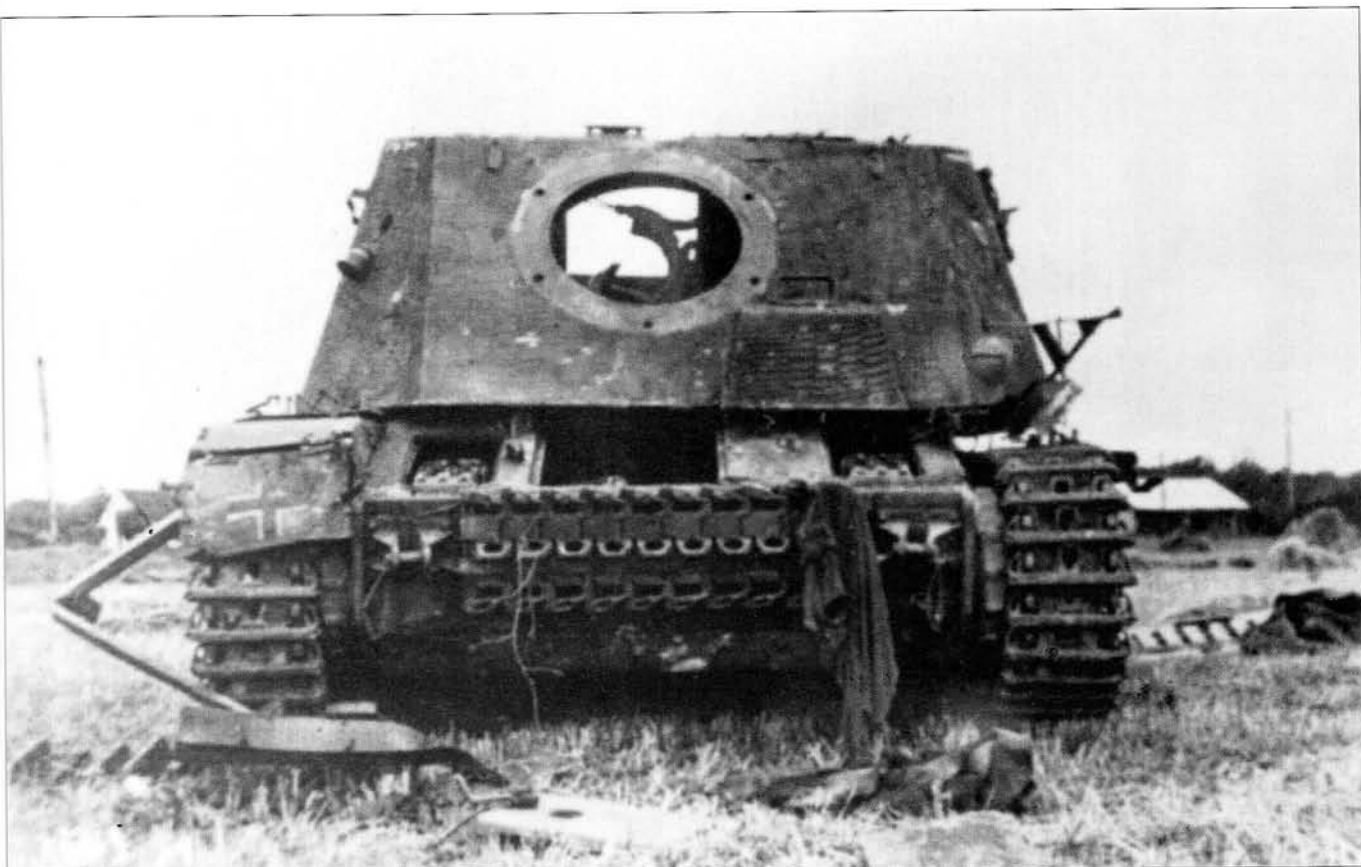
The 15-centimeter assault howitzer is missing and the superstructure has been displaced to the side. Note the *Balkenkreuz* on the right front mudguard. • Die 15cm Sturmhaubitze 43 fehlt, der Aufbau ist seitlich versetzt. Man beachte das Balkenkreuz auf der rechten vorderen Kettenabdeckung.

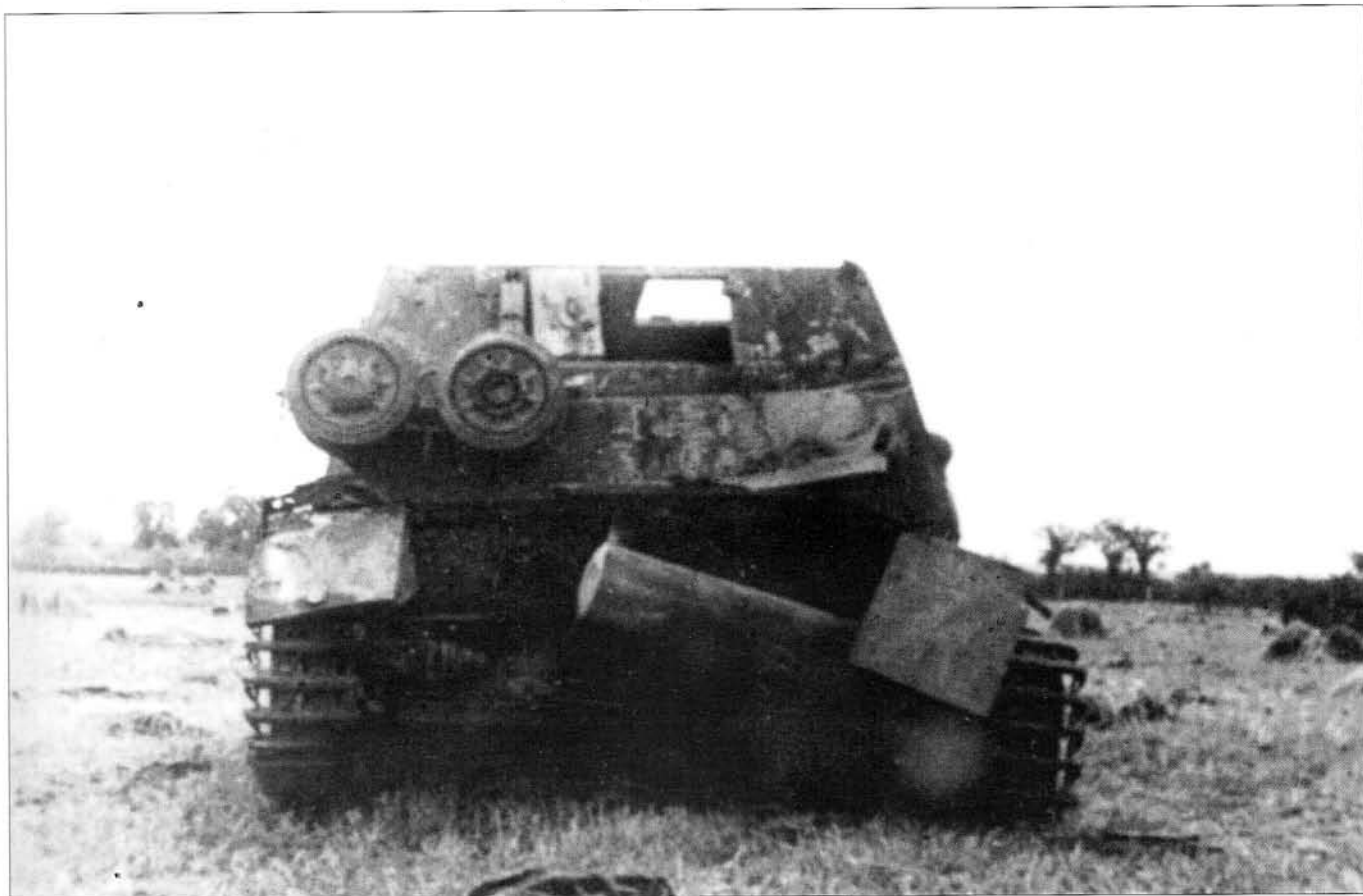
The vehicle's rear deck has also been considerably damaged. • Auch das Fahrzeugheck ist erheblich beschädigt.

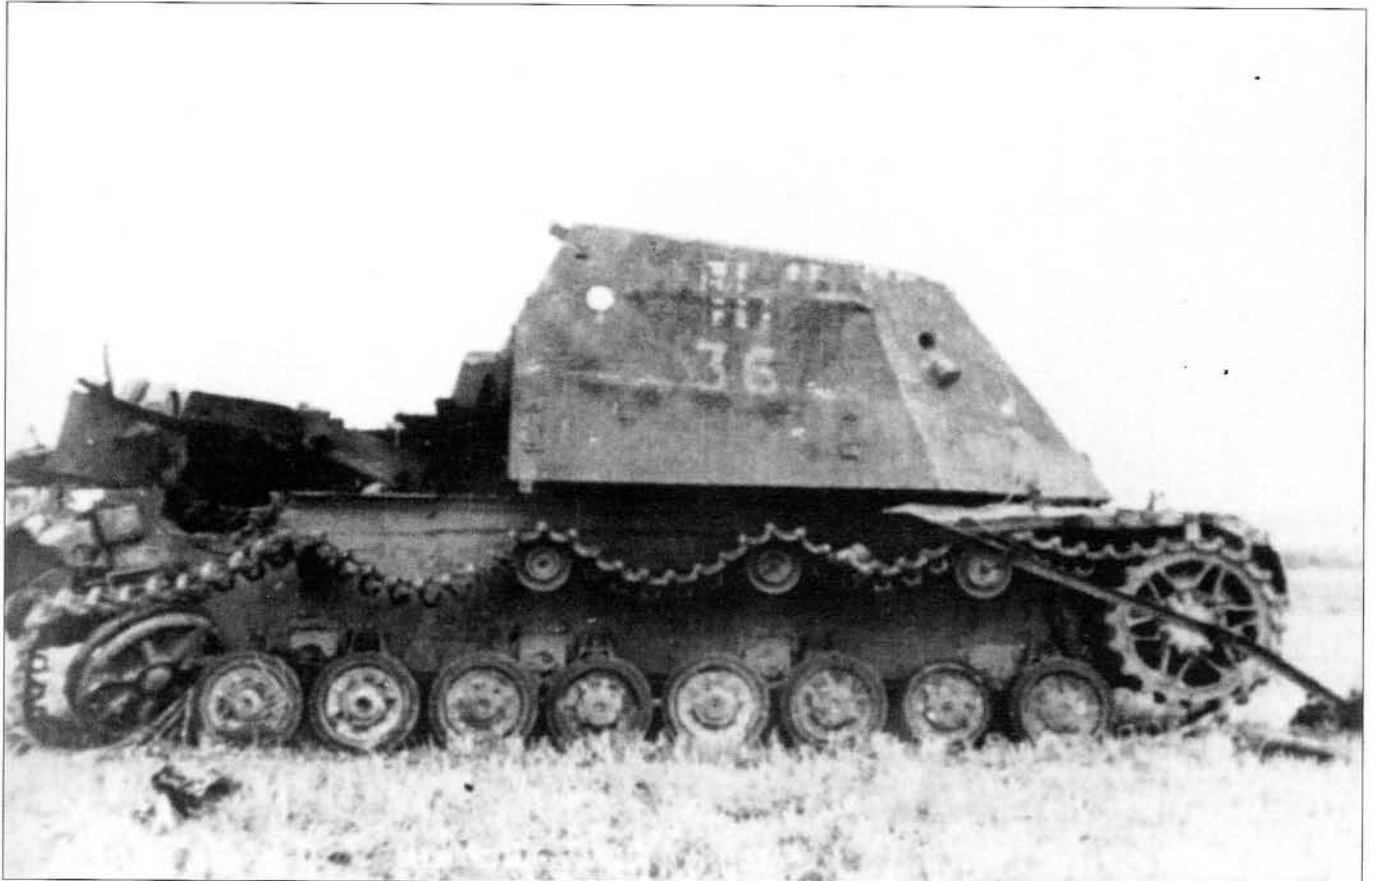
The reader can plainly see how the vehicle's superstructure was moved forward by the explosion. • Man sieht deutlich, dass sich der Aufbau durch die Explosion auch nach vorne verschoben hat.

As a result of the explosion in the vehicle's interior, parts of the commander's and loader's hatches were torn off and scattered. • Durch die Wucht der Explosion im Fahrzeuginnern wurden Teile der Kommandanten- und Ladeschützenluke abgerissen und weggeschleudert.

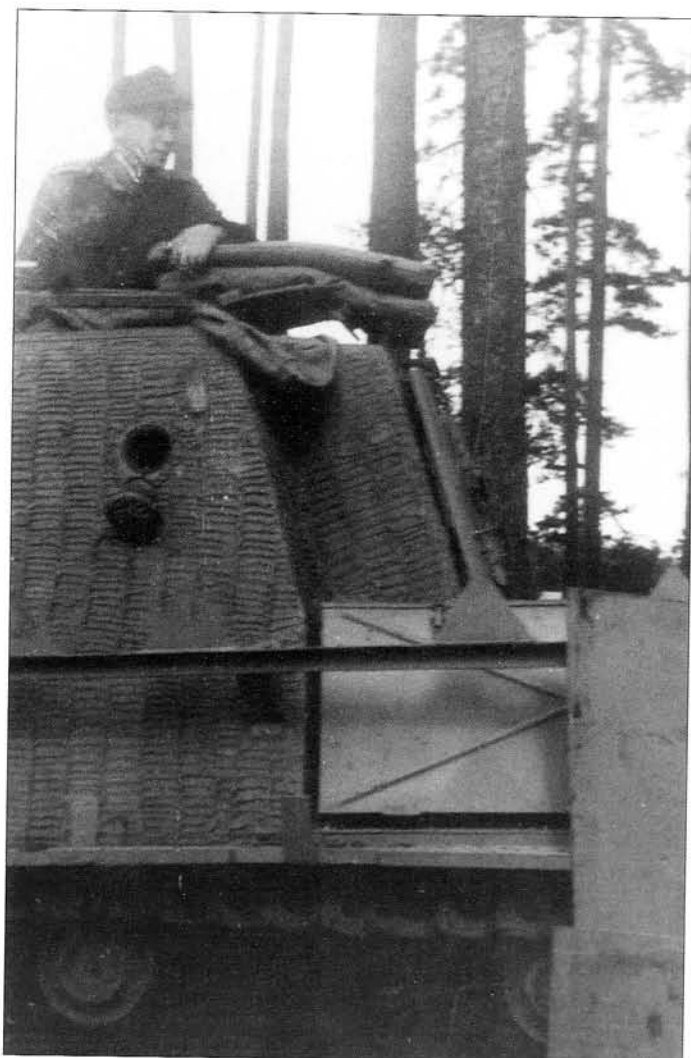
A view of the left-hand side of the superstructure. The machine-gun plugs are seen hanging. The gun commander has made himself comfortable at his station. • Blick auf die linke Aufbauseite. Die MG-Pfropfen hängen herunter. Der Kommandant hat es sich in seiner Luke bequem gemacht.

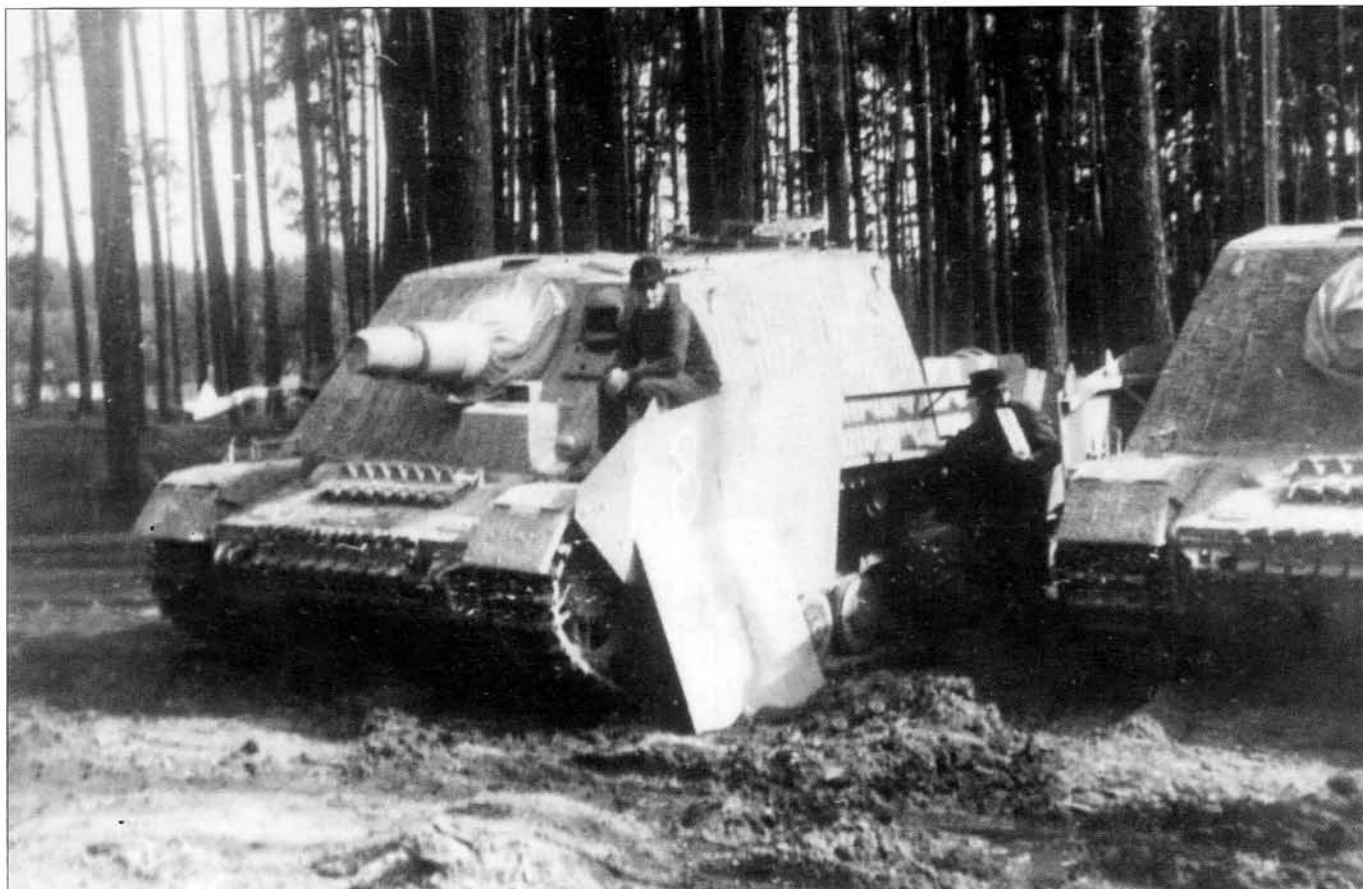
Apparently, this assault tank was not given the three-tone camouflage scheme. A few of the sideskirts have been removed. It appears the vehicle is being refueled. • Anscheinend haben die Sturmpanzer noch keinen dreifarbigen Flecktarnanstrich. Einige Schürzen wurden abgenommen, wahrscheinlich wurde das Fahrzeug betankt.

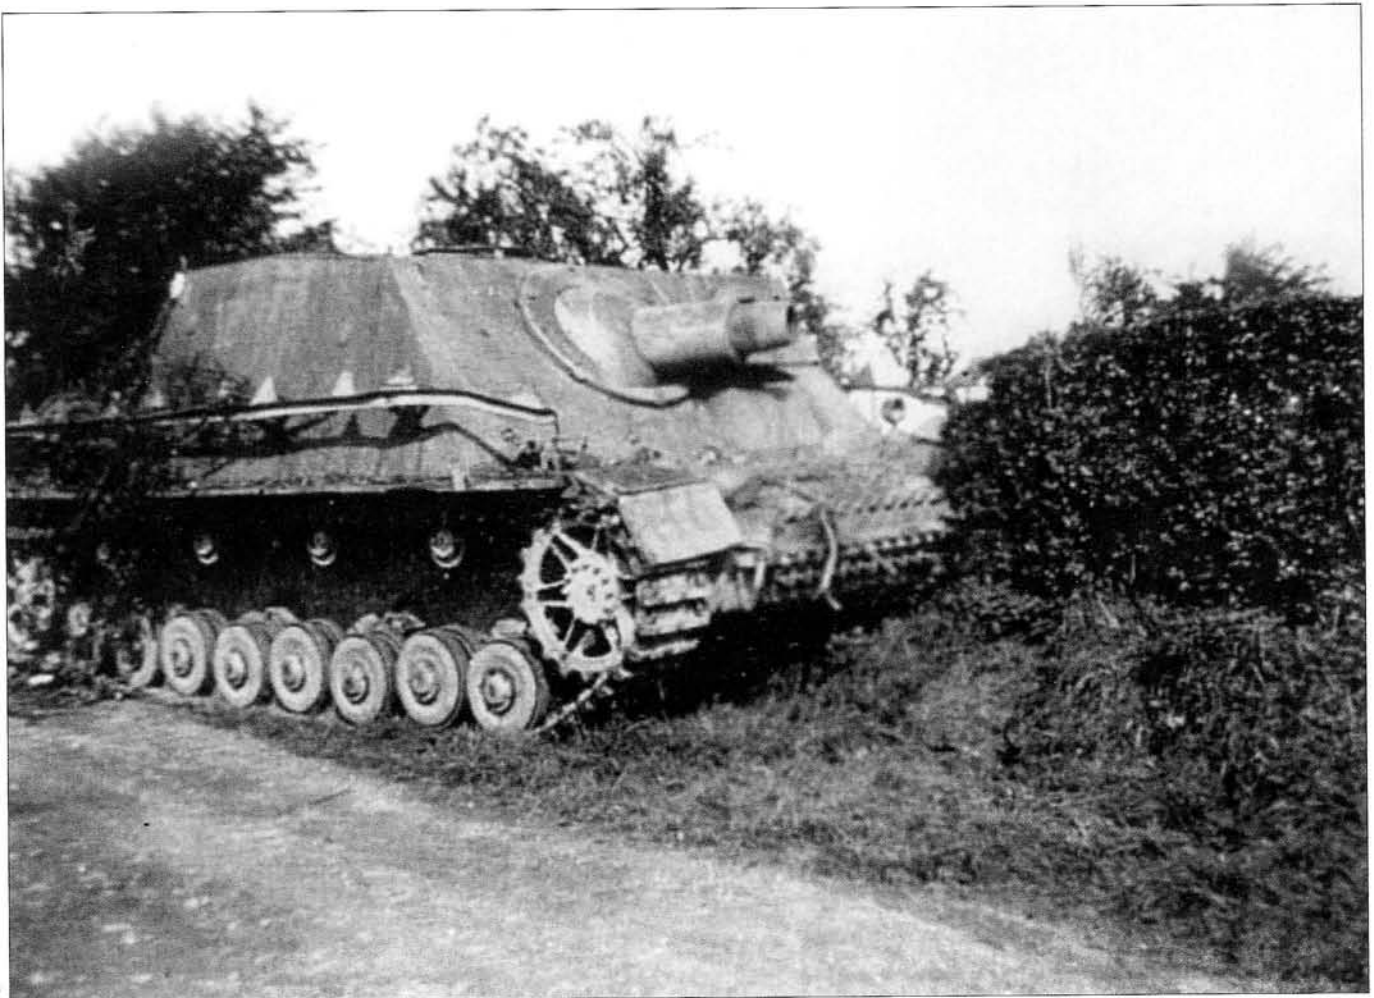
Another one was lost to enemy fire not too far from the village of Heggen. Note that the assault tank has been completely outfitted with steel roadwheels. • Ein weiterer fiel unweit der Ortschaft Heggen durch Feindbeschuss aus. Man beachte, dass der Panzer komplett mit Stahllaufrollen ausgerüstet ist.

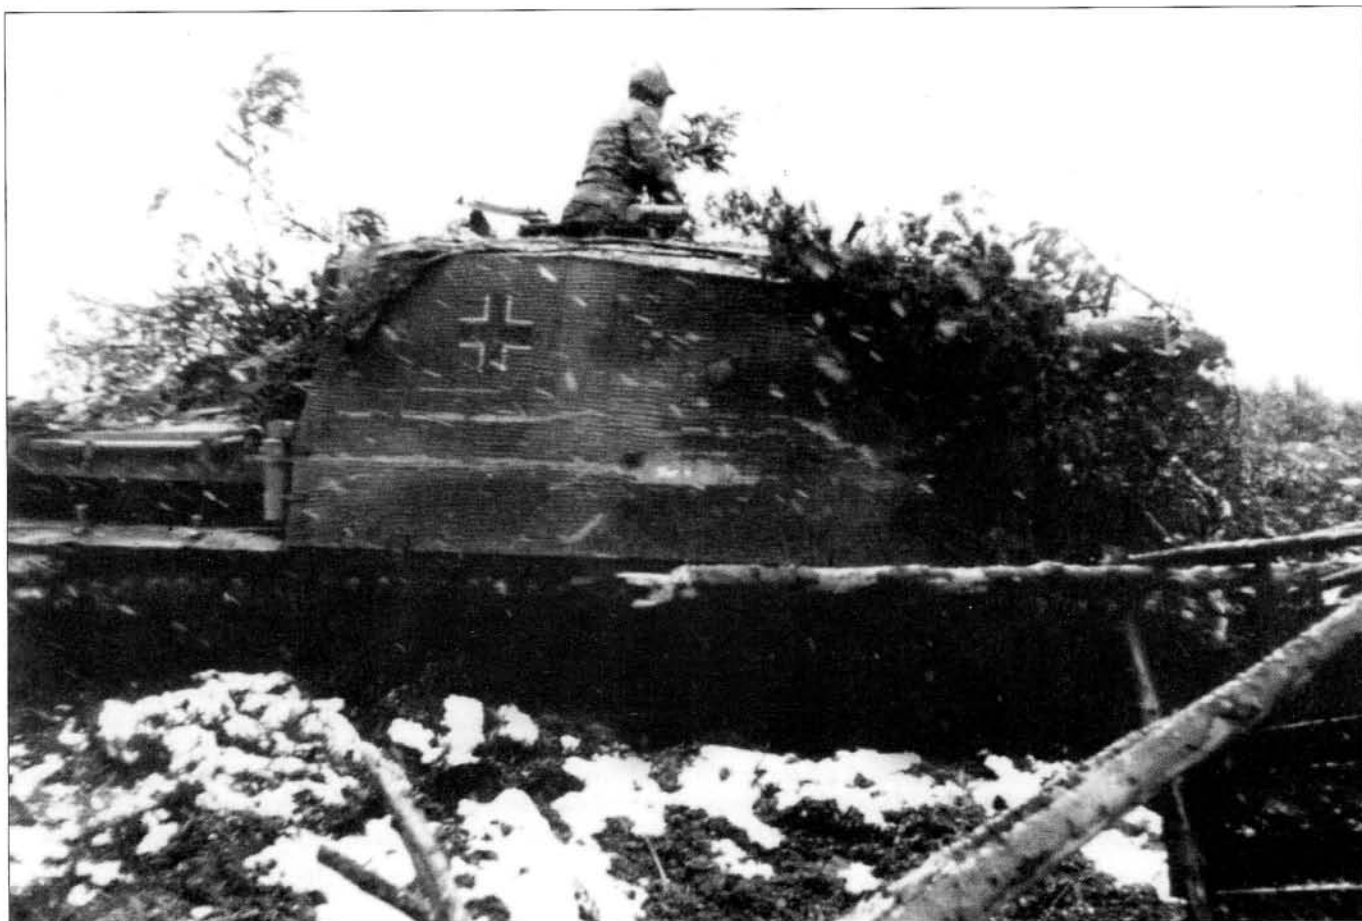
The assault tank has been given a complete coat of *Zimmerit* and features a three-tone camouflage scheme. • Der Sturmpanzer ist mit einem vollständigen Zimmeritanstrich versehen und trägt einen dreifarbigem Tarnanstrich.

All of the skirts have been removed. This assault tank also has only steel roadwheels. • Alle Schürzen sind abgenommen. Auch dieses Fahrzeug ist an allen Rollenwagen mit Stahlaufrollen ausgerüstet.

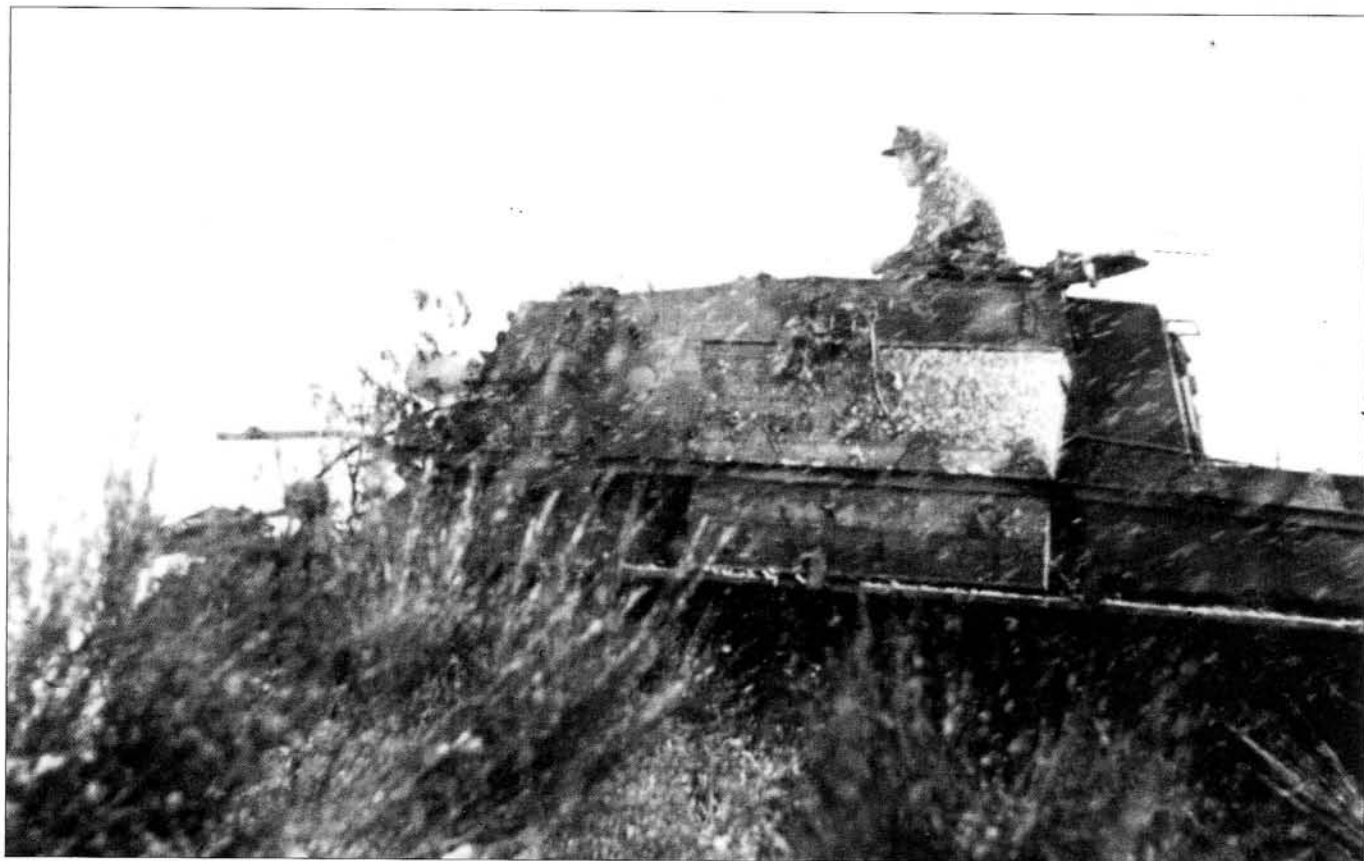
A wooden crate has been added to the left side of the superstructure in a field-expedient manner by the crew. • Behelfsmäßig wurde eine Holzkiste an der linken Aufbauseite von der Truppe angebracht.

The reader can see the dismounted anti-aircraft machine-gun mount behind the vehicle commander. It was mounted on the vehicle commander's hatch. • Hinter dem Kommandanten sieht man die umgeklappte Fla-MG Halterung. Diese wurde an der Kommandanten-Kuppel befestigt.

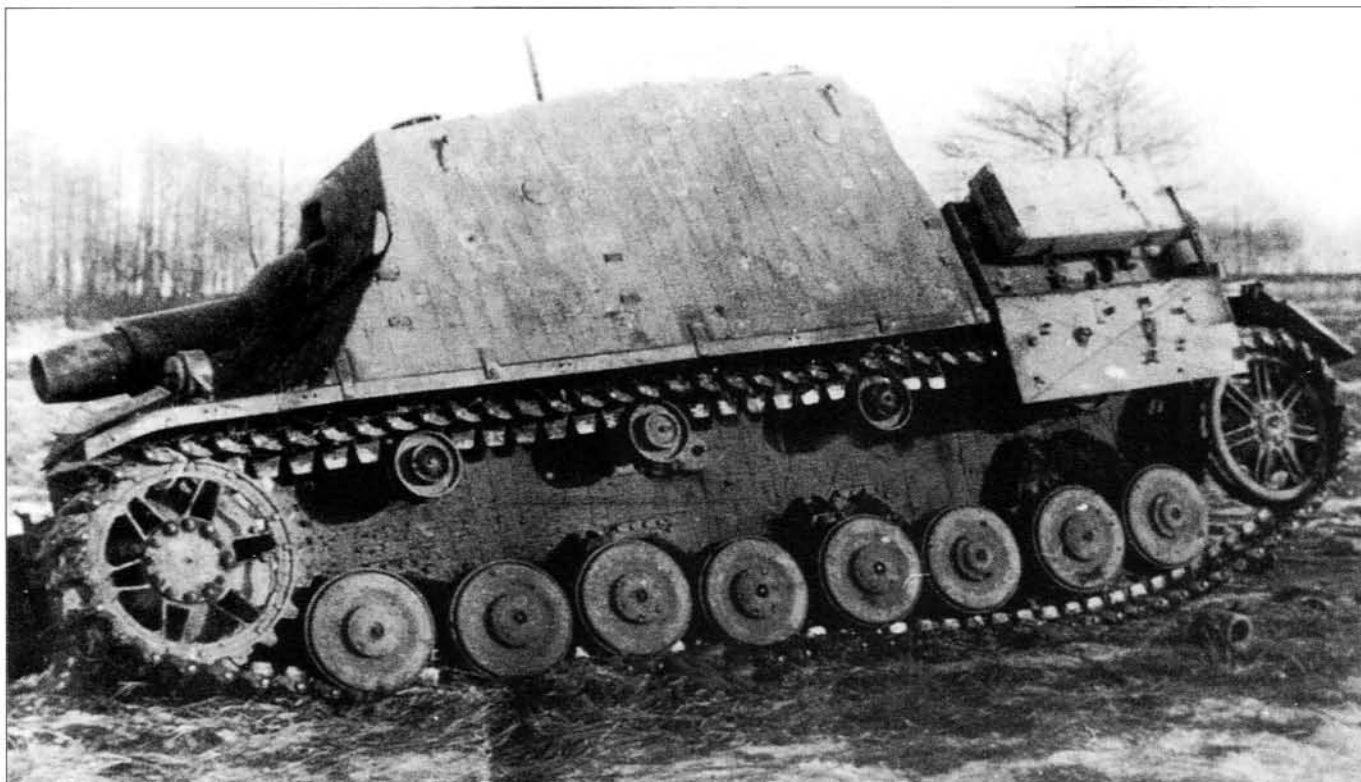
This assault tank was lost during the fighting in the spring of 1945. • Bei den Kampfhandlungen im Frühjahr 1945 geht dieser Sturmpanzer verloren. Auffällig ist an diesem Fahrzeug das Laufwerk. Er hat acht Stahllaufrollen, wobei sowohl gegossene wie auch gepresste Abdeckkappen verwendet wurden.

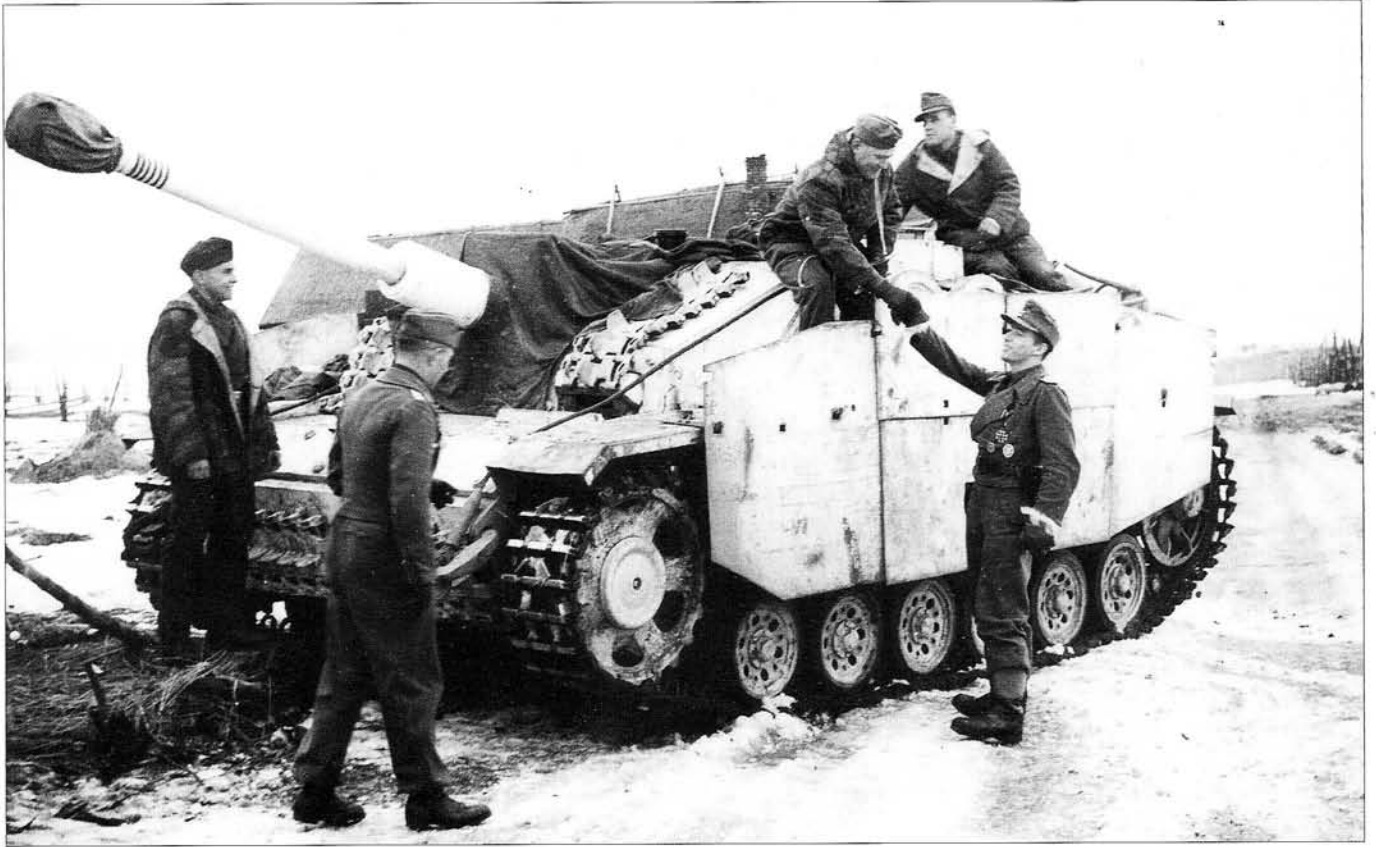
A successful crew is congratulated. Additional armor has been bolted to the front of this assault gun. And the next 3 pages •
 Glückwünsche an eine erfolgreiche Besatzung. Am Wannenbug dieses Sturmgeschützes ist eine zusätzliche Panzerung
 befestigt. Und weitere 3 Seiten

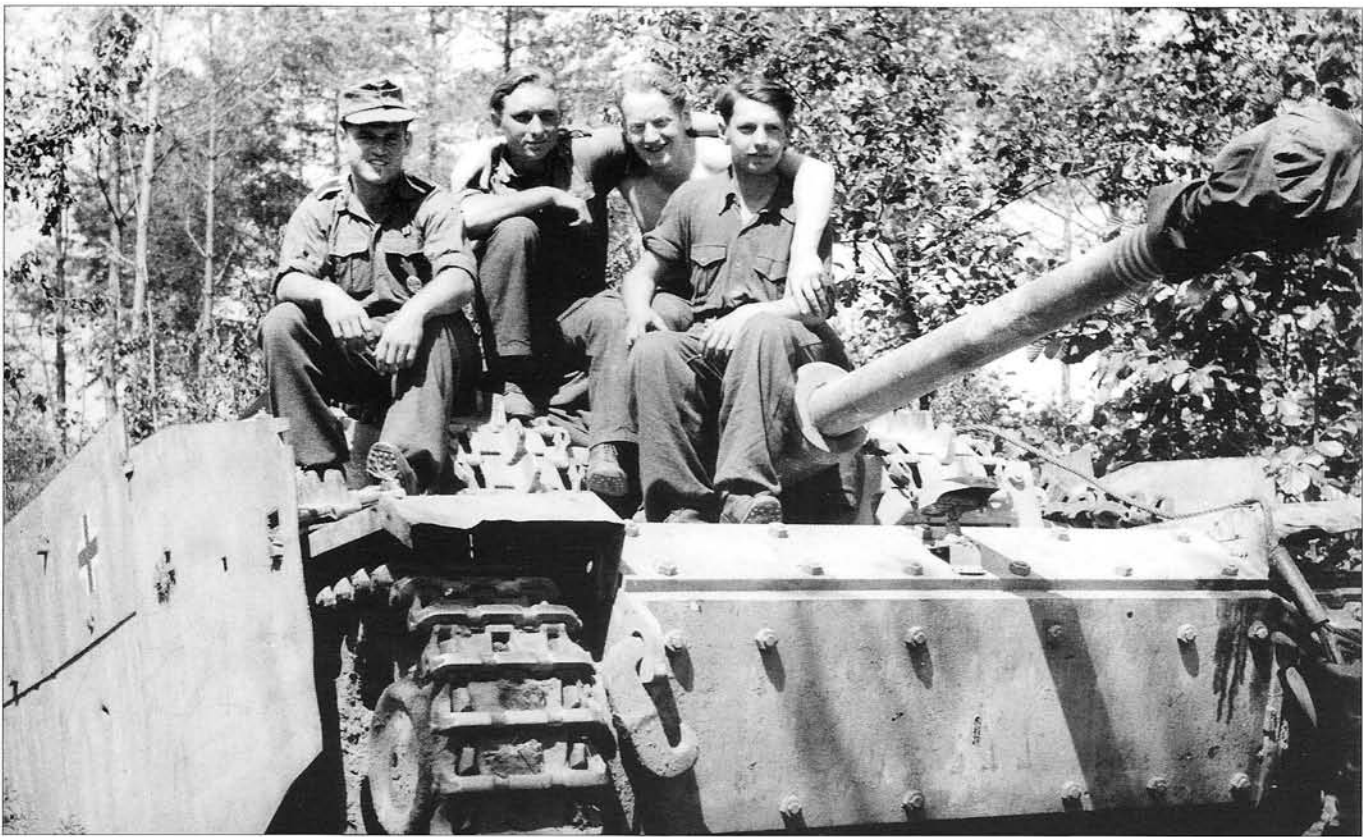
The supplemental armor plating added to this vehicle can be seen to good advantage. • An diesem Geschütz kann man gut die zusätzlich angebrachte Bugpanzerung erkennen.

A large number of the assault guns have already had the *Saukopf* mantlets installed. The name „Erika“ can be seen on the front of the hull. • Der Großteil der Sturmgeschütze ist bereits mit Saukopfblende ausgerüstet. Am Fahrzeugbug kann man den Namen „Erika“ erkennen.
