STURMTIGER and STURMPANZER in COMBAT

Sturmtiger and Sturmpanzer in Combat

Katowice – Speyer 2008

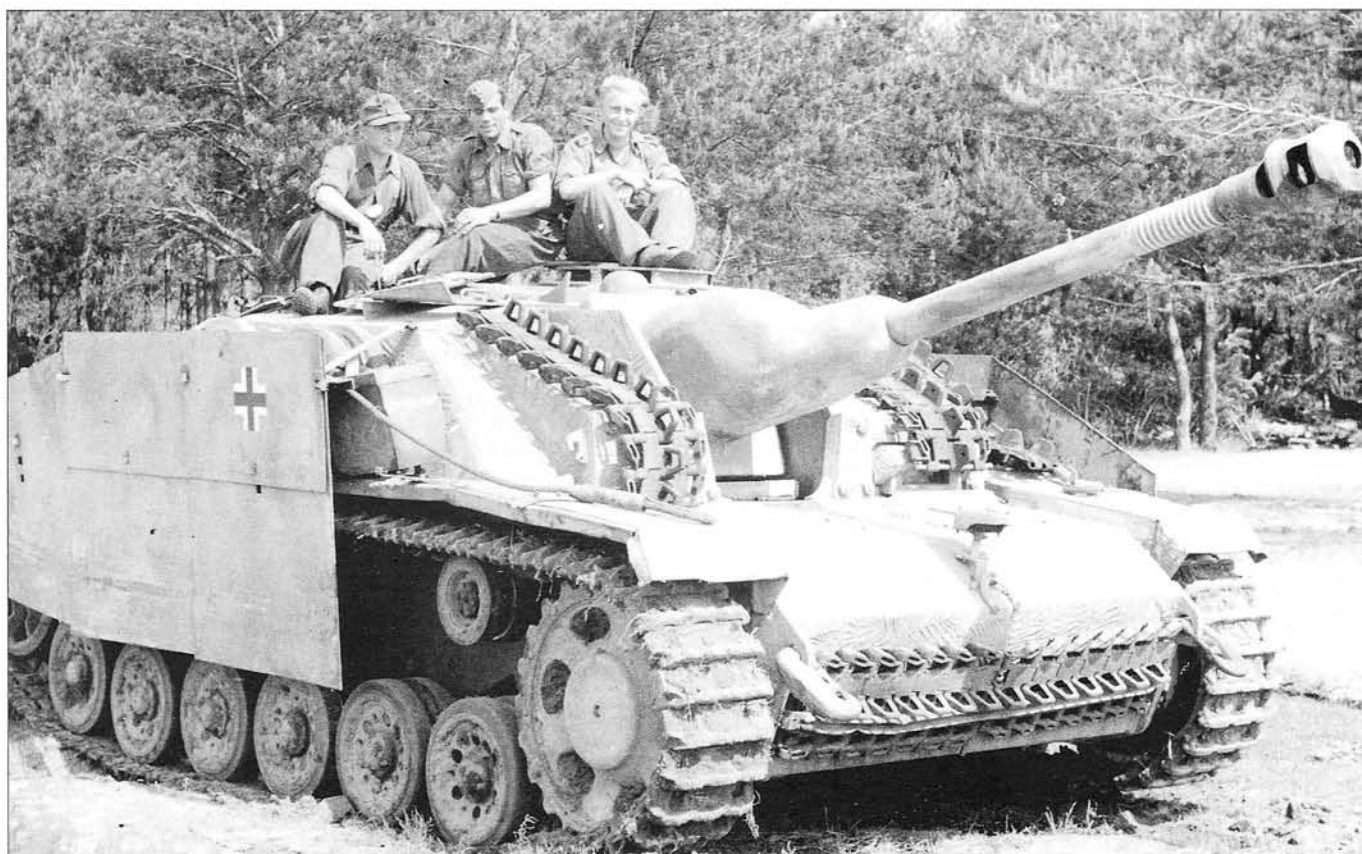
Note the mounting of additional track links to the right and left of the main gun. • Man beachte die Anbringung der zusätzlichen Kettenglieder am Aufbau rechts und links neben der Kanone.

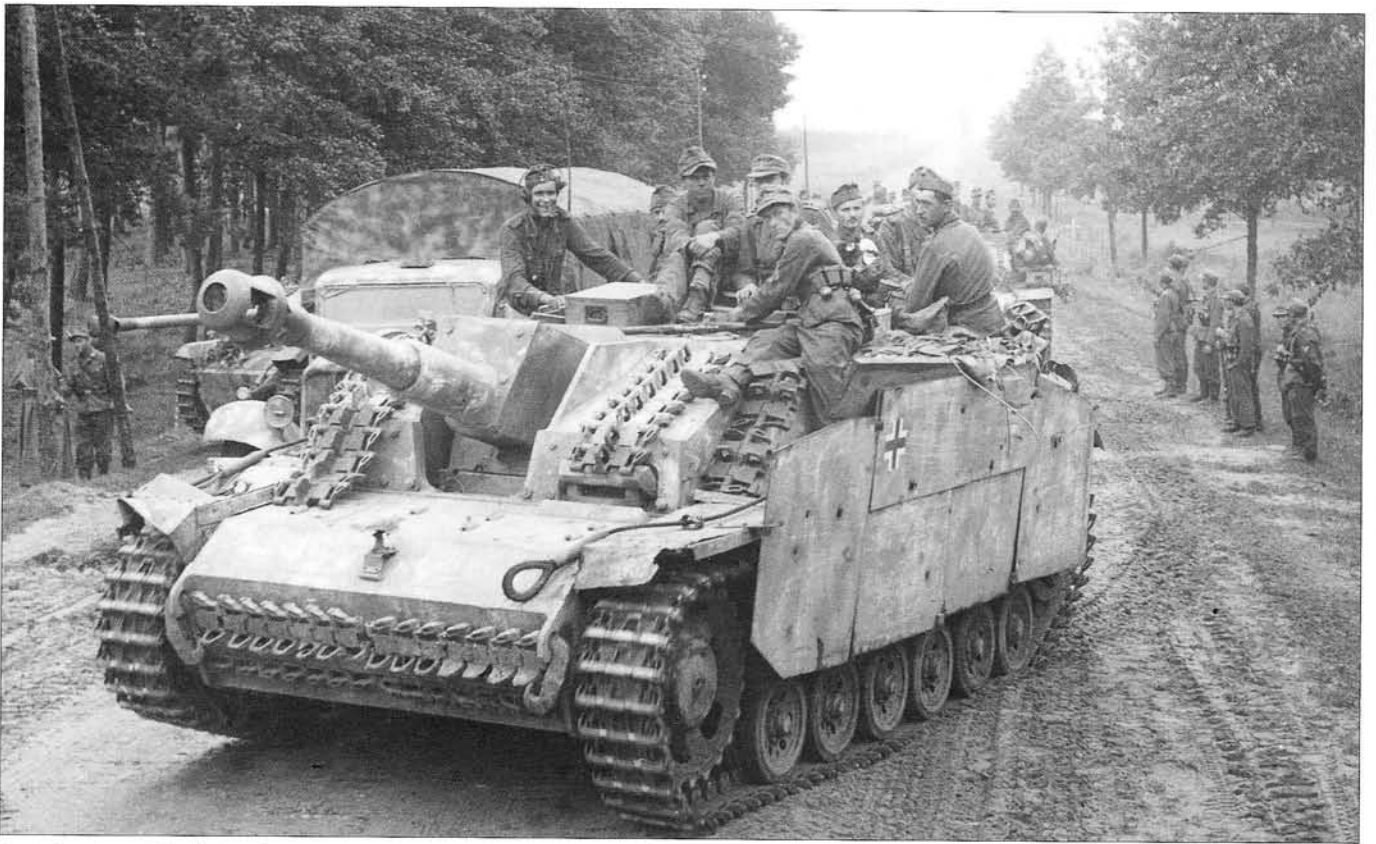
In July 1944, the battalion supported elements of the Hungarian 12th Division (Reserve). • Im Juli 1944 unterstützt die Abteilung Verbände der 12. ungarischen Reserve-Division. So auch diese Sturmhaubitze.

A portion of the track mount on the hull front has been torn away. • Ein Teil der Kettenhalterung am Fahrzeugbug ist weggerissen.

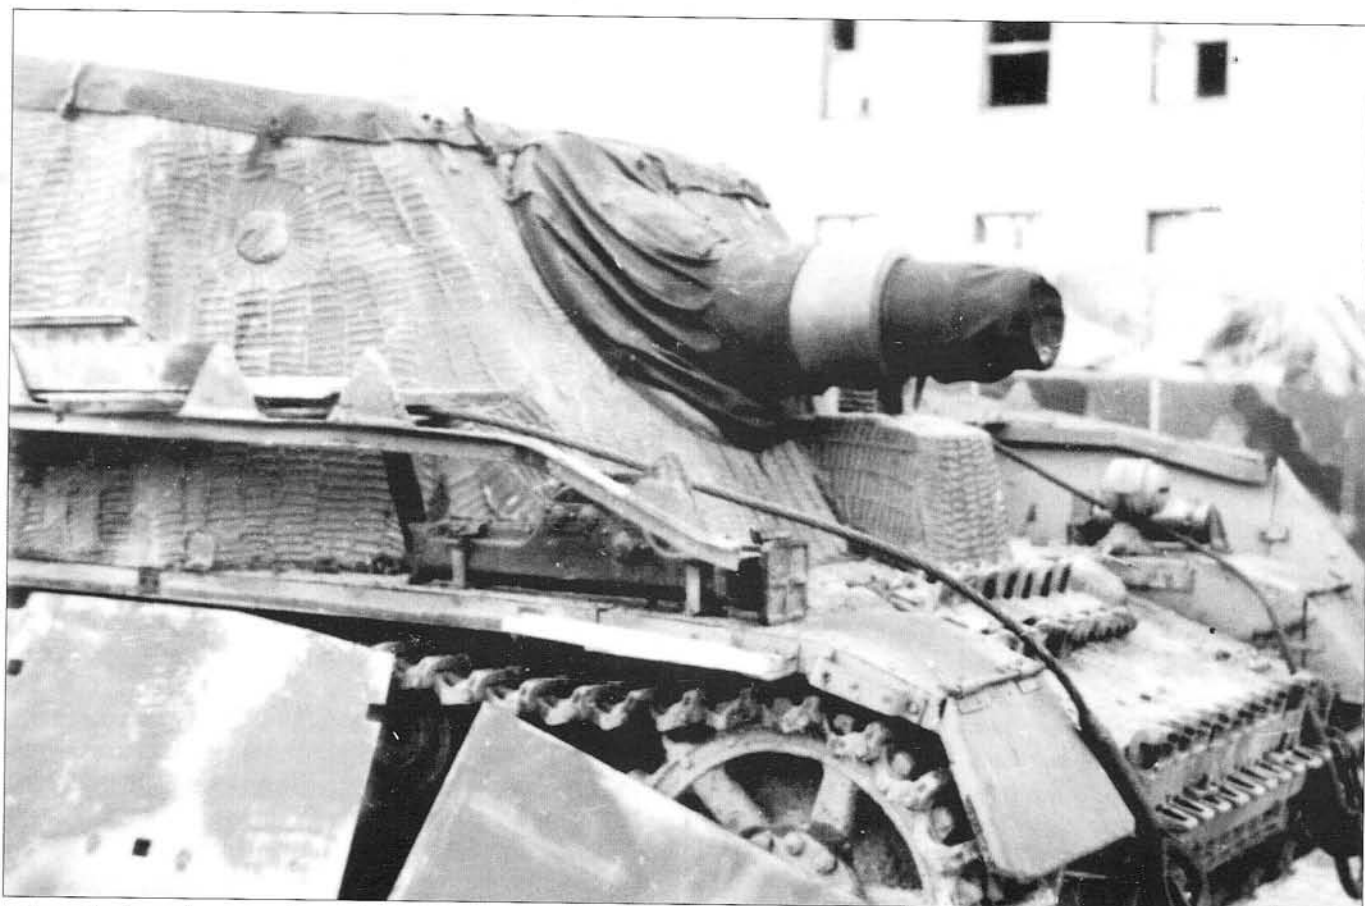
When the battalion was formed, it also received some older assault tanks for training purposes. This vehicle was a 3rd variant. It has a drive sprocket that was also used on the F and G models of the *Panzer IV*. • Bei der Aufstellung der Abteilung erhält der Verband zur Ausbildung auch einige ältere Sturmpanzer. Dieses Fahrzeug der Ausführung III. ist mit einem Antriebsrad ausgerüstet, wie es bei den Panzerkampfwagen IV Ausführung F und G standart war.

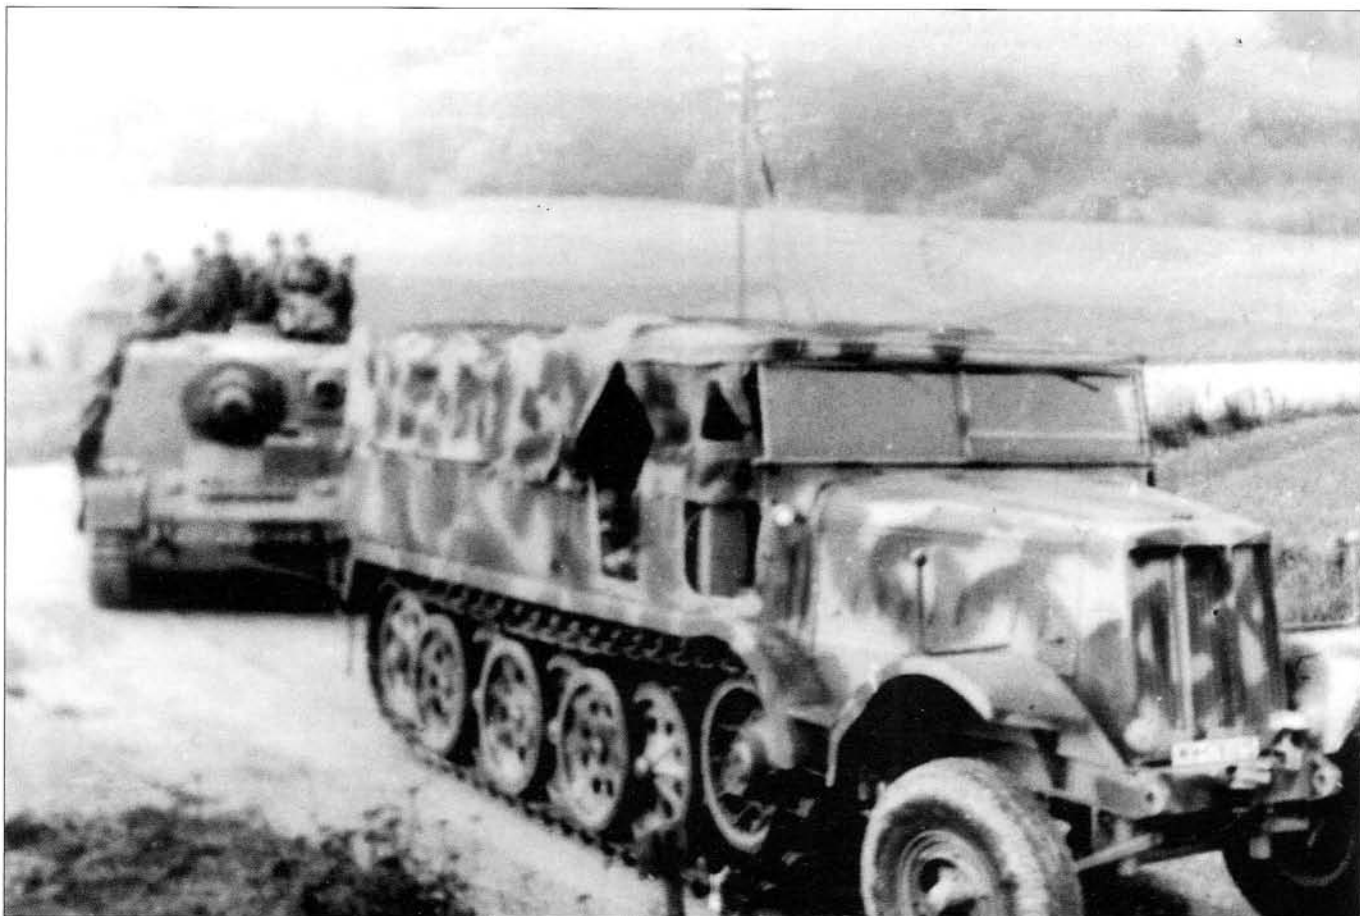
The maintenance personnel were constantly busy. In this photograph, we see a later version of the 18-ton prime mover towing a damaged vehicle. • Immer wieder müssen die Instandsetzungsdienste tätig werden. Hier schleppt eine späte Ausführung eines 18 to Zugkraftwagen einen Schadpanzer ab.

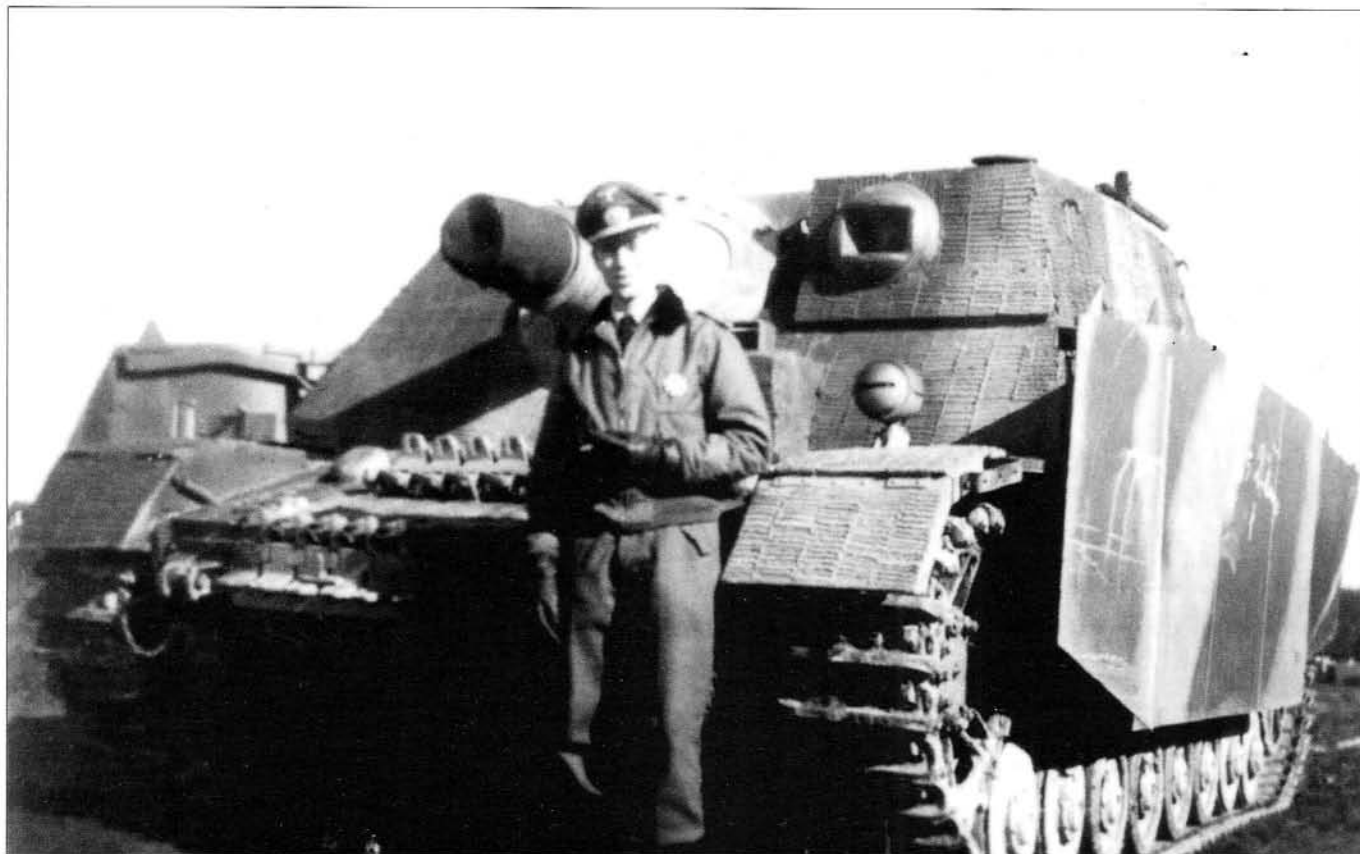
This assault tank has been given a thorough coating of *Zimmerit*. It has even been placed on the mudguards. • Der Sturmpanzer ist mit einer umfassenden Zimmeritbeschichtung versehen. Sogar auf den Kettenabdeckungen ist dieser aufgetragen.

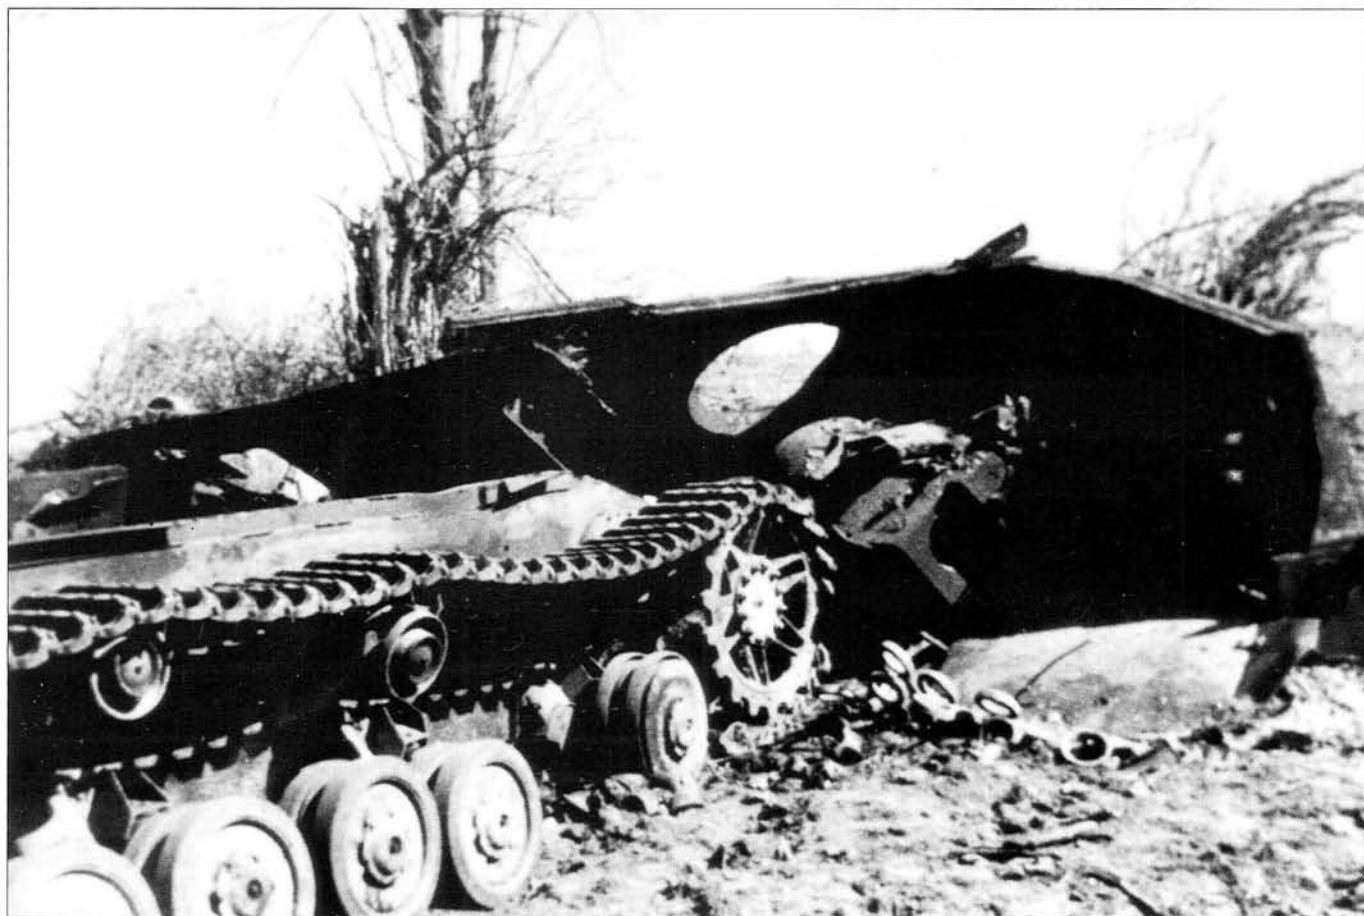
Several assault tanks of the 1st Company were lost as the result of faulty ammunition. This destroyed assault tank only had steel roadwheels on its front set of bogies. • Mehrere Sturmpanzer der 1.Kompanie gegen durch fehlerhafte Munition verloren. Bei diesem zerstörten Panzer waren nur der vordere Laufrollenwagen mit Stahllaufrollen ausgerüstet.

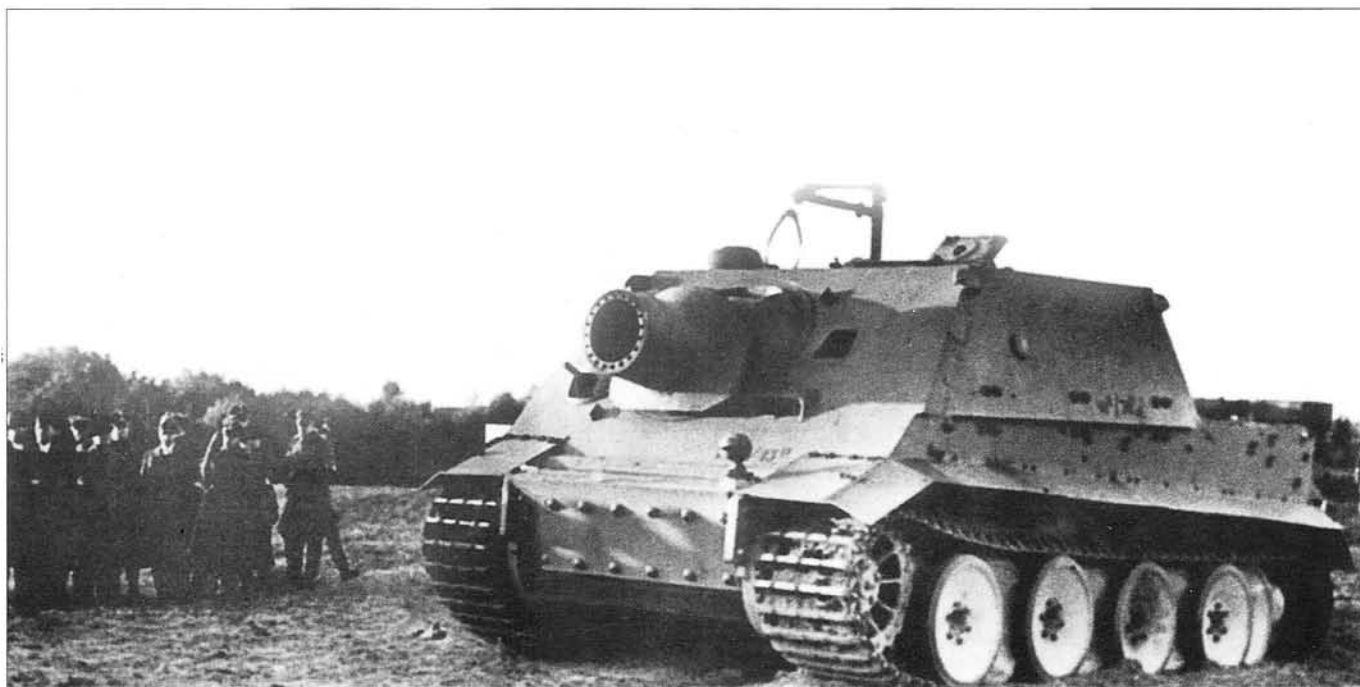
Demonstration of the *Sturmtiger* for Hitler. The lifting shackles on the crane can be seen to good advantage. • Vorführung des Sturmtiger-Prototyps vor Hitler. Gut erkennbar das Hebegeschirr am Ladekran.

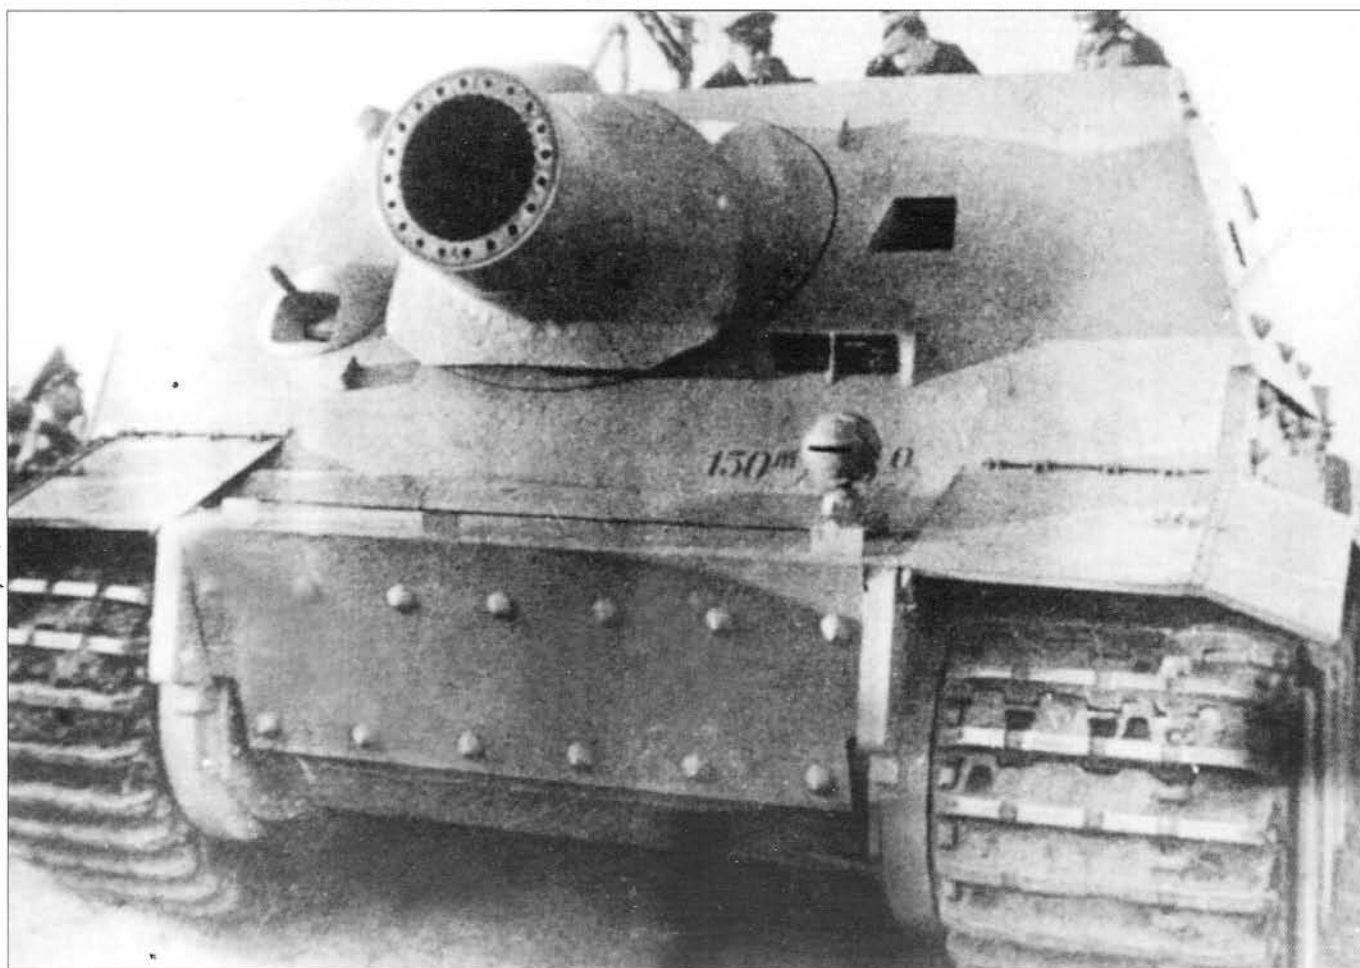
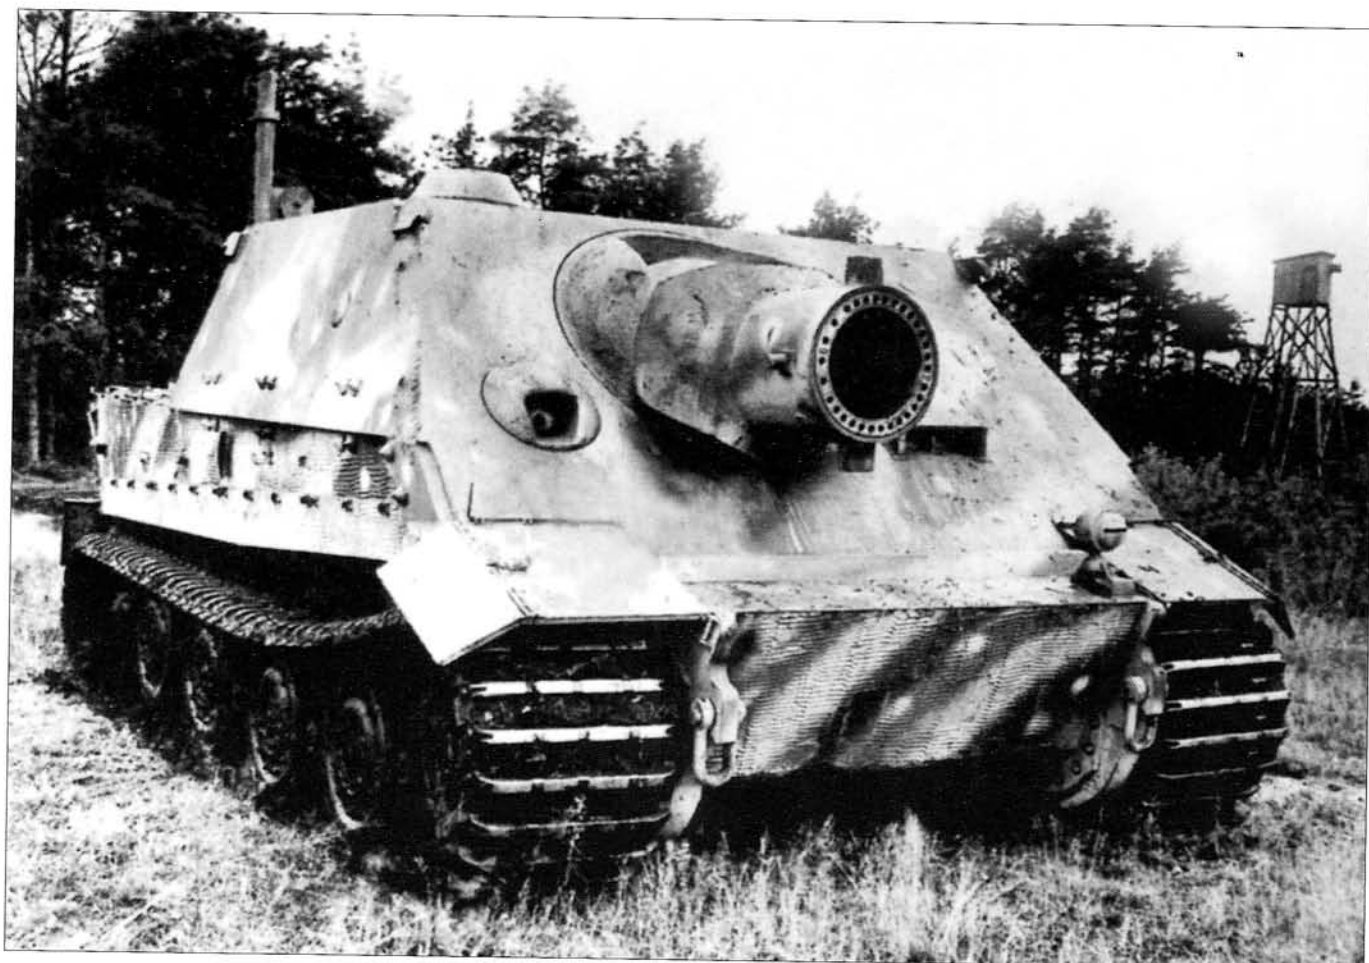
For training the *Sturmpanzer* crews, an illustrated training guide for loading and stowing ammunition was produced. The gun mantlet had only 30 openings for venting the gases. • Für die Ausbildung der Sturmpanzerbesatzungen wird eine bebilderte Darstellung des Aufmunitionier- und Ladevorgangs zusammengefasst. Das Mantelrohr hat nur 30 Gasaustrittsöffnungen.

After the round had been brought up, it was rolled to the vehicle. • Nachdem das Geschoss herangeführt worden ist, wird es zum Sturmpanzer gerollt.

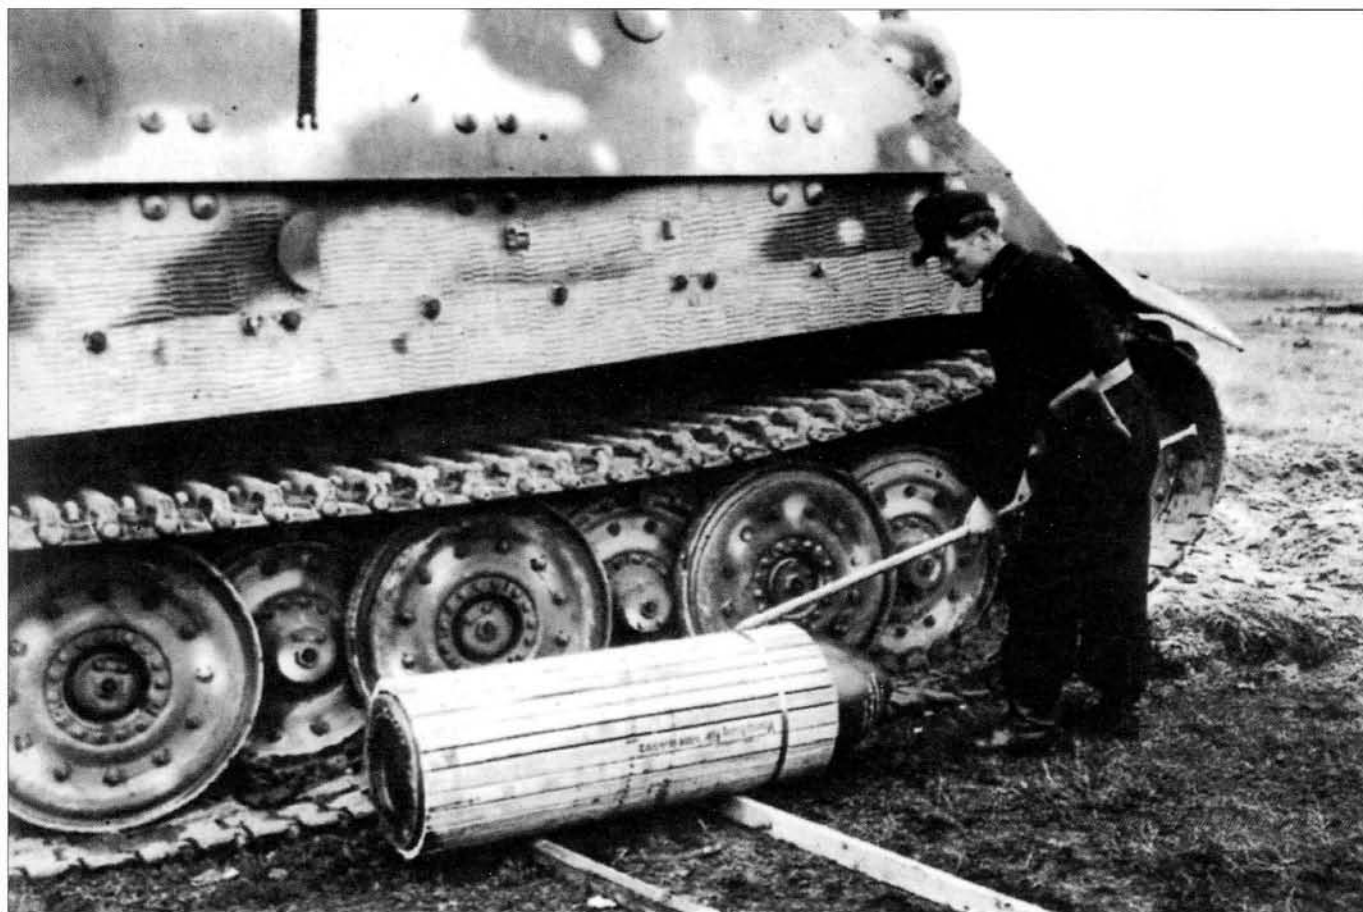
A member of the crew then removed the wooden jacket... • Danach entfernt ein Besatzungsmitglied die hölzerne Schutzummantelung...

...and then fastened the lifting device from the on-board crane to the round. • ...und befestigt die Hebevorrichtung des Bordkranes an der Granate.

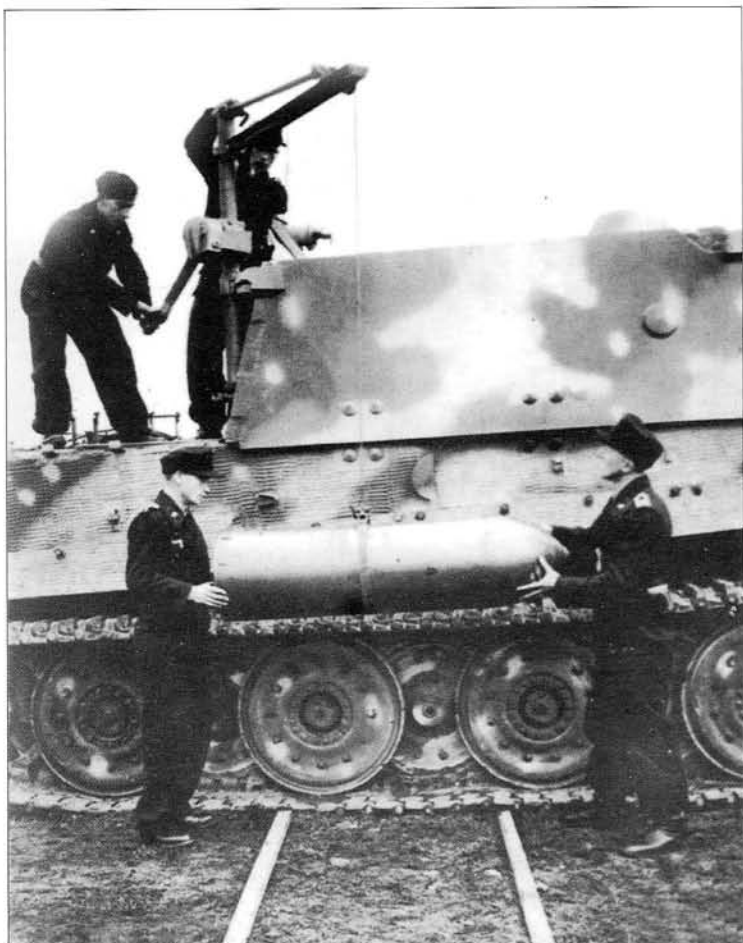
The round was then lifted up carefully. Two members of the crew on the ground steadied the round. • Vorsichtig wird das Geschoss nach oben gezogen. 2 Besatzungsmitglieder am Boden sichern die Granate.

Once up top, the crane was pivoted and the round was led into the fighting compartment interior through the loading hatch. • Oben angelangt, wird der Kran geschwenkt und das Geschoss durch die Ladeluke in den Fahrzeuginnenraum abgelassen.

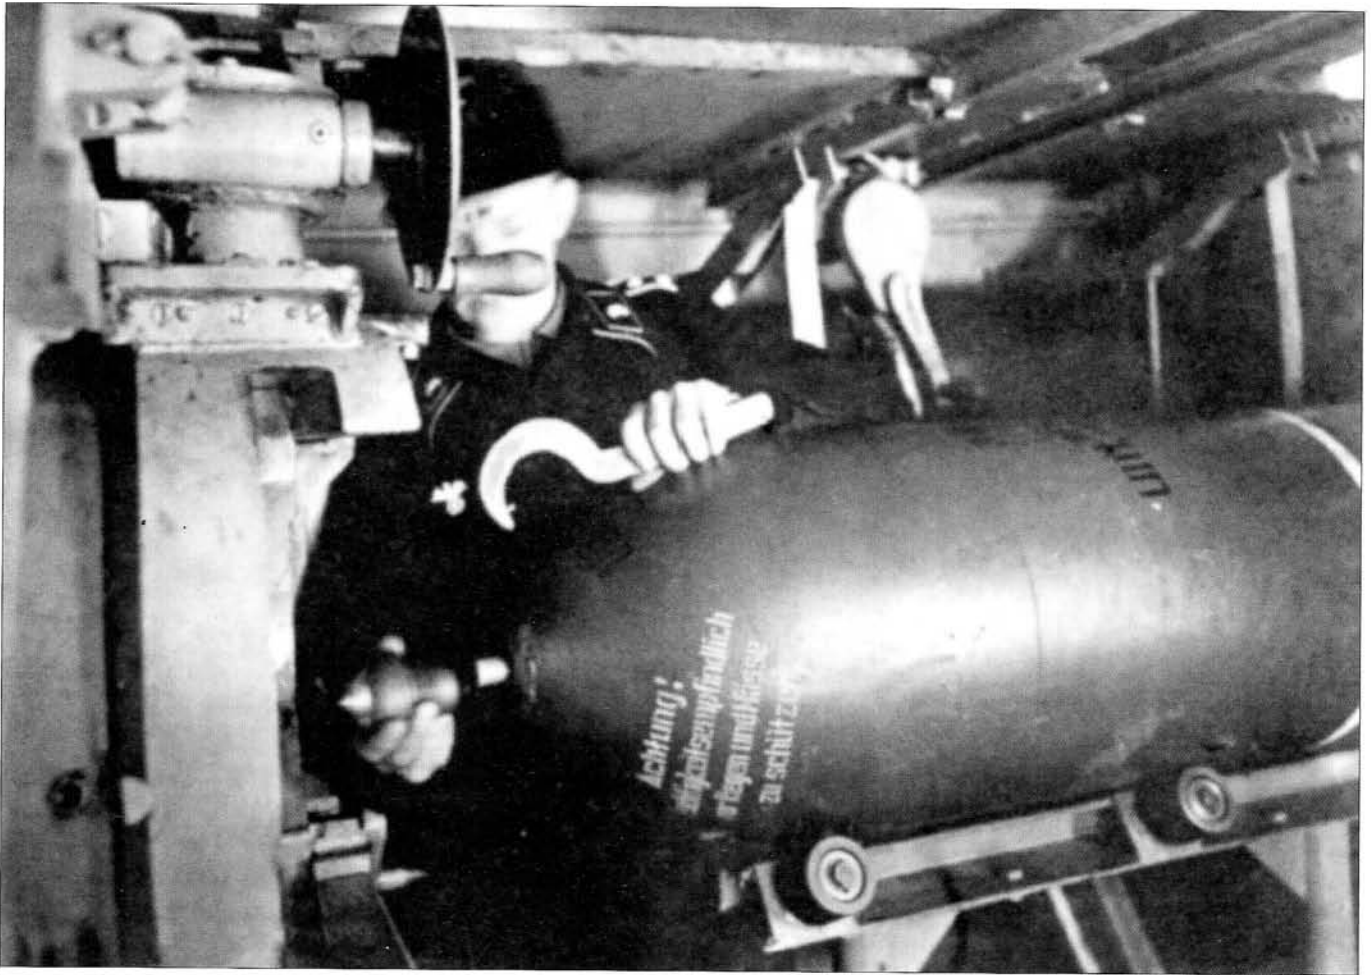
A member of the crew attaches an igniter to the round on the loading tray. • Ein Besatzungsmitglied bringt an einem auf der Ladeschale befindlichen Geschoss den Zünder an.

The armed round was then pushed into the barrel. • Danach wird das scharfe Geschoss in das Rohr geschoben.

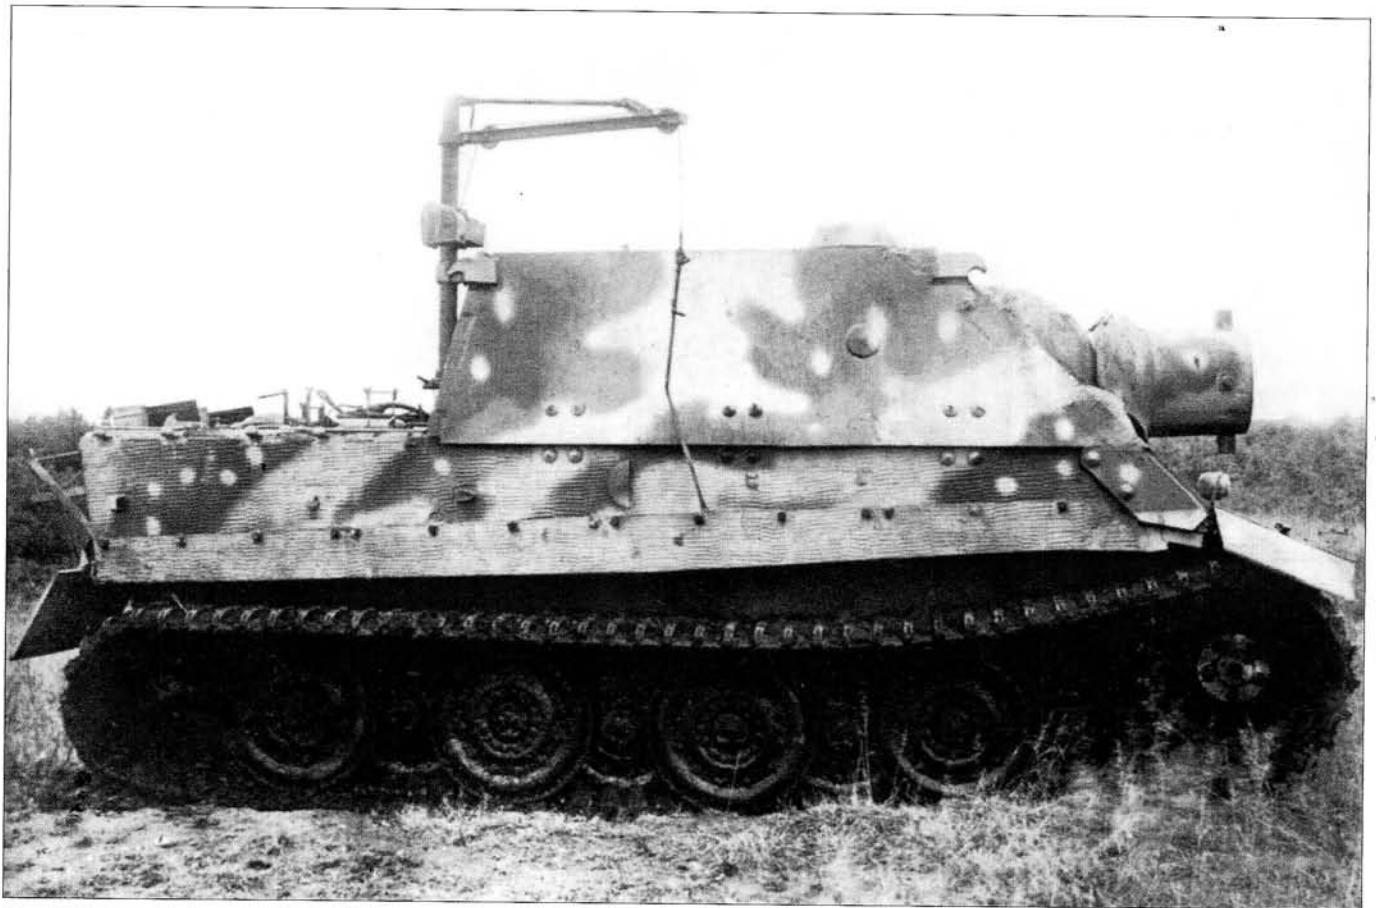
The mortar was then ready to fire. • Jetzt ist der Mörser einsatzbereit.

Fire! The round leaves the barrel. • Abschuss!! Die Granate verlässt das Rohr. [KHM]

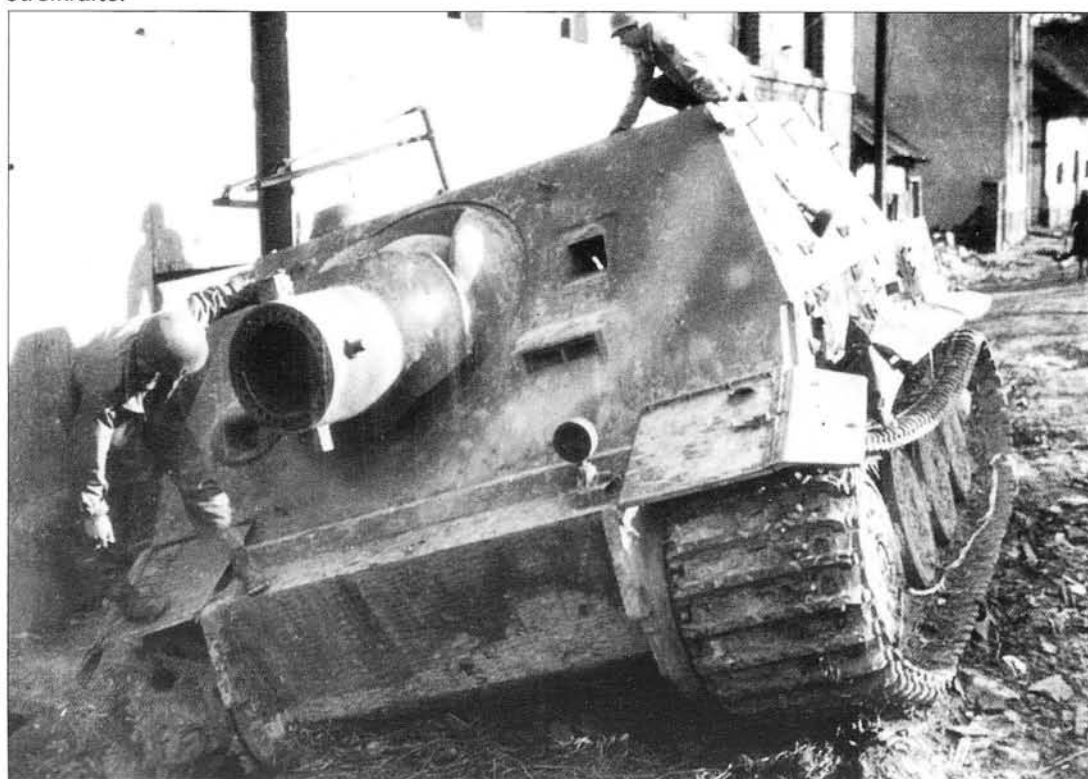
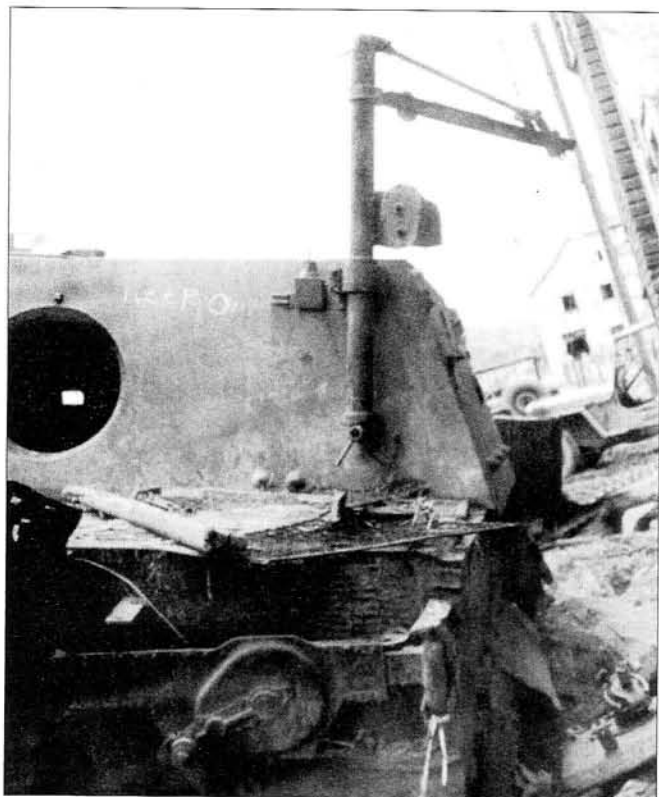
The handle has been positioned up on the entry hatch on the superstructure. In the case of some *Sturmtigers*, this handle was also placed on the exterior of the right side. • An der Anstiegsluke am Aufbau ist der Griff oben befestigt. Bei einigen Sturmtiger war dieser auch an der rechten Seite außen angebracht.

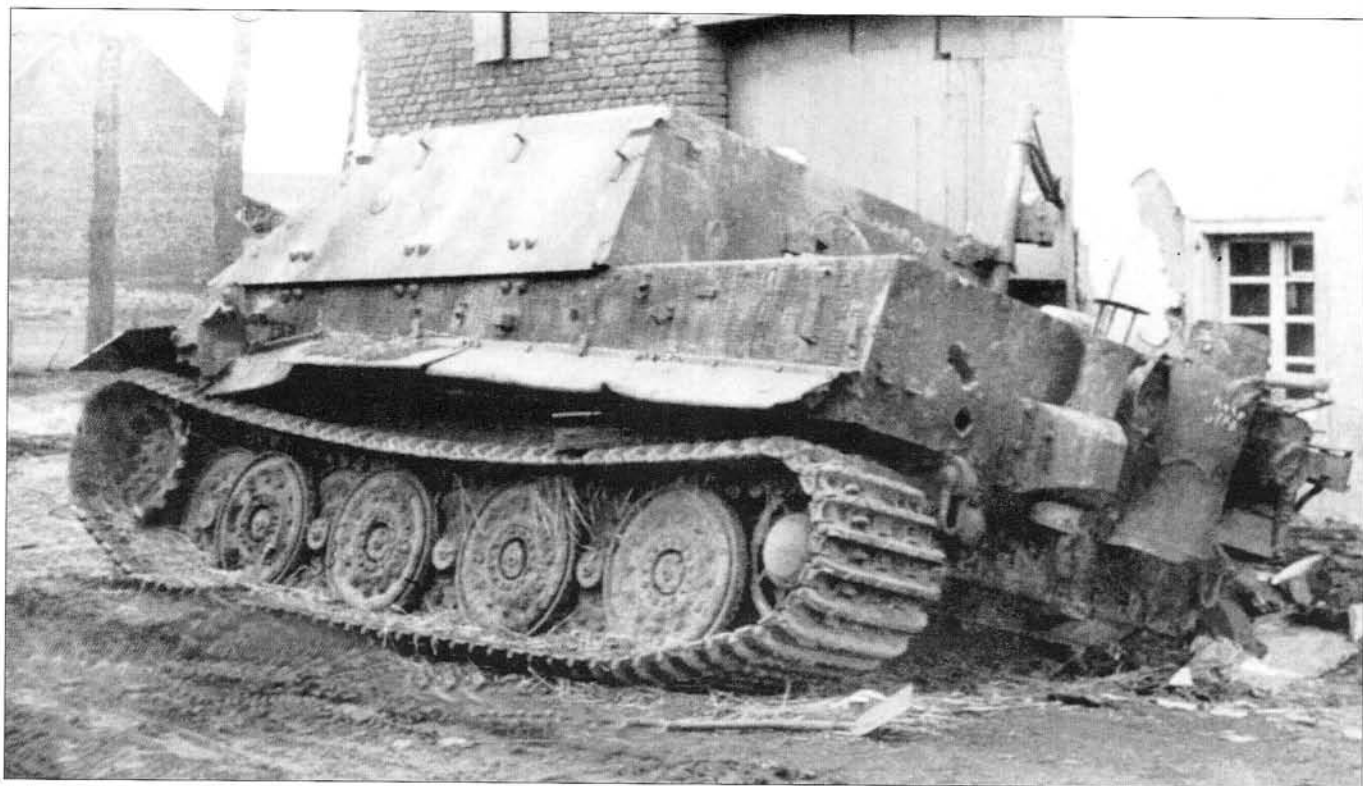
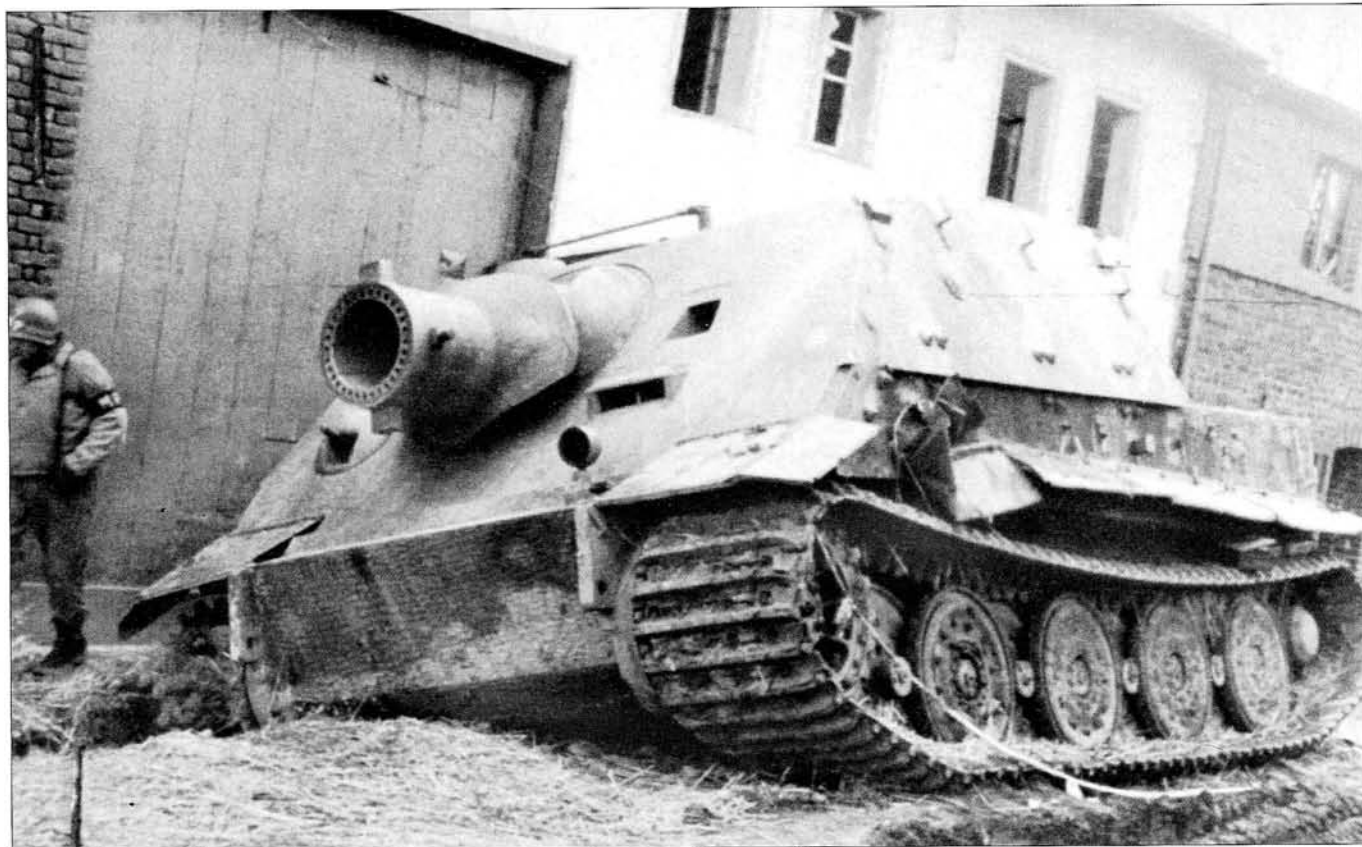
Several directives to „keep off“ have been placed on the vehicle. • Am Sturmtiger sind mehrere Hinweise „keep off - fernbleiben“ angebracht.

View from the front left. A military policeman guards the vehicle. The *Sturmtiger* was located in Oberembt, near Düren. •
 Ansicht von links vorn. Ein Militärpolizist bewacht das Fahrzeug. Der *Sturmtiger* stand in Oberembt bei Düren.

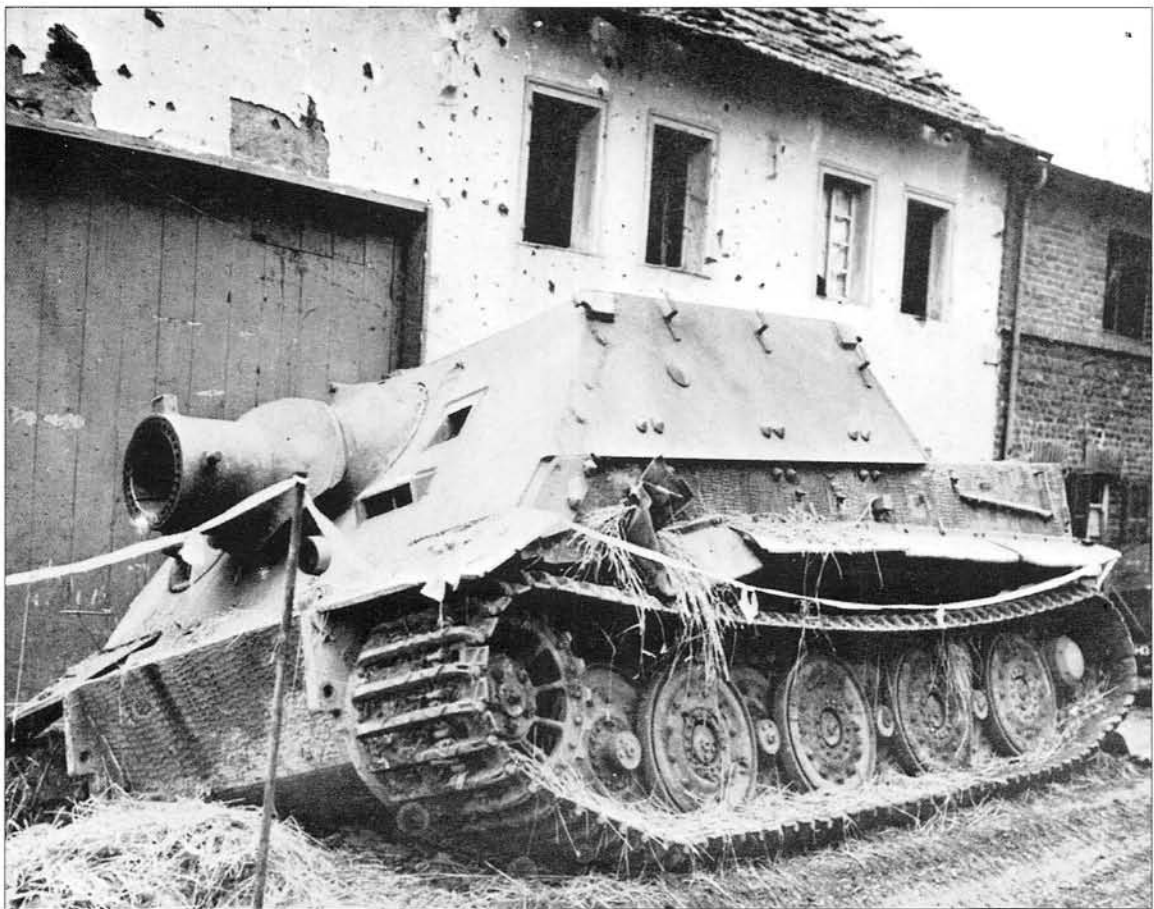
This photograph was also taken at the end of February. A dead crewmember, covered with straw, can be seen in the foreground. • Dieses Foto ist auch bereits Ende Februar entstanden. Im Vordergrund - mit Stroh bedeckt - ein gefallenes Besatzungsmitglied.

This *Sturmtiger* received a hit in the area of the rear deck, which penetrated the hull in the engine compartment. • Der Sturmtiger erhielt Treffer am Fahrzeugheck, welche die Rückseite der Wanne beim Motorraum durchschlugen.

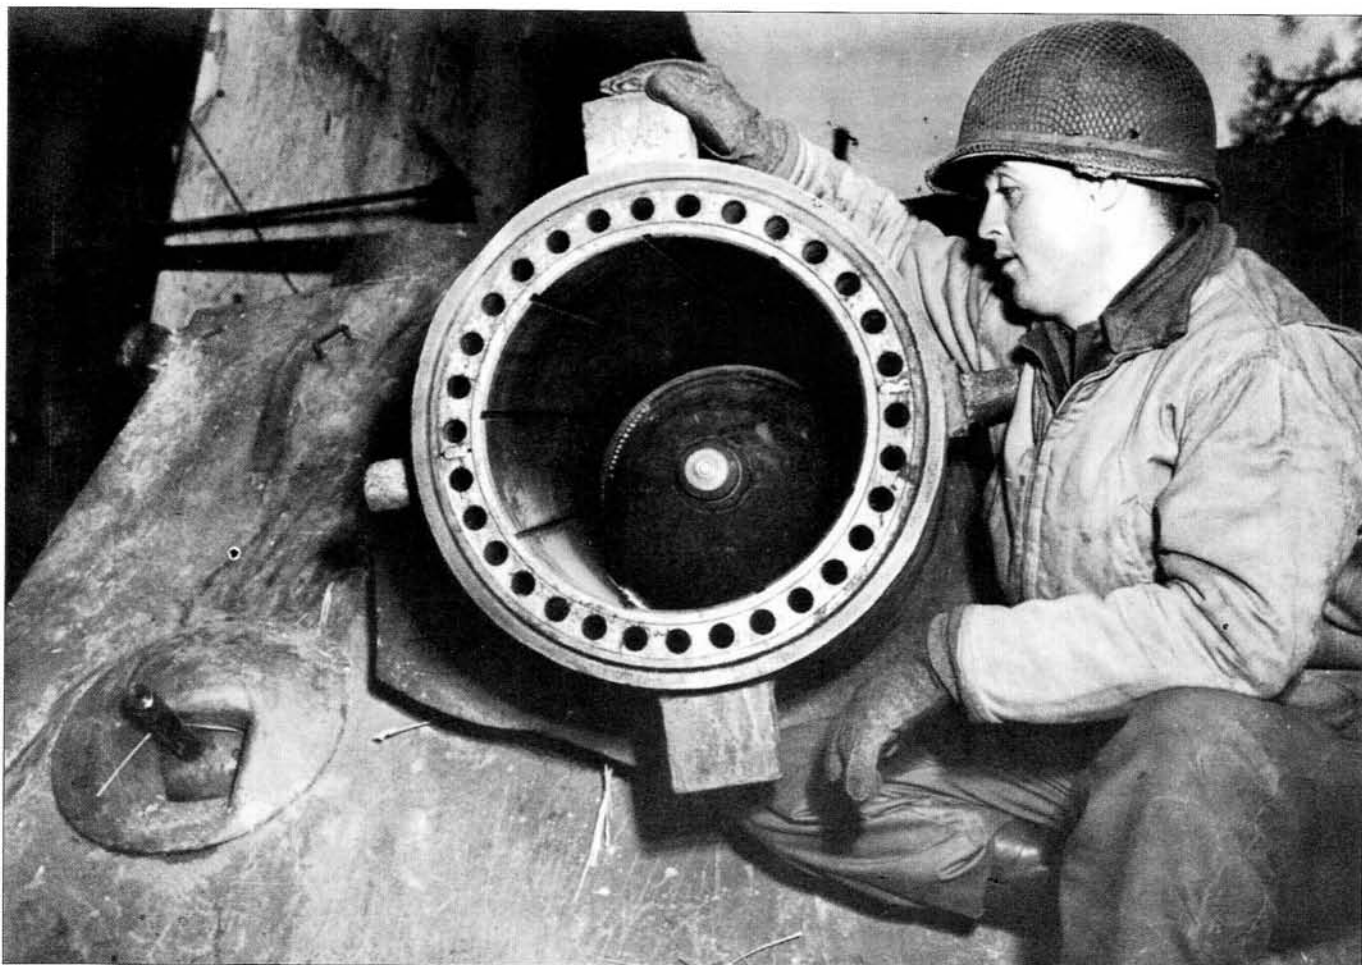
A view of the barrel. Thirty-one escape vents have been bored into the barrel. The counterweight is missing. • Blick auf das Rohr. Im Mantelrohr sind 31 Bohrungen zu erkennen. Das Gegengewicht fehlt.

A GI takes a critical view of the round in the barrel. • Ein GI wirft einen kritischen Blick auf das im Rohr befindliche Geschoss.

A view of the interior and the opened breech. • Blick im Innenraum auf den geöffneten Verschluss.
