STURMTIGER and STURMPANZER in COMBAT

Sturmtiger and Sturmpanzer in Combat

Katowice – Speyer 2008

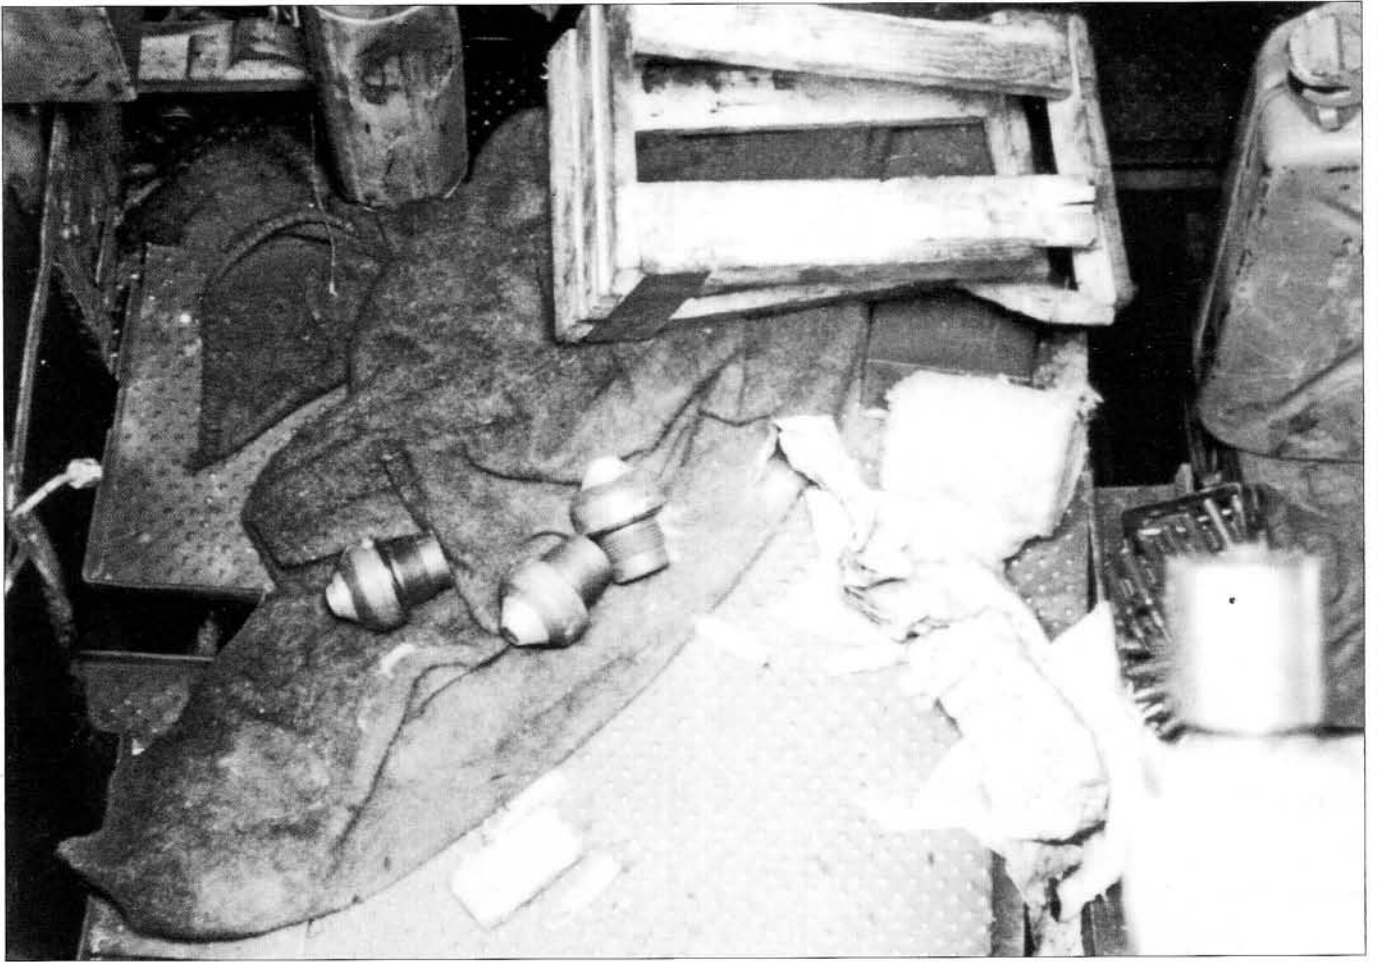
Three removed igniters for the rounds lie on the tarpaulin on the floor of the hull. • Auf der Plane am Wanneboden liegen drei ausgebaute Zünder für die Granate.

A view of the rifling in the barrel. • Blick auf die Züge im Rohr. [2xKHM]

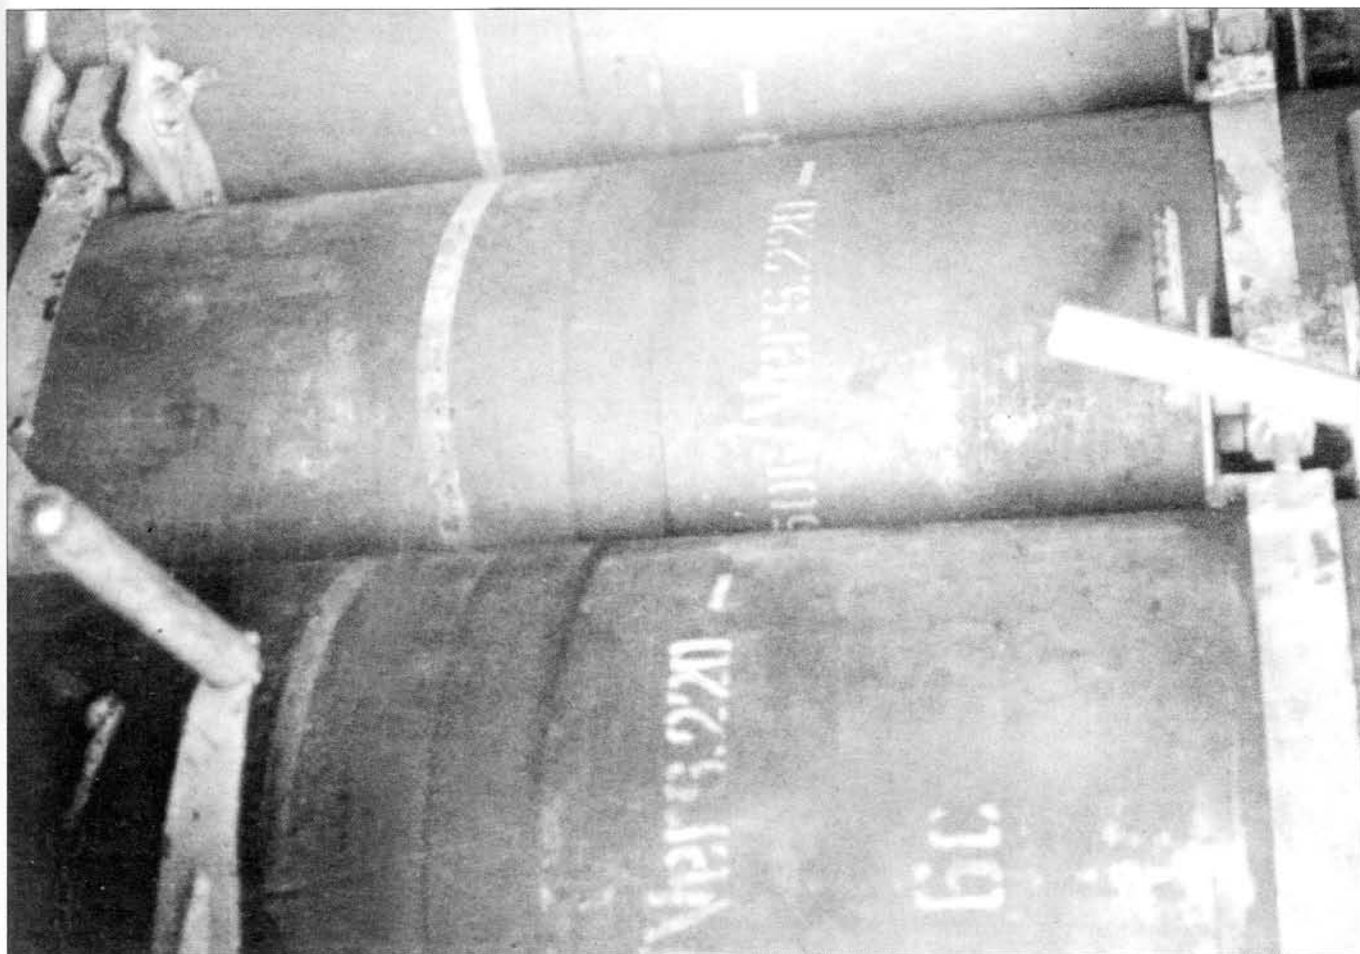
A white line has been drawn around the round in the middle. It was at that location that the lifting device of the crane had to be fastened. • Um die Granate herum ist mittig eine weiße Linie aufgezeichnet. An dieser Stelle mußte das Hebegeschirr des Kranes befestigt werden. [KHM]

With the assistance of a captured *Bergepanther*, the *Sturmtiger* was towed away. • Mit Hilfe eines gleichfalls erbeuteten *Bergepanthers* wird der *Sturmtiger* abgeschleppt.

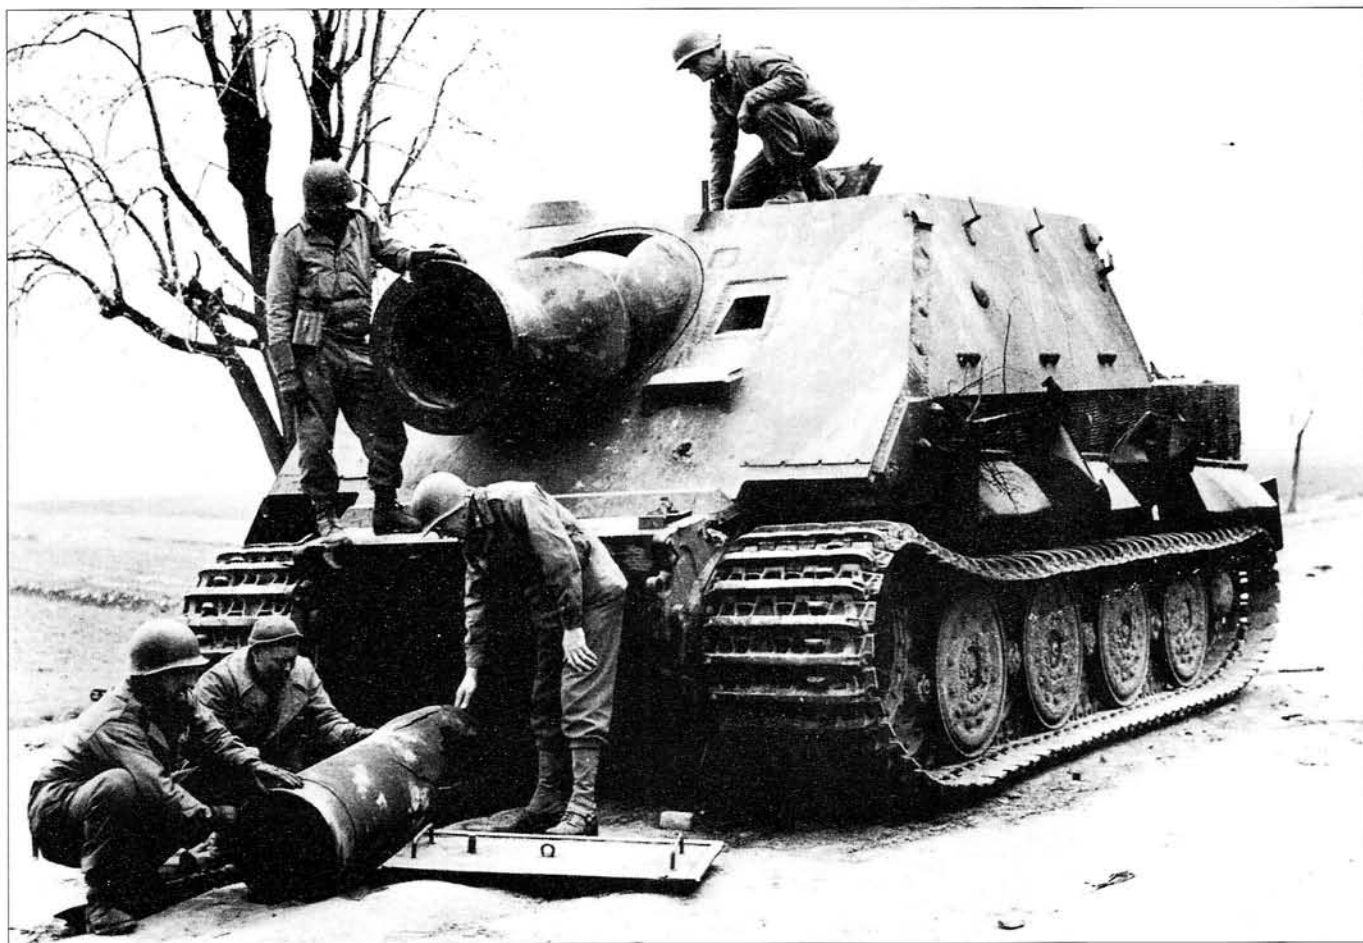
This knocked-out *Sturmtiger* is checked out by GI's. Note the penetration below the driver's optics. A destroyed 38-centimeter round lies in front of the vehicle. • Dieser abgeschossenen *Sturmtiger* wird von GI's inspiziert. Man beachte das Einschussloch unterhalb der Fahrersichtoptik. Ein zerstörtes 38cm Geschoss liegt vor dem Fahrzeug.

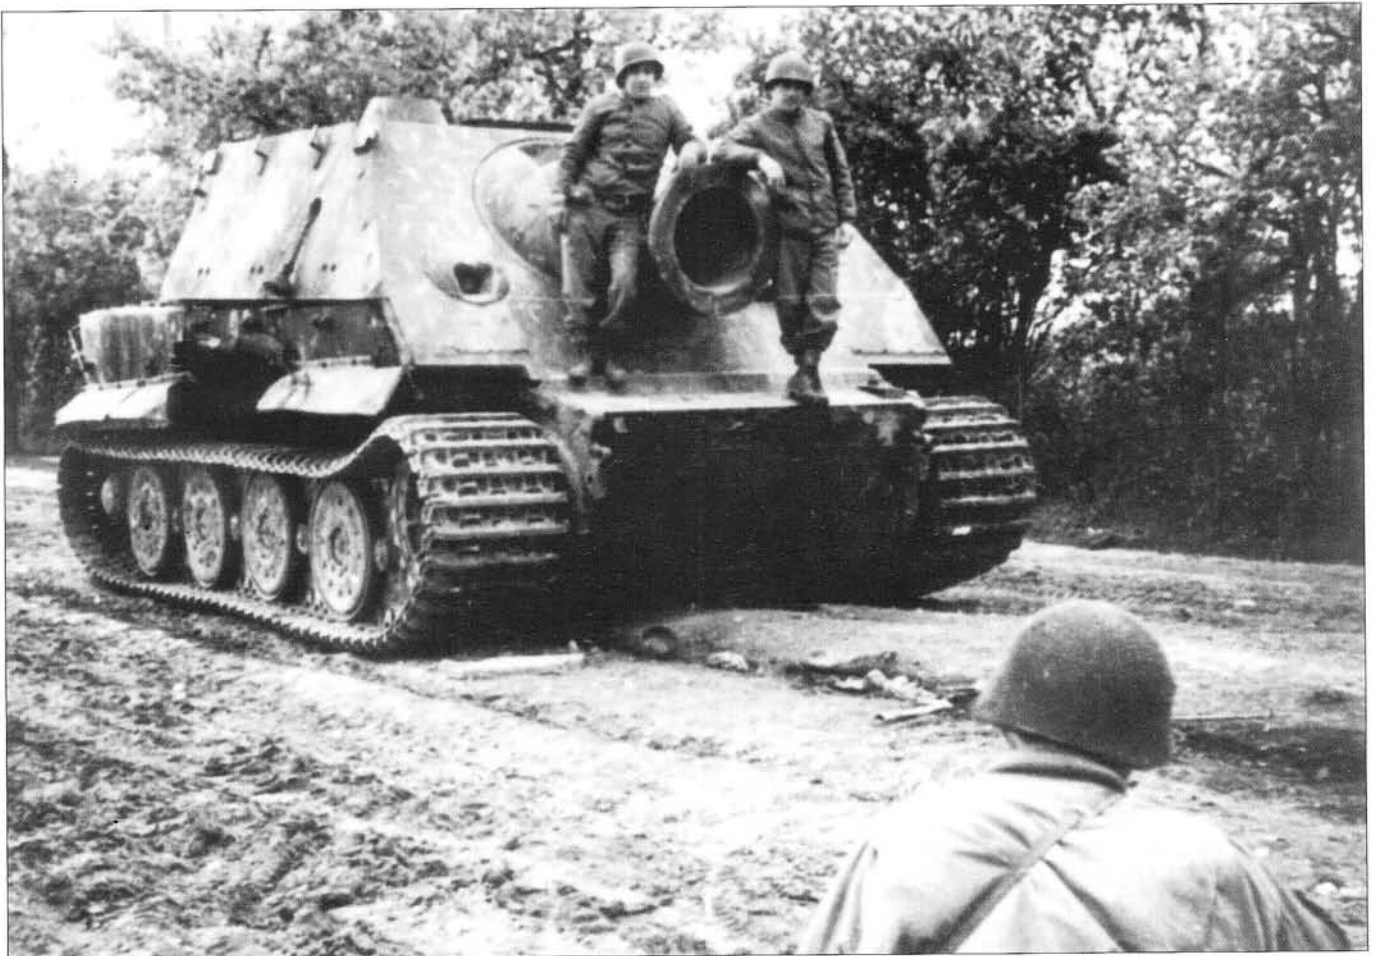
The same vehicle seen from another perspective. The height of the superstructure is quite noticeable when compared to the two US soldiers. • Derselbe Panzer aus einer anderen Perspektive. Durch die beiden US-Soldaten wird die Höhe des Aufbaues erst deutlich.

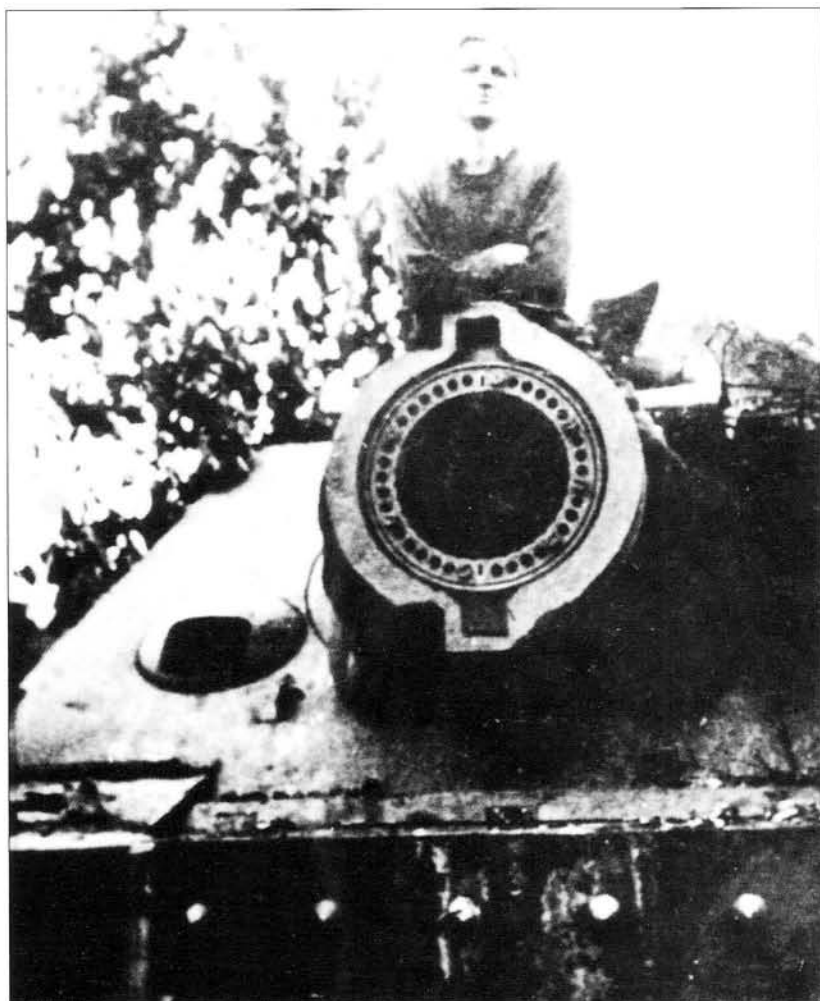
After the Ardennes offensive failed, German forces pulled back toward the Rhine. The battalion waits for a chance to cross the river. Of interest is the unusual counterweight on the barrel of the main gun. Additional armor plating has been mounted on the front slope of the vehicle. The last *Sturmtiger* of *Stürmmörser-Kompanie 1001* being transported by MAL 45 of 3. T.F.L. across the Rhine (from Rodenkirchen to Westboon) in March 1945. Of interest is the unusual form of the counterweight on the barrel of the main gun. Additional armor plating has been mounted on the front slope of the vehicle. • Nach dem Scheitern der Ardennenoffensive ziehen sich die deutschen Truppen in Richtung Rhein zurück. Die Einheit wartet auf eine Übersetzmöglichkeit über den Rhein. Man beachte die außergewöhnliche Form des Gegengewichtes an der Kanone. Am Fahrzeugbug ist eine zusätzliche Panzerung befestigt.

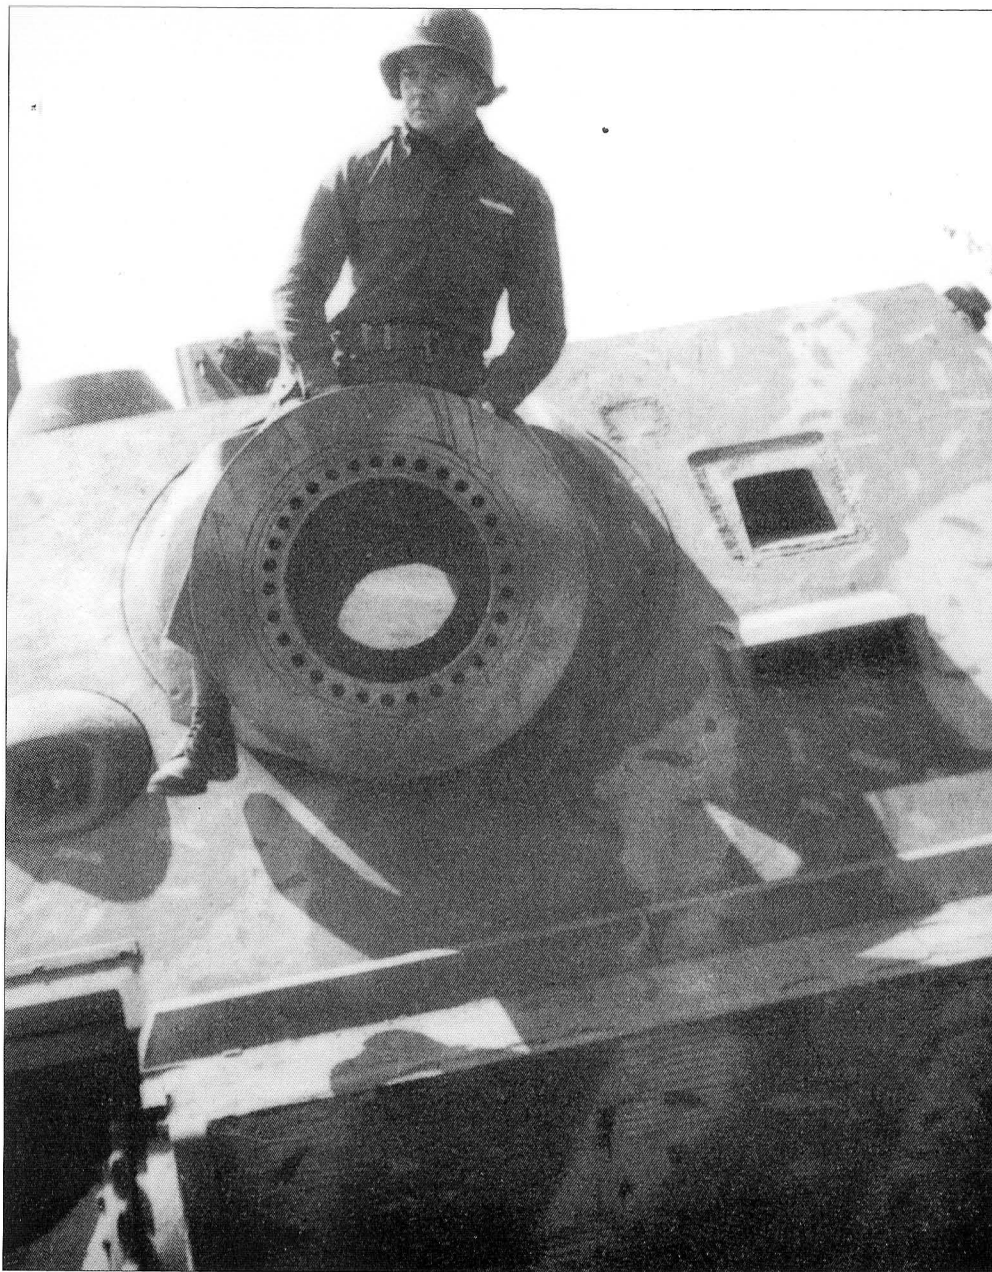
A new camouflage pattern was painted over the original camouflage on the hull. • Auf der Panzerwanne wurde auf den vorhandenen Tarnanstrich ein neues Tarnmuster aufgemalt.

The front mudguards are missing. No other damage to the vehicle can be seen. • Die vorderen Kettenabdeckungen fehlen. Weitere Beschädigungen am Fahrzeug sind nicht erkennbar. [KHM]

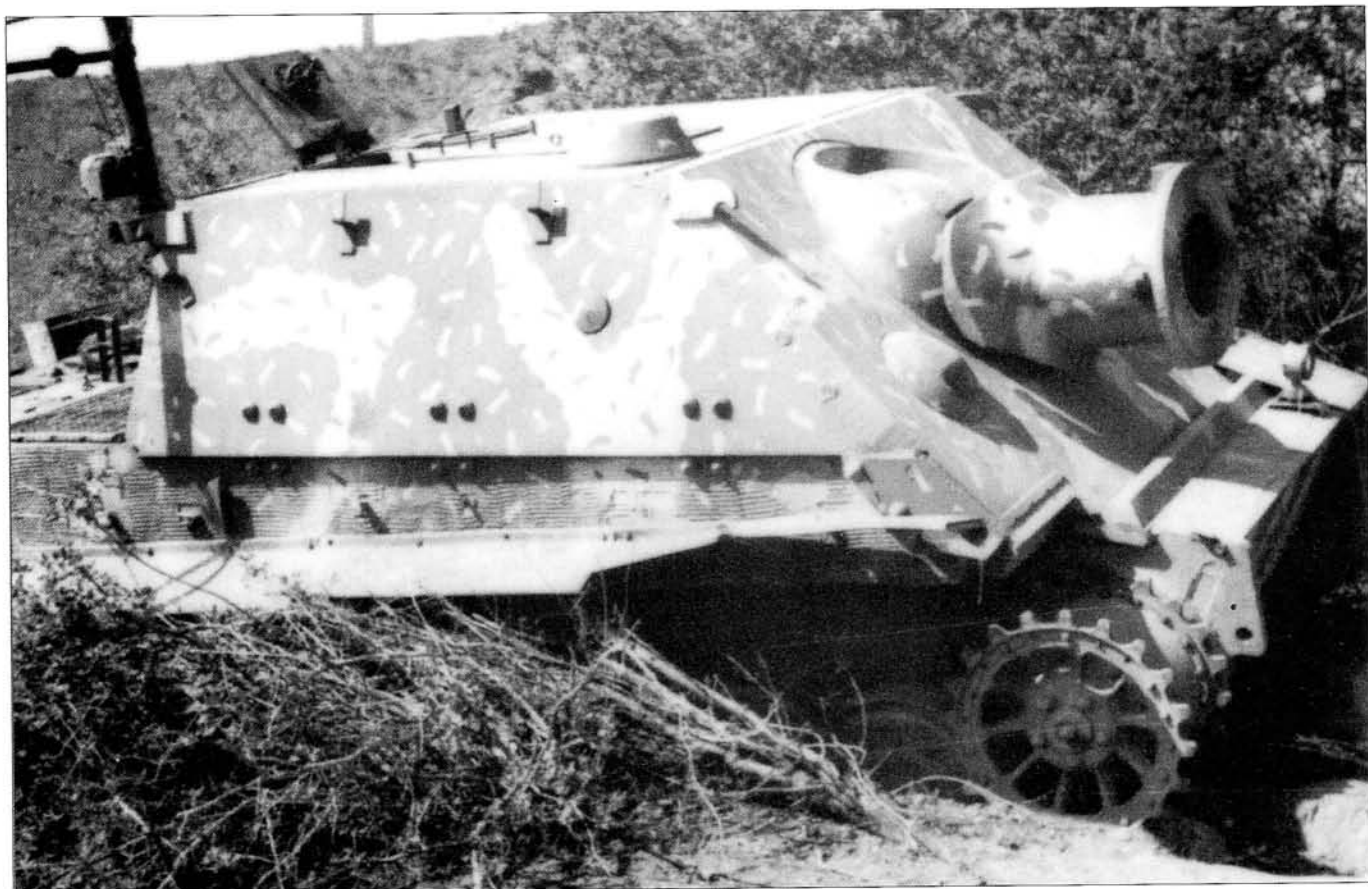
This photograph shows details of the front and side armor, as well as the roof of the fighting compartment, to good advantage. • Auf dieser Aufnahme erkennt man Details der Front- und Seitenpanzerung sowie des Aufbaudachs.

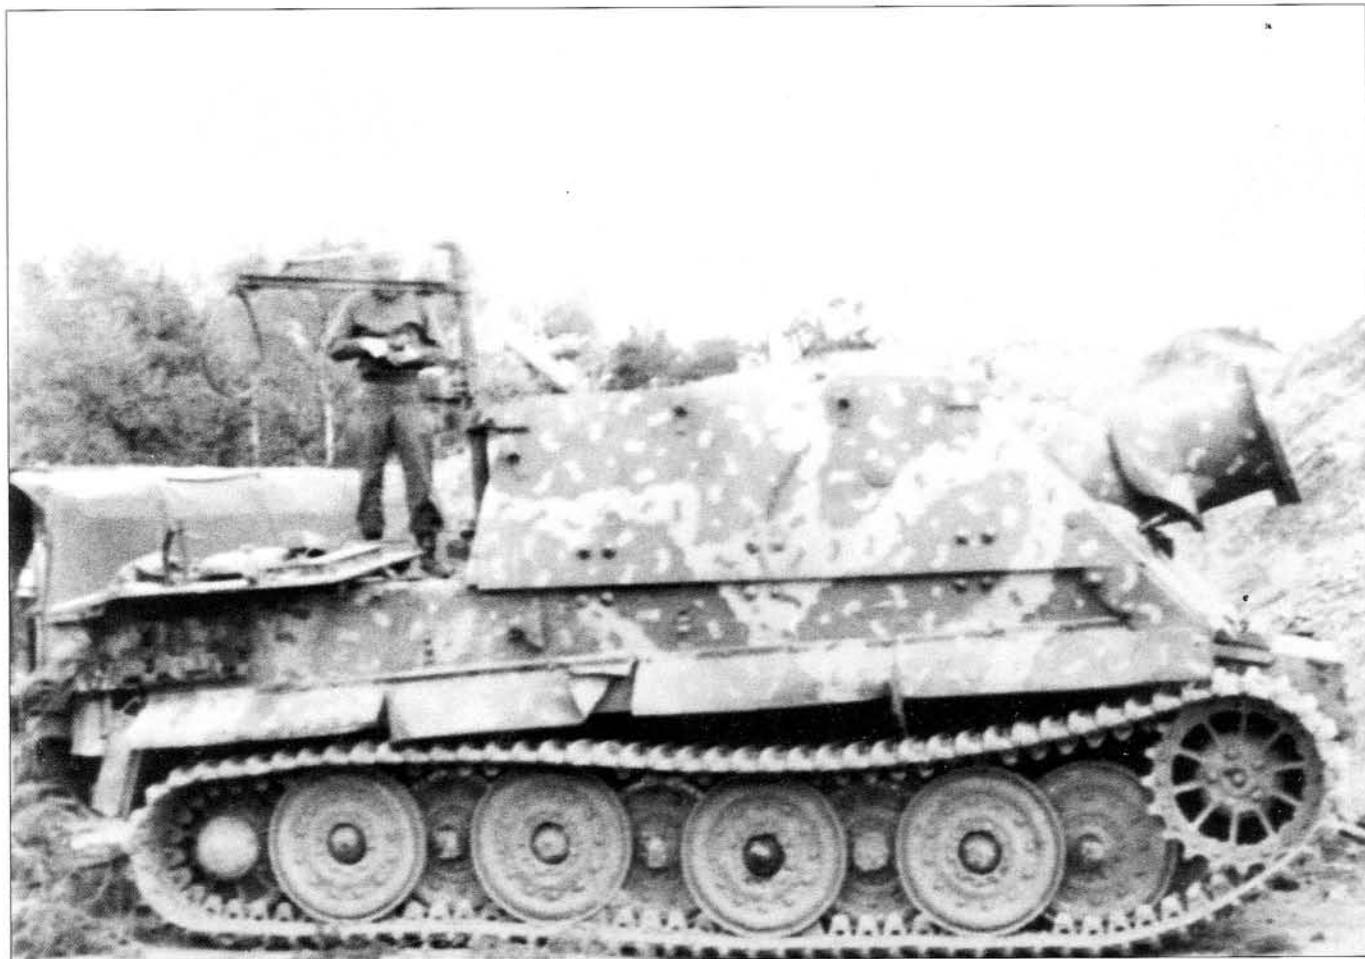
A GI takes a look at the interior of a *Sturmörser*. The sideskirt (protective sheet metal?) on the right side shows signs of battle damage. And next page. • Ein GI inspiziert den Innenraum des Sturmörser. Die Schutzbleche auf der rechten Seite zeigen einige Beschädigungen. Und weitere Seite. [2xKHM]

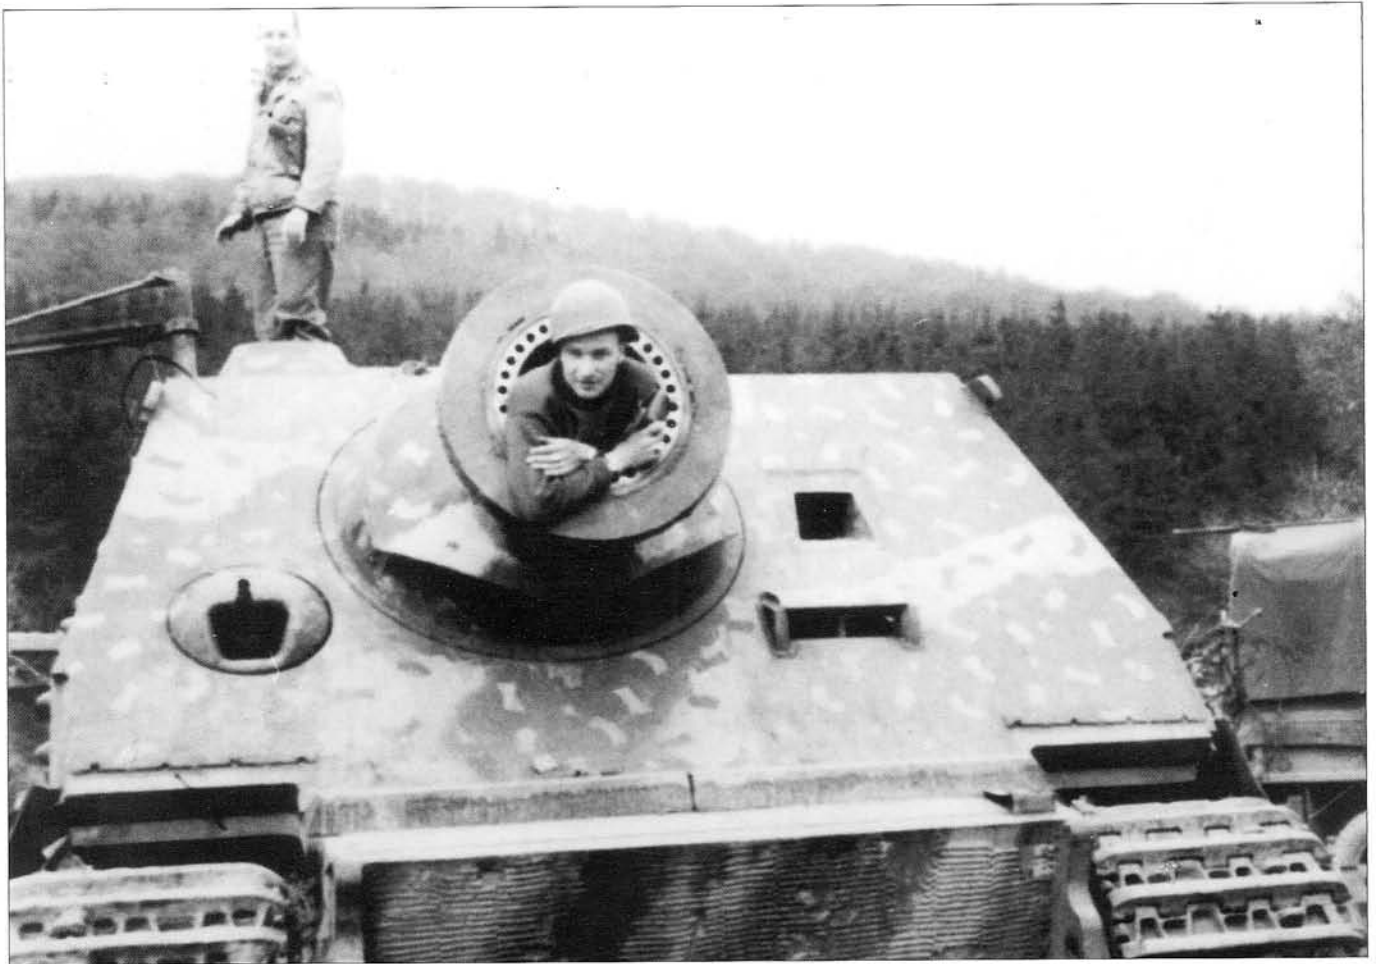
This photograph demonstrates the dimensions of the barrel. This GI was able to crawl into it without a problem. The Bosch headlight is missing on this vehicle. • Diese Aufnahme verdeutlicht die Dimensionen des Geschützrohrs. Problemlos konnte der GI hineinkriechen. Der Bosch-Scheinwerfer am Fahrzeugbug fehlt

Seen to good advantage is the round counterweight on the main gun and the gas escape ports at the mouth of the barrel. • Gut erkennbar ist das runde Gegengewicht an der Kanone und die Bohrungen an der Rohrmündung für den Gasaustritt [2xKHM]

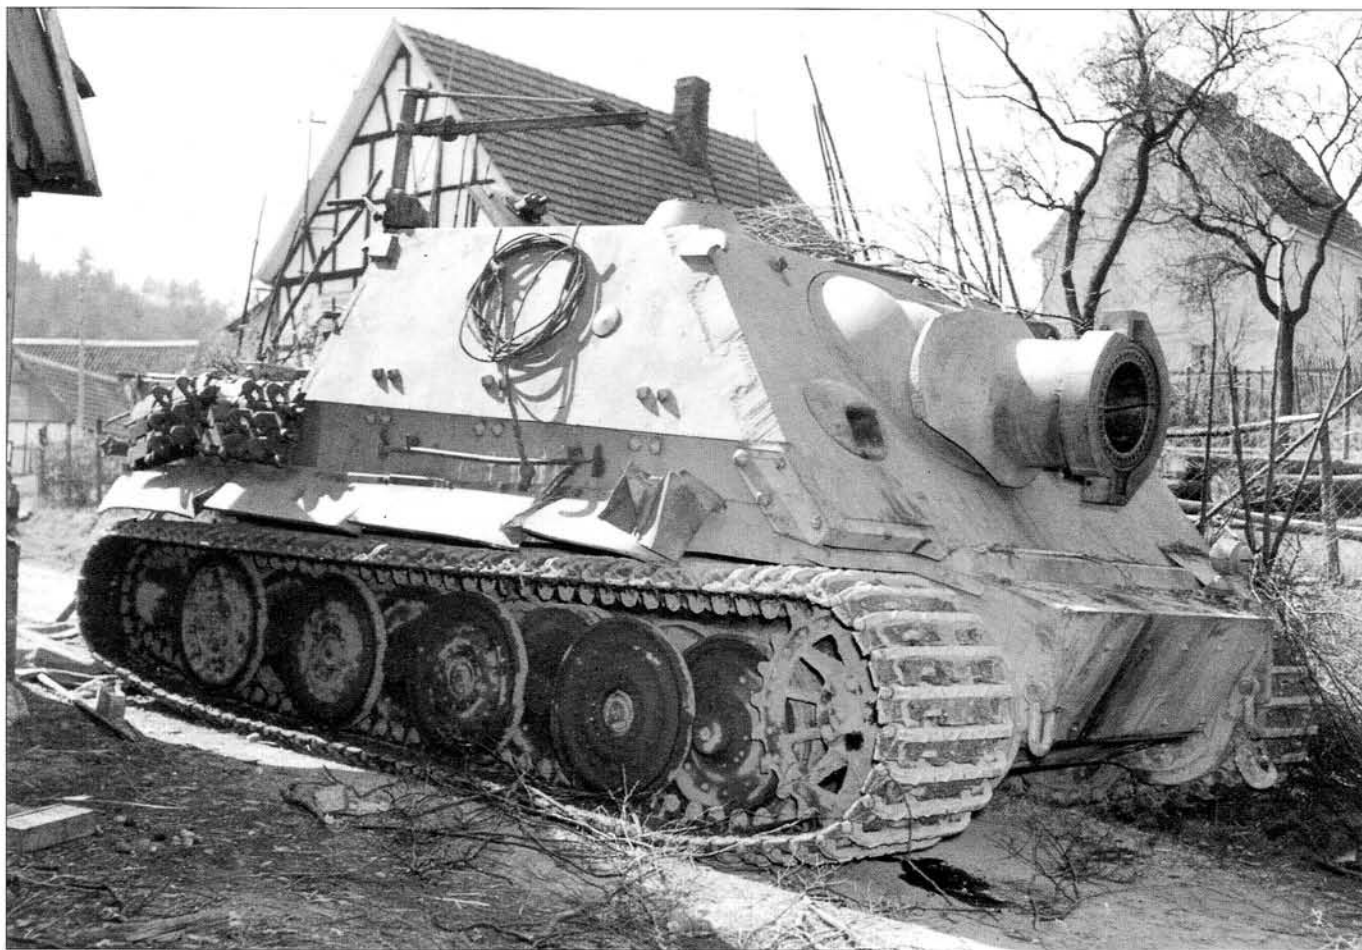
This *Sturmmörser* fell into US hands in the Nordrhein-Westfalen town of Drolshagen. Note the additional armor plating on the front slope of the vehicle. • Dieser Sturmpanzer fiel den US-Streitkräften im nordrhein-westfälischen Drolshagen fast unbeschädigt in die Hände. Man beachte die zusätzliche Panzerplatte am Fahrzeugbug. Das Fahrzeug ist anscheinend nur in sandgelb gestrichen. Auch der sonst übliche Zimmerit-Anstrich an der Wanne fehlt

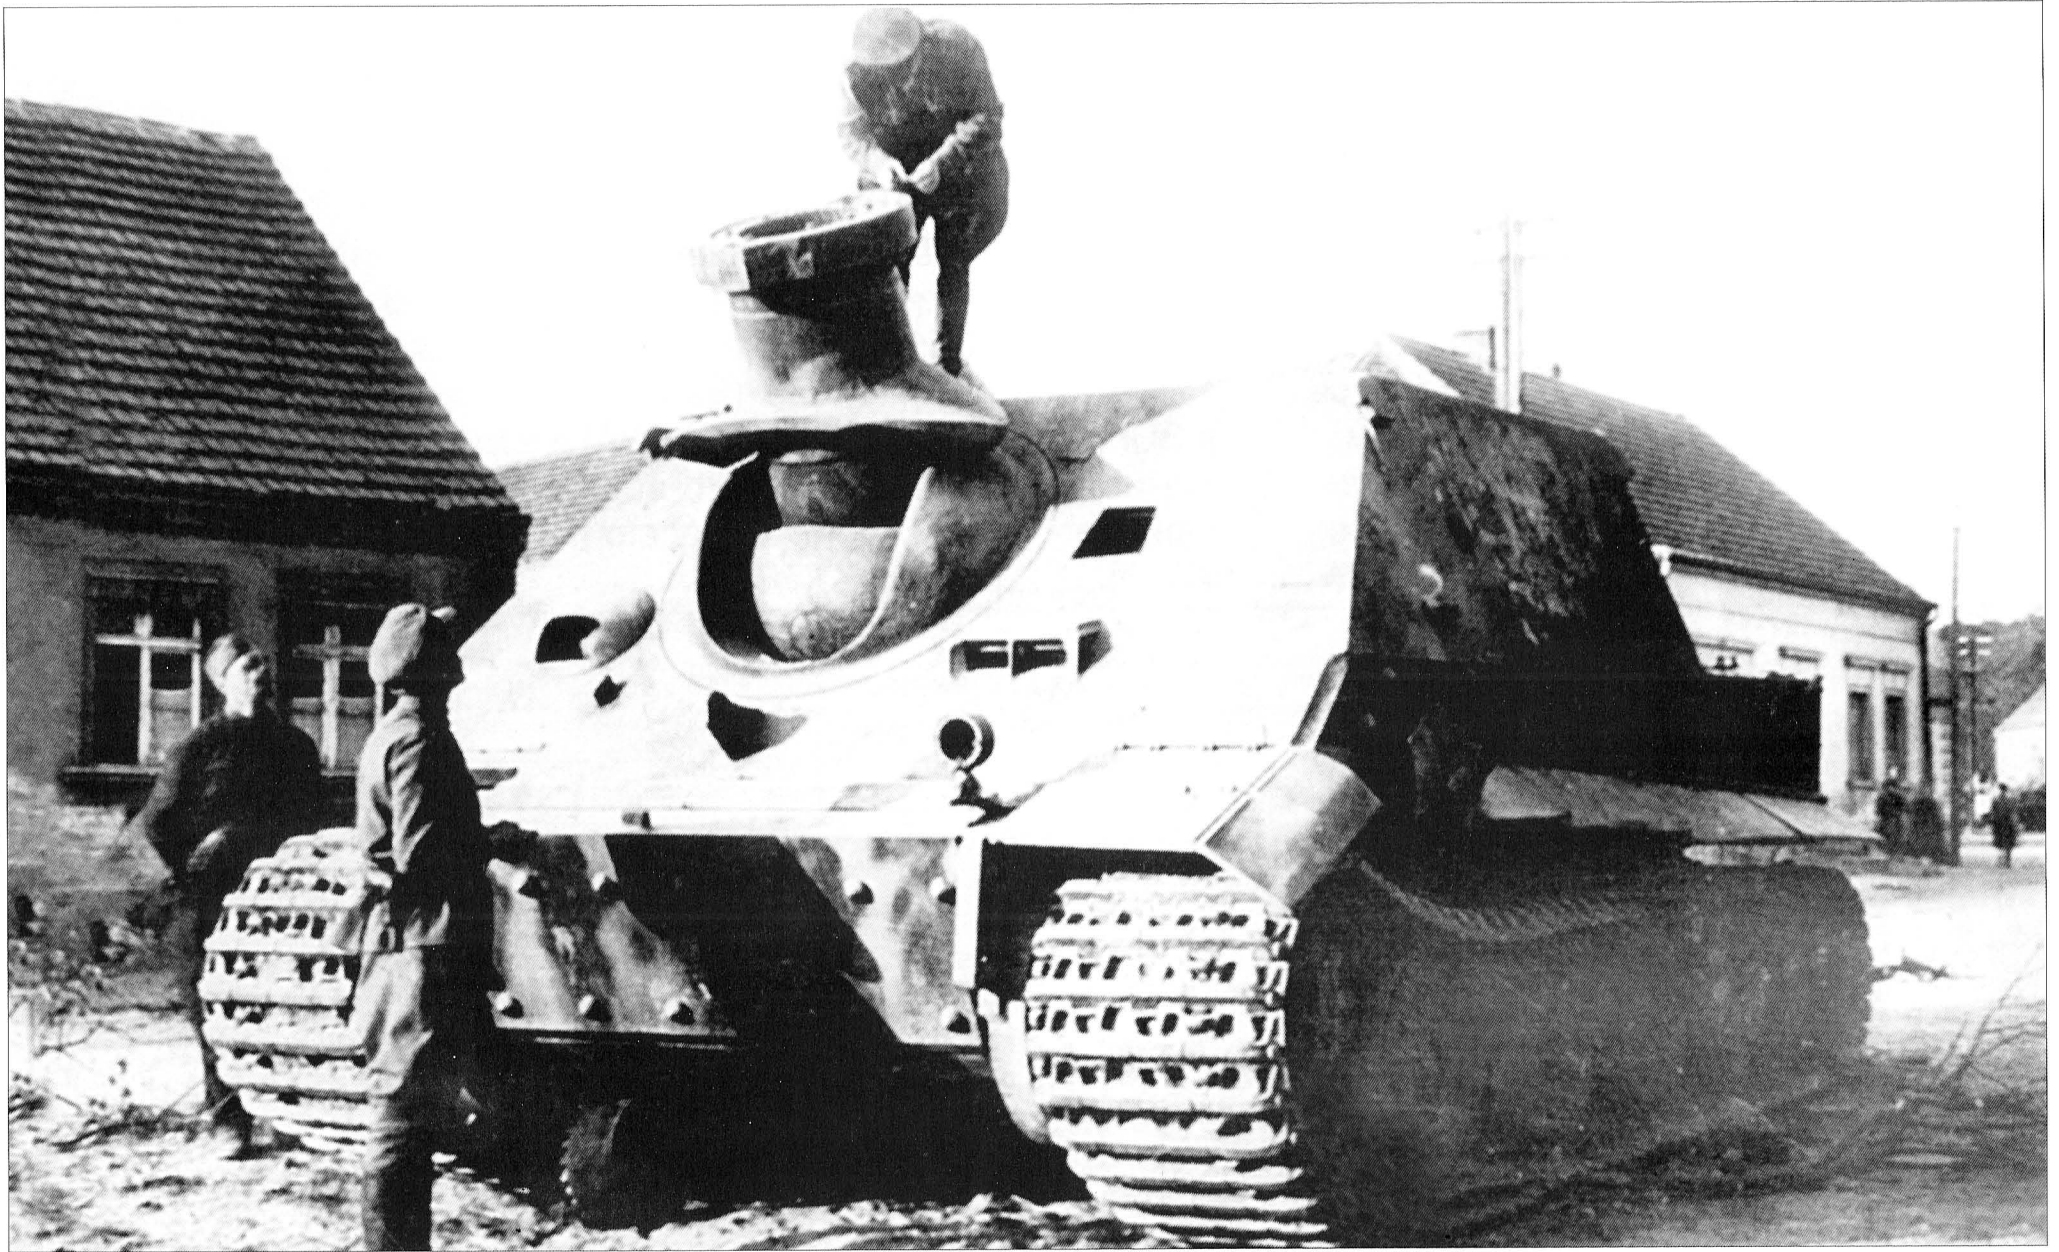
During the final fighting in the East, the Soviet forces were able to capture the prototype of the *Sturmörser*. The prototype was outfitted with a steel superstructure and steel roadwheels after it returned from employment in Warsaw. The vehicle is currently on display at Kubinka. • Beim Endkampf im Osten erbeuteten die sowjetischen Streitkräfte den Prototyp des Sturmörser. Dieser wurde nach seiner Rückführung aus Warschau mit einem Stahlaufbau und Stahlaufrollen ausgerüstet. Der Panzer steht heute im Museum in Kubinka

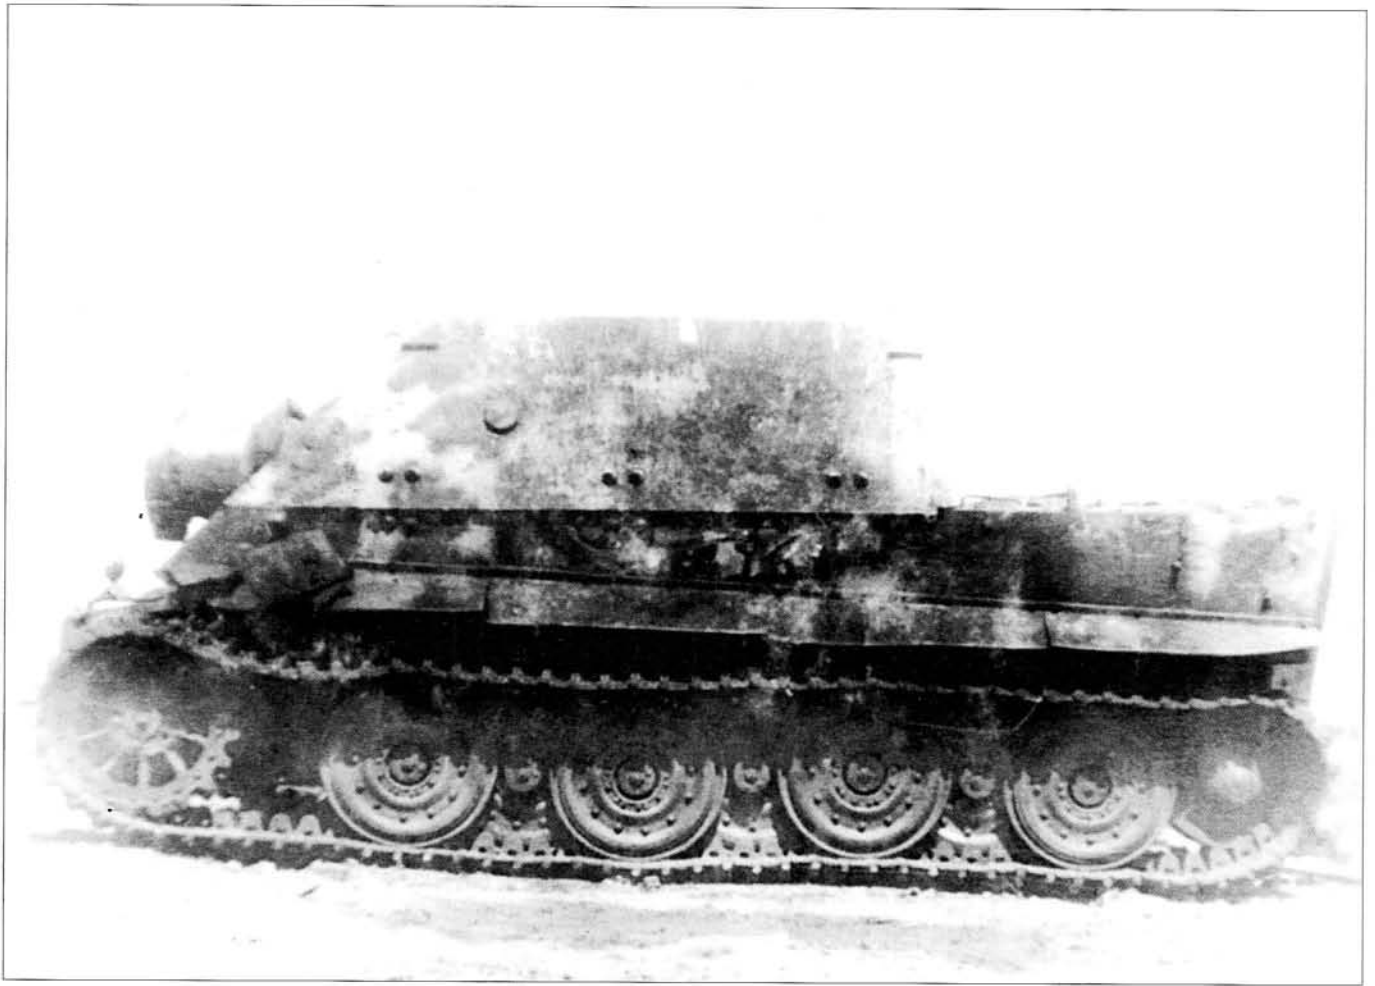
The same vehicle seen from another angle. The bolted-on supplemental armor plating on the front of the hull can be seen to good advantage. • Das gleiche Fahrzeug aus einer anderen Perspektive. Gut erkennbar die aufgeschraubte Zusatzpanzerung am Wannenbug
