STURMTIGER and STURMPANZER in COMBAT

Sturmtiger and Sturmpanzer in Combat

Katowice – Speyer 2008

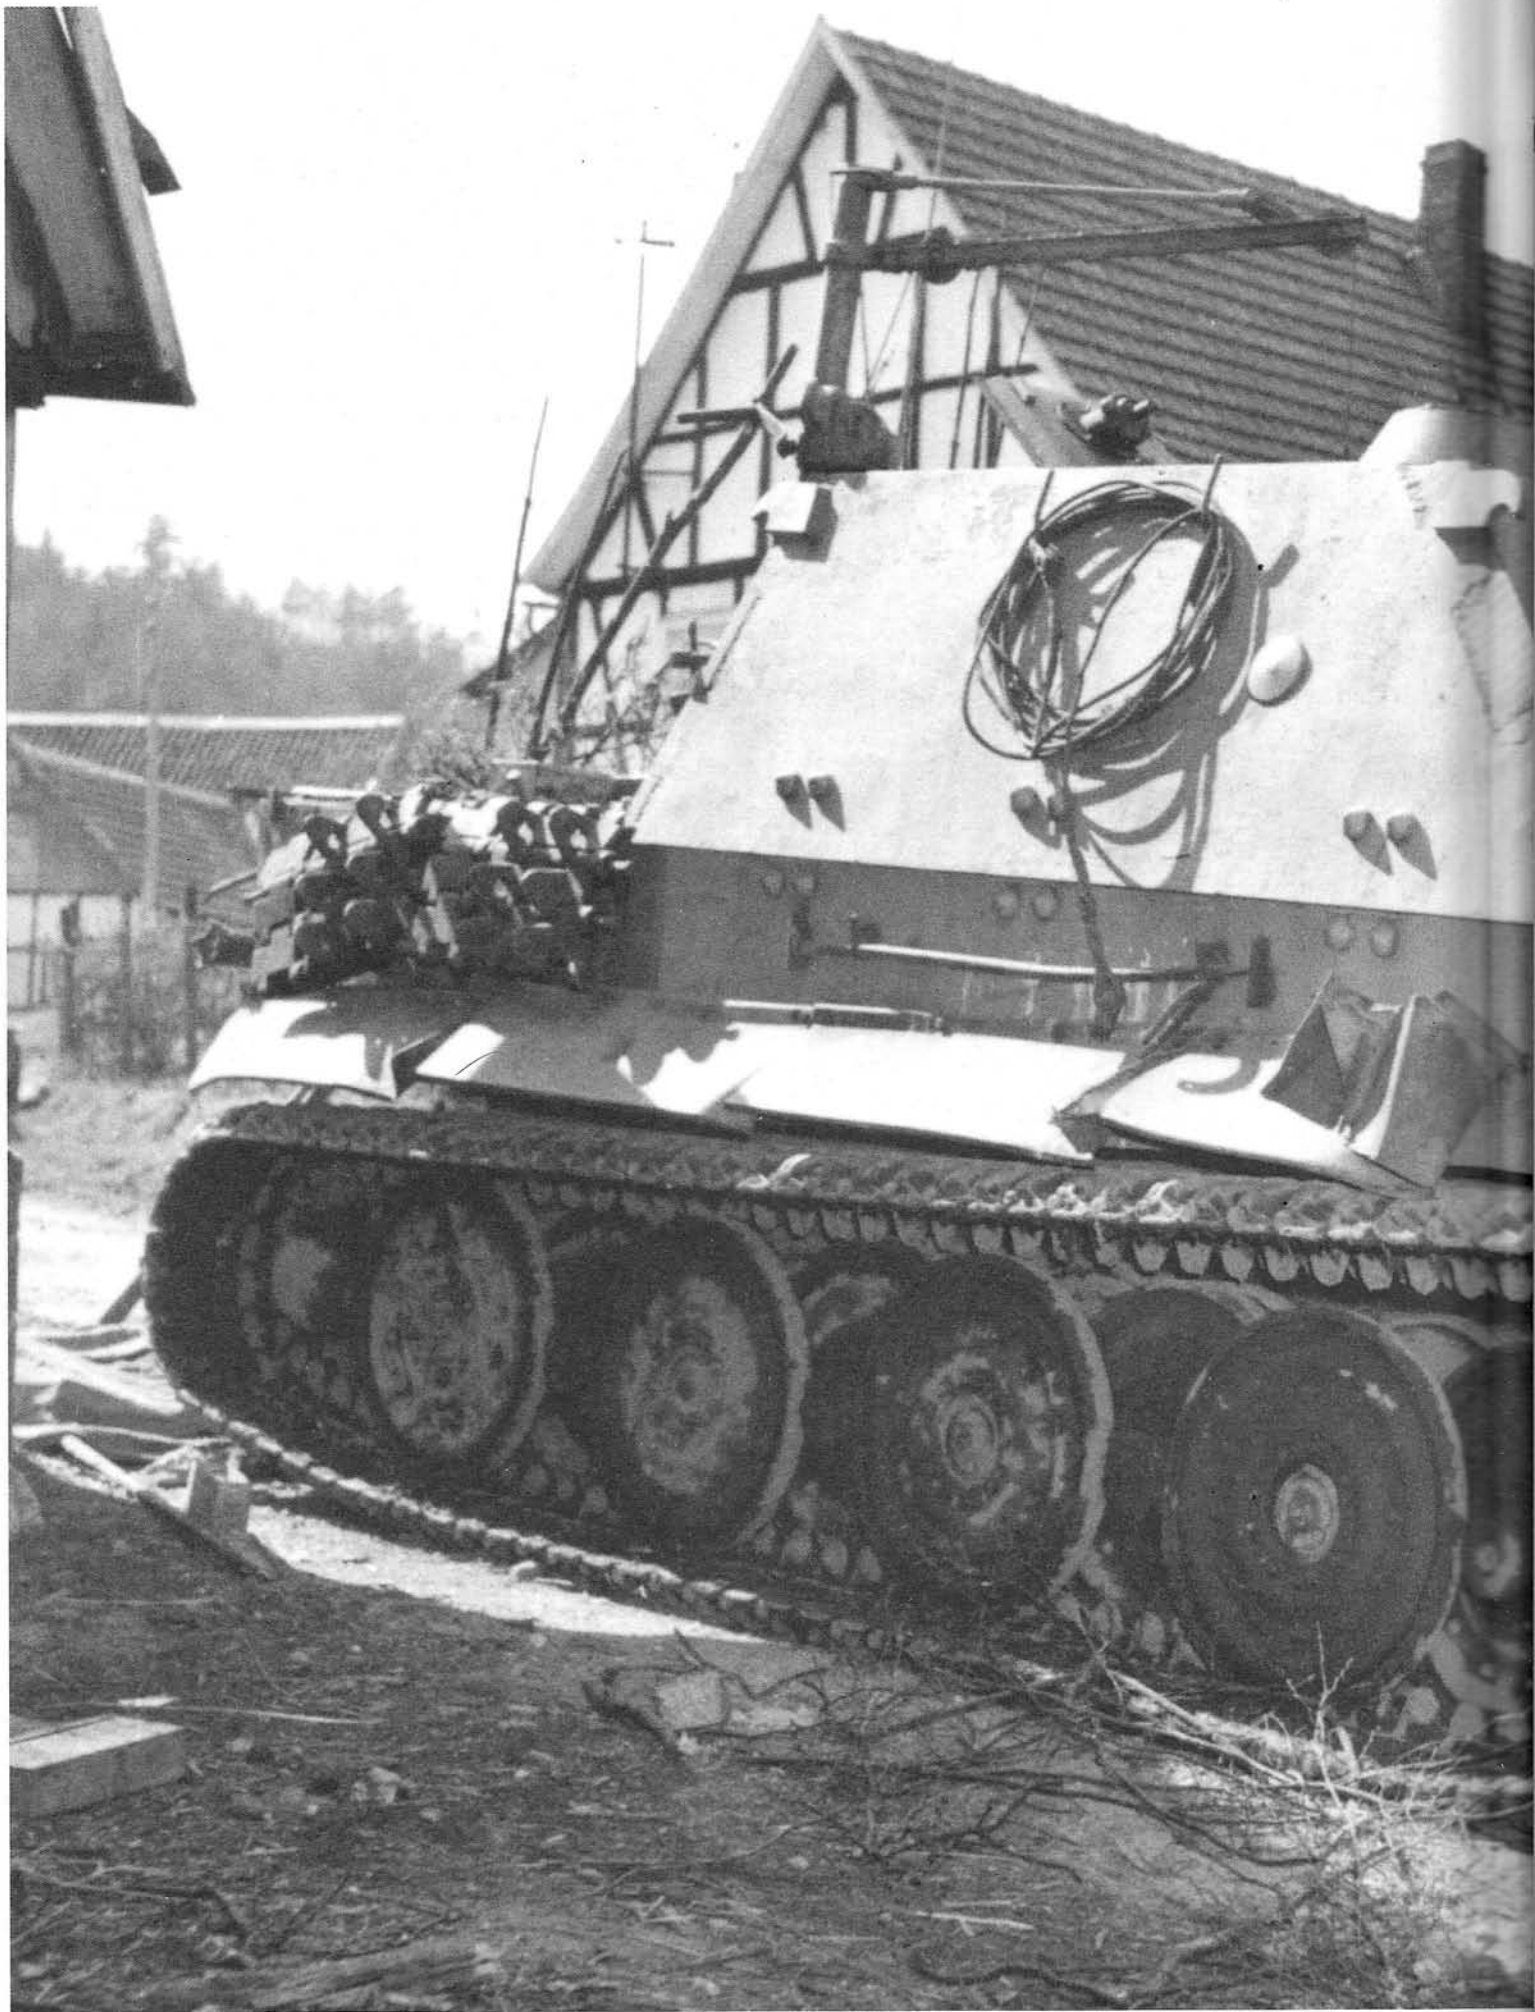
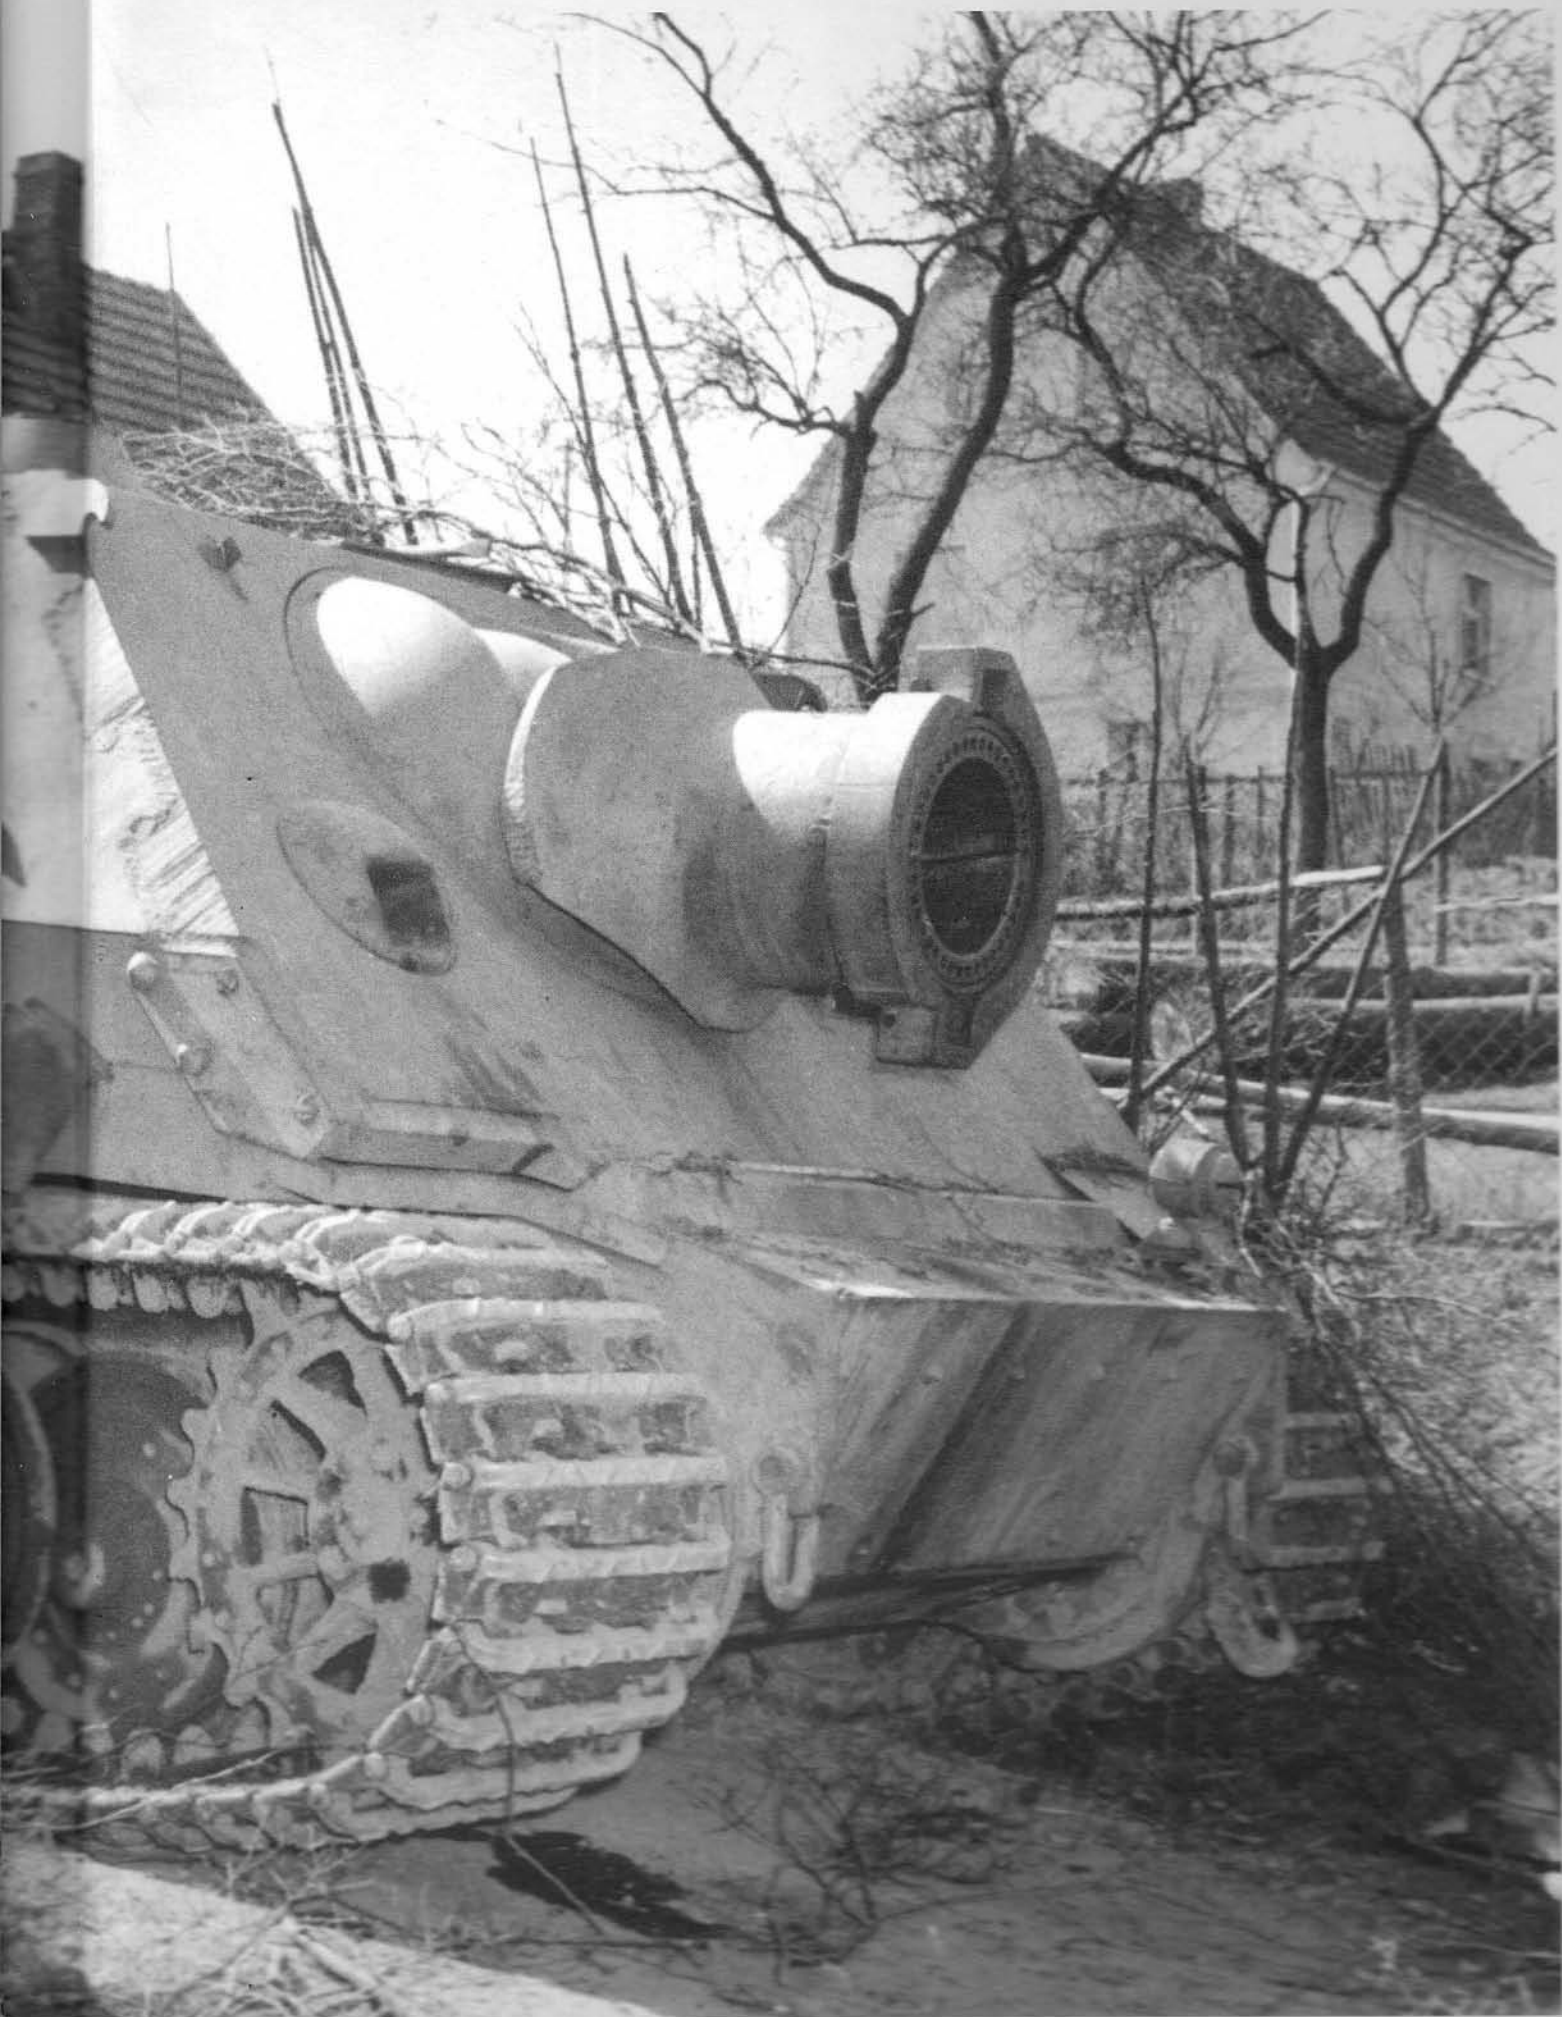
Sturmtiger, Sturm-Mörser-Kp. 1001, Germany, April, 1945.
