LA-10697-MS

*General-Purpose Heat Source Development:
Safety Verification Test Program
Explosion Overpressure Test Series*

GENERAL-PURPOSE HEAT SOURCE DEVELOPMENT: SAFETY VERIFICATION TEST PROGRAM

Explosion Overpressure Test Series

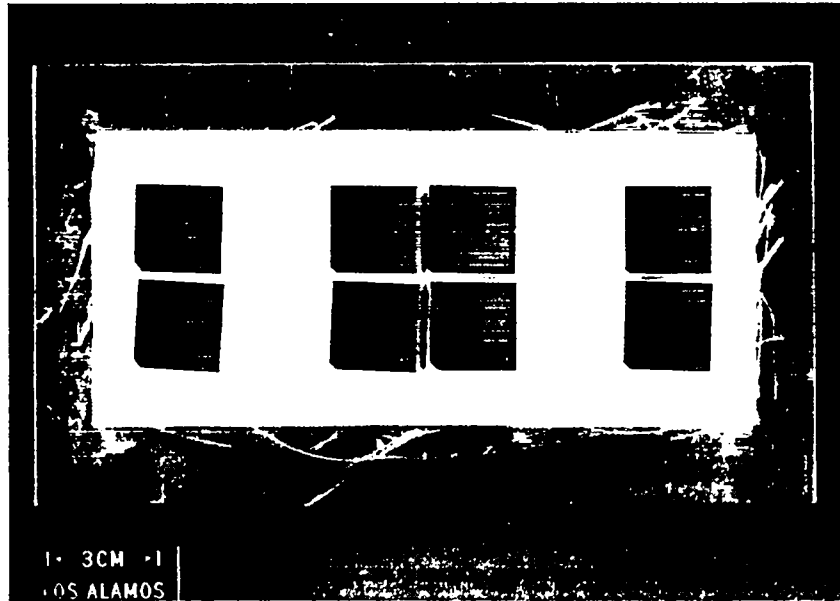
Fig. 2. The GE segment for the shock tube tests (C-shaped housing simulant) consisted of a 1.52-mm-thick aluminum (6061-T6) plate with flight-quality thermoelements and insulation attached; (a) face-on view and (b) overhead view.

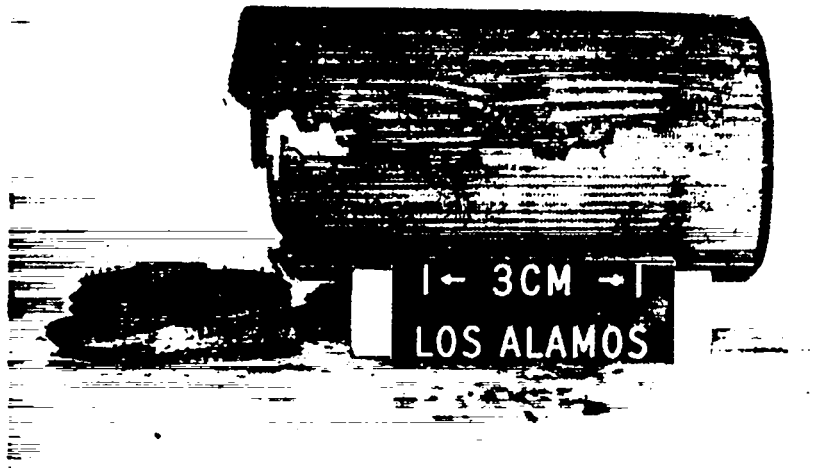
Fig. 9. The C-GIS containing capsules IRG-117 and IRG-118 was broken after the 5.1-MPa blast. Simulant-fueled clad IRG-118 is visible.

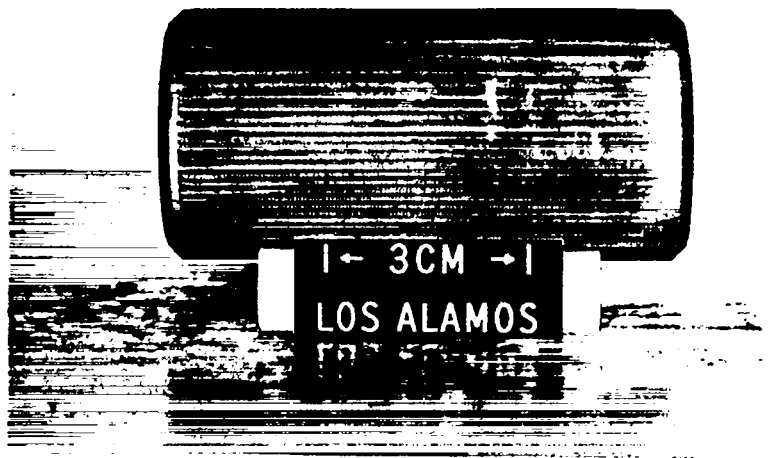
Fig. 10. The A-GIS containing simulant-fueled clad IRG-115 and IRG-116 appeared undamaged after the 5.1-MPa blast. The A-GIS was on the blast side of the module.

In this test (BMT-2), we heated the BMT-1 test module to $1093 \pm 5^\circ\text{C}$, and we detonated 27.2 kg (60 lb) of explosive at the end of a 20.1-m-long shock tube to create a blast wave of 5.1 ± 0.21 MPa (735 ± 30 psi) overpressure and 22.1 ± 2.8 kPa \cdot s (3.2 ± 0.4 psi \cdot s) impulse. The test module was driven 1 m into the catch tube. The recovered module is shown in Fig. 8. The aeroshell fractured on a broad face that had been oriented parallel to the blast direction. The C-GIS (Fig. 9) was broken and fueled clad IRG-118 was visible. The A-GIS (Fig. 10), which was on the blast side of the module, appeared undamaged.

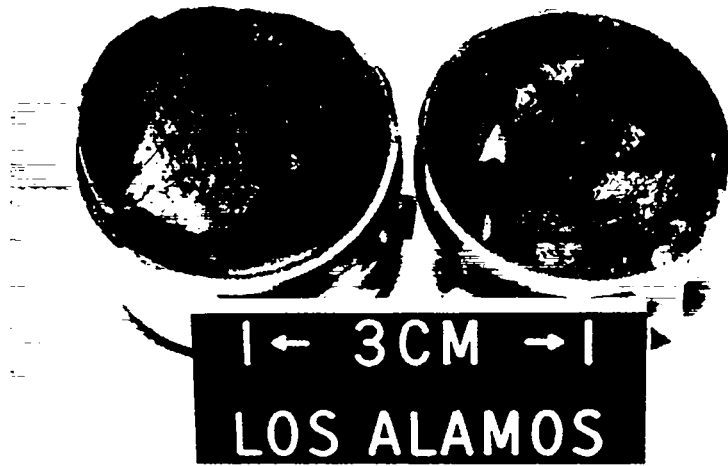
Fig. 12. The simulant fuel (UO_2) in clad IRG-118 was broken into relatively large fragments after the two sequential explosion tests.

The clads were removed from the impact shells and photographed (Fig. 11). None of the clads breached. Diametral measurements indicated an M/m ranging from 1.002 to 1.029. Capsule IRG-118, which had the greatest local deformation, was selected for microscopic examination. The IRG-118 fuel simulant (Fig. 12) was broken into relatively large pieces.

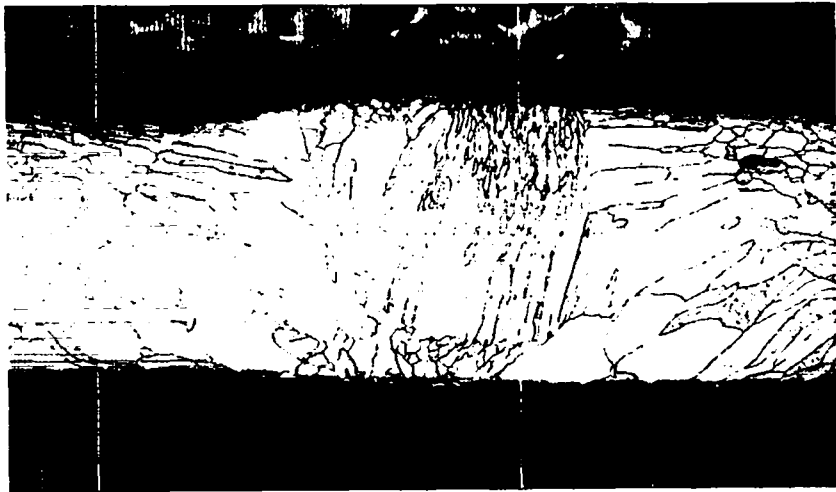
Fig. 24. The L-12 closure weld had a very unusual microstructure. (a) As polished and (b) etched; both at 50X.

Although the closure weld (Fig. 24a) was completely free of porosity and other defects, it had an abnormal microstructure (Fig. 24b). While it is unclear how such an unusual microstructure could form, the orientation of long columnar grains along the weld centerline would substantially reduce the tensile strength of the weld. No cracks or other defects were observed at any point on the weld surface.

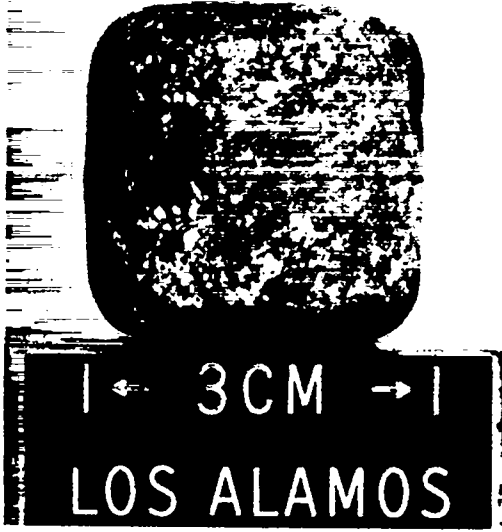
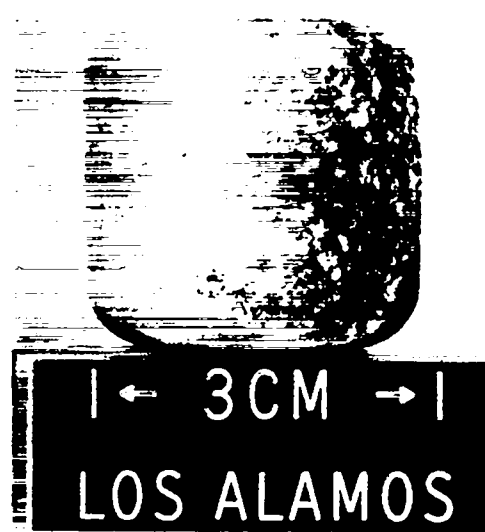
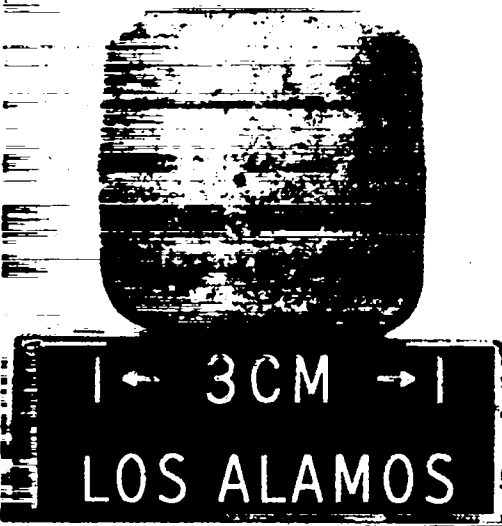
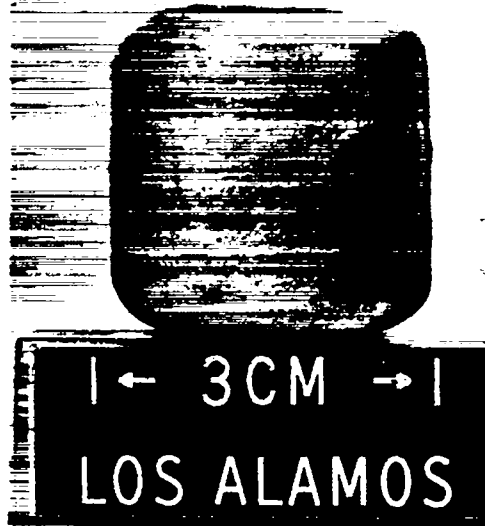
Fig. 28. The simulant-fueled clads after CST-4 at 12.2 MPa overpressure.

The clads, shown in Fig. 28, were identified from laser etchings on the clad exteriors. The diametral strains ranged from 1.009 to 1.094. Clad L-10, with an M/m of 1.094, was sectioned. Particle size data are shown in Table II.

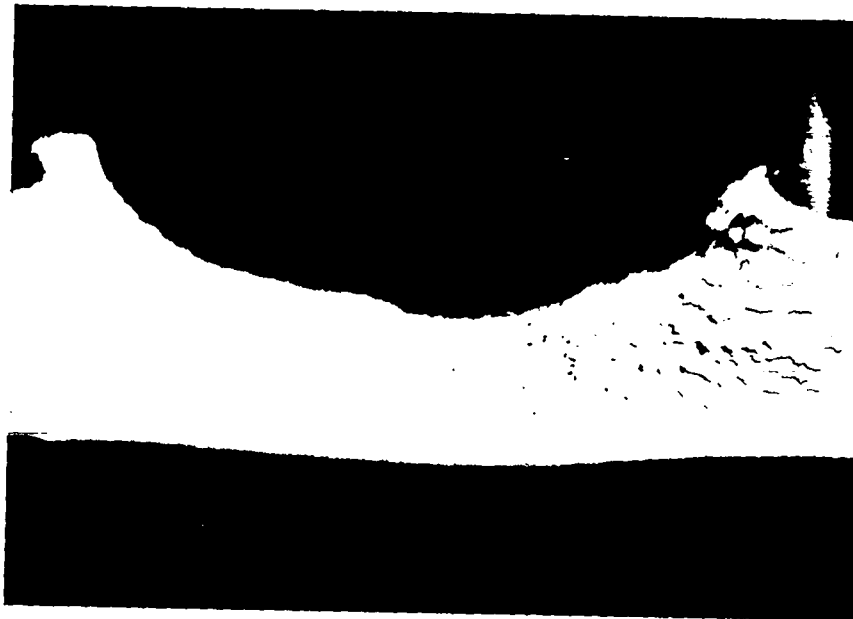
Fig. 34. The large crater in the vent cup of clad L-10 produced a pattern of internal grain boundary cracks. (a) As polished and (b) etched; both at 50X.

A cratered section of the L-10 vent cup (Fig. 33) was also removed for examination. A large crater in this cup penetrated approximately 40% of the wall thickness. The deformation produced a remarkable pattern of internal grain boundary cracks (Fig. 34) on one side of the crater.

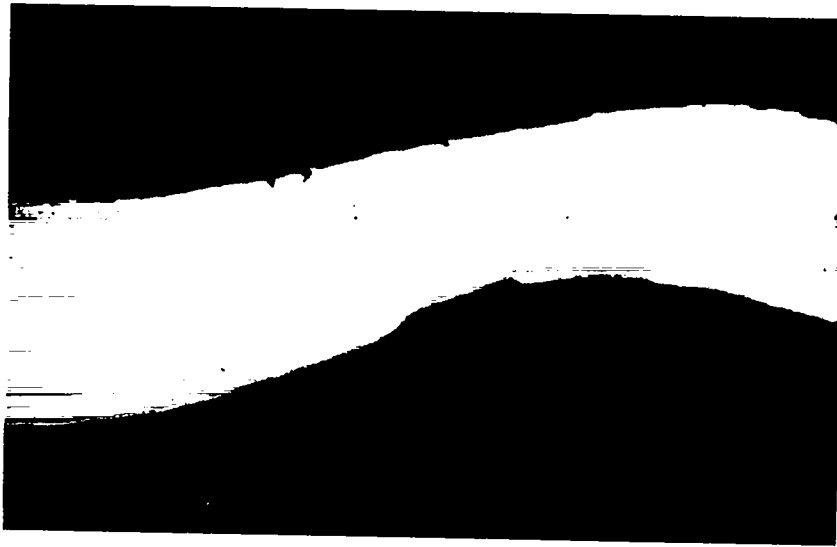
Fig. 40. Grain elongation was also observed in the shield cup section. (a) As polished and (b) etched; both at 50X.

Metallographic specimens were removed from both of the L-24 iridium cups. Examination of a severely deformed shield cup section (Fig. 39) revealed slight surface gouging and an unusual amount of grain elongation (Fig. 40). Similar grain elongation was observed in a deformed section of the vent cup (Fig. 41). Both cups were uniformly fine grained (Table III). The closure weld did not contain any observable defects and had an acceptable microstructure.

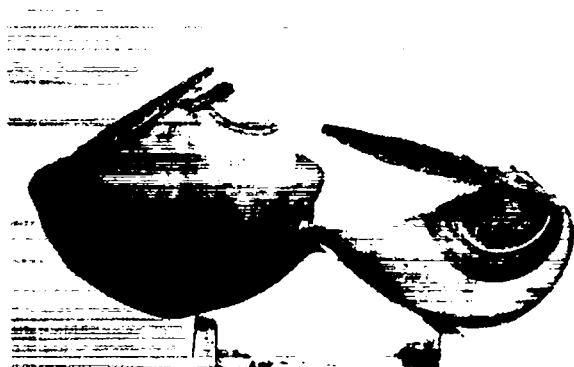
Fig. 53. Three clads were recovered breached: (a) M-8 (bottom module, A-GIS); (b) M-20 (bottom module, C-GIS); and (c) M-22 (middle module, A-GIS).

Fig. 53 (cont)

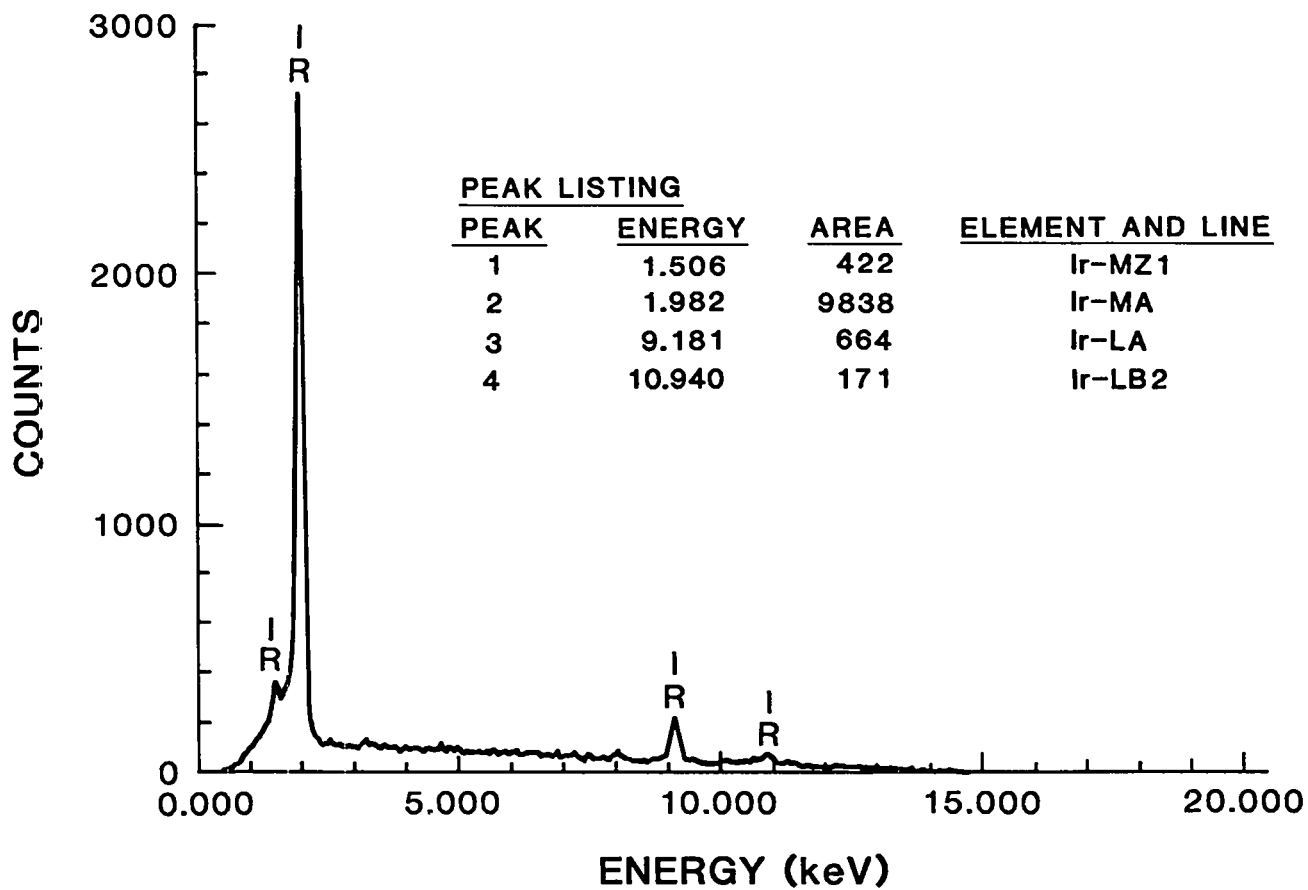
Fig. 58. X-ray spectrum from the area seen in Fig. 57 (50-s counting time). Only iridium was detected.

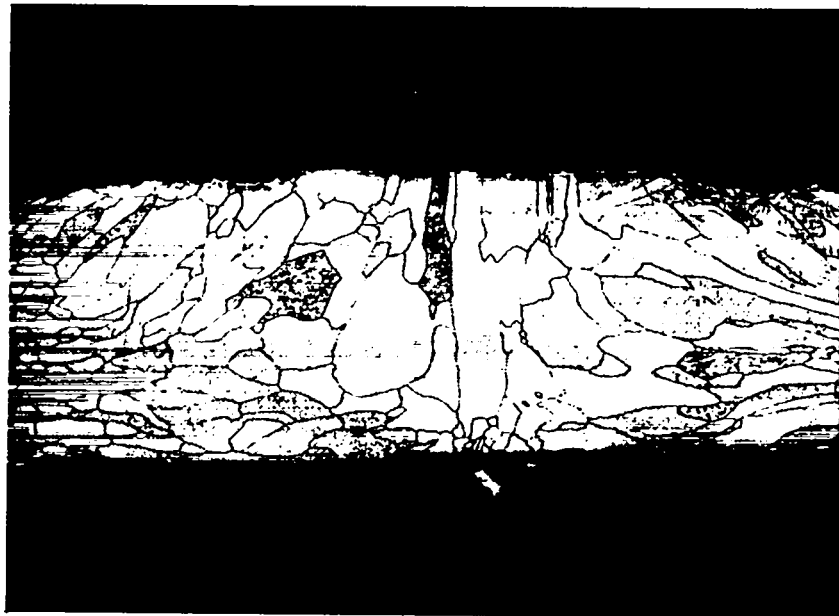
Fig. 62. The M-35 capsule weld was unusually coarse grained; 50X.

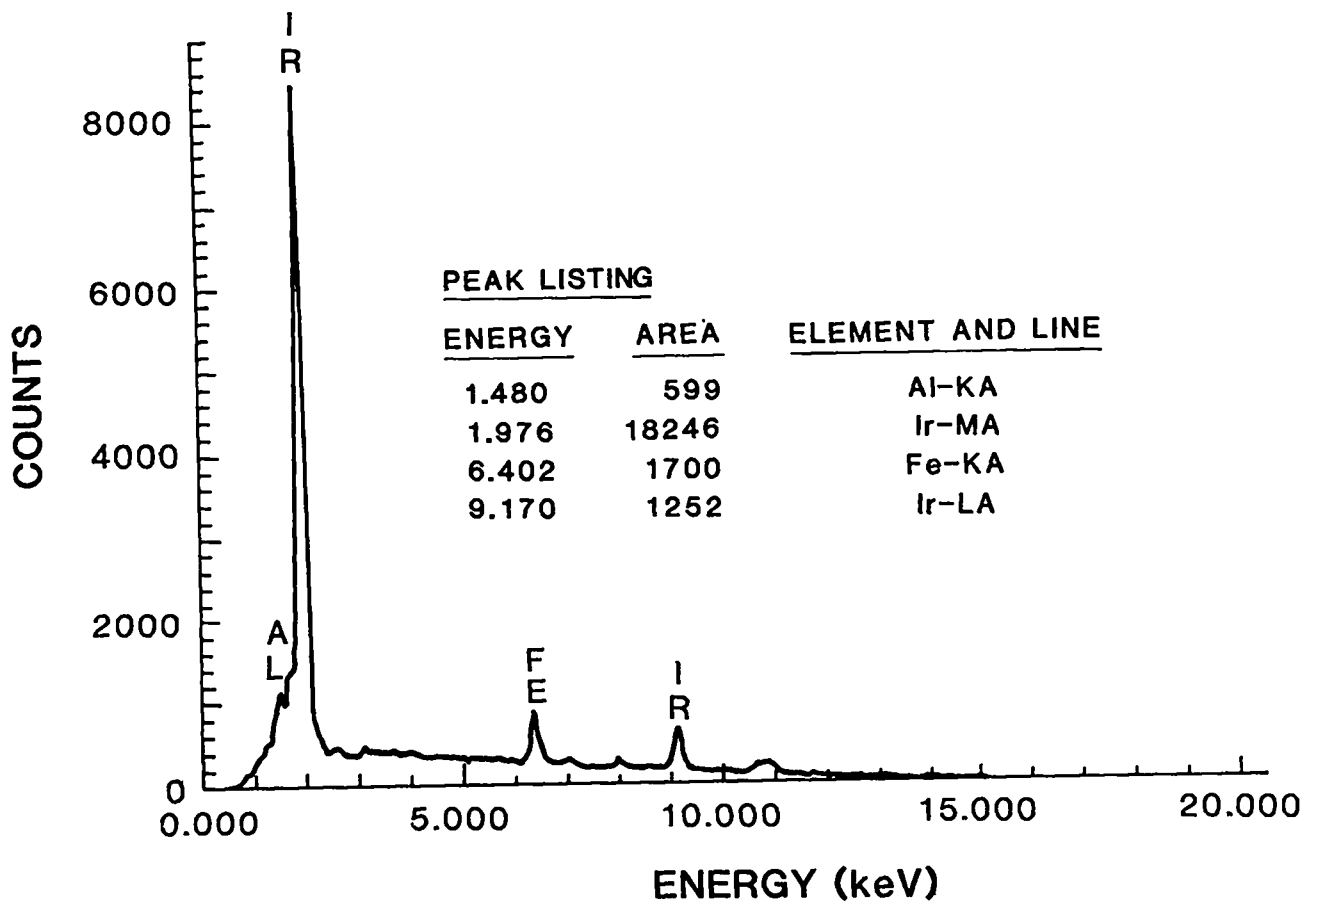
Fig. 70. Low-magnification x-ray spectra of the area in Fig. 71a (20-s counting time). Iridium, iron, and aluminum were detected.
