## Los Alamos DP West Plutonium Facility Decontamination Project 1978 — 1981

The DP West Plutonium Facility operated by the Los Alamos National Laboratory, Los Alamos, New Mexico was decontaminated between April 1978 and April 1981. The facility was constructed in 1944-45 to produce plutonium metal and fabricate parts for nuclear weapons. It was continually used as a plutonium processing and research facility until mid-1978.

Decontamination operations included dismantling and removing gloveboxes and conveyor tunnels; removing process systems, utilities, and exhaust ducts; and decontaminating all remaining surfaces. This report describes glovebox and conveyor tunnel separations, decontamination techniques, health and safety considerations, waste management procedures, and costs of the operation.

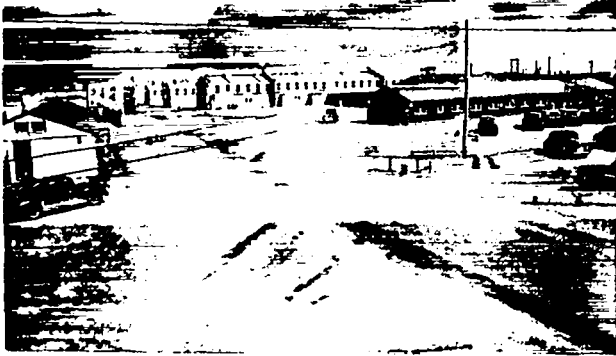
Fig. 3. TA-21, DP West, 1947.

The DP Site Plutonium Facilities replaced the original D Building Plutonium Facility in the Los Alamos Technical Area (TA-1). Most of the facilities were constructed in 1944-1945 by moving in used warehouses and installing necessary equipment (Fig. 3).

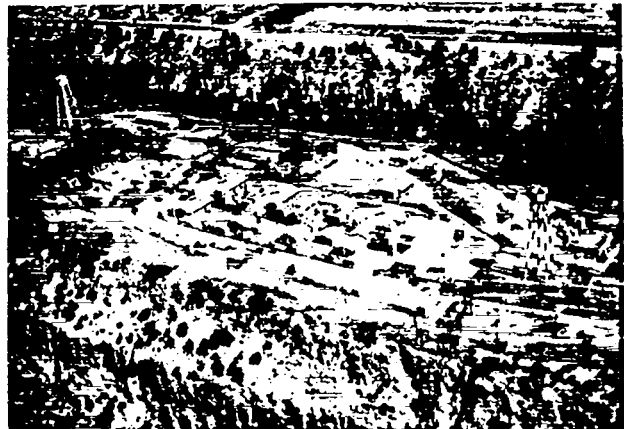
Fig. 4. TA-21, DP West after decontamination, 1981.

- o In 1968, personnel corridors between major buildings were converted to ventilated air locks.
- o In 1971, new room exhaust air systems were installed in plutonium areas and utility services were upgraded.
- o In 1973, the exhaust filter building (TA-21-12), abandoned in 1959, was decommissioned.<sup>3</sup>
- o In 1974, a wet pipe sprinkler system was installed throughout the plutonium processing buildings.
- o In 1977, the transfer of equipment to the new TA-55 Plutonium Facility began.
- o In 1981, decontamination was completed and the areas were transferred to new tenants (Fig. 4).

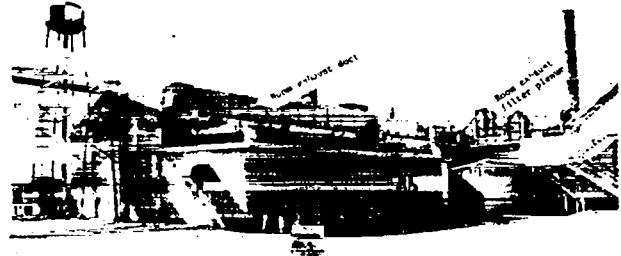
Fig. 16. Northwest side of Building 5.

Building 5 (Figs. 16 and 17) was the plutonium metal fabrication facility. In 1963, Room 506 was constructed to house electrorefining equipment needed to produce high-purity plutonium metal. Also in 1963, room 500A was added to house an air drying system for air supply to the conveyor tunnels and gloveboxes.

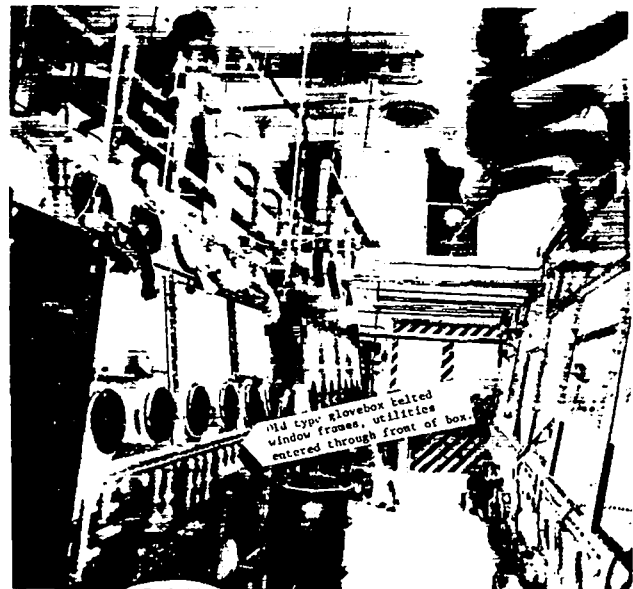
Fig. 31. Gloveboxes in room 308.

The records search indicated that Room 308 was possibly the most highly contaminated room to be decontaminated. Plutonium-238 and  $^{239}\text{Pu}$  had been processed in the room in old gloveboxes (Fig. 31) and numerous contamination incidents had occurred. The decontamination approach was similar to that used in all the other buildings, except in Room 308 almost all work required respirators. The west wall and a portion of the ceiling plaster were highly contaminated and had to be removed. These walls and ceilings were replastered and painted.

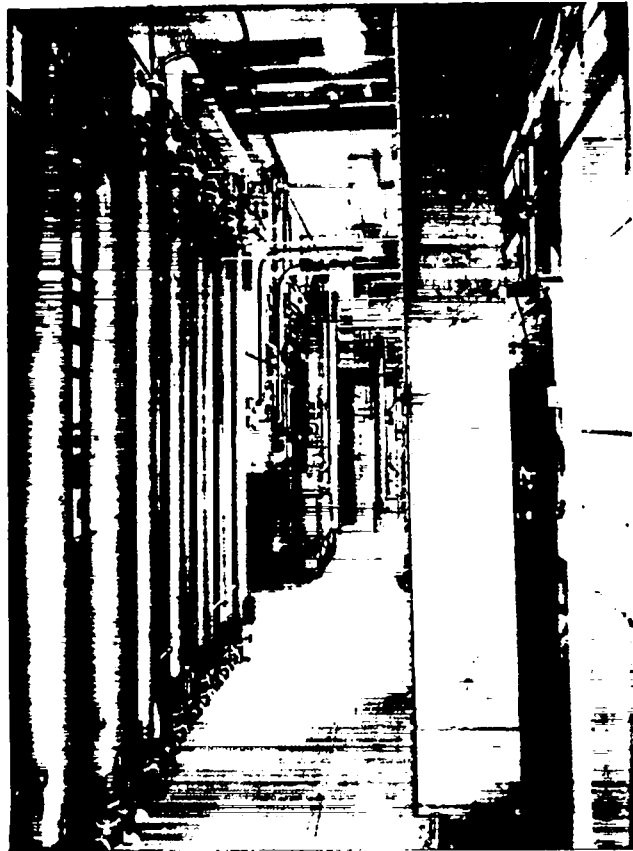
Fig. 33. Storage tanks and column in Building 2.

A team of two pipefitters and one health physics technician (HPT) separated the storage tanks, columns, and lines. This operation was begun as early as possible in 1978 to avoid the maintenance that would be required if the tanks were unattended until the regular decontamination crews arrived in Building 2.

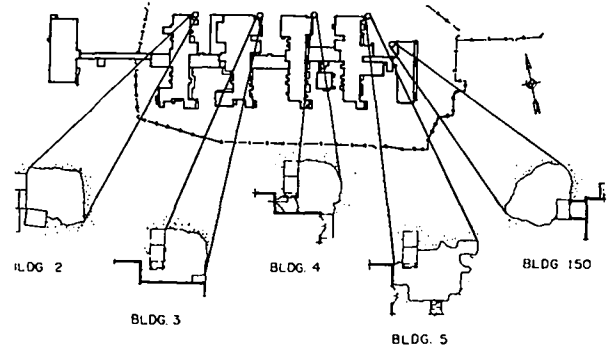
Fig. 36. Location of acid waste sampling wells.

The project also removed five industrial liquid-waste collection and sampling wells. The wells were at the northeast corners of the four original buildings and the northwest corner of Building 150 (Fig. 36). The original well structures for Buildings 2, 3, 4, and 5 were 4.65 m deep and 1.5 m in diameter and constructed of brick. Stainless steel liners were added later. The reinforced concrete structure for Building 150 was 1.8 m x 1.8 m x 4.65 m deep. Prior to removal, the remaining liquids were pumped from the wells and dry cement placed in each well to absorb any free water. When the cement had set, approximately 1.5 m of urethane foam was sprayed on top of it.

Four of the five wells were removed in one piece by exposing them as much as possible with a backhoe then pulling them out with a crane. All surfaces were then sprayed with asphalt and the structures were wrapped in plastic and tarpaulins and transported to TA-54.

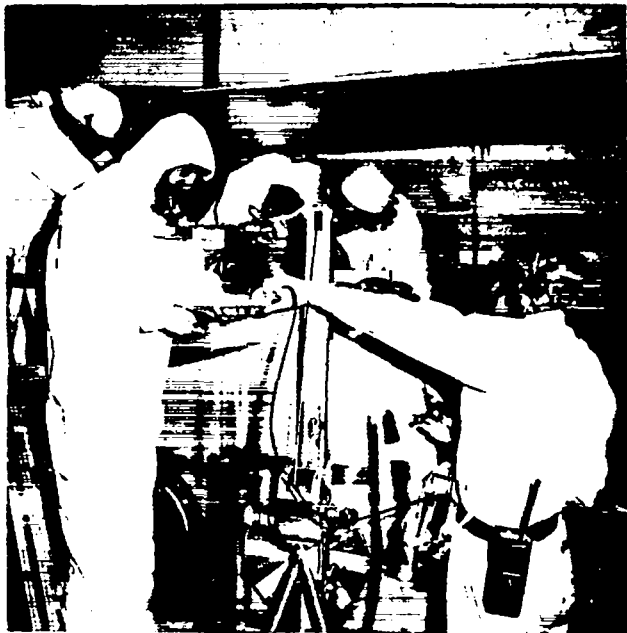
Fig. 37. Health physics monitoring during glovebox separation.

The RWP caused some delays while personnel became accustomed to ensuring that the permit was available when needed. It soon proved very valuable in assuring that personnel were protected and that changes were reviewed. Decontamination activities were monitored by HPTs either continuously or intermittently, commensurate with the requirements identified in the RWP. All workers were required to wear thermoluminescent dosimetry (TLD) badges. Figure 37 shows monitoring activities during decontamination operations.

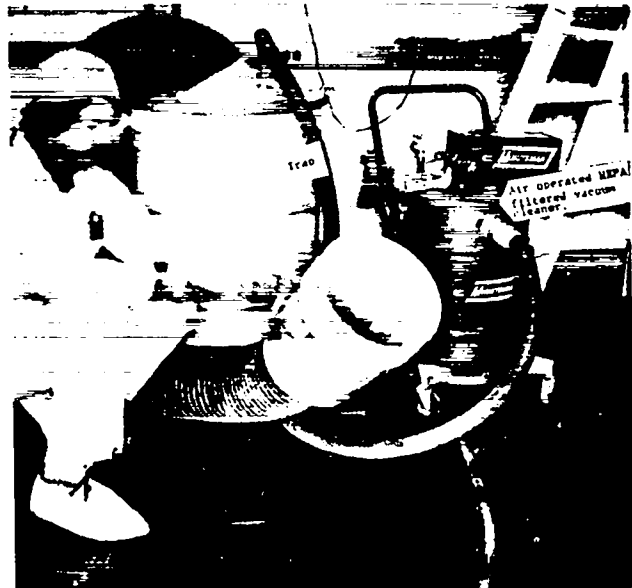
Fig. 48. Device used to collect plaster and paint chips.

A very useful contamination control aid used while scarifying or chipping contaminated plaster and paint was a filtered vacuum cleaning system which could be positioned to collect chips and dust from the operation. The 200- (55-gal) drum which served as a trap was later sealed and used as the primary waste disposal container (Fig. 48). The vacuum cleaner was a commercially available, air operated, HEPA-filtered system.
