LA-6064-MS

**Ductile to Brittle Transition of U-0.75 wt% Ti  
Penetrator Cores**

Work supported by the Air Force Armament Laboratory, Air Force Systems  
Command, Eglin Air Force Base, FL.

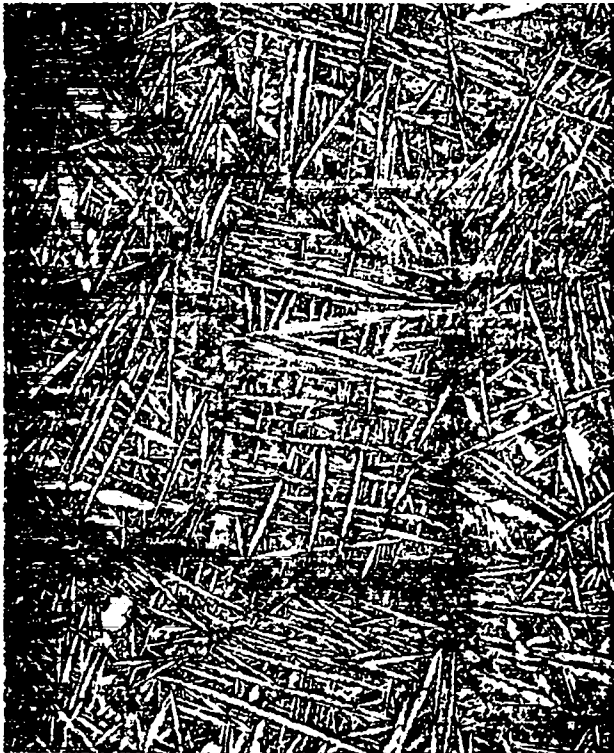
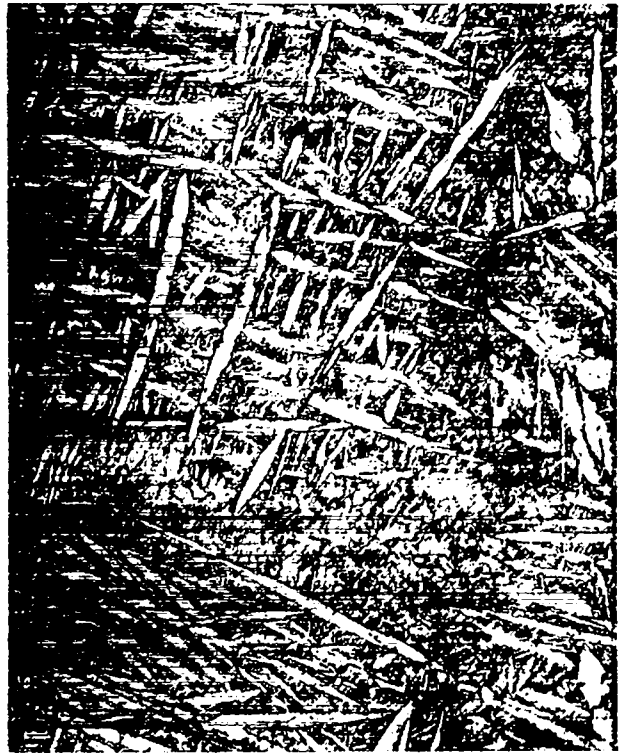
*Fig. 4.  
Charpy bar tested at 23°C.*

*c. Optical, 100X, side 2, 430 DPH*

*d. Optical, 250X, side 2*

Figures 4a and b show a structure just past the optimum aging peak on one side of the specimen, whereas Figs. 4c and d show a structure on the opposite surface that represented a more overaged condition. The diamond pyramid hardnesses (DPH) generally confirmed this observation. The appearance of these two structures in the proximity of a penetrator core suggests a difference in quenching rate from the solution treatment temperature across this sample. Figure 4e again represents a brittle, cleavage fracture.

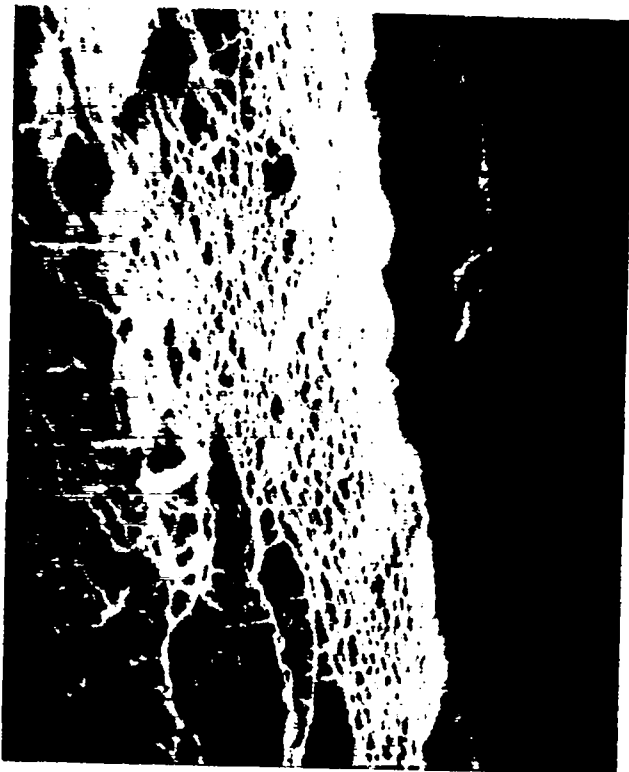
*Fig. 6.  
Charpy bar tested at 100°C.*

*a. Optical, 100X, 465 DPH*

*b. SEM, 700X*

*c. SEM, 2000X*

Figures 6a, b, and c were similar to previous specimens, that is, an overaged structure and a thin

ductile band at the notch changing to cleavage fracture over a preponderance of the fracture.

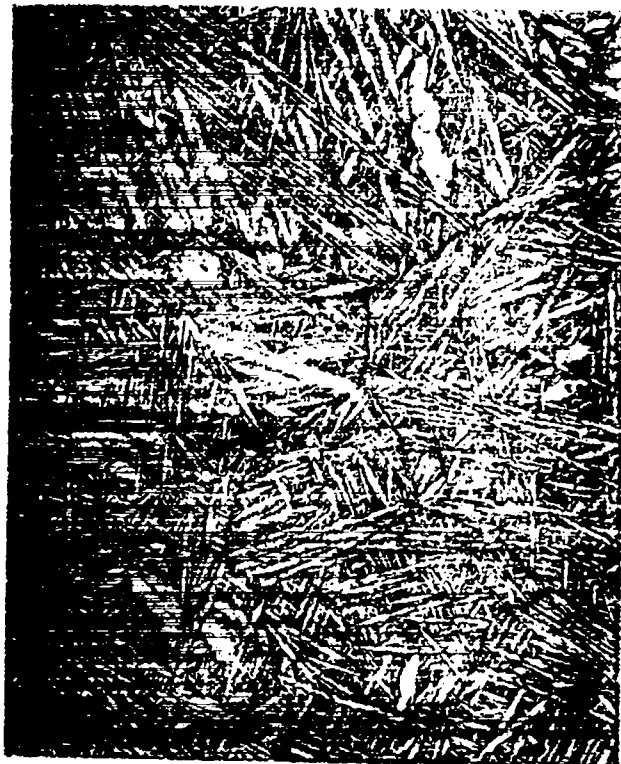
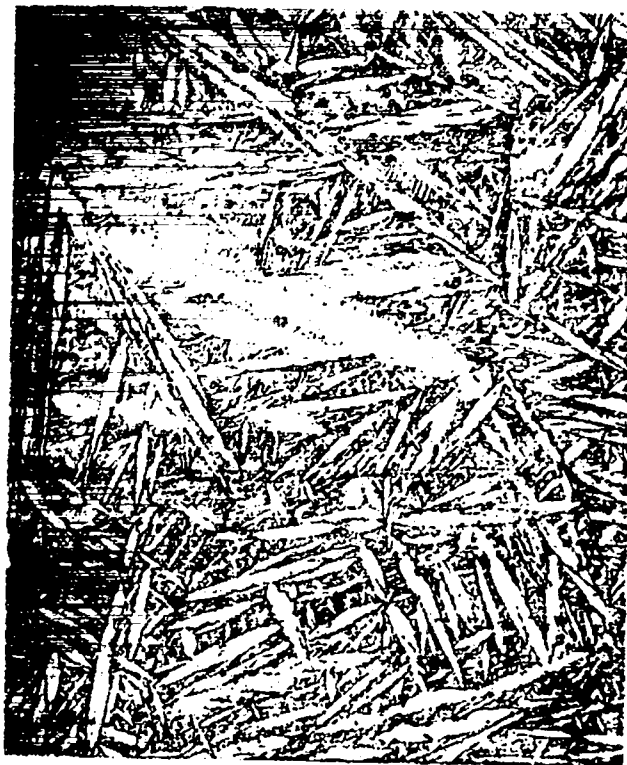
*Fig. 7.  
Charpy bar tested at 200°C.*

*a. Optical, 100X, 460 DPH*

*b. Optical, 250X*

Figures 7a and b represent a structure with very little overaging. Figure 7c shows the entire width of the ductile zone at the notch, and Fig. 7d shows a higher magnification view. Figure 7e shows the transition from ductile to brittle fracture.

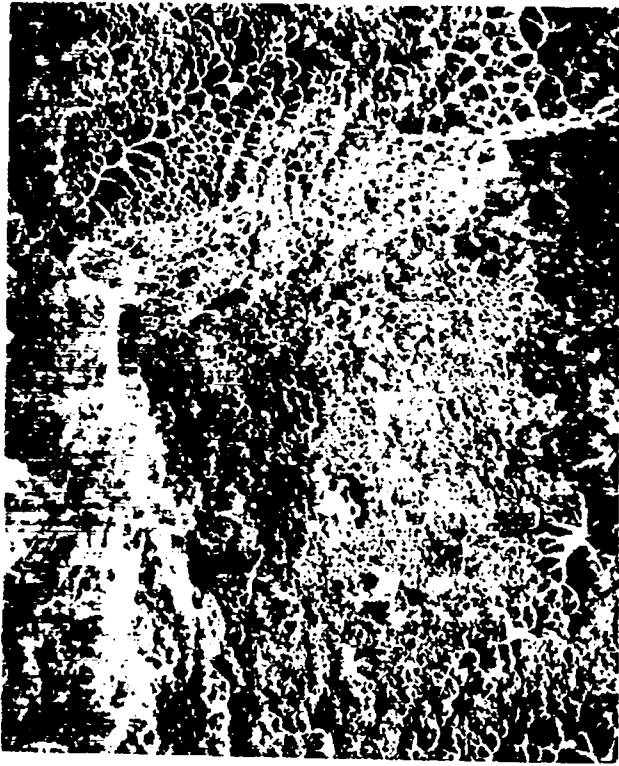
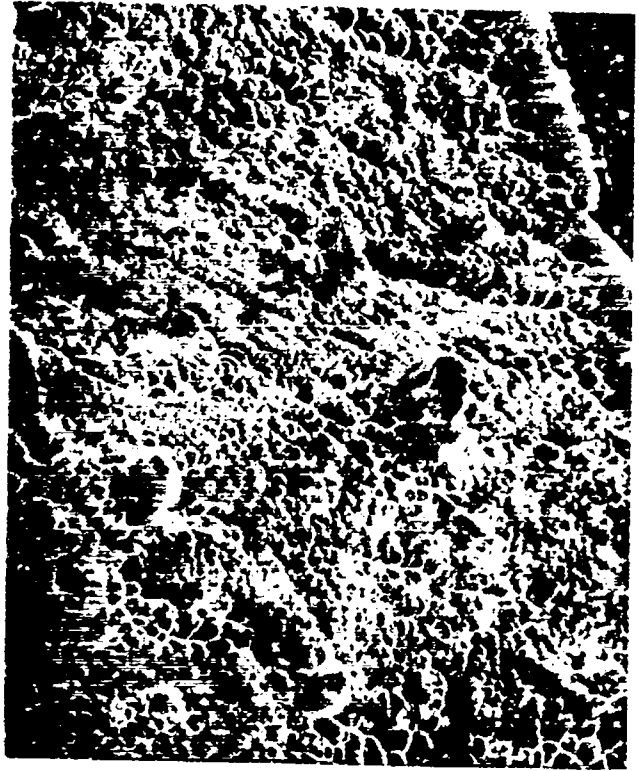
Fig. 7.  
Continued.

c. SEM, 700X

d. SEM, 1000X

e. SEM, 1000X
