LA-3446

LOS ALAMOS SCIENTIFIC LABORATORY
of the
University of California
LOS ALAMOS • NEW MEXICO

Gamma Dose Rate Measurements --
Kiwi Transient Nuclear Test

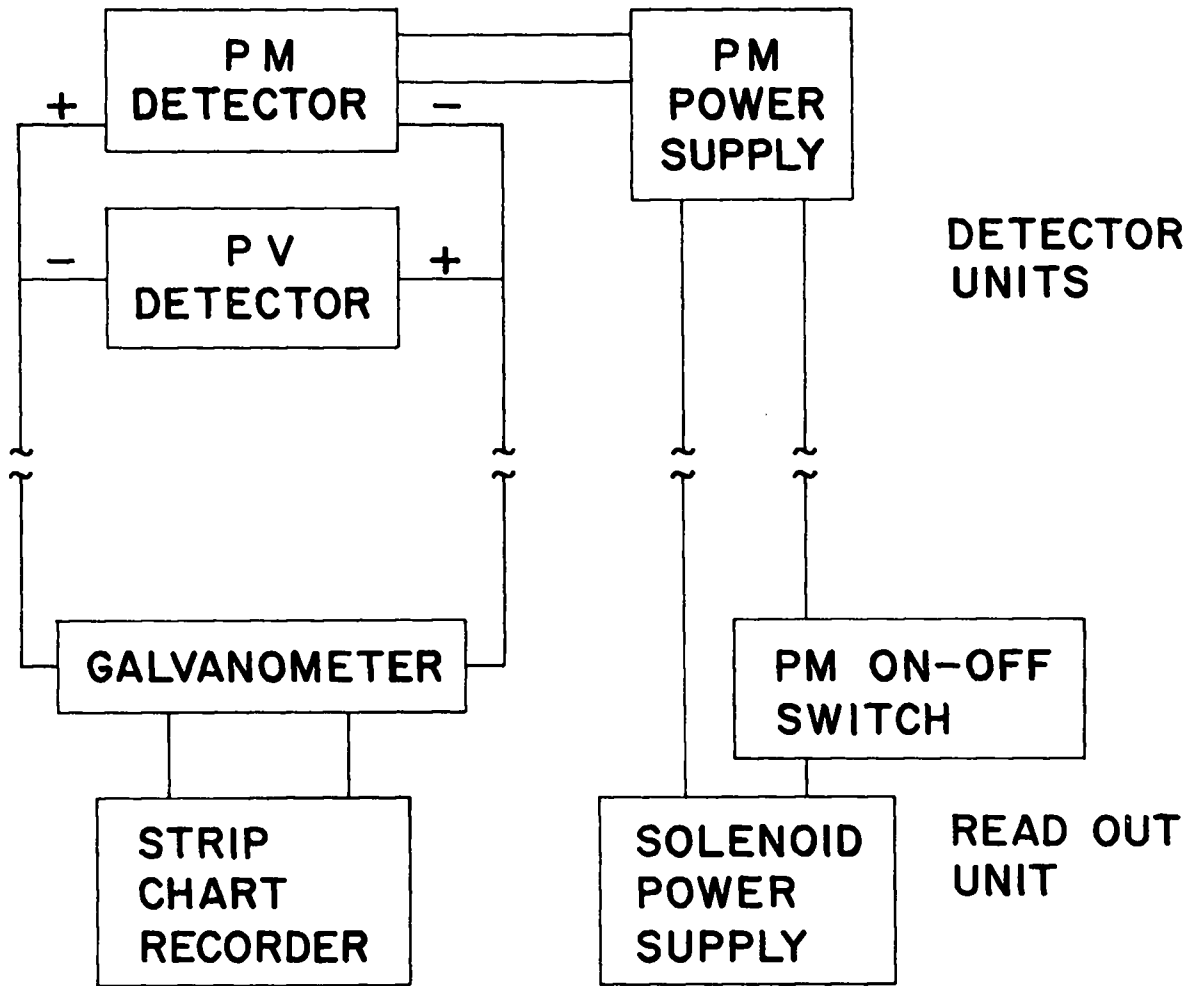
Fig. 6. Block diagram of PV/PM system.

A block diagram of the PV/PM system is shown in Fig. 6. The PM and PV detectors provided direct current signals of opposite polarity, which required changing the polarity of the connections to the galvanometers when the PM detectors were energized. The range of a typical PM detector was approximately 60 mR/hr to 10^2 R/hr; that of a typical PV detector was approximately 20 R/hr to 10^4 R/hr. Figure 7 shows the relationship between dose rate and signal current for typical PV and PM

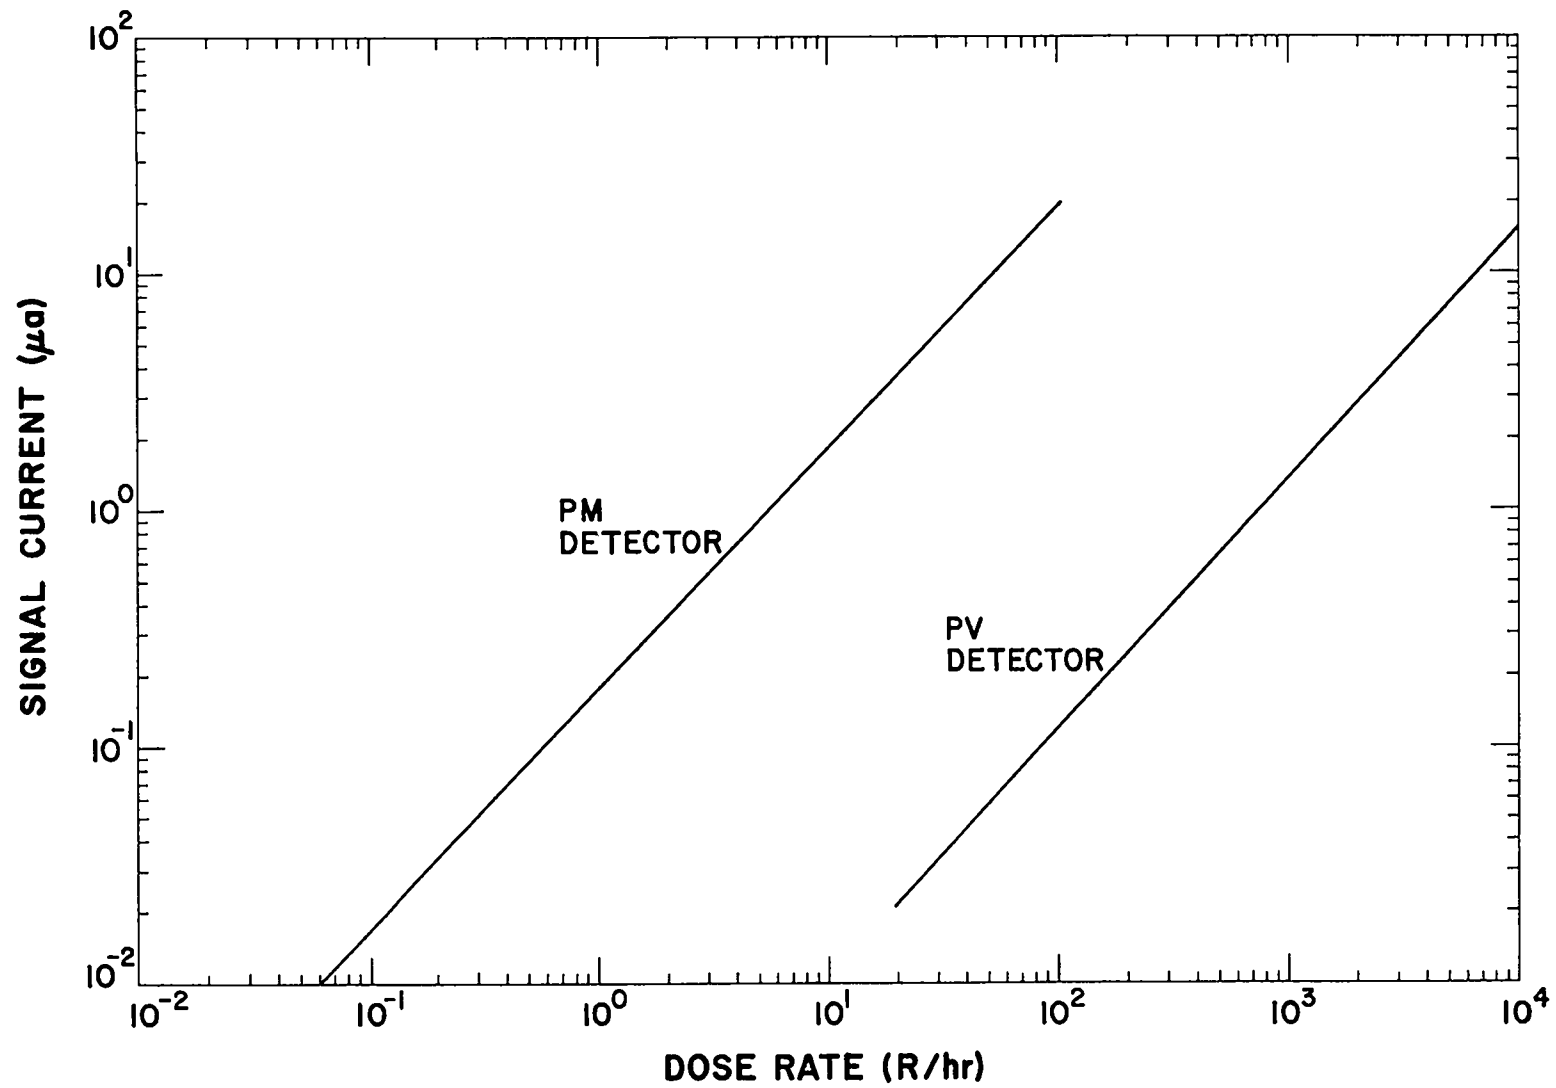
Fig. 7. Response of typical PV and PM detector units.

detector units. In radiation fields greater than 10^2 R/hr, the PM detector power supply was turned off. When the PM detector power supply was turned on, in radiation fields less than 10^2 R/hr, the magnitude of the signal current from the PV detector was approximately 0.6 percent of the magnitude of that from the PM detector. The effect of the PV signal current on the PM signal current was, therefore, negligible.

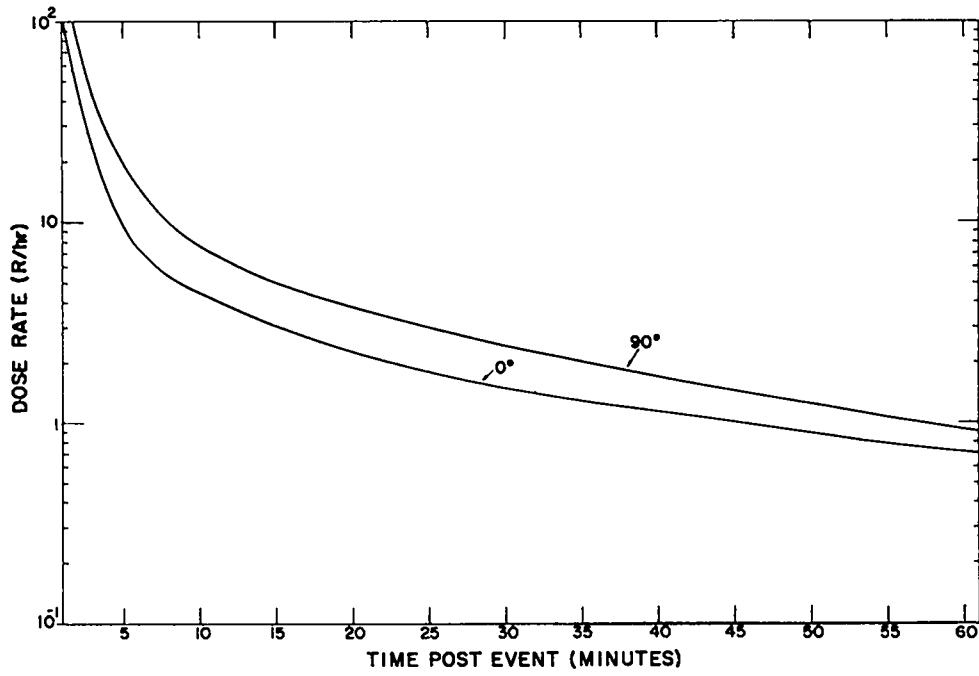
Figures 13 through 27 show dose rate at the various instrument stations as a function of time. The length of time during which data were obtained from the individual instruments depended upon individual range limitations, damage, and erratic response. Differences in the rate of decay of the dose rate at various stations were due to the variations in the particular type of debris present.
