TITLE: THE DECOMMISSIONING OF A TRITIUM-CONTAMINATED LABORATORY

AUTHOR(S): Johnny R. Harper and Raymond Garde

SUBMITTED TO 1982 International Decommissioning Symposium,
Seattle, WA, October 10-14, 1982

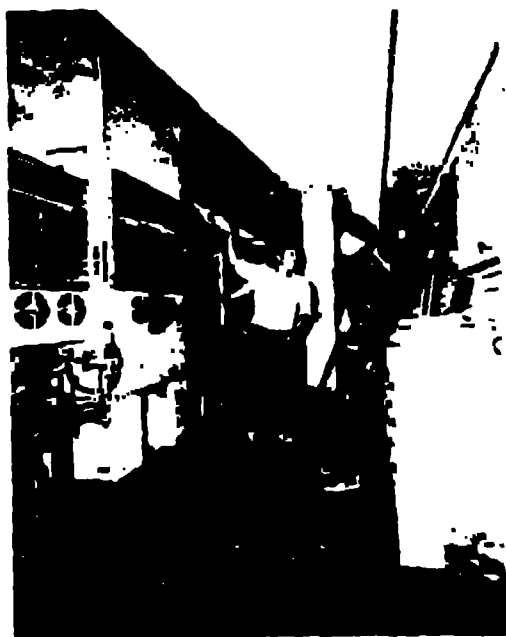
Fig. 2.
 North glovebox line.

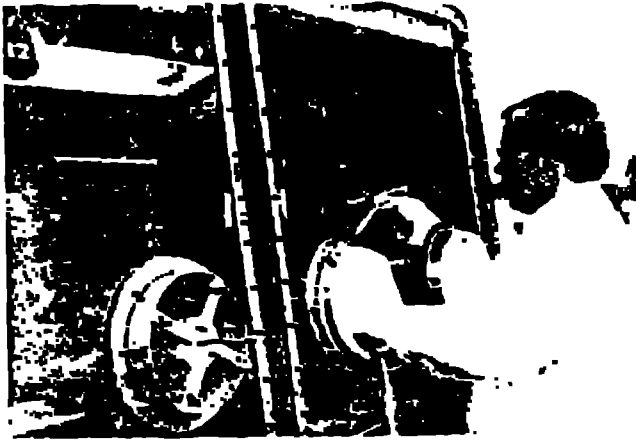
Fig. 8.
Applying of tar undercoating.

A commercially available asphalt gun (Fig. 7) was used to apply tar undercoating to the interiors of all gloveboxes and hoods to fix residual dust and particulate material (Fig. 8). A 5-meter deep pit was excavated adjacent to the building to provide access to a removable portion of the south wall of Room A-12-A. Reinforced concrete walls were poured for shoring in the pit, a plywood door was installed between the excavated pit and Room A-12-A, and the top of the pit was covered with a removable roof. All equipment was removed through this pit for transfer to waste disposal.

Roofing tar provided an excellent seal for tritium contamination as did putty tape and silicon rubber. Asphalt coating also proved effective in holding down particulates inside gloveboxes.

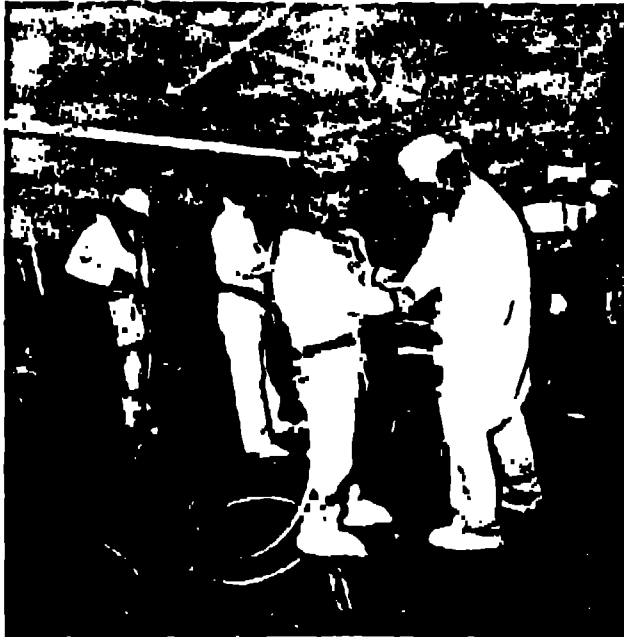
Fig. 18.
Supplied-air suits.

Workers used protective (anticontamination) clothing for all work, including coveralls, gloves, hoods, and booties. Other protective items used, depending on exposure potential, were the following: (1) a 0.006-gauge polyvinyl chloride supplied-air suit consisting of a slipover jacket with sealed-on hood and trousers with sealed-on boots (Fig. 18); (2) breathing air from compressors located outside the work area (Fig. 19); (3) self-contained breathing apparatus; and (4) arm-length plastic gloves.

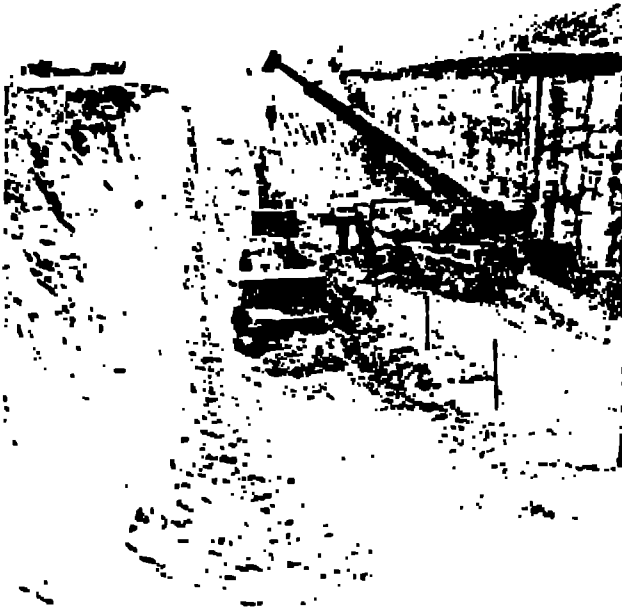
Fig. 20.
Disposal of tritium waste.

All wastes generated by this operation were buried at the Laboratory's Radioactive Waste Disposal/Storage Site in a 1.9-m-deep by 3.9-m-wide by 33-m-long trench at the bottom of a large burial pit (Fig. 20), located 8 km from the decommissioning site. Wastes were transported in plastic-lined dump trucks covered with tarpaulins. The 183 m^3 of contaminated debris containing an estimated 6×10^3 curies of tritium were placed in the trench, which was covered with noncontaminated soil. The pit was then used to receive other routine low-level solid radioactive wastes.
